## **Fort Street Public School**

Fort Street Public School – Conservation Management Plan

January 2024

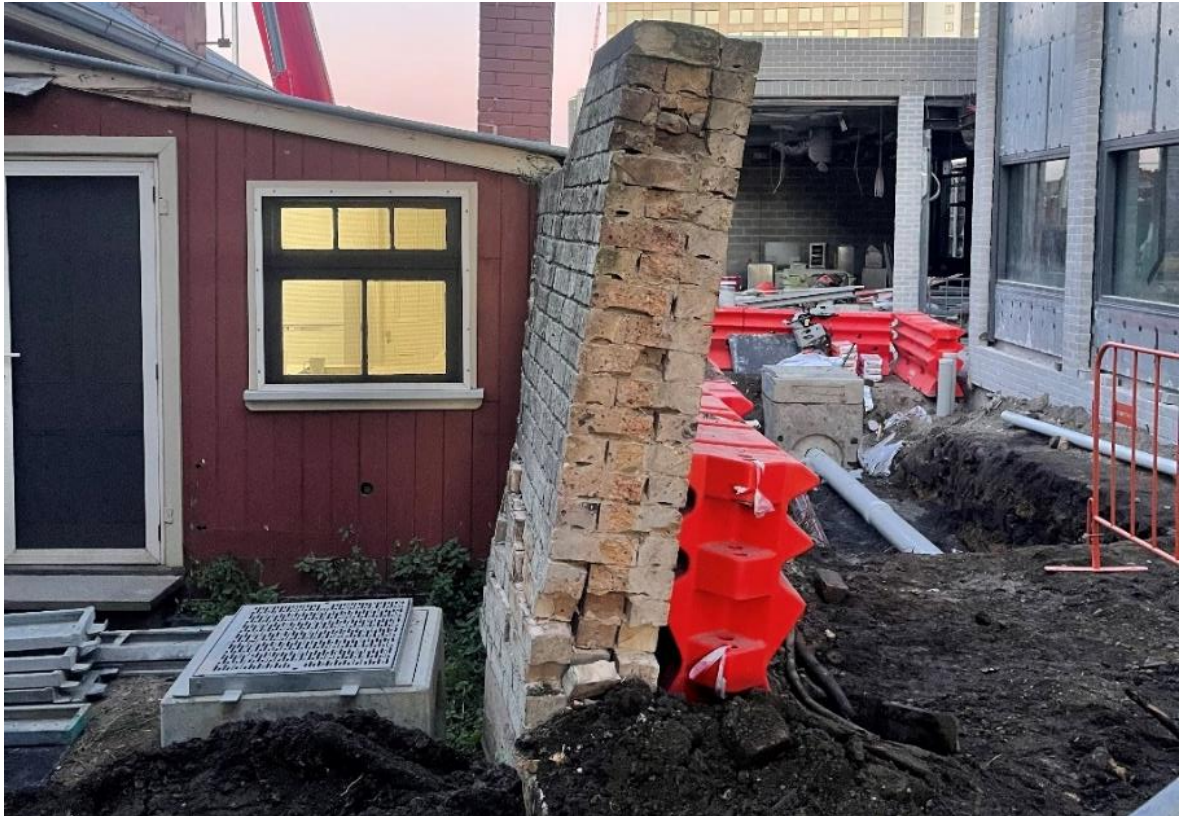
Figure 5.17: An example of a compromised section of the Wall -East Elevation pre-reconstruction (Curio Projects 2023)

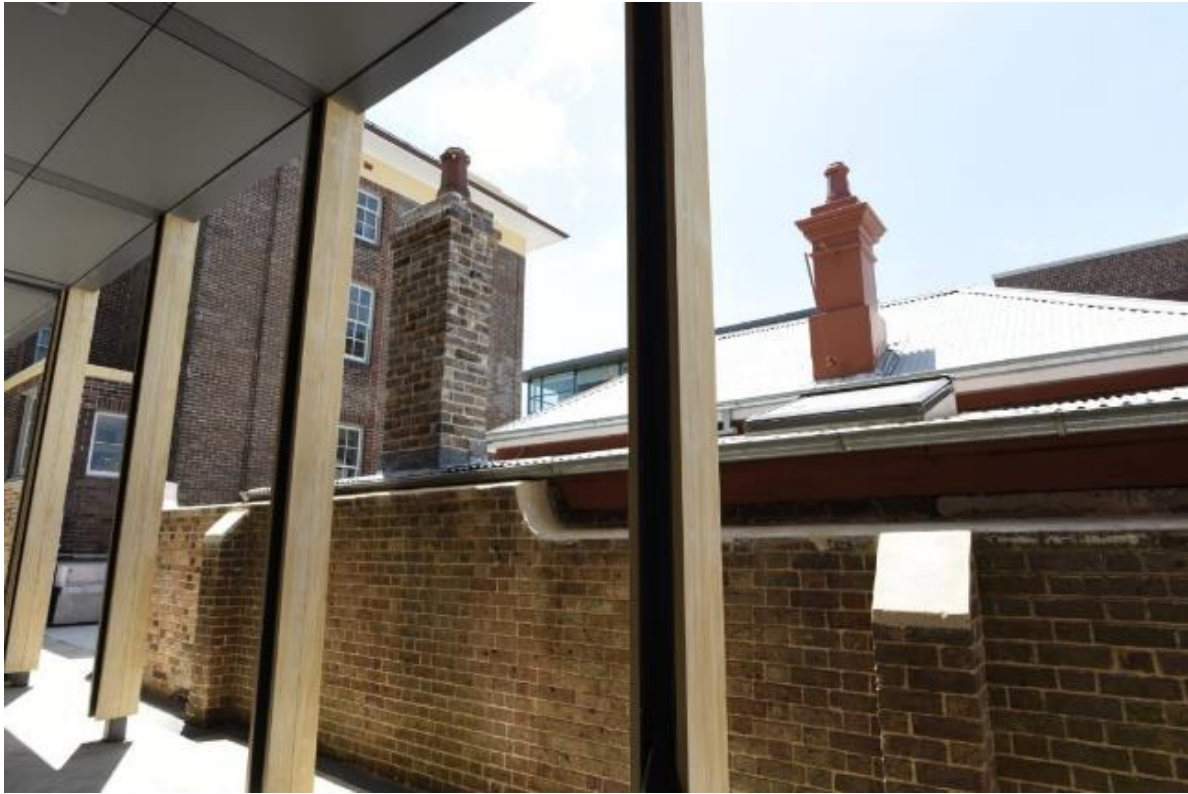
Figure 5-23: The rear southern elevation of the Messengers Cottage, showing the reconstructed chimney (unpainted brick chimney) and reconstructed section of boundary wall (to the left). (Source: Curio 2023).

The existing heritage façade was retained, with all existing brickwork, ashlar treatments and timber elements repaired and made good to existing in accordance with the overseeing Heritage Architect's specifications. The southern-most chimney due to structural instability determined by a structural engineer during the 2023 redevelopment works. The draft scope of conservation works (Purcell 2019) required that the chimney remain unpainted, however, the rest of the building and the other two original chimneys on the building remain painted. Internally, the development retained the existing room configuration of the Cottage, with a future management solution required for the building to address accessibility.<sup>24</sup>

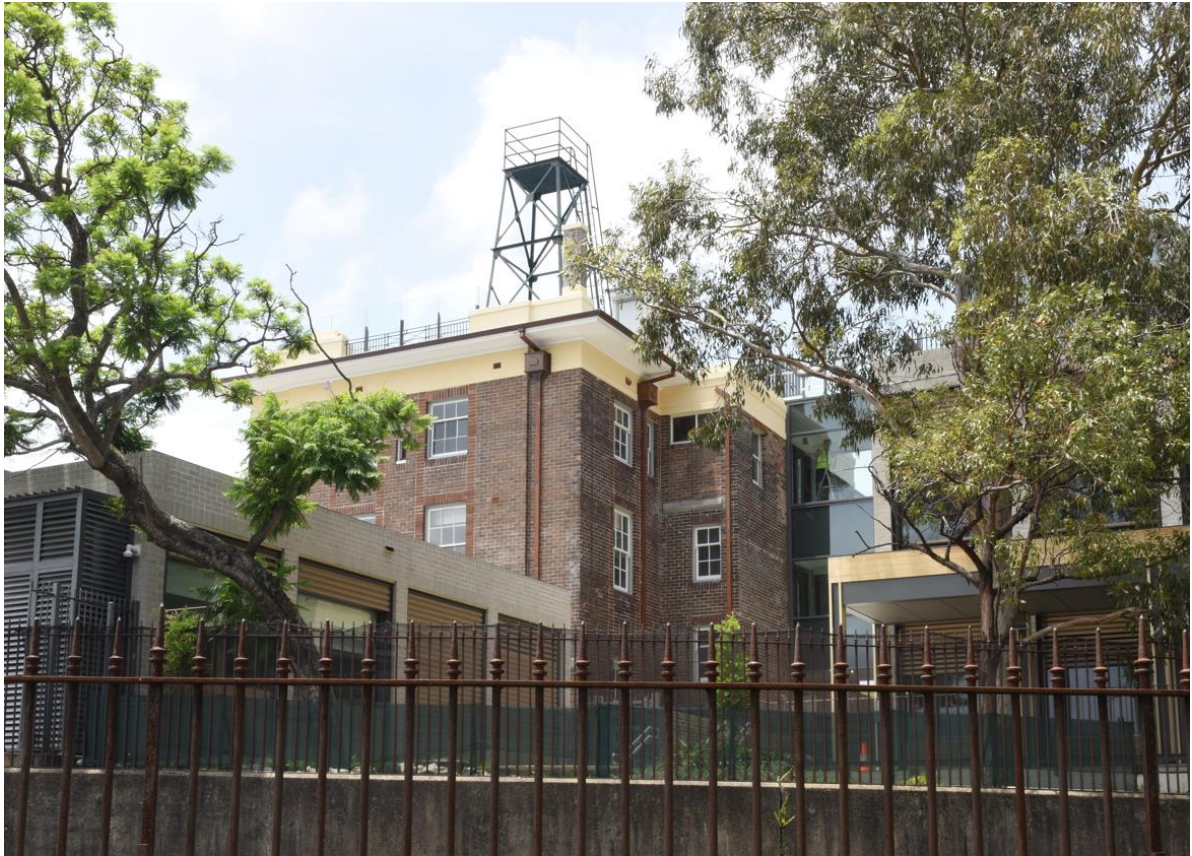
Figure: 5- 51 View of the Rooftop Weather Station, copper downpipes and contemporary bridge connection to Building J (to the right).
