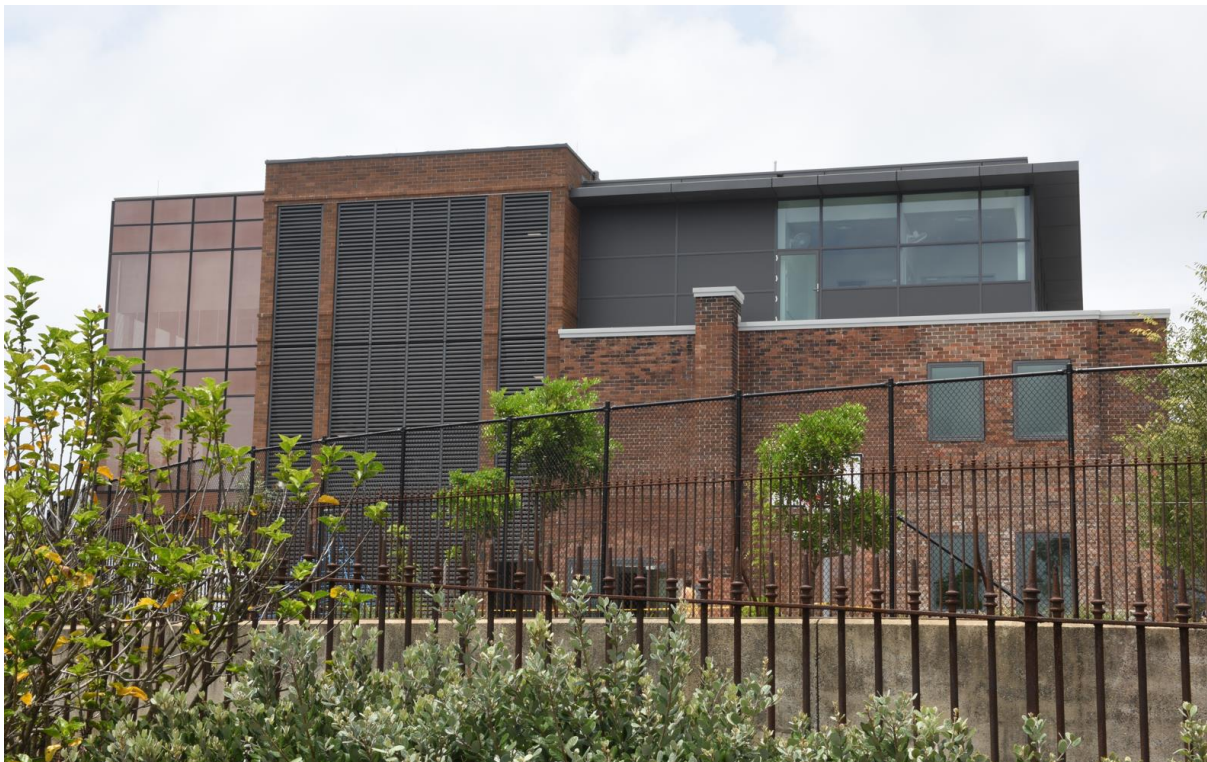
5-58: The northern elevation of the Fort Street Public School building. (Source:Curio 2023)

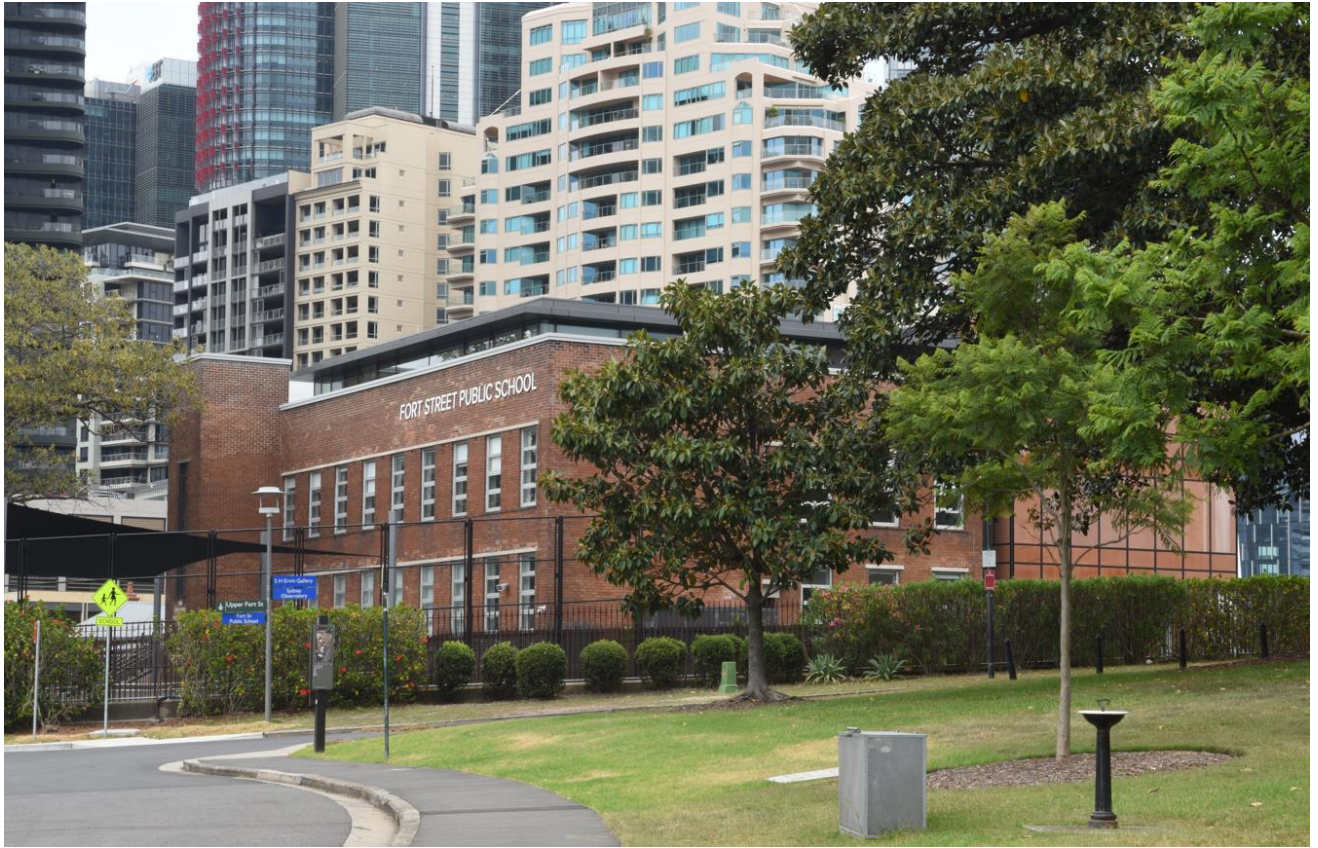
Figure 5-59: The North- Eastern front corner elevation of the Fort Street Public School building.

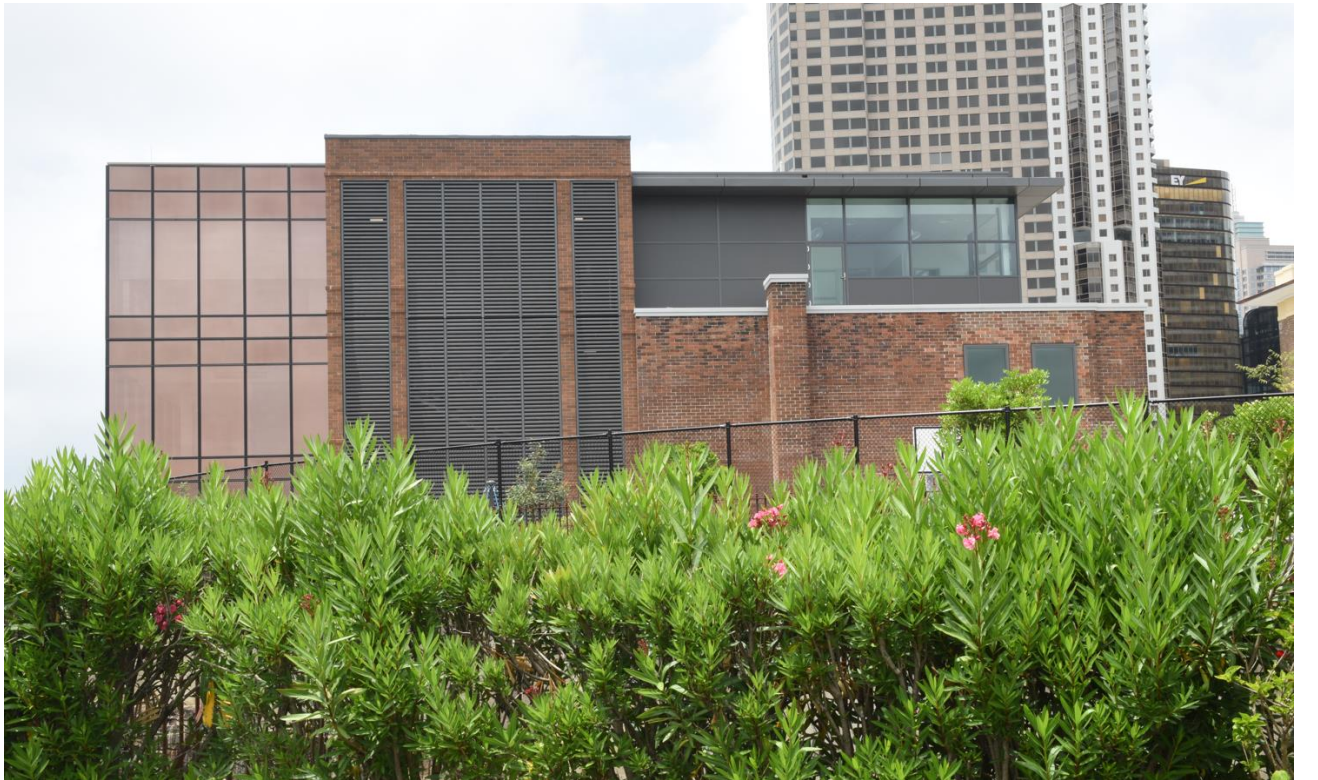
Figure 5-60: The Western Façade of the Fort Street Public School Building with new additions (Source: Curio 2023).

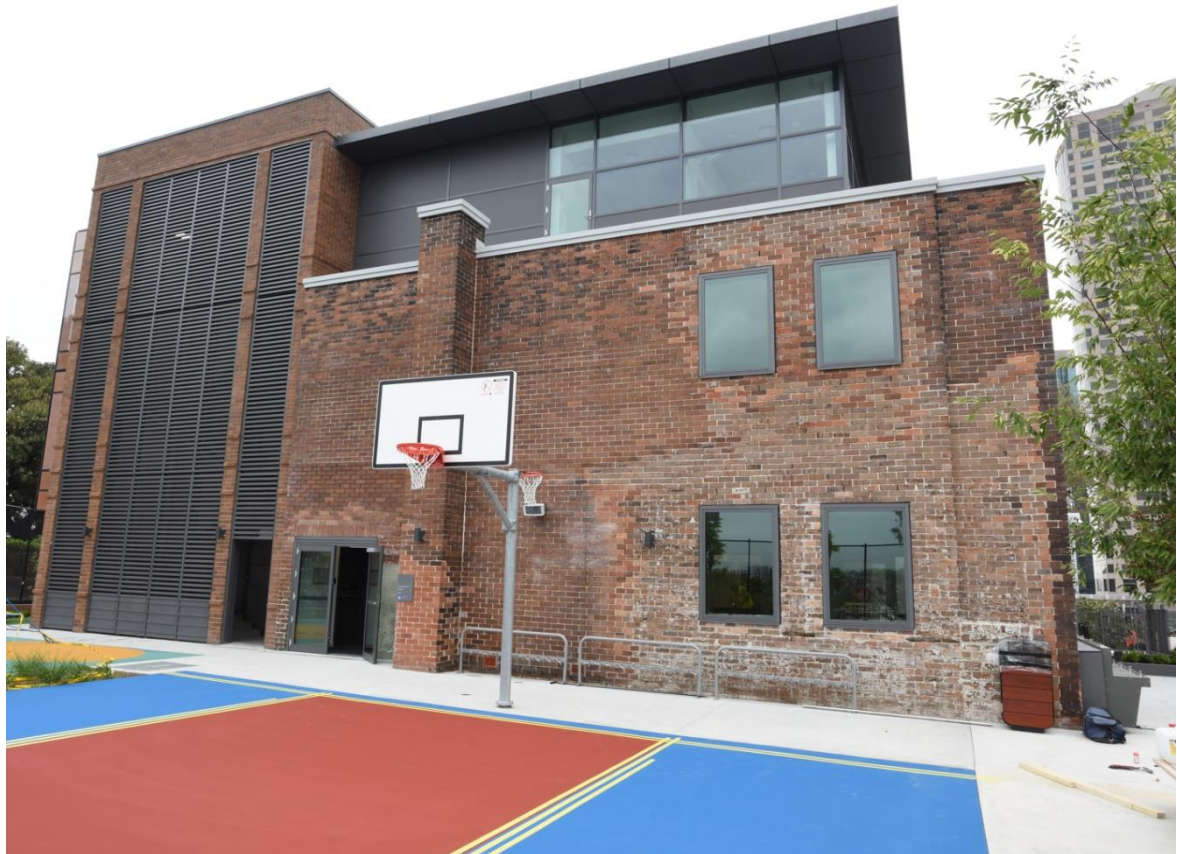
Figure 5-61: The western elevation of the Fort Street Public School building looking towards Circular Quay (Source: Curio 2023).

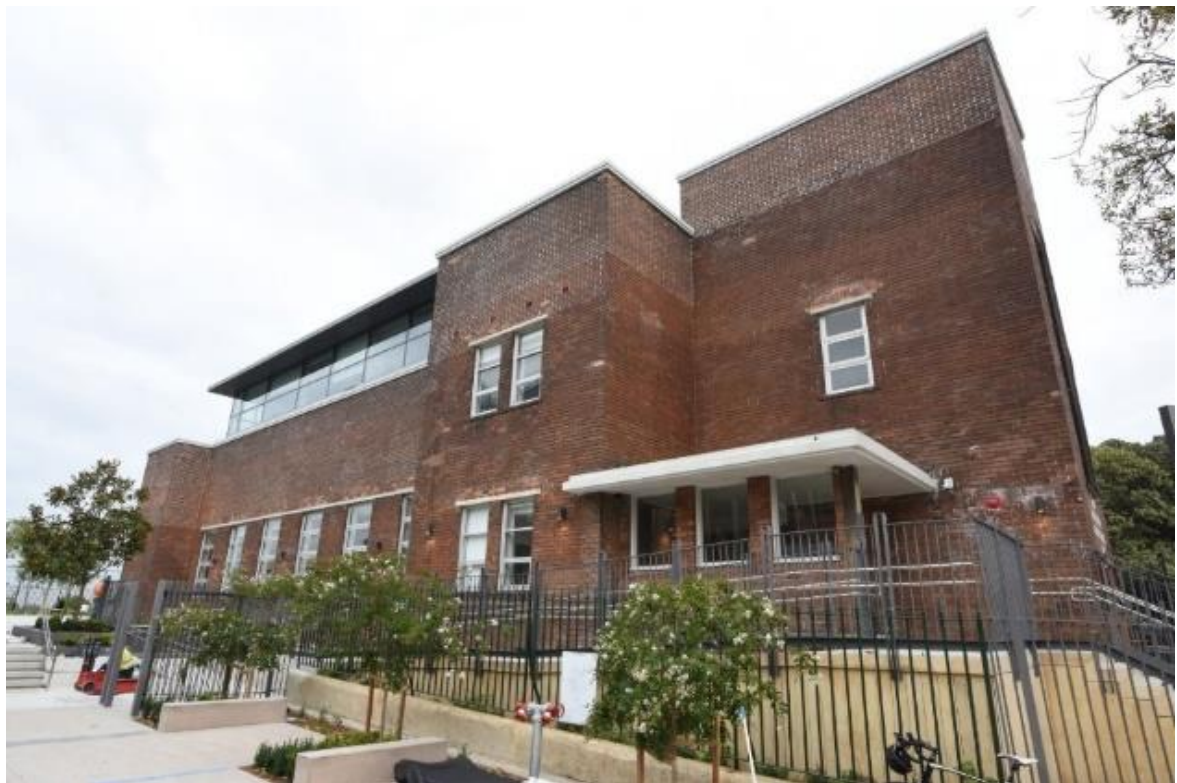
Figure 5-62: The Southern elevation of the Fort Street Public School Building (Source: Curio 2023).

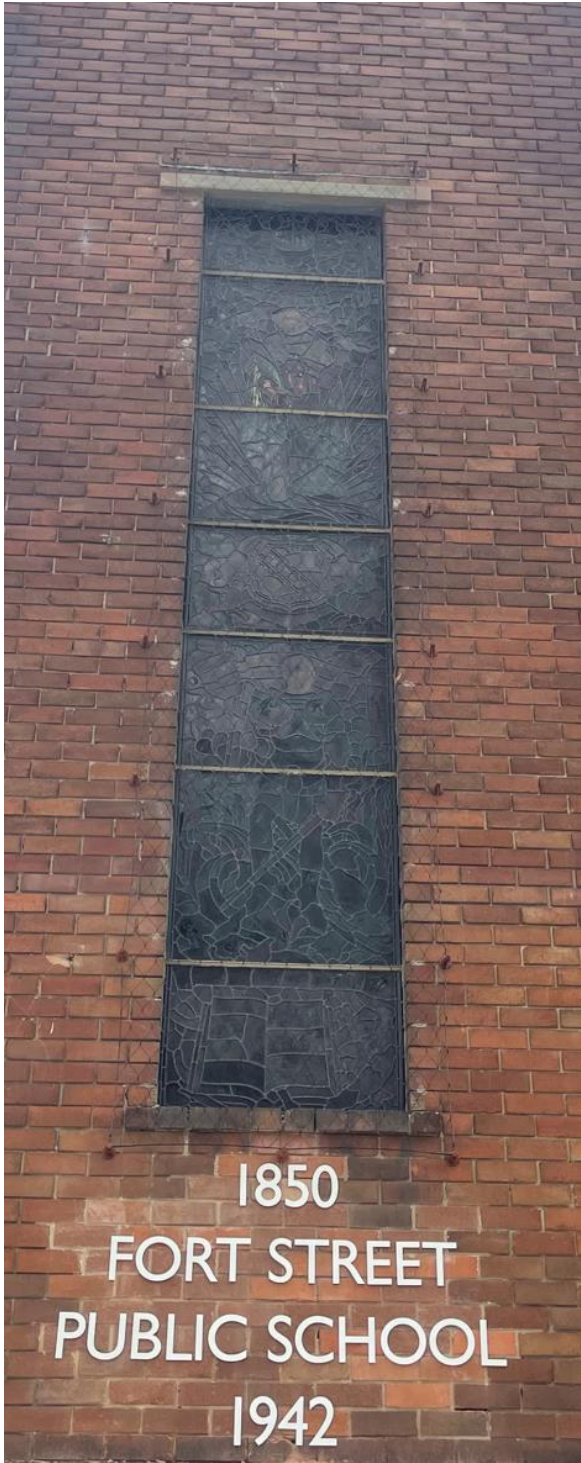
Figure 5-63 Non-Visible Tensile Protective Mesh for the Stain Glass (Source Curio 2023).

The main southeastern staircase and the stained-glass window within it were retained and conserved. Prior to the redevelopment the stain glass window was protected from external impacts related to ballsports with a heavy, intrusive stainless steel mesh erected c1980- c1990s. It obscured the decorative window and was an intrusive façade element. The screen was removed and replaced with a minimalist black stainless tensile wire protective screen (see Figure 64).

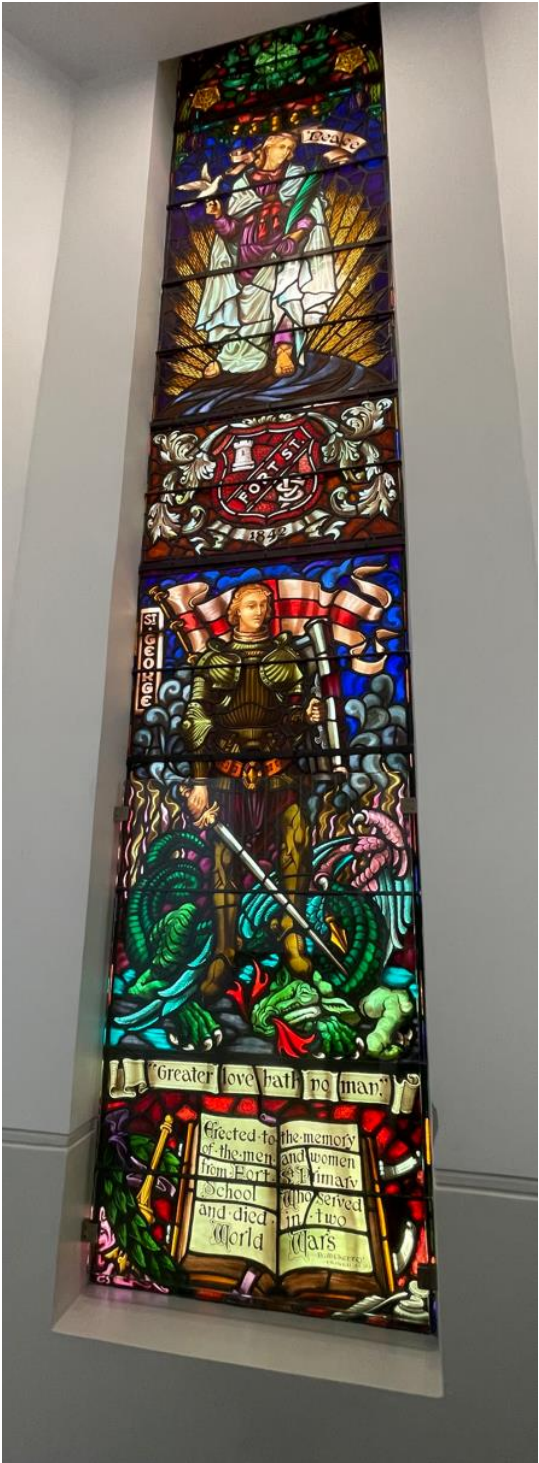
Figure 5- 64 Stained Glass Window (Source: Curio 2023)

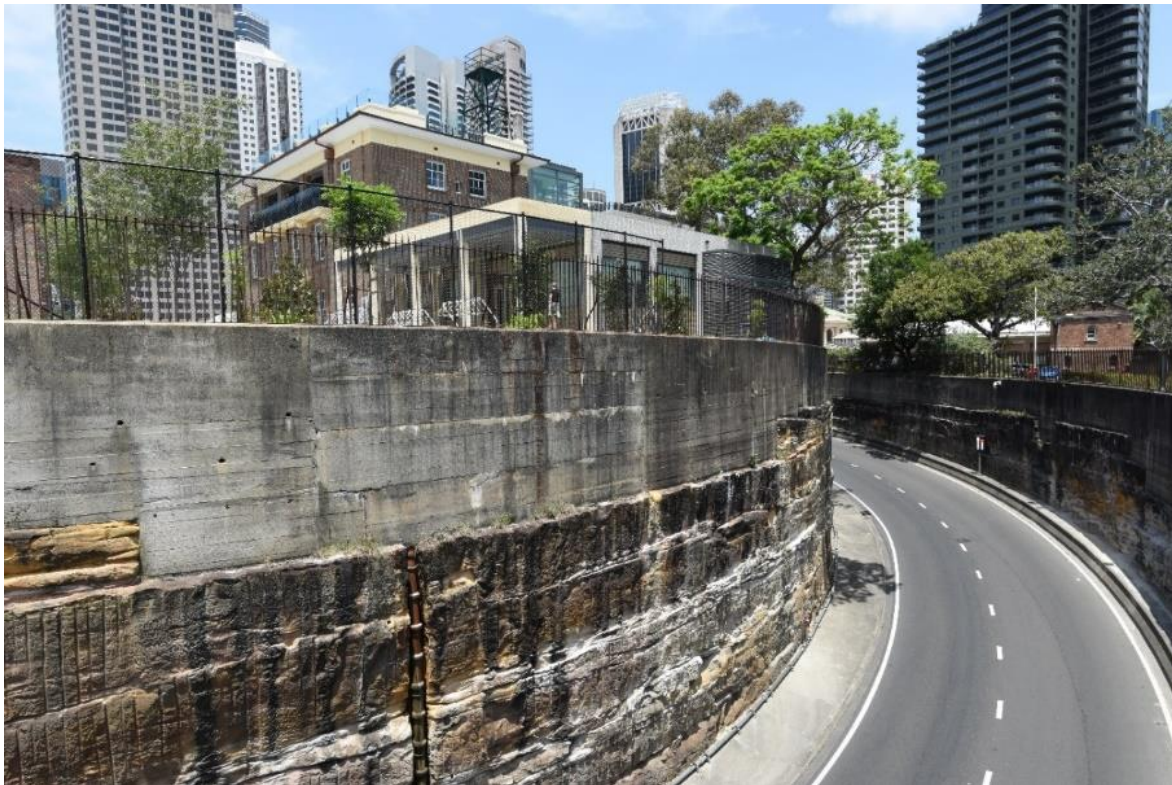
Figure 5-79: Cahill Expressway Cut, with Fort Street Public School on the left and the National Trust to the right background (Source: Curio 2023)

While the cutting for the Cahill Expressway is a dominant physical and visual feature in relation to the Fort Street Public School site, the Cahill Expressway is not part of the Fort Street Public School listing, but provides the unique geographic constraint to the physical curtilage of the Fort Street Public School Site. As part of the redevelopment of the site in 2023, there were no changes to the access across the Cahill Expressway, however, there is an approval for the creation of a new pedestrian access point across to Observatory Hill, as part of the existing SSDA approvals in place.

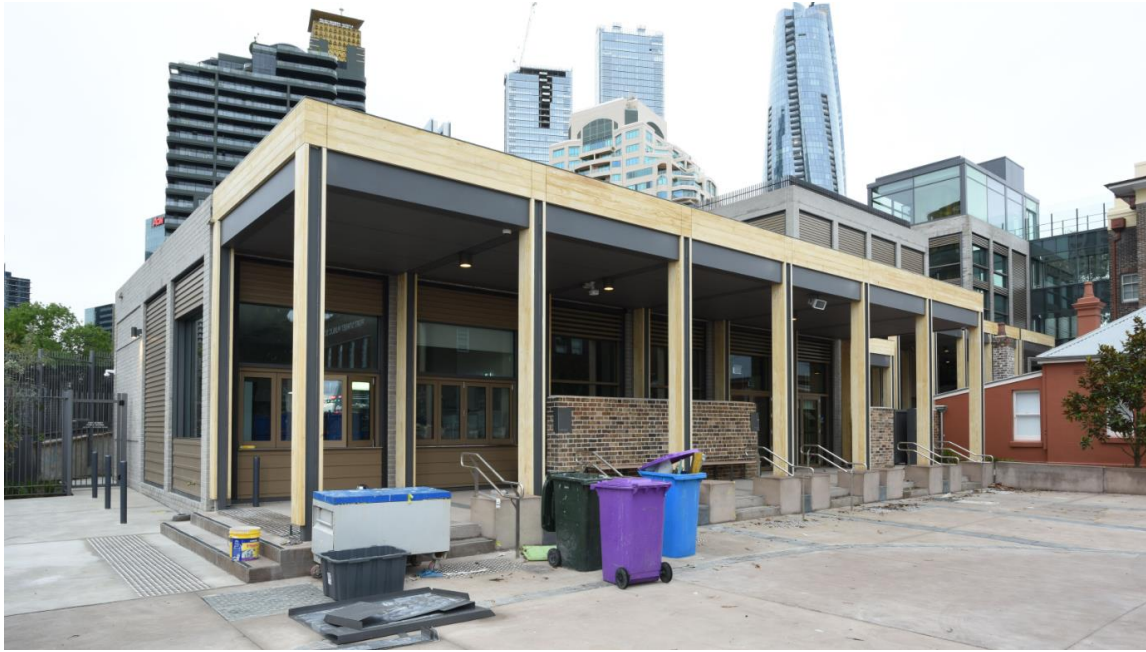
Building G consists of grey brick work, contemporary glazing with external louvres and has two hipped roofs with metal roof cladding. The larger part of building G contains the communal hall, whilst the smaller section of the building contains the canteen and kitchen.

Figure 5-80: Looking South towards the front elevation of Building G (Source:Curio 2023)

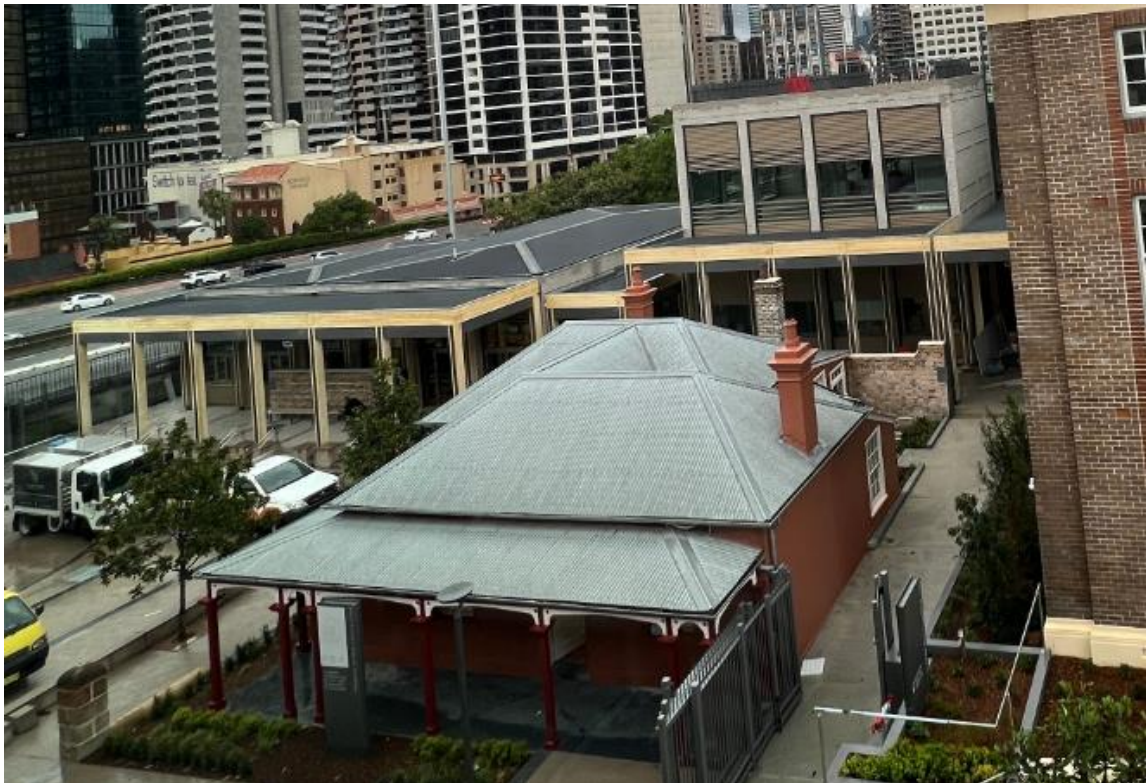
Building J and Building H form the Windmill Wing. Building J and Building H employ simple geometric forms, grey face brick work, large areas of glazing, external louvres and metal balustrades. Building J connects to the Bureau of Meteorology via a glass bridge connection and consists of school learning spaces. Building H contains the sick bay, administrative rooms, and a storage room. Both buildings have outdoor rooftop play areas.

Figure 5-81: Looking South towards Building J and Building H. (Source: Curio 2023)

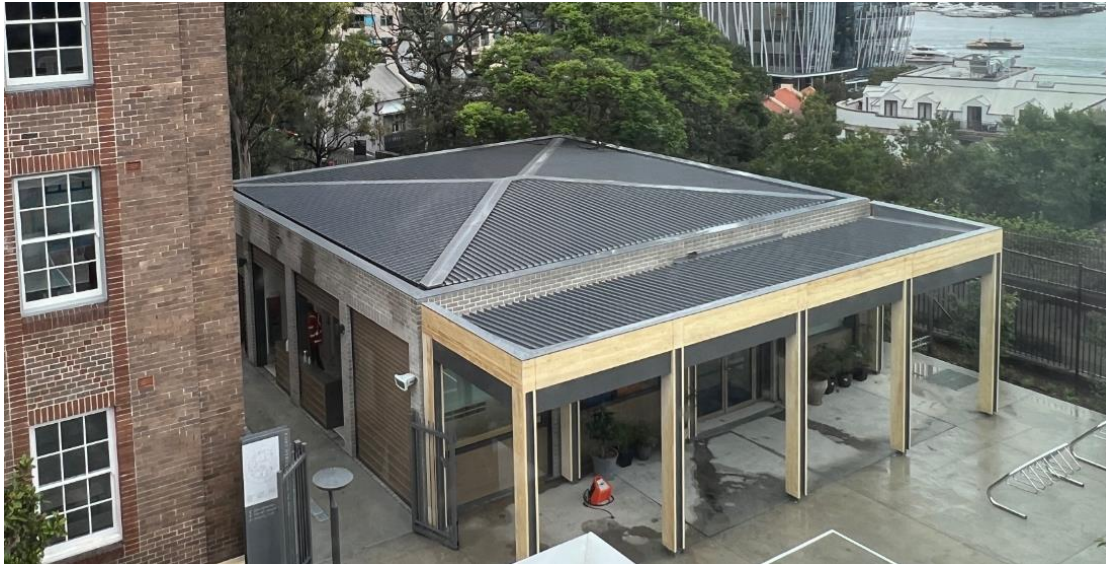
Building F contains the staff room and staff bathrooms. The building is grey face brick work construction with a metal, hipped roof, and comprises simple geometric shape and forms, and large areas of glazing with external louvres.

Figure 5-85: Looking directly towards Building F. (Source: Curio 2023)

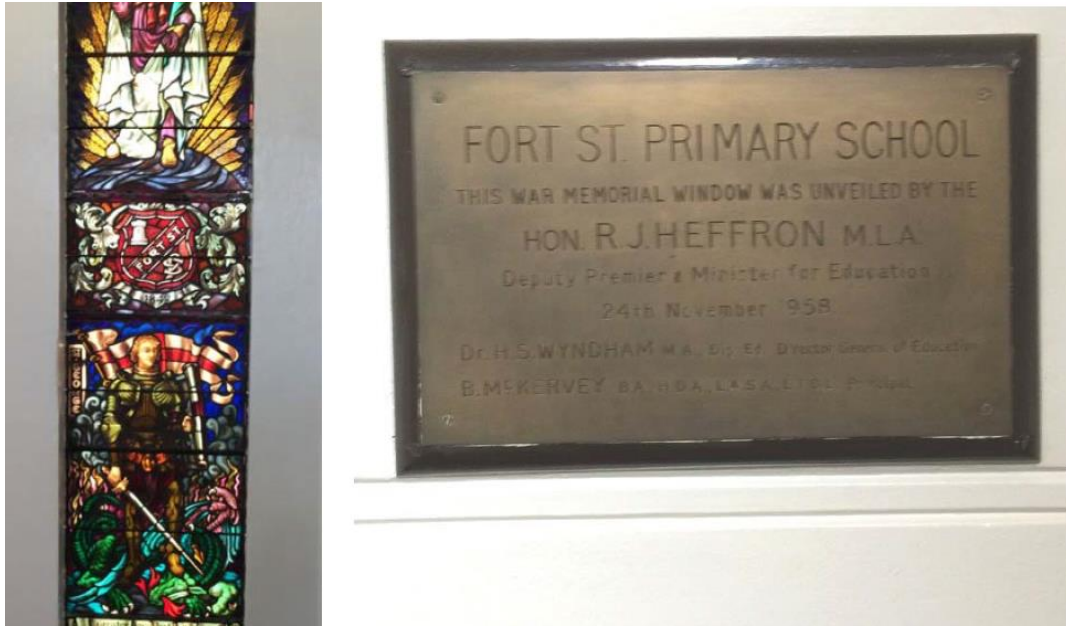
Figure 5-90: Memorial stained-glass window (left) (incorrectly identified as moveable heritage) and opening plaque (right). (Source: TKD 2016: Fig. 67)

It should be noted that the stained-glass memorial window was incorrectly identified as moveable heritage, when in fact it forms part of the building fabric. As Curio did not have access to the moveable heritage items identified in the 2016 TKD CMP, images of these items have been sourced from the TKD CMP and it is understood that these items are in the care and control of Schools Infrastructure (Figure 5-88. To Figure 5-92.).

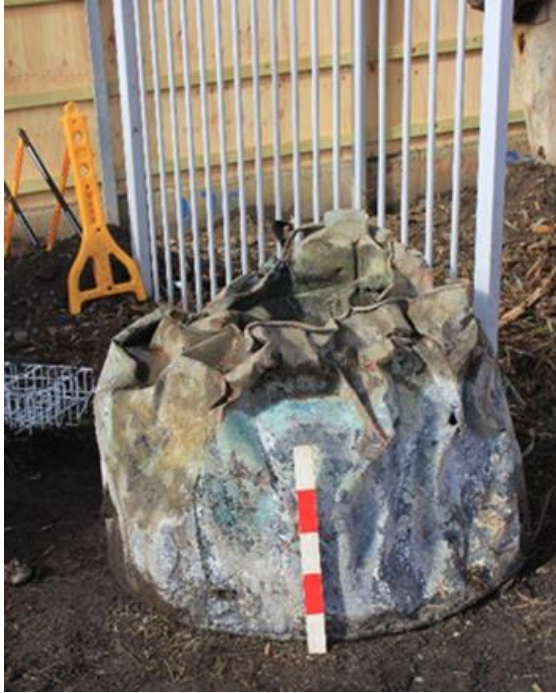
Figure 5-92: Copper evaporation basin immediately after excavation (Source: Curio, 2021)

- Meteorological artefact (I.e. evaporation basin) recovered from the area adjacent to the Messenger's Cottage (Figure 5-93. and Figure 5-94.);
- Artefact collection from the excavation of the Surgeon's Cottage (Figure 5-95. to Figure 5-96).

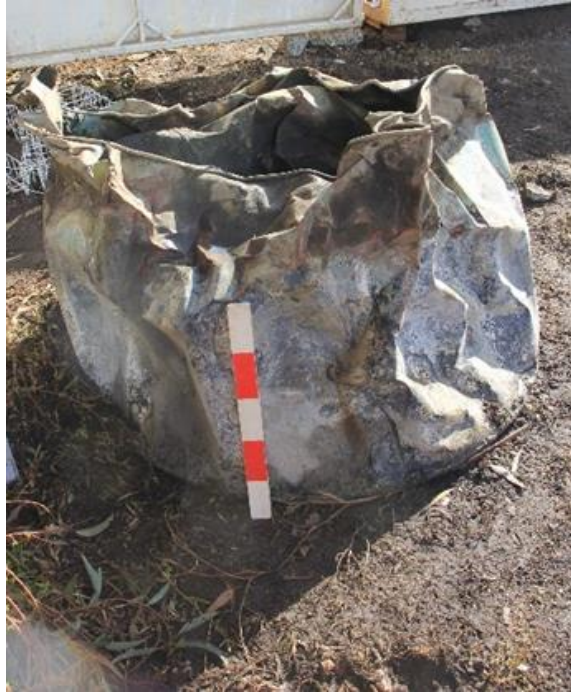
Figure 5-93: Copper basin immediately after excavation (Source: Curio, 2021).

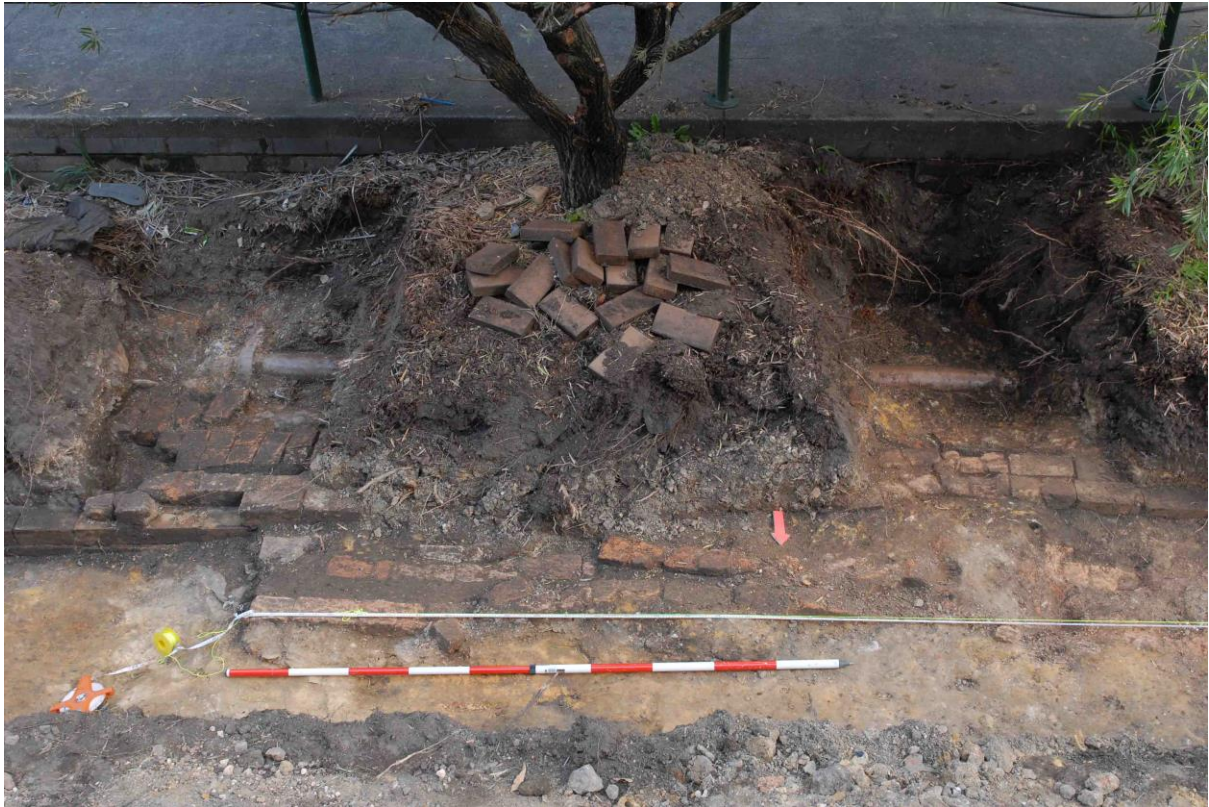
Figure 5-98: Remnant footings of Surgeons Cottage on northern side of EEC (Source: Curio 2019).

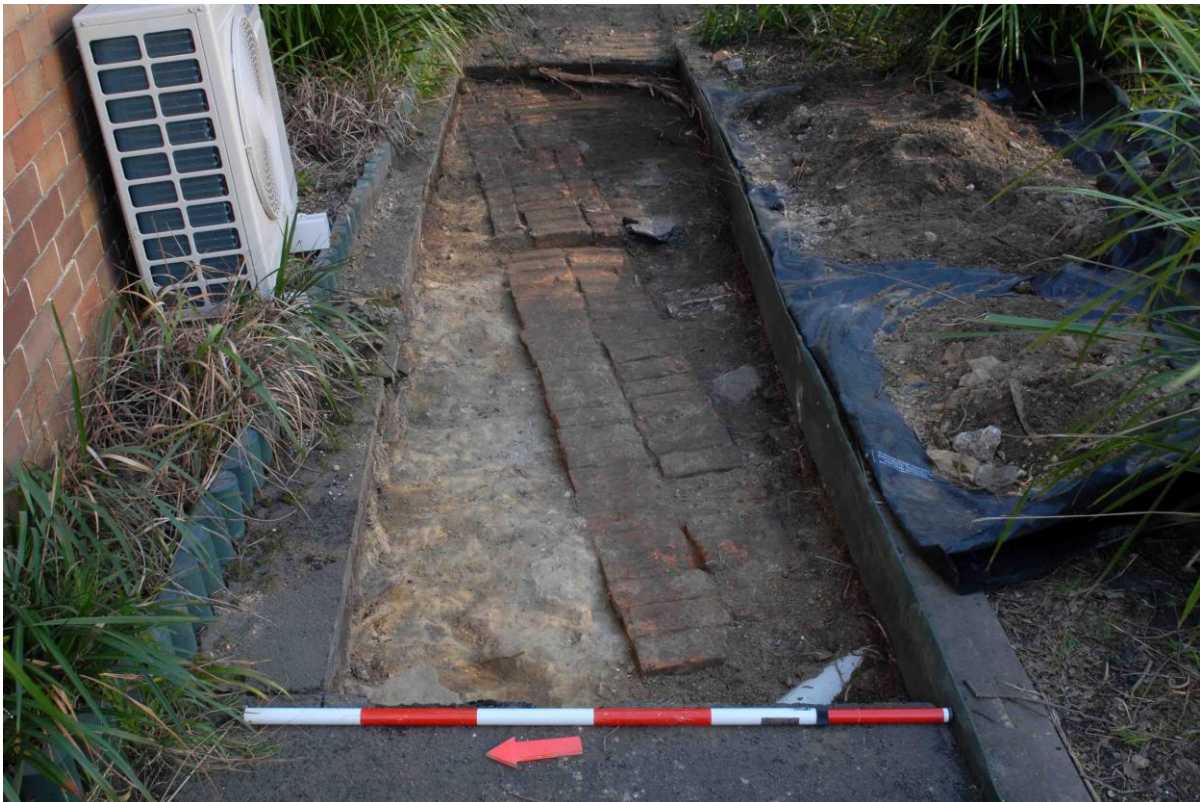
Figure 5-99 Remnant footings of Surgeons Cottage on southern side of EEC (Source: Curio 2019).

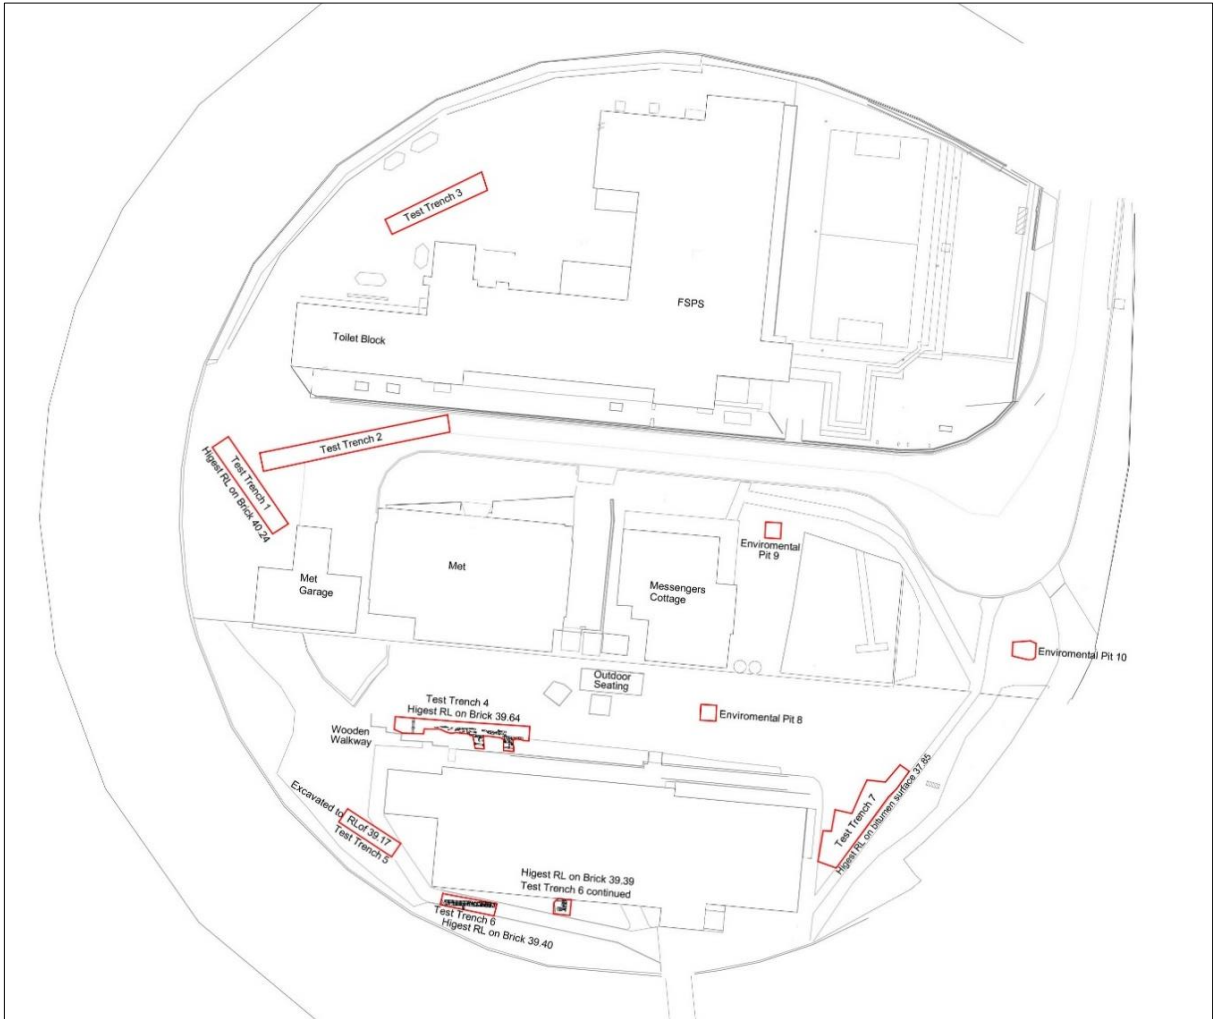
Figure 5-100: Historical Archaeological Test Excavation Trenches Location (Source: Curio 2019b, drawn by B. Owens)

Test Trenches 1 and 2 were located to investigate the potential for evidence of the third government windmill and early quarrying, however recovered no archaeological evidence of this former feature—with investigation demonstrating substantial modern truncation of the soil profile at the crest of the site and extensive nature of construction disturbance around the main Fort Street Public School building.

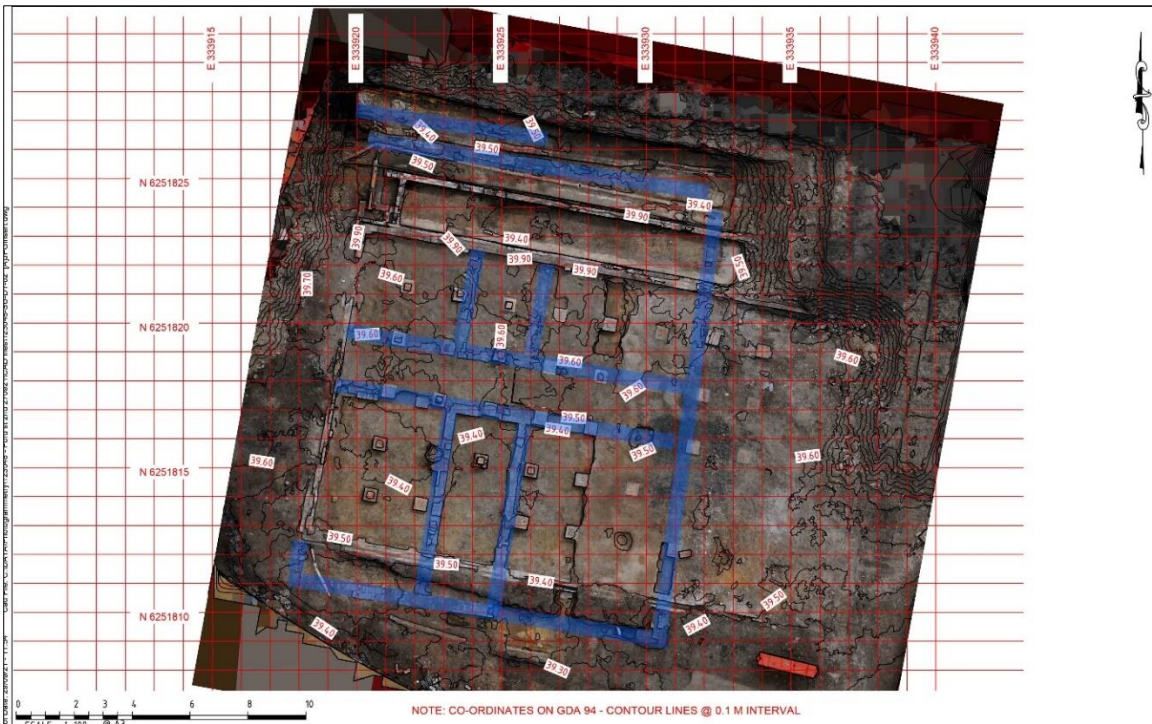
Figure 5-103: Survey of Surgeons' Cottage remains that remain in situ below Building J.

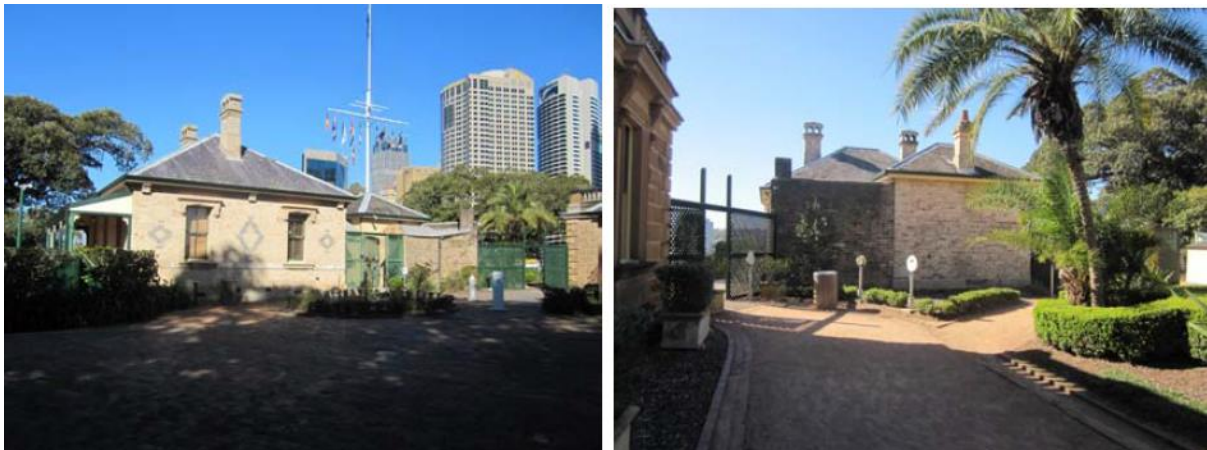
Figure 6-18: The Messenger's Cottage viewed from the west (left) and south (right), 2015 (Source: TKD 2016, Fig. 136)

The Messenger's Cottage is representative of modestly scaled Victorian era residential buildings. Although a relatively large amount of internal and external fabric has been replaced or reconstructed, its early character can still be interpreted.

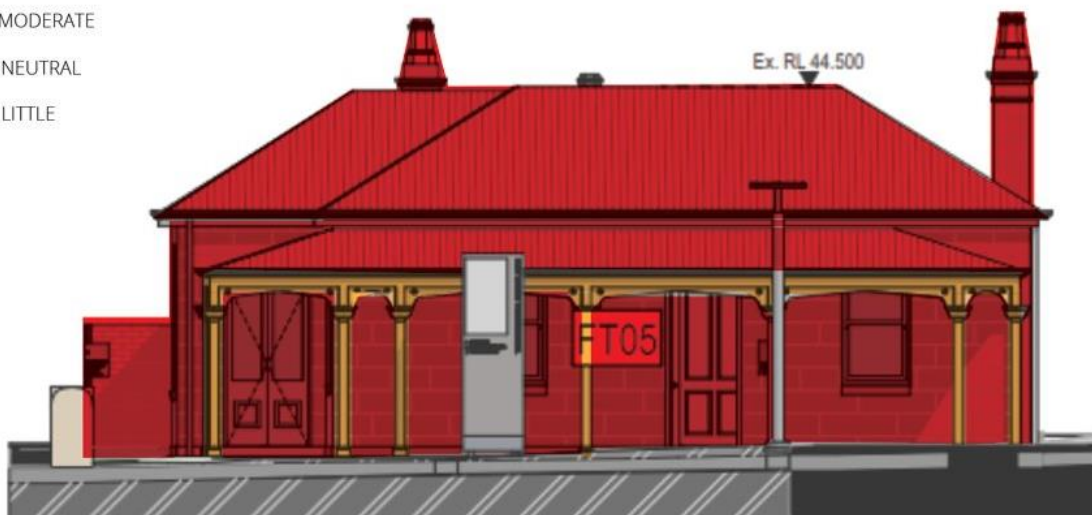
Figure 8-2: Northern Façade of the Messengers Cottage showing Gradings of Significance
(Source: FJMT with Curio Projects additions)

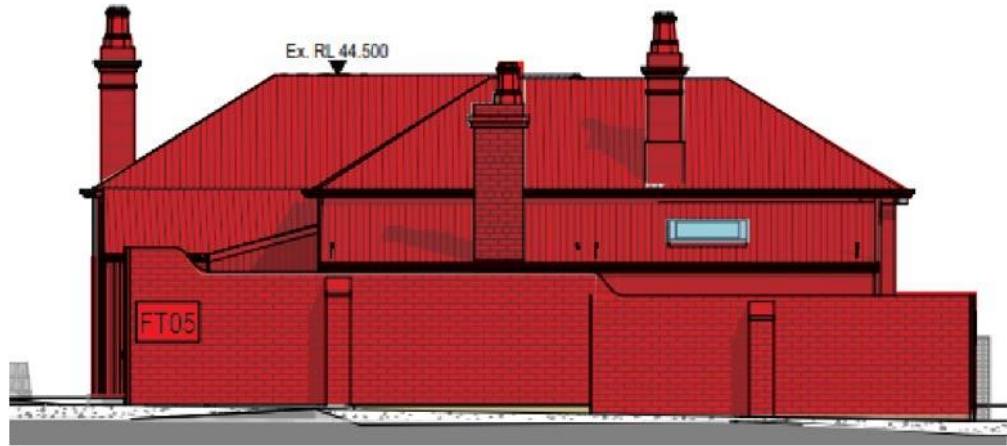
Figure 8-3: Southern Façade of the Messengers Cottage showing Gradings of Significance
(Source: FJMT with Curio Projects additions)

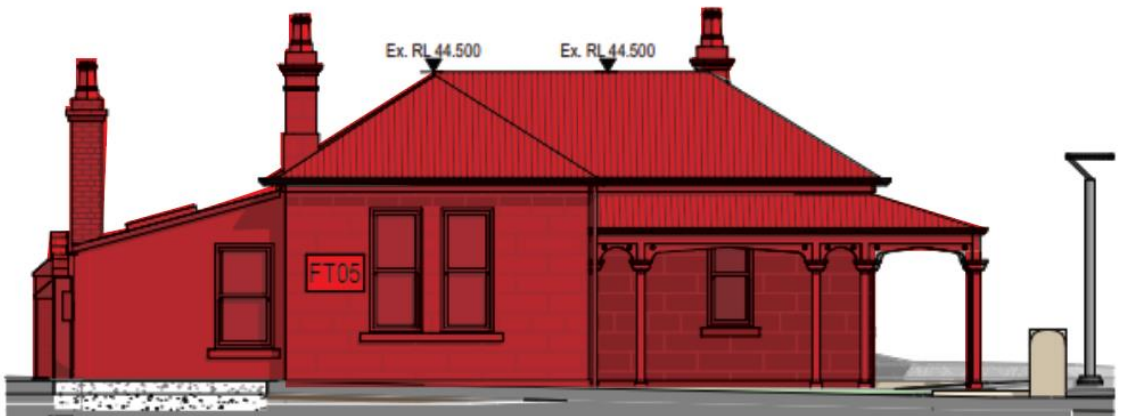
Figure 8-4: Eastern Façade of the Messengers Cottage showing Gradings of Significance
(Source: FJMT with Curio Projects additions)

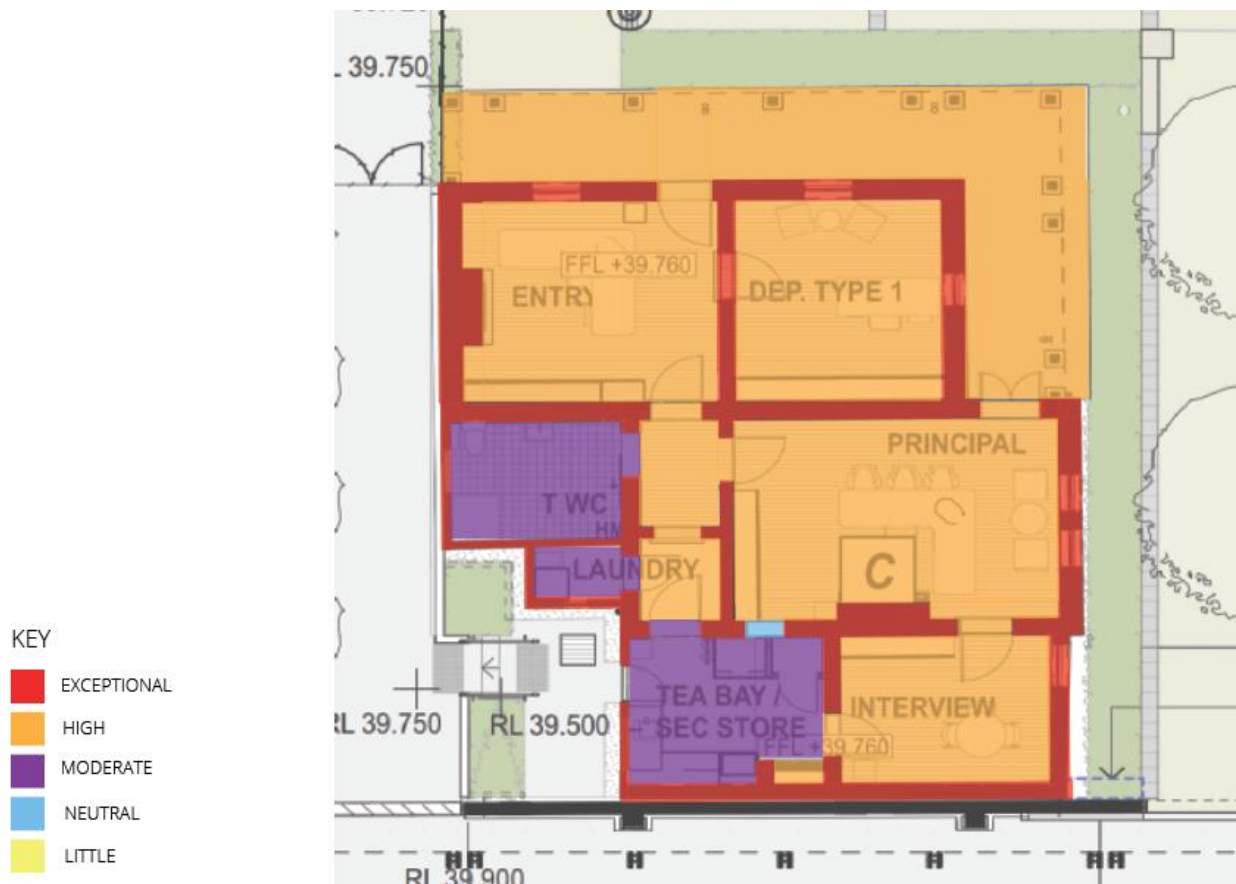
Figure 8.6: Messengers Cottage Grading of Significance plan for Internal Elements (Source: FJMT Base Plan with Curio Additions, 2023)

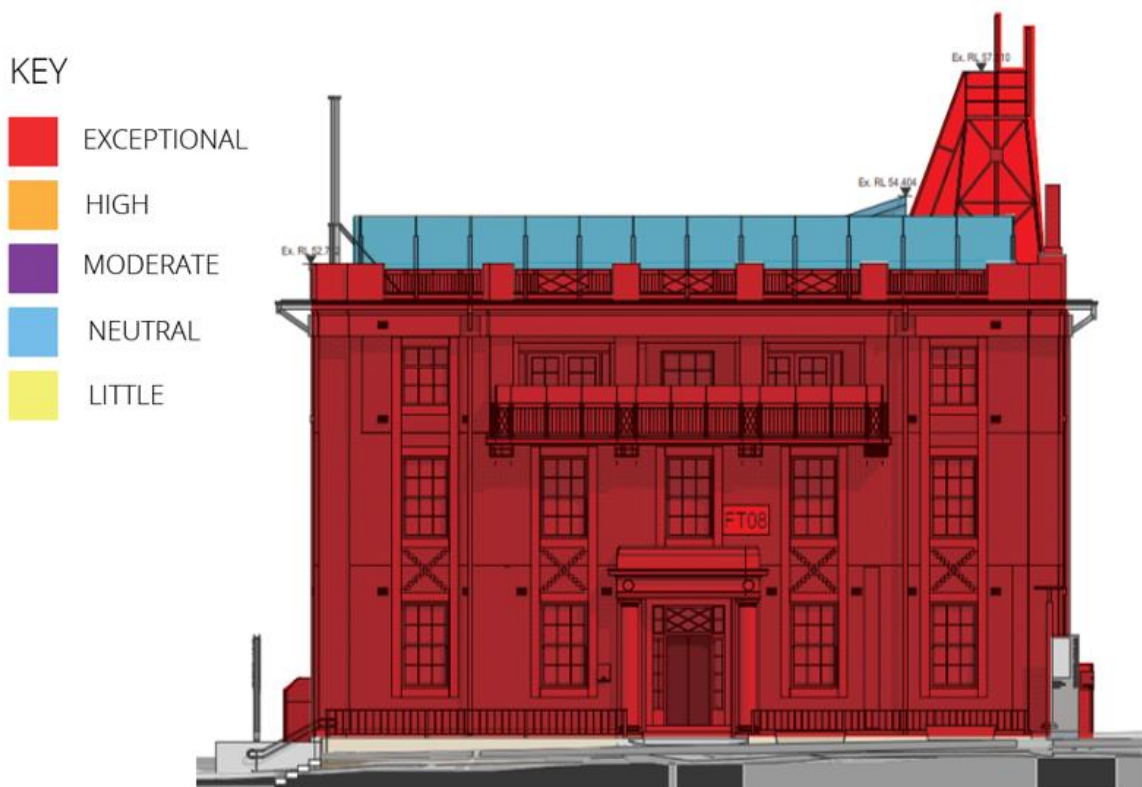
Figure 8-7: The Bureau of Meteorology Northern Facade (FJMT Base Plan with Curio Additions, 2023).

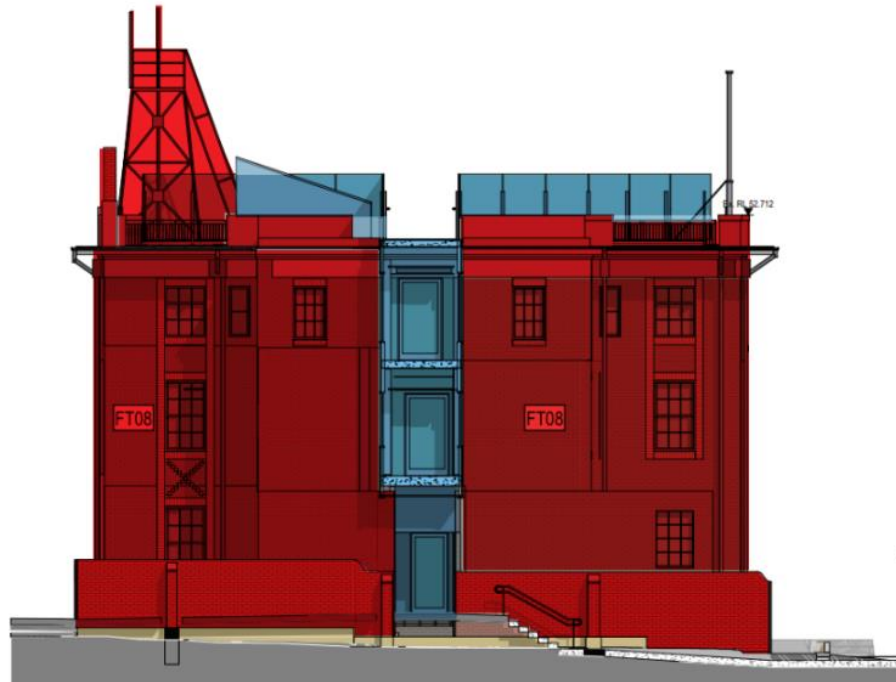
Figure 8.8: The Bureau of Meteorology Southern Façade with modern glazing highlighted in blue. (FJMT Base Plan with Curio Additions, 2023)

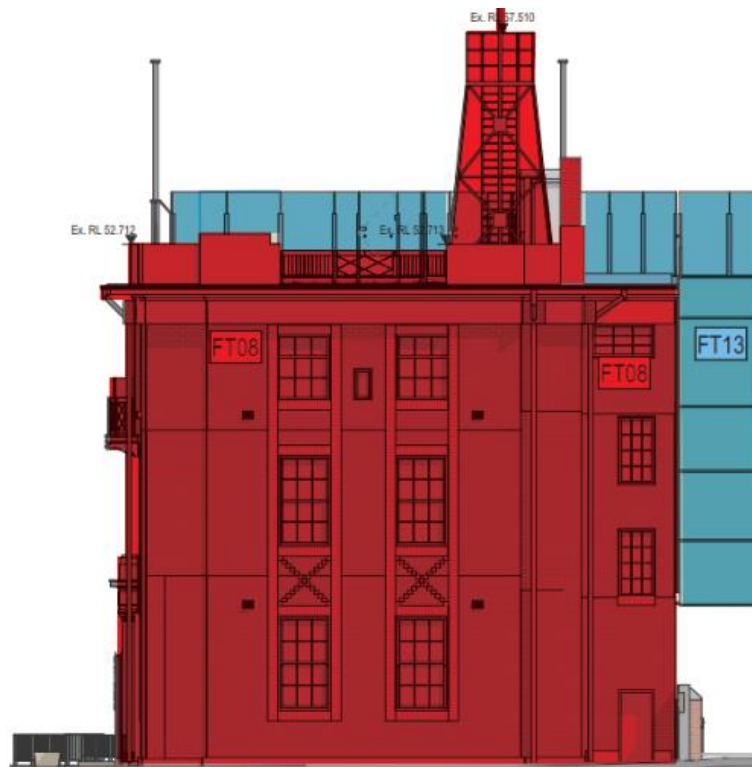
Figure 8.9: The Bureau of Meteorology Western Façade with modern glazing highlighted in blue (FJMT Base Plan with Curio Additions, 2023).

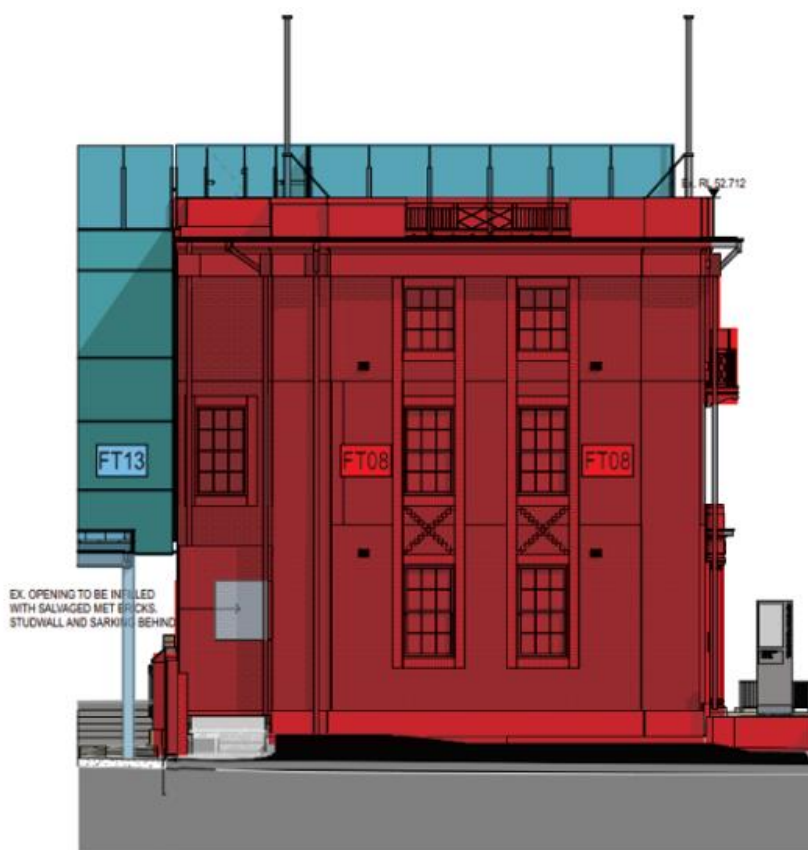
Figure 8.10: The Bureau of Meteorology Eastern Façade with modern glazing highlighted in blue (FJMT Base Plan with Curio Additions, 2023).
