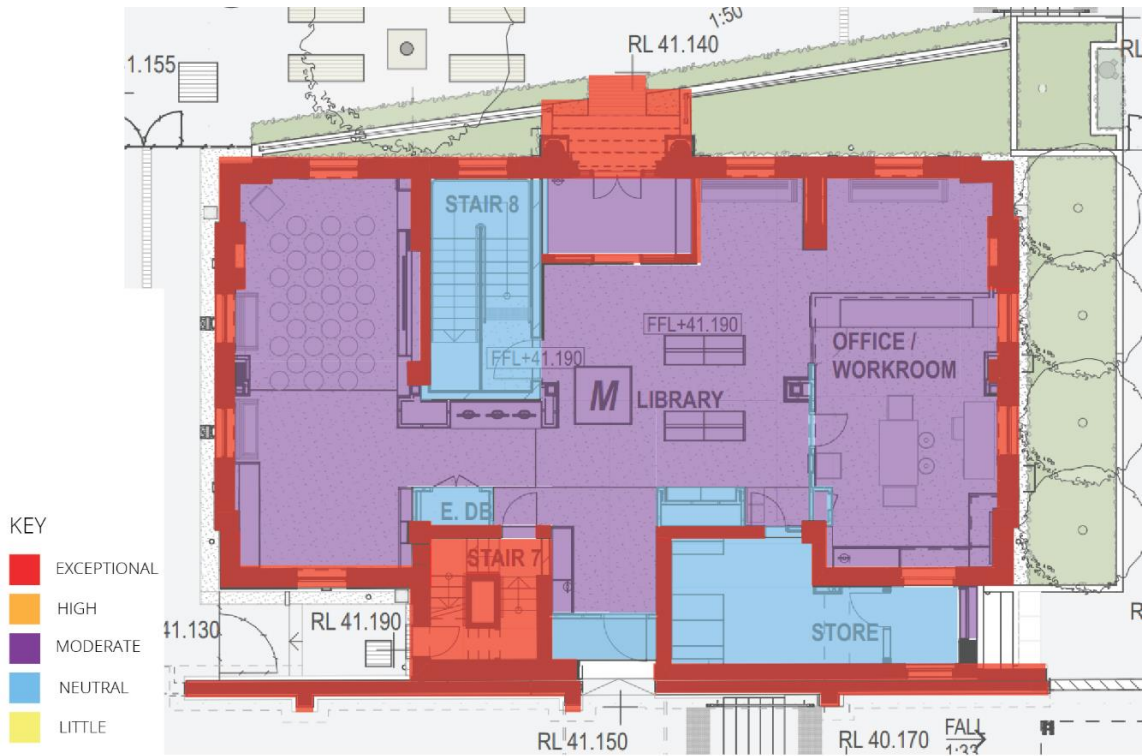
Figure 8.11: Bureau of Meteorology Ground Floor Grading Of Significance Diagram. (FJMT Base Plan with Curio Additions, 2023).

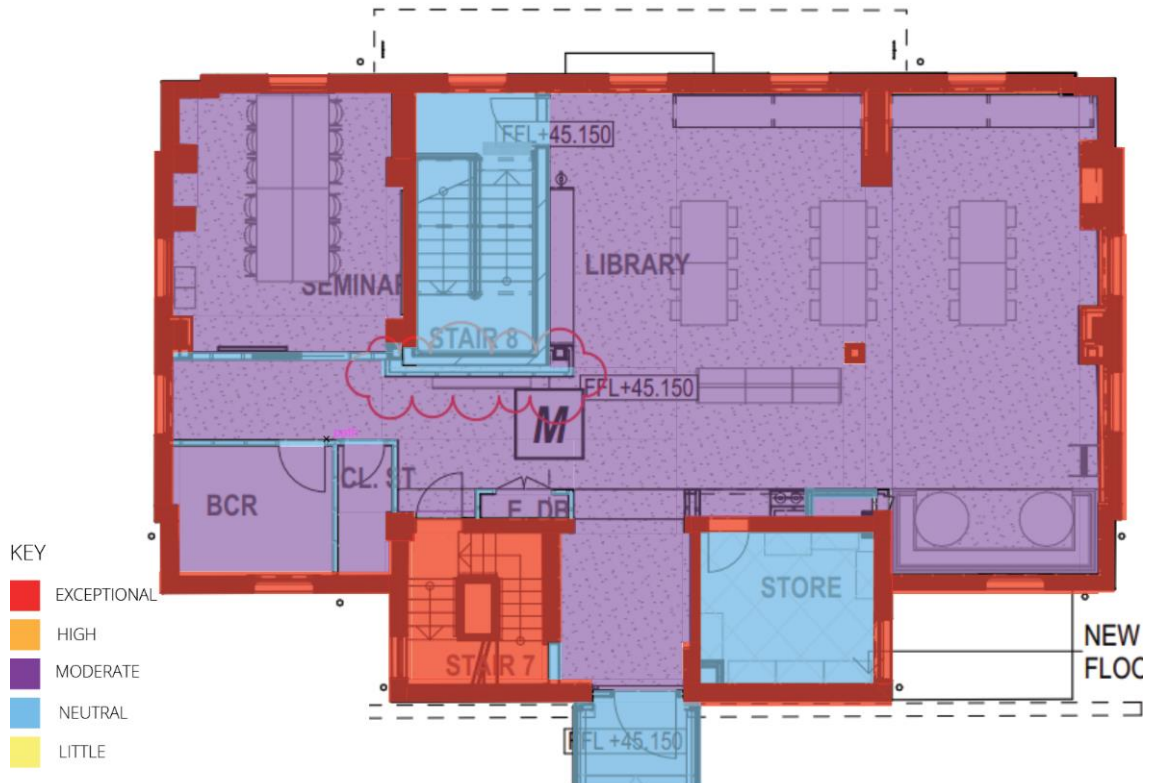
Figure 8.12: Bureau of Meteorology Level 1 Ground Floor Grading Of Significance Diagram. (FJMT Base Plan with Curio Additions, 2023).

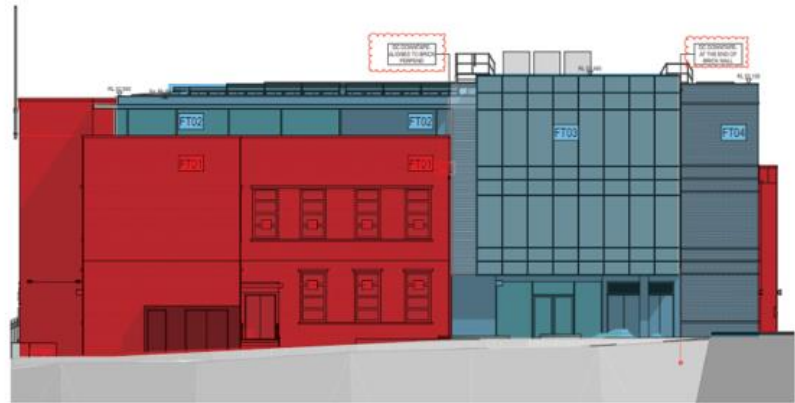
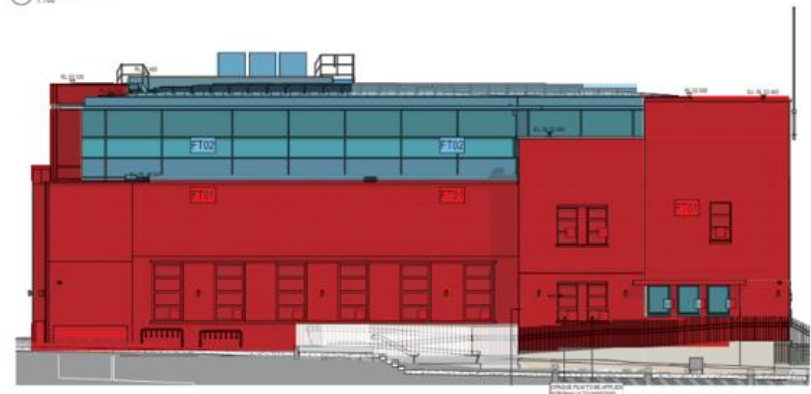
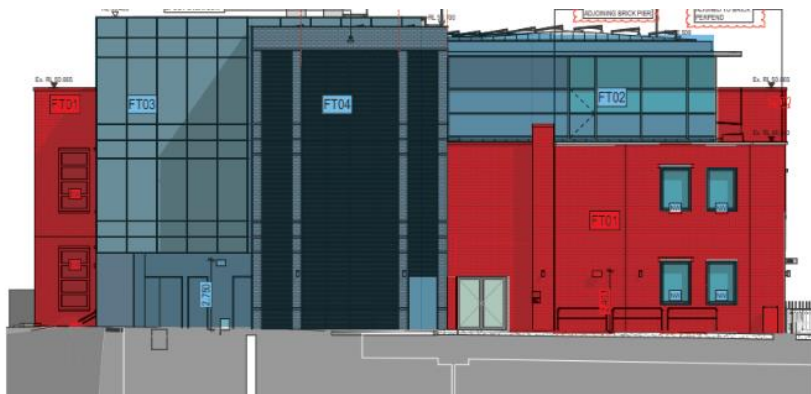
Figure 8.14 to 8-17 Fort Street Public School Ground Floor Grading Of Significance Diagram. Elevations in order from Top to Bottom. Northern Façade (Top Image), Southern Façade, Western Façade and Eastern Façade (Bottom) (Source:FJMT Base Plans with Curio Additions 2023)

Figures 8.14 – 8.17 highlight the gradings of significance for the external façades of the Fort Street Public School.

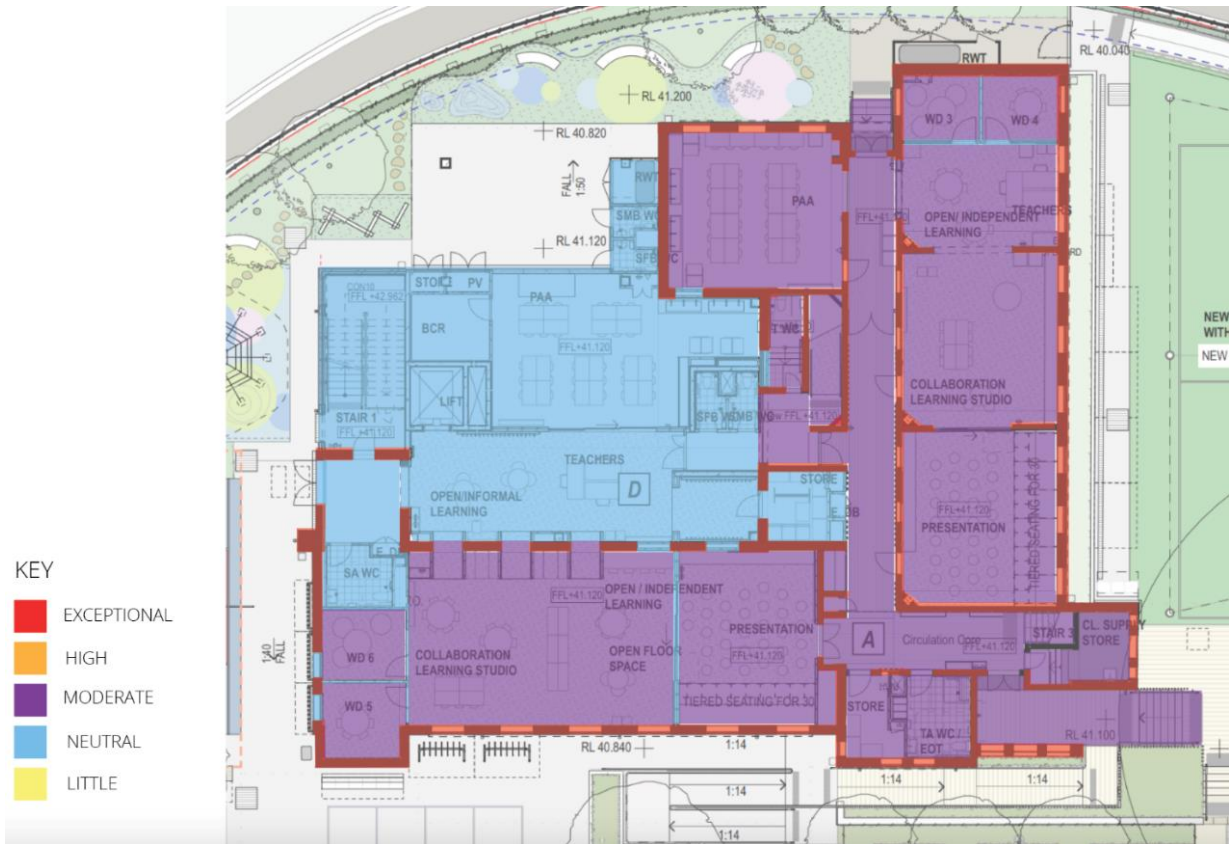
Figure 8-18: Ground Floor Fort Street Public School Ground Floor Grading Of Significance Diagram. (Source: FJMT Base Plans with Curio Additions 2023)

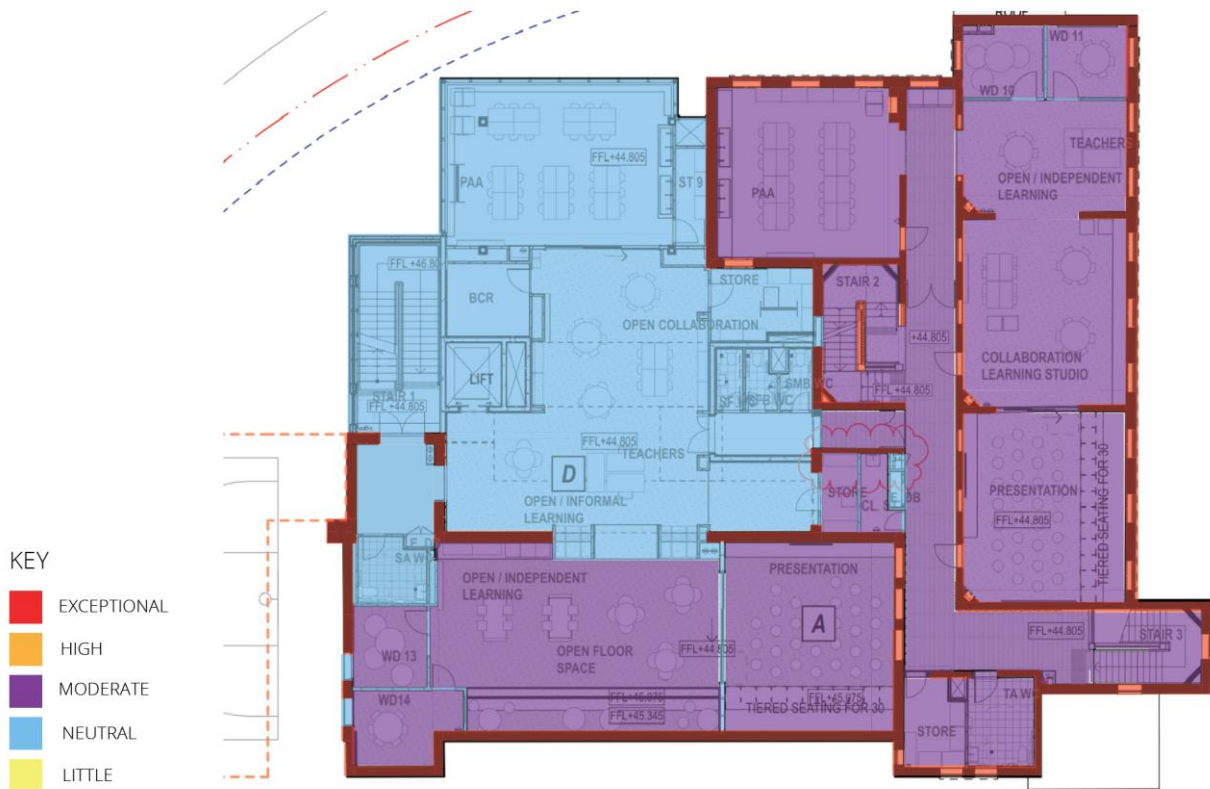
Figure 8.19: Level 2 Fort Street Public School Grading Of Significance Diagram.
 (Source: FJMT Base Plans with Curio Additions 2023)

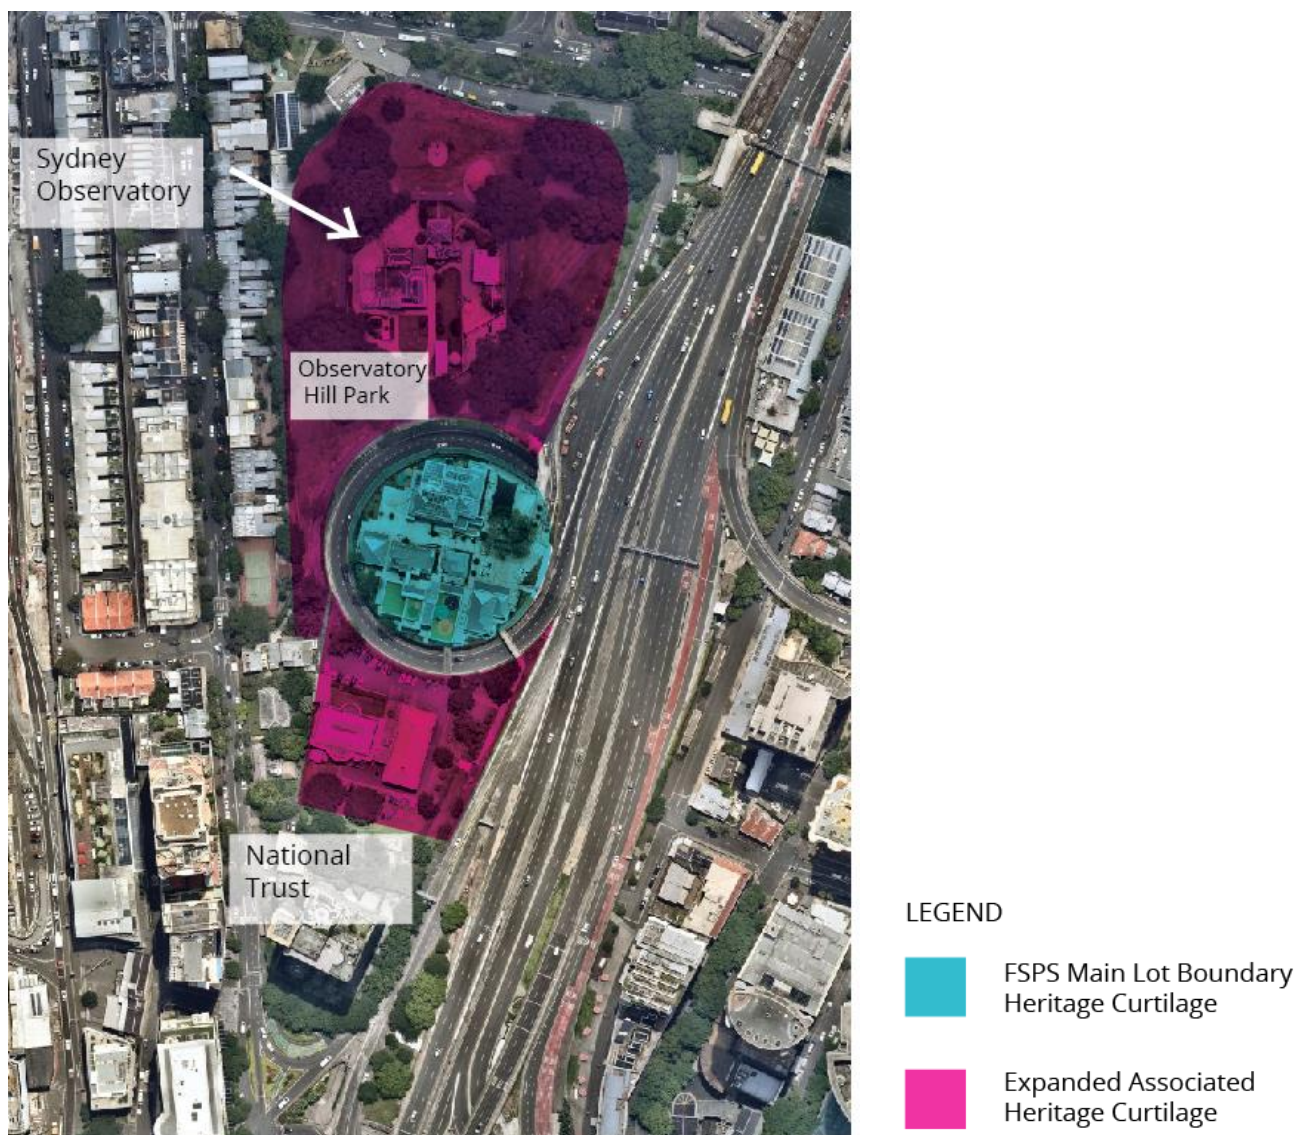
Figure 9.1: Heritage Curtilage for Fort Street Public School Site. Main lot boundary vs expanded associated curtilage (Source: Near Maps with Curio overlay 2023).

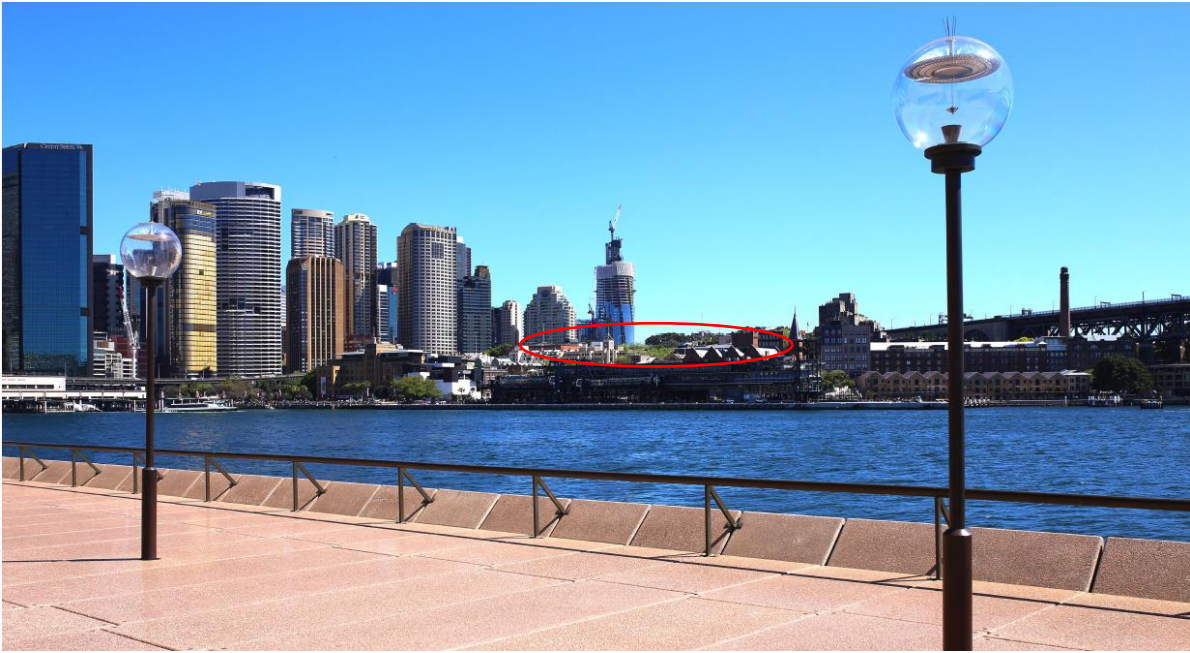
Figure 10-2: View from Sydney Opera House towards Fort Street Public School Site (indicated in red). Site not readily visible, view line already dominated by Barangaroo Development (Source: Ethos Urban 2019)

Due to its significance, potential views and vistas between the Fort Street Public School site and the Sydney Opera House were considered for this assessment of significant views, however the nature of the landforms and built environment of the area means that no clear view lines or vistas exist between the two sites (Figure 10-).

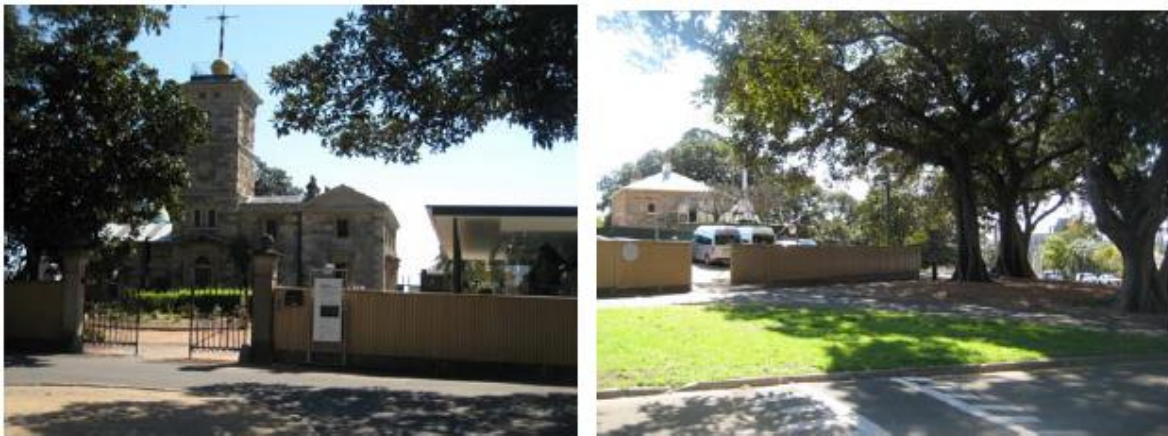
Figure 10-5: View north from northern side of Cahill Cut, to Sydney Observatory. The open space and mature trees in front of the Observatory are an important component of the Public School's setting. (Source: TKD 2016: Fig 113)

The open space and mature trees in the southern extent of Observatory Hill Park to the north of the Fort Street Public School site, are also significant in providing landscape context and heritage character of the Fort Street Public School site (Figure 10-). Views from the open space at the southern extent of the Observatory Hill Park, back south across the Fort Street Public School site, are also framed by the insistent backdrop of the Central Sydney CBD (Figure 10-).

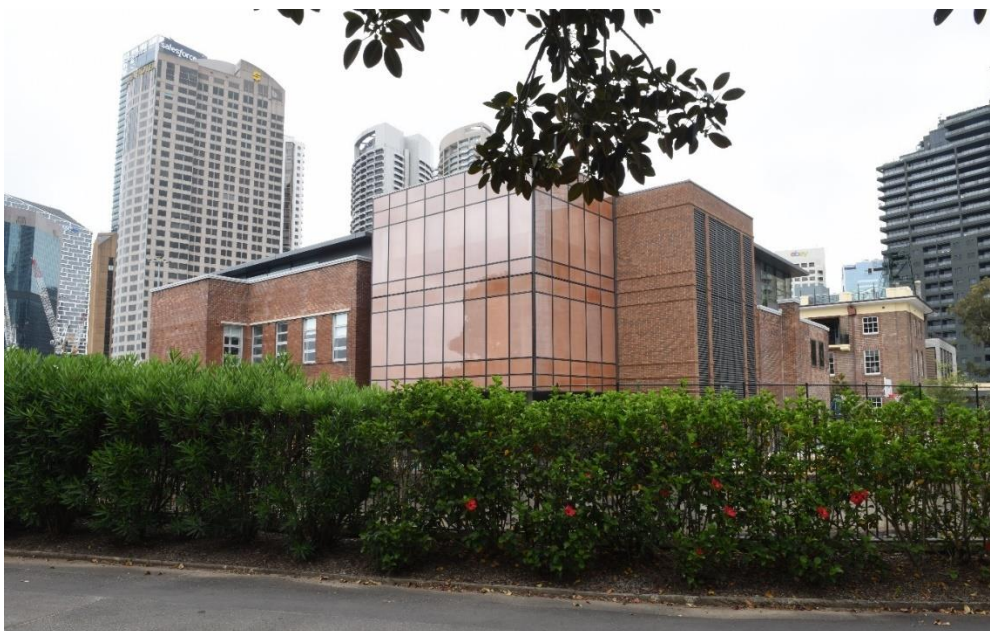
Figure 10-6: Fort Street Public School viewed from the open space at the southern edge of Observatory Hill Park. Buildings in Central Sydney form an insistent backdrop when the school is seen from the north. (Source: Curio, 2023)
