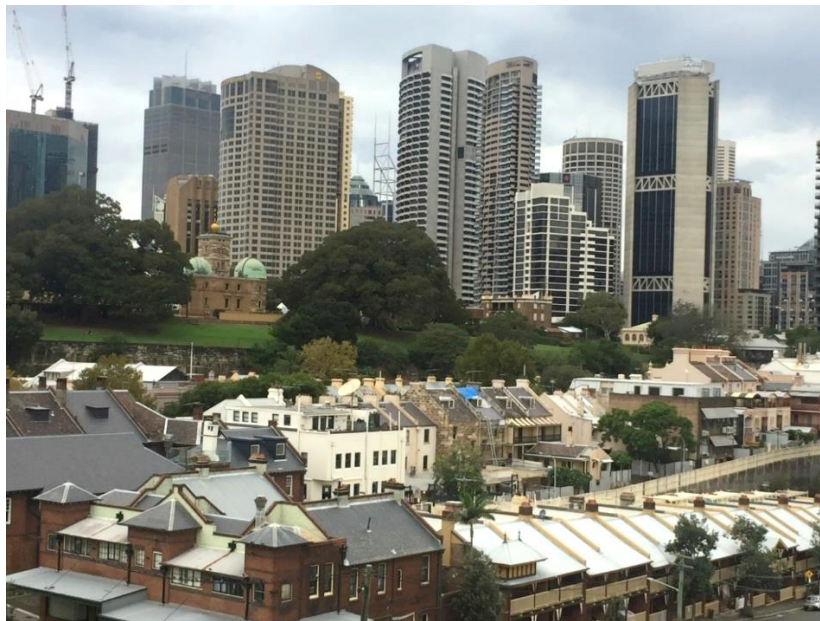
Figure 10-9: View from Palisade Hotel (Millers Point) to Observatory Hill and Fort Street Public School. Bureau of Meteorology visible (Source: Curio 2019)

While clear visual connections between the Fort Street Public School Site and Millers Point are mainly afforded from higher elements in the landscape only (i.e. from the Palisade Hotel in Millers Point back towards Observatory Hill – Figure 10-9 and Figure 10.10 – and from the roof of the Bureau of Meteorology down over Millers Point- Figure 10-9 and Figure 10-10), these views still retain significance for their ability to demonstrate the position of the Fort Street Public School Site in its heritage and landscape context.

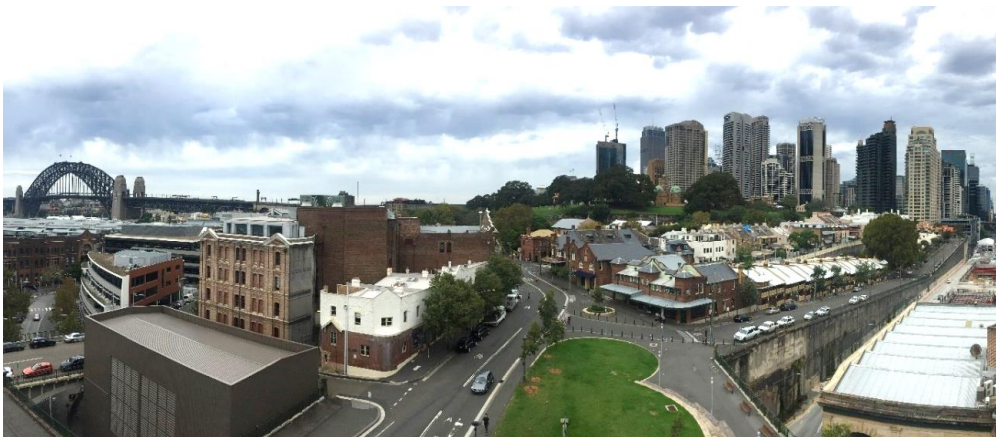
Figure 10-10: Setting of Observatory Hill and Fort Street Public School (taken from Palisade Hotel, Millers Point) (Source: Curio 2019)

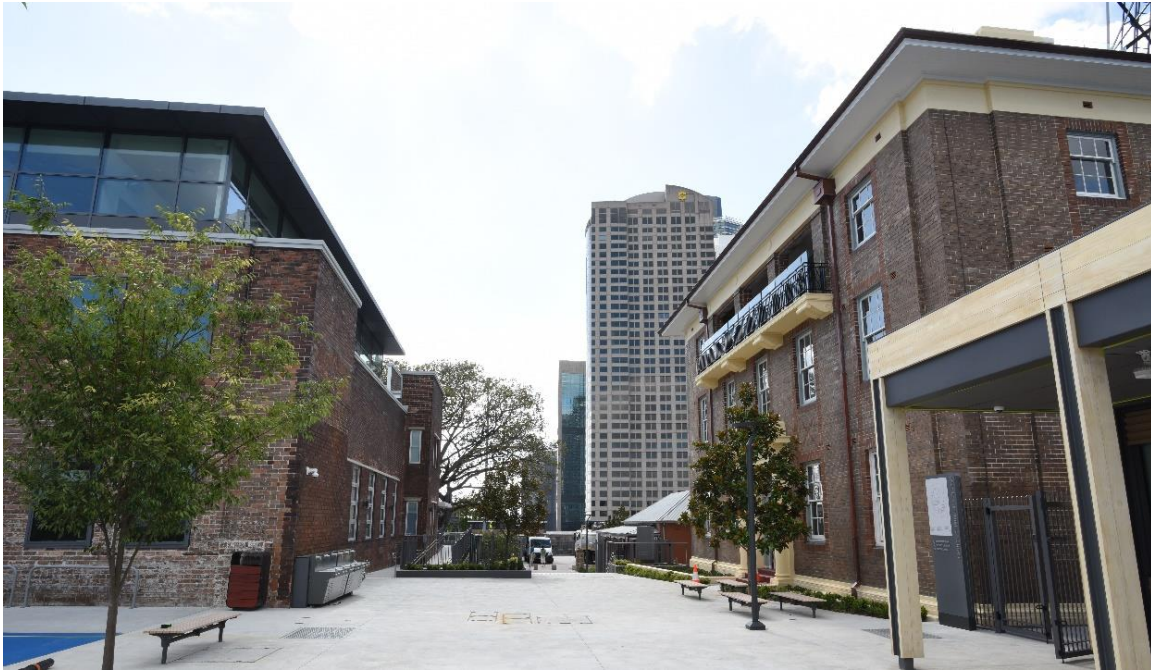
Figure 10-19: View east along central circulation spine between the Bureau of Meteorology (right) and Fort Street Public School (Left) (Source: Curio, 2023)

1. Central Spine/Path east-west between Fort Street Public School Building and Messenger's Cottage/Bureau of Meteorology (Figure 10- and Figure 10 -)
2. Boundary wall (South of Messenger's Cottage/ Bureau of Meteorology) (Figure and Figure)

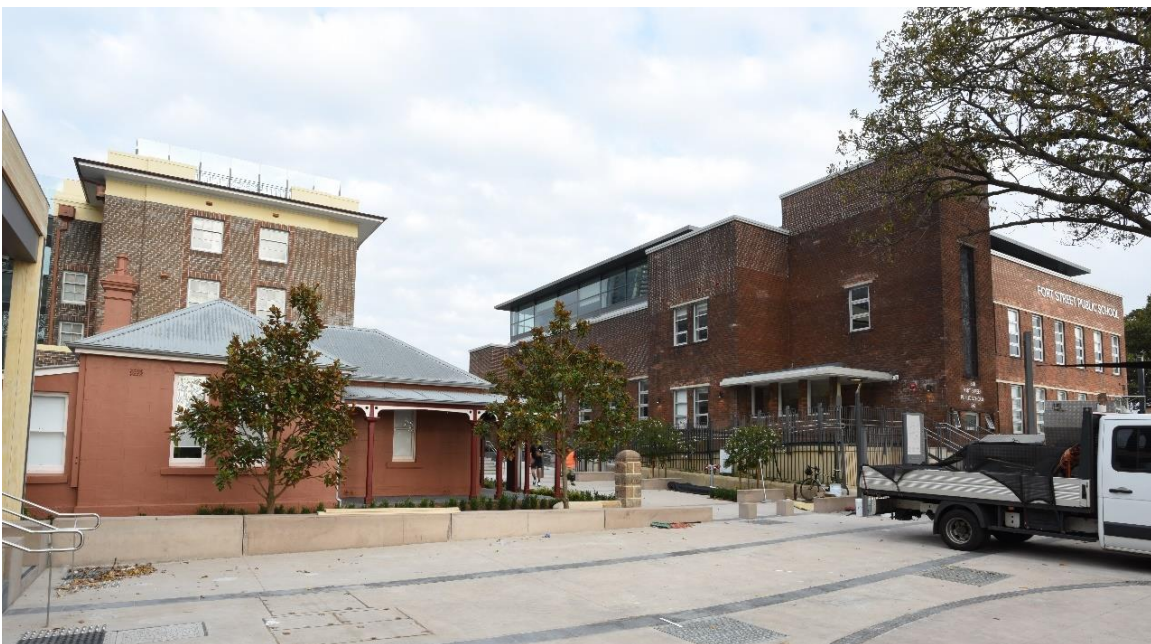
Figure 10 -20: View east along central corridor, with all three heritage listed buildings in view (Source: Curio, 2023)

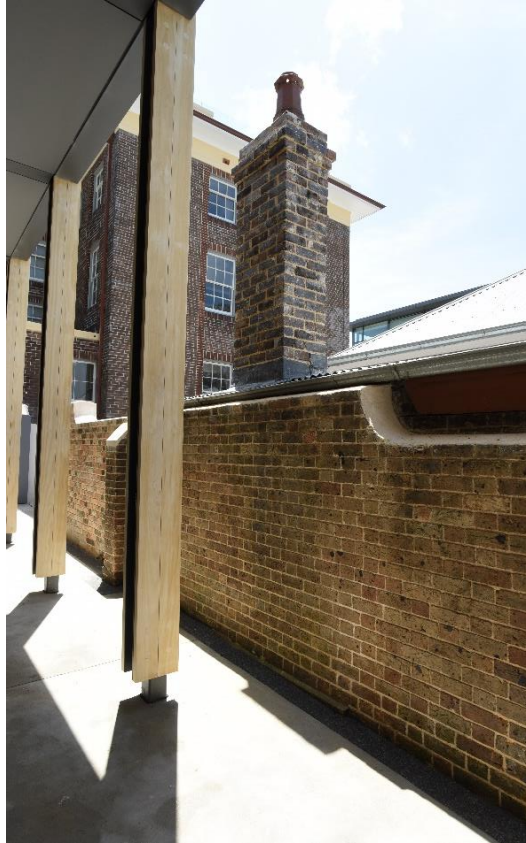
Figure 10-21: View of the Boundary Wall behind the Messenger's Cottage (Source: Curio, 2023)

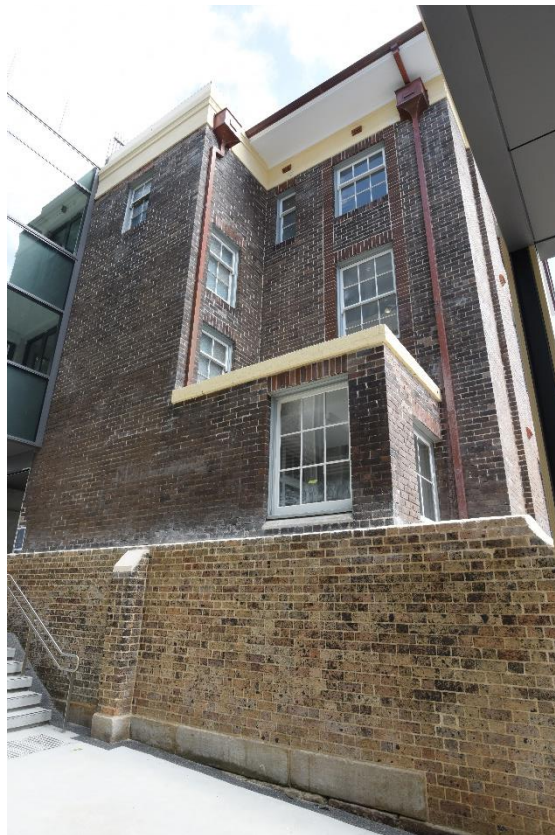
Figure 10-22: View north of the Boundary Wall behind the Bureau of Meteorology (Source: Curio, 2023)

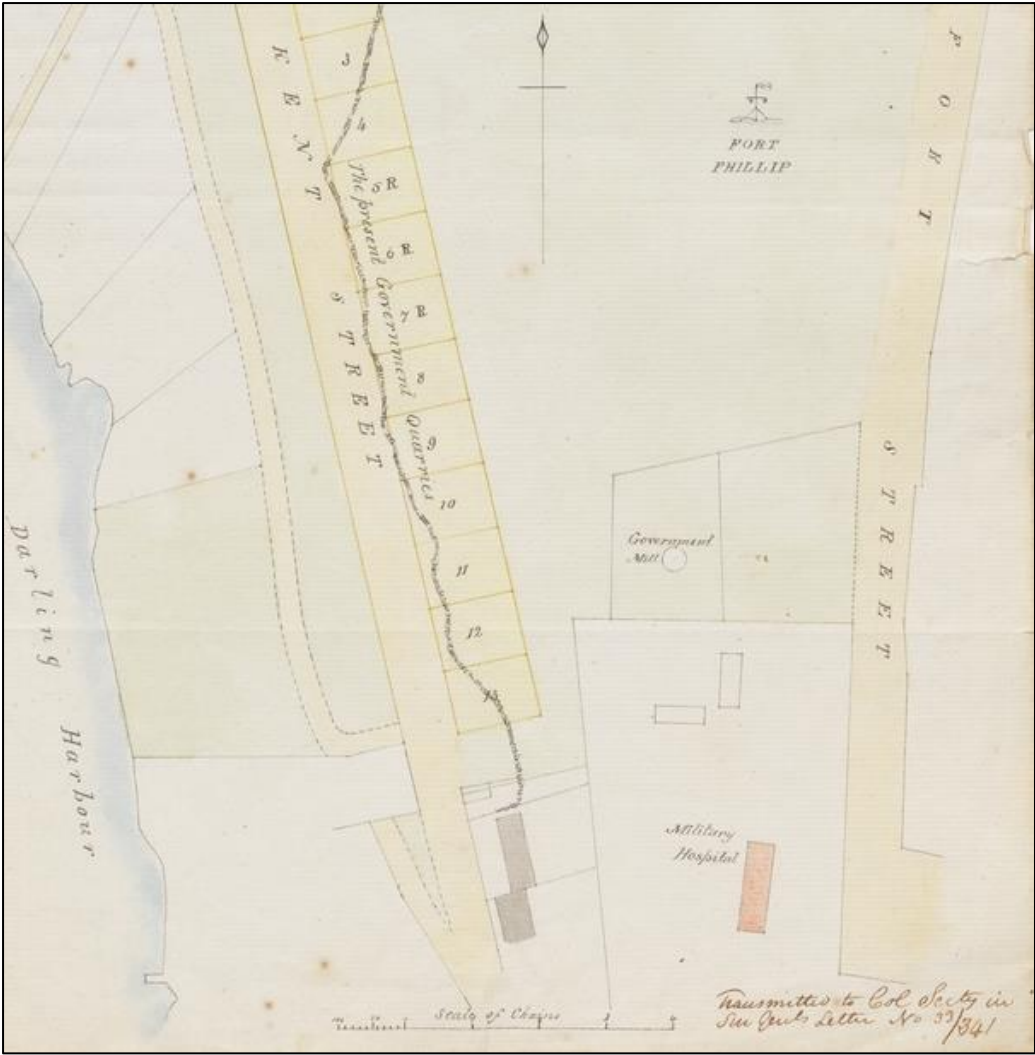
Figure 0-6: 1833 Plan, Thomas Livingstone Mitchell, 3rd Government mill within Fort Street Public School Site (Source: SLNSW A4694001/Ca83/14)

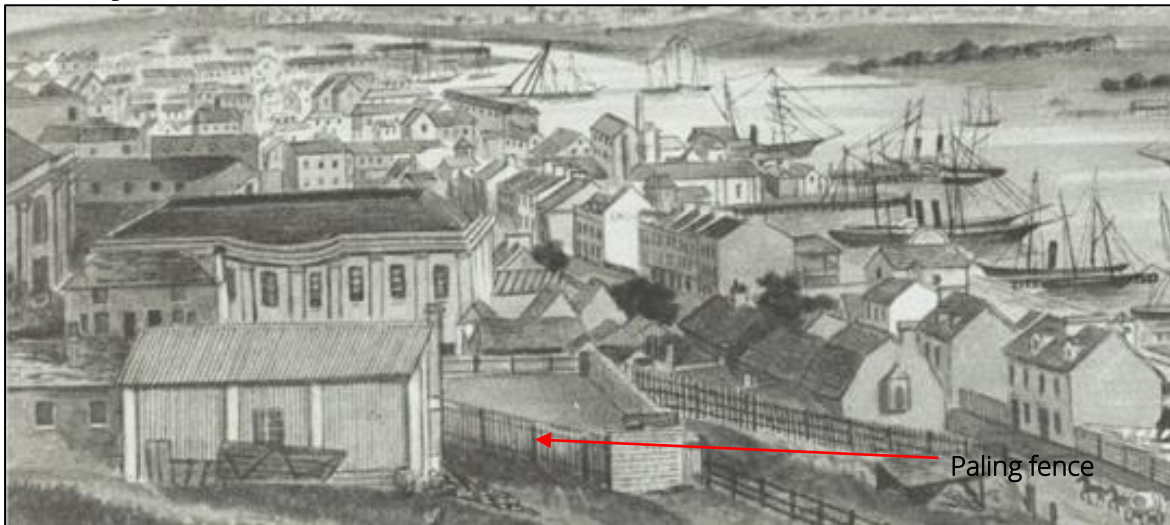
Figure 0-8: W. S. Hatton Drawing, Post 1856 (1859?) Showing fence.

There remains some uncertainty through the historical records as to when the boundary wall was first constructed (and hence what date the extant wall within the site dates to). A plan of the compound in 1836 shows the main hospital and its two main out-buildings, all of which appear to be surrounded by a perimeter fence or wall- however, the drawing does not detail the wall, and the depiction of the northern boundary appears to be slightly splayed (Figure 0-7). An annotated drawing from the Surveyors Sketch Books dated 1854 notes that the northern boundary was fenced, the remainder of the site (including the extension to Princes Street) being walled. A 1856 plan of the site depicts the boundary line as a single faint line does not double as stone wall as for other clearly depicted walls in the plan. A 1864 photograph of the site appears to depict the boundary as a wall, indicating that the boundary was constructed first as a wall sometime in the early 1860s.

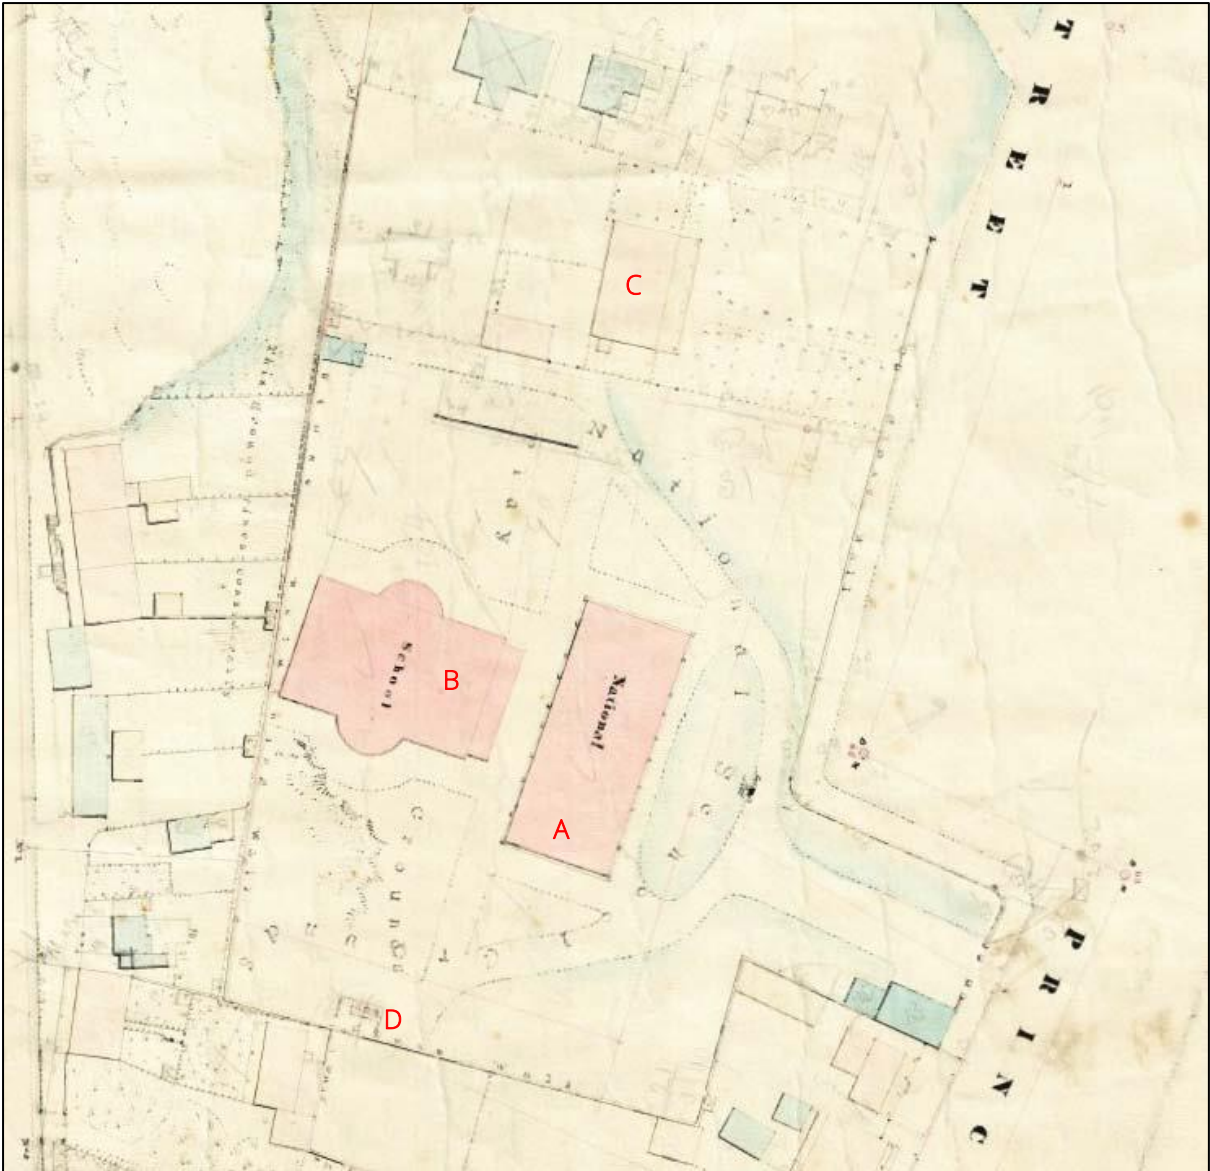
Figure 0-10: Portion of a survey prepared by H Chauncy and dated 7 October 7 1856 showing development across the National School site, which included the modified Military Hospital (A), Henry Robertson's recently completed classroom block (B), the former doctor's residence (C) and privies (D). (Source: Historical Atlas of Sydney - City Detail Sheets, 1855 - Sheet_01.)

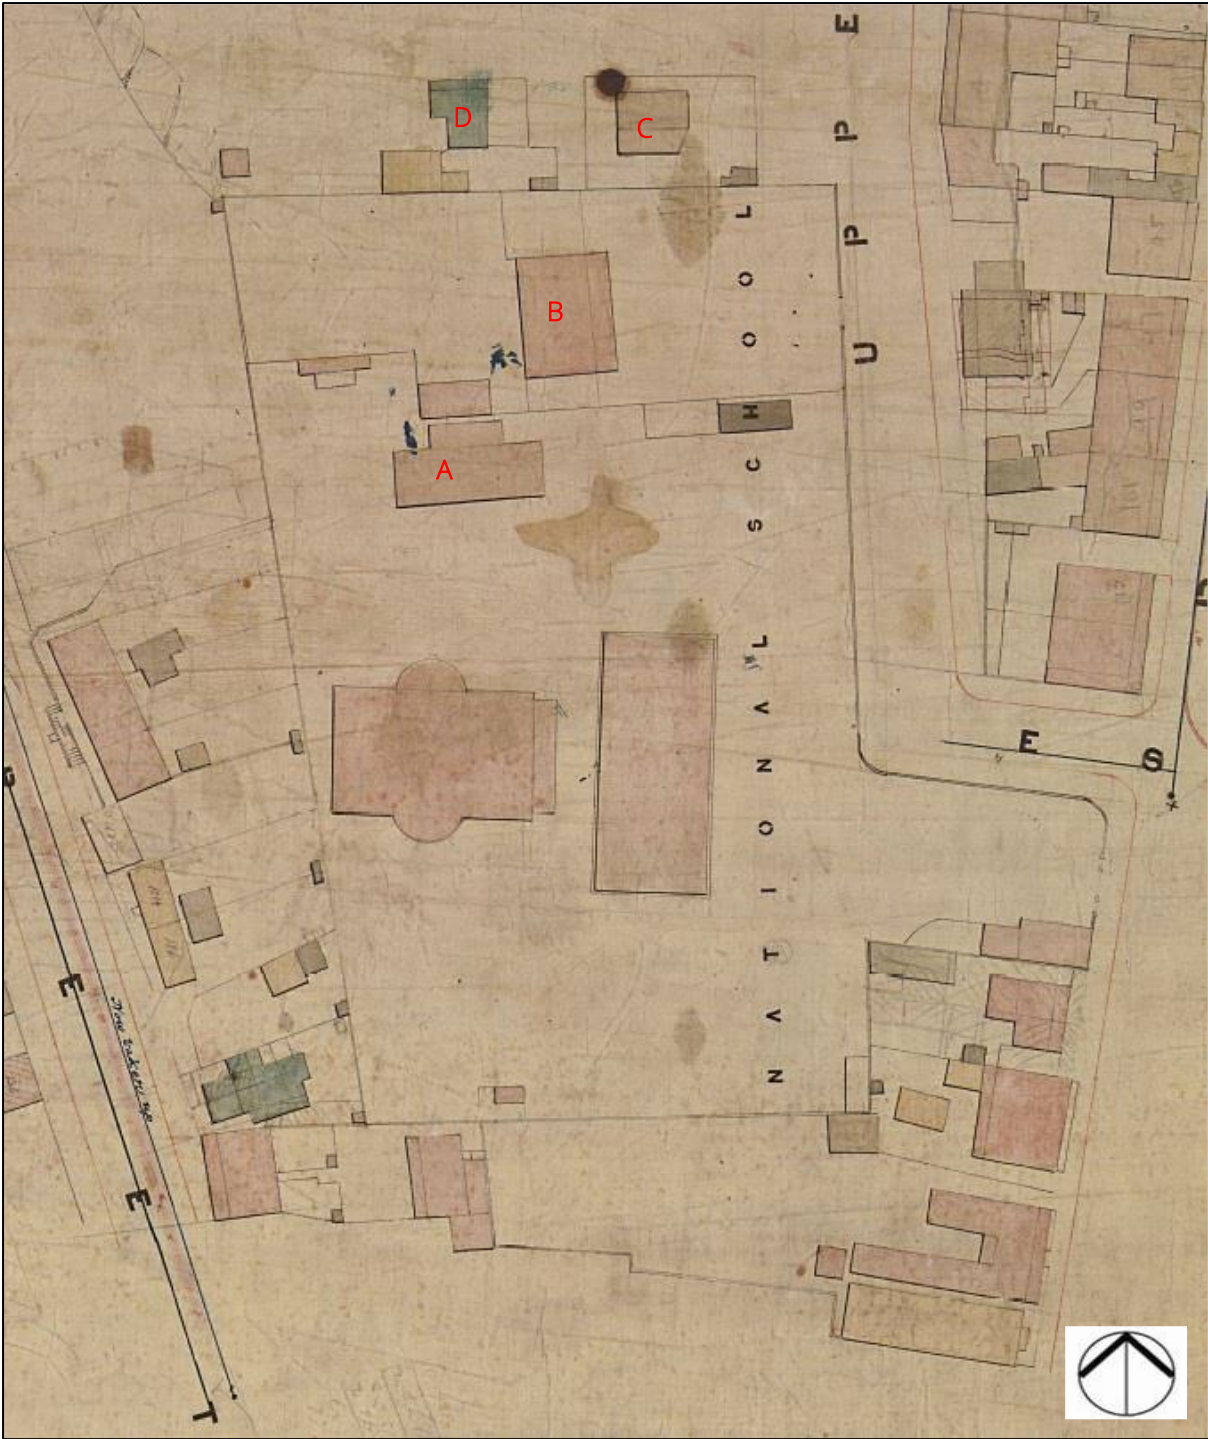
Figure 0-11: Portion of a survey showing Fort Street School circa 1865. The infants' school is located at A, close to the former surgeon's residence at B. C= Messengers cottage. D= Cottage/outbuilding present on site c.1855-1880 (Source: City of Sydney Archives, Historical Atlas of Sydney – Trigonometrical Survey of Sydney, 1855-1865, Block A1)

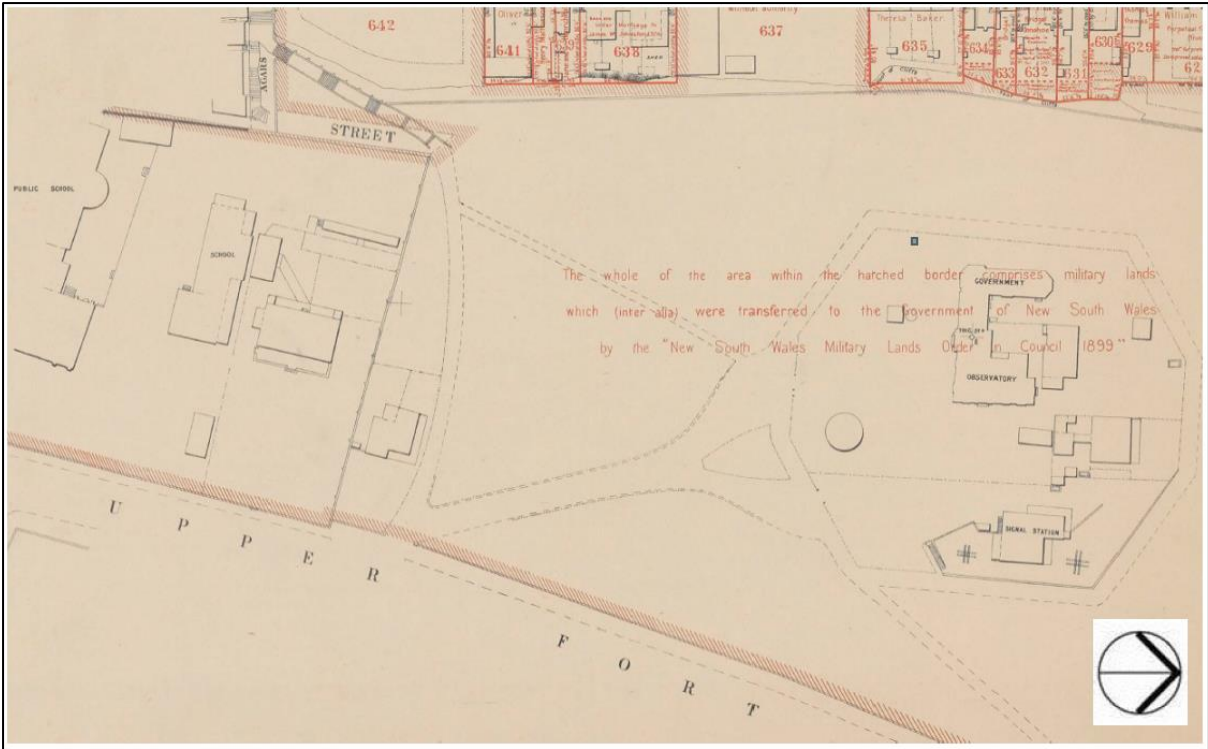
Figure 0-14: Layout of the northern section of the School and its relationship with Sydney Observatory and parklands in 1900. The wide hatched border shows the extent of military lands transferred to the Government of NSW in 1899. (Source: Historical Atlas of Sydney – The Rocks and Foreshore Resumptions, Plan S.)

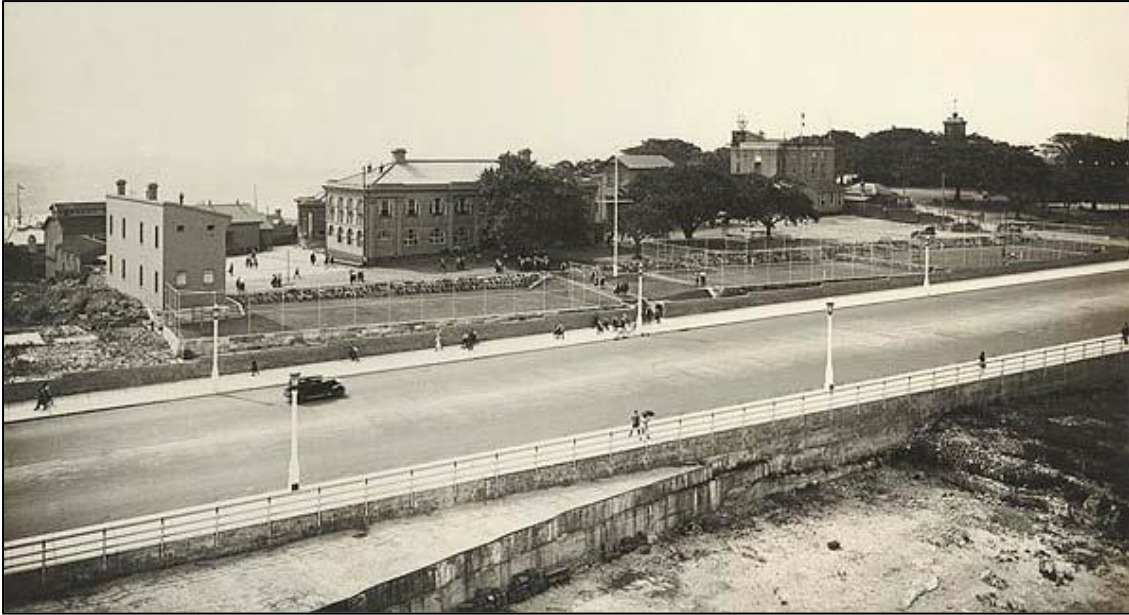
Figure 0-18: View looking west towards Fort Street School in 1932, after completion of the approaches to the Sydney Harbour Bridge. (Source: State Records digital id.12685_a007_a00704_8735000188)

The most substantial physical impact on Fort Street School resulted from the resumption of land for the approaches to the Sydney Harbour Bridge. These works required the resumption, demolition and excavation of a large portion of the eastern part of the school. This meant the loss of several buildings including the former doctor's residence and the Princes Street entrance to the school, which had iron gates and a fountain to one side. The former Wesleyan chapel may also have disappeared at this time. Once the approaches were complete the space between them and school buildings was put to use as tennis courts (Figure 0-18).

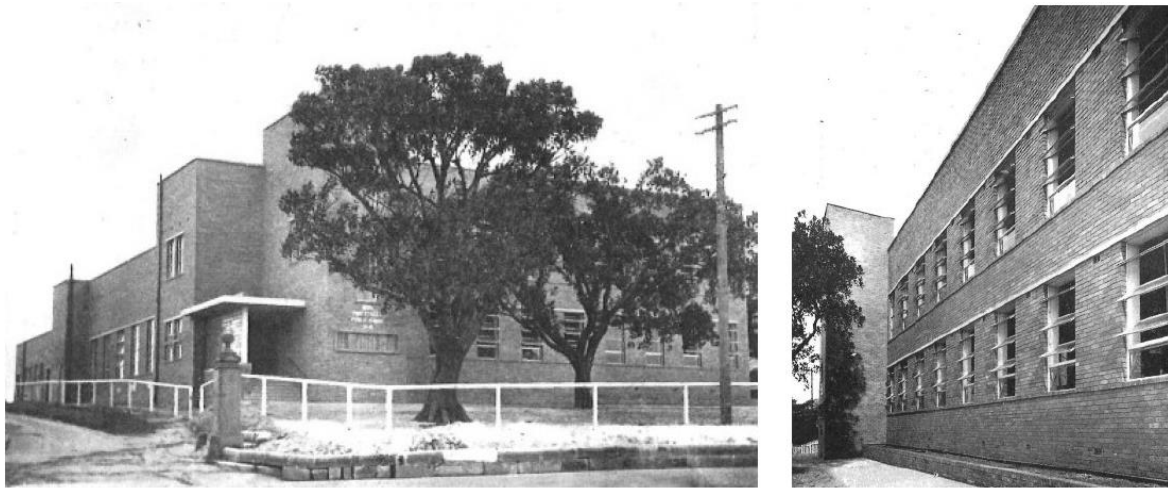
Figure 0-25: Photographs of Fort Street Public School taken shortly after the building was completed. (Source: Building, August 1942, pp.26-27.)

The Minister for Education, Clive Evatt, officially opened the new building on 20 November 1942,⁹⁰ although it seems to have been completed and occupied several months earlier. The building, which was L-shaped in plan, contained five classrooms, a library and sewing room over two levels and a lofty assembly hall with a stage and dressing rooms. There was also a headmaster's room, staff room and lavatories and a shelter for boys and girls. Steel framed awning sash windows provided light and air while the classrooms and library were provided with fireplaces. Two existing Moreton Bay fig trees in the eastern part of the site were retained to enhance the setting of the school.⁹¹ Between 1943 and 1949 a bridge was constructed across the road cutting to provide a narrow connection between the new primary school building and the rest of Fort Street School.

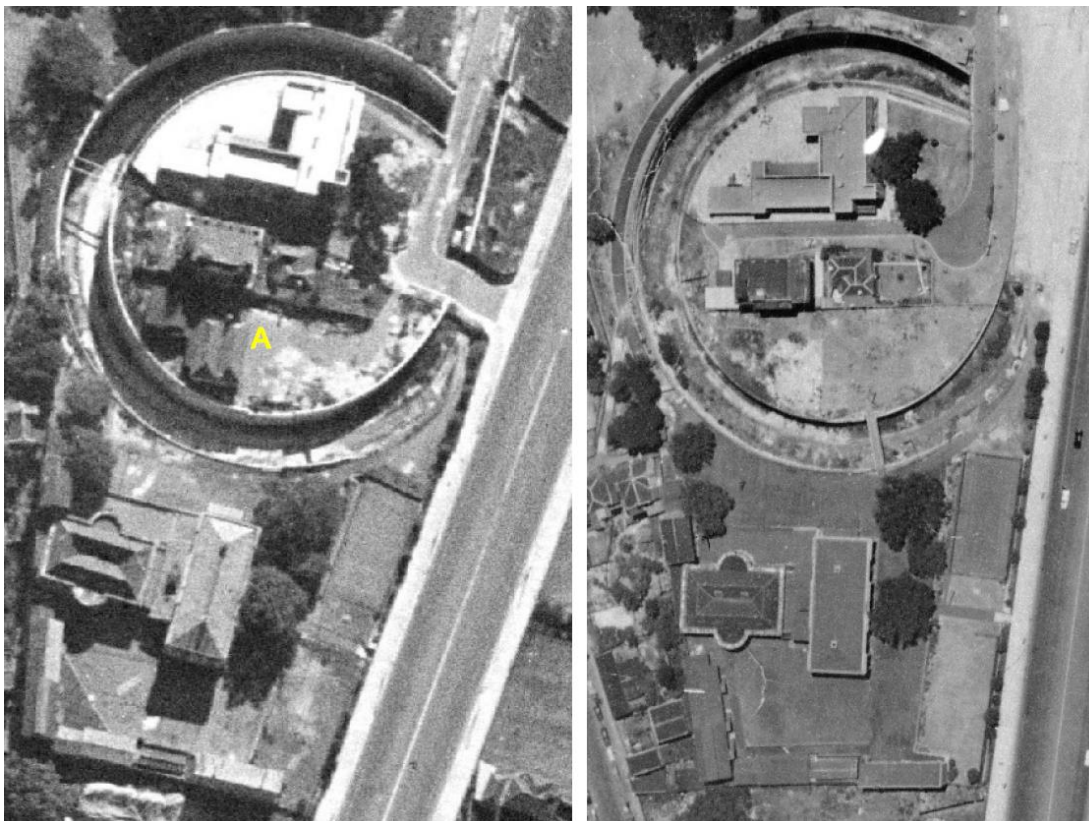
Figure 0-27: Aerial photographs taken in 1943 (left) and 1949 (right). During the intervening period of six years buildings associated with Fort Street School that were situated behind the Bureau of Meteorology, including the former surgeon's cottage associated with the Military Hospital (indicated at A), were demolished. (Sources: City of Sydney Archives Historical Atlas of Sydney; Spatial Information Exchange.)

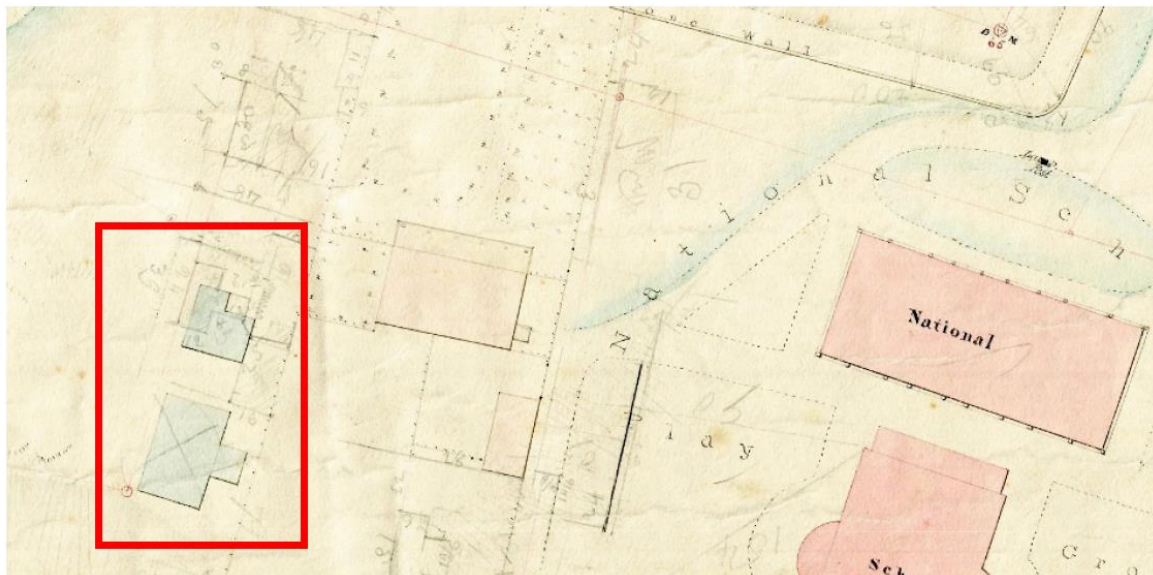
Figure 0-38: Cottages on the site of the Bureau of Meteorology Building, depicted on a circa 1855 survey of Observatory Hill. The footprint of the Messenger's Cottage roughed in above the cottages. (Source: TKD 2016: Fig 35).

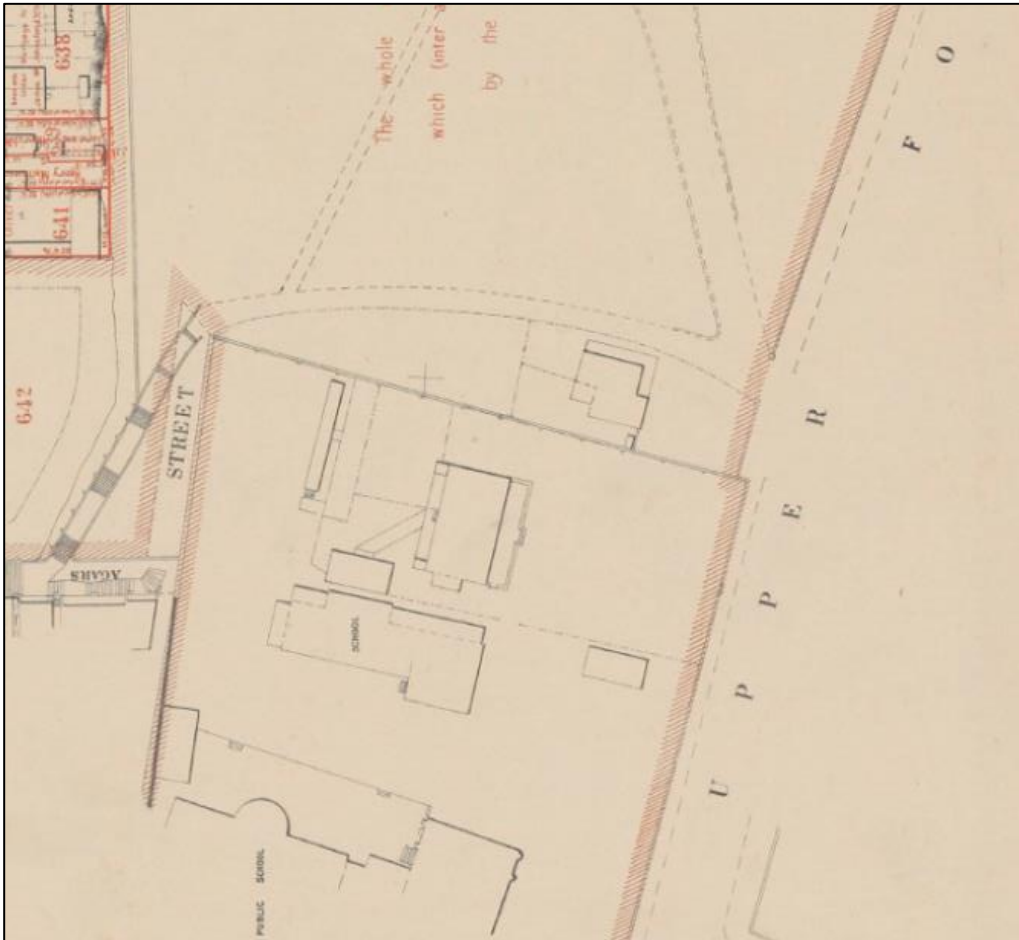
Figure 0.50: Sydney 1900-01 Resumption plan showing northern boundary in its current location as a wall

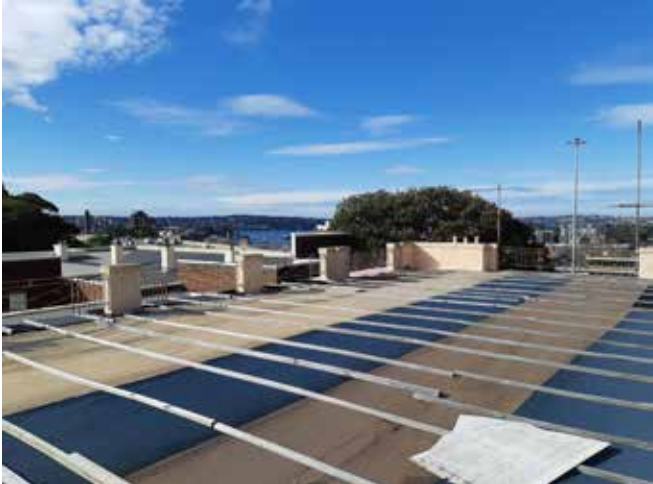
<p>The roof is currently in a very poor state. it has completely perished in some places and a temporary sarlon covering is doing nothing to halt further water ingress.</p> <p>URGENT WORKS: Install a temporary roof to the building that overhangs the parapet and which has temporary downpipes installed.</p> <p>NOTE: Weatherproofing the roof is the major priority. Unless the roof is repaired, additional make-safe works will be of little effect. The building needs to be able to dry-out before the majority of further assessment can be undertaken. Works are to be specified by an experienced heritage architect.</p>

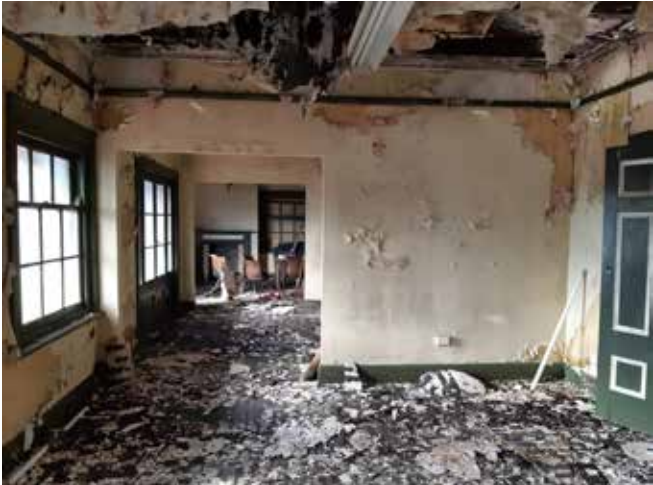
<p>The interior of the building is currently full of broken-down material, much of it related to the ceilings which have collapsed. There is likely to be a number of hazardous materials within the detritus.</p> <p>URGENT WORKS: Undertake a general clean-up of the building using approved contractors, taking care to avoid areas of collapsed floor etc. Scope of Works for clean up to be specified by an experienced heritage architect (to prevent removal/disposal of potentially significant fabric).</p>

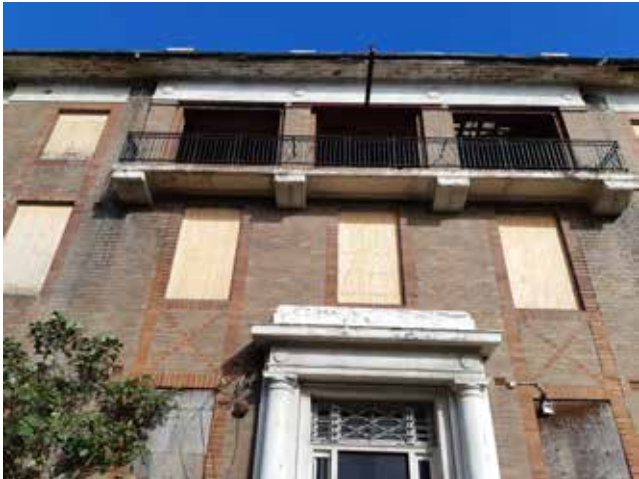
<p>The external brickwork to the building is in various states of repair. The patterned nature of the brickwork is no longer apparent due to the build-up of pollution on the facade.</p> <p>Downpipes and rainwater heads to the building are mostly no longer in place. Only the SE corner has a rainwater head intact.</p> <p>WORKS:</p> <p>Allow for a general clean of the brickwork on all elevations. Allow for approximately 75% repointing of brickwork.</p> <p>Allow for three new custom copper rainwater heads and associated downpipes.</p>

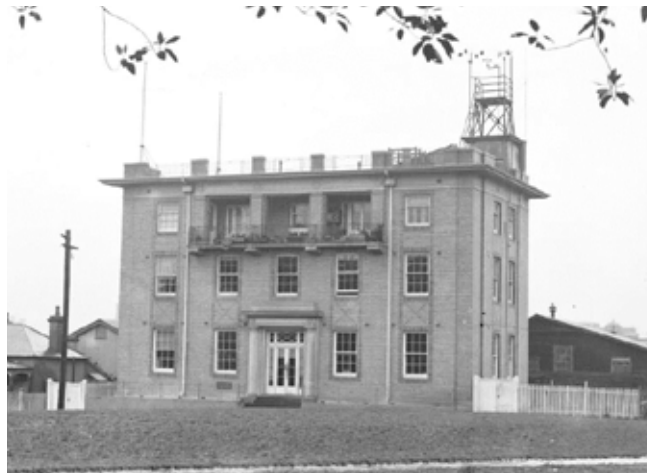
<p>The concrete parapets, door surround and base to the building appear to not have originally been painted. Window and door frames, along with metalwork were painted.</p> <p>WORKS:</p> <p>Allow for historic paint analysis to determine original colour scheme.</p> <p>Allow for complete removal of existing (presumed acrylic) paint from concrete surfaces using approved paint stripping method.</p> <p>Allow to repaint all metalwork following stripping back, repair and application of protective coating.</p> <p>Allow to repaint all timber windows and doors.</p>

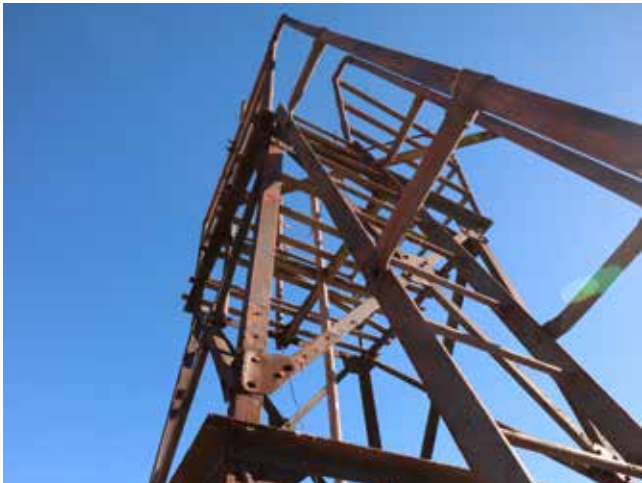
<p>The "wind recording apparatus" to the SW corner of the building is an important element related to the original function of the building.</p> <p>WORKS:</p> <p>Allow for complete restoration of this element. This may involve substantial off-site repair work, sandblasting, repainting, installation of missing elements or new structural members, etc. The two flagpoles (seen in the image above) should also be considered for reinstatement.</p>

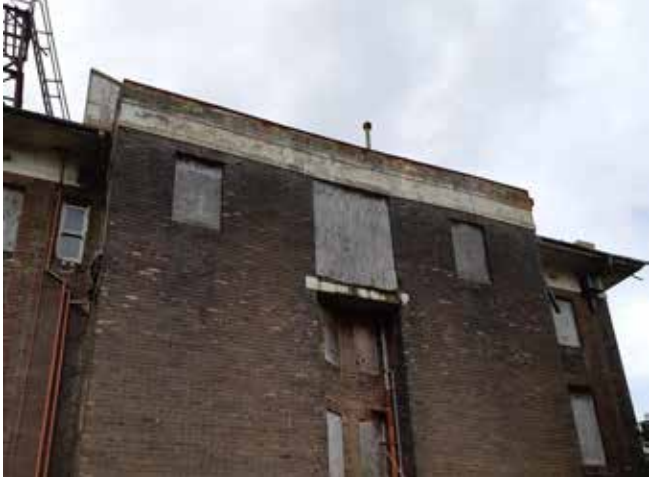
<p>A number of noticeable structural repairs are required on the exterior of the building. Of particular concern is the major cracking to the parapet on the southern elevation.</p> <p>WORKS:</p> <p>Advice of a specialist structural engineer should be sought. Allow for complete dismantling and rebuilding of this section of parapet.</p>

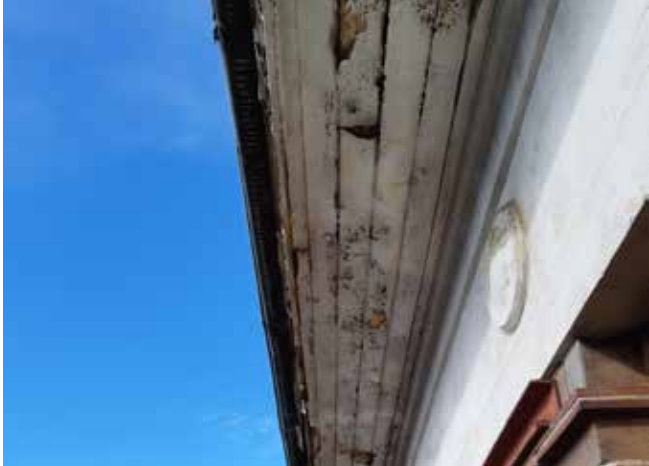
<p>The eaves to the building are in generally poor condition. In some cases they are missing or have completely rotted through. Where they remain in good condition they should be repaired.</p> <p>WORKS:</p> <p>Allow for 100% replacement of eaves using exact matching profile.</p>

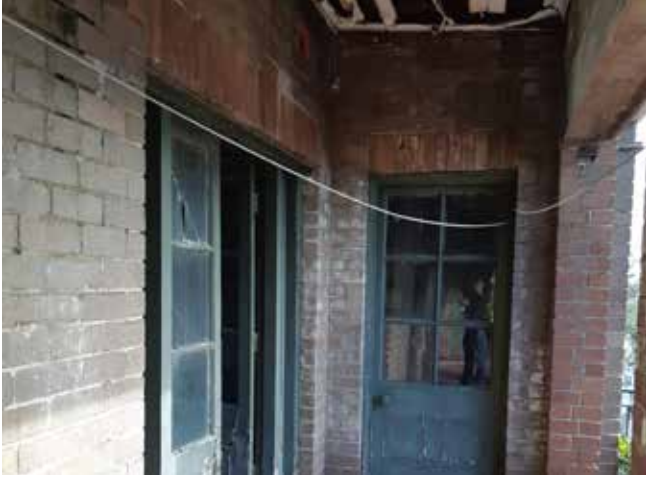
<p>The lining boards to the upper verandah have rotted. External doors and windows are generally in moderate condition.</p> <p>WORKS:</p> <p>Replace the lining boards to the upper verandah.</p> <p>Allow to remove all external doors and windows for repair in a factory. These elements (and their frames) should be sanded back, re-primed and re-painted. New glass should be installed that assists in meeting acoustic requirements. Sash windows should be repaired and made operational. Install appropriate acoustic brush seals to the windows. Original hardware is to be retained and repaired where possible.</p>

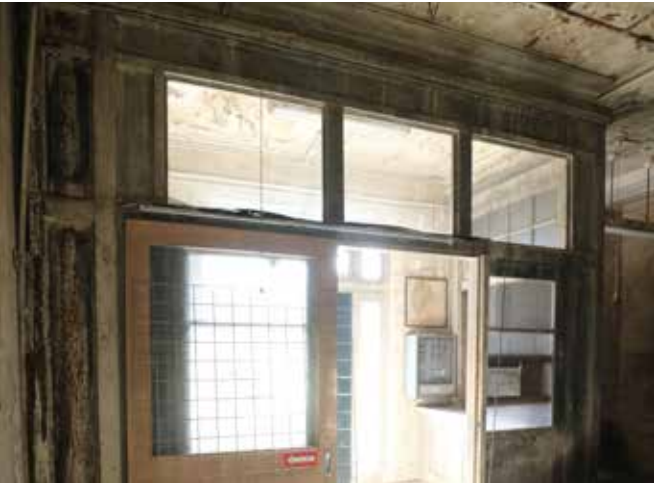
<p>Substantial early joinery remains in the building. it is in generally moderate condition and should be repaired to match. This includes internal doors, the entrance vestibule, fireplaces, skirtingboards, picture rails, and dividing screens.</p> <p>WORKS:</p> <p>Repair all timberwork to the building. Replace elements where missing or damaged (allow 50%). Repaint.</p>

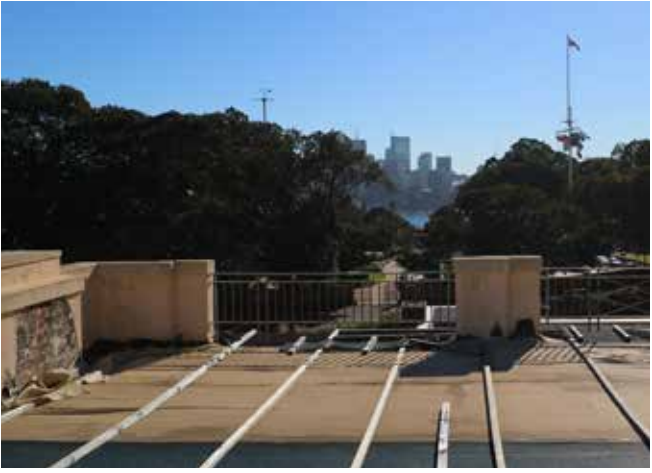
<p>The roof and guttering to the building is missing.</p> <p>WORKS:</p> <p>Repair the existing roof. Exact roof type is to be determined, but this roof is to be trafficable. Existing handrails are to be repaired and repainted, and a new compliant barrier is likely required.</p> <p>Allow for full replacement of the guttering to the building.</p> <p>Allow for full replacement of perimeter membrane above eaves. Allow for new cement topping to all parapets to prevent further water ingress.</p>

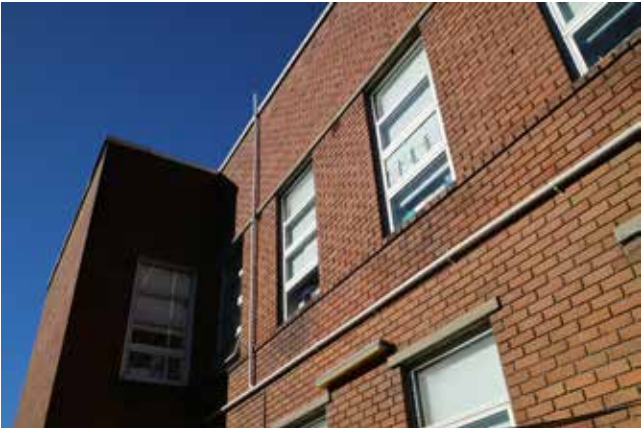
<p>The external brickwork to the building is in generally good condition. Cement string courses and parapet capping are in moderate condition.</p> <p>WORKS:</p> <p>Allow for a general clean of the brickwork and cement elements on all elevations. Allow for approximately 25% repointing of brickwork.</p> <p>Allow for removal of all non-original signage, conduit, lighting, etc and repairs to fabric as necessary. Allow for a new capping element (possibly in folded metal) to the parapet line.</p>

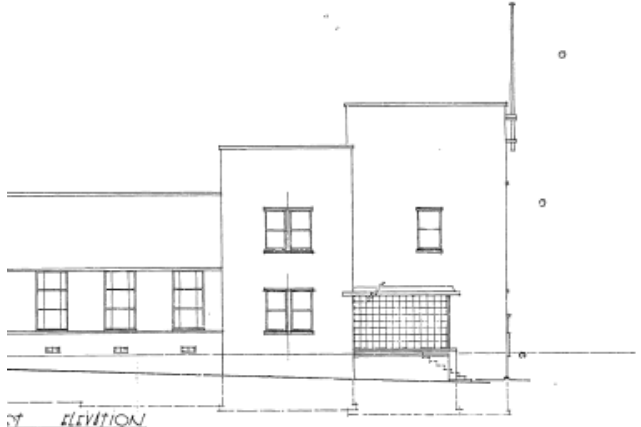
<p>The main entry to the building and the three small windows at the base of the tower have had their glass block windows removed.</p> <p>The flagpole to the main tower has also been removed.</p> <p>WORKS:</p> <p>Allow for reinstatement of the original glass block wall as per the original design.</p> <p>Allow for a new flagpole to the main tower.</p>

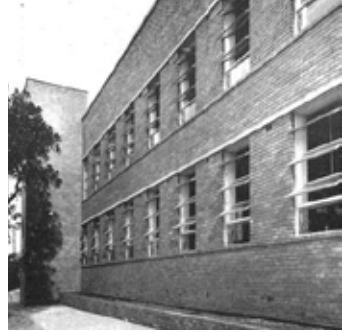
<p>The original steel windows that were an integral part of the design have been replaced. Current windows do not meet acoustic requirements.</p> <p>WORKS:</p> <p>Allow for complete replacement of all external windows. The detail of the new window is to match the original historic steel windows for the building.</p>

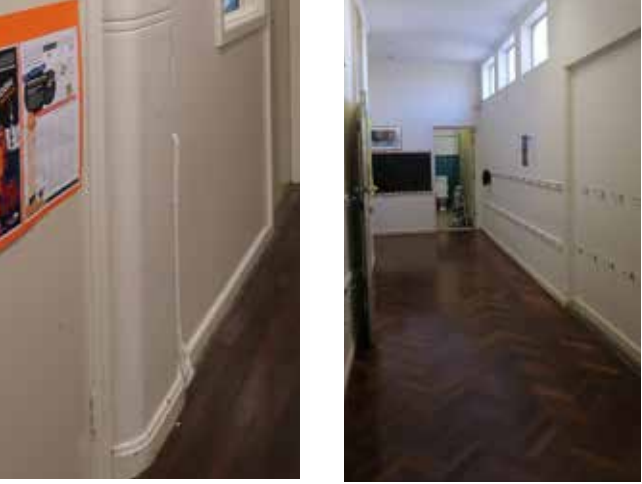
<p>The significant elements of the building interior should be retained and conserved.</p> <p>WORKS:</p> <p>Allow for a light sanding and repolishing of the original floorboards and parquetry flooring. Repair walls to match existing where any new openings are made or original openings restored. Restore the original curved corner elements to the interior.</p>

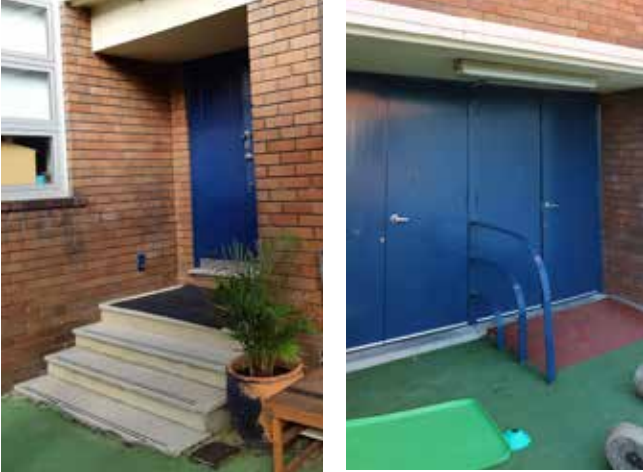
<p>Original elements to the exterior of the building remain in place and should be conserved. These include the original timber doors, terrazzo steps, and metal handrails.</p> <p>WORKS:</p> <p>Allow for repairs to terrazzo steps.</p>

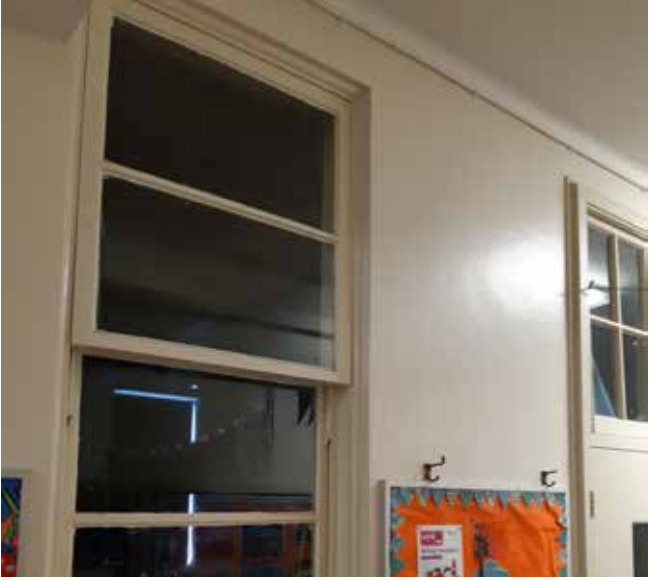
<p>The internal windows, doors and fanlights are in good condition. They should be retained and conserved wherever possible.</p> <p>WORKS:</p> <p>Minimal repair works required to these elements.</p>

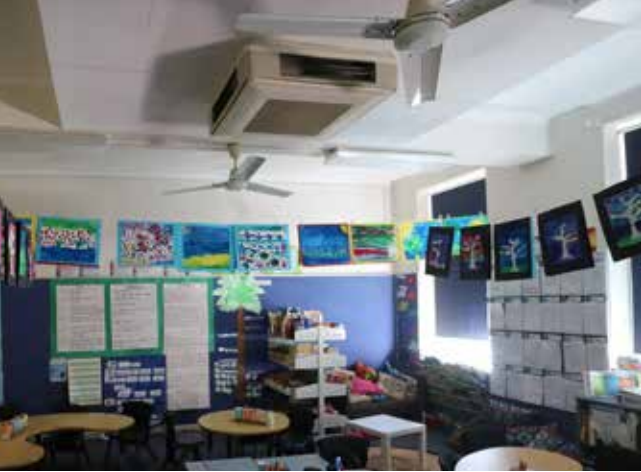
<p>Existing air conditioning units, fans, lights etc are presumed to be upgraded in some way as part of the planned works.</p> <p>WORKS:</p> <p>Allow for repairs to ceilings and walls to match existing surfaces.</p>

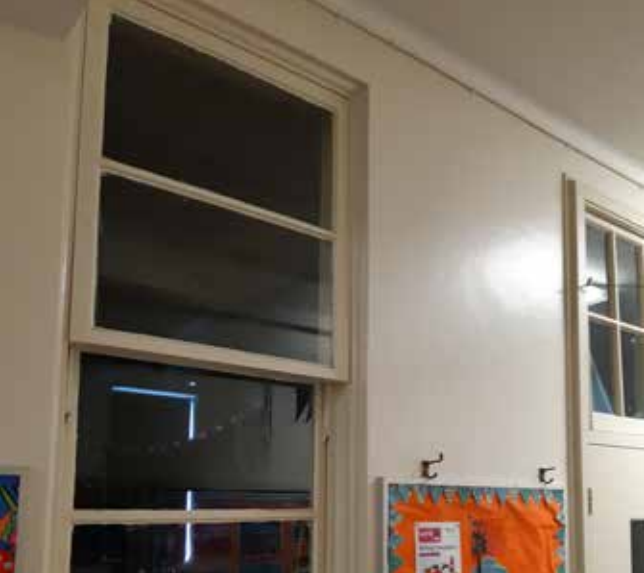
<p>The interior of the building (and selected parts of the exterior such as the doors) may be repainted as part of the works.</p> <p>WORKS:</p> <p>Allow for historic paint scrape analysis to selected original features (timber doors, handrails, internal window frames, skirtings, etc) to assist in preparation of historic colour schedule for appropriate elements.</p>

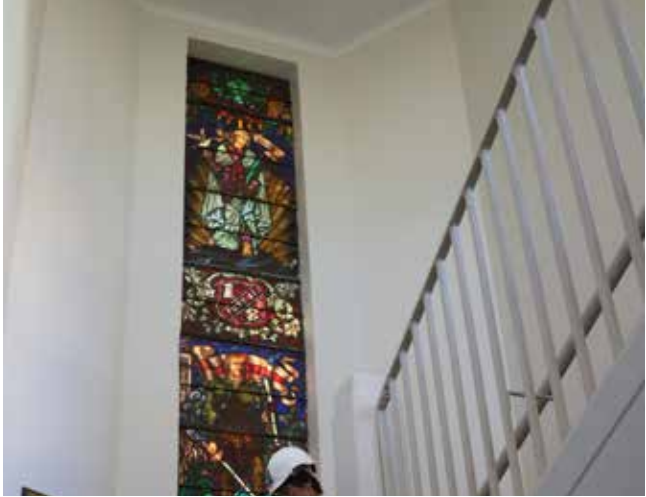
<p>The historic stained glass War Memorial window may require some repair. It would be a positive outcome to remove (or at least upgrade) the external protective grille which is in poor condition</p> <p>WORKS:</p> <p>Allow for the removal or replacement of the security grille to the window. Allow for any necessary cleaning and repairs.</p>

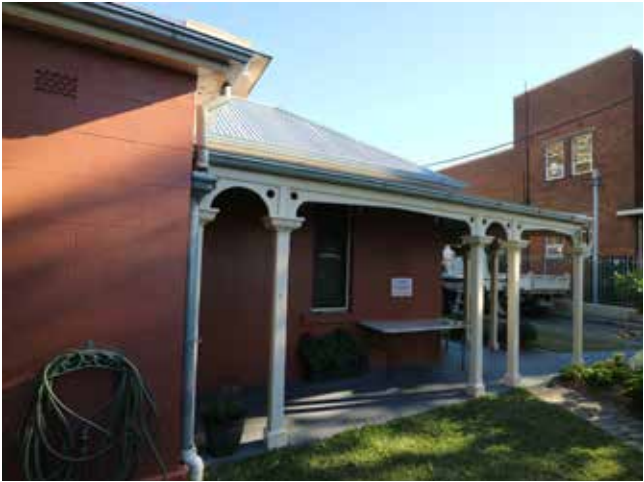
<p>The exterior of the building is in generally good condition.</p> <p>WORKS:</p> <p>Allow for minor repairs only.</p>
