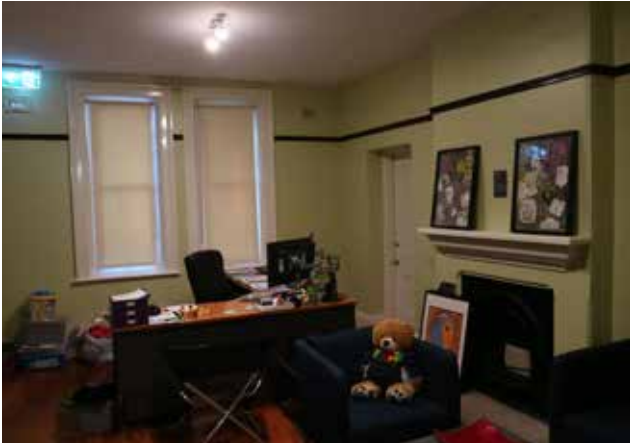
<p>The interior of the cottage is in generally good condition, with a substantial amount of the internal fabric being of new construction but to historically appropriate design.</p> <p>WORKS:</p> <p>Allow for minor repairs only.</p>

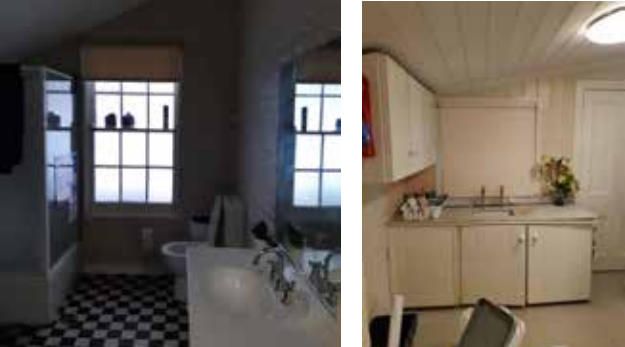
<p>The current bathroom and kitchen are presumed to be modified as part of the works.</p> <p>WORKS:</p> <p>Allow for careful removal and repair any elements as necessary. There may be an opportunity to expose the original external brick wall of the 1862 cottage currently in the bathroom, and this would require appropriate paint stripping.</p>

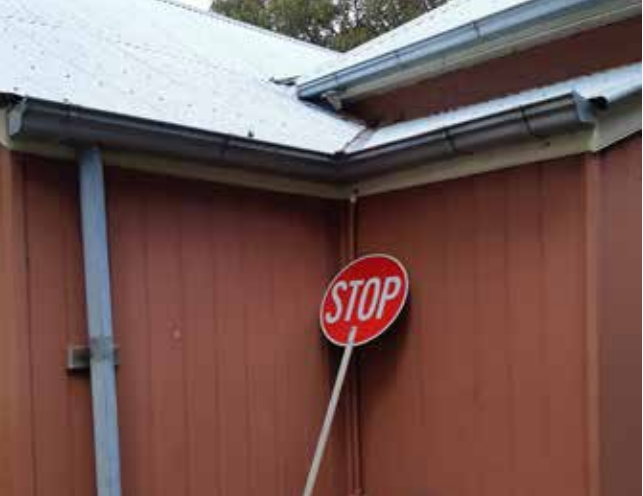
<p>The new roof was installed in 2016. It is in good condition, but there are some loose downpipes and gutter connections.</p> <p>WORKS:</p> <p>Allow for repair to downpipes.</p>

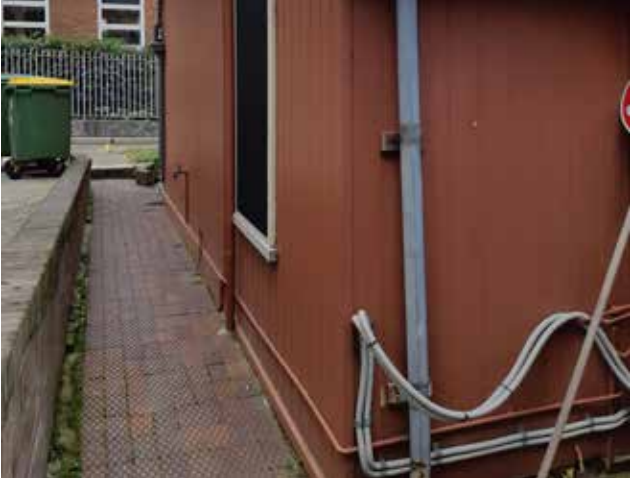
<p>Numerous modern services have been inappropriately installed to the rear of the building.</p> <p>Circulation paths around the building will likely need to be reconfigured.</p> <p>WORKS:</p> <p>Allow for removal/consolidation of necessary cabling. Install cover and paint in to reduce visual impact.</p> <p>Allow for new pathways to the building perimeter. Consider upgrading the modern concrete verandah with sandstone to appropriate detail (it is presumed the building had a stone flagged verandah).</p>

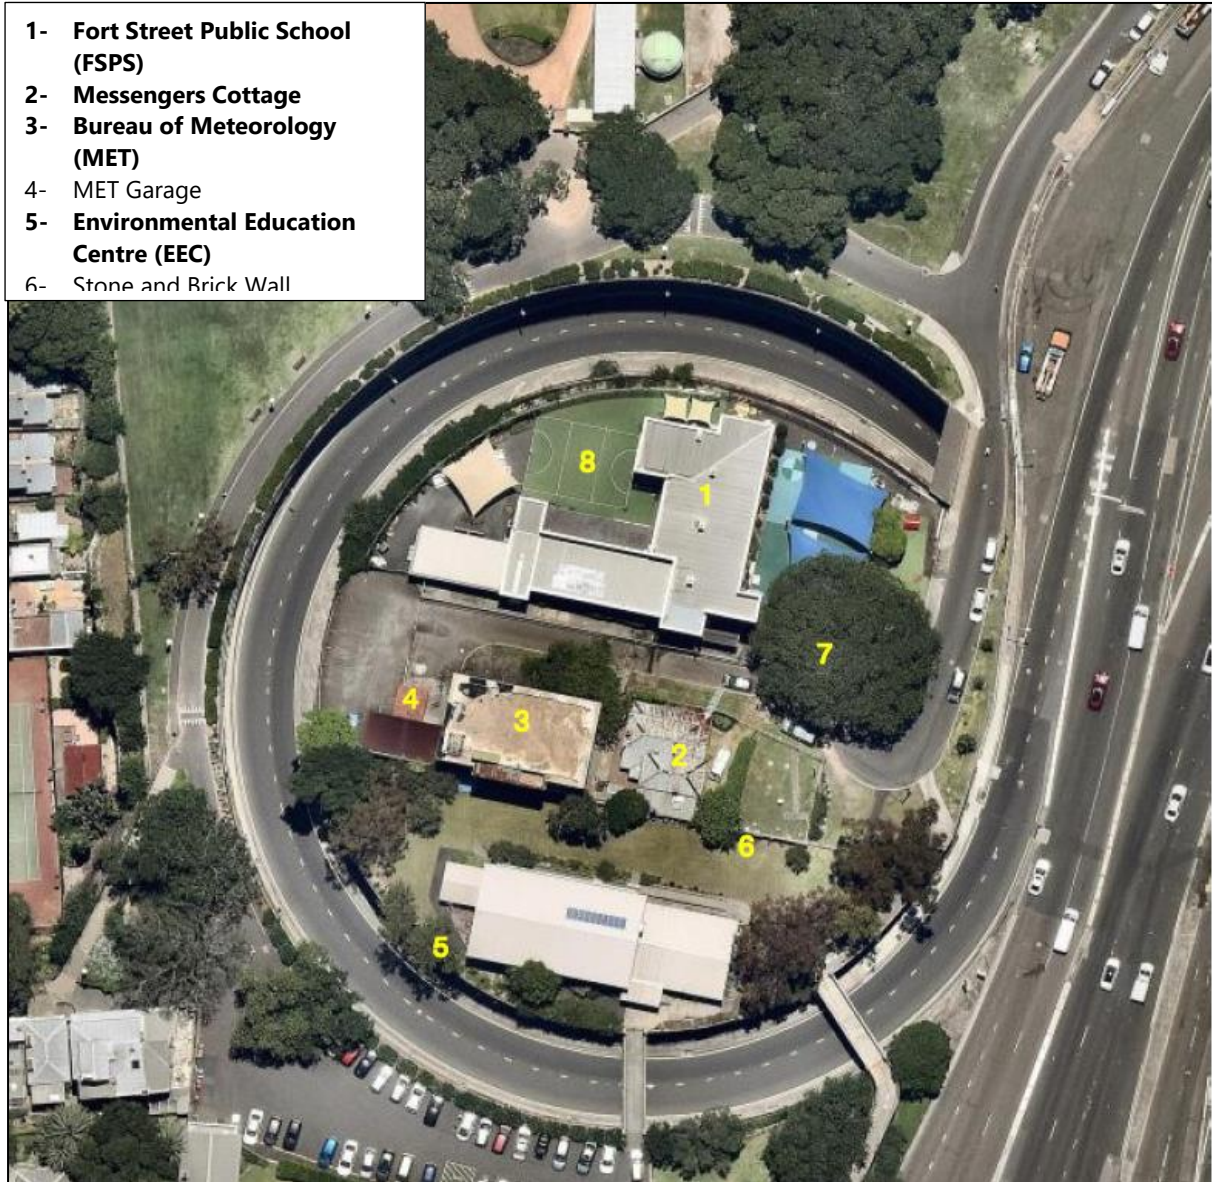
Figure 1-2 Fort Street Public School site photo showing major built elements currently on site. (Source: TKD 2016, Fig. 36)

The Fort Street School (FSPS) site currently consists of four main buildings (Figure 1-2): The Fort Street School; The Messengers Cottage; The Bureau of Meteorology building (MET Building), and the Environmental Educational Centre (EEC) building. Of these four structures, only the EEC building is not heritage listed.

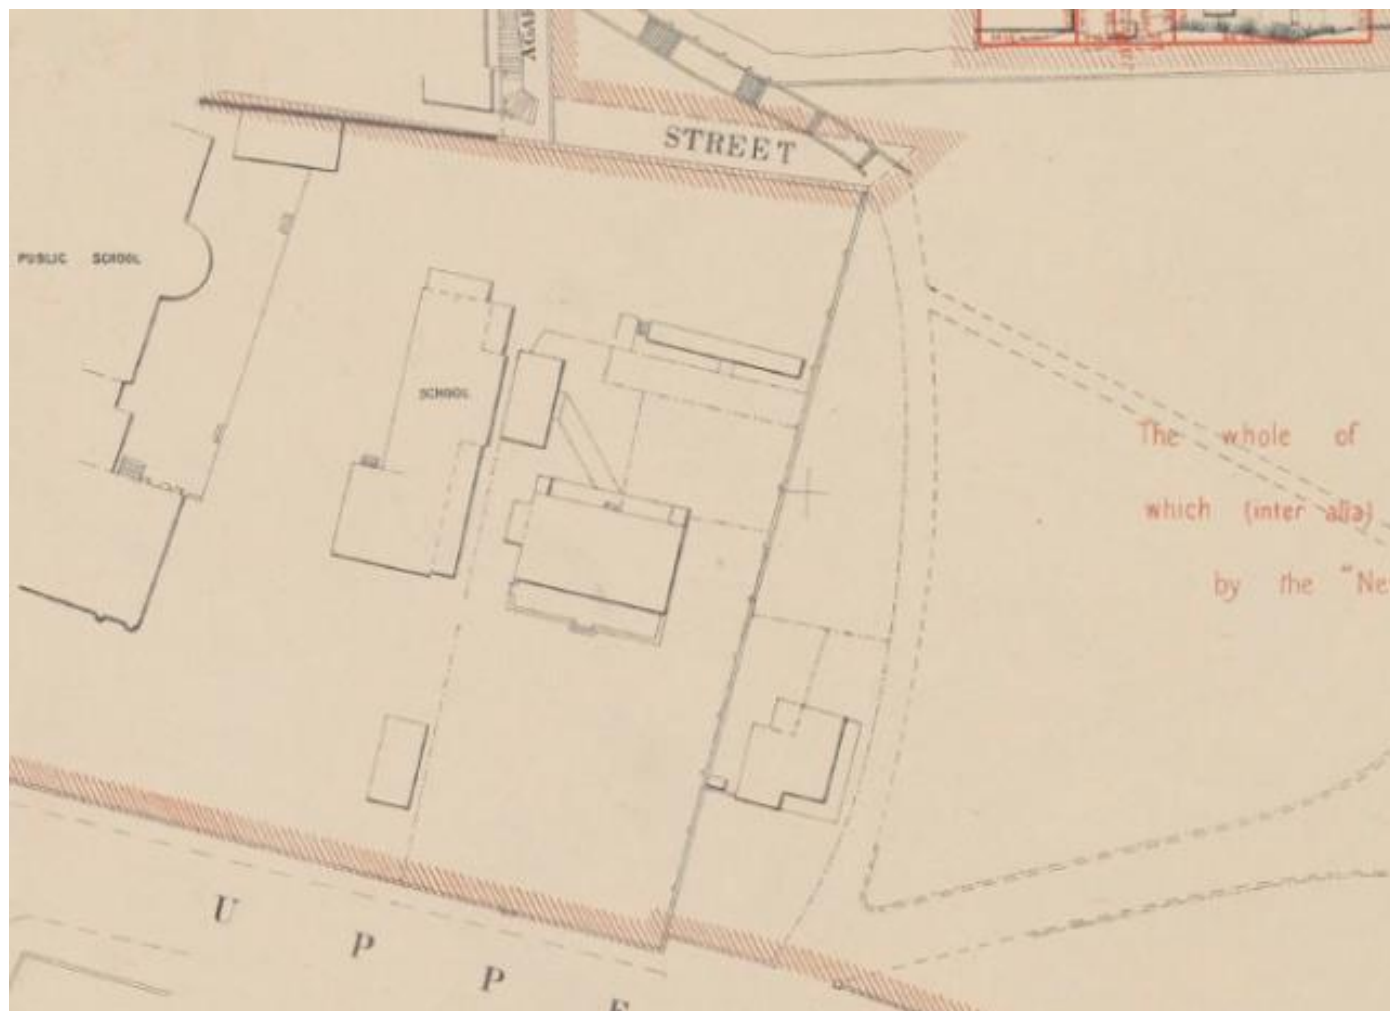
Figure 2-2 Detail of plan of the Fort Street study area in 1901. Note the additional structures, fences etc adjacent to the Surgeon's Quarters. (Source: NSW State Archives 1901 Resumption Plans)
