FORT STREET PUBLIC SCHOOL
OBSERVATORY HILL
SYDNEY, NSW, 2000

STORMWATER DRAINAGE PLAN

DRAWING No. FS-CV-DRG-104.0000

Aboriginal Cultural Heritage Assessment Report

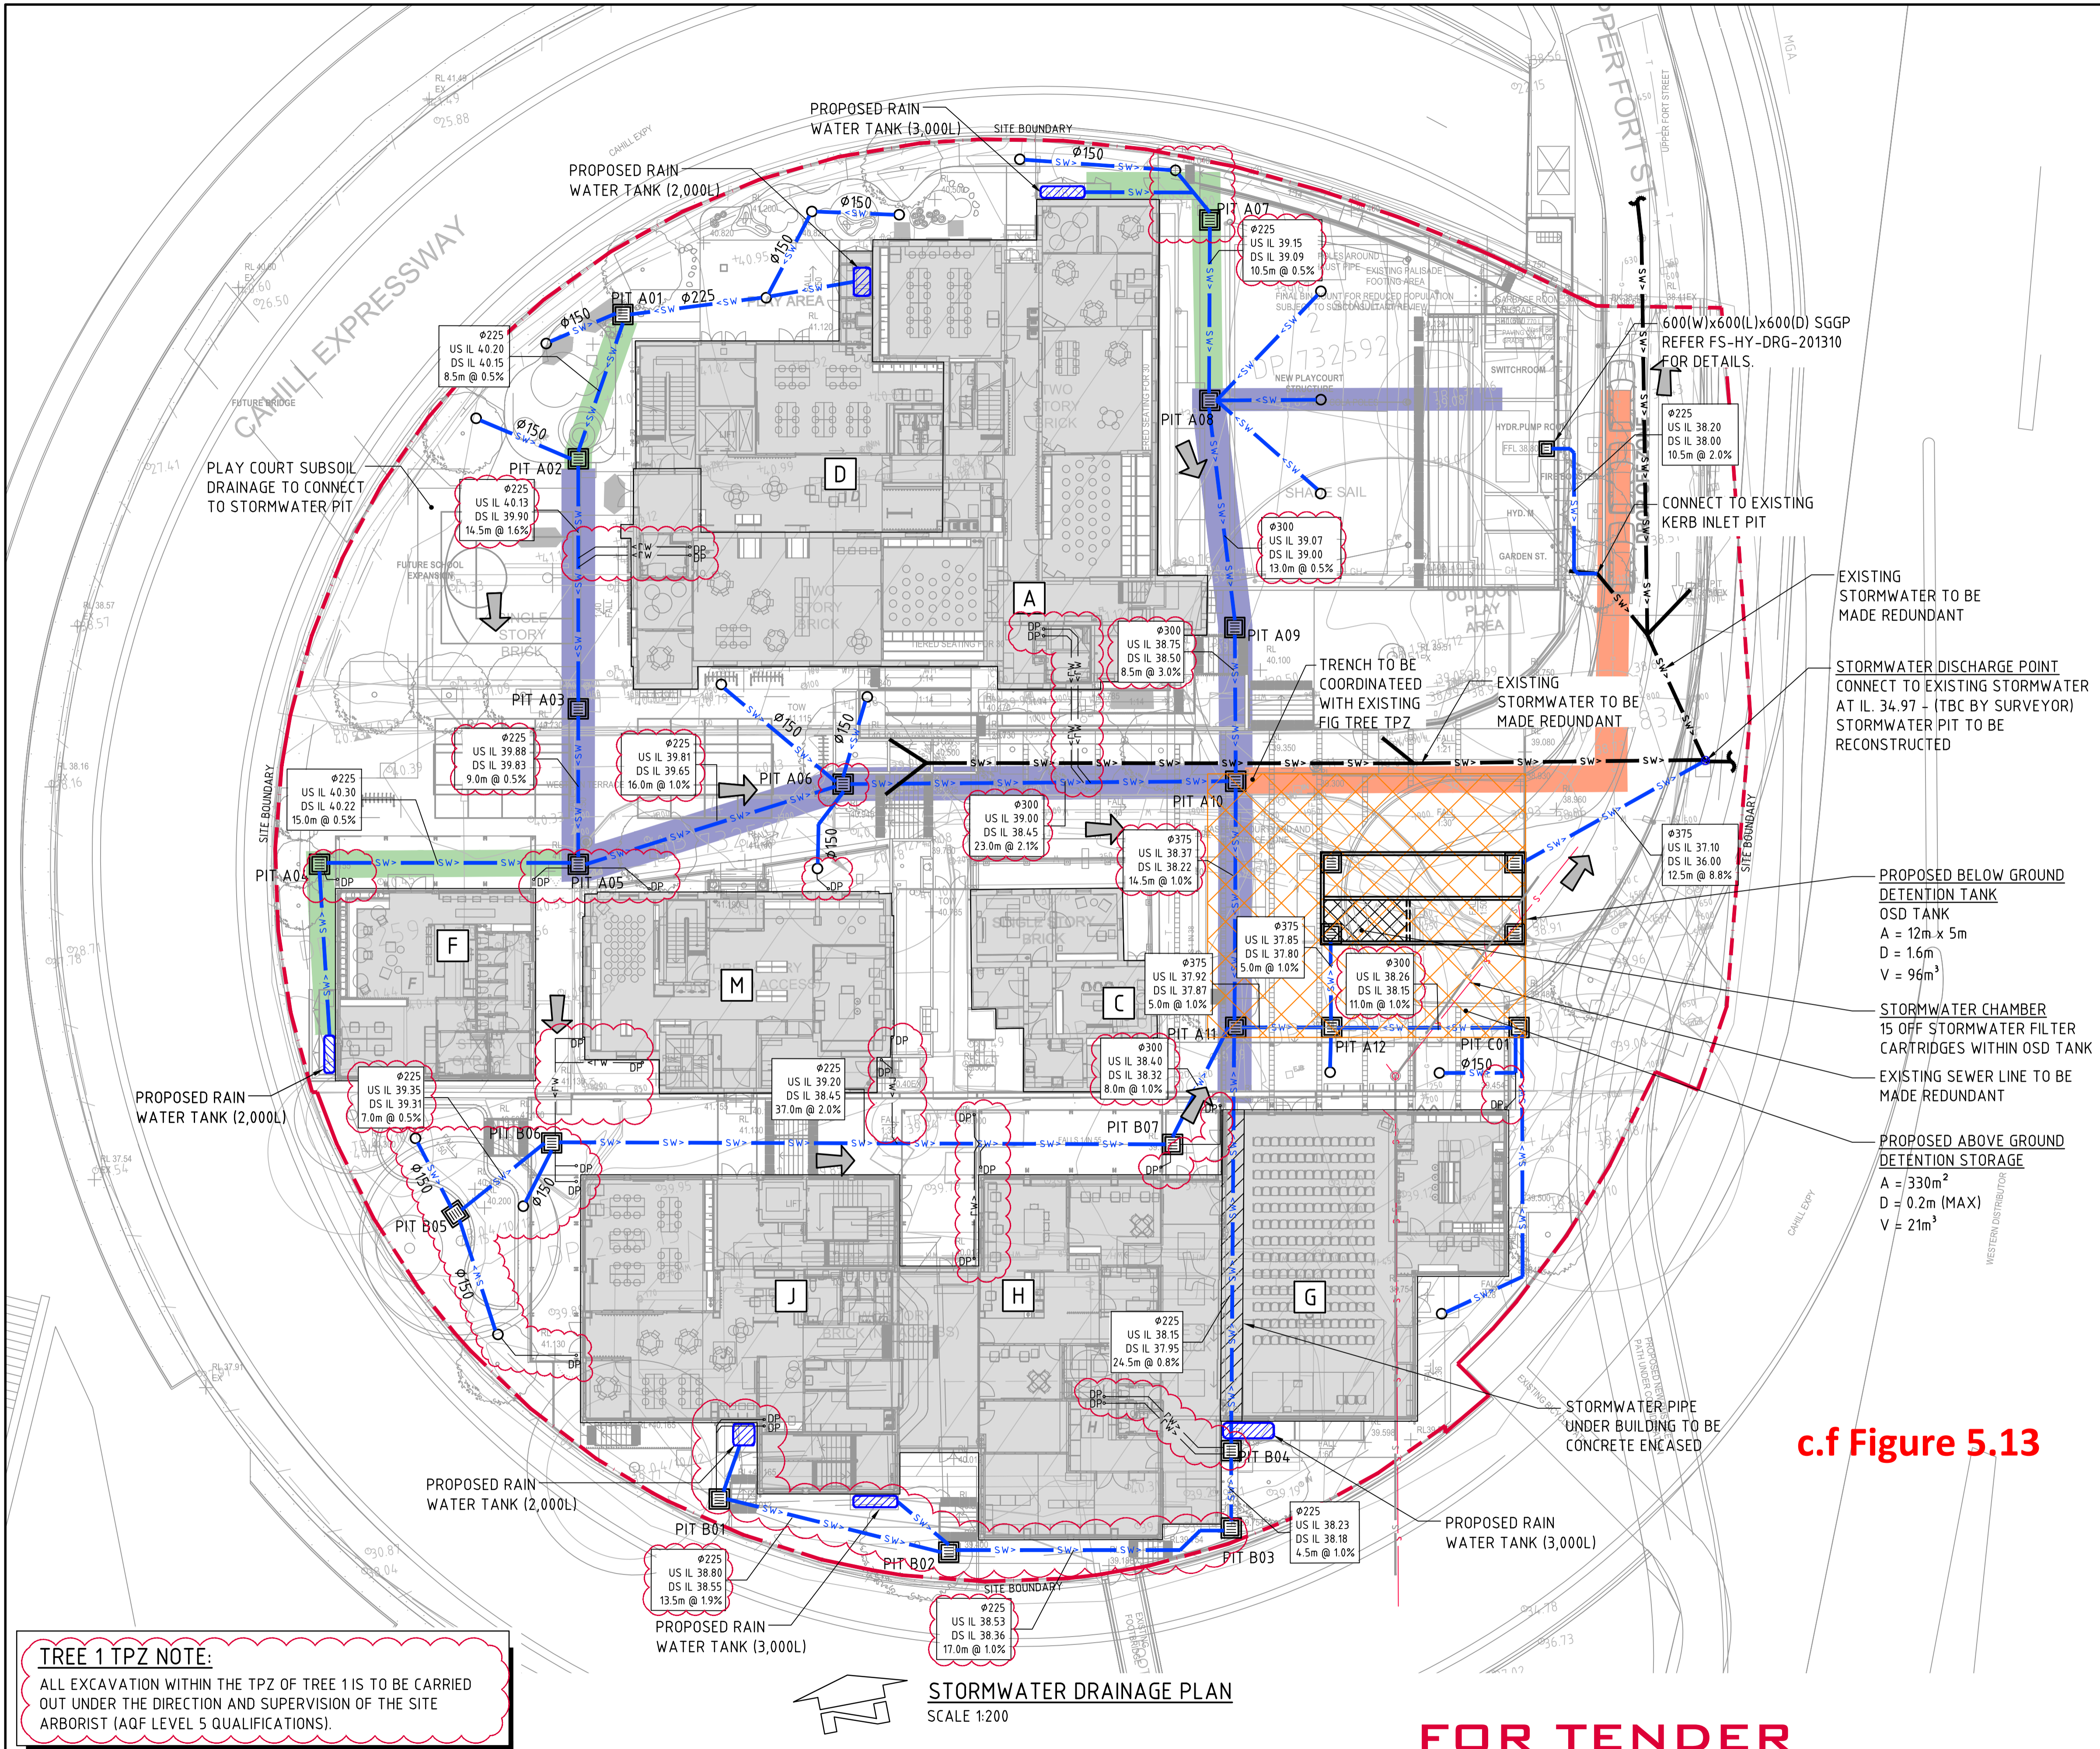
STORMWATER DRAINAGE PLAN
SCALE 1:200

- SGGP, SINGLE GRATED GULLY PIT
- RWO, RAINWATER OUTLET
- GD, GRATED DRAIN
- PROPOSED DRAINAGE LINE
- EXISTING DRAINAGE LINE
- ROOFWATER DOWNPIPE (INDICATIVE)
- ROOFWATER LINE
- EXISTING SEWER LINE
- PROPOSED RAINWATER TANK
- OVERLAND FLOW DIRECTION
- DENOTES SHARED TRENCH - TYPE 1
- STORMWATER - HYD
- POWER - FIRE
- COMMS - SEWER
- DENOTES SHARED TRENCH - TYPE 2
- HYD - POWER
- FIRE - SEWER
- DENOTES SHARED TRENCH - TYPE 3
- STORMWATER - HYD/SEWER
- DENOTES ABOVE GROUND DETENTION STORAGE

NOTE:
ALL SURFACE INLET PITS TO BE FITTED WITH OCEAN PROTECT OCEAN GUARD PIT INSERTS.

NOTE:
ALL NEW ROOF AREAS TO DISCHARGE TO PROPOSED RAINWATER TANK WITH OVERFLOW TO NEAREST STORMWATER PIT U.N.O.

TREE 1 TPZ NOTE:
ALL EXCAVATION WITHIN THE TPZ OF TREE 1 IS TO BE CARRIED OUT UNDER THE DIRECTION AND SUPERVISION OF THE SITE ARBORIST (AQF LEVEL 5 QUALIFICATIONS).

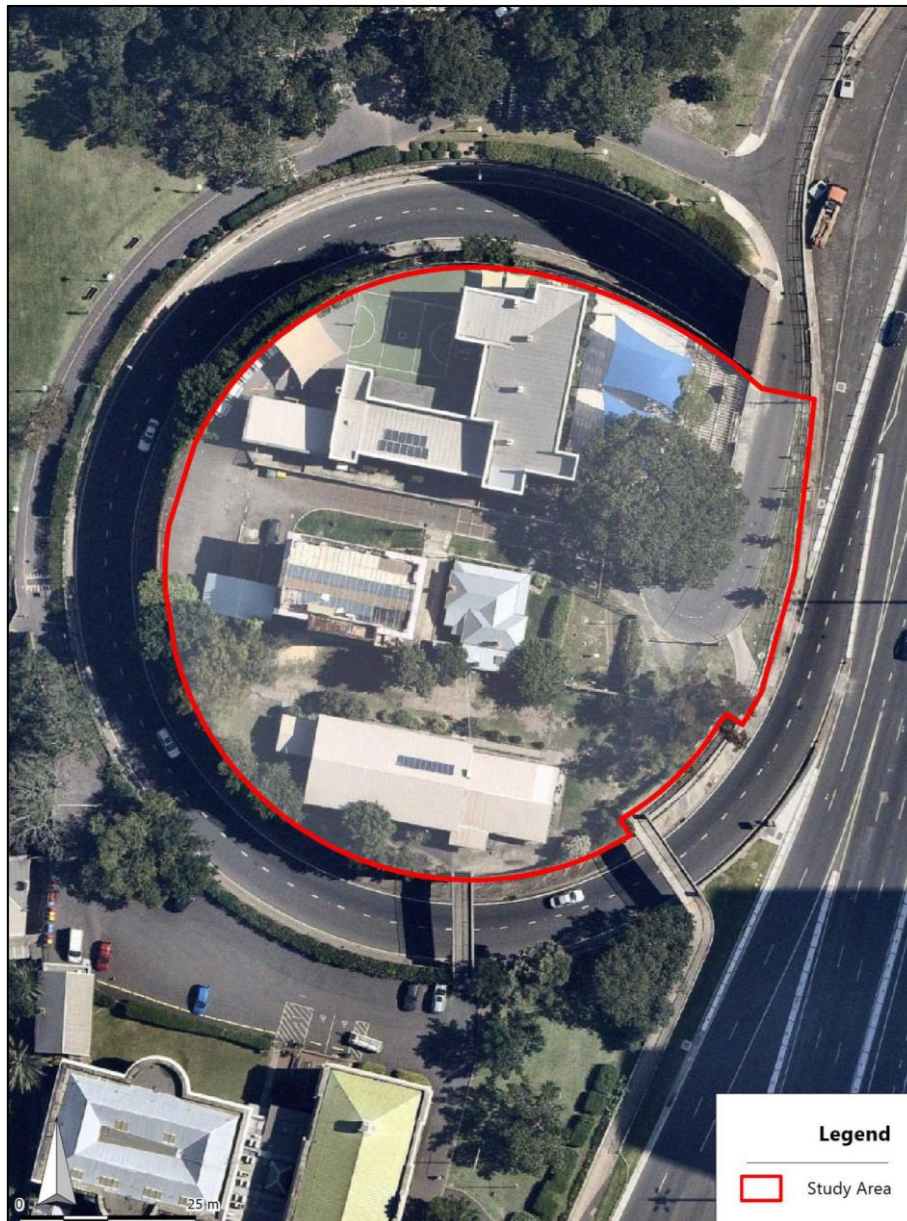
Figure 1.1: General FSPS Study area Location. (Source: Curio 2019)

The Fort Street Public School site (the study area) is located on Observatory Hill, at Upper Fort Street, Millers Point, and is generally defined by the circular cut of the Cahill Expressway on ramp (Figure 1.1). The study area is located to the south of the Sydney Observatory, between the Bradfield Highway in the east, and residential development along Kent Street to the west (Figure 1.2).

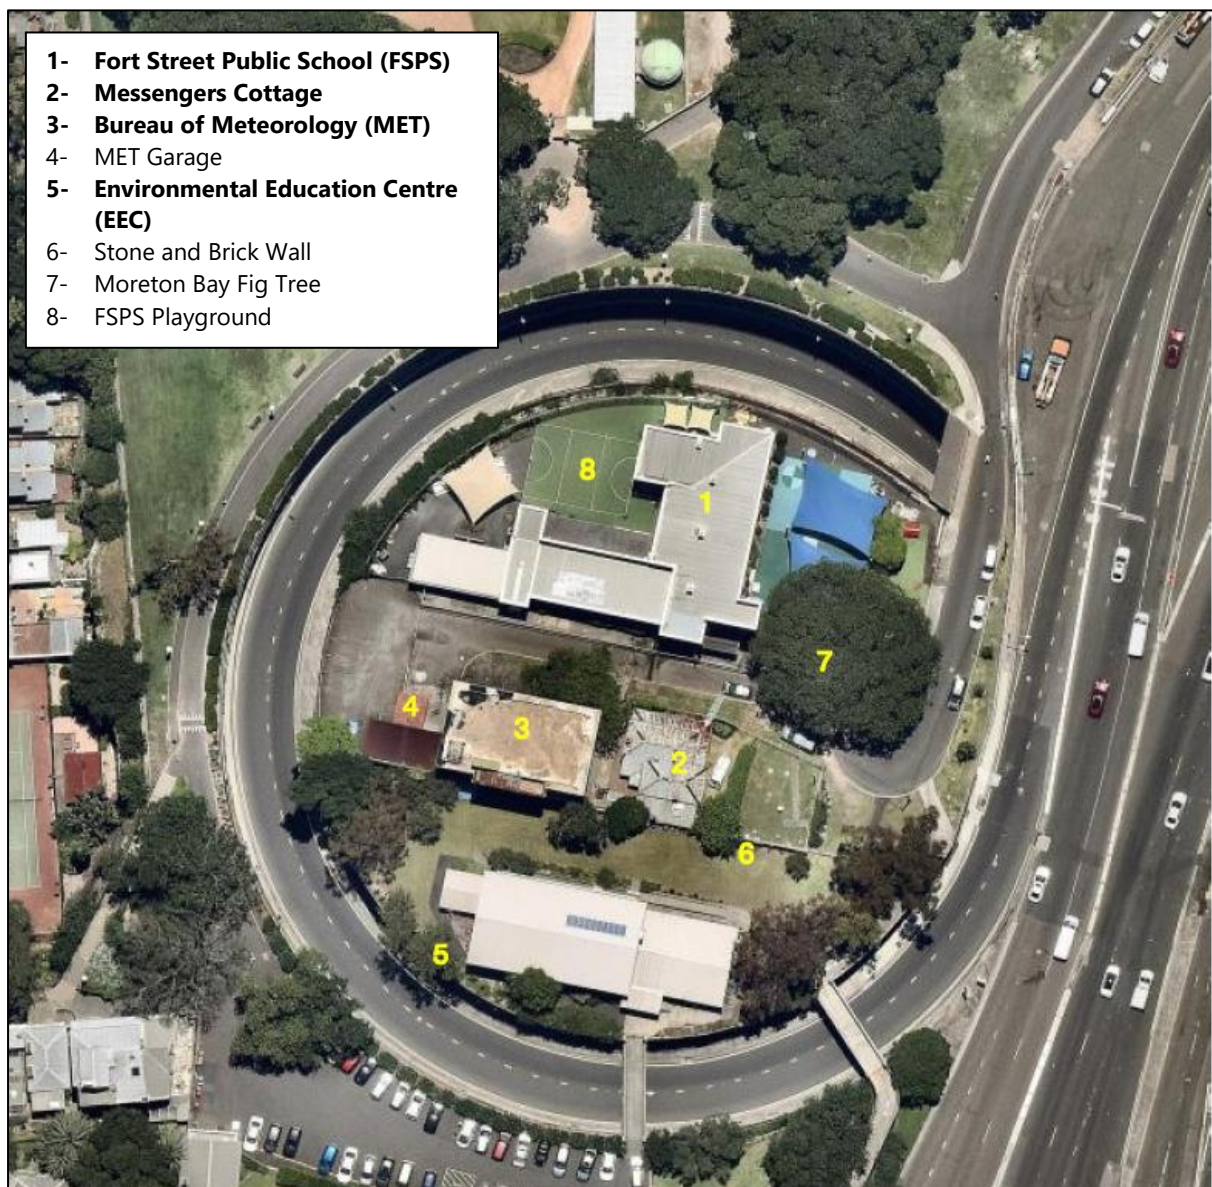
Figure 1.3: FSPS Site Plan (Source: TKD 2016, Fig. 36)

The Fort Street School (FSPS) site currently consists of four main buildings (Figure 1.3): The Fort Street School; The Messengers Cottage; The Bureau of Meteorology building (MET Building), and the Environmental Educational Centre (EEC) building. Of these four structures, only the EEC building is not heritage listed.

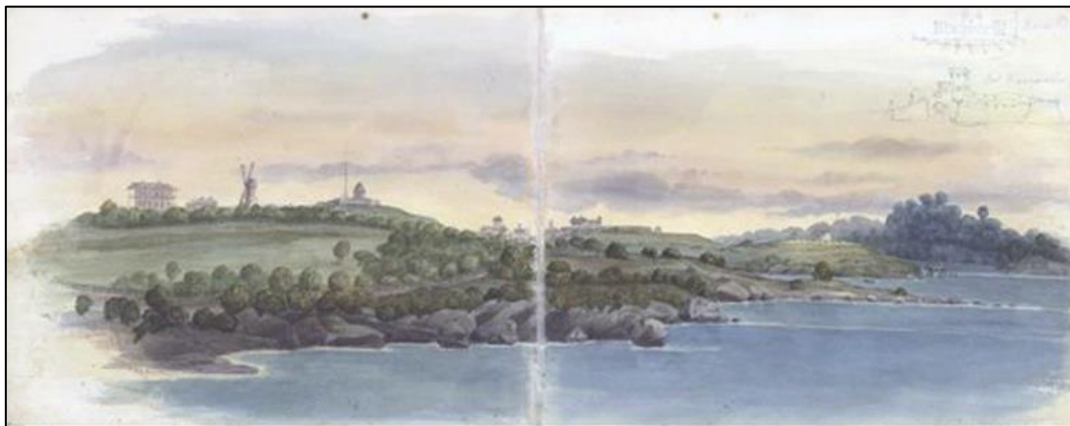
Figure 3.3: Illustration of early European alterations to the nature environment, c.1818. (L to R) Military Hospital, Third Government Windmill and Fort Phillip (Source: NLA.Pic-An4563834-S8).

Very early in the history of the NSW colony, the natural environment of the Millers Point and Observatory Hill area was subject to early alterations by colonists including extensive land clearing, establishment of quarries and early roadway infrastructure (Figure 3.3).

- Initial vegetation and land clearing (1788-1790s) (Figure 3.3);
- Construction of government windmills (1790s) Fort Phillip (1804) and later Sydney Observatory;
- Construction of the Military Hospital and associated buildings (1815-1849);
- Modification of Military Hospital for Fort Street School including additional buildings for school use (1849-1960s), construction of the Messengers Cottage (associated with the Observatory) (1862), and the Bureau of Meteorology Building (1922);
- Construction of the Cahill Expressway, including deep excavation and demolition of previous site buildings (1940s-50s) (Figure 3.5).

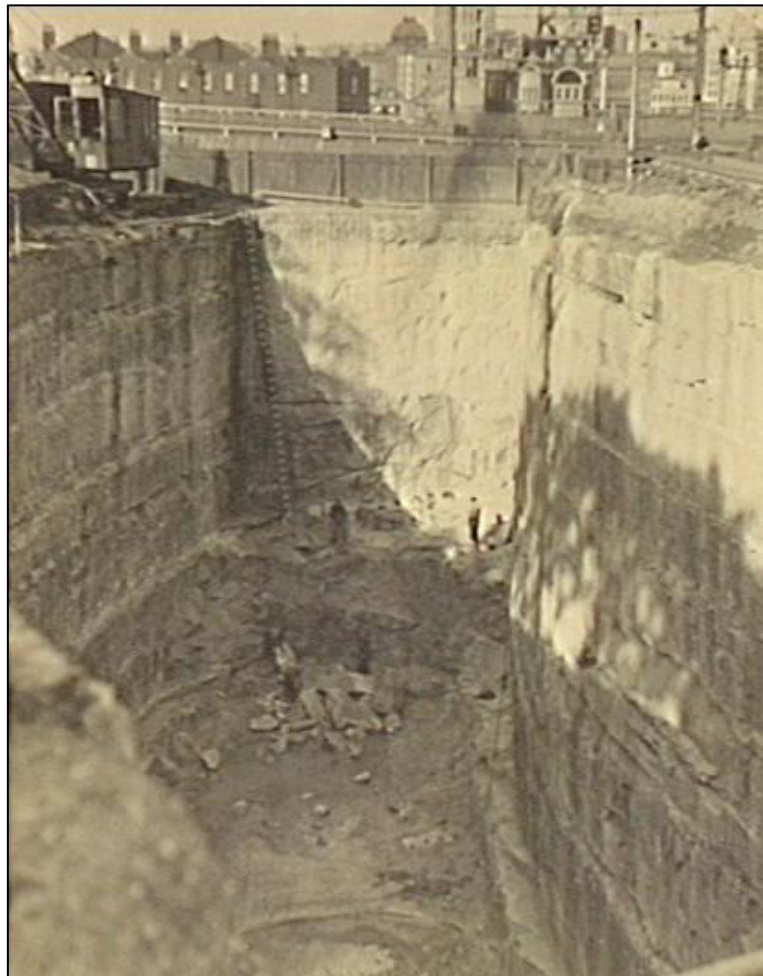
Figure 3.5: Deep Excavation for the Cahill Expressway, 1940

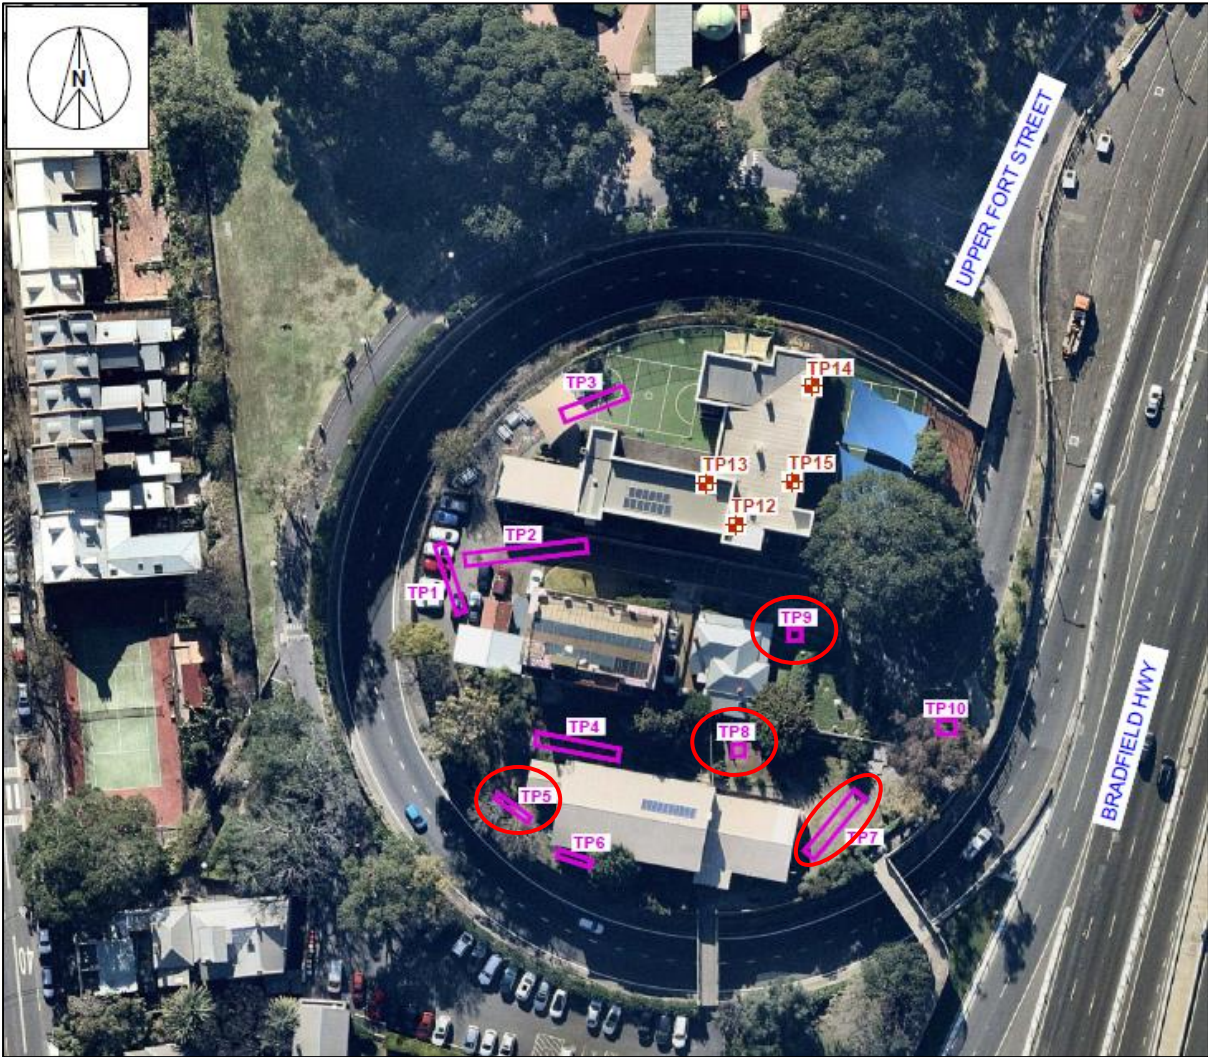
Figure 3.7: 2019 Test Pits (Historical Archaeological trenches in pink, DP in red (Source: Douglas Partners 2019). Locations with potential natural soil profiles circled in red.

The 2019 investigation generally confirmed the results of that undertaken in 2017: that residual soils have likely been historically removed across most of the site- shown by locations presenting as historical fill directly over sandstone bedrock- with some small select areas potentially presenting with isolated pockets of residual clayey sand soils.

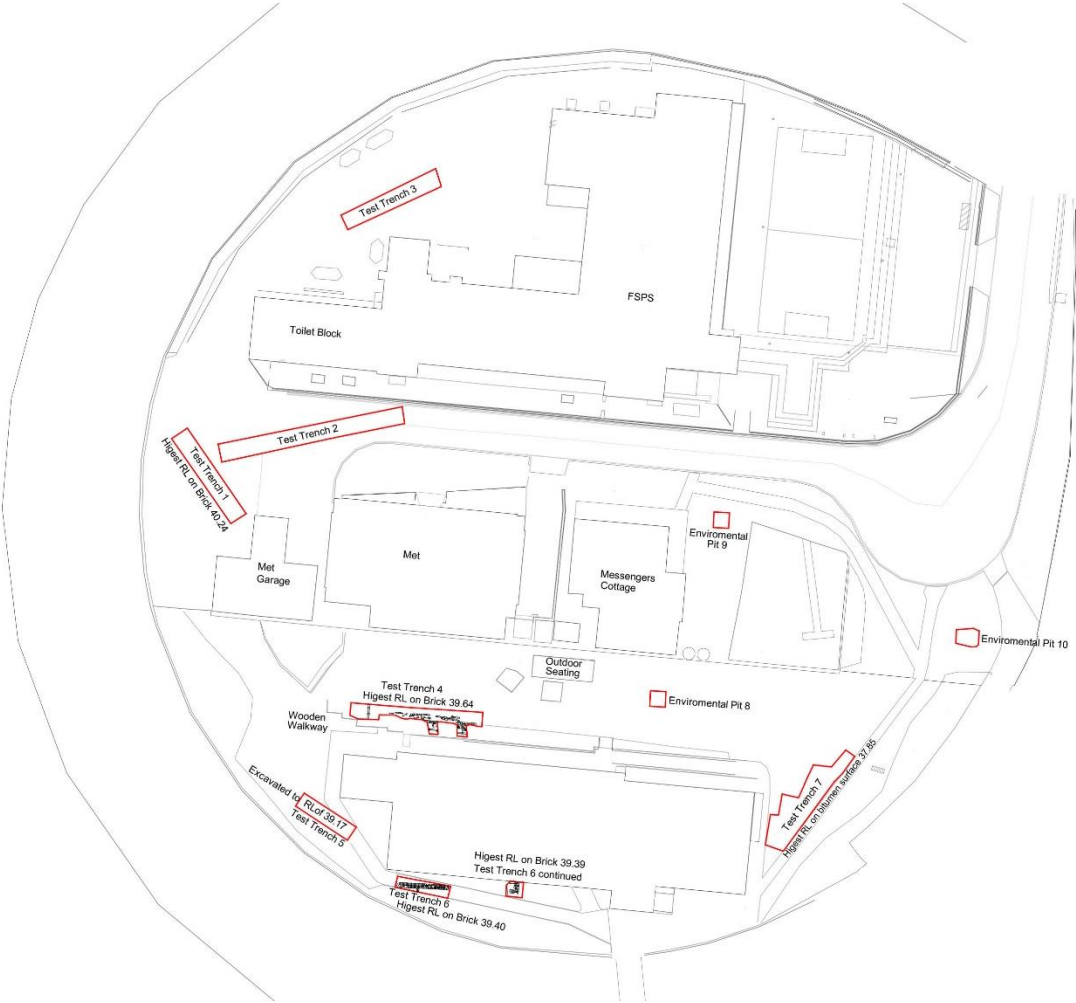
Figure 3.9: Historical Archaeological Test Excavation Trenches Plan (Source: Curio 2019, drawn by B. Owens)

Of the test trenches, Trenches 1, 2, 3, 4, and 6 presented with historical archaeology/fill directly overlying sandstone bedrock. Trench 5 presented with a potential thin natural soil profile- partly disturbed- described as a 'mid brown sandy soil with extensive root disturbance'. Trench 7 was highly disturbed in the upper stratigraphy, with the deeper layers not able to be recorded properly due to WHS restrictions, however the trench extended to a maximum depth of 2.6m, with potentially buried natural soil profiles in its deeper stratigraphy underlying a layer of bitumen (Figure 3.10).
