4. Preliminary Assessment of Non-Aboriginal Archaeological Potential and Significance

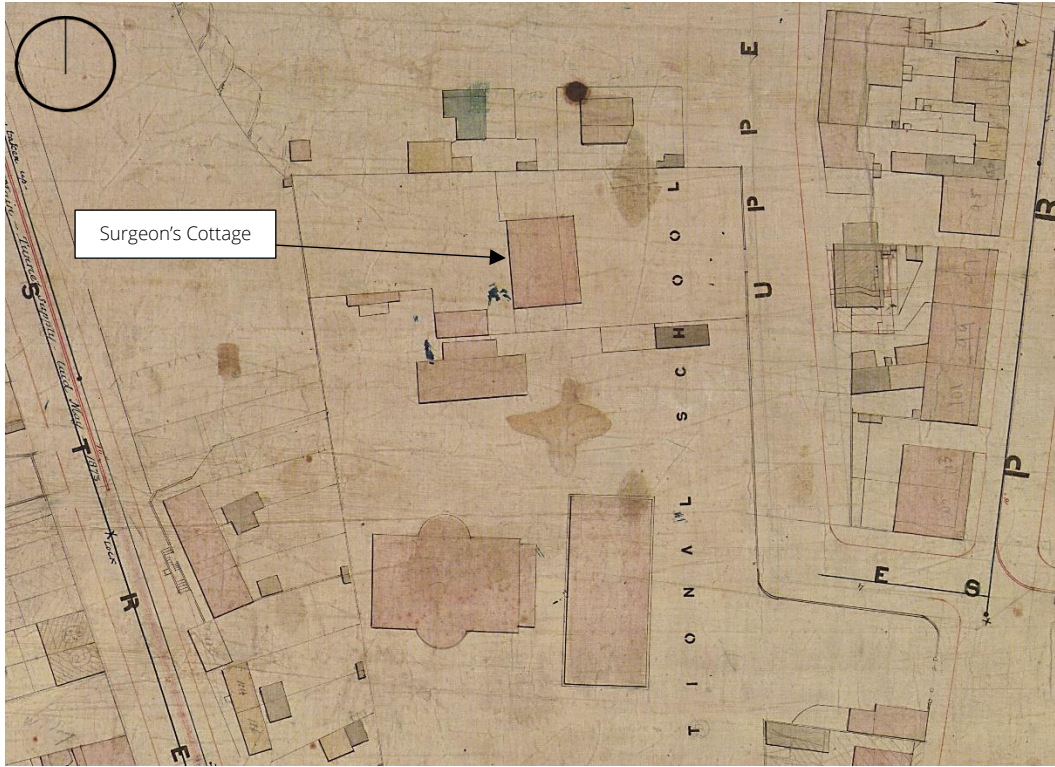
Figure 3-16 Detail of Block A1, City of Sydney - Trigonometrical Survey, 1855-1865. (Source: Historical Atlas of Sydney)

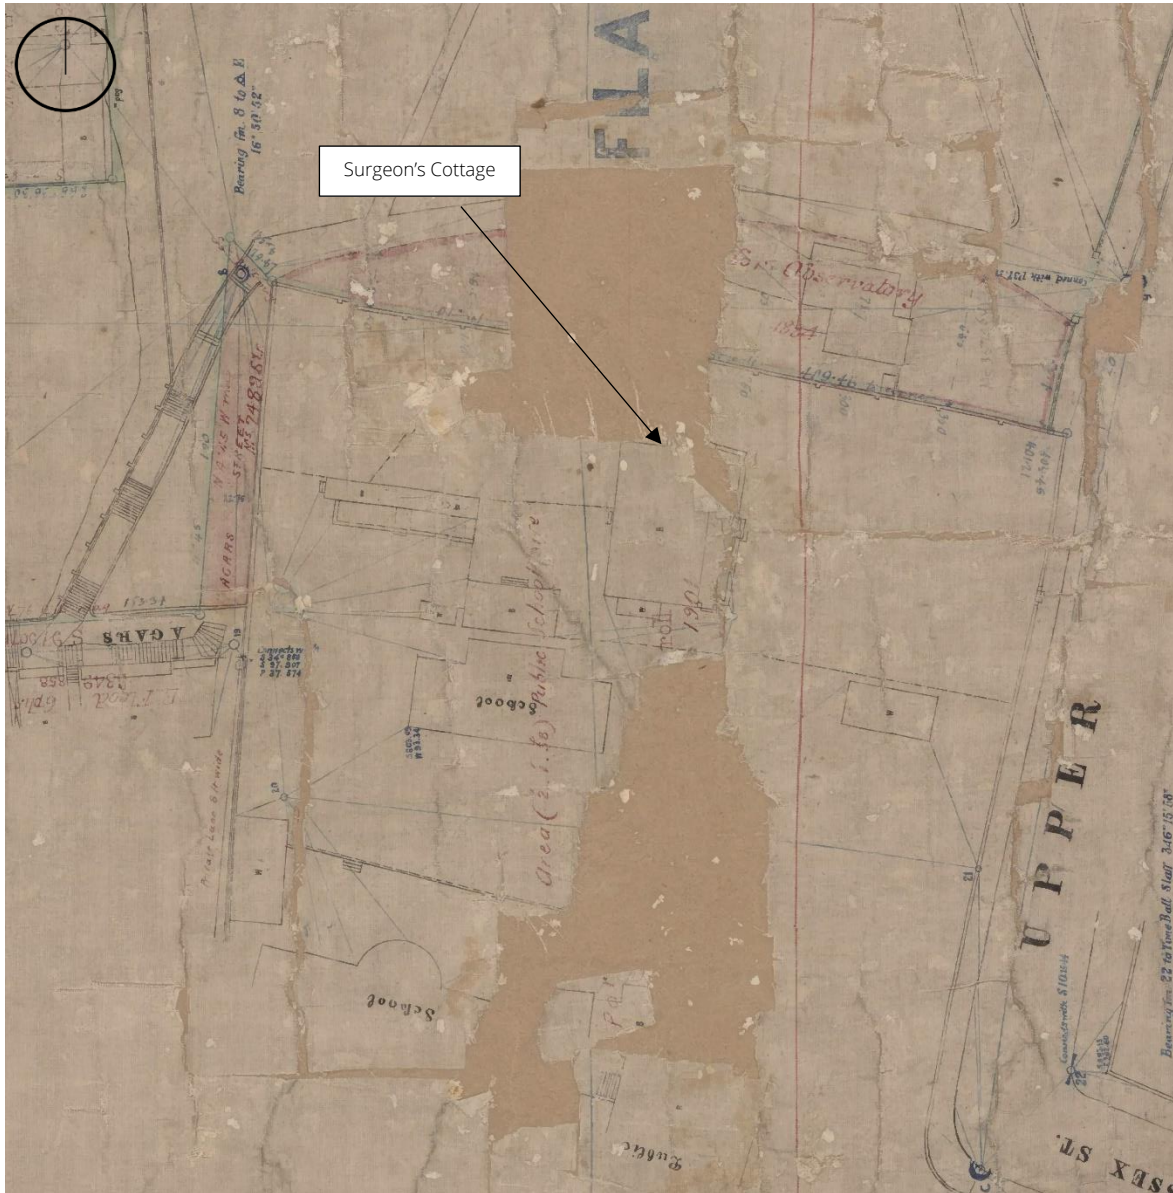
Figure 3-18 Detail of a badly damaged Crown Plan showing the surgeon's cottage in 1882. (Source: LPI CP34.2063)

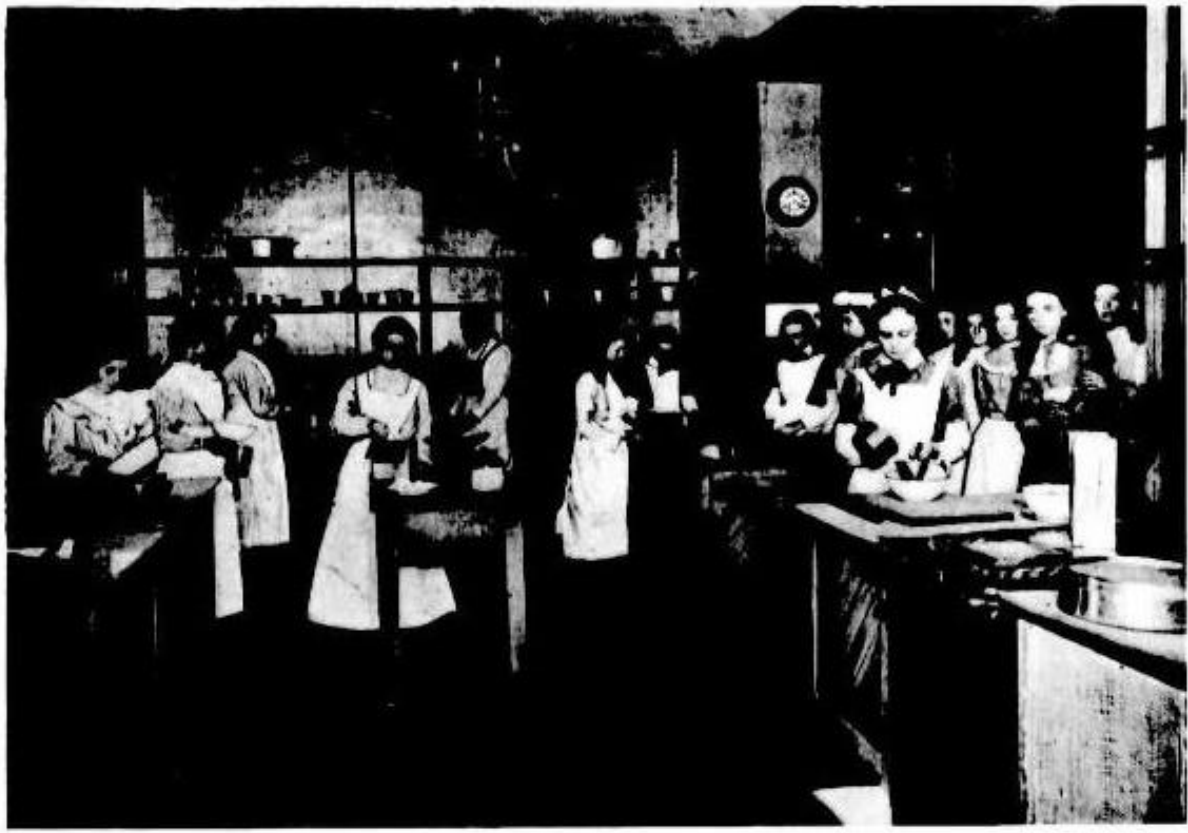
THE COOKING SCHOOL.

Figure 3-20. The newly opened Fort Street Public's Cookery School in the former Surgeon's Cottage. Source. Australian Town and Country Journal, 27 May 1903. The Girls' School at Fort-street, Sydney, p. 33.

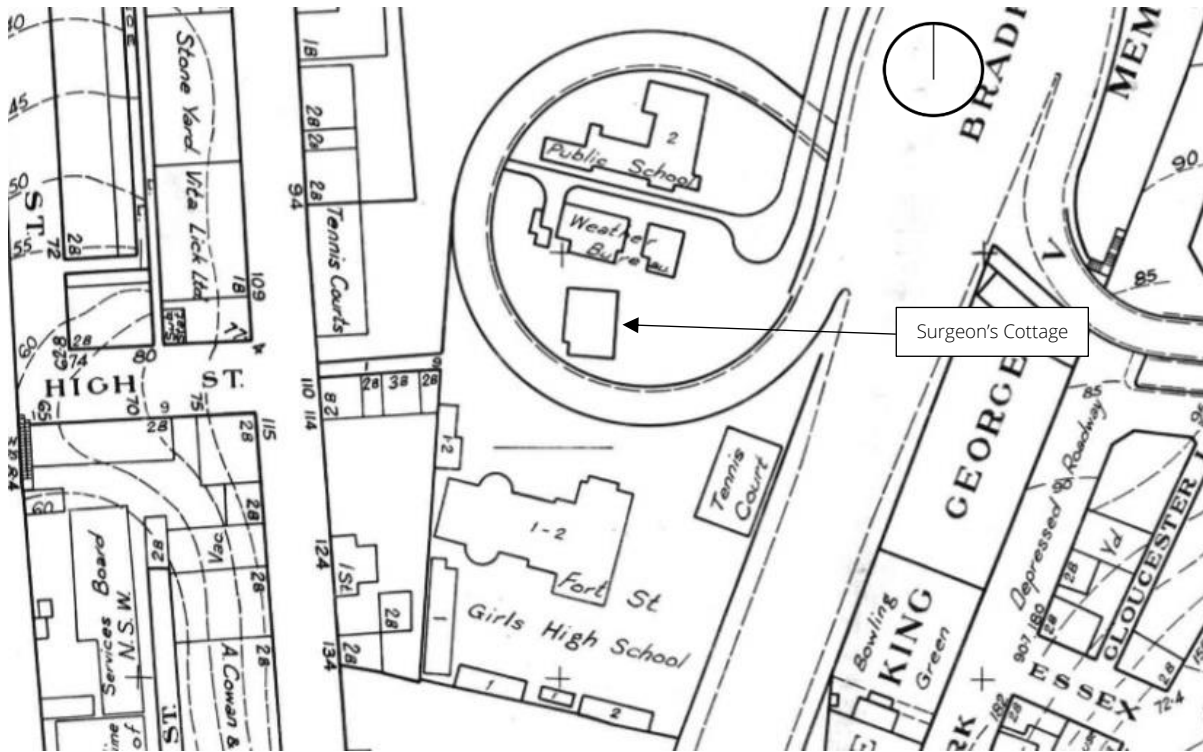
Figure 3-27. City of Sydney Civic Survey (Map 6) prepared in 1948 after the construction of the Sydney Harbour Bridge, Bradfield Highway, and circular cut for the Cahill Expressway. Note all outbuildings west of the cottage have been demolished, and only the cottage remains. Source. City of Sydney Archives, Unique ID A-00880366.

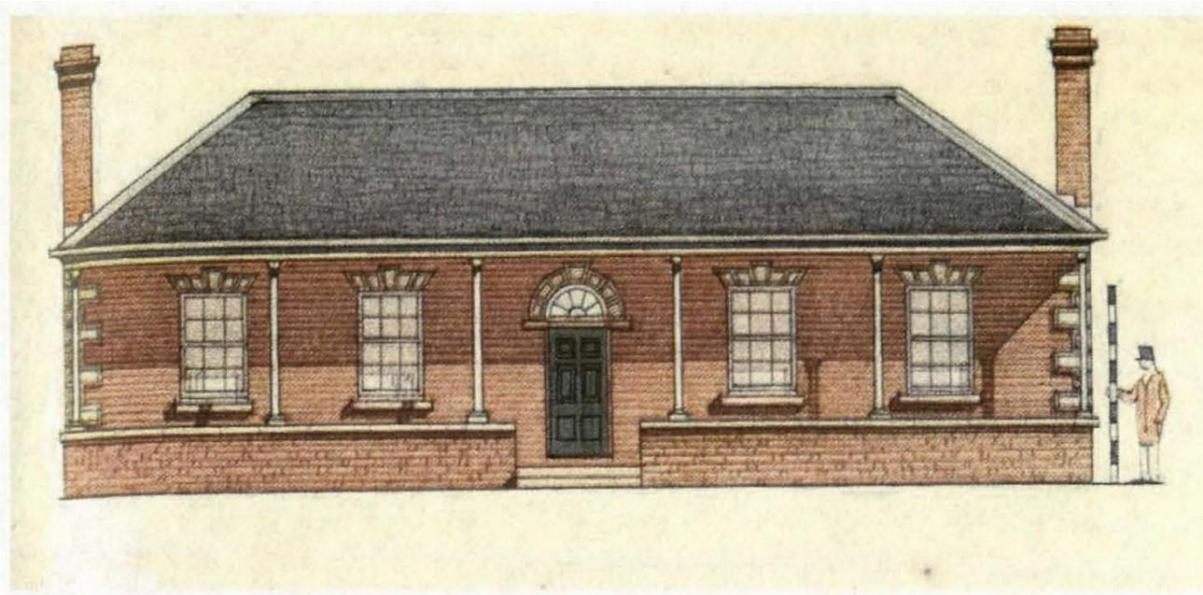
Figure 3-28. Elevation of the Surgeon's Cottage drawn by Morton Herman prior to its demolition. Source. Herman 1954, Figure 39, in Casey and Lowe, 2005, p. 18.

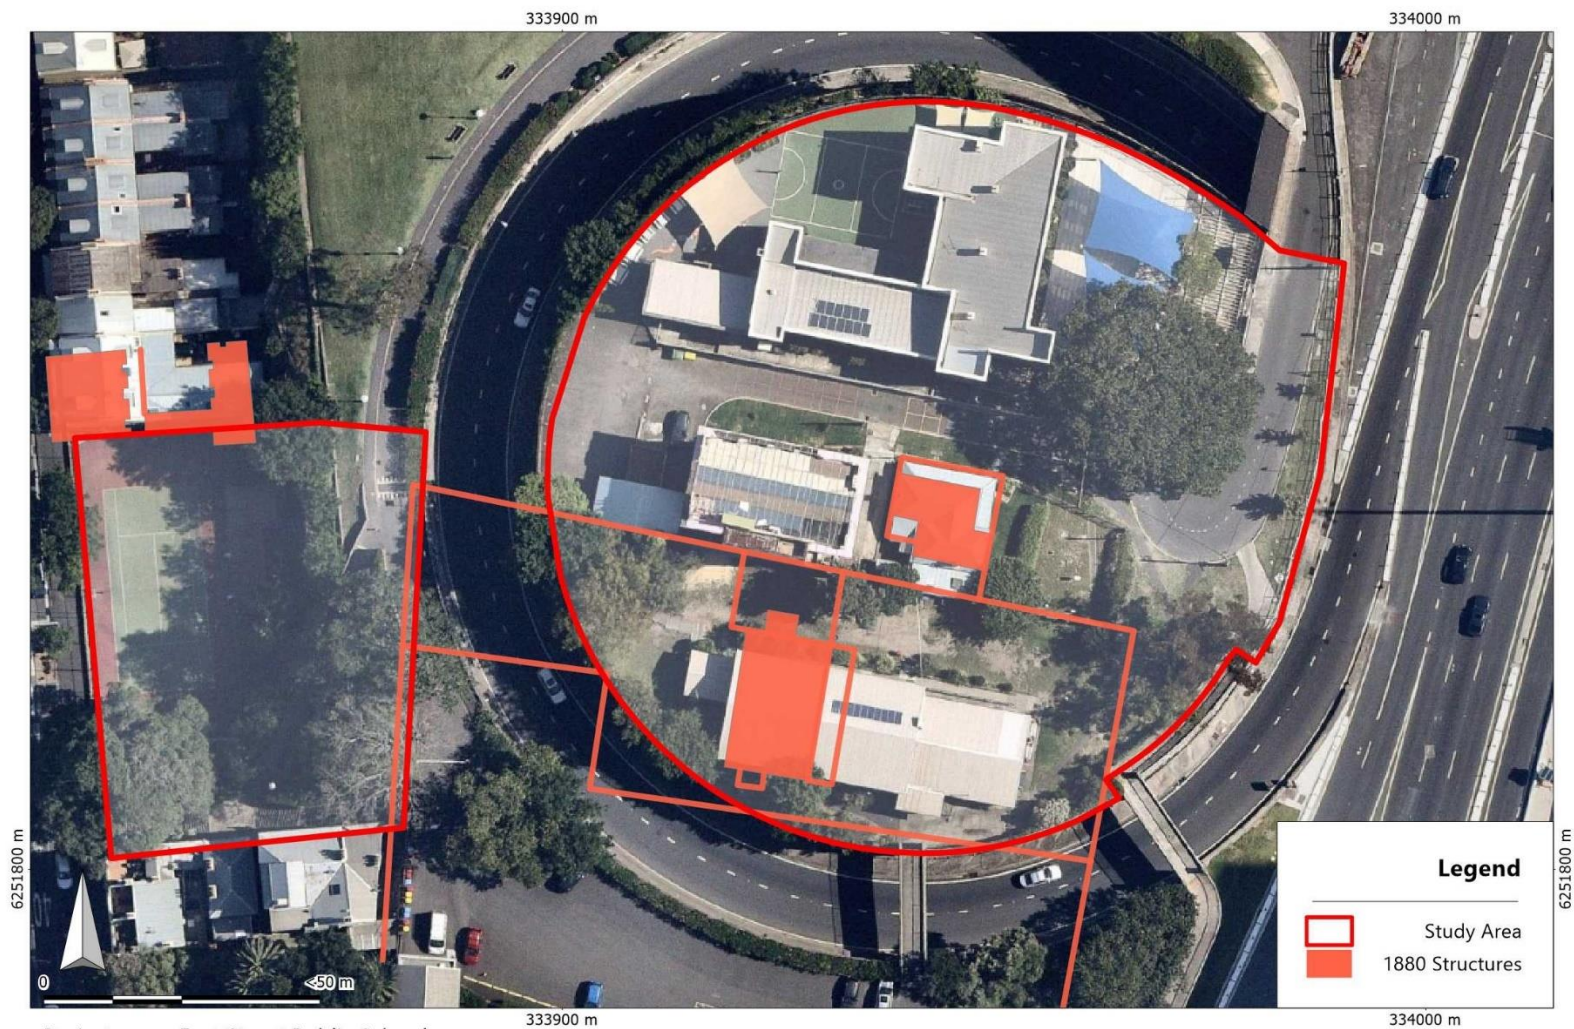
Figure 4-1 Overlay of 1880s plan of the study area. Note the small structures attached to the north and south walls of the Surgeon's Cottage. Source: Curio 2019.

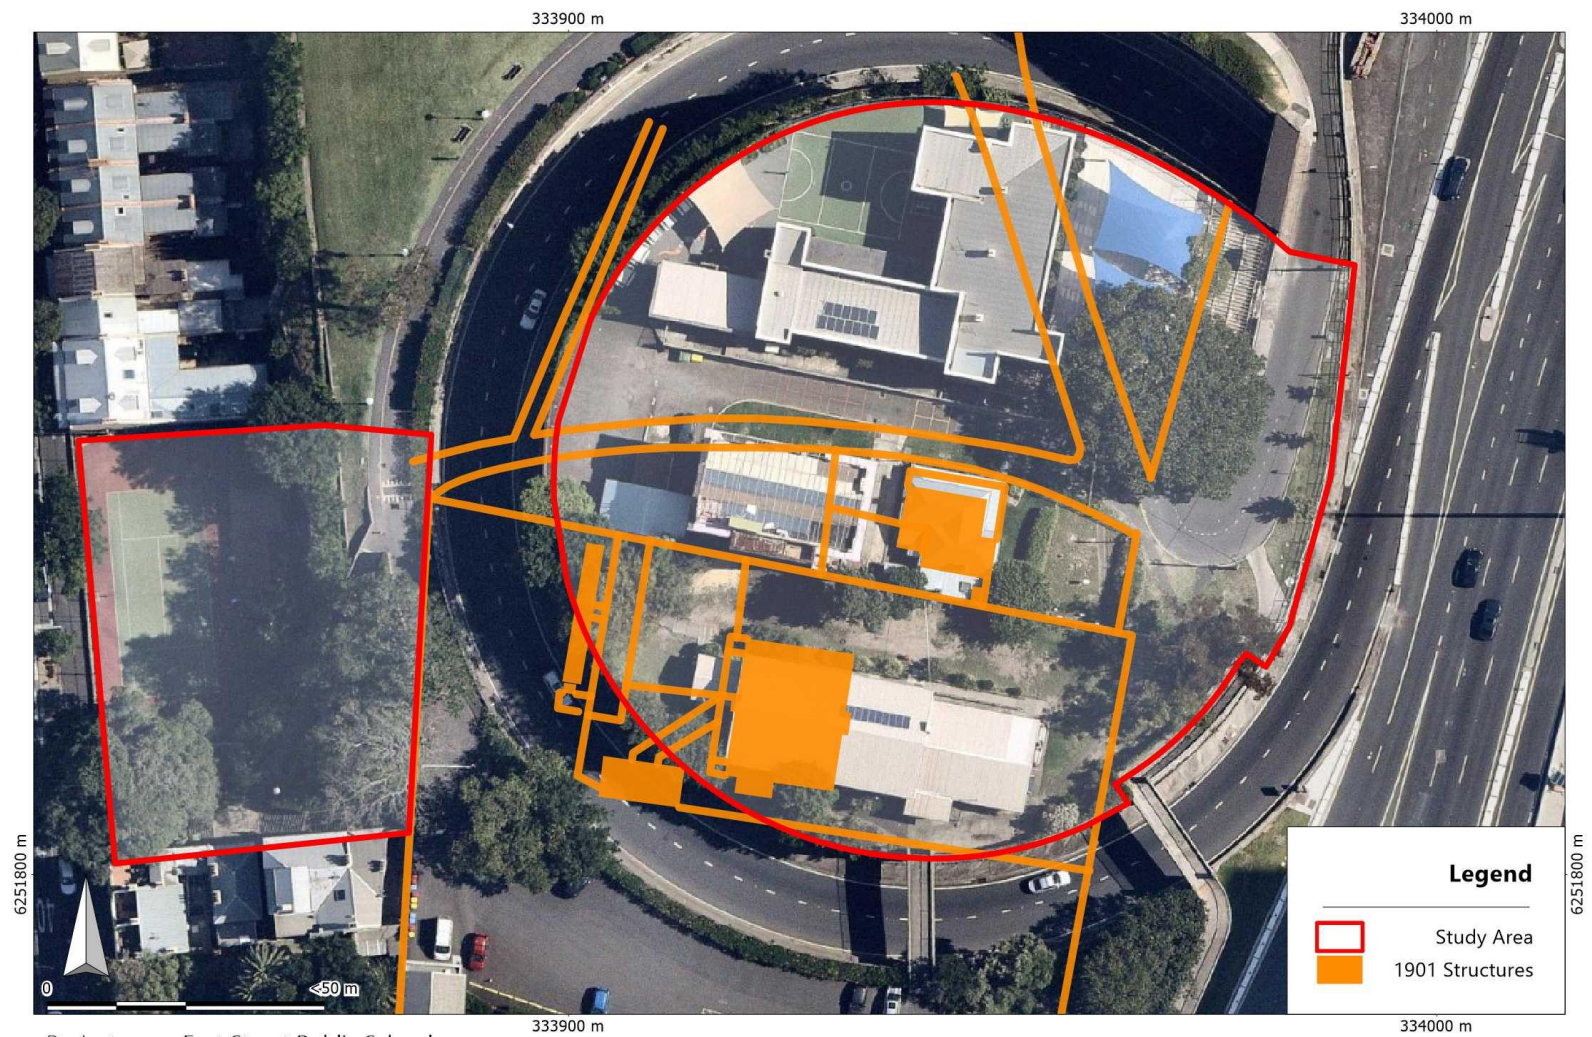
Figure 4-2 Overlay of 1901 plan of the study area. Note the small structures and wall lines surrounding the Surgeon's Cottage. (Source: Curio 2019)

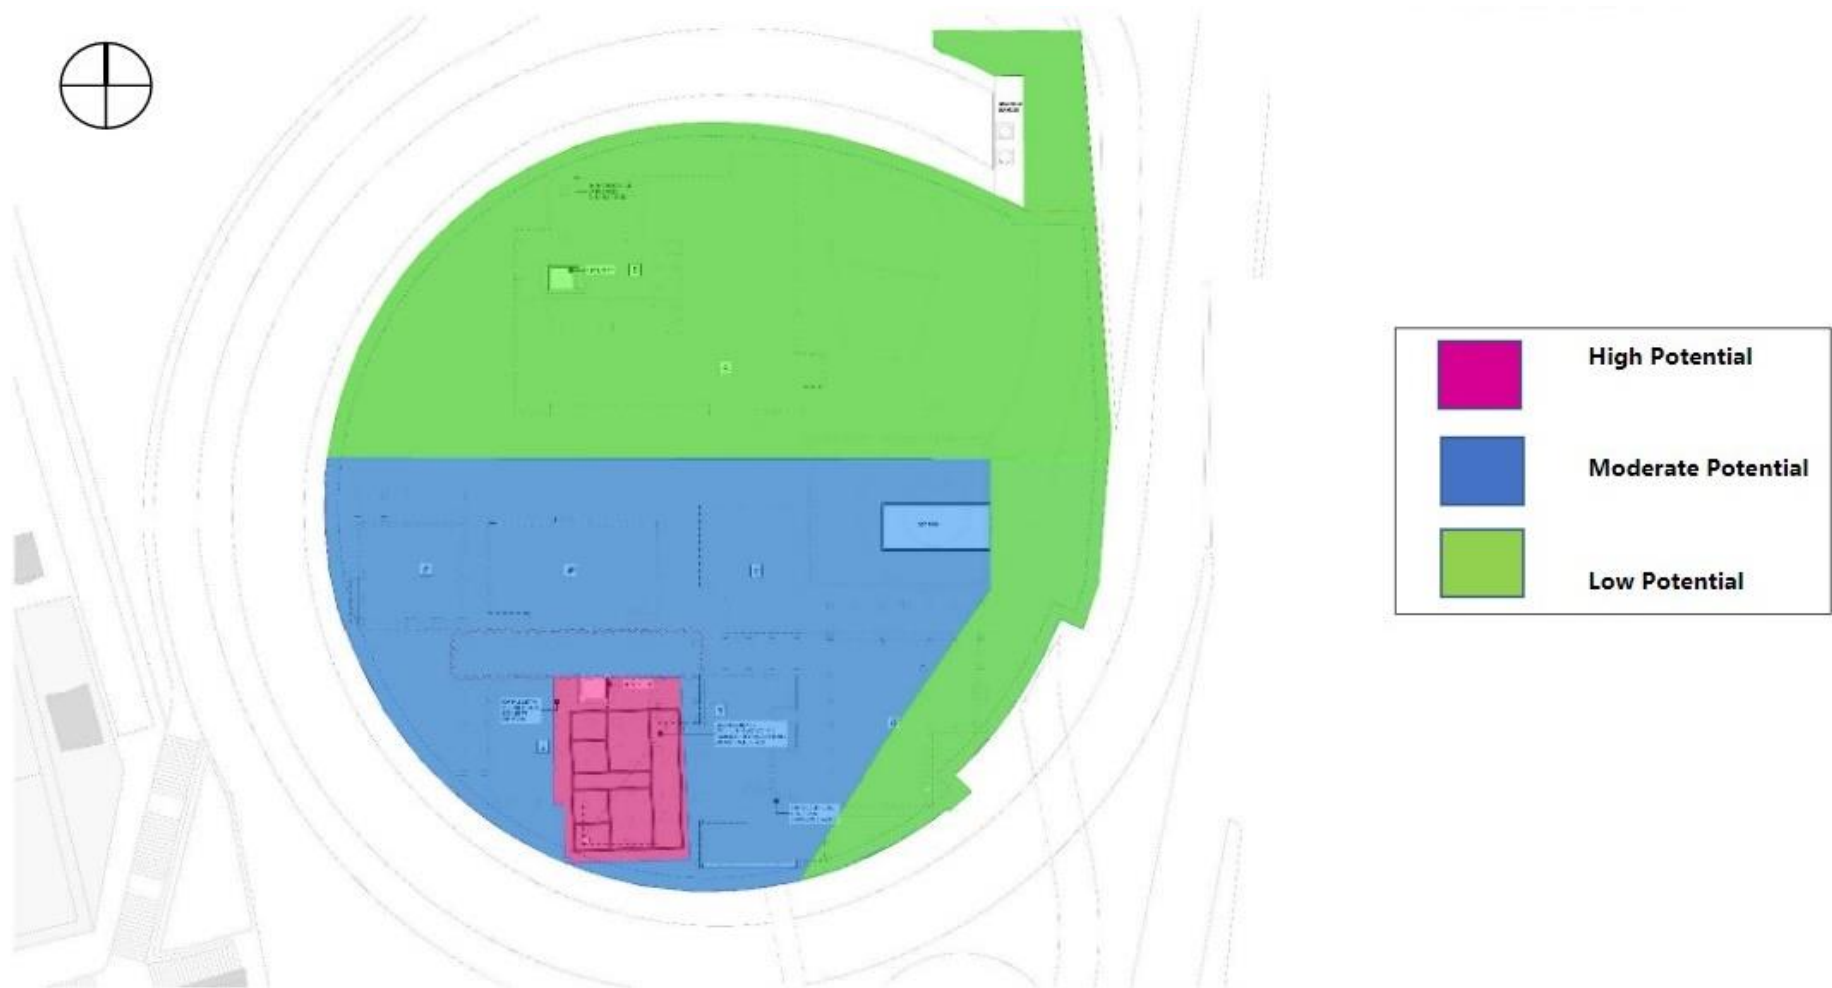
Figure 4-3. Amended Archaeological Potential. Source: Curio 2020.

*The amended archaeological potential is illustrated in Figure 4-3 which divides the site into areas of **High**, **Moderate** and **Low** archaeological potential.*

11. *The demolition contractor should make reference to Figure 4-3 of the Archaeological Research Design*
12. *During demolition the contractor may be asked by the archaeologist to cease work briefly while newly exposed fabric is observed - this may require some recording - stoppage would be minimal.*

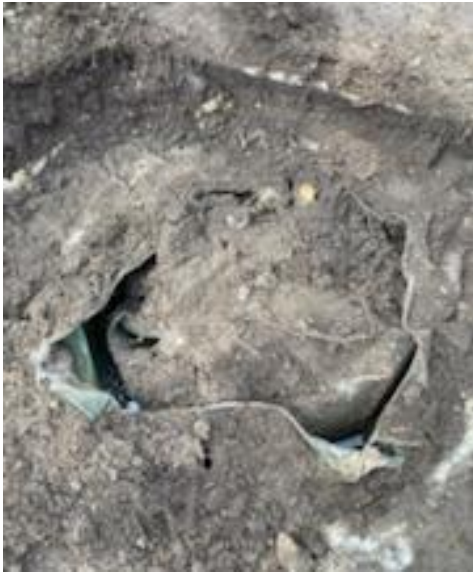
Figure 6-1 Copper basin as exposed in the ground. Note that it filled with concrete.

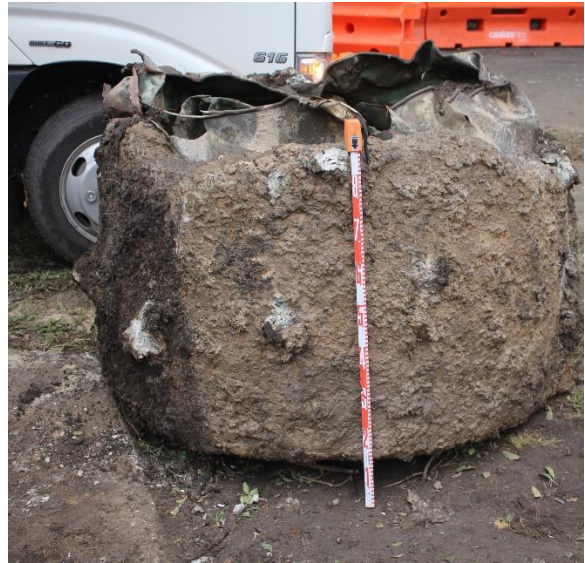
Figure 6-2 Copper basin once removed from the ground still encased in the concrete base.

Excavations to the east of the Messengers Cottage for installation of services for the site accommodation revealed a substantial artefact in a purposely excavated pit, set within a concrete base and partially crushed, probably by machine (Figure 6-1 and Figure 6-2).

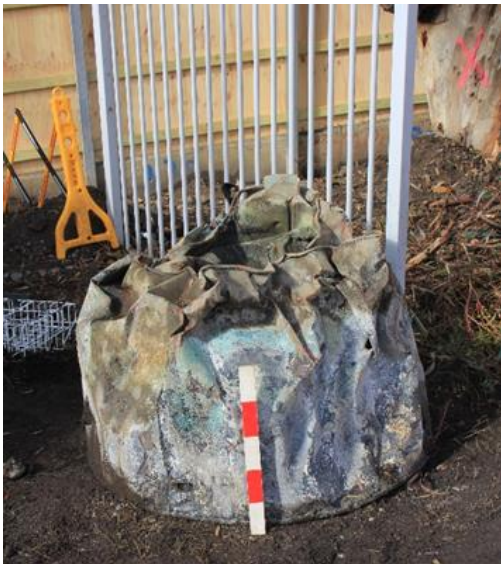
Figure 6-3 Copper basin immediately after excavation.

The item comprised two 'nested' heavy gauge Cu alloy sheet bowls that had been crushed as part of the effort to bury them (Figure 6-3 and Figure 6-4). The body of the outer and inner bowls were separated by spacers in the form of sheet copper staples and these had been attached to the body with copper rivets (Figure 6-6). The outer bowl had been fabricated from three sheets and each join was formed as a double seam with the body then seated in a bottom plate with a flange to complete the seal there. The upper rim had been turned over a piece of copper wire (Figure 6-5).

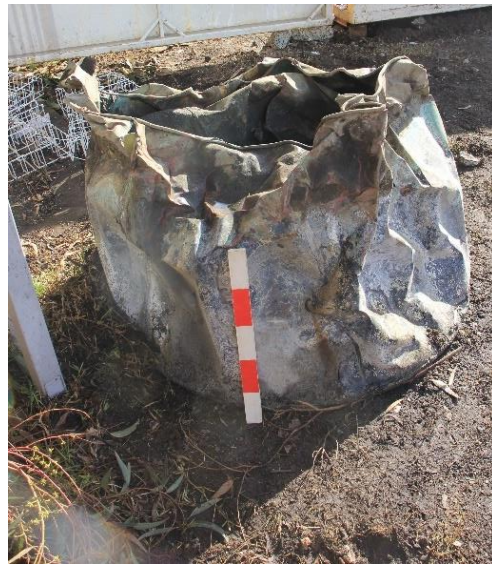
Figure 6-4 Copper basin immediately after excavation.

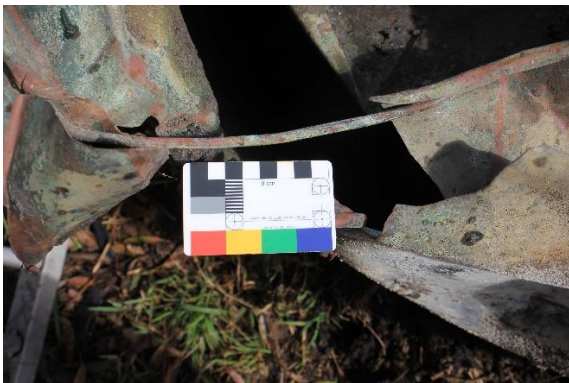
Figure 6-5 Detail of turned lip of basin showing Cu alloy wire.

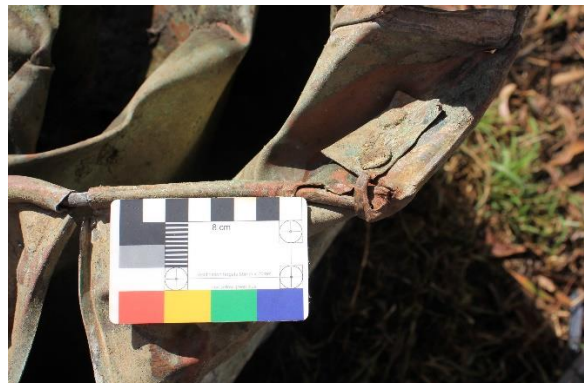
Figure 6-6 Detail of rivetted joint at basin side

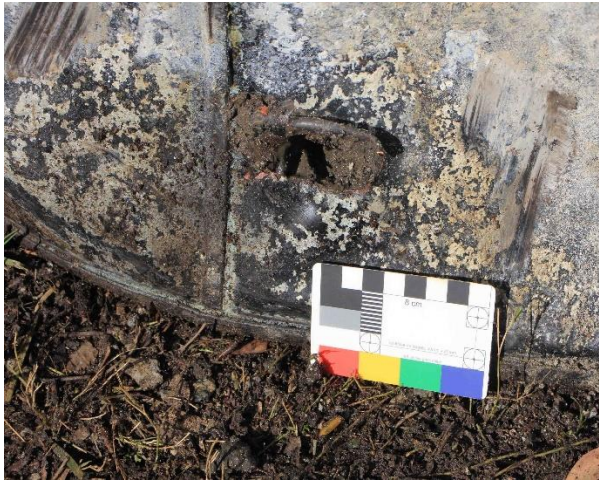
Figure 6-7 Detail of side seam and base seam. Note the puncture in the body.

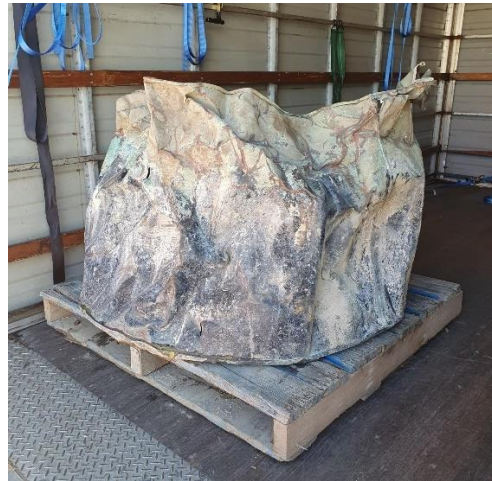
Figure 6-8 The basin ready for transport to the Powerhouse Museum.

After discussions with representatives of the Powerhouse Museum (MAAS) and a conservator's report (Appendices Section 14.4) the bowl was transported to the Museum for accession (Figure 6-8).

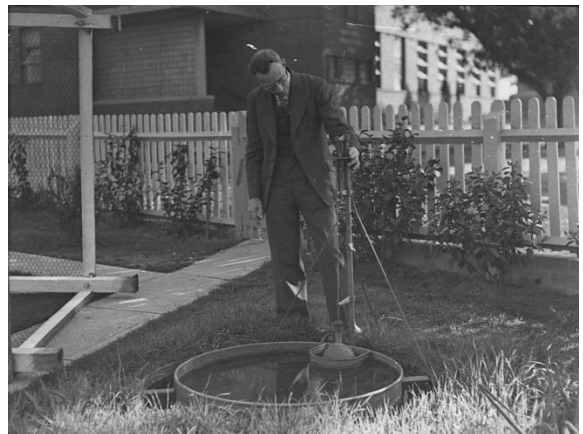
Figure 6-12 The evaporation tank now installed adjacent to the Messenger's Cottage, 27 July 1947. (Source: SLNSW Hood_25026h)

meteorology become a Federal responsibility while astronomical observation by default remained the preserve of each State (Figure 6-12).⁹⁷

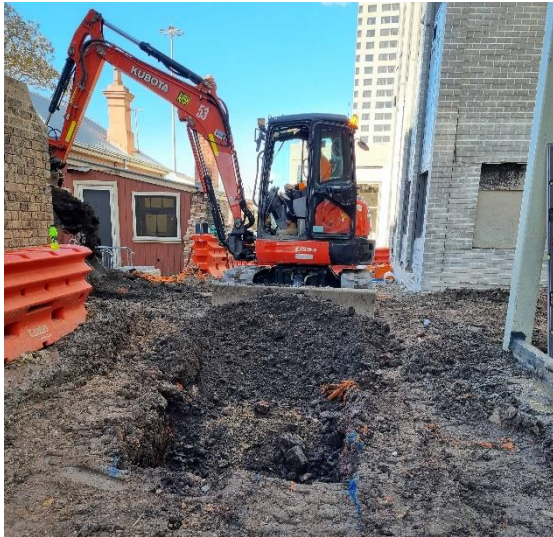
Figure 6-13 Excavator between Messenger's Cottage and Building H..

The excavation work was conducted by a 5-ton excavator using a bladed bucket (Figure 6-13). Direct monitoring of the excavations could not be accomplished as subcontractor safety requirements meant that the archaeologist was required to observe the work from 3 m away from behind a crash barrier. Closer inspection of any exposed deposits of sections was only permissible once the machine had ceased moving.

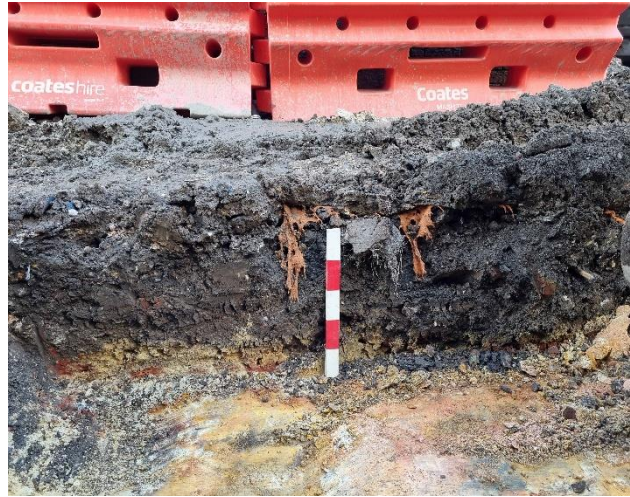
Figure 6-14 Typical section of excavations showing recent backfill over bedrock.

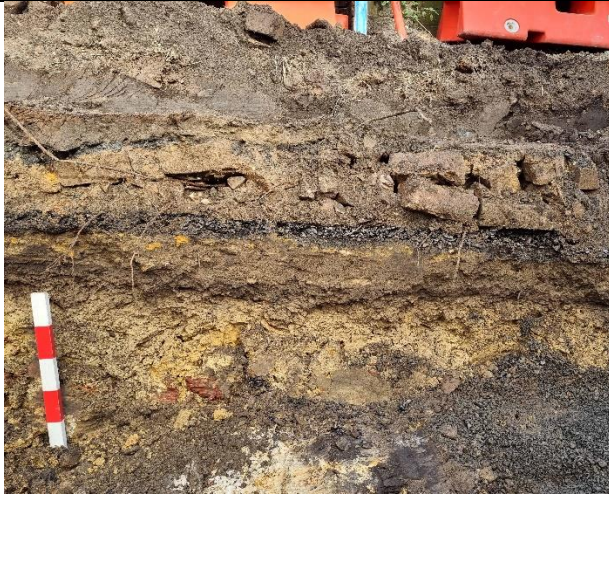
Figure 6-15 Intact stratified section north side..

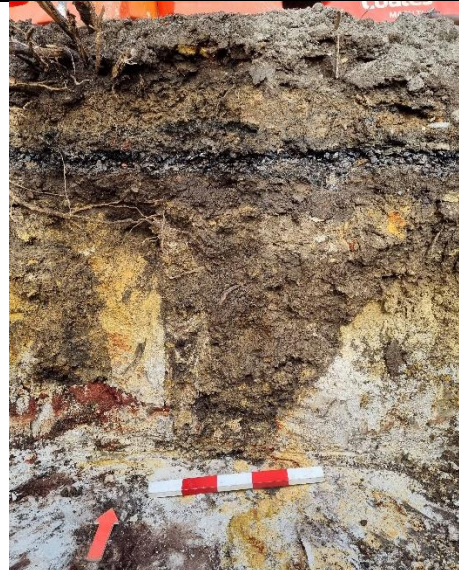
Figure 6-16 Possible post hole in section north side of trench..

It should be noted that in the 1930s this area contained a school building set hard up against the boundary wall and probably associated with the cooking school (Figure 3-25). It is likely that the post hole relates to the construction of this structure.

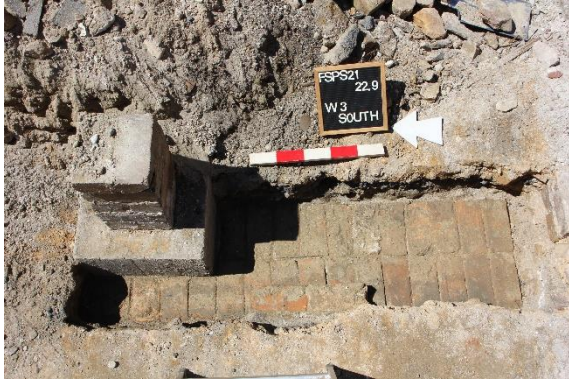
Figure 6-19. Detail of partially exposed Wall 3 footing (eastern elevation of the Cottage's verandah) sitting below an EEC Building concrete support pad and demolition fill (1.001).

The Cottage's foundations were constructed using sandstock brick laid three courses wide and bonded with a pale beige-yellow sandy shell lime mortar in a Flemish bond (Figure 6-32 - Figure 6-20 and Figure 6-24). No frogs or arrow marks were observed on the bricks. External wall widths averaged 410mm, while internal partition walls measured approximately 300mm in width. In most cases, the building's foundations had been laid directly over sandstone bedrock (context 5.003) or degraded shale (contexts 4.009, 5.002, 5.010 and 6.003). No evidence of cuts into bedrock to provide additional support for the structure were observed. The majority of footings encountered during the excavations were two to three courses deep, their upper courses having been removed at the time of the Cottage's demolition.

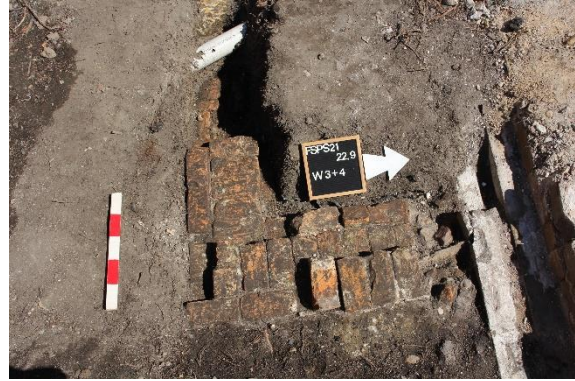
Figure 6-20. Detail of partially exposed Wall 3 and Wall 4 return (southeast elevation of the Cottage verandah). Wall 3 is partially truncated by an EEC Building footing to the north (right) and PVC pipe to the west (top of photo).

Rooms 1 and 3 (the cottage’s back rooms), had been heavily disturbed by development activities for the EEC Building, its associated services and earlier modifications associated with the Fort Street School’s use of the building as a Principal’s residence and later a Cookery School (Figure 6-20, Figure 6-36 - Figure 6-30). Consequently, no evidence of the partition walls recorded in the 1824 or 1948 plans (Figure 3-10 and Figure 3-29) or occupation deposits survived. It is likely that at some stage that the floors were lifted and the subfloor space cleared out, leaving only the natural weathered rock (5.010) below.

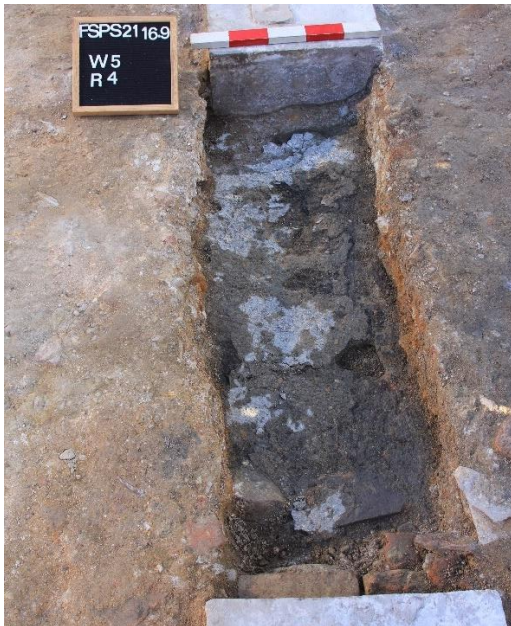
Figure 6-21. Exposed vitrified material (4.002) in TT6, excavated to locate the Cottage's eastern elevation (Room 4, Wall 5). This was encountered below context (4.001).

Context No.	Location	Description	Phase
(4.002)	Room 4 Front Room	Hard, dark to medium black/grey layer of vitrified material encountered below context (4.001) in alignment with eastern elevation of former Surgeon's Cottage and overlying loose medium black sand (4.003)	Phase 5-6

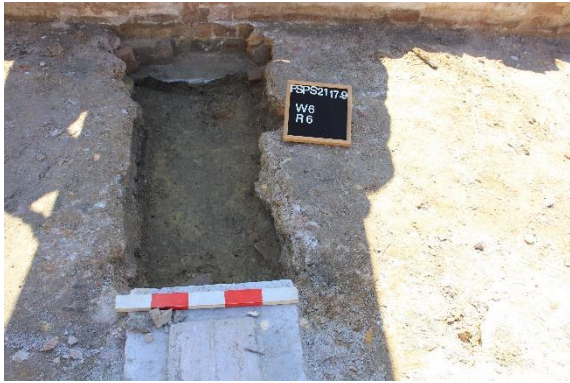
Figure 6-23. View north of TT3 showing the exposed surface of context (6.003) in the footprint of Wall 6, the cottage's eastern elevation. This divided Room 6 from the verandah. Evidence of this elevation had been removed or truncated at some time prior to the construction of the EEC Building. View north.

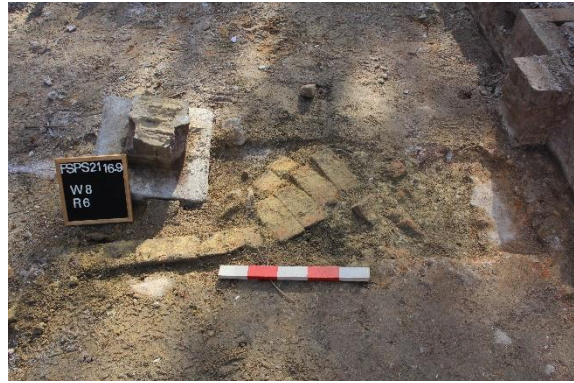
Figure 6-24. Mid excavation photo of contexts (6.001) and (6.002) showing, partially disturbed internal partition wall (W8) footings between Room 3 and Room 6. View west.

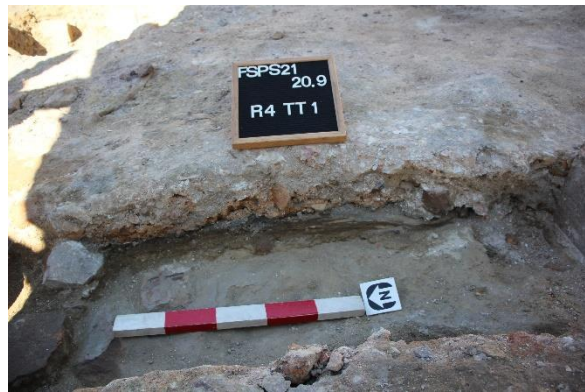
Figure 6-26. Post-excitation of TT1 in Room 4 (Wall 5) showing exposed bedrock below overlying contexts (4.001)-(4.010).

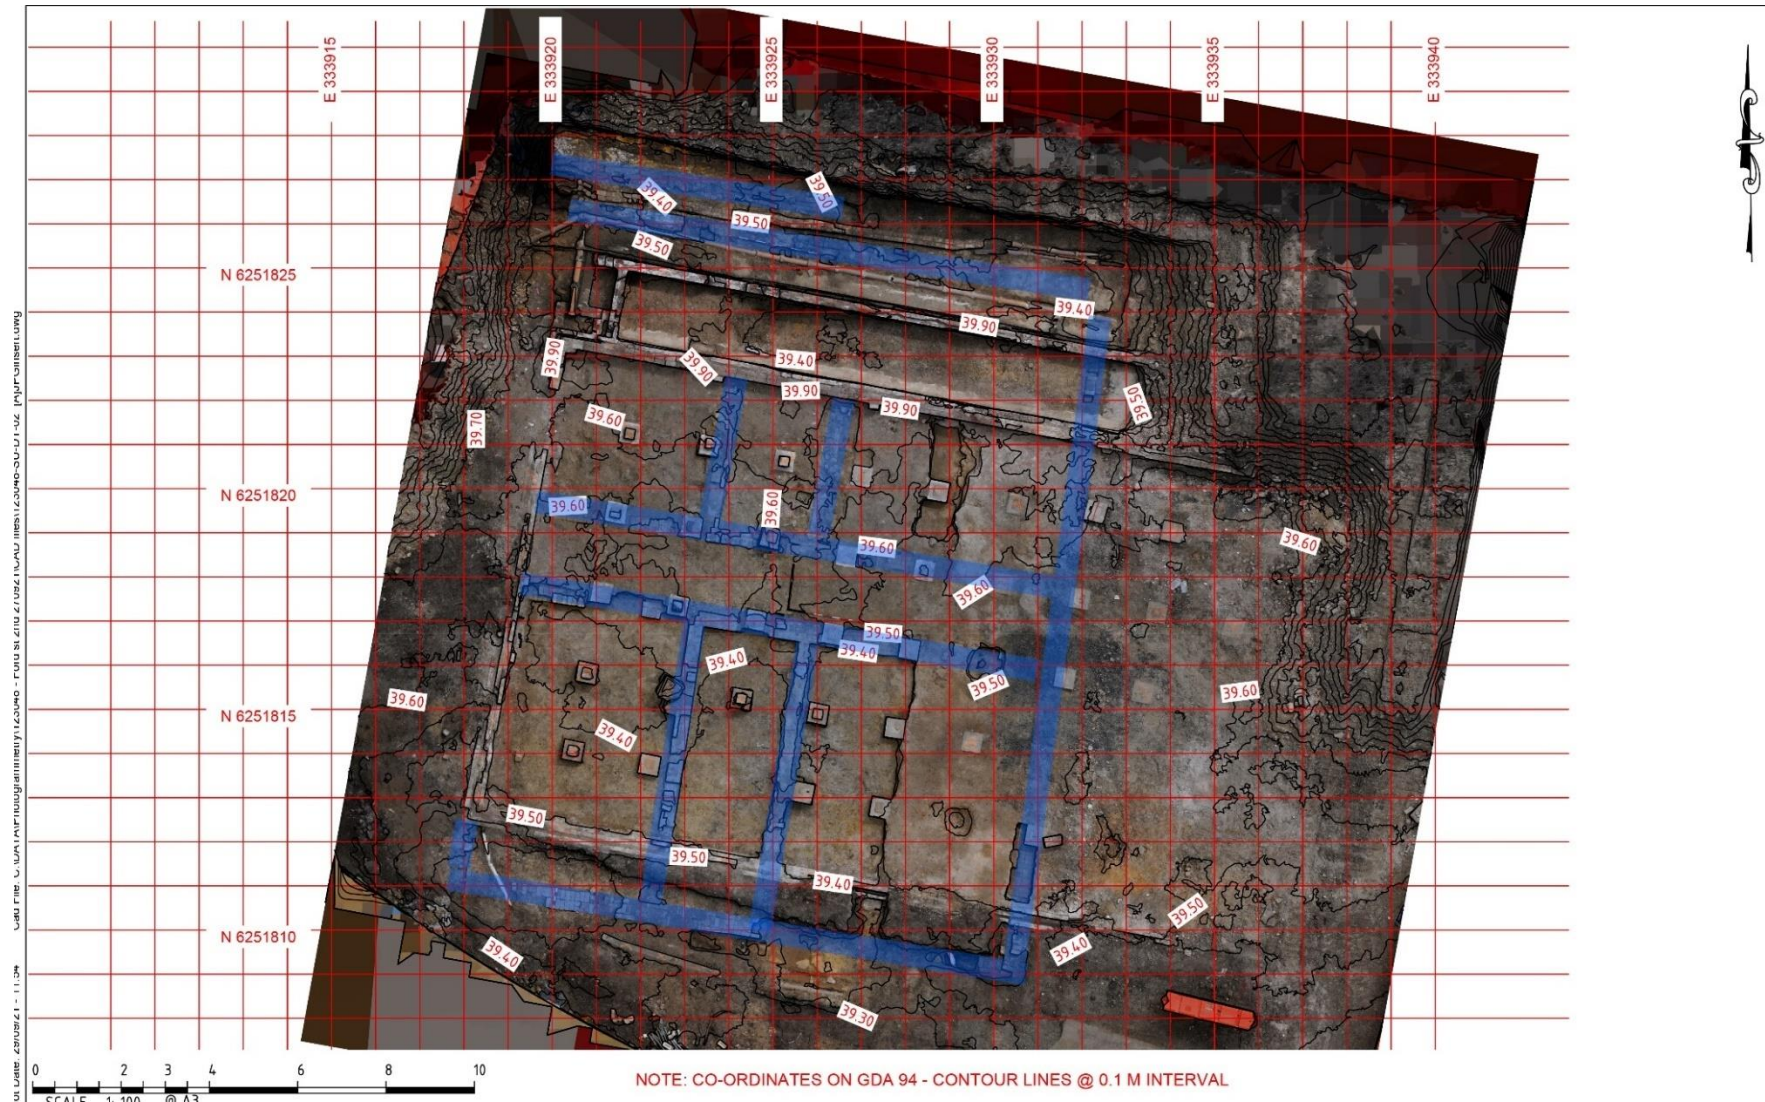
Figure 6-27. Overview of the Surgeon's Cottage footprint (shaded blue) following the completion of test and salvage excavations. Source. Crux Surveying, 2021

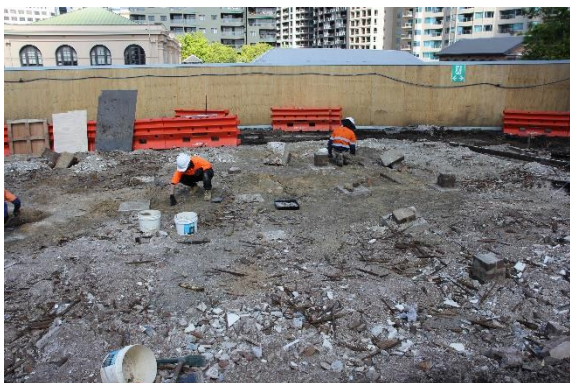
Figure 6-28. View south towards Surgeon’s Cottage excavation area. Unstratified fills and demolition contexts (1.001) and (4.001) visible across the site.

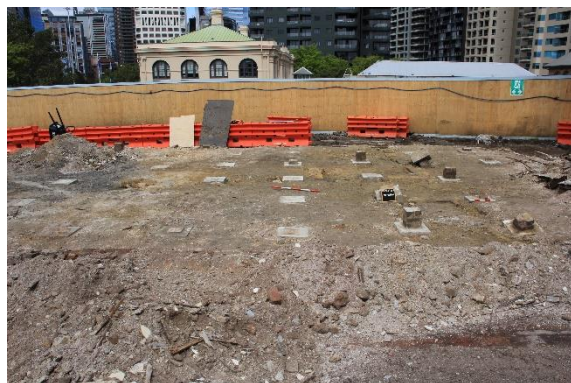
Figure 6-29. View south towards Surgeon’s Cottage showing exposed contexts (4.004), (5.002) and (6.001) following the removal of demolition contexts (1.001) and (4.001).

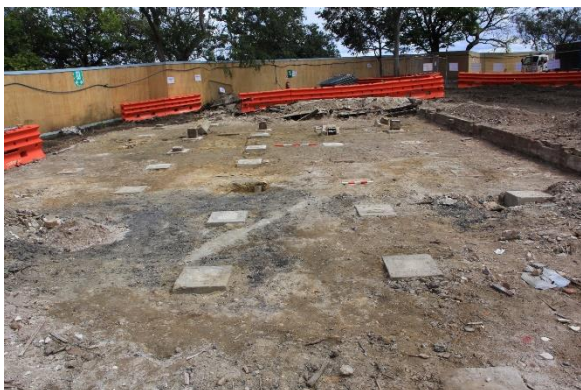
Figure 6-30. Overview of the Surgeon’s Cottage excavation area showing exposed concrete pads associated with the EEC Building (Phase 6) and partially removed demolition fill (1-001). View west.

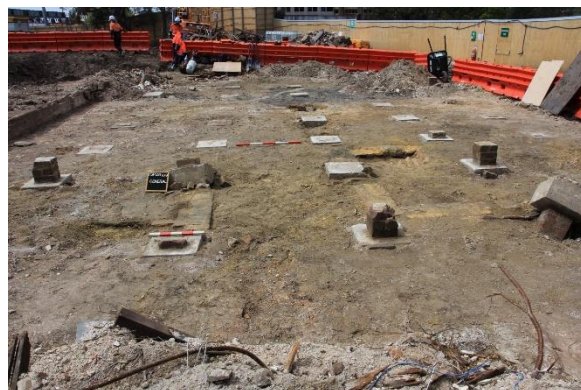
Figure 6-31. Overview of the Surgeon’s Cottage excavation area showing exposed concrete pads associated with Phase 6 school building and partially removed demolition fill (1-001). View east.

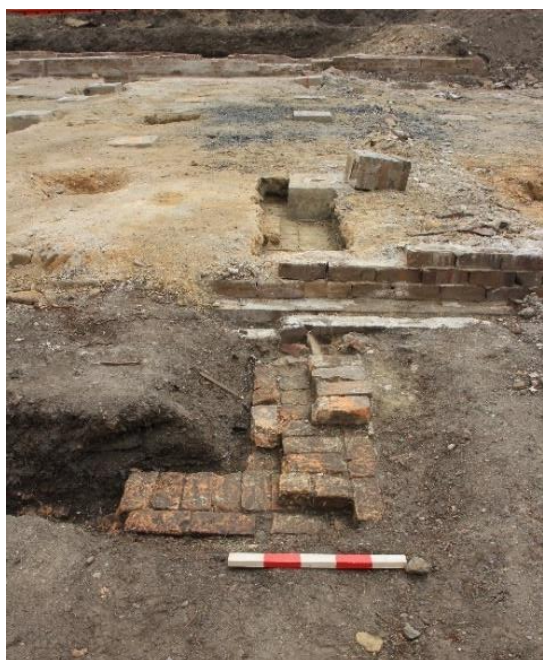
Figure 6-32. View north showing truncated return for the Cottage's southern and eastern elevations (Room 4). Modern brick footings and concrete pads for the EEC Building are visible in the background, also truncating the Cottage foundations

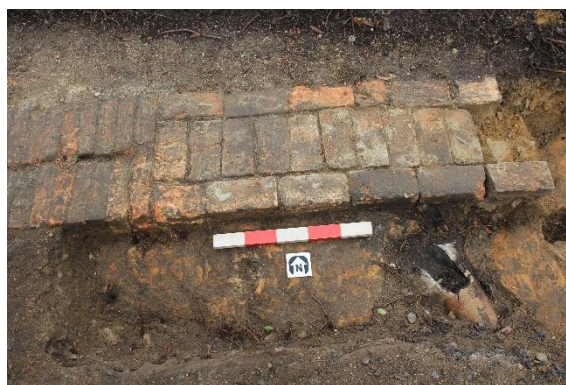
Figure 6-33. View north showing the Cottage's southern elevation sitting over exposed sandstone bedrock (5.010) which is visible in the foreground. An earthenware pipe associated with a later phase of development but not truncating the Cottage footing can be seen abutting the footing to the south. This has been laid into a cut excavated into bedrock - [5.011]

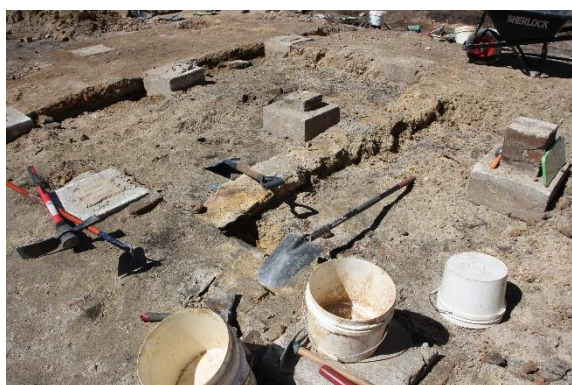
Figure 6-34 View northeast towards Room 4 and partially removed underfloor deposits (4.006), (4.008) and (4.010).

Underfloor deposit (4.010) was encountered below (4.008) and dated to c.1832-1850. It also contained sewing and clothing related material such as a wound-wire pin, machine-made conical pins (post 1832) and two clothing eyelets. One fragment of an oriental porcelain plate with the border pattern 'Canton' and rosehead wrought iron nails were also recovered from this context. Like (4.008) and (4.006), its survival was limited to the periphery of the room, suggesting later activities associated with modifications to the building had necessitated its removal.

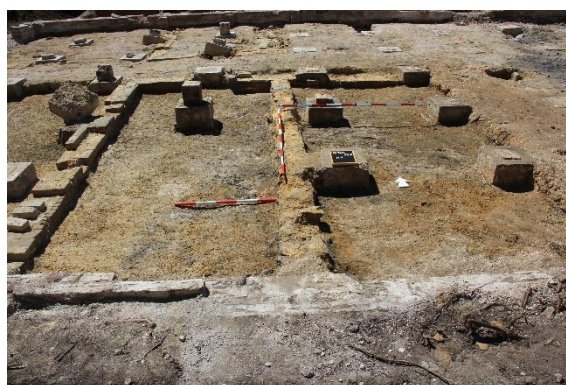
Figure 6-35. View north towards Room 4 showing north-south aligned bearer footing constructed from crushed sandstone and exposed (4.009).

The Cottage's two front rooms (assigned Rooms 4 and 6) each contained north-south aligned footings constructed using fragmented sandstone (assigned W11 and W12), shown in Figure 6-18,

Figure 6-27, Figure 6-34 and Figure 6-35. These ran through the centre of the rooms and may have functioned as rudimentary support for timber bearers associated with the building’s construction or later modifications to the Cottage. Their location would suggest that in the front room it was not possible to get the bearers to span the full depth (i.e. 5 m) of these rooms.

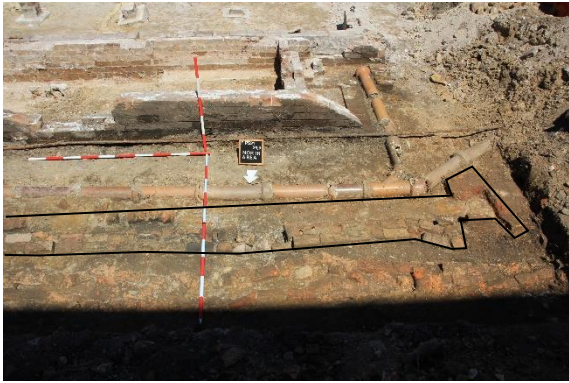
Figure 6-36. View south towards the former EEC Building (Phase 7), the heavily truncated Surgeon Cottage's northern elevation (outlined in black) and a series of earthenware pipes (Phase 5 and 6) running north-south and east-west between footings for each former structure. View south.

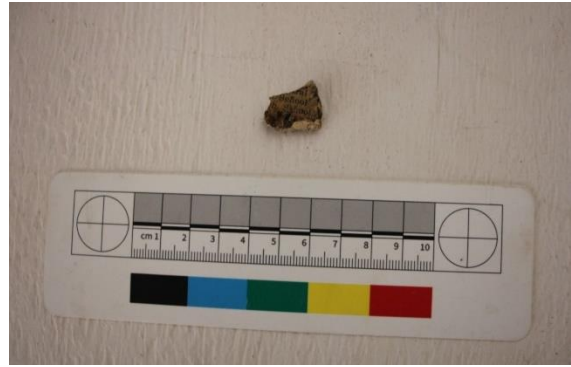
Figure 6-37. Small fragment of plaster wall lined with newspaper recovered from demolition deposit (1.001).

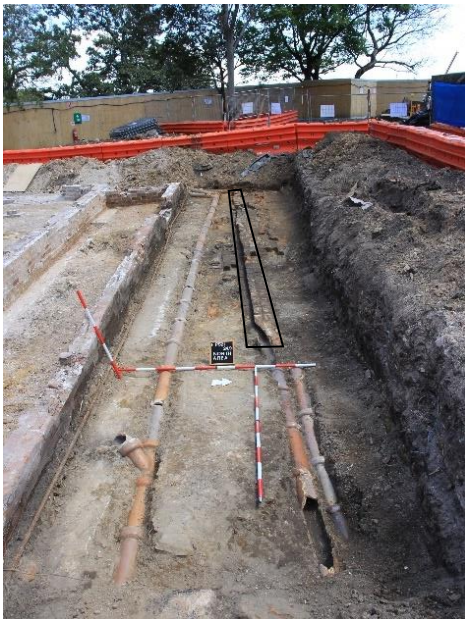
Figure 6-38. View west towards the northern elevations of the former EEC Building, the heavily truncated Surgeon Cottage's northern elevation (outlined in black) and a series of earthenware pipes (Phase 5 and/or 6) running north-south and east-west between footings for each former structure. View west.

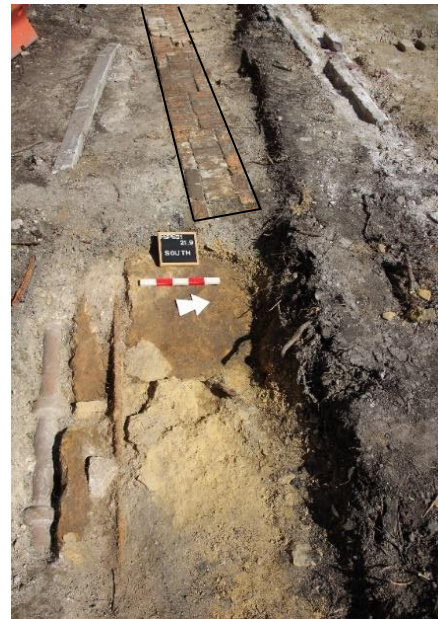
Figure 6-39. View west along the southern elevation of the Surgeon's Cottage (outlined in black) showing modern garden soils to the right (south) of exposed Cottage and EEC Building footings and partially exposed bedrock in the foreground. Two services in the bottom left of the photo may represent Phase 5-7 utilities.
