4. Preliminary Assessment of Non-Aboriginal Archaeological Potential and Significance

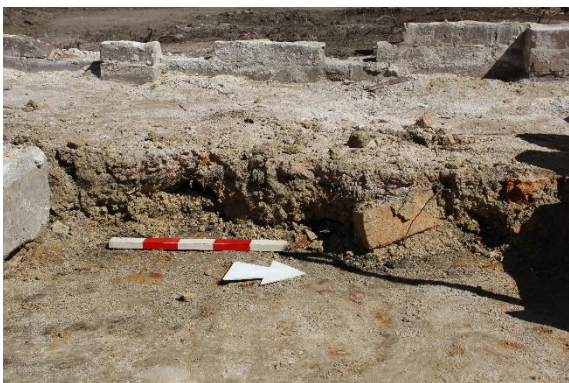
Figure 6-40. View west towards exploratory trench in Room 4 showing depth of Phase 6 demolition fill (4.001) over context (4.008).

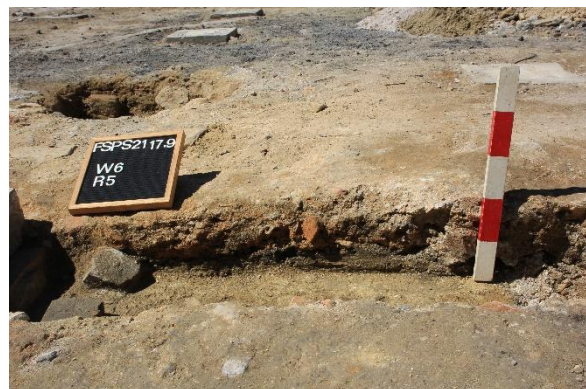
Figure 6-41. View north towards exploratory trench in Room 5 and depth of Phase 6 demolition fill (4.001) over exposed floorboard context <4.007>.

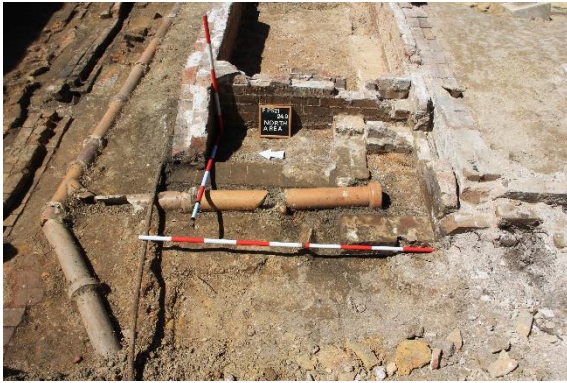
Figure 6-42. View east towards the former EEC Building's northern elevation, the heavily truncated Surgeon Cottage's northern elevation and a series of earthenware pipes (Phase 5 and 6) running north-south and east-west between footings for each former structure.

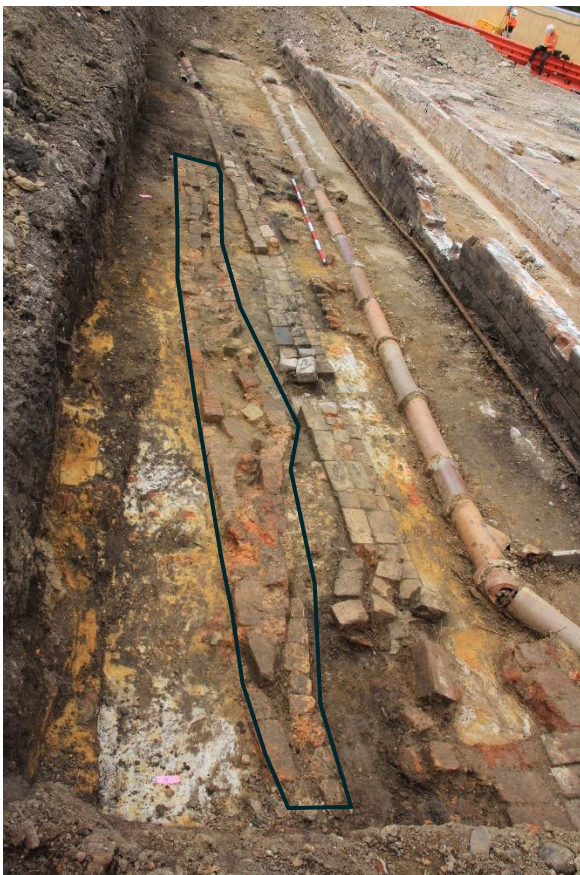
Figure 6-44. View east on the north side of the Cottage. Running to the east is a remnant sandstock brick drain (outlined in black) adjacent to the brick footing for the EEC Building. .

The only evidence of ancillary Phase 3 features found to have survived outside of the Cottage footprint was an east-west aligned sandstock brick drain along the building's northern elevation (Figure 6-44). No evidence of fence lines, garden soils or refuse deposits were in the cottage's immediate landscape. This may reflect the nature and extent of continuous development that has occurred in the area since 1850 which would have involved significant disturbance for the construction of the Cahill Expressway on-ramp cutting and EEC Building.

This drain was in a severely damaged condition due to the construction of the verandah of the Fanny Cohen Gymnasium. It consisted of a double row of sandstock bricks lain 'on bed' with a single brick forming a base course for the drain. Both ends of the drain were truncated and its direct relationship to the cottage could not be demonstrated. Nevertheless, its position, general alignment and materials make it almost certain that this feature is associated with the cottage.

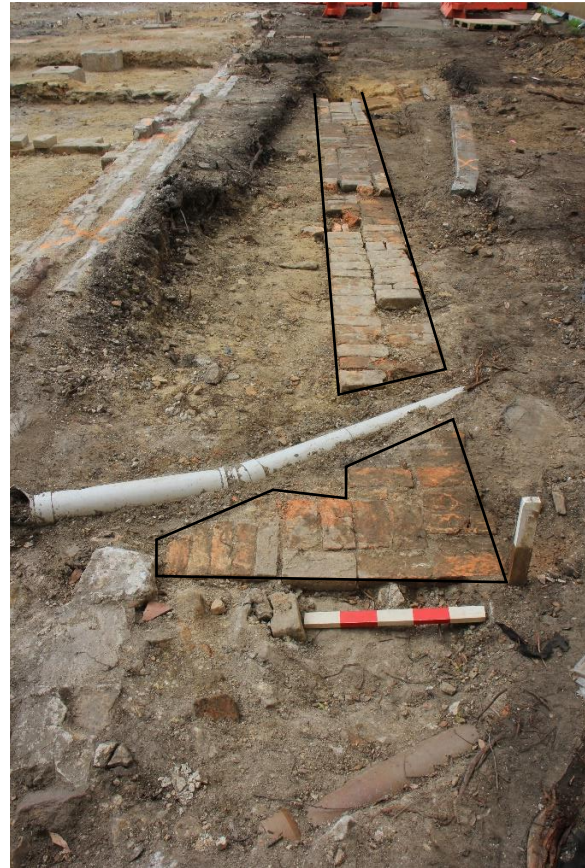
Figure 6-43. View east along the Cottage's southern elevation (outlined in black) showing a modern PVC pipe truncating its southwest return.

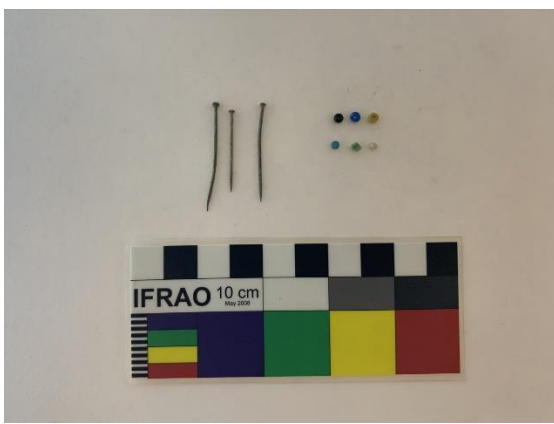
Figure 7-1. Pins and glass beads recovered from context (4.008).

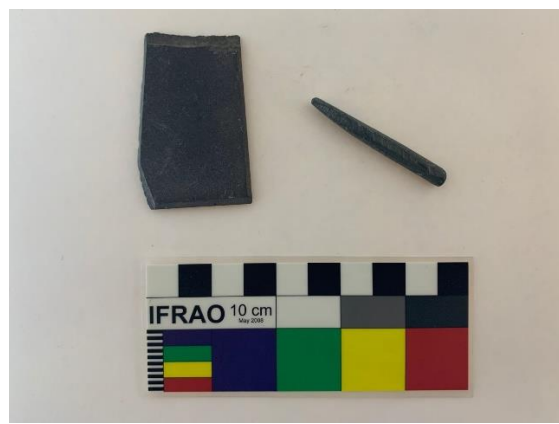
Figure 7-2. Slate and slate pencil recovered from demolition deposit context (1.002) and (4.002), respectively.

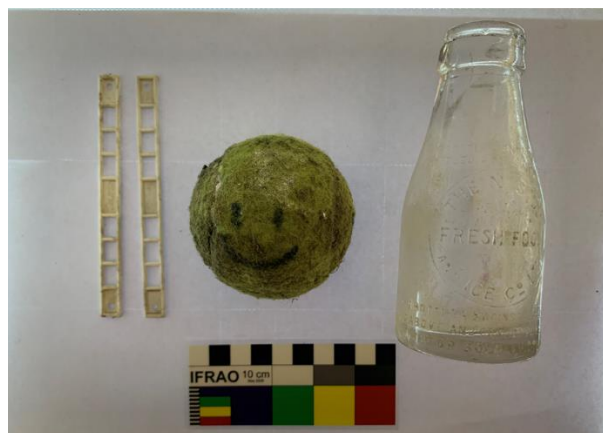
Figure 7-4. Two Streets ice-cream sticks, a tennis ball and a 1/4 milk pint recovered from unstratified fills and (4.006) / (4.007) interface, respectively.

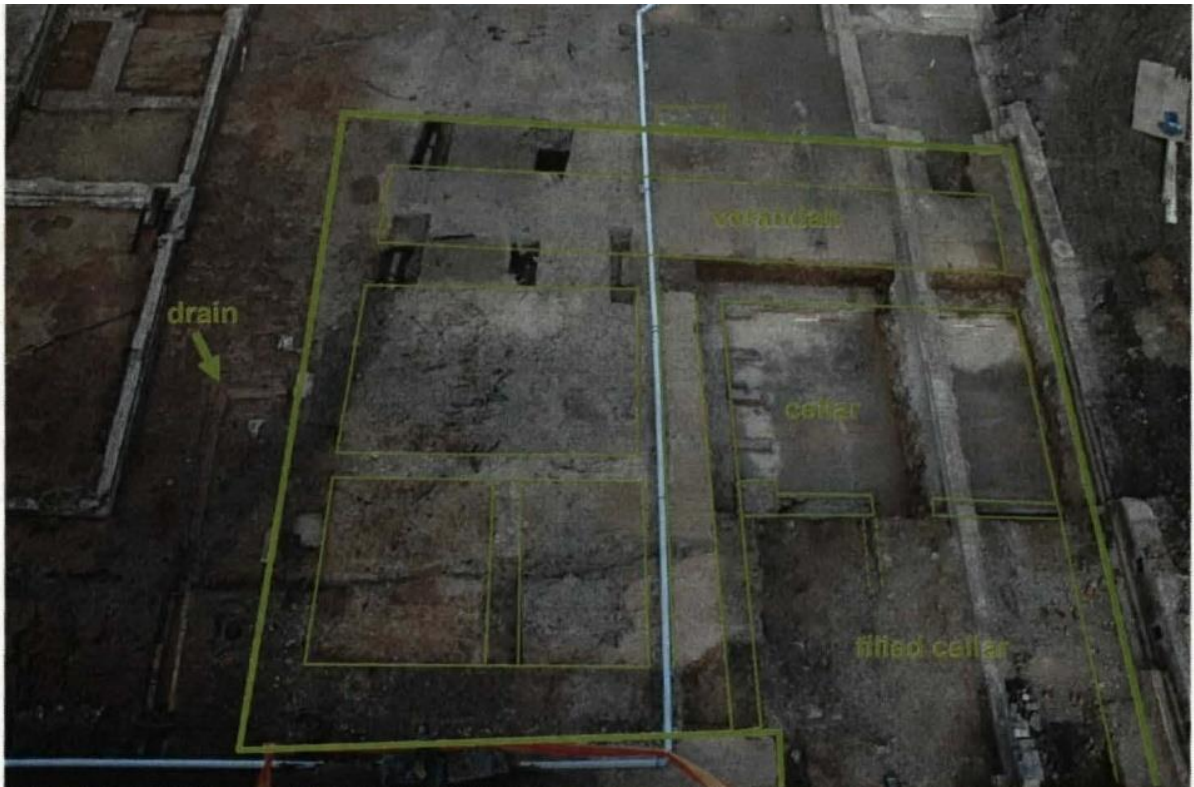
Figure 8-1. View of the Surgeon's Residence excavated by Casey and Lowe in 2005. The cellar is partially excavated and drain along its eastern elevation visible to the left. Scale 1 m. Source. Taken from Casey and Lowe, 2005, p. 17.

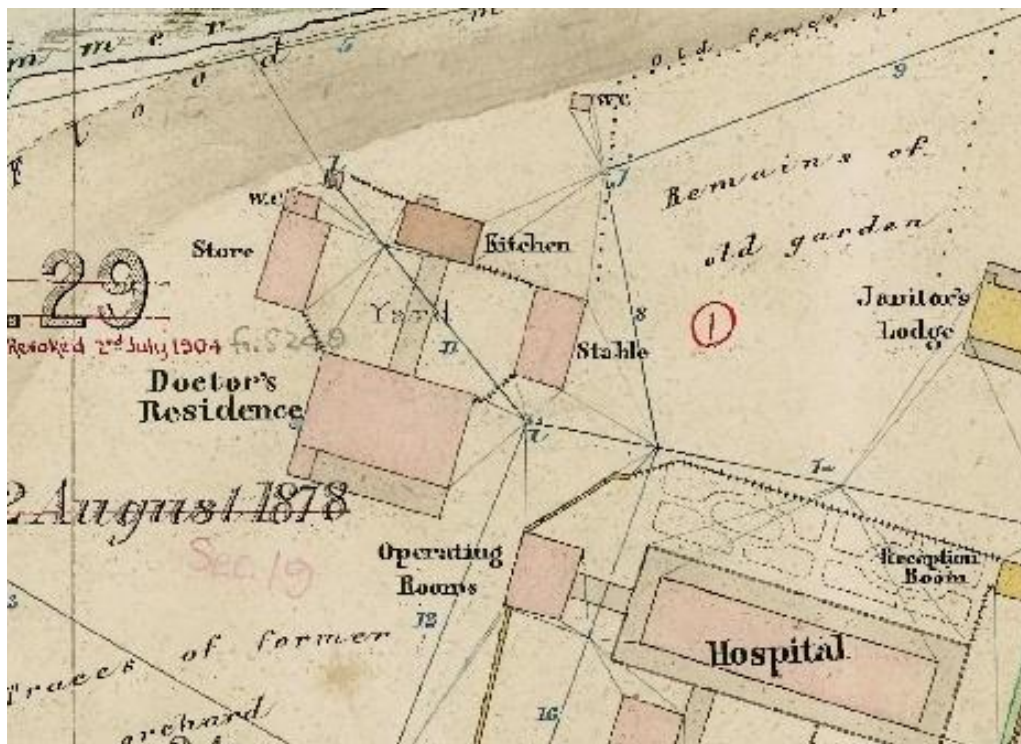
Figure 8-2. Plan of the Parramatta Surgeons Quarters from 1882. Note the arrangement of the kitchen, store and stable, in relation to the main house, forming a semi enclosed space at the rear. (Source: LPI CP171-750)

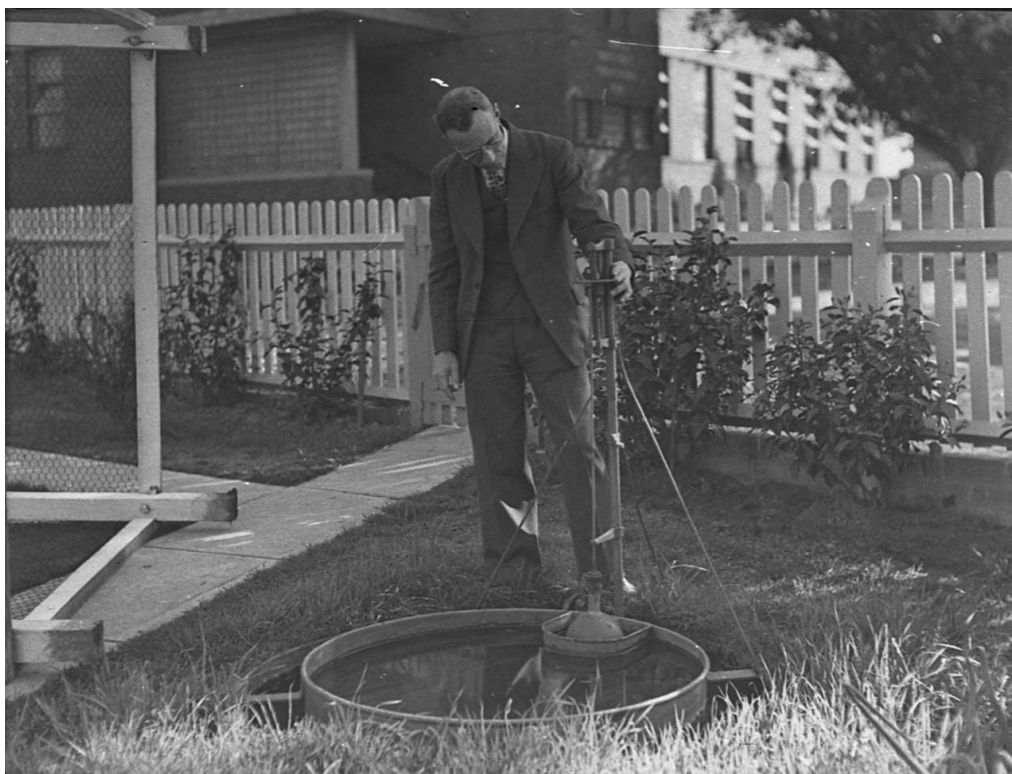
Figure 1. 1947 Image of meteorological evaporation pans in use (supplied by Curio Projects)

The curved sides of the pans are joined to the flat bases by folded seams. There appear to be three seams in the walls of the pans: one vertical on one side, with two vertical, closely spaced on the opposite side. The double seams may coincide with the position of the float assembly visible in the 1947 photograph (Fig. 1), but no longer attached to the pans.

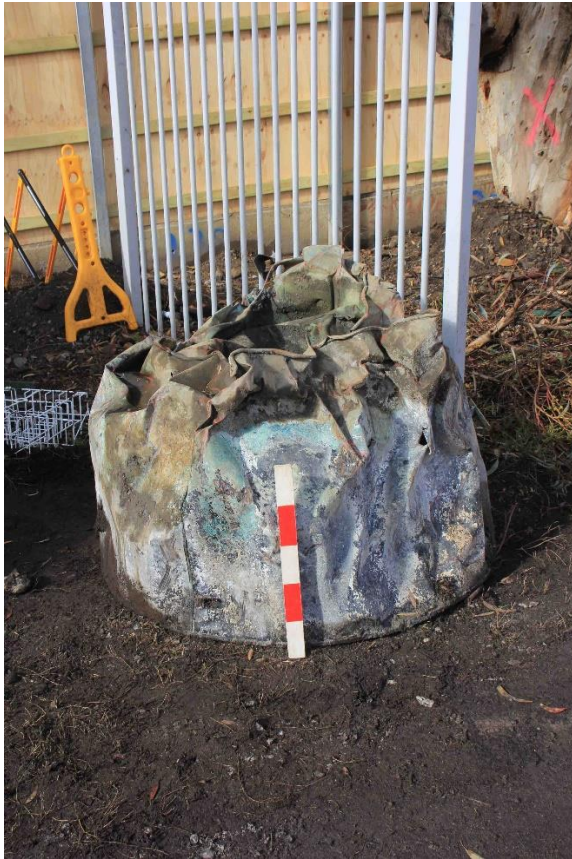
Figure 3. Pans as excavated (supplied by Curio Projects)

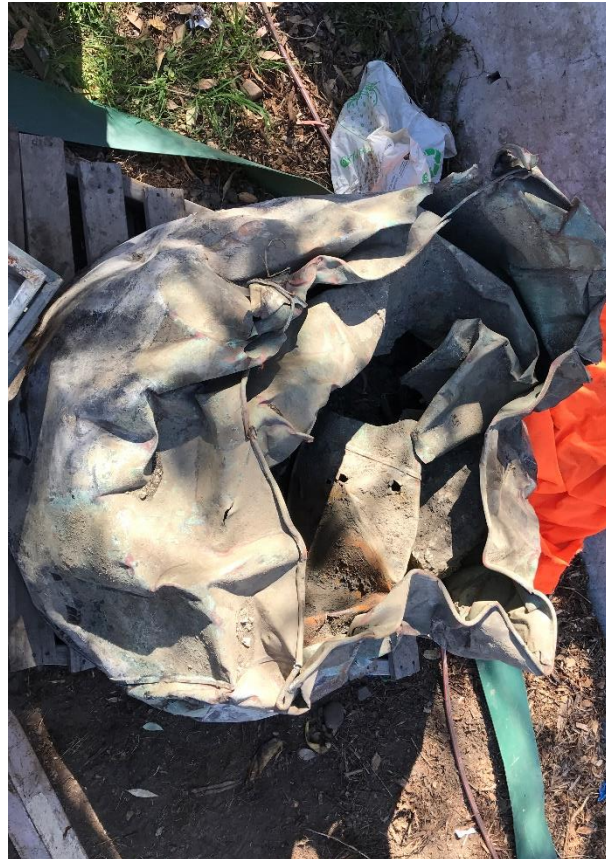
Figure 4. View of crumpled in rims of pans from above

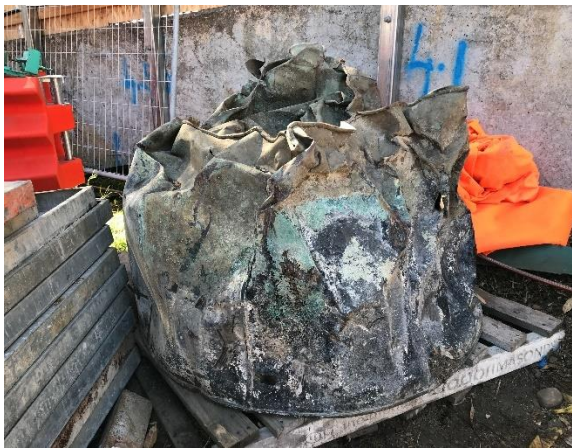
Figure 5. Side view of pans on pallet, showing folded base and side seams

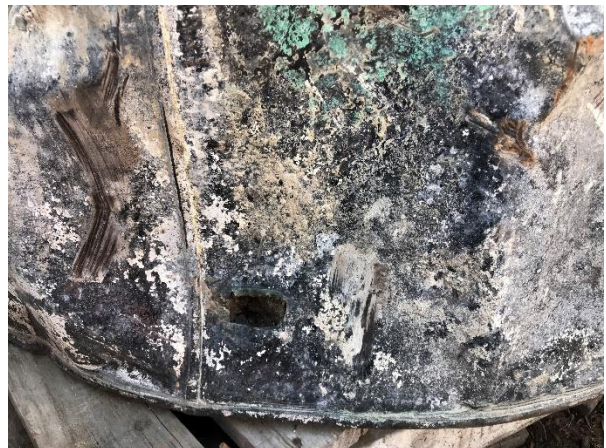
Figure 6. Detail of folded seams and punched hole to the right

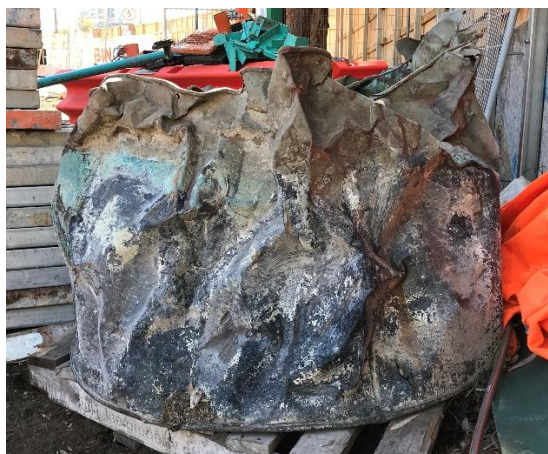
Figure 7. Side view of pans on pallet, showing adherent soil, black substance and green corrosion products

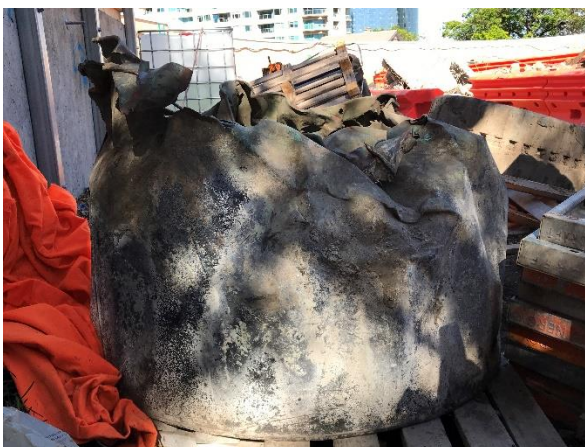
Figure 8. Opposite side view of pans

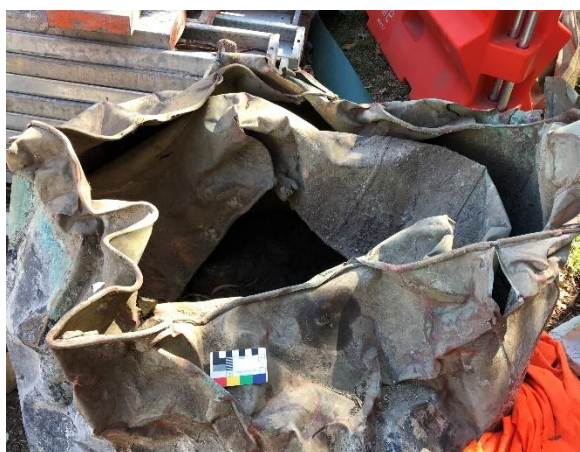
Figure 9. View of crumpled rims of nested pans. Note rolled rim and double side seams of inner pan

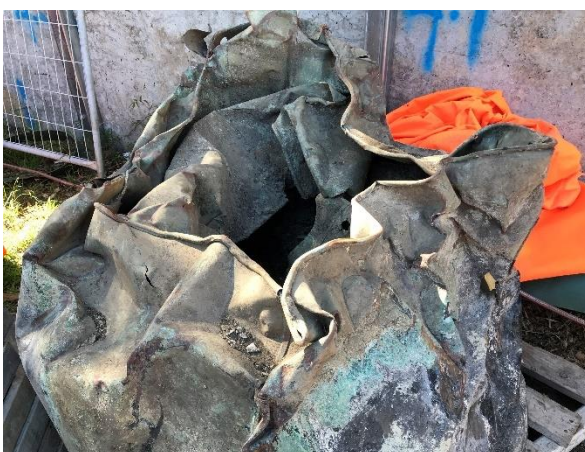
Figure 10. View of crumpled rims of nested pans

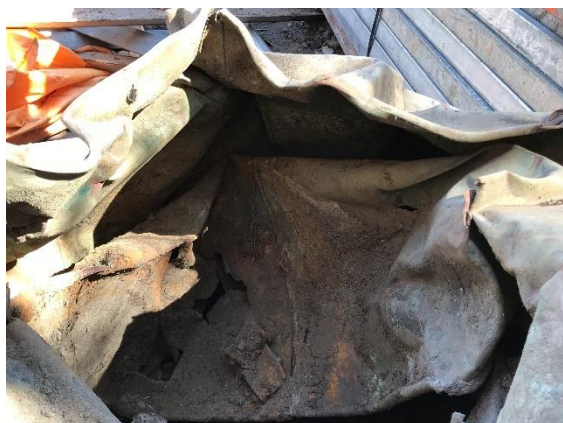
Figure 11. View inside pans, broken strut is visible at bottom centre

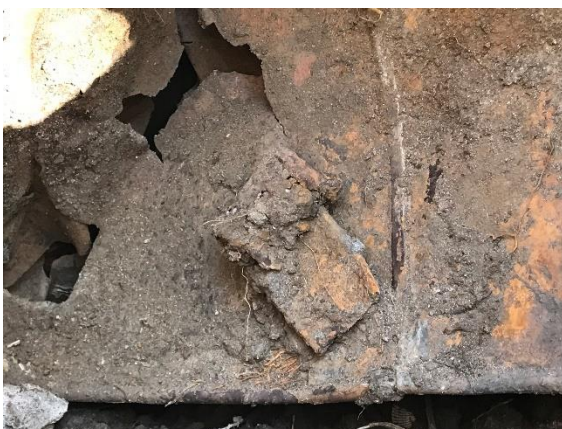
Figure 12. Detail of damaged strut, and tears in the metal
