PRE CONSTRUCTION CONDITION SURVEY

Green Square Integrated Community Facility &
School - 3 Joynton Avenue, Zetland NSW

Council Assets
3 Joynton Avenue and Portman Street
ZETLAND NSW 2017

01 August 2022

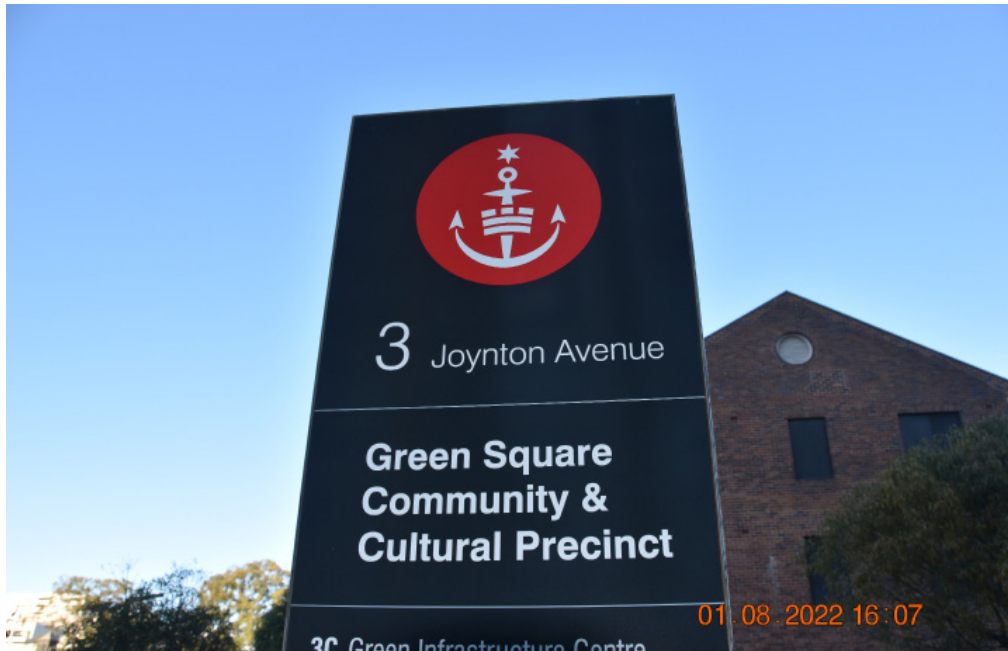
Figure: 0001

**3 JOYNTON
AVENUE AND
PORTMAN
STREET, ZETLAND**

COUNCIL ASSETS

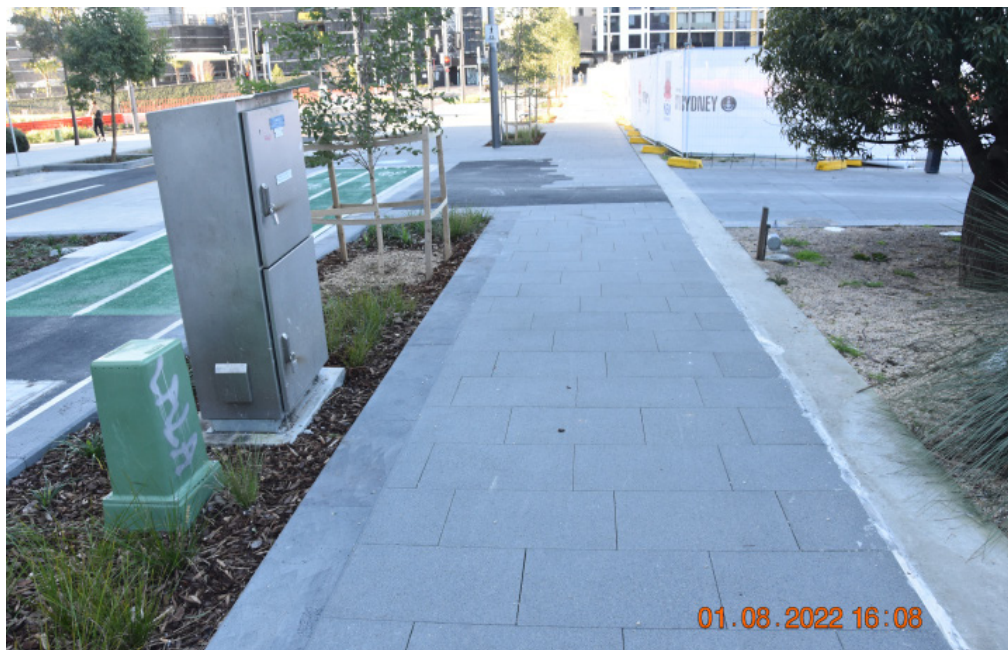
Figure: 0002

Footpath at the northwest corner on Portman Street, outside 3 Joynton Avenue.

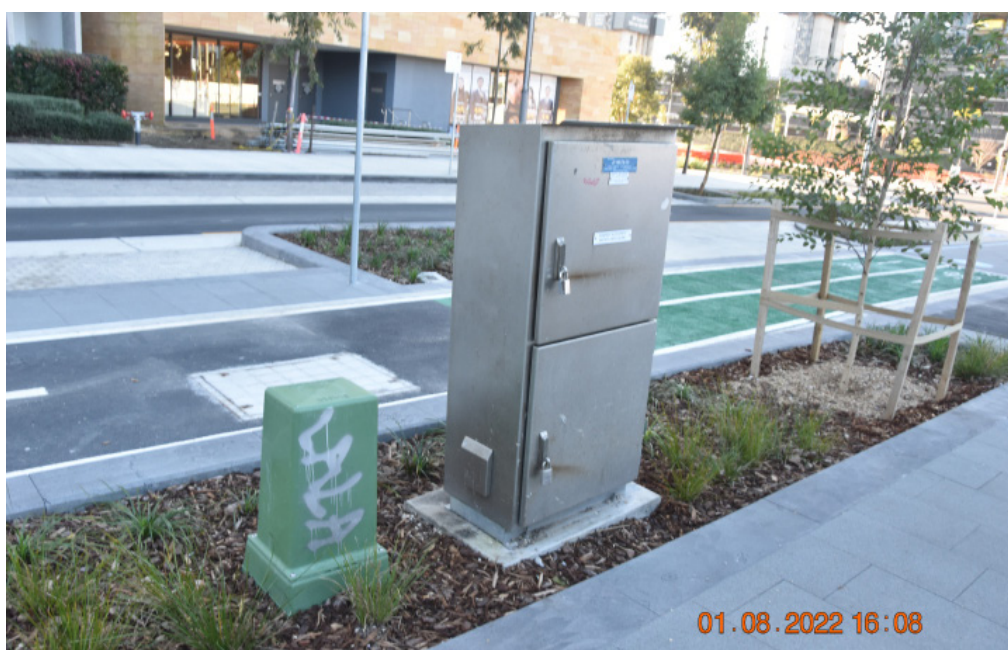
Figure: 0003

General view of the switch box and electricity box northwest corner on Portman Street, outside 3 Joynton Avenue.

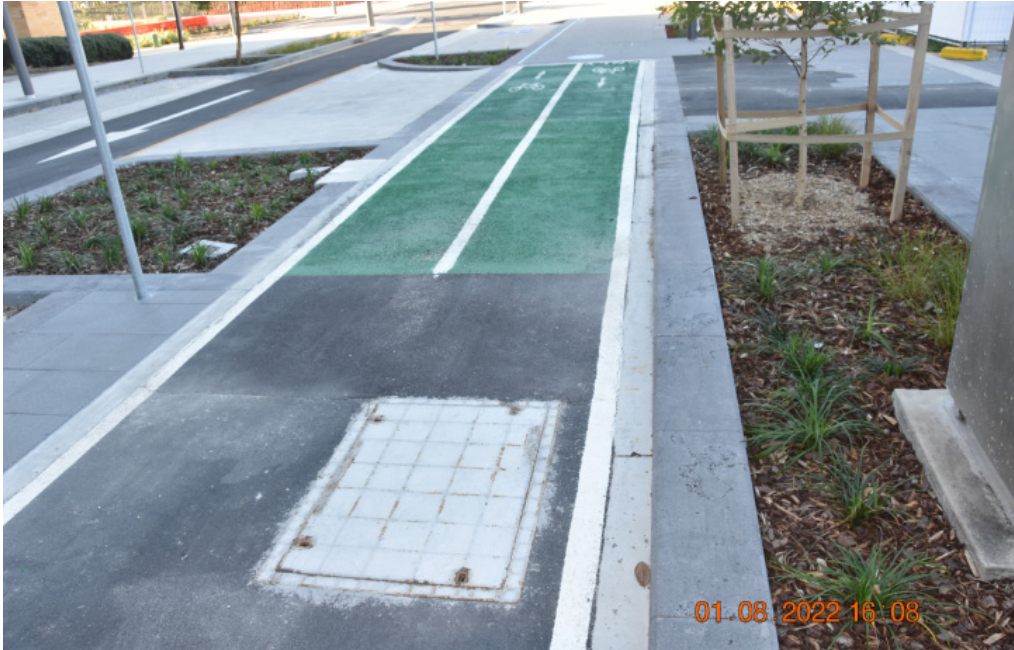
Figure: 0004

General view of the bicycle lane at the northwest corner on Portman Street, outside 3 Joynton Avenue.

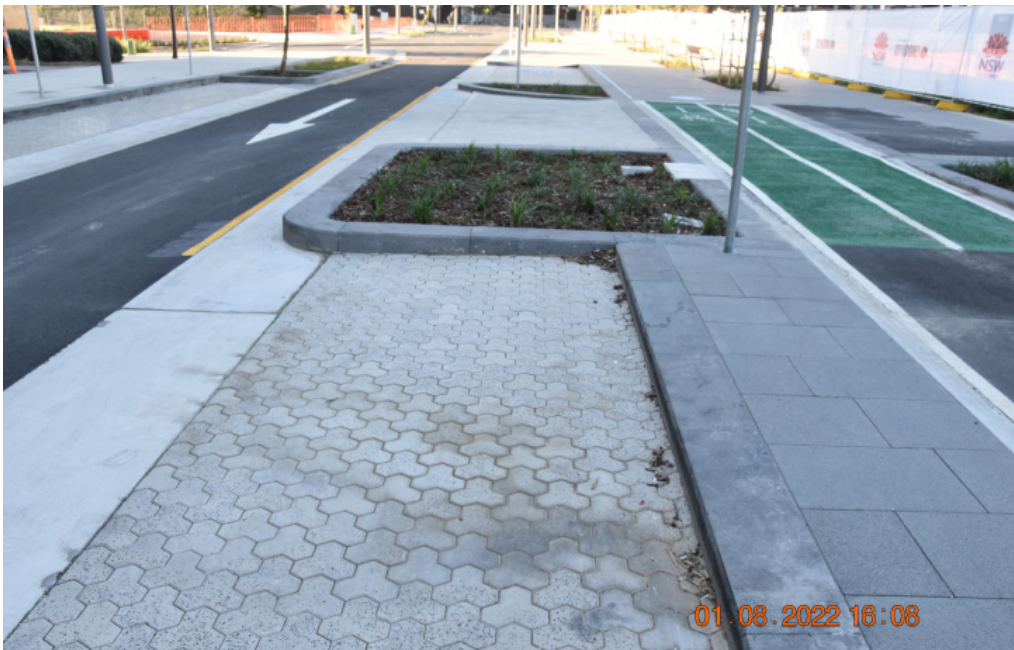
Figure: 0005

General view of the crossover at the northwest corner on Portman Street, outside 3 Joynton Avenue.

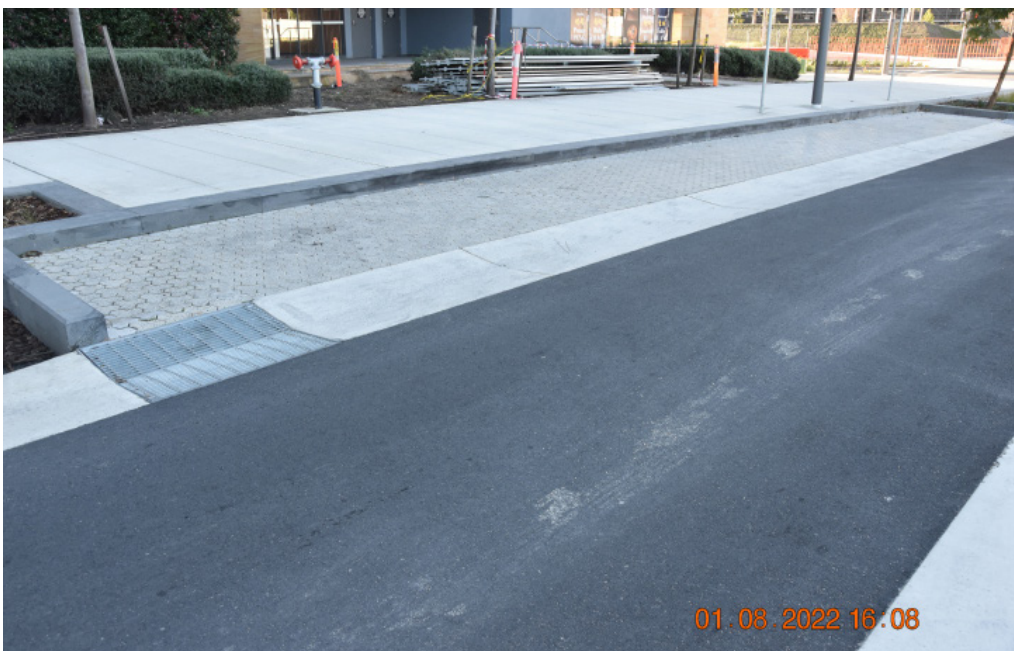
Figure: 0006

General view of the roadway at the northwest corner on Portman Street, outside 3 Joynton Avenue.

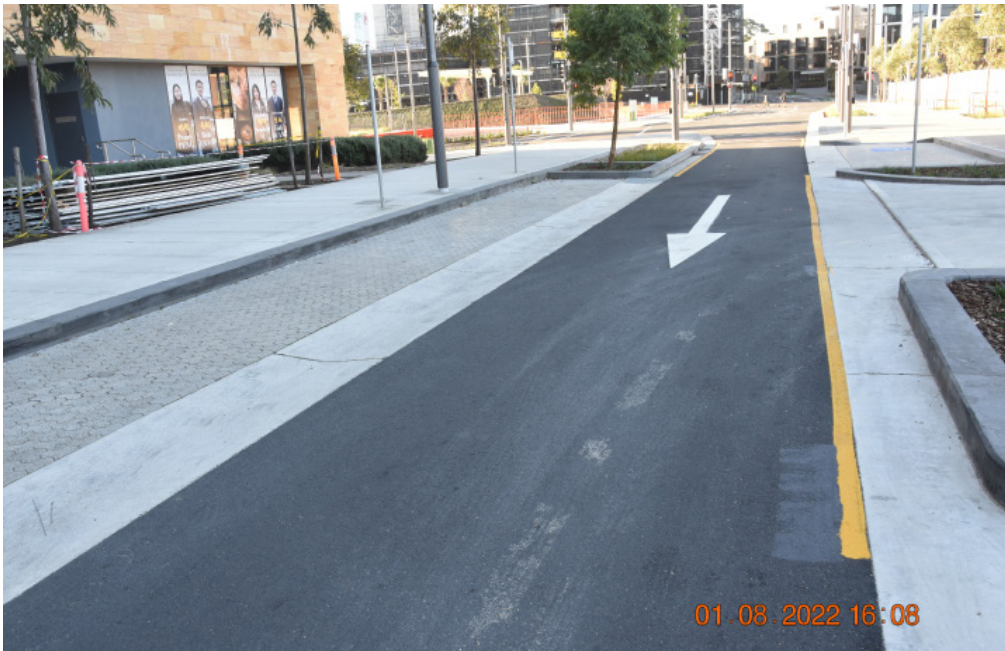
Figure: 0007

General view of the roadway at the northwest corner on Portman Street, outside 3 Joynton Avenue.

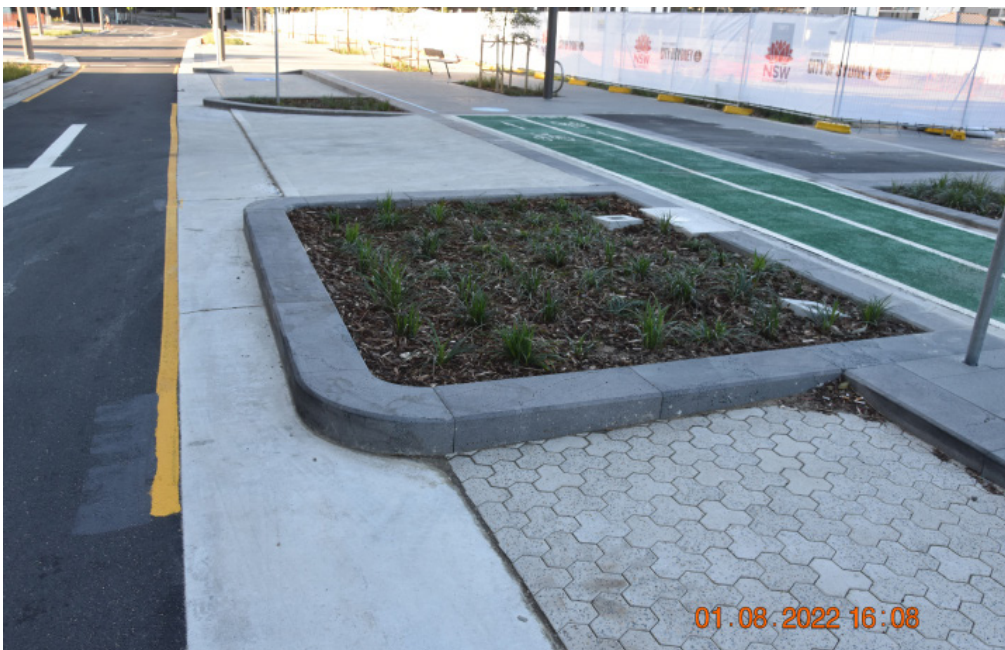
Figure: 0008

General view of the kerb and gutter at the northwest corner on Portman Street, outside 3 Joynton Avenue.

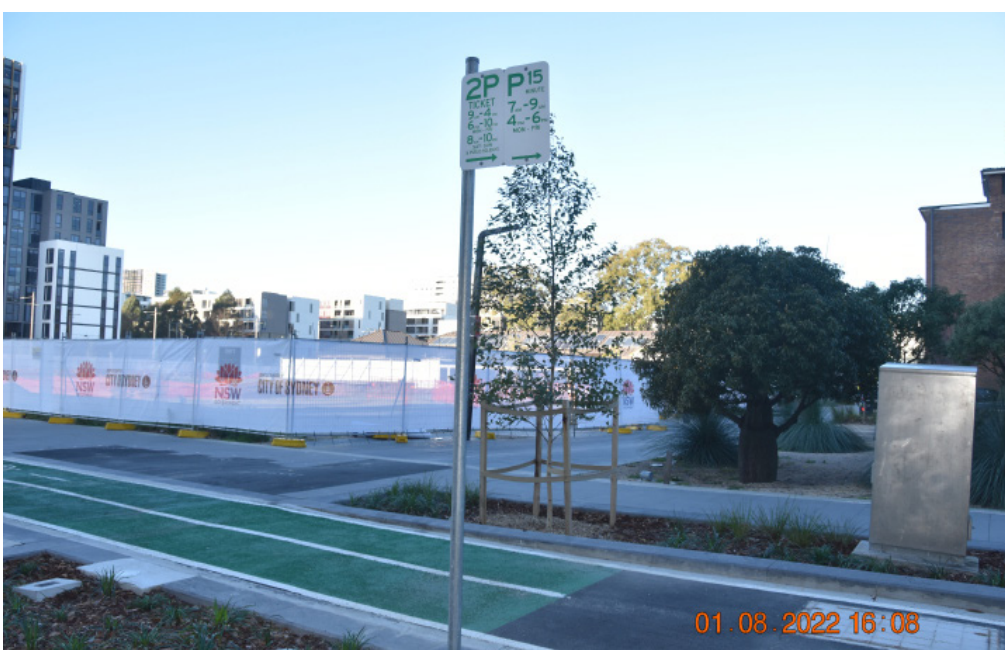
Figure: 0009

General view of the street sign at the northwest corner on Portman Street, outside 3 Joynton Avenue.

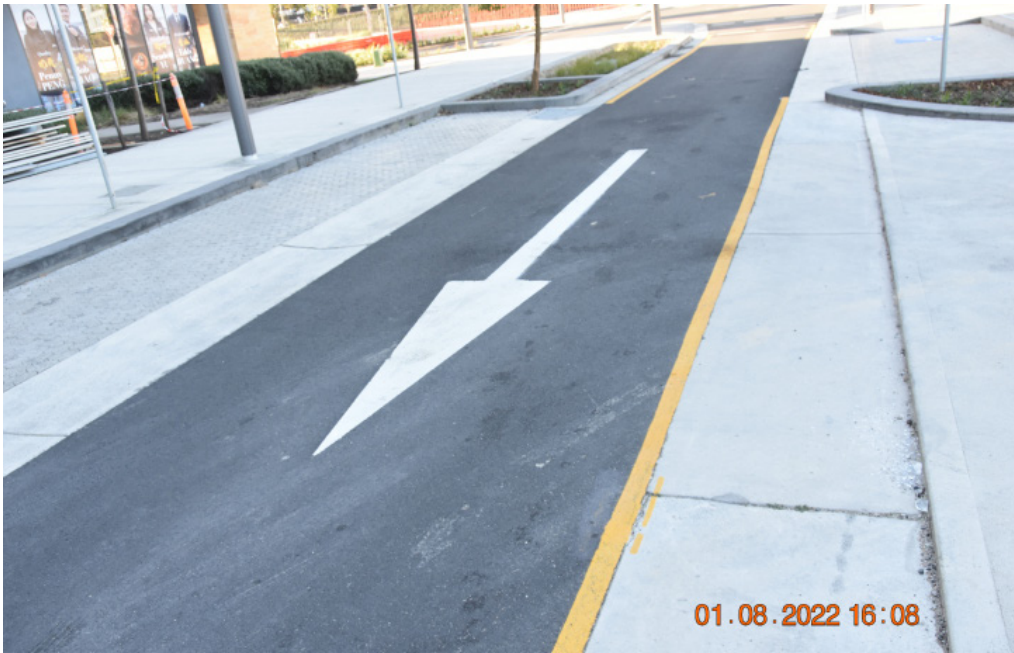
Figure: 0010

General view of the roadway at the northwest corner on Portman Street, outside 3 Joynton Avenue.

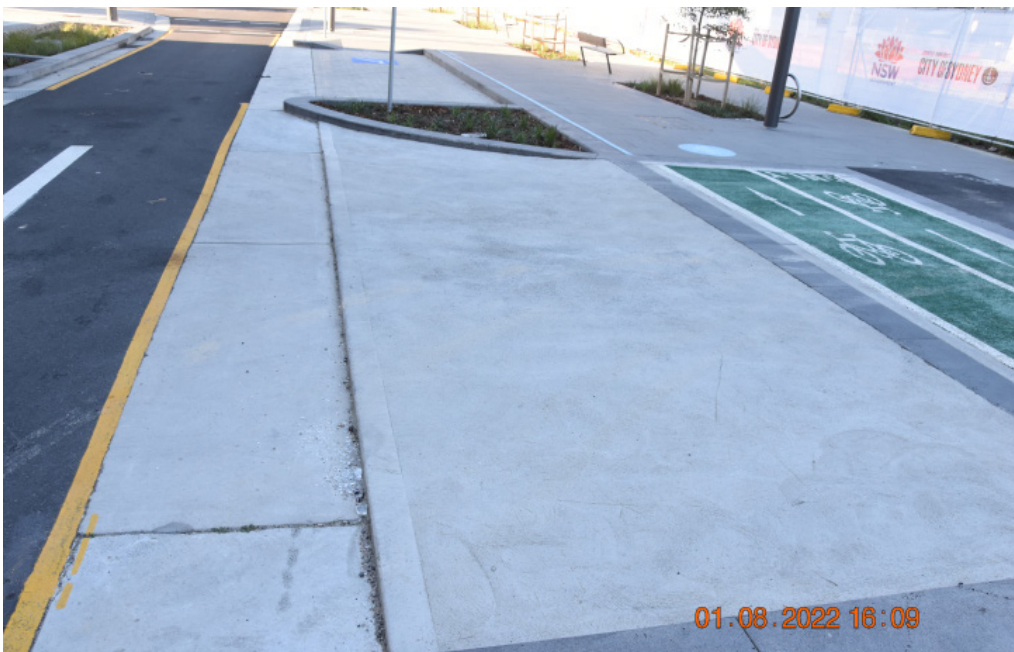
Figure: 0011

General view of the crossover at the northwest corner on Portman Street, outside 3 Joynton Avenue.

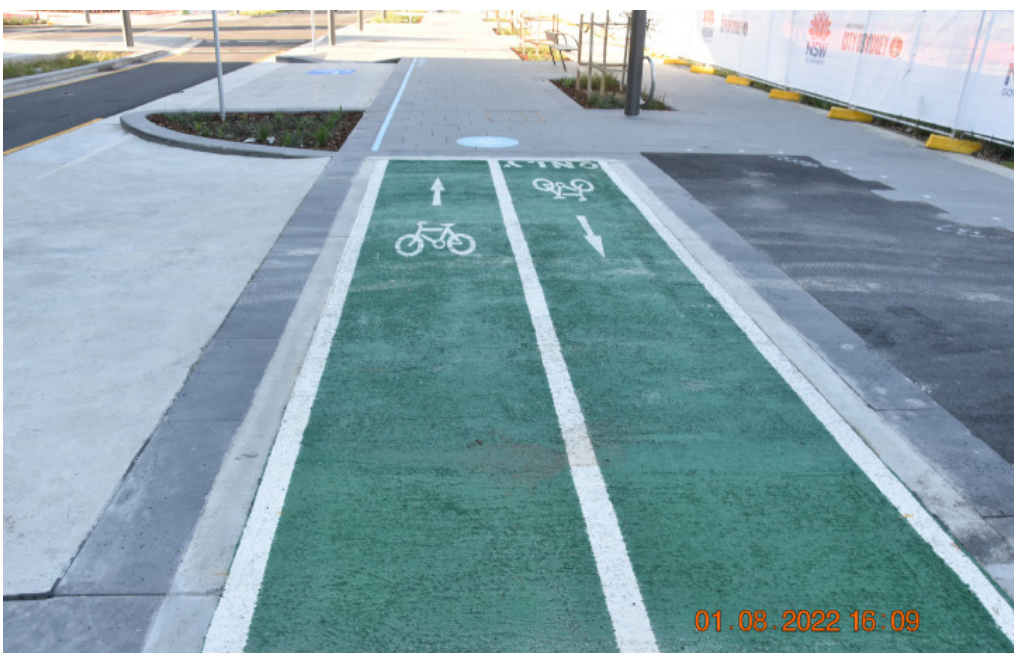
Figure: 0012

General view of the bicycle lane at the northwest corner on Portman Street, outside 3 Joynton Avenue.

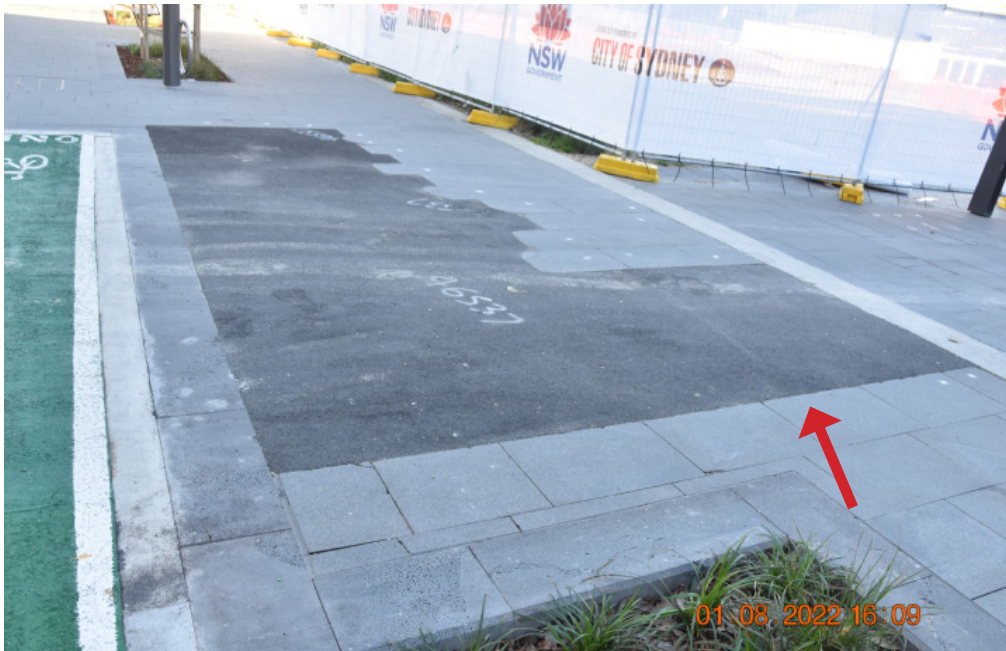
Figure: 0013

General view of the footpath at the northwest corner on Portman Street, outside 3 Joynton Avenue. Showing patching.

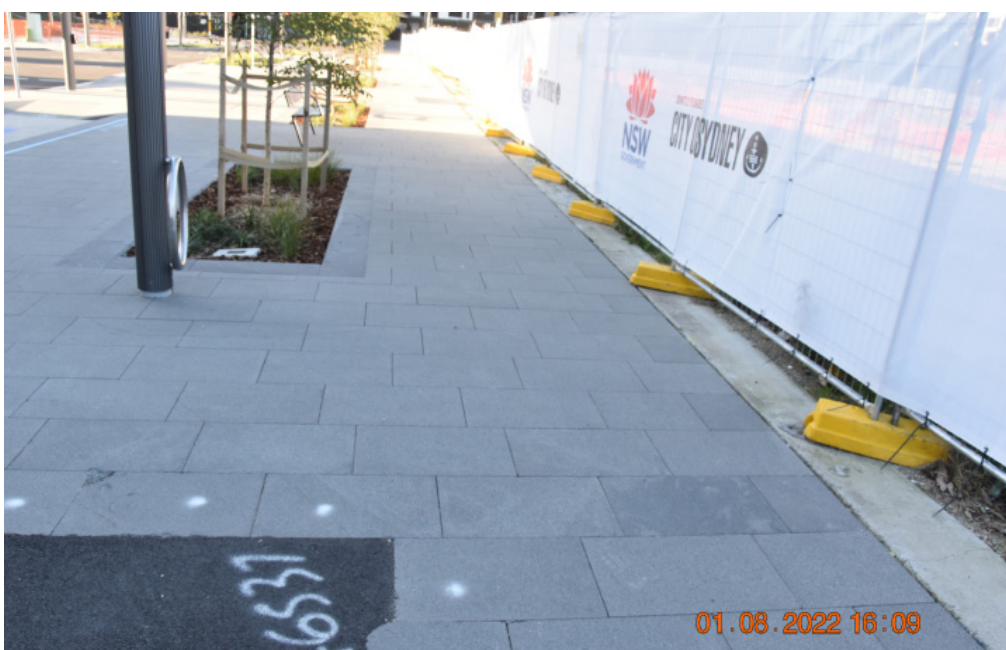
Figure: 0014

General view of the footpath at the northwest corner on Portman Street, outside 3 Joynton Avenue. Showing fine cracking.

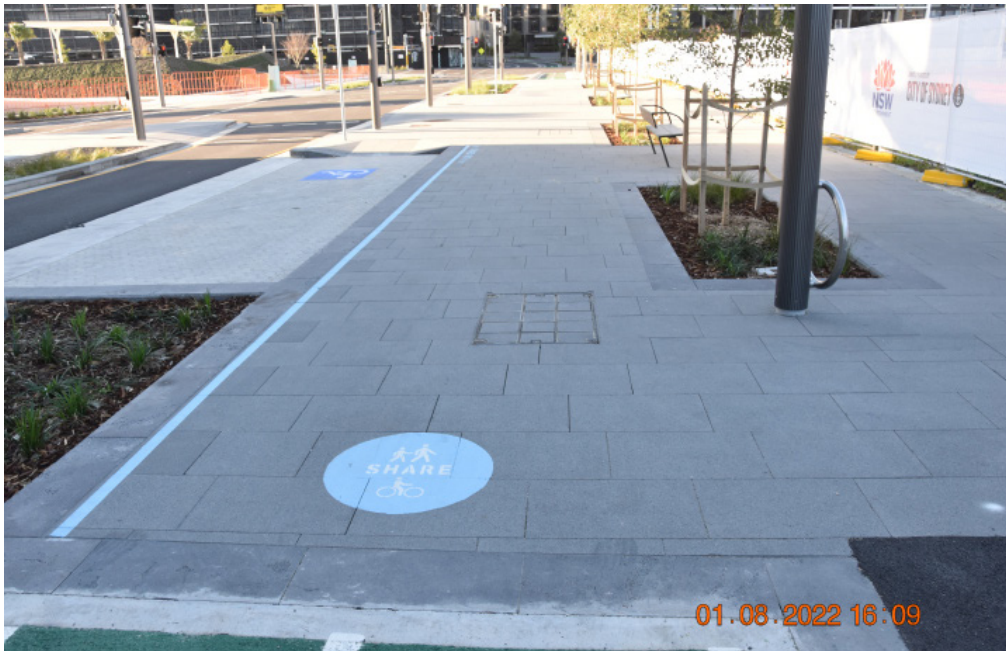
Figure: 0016

General view of the footpath on Portman Street, outside 3 Joynton Avenue, west side.

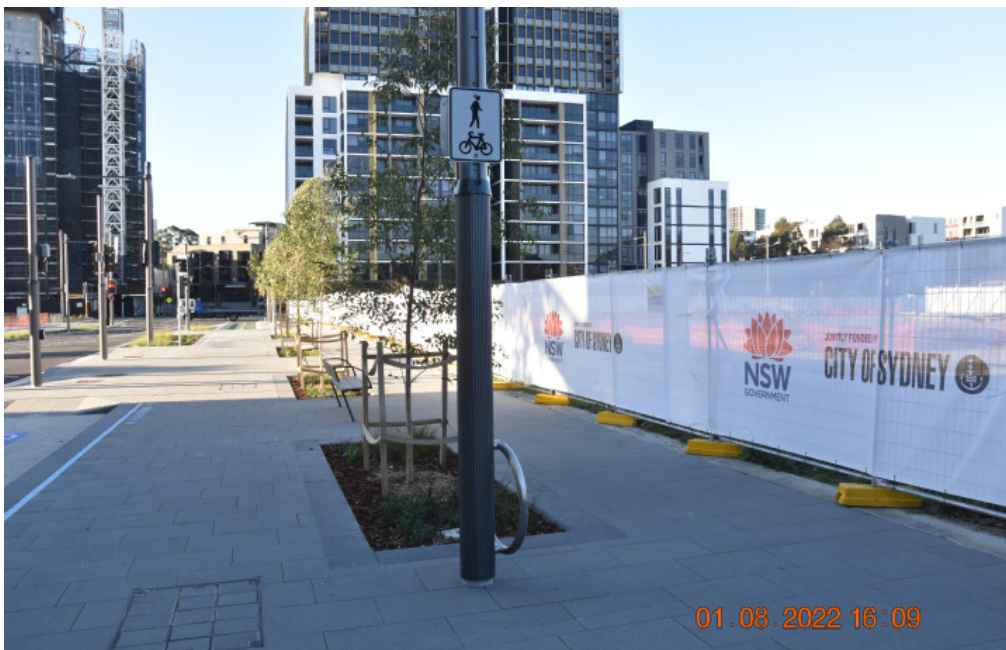
Figure: 0017

General view of the light pole on Portman Street, outside 3 Joynton Avenue, west side.

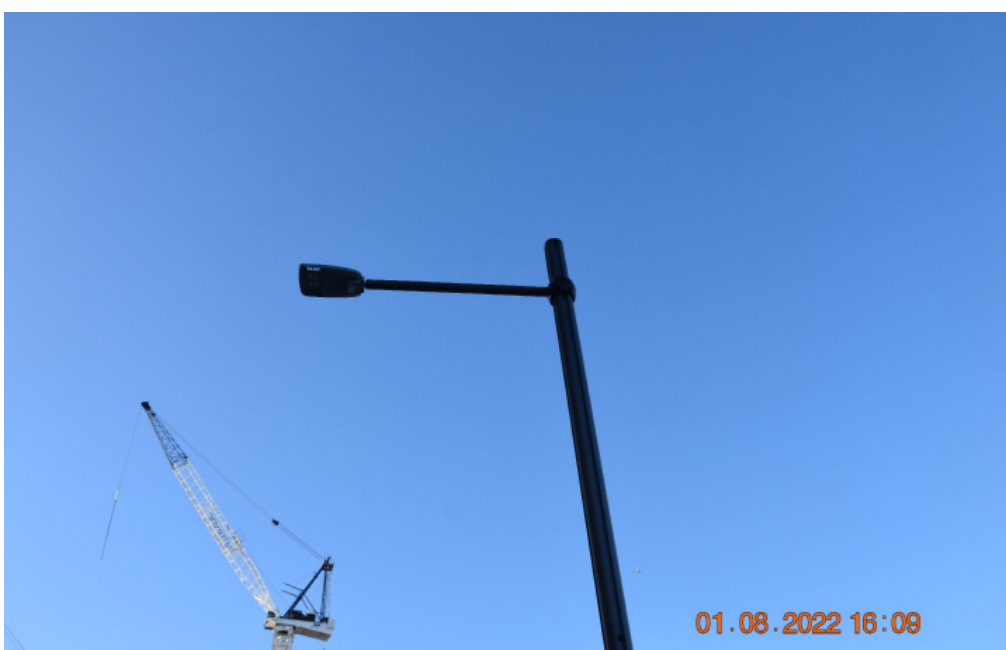
Figure: 0018

General view of the light pole on Portman Street, outside 3 Joynton Avenue, west side.

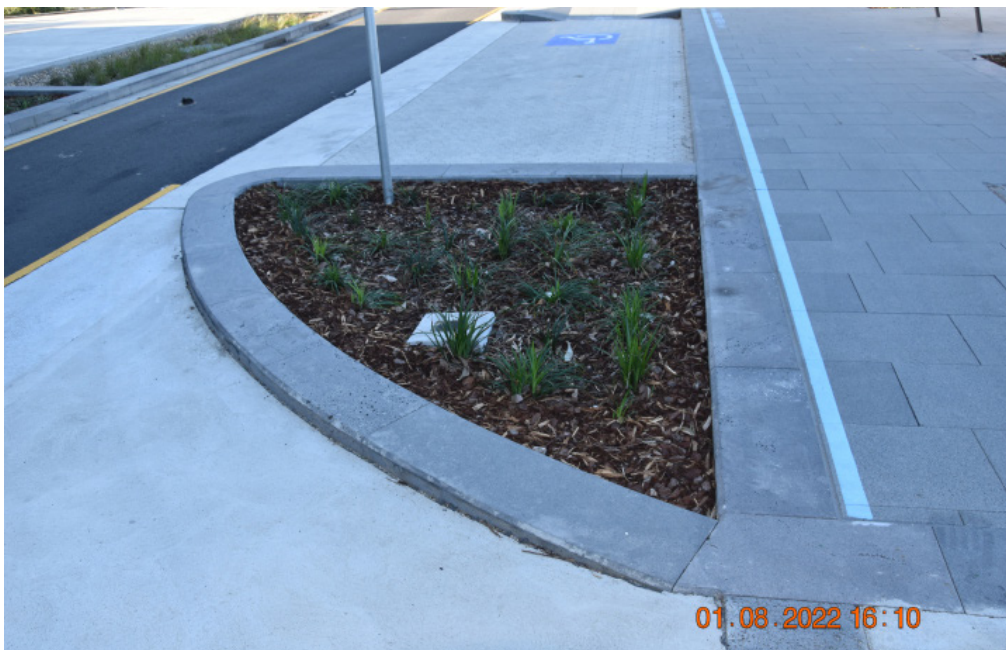
Figure: 0020

General view of the garden bed on Portman Street, outside 3 Joynton Avenue, west side.

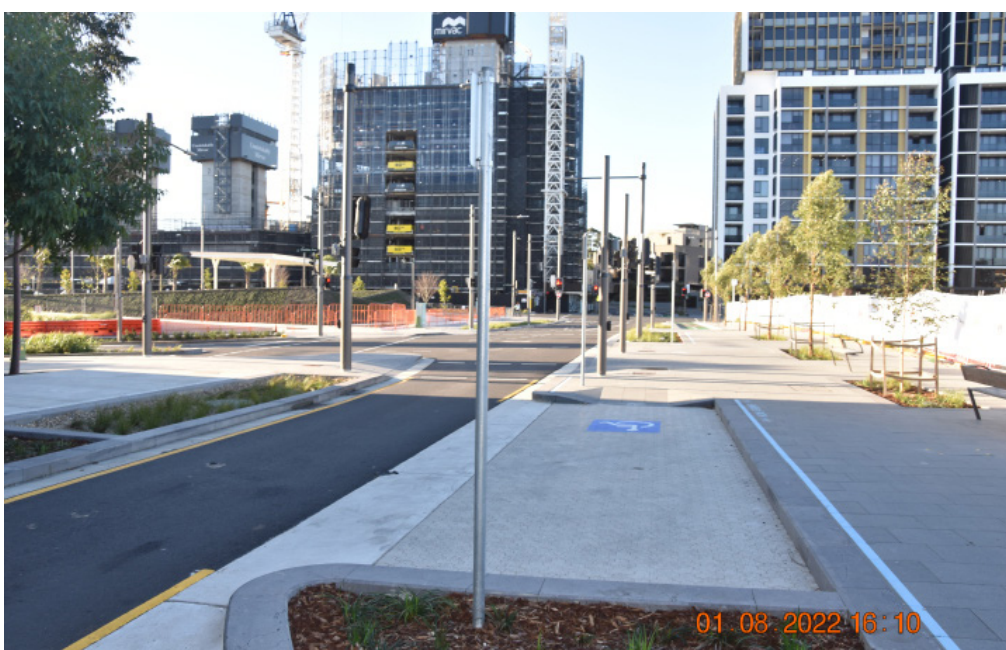
Figure: 0021

General view of the street sign on Portman Street, outside 3 Joynton Avenue, west side.

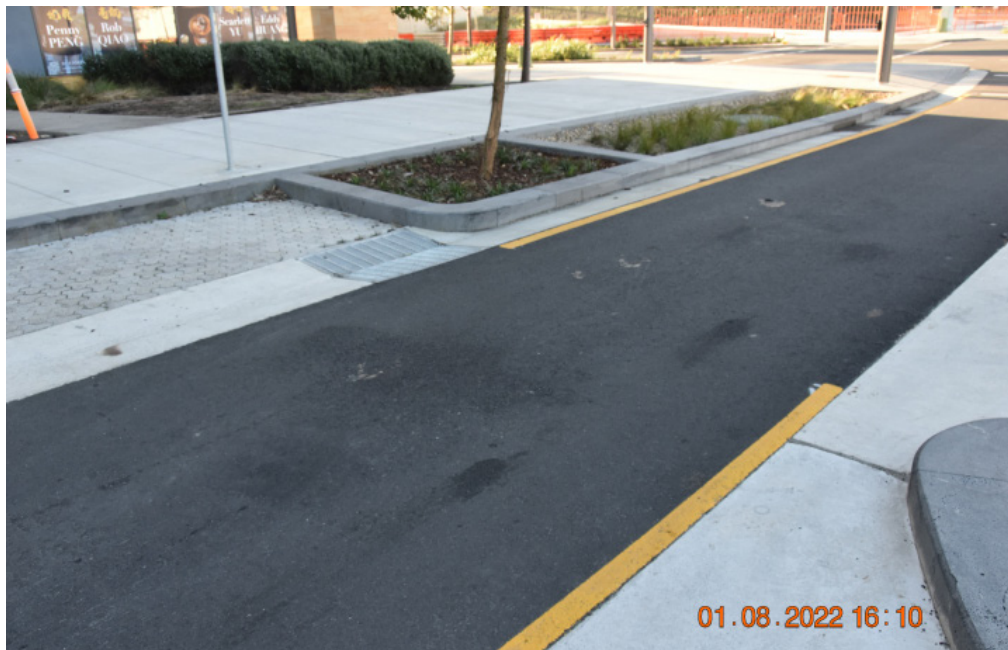
Figure: 0022

General view of the roadway on Portman Street, outside 3 Joynton Avenue, west side.

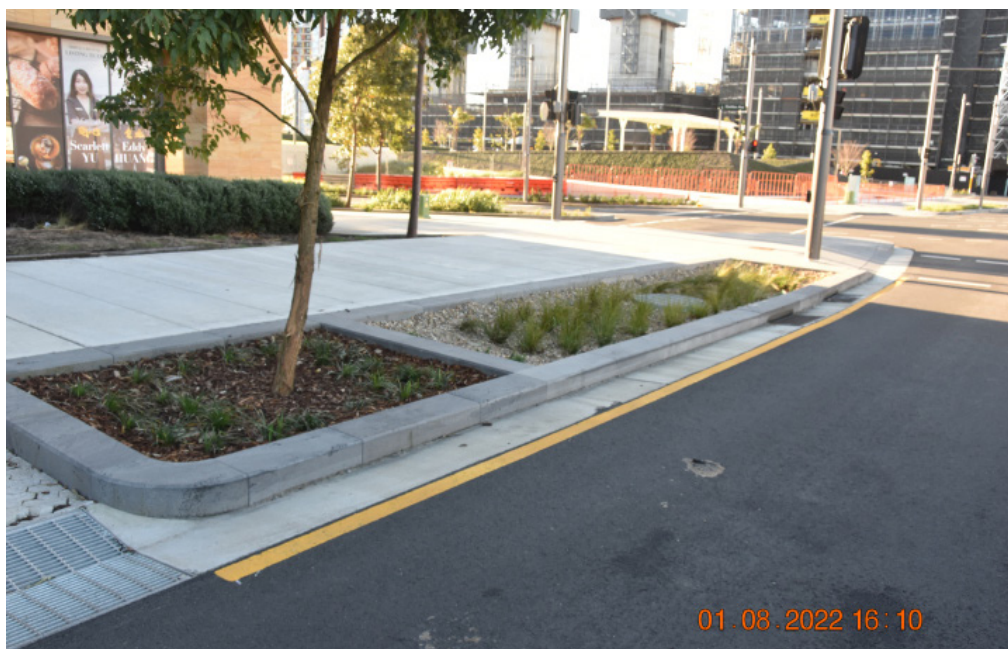
Figure: 0023

General view of the garden bed on Portman Street outside 3 Joynton Avenue, at approximately 5 meters from the west end.

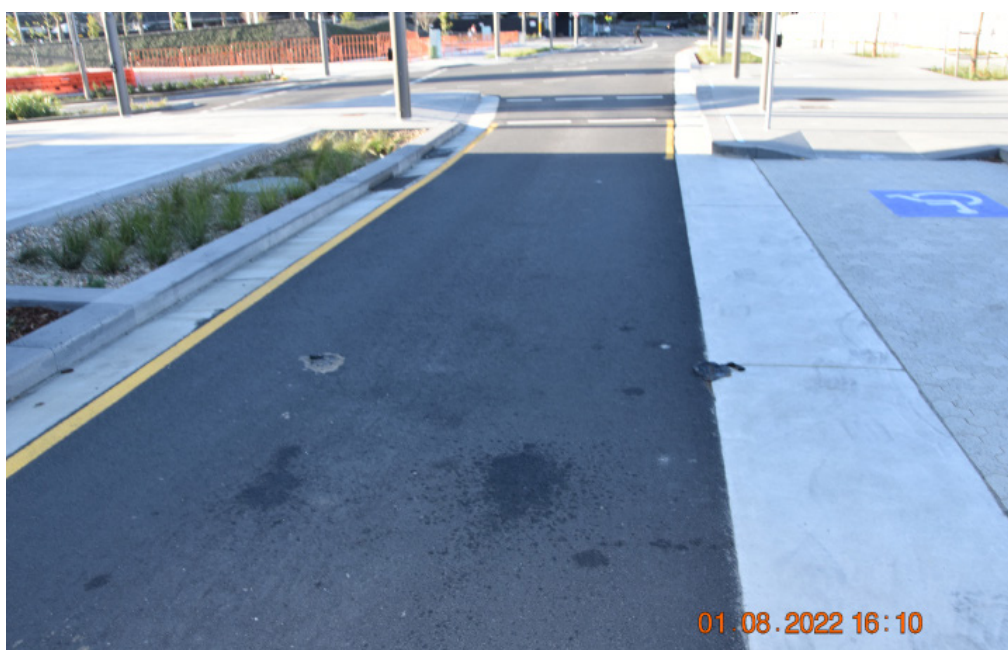
Figure: 0024

General view of the roadway on Portman Street outside 3 Joynton Avenue, at approximately 5 meters from the west end.

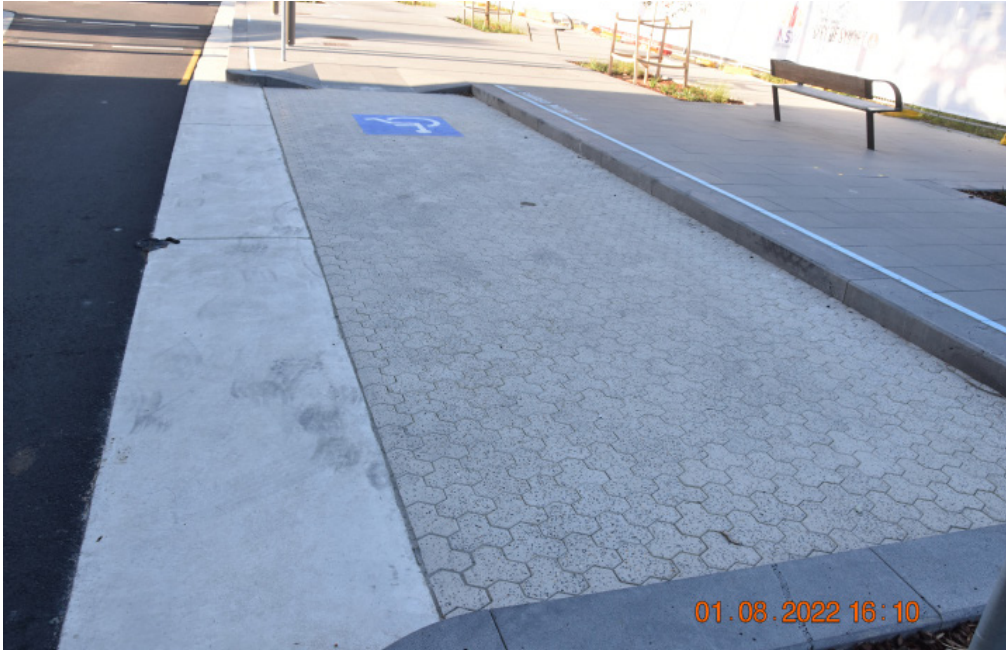
Figure: 0025

General view of the parking bay on Portman Street outside 3 Joynton Avenue, at approximately 5 meters from the west end.

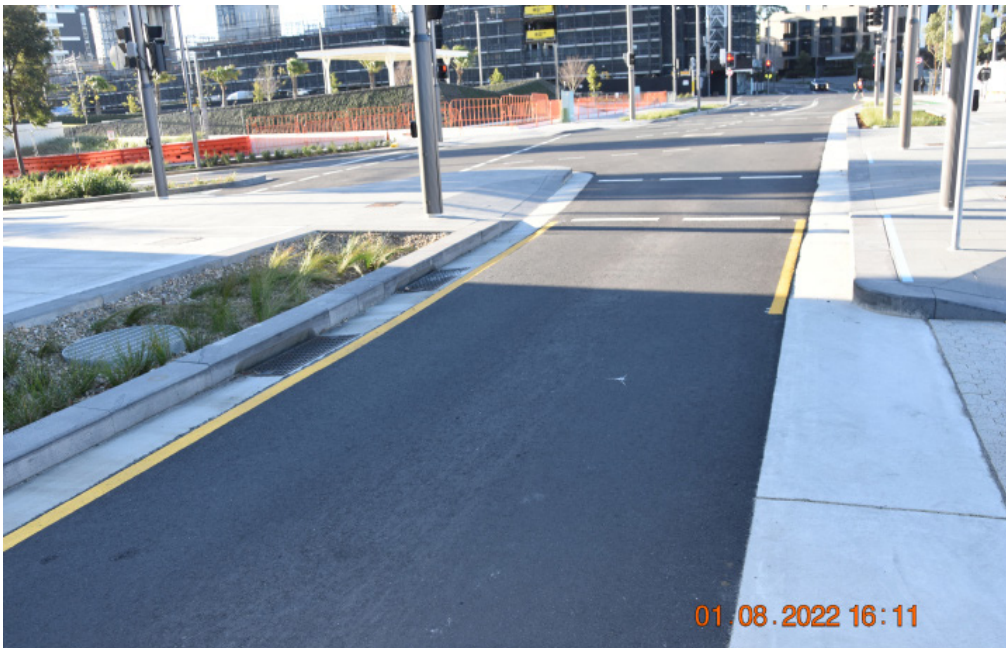
Figure: 0026

General view of the roadway on Portman Street outside 3 Joynton Avenue, at approximately 5 meters from the west end.

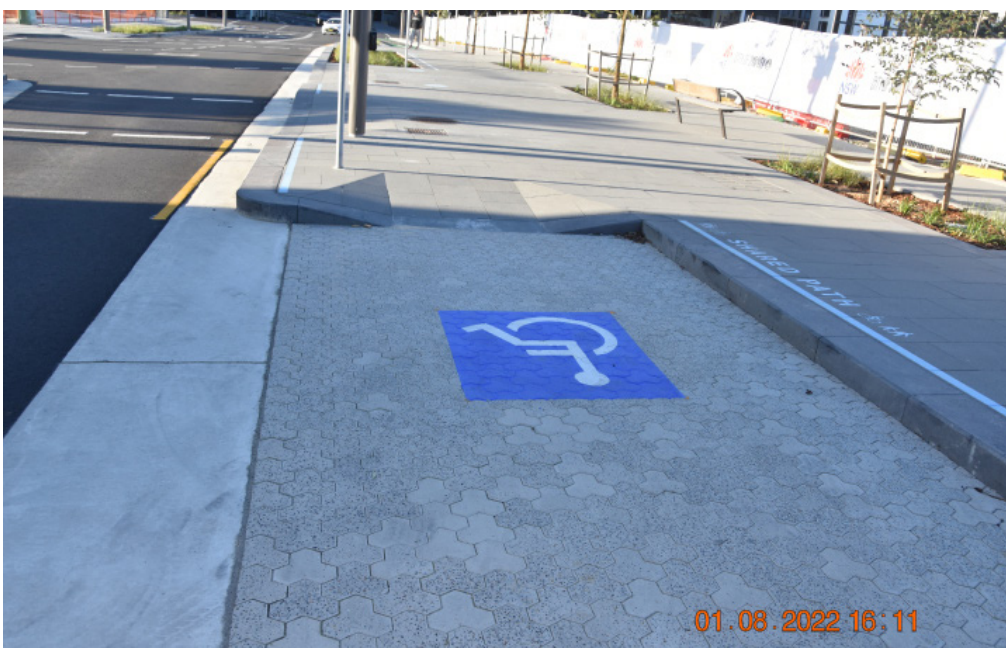
Figure: 0027

General view of the parking bay on Portman Street outside 3 Joynton Avenue, at approximately 5 meters from the west end.

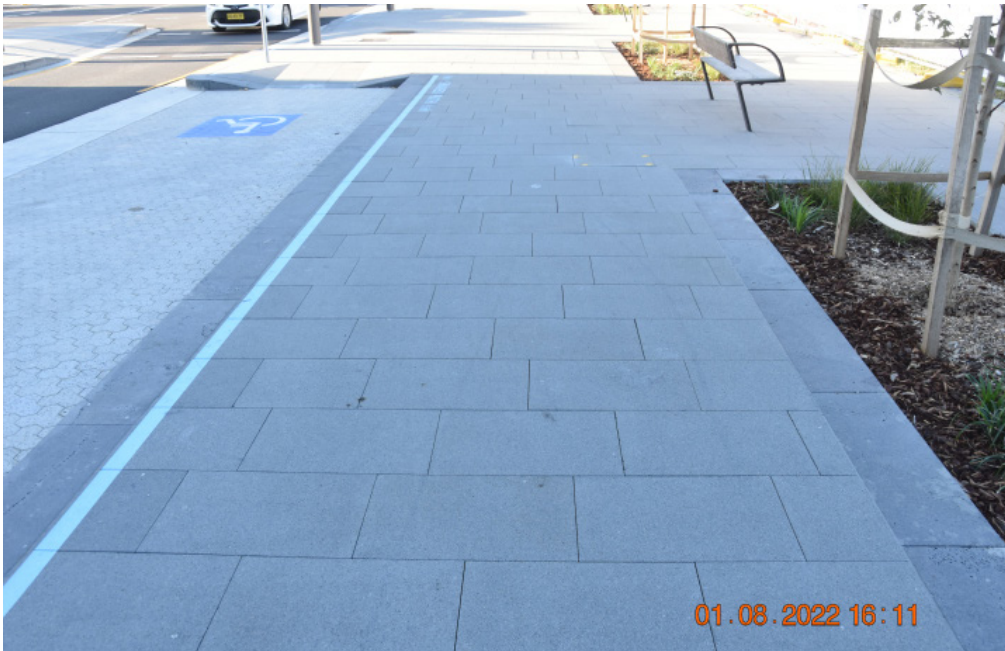
Figure: 0028

General view of the footpath on Portman Street outside 3 Joynton Avenue, at approximately 5 meters from the west end.

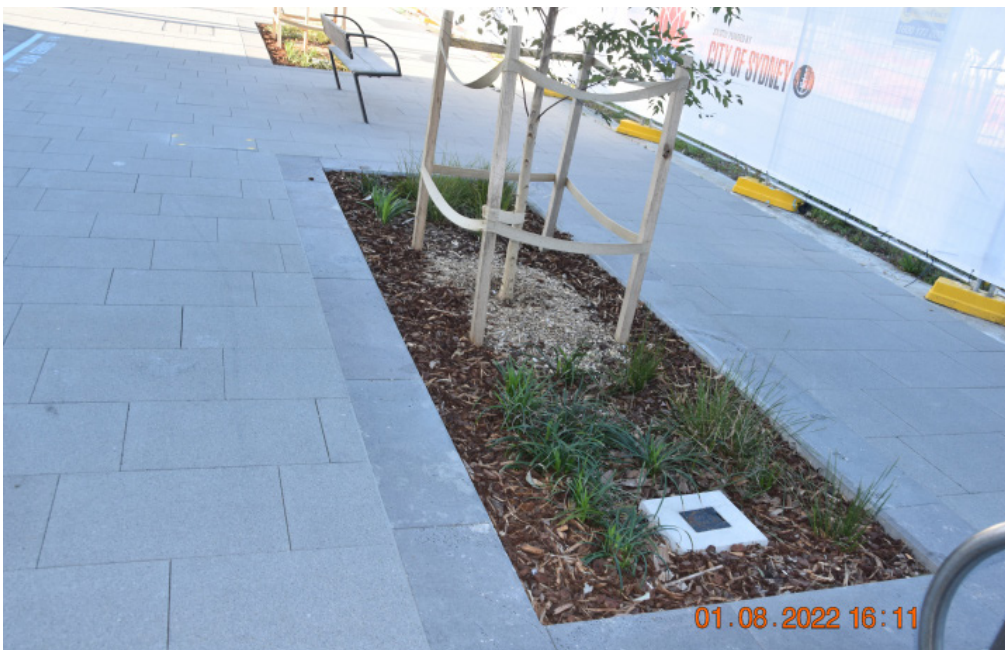
Figure: 0029

General view of the footpath on Portman Street outside 3 Joynton Avenue, at approximately 5 meters from the west end.

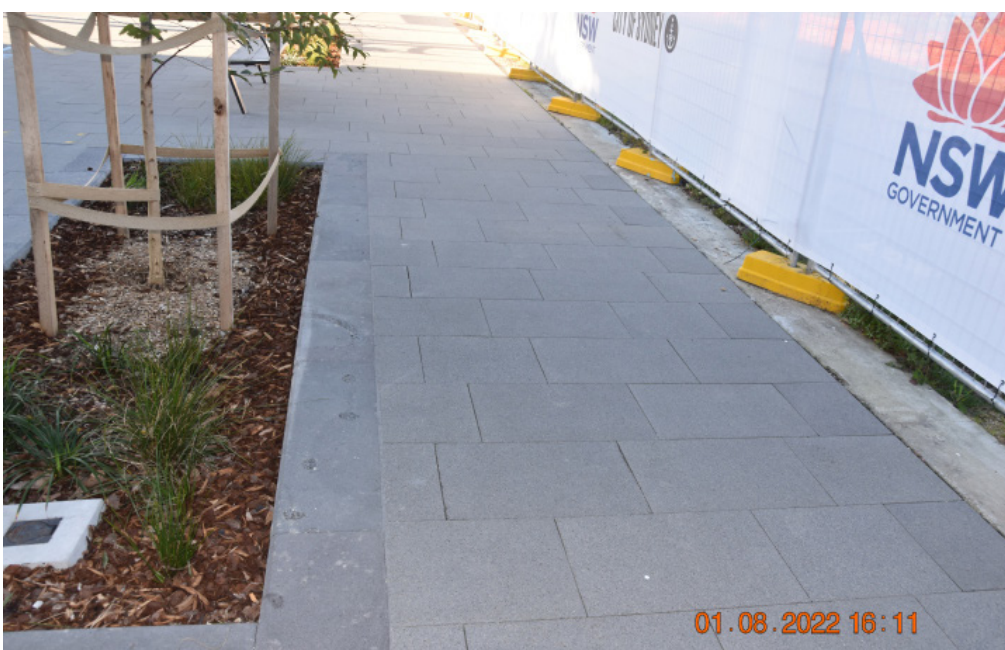
Figure: 0030

General view of the footpath on Portman Street outside 3 Joynton Avenue, at approximately 5 meters from the west end.

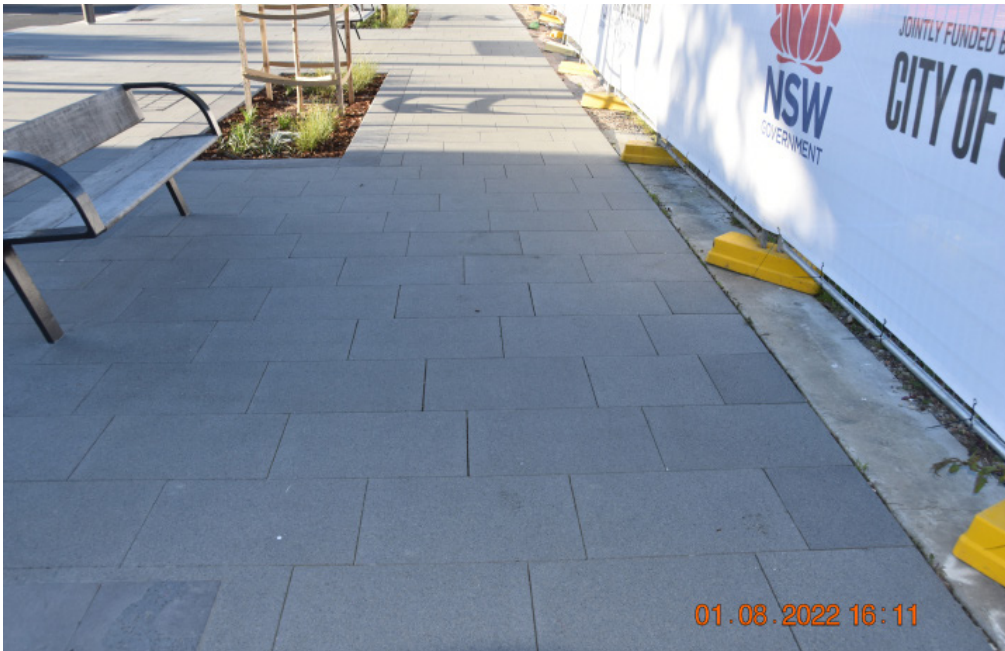
Figure: 0031

General view of the footpath on Portman Street outside 3 Joynton Avenue, at approximately 5 meters from the west end.

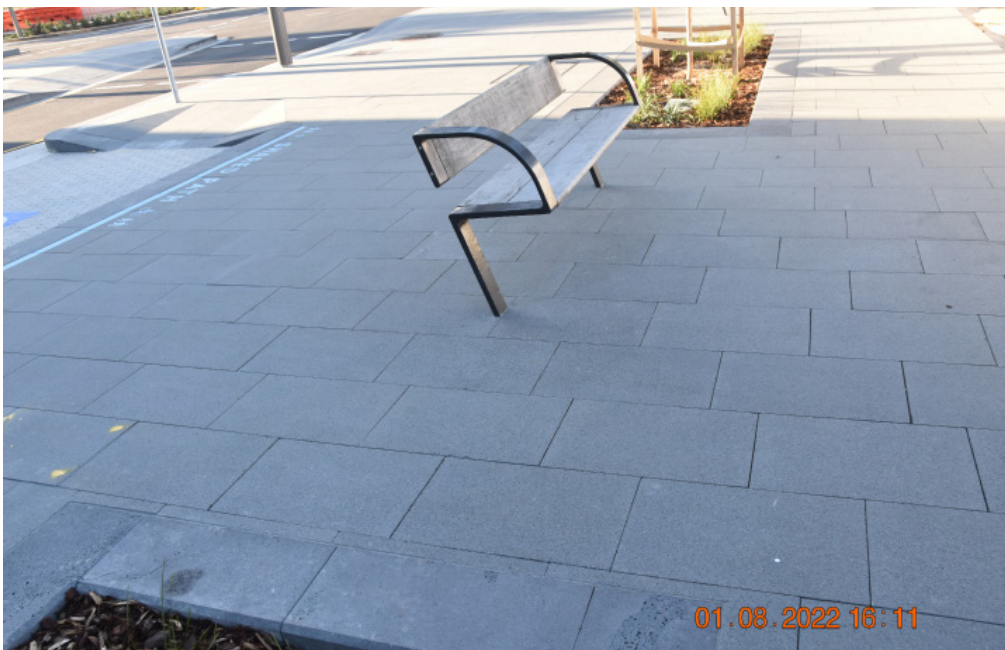
Figure: 0032

General view of the footpath on Portman Street outside 3 Joynton Avenue, at approximately 5 meters from the west end.

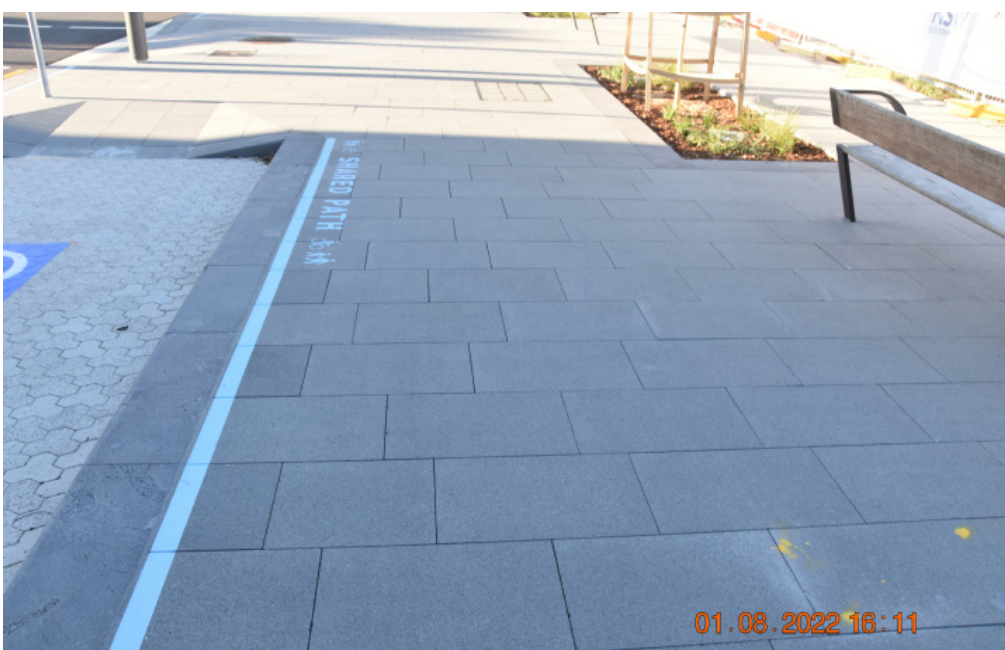
Figure: 0033

General view of the footpath on Portman Street outside 3 Joynton Avenue, at approximately 5 meters from the west end.

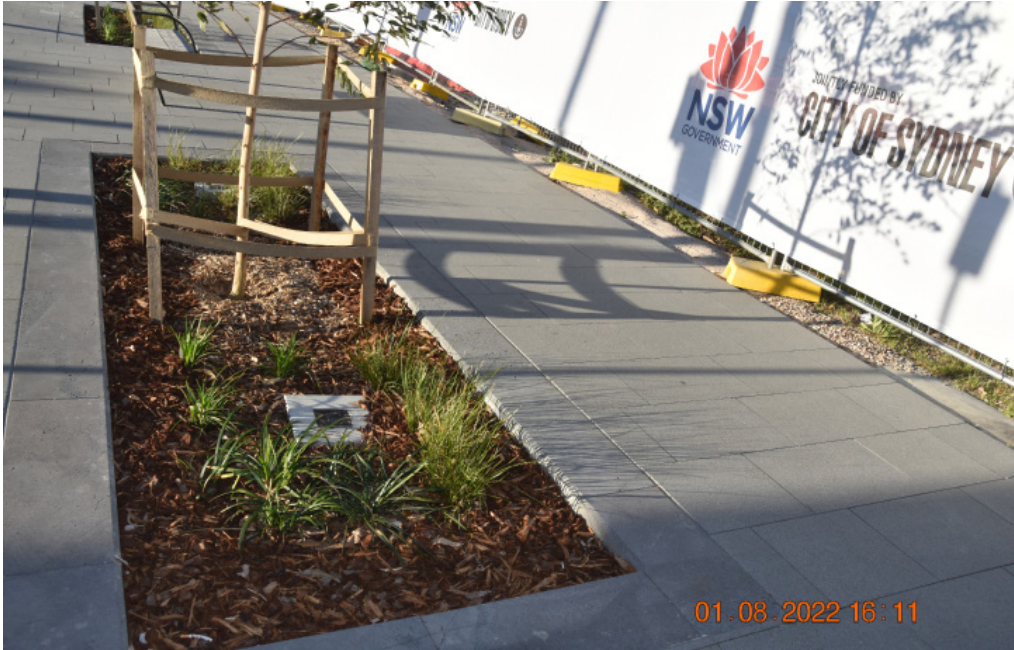
Figure: 0034

General view of the footpath on Portman Street outside 3 Joynton Avenue, at approximately 10 meters from the west end.

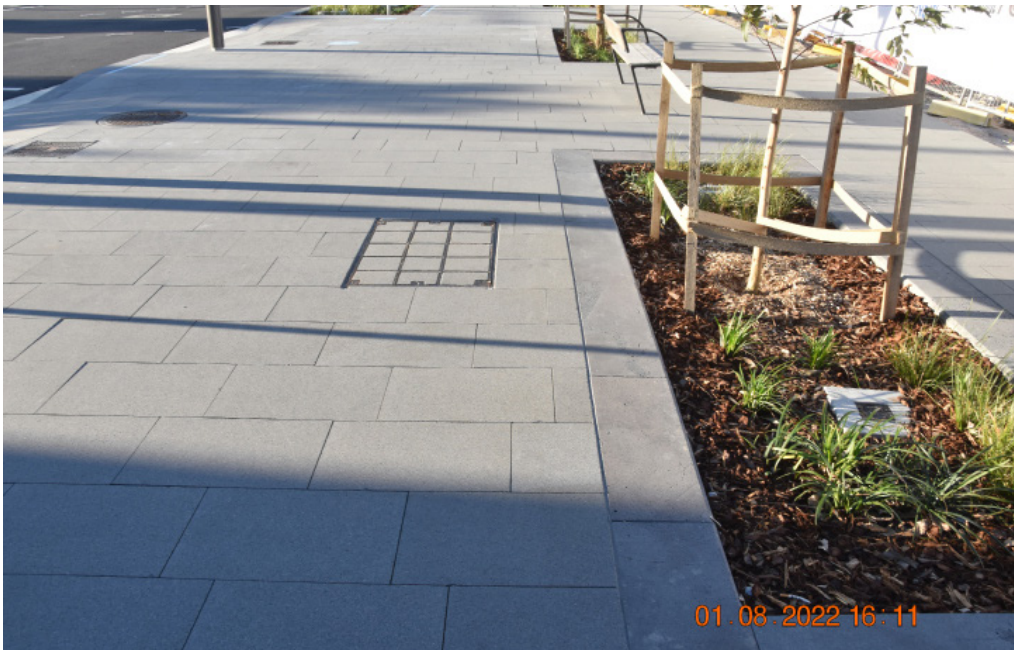
Figure: 0035

General view of the footpath on Portman Street outside 3 Joynton Avenue, at approximately 10 meters from the west end.
