PRE CONSTRUCTION CONDITION SURVEY

Green Square Integrated Community Facility &
School - 3 Joynton Avenue, Zetland NSW

Council Assets
3 Joynton Avenue and Portman Street
ZETLAND NSW 2017

01 August 2022

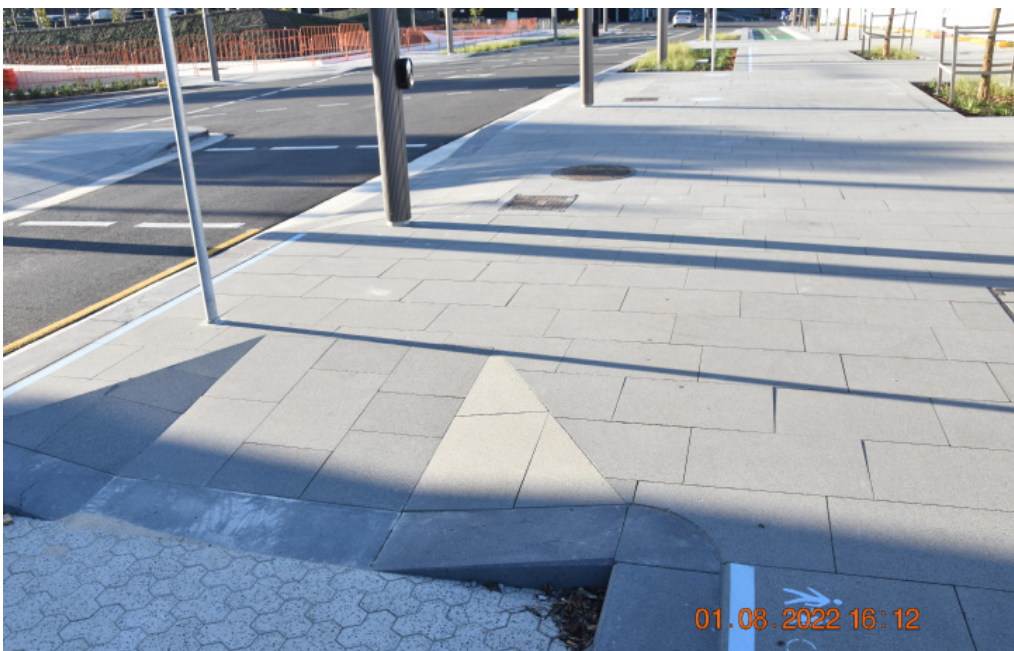
Figure: 0036

General view of the footpath on Portman Street outside 3 Joynton Avenue, at approximately 10 meters from the west end.

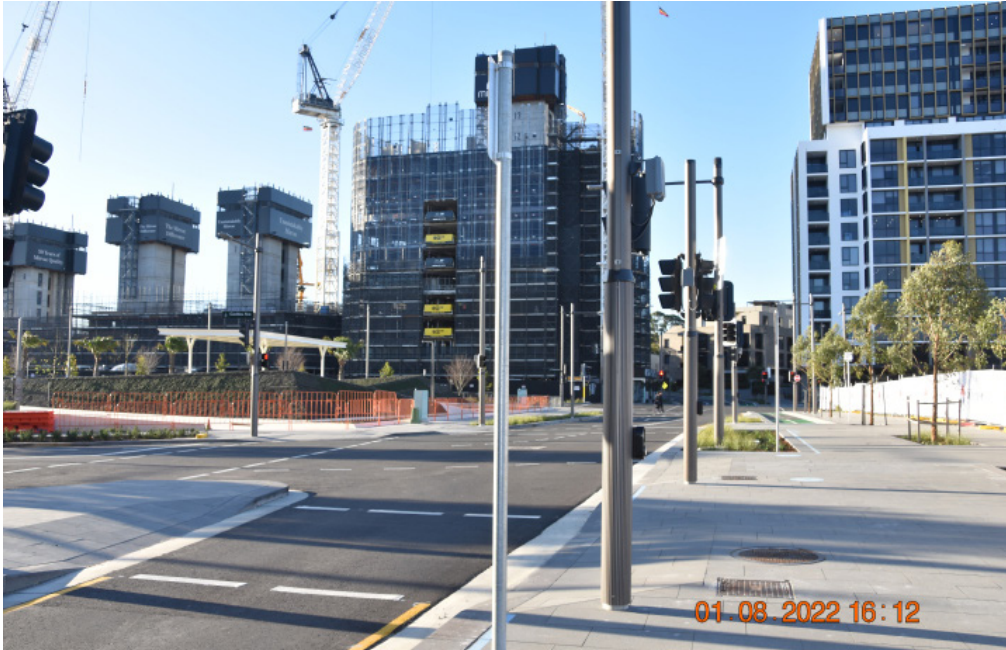
Figure: 0037

General view of the street sign on Portman Street outside 3 Joynton Avenue, at approximately 10 meters from the west end.

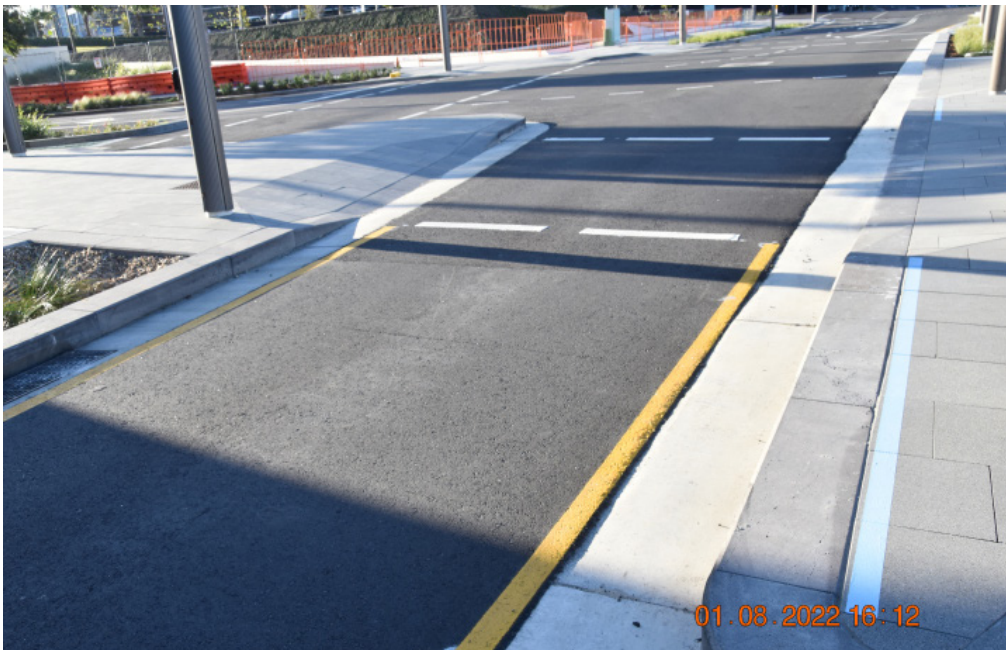
Figure: 0038

General view of the roadway on Portman Street outside 3 Joynton Avenue, at approximately 10 meters from the west end.

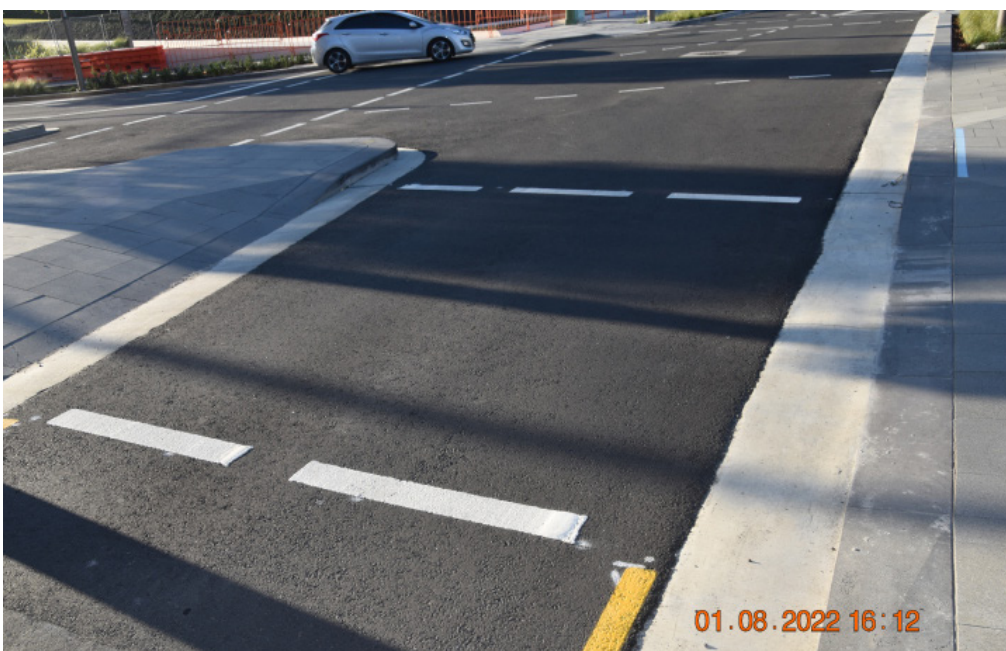
Figure: 0039

General view of the crossover on Portman Street outside 3 Joynton Avenue, at approximately 10 meters from the west end.

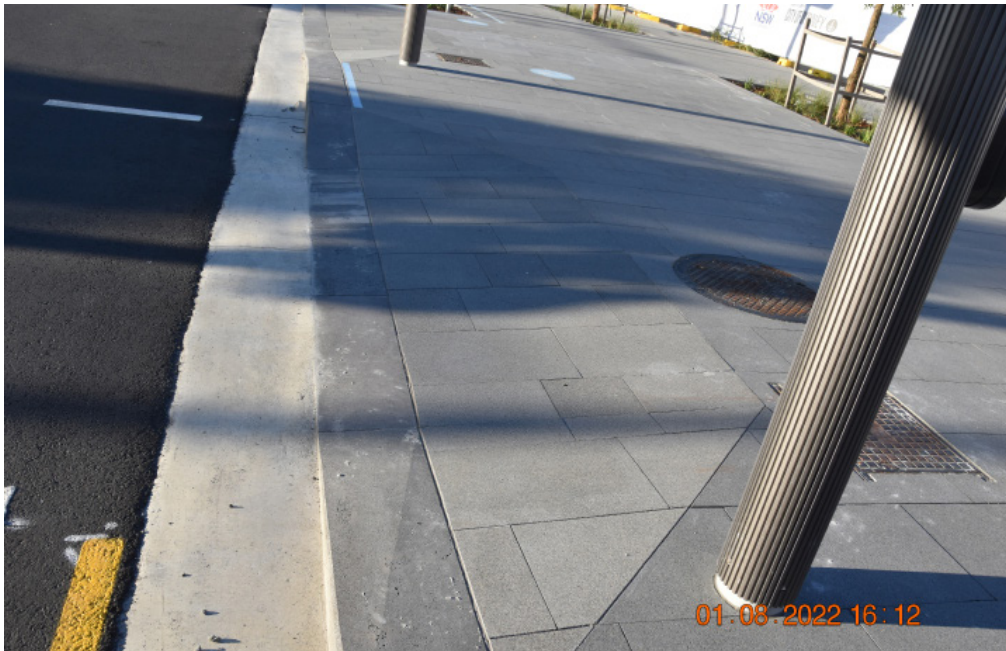
Figure: 0040

General view of the footpath on Portman Street outside 3 Joynton Avenue, at approximately 10 meters from the west end.

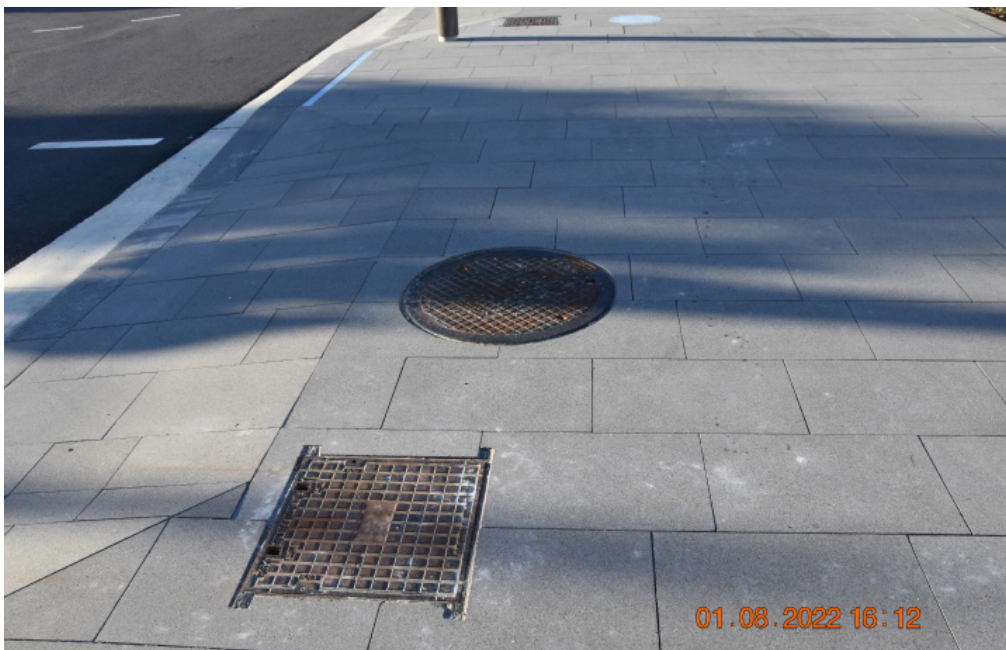
Figure: 0041

General view of the pit lid on Portman Street outside 3 Joynton Avenue, at approximately 10 meters from the west end.

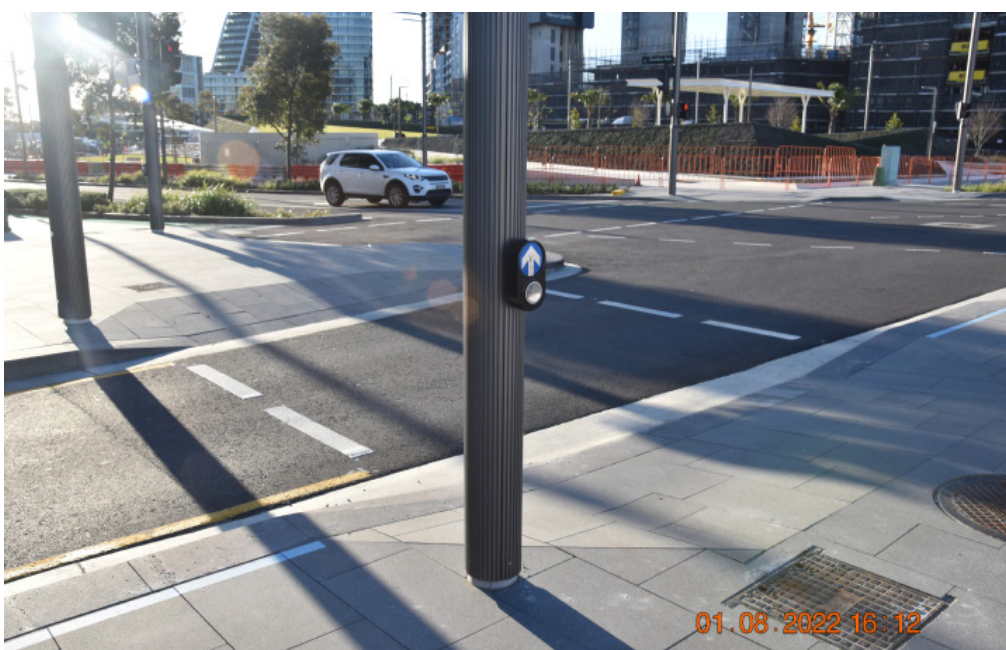
Figure: 0042

General view of the traffic light on Portman Street outside 3 Joynton Avenue, at approximately 10 meters from the west end.

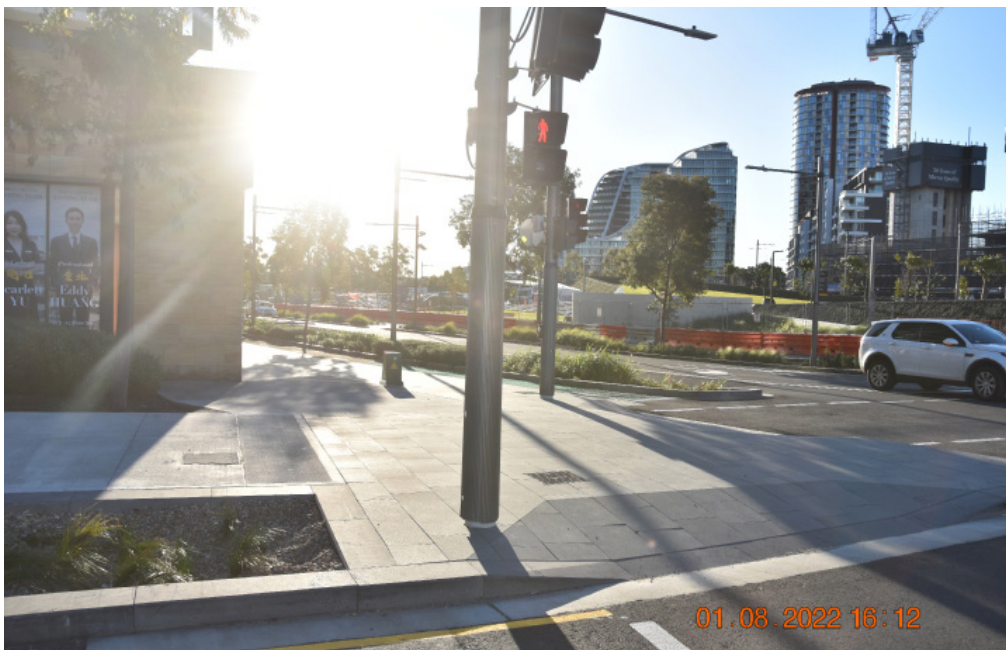
Figure: 0043

General view of the traffic light on Portman Street outside 3 Joynton Avenue, at approximately 10 meters from the west end.

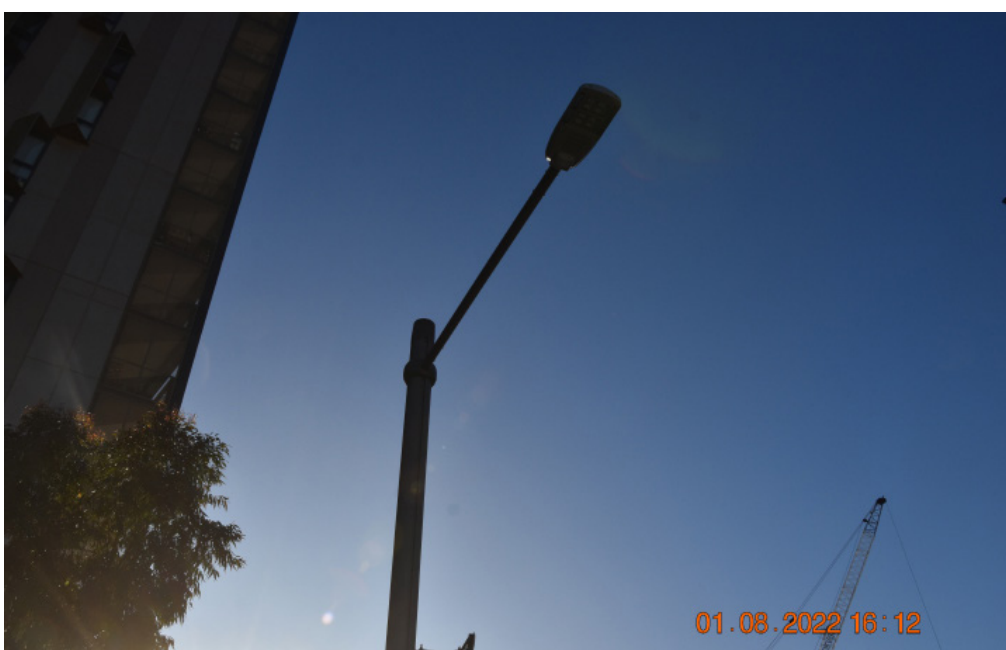
Figure: 0044

General view of the light pole on Portman Street outside 3 Joynton Avenue, at approximately 10 meters from the west end.

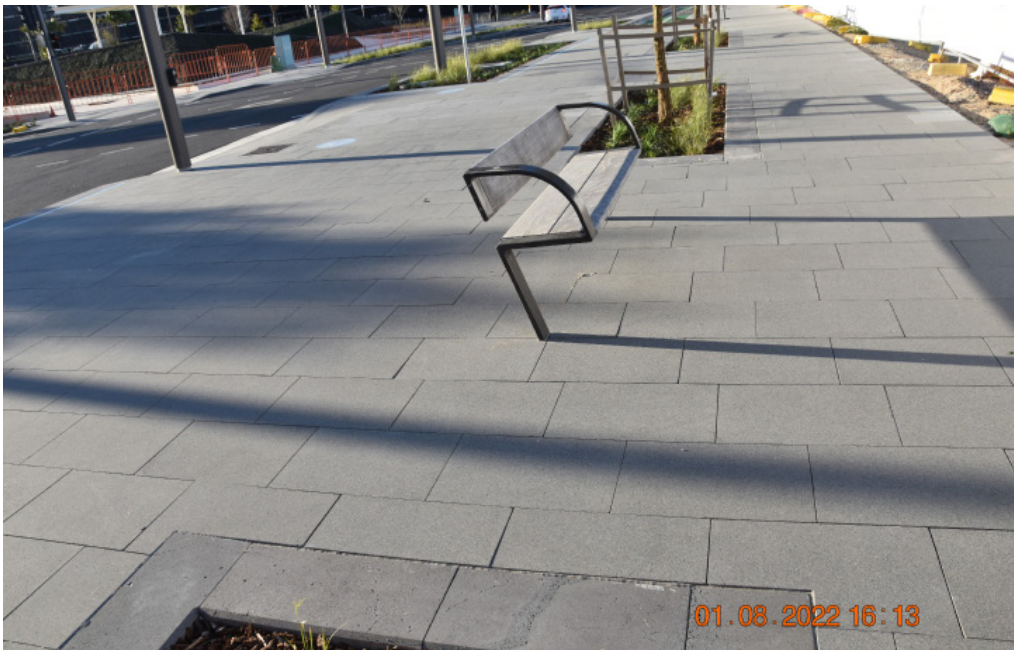
Figure: 0046

General view of the footpath on Portman Street outside 3 Joynton Avenue, at approximately 10 meters from the west end.

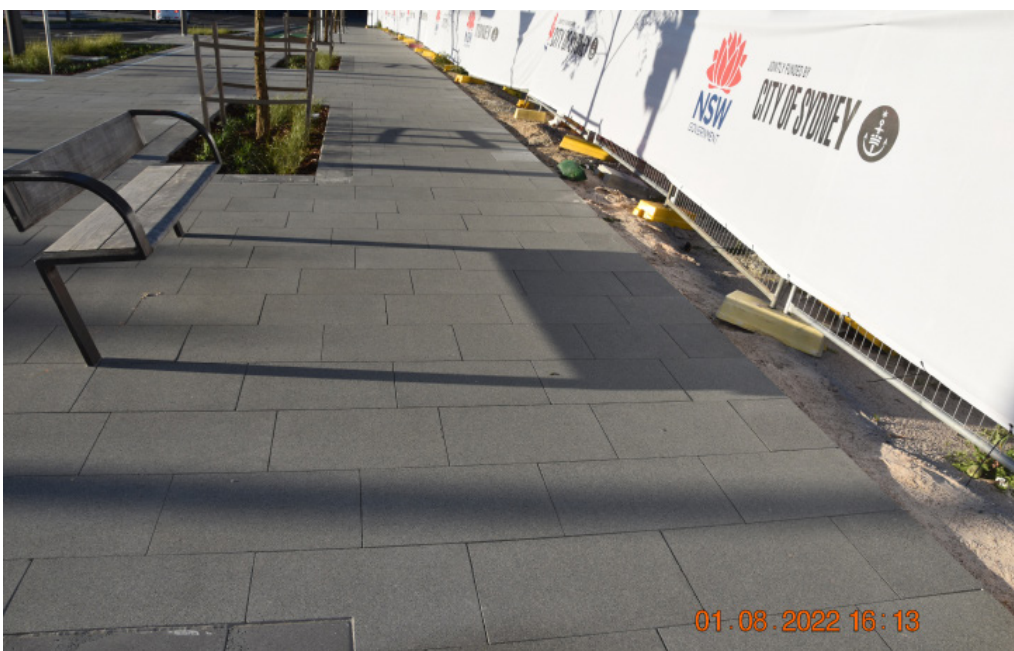
Figure: 0047

General view of the footpath on Portman Street outside 3 Joynton Avenue, at approximately 10 meters from the west end.

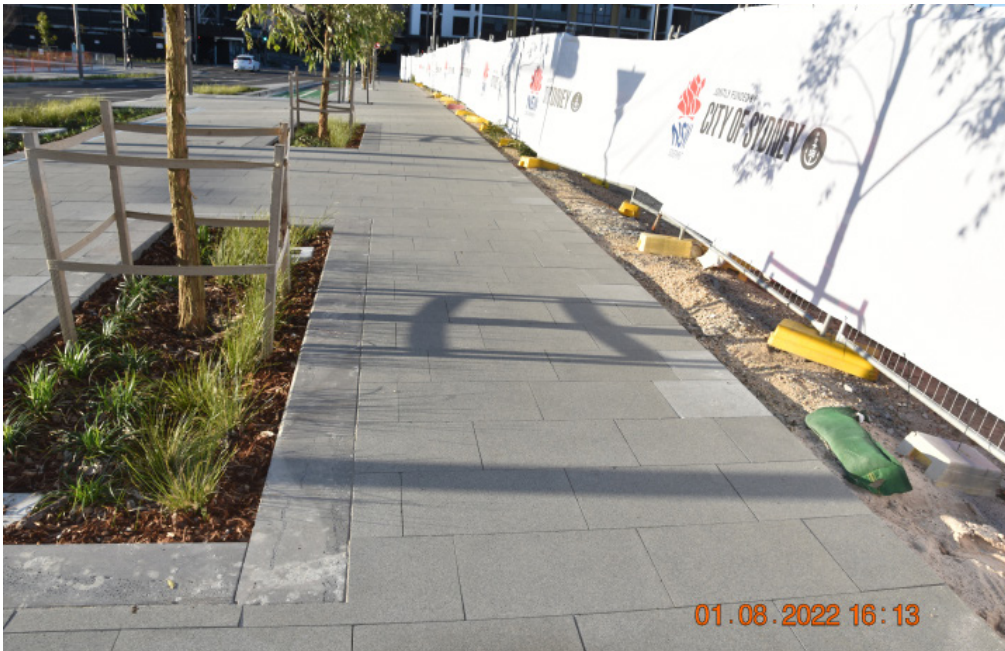
Figure: 0049

General view of the footpath on Portman Street outside 3 Joynton Avenue, at approximately 15 meters from the west end.

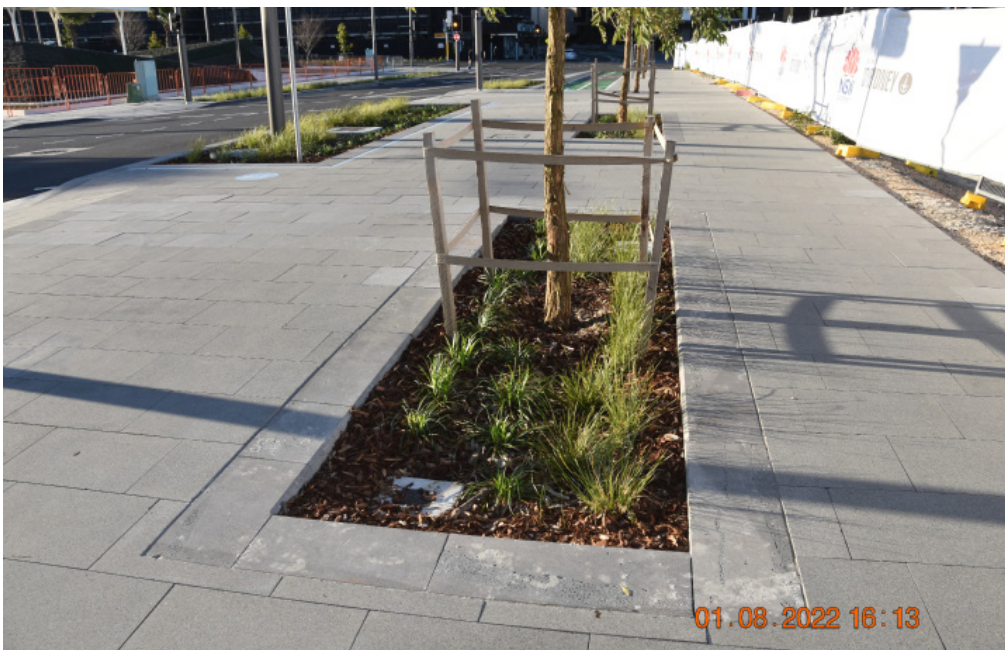
Figure: 0050

General view of the footpath on Portman Street outside 3 Joynton Avenue, at approximately 15 meters from the west end.

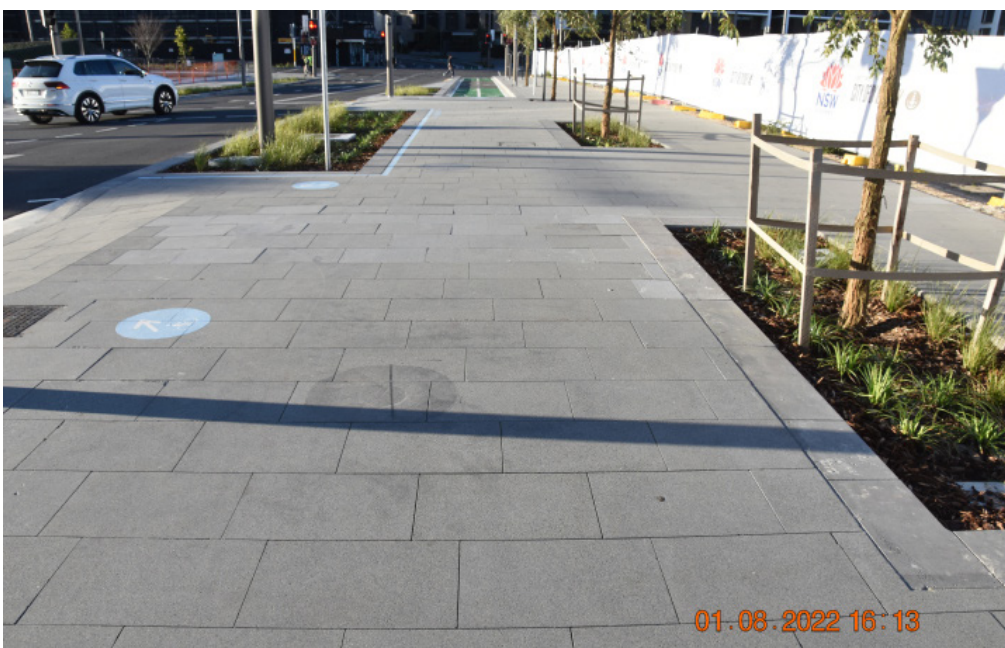
Figure: 0051

General view of the footpath on Portman Street outside 3 Joynton Avenue, at approximately 15 meters from the west end.

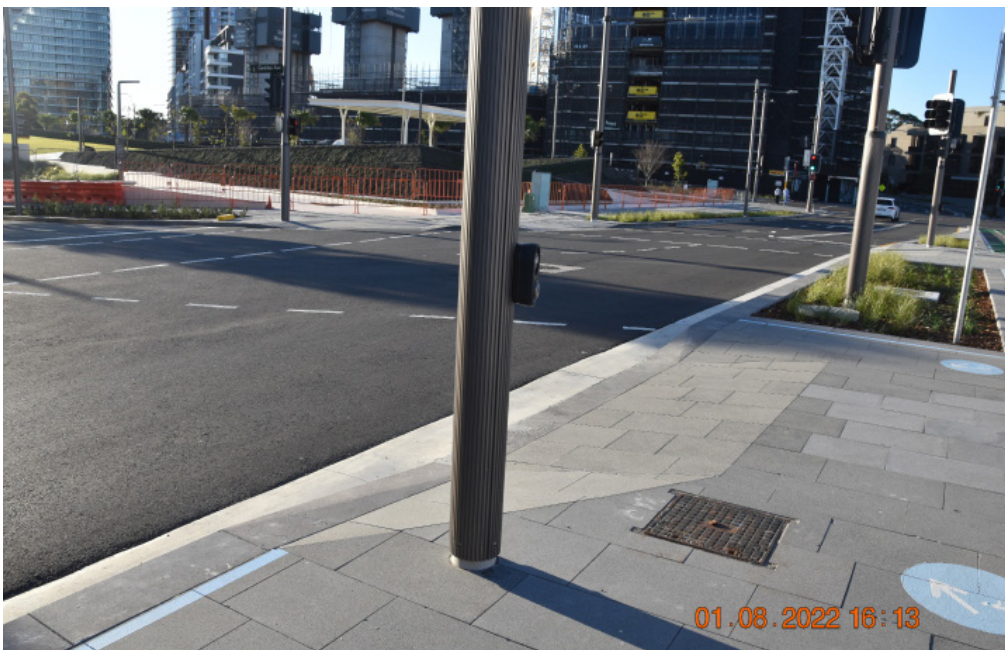
Figure: 0052

General view of the traffic light on Portman Street outside 3 Joynton Avenue, at approximately 15 meters from the west end.

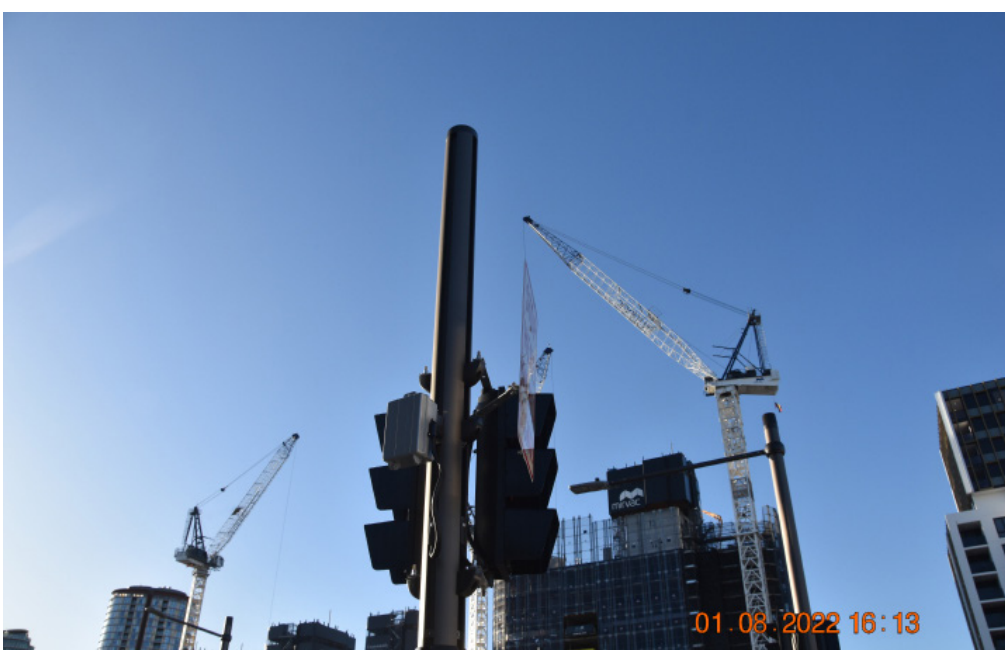
Figure: 0053

General view of the traffic light on Portman Street outside 3 Joynton Avenue, at approximately 15 meters from the west end.

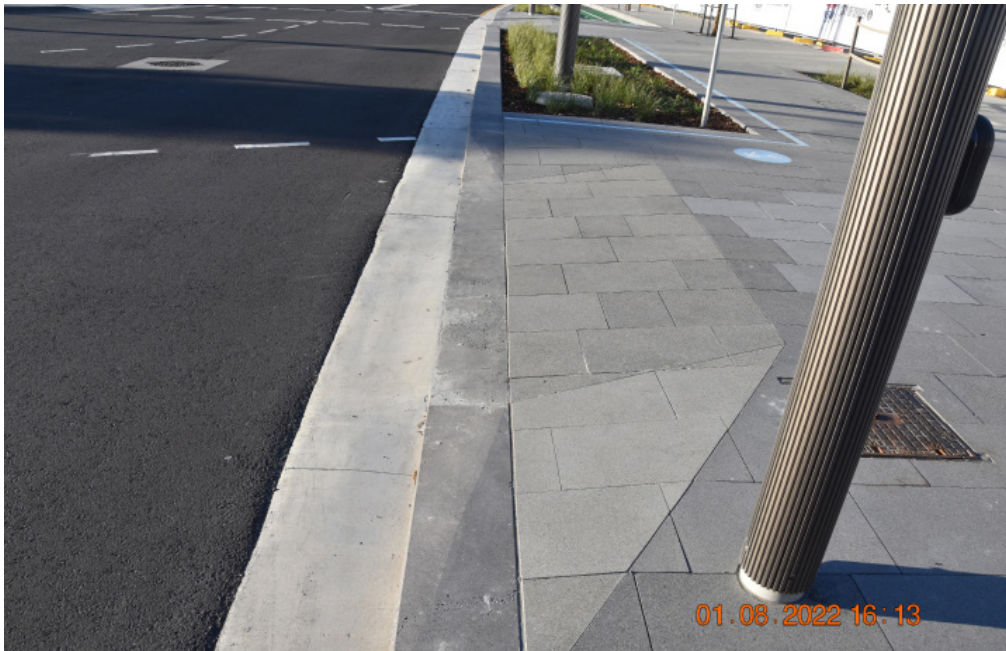
Figure: 0054

General view of the traffic light on Portman Street outside 3 Joynton Avenue, at approximately 15 meters from the west end.

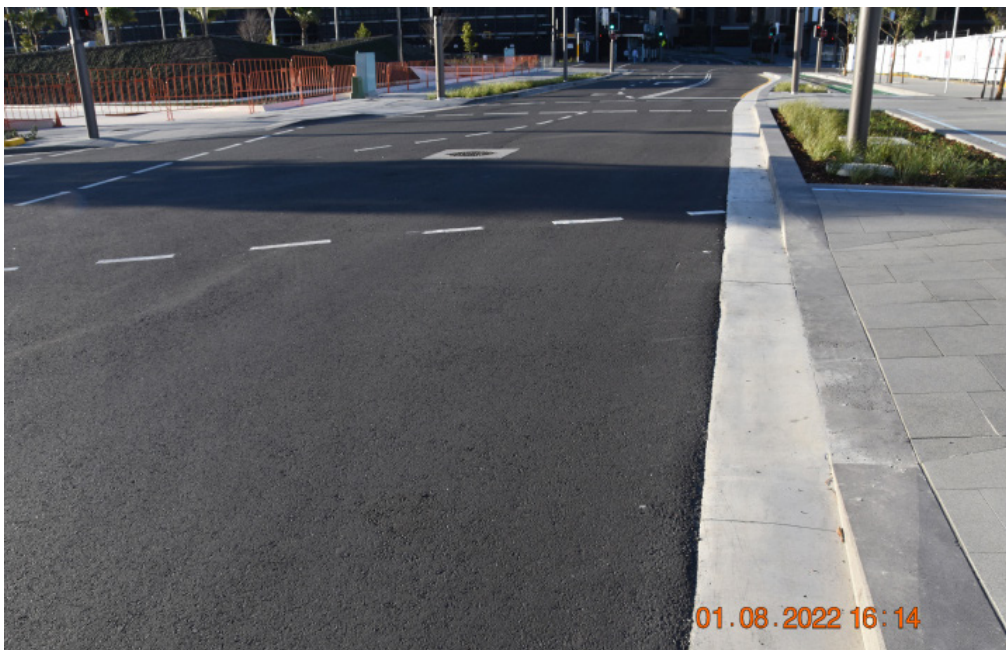
Figure: 0055

General view of the crossover on Portman Street outside 3 Joynton Avenue, at approximately 15 meters from the west end.

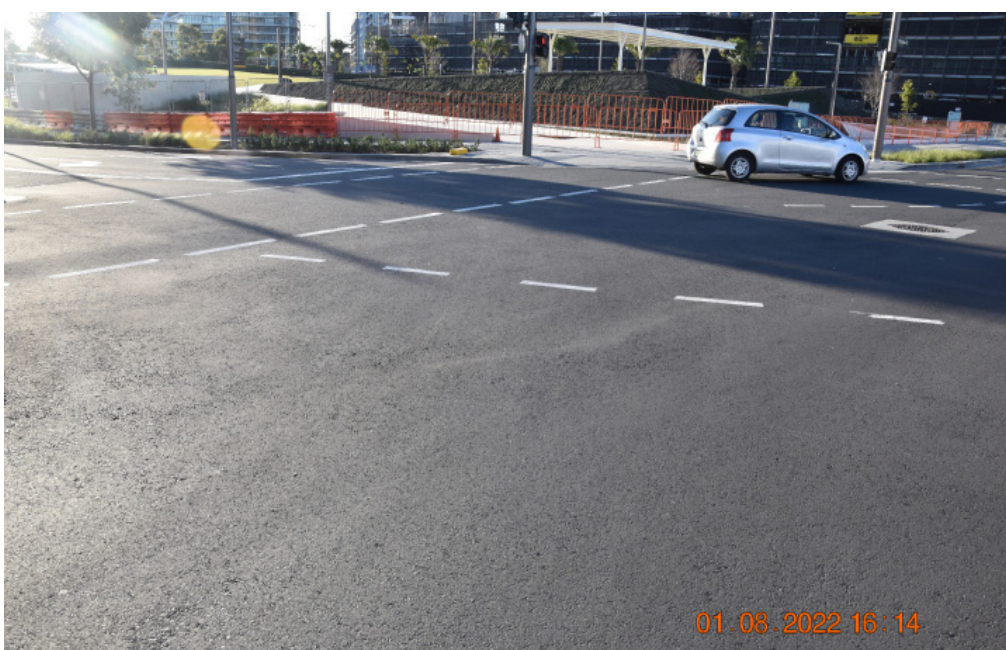
Figure: 0056

General view of the roadway on Portman Street outside 3 Joynton Avenue, at approximately 15 meters from the west end.

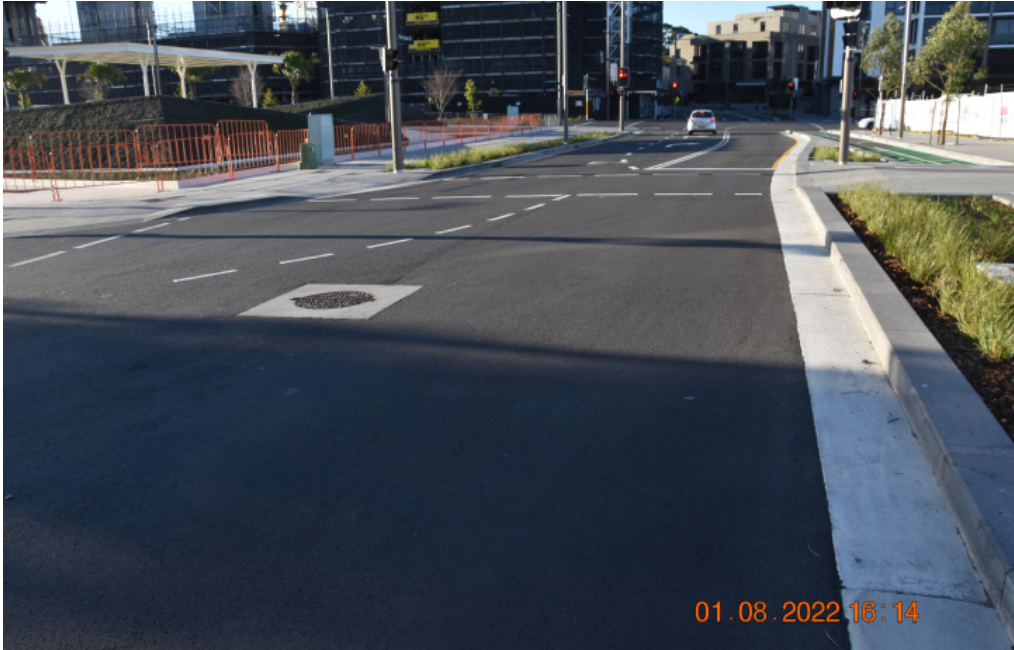
Figure: 0057

General view of the roadway on Portman Street outside 3 Joynton Avenue, at approximately 15 meters from the west end.

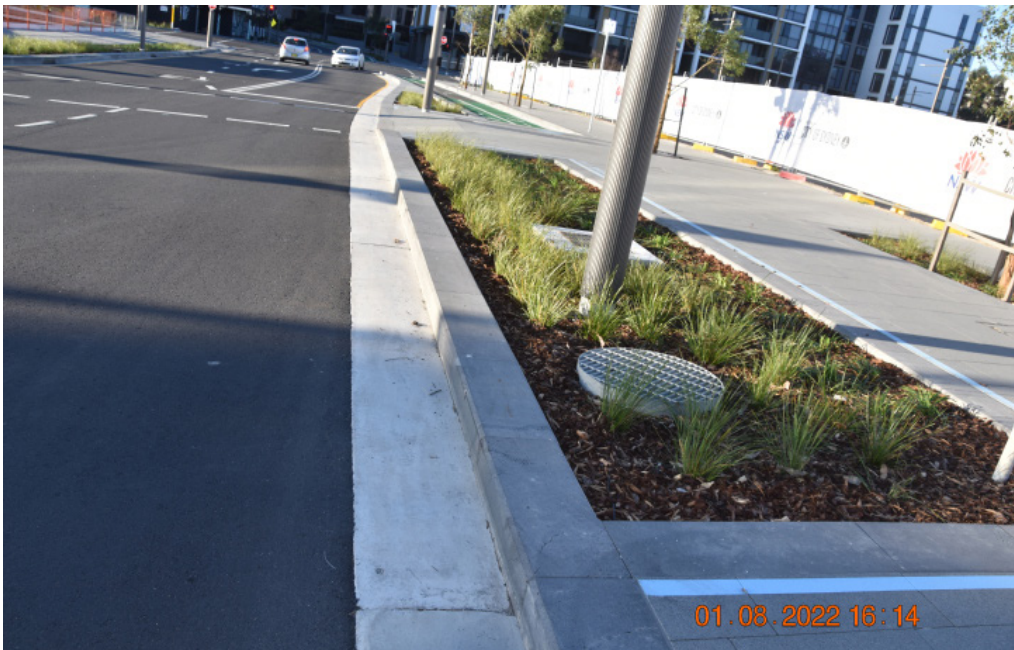
Figure: 0058

General view of the roadway on Portman Street outside 3 Joynton Avenue, at approximately 20 meters from the west end.

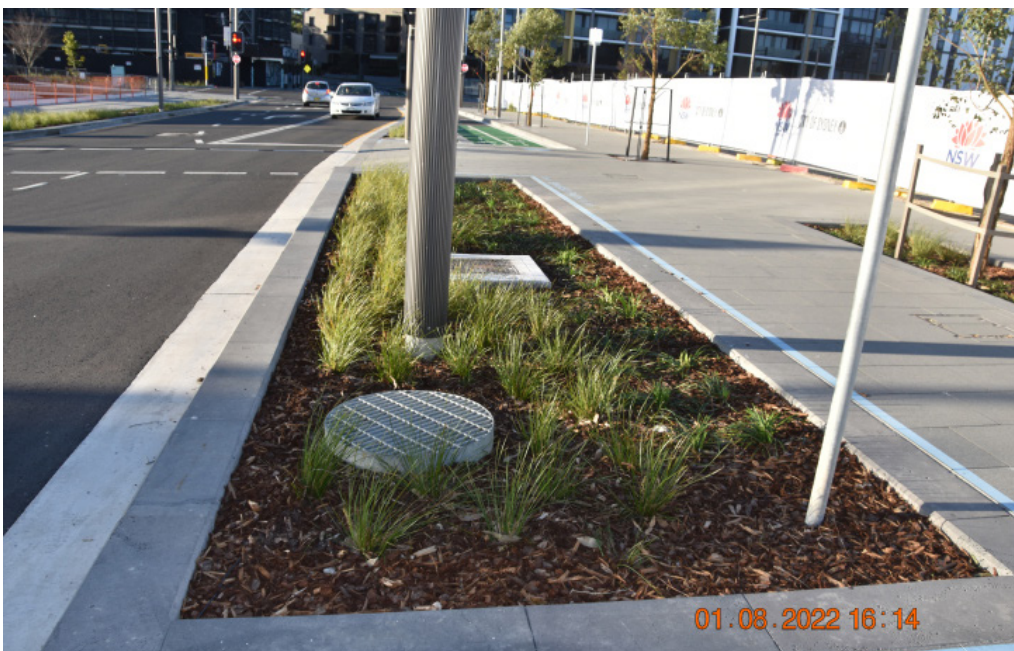
Figure: 0059

General view of the kerb and gutter on Portman Street outside 3 Joynton Avenue, at approximately 20 meters from the west end.

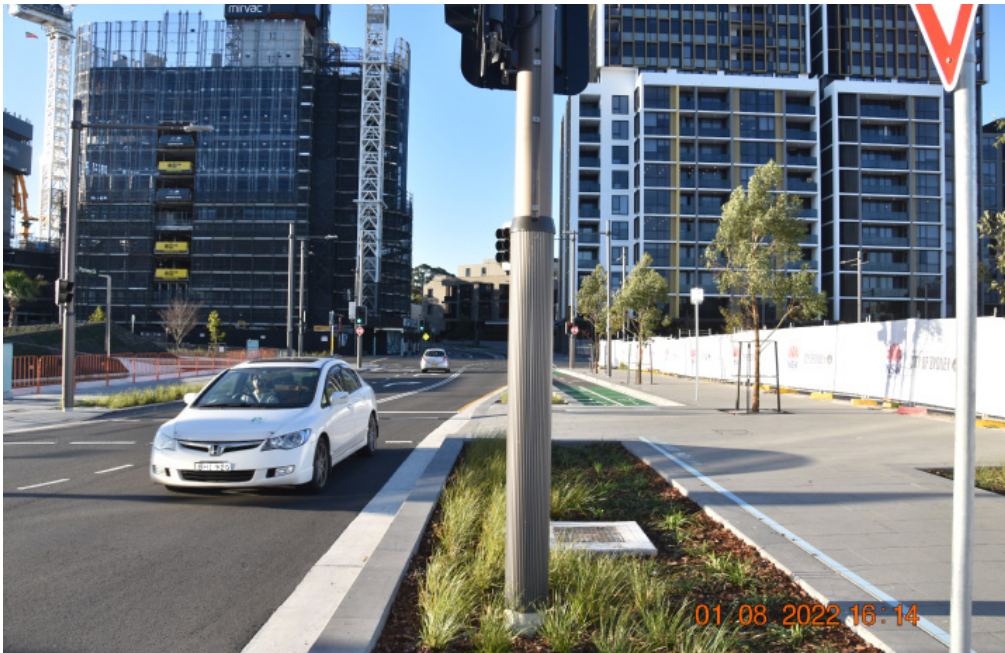
Figure: 0060

General view of the garden bed on Portman Street outside 3 Joynton Avenue, at approximately 20 meters from the west end.

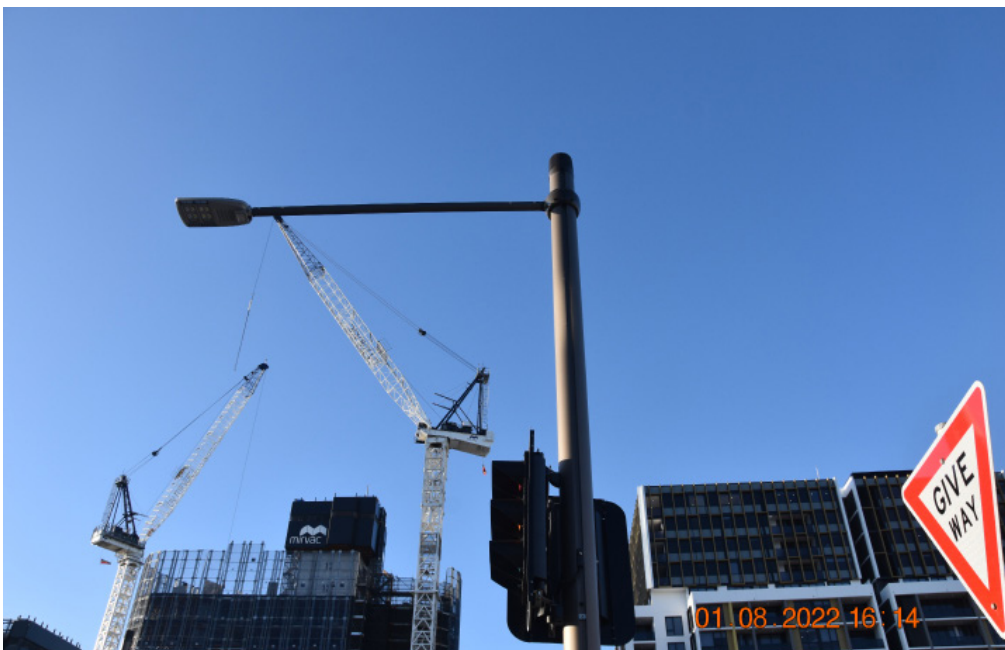
Figure: 0061

General view of the light pole on Portman Street outside 3 Joynton Avenue, at approximately 20 meters from the west end.

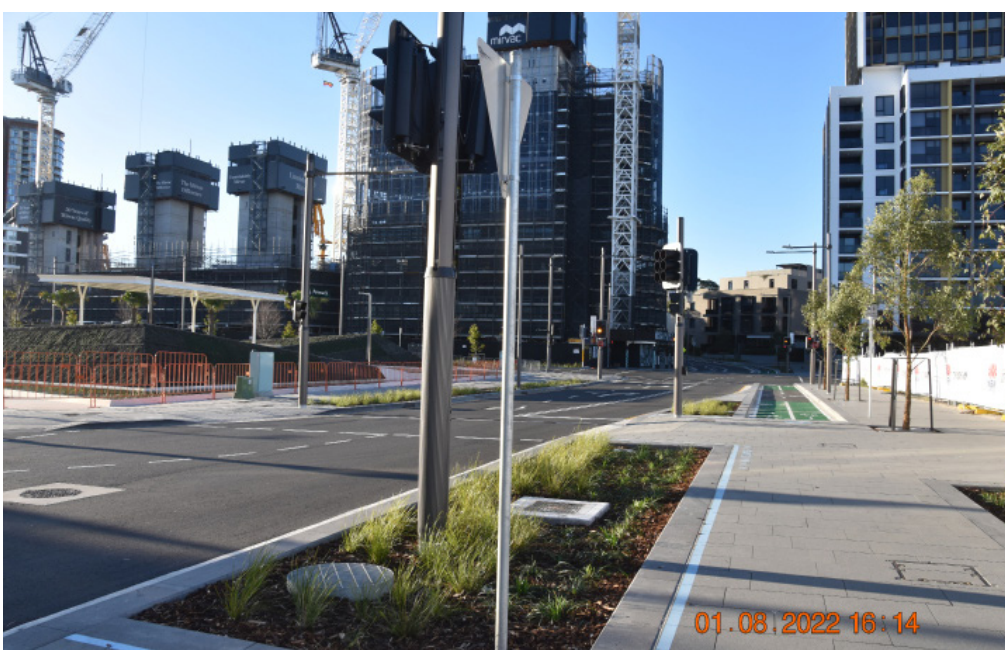
Figure: 0062

General view of the light pole on Portman Street outside 3 Joynton Avenue, at approximately 20 meters from the west end.

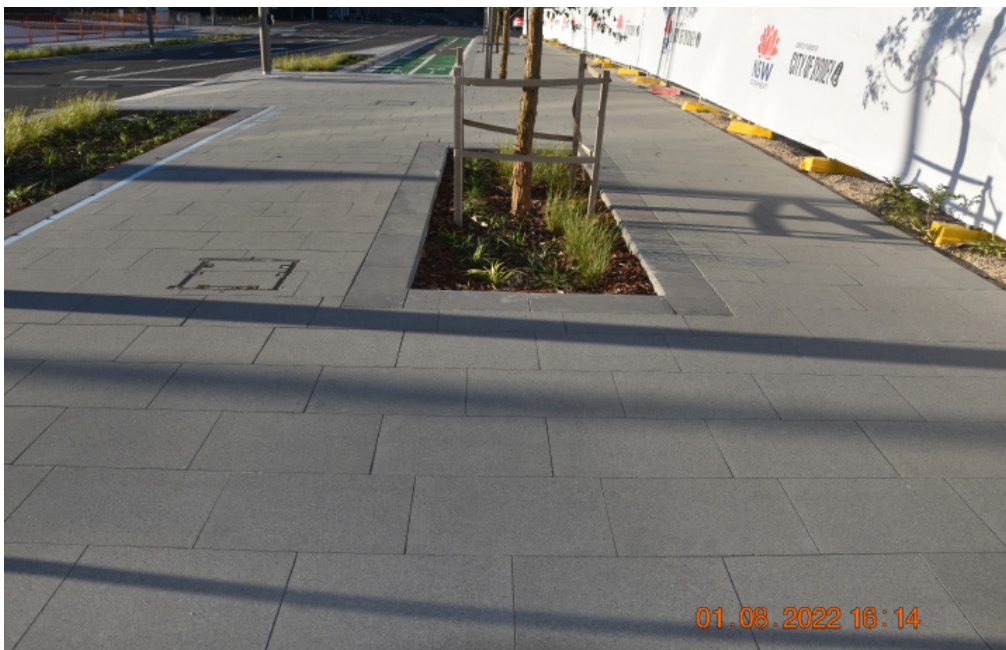
Figure: 0064

General view of the footpath on Portman Street outside 3 Joynton Avenue, at approximately 20 meters from the west end.

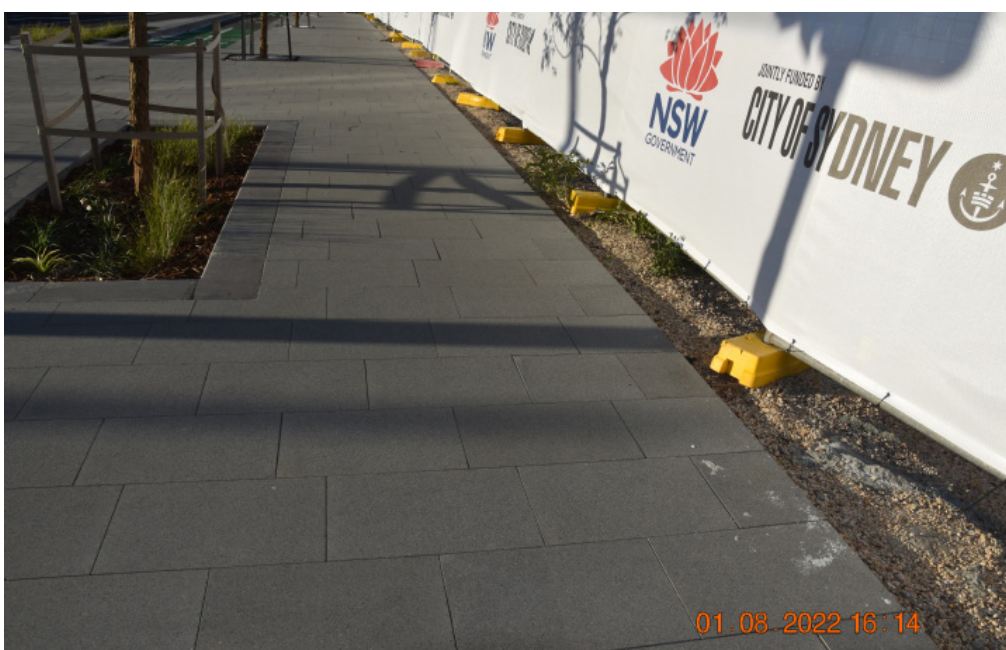
Figure: 0065

General view of the footpath on Portman Street outside 3 Joynton Avenue, at approximately 20 meters from the west end.

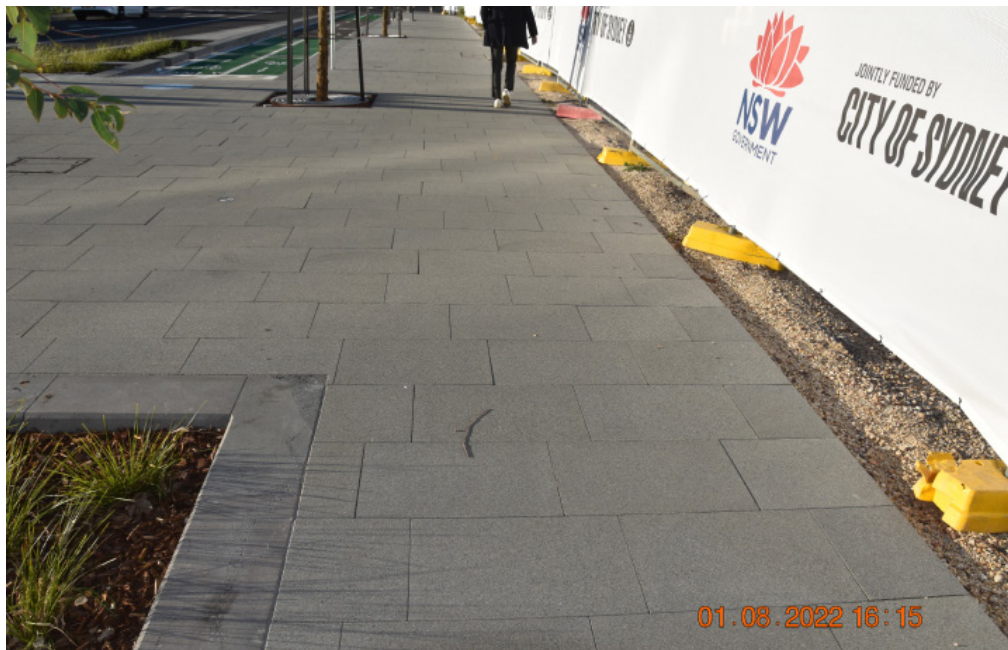
Figure: 0066

General view of the footpath on Portman Street outside 3 Joynton Avenue, at approximately 20 meters from the west end.

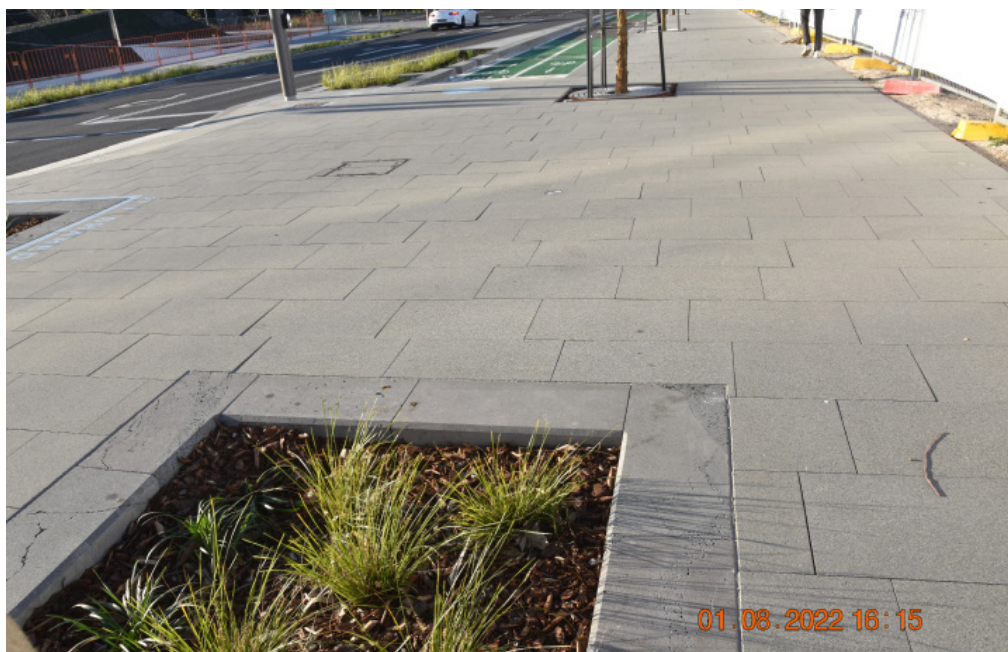
Figure: 0067

General view of the footpath on Portman Street outside 3 Joynton Avenue, at approximately 20 meters from the west end.

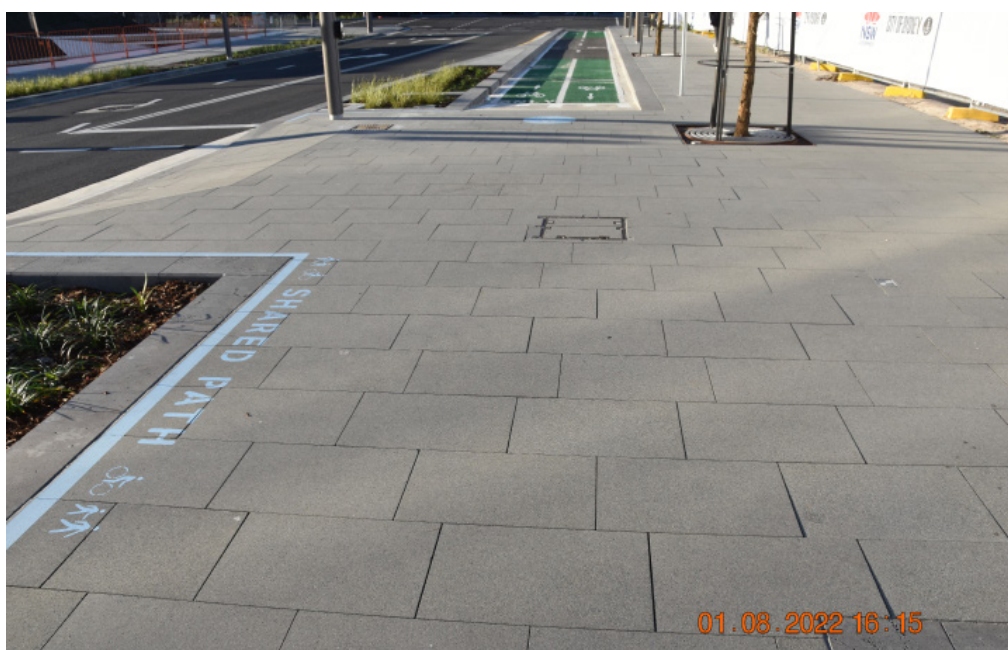
Figure: 0068

General view of the footpath on Portman Street outside 3 Joynton Avenue, at approximately 20 meters from the west end.

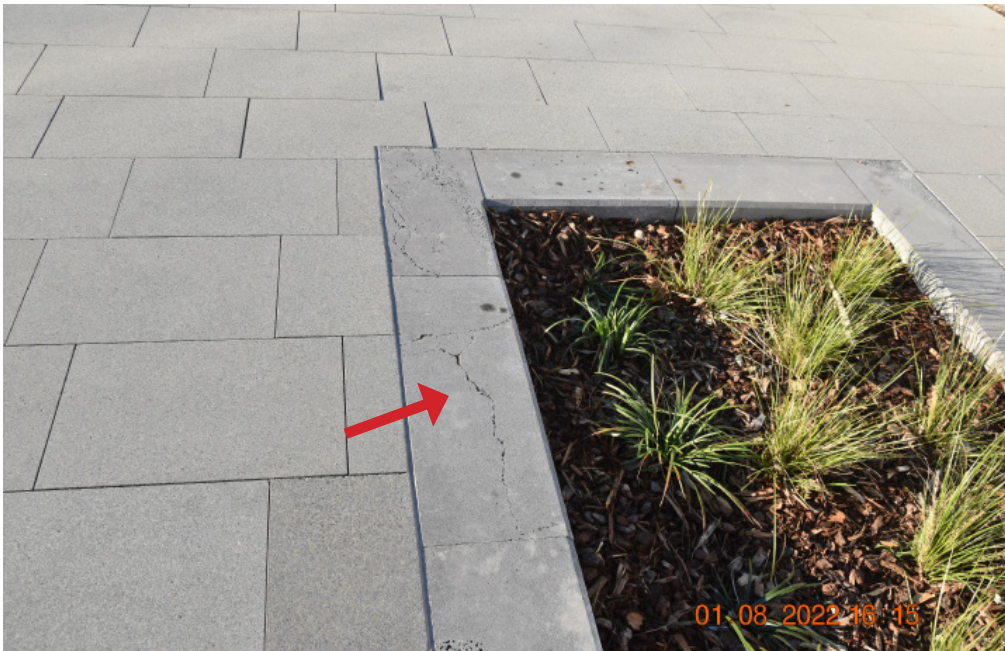
General view of the footpath on Portman Street outside 3 Joynton Avenue, at approximately 20 meters from the west end. Showing fine cracking.

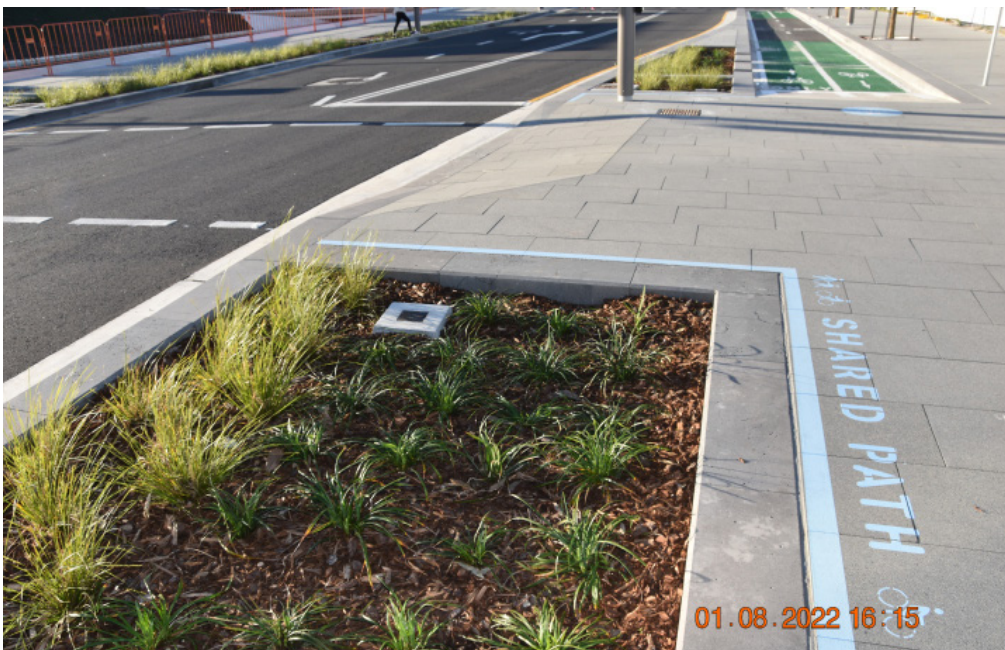
Figure: 0071

General view of the footpath on Portman Street outside 3 Joynton Avenue, at approximately 20 meters from the west end.

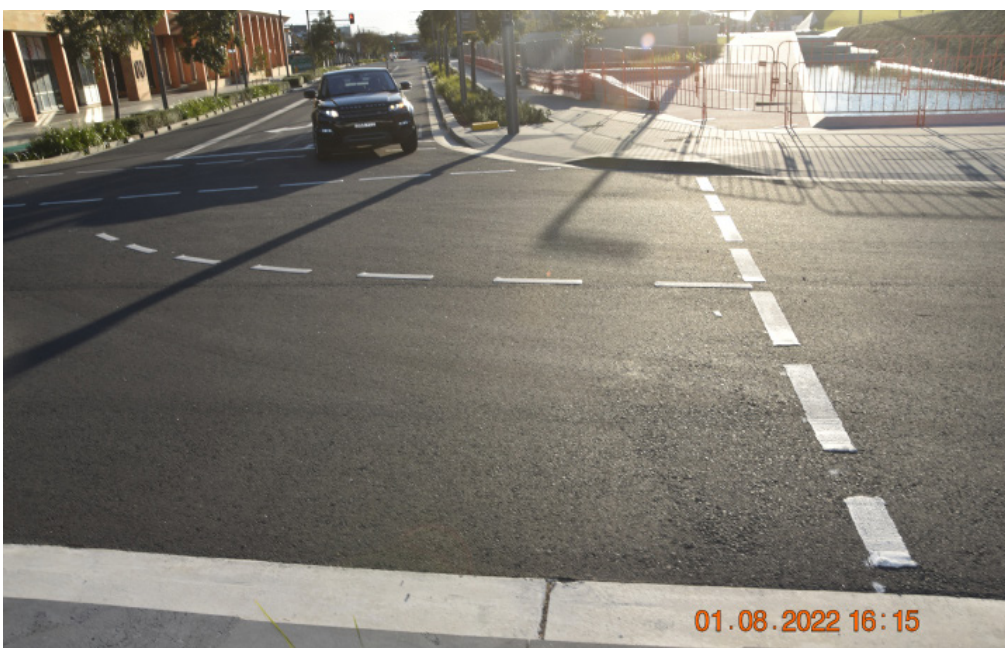
Figure: 0072

General view of the roadway on Portman Street outside 3 Joynton Avenue, at approximately 20 meters from the west end.
