PRE CONSTRUCTION CONDITION SURVEY

Green Square Integrated Community Facility &
School - 3 Joynton Avenue, Zetland NSW

Council Assets
3 Joynton Avenue and Portman Street
ZETLAND NSW 2017

01 August 2022

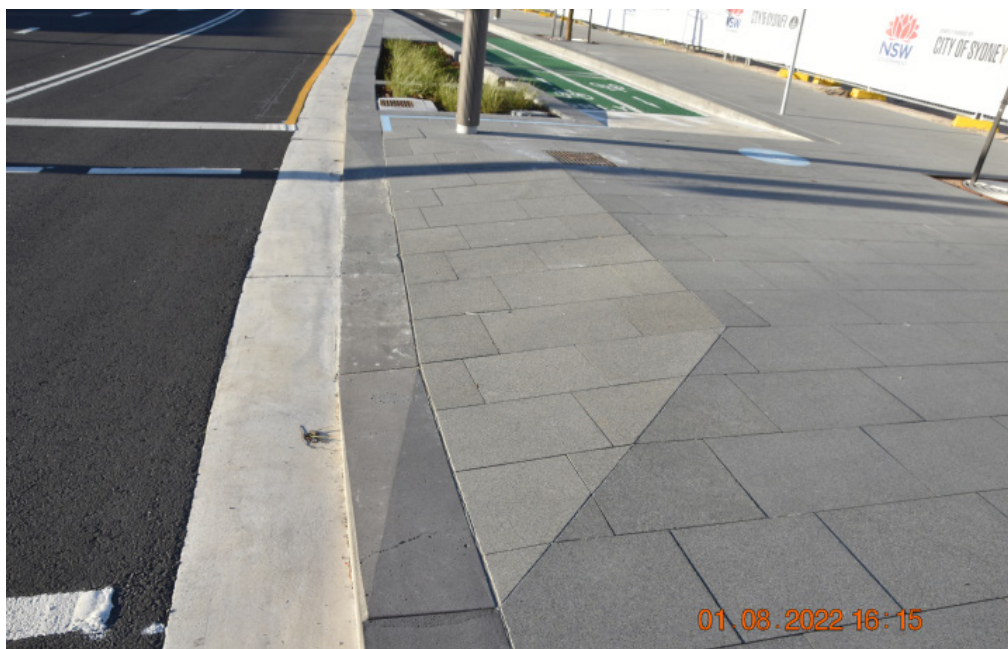
Figure: 0073

General view of the crossover on Portman Street outside 3 Joynton Avenue, at approximately 20 meters from the west end.

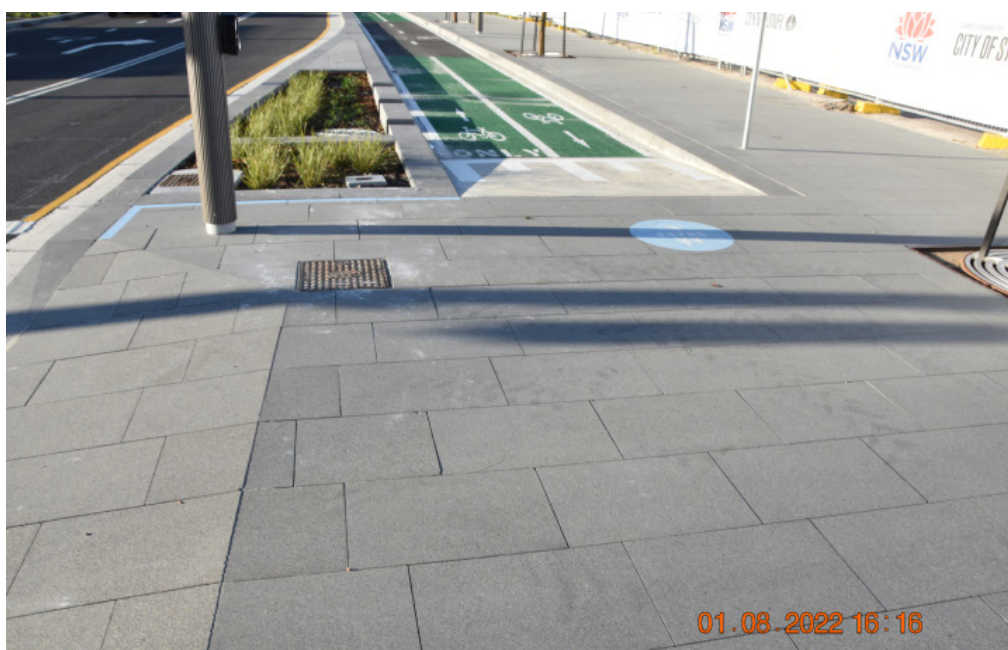
Figure: 0074

General view of the footpath on Portman Street outside 3 Joynton Avenue, at approximately 20 meters from the west end.

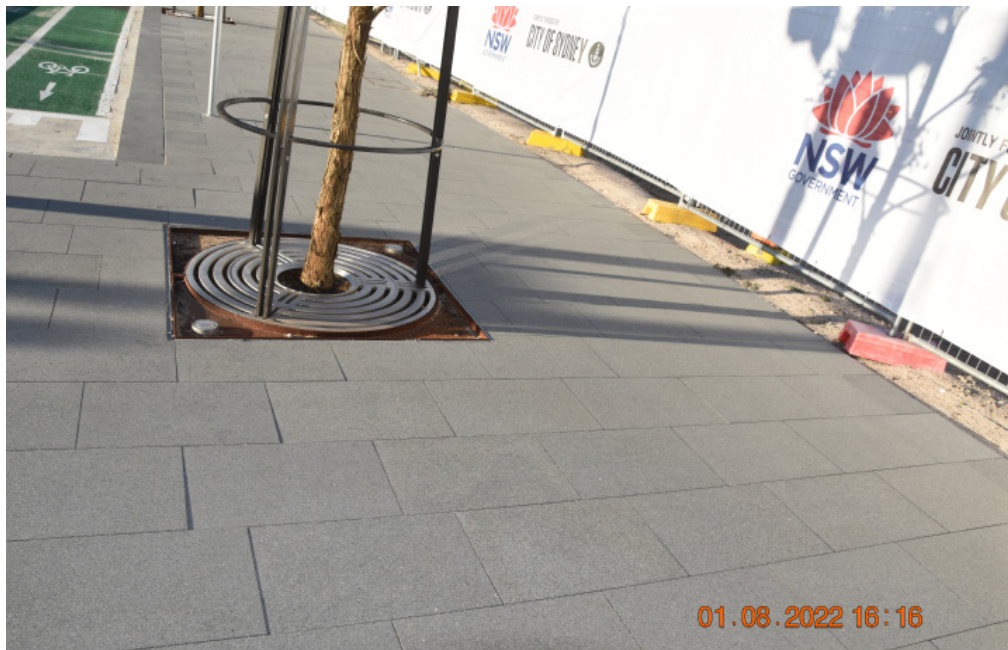
Figure: 0075

General view of the footpath on Portman Street outside 3 Joynton Avenue, at approximately 20 meters from the west end.

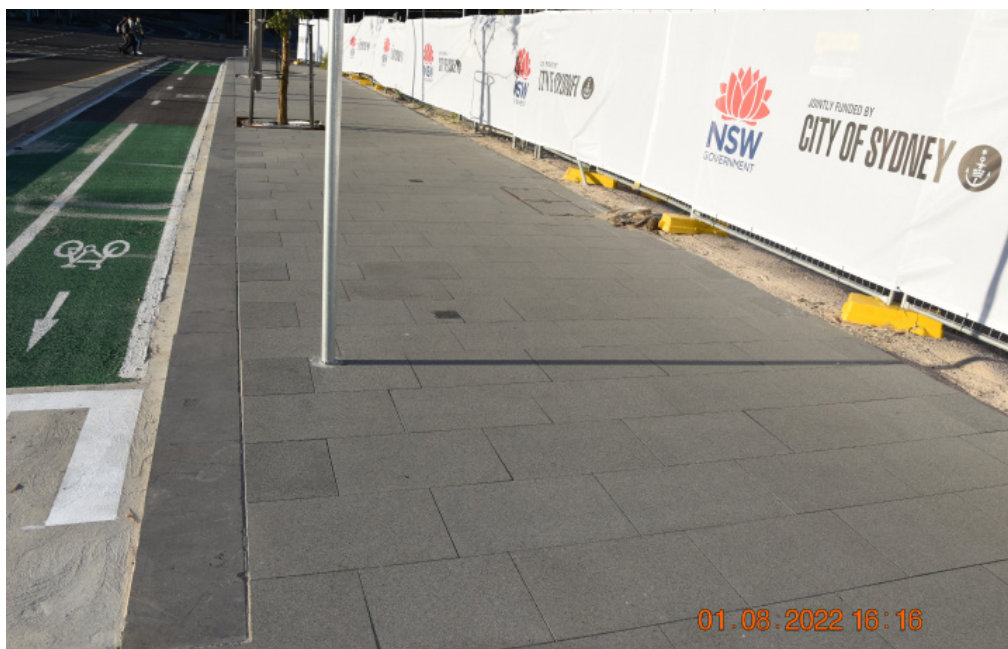
Figure: 0076

General view of the footpath on Portman Street outside 3 Joynton Avenue, at approximately 20 meters from the west end.

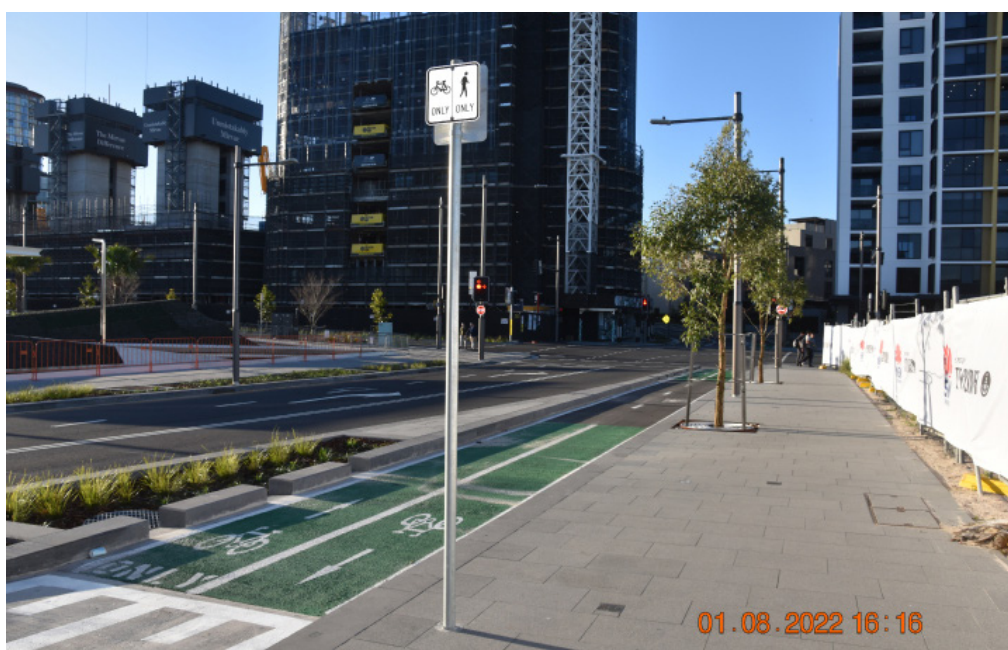
Figure: 0077

General view of the footpath on Portman Street outside 3 Joynton Avenue, at approximately 25 meters from the west end.

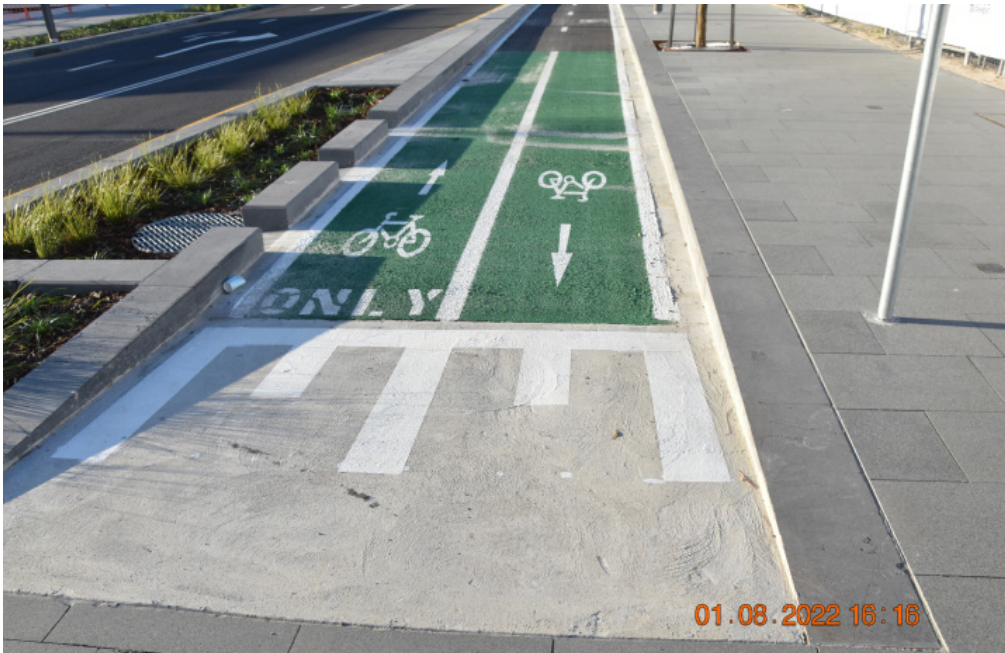
Figure: 0078

General view of the street sign on Portman Street outside 3 Joynton Avenue, at approximately 25 meters from the west end.

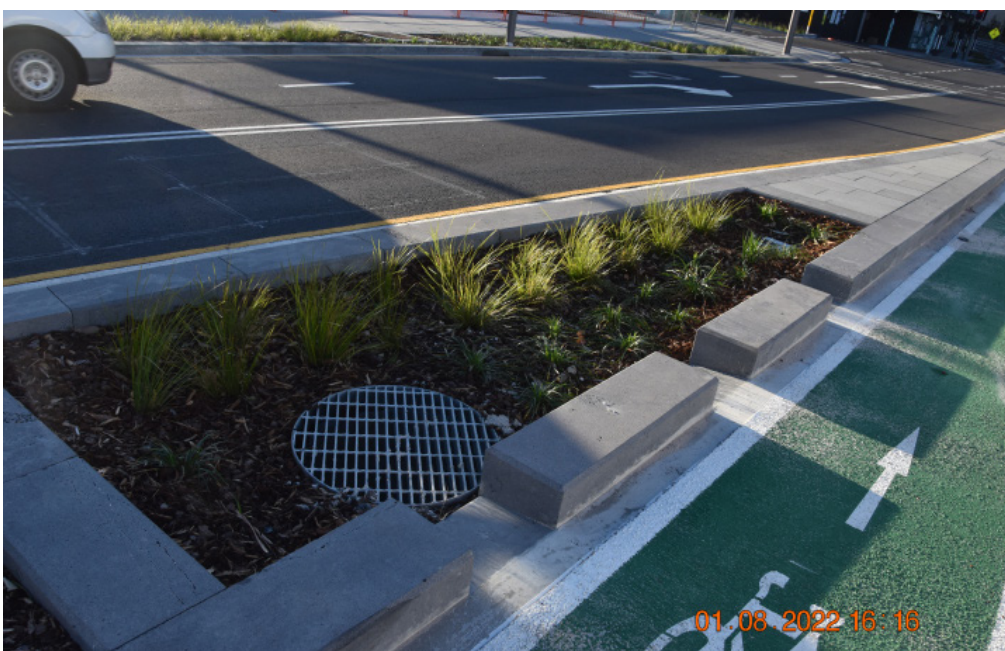
Figure: 0080

General view of the garden bed on Portman Street outside 3 Joynton Avenue, at approximately 25 meters from the west end.

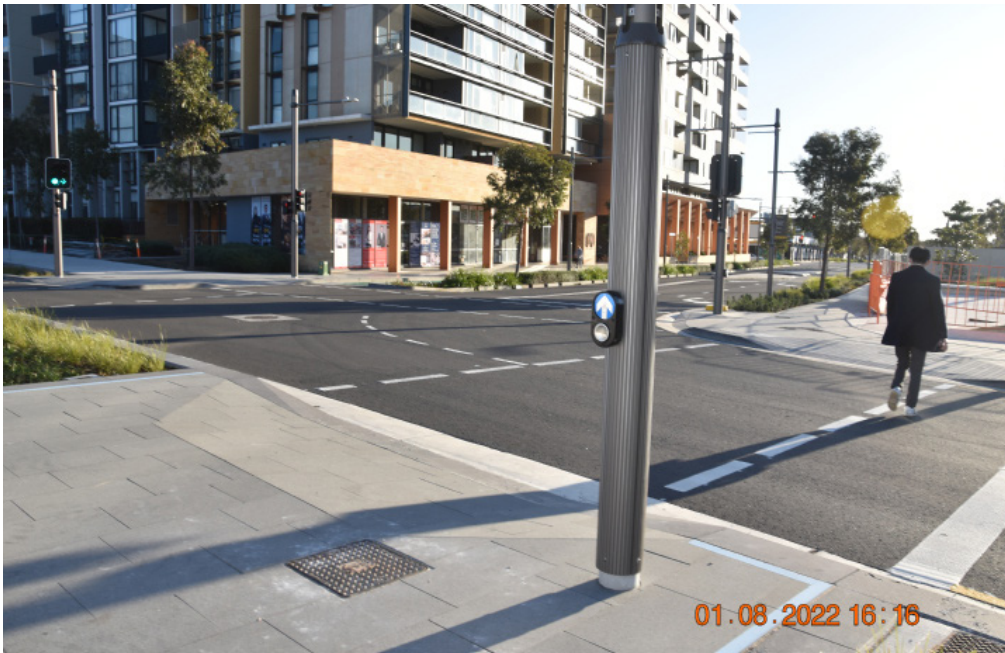
Figure: 0082

General view of the traffic light on Portman Street outside 3 Joynton Avenue, at approximately 25 meters from the west end.

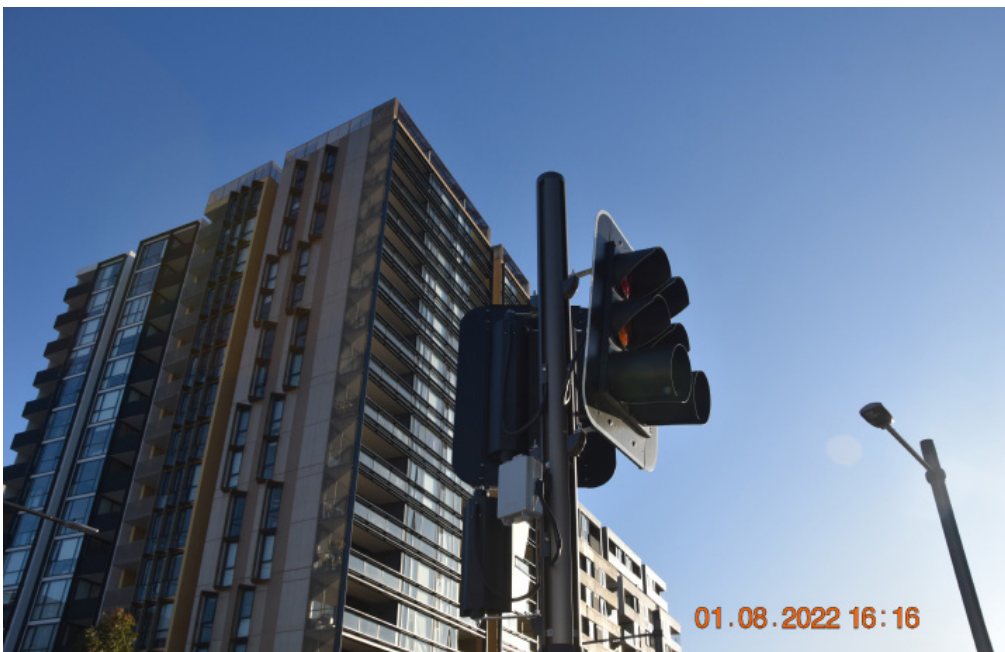
Figure: 0083

General view of the traffic light on Portman Street outside 3 Joynton Avenue, at approximately 25 meters from the west end.

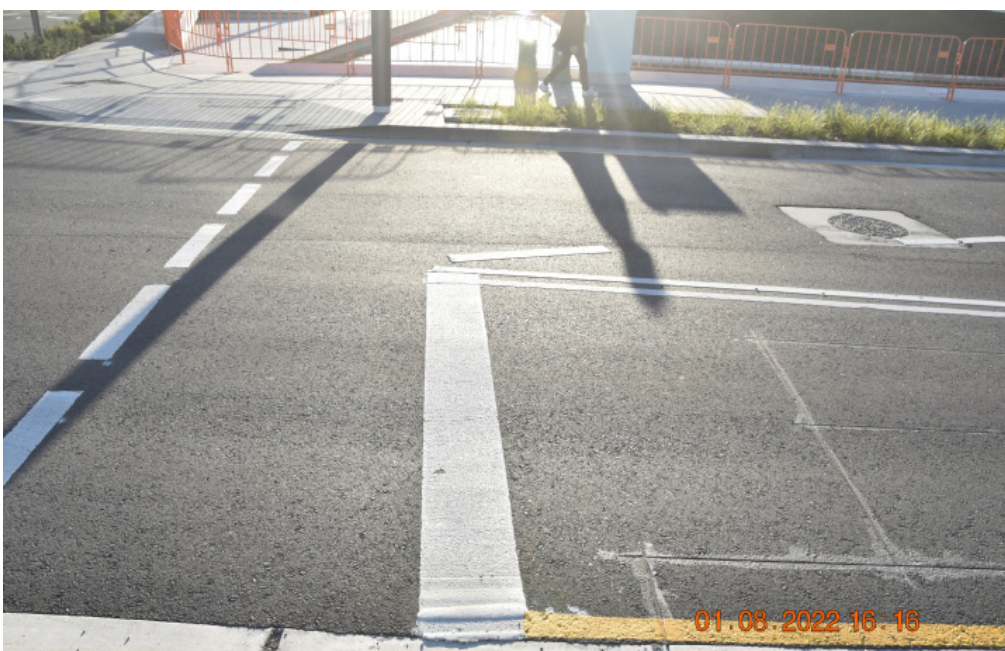
Figure: 0084

General view of the roadway on Portman Street outside 3 Joynton Avenue, at approximately 25 meters from the west end.

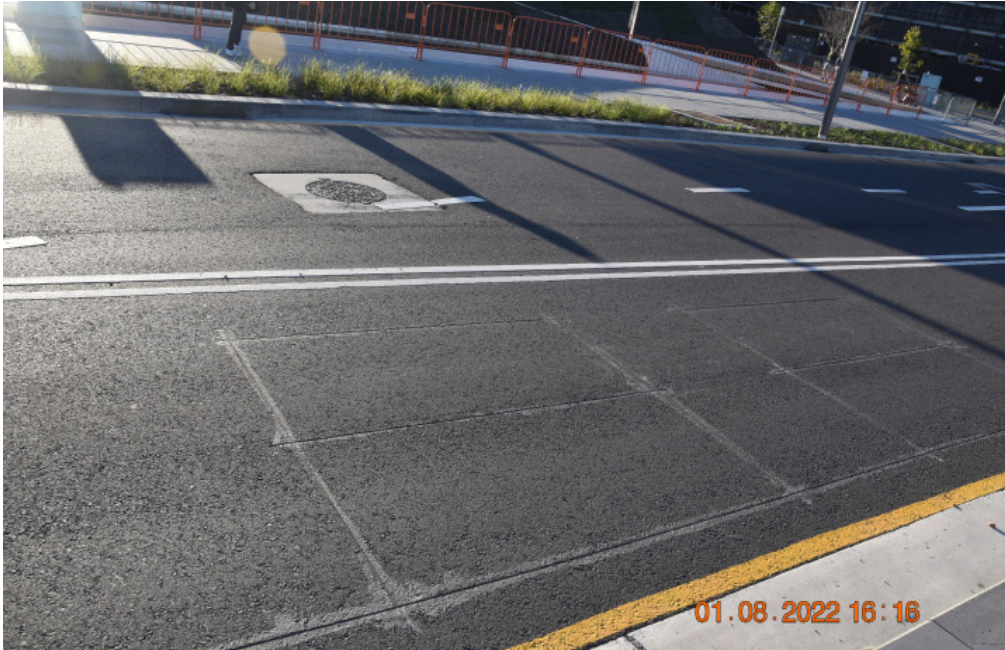
Figure: 0085

General view of the roadway on Portman Street outside 3 Joynton Avenue, at approximately 25 meters from the west end.

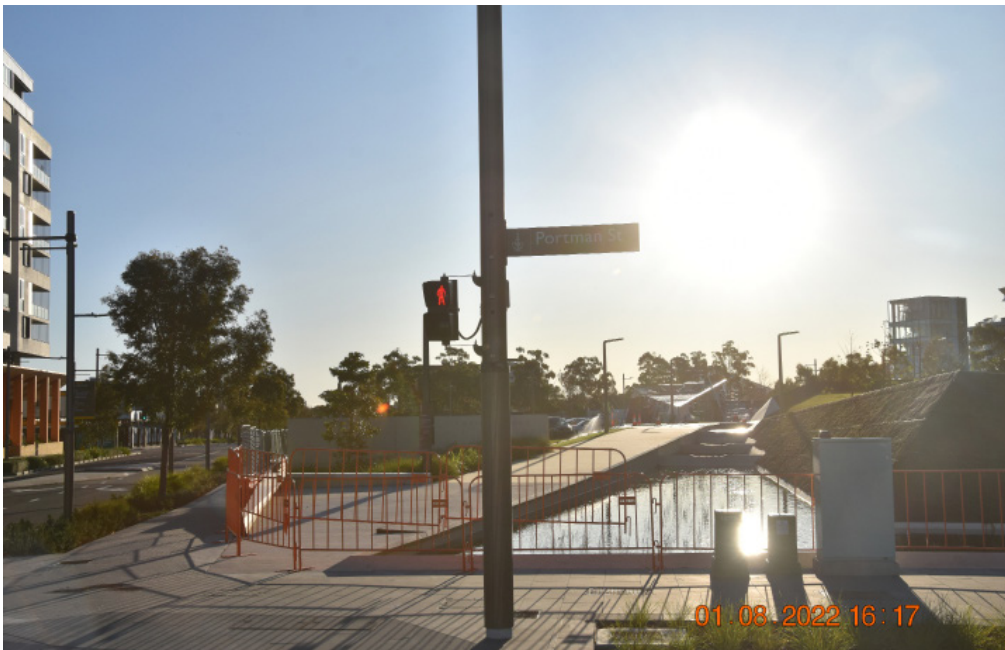
Figure: 0086

General view of the light pole on the south side outside 3 Joynton Avenue, at approximately 25 meters from the west end.

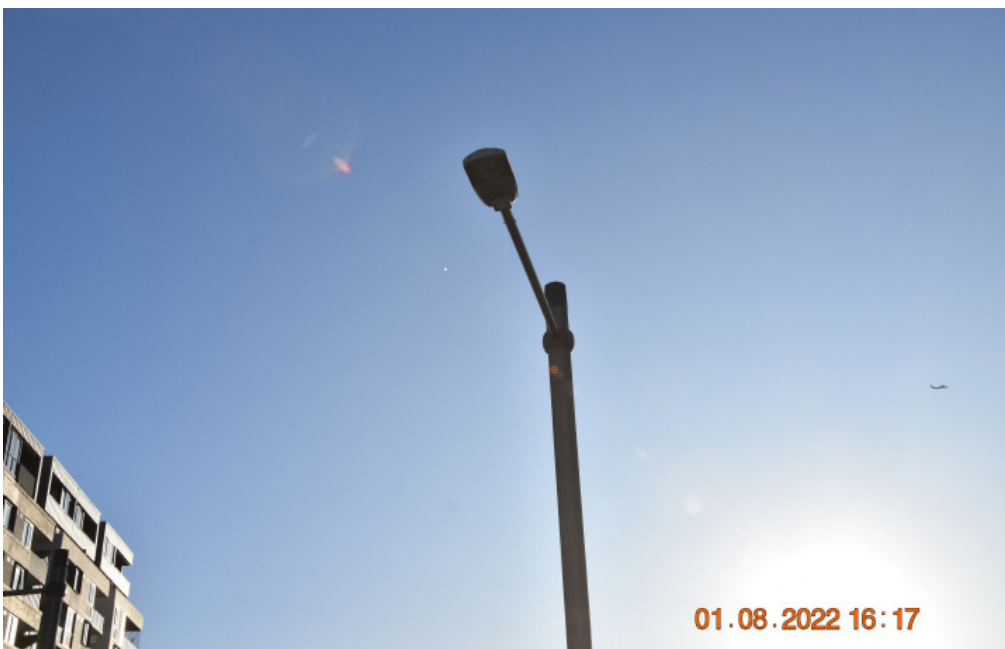
Figure: 0087

General view of the light pole on the south side outside 3 Joynton Avenue, at approximately 25 meters from the west end.

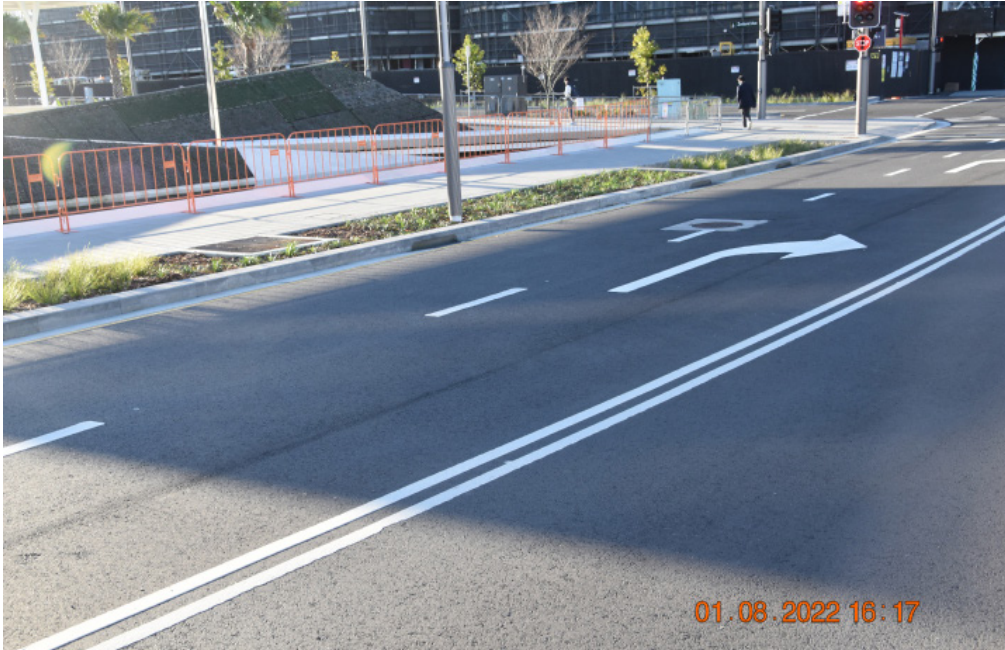
Figure: 0088

General view of the roadway on Portman Street outside 3 Joynton Avenue, at approximately 30 meters from the west end.

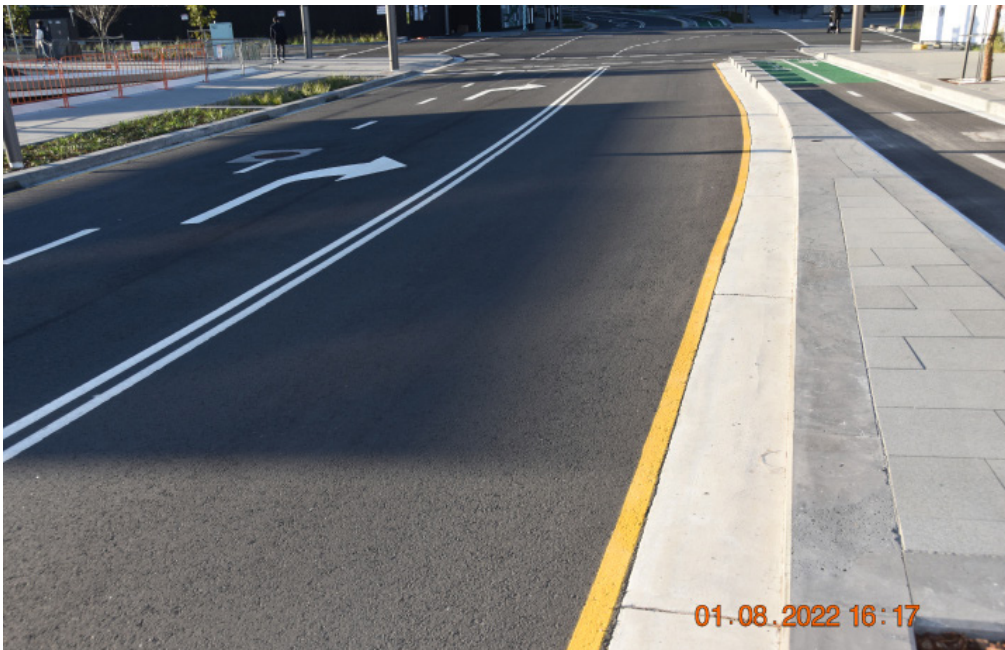
Figure: 0089

General view of the roadway on Portman Street outside 3 Joynton Avenue, at approximately 30 meters from the west end.

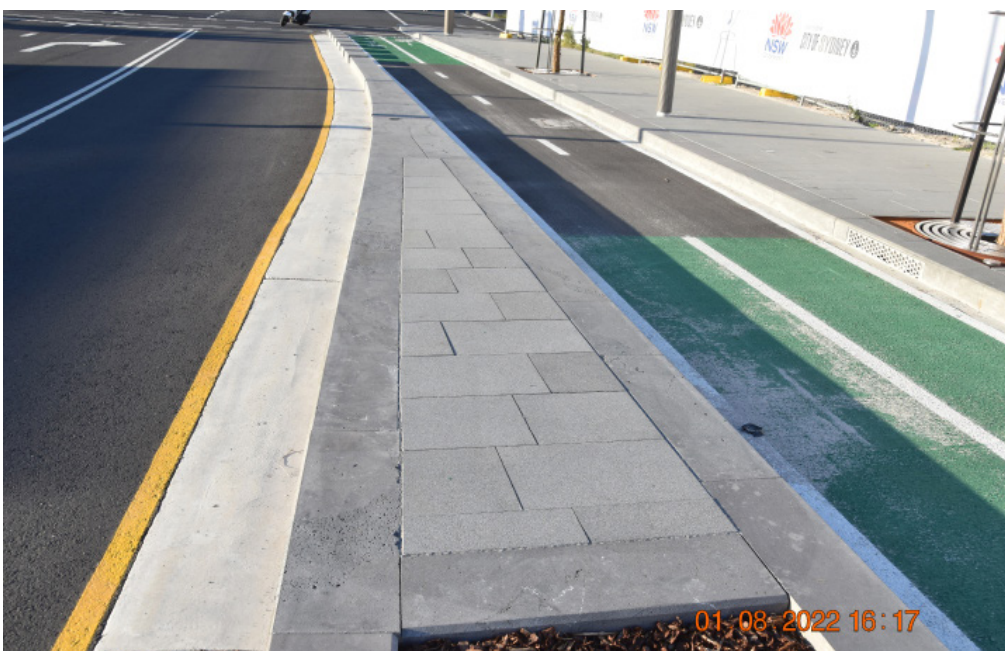
Figure: 0090

General view of the garden bed on Portman Street outside 3 Joynton Avenue, at approximately 30 meters from the west end.

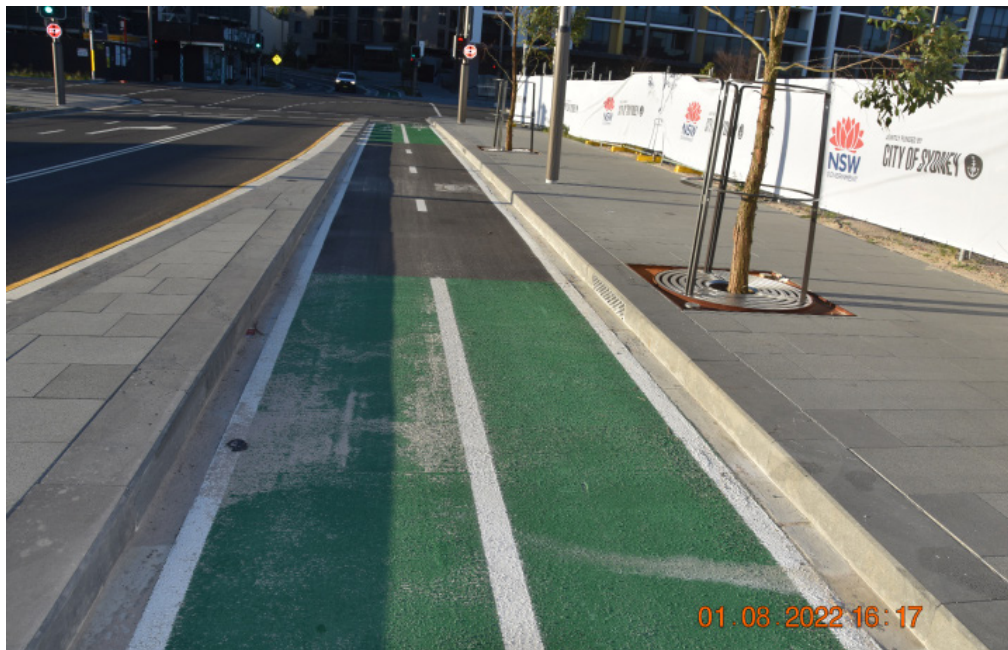
Figure: 0091

General view of the bicycle lane on Portman Street outside 3 Joynton Avenue, at approximately 30 meters from the west end.

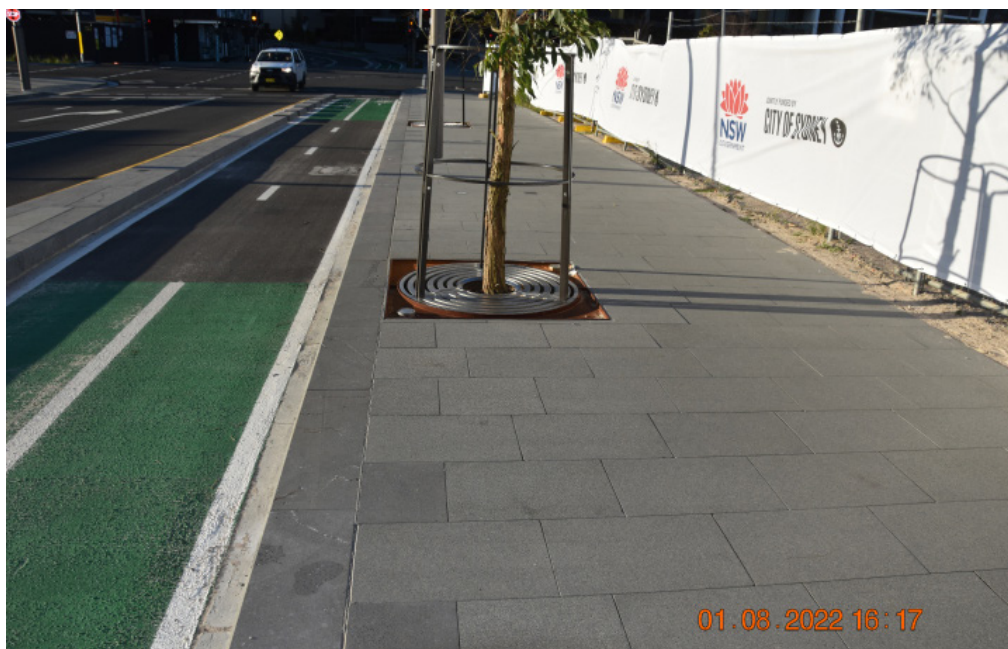
Figure: 0092

General view of the footpath on Portman Street outside 3 Joynton Avenue, at approximately 30 meters from the west end.

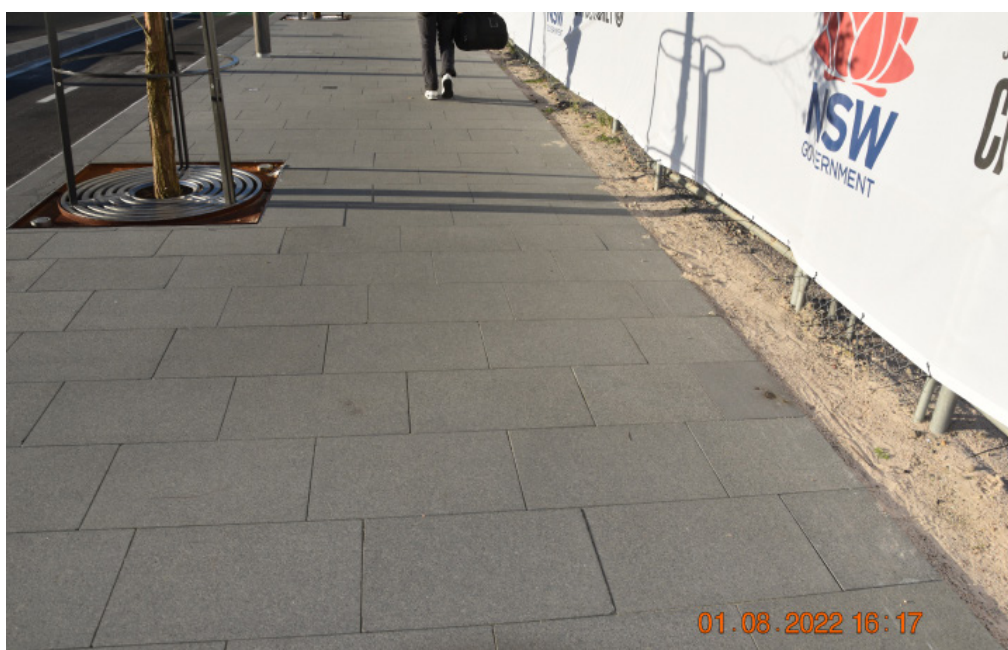
Figure: 0093

General view of the footpath on Portman Street outside 3 Joynton Avenue, at approximately 30 meters from the west end.

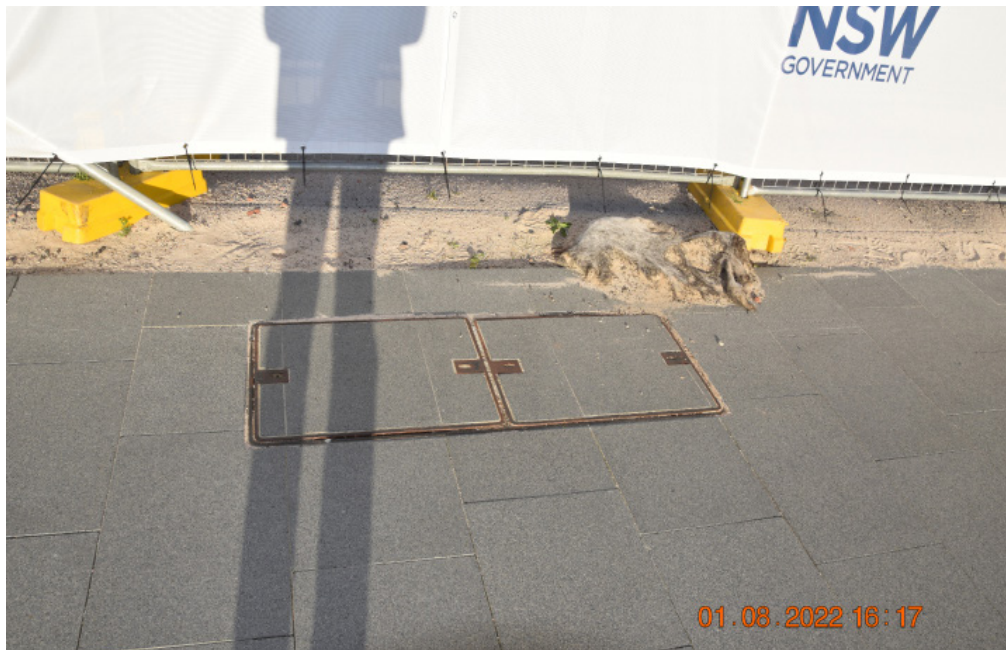
Figure: 0094

General view of the pit lid on Portman Street outside 3 Joynton Avenue, at approximately 30 meters from the west end.

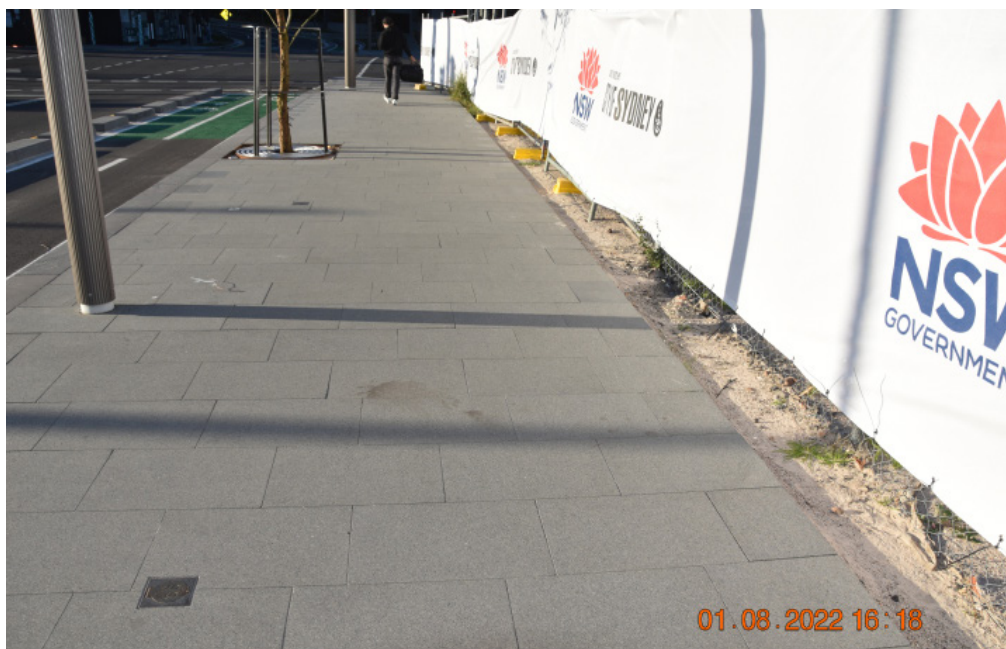
Figure: 0095

General view of the footpath on Portman Street outside 3 Joynton Avenue, at approximately 35 meters from the west end.

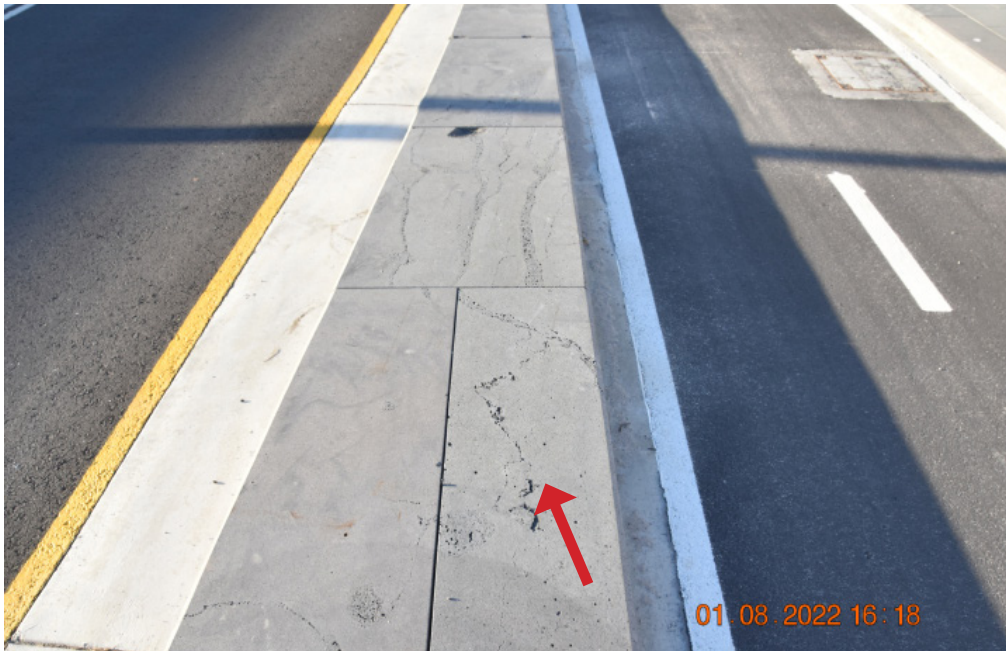
Figure: 0100

General view of the kerb and gutter on Portman Street outside 3 Joynton Avenue, at approximately 35 meters from the west end. Showing chipping.

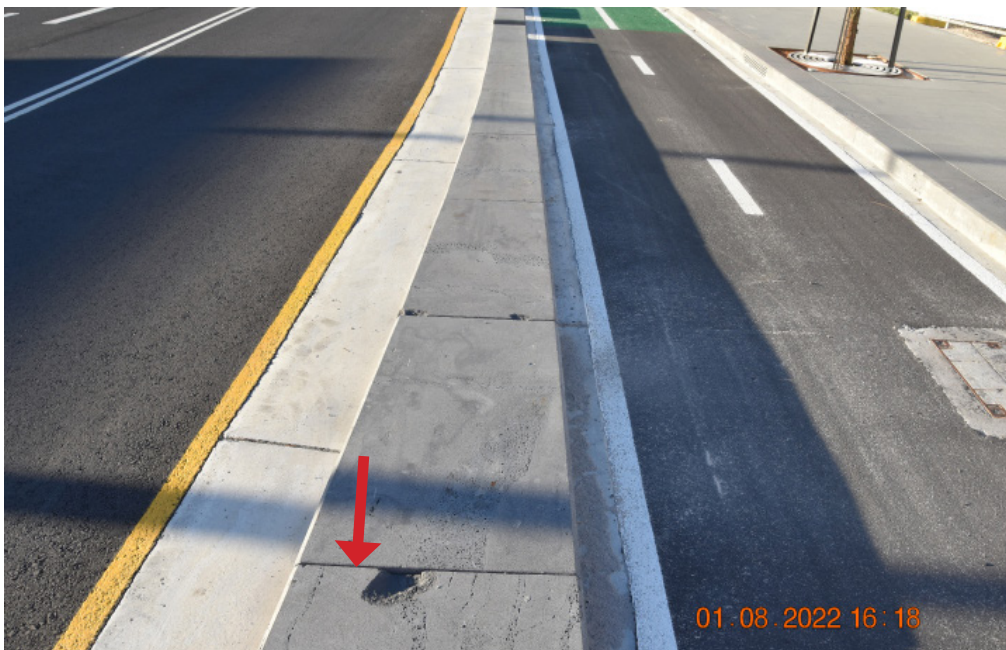
Figure: 0101

General view of the kerb and gutter on Portman Street outside 3 Joynton Avenue, at approximately 35 meters from the west end. Showing chipping.

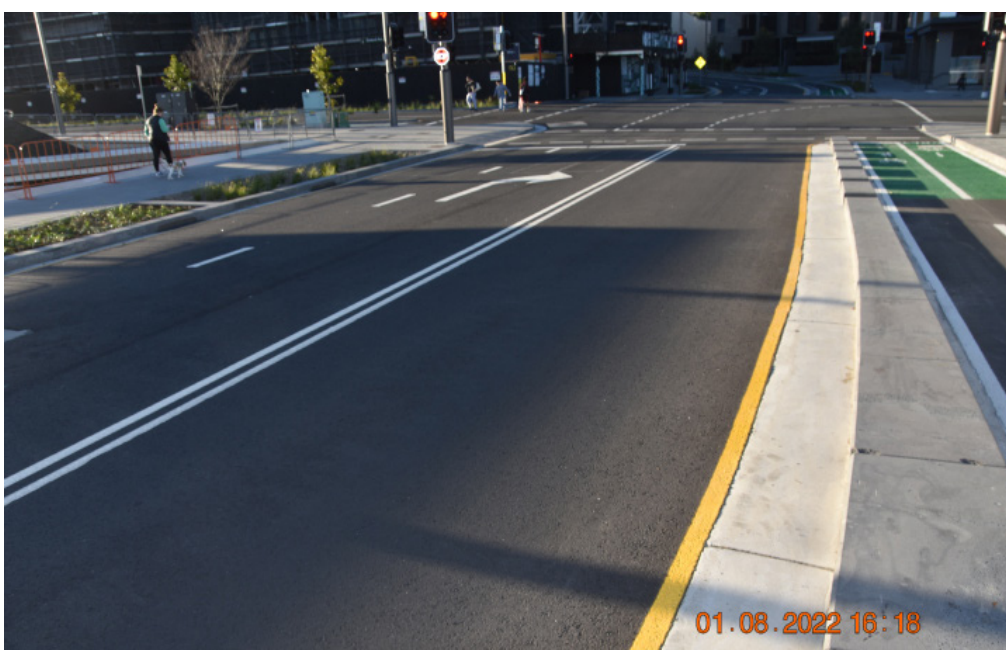
Figure: 0102

General view of the roadway on Portman Street outside 3 Joynton Avenue, at approximately 35 meters from the west end.

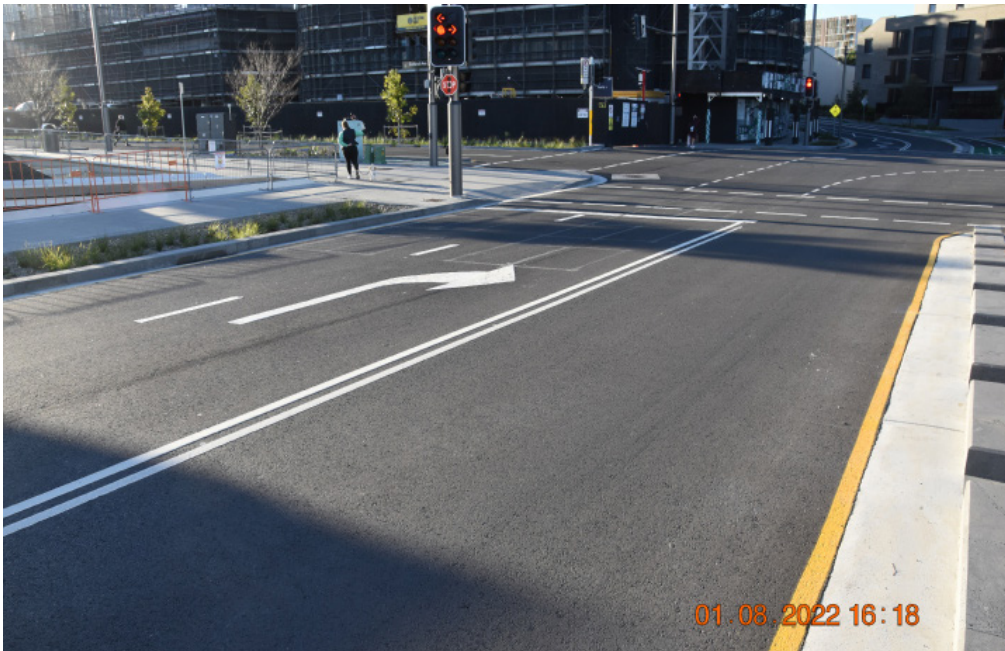
Figure: 0103

General view of the roadway on Portman Street outside 3 Joynton Avenue, at approximately 40 meters from the west end.

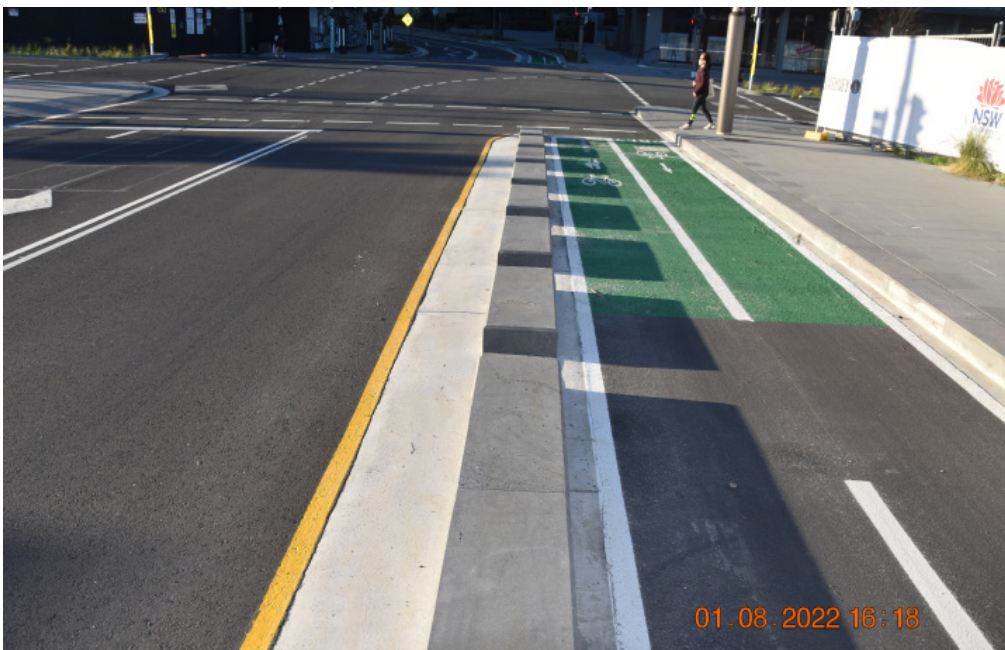
Figure: 0104

General view of the kerb and gutter on Portman Street outside 3 Joynton Avenue, at approximately 40 meters from the west end.

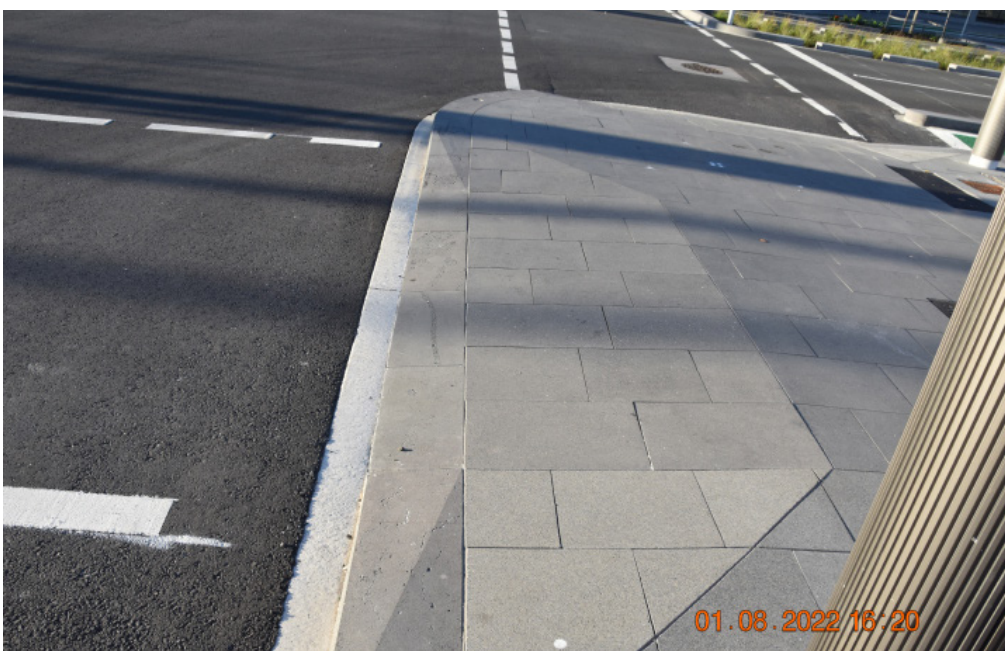
Figure: 0114

General view of the crossover on Portman Street, outside 3 Joynton Avenue, east end.

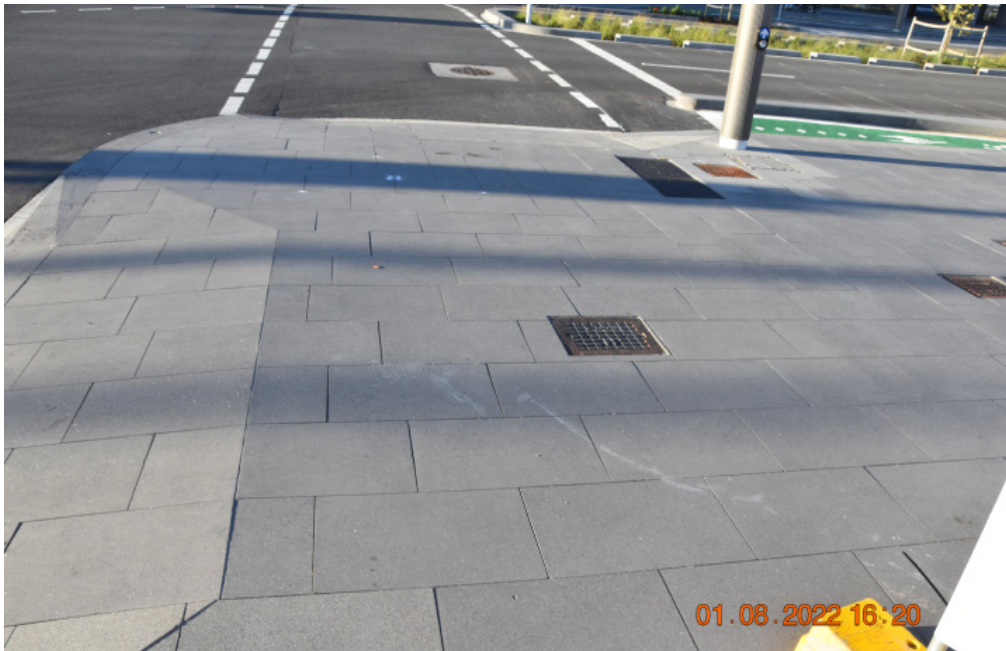
Figure: 0115

General view of the footpath on Portman Street, outside 3 Joynton Avenue, east end.

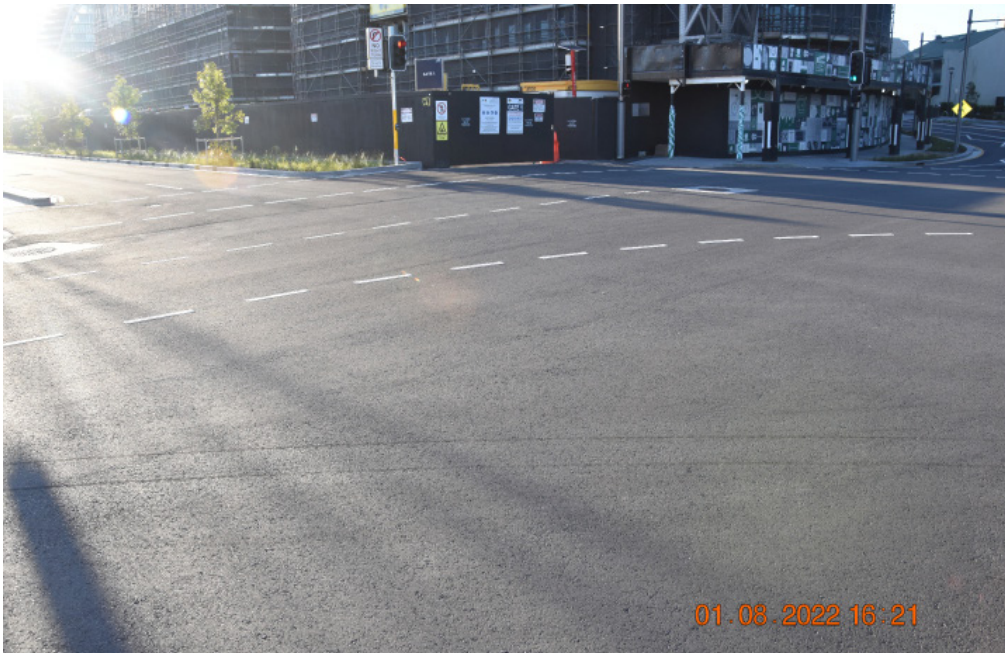
Figure: 0119

General view of the roadway on Portman Street at the intersection with Zetland Avenue.

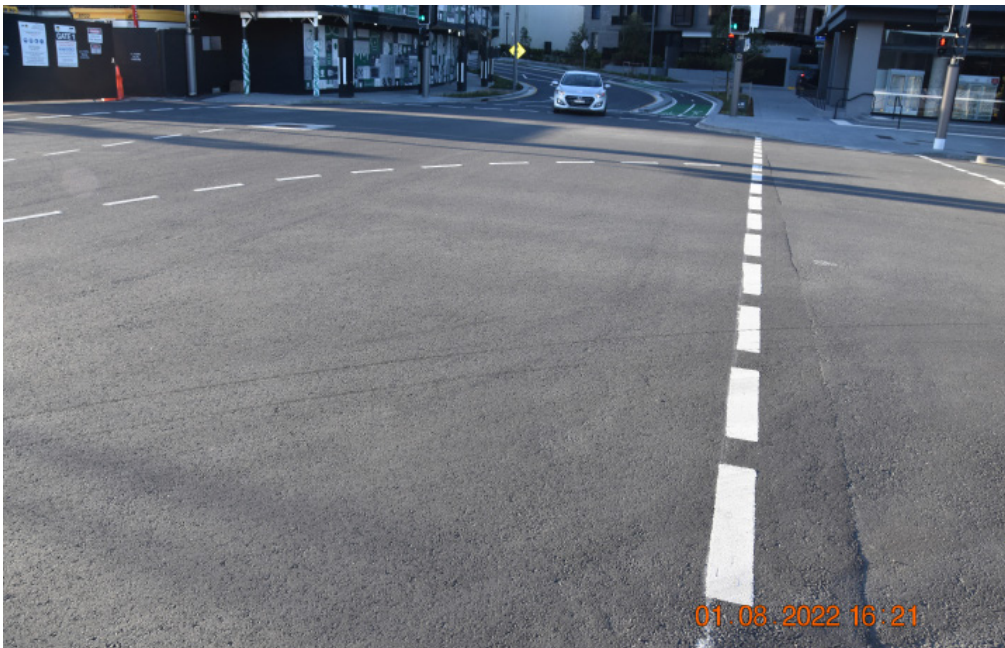
Figure: 0120

General view of the roadway on Portman Street at the intersection with Zetland Avenue.

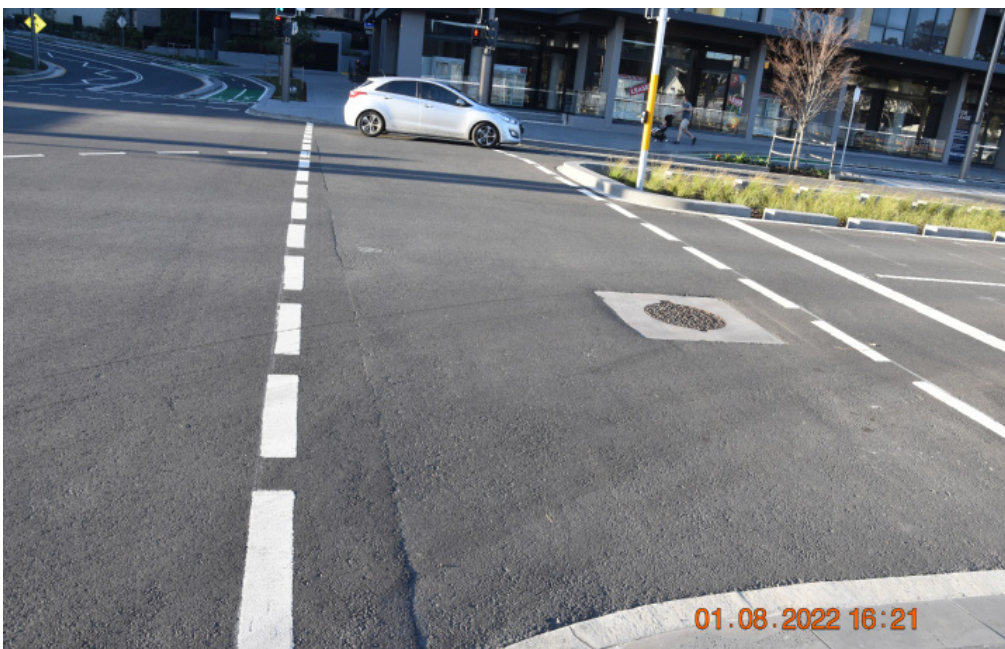
Figure: 0121

General view of the footpath on the east side of Zetland Avenue, outside 3 Joynton Avenue

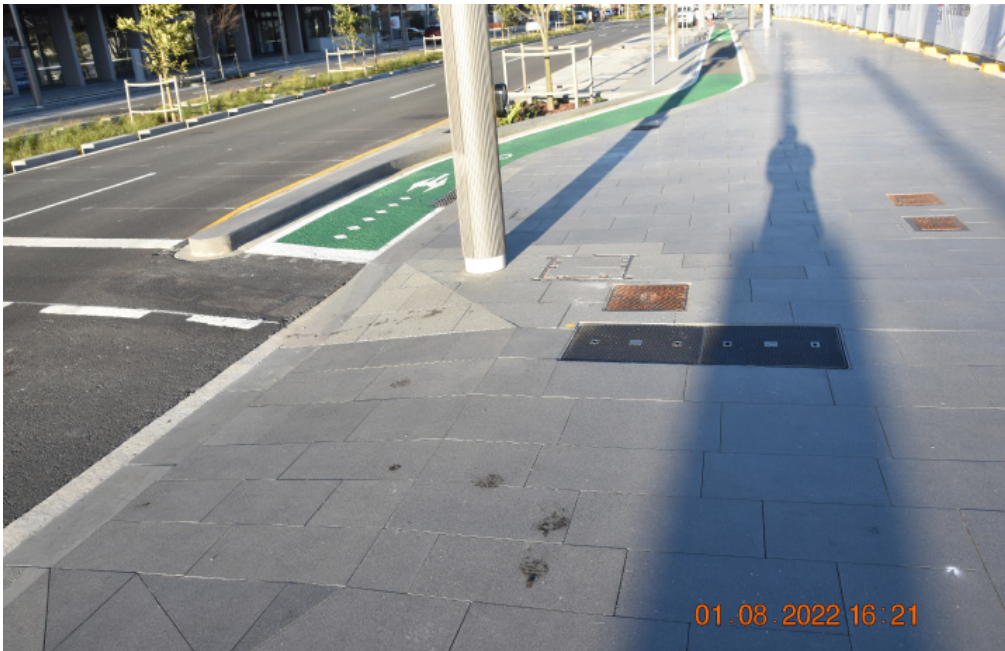
Figure: 0122

General view of the footpath on the east side of Zetland Avenue, outside 3 Joynton Avenue

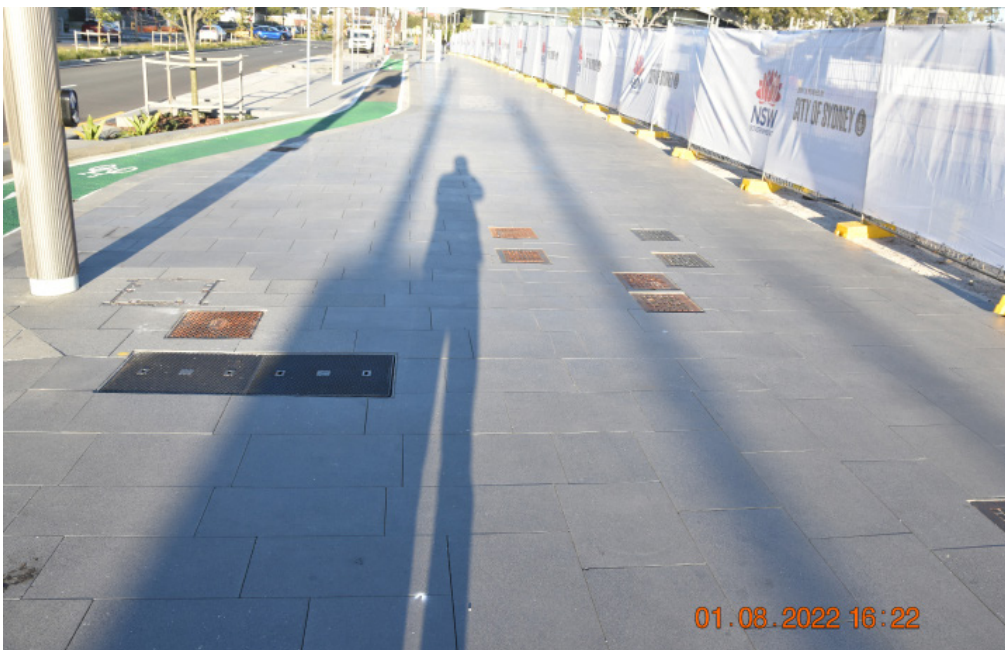
Figure: 0123

General view of the footpath on the east side of Zetland Avenue, outside 3 Joynton Avenue
