PRE CONSTRUCTION CONDITION SURVEY

Green Square Integrated Community Facility &
School - 3 Joynton Avenue, Zetland NSW

Council Assets
3 Joynton Avenue and Portman Street
ZETLAND NSW 2017

01 August 2022

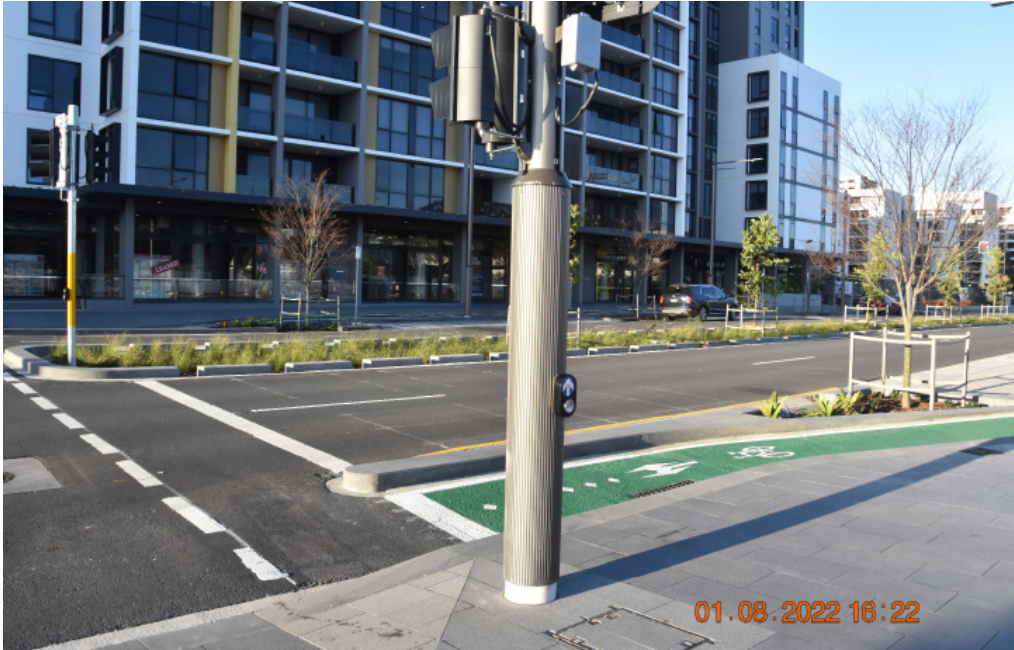
Figure: 0124

General view of the traffic light on the east side of Zetland Avenue, north end.

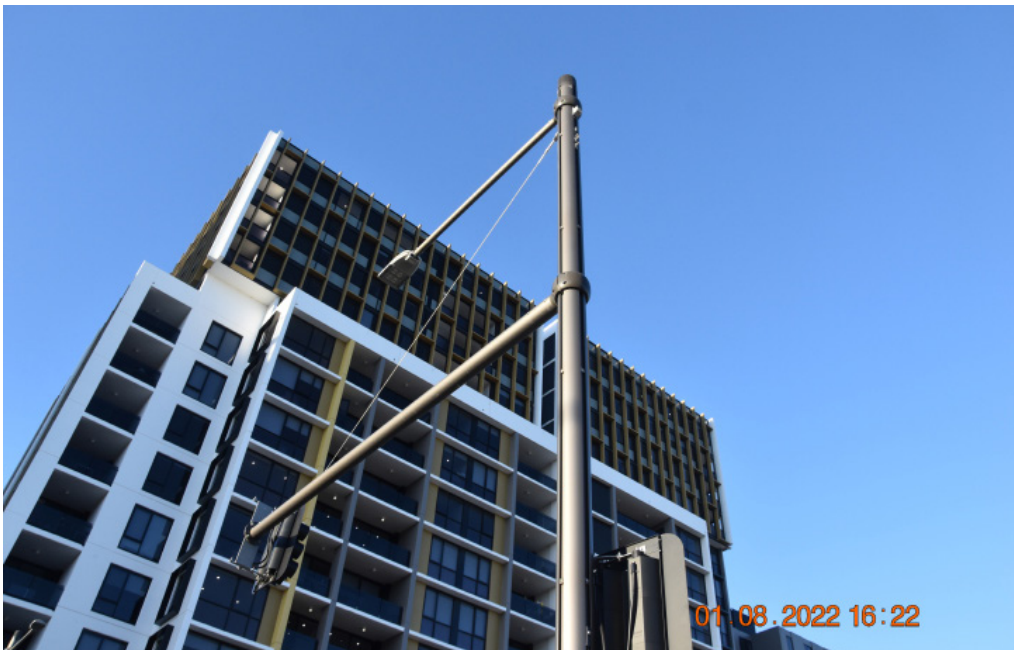
Figure: 0125

General view of the traffic light on the east side of Zetland Avenue, north end.

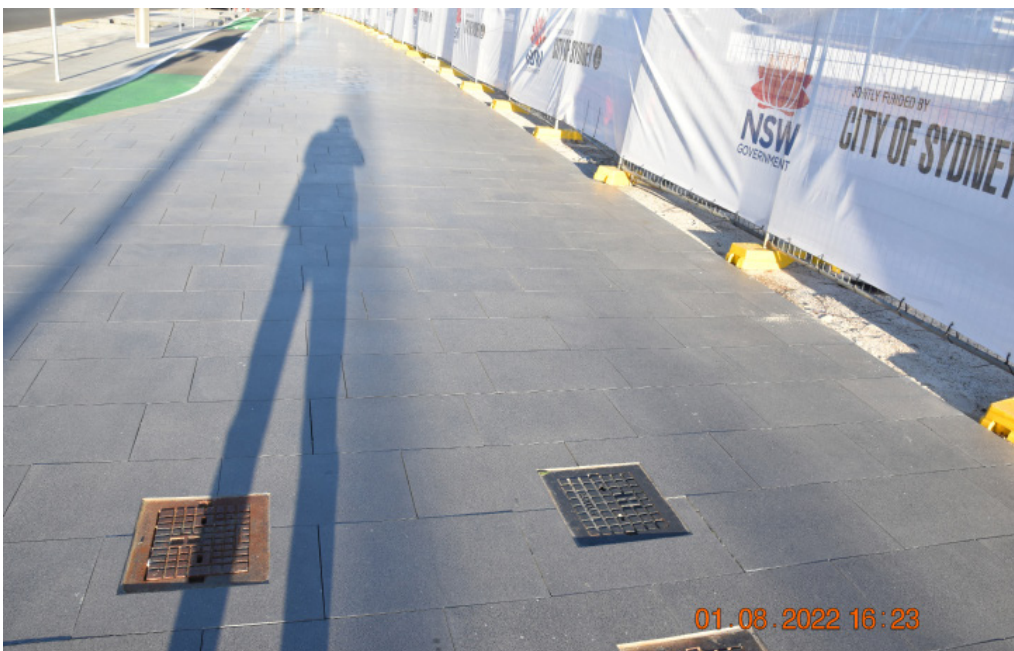
Figure: 0126

General view of the footpath on the east side of Zetland Avenue, at approximately 5 meters from the north end.

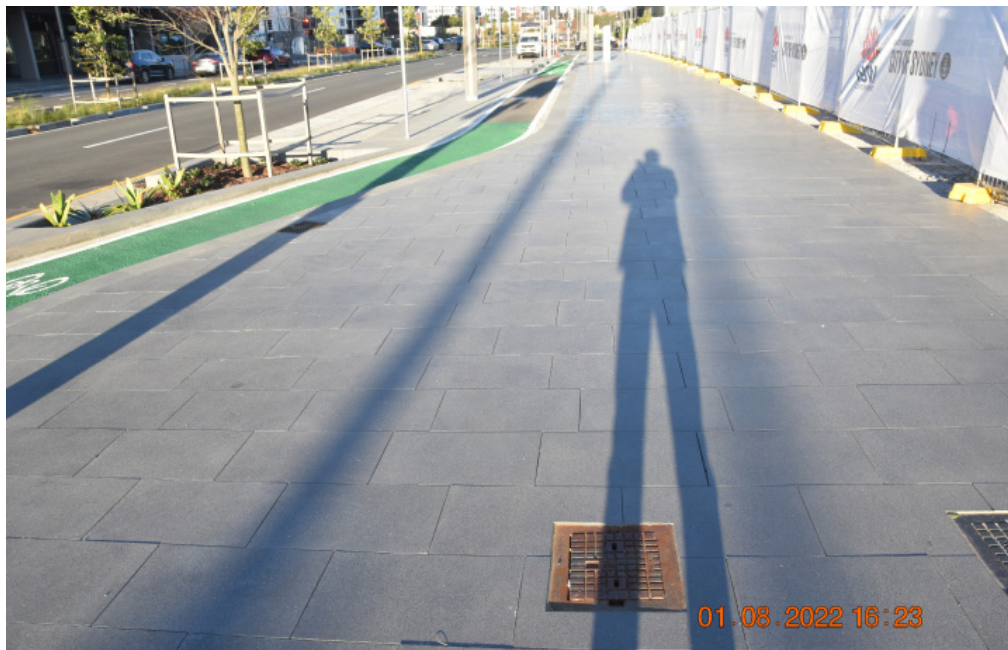
Figure: 0127

General view of the footpath on the east side of Zetland Avenue, at approximately 5 meters from the north end.

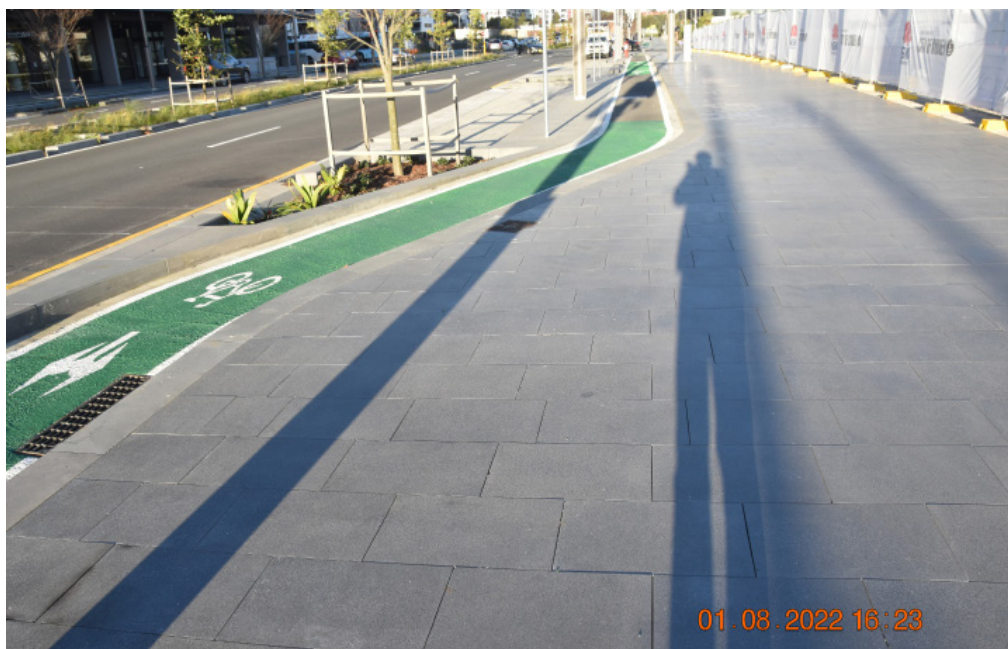
Figure: 0128

General view of the footpath on the east side of Zetland Avenue, at approximately 5 meters from the north end.

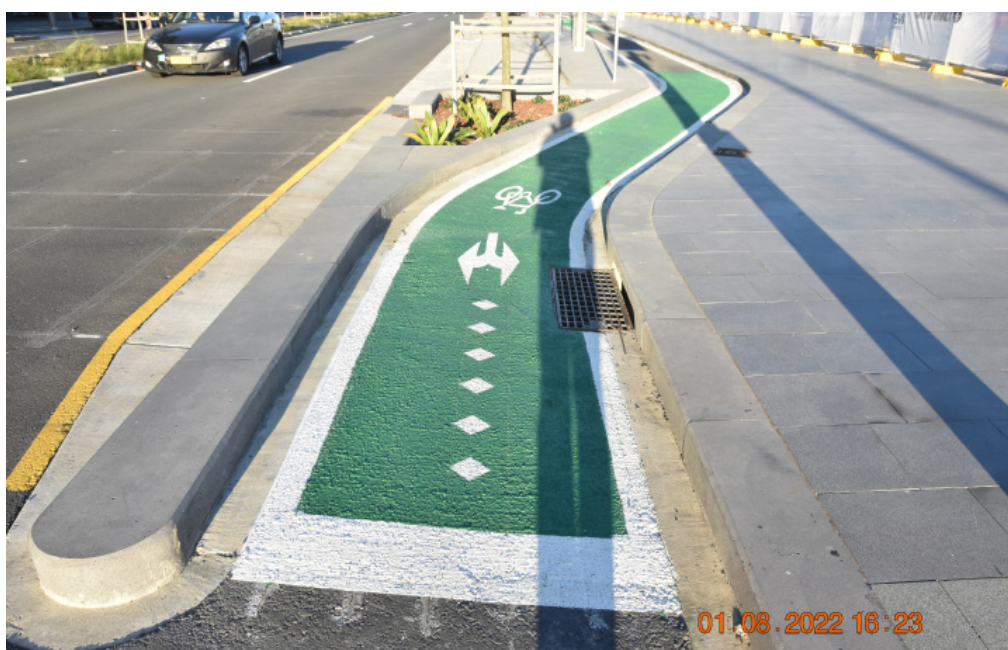
Figure: 0129

General view of the bicycle on the east side of Zetland Avenue, at approximately 5 meters from the north end.

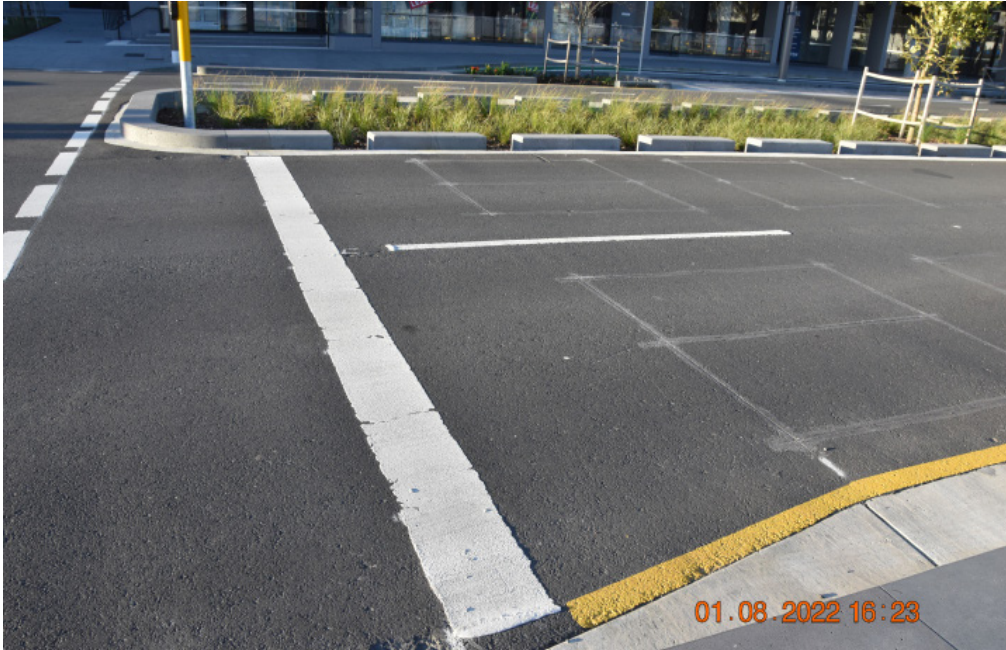
Figure: 0130

General view of the roadway on the east side of Zetland Avenue, at approximately 5 meters from the north end.

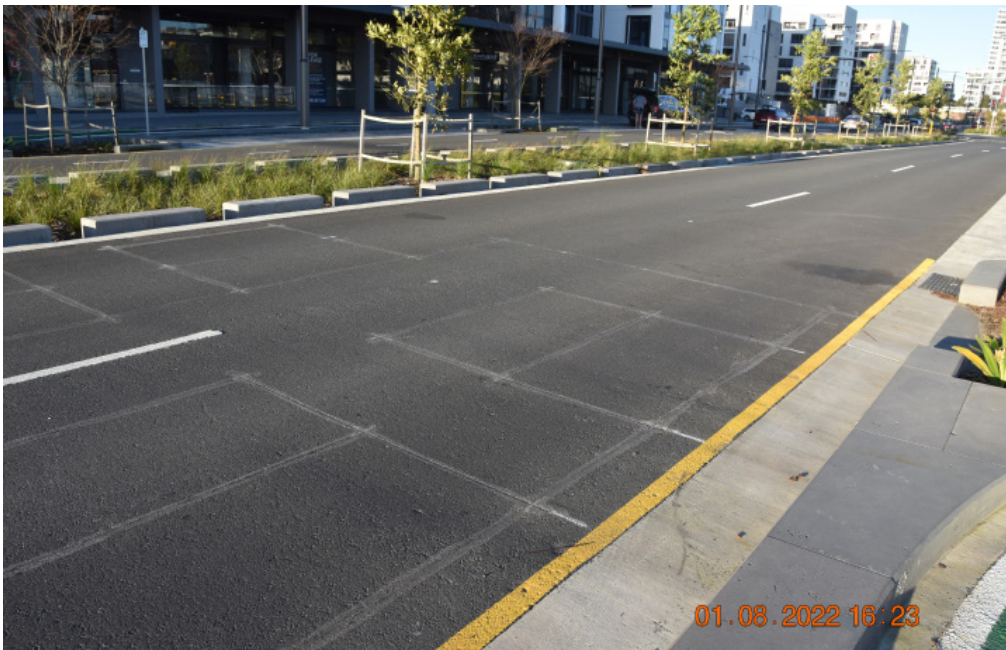
Figure: 0131

General view of the roadway on the east side of Zetland Avenue, at approximately 5 meters from the north end.

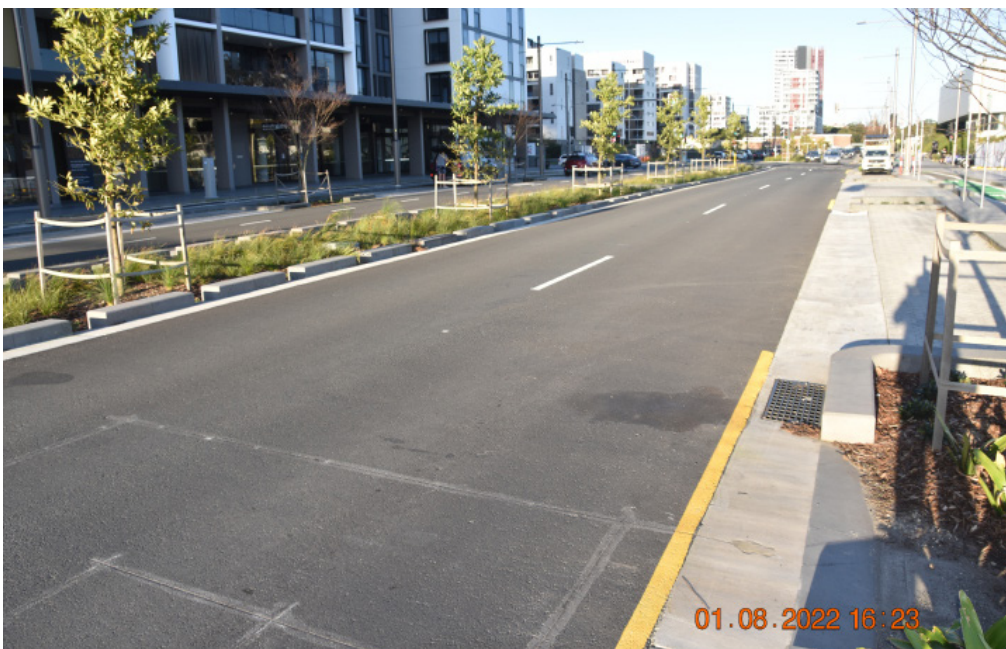
Figure: 0132

General view of the roadway on the east side of Zetland Avenue, at approximately 10 meters from the north end.

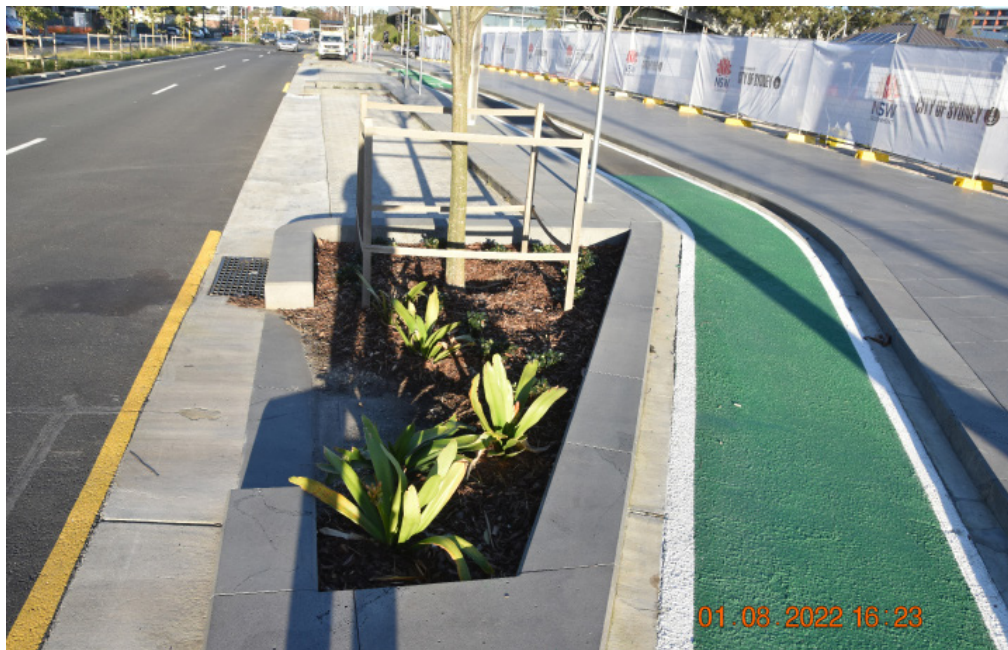
Figure: 0133

General view of the garden bed on the east side of Zetland Avenue, at approximately 10 meters from the north end.

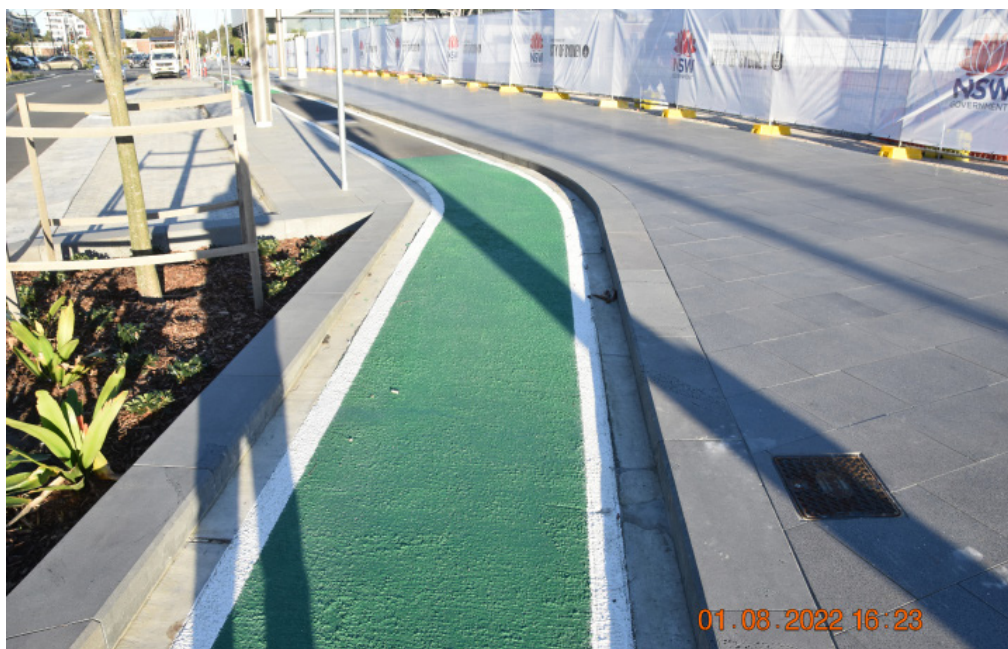
Figure: 0134

General view of the bicycle lane on the east side of Zetland Avenue, at approximately 10 meters from the north end.

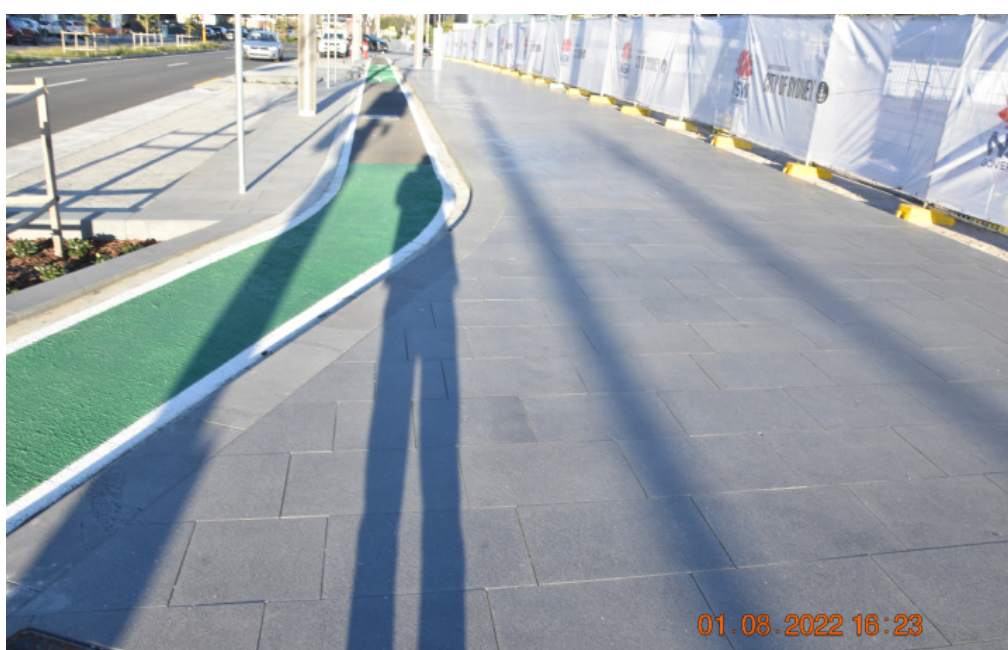
Figure: 0135

General view of the footpath on the east side of Zetland Avenue, at approximately 10 meters from the north end.

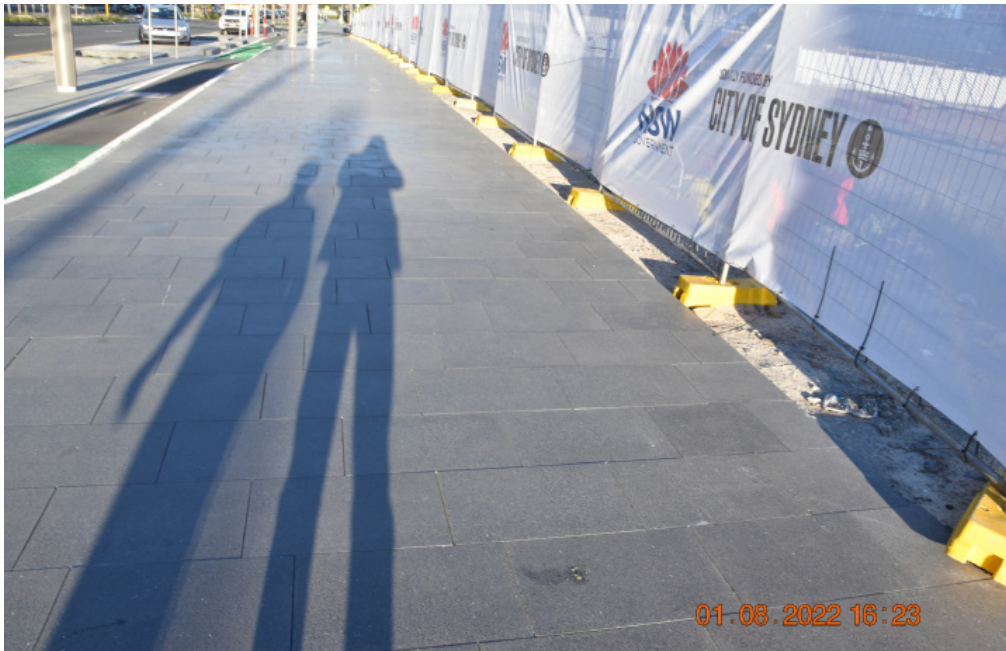
Figure: 0136

General view of the footpath on the east side of Zetland Avenue, at approximately 10 meters from the north end.

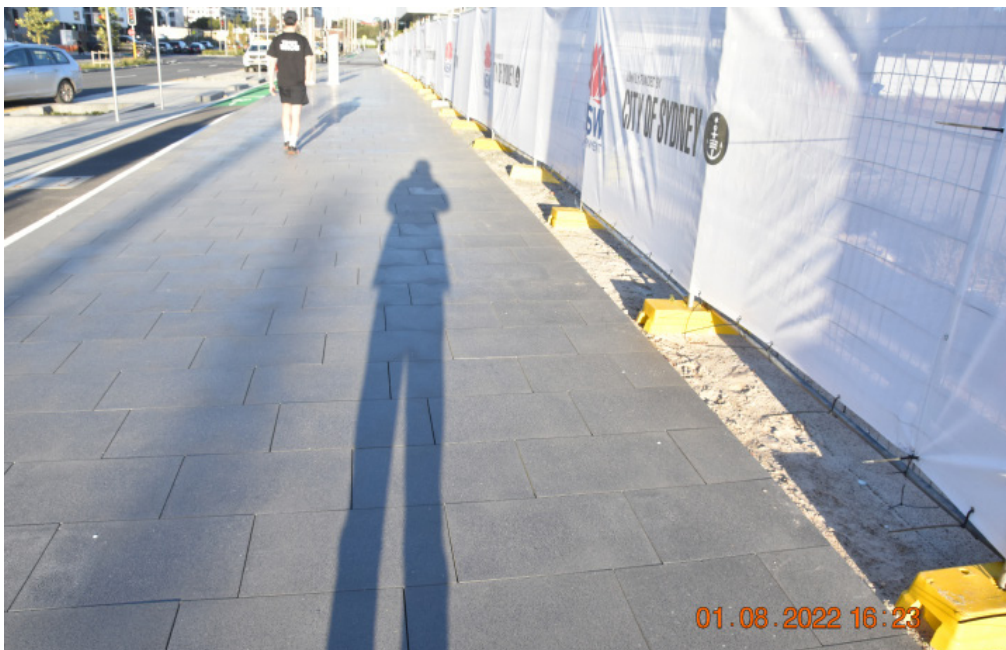
Figure: 0137

General view of the footpath on the east side of Zetland Avenue, at approximately 15 meters from the north end.

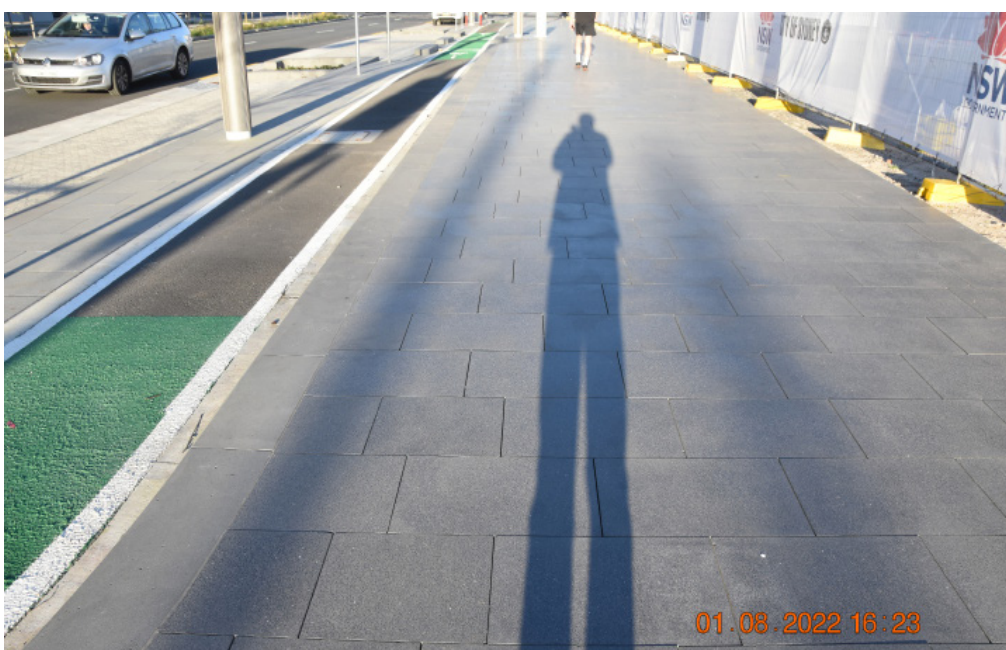
Figure: 0138

General view of the footpath on the east side of Zetland Avenue, at approximately 15 meters from the north end.

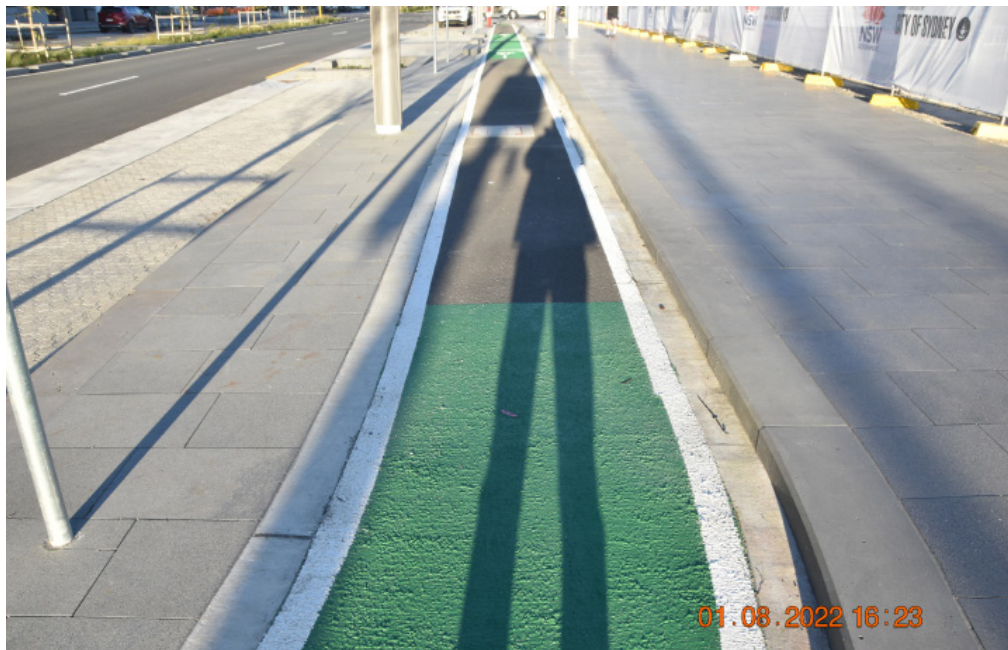
Figure: 0139

General view of the bicycle lane on the east side of Zetland Avenue, at approximately 15 meters from the north end.

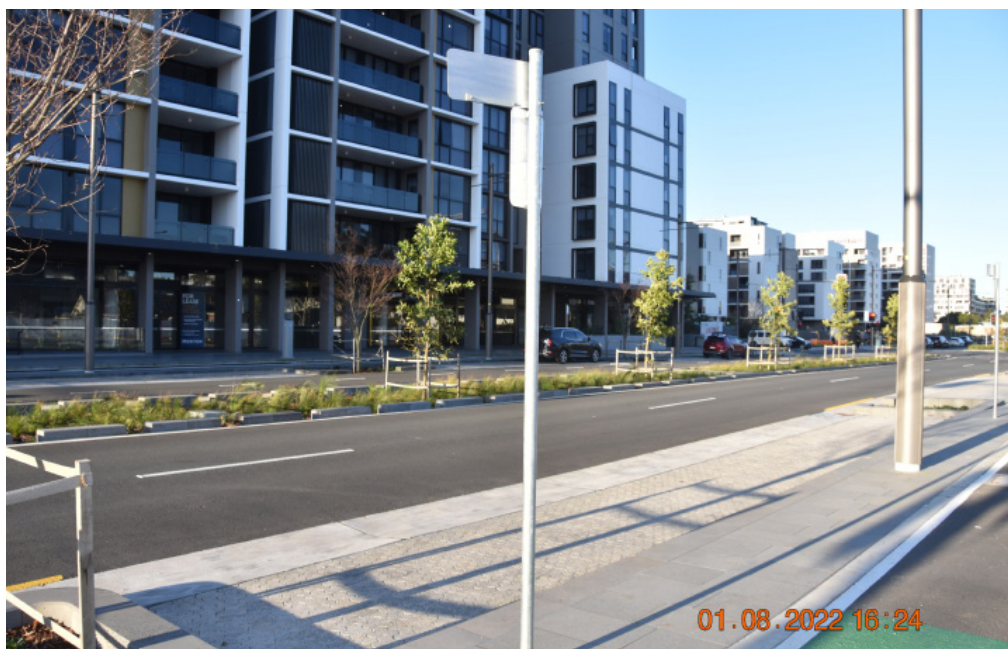
Figure: 0140

General view of the street sign on the east side of Zetland Avenue, at approximately 15 meters from the north end.

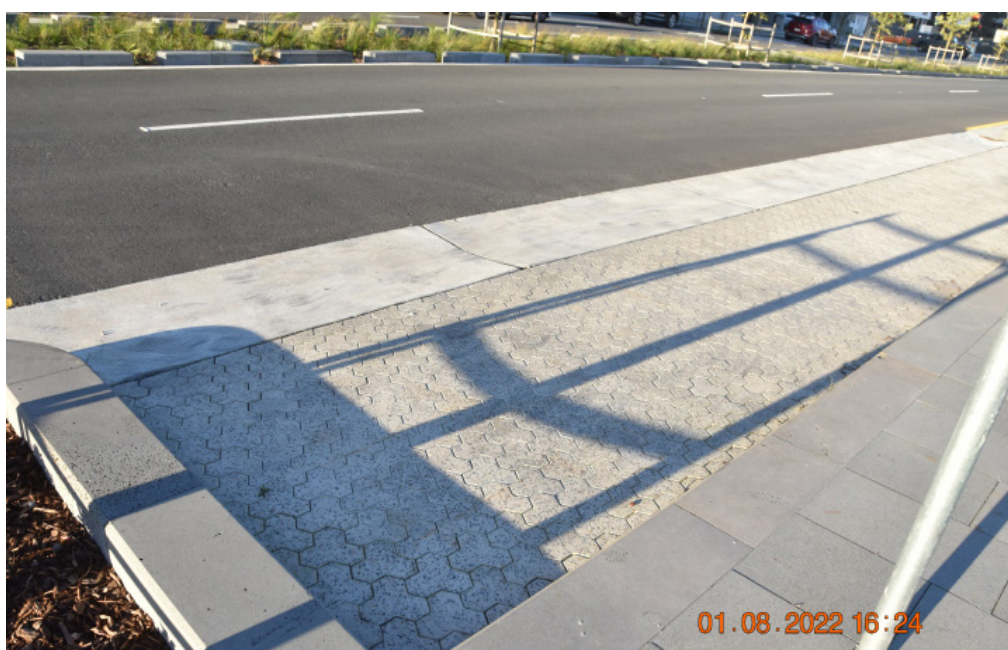
Figure: 0141

General view of the parking bay on the east side of Zetland Avenue, at approximately 15 meters from the north end.

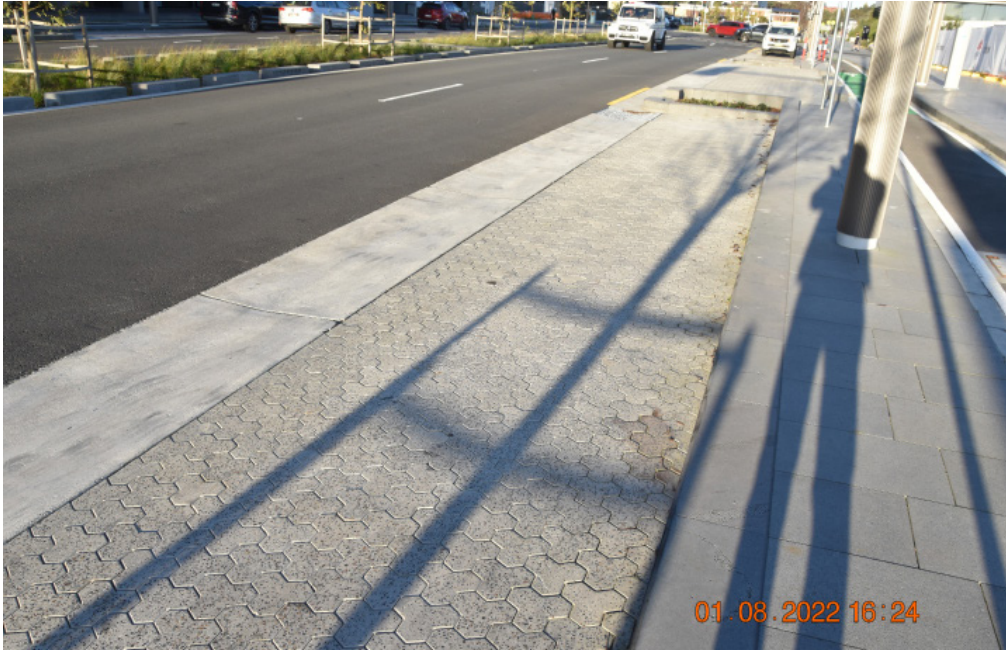
Figure: 0142

General view of the parking bay on the east side of Zetland Avenue, at approximately 15 meters from the north end.

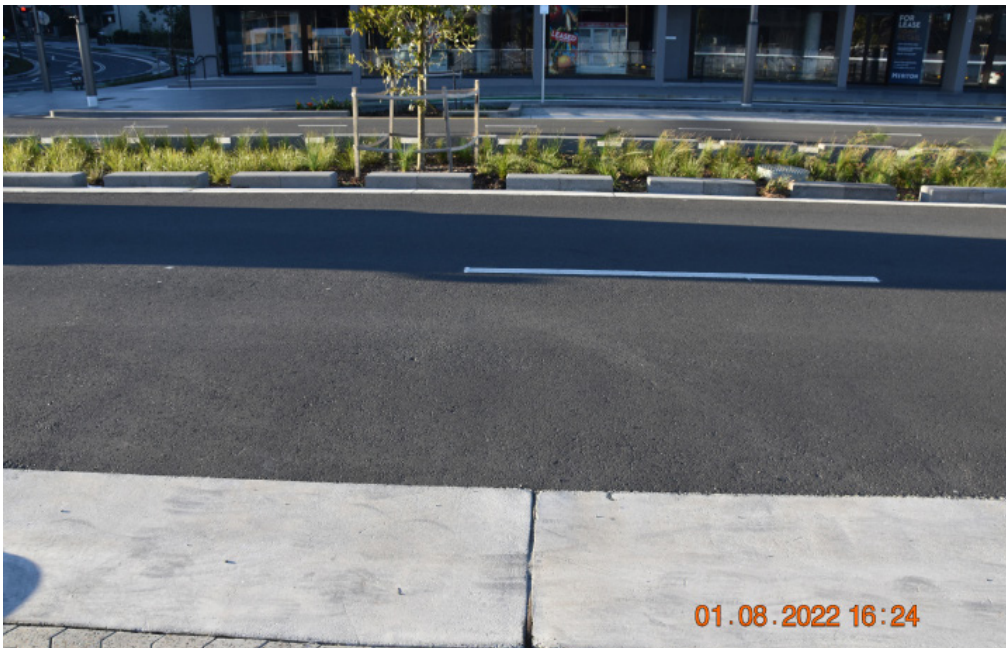
Figure: 0143

General view of the roadway on the east side of Zetland Avenue, at approximately 15 meters from the north end.

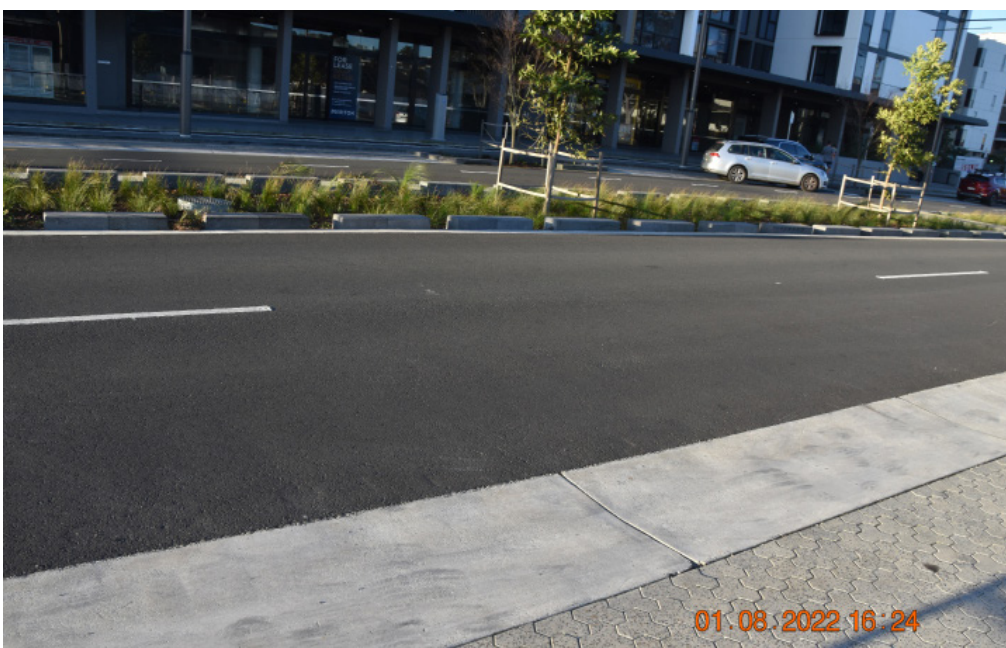
Figure: 0144

General view of the roadway on the east side of Zetland Avenue, at approximately 20 meters from the north end.

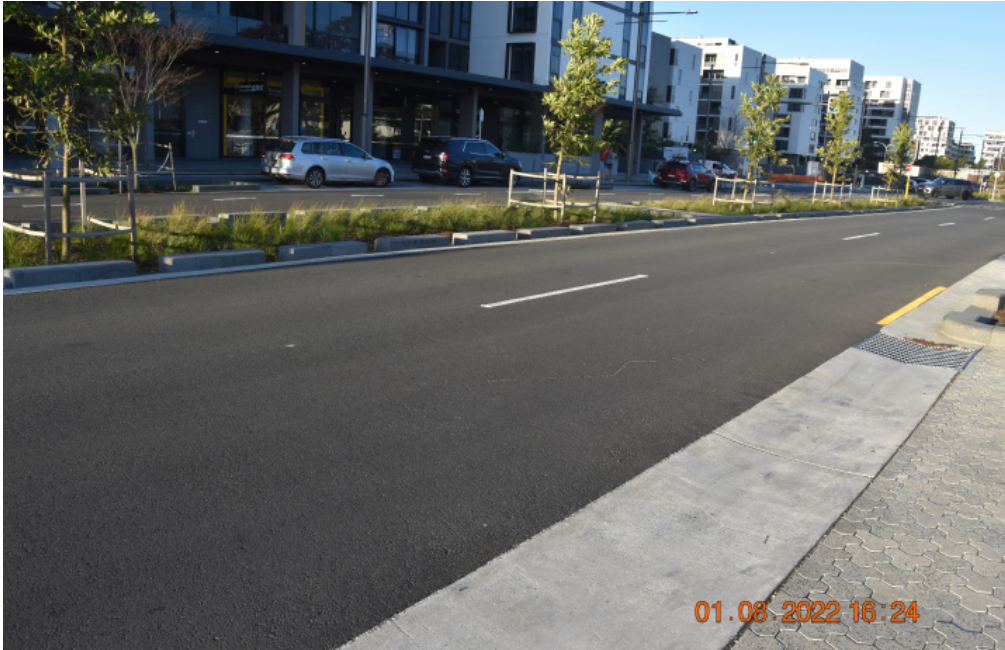
Figure: 0145

General view of the roadway on the east side of Zetland Avenue, at approximately 20 meters from the north end.

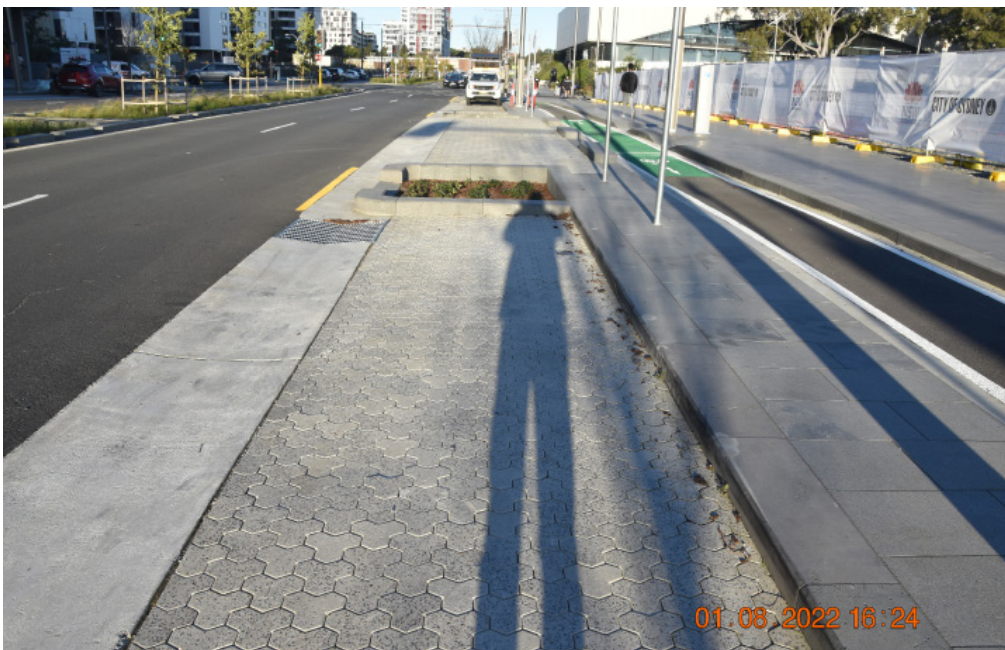
Figure: 0146

General view of the park bay on the east side of Zetland Avenue, at approximately 20 meters from the north end.

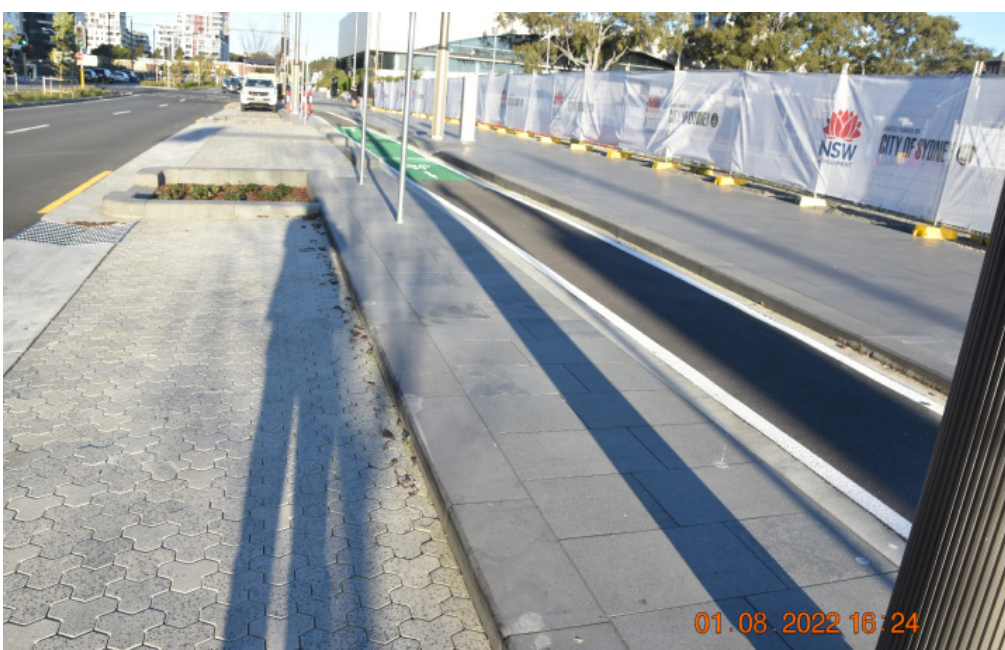
Figure: 0147

General view of the kerb and gutter on the east side of Zetland Avenue, at approximately 20 meters from the north end.

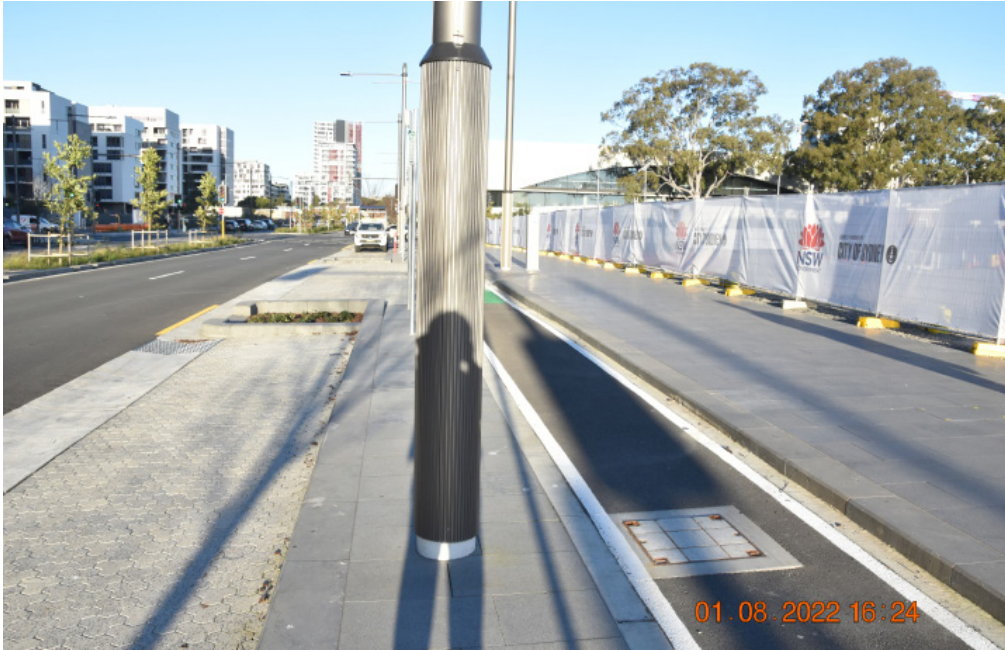
Figure: 0149

General view of the light pole on the east side of Zetland Avenue, at approximately 20 meters from the north end.

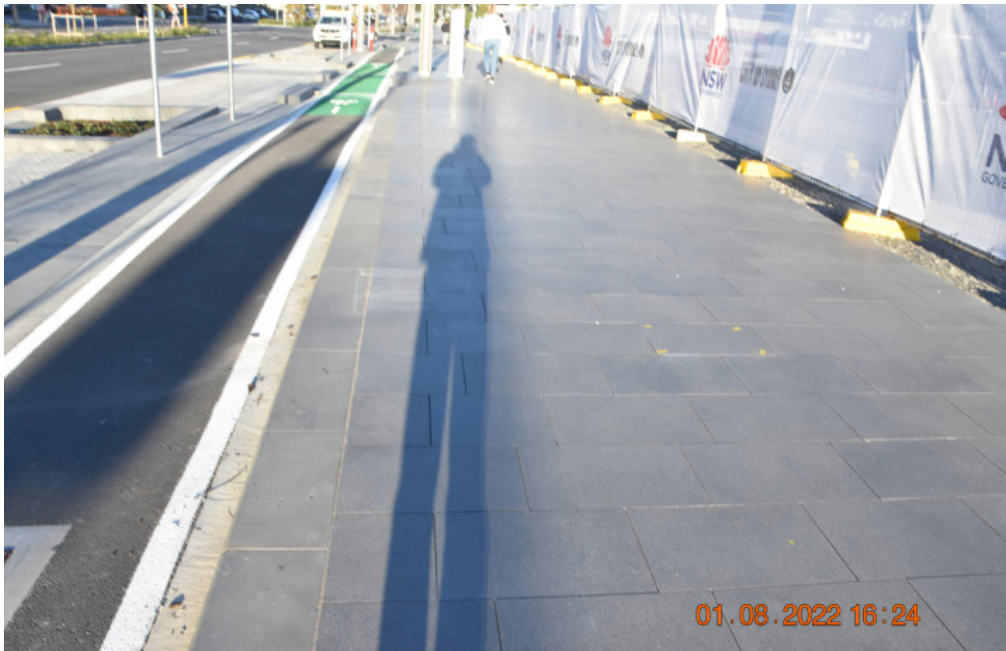
Figure: 0151

General view of the footpath on the east side of Zetland Avenue, at approximately 20 meters from the north end.

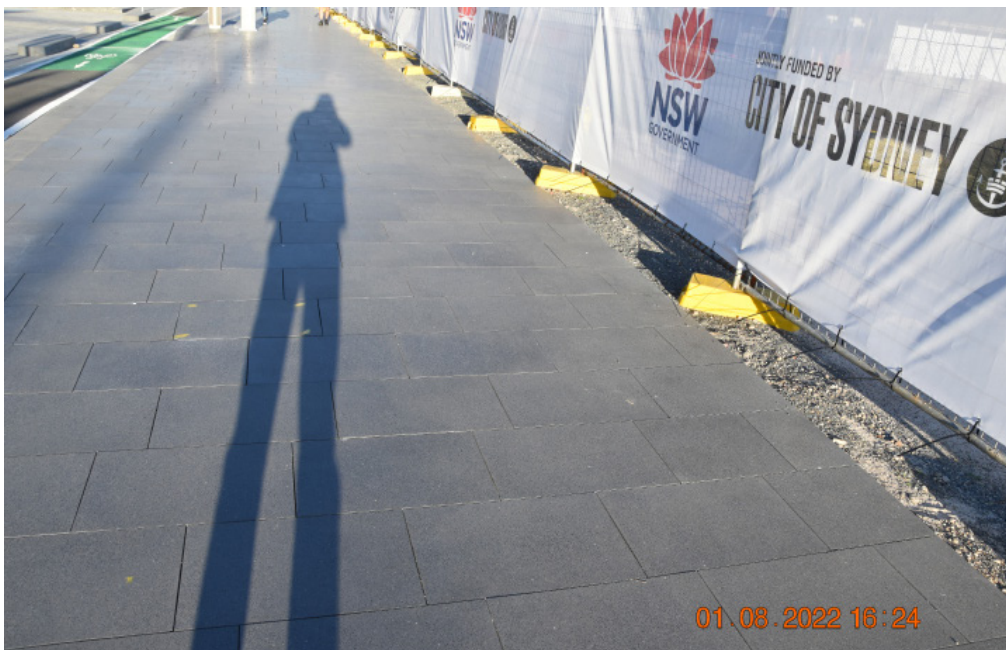
Figure: 0152

General view of the footpath on the east side of Zetland Avenue, at approximately 20 meters from the north end.

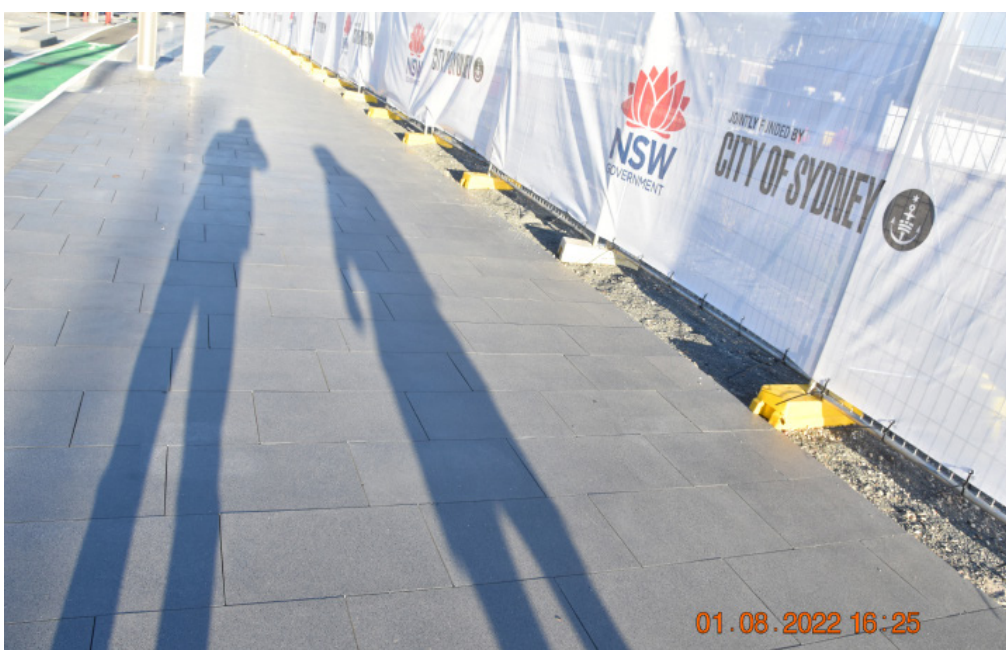
Figure: 0153

General view of the footpath on the east side of Zetland Avenue, at approximately 25 meters from the north end.

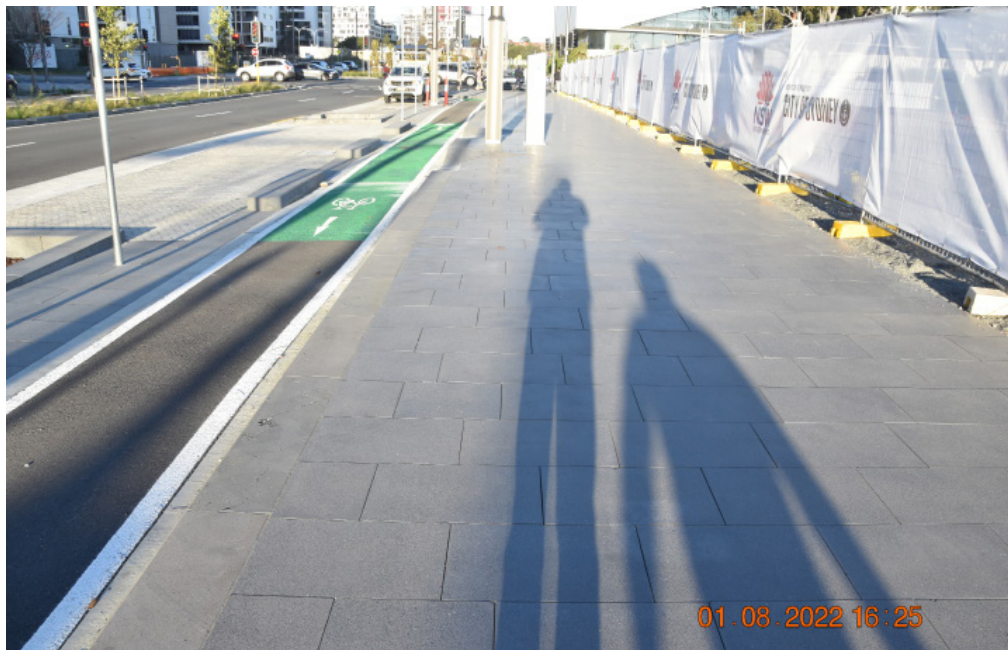
Figure: 0154

General view of the footpath on the east side of Zetland Avenue, at approximately 25 meters from the north end.

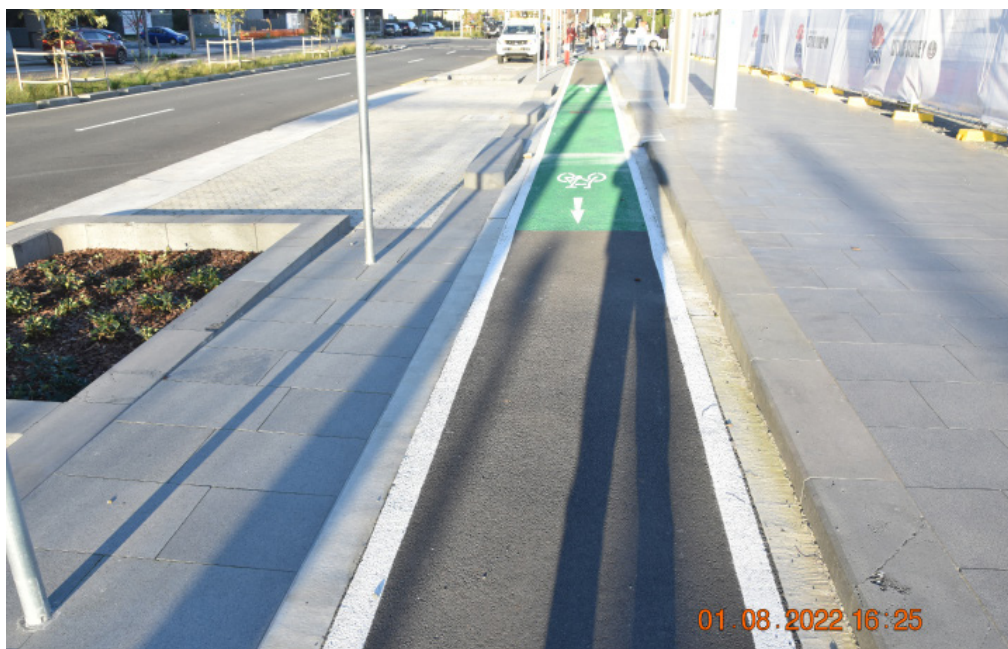
Figure: 0155

General view of the bicycle lane on the east side of Zetland Avenue, at approximately 25 meters from the north end.

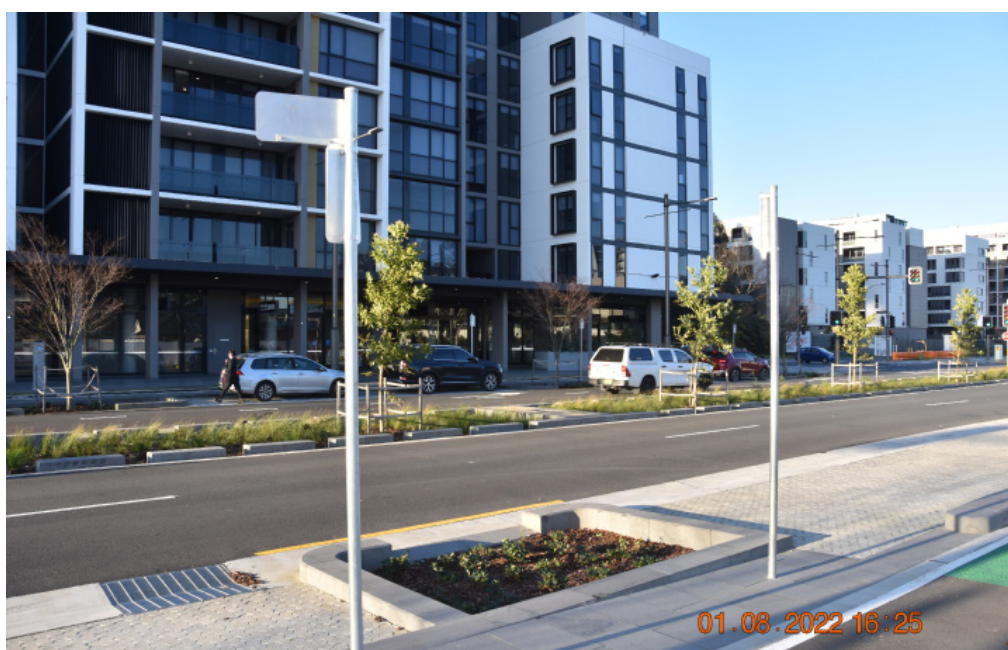
Figure: 0156

General view of the street sign on the east side of Zetland Avenue, at approximately 25 meters from the north end.

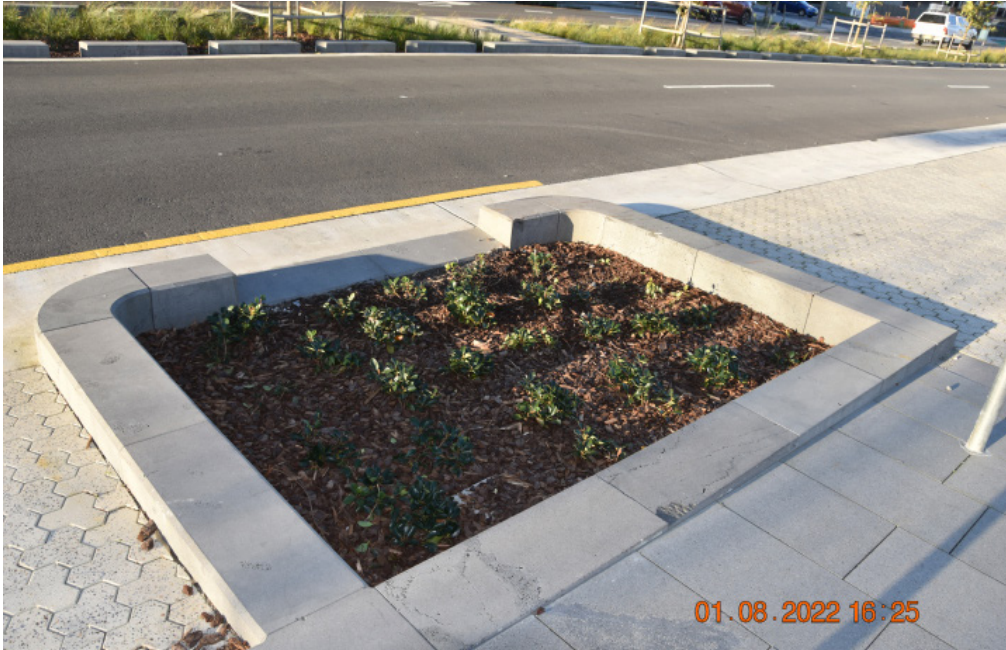
Figure: 0157

General view of the garden bed on the east side of Zetland Avenue, at approximately 25 meters from the north end.

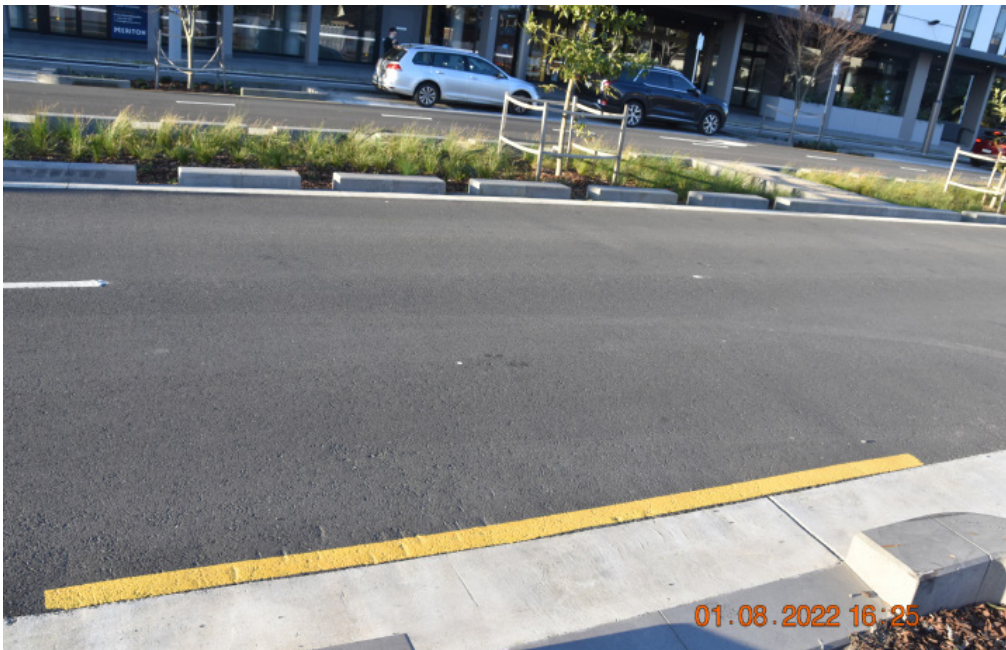
Figure: 0158

General view of the roadway on the east side of Zetland Avenue, at approximately 25 meters from the north end.
