PRE CONSTRUCTION CONDITION SURVEY

Green Square Integrated Community Facility &
School - 3 Joynton Avenue, Zetland NSW

Council Assets
3 Joynton Avenue and Portman Street
ZETLAND NSW 2017

01 August 2022

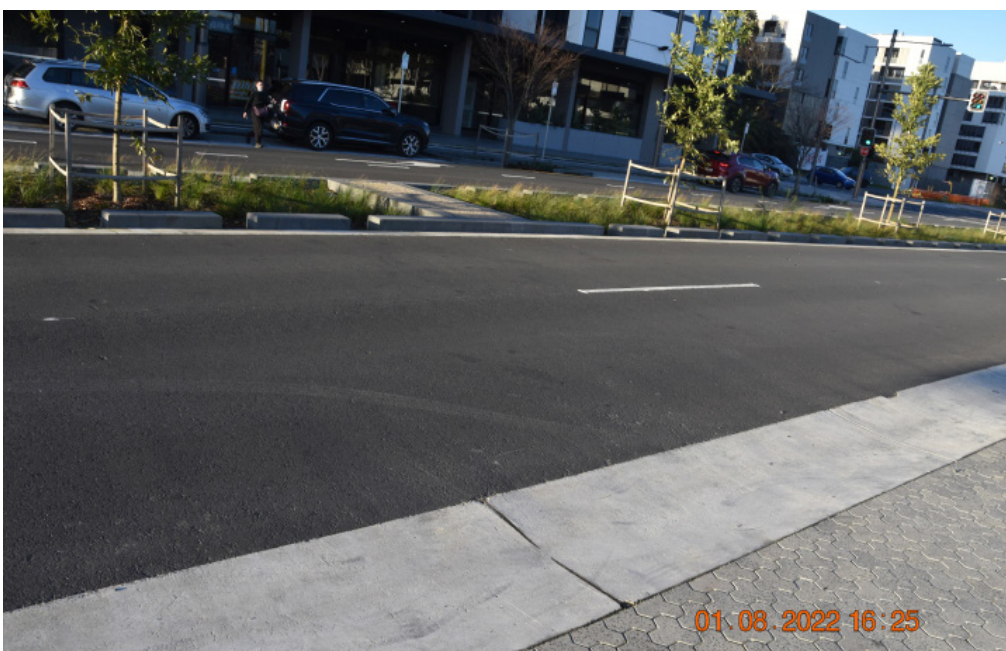
Figure: 0159

General view of the roadway on the east side of Zetland Avenue, at approximately 30 meters from the north end.

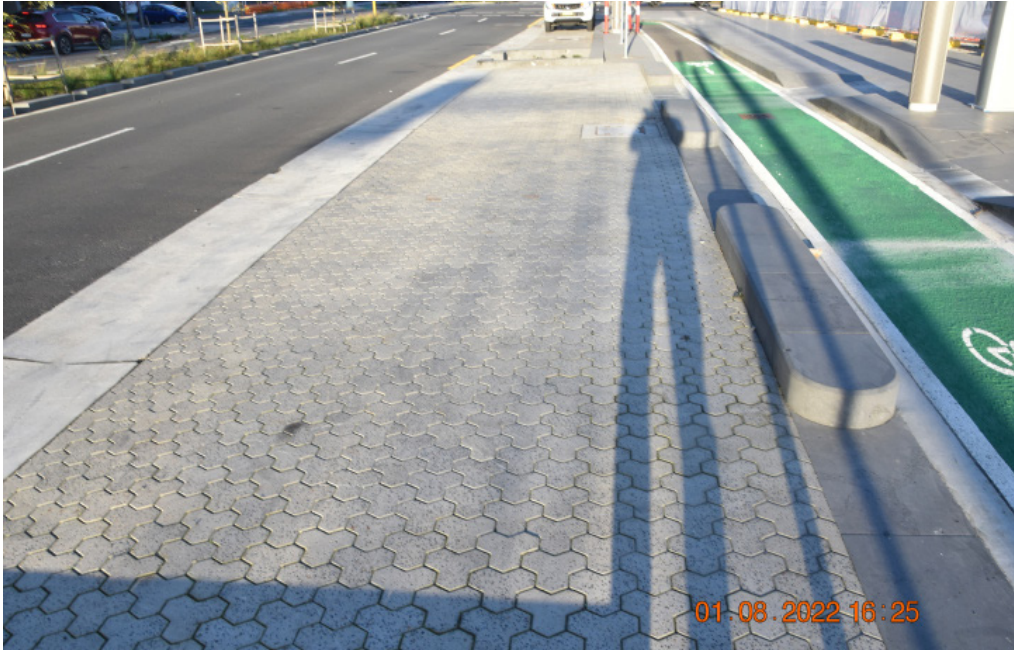
Figure: 0160

General view of the park bay on the east side of Zetland Avenue, at approximately 30 meters from the north end.

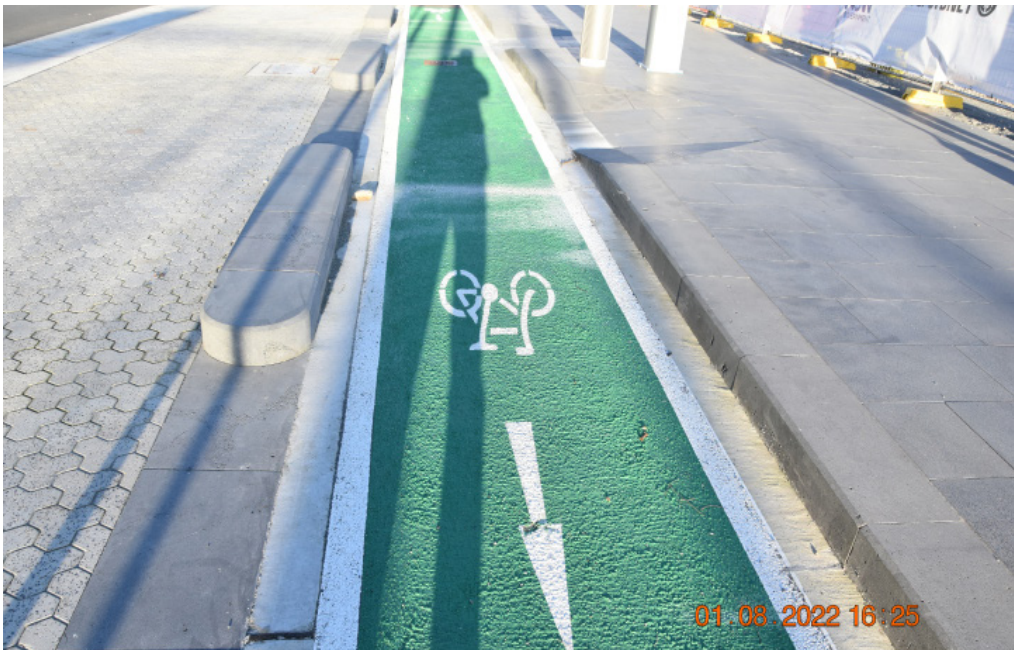
Figure: 0161

General view of the bicycle lane on the east side of Zetland Avenue, at approximately 30 meters from the north end.

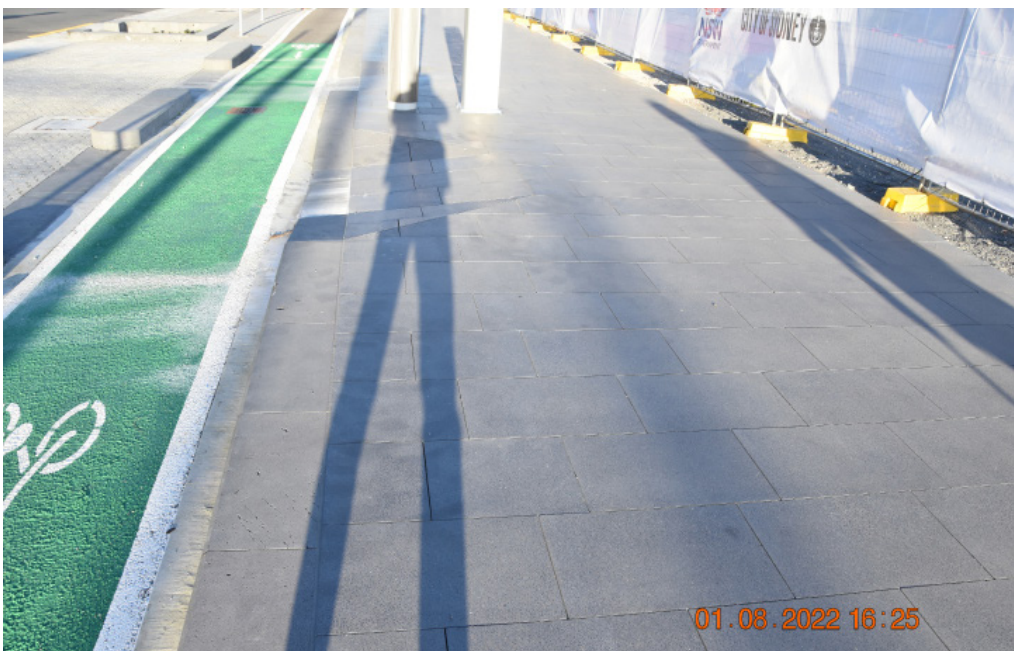
Figure: 0162

General view of the footpath on the east side of Zetland Avenue, at approximately 30 meters from the north end.

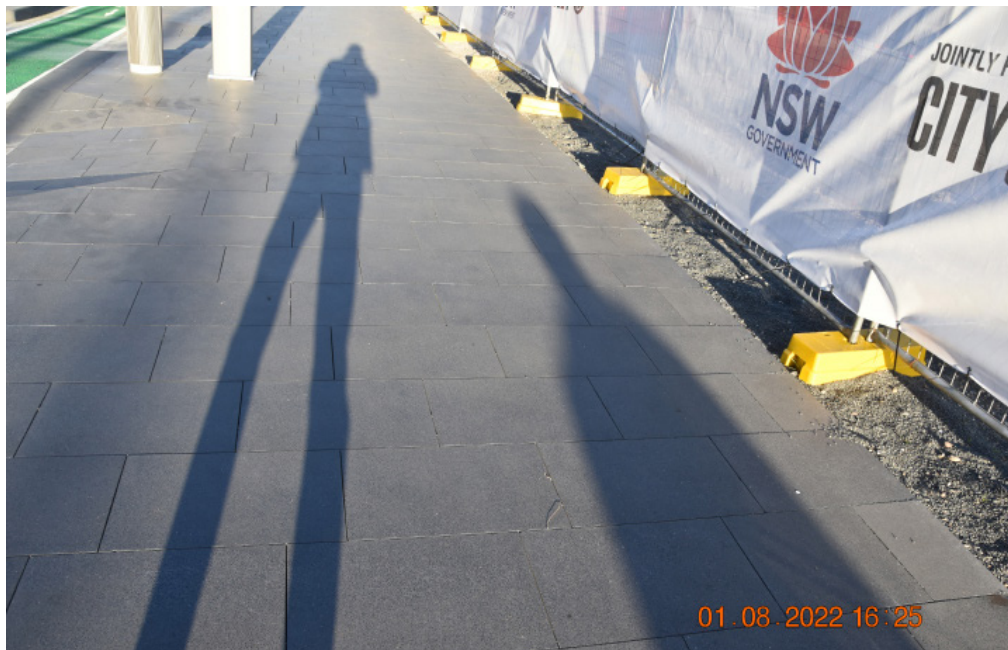
Figure: 0163

General view of the footpath on the east side of Zetland Avenue, at approximately 30 meters from the north end.

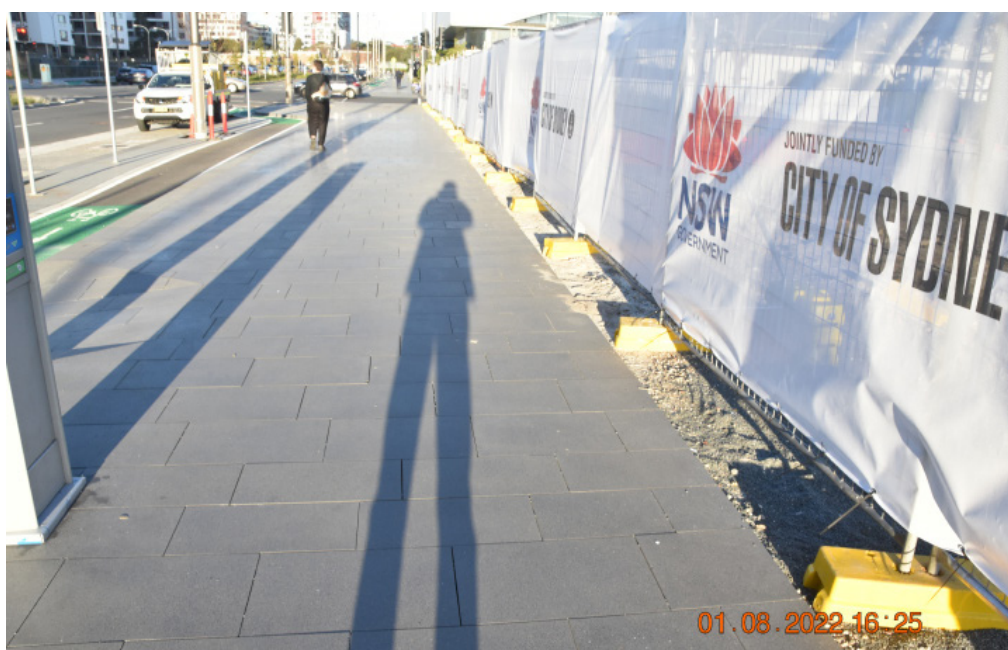
Figure: 0164

General view of the crossover on the east side of Zetland Avenue, at approximately 30 meters from the north end.

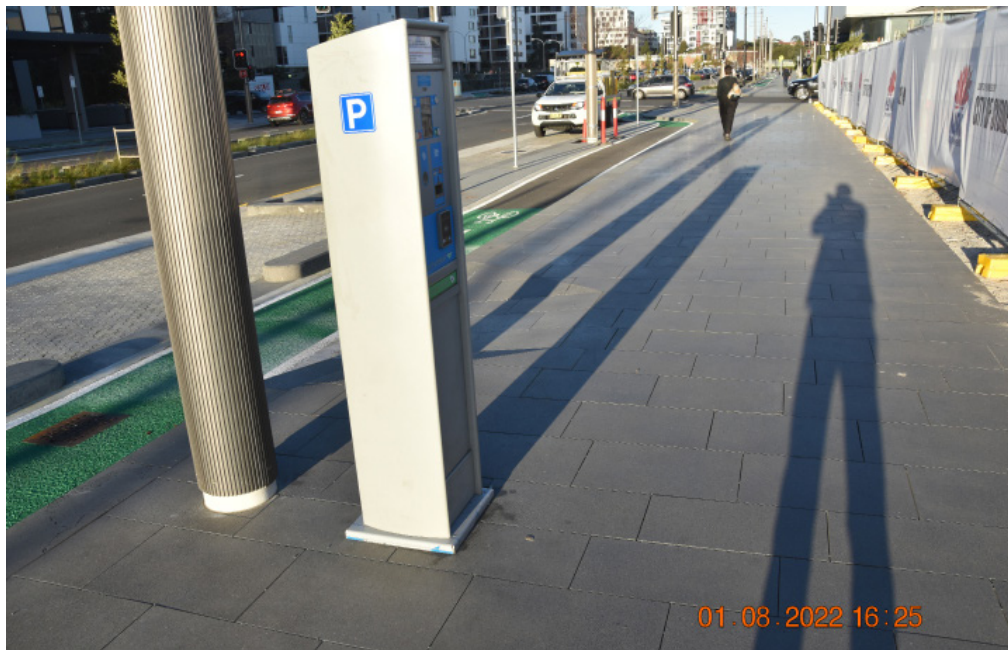
Figure: 0165

General view of the footpath on the east side of Zetland Avenue, at approximately 35 meters from the north end.

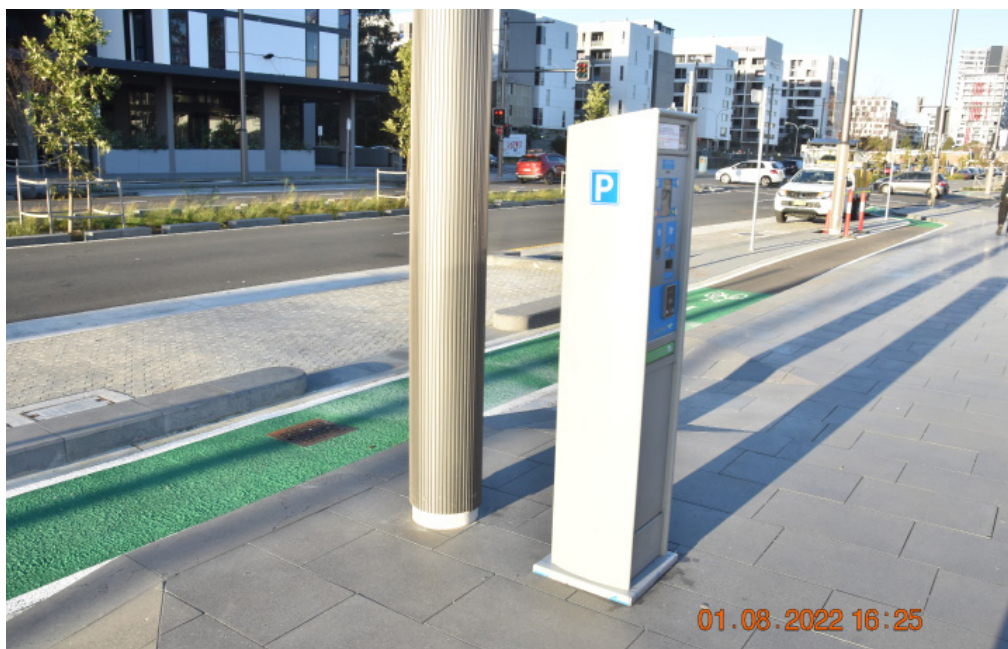
Figure: 0166

General view of the footpath on the east side of Zetland Avenue, at approximately 35 meters from the north end.

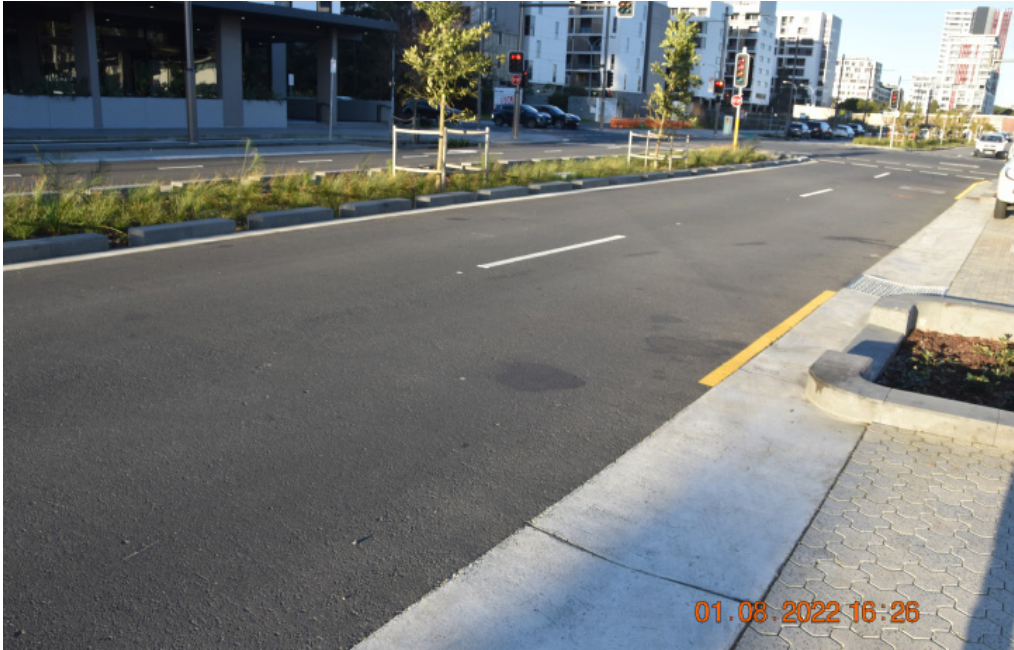
Figure: 0171

General view of the roadway on the east side of Zetland Avenue, at approximately 35 meters from the north end.

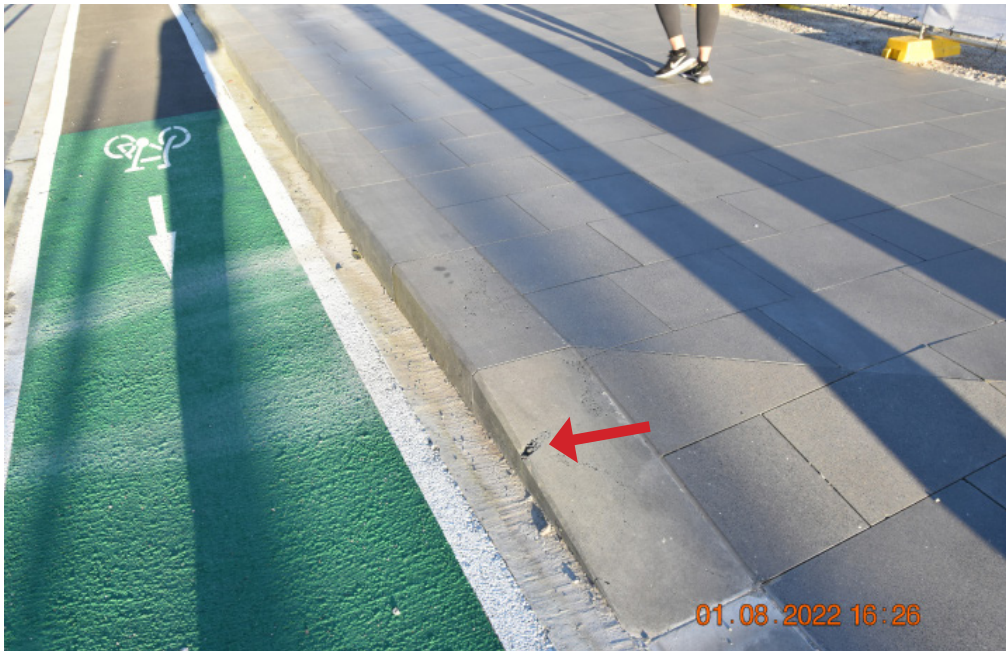
Figure: 0174

General view of the bicycle lane on the east side of Zetland Avenue, at approximately 40 meters from the north end.

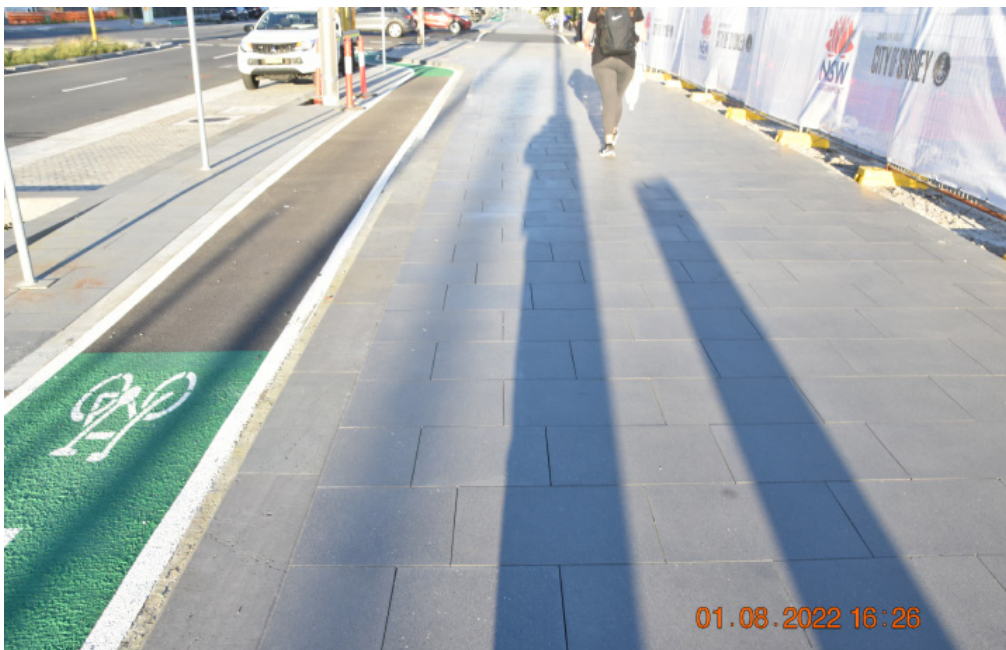
Figure: 0175

General view of the kerb and gutter on the east side of Zetland Avenue, at approximately 40 meters from the north end. Showing chipping.

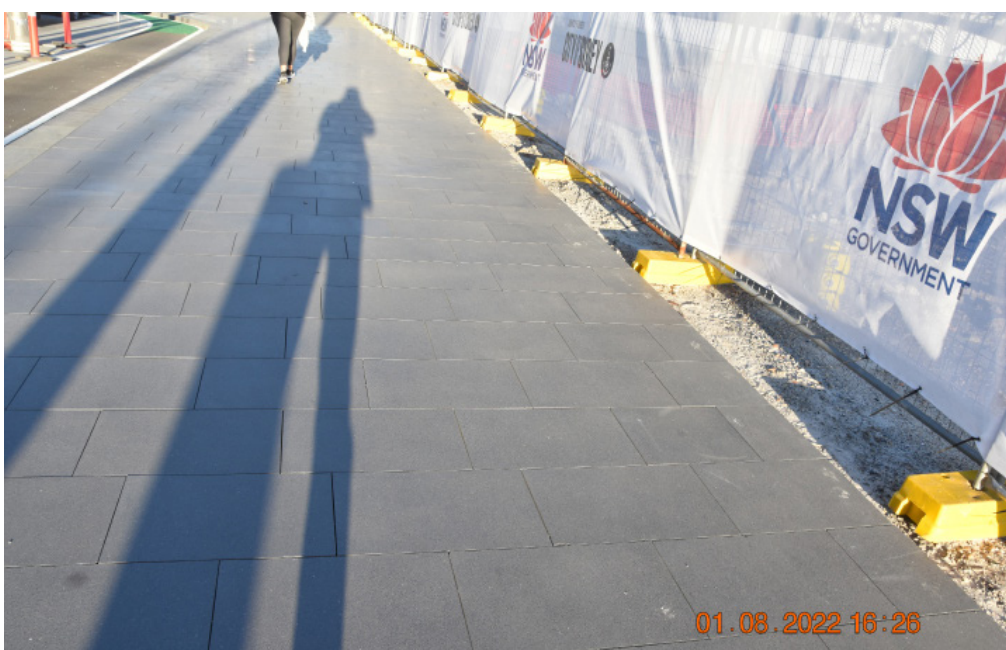
Figure: 0176

General view of the footpath on the east side of Zetland Avenue, at approximately 40 meters from the north end.

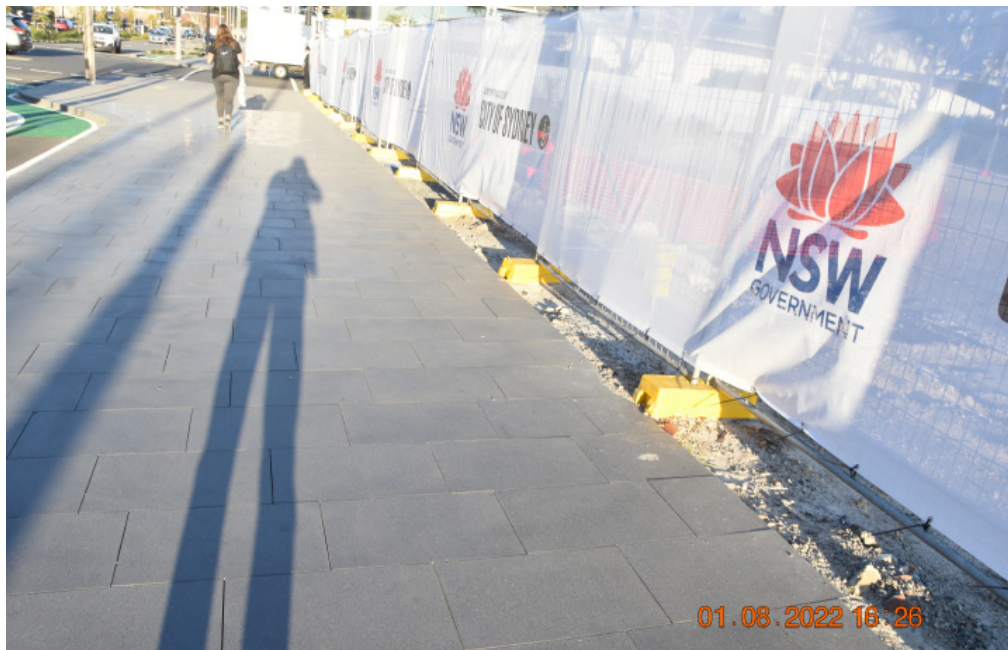
Figure: 0177

General view of the footpath on the east side of Zetland Avenue, at approximately 40 meters from the north end.

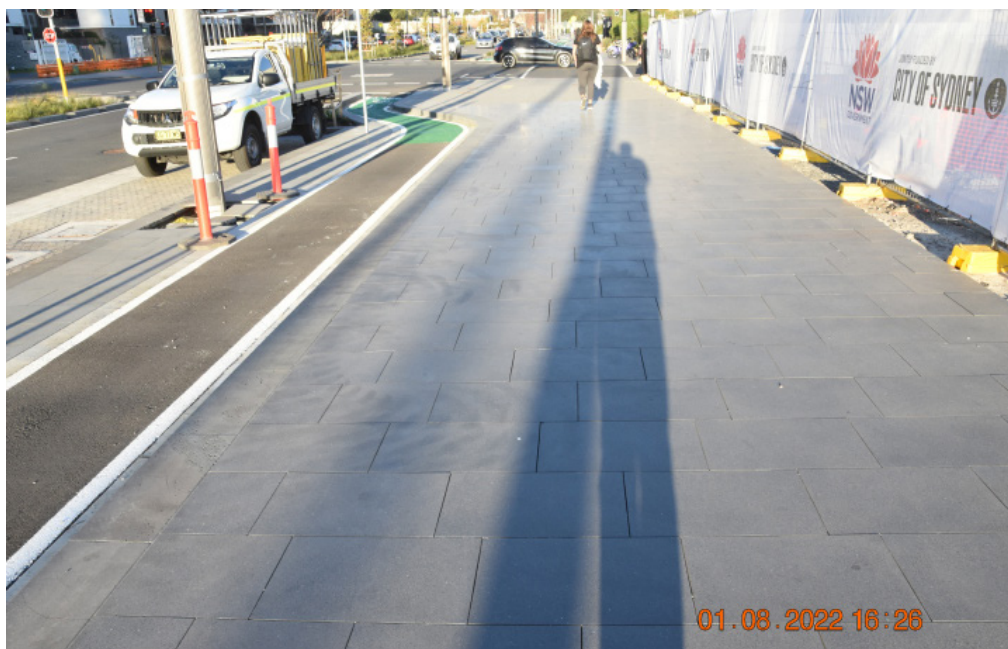
Figure: 0178

General view of the footpath on the east side of Zetland Avenue, at approximately 45meters from the north end.

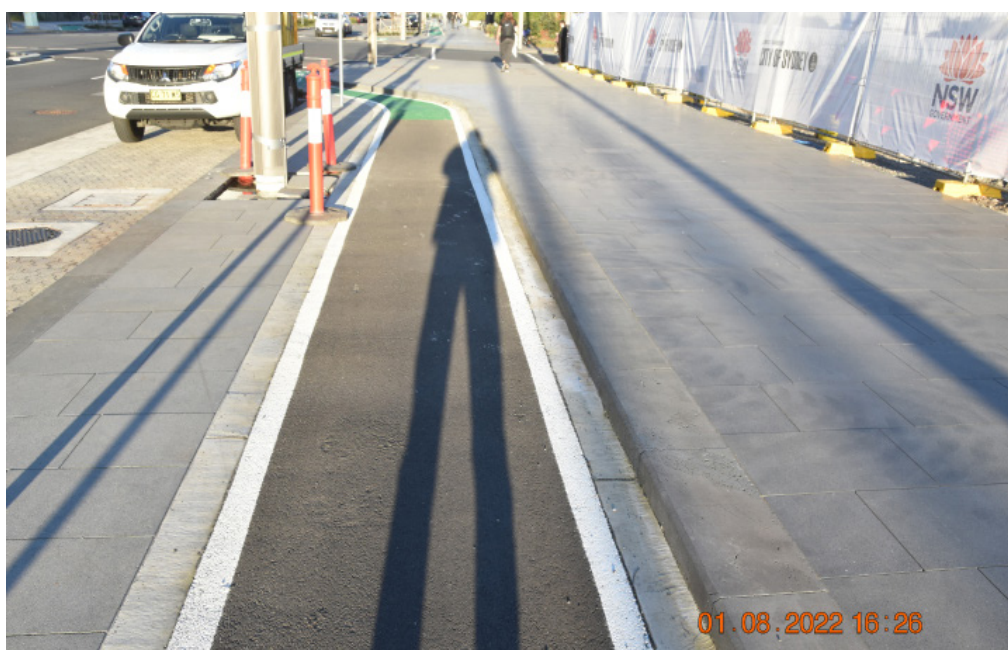
Figure: 0179

General view of the footpath on the east side of Zetland Avenue, at approximately 45meters from the north end.

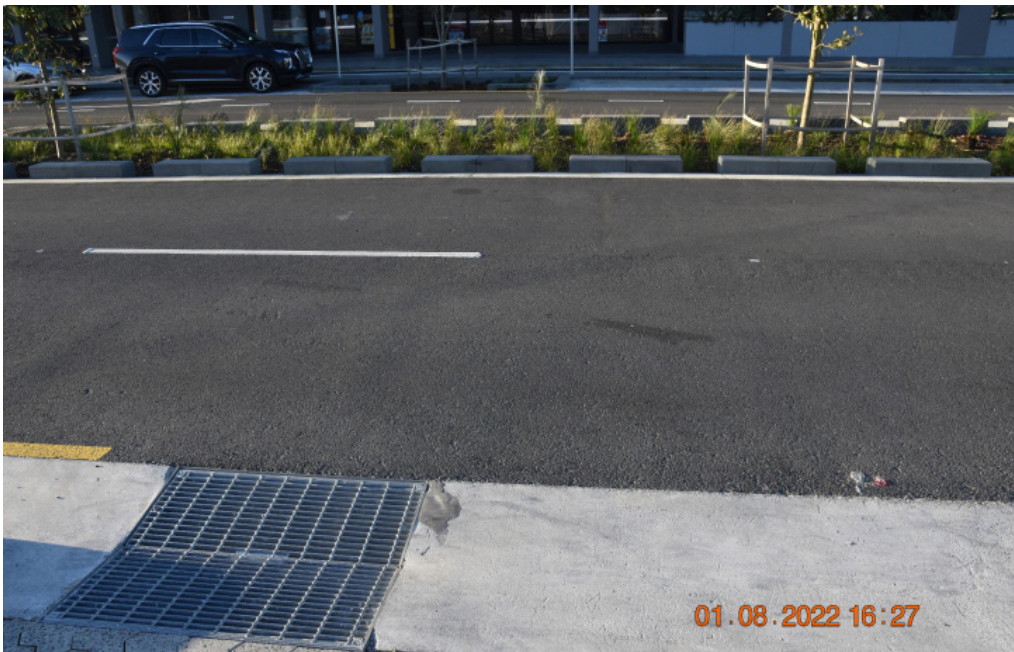
Figure: 0182

General view of the parking bay on the east side of Zetland Avenue, at approximately 45meters from the north end.

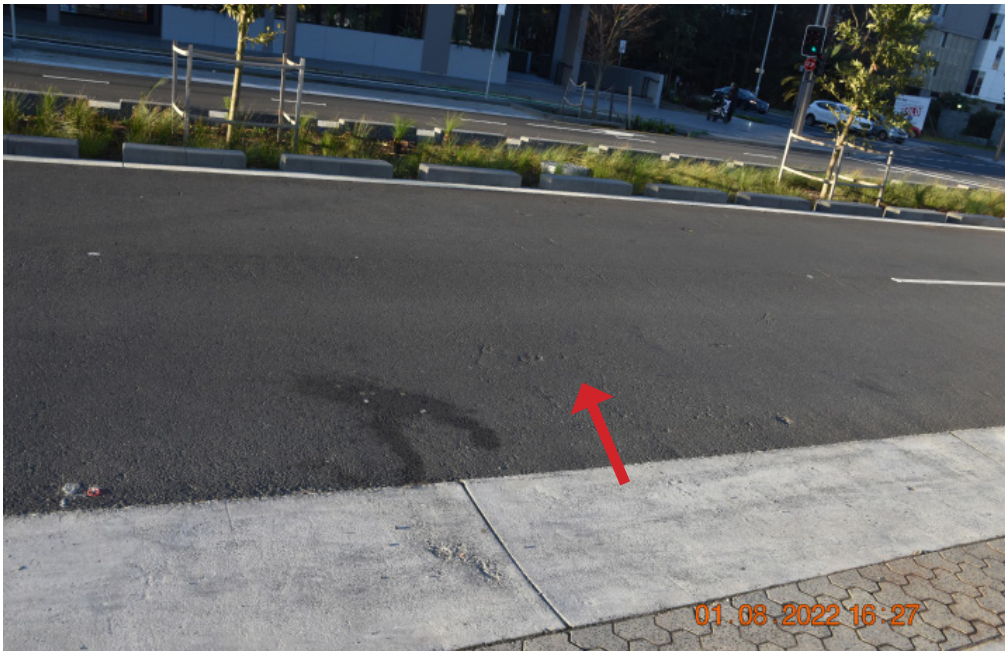
Figure: 0184

General view of the roadway on the east side of Zetland Avenue, at approximately 45 meters from the north end. Showing scoring.

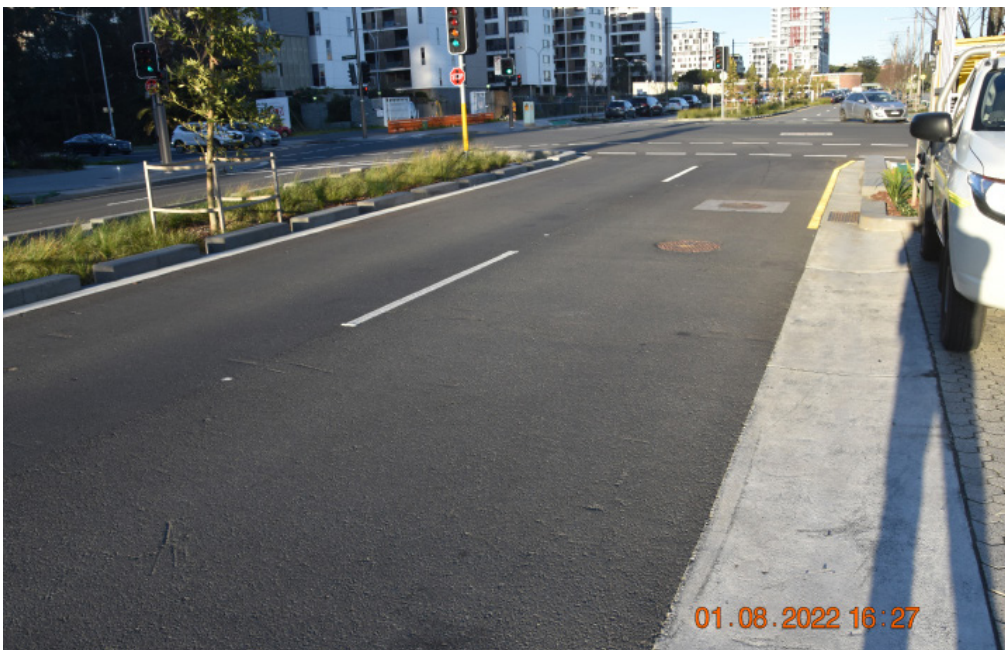
Figure: 0185

General view of the roadway on the east side of Zetland Avenue, at approximately 50 meters from the north end.

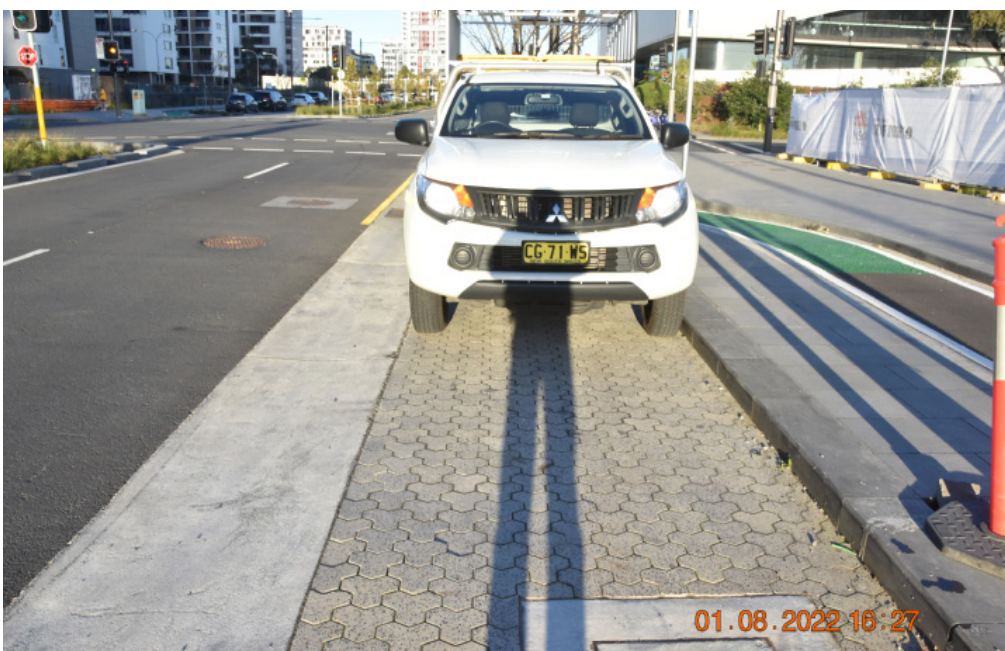
Figure: 0186

General view of the parking bay on the east side of Zetland Avenue, at approximately 50 meters from the north end.

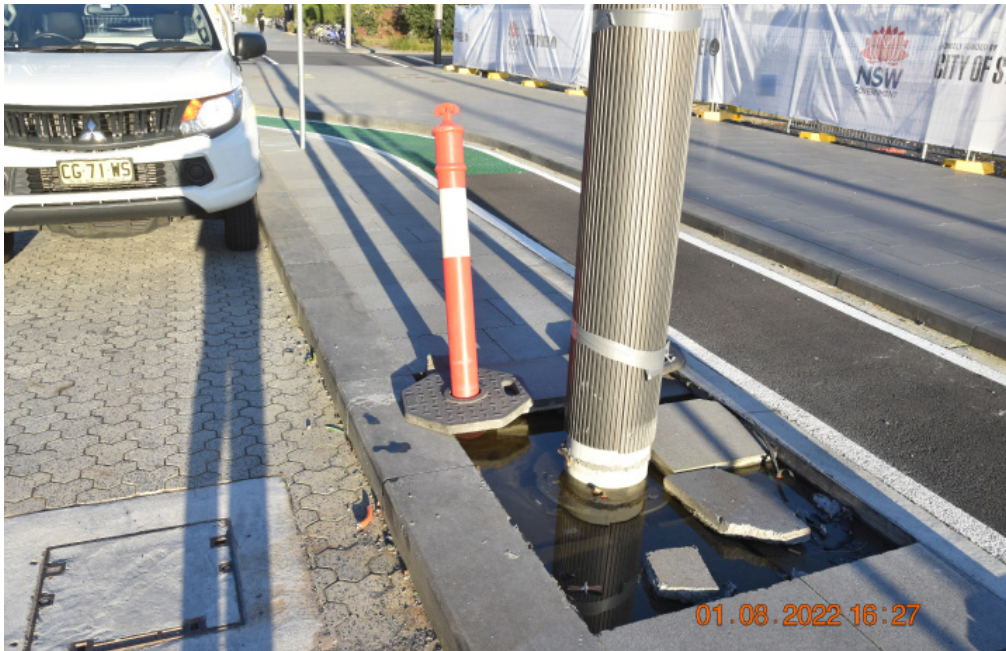
Figure: 0187

General view of the kerb and gutter on the east side of Zetland Avenue, at approximately 50 meters from the north end.

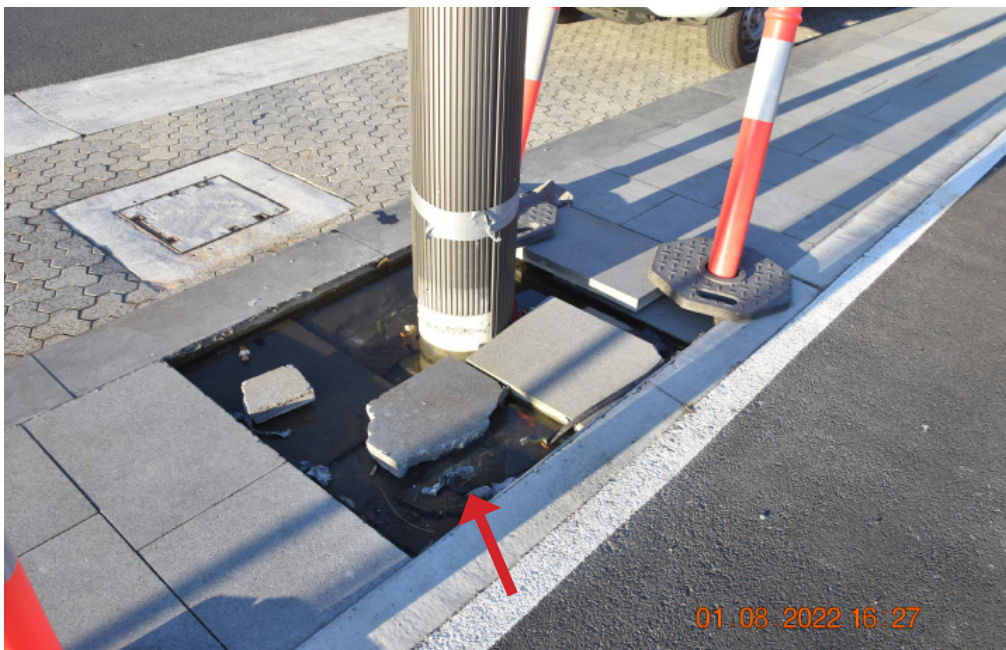
General view of the light pole on the east side of Zetland Avenue, at approximately 50 meters from the north end. Showing damage at the base.

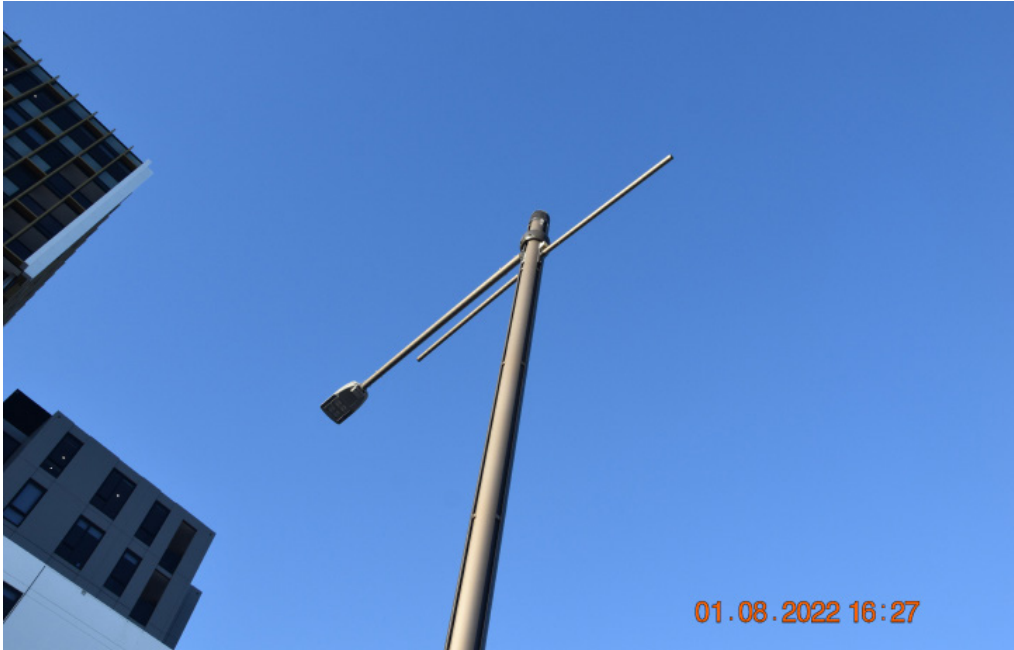
Figure: 0189

General view of the light pole on the east side of Zetland Avenue, at approximately 50 meters from the north end.

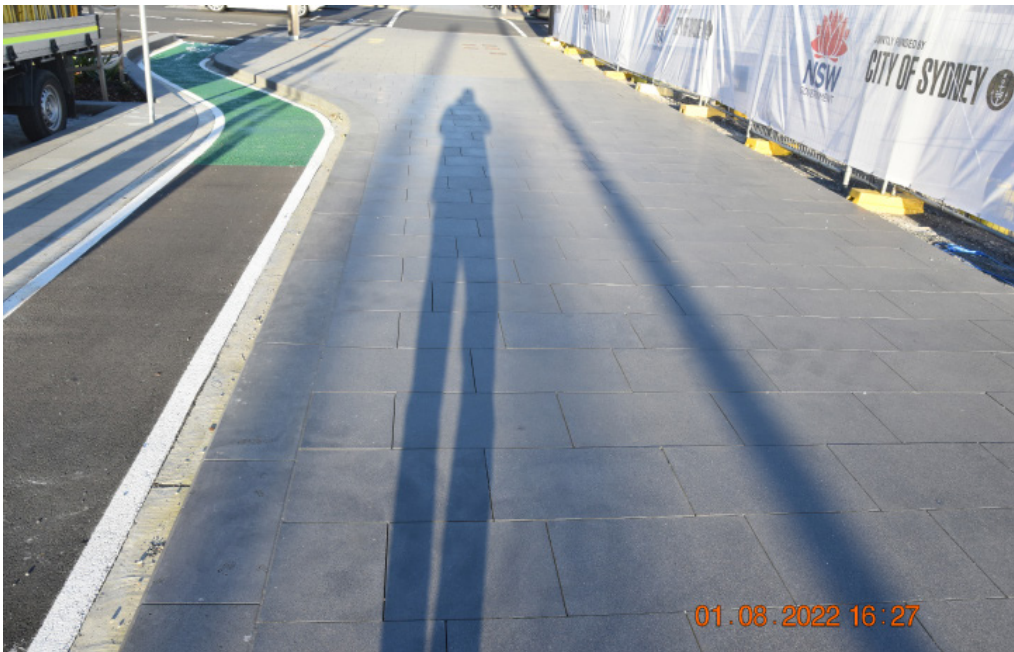
Figure: 0191

General view of the bicycle lane on the east side of Zetland Avenue, at approximately 50 meters from the north end.

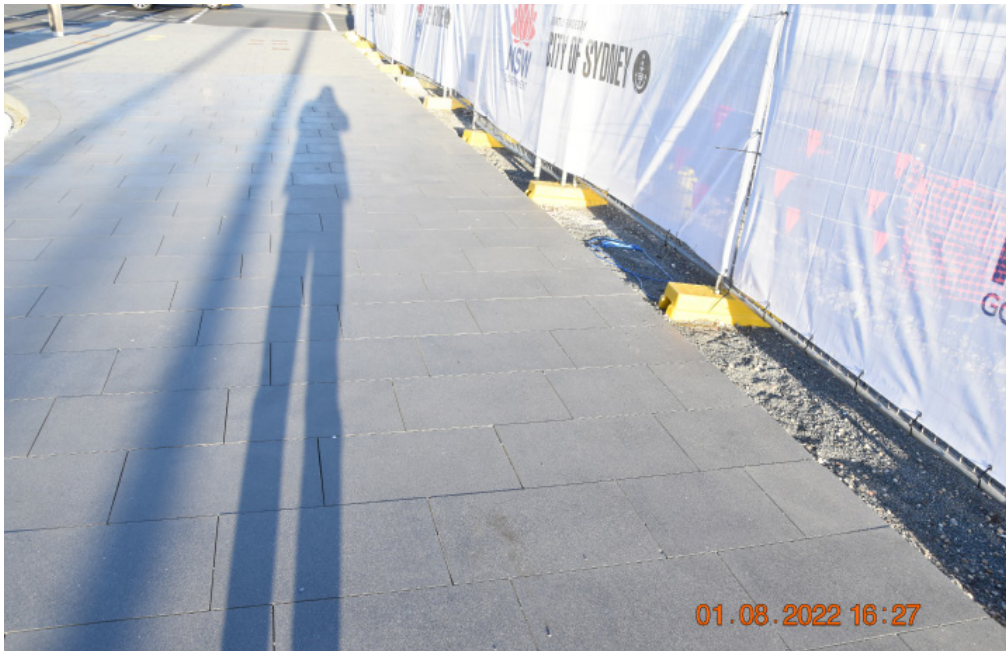
Figure: 0192

General view of the footpath on the east side of Zetland Avenue, at approximately 50 meters from the north end.

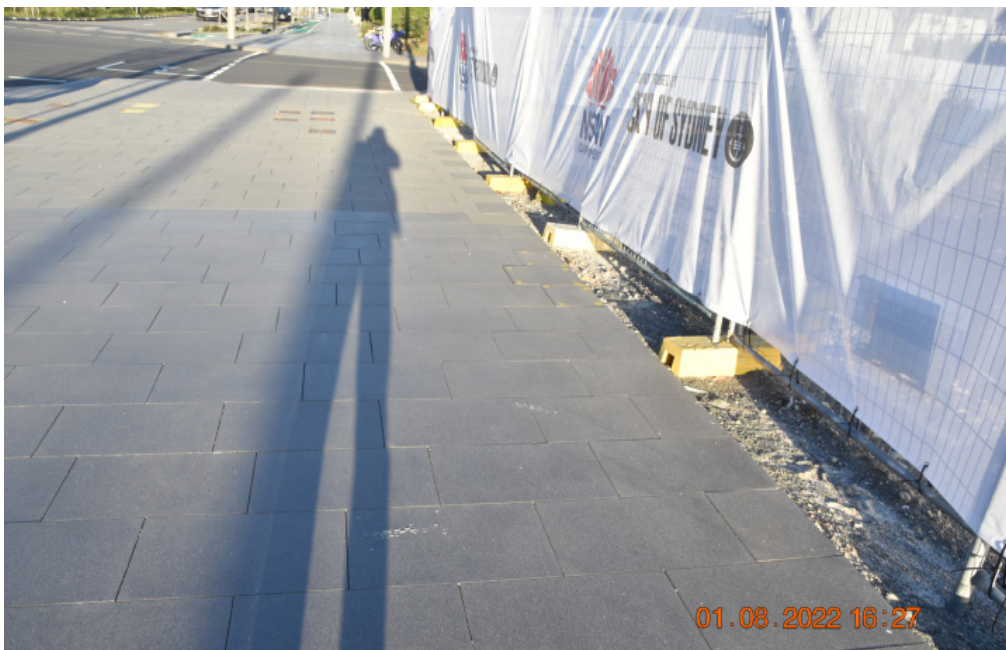
Figure: 0193

General view of the footpath on the east side of Zetland Avenue, at approximately 50 meters from the north end.

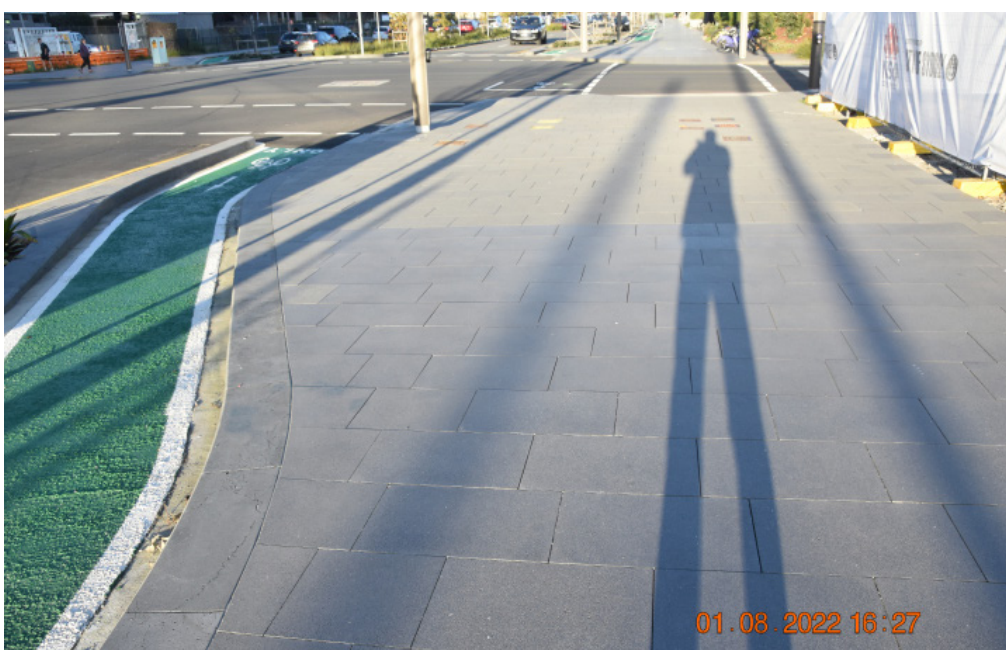
Figure: 0194

General view of the footpath on the east side of Zetland Avenue, at approximately 55 meters from the north end.

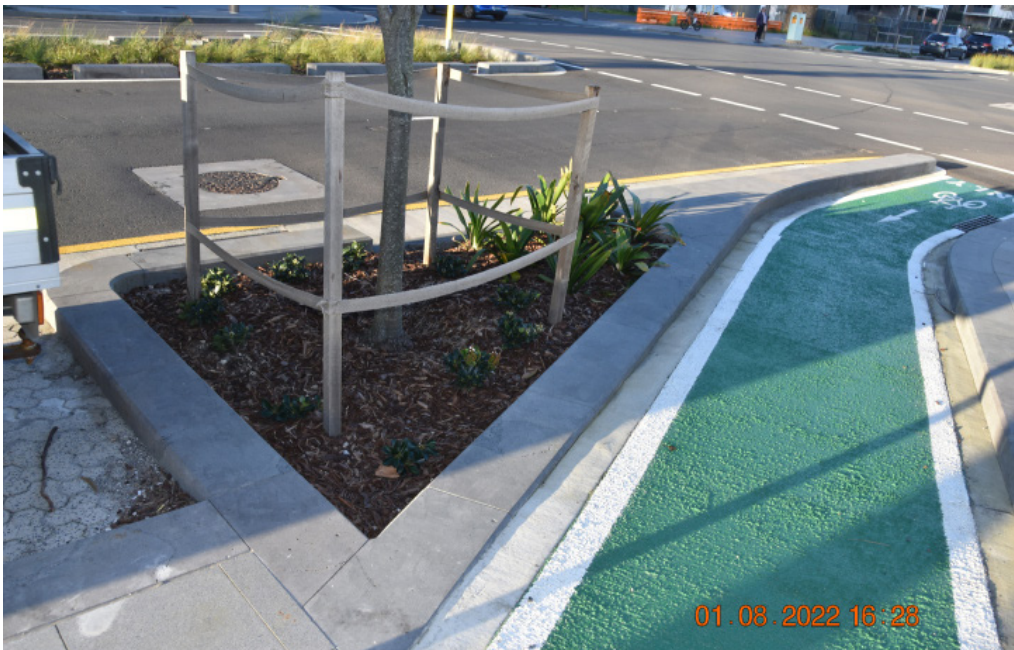
Figure: 0196

General view of the bicycle lane on the east side of Zetland Avenue, at approximately 55 meters from the north end.

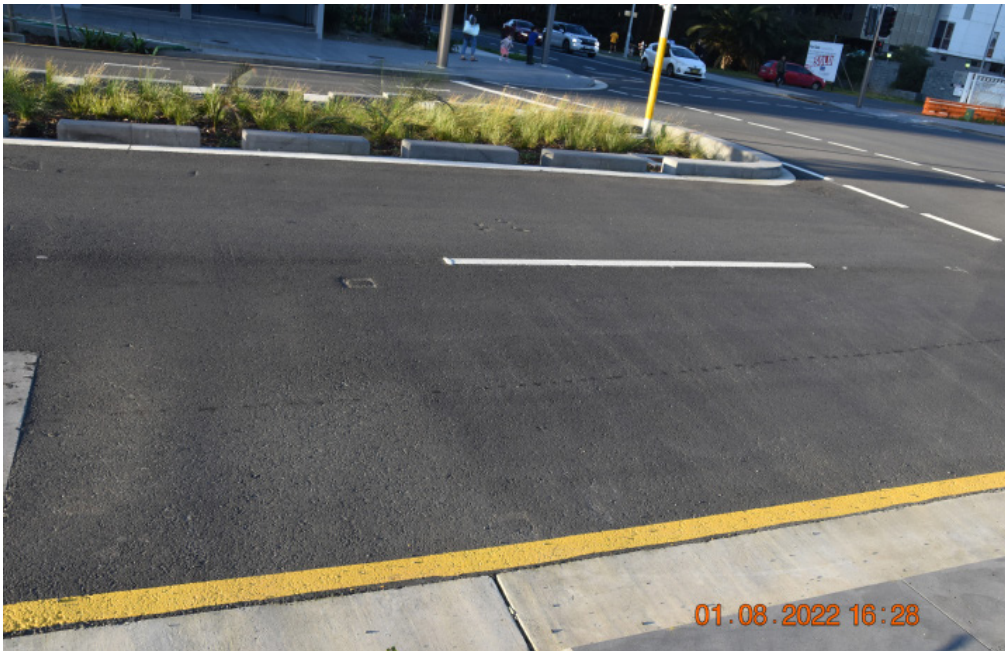
Figure: 0199

General view of the roadway on the east side of Zetland Avenue, at approximately 55 meters from the north end.

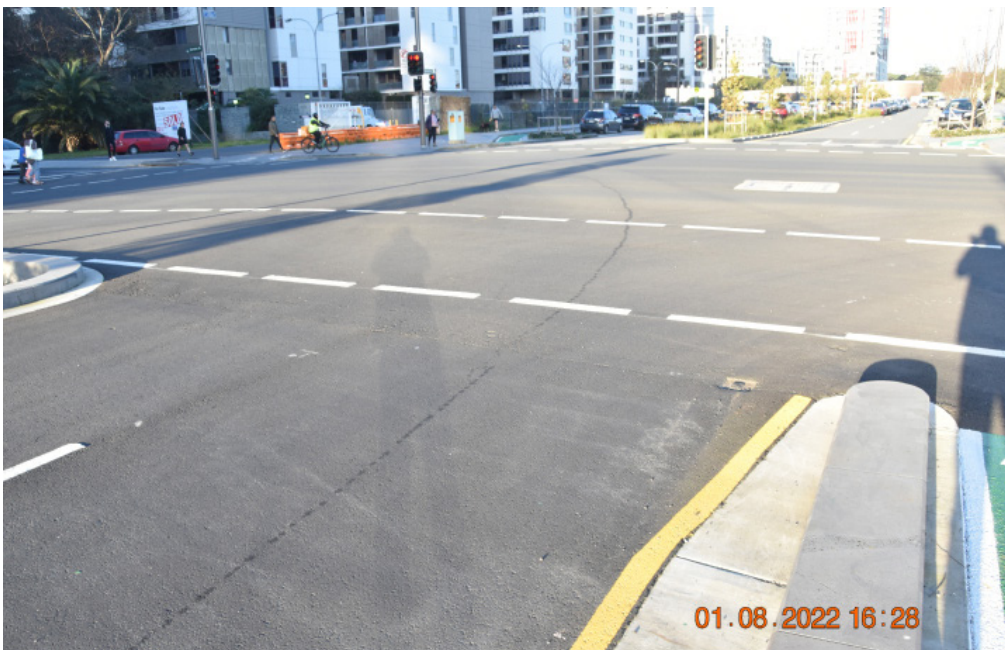
Figure: 0200

General view of the roadway on the east side of Zetland Avenue, at approximately 60 meters from the north end.

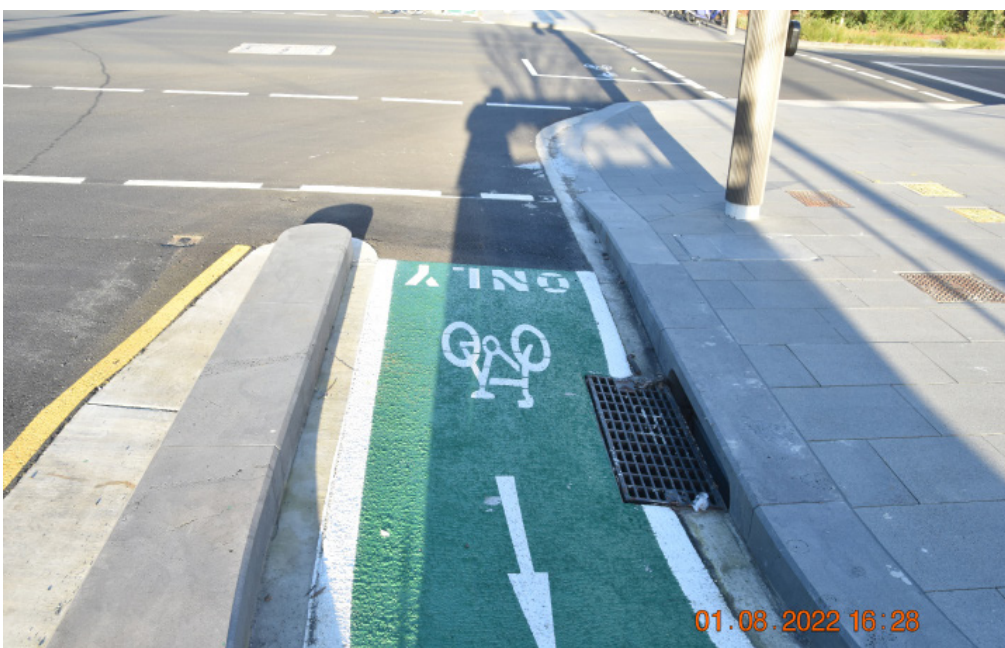
Figure: 0201

General view of the bicycle lane on the east side of Zetland Avenue, at approximately 60 meters from the north end.

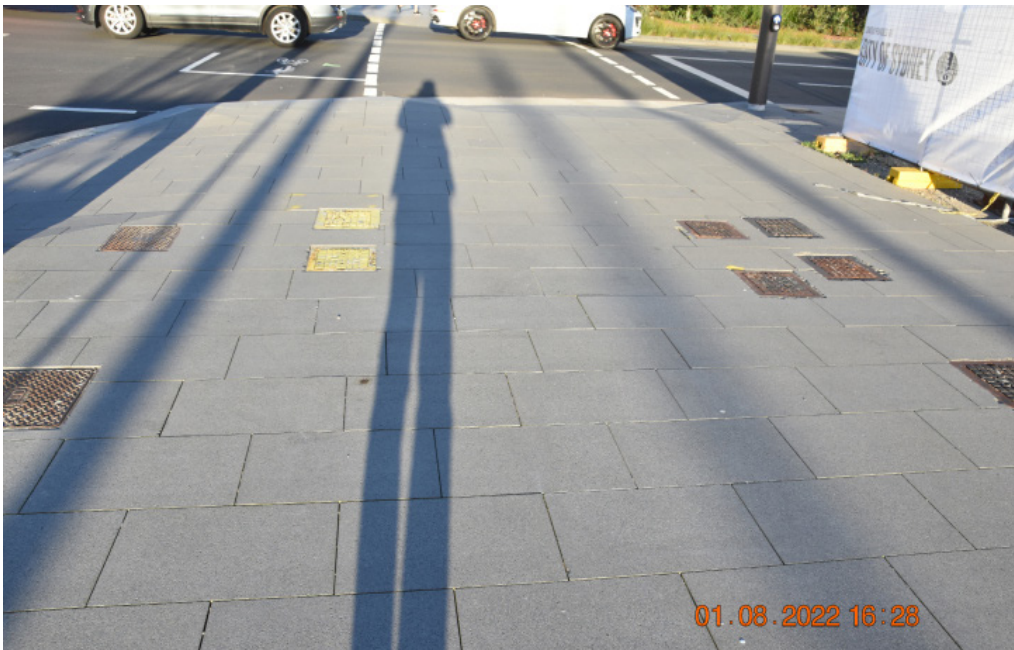
Figure: 0202

General view of the footpath on the east side of Zetland Avenue, at approximately 60 meters from the north end.

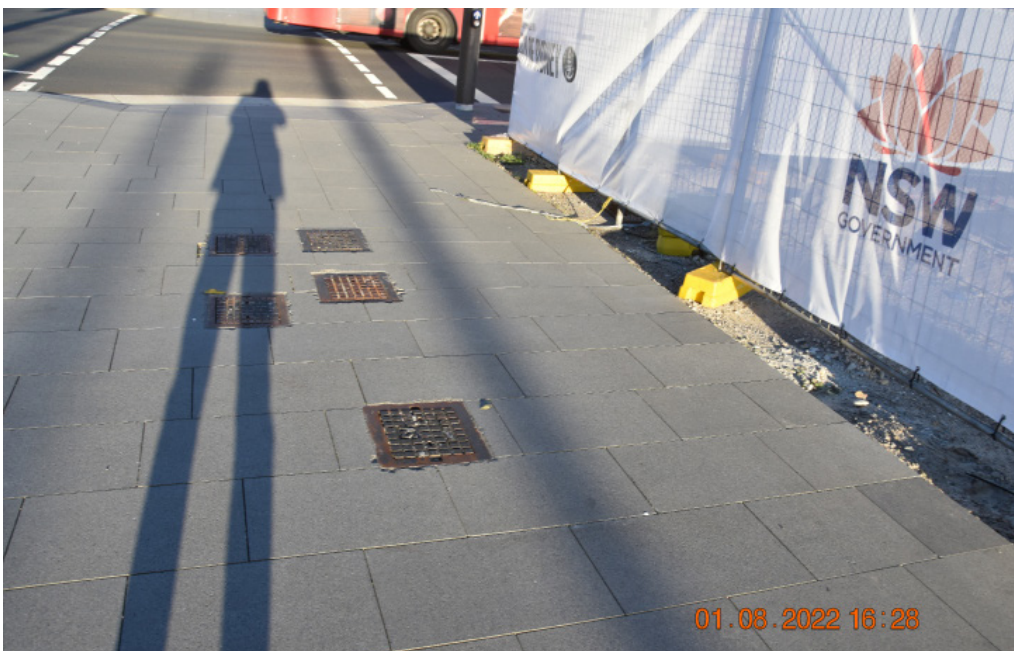
Figure: 0203

General view of the footpath on the east side of Zetland Avenue, at approximately 60 meters from the north end.

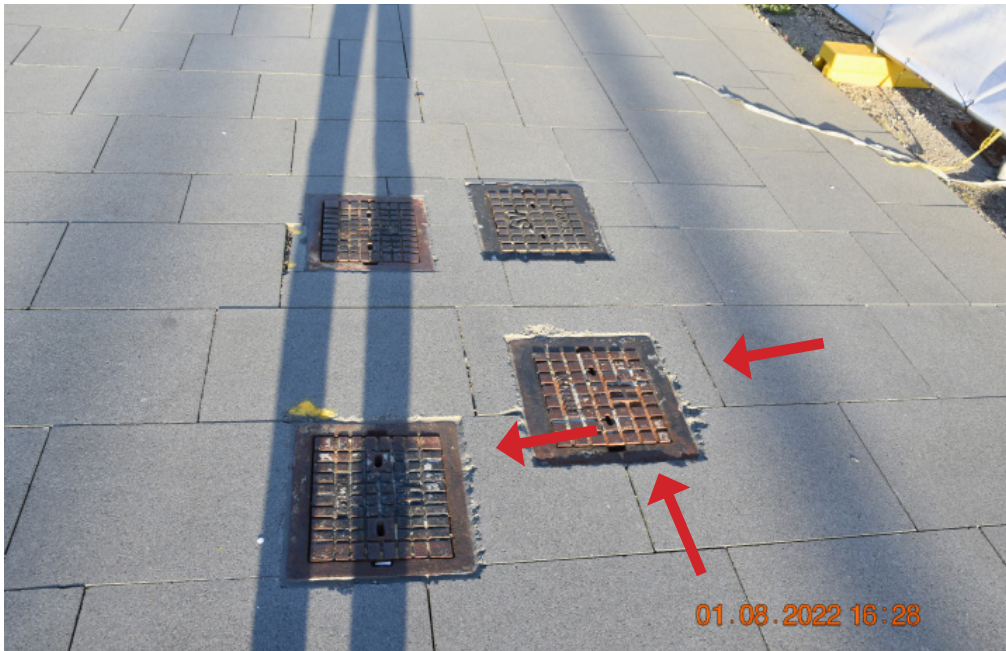
Figure: 0204

General view of the footpath on the east side of Zetland Avenue, at approximately 60 meters from the north end.
