PRE CONSTRUCTION CONDITION SURVEY

Green Square Integrated Community Facility &
School - 3 Joynton Avenue, Zetland NSW

Council Assets
3 Joynton Avenue and Portman Street
ZETLAND NSW 2017

01 August 2022

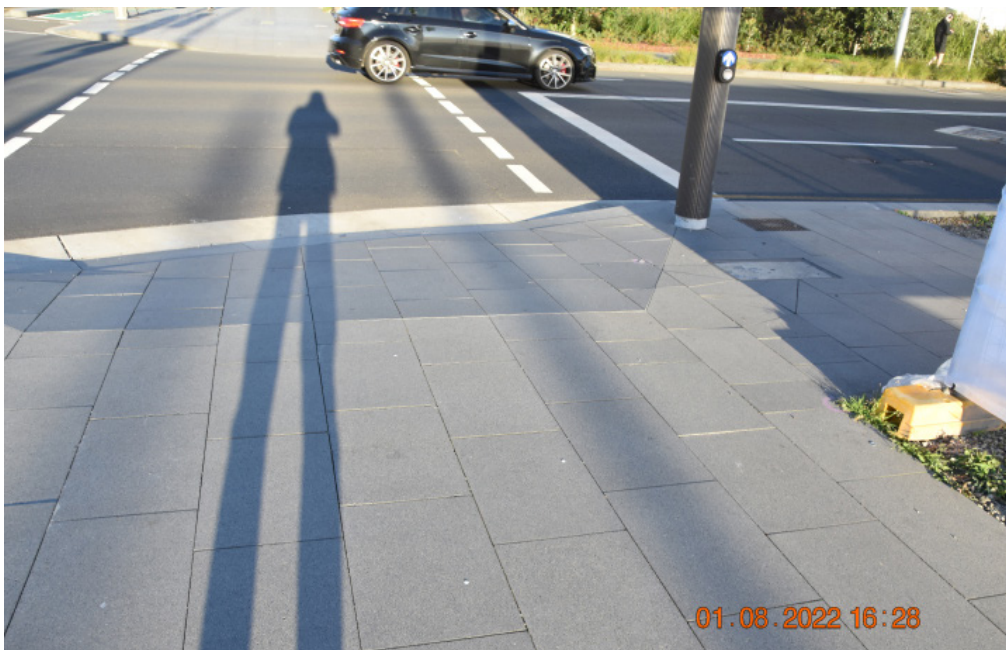
Figure: 0205

General view of the footpath on the east side of Zetland Avenue, at approximately 60 meters from the north end. Showing chipping.

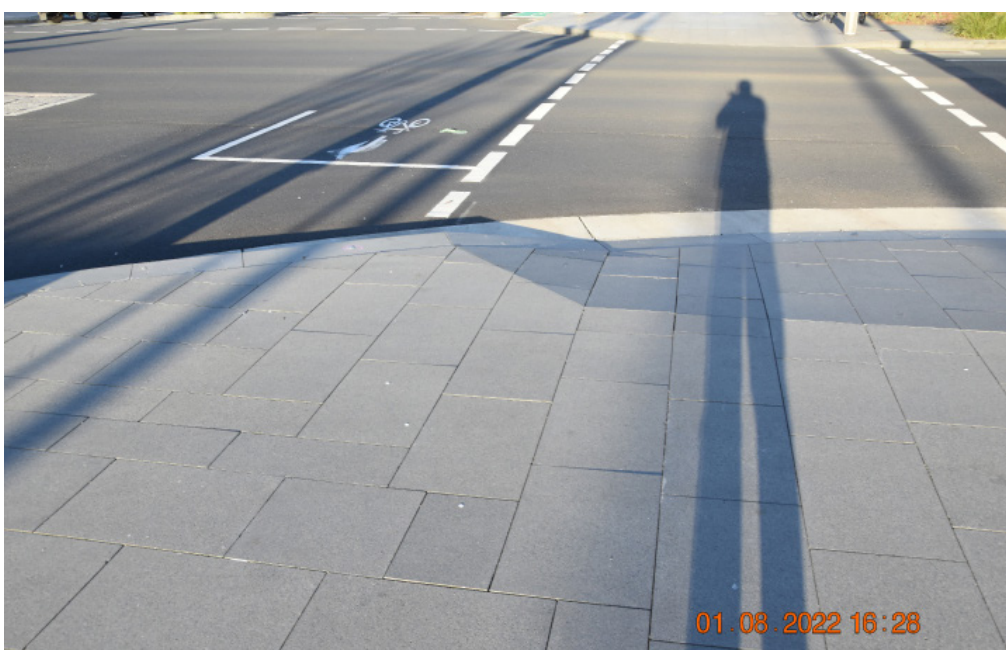
Figure: 0206

General view of the footpath on the east side of Zetland Avenue, at approximately 60 meters from the north end.

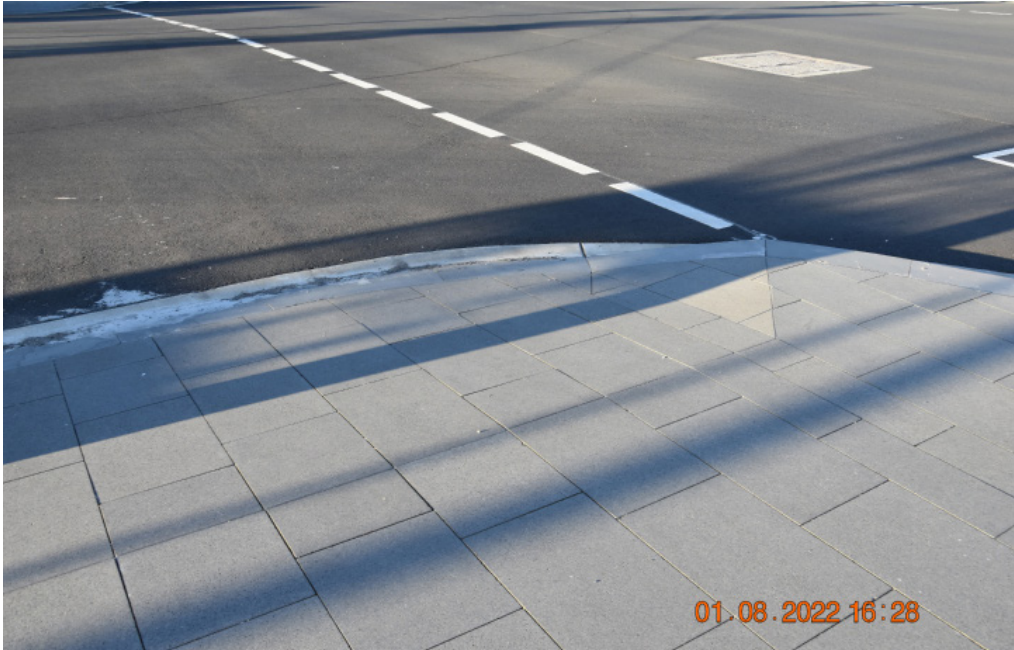
Figure: 0207

General view of the footpath on the east side of Zetland Avenue, at approximately 60 meters from the north end.

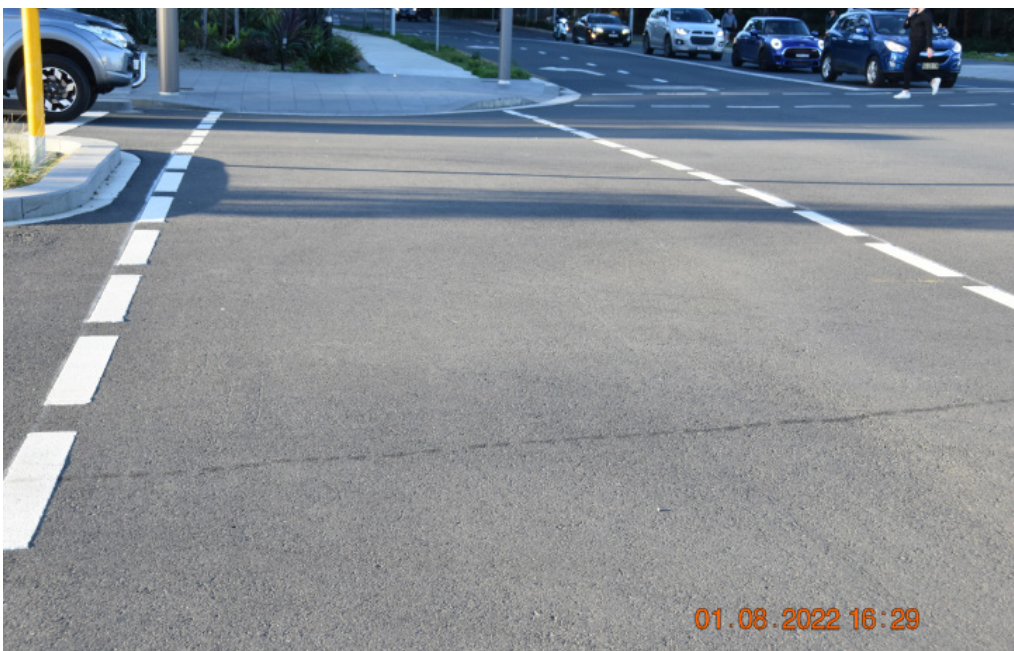
Figure: 0209

General view of the roadway on the east side of Zetland Avenue, at approximately 60 meters from the north end.

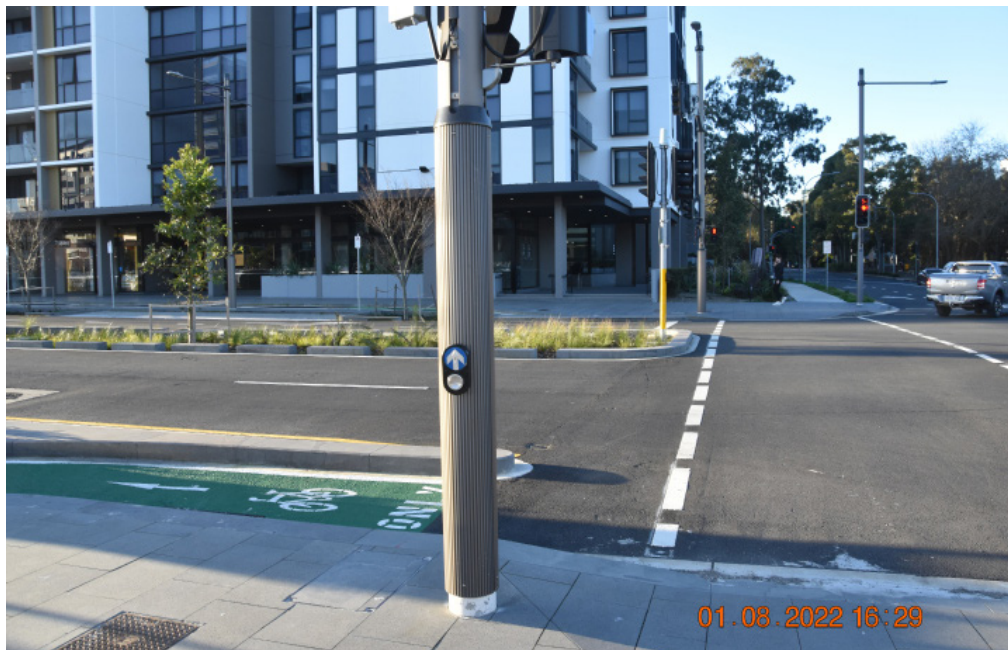
Figure: 0210

General view of the roadway on the east side of Zetland Avenue, at approximately 60 meters from the north end.

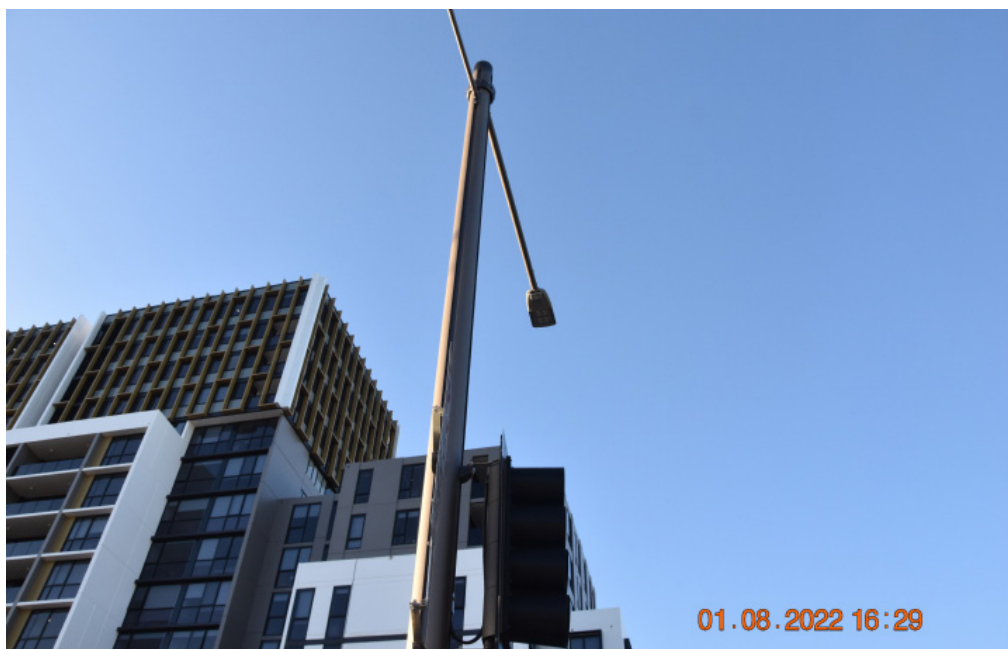
Figure: 0211

General view of the traffic light on the east side of Zetland Avenue, at approximately 60 meters from the north end.

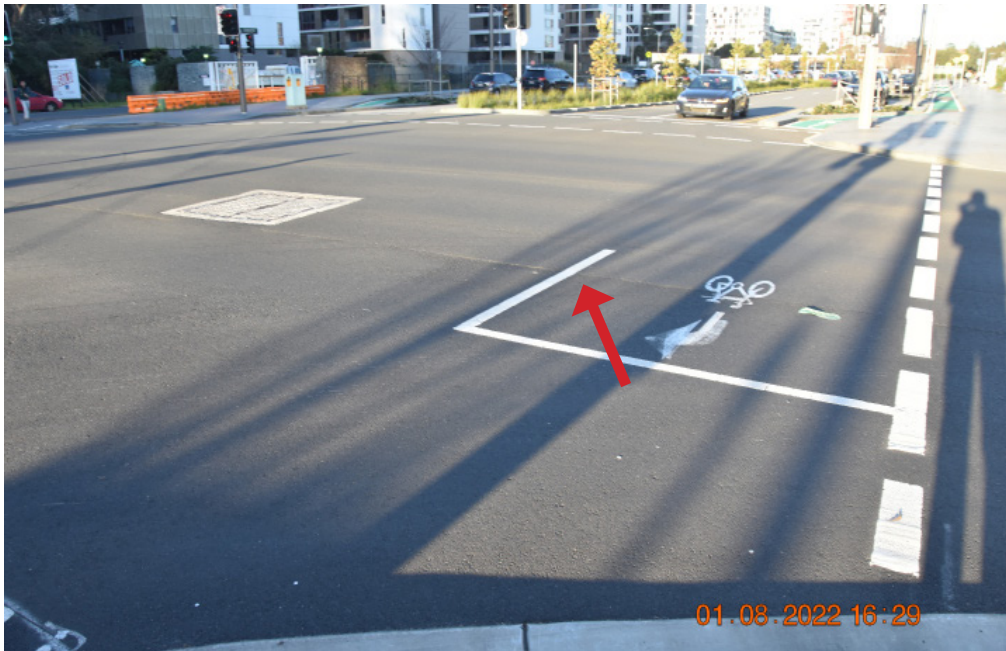
General view of the roadway on the east side of Zetland Avenue, at the intersection with Joynton Avenue. Showing fine cracking.

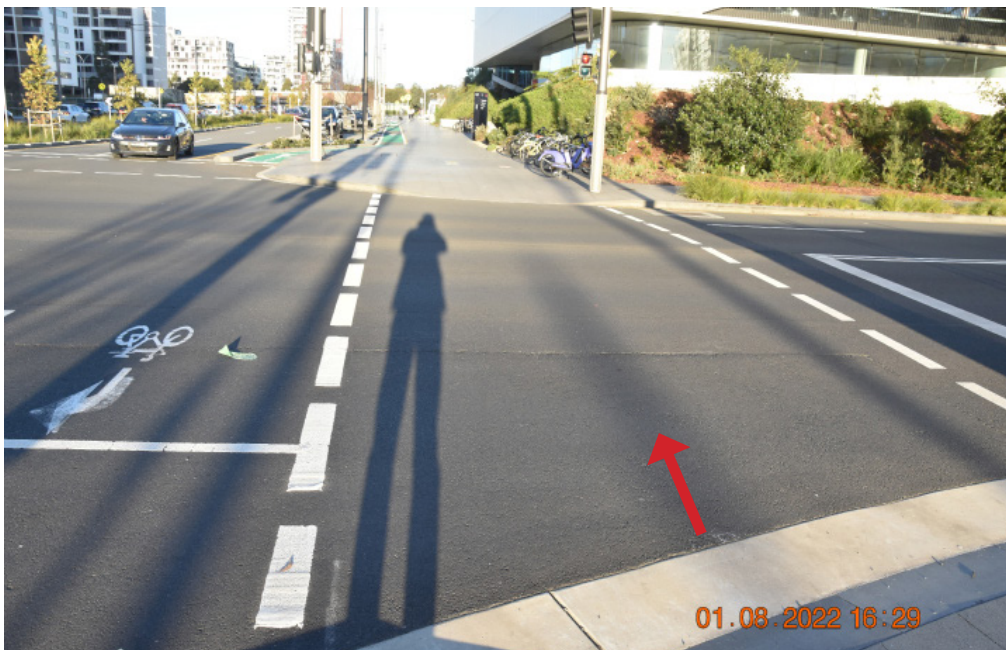
General view of the roadway on the east side of Zetland Avenue, at the intersection with Joynton Avenue. Showing fine cracking.

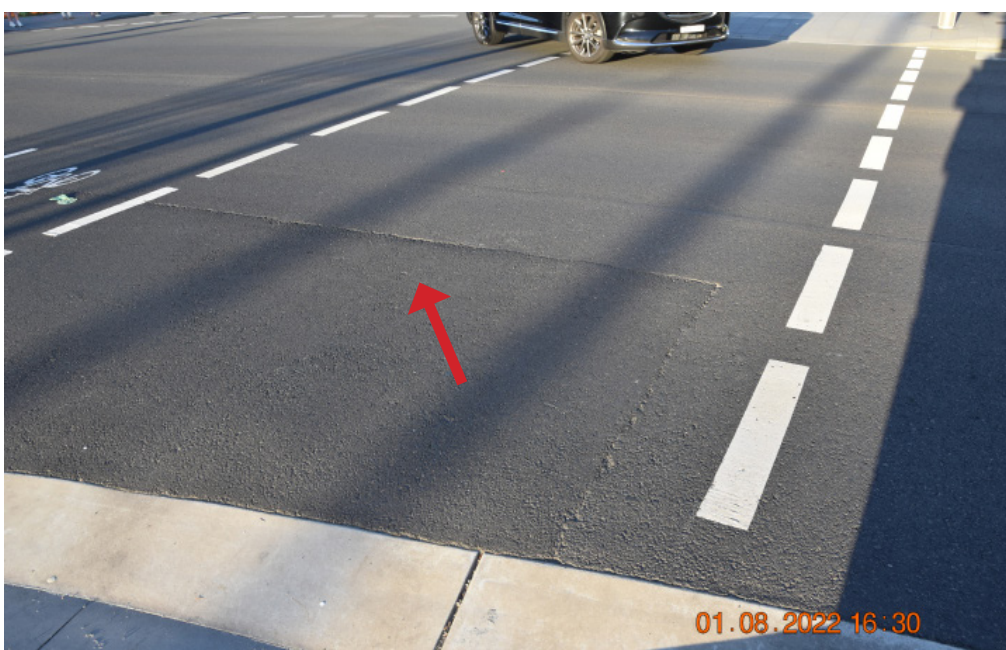
General view of the roadway on the east side of Zetland Avenue, at the intersection with Joynton Avenue. Showing fine cracking.

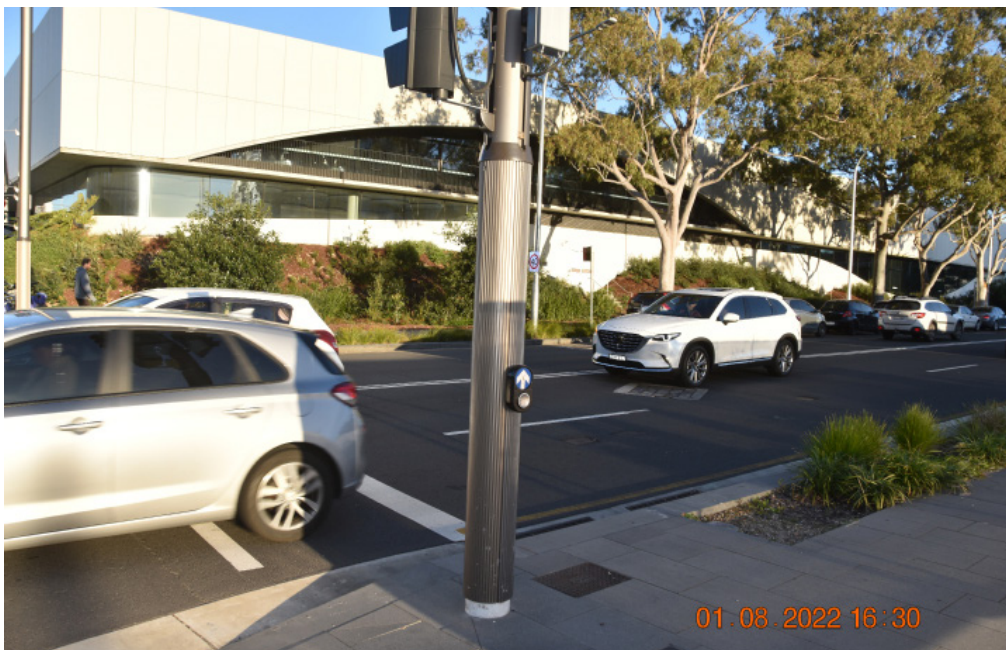
Figure: 0217

General view of the traffic light on the west side of Zetland Avenue, at the intersection with Joynton Avenue.

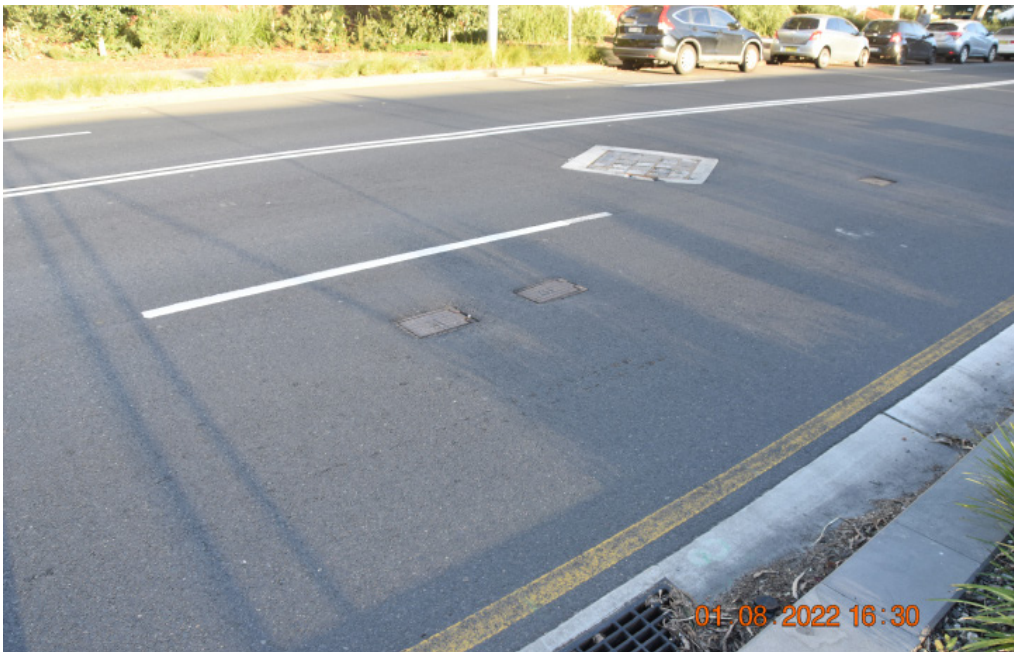
Figure: 0220

General view of the roadway outside 3 Joynton Avenue, east end.

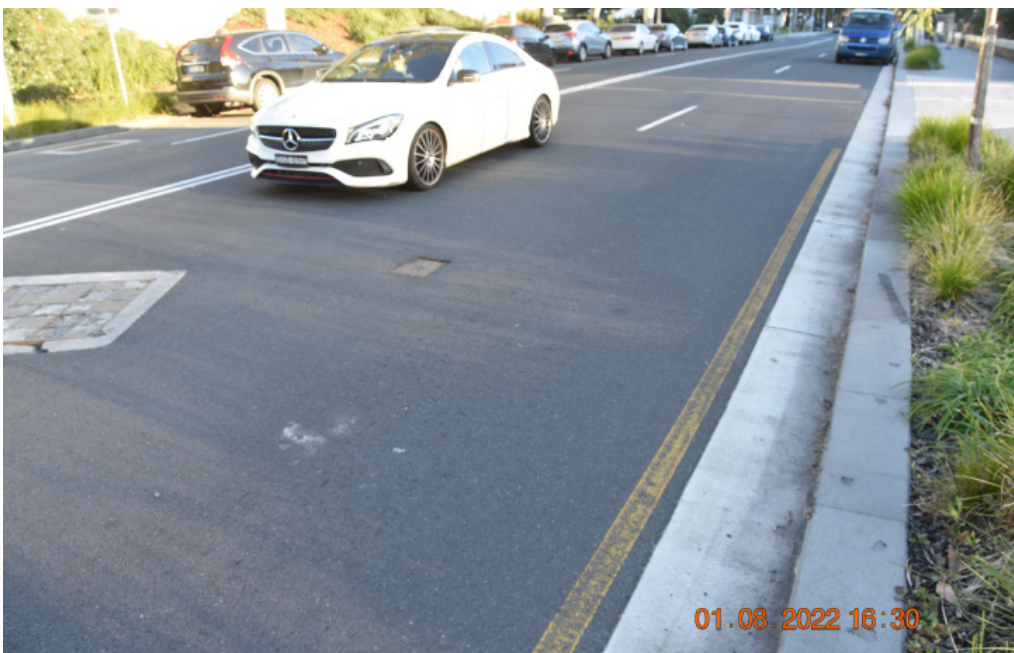
Figure: 0221

General view of the roadway outside 3 Joynton Avenue, at approximately 5 meters from the east end.

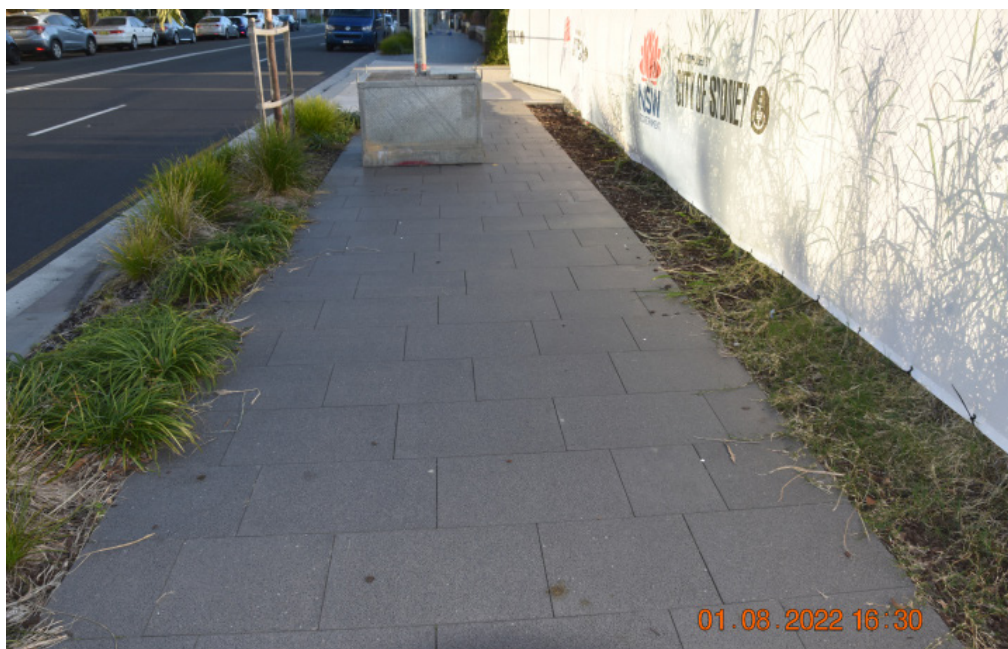
Figure: 0223

General view of the footpath outside 3 Joynton Avenue, at approximately 5 meters from the east end.

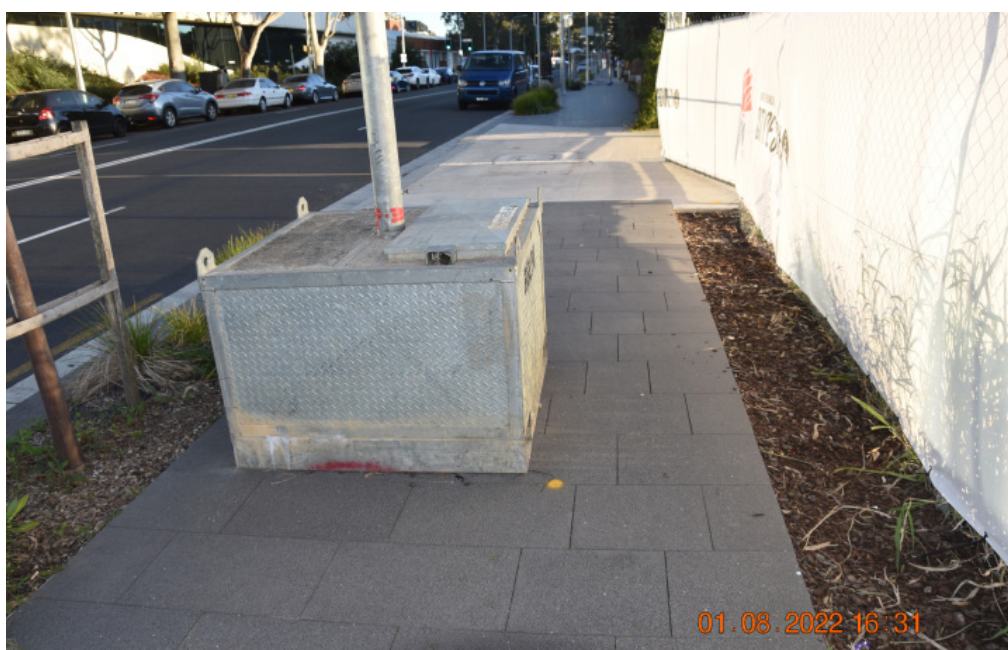
Figure: 0224

General view of the footpath outside 3 Joynton Avenue, at approximately 10 meters from the east end.

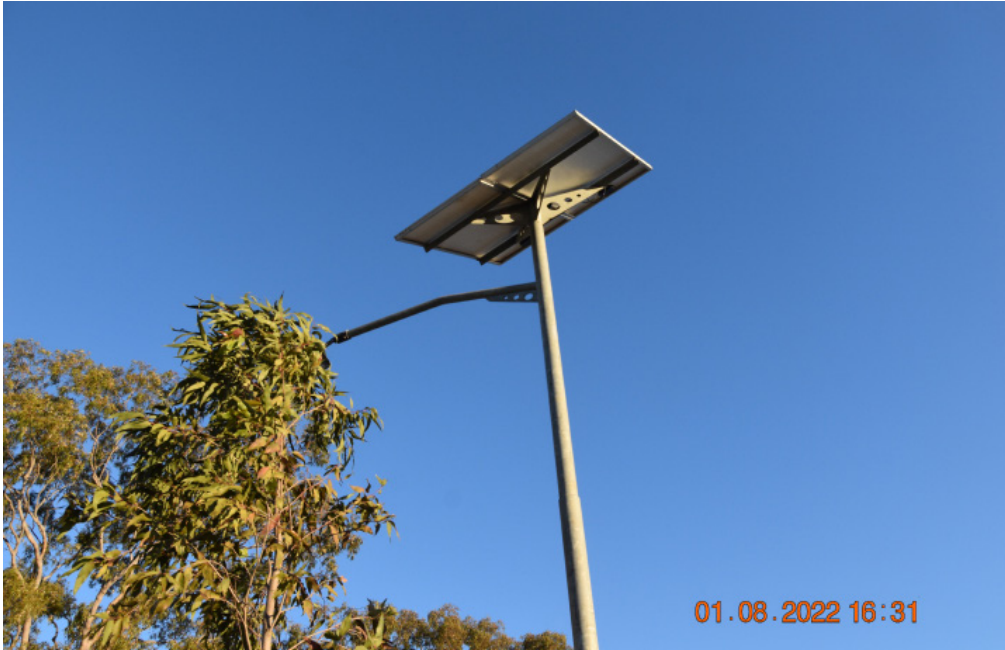
Figure: 0226

General view of the light pole outside 3 Joynton Avenue, at approximately 10 meters from the east end.

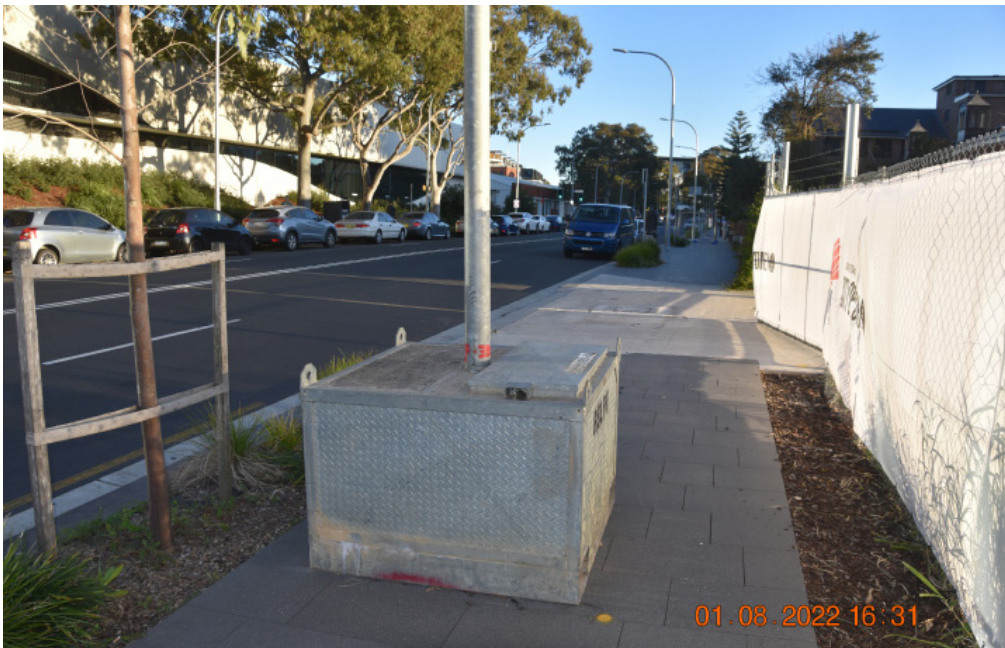
Figure: 0227

General view of the light pole outside 3 Joynton Avenue, at approximately 10 meters from the east end.

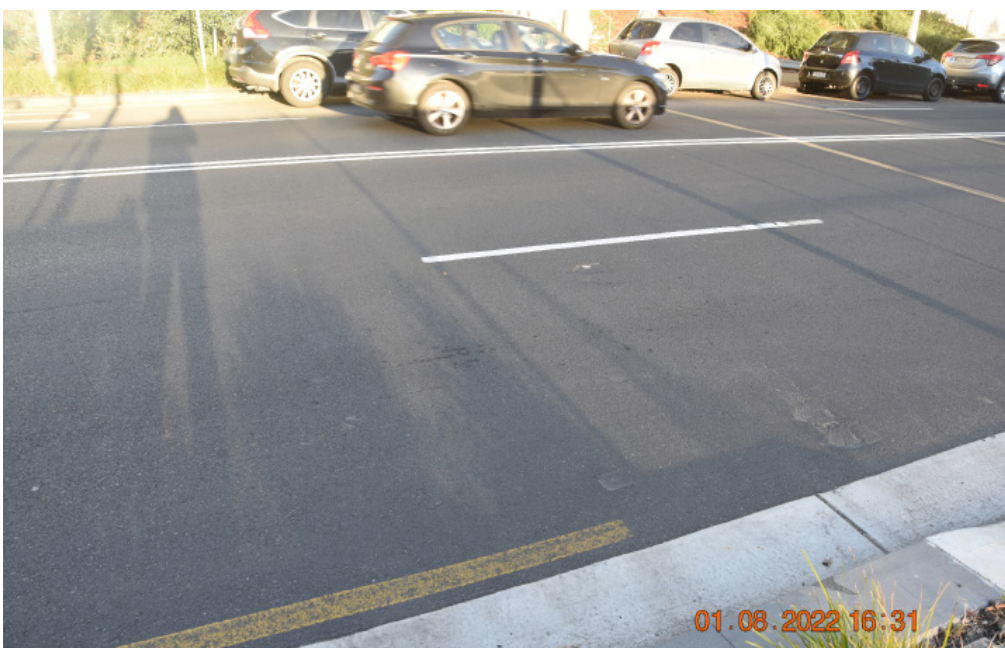
Figure: 0228

General view of the roadway outside 3 Joynton Avenue, at approximately 10 meters from the east end.

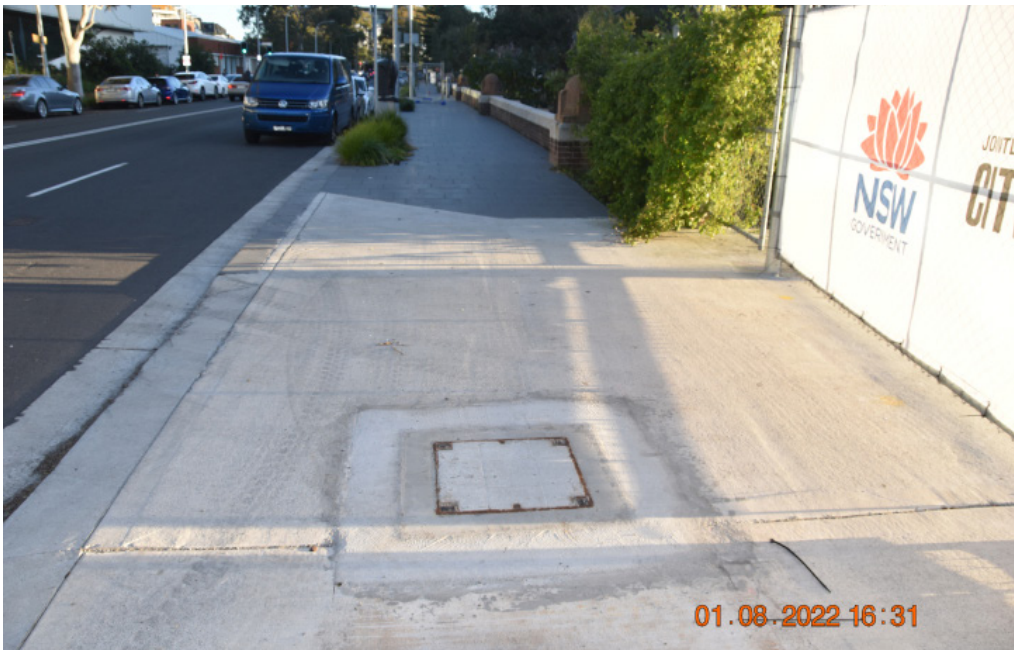
Figure: 0229

General view of the footpath outside 3 Joynton Avenue, at approximately 15 meters from the east end.

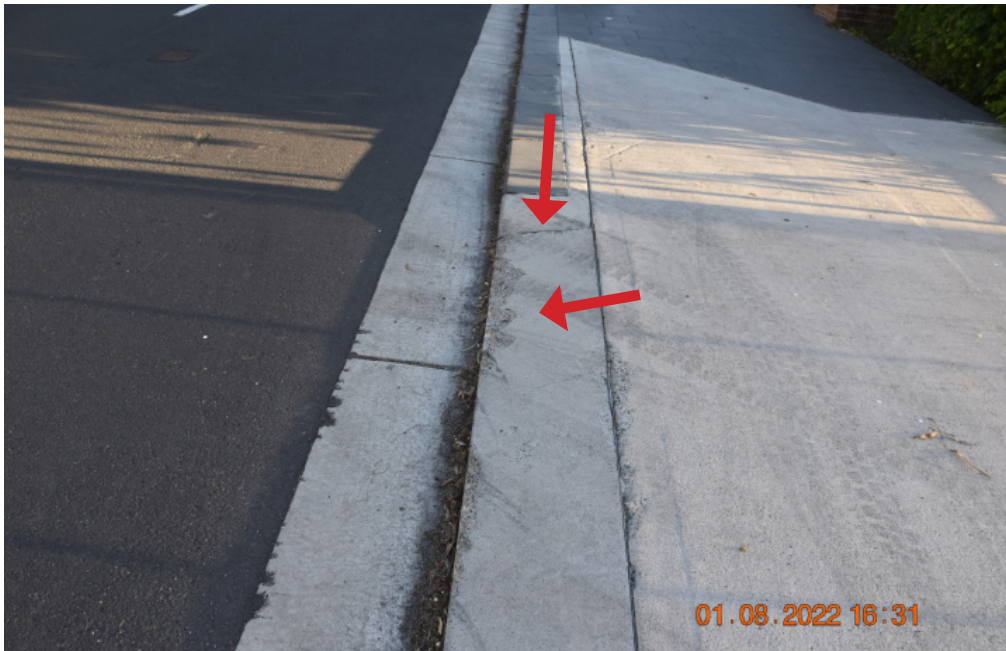
General view of the driveway outside 3 Joynton Avenue, at approximately 15 meters from the east end. Showing chipping and fine cracking.

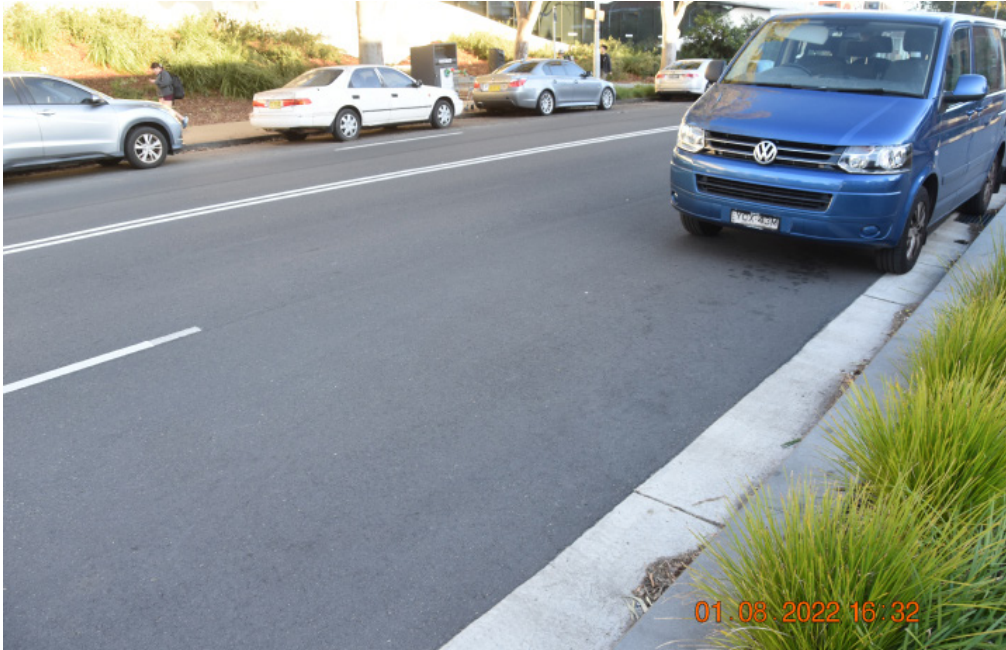
Figure: 0234

General view of the roadway outside 3 Joynton Avenue, at approximately 20 meters from the east end.

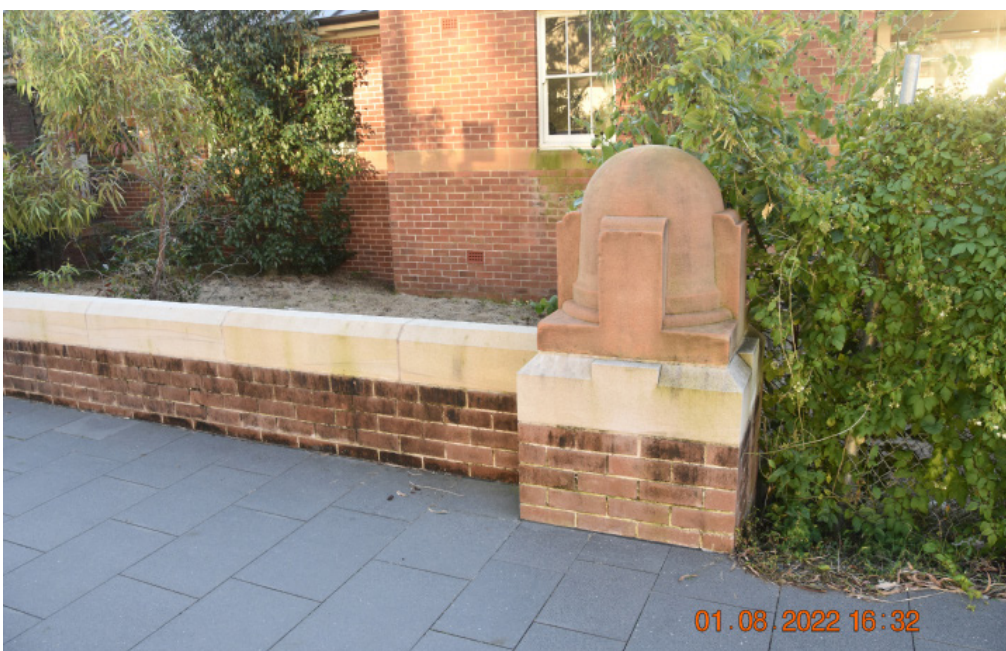
Figure: 0236

General view of the footpath outside 3 Joynton Avenue, at approximately 20 meters from the east end.

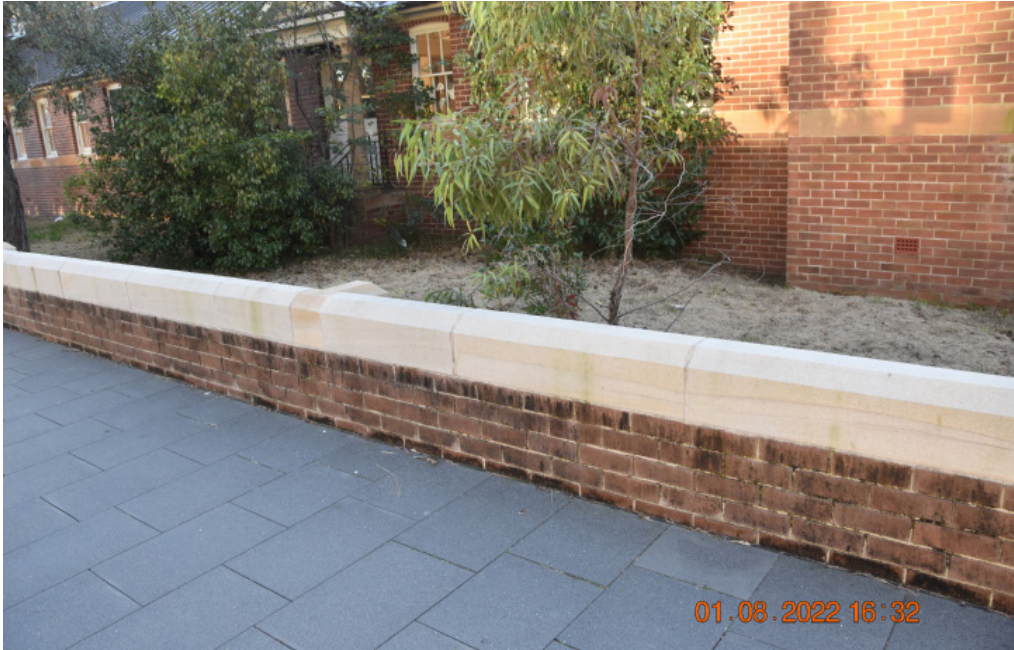
Figure: 0237

General view of the south fence outside 3 Joynton Avenue, at approximately 20 meters from the east end.

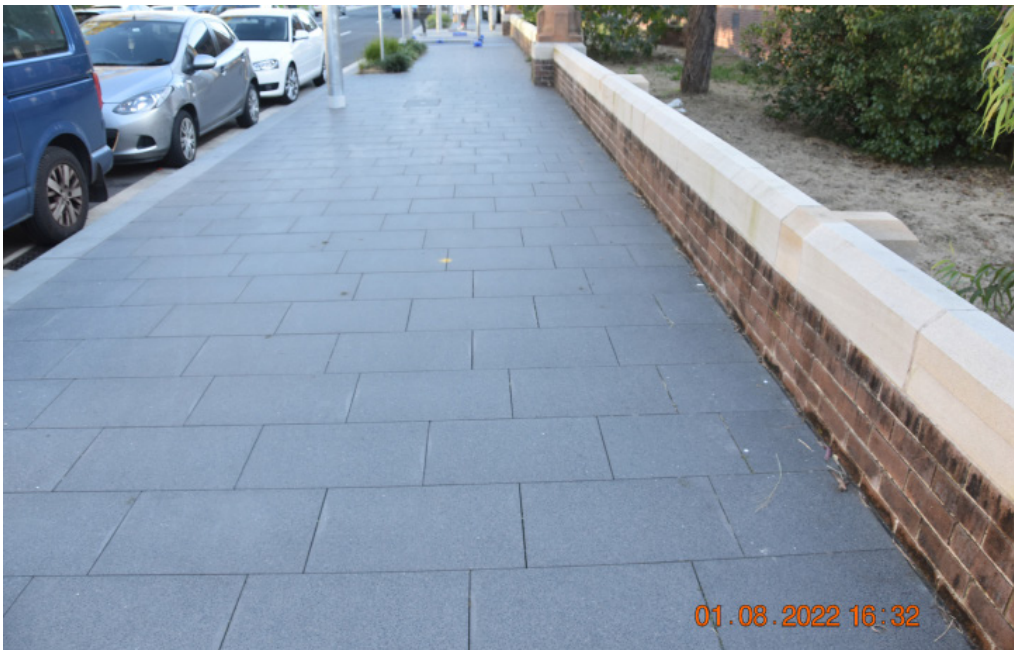
Figure: 0238

General view of the south fence outside 3 Joynton Avenue, at approximately 20 meters from the east end.

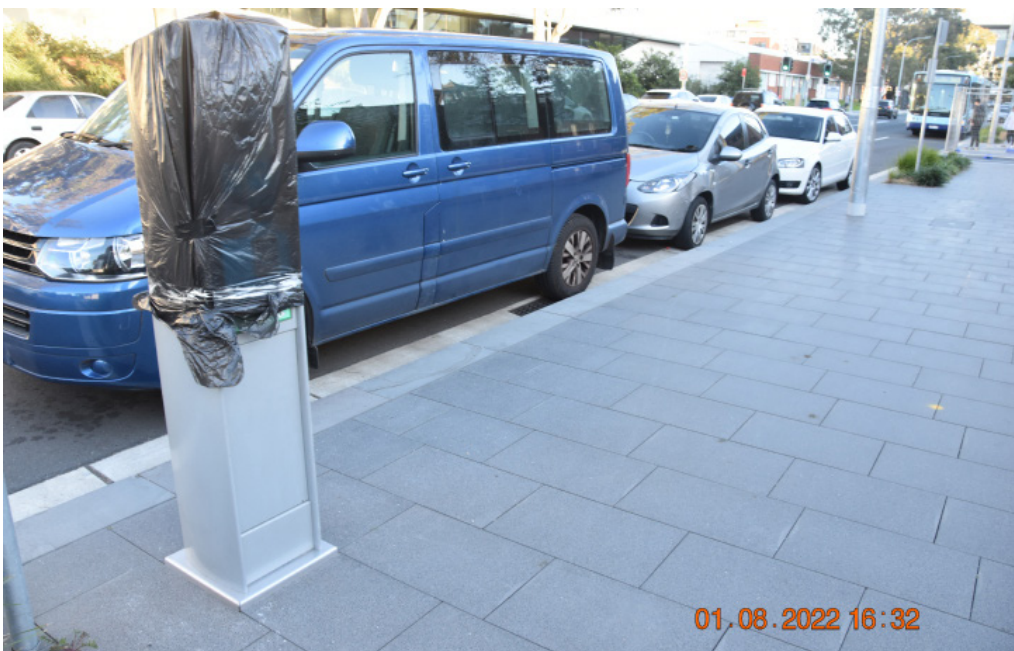
Figure: 0239

General view of the footpath outside 3 Joynton Avenue, at approximately 25 meters from the east end.

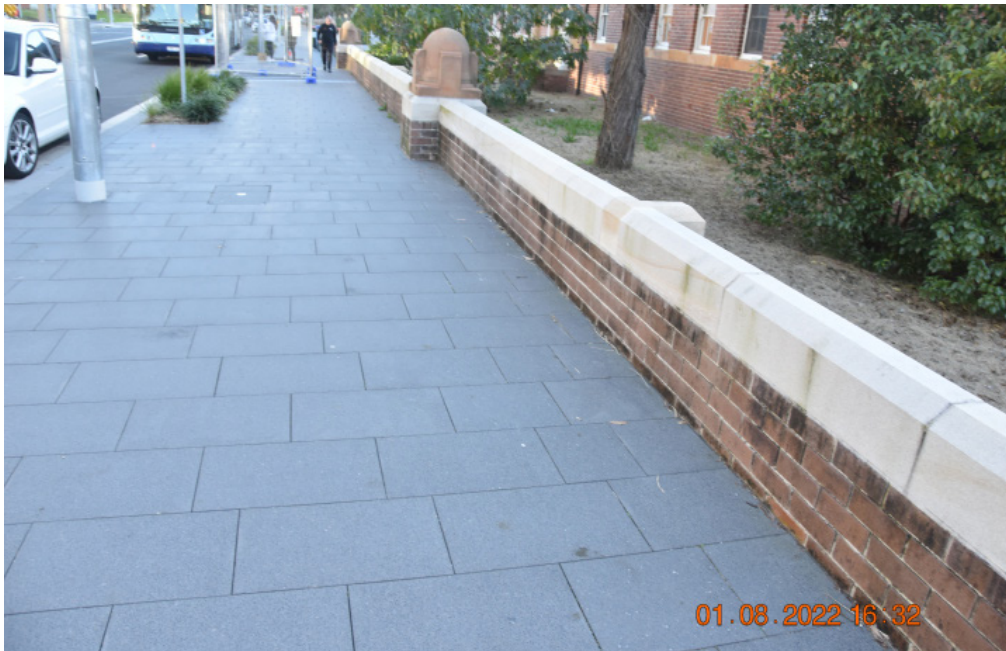
Figure: 0240

General view of the footpath outside 3 Joynton Avenue, at approximately 25 meters from the east end.

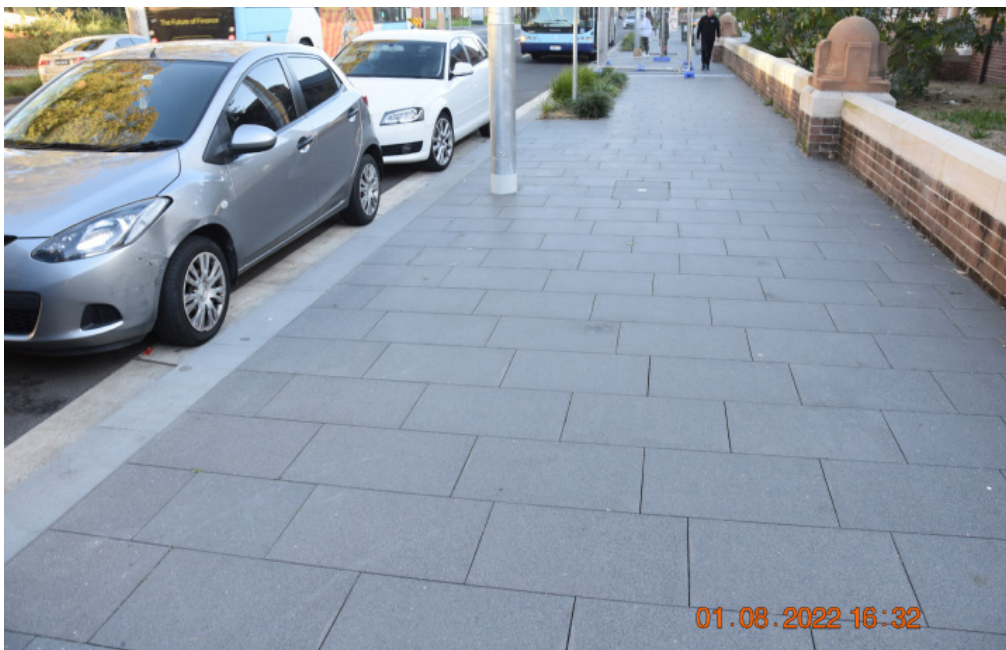
Figure: 0241

General view of the footpath outside 3 Joynton Avenue, at approximately 25 meters from the east end.

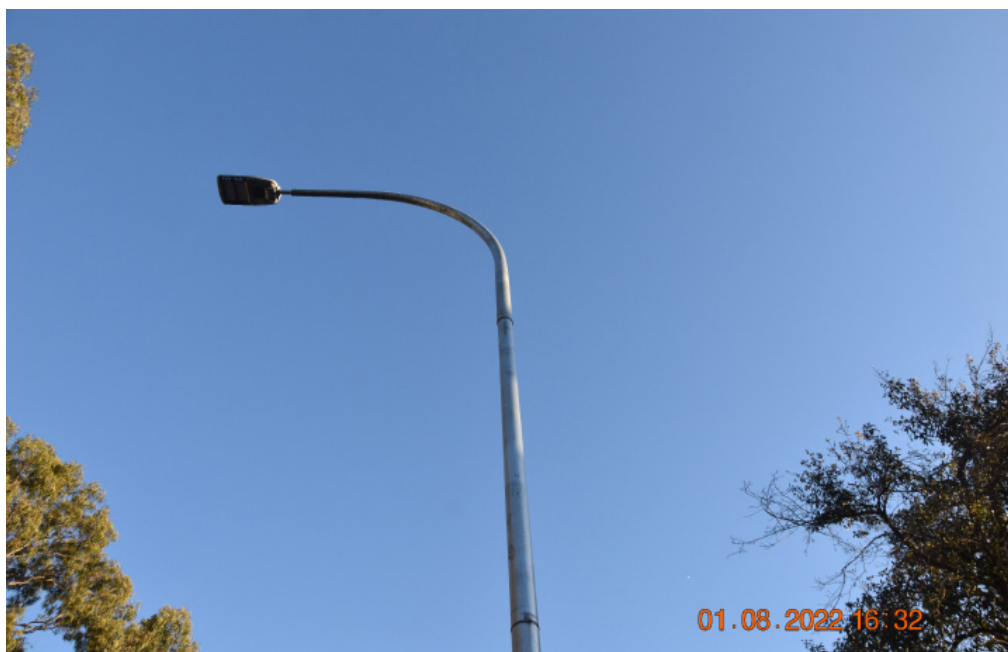
Figure: 0244

General view of the light pole outside 3 Joynton Avenue, at approximately 25 meters from the east end.

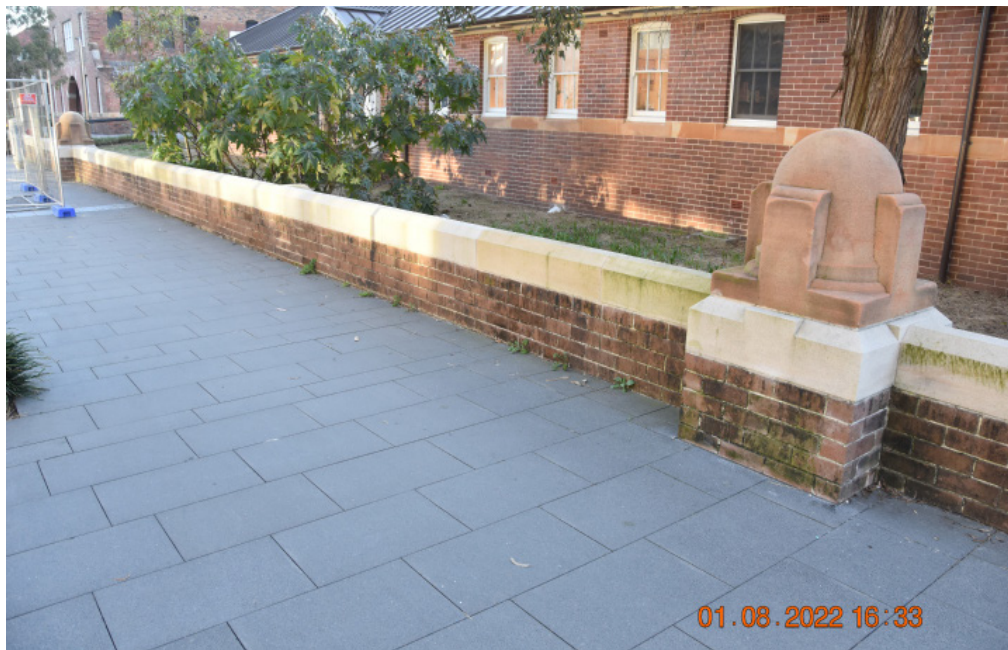
Figure: 0246

General view of the footpath outside 3 Joynton Avenue, at approximately 30 meters from the east end.

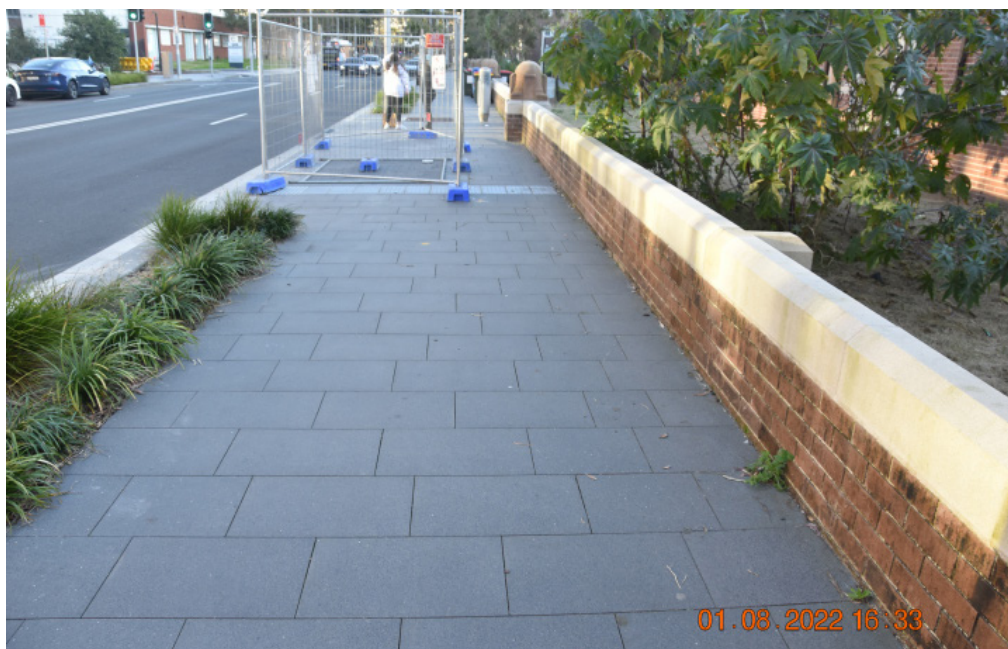
Figure: 0247

General view of the footpath outside 3 Joynton Avenue, at approximately 30 meters from the east end.

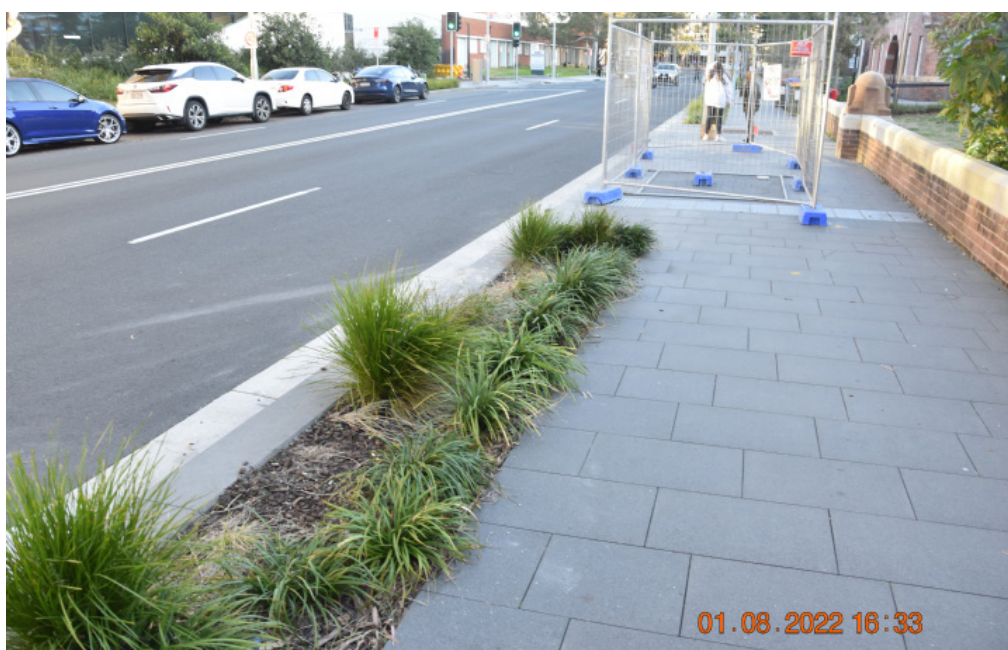
Figure: 0248

General view of the footpath outside 3 Joynton Avenue, at approximately 30 meters from the east end.

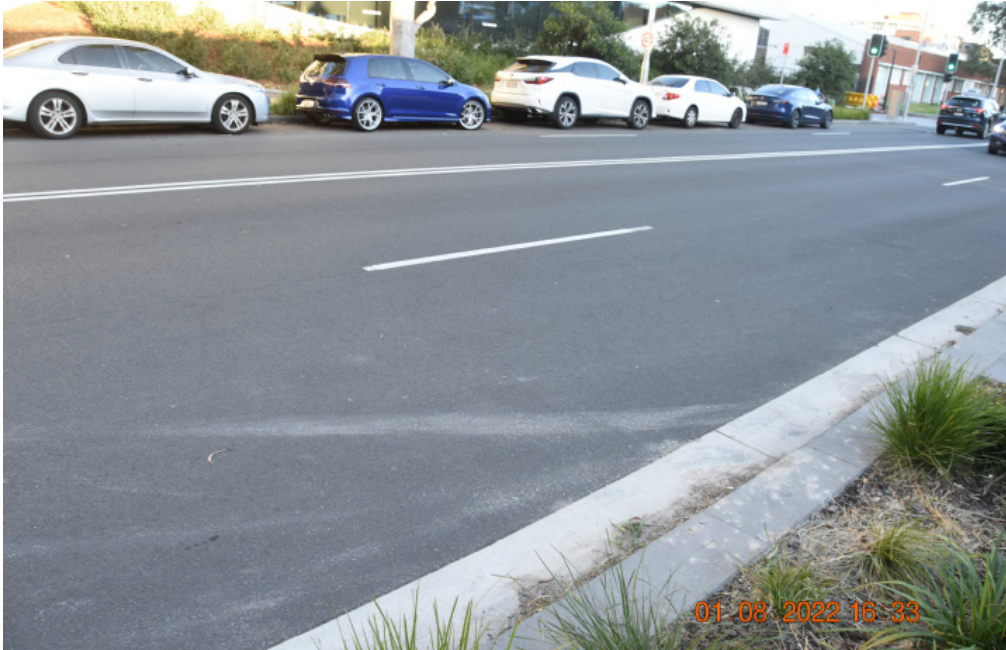
Figure: 0252

General view of the roadway outside 3 Joynton Avenue, at approximately 30 meters from the east end.

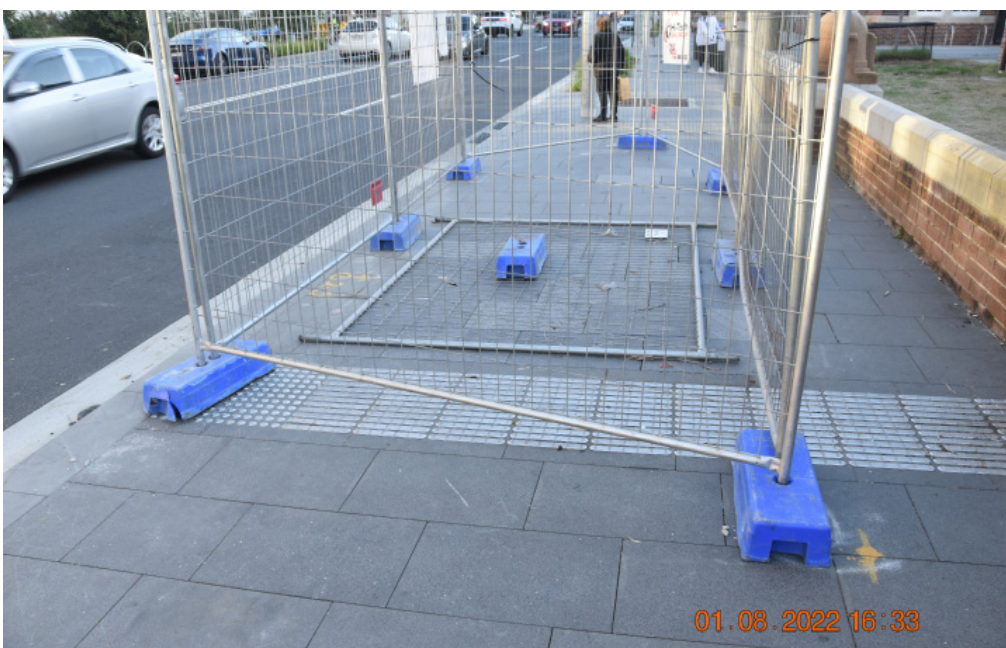
Figure: 0254

General view of the footpath outside 3 Joynton Avenue, at approximately 35 meters from the east end.

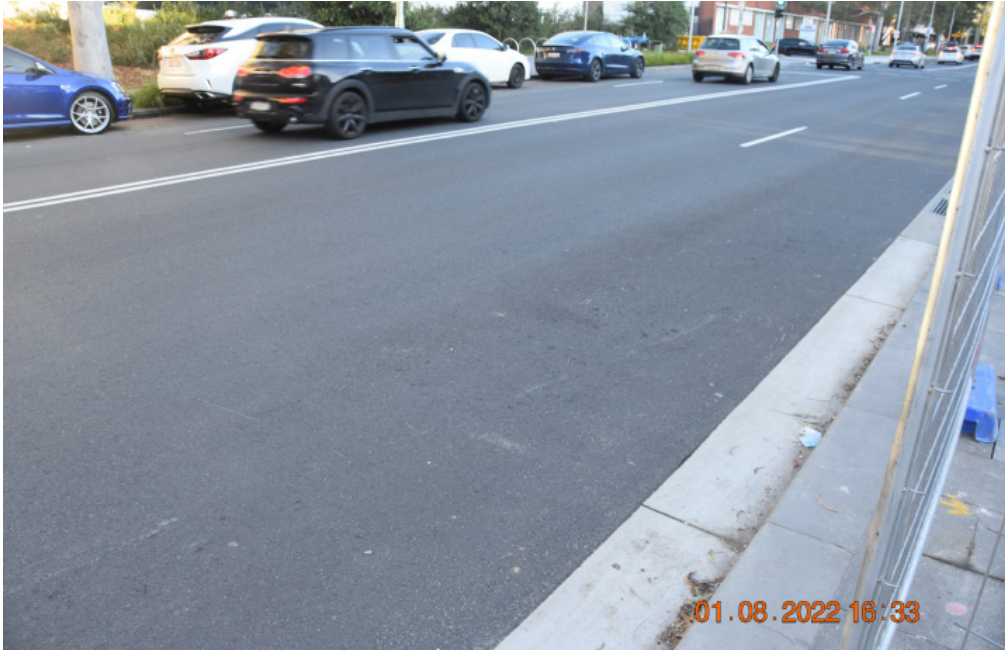
Figure: 0255

General view of the footpath outside 3 Joynton Avenue, at approximately 35 meters from the east end.
