PRE CONSTRUCTION CONDITION SURVEY

Green Square Integrated Community Facility &
School - 3 Joynton Avenue, Zetland NSW

Council Assets
3 Joynton Avenue and Portman Street
ZETLAND NSW 2017

01 August 2022

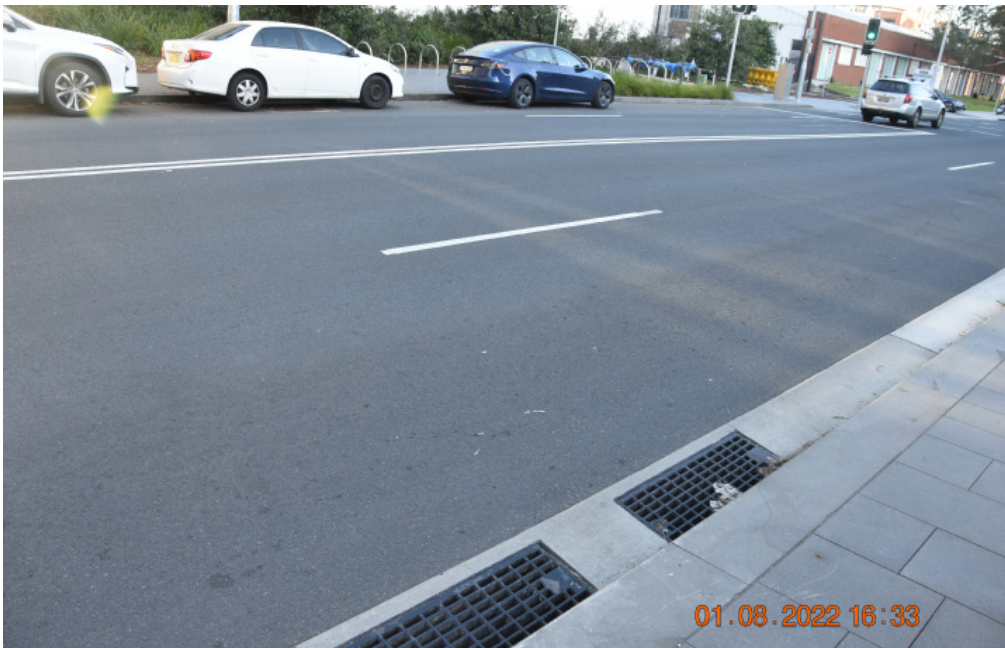
Figure: 0256

General view of the roadway outside 3 Joynton Avenue, at approximately 35 meters from the east end.

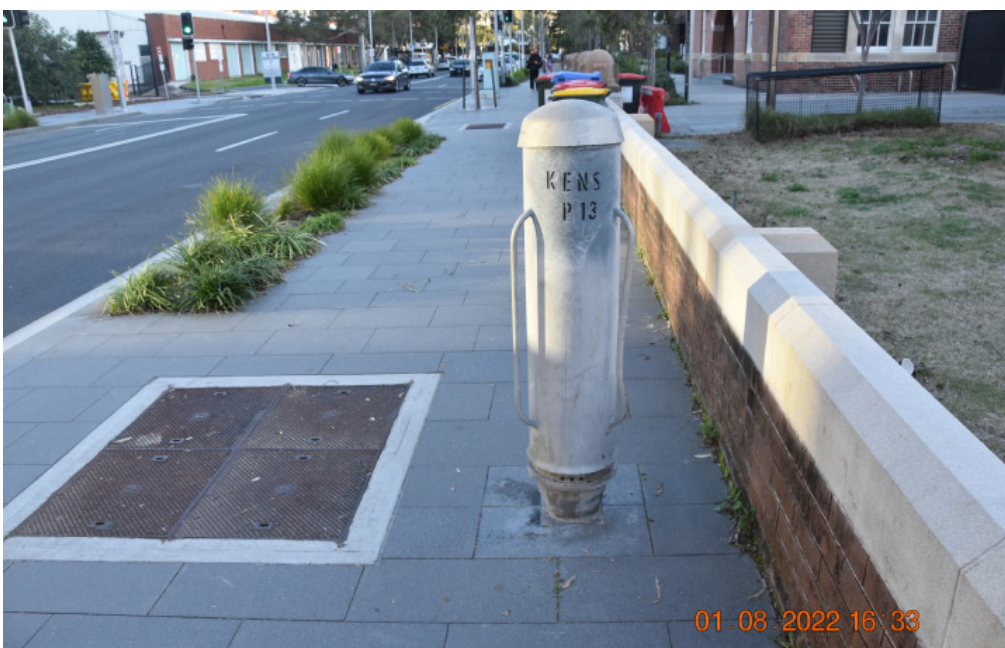
Figure: 0257

General view of the roadway outside 3 Joynton Avenue, at approximately 40 meters from the east end.

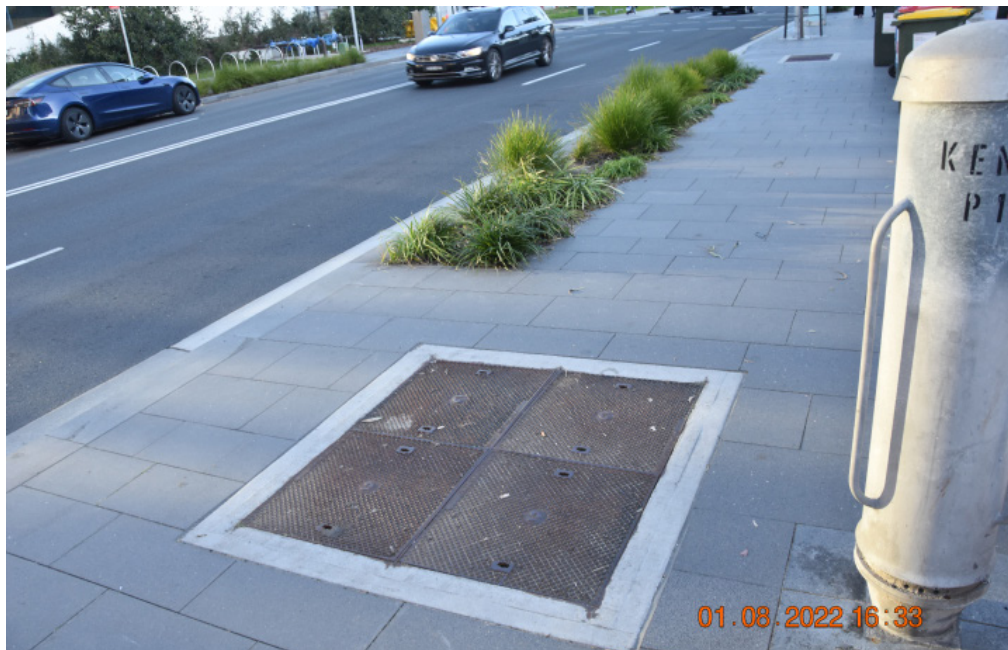
Figure: 0258

General view of the footpath outside 3 Joynton Avenue, at approximately 40 meters from the east end.

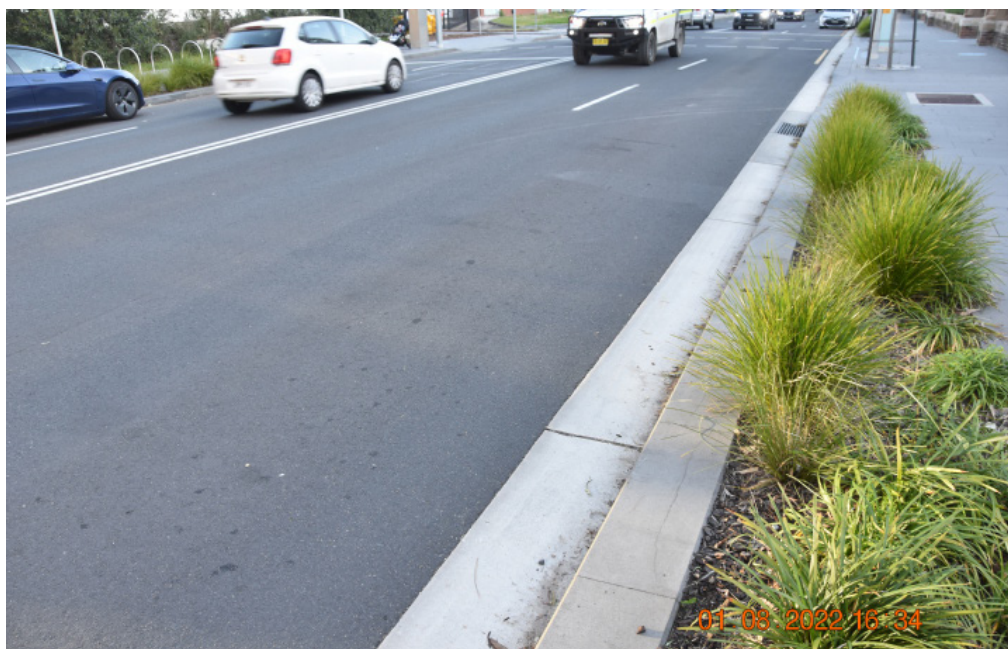
Figure: 0259

General view of the footpath outside 3 Joynton Avenue, at approximately 40 meters from the east end.

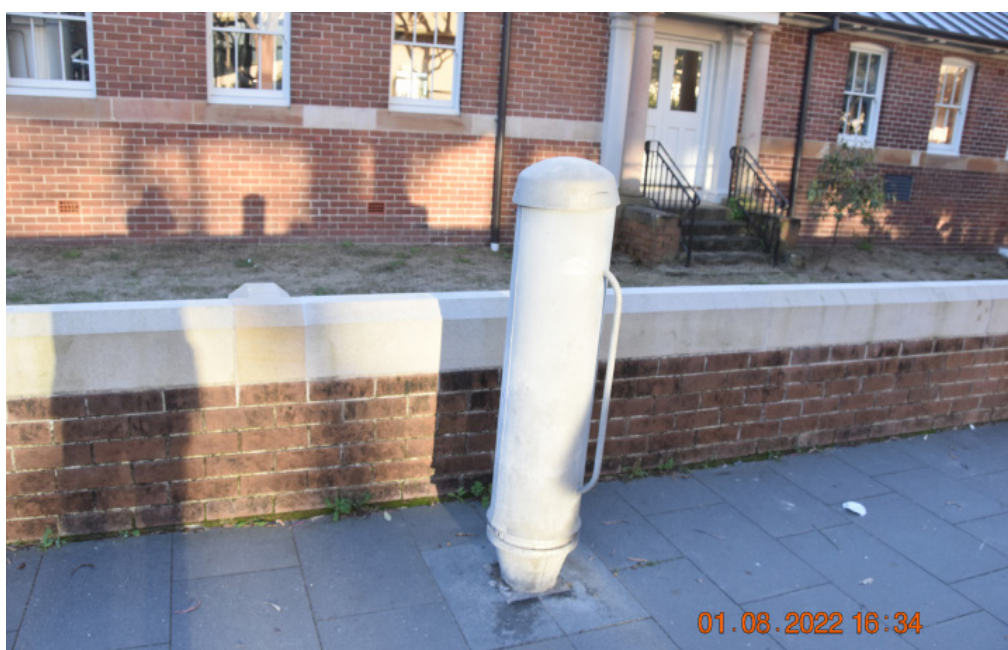
Figure: 0260

General view of the roadway outside 3 Joynton Avenue, at approximately 40 meters from the east end.

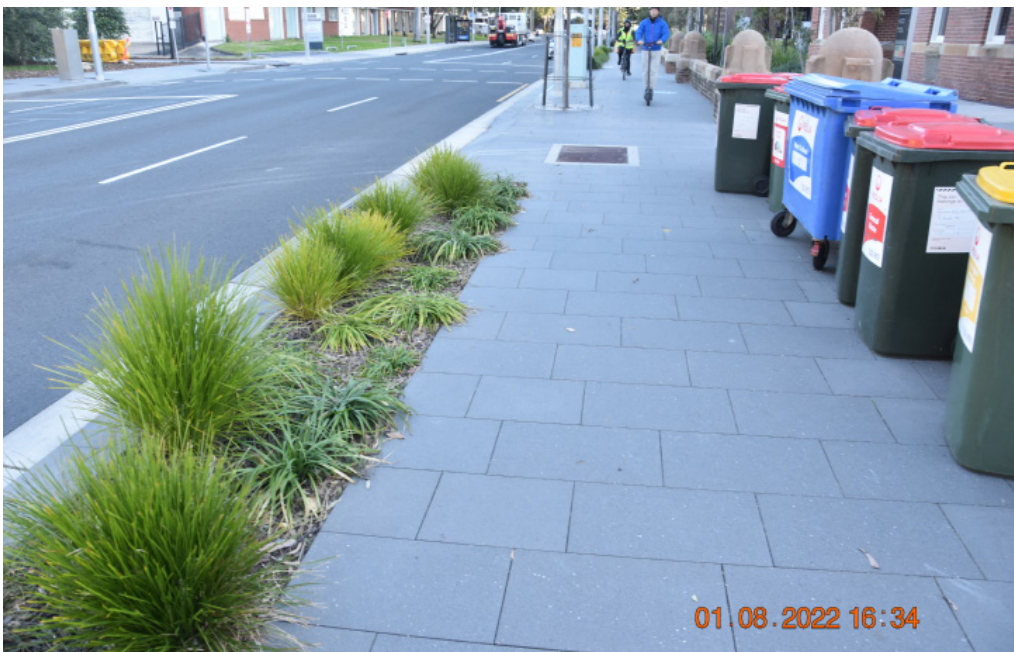
Figure: 0262

General view of the footpath outside 3 Joynton Avenue, at approximately 45 meters from the east end.

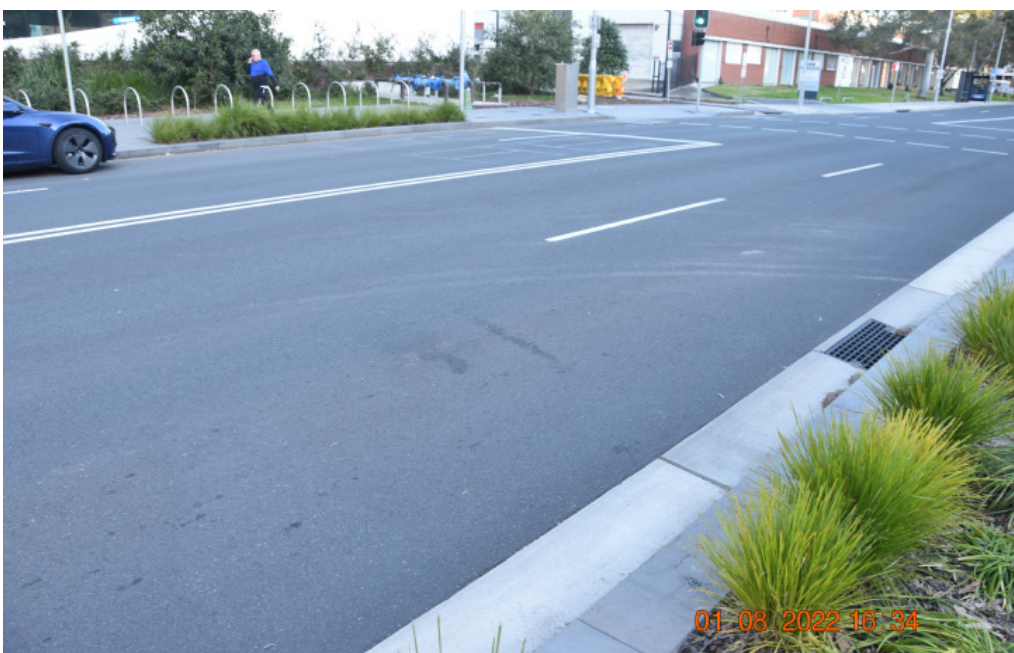
Figure: 0263

General view of the footpath outside 3 Joynton Avenue, at approximately 45 meters from the east end.

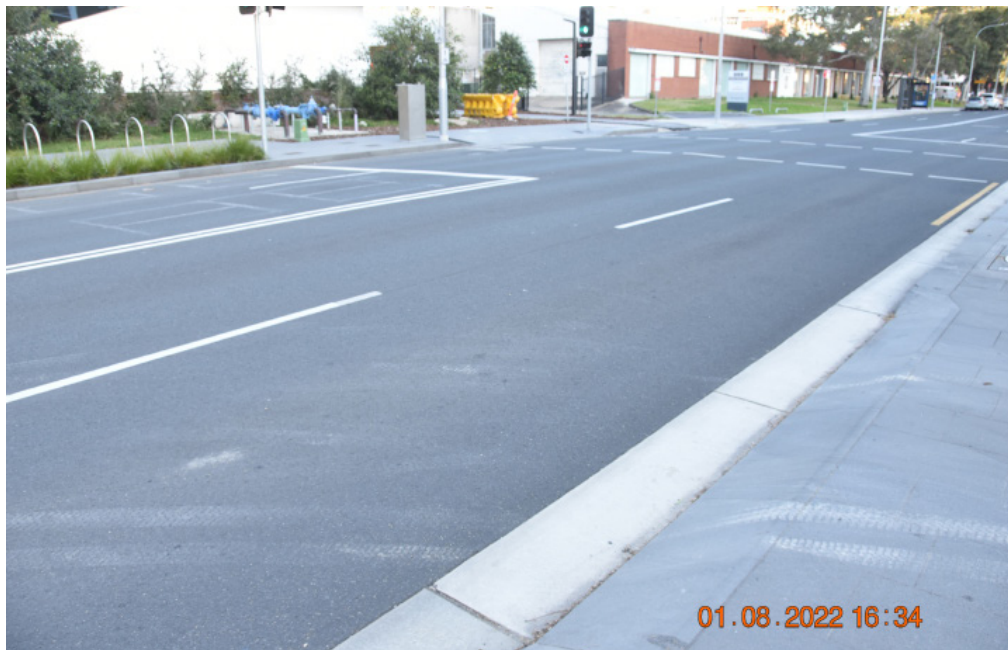
Figure: 0264

General view of the roadway outside 3 Joynton Avenue, at approximately 45 meters from the east end.

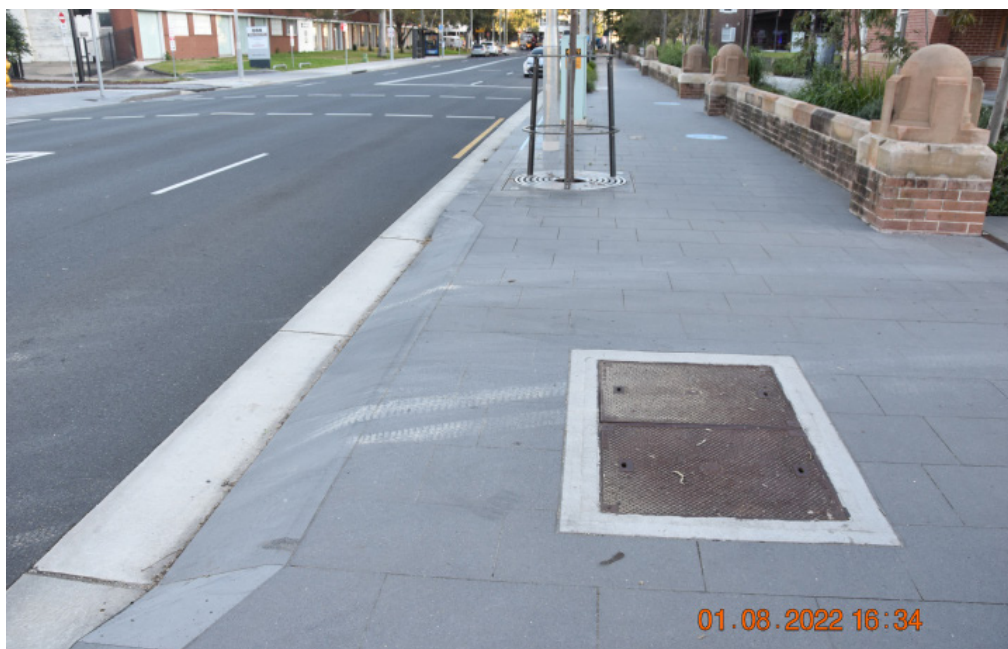
Figure: 0265

General view of the roadway outside 3 Joynton Avenue, at approximately 50 meters from the east end.

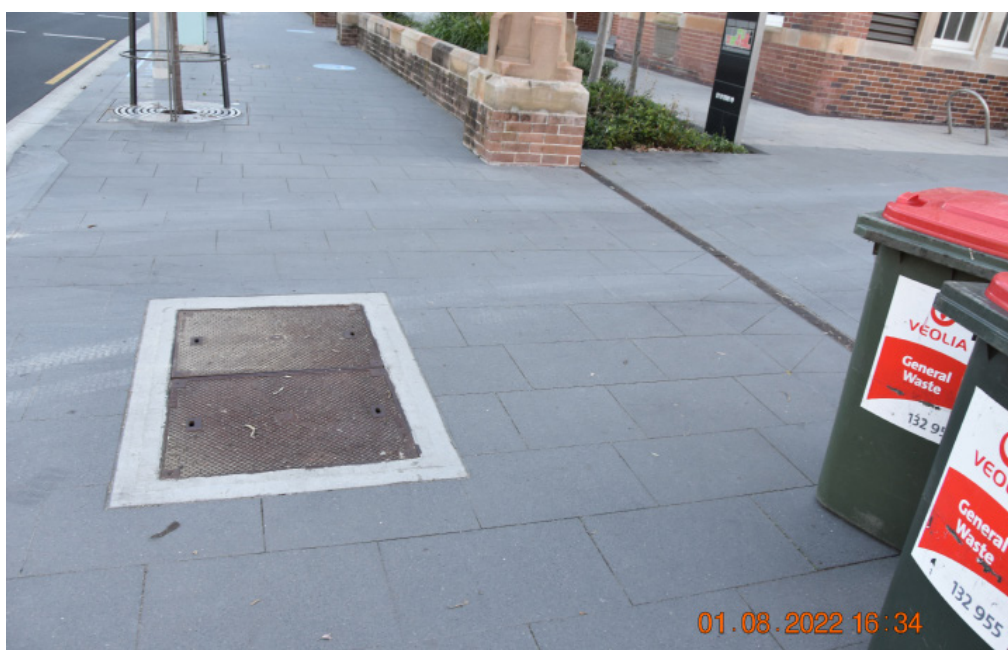
Figure: 0266

General view of the footpath outside 3 Joynton Avenue, at approximately 50 meters from the east end.

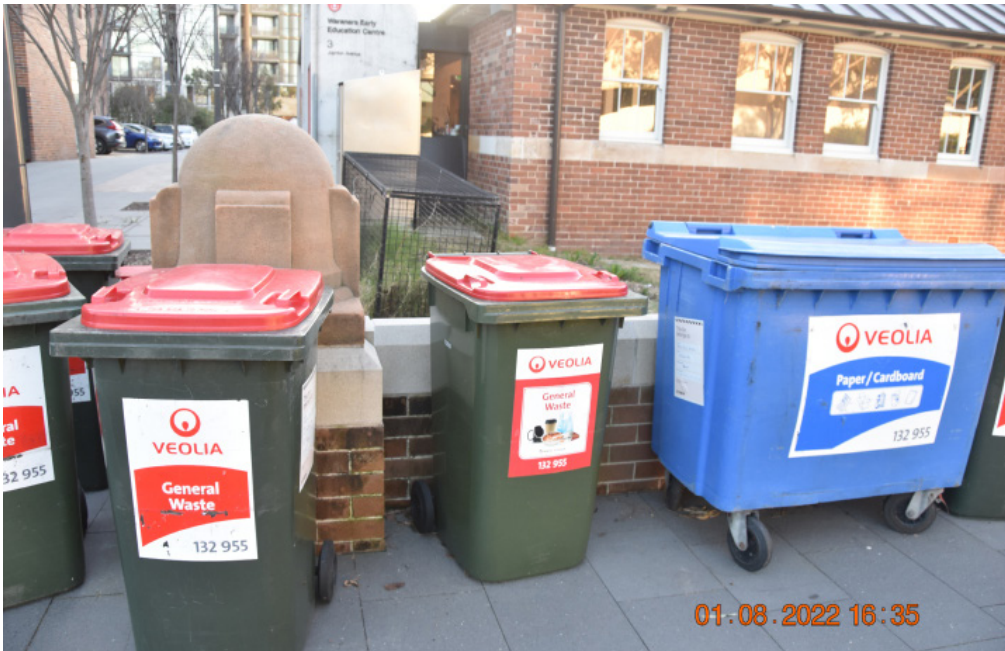
Figure: 0268

General view of the south fence outside 3 Joynton Avenue, at approximately 50 meters from the east end.

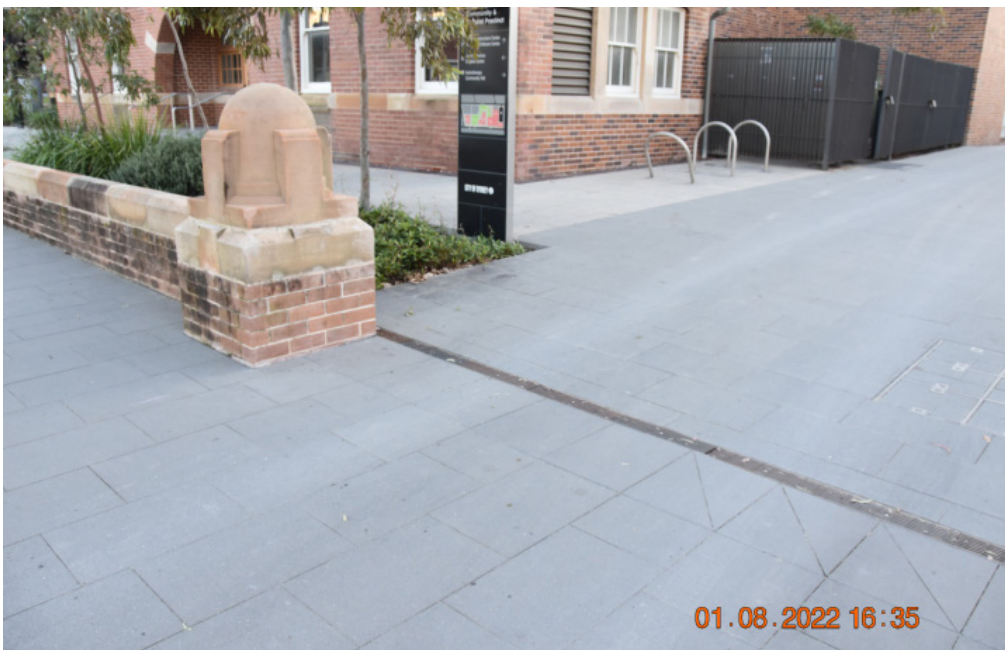
Figure: 0269

General view of the footpath outside 3 Joynton Avenue, at approximately 50 meters from the east end.

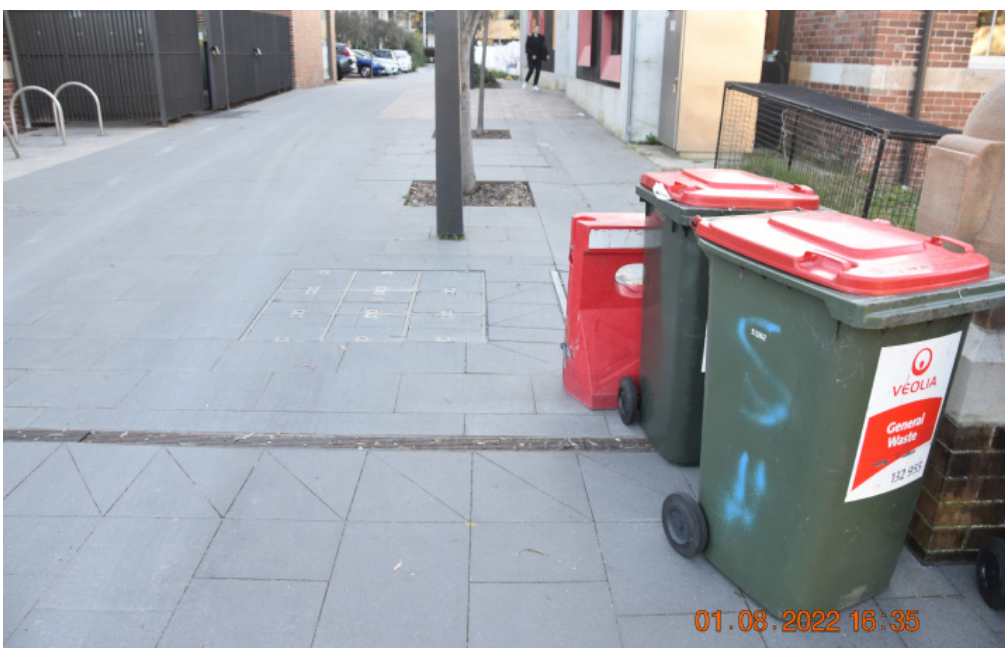
Figure: 0270

General view of the footpath outside 3 Joynton Avenue, at approximately 50 meters from the east end.

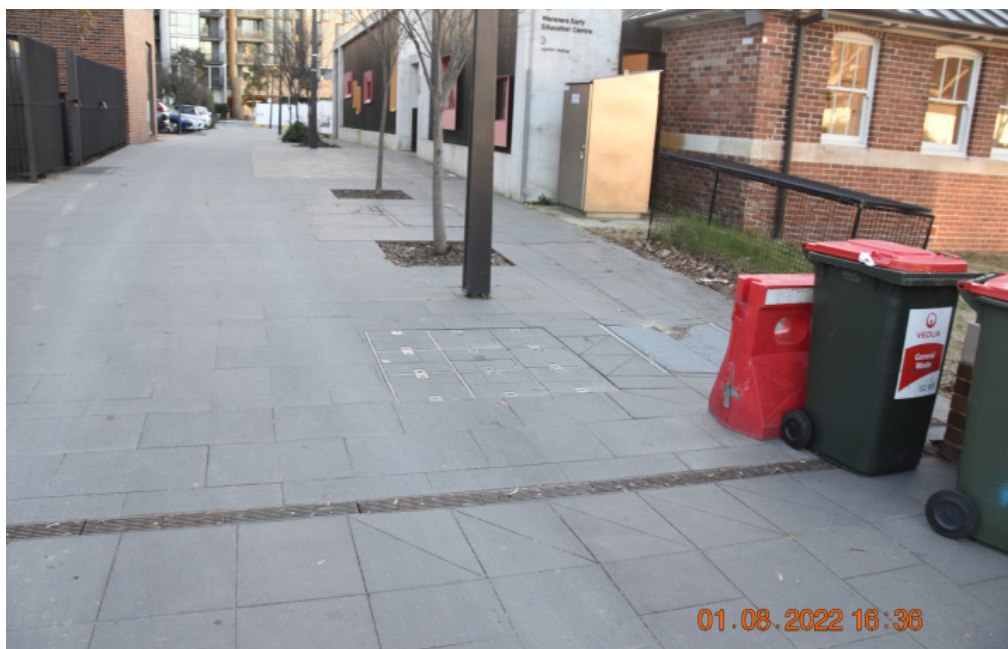
Figure: 0271

General view of the footpath in the lane way between 3 Joynton Avenue and 130 Portman Street, south end.

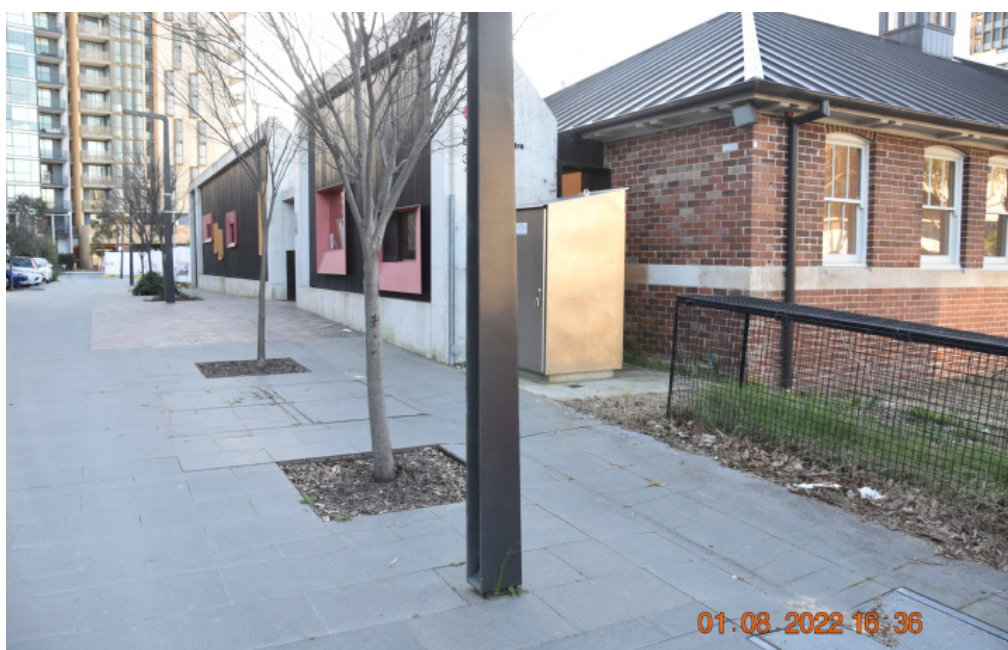
Figure: 0272

General view of the footpath in the lane way between 3 Joynton Avenue and 130 Portman Street, south end.

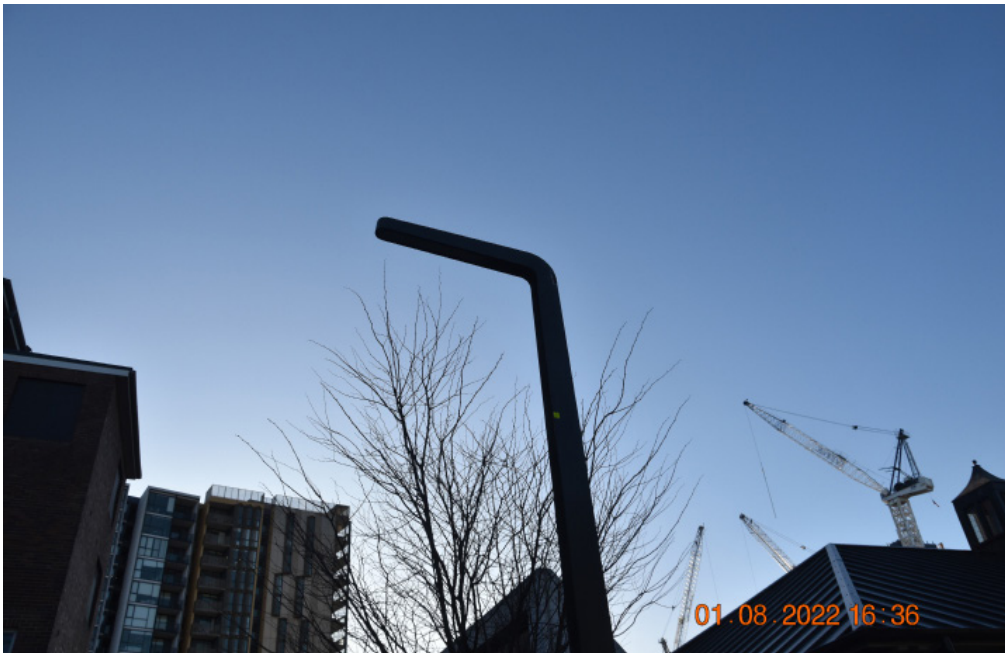
Figure: 0274

General view of the sign post in the lane way between 3 Joynton Avenue and 130 Portman Street, south end.

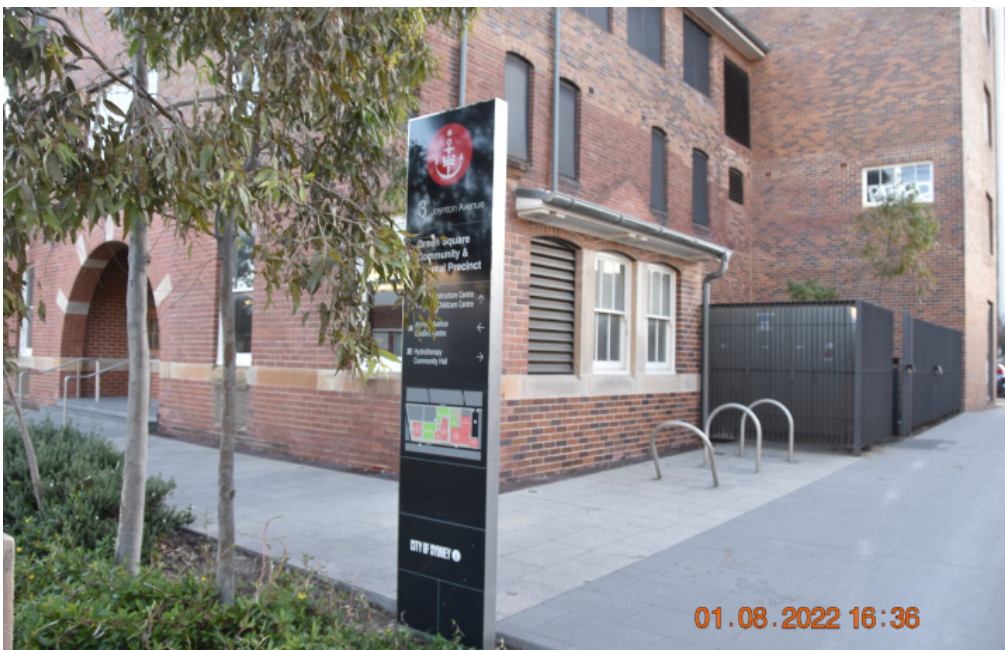
Fine cracking in the lane way between 3 Joynton Avenue and 130 Portman Street, south end.

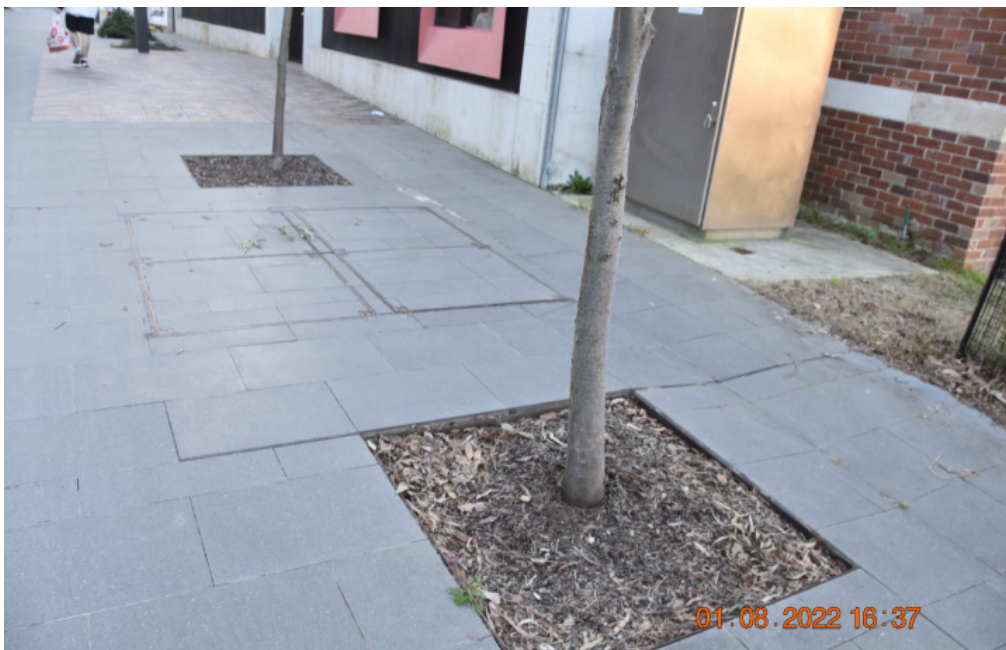
Figure: 0277

General view of the pit lid in the lane way between 3 Joynton Avenue and 130 Portman Street, south end.

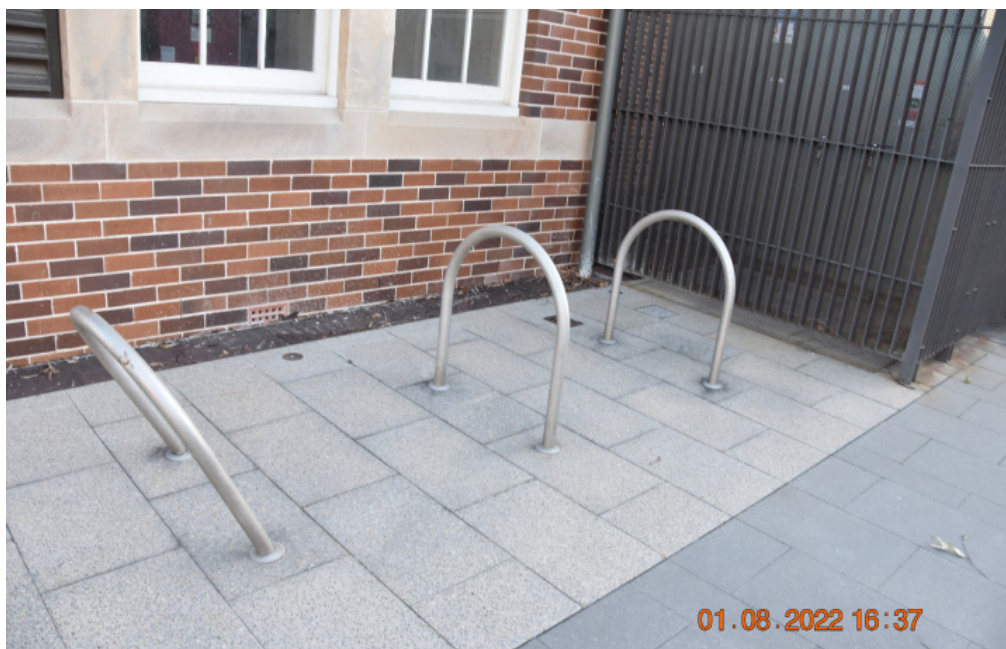
Figure: 0280

General view of the bicycle locker in the lane way between 3 Joynton Avenue and 130 Portman Street, at approximately 5 meters from the south end. Showing leaning.

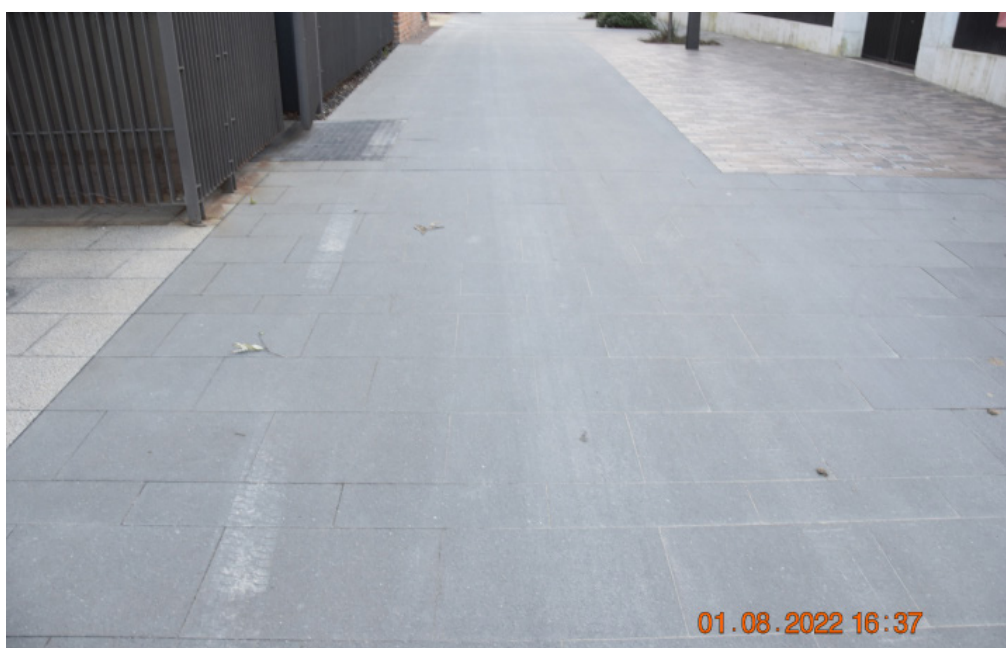
Figure: 0281

General view of the bicycle locker in the lane way between 3 Joynton Avenue and 130 Portman Street, at approximately 5 meters from the south end.

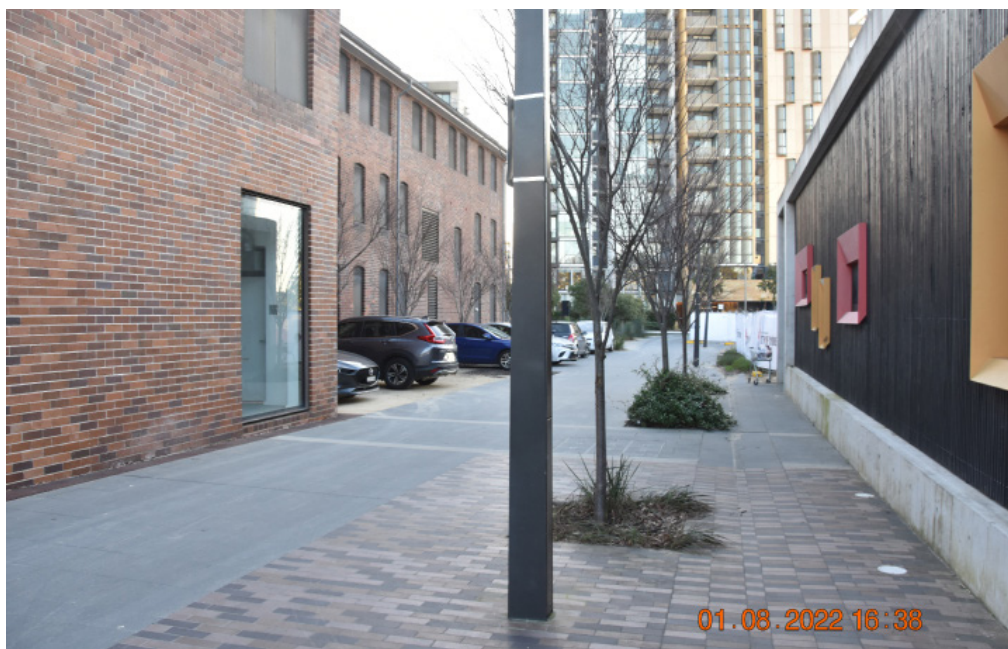
Figure: 0289

General view of the footpath in the lane way between 3 Joynton Avenue and 130 Portman Street, at approximately 15 meters from the south end.

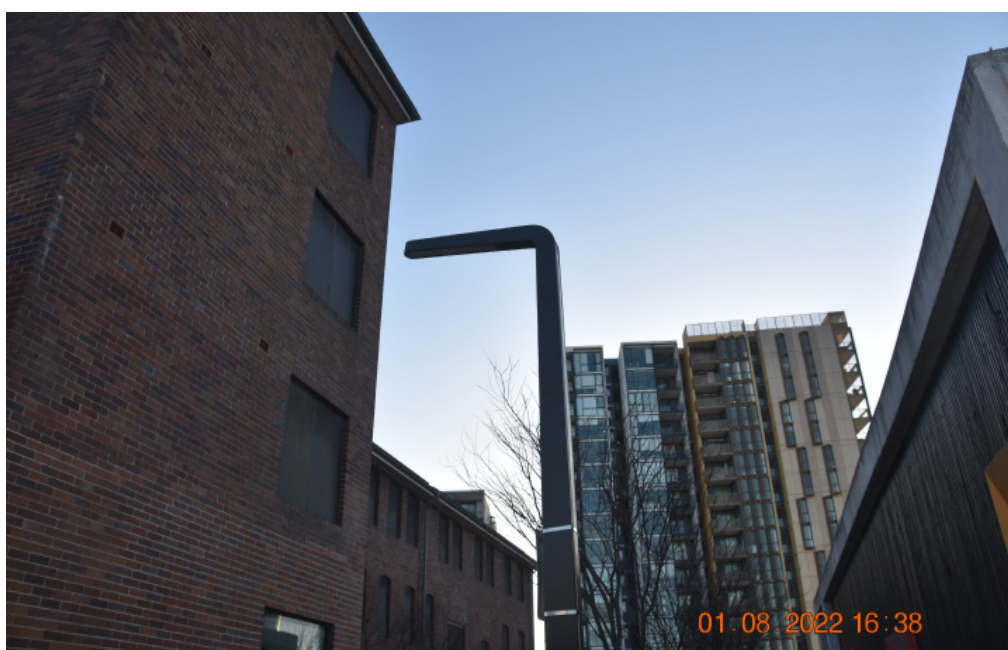
Figure: 0290

General view of the sign post in the lane way between 3 Joynton Avenue and 130 Portman Street, at approximately 15 meters from the south end.

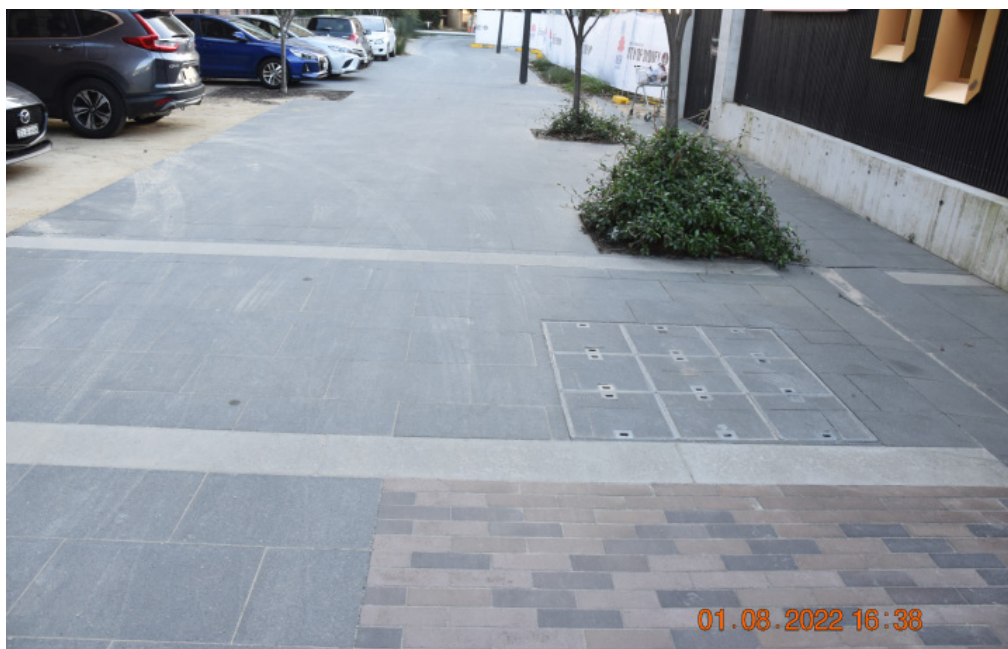
Figure: 0292

General view of the footpath in the lane way between 3 Joynton Avenue and 130 Portman Street, at approximately 20 meters from the south end.

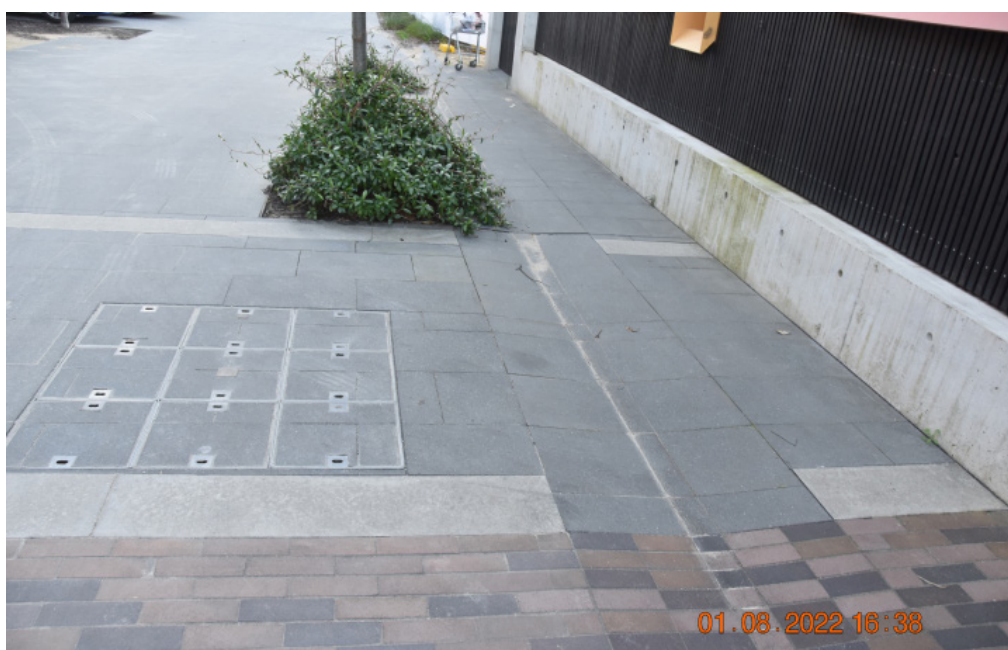
Figure: 0293

General view of the footpath in the lane way between 3 Joynton Avenue and 130 Portman Street, at approximately 20 meters from the south end.

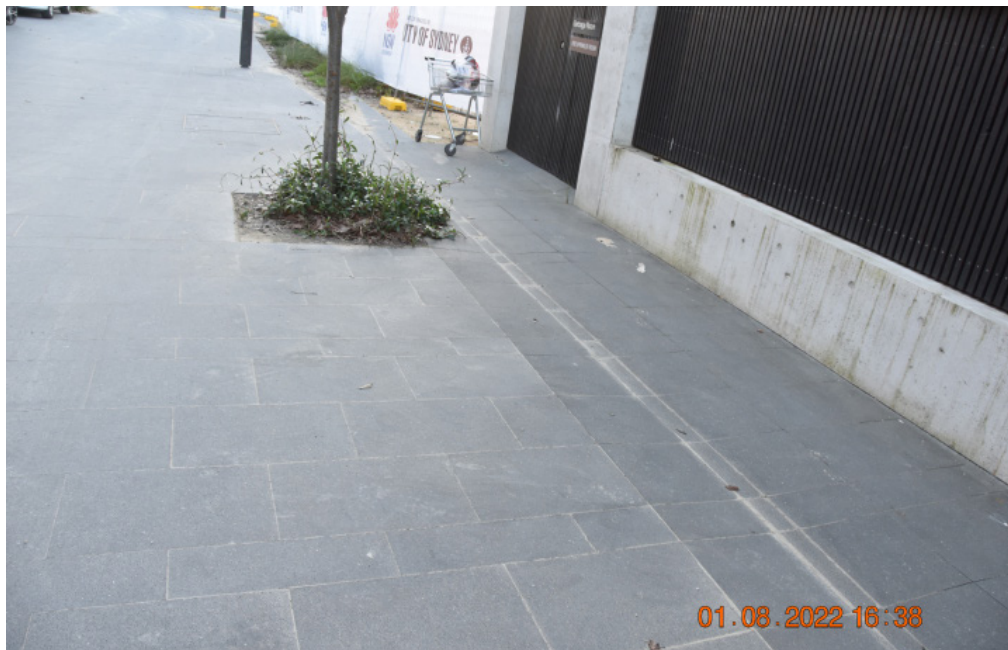
Figure: 0294

General view of the footpath in the lane way between 3 Joynton Avenue and 130 Portman Street, at approximately 20 meters from the south end.

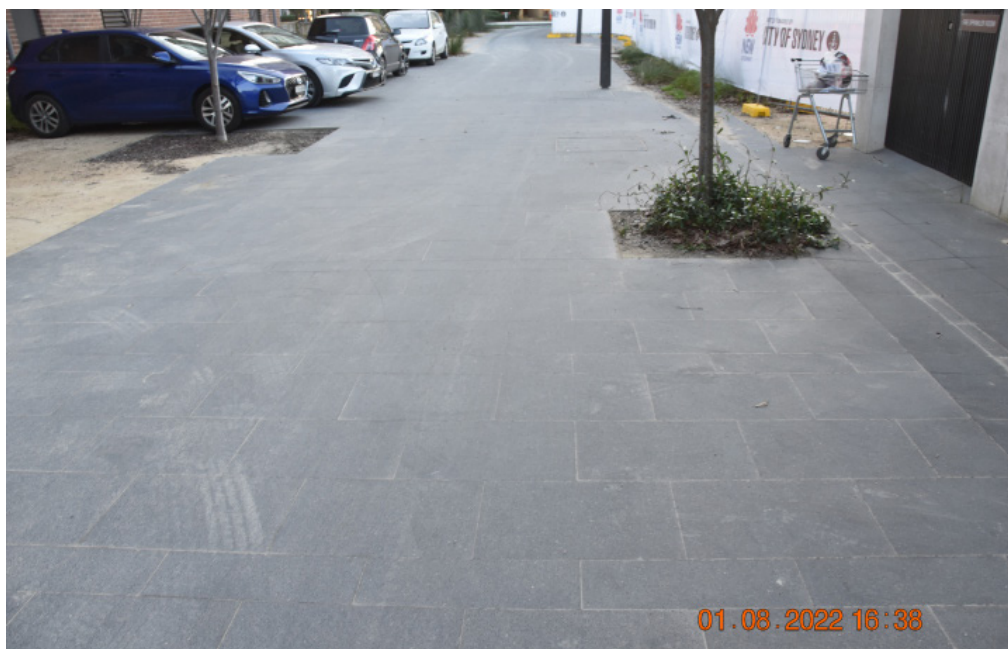
Figure: 0295

General view of the footpath in the lane way between 3 Joynton Avenue and 130 Portman Street, at approximately 20 meters from the south end.

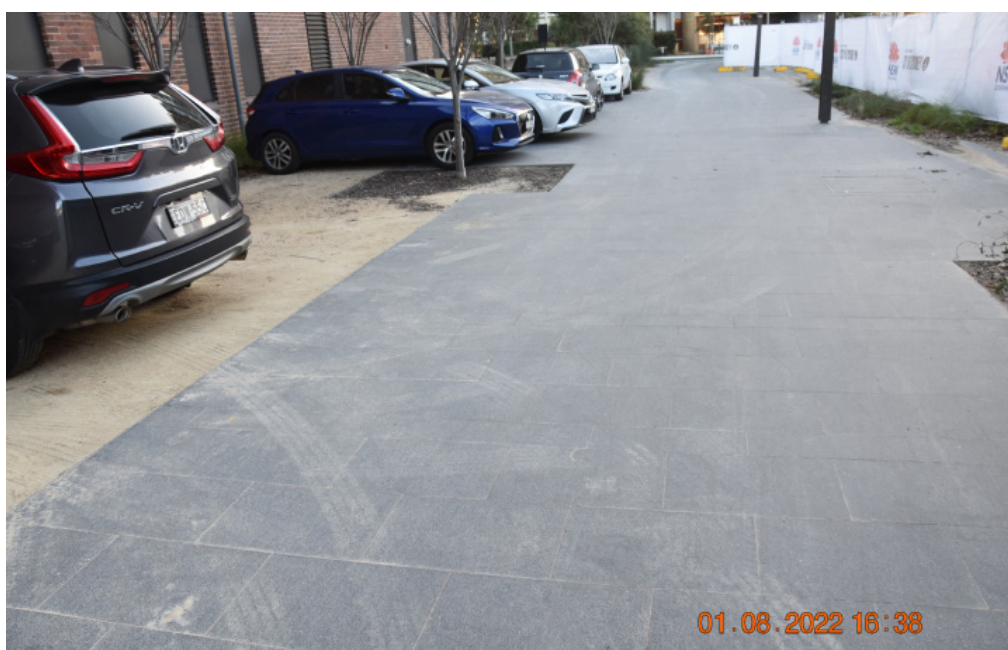
Figure: 0296

General view of the footpath in the lane way between 3 Joynton Avenue and 130 Portman Street, at approximately 20 meters from the south end.

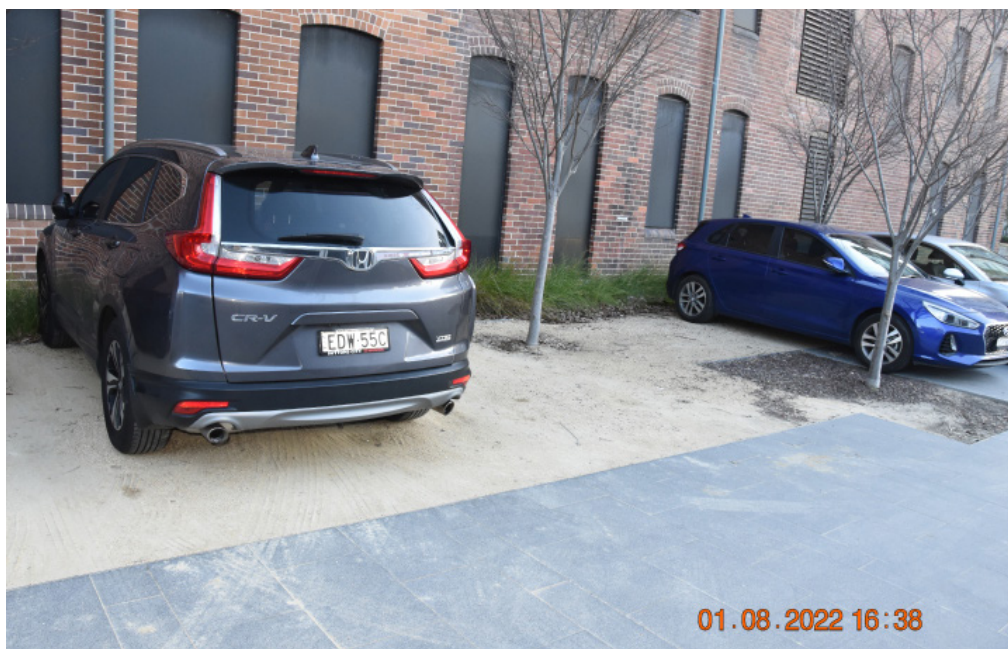
Figure: 0298

General view of the parking in the lane way between 3 Joynton Avenue and 130 Portman Street, at approximately 20 meters from the south end.

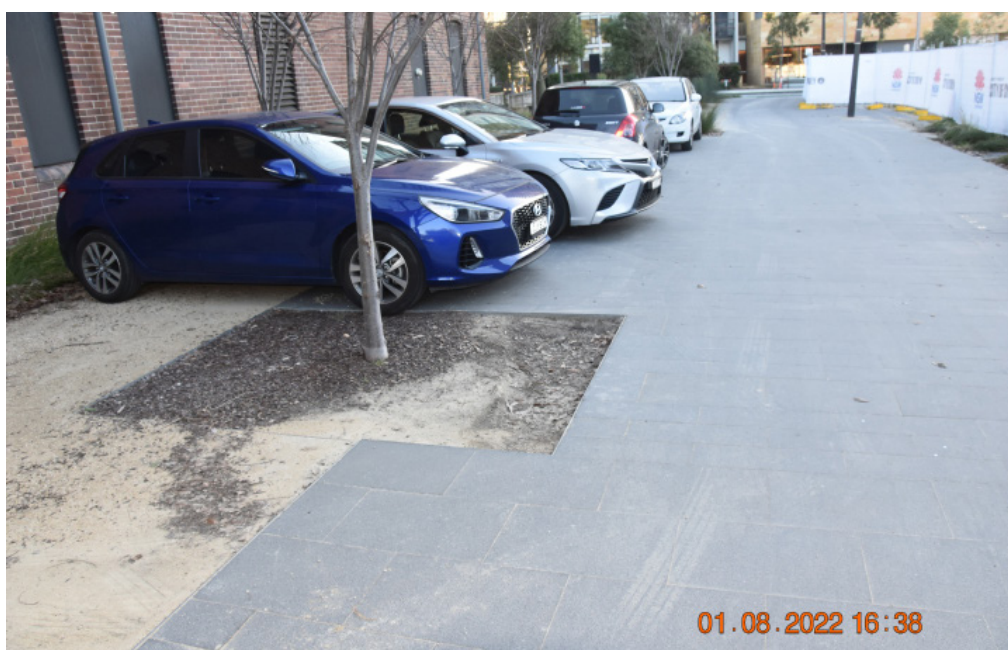
Figure: 0299

General view of the parking in the lane way between 3 Joynton Avenue and 130 Portman Street, at approximately 20 meters from the south end.

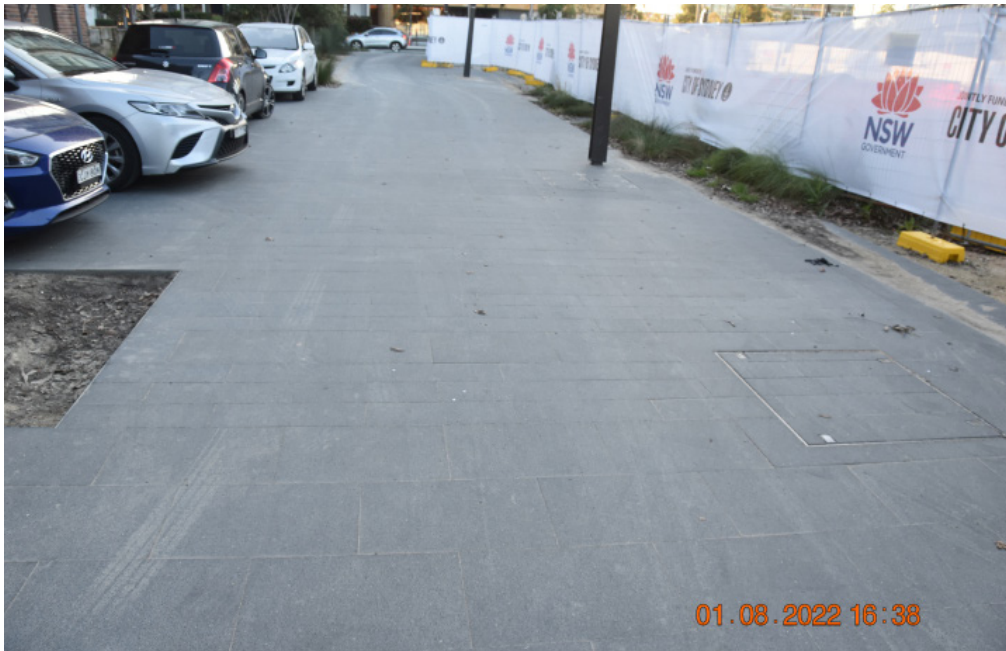
Figure: 0300

General view of the footpath in the lane way between 3 Joynton Avenue and 30 Portman Street, at approximately 25 meters from the south end.

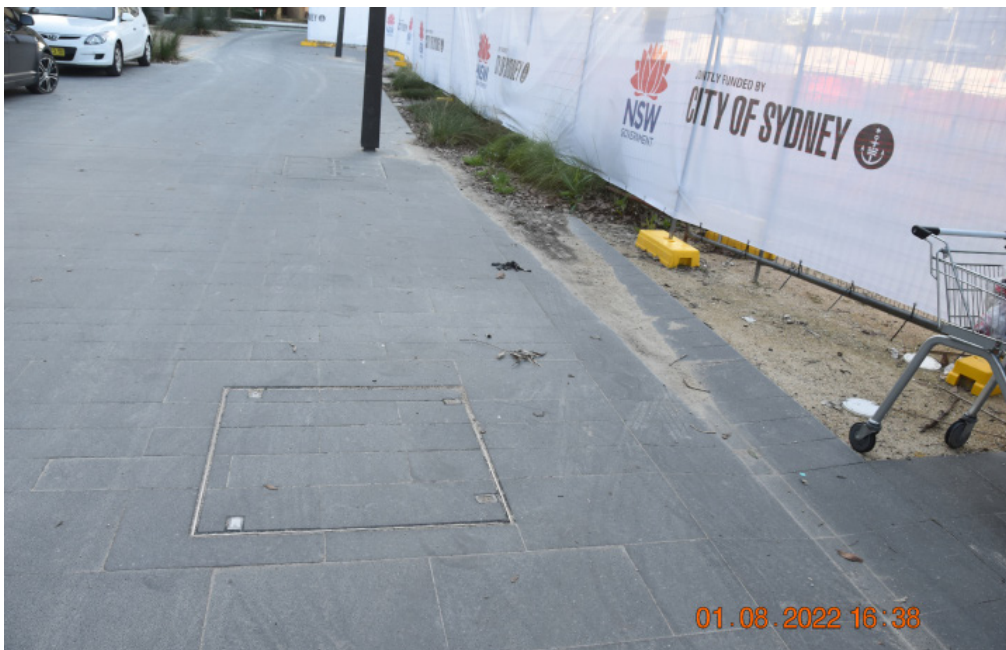
Figure: 0301

General view of the footpath in the lane way between 3 Joynton Avenue and 30 Portman Street, at approximately 25 meters from the south end.

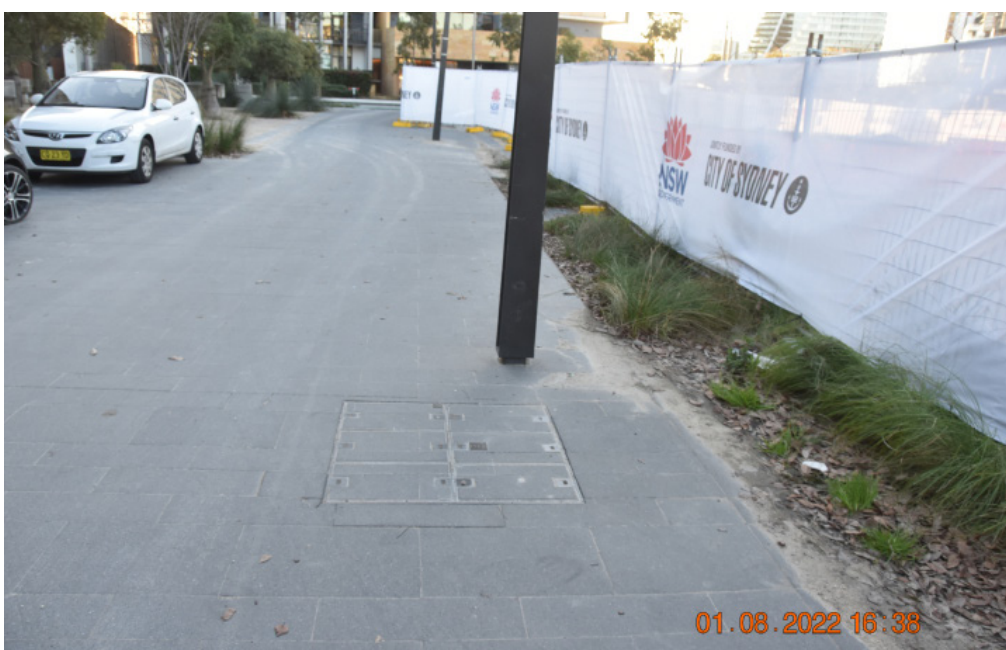
Figure: 0302

General view of the footpath in the lane way between 3 Joynton Avenue and 130 Portman Street, at approximately 35 meters from the south end.

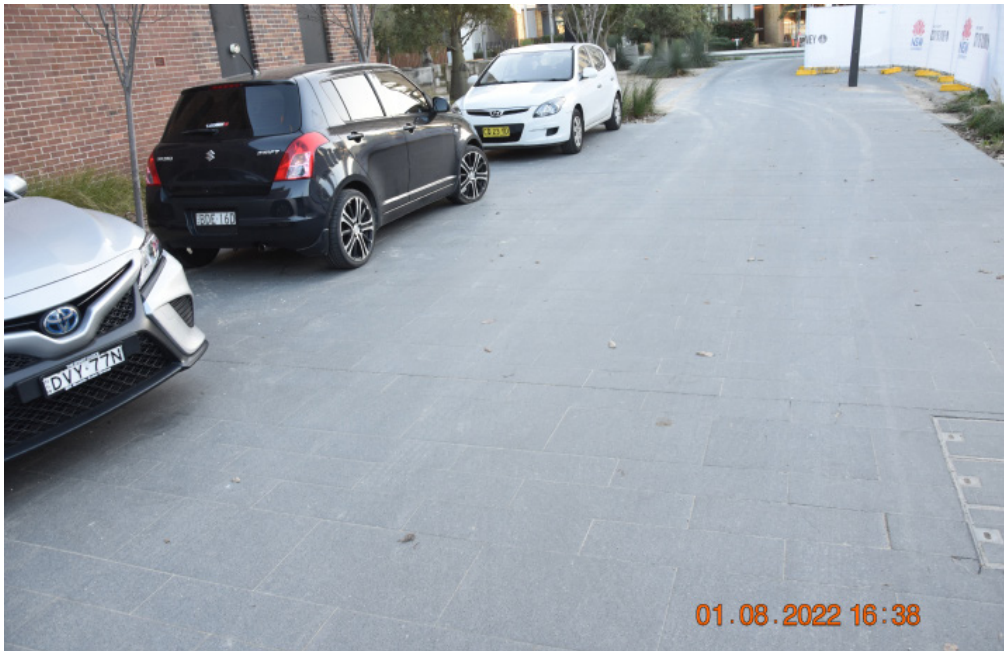
Figure: 0303

General view of the footpath in the lane way between 3 Joynton Avenue and 130 Portman Street, at approximately 35 meters from the south end.
