PRE CONSTRUCTION CONDITION SURVEY

Green Square Integrated Community Facility &
School - 3 Joynton Avenue, Zetland NSW

Council Assets
3 Joynton Avenue and Portman Street
ZETLAND NSW 2017

01 August 2022

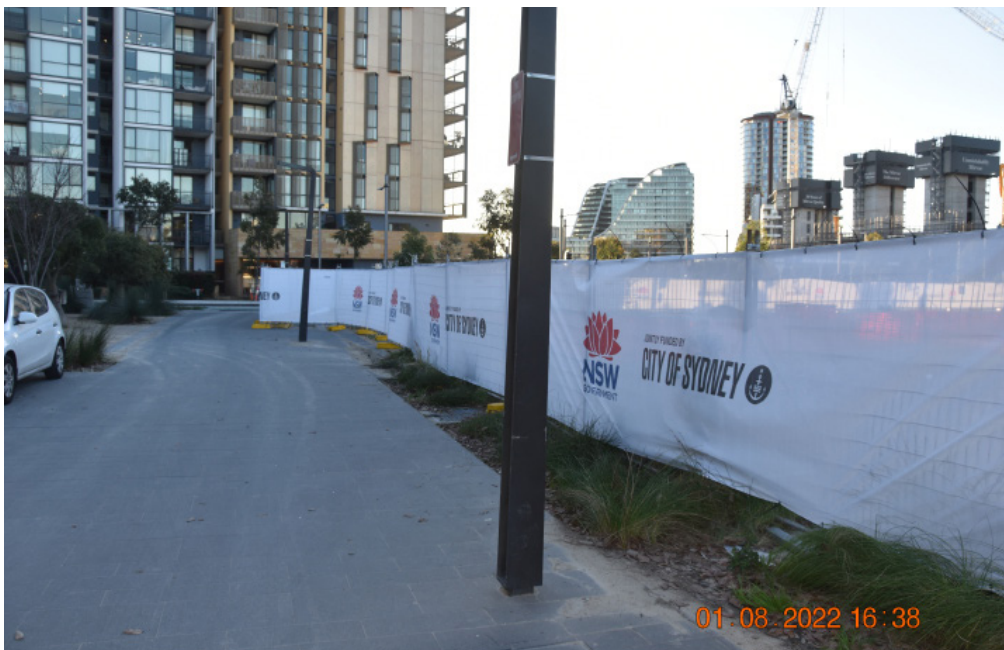
Figure: 0304

General view of the footpath in the lane way between 3 Joynton Avenue and 130 Portman Street, at approximately 35 meters from the south end.

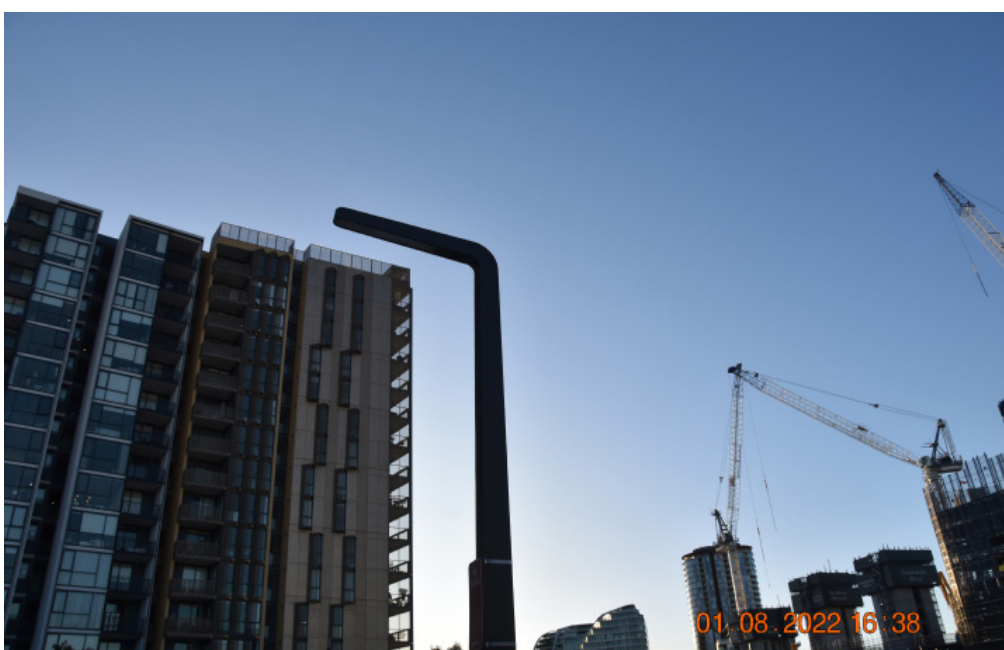
Figure: 0305

General view of the sign post in the lane way between 3 Joynton Avenue and 130 Portman Street, at approximately 30 meters from the south end.

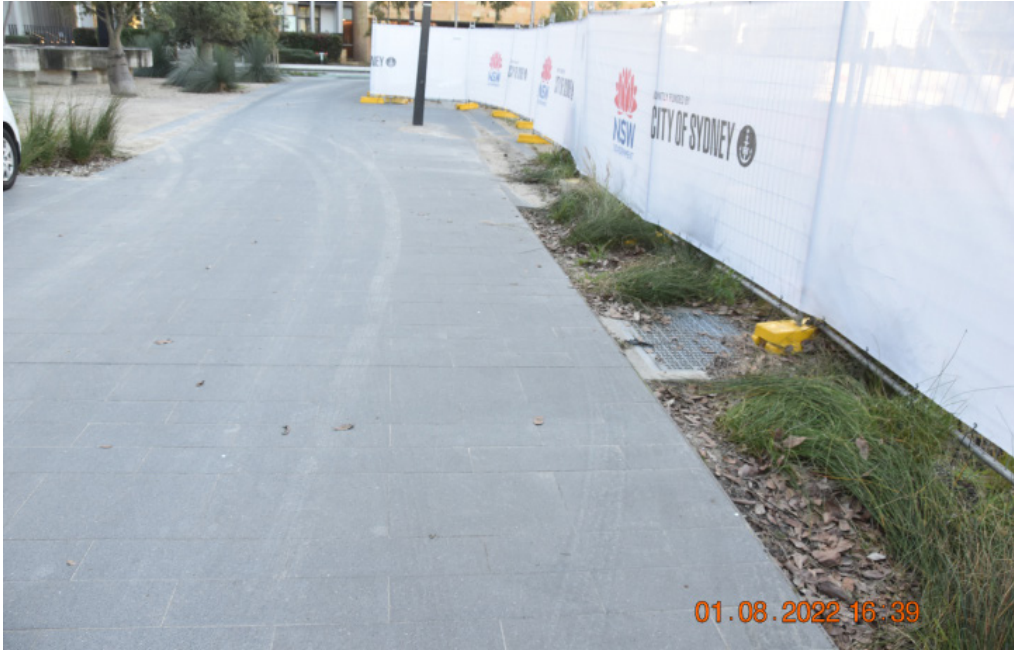
Figure: 0306

General view of the sign post in the lane way between 3 Joynton Avenue and 130 Portman Street, at approximately 30 meters from the south end.

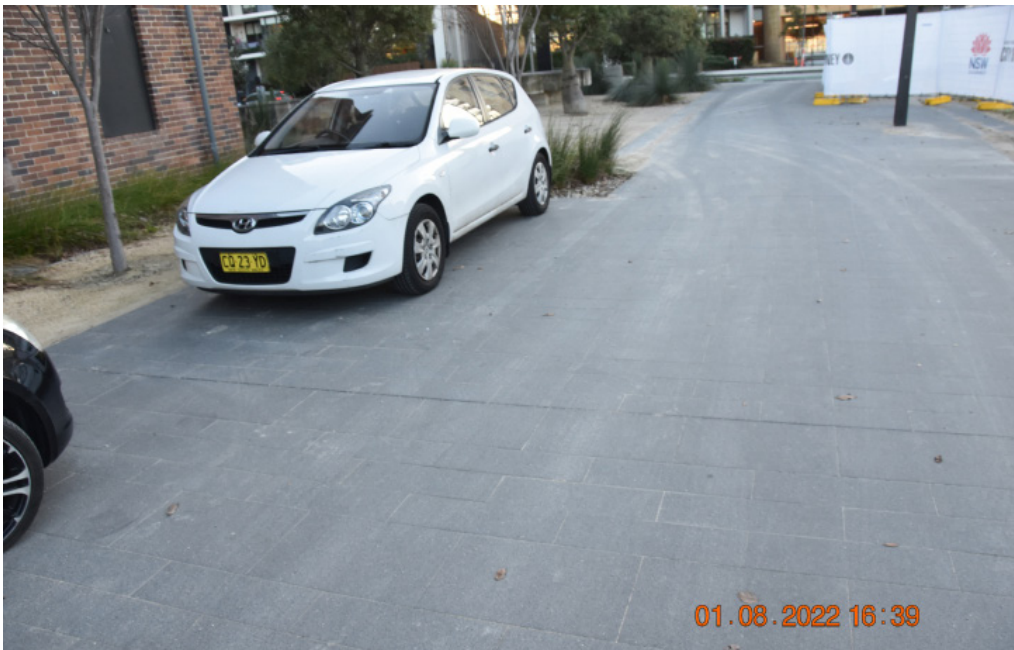
Figure: 0307

General view of the footpath in the lane way between 3 Joynton Avenue and 130 Portman Street, at approximately 35 meters from the south end.

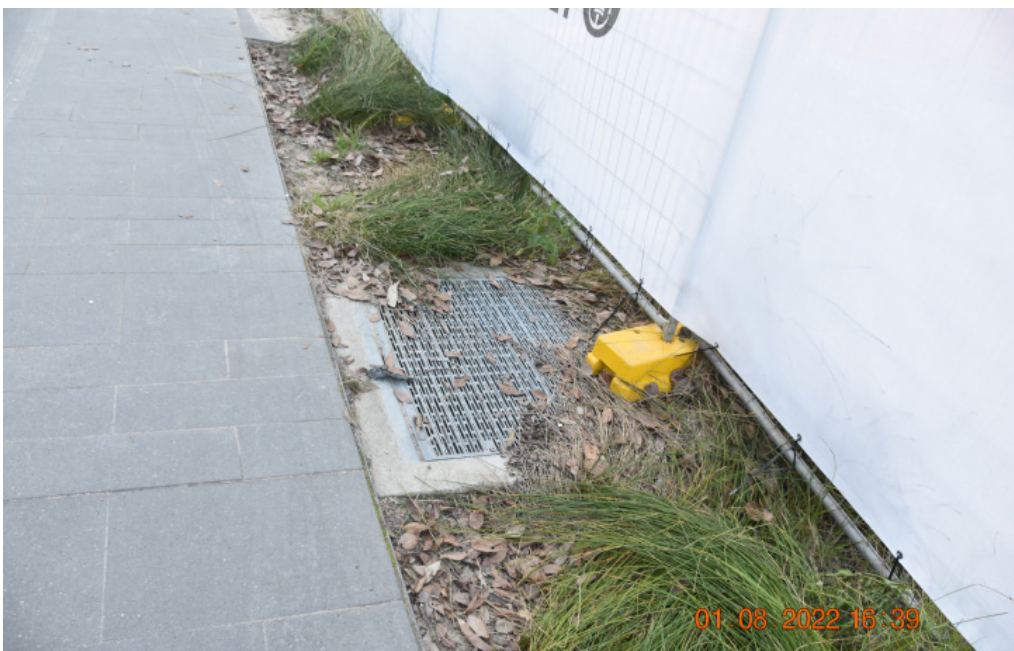
Figure: 0308

General view of the footpath in the lane way between 3 Joynton Avenue and 130 Portman Street, at approximately 35 meters from the south end.

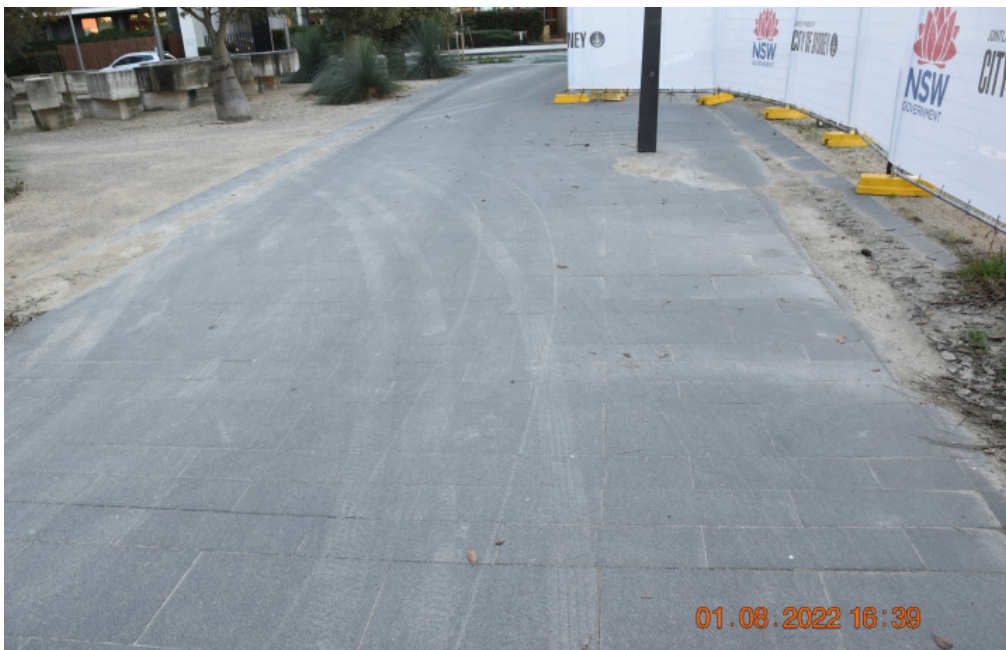
Figure: 0310

General view of the footpath in the lane way between 3 Joynton Avenue and 130 Portman Street, at approximately 40 meters from the south end.

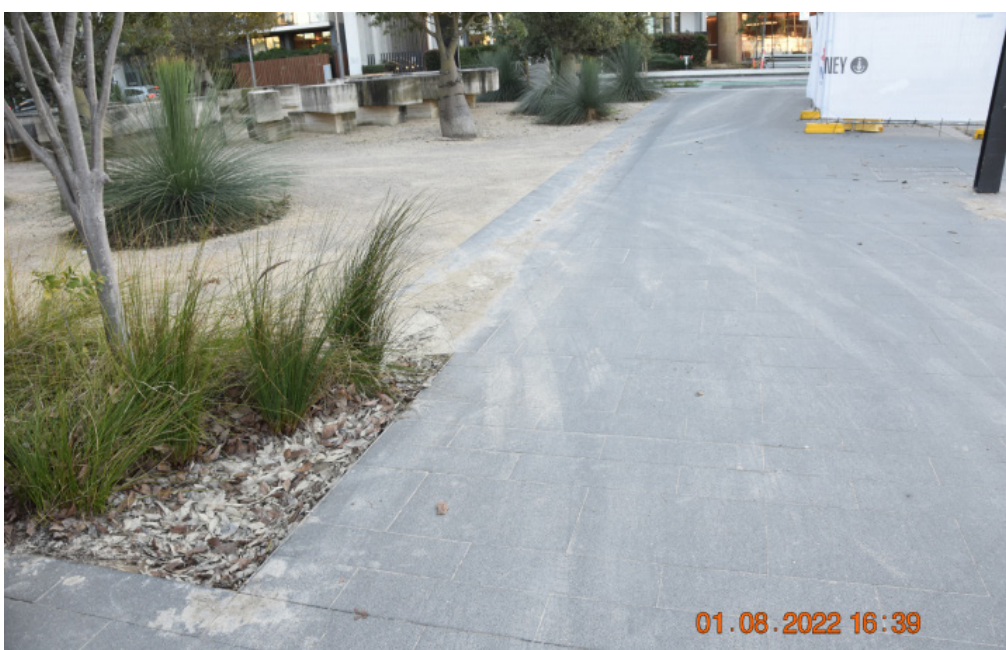
Figure: 0311

General view of the footpath in the lane way between 3 Joynton Avenue and 130 Portman Street, at approximately 40 meters from the south end.

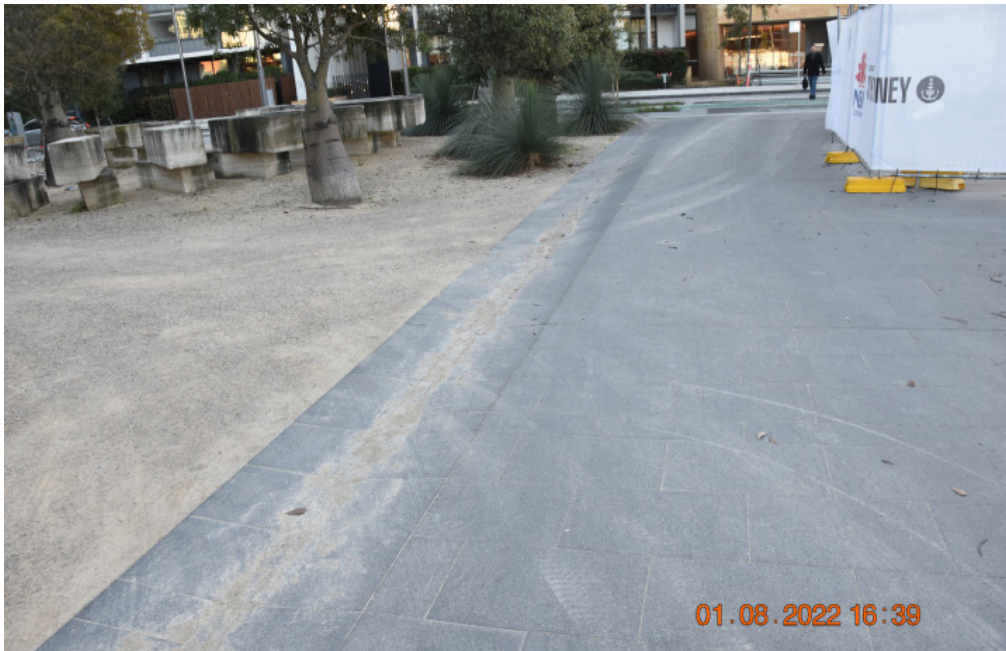
Figure: 0312

General view of the footpath in the lane way between 3 Joynton Avenue and 130 Portman Street, at approximately 45 meters from the south end.

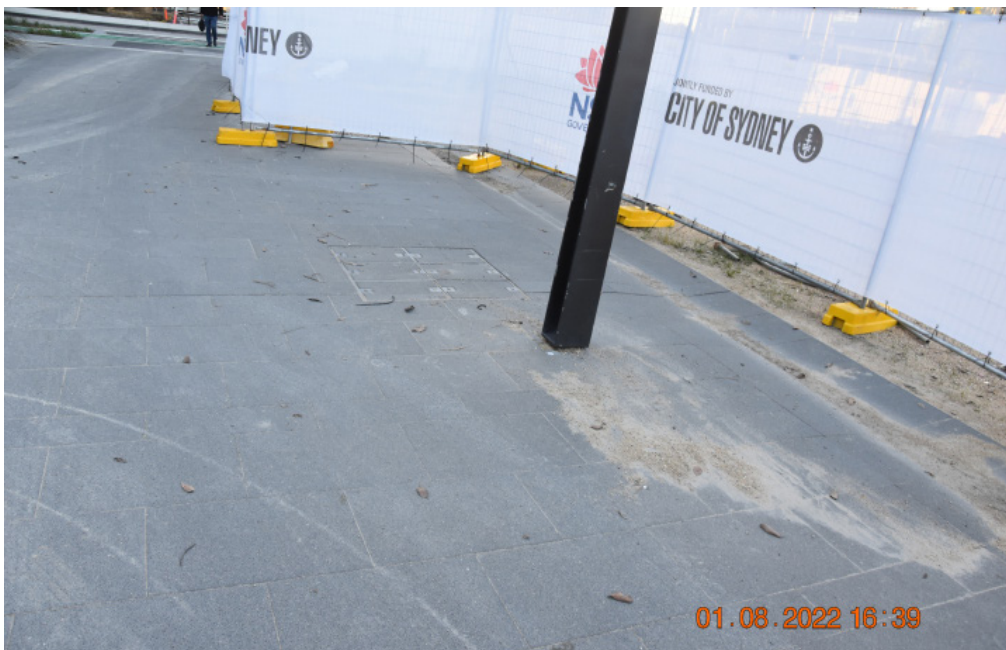
Figure: 0313

General view of the footpath in the lane way between 3 Joynton Avenue and 130 Portman Street, at approximately 45 meters from the south end.

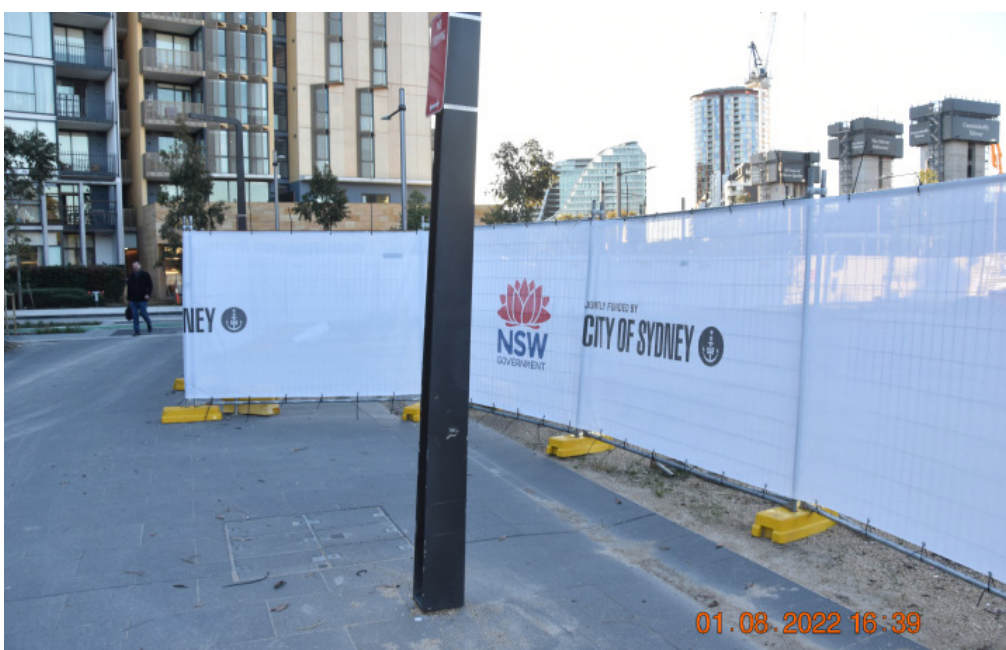
Figure: 0314

General view of the sign post in the lane way between 3 Joynton Avenue and 130 Portman Street, at approximately 45 meters from the south end.

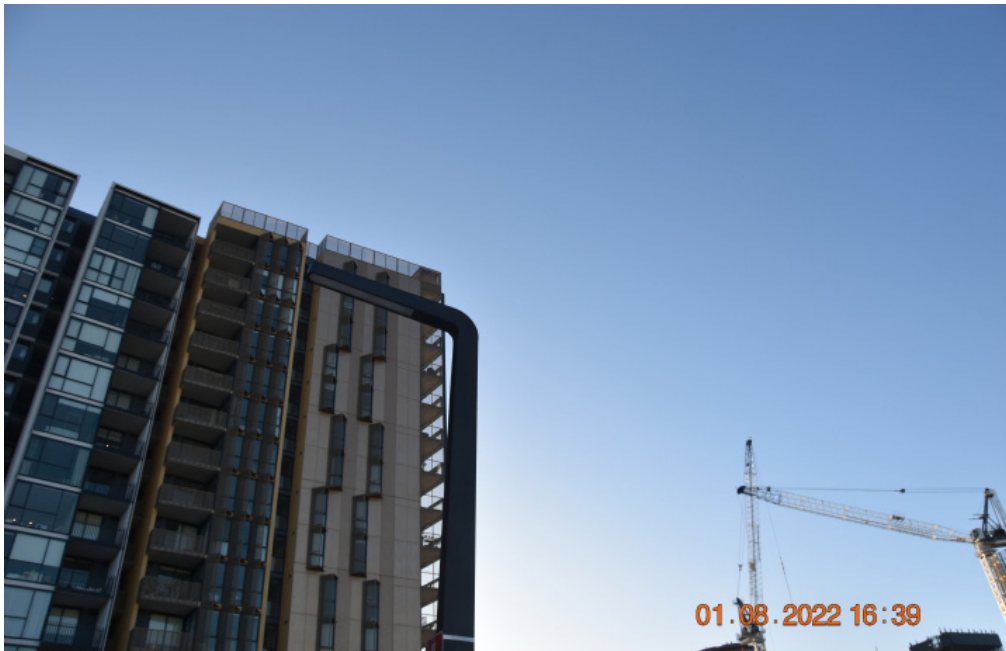
Figure: 0315

General view of the sign post in the lane way between 3 Joynton Avenue and 130 Portman Street, at approximately 45 meters from the south end.

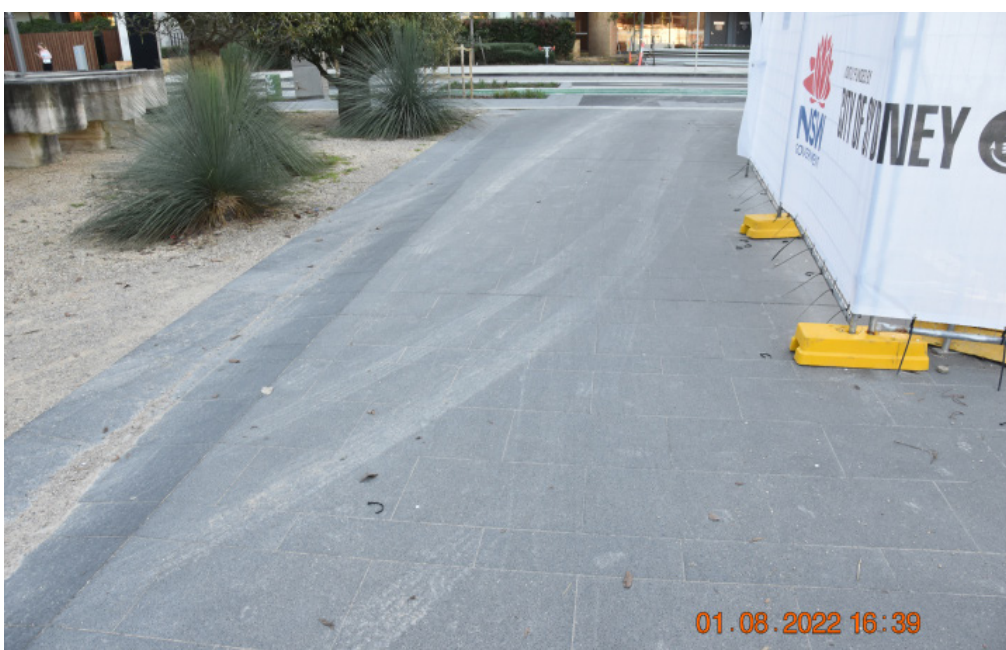
Figure: 0317

General view of the footpath in the lane way between 3 Joynton Avenue and 130 Portman Street, at approximately 50 meters from the south end.

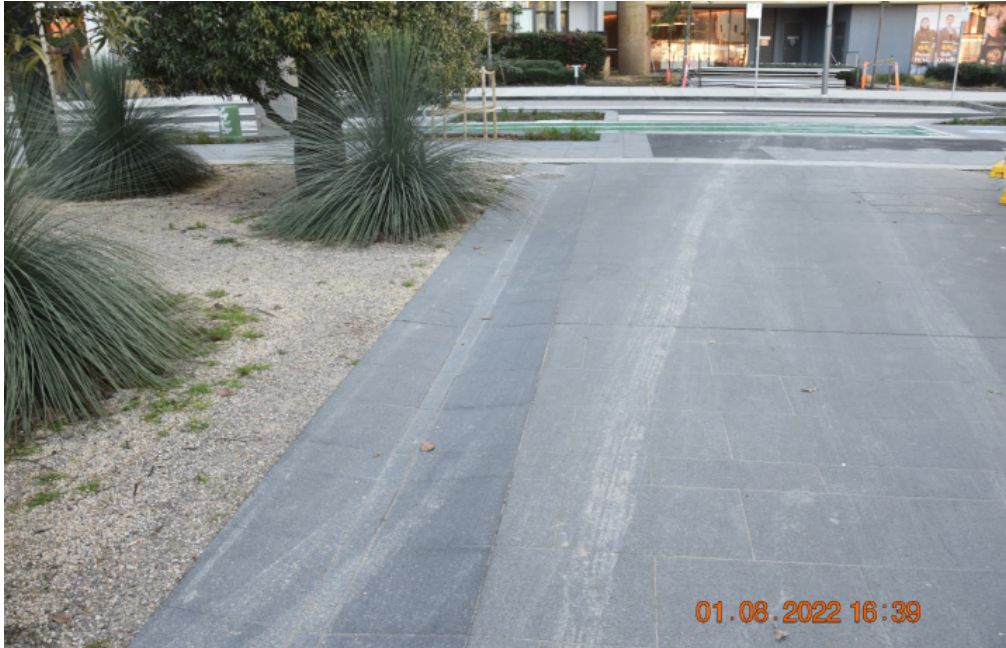
Figure: 0318

General view of the footpath in the lane way between 3 Joynton Avenue and 130 Portman Street, at approximately 50 meters from the south end.

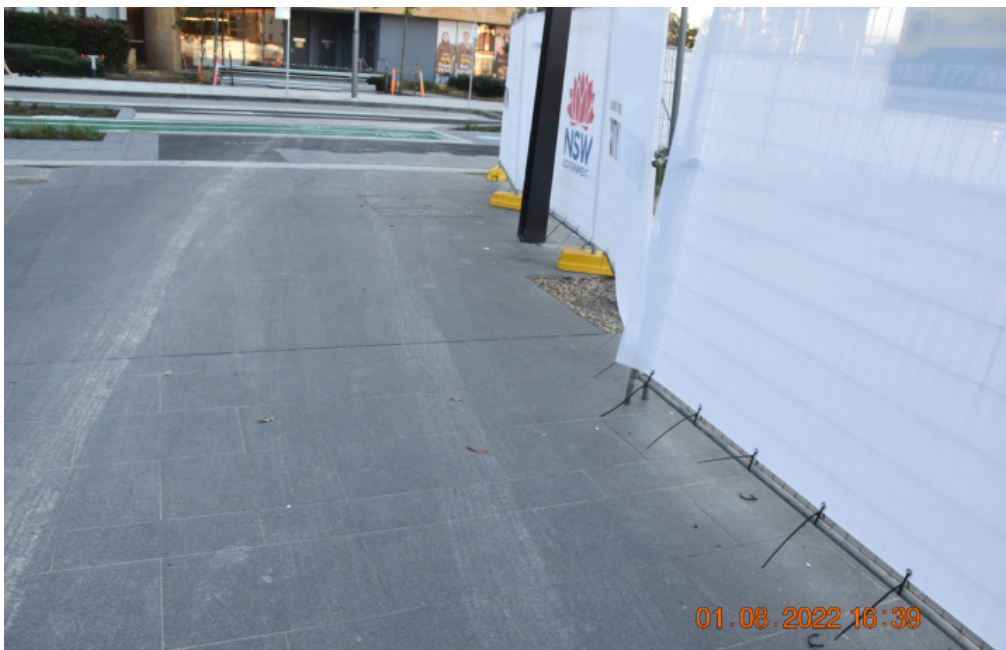
Figure: 0319

General view of the footpath in the lane way between 3 Joynton Avenue and 130 Portman Street, at approximately 55 meters from the south end.

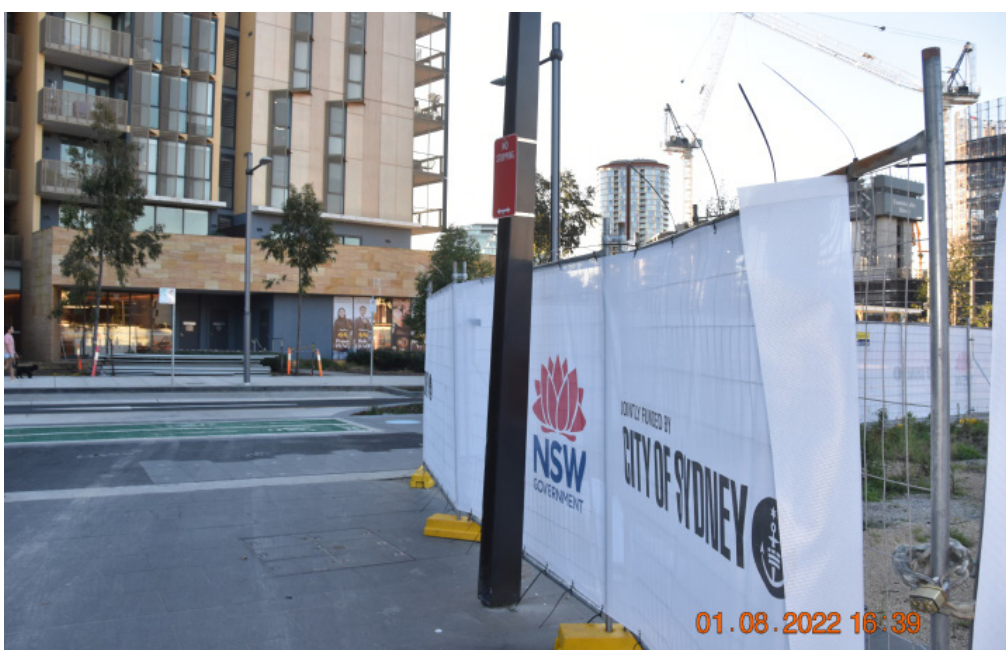
Figure: 0320

General view of the footpath in the lane way between 3 Joynton Avenue and 130 Portman Street, at approximately 55 meters from the south end.

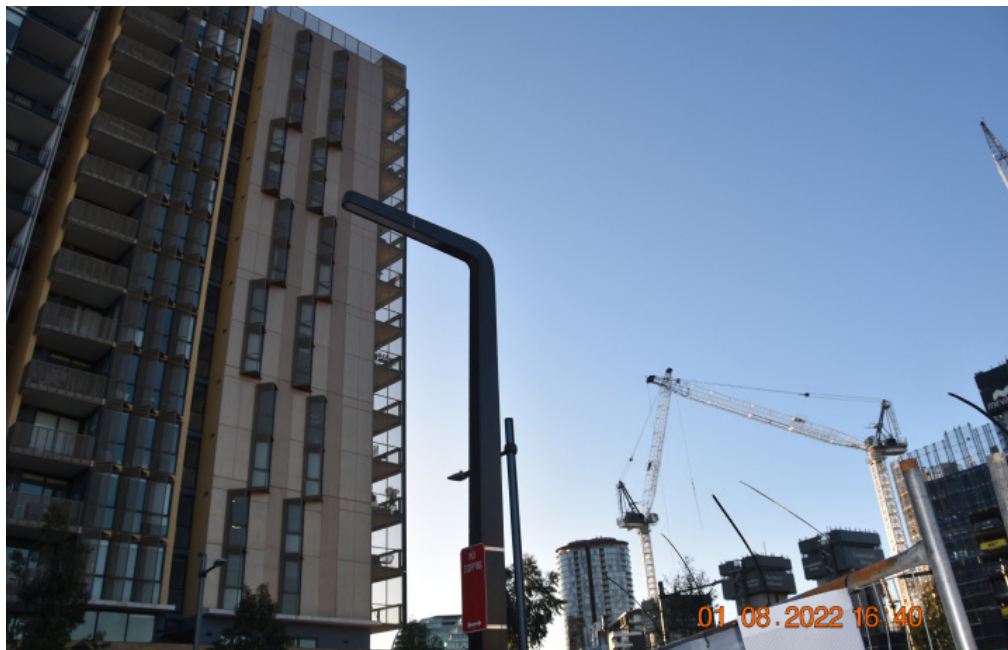
Figure: 0321

General view of the sign post in the lane way between 3 Joynton Avenue and 130 Portman Street, at approximately 55 meters from the south end.

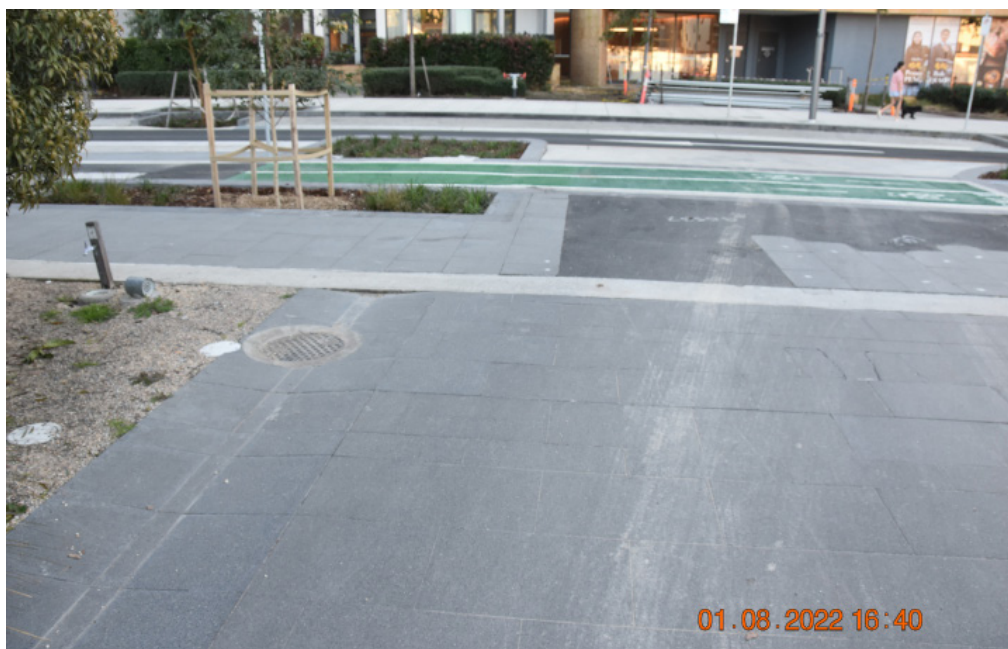
Figure: 0322

General view of the sign post in the lane way between 3 Joynton Avenue and 130 Portman Street, at approximately 55 meters from the south end.

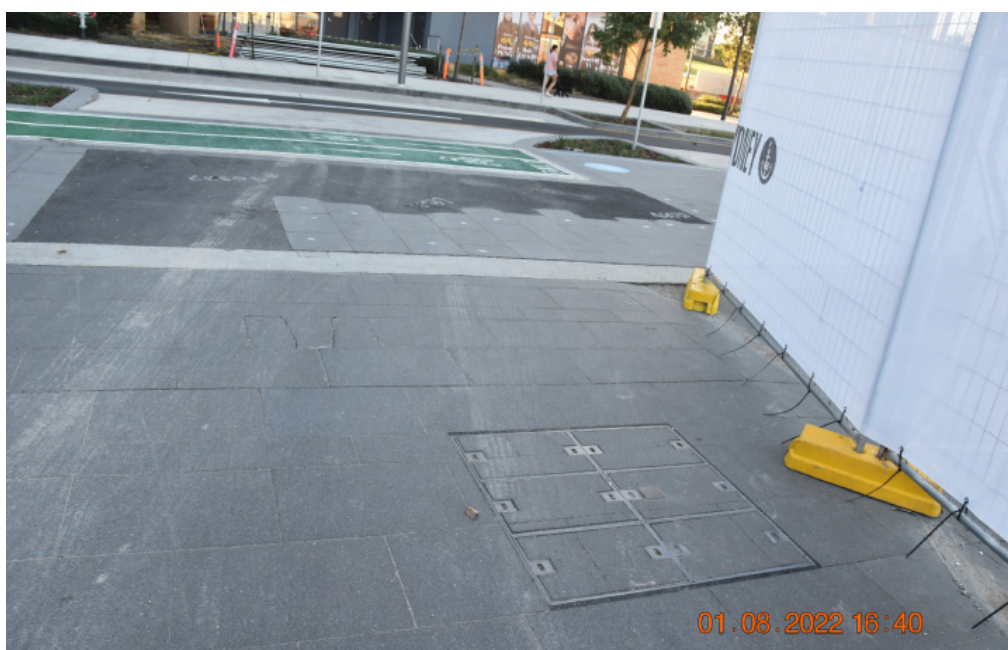
Figure: 0323

General view of the pathway in the lane way between 3 Joynton Avenue and 130 Portman Street, at approximately 60 meters from the south end.

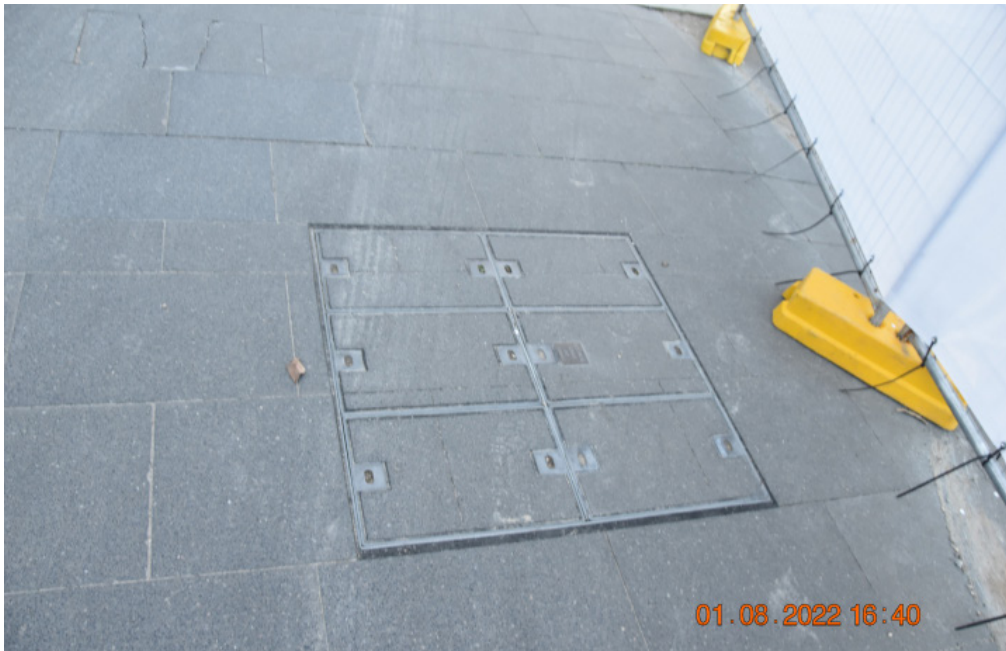
Figure: 0324

General view of the pathway in the lane way between 3 Joynton Avenue and 130 Portman Street, at approximately 60 meters from the south end.

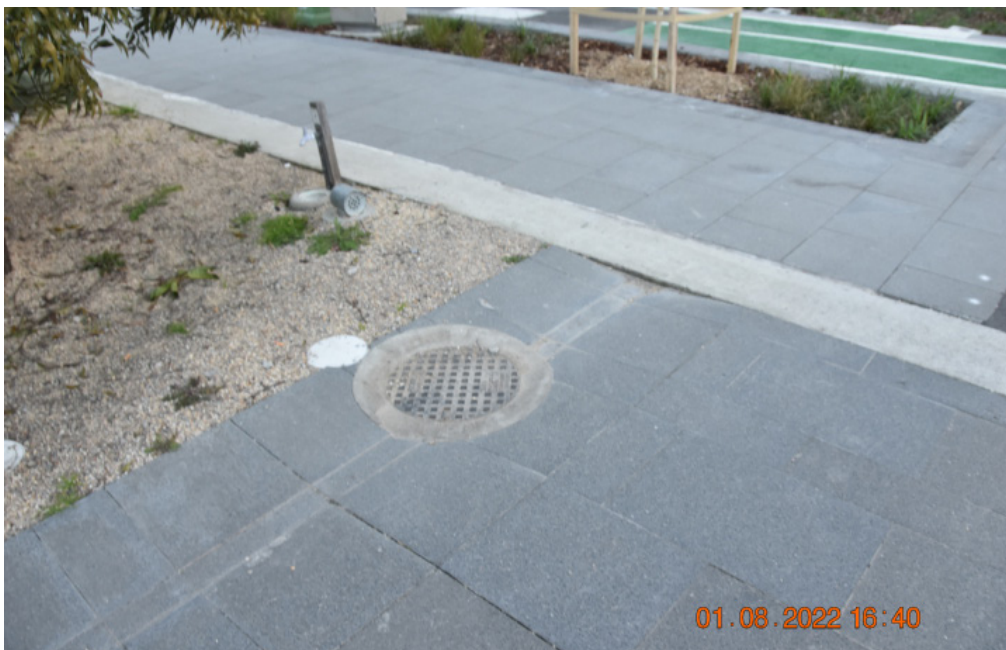
Figure: 0325

General view of the pit lid in the lane way between 3 Joynton Avenue and 130 Portman Street, at approximately 60 meters from the south end.

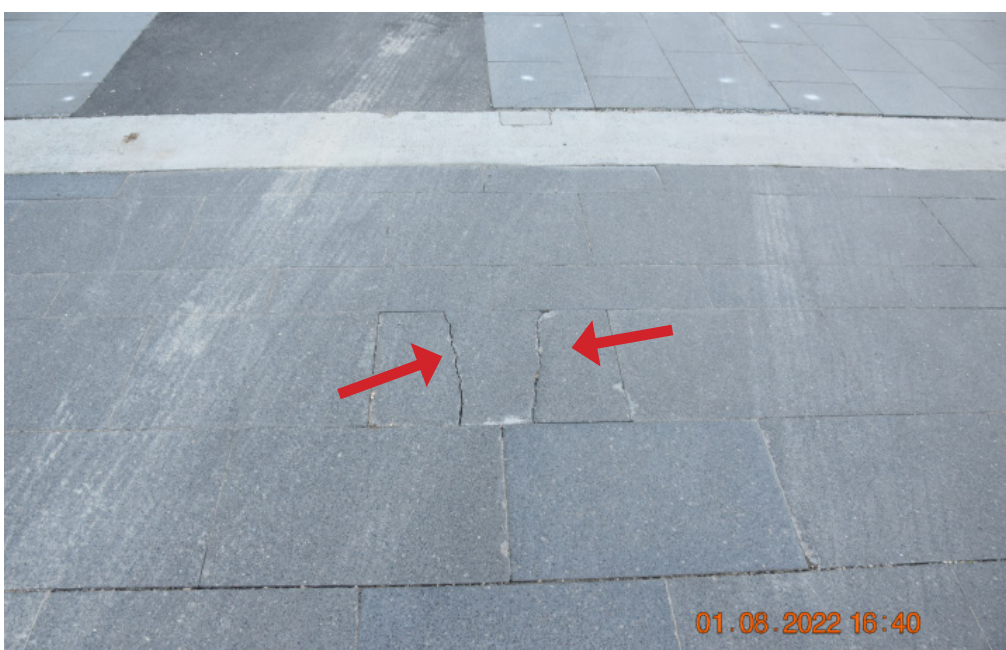
General view of the footpath in the lane way between 3 Joynton Avenue and 130 Portman Street, at approximately 60 meters from the south end. Showing fine cracking.

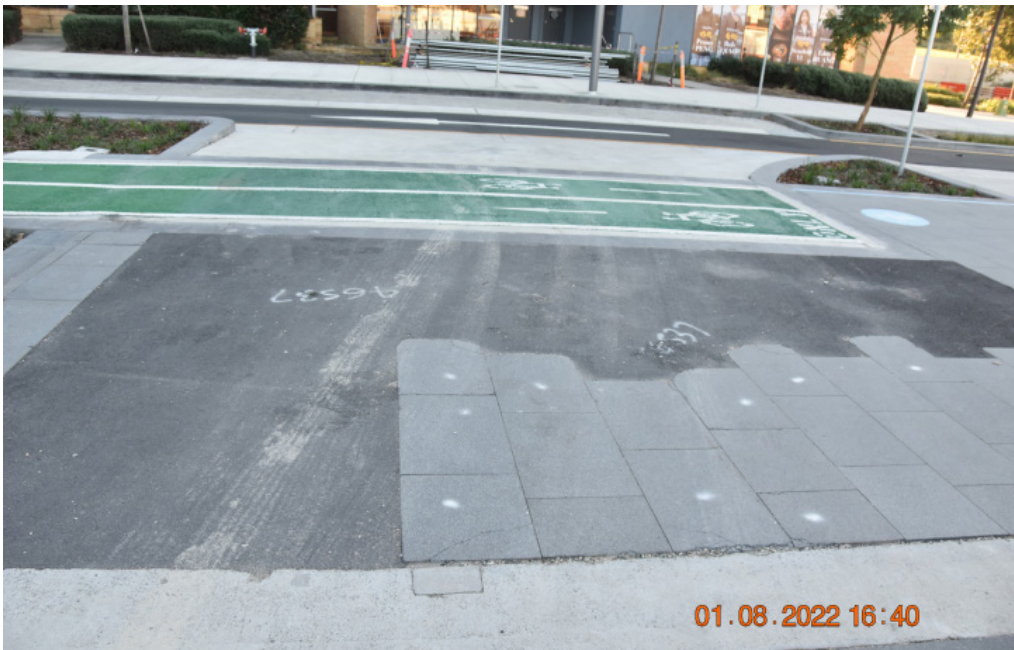
Figure: 0328

General view of the footpath in the lane way between 3 Joynton Avenue and 130 Portman Street, north end.

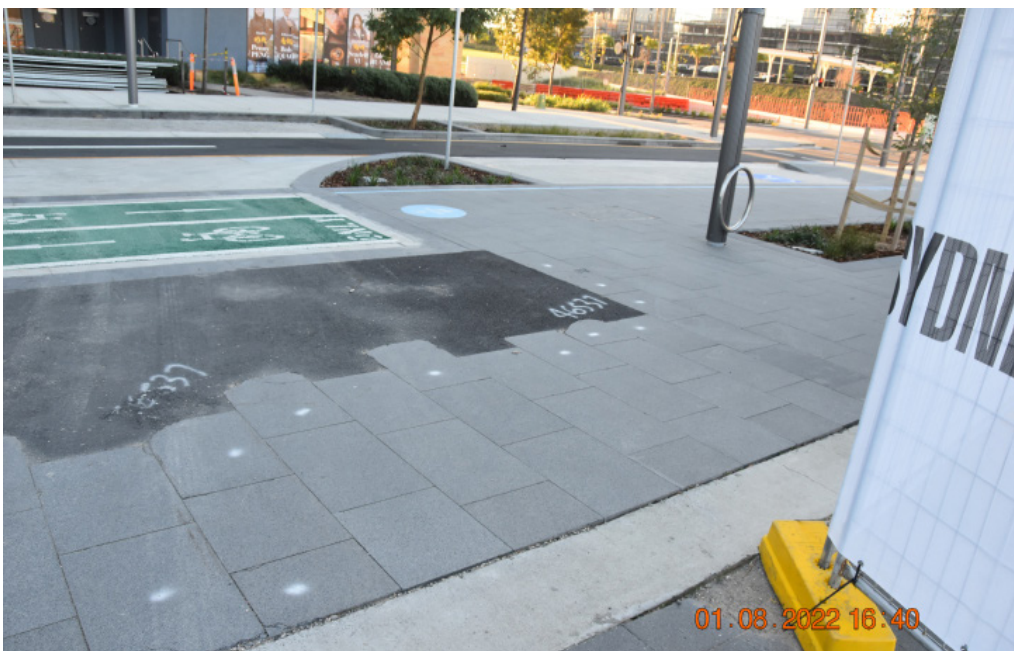
Figure: 0329

General view of the footpath in the lane way between 3 Joynton Avenue and 130 Portman Street, north end.

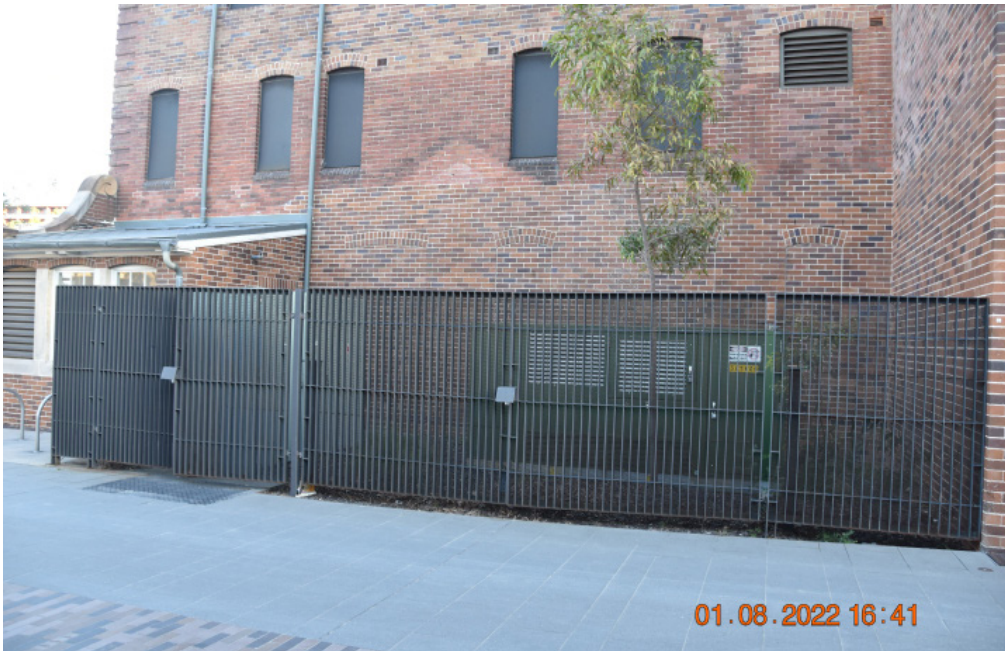
Figure: 0332

General view of the
main switch board
outside 130 Portman
Street.

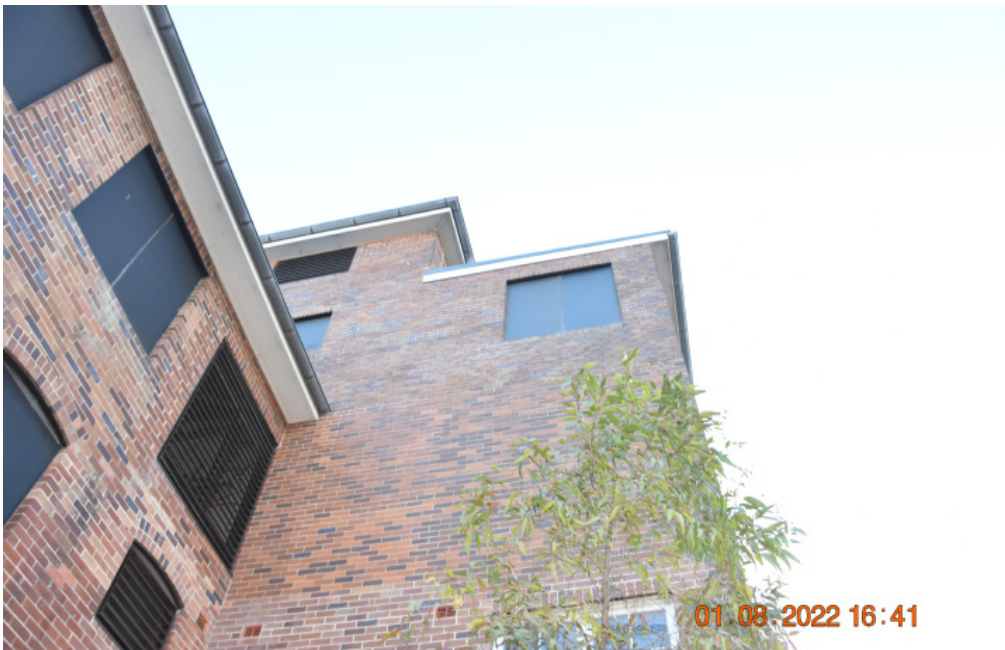
Figure: 0333

North wall outside
130 Portman Street.

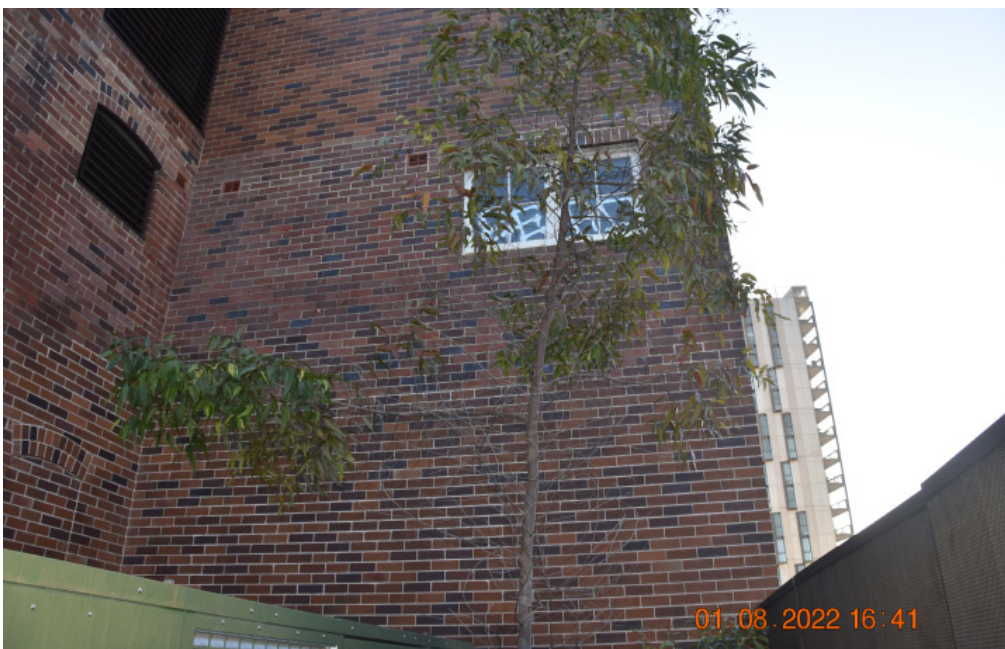
Figure: 0334

North wall outside
130 Portman Street.

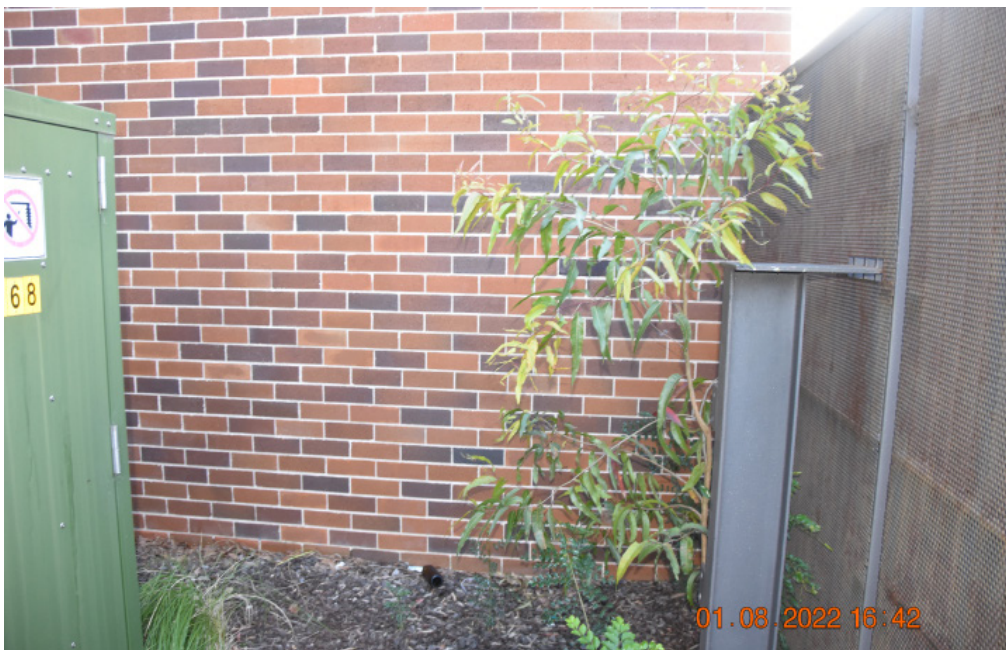
Figure: 0335

North wall outside
130 Portman Street.

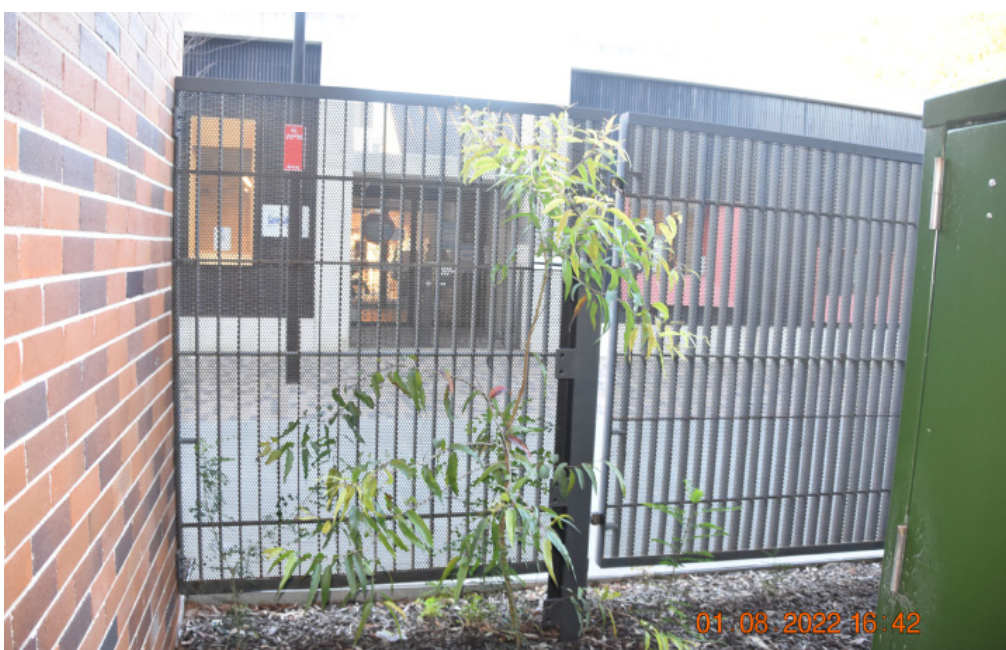
Figure: 0336

North wall outside
130 Portman Street.

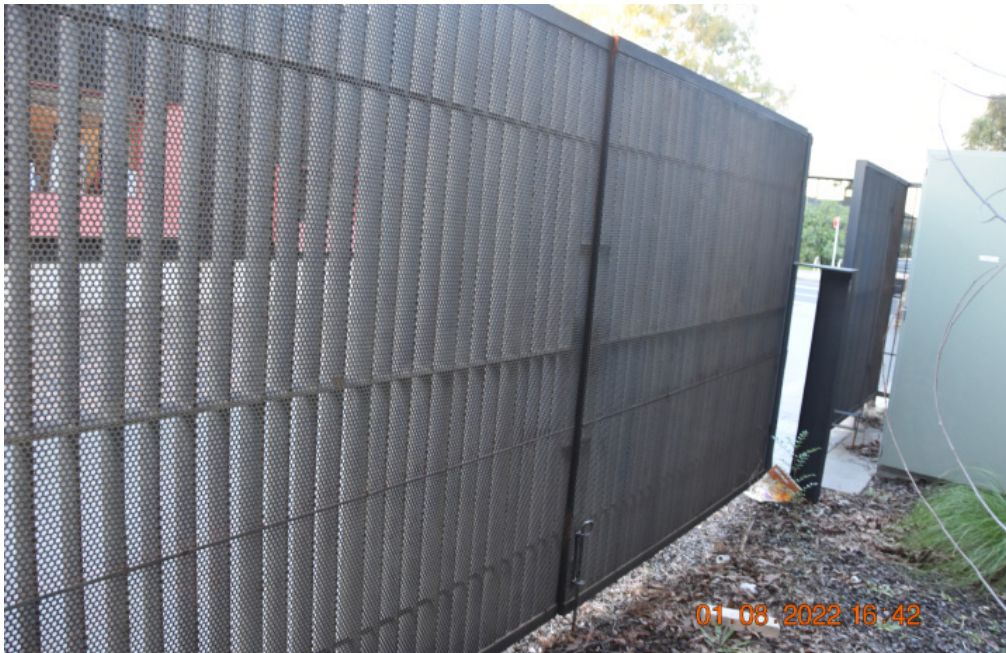
Figure: 0337

East fence outside
130 Portman Street.

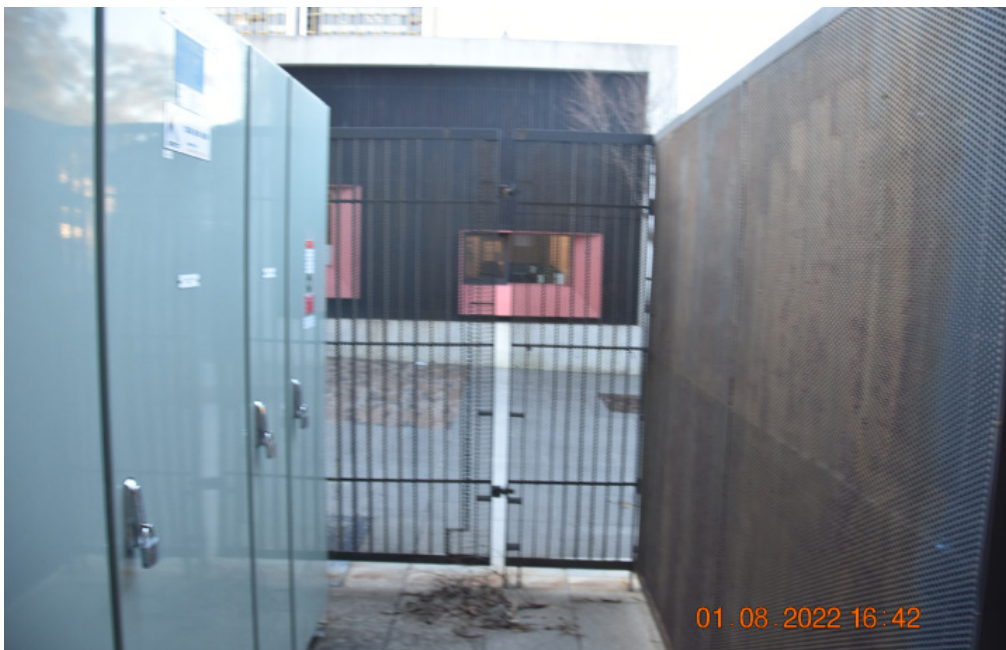
Figure: 0338

East fence outside
130 Portman Street.

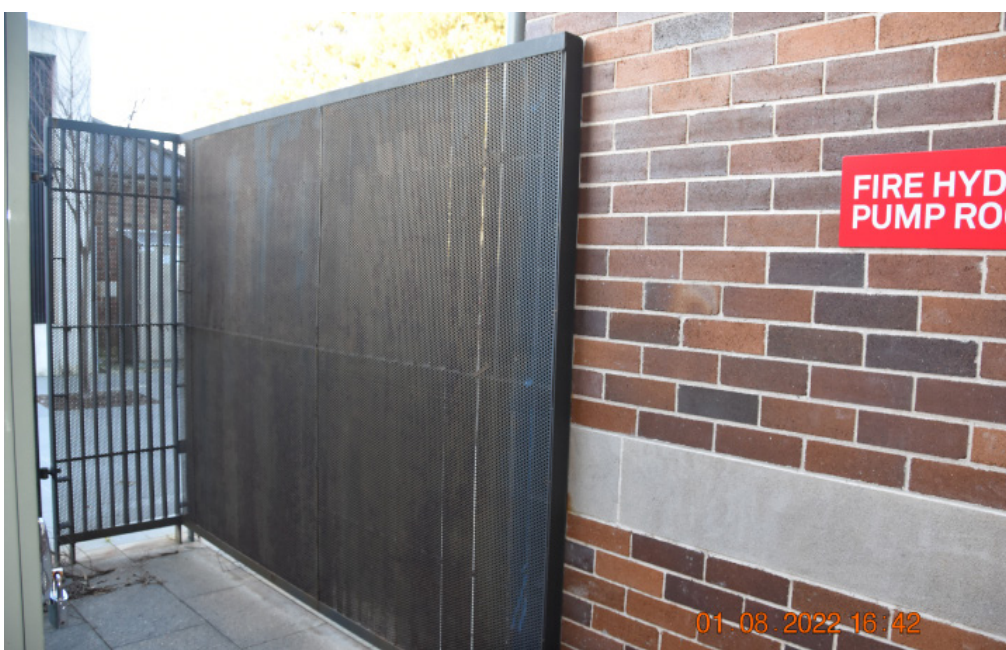
Figure: 0339

East fence outside
130 Portman Street.

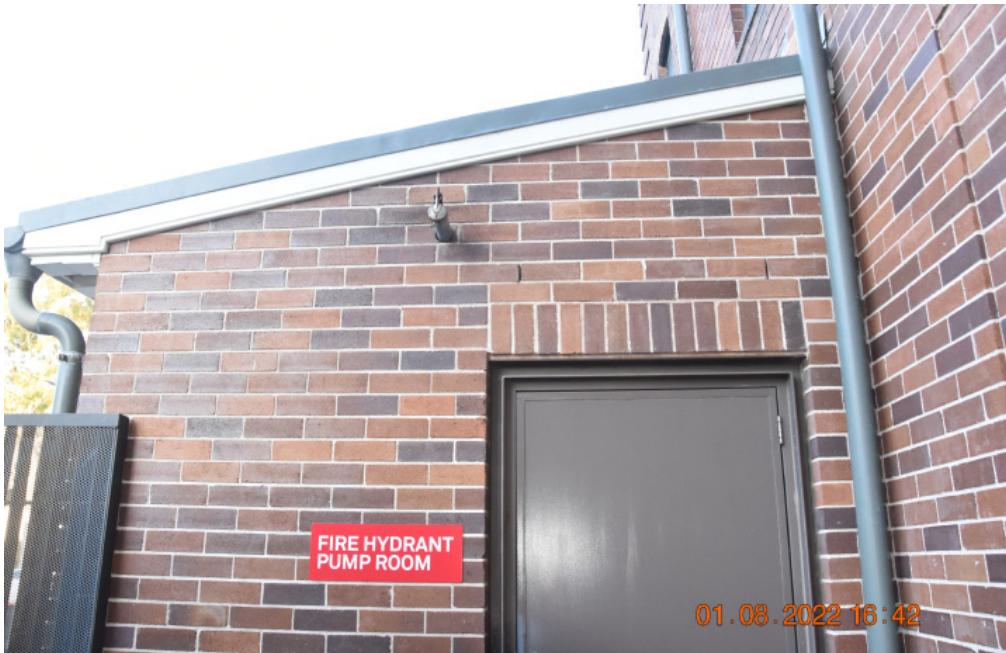
Figure: 0340

East fence outside
130 Portman Street.

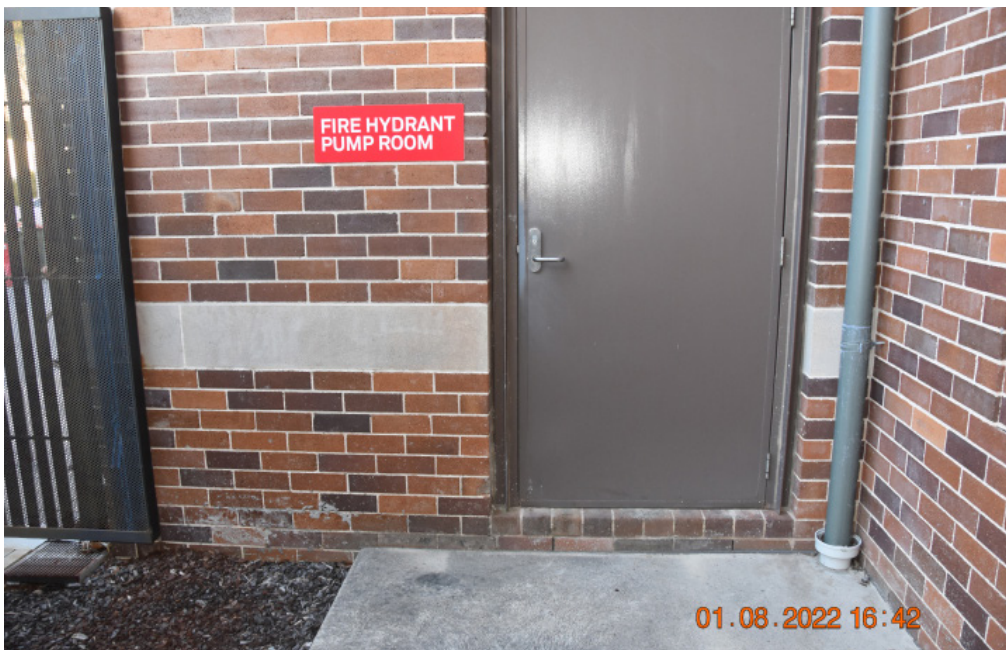
Figure: 0341

South wall outside
130 Portman Street.
