PRE CONSTRUCTION CONDITION SURVEY

Green Square Integrated Community Facility &
School - 3 Joynton Avenue, Zetland NSW

Council Assets
3 Joynton Avenue and Portman Street
ZETLAND NSW 2017

01 August 2022

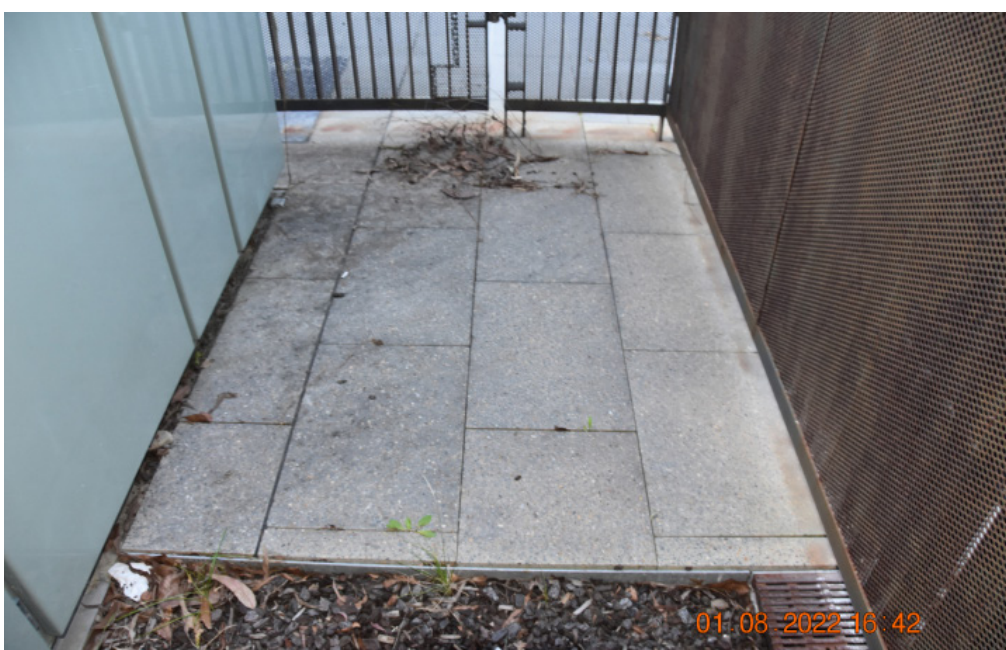
Figure: 0342

South wall outside
130 Portman Street.

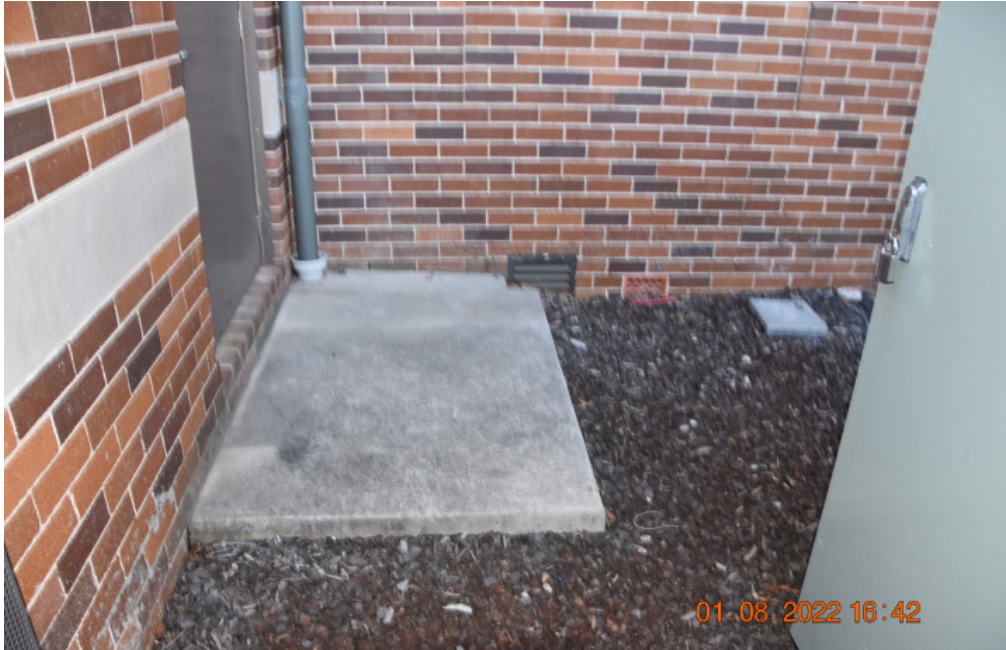
Figure: 0343

Tile paving at the
southeast corner
outside 130 Portman
Street.

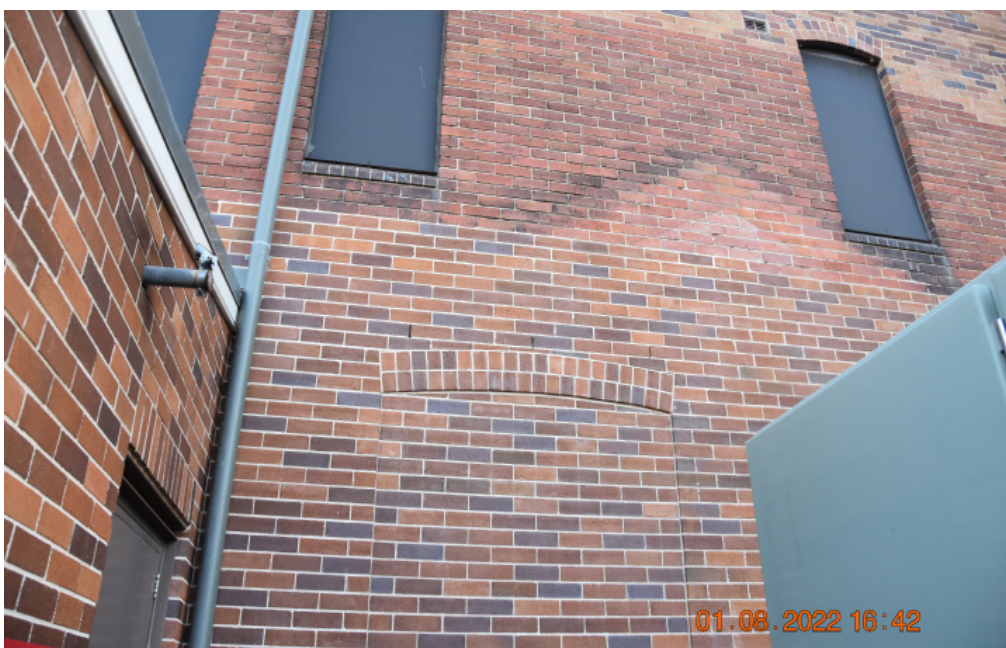
Figure: 0345

West wall outside 130 Portman Street.

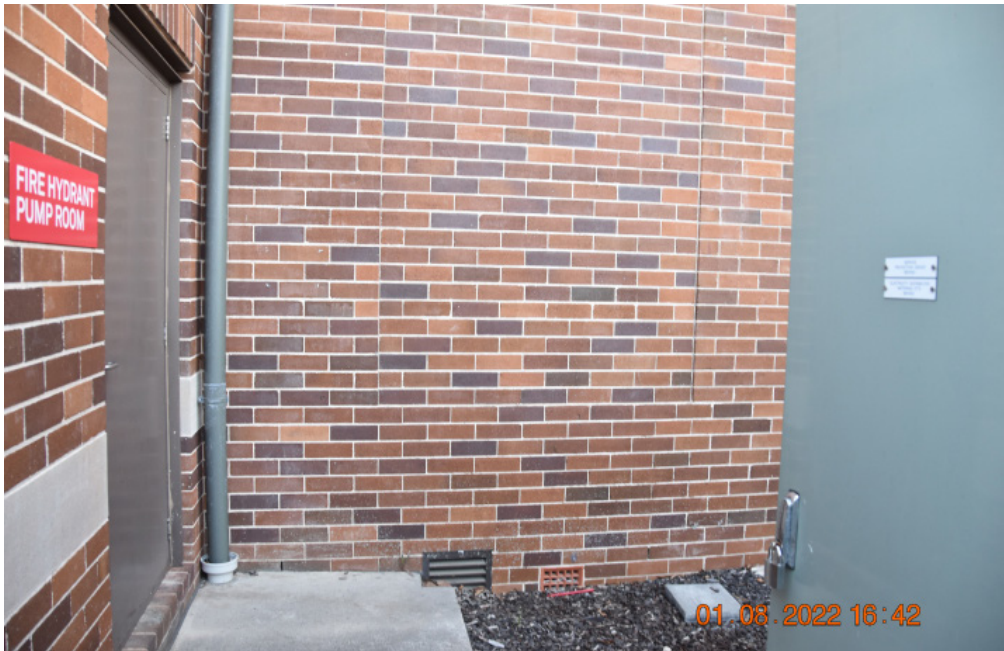
Figure: 0346

West wall outside 130 Portman Street.

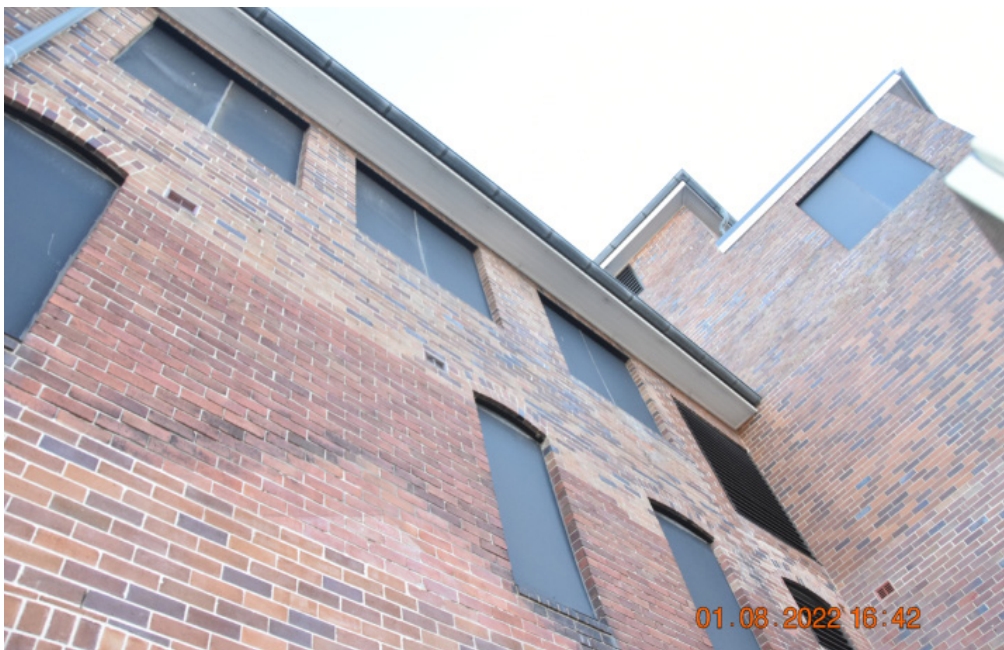
Figure: 0347

West wall outside 130
Portman Street.

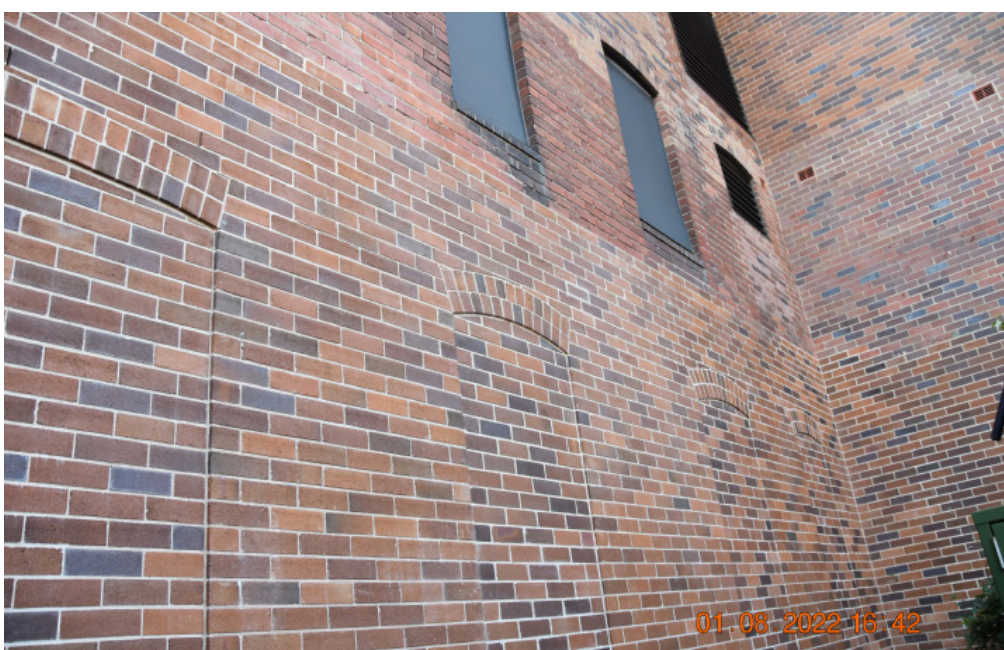
Figure: 0348

West wall outside 130
Portman Street.

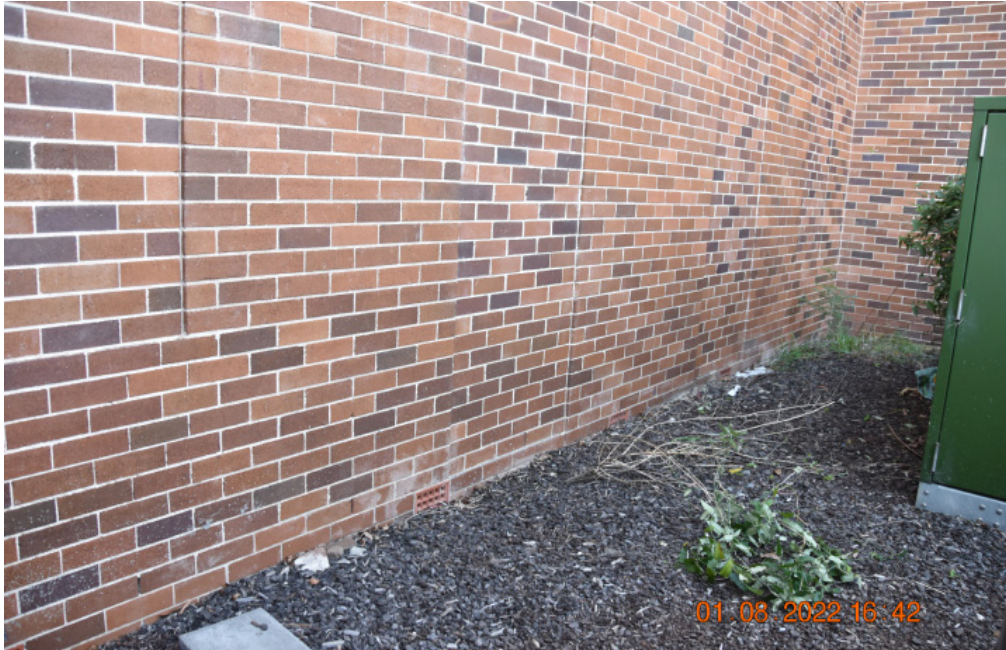
Figure: 0349

West wall outside 130
Portman Street.

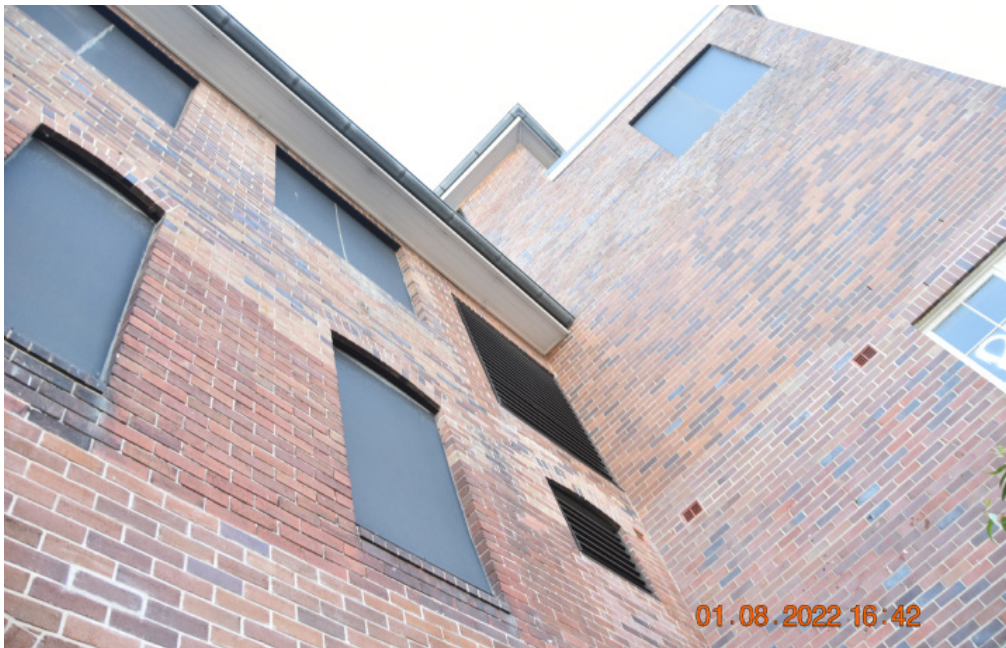
Figure: 0350

West wall outside 130
Portman Street.

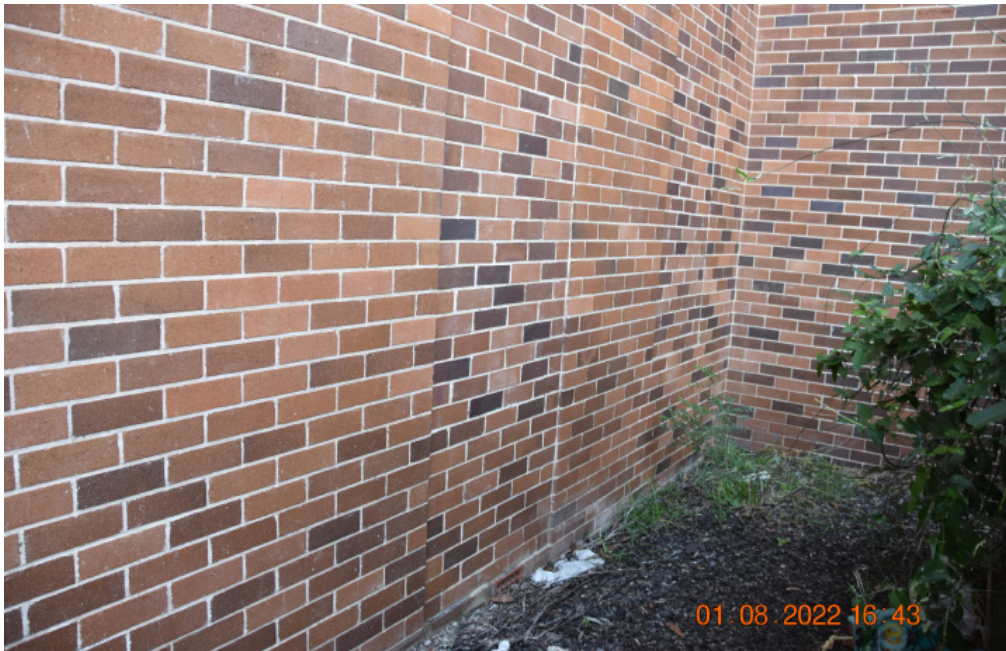
Figure: 0352

West wall outside 130
Portman Street.

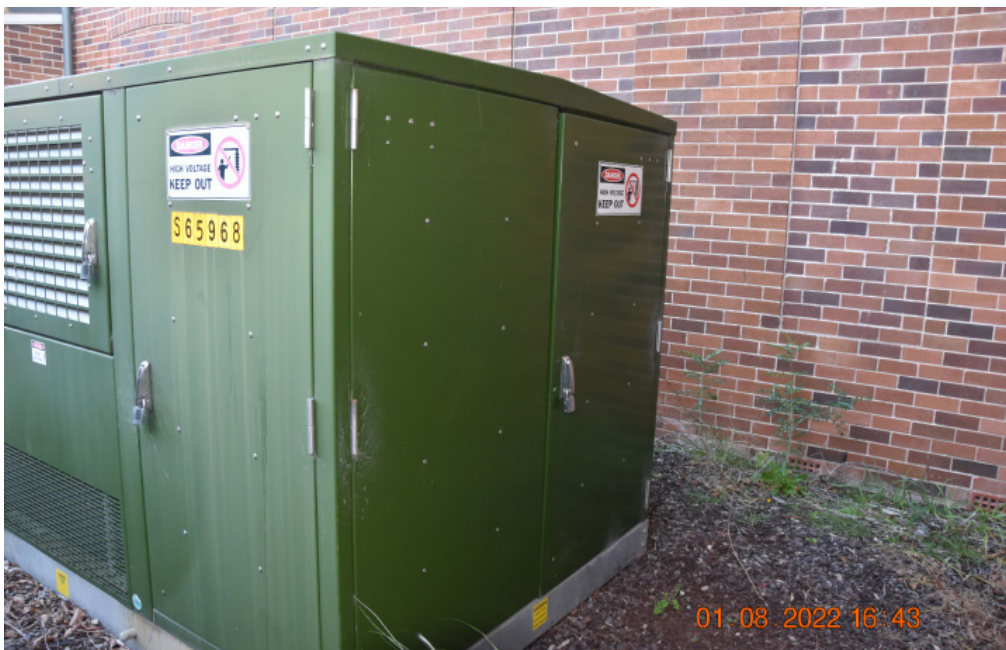
Figure: 0353

West wall outside 130 Portman Street.

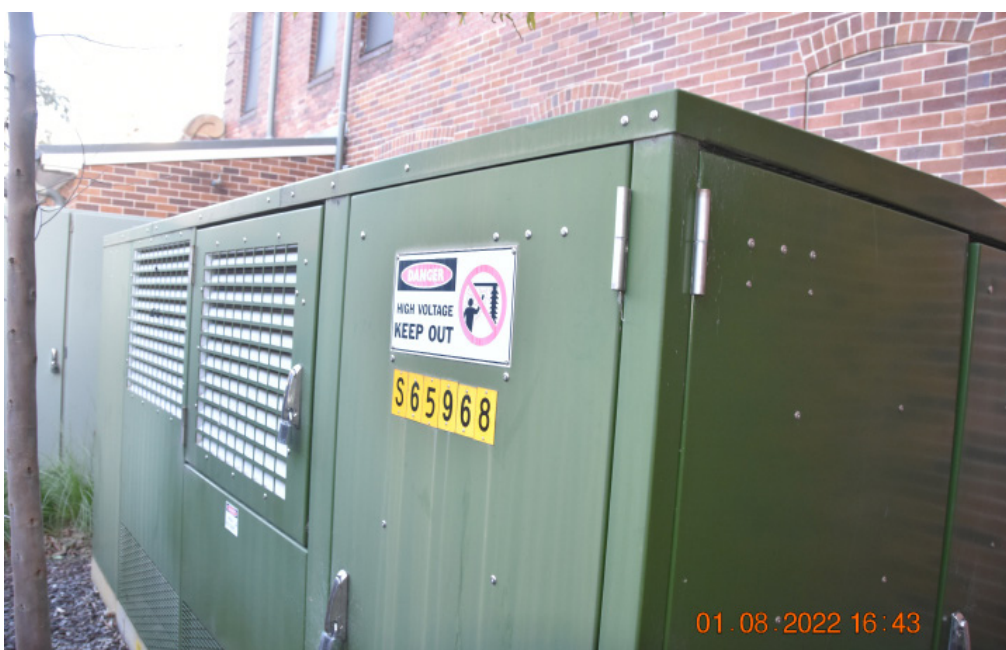
Figure: 0354

North side of the substation.

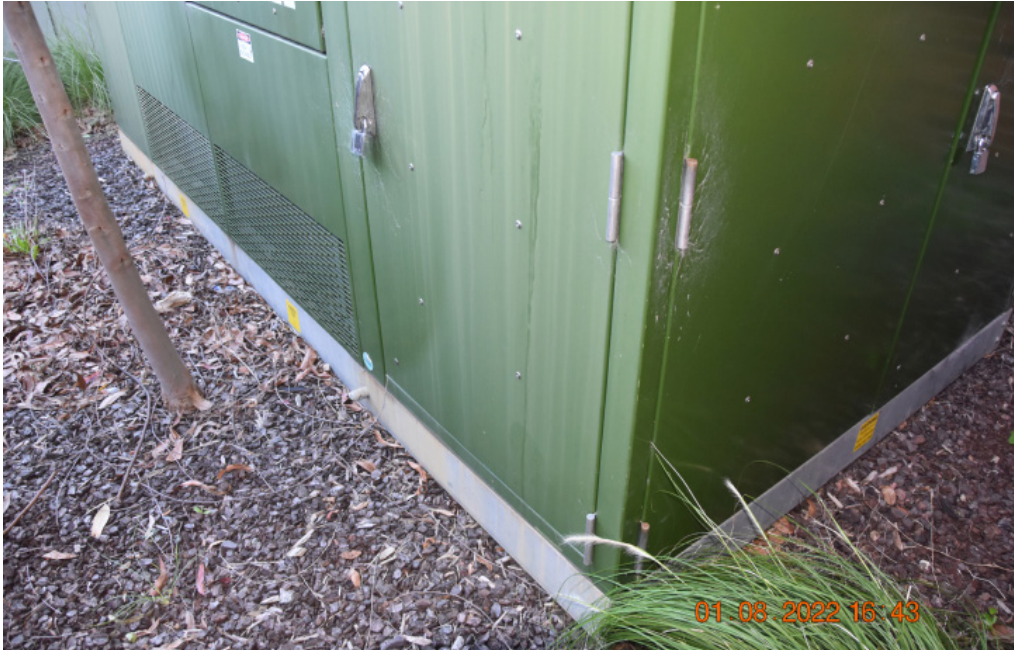
Figure: 0355

East side of the substation.

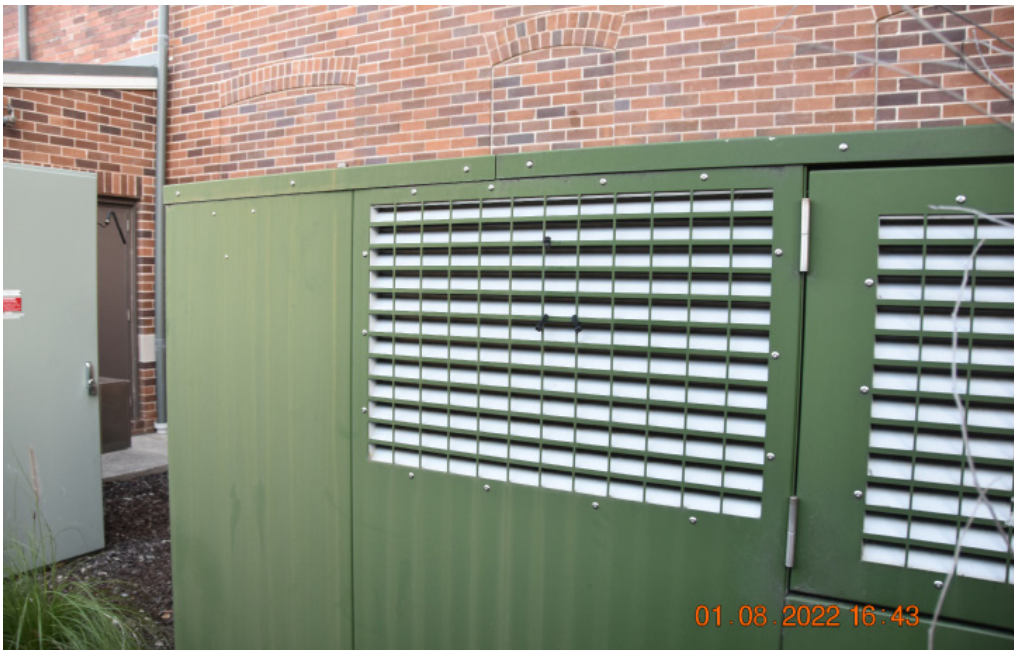
Figure: 0356

East side of the substation.

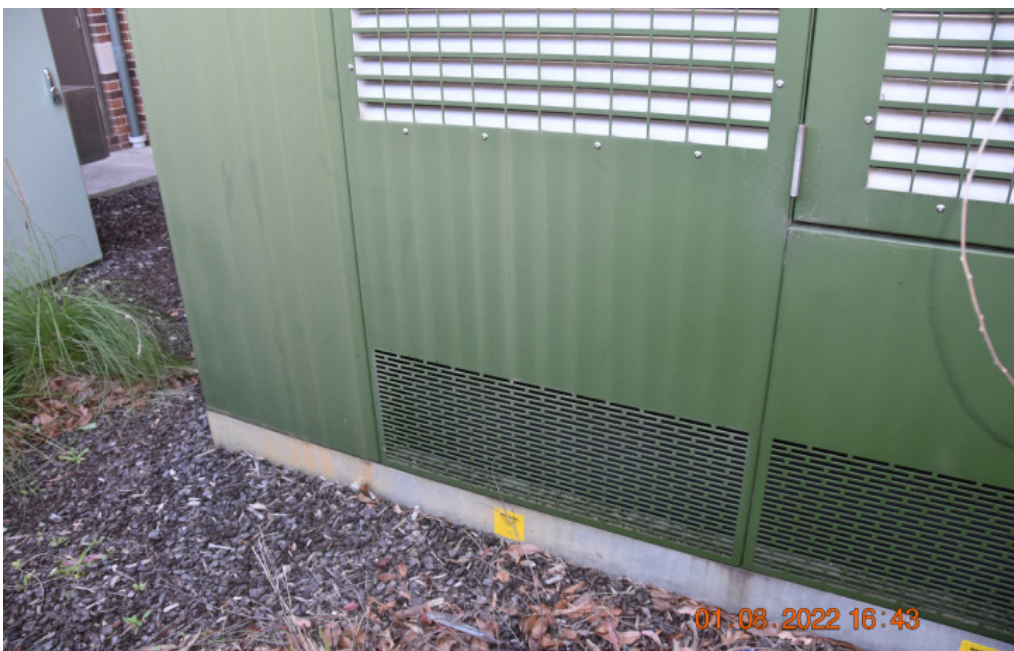
Figure: 0357

East side of the substation.

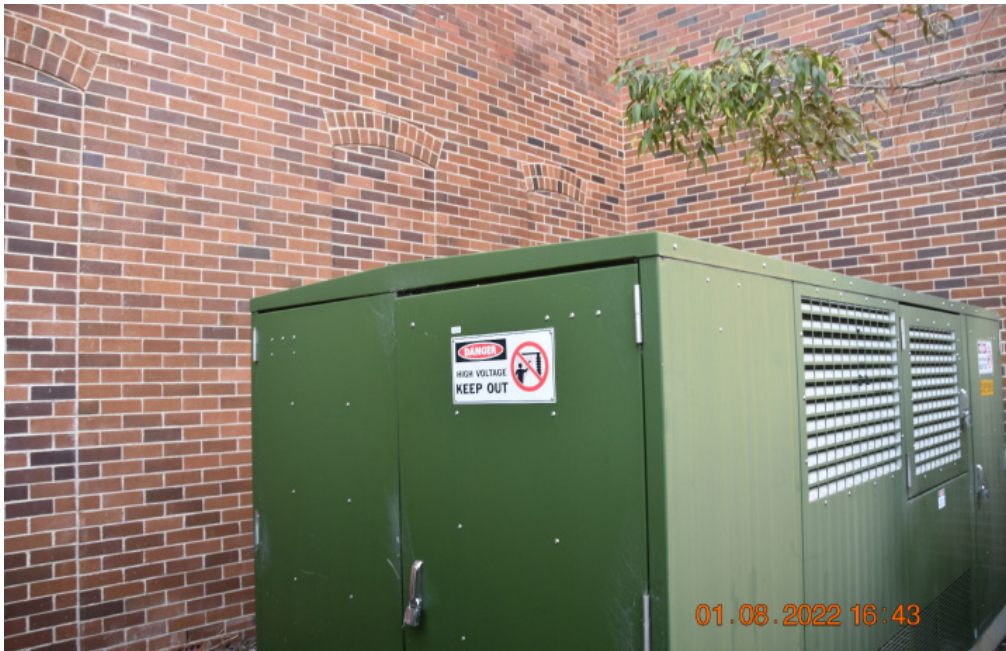
Figure: 0358

East side of the substation.

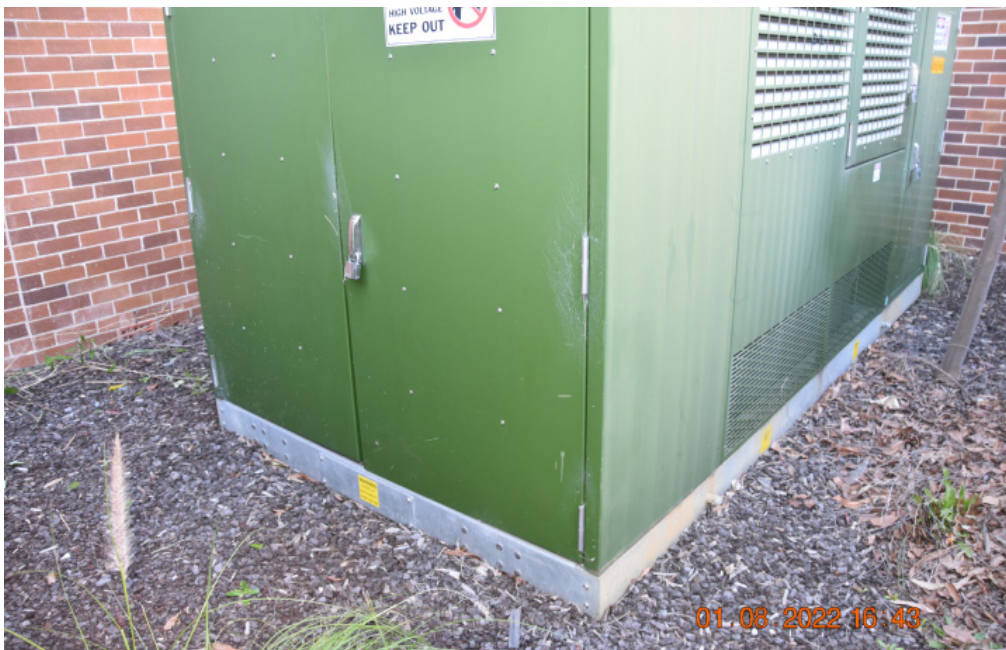
Figure: 0359

South side of the substation.

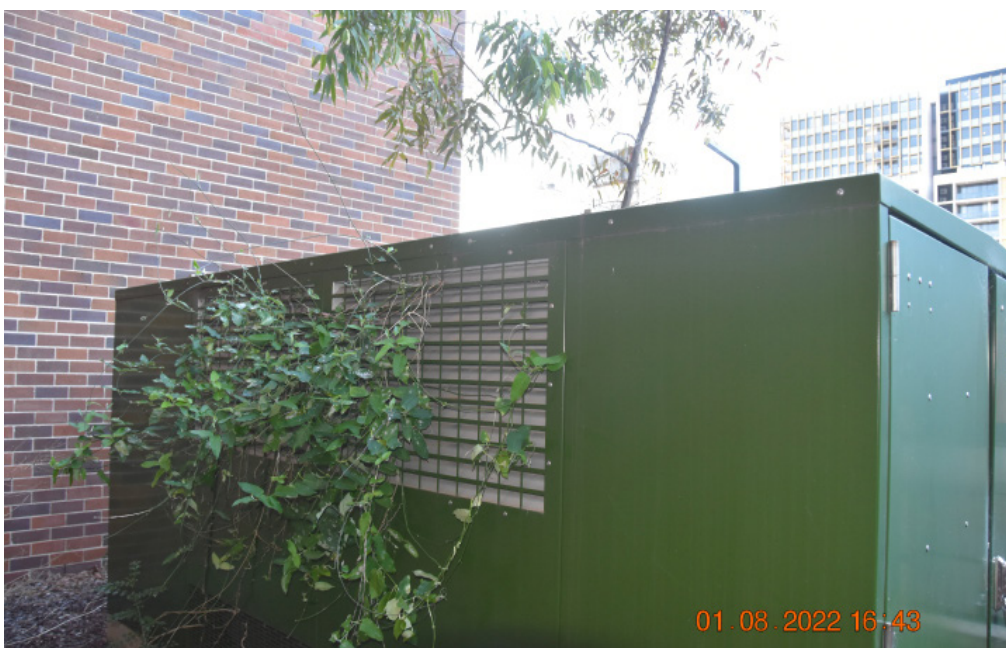
Figure: 0360

South side of the substation.

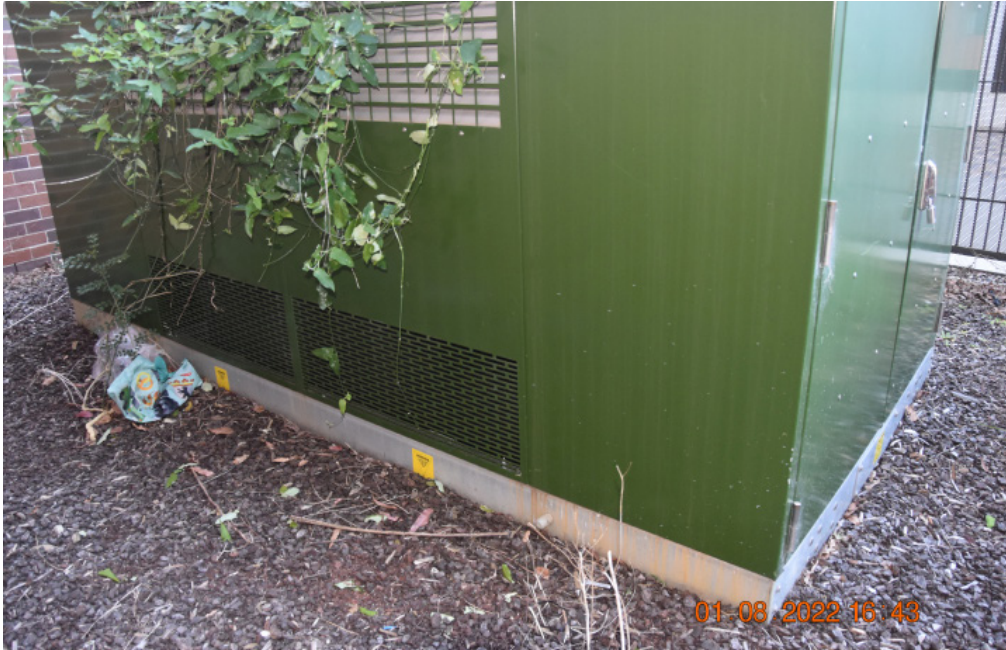
Figure: 0361

South side of the substation.

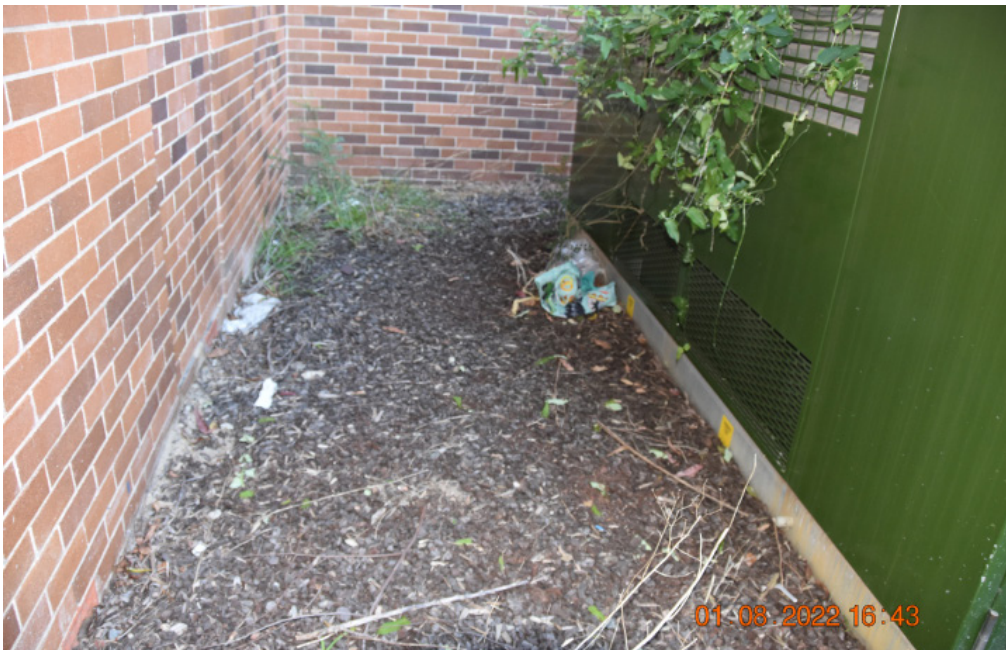
Figure: 0362

West side of the substation.

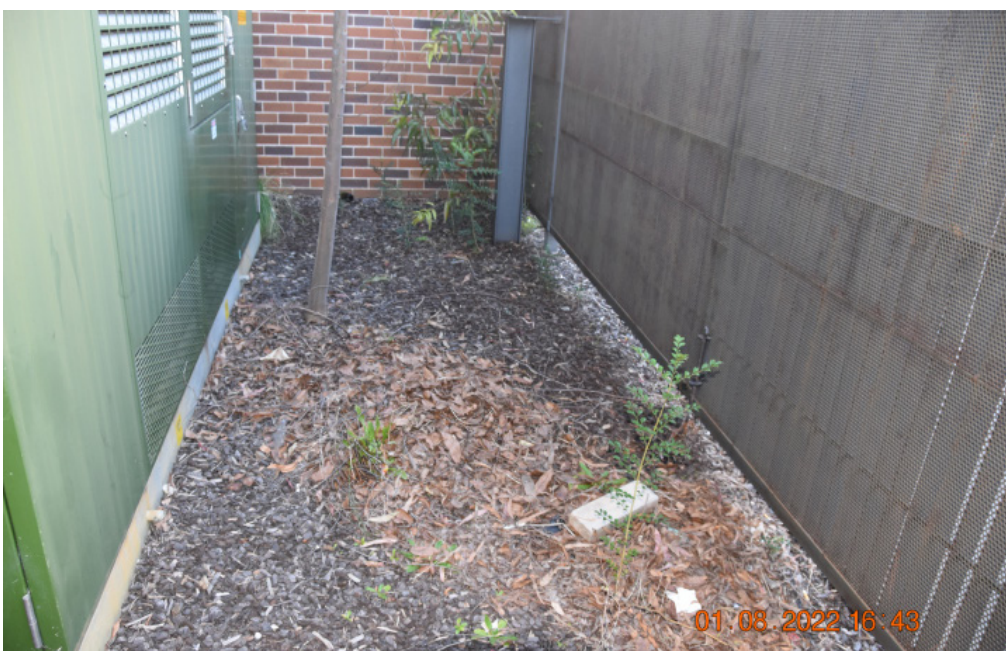
Figure: 0363

West side of the substation.

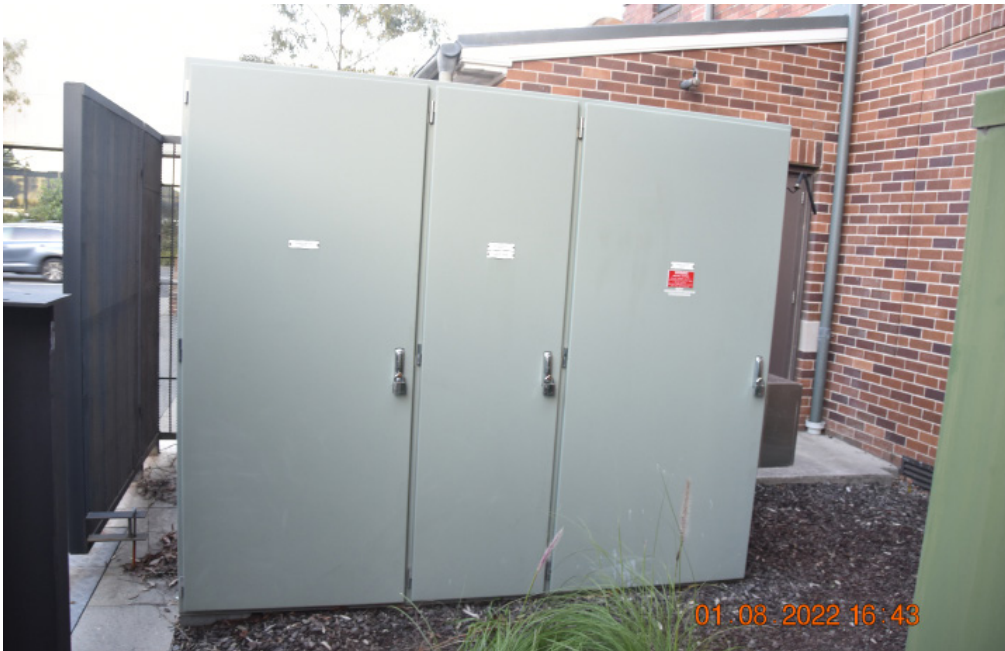
Figure: 0364

General view of the terrace adjacent to the substation.

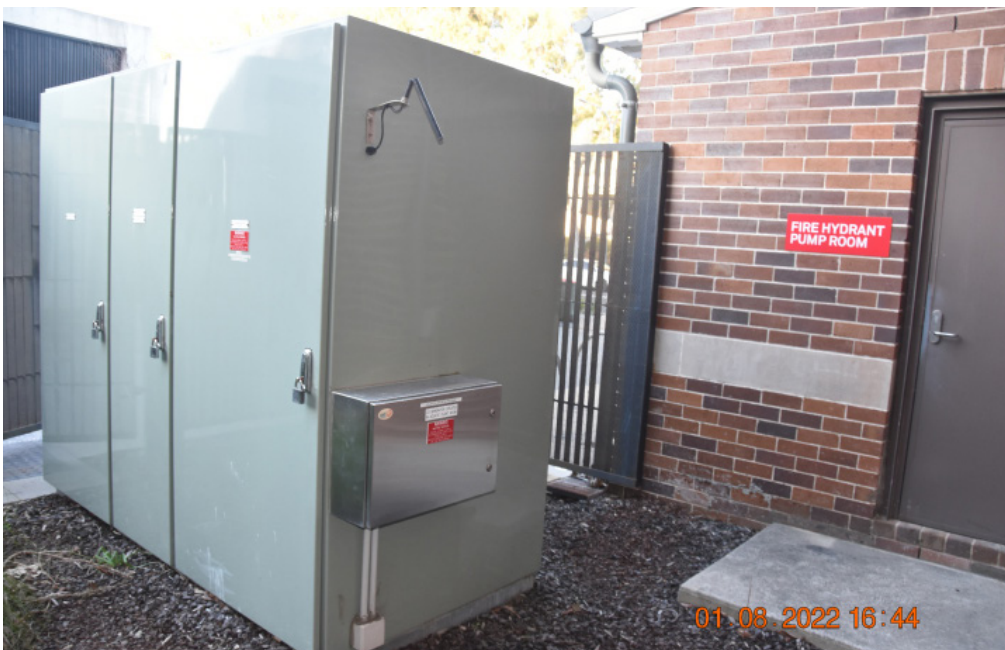
Figure: 0365

North side of the switch board.

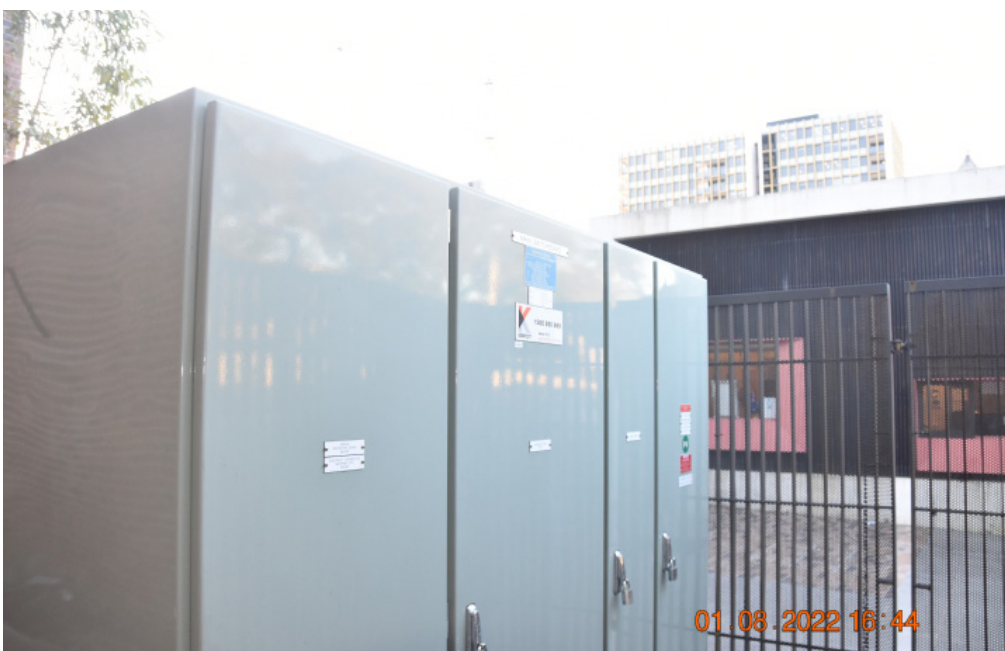
Figure: 0366

West side of the switch board.

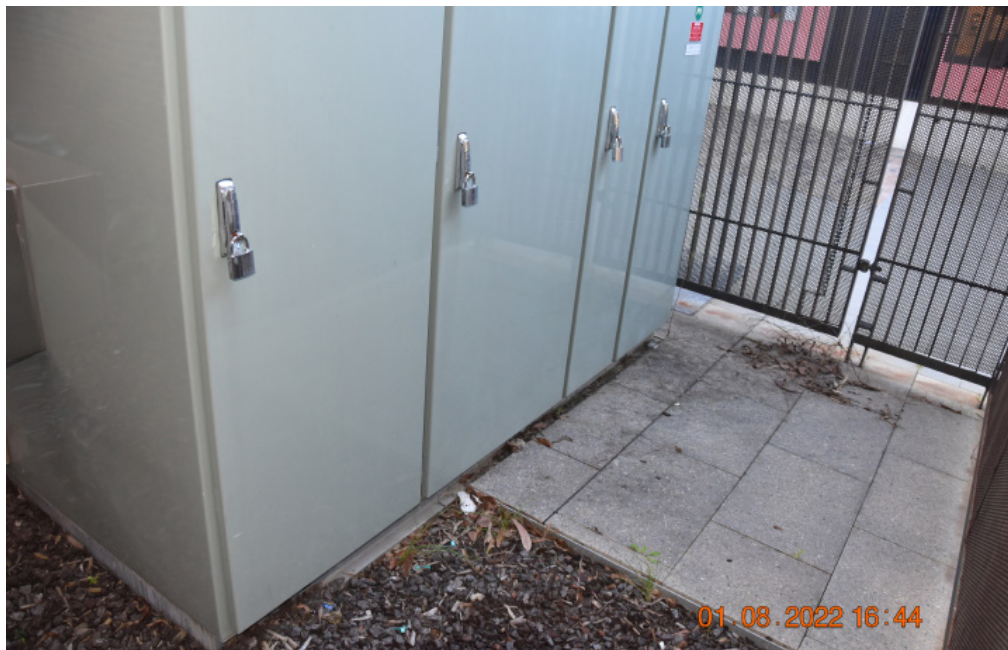
Figure: 0367

South side of the switch board.

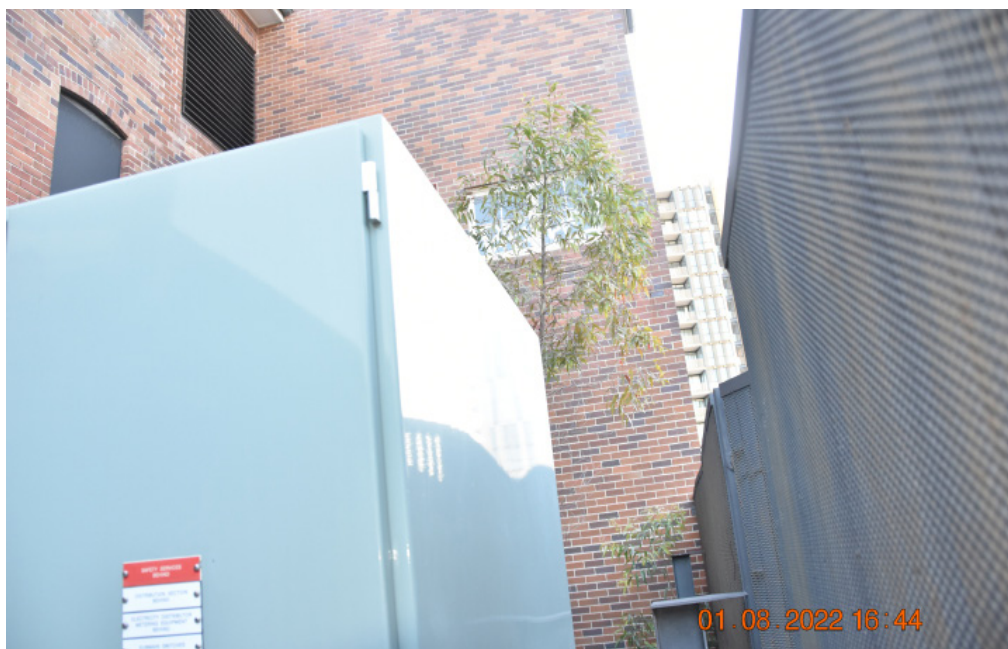
Figure: 0368

South side of the switch board.

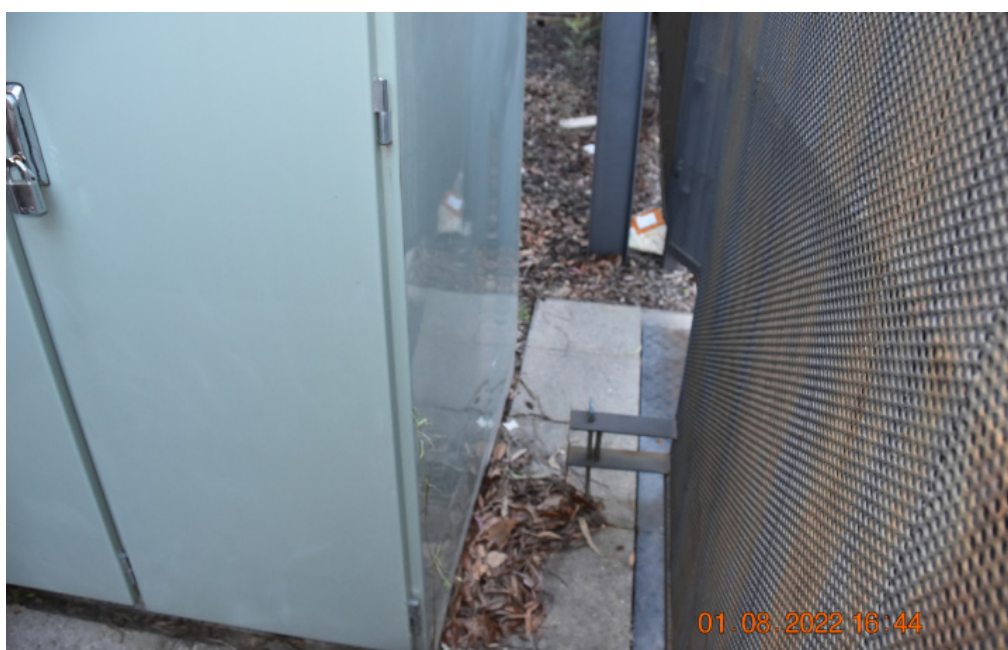
Figure: 0369

East side of the switch board.

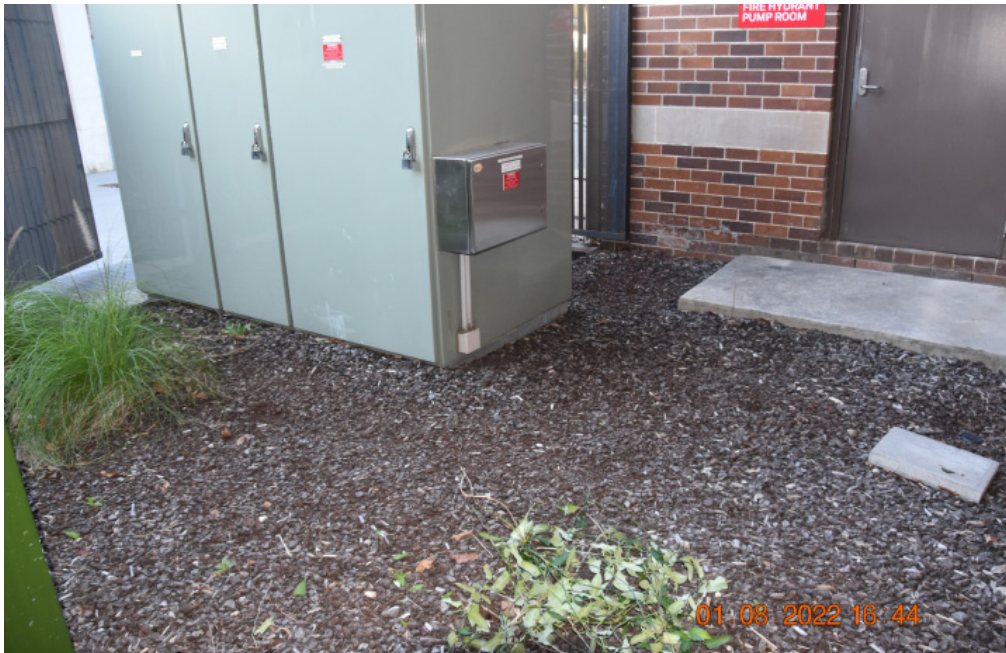
Figure: 0370

East side of the switch board.
