Construction Waste Management Sub-Plan

Gregory Hills Public School (SSD41306367)

Revision: 2

Date: 30/5/2023

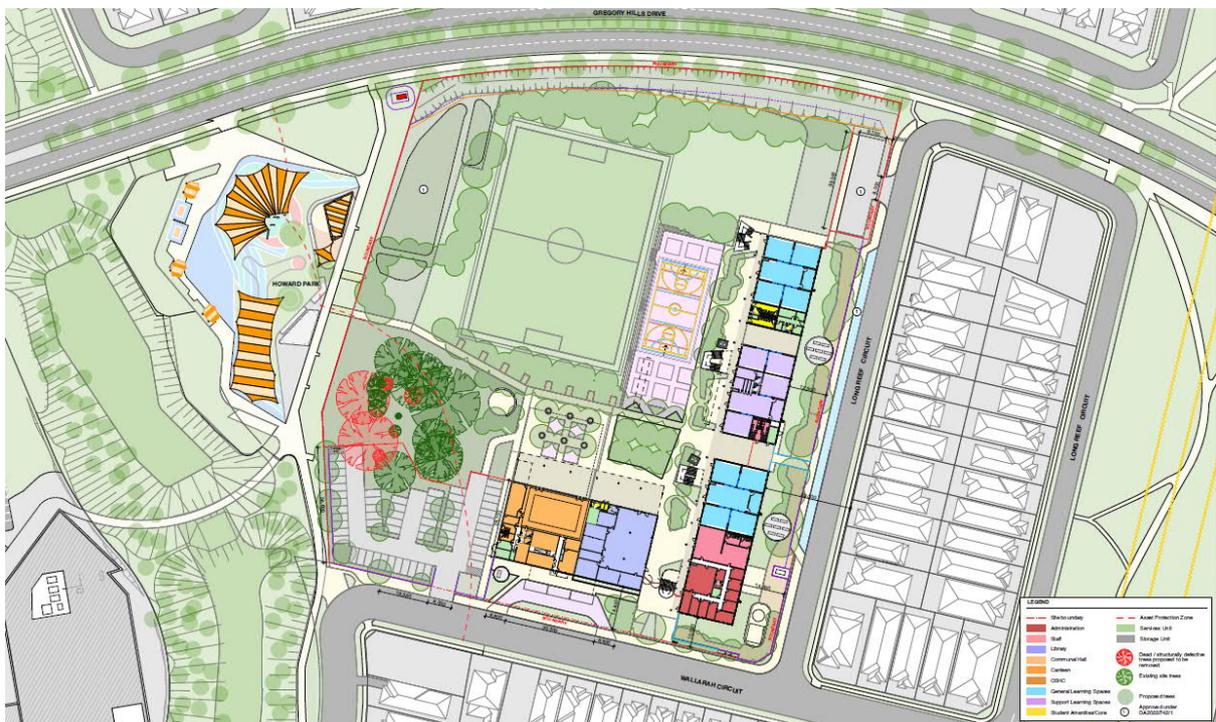
Figure 1 Site plan (source Bennett and Trimble)

- 44 General Learning Spaces;
- 4 Support Learning Spaces;
- Administration, staff hub, amenity and building service areas;
- Library, communal hall and canteen;

- Outside School Hours Care (OSHC) services;
- Sport courts, outdoor play space, a Covered Outdoor Learning Area (COLA) and site landscaping;
- Dedicated bicycle and scooter parking;
- Three (3) kiss and drop spaces for Supported Learning Students (SLS) located on Wallarah Circuit.
- On-site car parking.
- Signage.
- Footpath widening on Wallarah Circuit.
