Report on
Geotechnical Investigation

Proposed Hastings Secondary College Port Macquarie
Campus Upgrade
16 Owen Street, Port Macquarie

Prepared for
School Infrastructure NSW
c/- Currie & Brown

Project 89754.03
May 2021

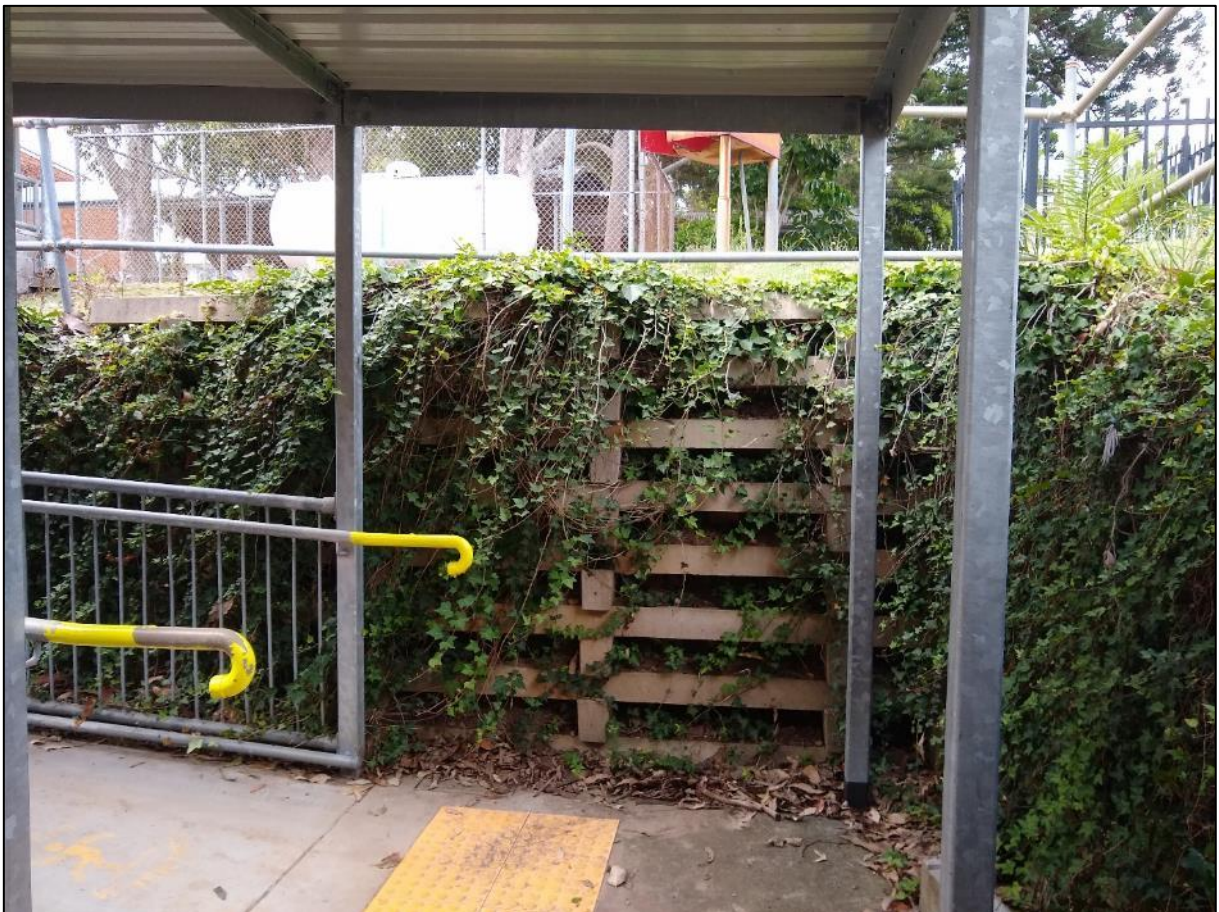
Figure 7: View of retaining wall along the northern boundary of Area 2

It should be noted that a retaining wall up to 2 m in height was observed near the proposed CAPA building (Area 2, refer Figure 7). All footings should be founded below a 45° line from the toe of the wall unless the retaining wall has been designed to accommodate the additional load from the building.

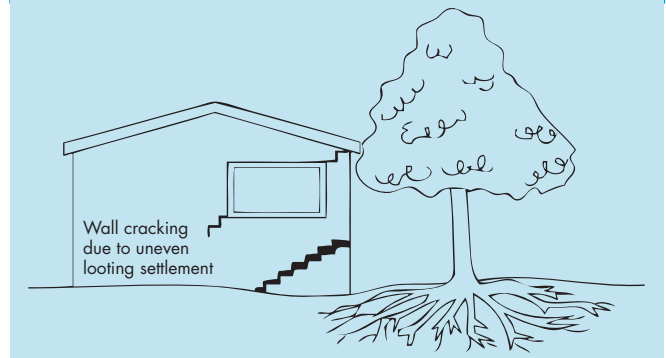
Trees can cause shrinkage and damage

As the weather pattern changes and the soil begins to dry out, the external footings will be first affected, beginning with the locations where the sun's effect is strongest. This has the effect of lowering the

external footings. The doming is accentuated and cracking reduces or disappears where it occurred because of dishing, but other cracks open up. The roof lines may become convex.

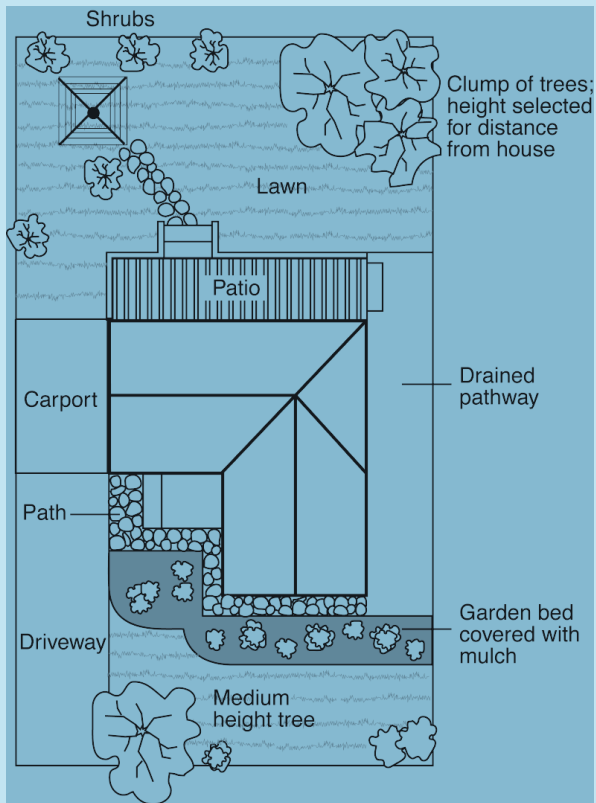
Gardens for a reactive site

extend outwards a minimum of 900 mm (more in highly reactive soil) and should have a minimum fall away from the building of 1:60. The finished paving should be no less than 100 mm below brick vent bases.
