Report on
Preliminary Site Investigation for Contamination

Proposed Hastings Secondary College Port Macquarie
Campus Upgrade
16 Owen Street, Port Macquarie

Project 89754.03
May 2021

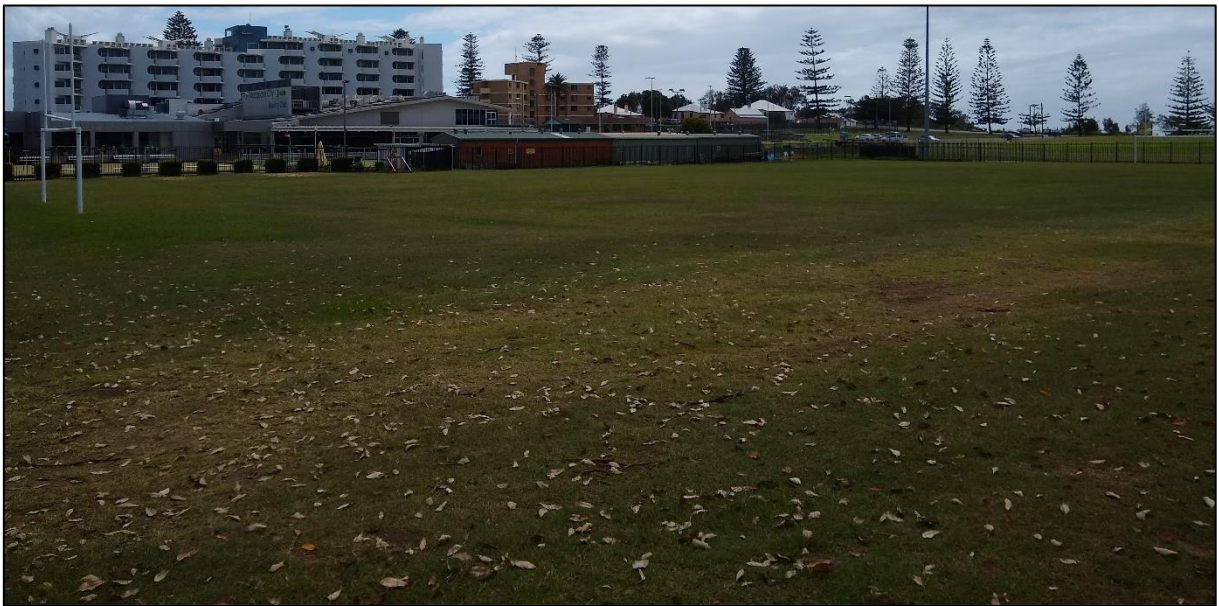
- The proposed building footprint is located within the existing grassed playing fields (refer to Figure 6 and 7);
- Site vegetation mainly consisted of a good covering of grass with a few mature trees on the north-western corner. Some localised bare areas were present which are likely to be associated with normal wear and tear of the sporting fields;

Figure 6: View from south west corner of proposed PCYC building - looking north-east at playing fields, Hastings Secondary College – Port Macquarie Campus

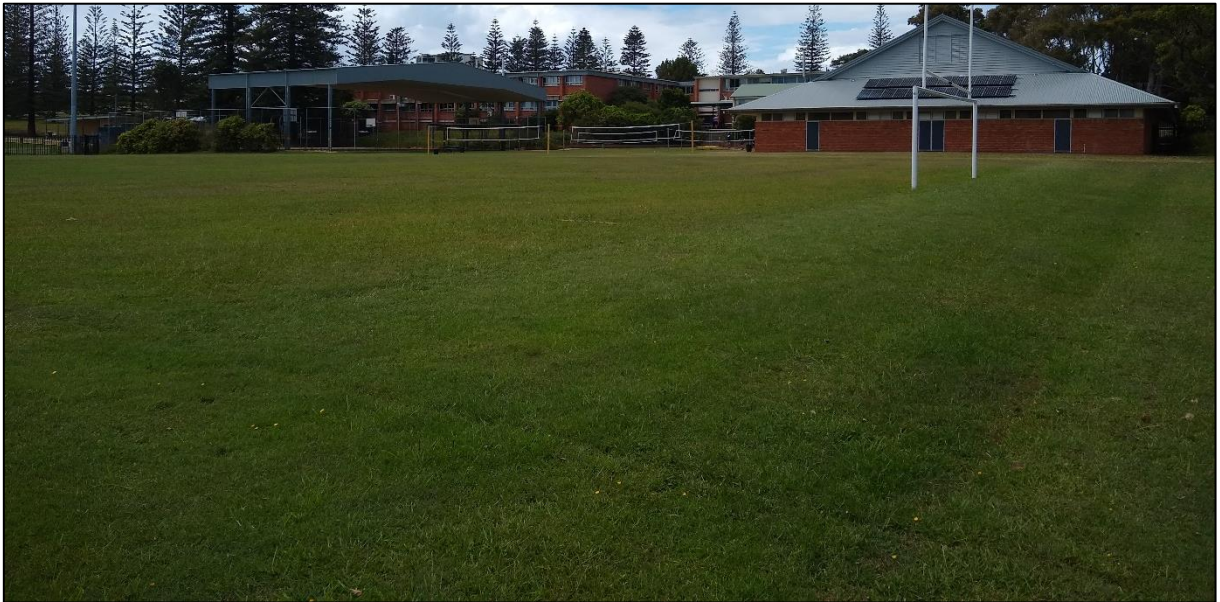
Figure 7: View from north west corner of proposed PCYC building View looking south-east at playing fields, volleyball courts and MPC hall

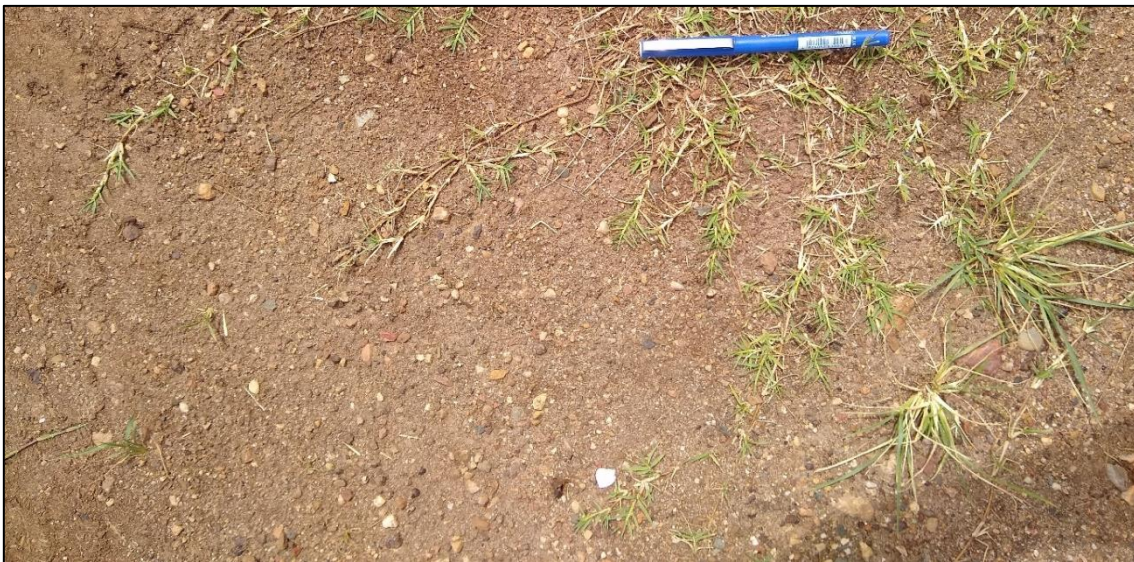
- Localised exposed surface soils were observed to comprise silty sand filling with some gravel (refer to Figure 8);
- Sand pits (long jump), concrete pad (shotput) and steel football posts were present within the playing fields;
- Some cut/fill may have been conducted to form the playing field together with possible imported fill, based on site topography;
- Rock outcrops were not observed;
- There were no obvious indicators of gross contamination at the surface of the site (i.e. staining/odours);
- South of the playing fields there was a covered concrete basketball court, an uncovered concrete basketball court, an MPC hall and two grassed volleyball courts (refer to Figure 7 - background);
- It is noted that a detailed inspection of the surface was precluded by the presence of vegetation.

Figure 8: Exposed surface soils on playing field (SW corner of proposed PCYC building footprint)

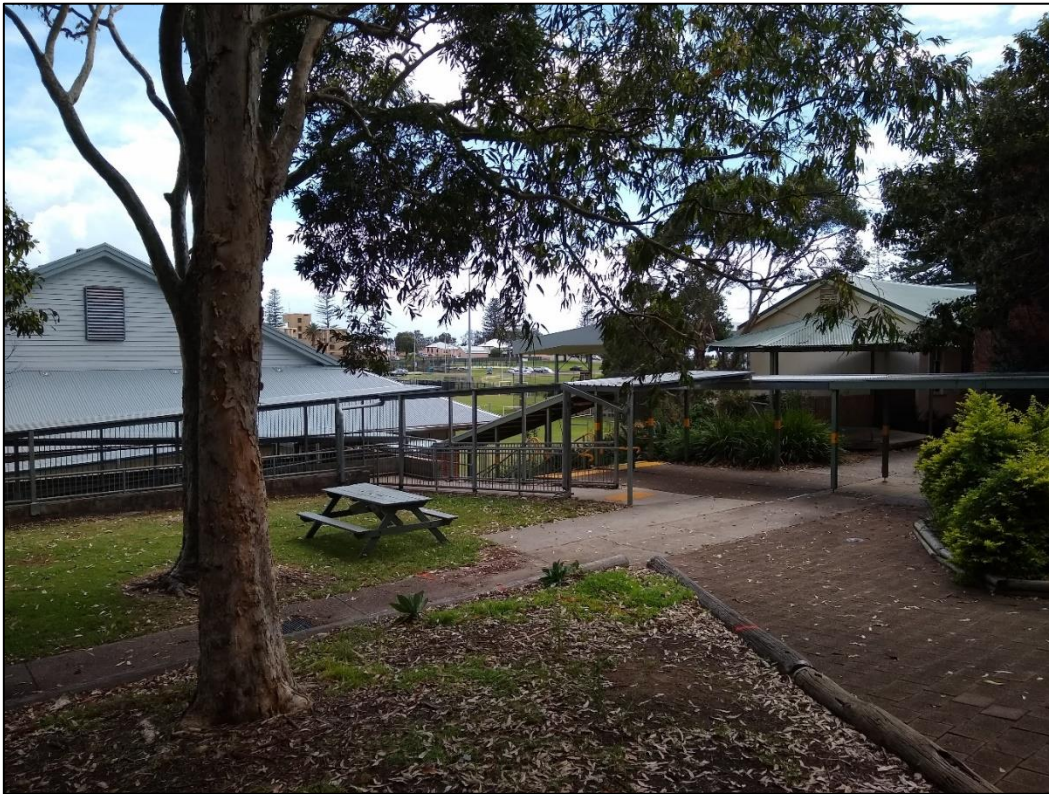
- Generally grassed and paved area containing the following (refer to Figures 9 and 10):
 - Some mature trees;
 - Above ground LPG tank;
 - Concrete lined surface drains with subsurface stormwater pits/pipe;
 - Paved access area with garden beds;
 - Exposed soils within garden beds generally comprised brown silty sands (refer to Figure 11)
- No obvious indication of gross contamination (staining/odours) at the surface or within exposed soils;
- It is noted that a detailed inspection of the surface was precluded by the presence of vegetation and paved surfaces.

Figure 10: View from the southern boundary of the CAPA building looking north east

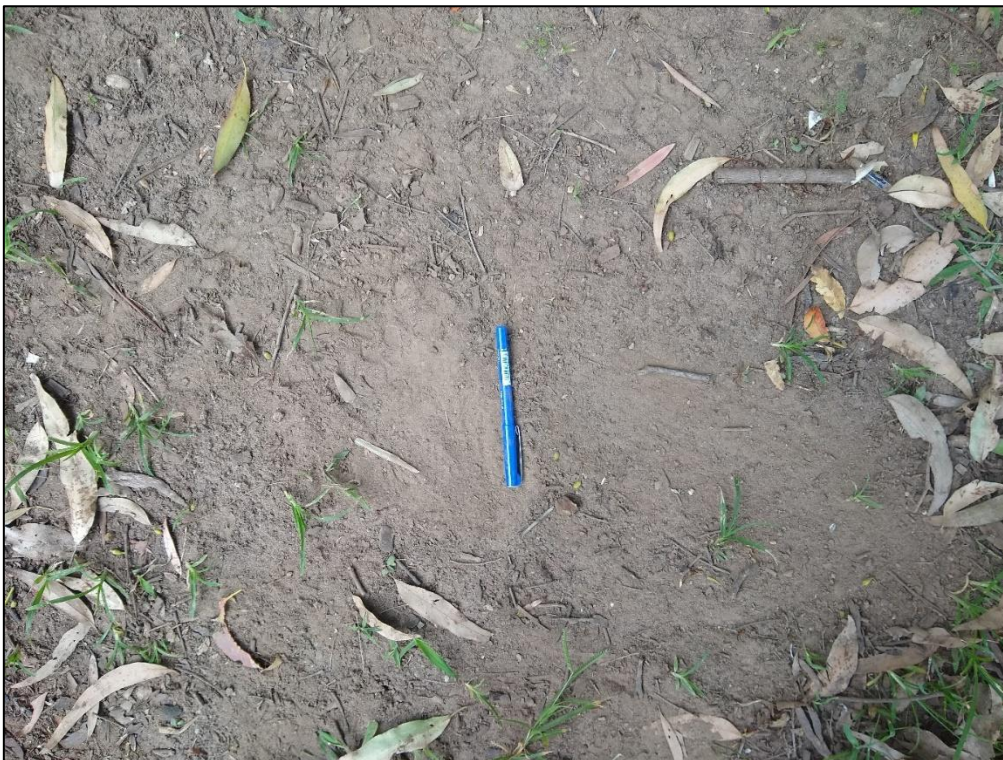
Figure 11: Typical exposed surface soils - proposed CAPA building footprint
