School Infrastructure NSW
c/o Richard Crookes

Remedial Action Plan
Hunter River High School

36 Elkin Avenue, Heatherbrae NSW

63780/147799 (Rev 3)
JBS&G Australia Pty Ltd

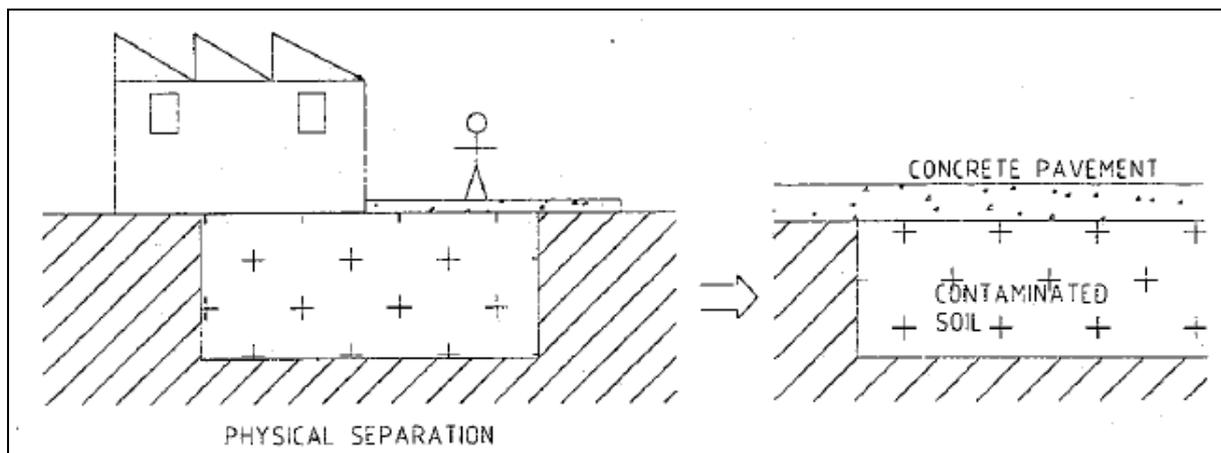
- Permanent concrete floor slab or asphalt surfaced pavement. The pavement outside of the building/basement footprint shall be underlain by a marker layer; or
- A thickness of soil that is unlikely to be penetrated by future users of the site under the intended land use, underlain by a layer of ‘marker layer’ in areas of exposed site soil (i.e., landscaped beds). A minimum soil cover thickness of 0.5m is commonly adopted however thinner soil cover may be acceptable where site constraints limit separation thickness and additional controls are implements (e.g., geogrid on top of marker layer).

As shown schematically below:

Given the specific development plans as understood at the time of preparation of this RAP, the proposed use of the site, the following physical separation arrangements are to be implemented within the extent of the site inclusive of accessible / open space areas:

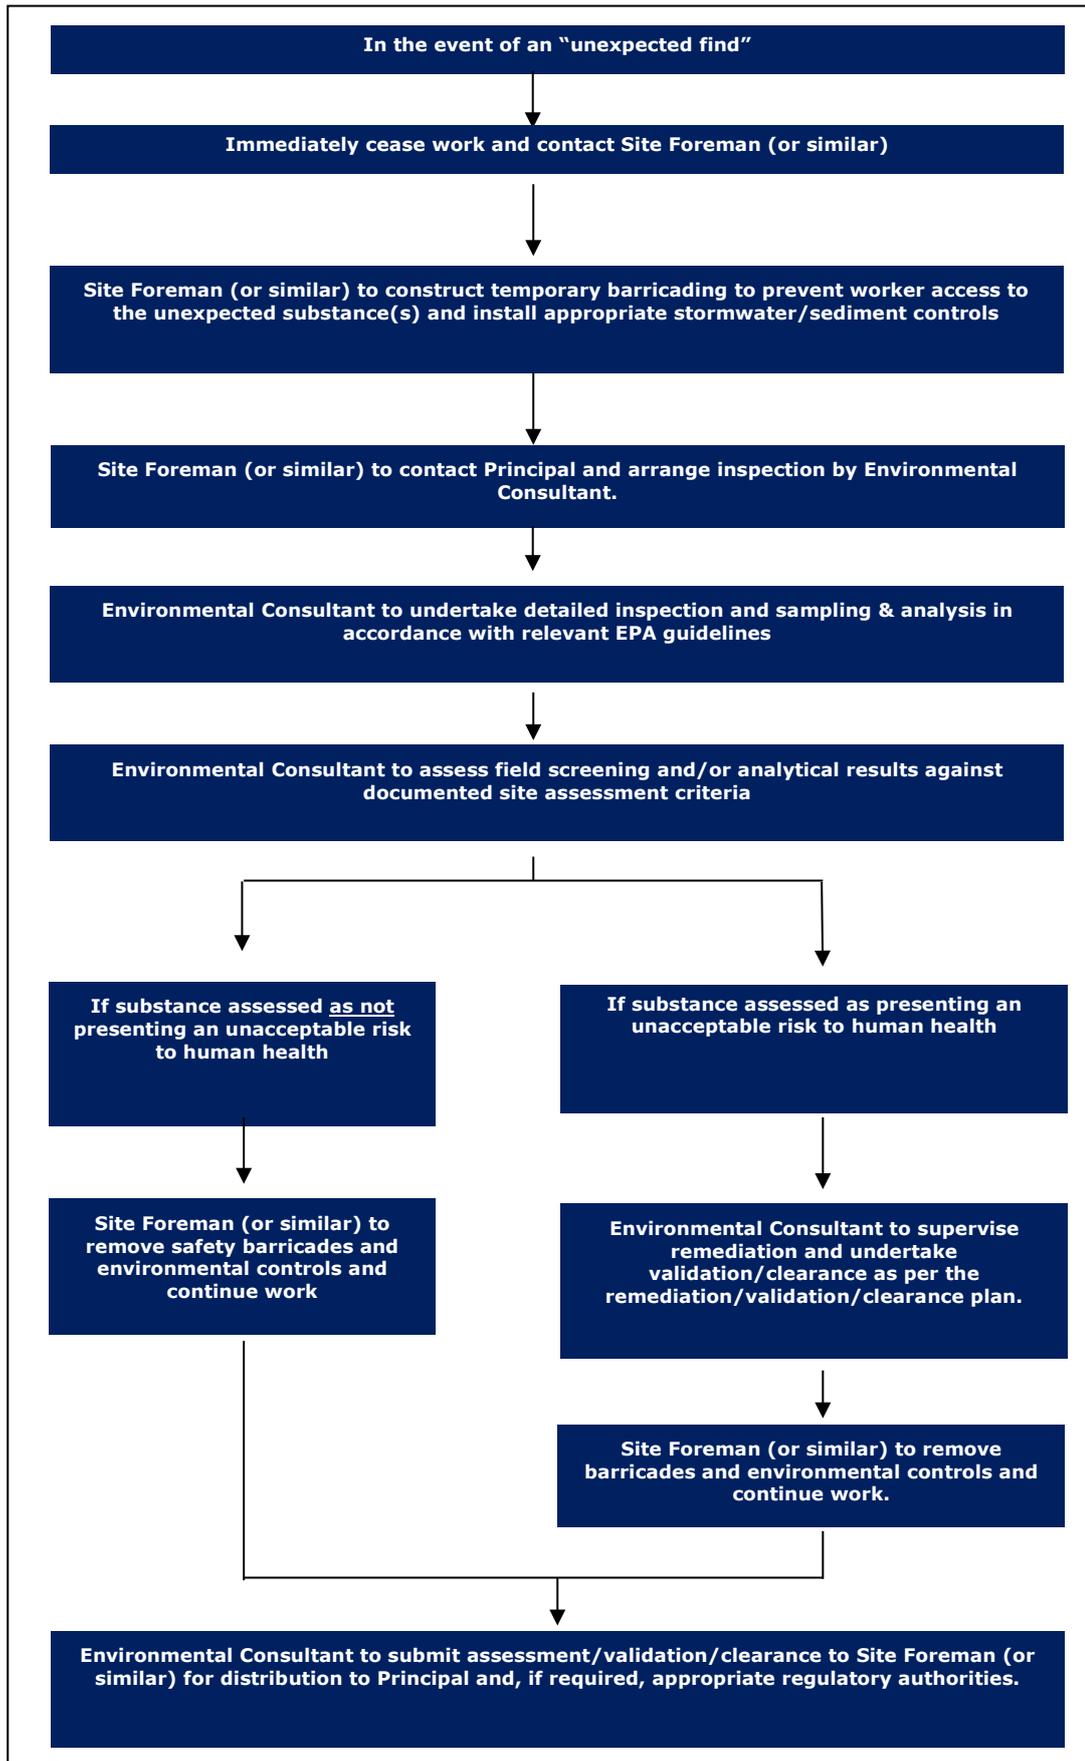
Flowchart 8.1 – Unexpected Finds Protocol

As a precautionary measure to ensure the protection of the workforce and surrounding community, should any of the abovementioned substances be identified (or any other unexpected potentially hazardous substance), the procedure summarised in **Flowchart 8.1** is to be followed.

An enlarged version of the unexpected finds protocol, suitable for use on-site, should be posted in the site office and referred to during the site-specific induction by the remedial / principal contractor.

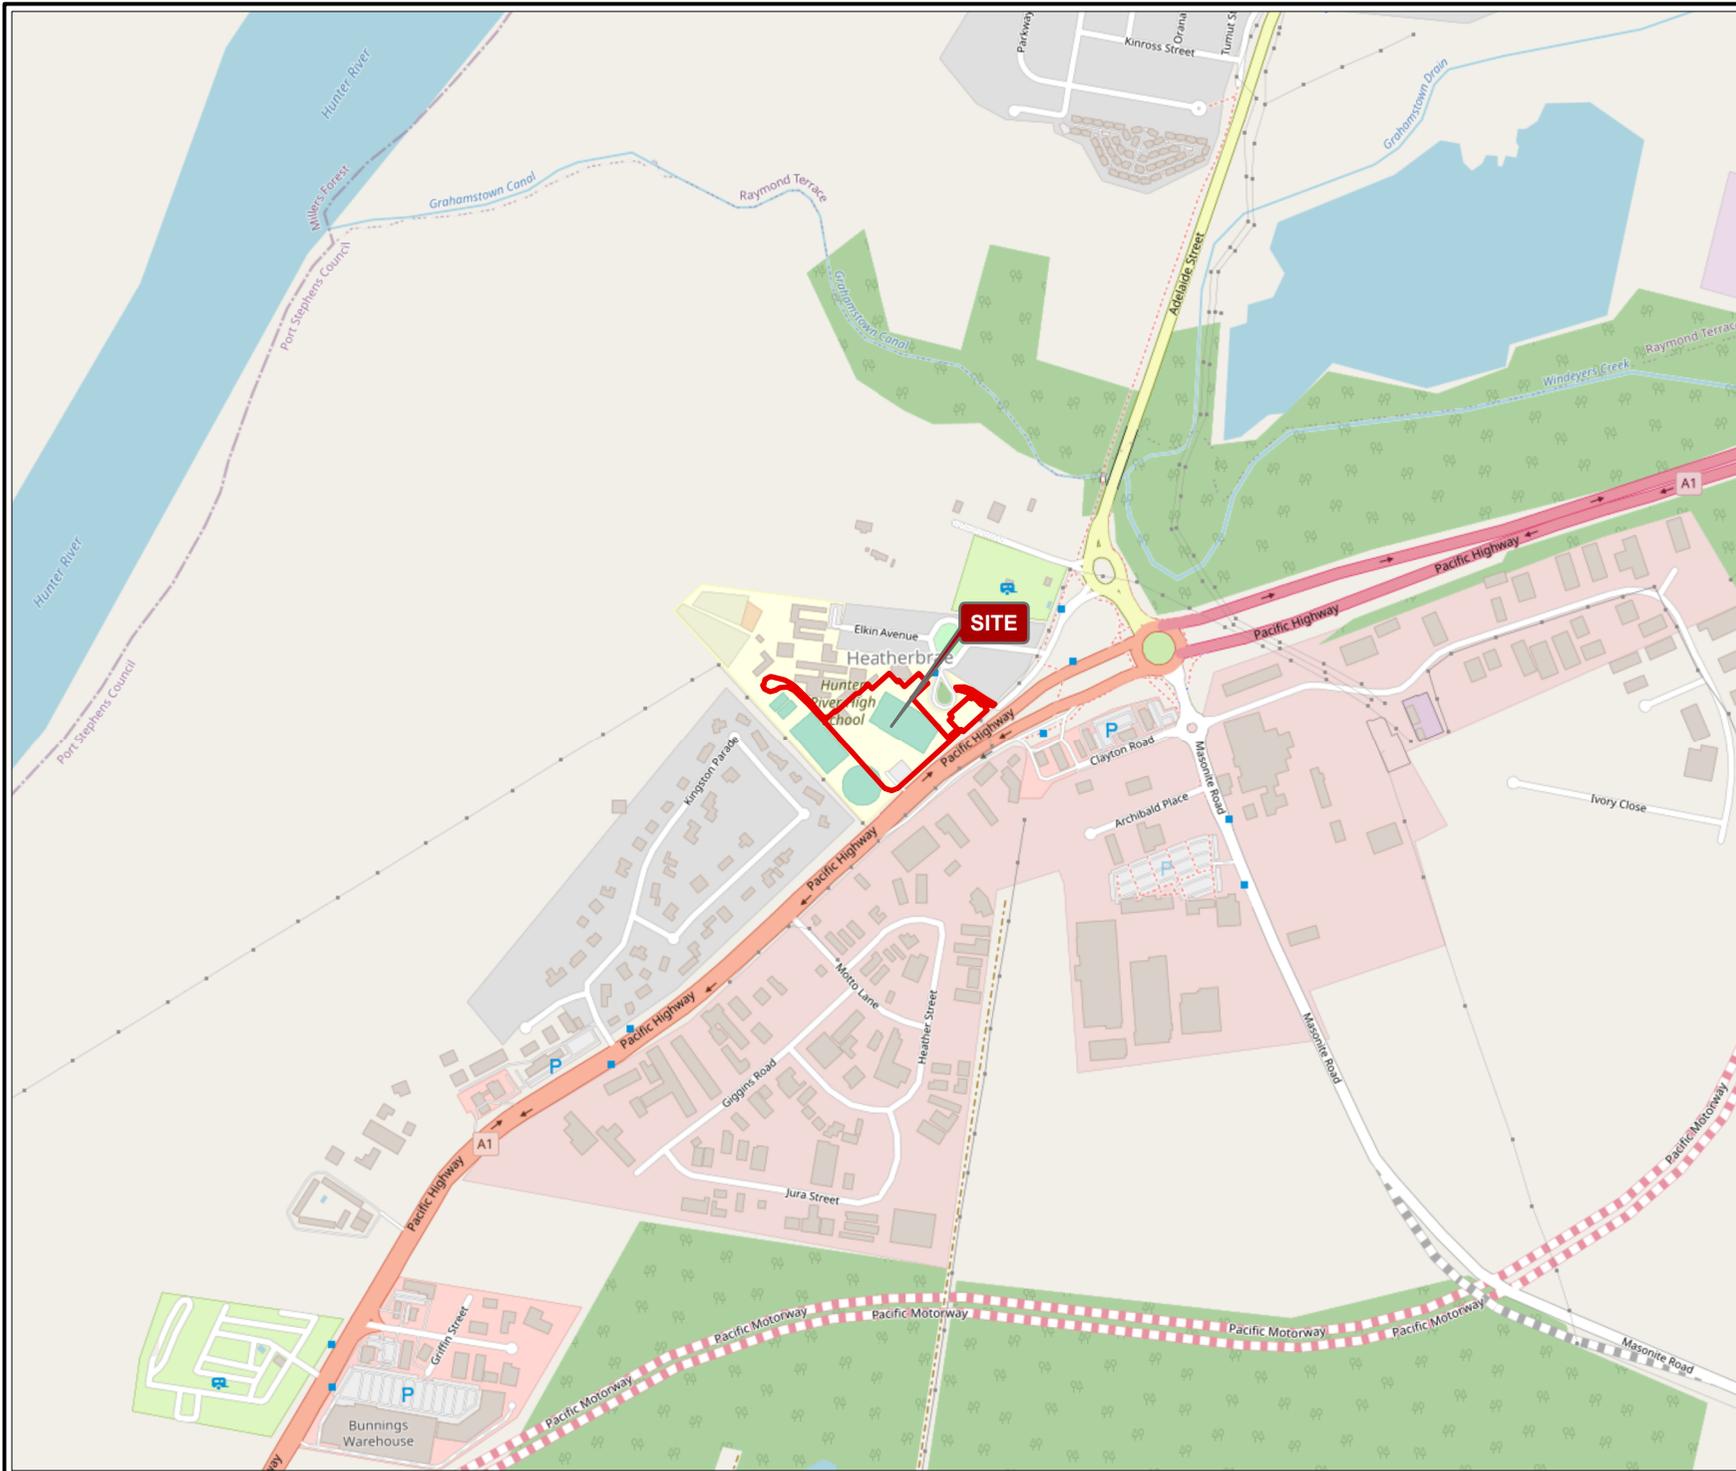
FIGURE 1

SITE LOCATION

JBS&G Australia Pty Ltd (JBS&G) was engaged by School Infrastructure NSW (SINSW, the client) to prepare a Remedial Action Plan (RAP) for a portion of Hunter River High School, located at 36 Elkin Avenue, Heatherbrae, NSW (the site). The site is legally identified as part Lot 1 of deposited plan (DP) 120189 and part Lot 1 DP 540114 and covers an area of approximately 4.3 hectares (ha) predominantly comprising sporting fields, carparks and entrance road in the southeast of the school grounds. The site location and current site layout are shown in **Figures 1** and **2**, respectively.

The location of the site is shown in **Figure 1**, and the current layout is shown in **Figure 2**. The site details are summarised in **Table 2.1**.

A plan showing the location of the site is provided as **Figure 1**, and a plan showing the boundaries of the site is provided as **Figure 2**.

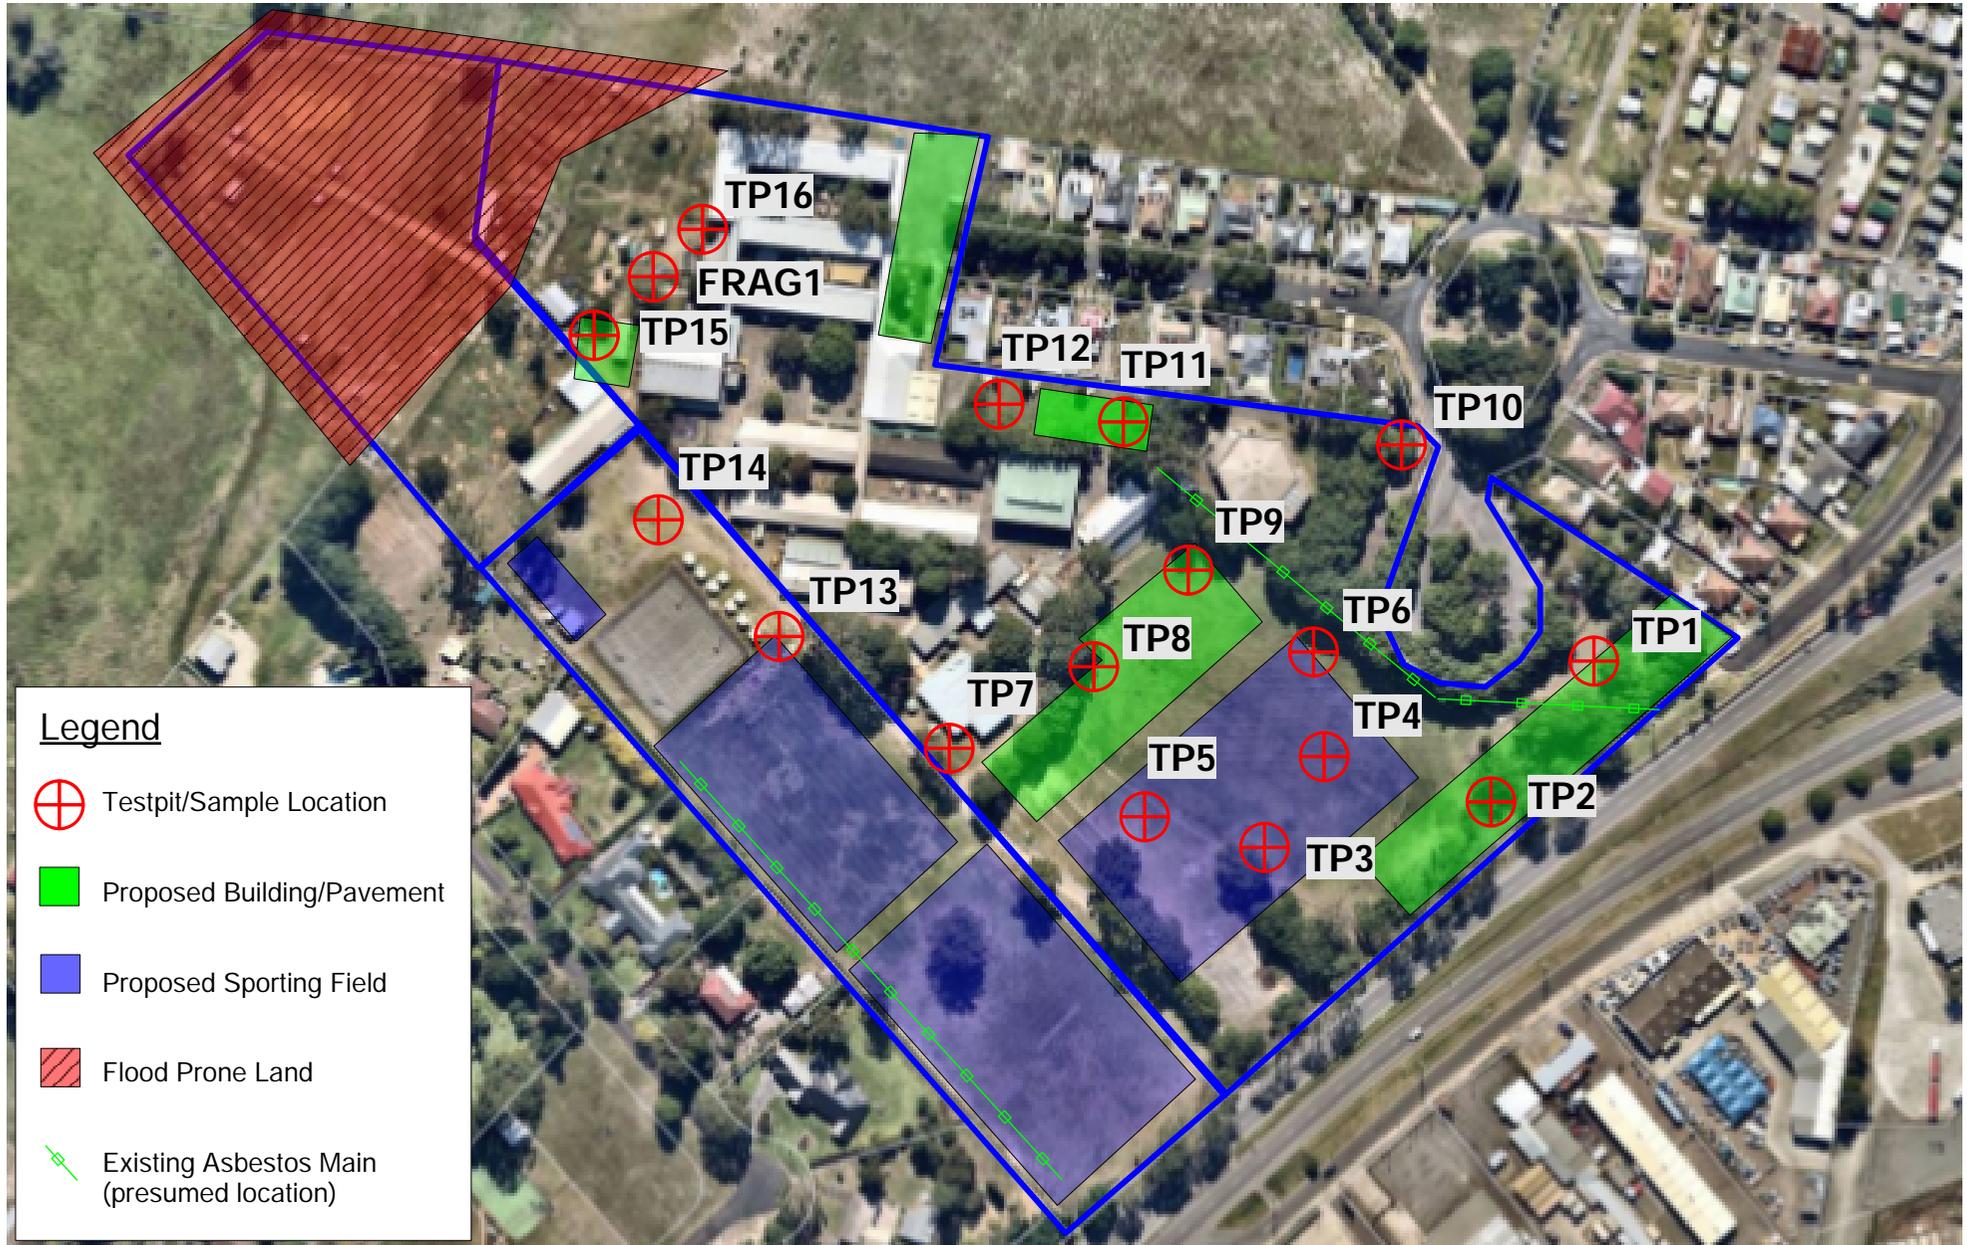
Appendix E Sampling Locations

- Testpit/Sample Location
- Proposed Building/Pavement
- Proposed Sporting Field
- Flood Prone Land
- Existing Asbestos Main (presumed location)

A total of 111 test pits were advanced across the proposed redevelopment site (the site) as shown in **Appendix E**. Subsurface conditions onsite identified fill between 0-0.4 m bgs pale brown or grey fine-grained sand with some discolouration, construction and demolition waste and traces of slag, gravel, brick, charcoal and other debris. Beneath the fill, natural pale brown or red/orange or yellow fine-grained sand was identified.

WSP (2023) identified bonded ACM in one location (TP2_14) and during the heritage investigations multiple fragments were found as shown in Figure 4, Appendix E. Additionally, trace levels of friable

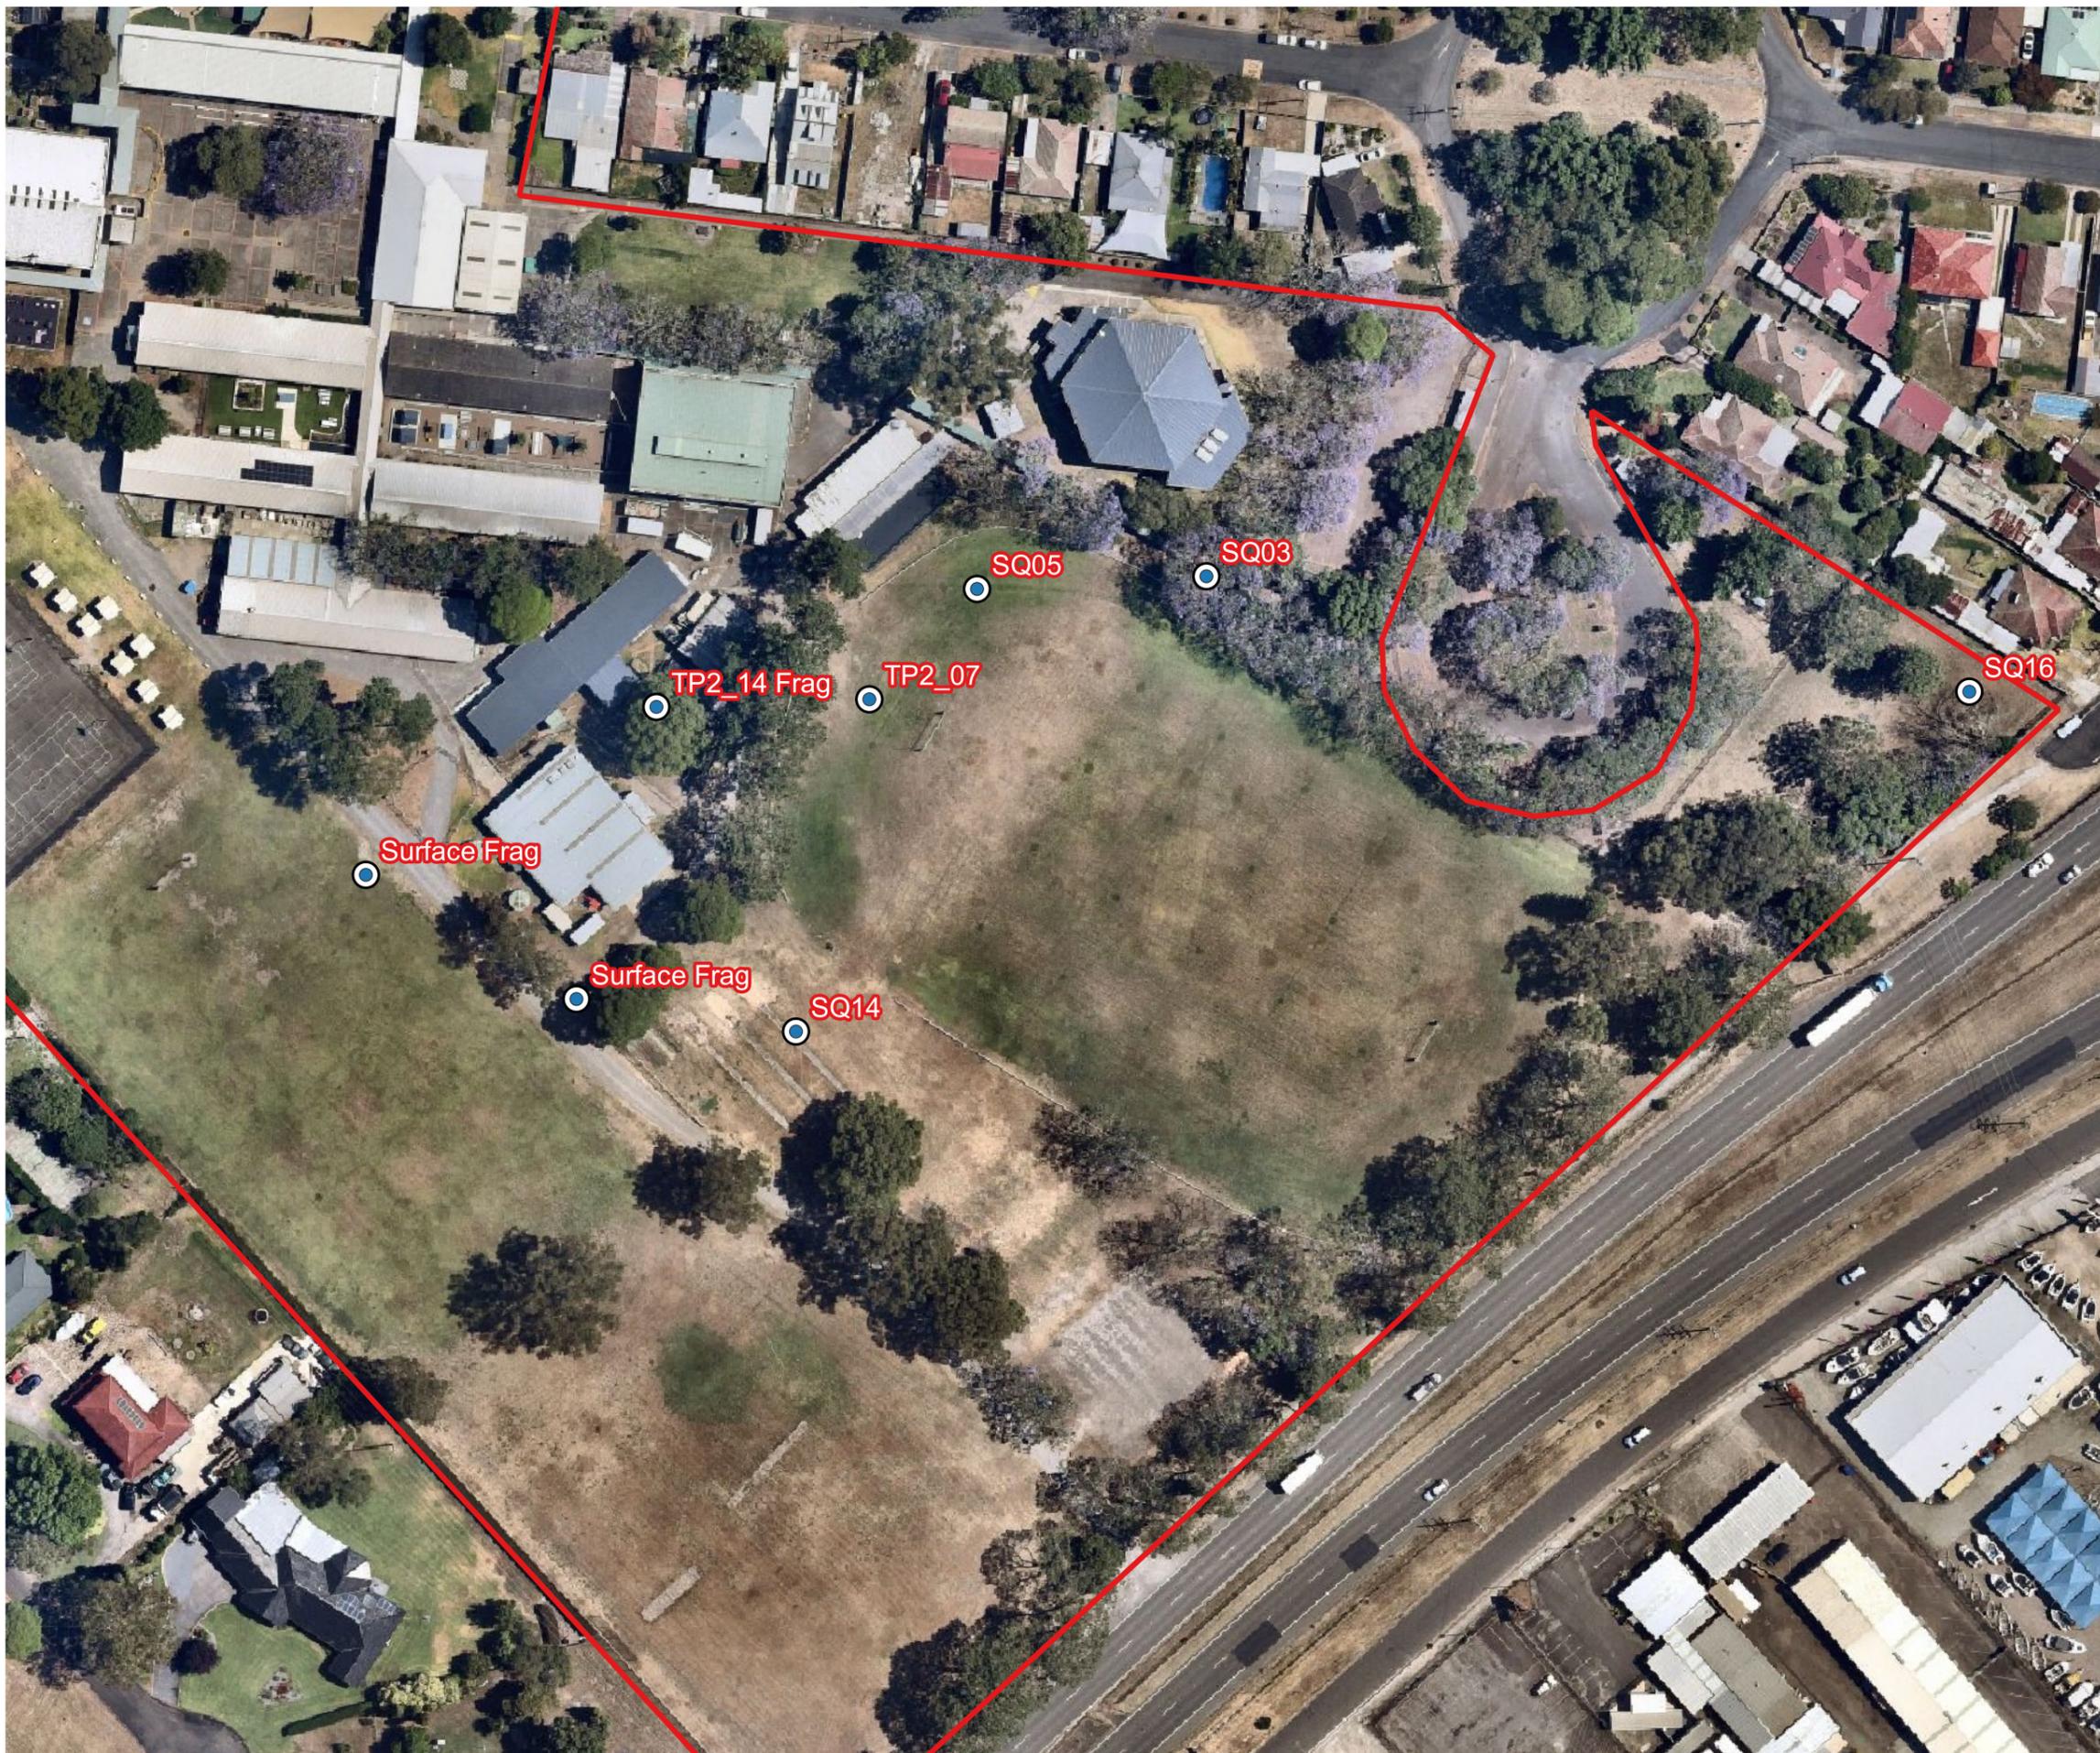
- Property boundary
- Asbestos location
