REMEDIATION ACTION PLAN

126 Kent Road, Marsfield NSW 2122

04 DECEMBER 2019

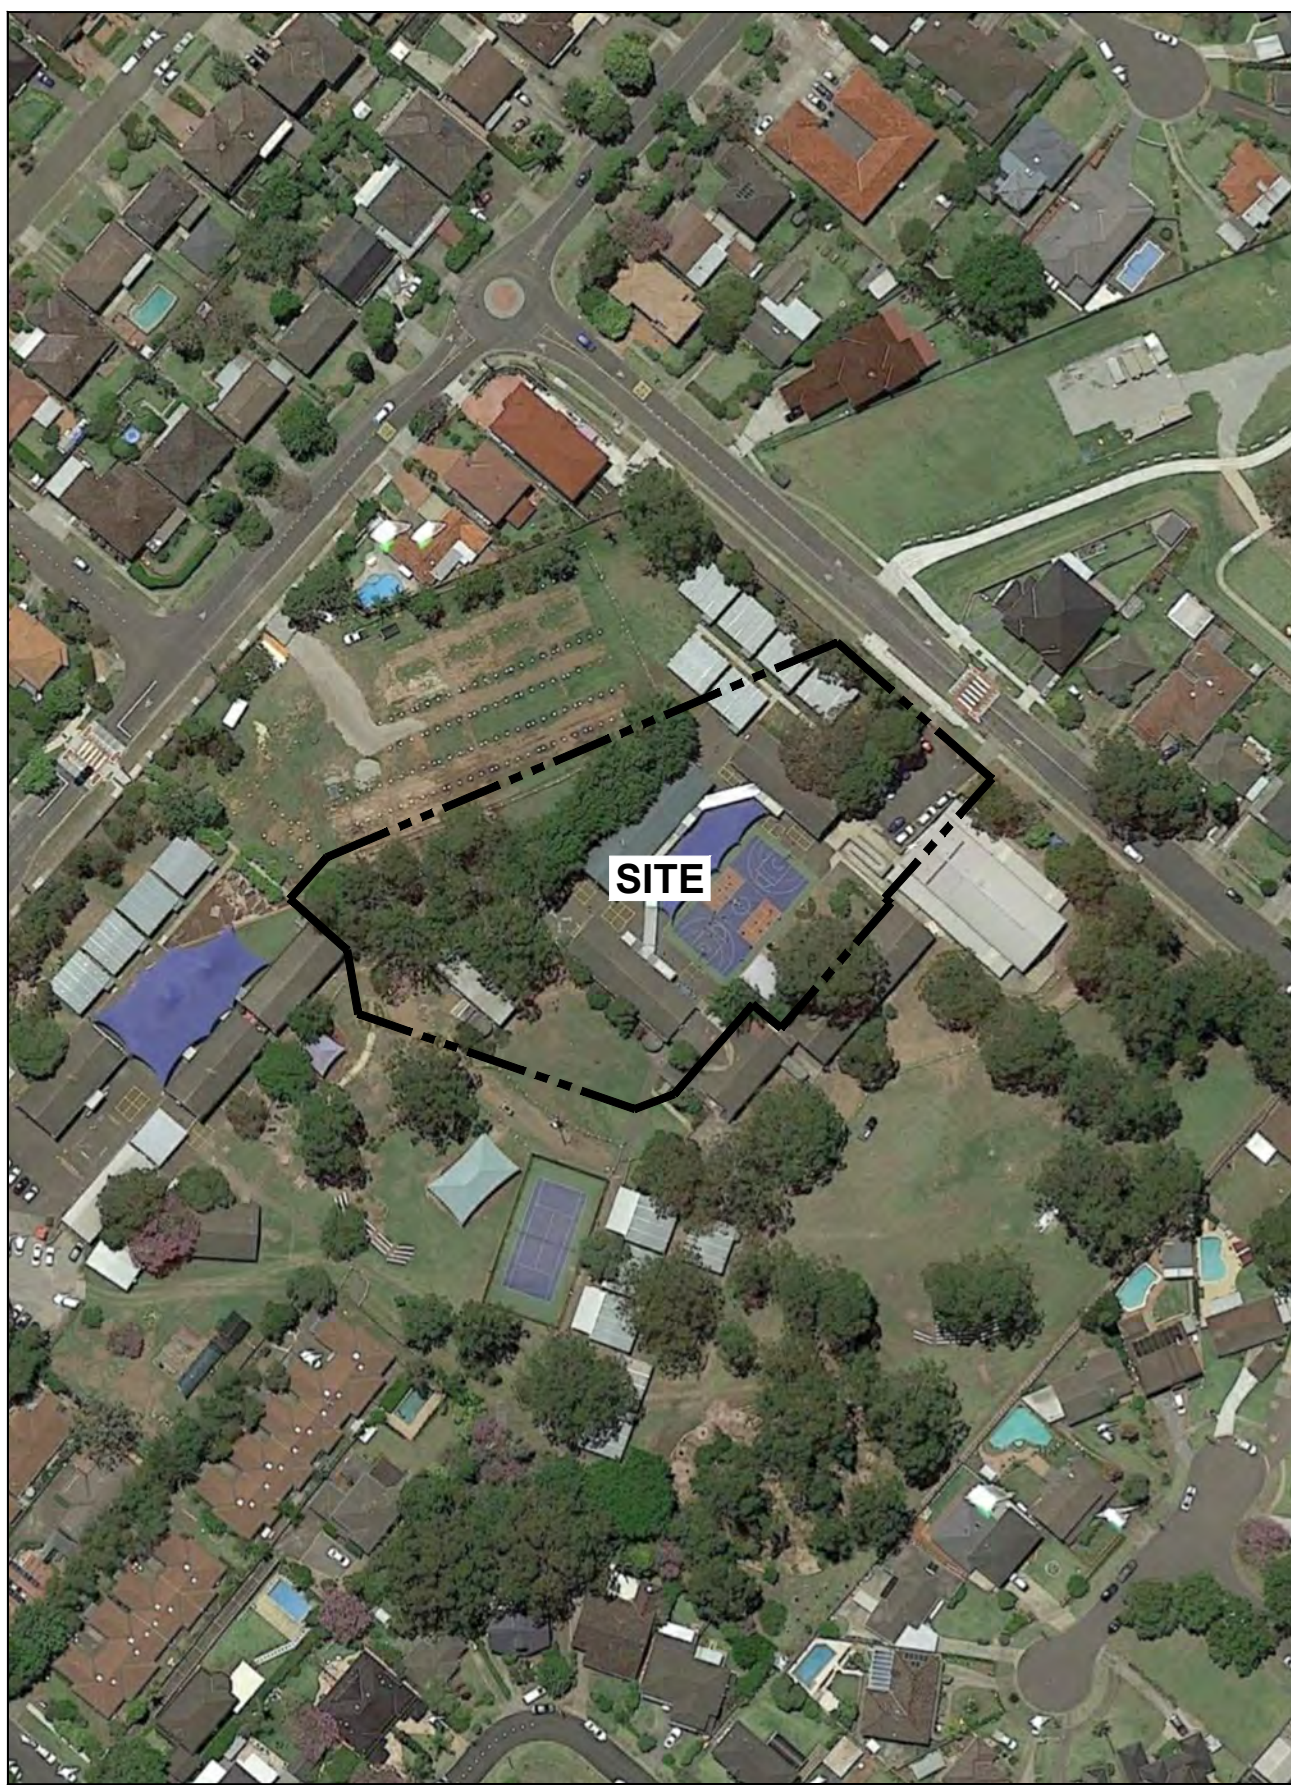
SITE LOCATION

The Site is located at 126 Kent Road, Marsfield NSW 2122, and the Site Location Investigation Area is shown in **Figure 1, Appendix A**. The site details are summarised in Table 2-1 below.

Arcadis Australia Pacific Pty Ltd (Arcadis) was commissioned by St Hilliers (NSW) Pty Ltd (St Hilliers) to complete a Remediation Action Plan (RAP) at 126 Kent Road, Marsfield NSW 2122 (herein known as 'the site') to address the conditions within the State Significant Development Approval (SSDA). The location of the subject site is shown on **Figure 1, Appendix A**.

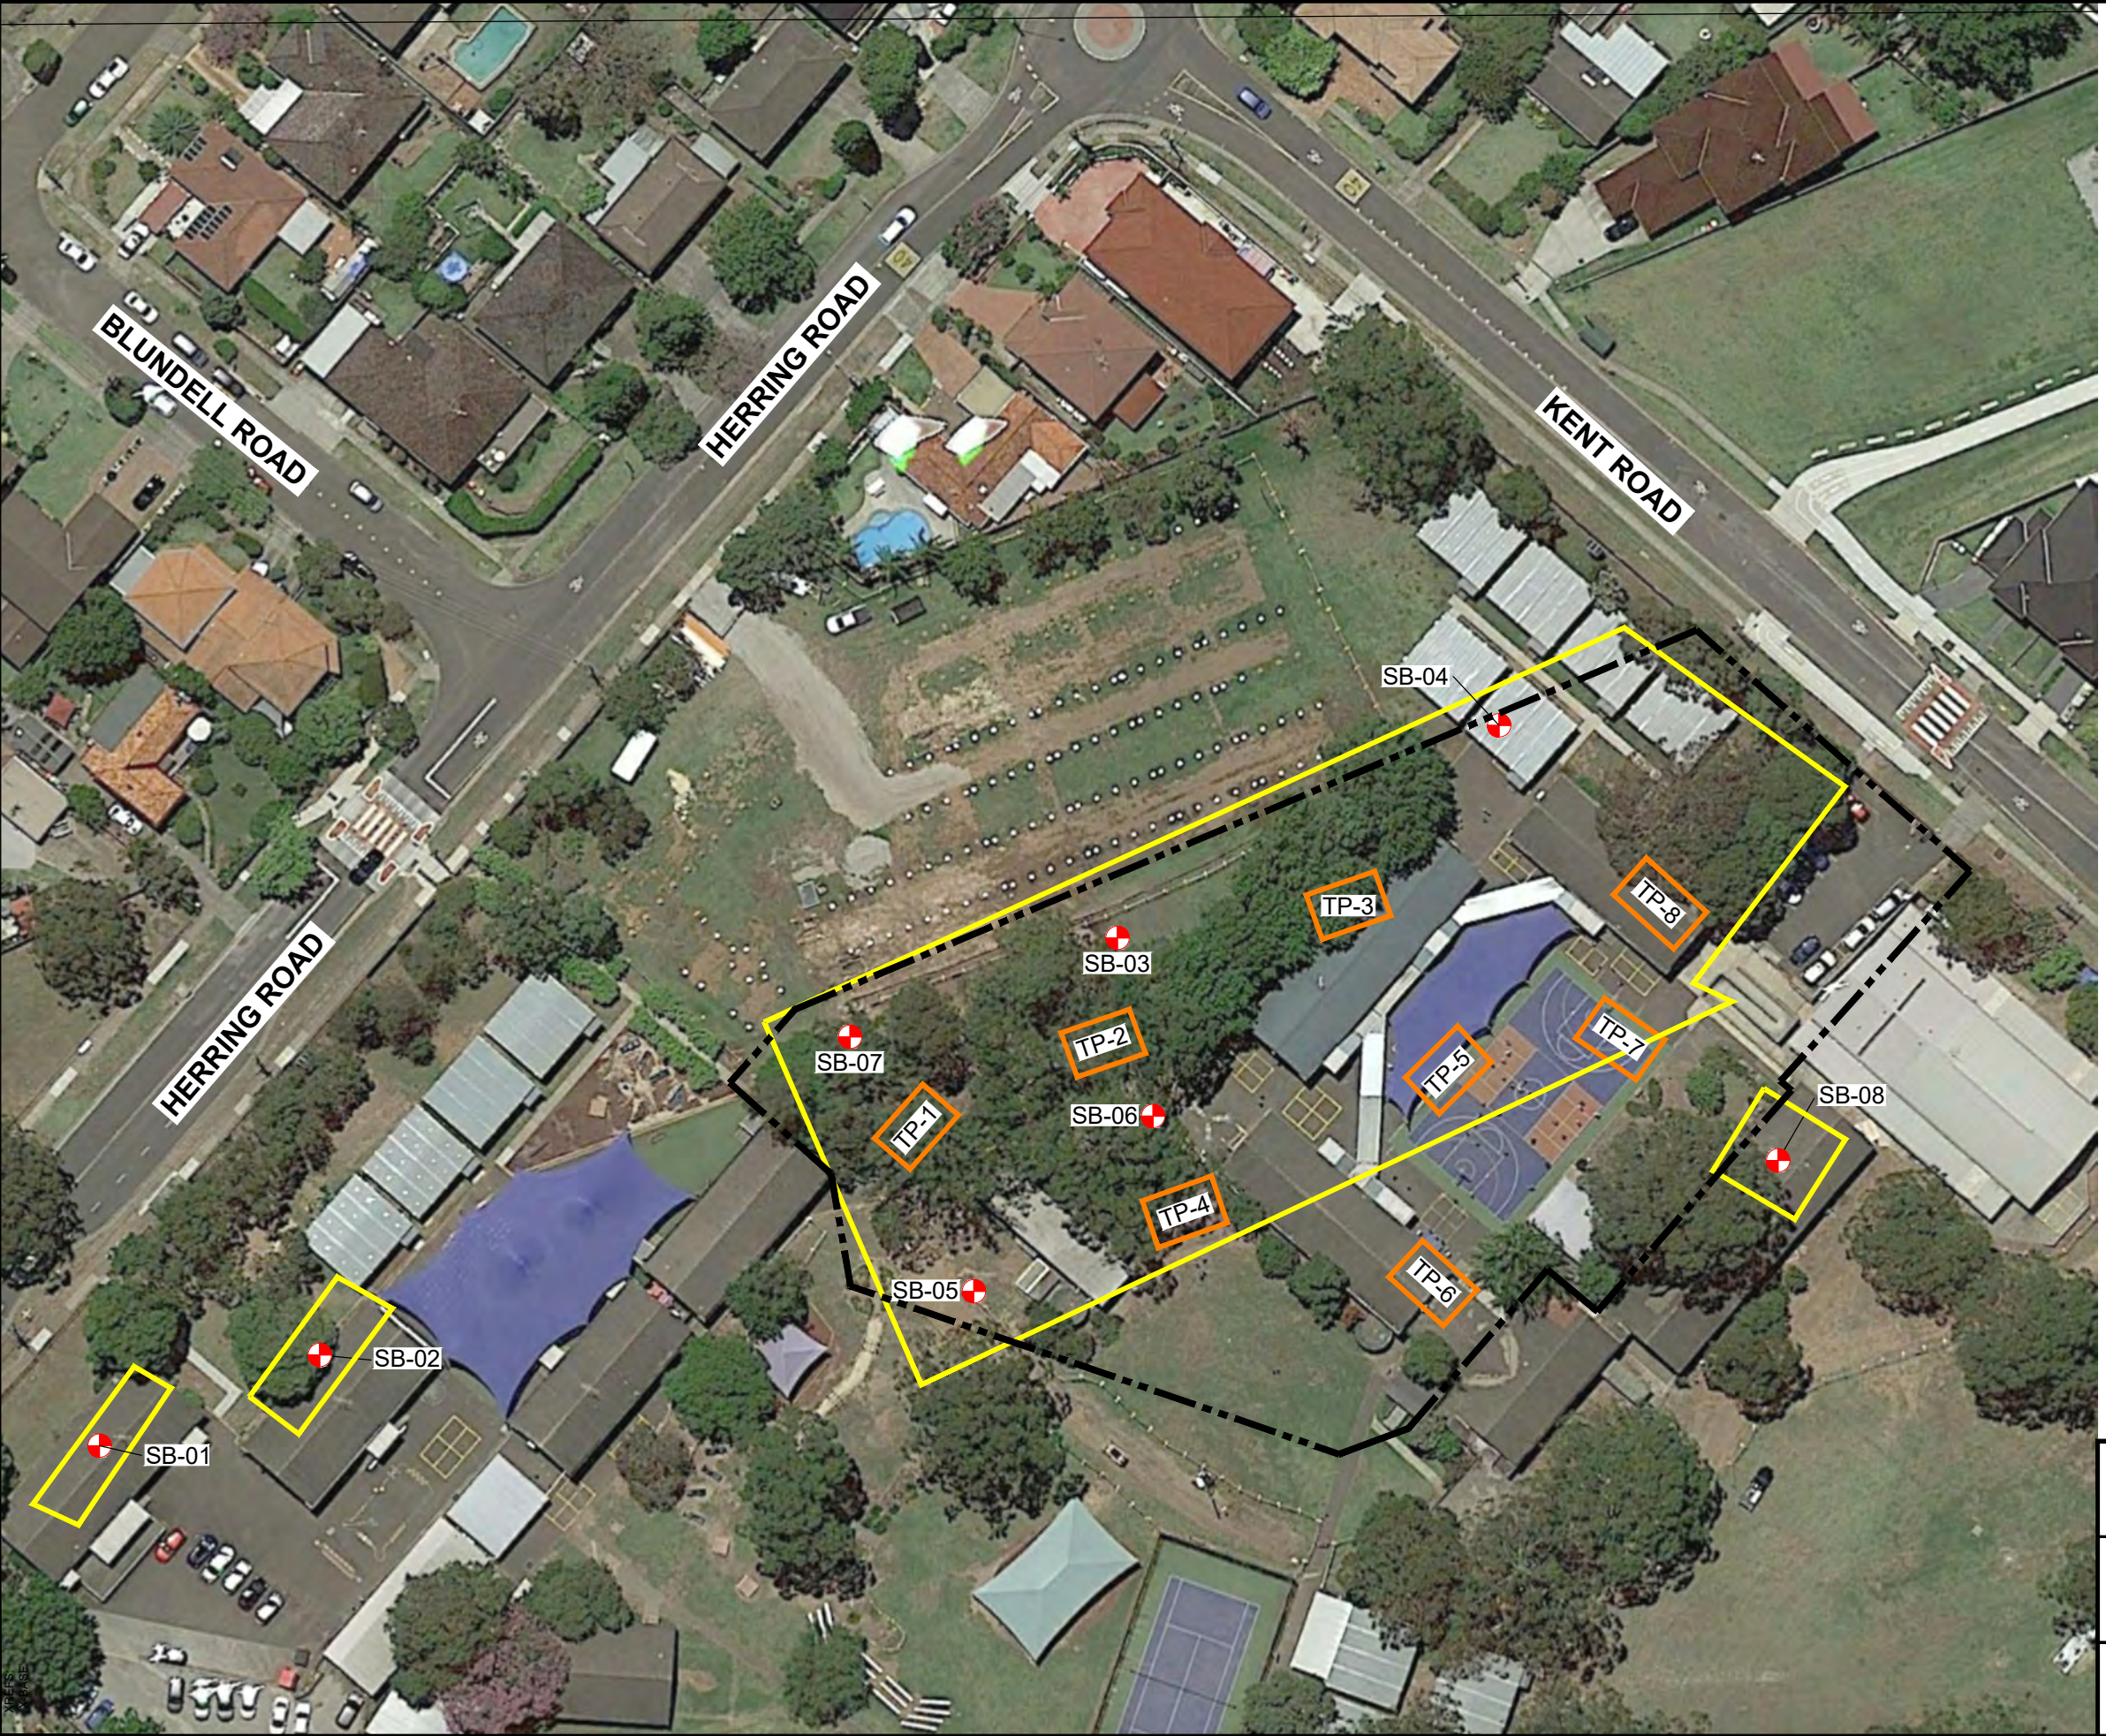
**LOCATION OF SOIL BORES AND
TEST PITS FROM PREVIOUS
INVESTIGATIONS**

Based on the development site area of 0.55 ha, a total of thirteen (13) soil sample locations was recommended to meet the required minimum number of sampling points to characterise a site in accordance with the relevant industry NSW EPA (1995) Sampling Design Guidelines. Eight (8) sampling locations were completed by hand auger during the Due Diligence Assessment to a depth of 0.3 m, and Arcadis completed a further seven (7) sampling locations as a part of the Supplementary Assessment to the natural soil profile providing a total of fifteen (15) investigation locations. These locations are presented in **Figure 2, Appendix A**.

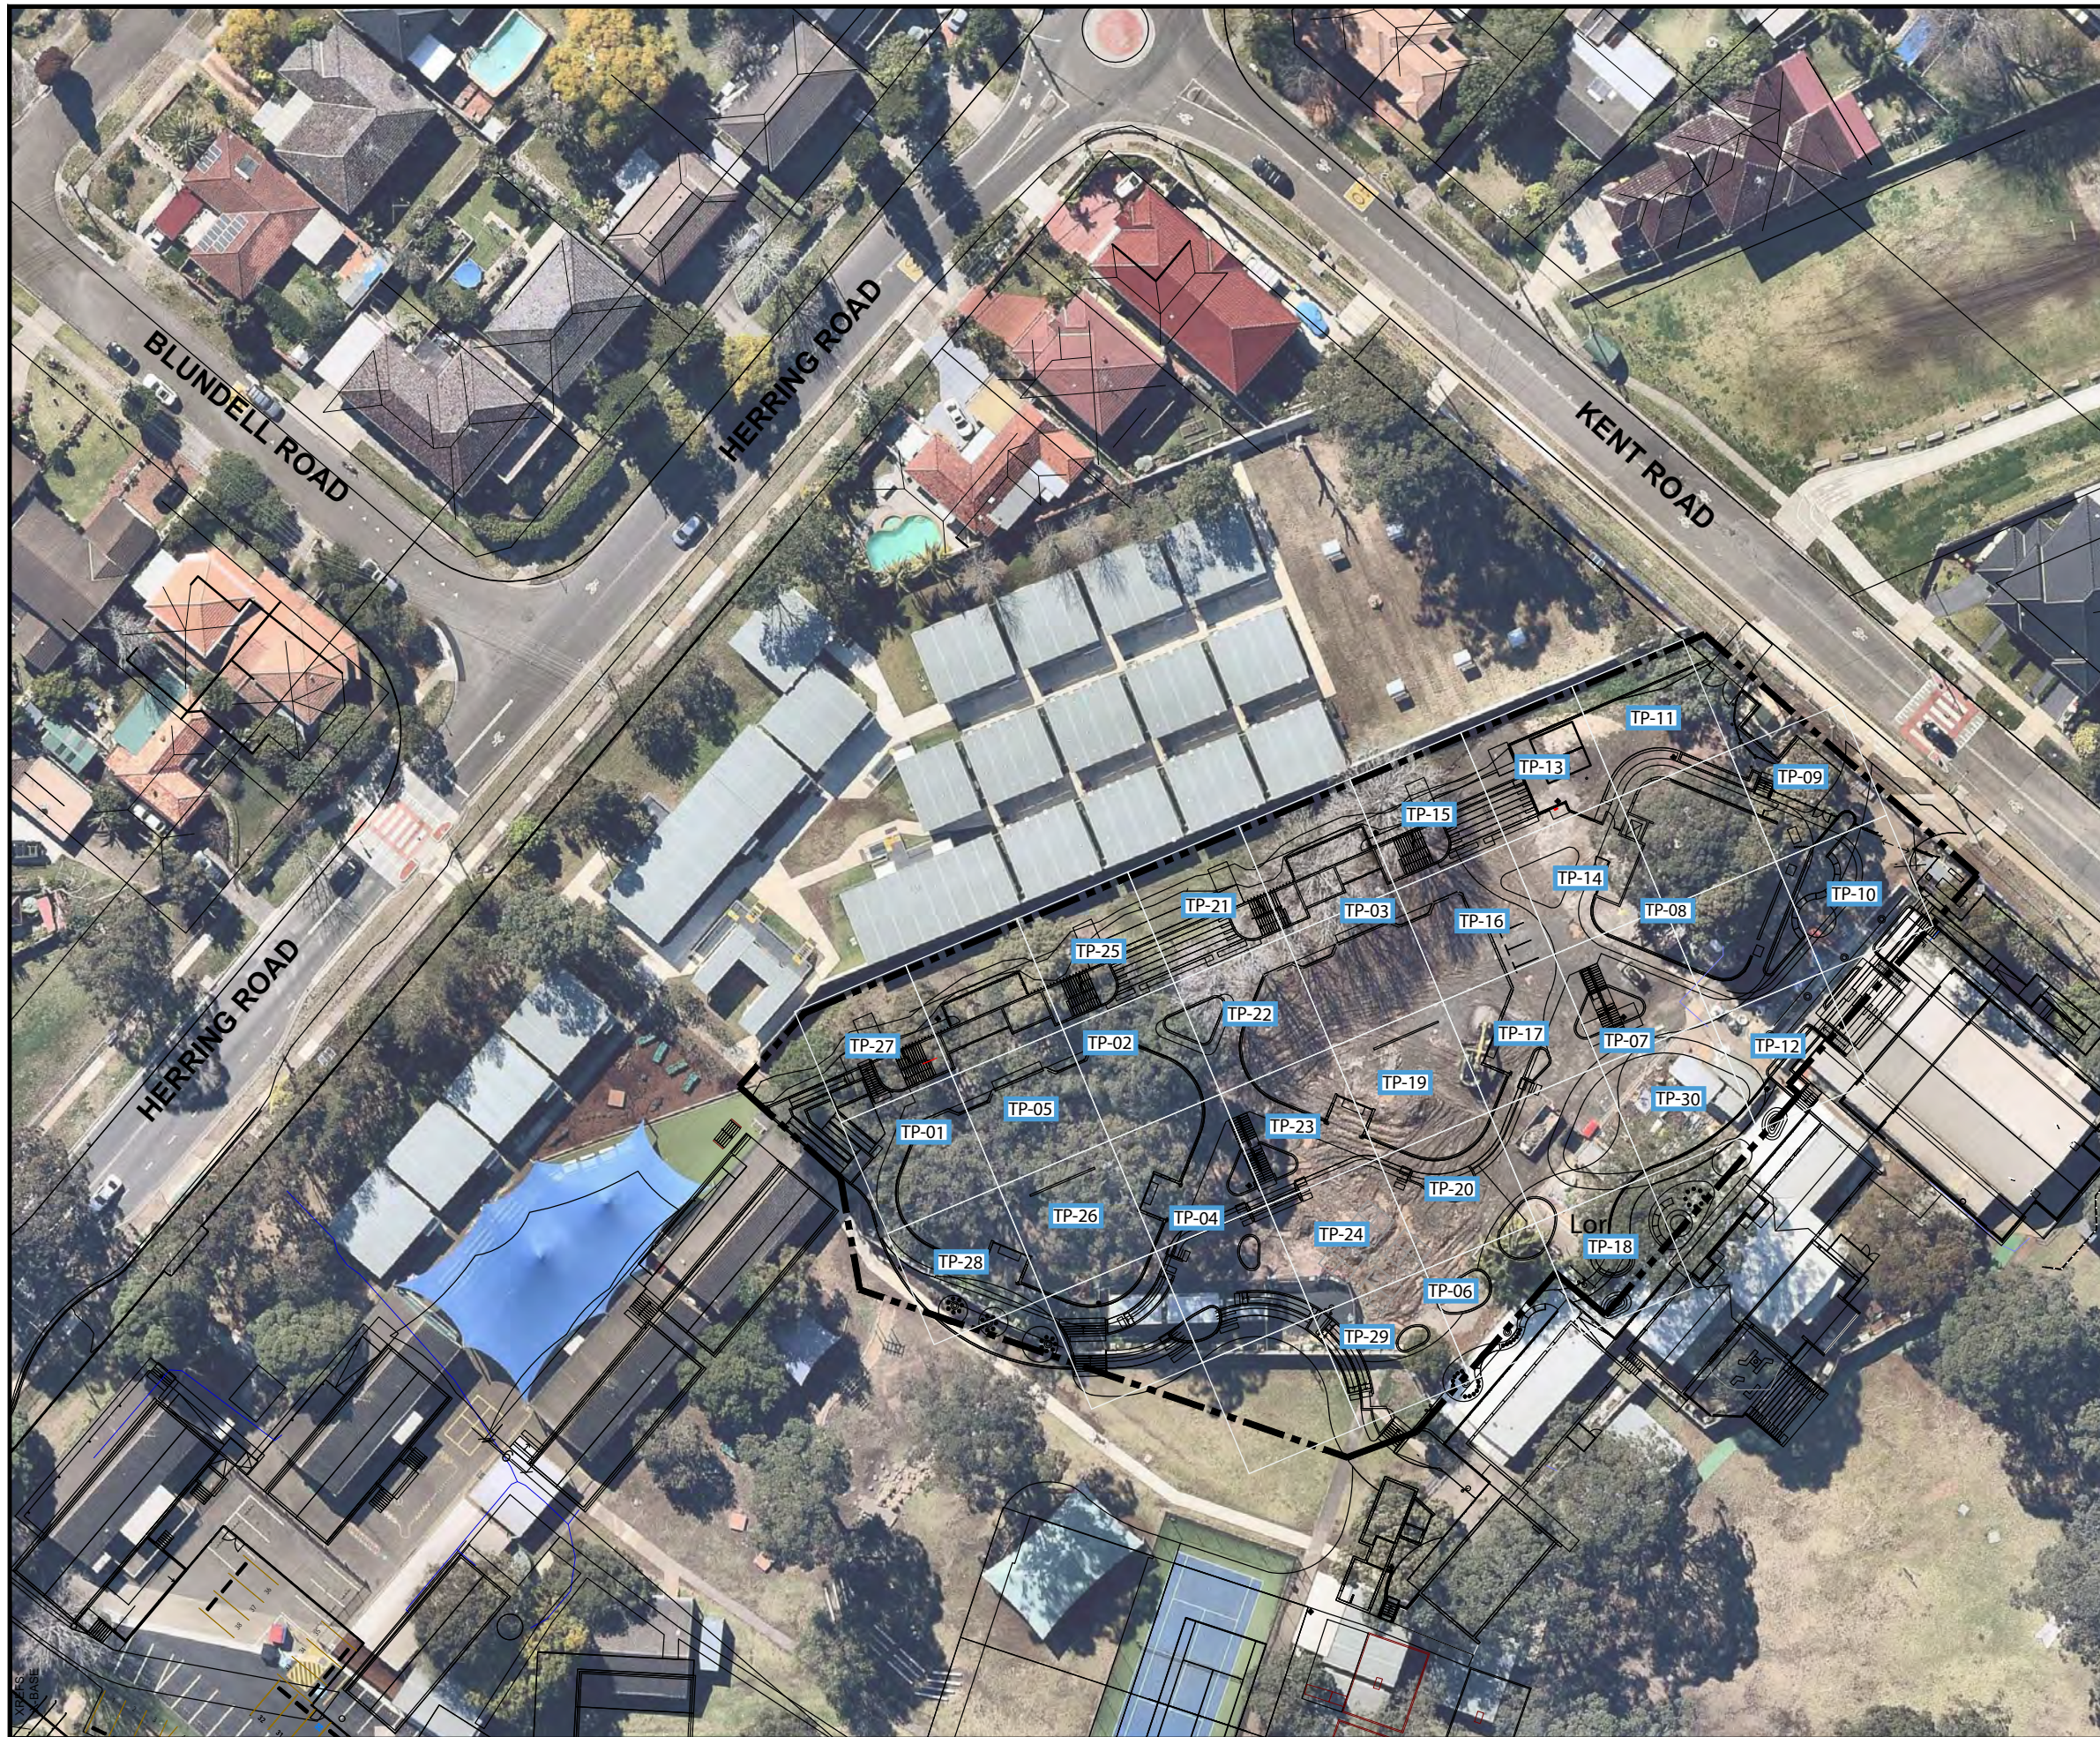
TEST PIT SAMPLING LOCATIONS

- Gross contamination in soils at the site was not identified during both investigations, with the exception of bonded ACM observed on the surface and top 100 mm at two test pit locations (TP3 and TP12), scattered surface locations near the garden beds and also other locations observed Arcadis, and within the uncontrolled fill at three (3) test pit locations (TP1, TP4, and GB2).

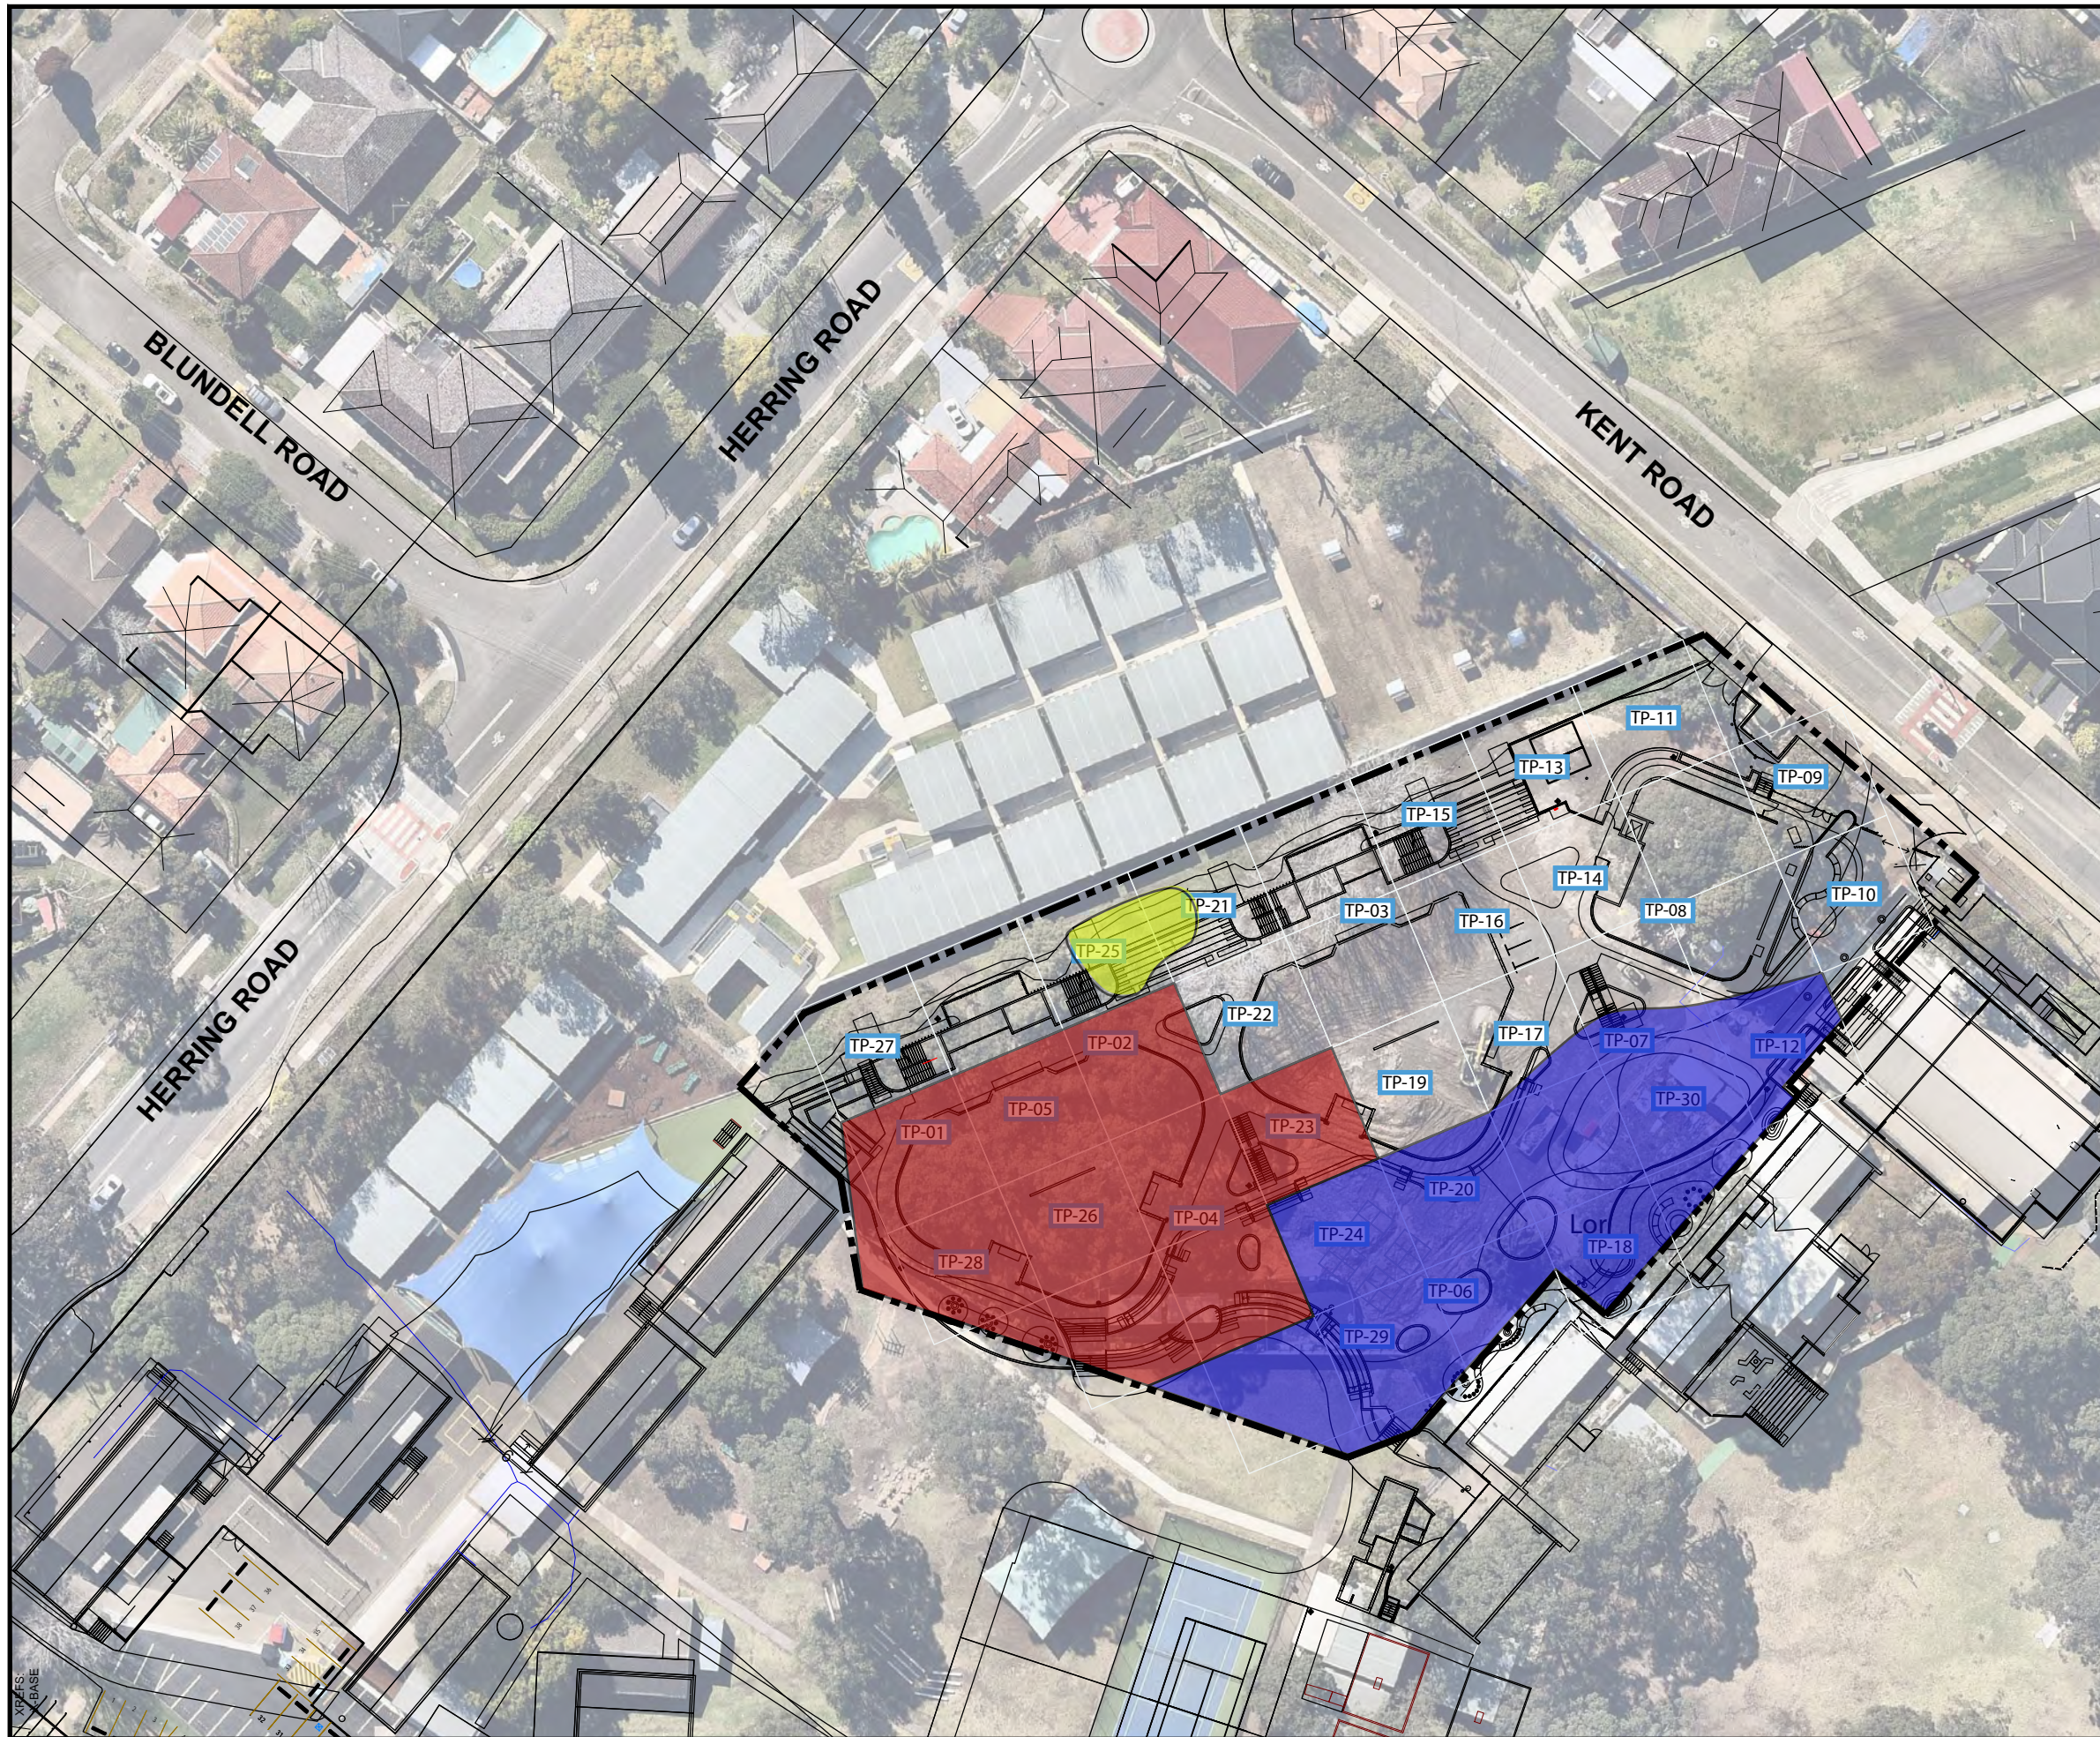
a total of thirteen (13) soil sample locations was recommended to meet the required minimum number of sampling points to characterise a site in accordance with the relevant industry NSW EPA (1995) Sampling Design Guidelines. Eight (8) sampling locations were completed by hand auger during the Due Diligence Assessment to a depth of 0.3 m, and Arcadis completed a further seven (7) sampling locations to the natural soil profile providing a total of fifteen (15) investigation locations.
