LONG TERM ENVIRONMENTAL MANAGEMENT PLAN

126 Kent Road, Marsfield NSW 2122

15 JULY 2020

Long Term Environmental Management Plan

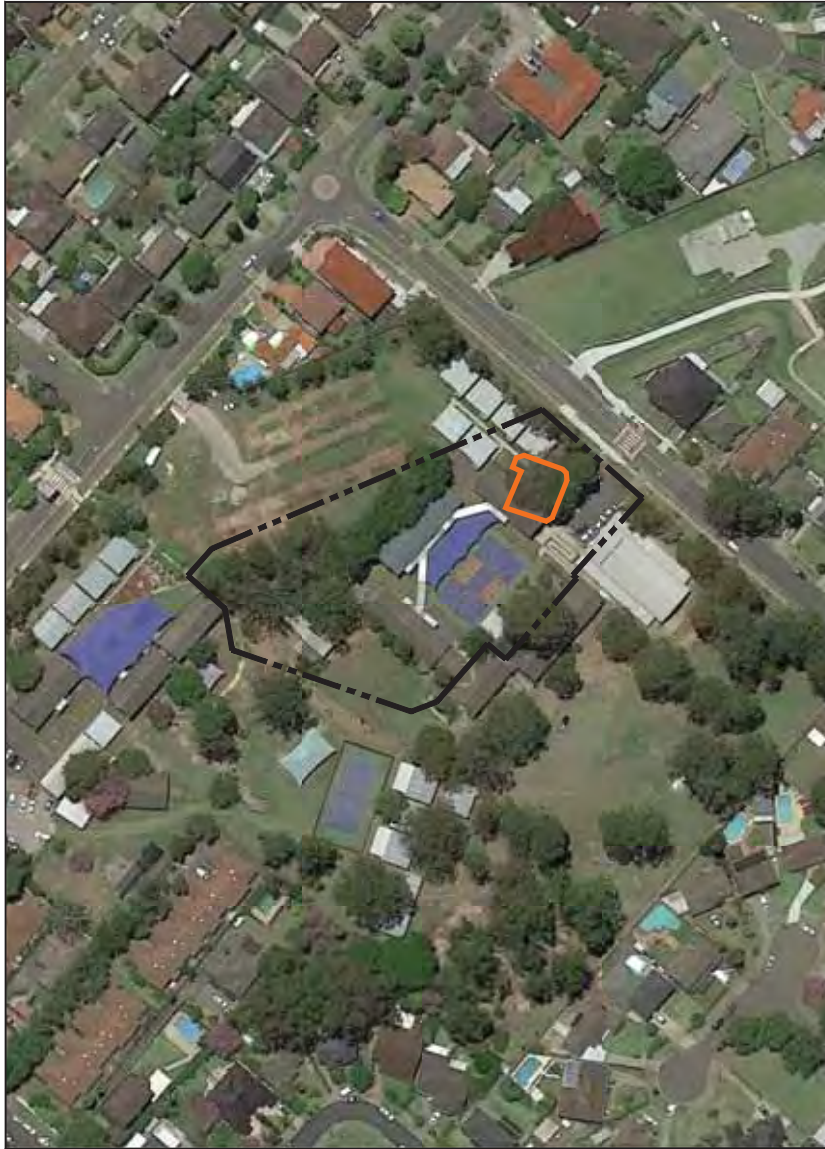
SITE LOCATION PLAN

- Audit Site Boundary /
- Development Footprint

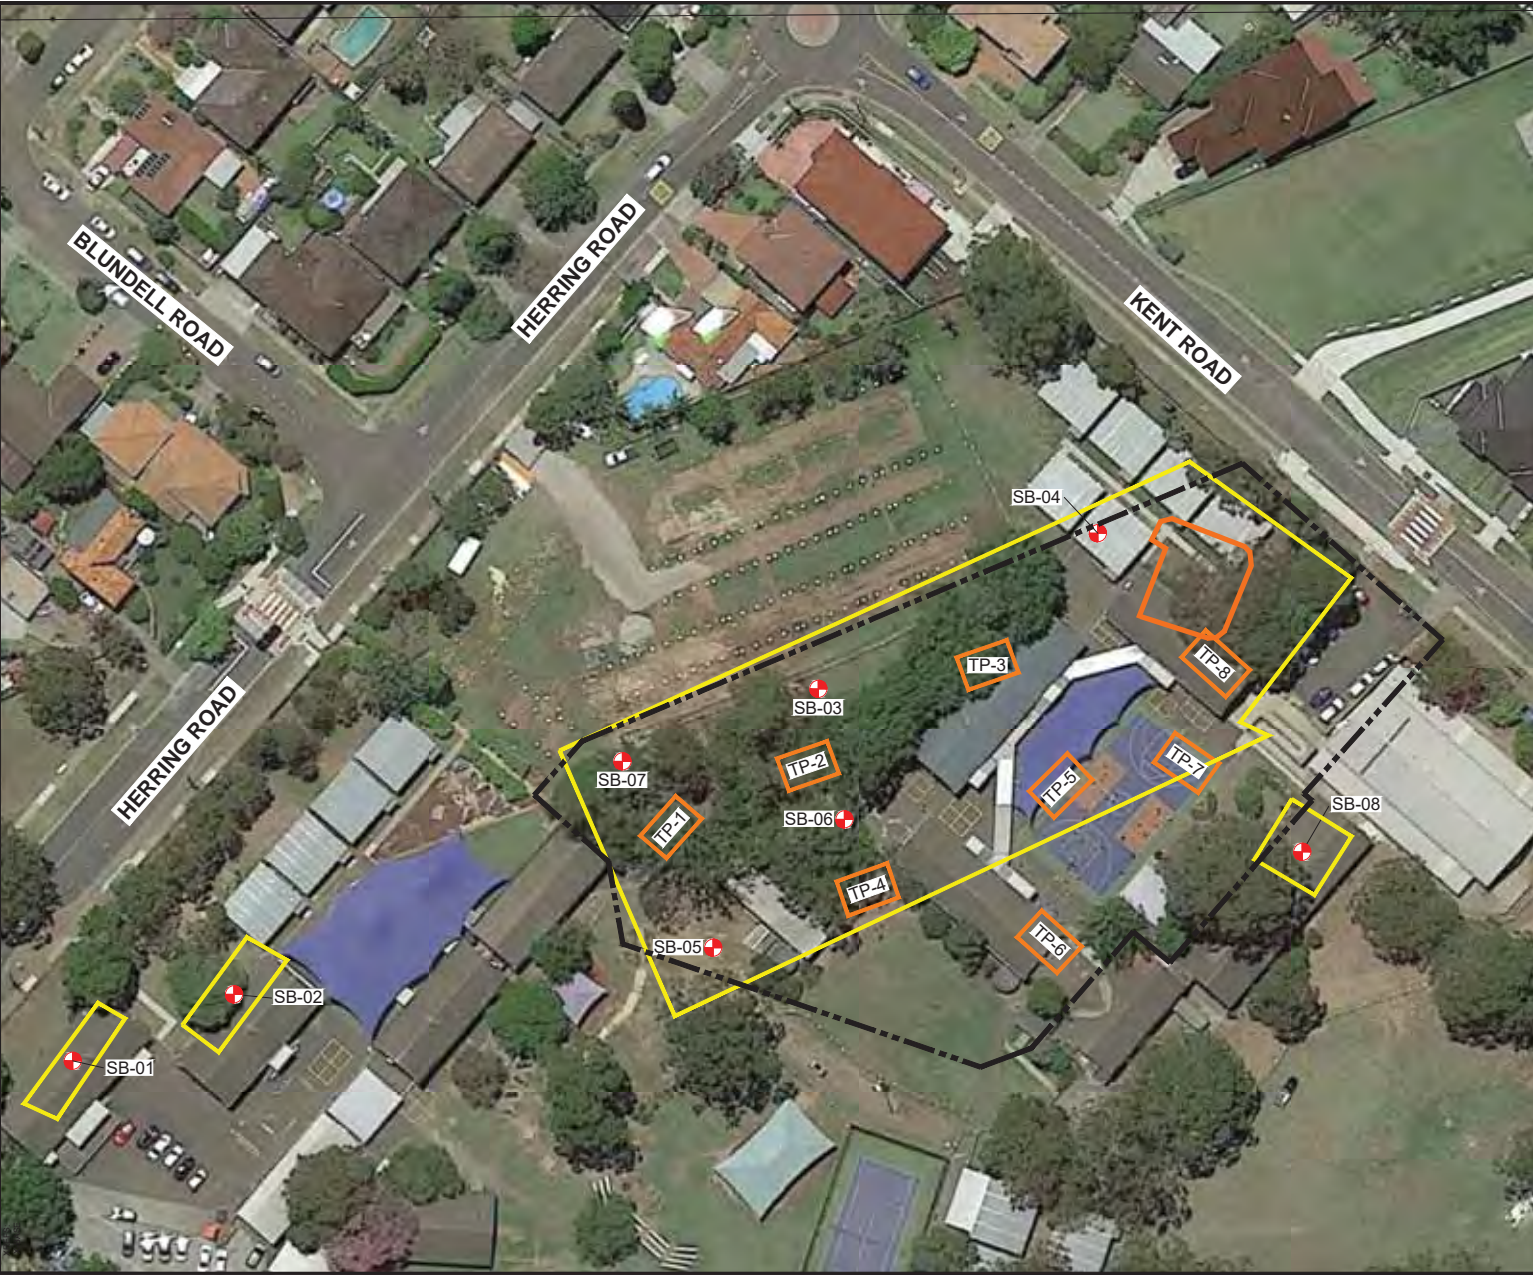
**LOCATION OF THE BLOCK R
CONTAINMENT CELL**

- Development Footprint
- Test Pit Location (2019)
- Borehole Location (2018)
- Study Area Due Diligence Assessment
- Approximate location of the Block R Containment Cell, to which the LTEMP applies.

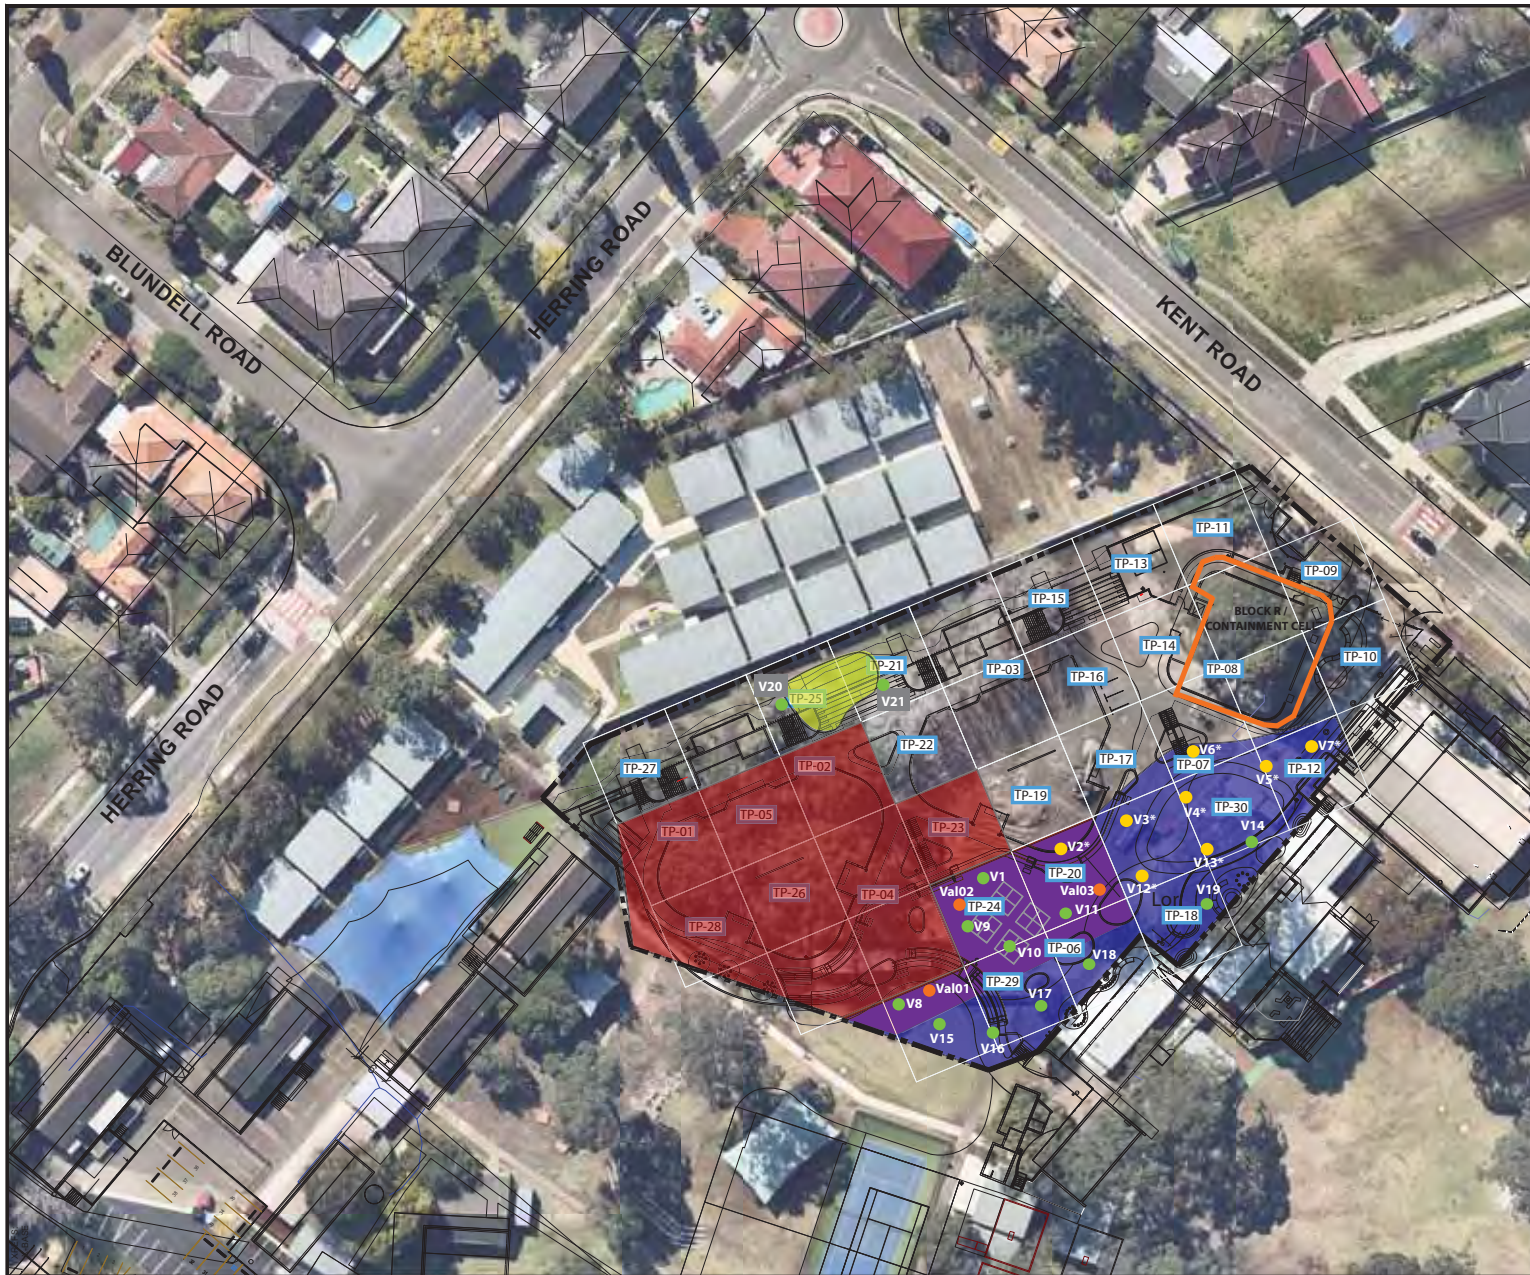
TEST PIT SAMPLING LOCATIONS

- Development Footprint
- Test Pit Location
- Approximately 14 m Grid
- Location of the Block R Containment Cell
- GSW CT1 Recyclable
- GSW due to TRH exceedance
- GSW CT1 Recyclable. Providing no ACM is observed when excavating anthropogenic material observed in fill
- Special Waste with GSW matrix
- Reclassified from GSW CT1 Recyclable to **Special Waste with GSW matrix** due to presence of friable asbestos
- Validation Sample Locations (11.12.2019)
- *Validation Sample Locations (11.12.2019) - Proposed location that were not collected due to observed exposed natural material
- Final Validation Sample Locations (23.01.2020)

- The fill soil containing anthropogenic materials within the area pre-classified as 'GSW (Recyclable)' (shaded in blue in **Appendix A, Figure 5**), if being excavated, were to be immediately be placed in a truck, re-sampled/visually observed from the truckload to confirm the classification, and then taken off-site to an appropriately licensed facility. The TRH hotspot were to also be disposed of with 'GSW (recyclable)' (shaded in yellow **Appendix A, Figure 5**) soils.

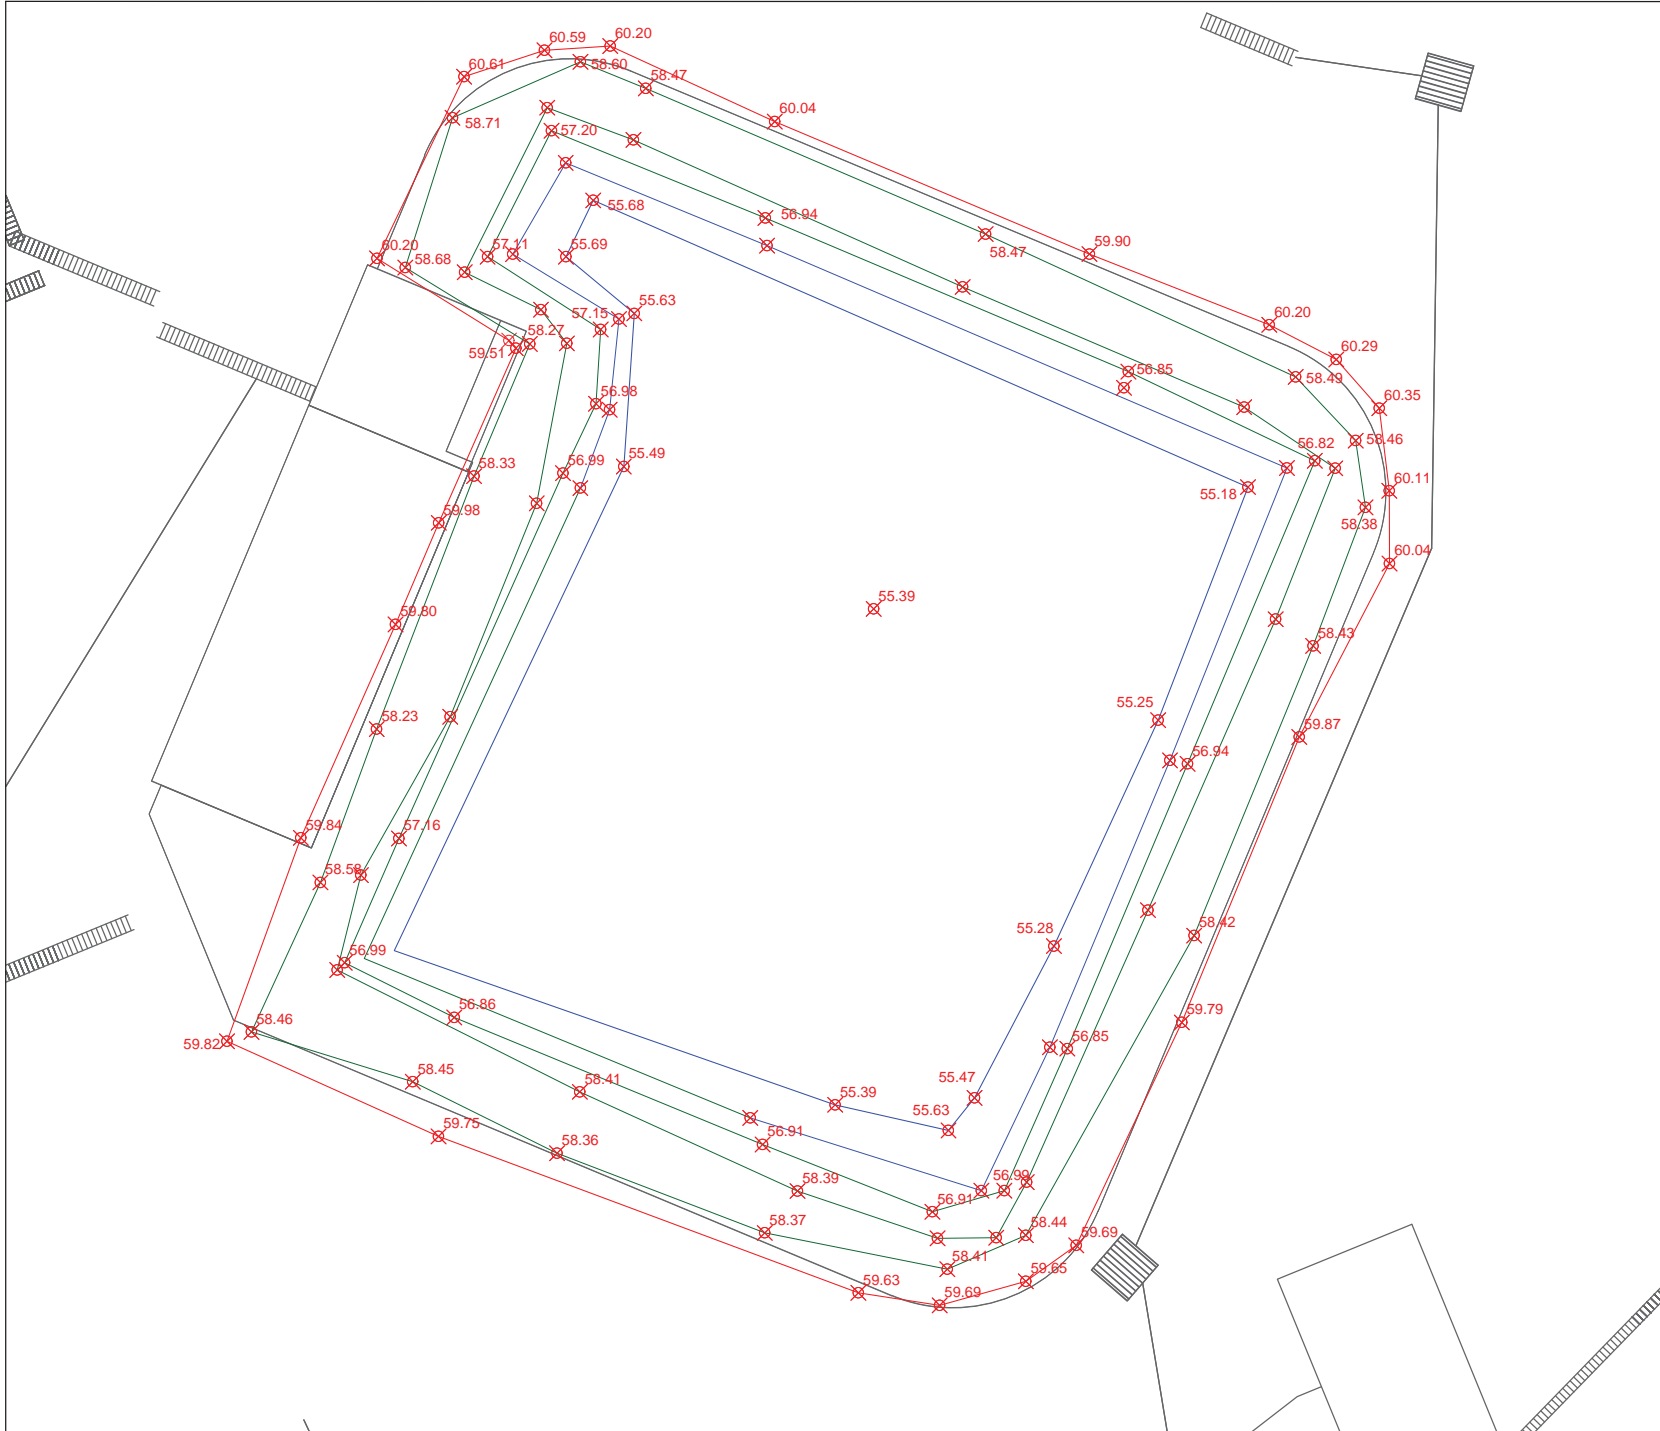
Client / Site	Rainbow Kent Rd Public School		
Drawing No:	9004b		
Area Of Survey	Borrow Pit		
Date	200109	Docket No 66804	
Measure File	200109AM		
Control File	Control Combined 191024		
Surveyor	AM		
Design Correct	Y	Resect 3PI+	Y
Orig BM CHK	Y	CHK SHOT	Y
Orig Control CHK	Y	All SOP Record	Y
SOP Looks Cor	Y	Offsets Clear	Y
All Labels Placed	Y	BM's Clear	Y
Measure CHK	Y	Shown Client	Y
All Works Complete	Y	Final Check Shot	Y
WFM Updated	Y	Next Visit Required	TBC
Drawing Ref			
Legend

- TOP OF BORROW PIT
- BOTTOM OF BORROW PIT
- BENCHING
- ⊗ SURVEYED POINTS

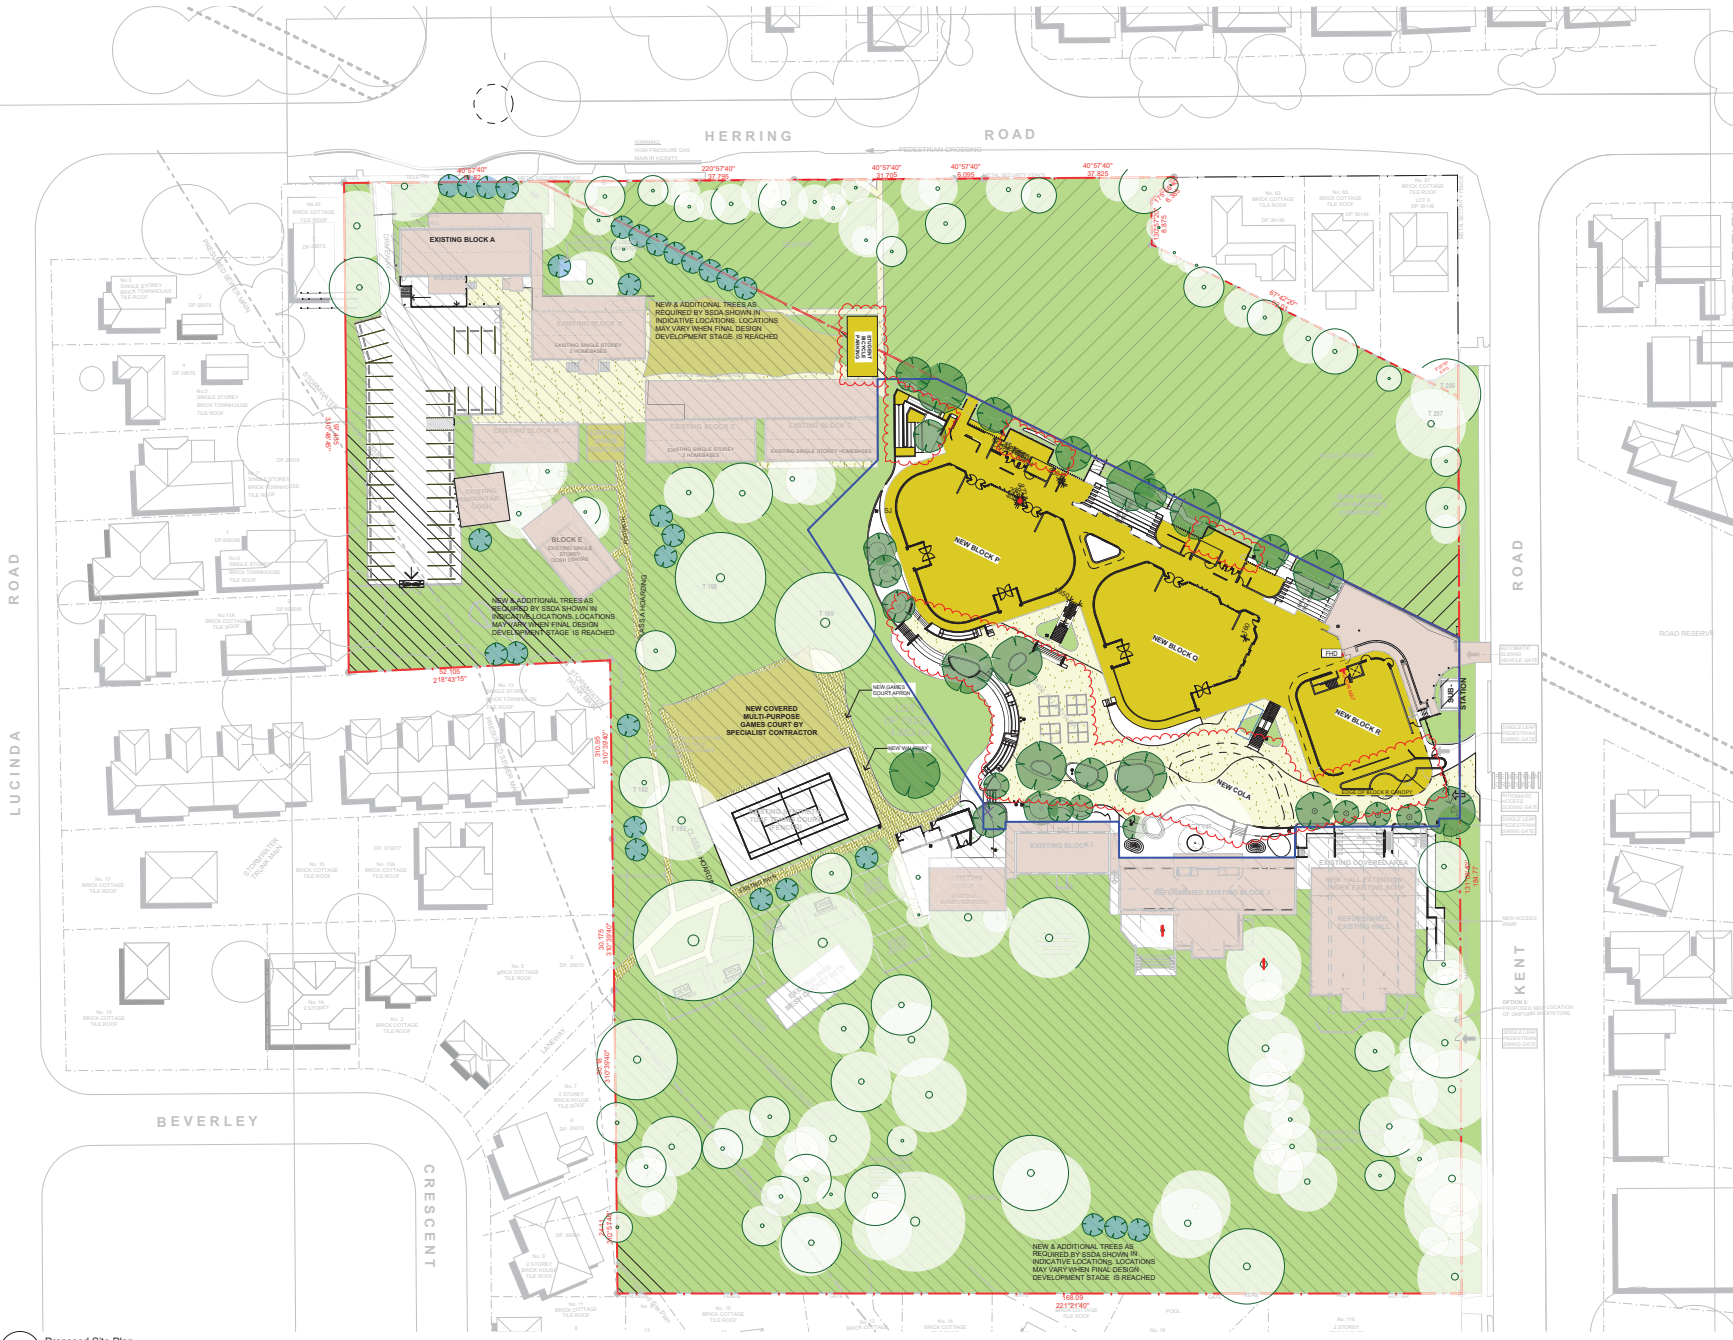
APPENDIX E BUILDING DESIGN PLANS

- EXISTING BUILDINGS
- NEW BUILDINGS AND EXTENSIONS TO EXISTING BUILDINGS
- EXISTING COLAND SHADE SAIL
- HARDPAVING / RAMP
- EXISTING TREES
- NEW TREES
- 20 NO. OFF NEW & ADDITIONAL TREES AS REQUIRED BY SSIA SHOWN IN INDICATIVE LOCATIONS. LOCATIONS MAY VARY WHEN FINAL DESIGN DEVELOPMENT STAGE IS REACHED
- ROAD RESERVE NO BUILDINGS NOT PART OF SSIA
- EXISTING CYCLEWAY
- NOT PART OF SSIA
- EXTENT OF SSIA

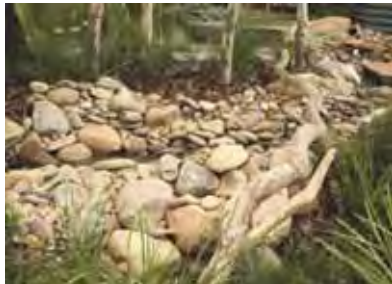
Planted sandstone spalls rain garden
