# **KINGSCLIFF PUBLIC SCHOOL**

## **ENVIRONMENTAL MONITORING**

Noise and Vibration Monitoring Compliance Report

**12 Orient Street, Kingscliff, NSW 2487**

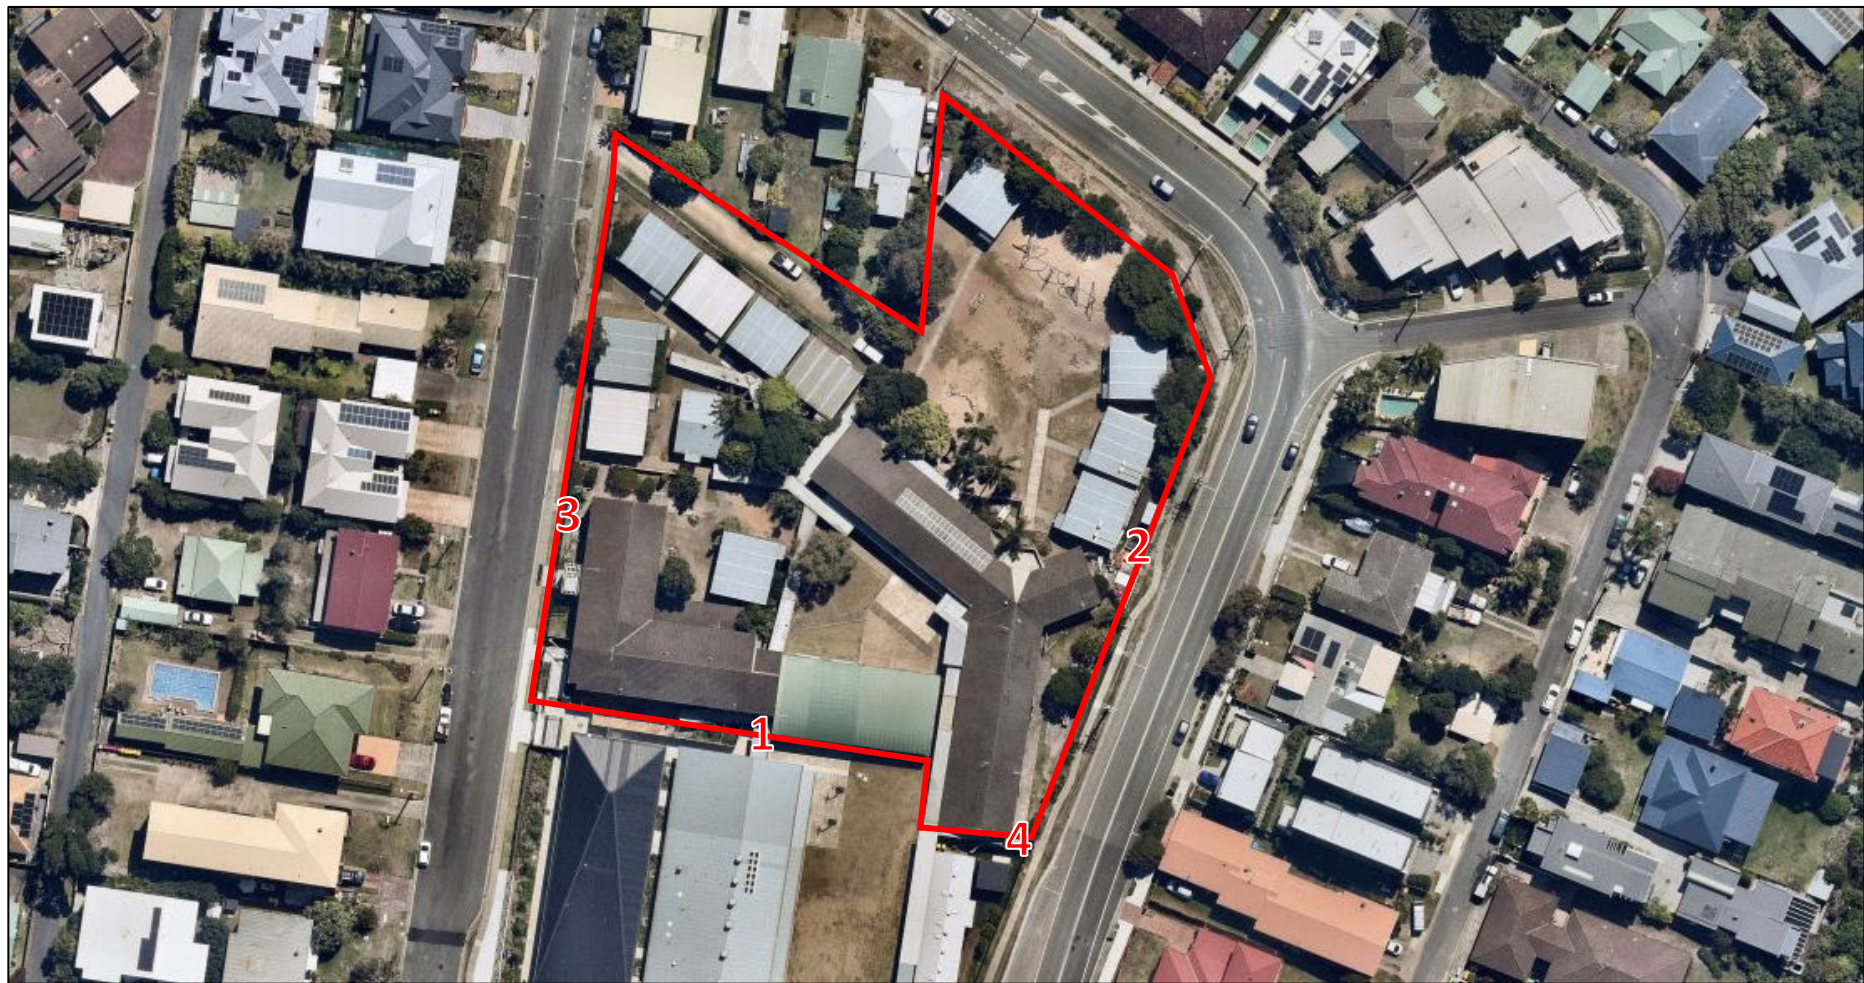
**Figure 2 – Noise and Vibration Monitoring**  
12 Orient Street, Kingscliff NSW 2487

- 1** 11<sup>th</sup>-26<sup>th</sup> October & 4<sup>th</sup> December – 13<sup>th</sup> December
- 2** 26<sup>th</sup> October – 13<sup>th</sup> November & 21<sup>st</sup> – 23<sup>rd</sup> November
- 3** 13<sup>th</sup> – 20<sup>th</sup> November
- 4** 23<sup>rd</sup> November - 4<sup>th</sup> December

The location of the noise and vibration meter was relocated throughout the monitoring period as demolition and earthworks progressed. The location of monitoring points and relevant dates are located illustrated in **Appendix A, Figure 2** and photographs of the noise monitor and general construction works are provided in Appendix B. The monitor was placed one metre away from the façade of the nearest building and at a height of 1.5 m above ground level. Noise Monitoring is generally conducted in accordance with AS 1055:2018 – Acoustics – Description and Measurement of Environmental Noise with Calibrated equipment. The monitor was erected within 1m of a temporary fence, however, this fence is not considered to be reflective. The meter provided RCC with instantaneous SMS alert notifications when noise levels of 75 LAeq<sub>15min</sub> dBA were recorded and vibration exceeded 5mm/s.

The vibration exceedance quickly peaked at 197mm/s at 4:57pm on the 20<sup>th</sup> October 2023 and immediately dropped well below the vibration limit. During this time, the monitor was situated at Location 1 (Appendix A, Figure 2) adjoining Building G. This exceedance was sharp and decayed quickly with no other vibration events of this magnitude detected immediately thereafter.

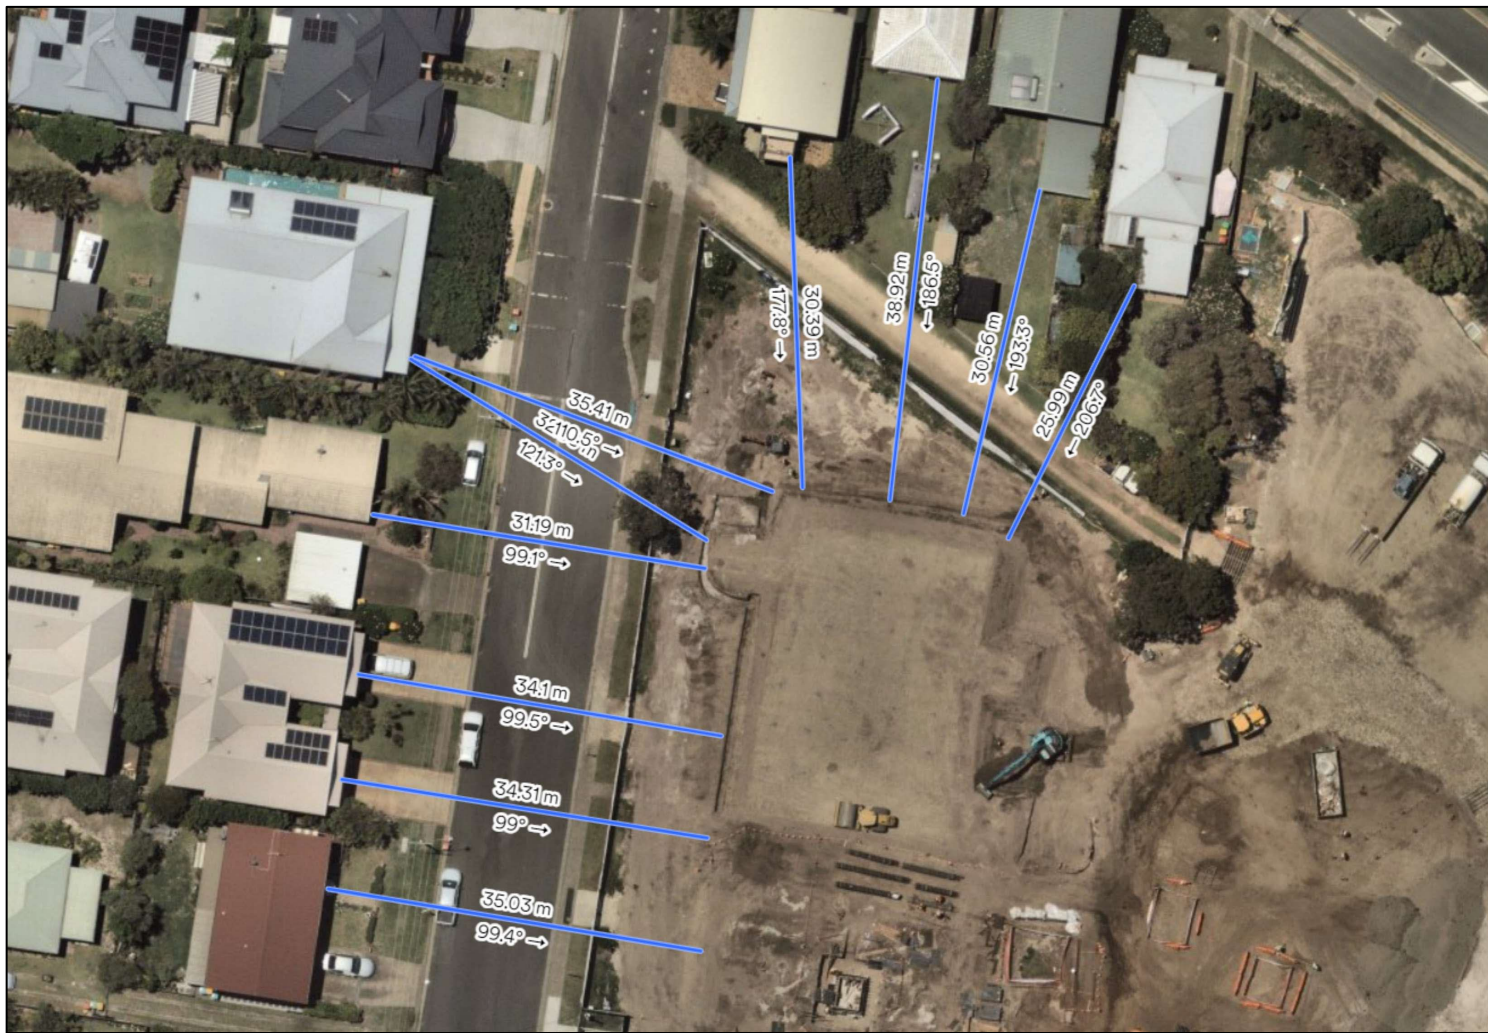
**Figure 3 – Vibratory Works in Relation to Sensitive Receivers**  
12 Orient Street, Kingscliff NSW 2487

Figure 3 illustrates the location of the vibratory compaction works and the closest residential receivers. All receivers excluding 11 Sutherland Street are 30m or greater from the vibratory compaction works. 11 Sunderland Street was approximately 25m from the vibration works and within the 30m vibration envelope specified within the Noise and Vibration Management Plan. The vibration exceedances on the 15/11/2023 to 23/11/2023 exceeded the residential human response criteria, however, did not exceed the residential criteria for structural damage. However, as vibratory works were within 30m of the dwelling, ENV recommends a dilapidation survey to be conducted on 11 Sutherland Street to determine if any cosmetic damage occurred.

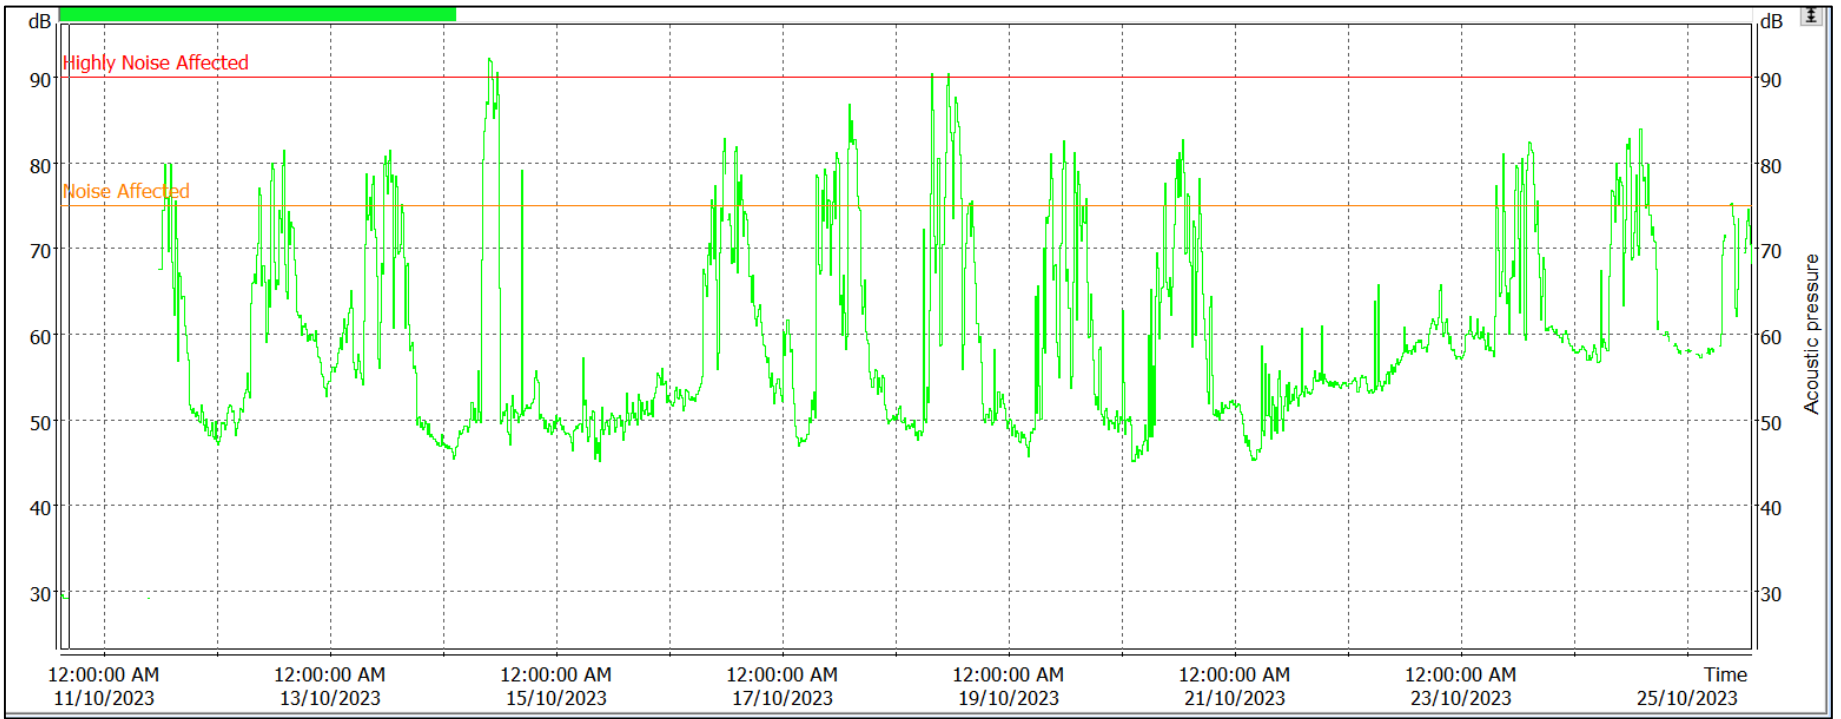
**Figure 4 – Noise Monitoring**  
12 Orient Street, Kingscliff NSW 2487

Figures 3 - 4 provided within Appendix B present a summary of the LAeq(15min) values recorded during the reporting period. The most sensitive NML of 52dBA was exceeded during and after construction hours with the NML being exceeded most mornings between 4:00am & 6:00am, before construction begins. Between 22<sup>nd</sup> October & 25<sup>th</sup> October, noise exceeded the NML at all times (including overnight outside constructions hours). Recorded daytime noise levels on Sundays (outside construction hours) reached a maximum between 55.5dBA to 75.8dBA (8:22am 03/12/2023). Due to the site being in close proximity of the roadway, the ocean and being located within a residential area (urban hum), background noise often exceeded the NML of 52dBA outside construction hours making compliance with the 52dBA NML practically impossible during construction hours.

As such, noise mitigation measures were focused on limiting demolition and construction noise to remain below the highly noise affected criteria of 75 dBA. Noise monitoring between the 11<sup>th</sup> - 26<sup>th</sup> October and 4<sup>th</sup> - 13<sup>th</sup> December was undertaken to assess noise at the school receivers. Noise monitoring occurring between 26<sup>th</sup> October - 4<sup>th</sup> December was undertaken to assess noise impacts to the adjoining residents with the noise monitor repositioned to three locations around the site boundary to assess compliance as illustrated in Appendix A, Figure 2. An adjustment to the recorded noise levels between the 26<sup>th</sup> October to the 4<sup>th</sup> December was calculated for all exceedances (Table 3) to compensate for the natural attenuation between the location of the noise monitor and the sensitive receivers.

As predicted in the noise assessment conducted by Acoustic Works in 2021 and outlined in the CNVMSP, the  $LA_{eq,15min}$  exceeded the highly noise affected threshold on multiple occasions when monitoring was conducted to determine the impact on classrooms. Noise levels recorded between 11-26<sup>th</sup> October and 4-13<sup>th</sup> December are likely to demonstrate ‘worst case’ as the noise monitor was situated in the centre of the school to monitor noise and vibration on school receivers. Recorded values during this time are shown to have significantly greater noise levels than the residential receivers. Calculated noise levels using the sound attenuation calculation determined the highest noise level on residential receivers during the project was 66.1dBA, well below the highly noise affected threshold.

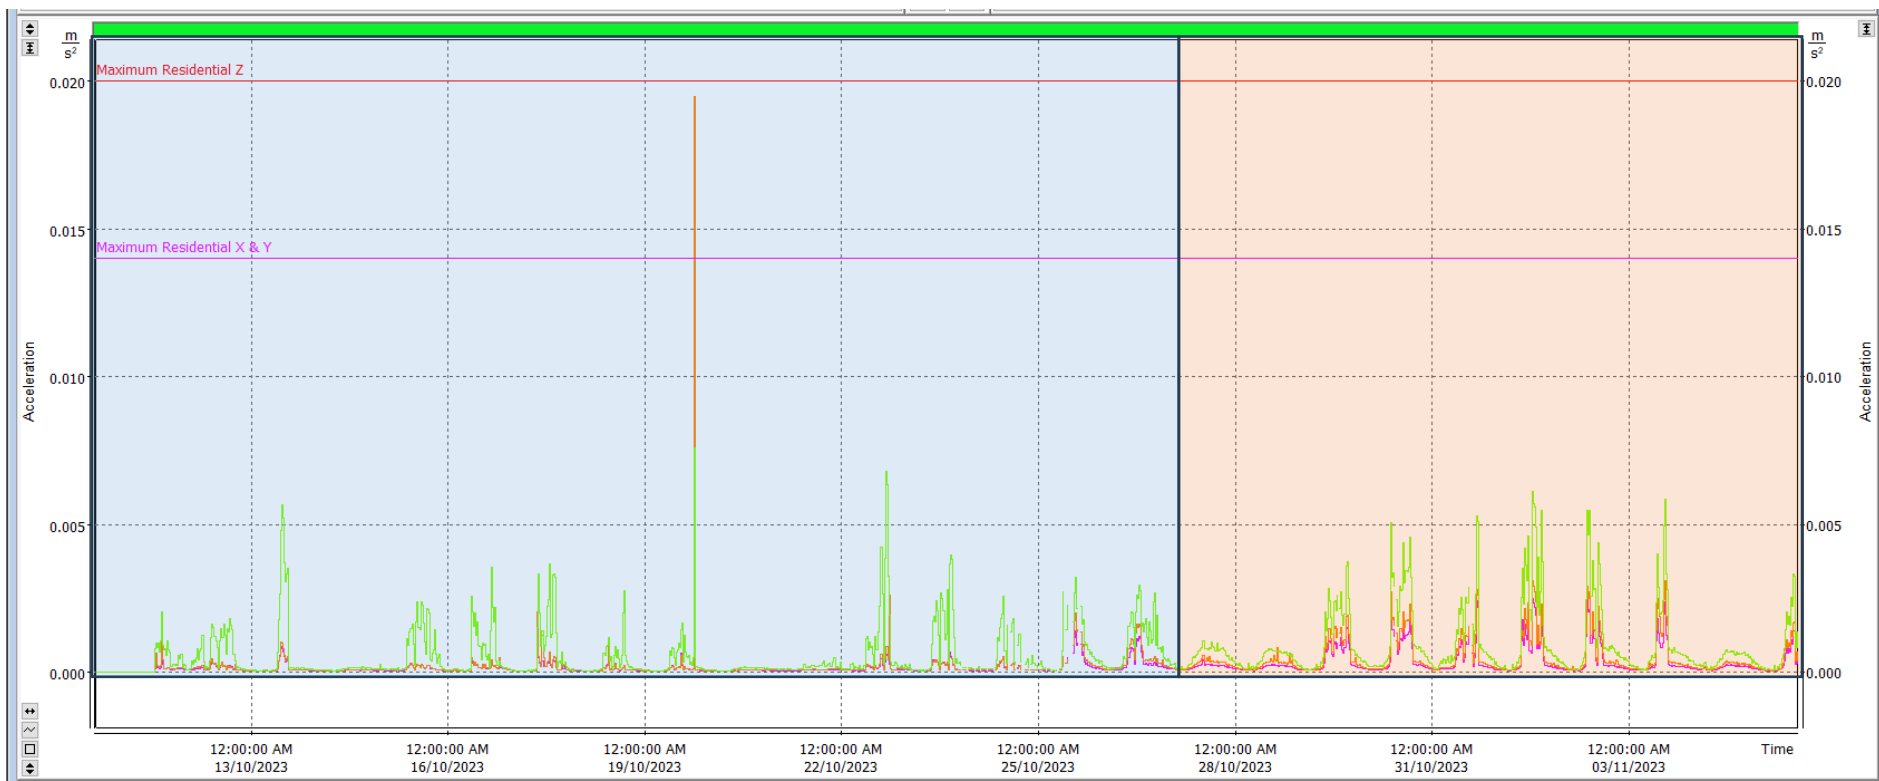
**Figure 9 – Vibration Monitoring for Human Response**  
12 Orient Street, Kingscliff NSW 2487

Vibration values (RMS) for continuous vibration are shown in Appendix A, Figure 9-11. Vibration exceedances recorded on the 13/11/2023, 23/11/2023 & 04/12/2023 are not construction related and were caused by setting up or moving the vibration monitor. Table 5 illustrates the vibration exceedances for the Project.

The vibration exceedances appear to have occurred during bulk earthworks and soil compaction works with the use of vibratory rollers and earthmoving machinery. To mitigate vibration levels, RCC utilized smaller vibratory compaction equipment (reduced the vibratory roller from a 12 tonne to a 10 tonne roller) on the 16<sup>th</sup> November after vibration exceedance on the 15<sup>th</sup> November. To further mitigate vibration levels, the intensity of the vibratory roller was reduced as low as possible to obtain level 1 compaction as per the project requirements. ENV have been advised that level 1 compaction was not possible without the use of vibratory rollers.

During the 15<sup>th</sup> – 17<sup>th</sup> November, the noise monitor was located on the western boundary of the site with Orient Street and the laneway on the northern boundary providing a buffer zone to reduce vibration on the residential receivers. Due to access, security and power concerns, monitoring equipment was not installed at the nearest residential receiver.

Vibration exceedance on the 23<sup>rd</sup> November between 10:20am and 11:05am was caused by localised vibration generated from trucks entering the site over the steel grid within 2m of the vibration monitor. It is anticipated the vibration generated from this event would be negligible at the residential receiver approximately 26m away on the other side of Sutherland Street. However, this exceedance is considered a noncompliance for human response. The highlighted exceedance on the 23<sup>rd</sup> of February (following the exceedance caused by the movement of trucks) at approximately 12pm as indicated on Figure 10 was caused by the physical movement of the monitor to a secondary monitoring location.

There was a single spike above the maximum residential criteria at  $0.021\text{m/s}^2$  (Y axis) at 6:27PM on 19<sup>th</sup> October 2023 however, the monitor was located at the centre of the school and is below the maximum threshold ( $0.028\text{m/s}^2$ ) for educational facilities and is therefore not considered an exceedance.

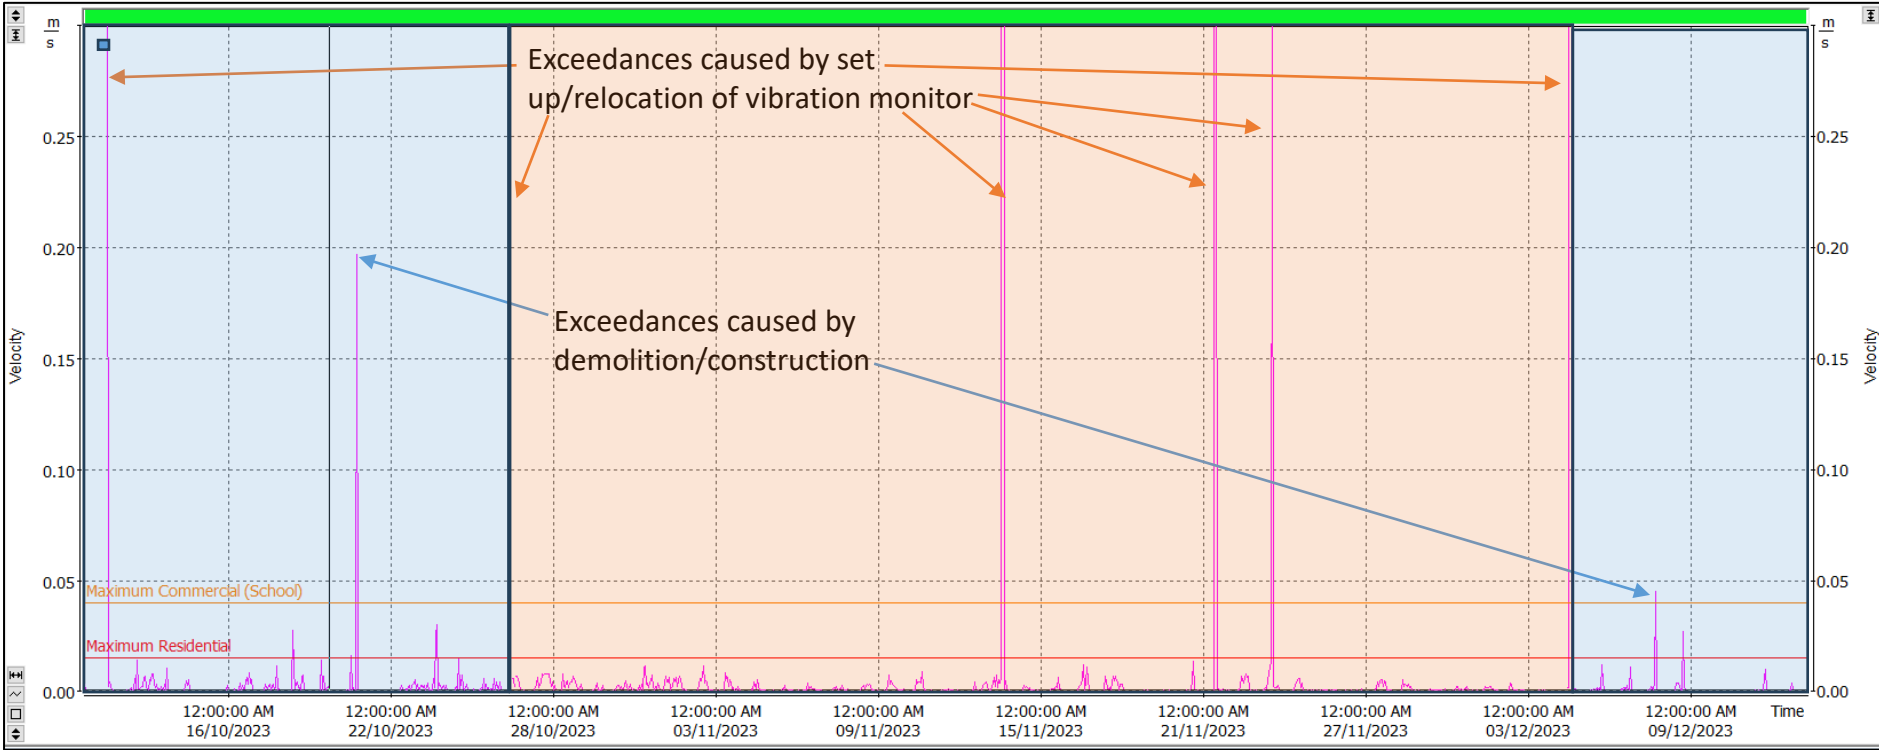
**Figure 12 – Vibration Monitoring for Structural Damage**  
12 Orient Street, Kingscliff NSW 2487

Vibration Values for short term structural damage are shown in Appendix A, Figure 12. Vibration exceedances on the 11/10/2023, 26/10/2023, 13/11/2023, 21/11/2023, 23/11/2023 & 04/12/2023 are not construction related and were caused by setting up or moving the vibration monitor.

Monitoring Location 1 was selected to monitor vibration on the school structures (classified as commercial structures). During the monitoring period there were two (2) vibration exceedances above the Commercial vibration limit outlined in Table 4.

Works during this time were associated with the demolition of the adjacent school building subject to redevelopment. As the vibration peaked and dropped immediately and no other vibration events of this magnitude were detected, it is assumed that the concrete slab the accelerometer (vibration meter) was situated on received a direct impact causing the large spike. The magnitude of this spike may have been isolated to the immediate area of the vibration plate (accelerometer), however this spike is still considered an exceedance.

A second exceedance on the 7<sup>th</sup> December 2023 at 3:42pm was detected peaking at 45mm/s. The spike immediately dropped below the adopted vibration criteria for commercial buildings. During this time, the monitor was situated at Location 1 (Appendix A, Figure) adjoining Building G.

Works during this time were bulk earthworks and fill compaction utilising vibratory rollers. To mitigate vibration emission and potential impact, RCC proactively adopted the use of smaller vibratory rollers whereby a 10t roller was utilized. To further mitigate vibration levels, the amplitude setting of the vibratory drum of the roller was set as low as possible to alleviate impact whilst ensuring level 1 compaction as per the project requirements was obtained to meet geotechnical requirements. ENV have been advised that level 1 compaction was not possible without the use of vibratory rollers.

Monitoring Location 1  
Commercial Vibration Limits Apply

Based on the outcomes of the monitoring event, ENV recommends a dilapidation survey to be conducted on Building G to ensure structural or cosmetic damage has not occurred.

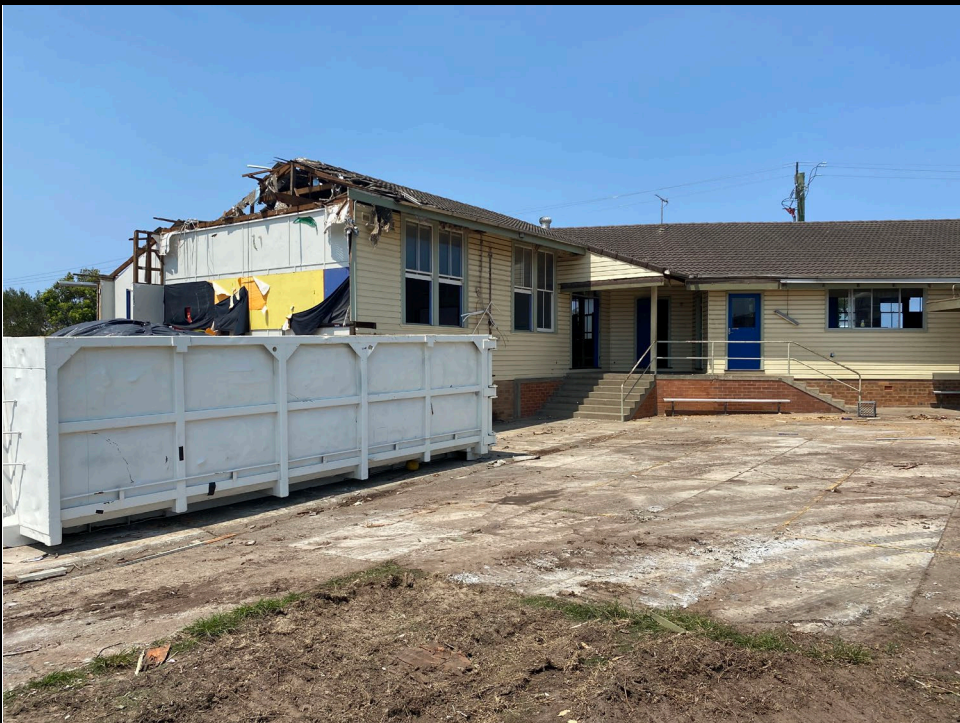
<b>Photo No.</b> 5	<b>Date</b> 24/10/2023

<b>Description</b> Image showing building C to be demolished

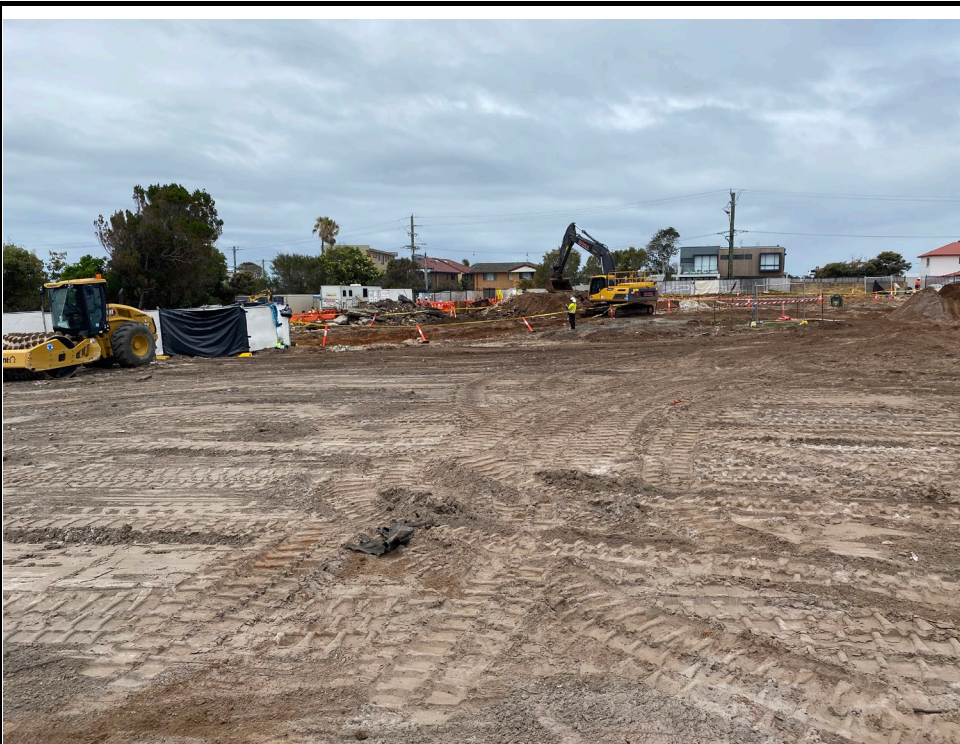
<b>Photo No.</b> 6	<b>Date</b> 13/11/2023

<b>Description</b> Image showing demolished area and earthworks.
