Report on
Unexpected Finds Protocol

Lake Cathie Public School Upgrade
1240 Ocean Drive, Lake Cathie

Project 89691.02
December 2019

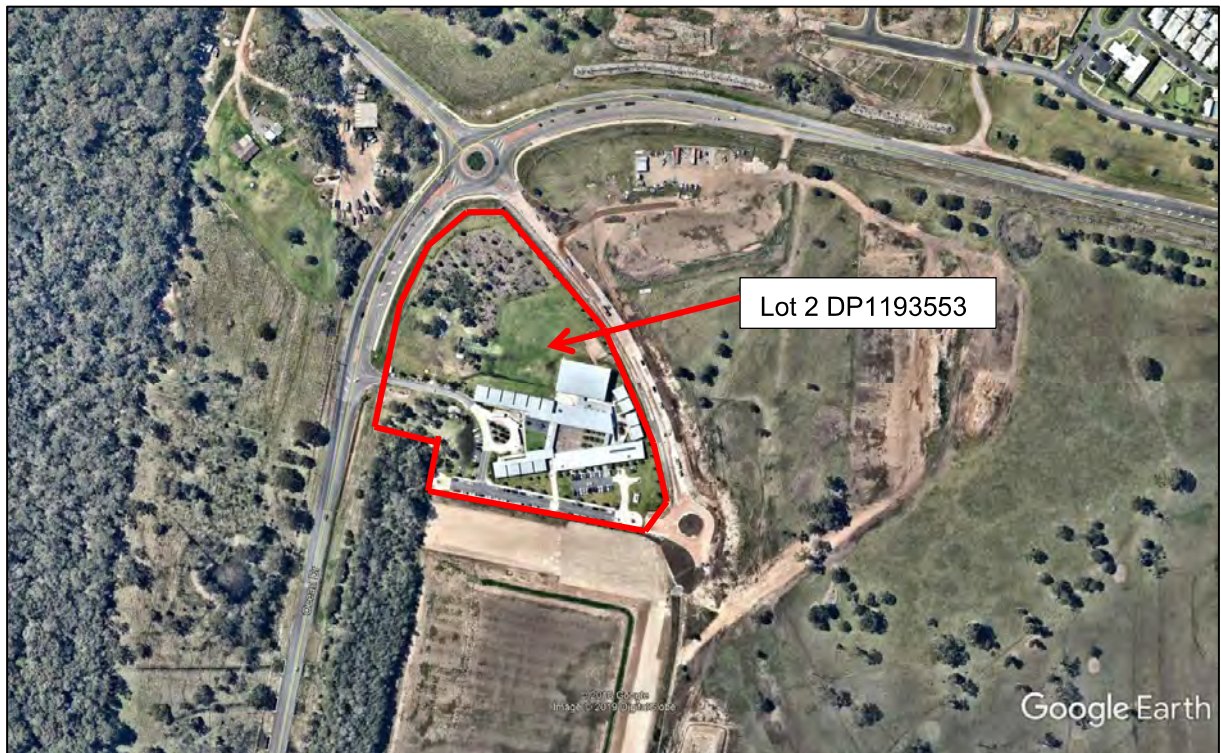
Figure 1: Aerial image of Lake Cathie Public School and surrounds (Nearmap Image dated 23 October 2018)

An aerial image showing the existing structures at Lake Cathie Public School and the surrounding infrastructure is shown below in **Figure 1**. Small to medium trees have been planted around the north-east perimeter of the school and in the area of the existing car parks and access roads.

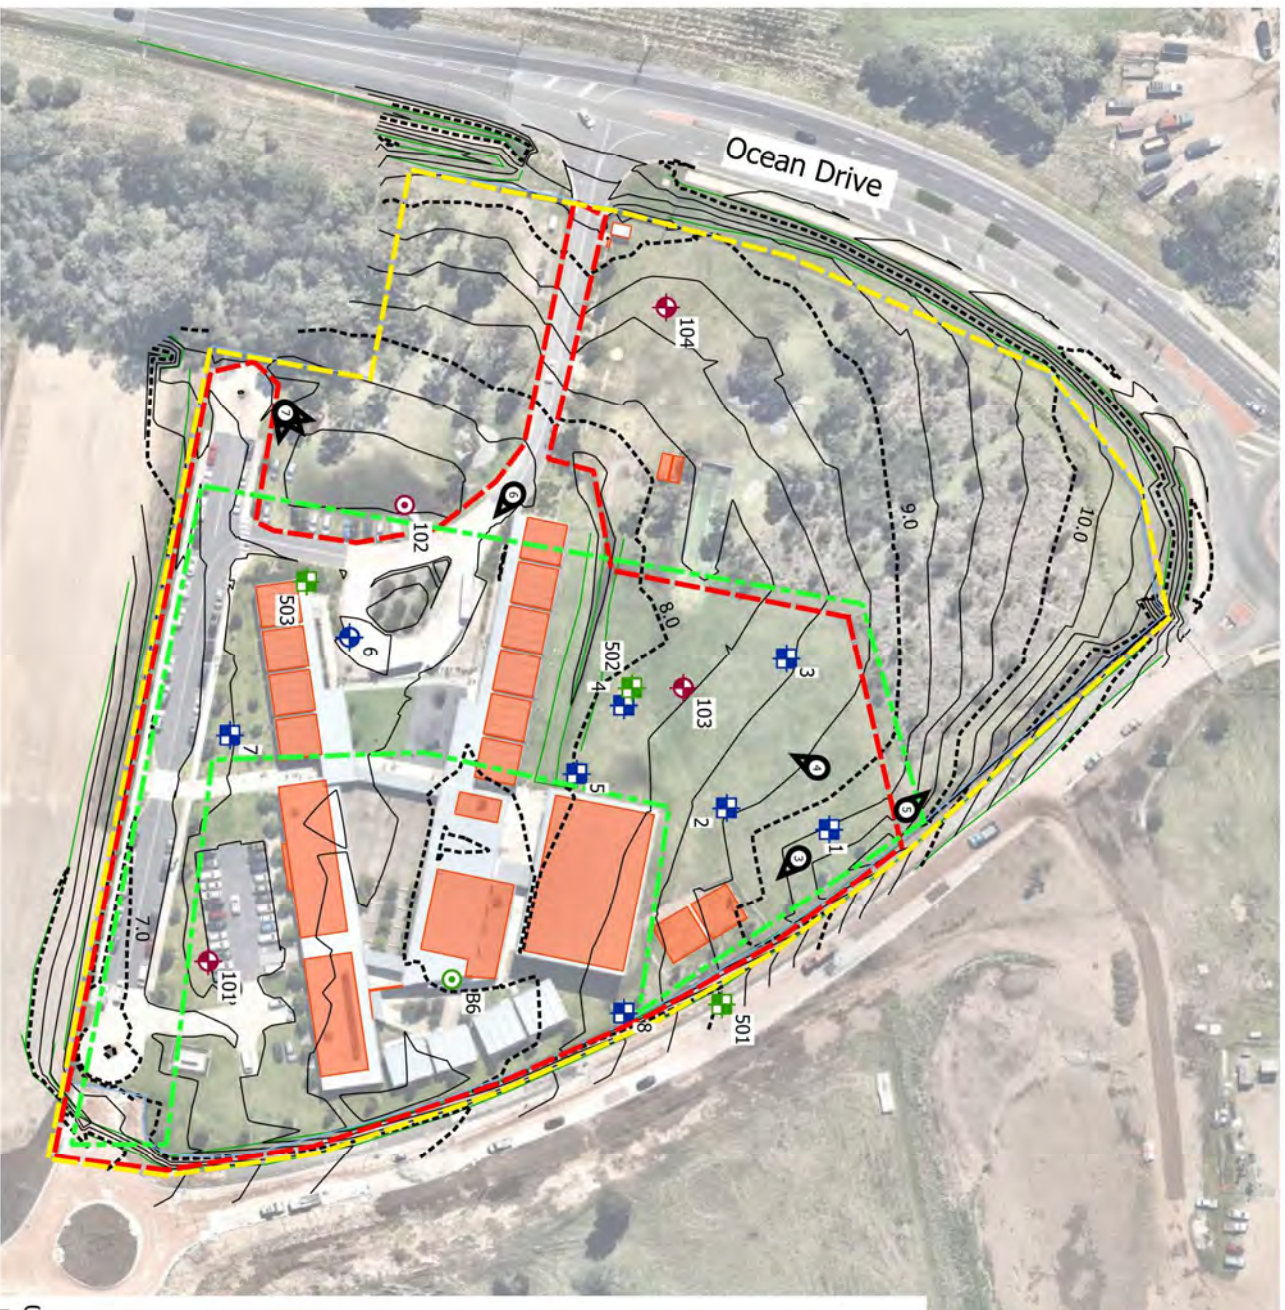
Drawing 1 from Previous Investigation (89691.01)

The existing area of the allotment to be further developed ('the site') is at approximate RL 9.5 m AHD in the north falling to RL 7.5 m AHD to the south, as shown on Drawing 1 in Appendix B.

Refer to Drawing 1 in Appendix B.
