**SOIL VALIDATION ASSESSMENT**

**PROPOSED LINDFIELD LEARNING VILLAGE**

**100 ETON ROAD, LINDFIELD, NSW**

**REF: E30259KDrpt-VAL**

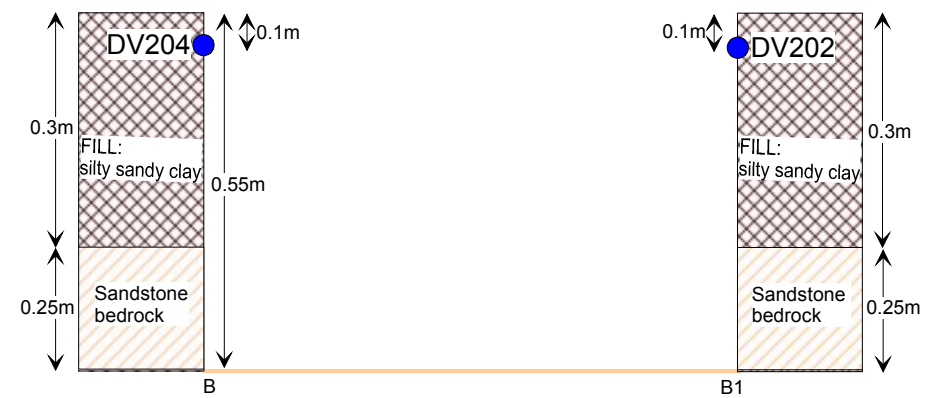
## Section B

- Wall validation sample and identification
- Base validation sample and identification, depth of sample(m)

Soil samples were obtained from the walls and base of the remediation excavation as detailed below (shown on Figure 7).

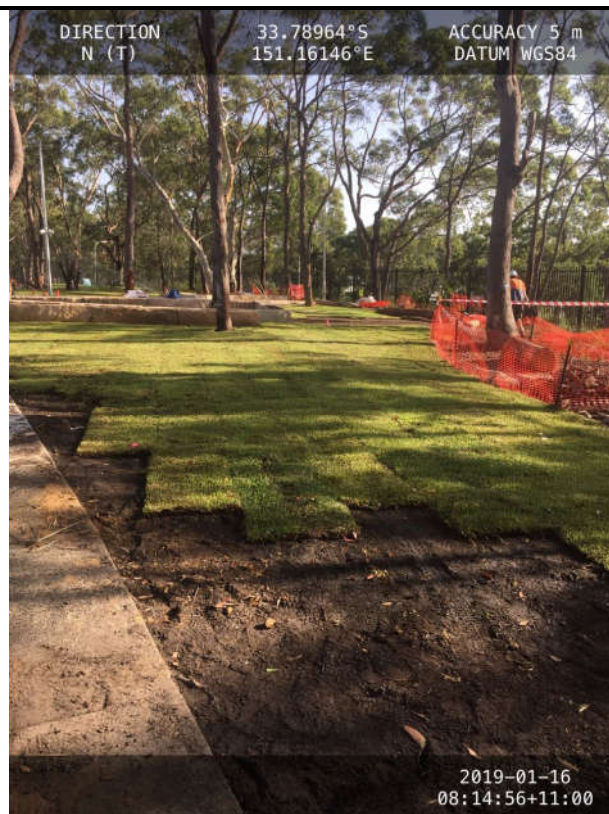
**Photograph 1:** Taken showing part of the eastern portion of the site, facing north. Note the dense recently laid grass turf covering the ground and imported topsoil beneath.

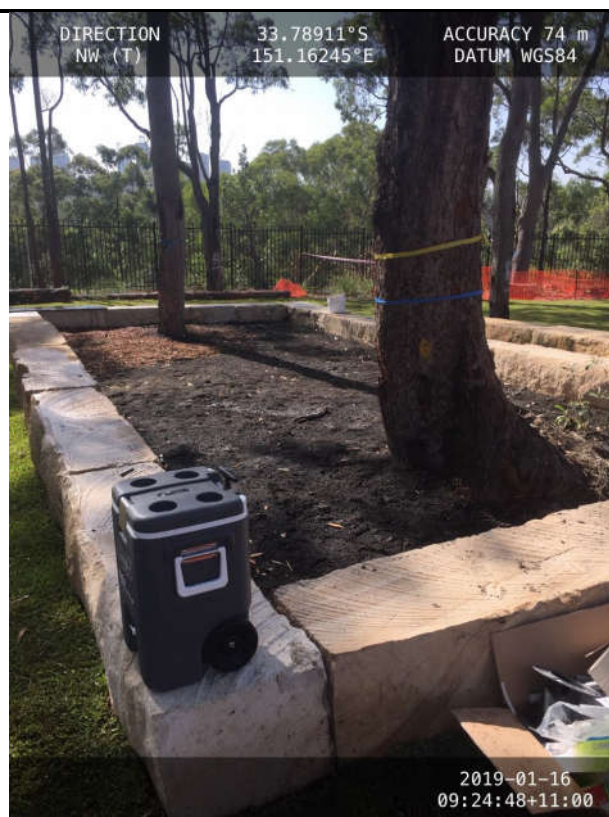
**Photograph 3:** Taken showing the eastern portion of the site, facing north-west. Note the sandstone features around the tree with topsoil and partial bark chip cover.

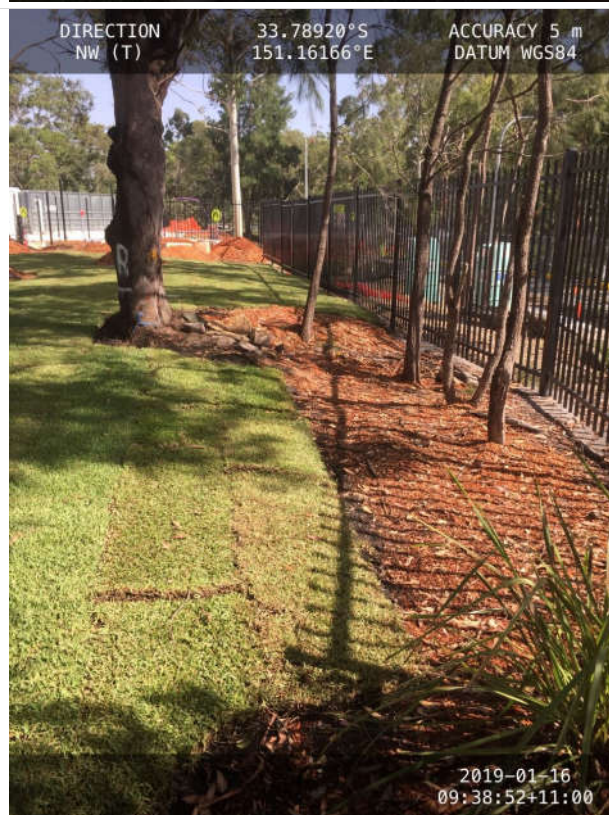
**Photograph 4:** Taken showing the eastern boundary of the site, facing north-west. Note the recently laid turf and bark chip cover.

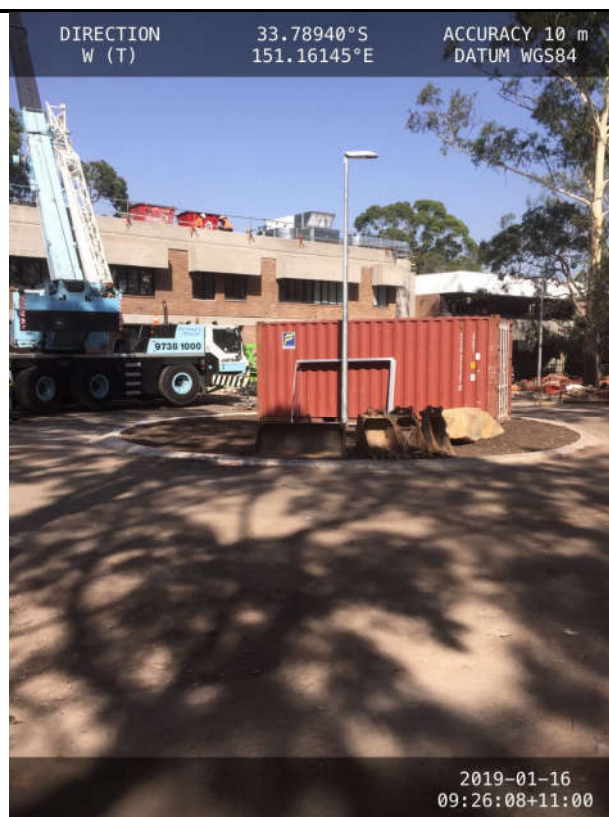
**Photograph 5:** Taken showing the central roundabout within the site, facing west. Note the asphaltic concrete road covering a large portion of the site.

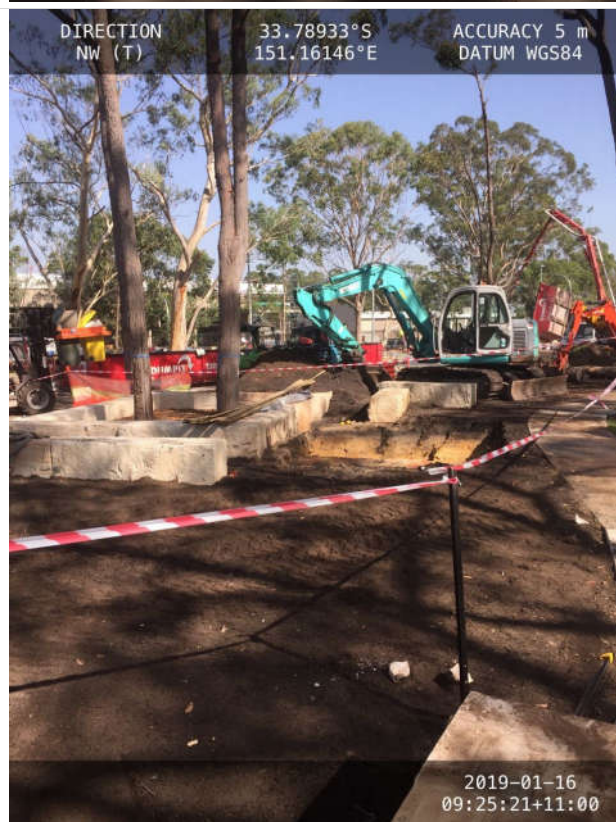
Validation of imported topsoil was undertaken by EIS on 14 January 2019. Approximately five FCF were observed on the surface in the north-east section of the site. The FCF appeared to be partially buried within the fill material. Two representative FCF (HWF1 and HWF2) were obtained and analysed for

The detection of ACM in the north-east section of the site was considered to be an unexpected find. The source of the ACM is considered to be associated with a localised historically filled area or may be associated with a larger FCF that has broken up over time.

**Photograph 6:** Taken showing the remediation area where asbestos cement fragments were identified, facing north-west. Note the excavated area and the imported topsoil in the immediate vicinity.

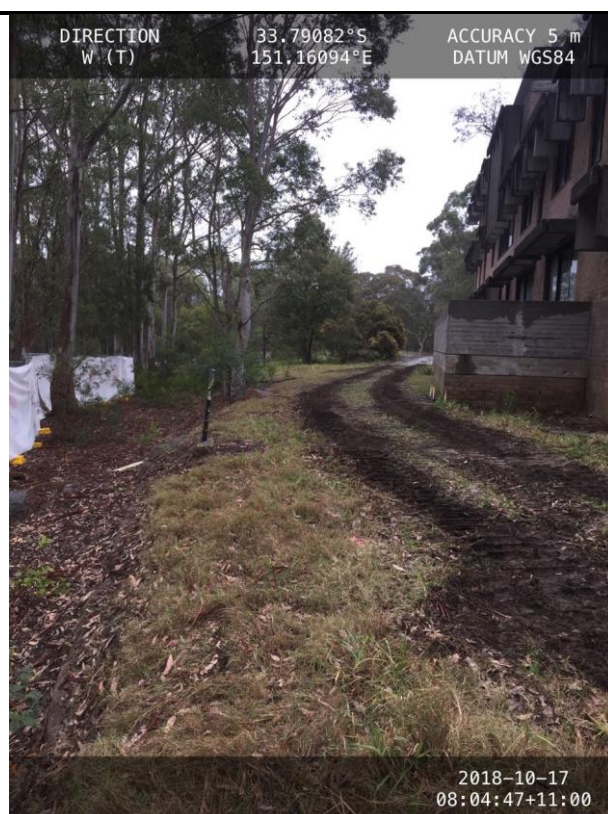
**Photograph 3:** Taken showing the southern portion of the site, facing west. Note the grass cover and dense leaf litter covering the ground. Some areas of exposed soil are visible.

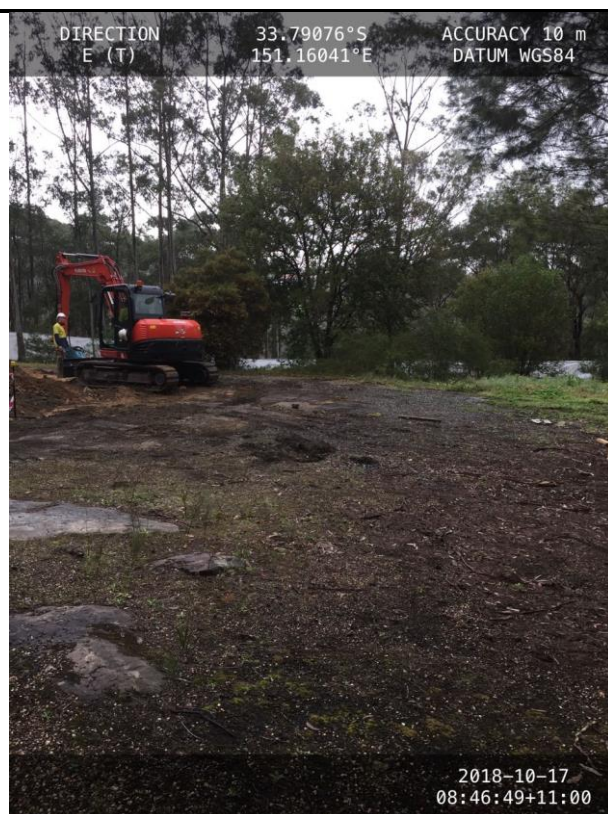
**Photograph 5:** Taken showing the southern portion of the site, facing east. Some excavations have commenced in this area. Note the sandstone outcropping adjacent the excavation.

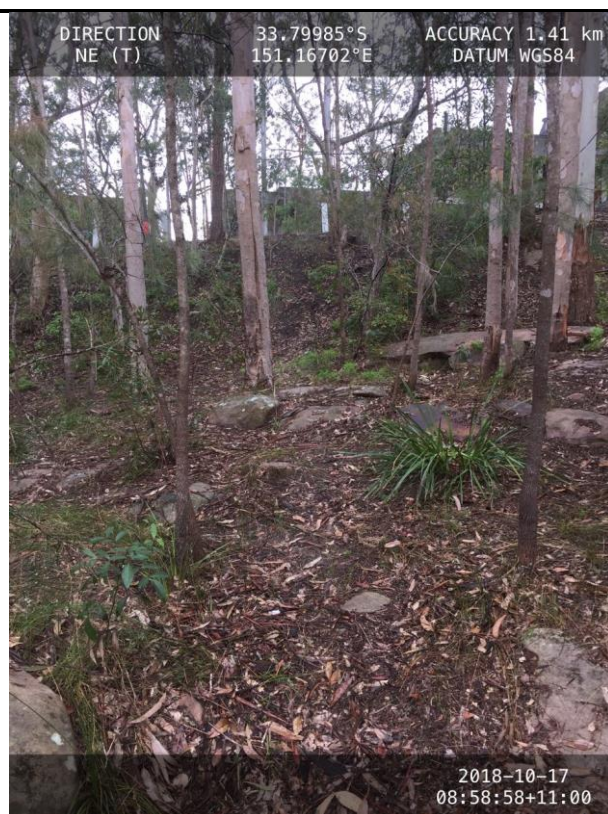
**Photograph 7:** Taken showing the garden bed adjacent the southern carpark, facing north-east. Note the dense leaf litter covering the ground and exposed sandstone outcropping at the surface.

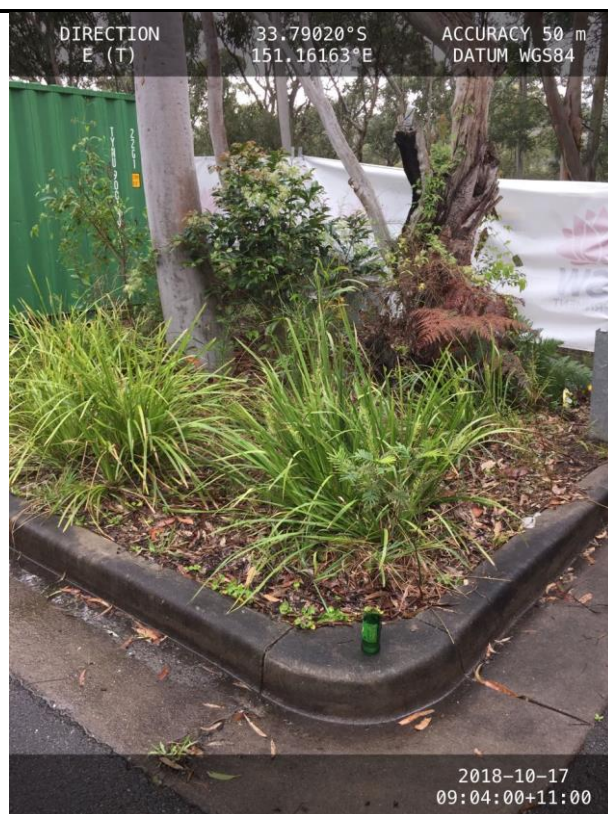
**Photograph 9:** Taken showing a corner garden bed adjacent the southern carpark, facing east. Note the dense leaf litter and vegetation cover.

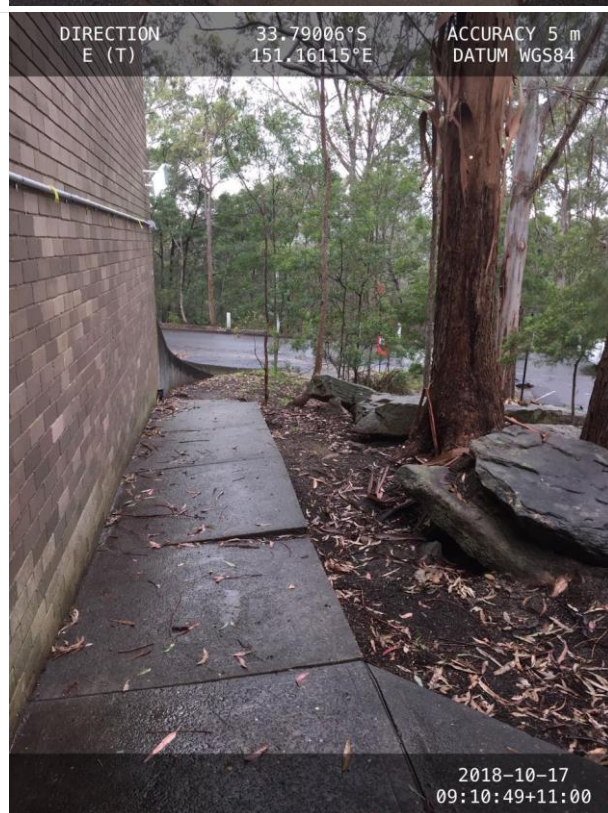
**Photograph 10:** Taken showing the central portion of the site adjacent the site office, facing east. Note the paved footpath, dense leaf litter covering the ground and exposed sandstone outcropping at the surface.

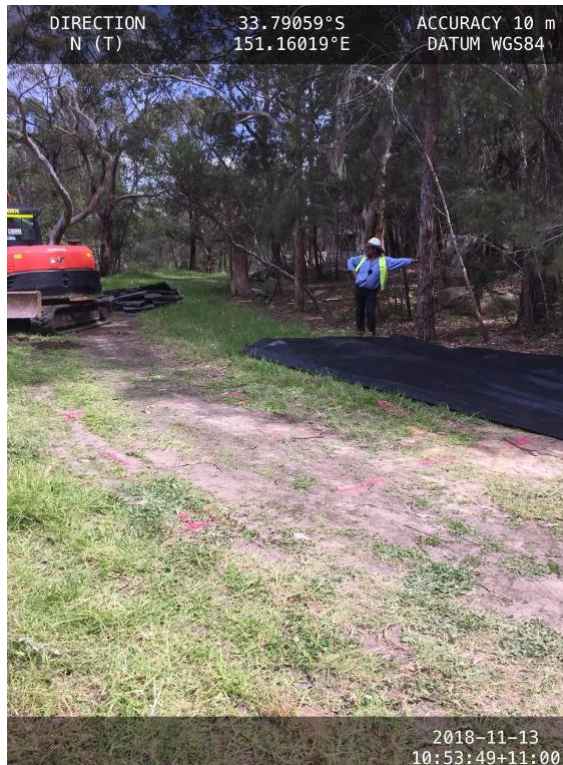
Showing remediation Area A (round 1) marked out with builder's plastic to the north. Photograph taken 13/11/18.

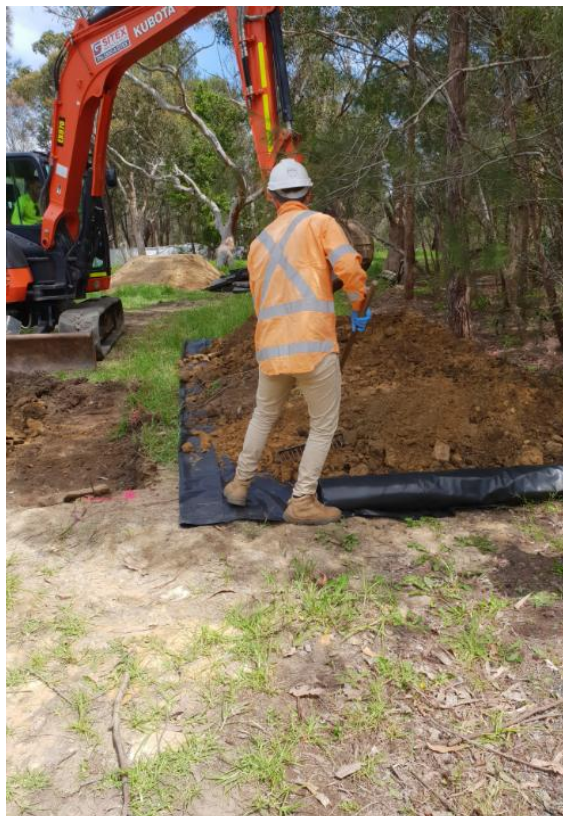
Showing remediation Area A (round 1) and raking of stockpiled excavated fill material by EIS Asbestos Assessor for assessment of potential ACM. Photograph taken 13/11/18.

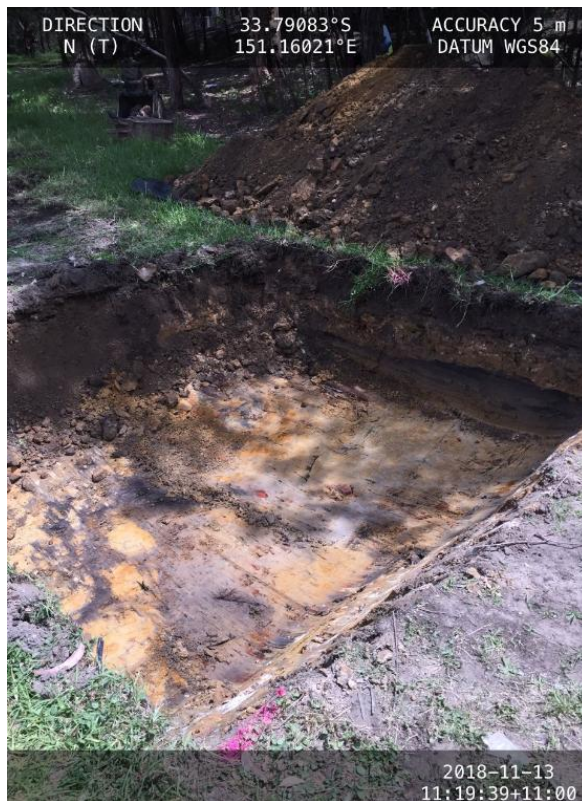
Showing remediation Area A (round 1) completed excavation and fill soil stockpiled on builder's plastic. Photograph taken 13/11/18.

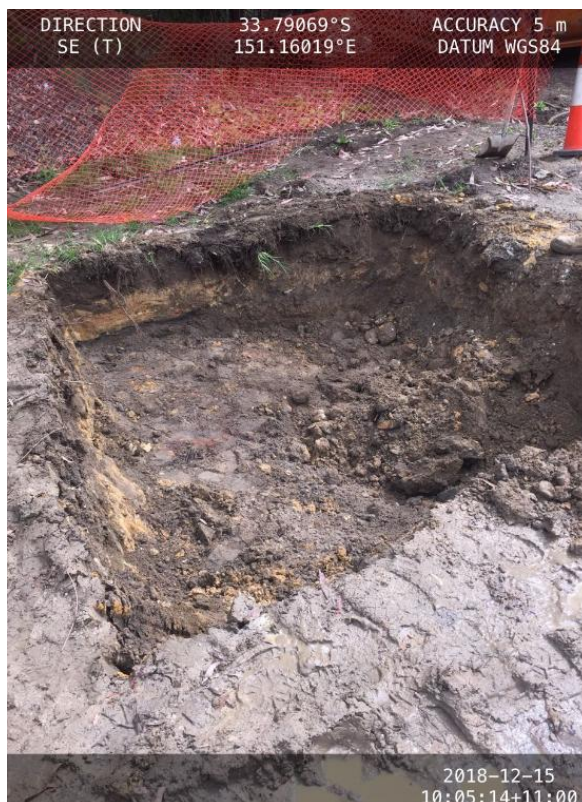
Showing remediation Area A (round 2) excavation. Photograph taken 15/12/18.

EIS's NSW SafeWork Asbestos Assessor (Lic. No 001028) attended site on 15 December 2018 to observe the excavation of the ACM impacted soils backfilled in Area A (outlined above), and to obtain validation soil samples. At the time of the inspection Area A had been barricaded to prevent access to site workers and vehicles. The remediation area was progressively excavated with an excavator, with the excavated material placed directly into a plastic lined skip bin to be disposed of off-site as Special Waste/General Solid Waste (non-putrescible) in accordance with EIS waste classification report (see Section 3.4). The locations of the validation samples obtained are shown in on Figure 4 attached in the appendices. EIS field notes and site photographs obtained during the remediation of Area A (round 2) are attached in the appendices.

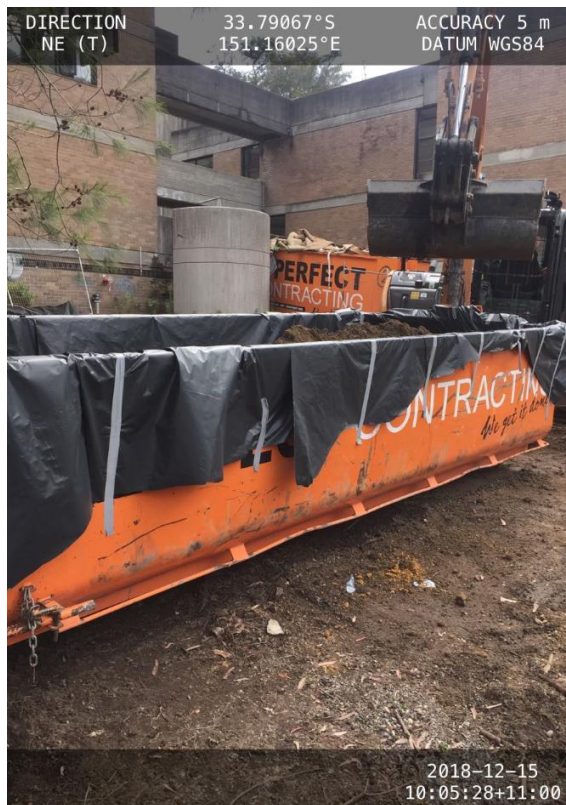
Showing remediation Area A (round 2) excavation spoil placed directly into skip bin. Photograph taken 15/12/18.

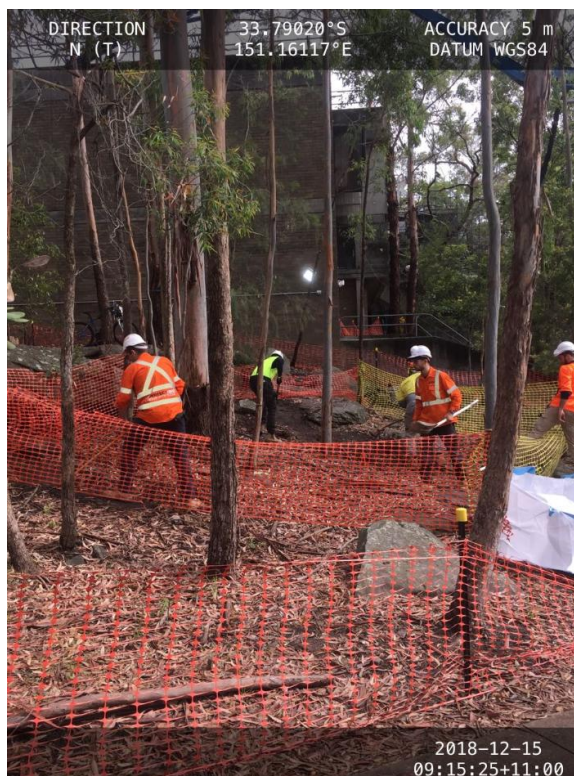
Showing barricaded and hand excavation works at remediation Area B. Photograph taken 15/12/18.

EIS's NSW SafeWork Asbestos Assessor (Lic. No 001028) attended site on 15 December 2018 to observe the excavation of the PCB impacted soils (Area B), and to obtain validation soil samples. At the time of the inspection, Area B had been barricaded to prevent access to site workers and vehicles. The remediation area was progressively excavated by hand tools and the soil was placed within a skip bin to be disposed of off-site as General Solid Waste (non-putrescible) in accordance with EIS waste classification report (see Section 3.4). The locations of the validation samples obtained are shown in Figure 5 attached in the appendices. EIS field notes and site photographs obtained during the remediation of Area B are attached in the appendices.

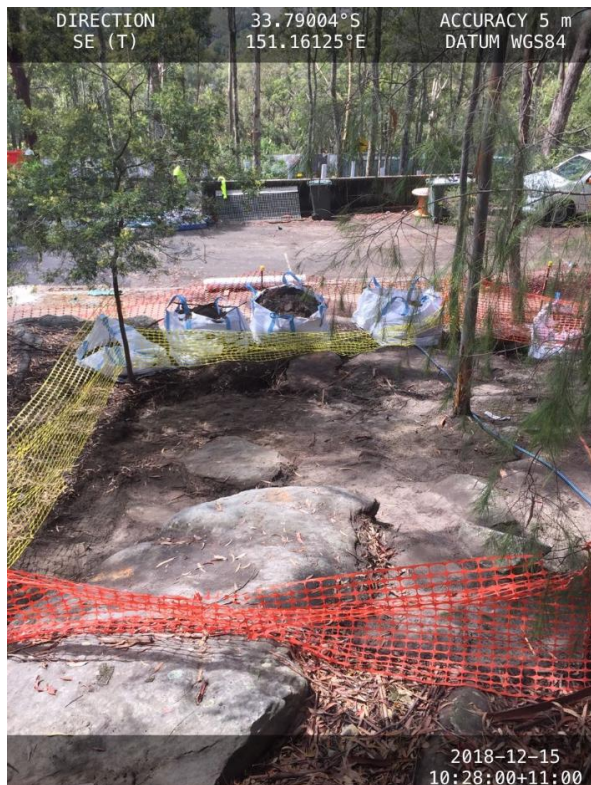
Showing remediation Area B completed excavation. Photograph taken 15/12/18.

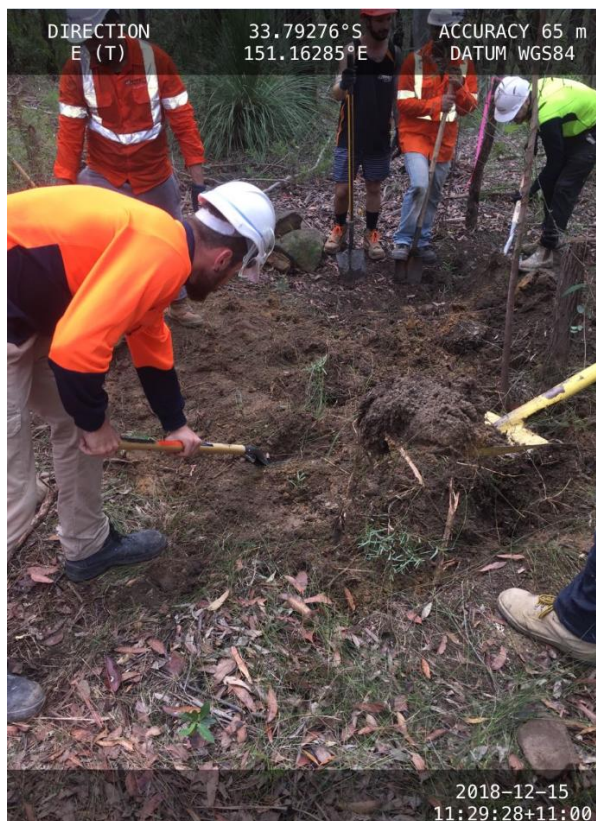
Showing hand excavation works at remediation Area C. Photograph taken 15/12/18.

EIS's NSW SafeWork Asbestos Assessor (Lic. No 001028) attended site on 15 December 2018 to observe the excavation of the lead impacted soil (Area C), and to obtain validation soil samples. At the time of the inspection, Area C had been barricaded to prevent access to site workers and vehicles. The remediation area was progressively excavated by hand tools and placed within a skip bin to be disposed of off-site as General Solid Waste (non-putrescible) in accordance with EIS waste classification report (see Section 3.4) . The locations of the validation samples obtained are shown in on Figure 6 attached in the appendices. EIS field notes and site photographs obtained during the remediation of Area C are attached in the appendices.

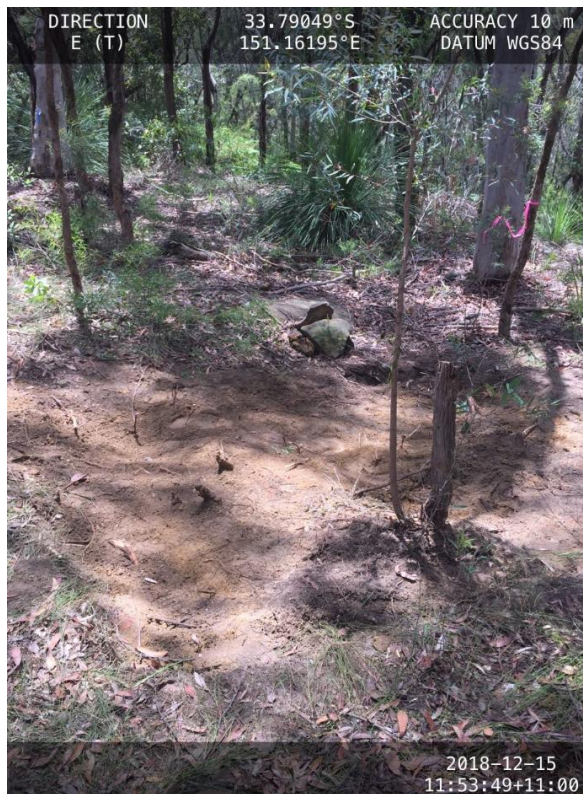
Showing remediation Area C completed excavation. Photograph taken 15/12/18.

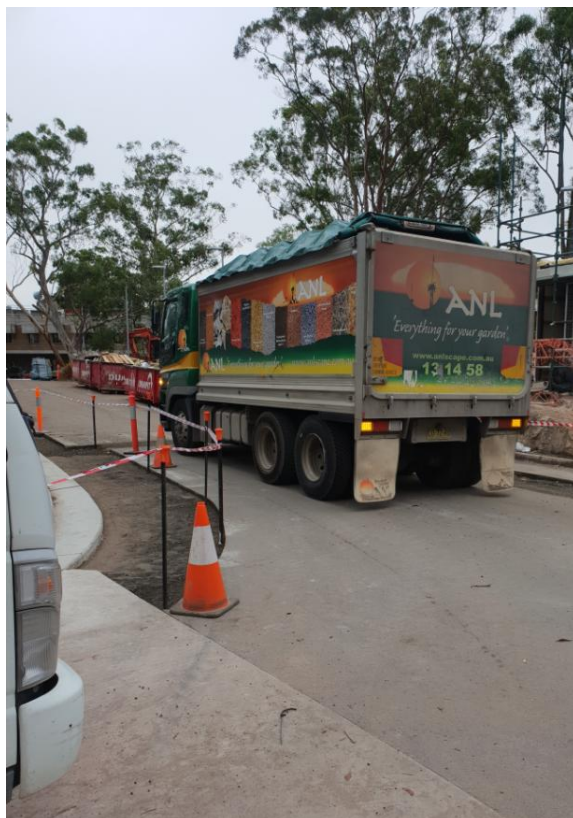
Showing delivery of topsoil from ANL. Photograph taken 10/1/19.

On 14 January 2019, EIS attended site to inspect the topsoil and to obtain validation soil samples of the imported materials. At the time of the inspection, delivery of topsoil from ANL was underway with the material stockpiled and progressively spread across the north-east section of the site. EIS inspected the placed/stockpiled topsoil and did not observe any FCF. Landscaping, including the placement of topsoil was yet to occur in the north-west section of the site. The locations of the topsoil validation samples obtained are shown on Figure 8 attached in the appendices. EIS field notes and site photographs obtained during the topsoil validation are attached in the appendices.

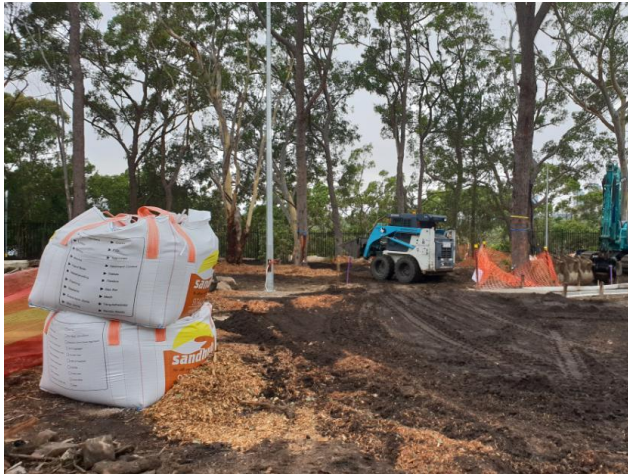
Showing spreading of topsoil in the far north-east section of the site. Photograph taken 10/1/19.

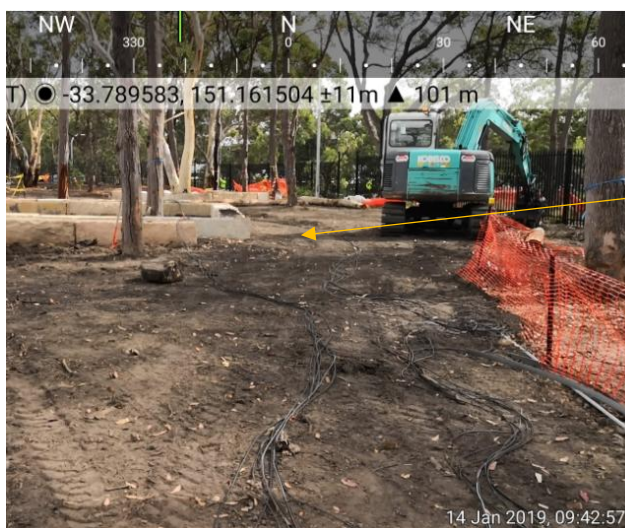
Showing the north-east section of the site during imported topsoil validation sampling. Photograph taken 14/1/19.

Note: Approximate location of unexpected FCF find (see below photograph).

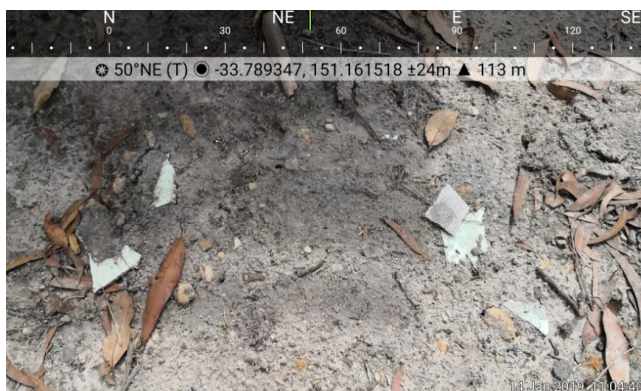
Showing FCF encountered on the surface in the north-east section of the site. Representative FCF samples HWF1 and HWF2 were confirmed by the laboratory to contain asbestos. Photograph taken 14/1/19.

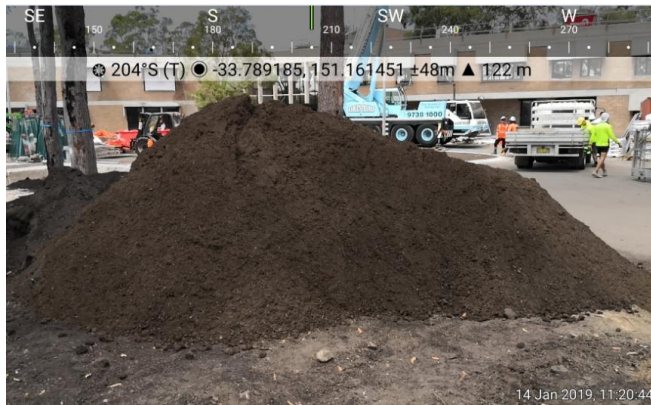
Showing stockpiled topsoil. Stockpile 1. Validation samples TOPSP1 and TOPSP5 were obtained from this stockpile. Photograph taken 14/1/19.

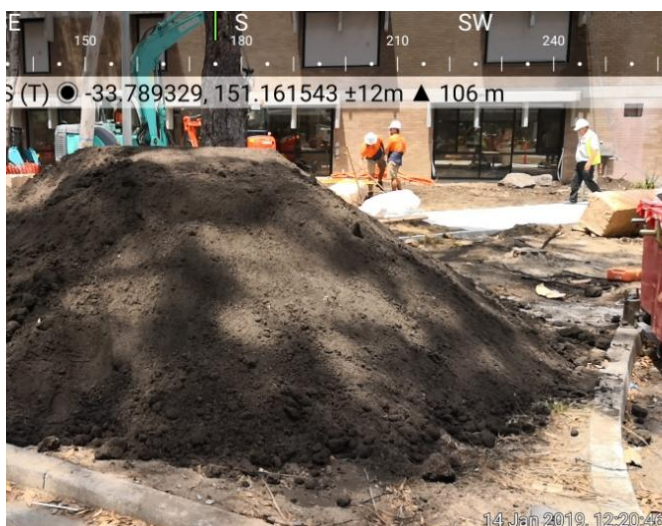
Stockpile 2. Validation sample TOPSP7 was obtained from this stockpile. Photograph taken 14/1/19.

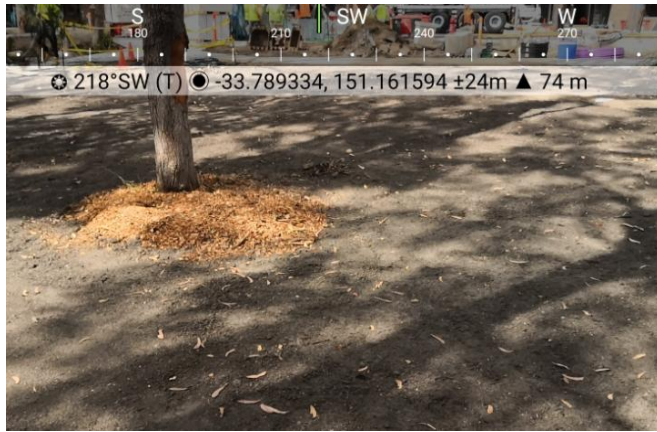
Showing placed topsoil in the far north-east section of the site. Validation samples TOP6 was obtained from this areas. Photograph taken 14/1/19.

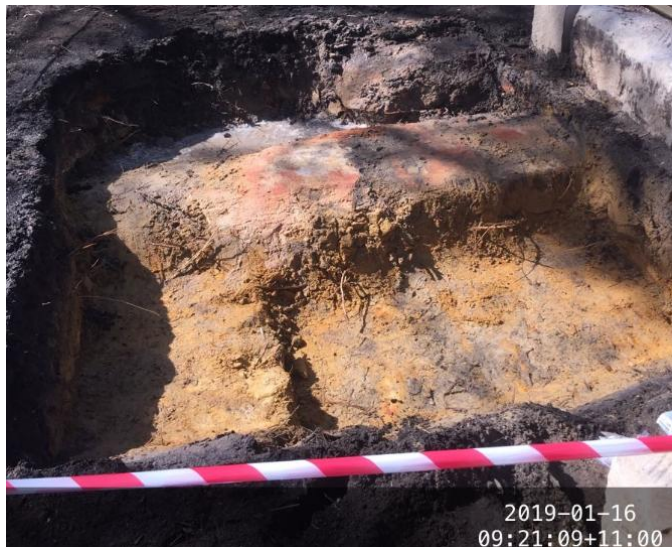
Showing remediation Area D completed excavation. Photograph taken 16/1/19.

EIS's NSW SafeWork Asbestos Assessor (Lic. No 001028) attended site on 16 January 2019 to observe the excavation of the ACM impacted soils (Area D), and to obtain validation soil samples. At the time of the inspection, Area D had been barricaded to prevent access to site workers and vehicles. The remediation area was progressively excavated with an excavator, with the excavated material placed directly in a skip bin lined with plastic, to be disposed of off-site as Special Waste/General Solid Waste (non-putrescible) in accordance with EIS waste classification report (see Section 3.4). The locations of the validation samples obtained are shown in on Figure 7 attached in the appendices. EIS field notes and site photographs obtained during the remediation of Area D are attached in the appendices.

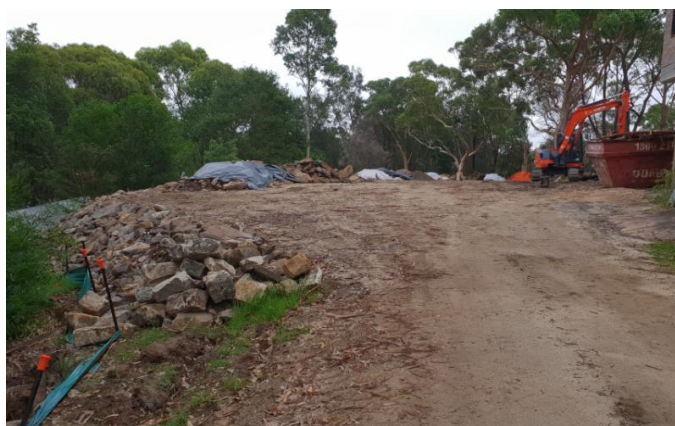
Showing south section of the site filled with no contaminated fill and natural soil/bedrock sourced from excavation in the north and east section of the site. A fire truck access trial was also filled along the souths section of the site. Photograph taken 10/1/19.

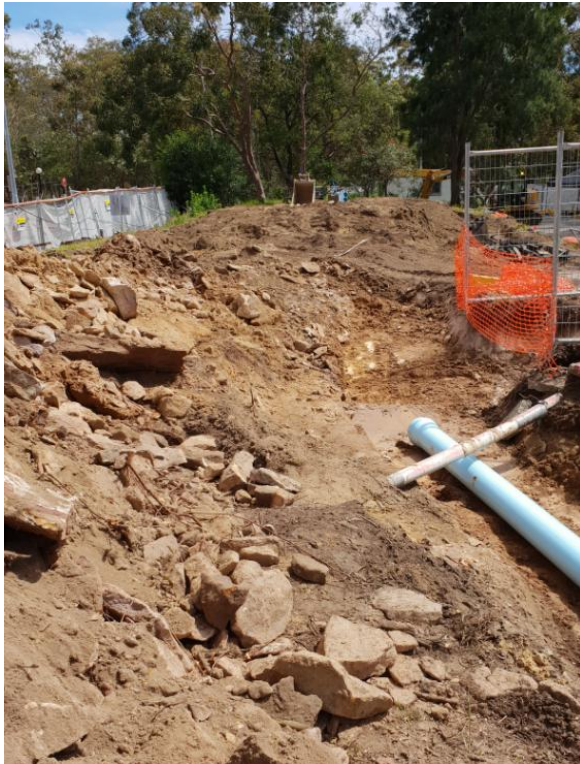
Showing excavation for fire hydrant services installation in the north-west section of the site. Photograph taken 13/11/18.

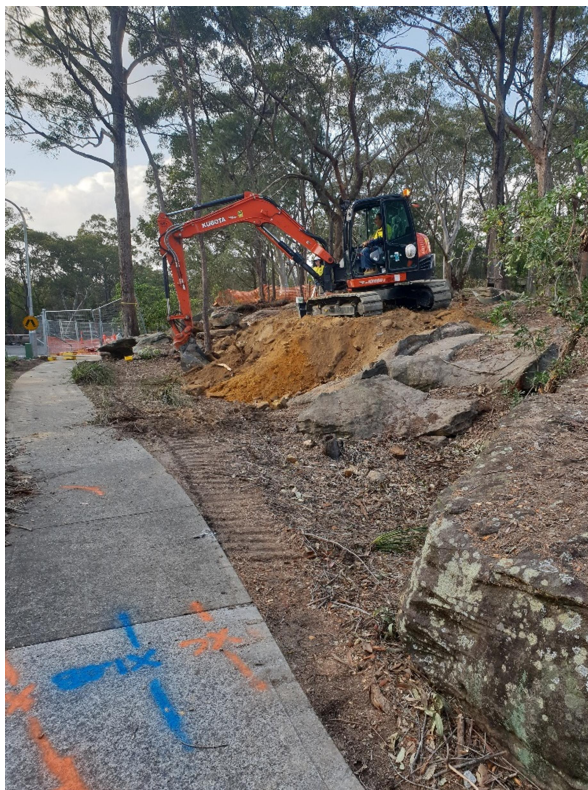
Showing excavation for electrical services installation in the north-east section of the site. Photograph taken 1/11/18.

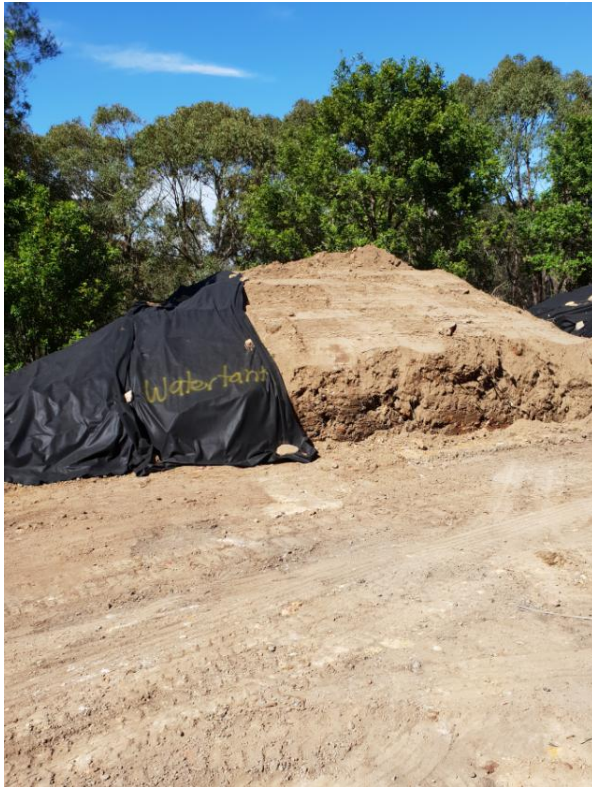
Showing stockpiled natural material in south section of the site, sourced from fire hydrant tank excavation located in the north-west section of the site. Photograph taken 23/11/18.

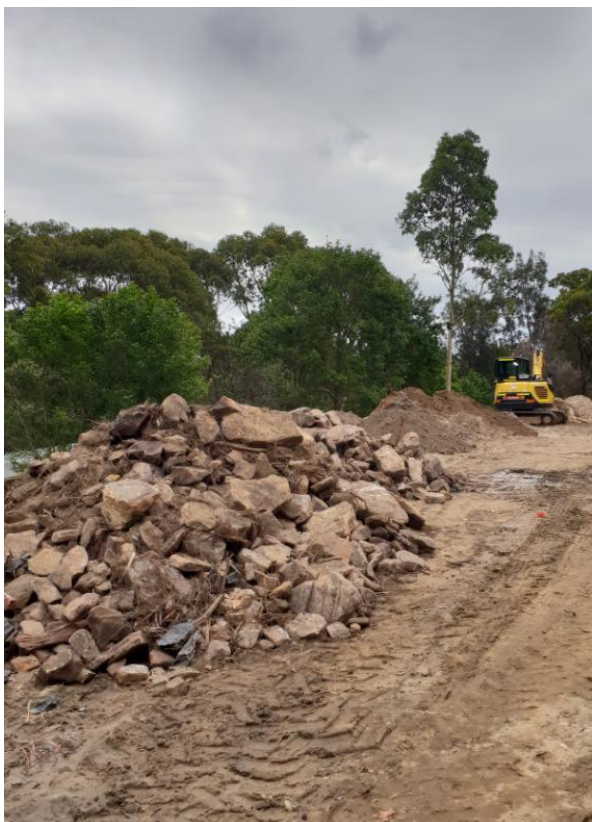
Showing stockpiled natural material in south section of the site. Photograph taken 5/12/18.

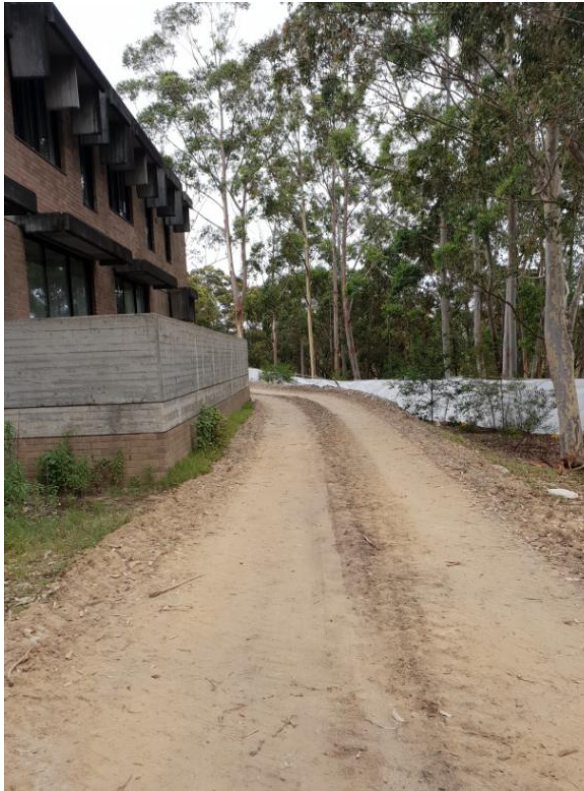
Showing south section of the site filled with no contaminated fill and natural soil/bedrock sourced from excavation in the north and east section of the site. Photograph taken 5/12/18.

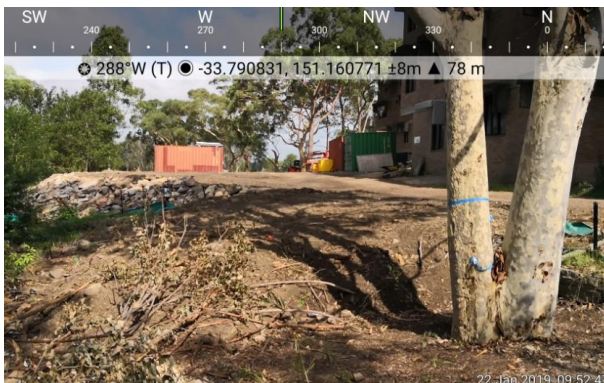
Showing south section of the site Photograph taken 22/1/19.

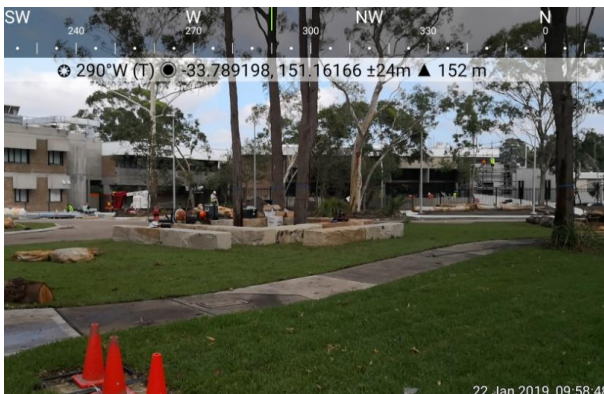
Showing completed landscaped area in the north-east section of the site. Remediation Area D formerly located in the foreground. Photograph taken 22/1/19.

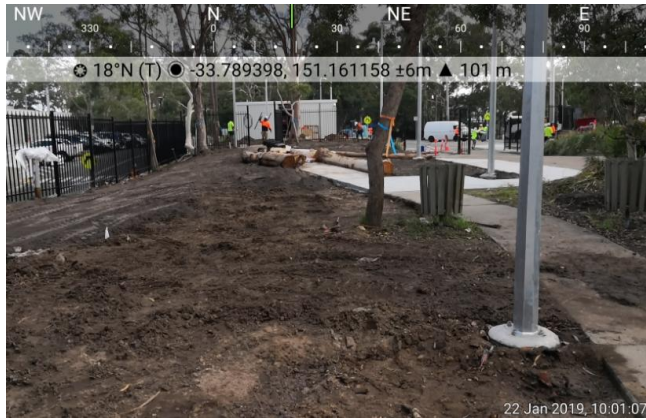
Showing north-west section of the site and ANL topsoil in place and awaiting turf cover. Photograph taken 22/1/19.
