CONSERVATION MANAGEMENT PLAN LINDFIELD LEARNING VILLAGE

16 NOVEMBER 2018
SH801
PREPARED FOR DEPARTMENT OF EDUCATION

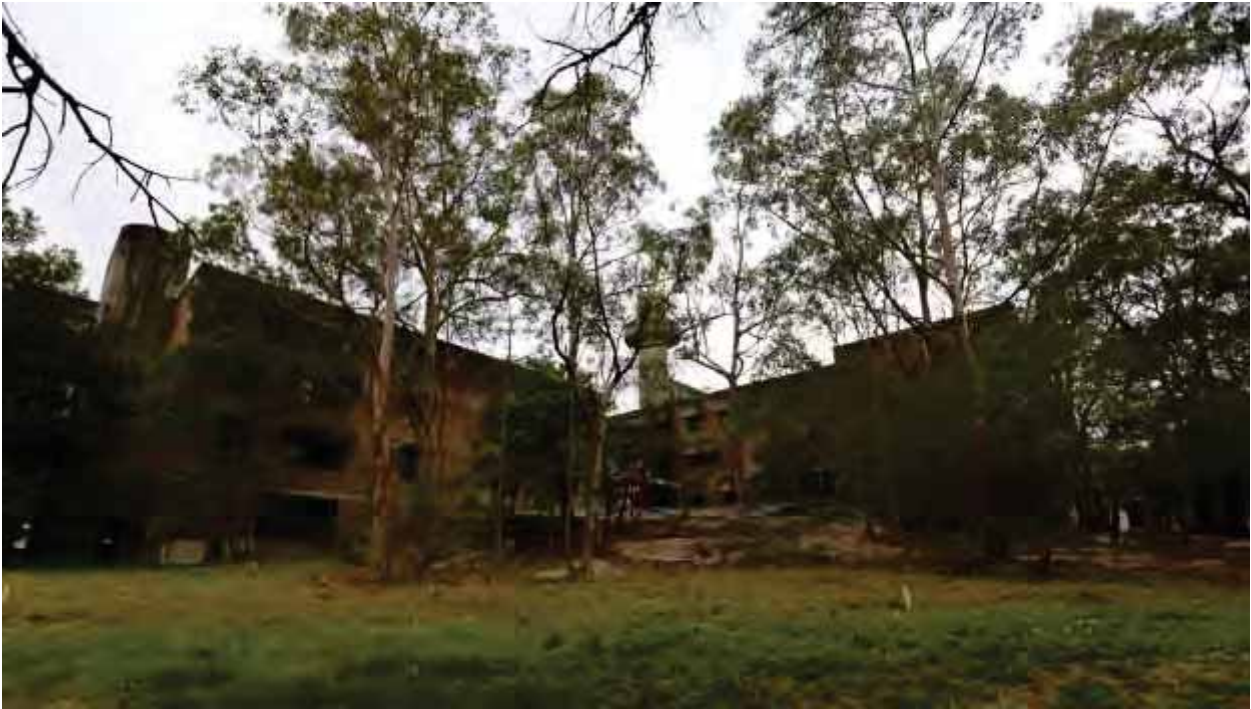
Figure 25 - Rock outcrop located to the south west of the Stage 1 building

Located directly to the south-west of the Stage 1 building is a large rock outcrop of Hawkesbury Sandstone which was carefully protected during the construction stage to ensure the preservation of the natural site features.

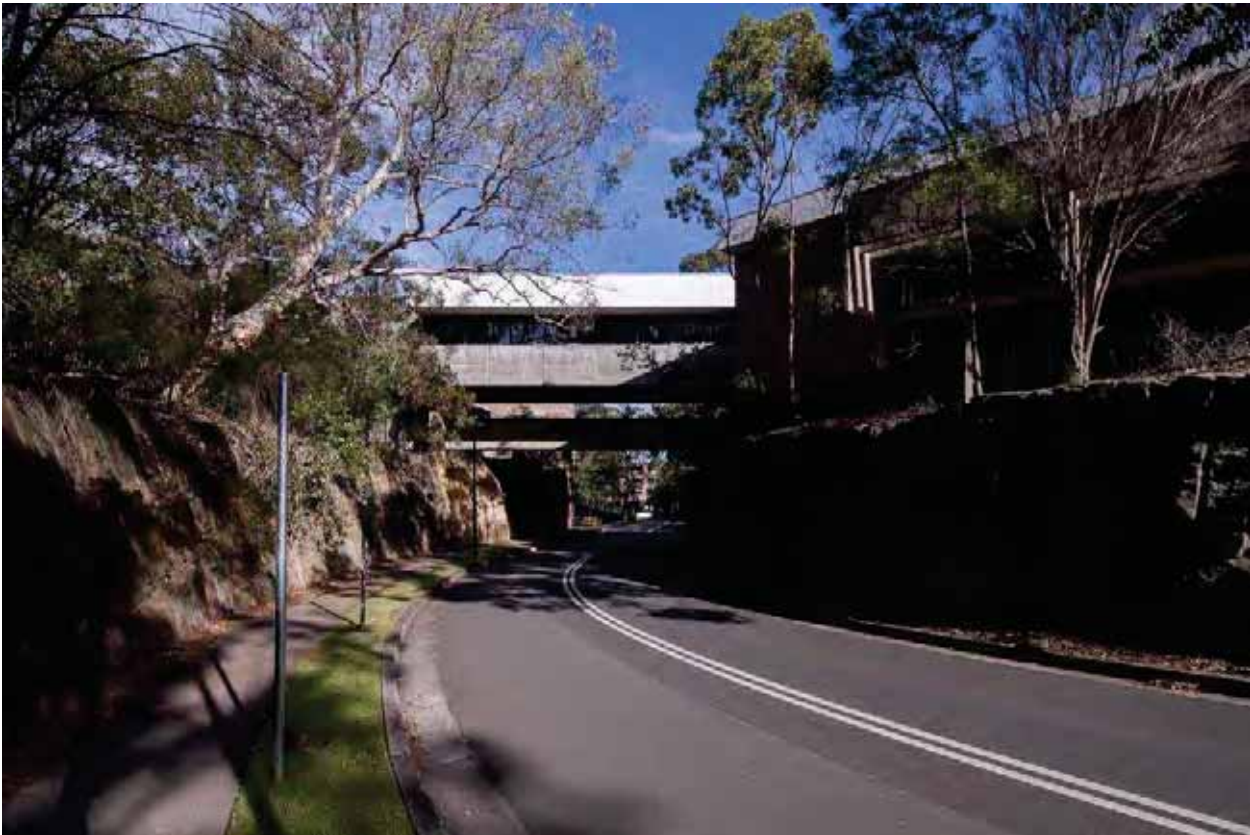
Figure 28 – Road cutting for Dunstan Grove, looking south-west

The road cutting was created during Stage 1 to provide access to the western part of the site. The road created by the rock cutting is now known as Dunstan Grove and now also provides access to a portion of the Crimson Hill residential development. The road cutting is softened by the planting of native vegetation such as tree ferns.

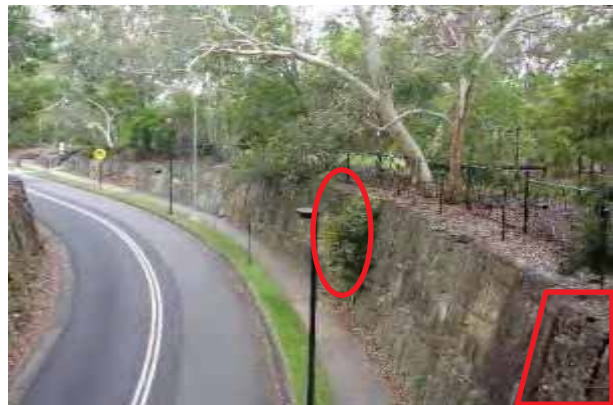
Figure 30 – Rock cutting with rock infills section circled in red.

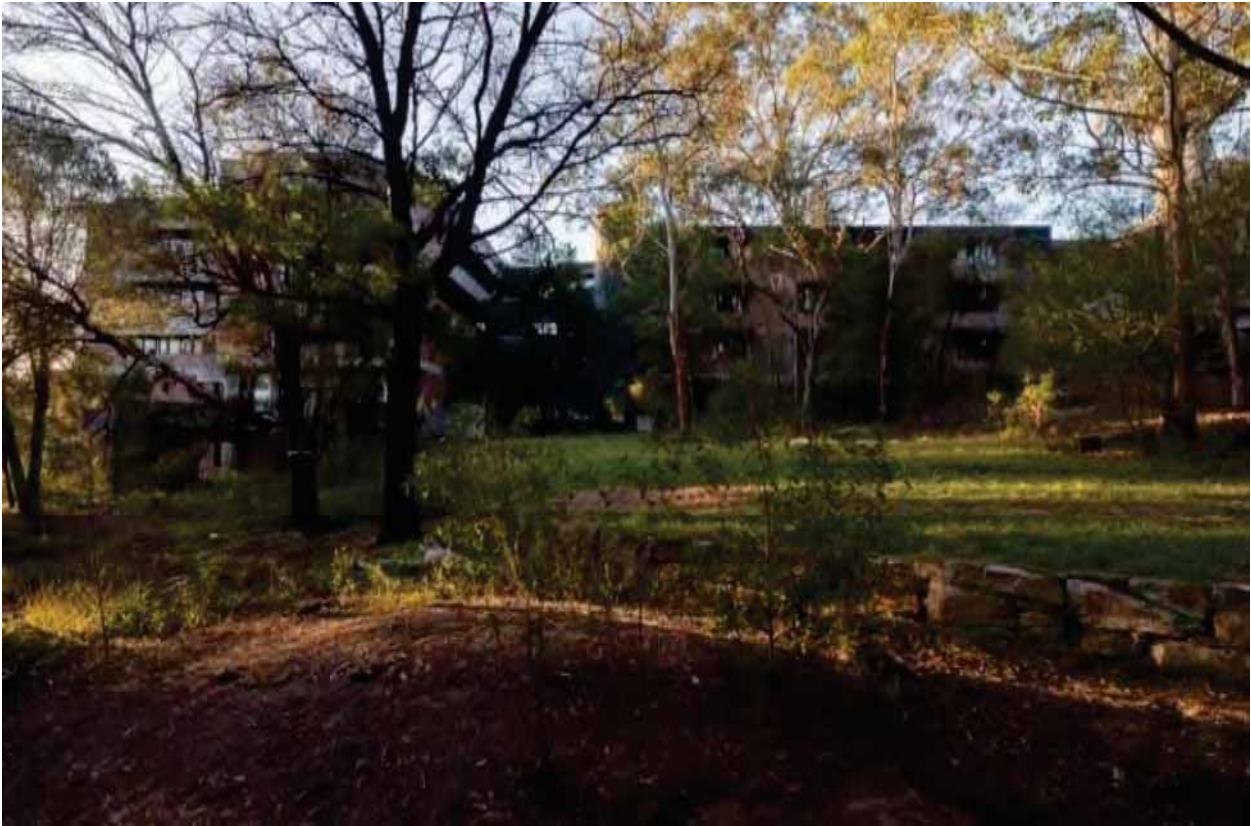
A large open lawn area is located directly to the south of the Stage 1 building and extends outside of the bounds of the site to the south. This area is the only open landscaped space on the site and was created to ensure fire separation between the building complex and the bushland to the south.

Figure 31 – Lawn area viewed from the south of Stage 5 and Stage 1 buildings, with low stone retaining wall.

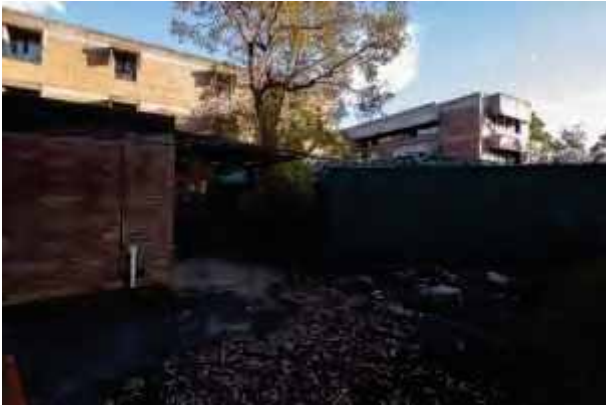
A set of small structures, formally used as green houses, are located directly to the north-west of the Stage 1 building and adjacent to the Dunstan Grove. The greenhouse are primarily constructed of off-board concrete, with aluminium framed windows for walls and roofs. A small brick structure is also located directly adjacent to the greenhouses.

Figure 34 – The brick outbuilding and greenhouse

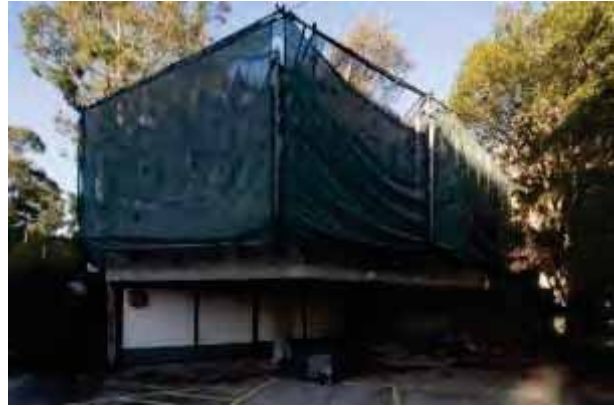
Figure 35 – The concrete greenhouse

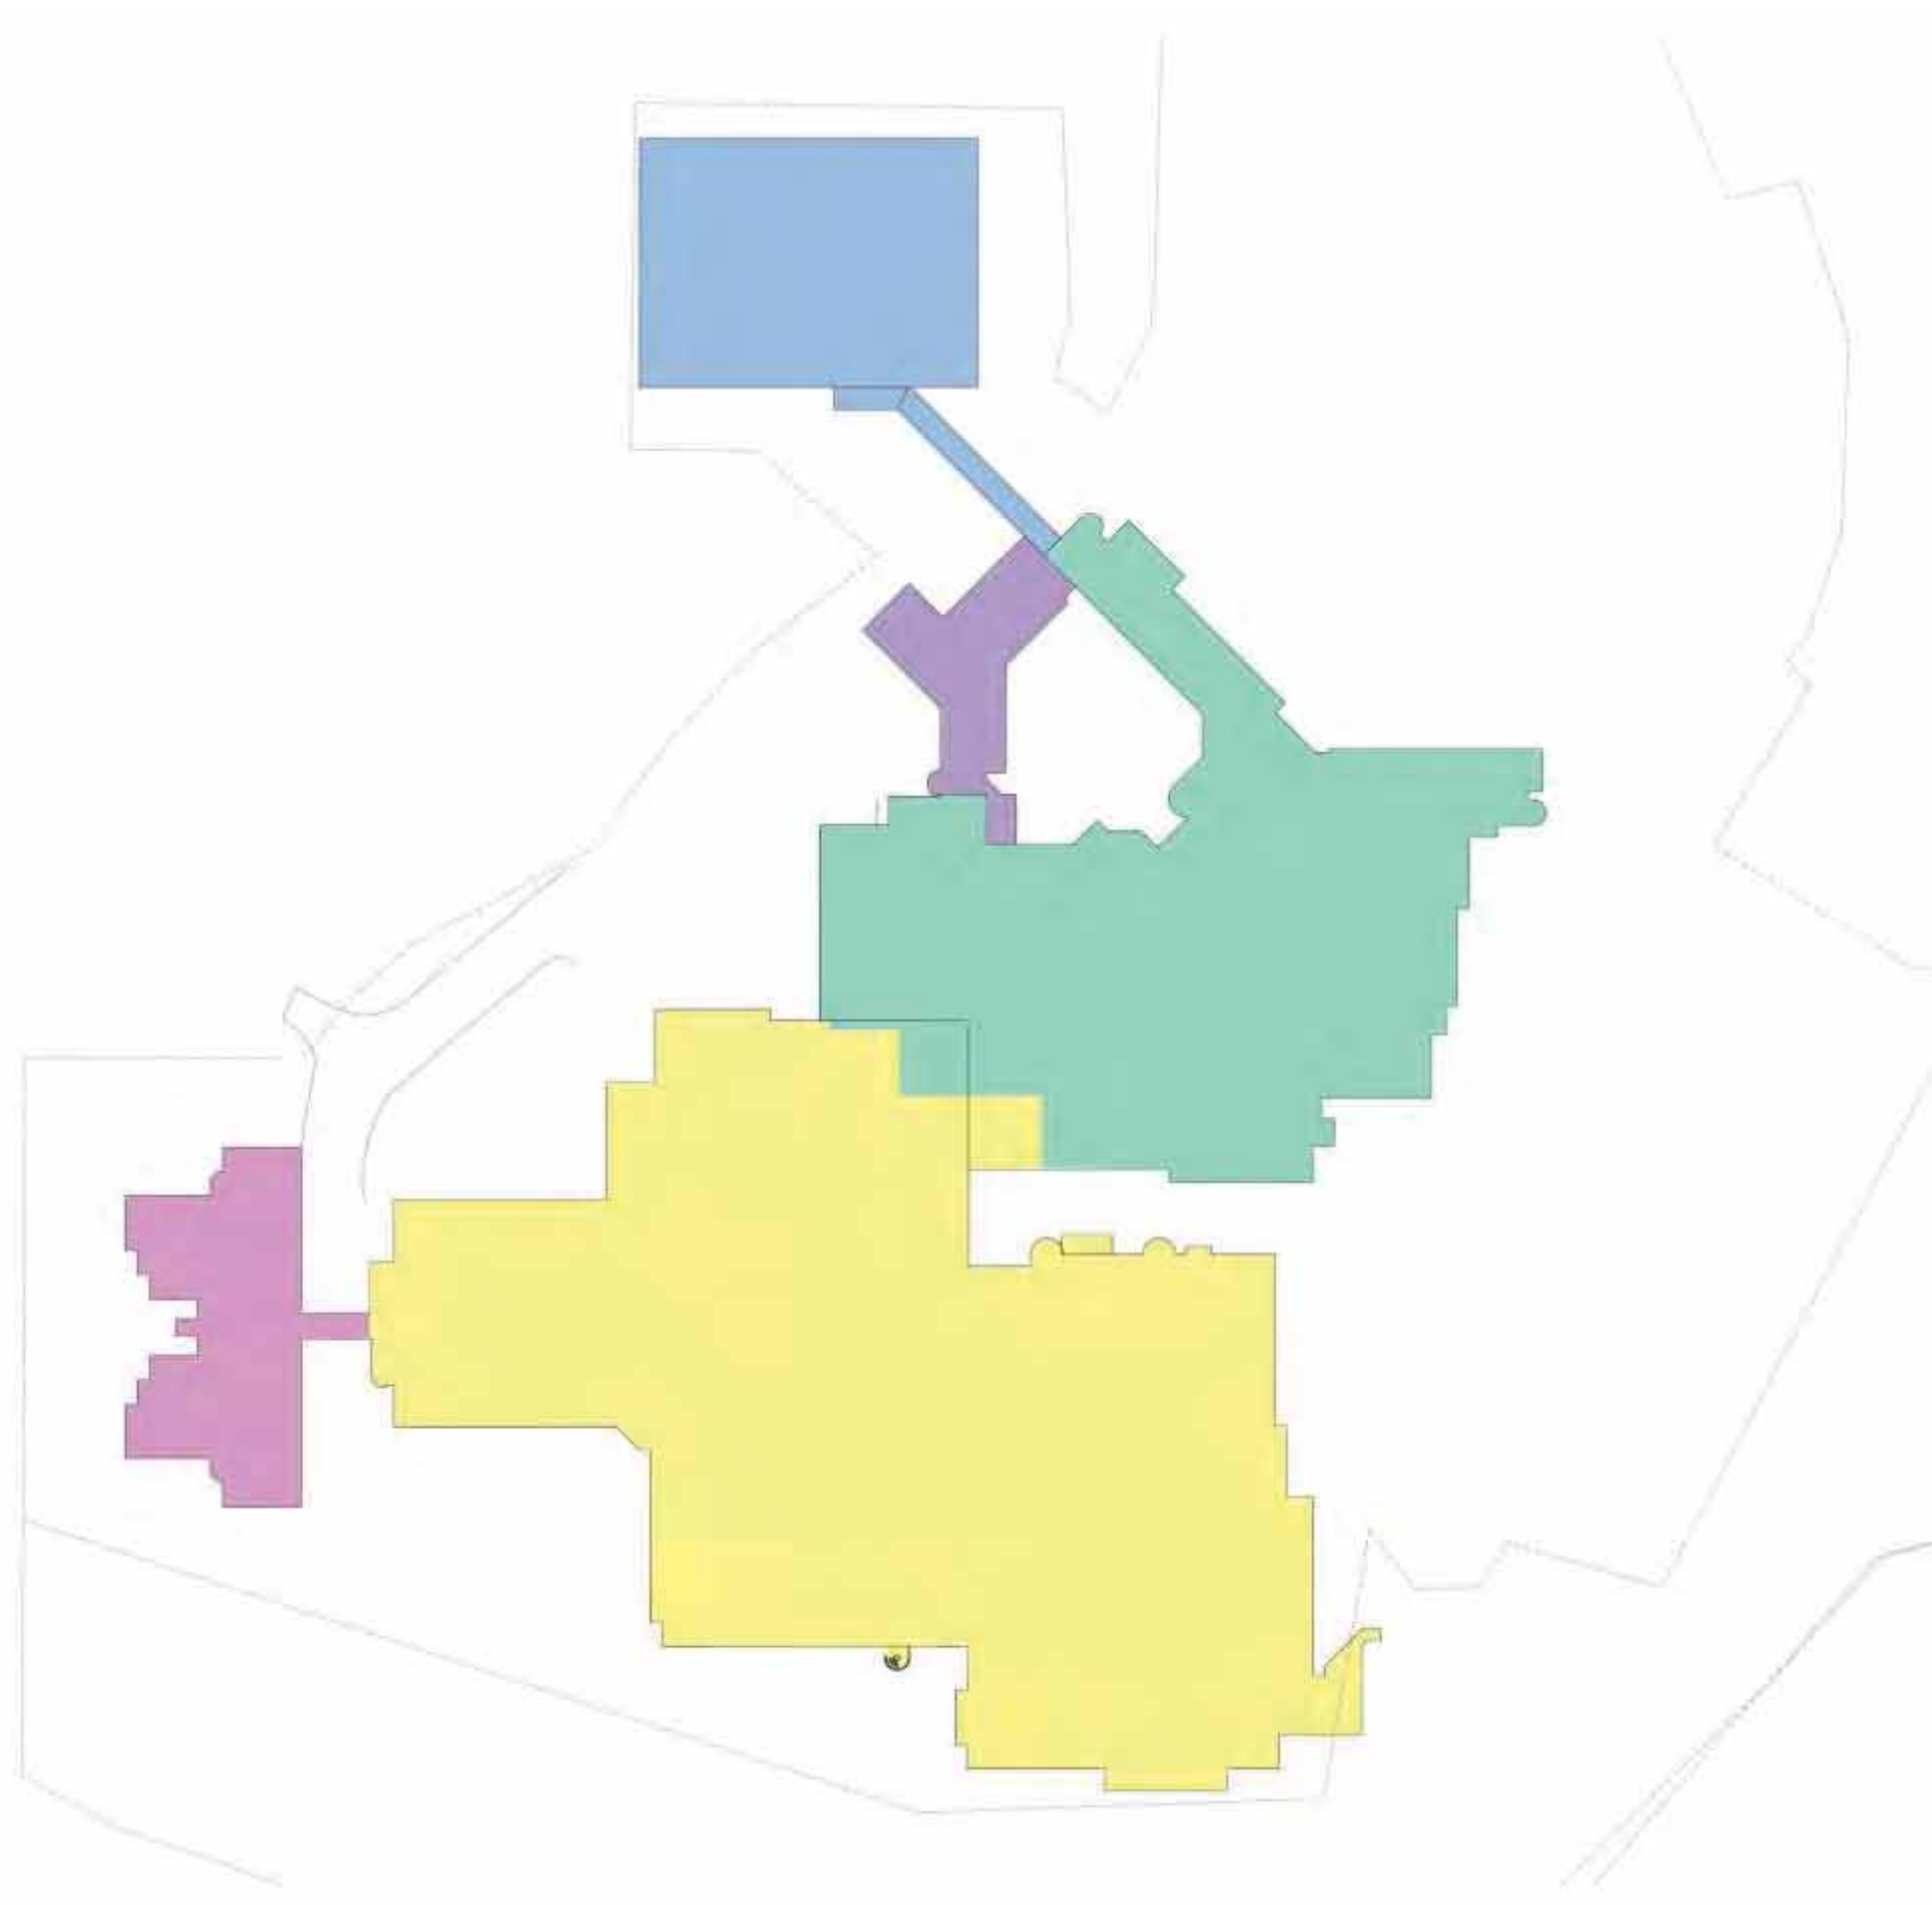
BUILDING COMPONENTS

Key	Description
Circulation	Corridors, stairs and lifts
Learning & Teaching	Classrooms, offices, library, laboratories, studios, storerooms
Auditorium	All auditoriums, including back of house spaces
Sports	Basketball courts and squash courts
Cafeteria	Cafeteria, including kitchen and mezzanine level
Service / Utility	Plant rooms, all service/utility related cupboards, kitchenettes and loading docks
Amenity	Bathrooms and changerooms
Carpark	Internal carparking
Outdoor Space	Courtyards, balconies, roof gardens, external stairs and ramps

The Lindfield Learning Village complex was constructed in 5 stages which now present as a single (up to) six-storey structure with basement, rooftop plant rooms and an astronomy observation tower. The massing of the building consists of various heights, which step down in response to the topography of the site. The bulk of the complex is broken up due to its highly articulated and modulated form, constructed of high-quality off-board concrete with brick infill, concrete window hoods and sun louvres, and raised rooftop deck and terraces. The building complex is linked together through an internal circulation route which navigates throughout the five stages. The whole structure nestles into its landscaped bushland setting.

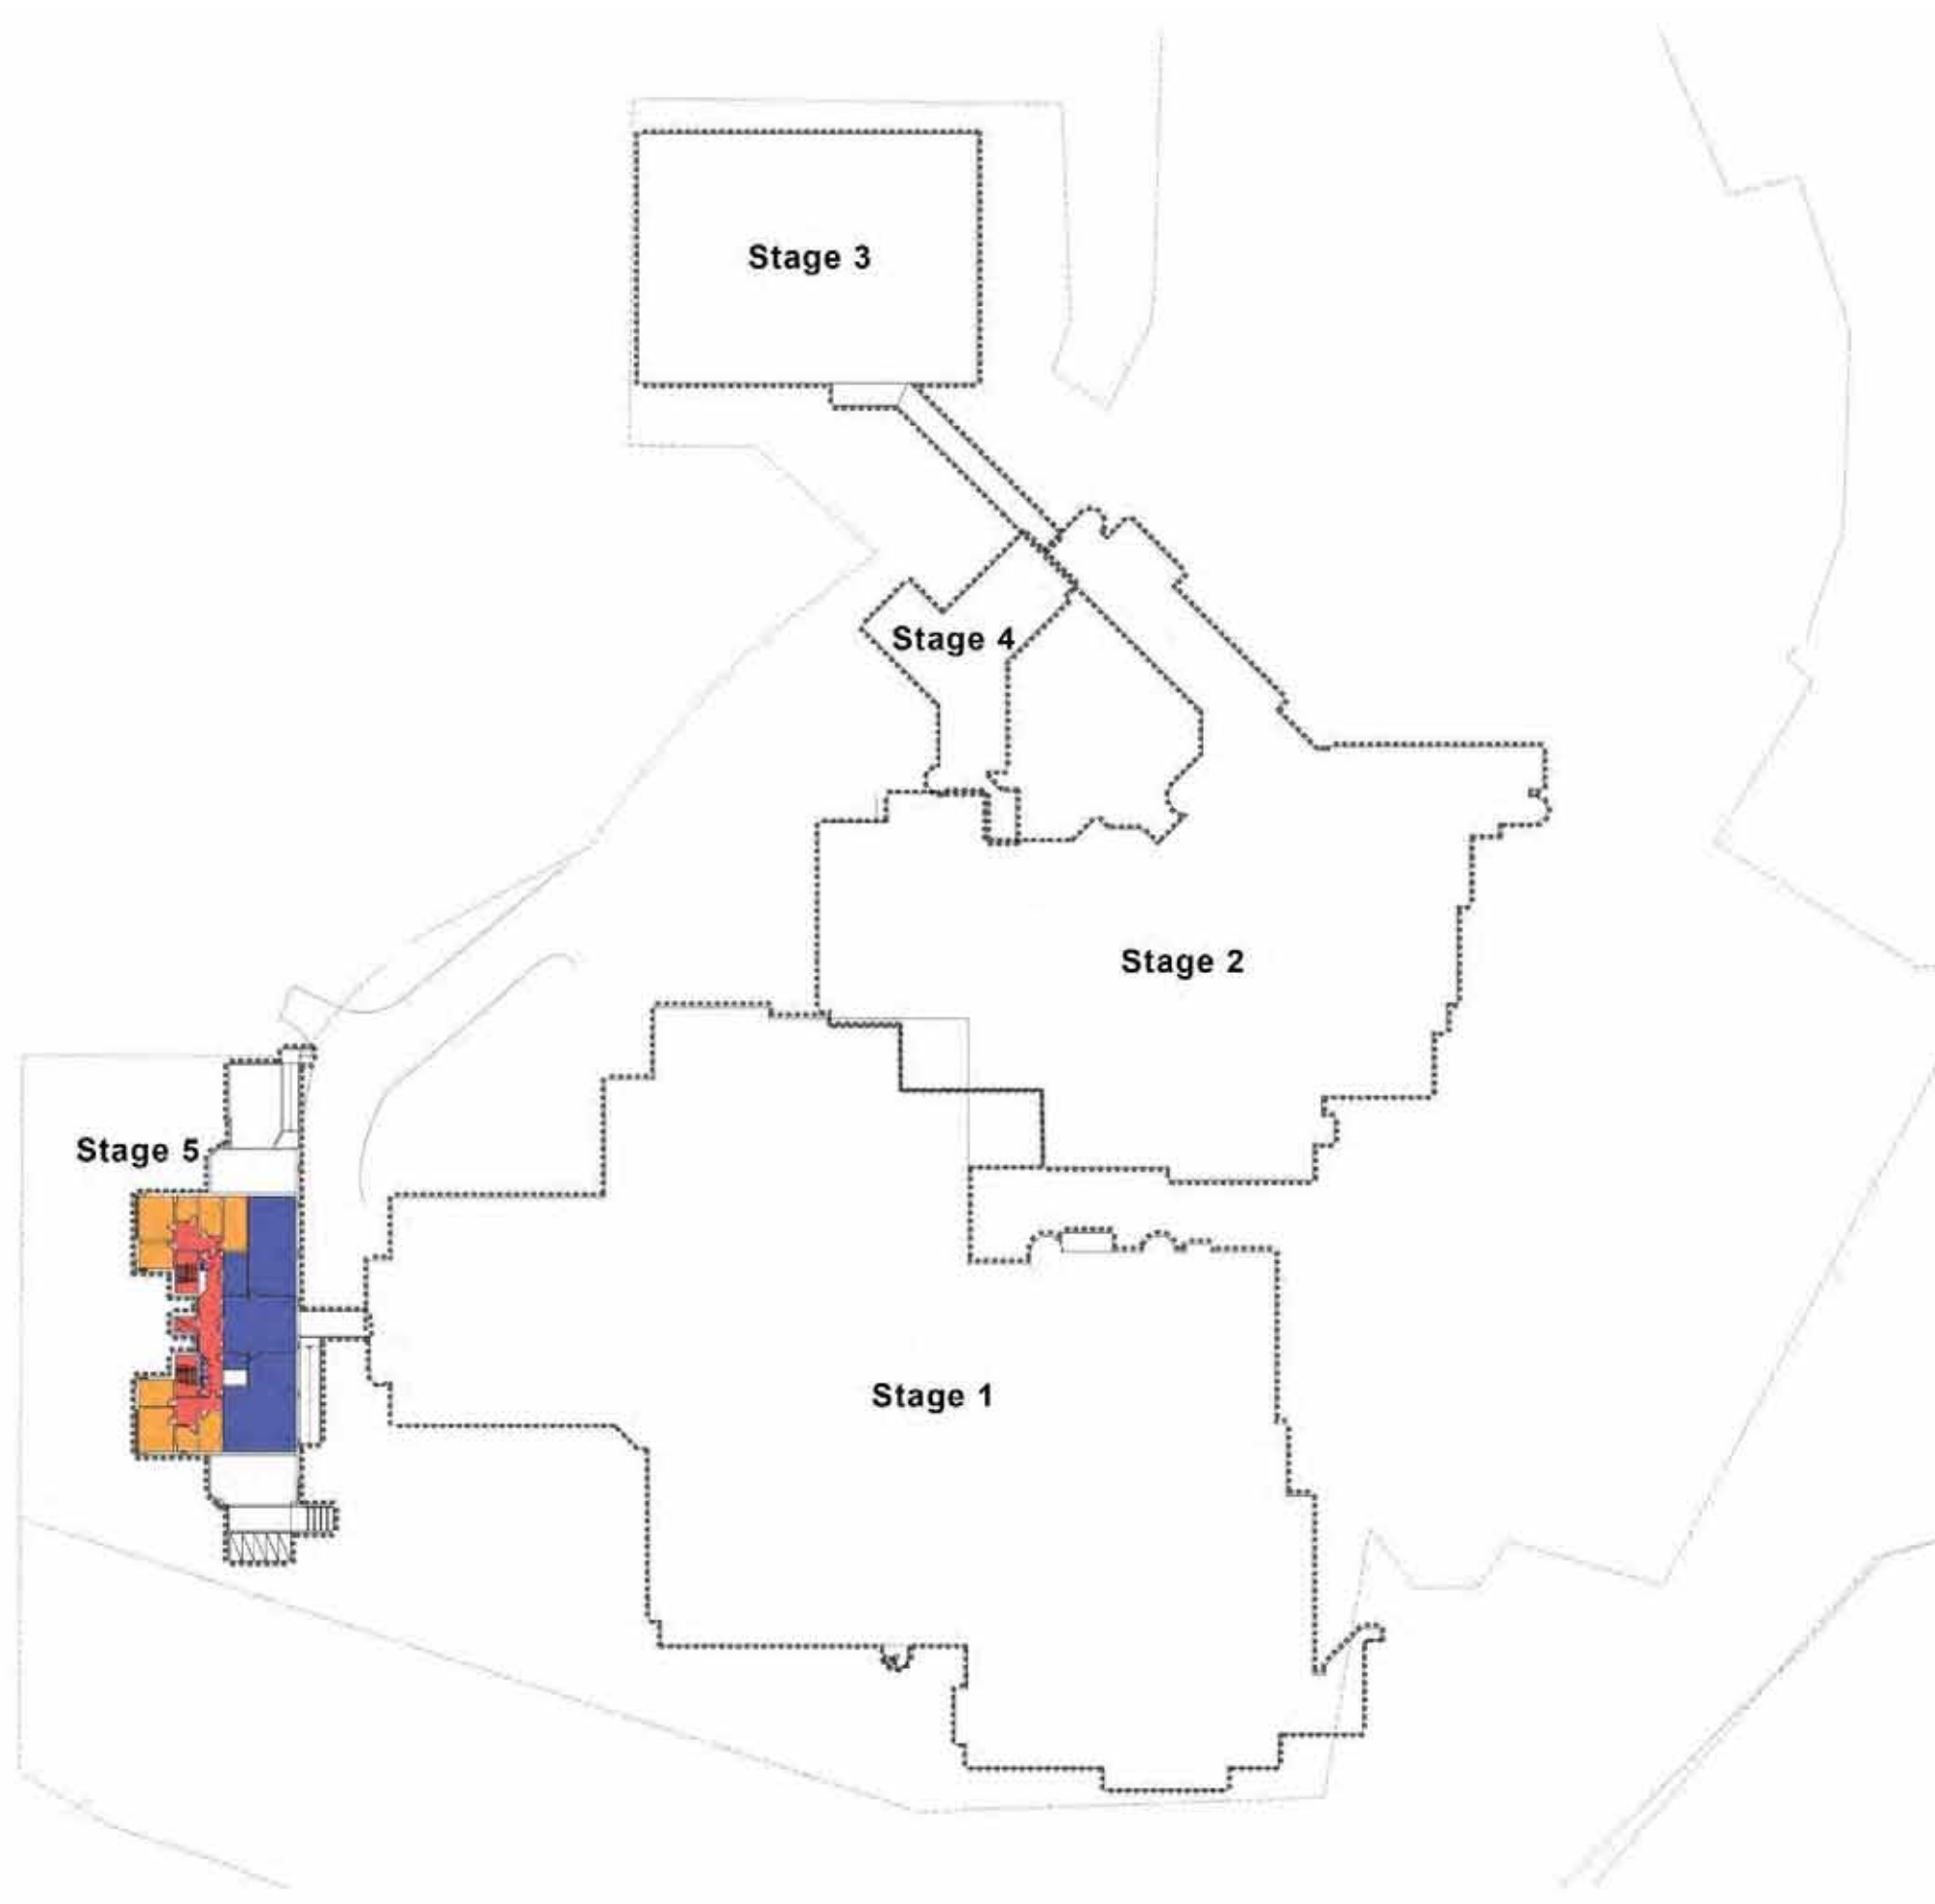
Level 0

BUILDING COMPONENTS

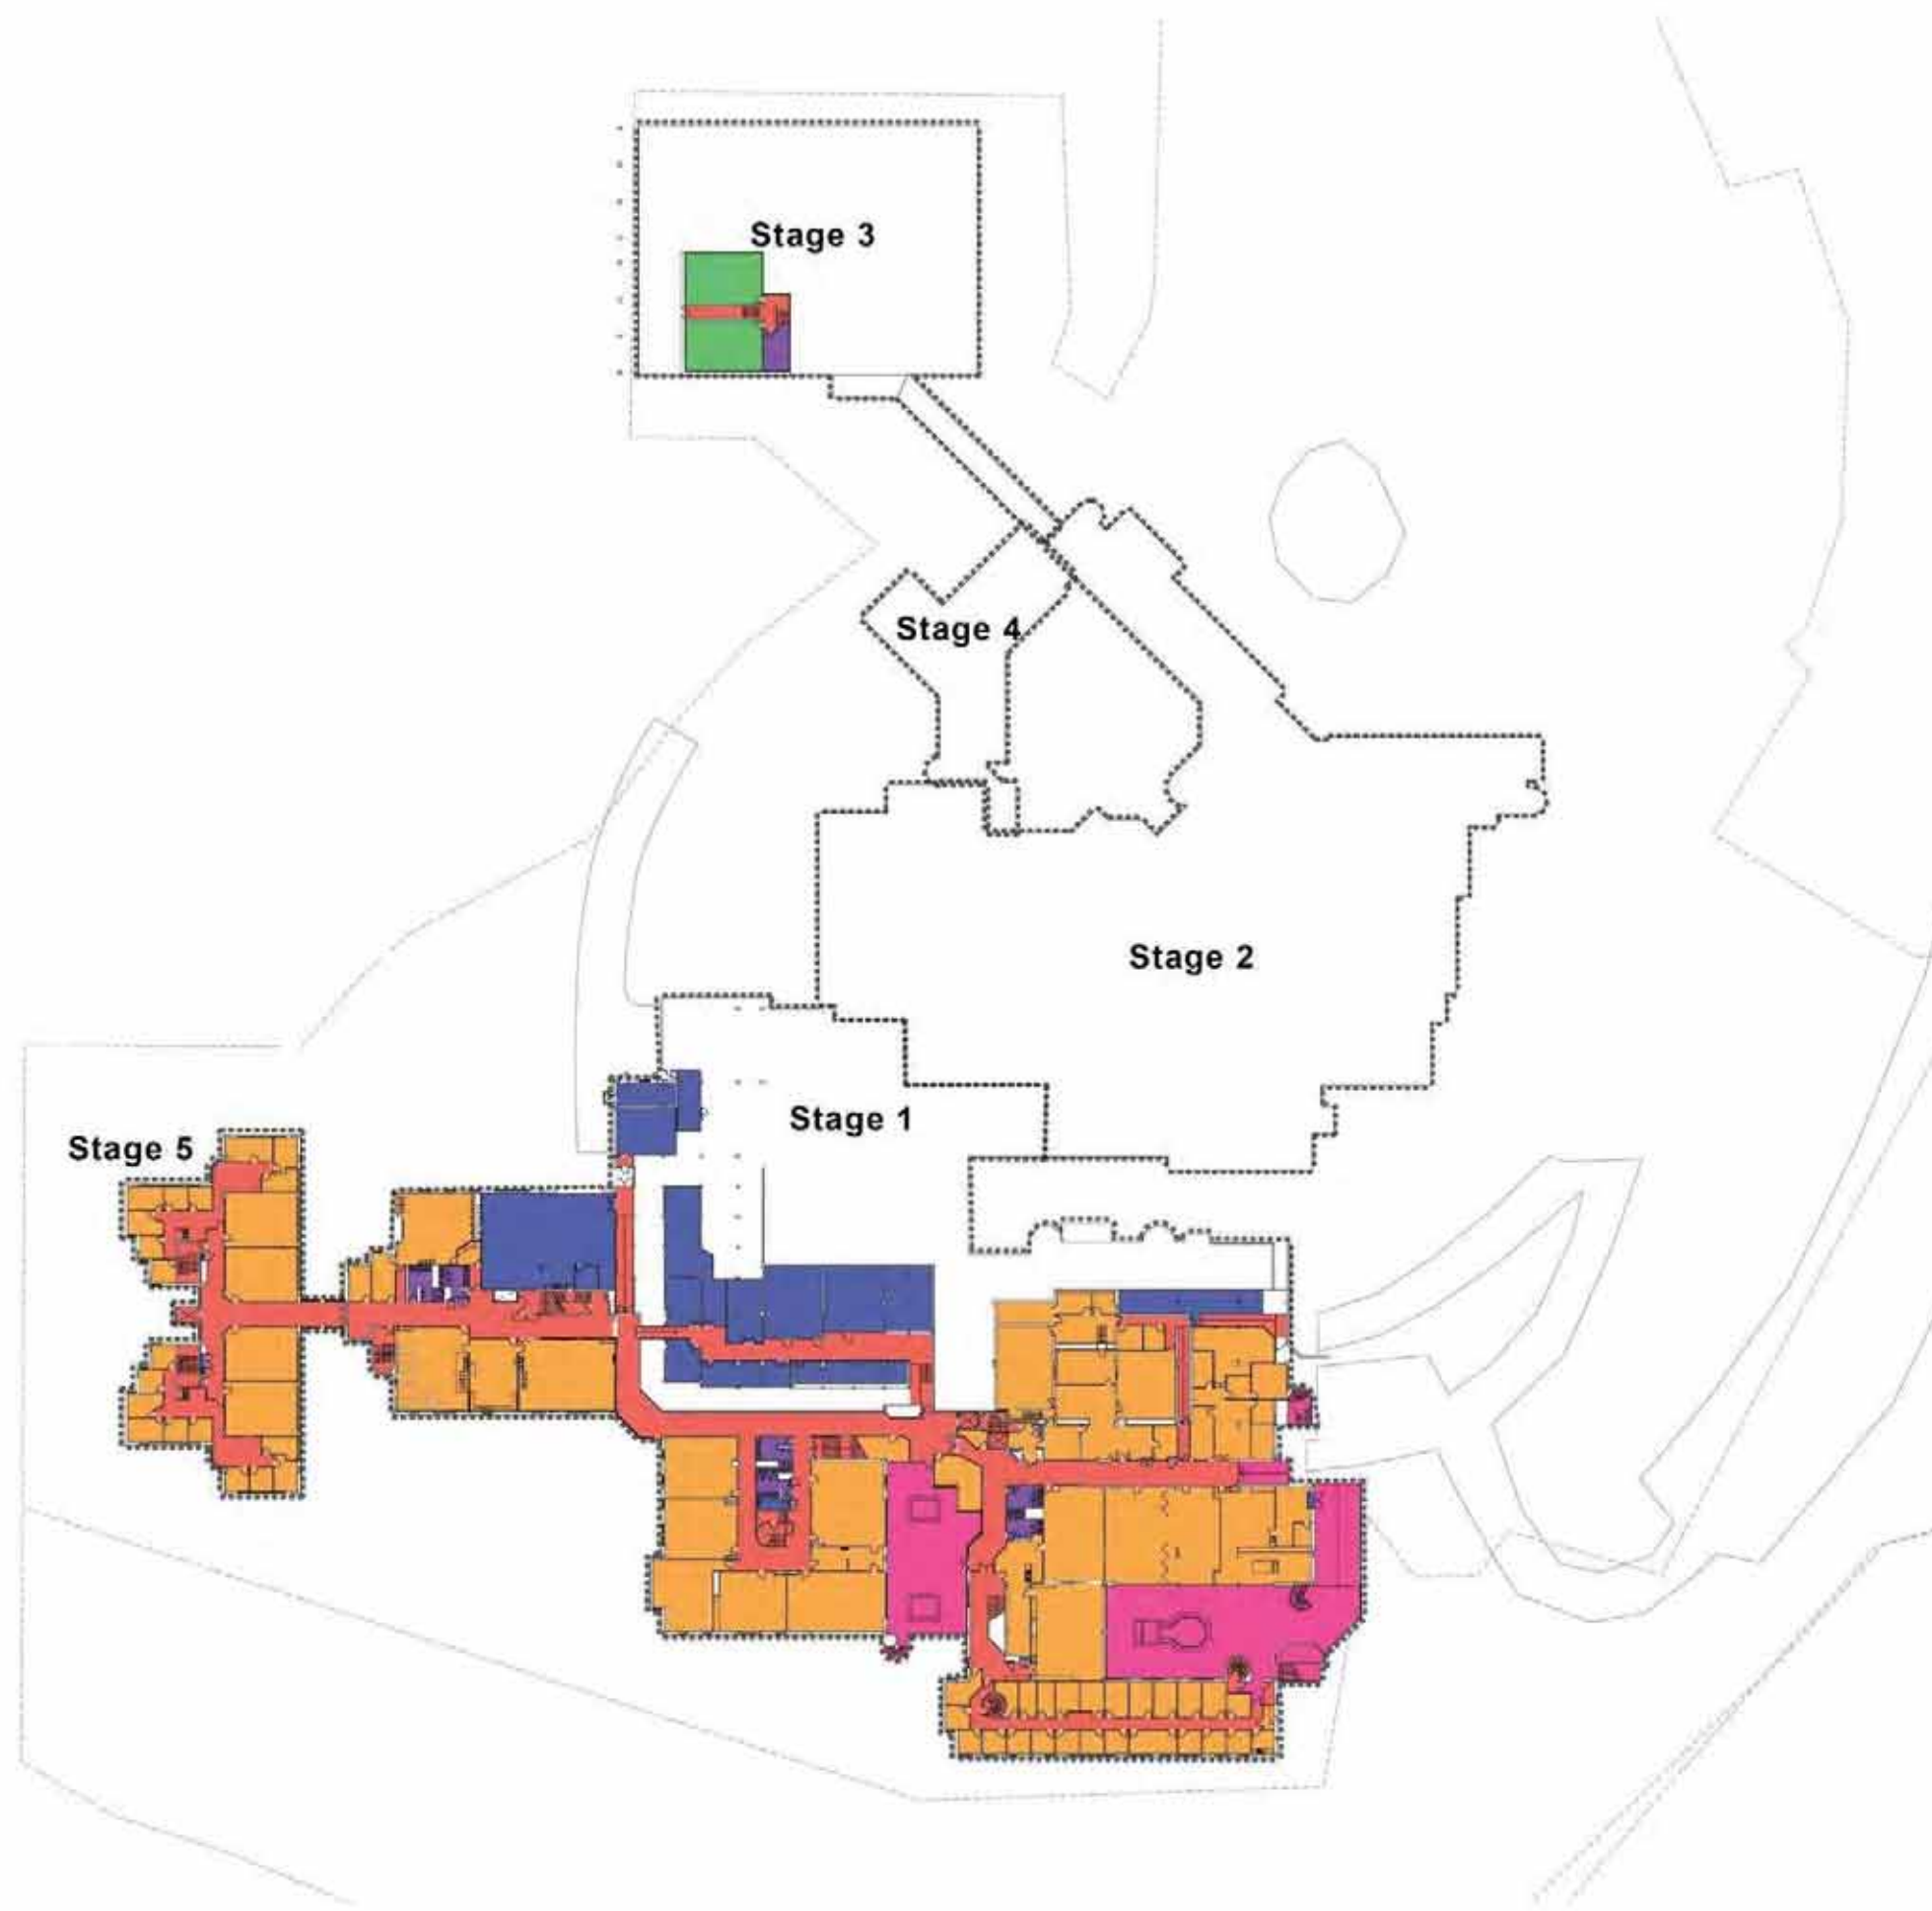
Level 2

BUILDING COMPONENTS

- Circulation
- Learning & Teaching
- Auditorium
- Sports
- Cafeteria
- Service / Utility
- Amenity
- Carpark
- Outdoor Space

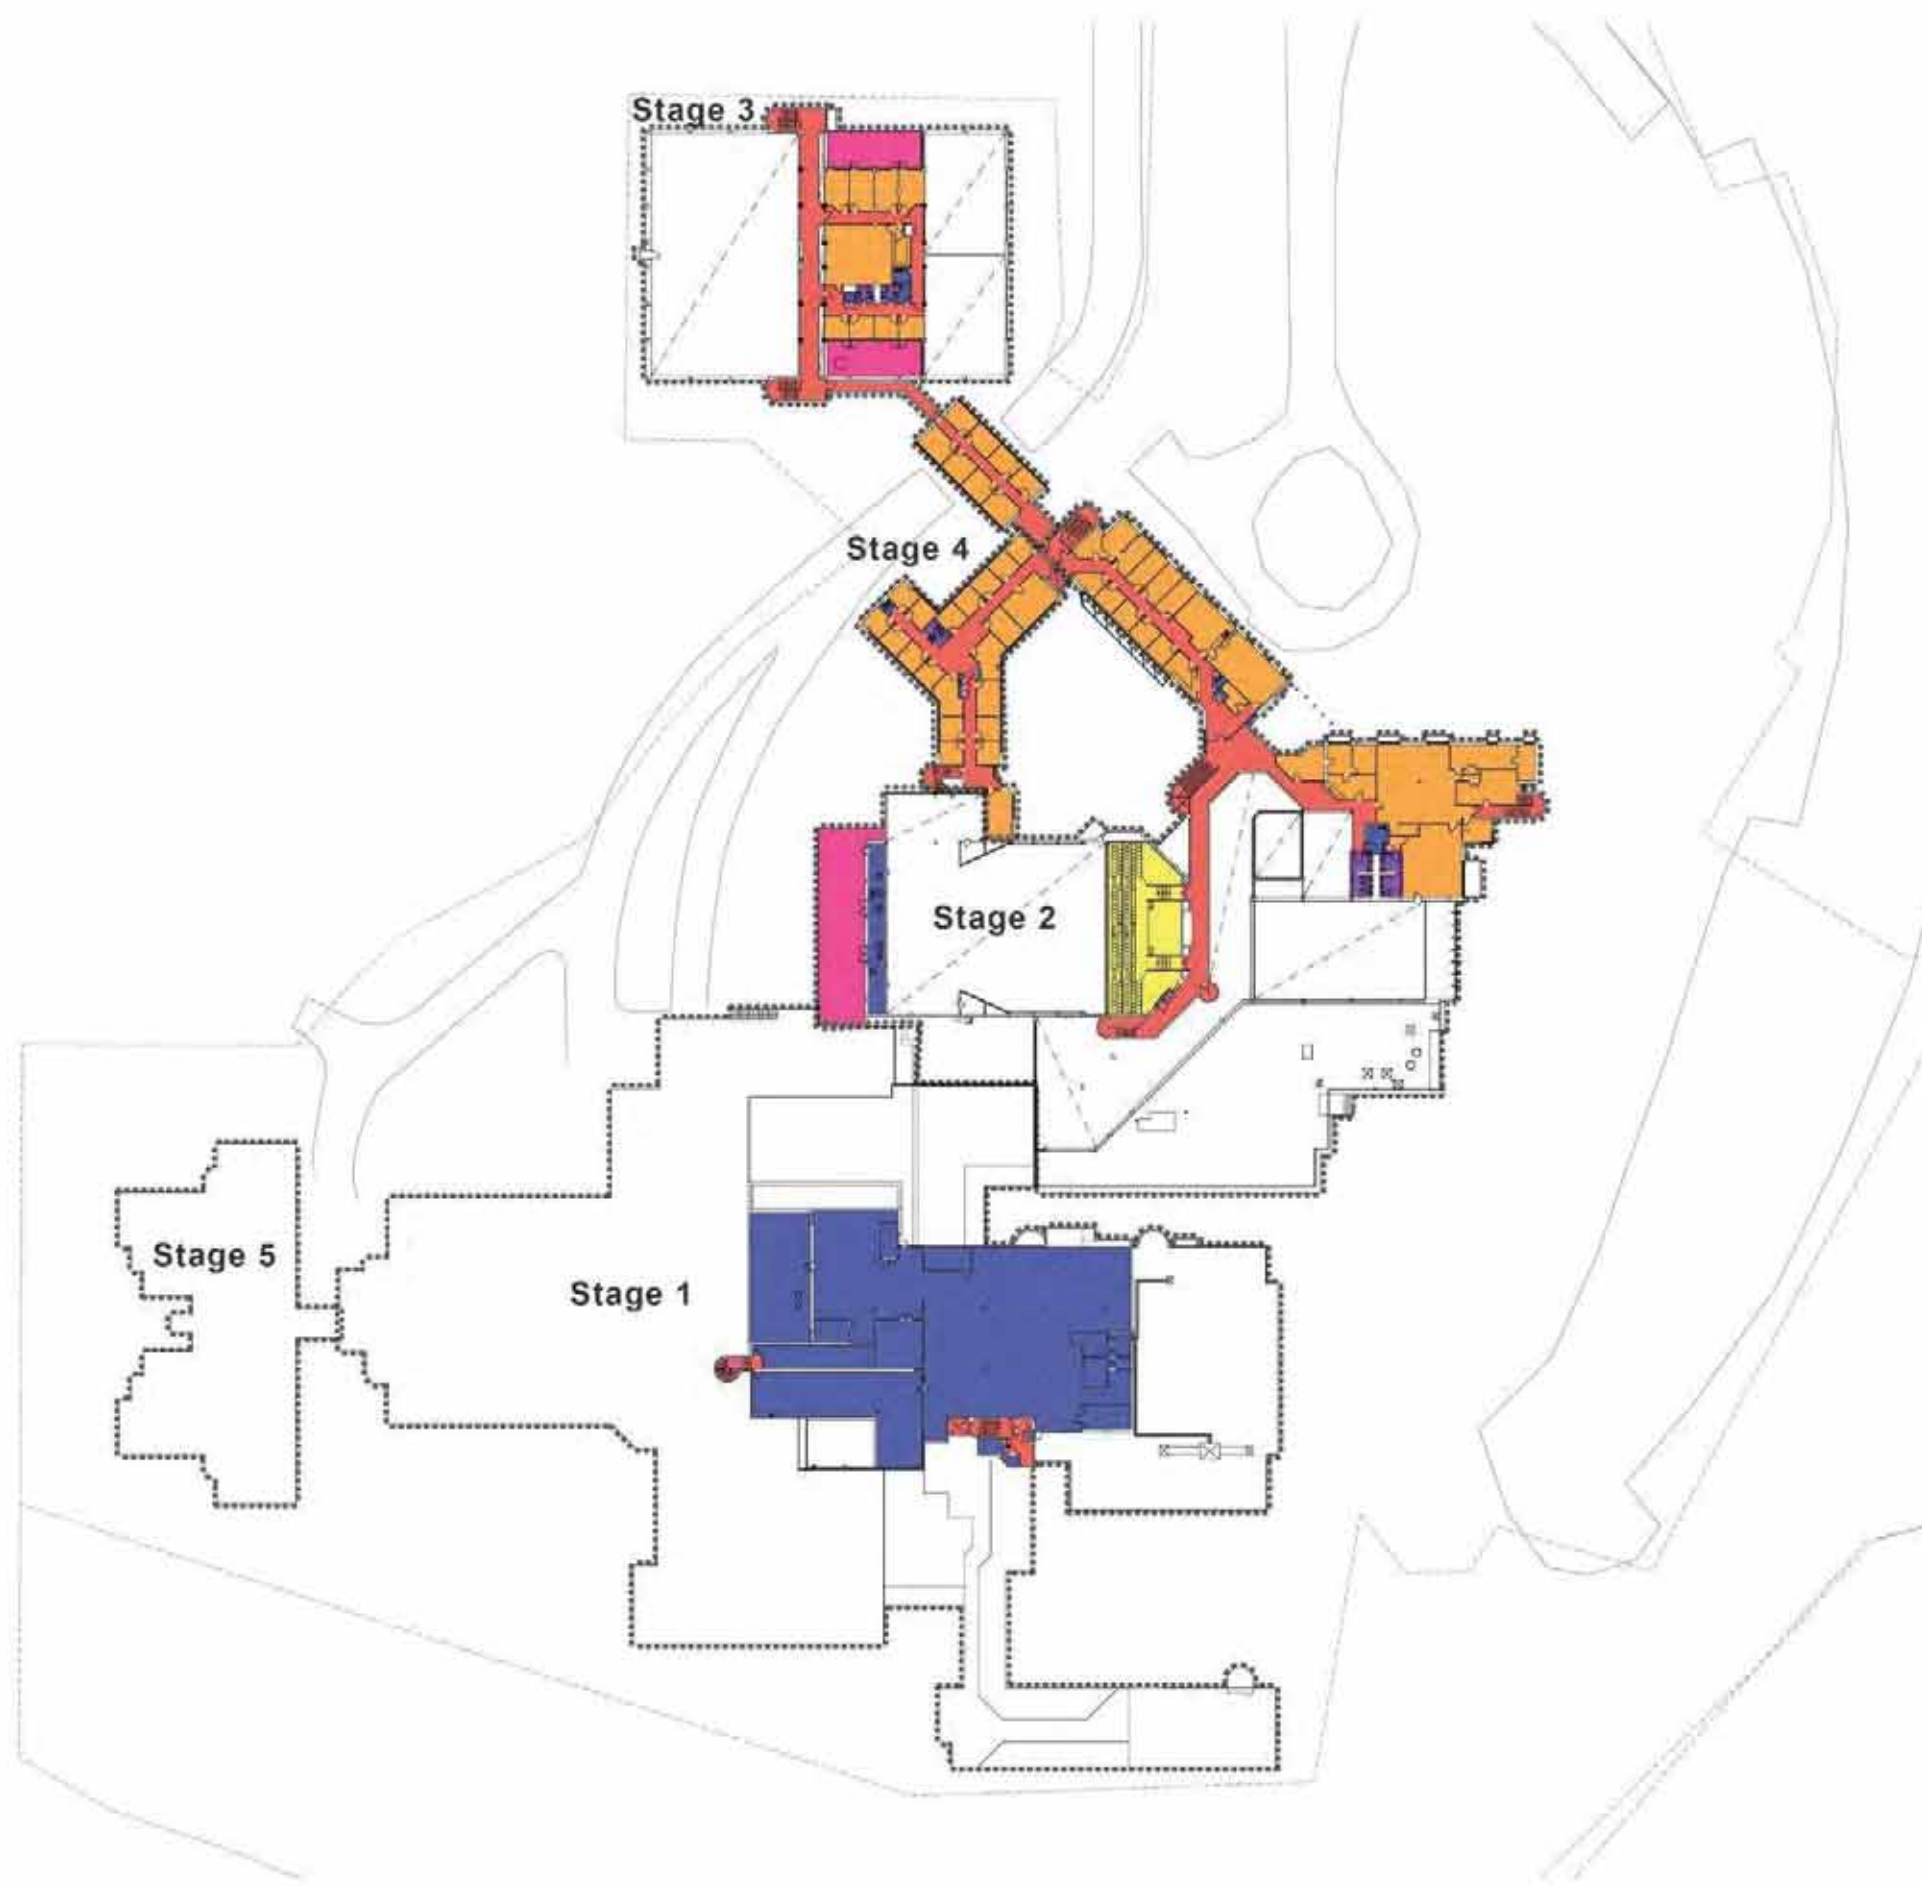
Level 6

BUILDING COMPONENTS

- Circulation
- Learning & Teaching
- Auditorium
- Sports
- Cafeteria
- Service / Utility
- Amenity
- Carpark
- Outdoor Space

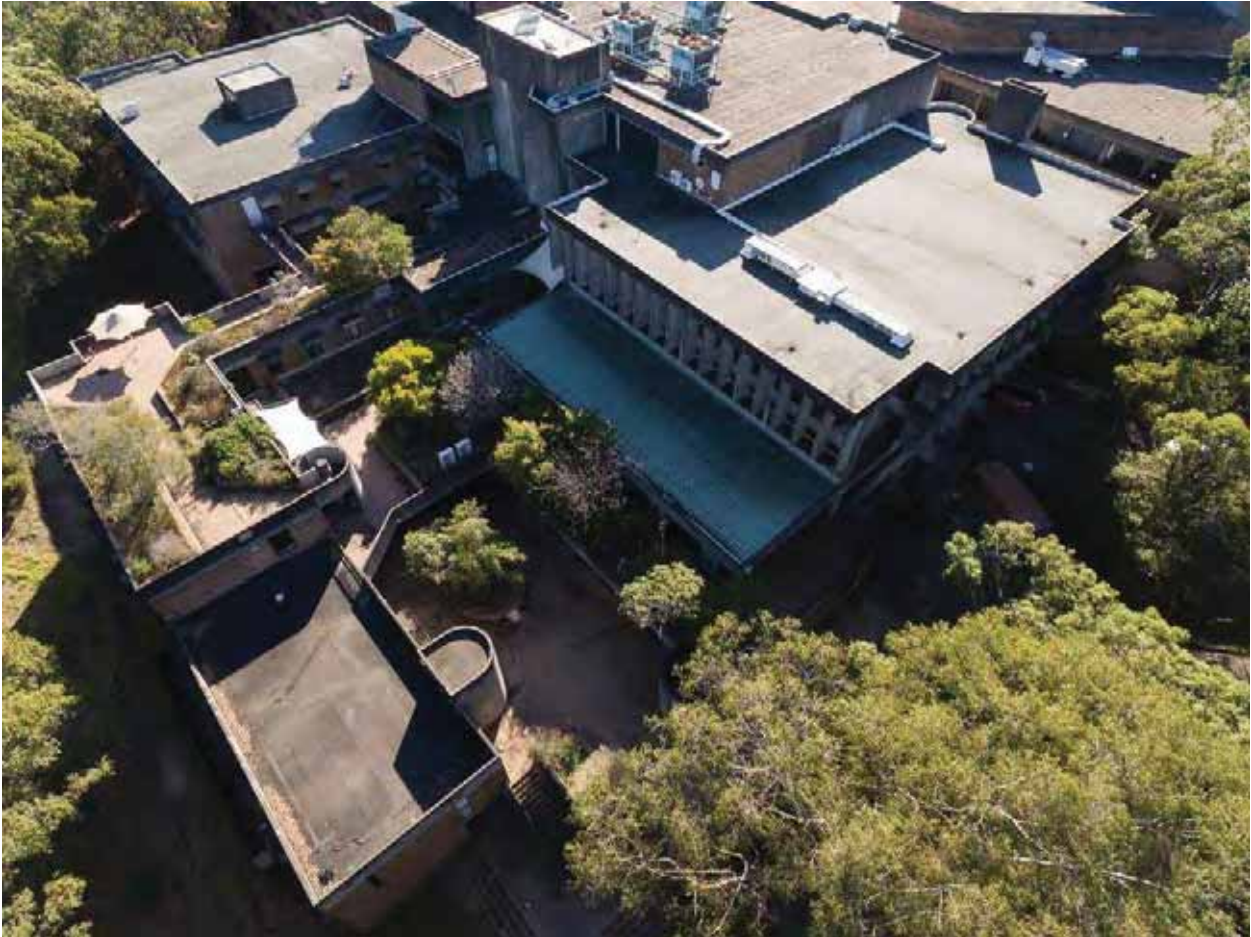
Figure 38 – Oblique aerial view showing the south-eastern portion of Stage 1 building, with extensive use of off-board concrete and face brickwork, integrated with rooftop gardens and courtyards.

All external windows are black aluminium framed. The roofs have a waterproof membrane – failing in some areas. The building does not present a single elevation but appears as form follows function with the exterior being the outward modelling of functional areas within the building. The building was also designed in such a manner as to allow for further additions in an agglutinative fashion.

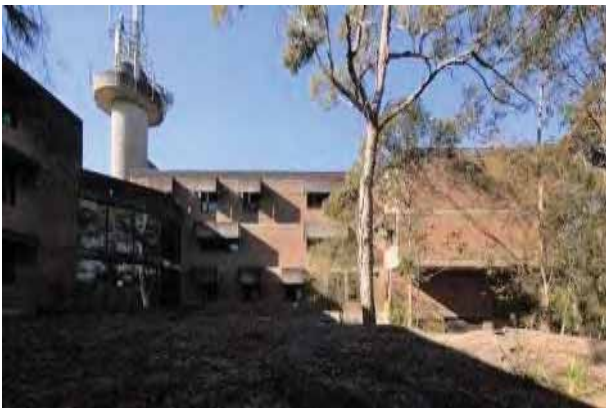
Figure 39 – Portion of western elevation, featuring pre-cast concrete window hoods

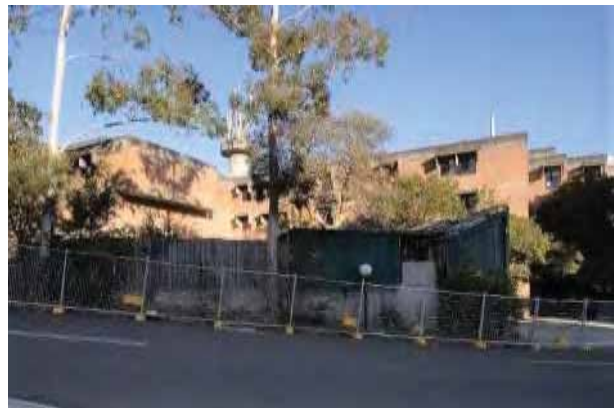
Figure 40 – Portion of northern elevation with facebrick work and pre-cast concrete window hoods

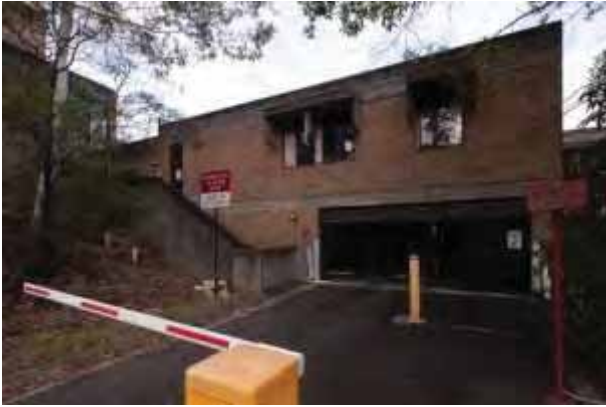
Figure 41 – Portion of north-western elevation with entrance to carpark at Level 3

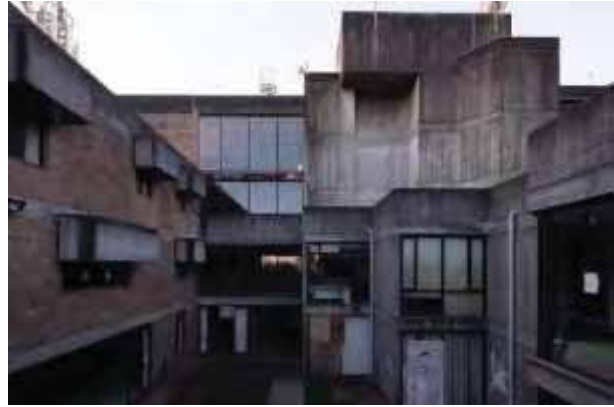
Figure 42 – Portion of southern elevation, with massing of off-board concrete forms and pre-cast concrete window hoods

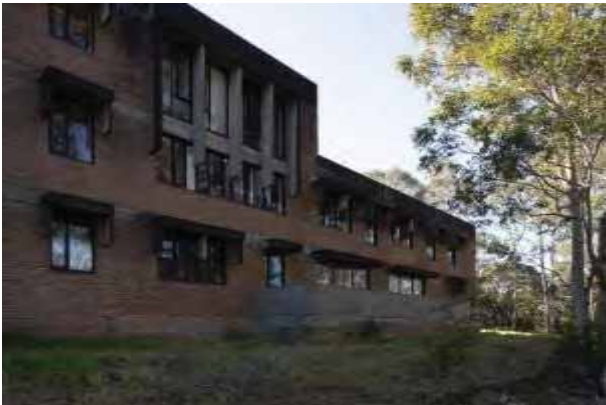
Figure 43 – Portion of southern elevation, with face brickwork and pre-cast concrete sunshades and window hoods

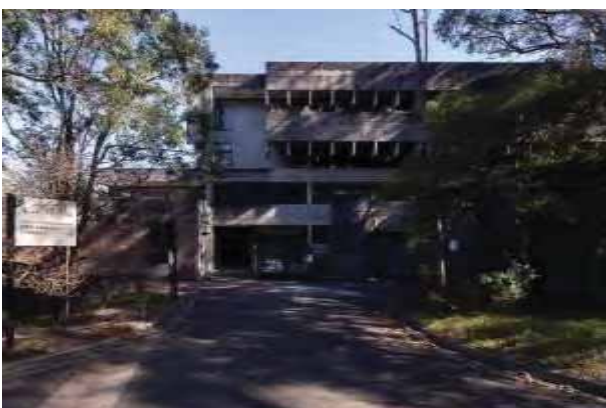
Figure 45 – Portion of eastern elevation with large sections of off-board concrete and sunshades

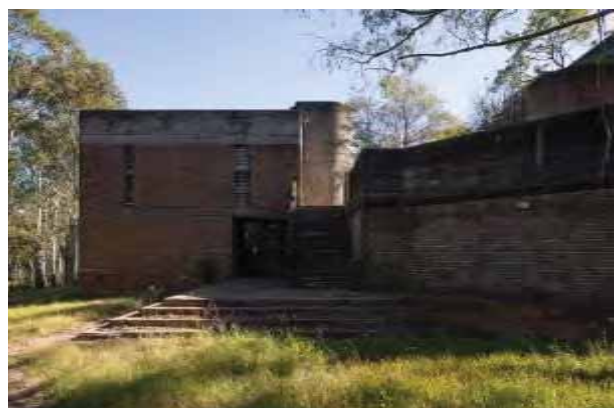
Figure 46 – Portion of eastern elevation with stairs extending up to courtyard.

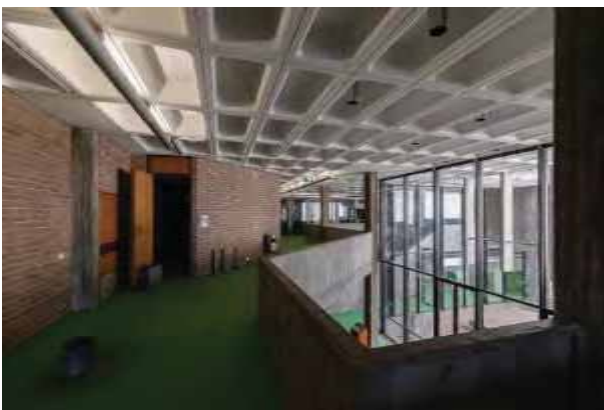
Figure 47 – Level 5 corridor to the east of the auditoriums showing voids to Level 4

The smaller corridors throughout the Stage 1 building loop around the various learning and teaching spaces within the former blocks designated for science, teaching education and arts and crafts. These corridors are generally narrower and feature off-board concrete and brick walls, waffle slab or plasterboard ceilings and green carpets. Two lightwells are incorporated into the circulation spaces on Levels 2 to 4 in the former science and teaching and education blocks.
