CONSERVATION MANAGEMENT PLAN LINDFIELD LEARNING VILLAGE

16 NOVEMBER 2018
SH801
PREPARED FOR DEPARTMENT OF EDUCATION

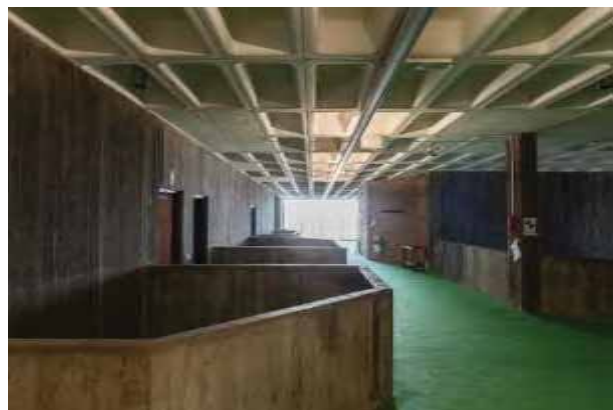
Figure 48 – Level 5 corridor to the west of the former library showing balustrades around voids to Level 4

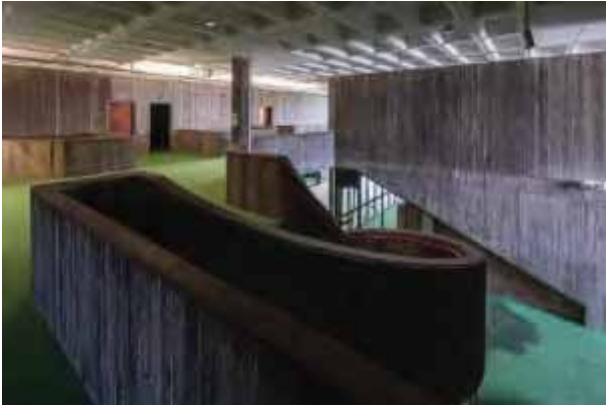
Figure 49 – Level 5 circulation spaces, with spiral staircase leading down to Level 4

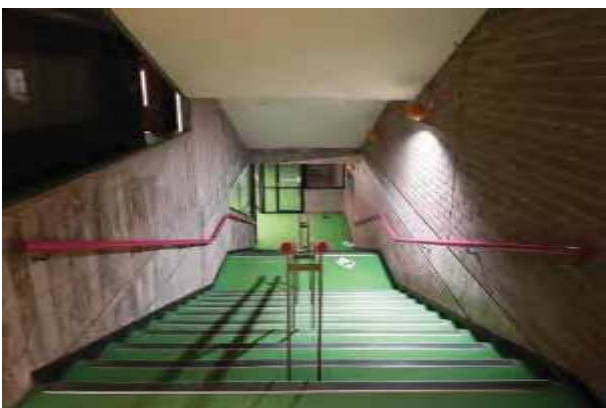
Figure 53 – Staircase leading from Level 3 to Level 2 located in the western portion of Stage 1 showing the distinctive pink handrails and spherical lights

Staircases throughout the Stage 1 building feature off-board concrete and/or brick walls, with pink metal handrails. Distinctive services and lighting is featured throughout some of the circulation spaces, including orange spherical lights and strategically placed services following the grid pattern of the waffle slab ceilings.

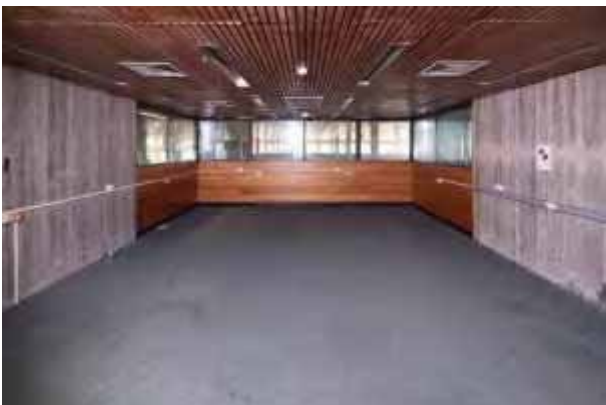
Figure 57 – Space within former library located on Level 5 showing the distinctive battened ceiling and off board concrete walls

A variety of learning teaching spaces are provided within the Stage 1 building, which were used for various purposes, including the former library, classrooms, laboratories, music rooms, offices, art rooms and TV studios. Ceilings within each of the various spaces range from waffle-slab ceilings, timber-boarded, off-board concrete, plasterboard and suspended ceilings. Walls too vary from off-board concrete, brick, plasterboard and glazed panels. A range of different floor covering are utilised including carpet, timber floorboards, tiles, vinyl flooring and concrete. The majority of the learning and teaching spaces have views to the outside, whether it be to the surrounding setting, to courtyards or other outside spaces, or into other internal spaces. Distinctive services and lighting is featured throughout some of the learning and teaching spaces, including bright orange cable trays on waffle slab ceilings, bright yellow air-conditioning ducts and strategically placed services following the grid pattern of the waffle slab ceilings. The following images provide an overview of the various learning and teaching spaces within the Stage 1 building.

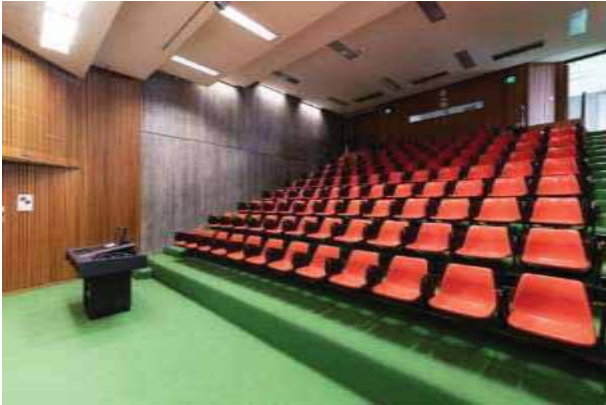
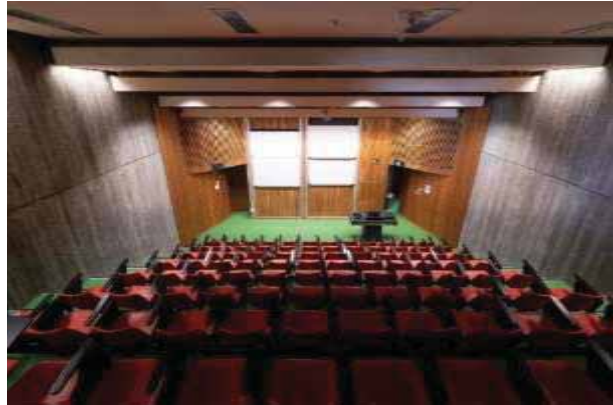
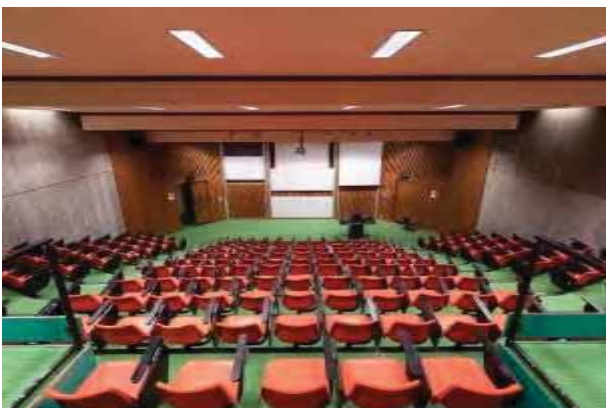
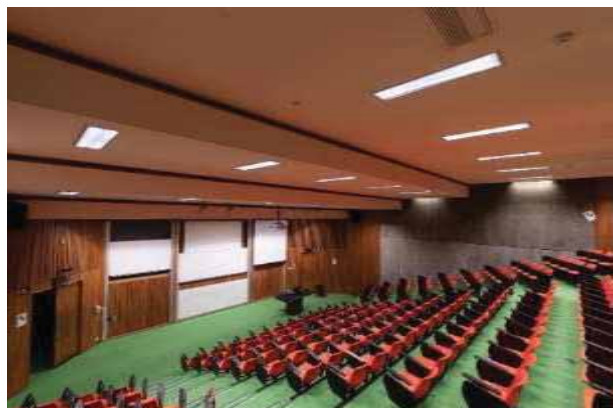
Figure 71 – Small Auditorium at Level 5

Figure 72 – Small Auditorium at Level 5

Figure 73 – Medium Auditorium at Level 5

Figure 74 – Medium Auditorium at Level 5

Two auditoriums are located within the Stage 1 building and are very similar in their design, although one is larger than the other. Both auditoriums are located in the centre of Levels 4 and 5 of the Stage 1 building. Both feature stepped floors with stepped plasterboard ceilings, off-board concrete and timber-batten walls, and green carpet.

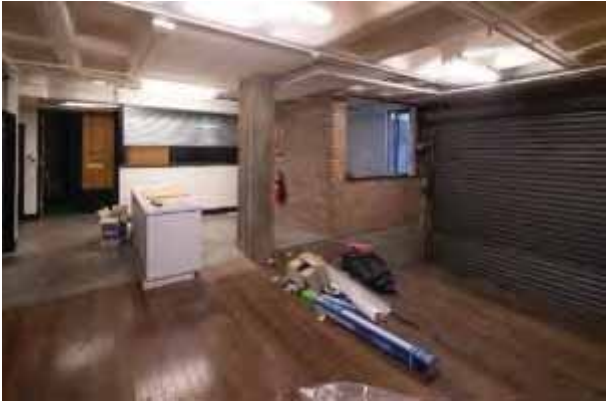
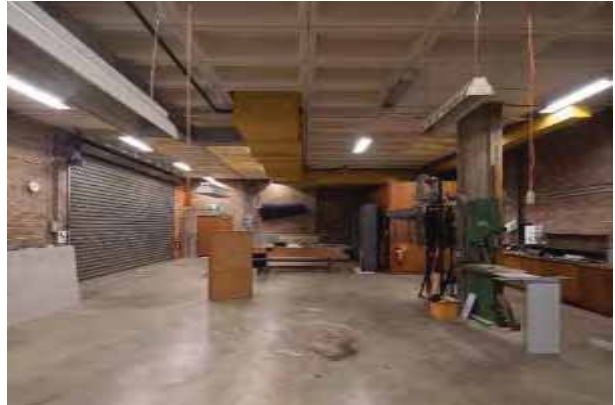
Figure 75 – Loading Dock located on eastern side of Level 2

Figure 76 – Loading dock located on western portion of Level 2

The Stage 1 building has multiple service areas primarily located on Level 2. Two loading docks are located on Level 2, one on the eastern side and one on the western side. Other service areas, including plantrooms and storage areas, built in the bedrock are located in the centre of the level. Various service cupboards are also located throughout all levels of the Stage 1 building.

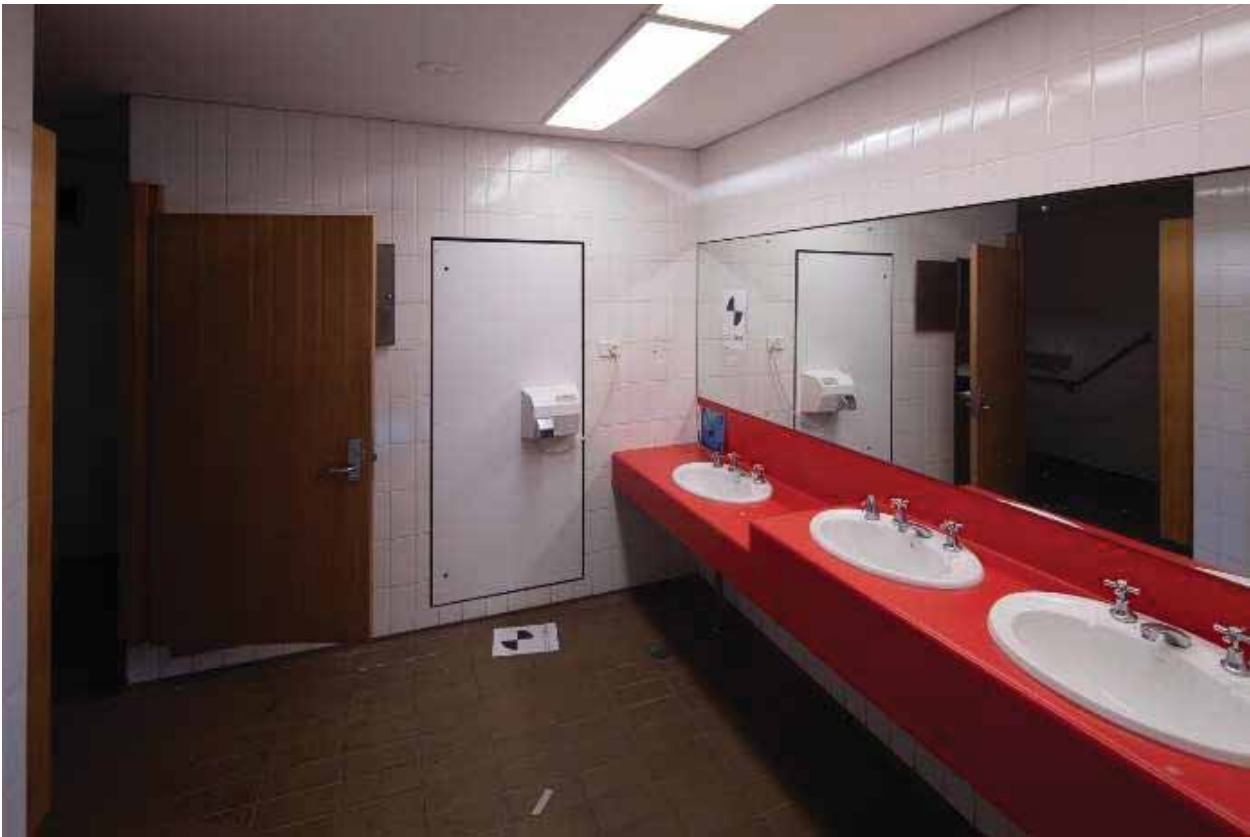
Figure 79 – Bathroom on Level 4

Bathrooms are located across Levels 1 to 4 of the Stage 1 building. The spaces feature tiled floors, painted walls and dropped plasterboard ceilings. All bathrooms within area Partial School (Phase 1 in the Stage 1 building) are to be refurbished. The remaining bathrooms are anticipated to be refurbished at later stages of development.

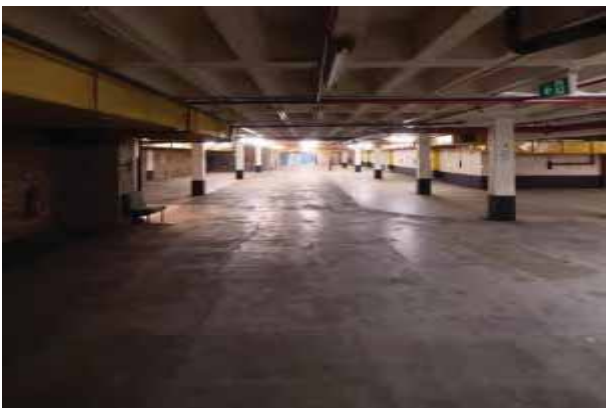
Figure 80 – View of the carpark at Level 3

An internal carpark is located on Level 3 of the Stage 1 building, accessed from Dunstan Grove. The carpark has painted concrete floors, with concrete columns and waffle slab ceilings. Air-conditioning ducts which snake around the ceiling are painted bright yellow, and the fire sprinkler system is painted bright red, both contrasting with the white of the ceilings.

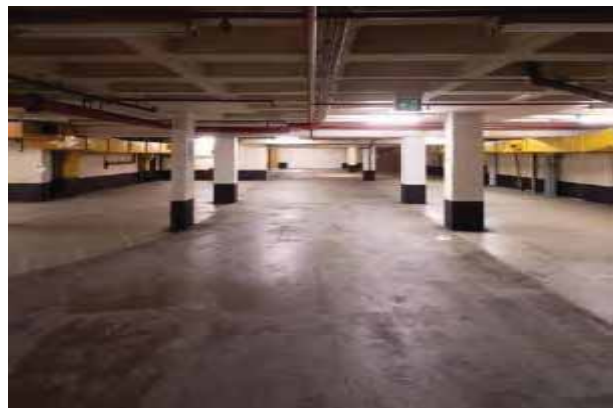
Figure 81 – View of the carpark at Level 3

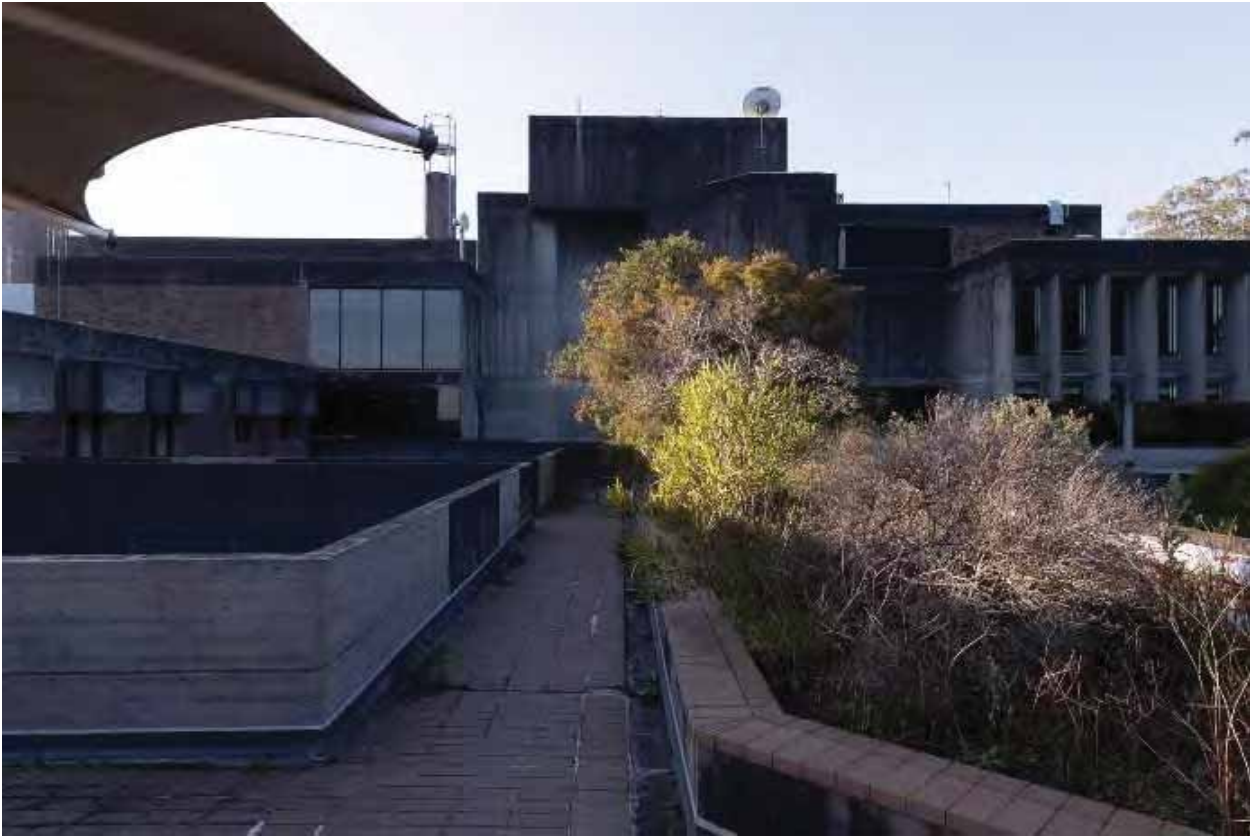
Figure 82 – Rooftop garden on Level 4

The Stage 1 buildings features a range of different outdoors spaces, including courtyards on Levels 2 and 4 rooftop gardens and walkways on Levels 3 and 4 and balconies on Levels 3 to 5. The rooftop gardens and walkways located in the southern portion of the building are one of the principal features of the Stage 1

building. While alterations have been made to the spaces over time, many of the original planters in the spaces remain intact. Three large courtyards are located on Levels 2 and 4 and a series of balconies are located on the eastern side of the building.

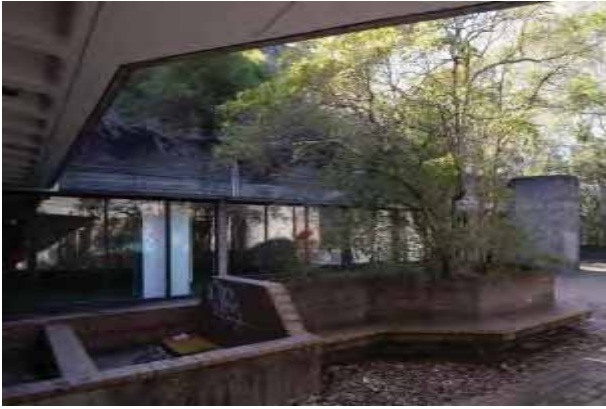
Figure 85 – Courtyard with water feature on Level 2
Source: Alexander Mayes

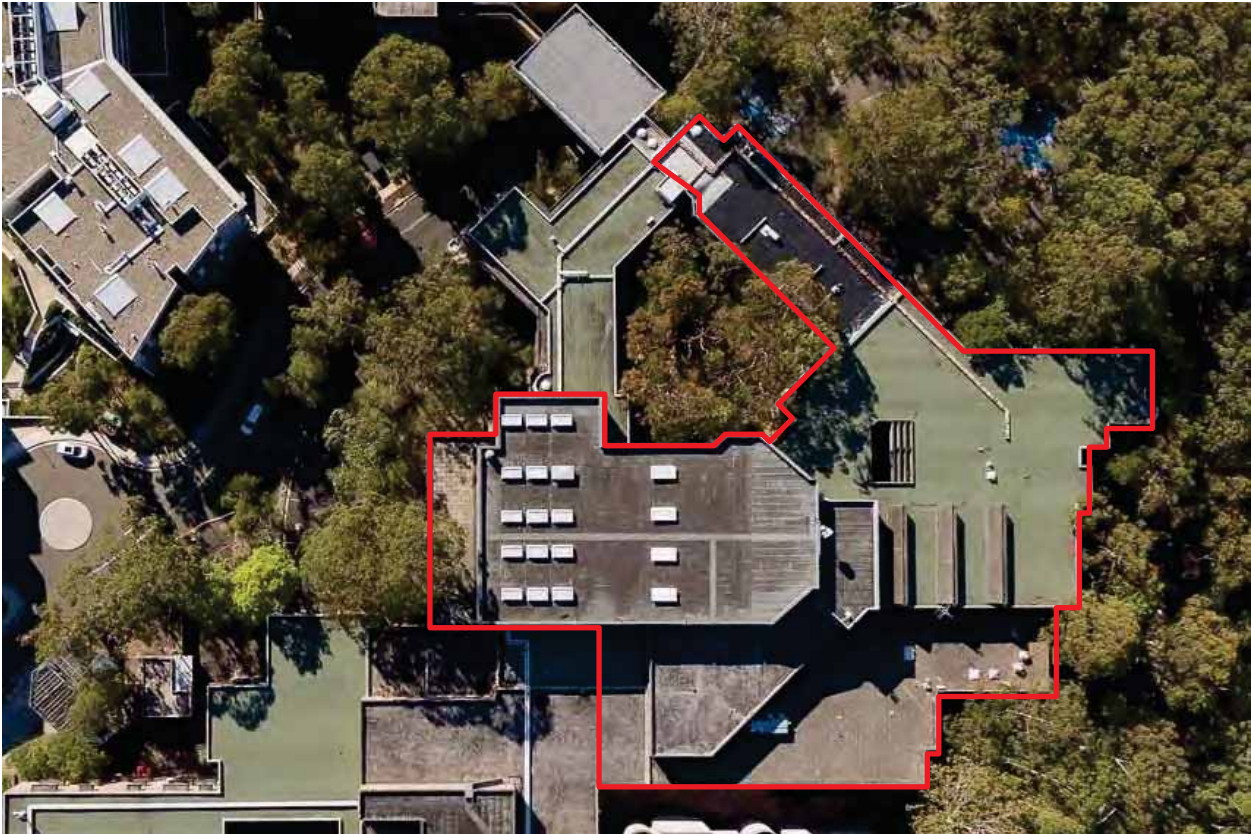
Figure 89 – Aerial view of Stage 2 building

The Stage 2 building was completed by 1974 and was constructed in the same manner as the Stage 1 building, integrating with its form.

Stage 2 defines the southern and western boundaries of the highly significant internal courtyard (which is also partly bound by Stage 4). The main entrance to the building is from the north eastern façade of Stage 2 and features double height glazing and an elaborate pre cast concrete sun shade and decorative blade walls.

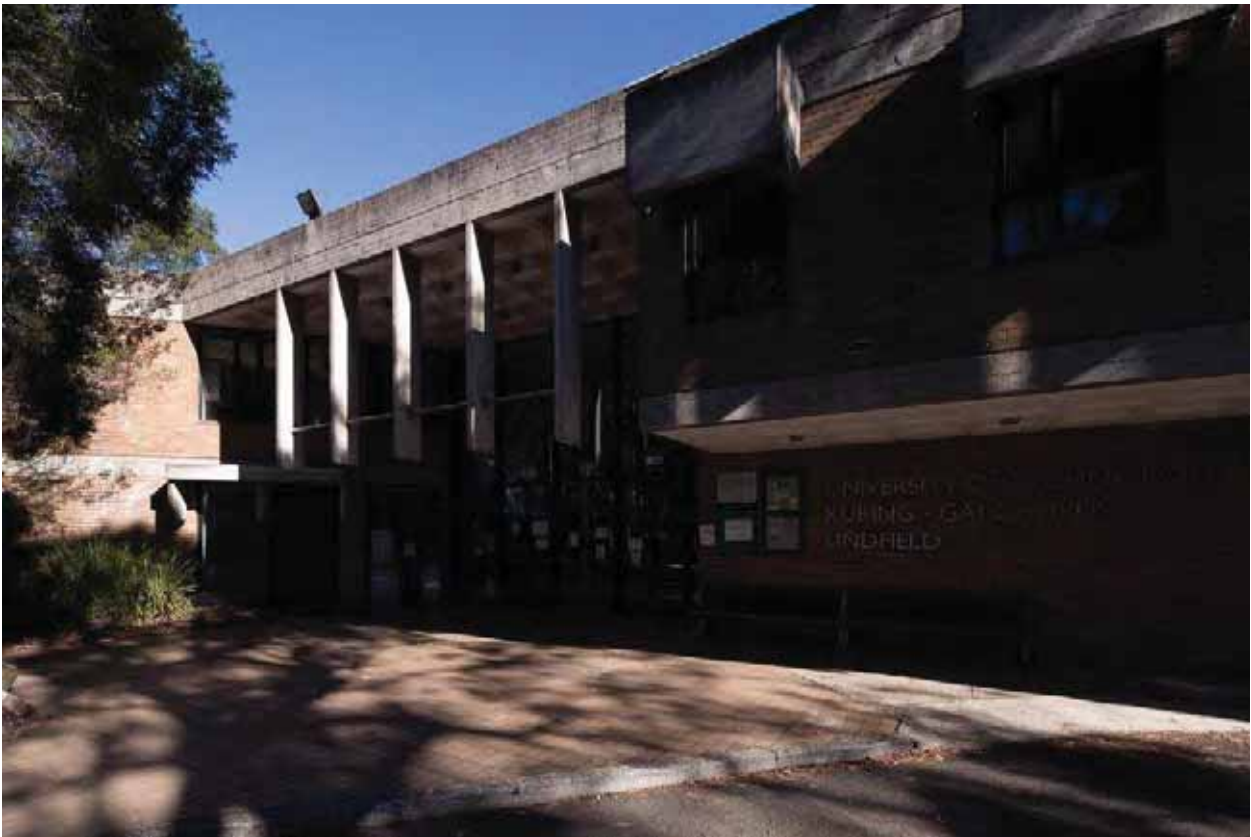
Figure 90 – Main entrance to the Stage 2 building on the north-eastern elevation

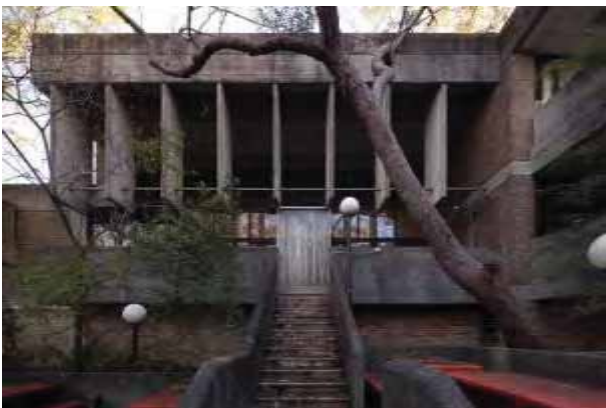
Figure 91 – Section of eastern elevation (outside cafeteria space) featuring pre-cast concrete sunshade

The same materials and detailing are utilised in the Stage 2 building as in the Stage 1 building. Extensive use of pre-cast concrete sunshades is continued which presents across the majority of the elevations, along with off-board concrete slabs, windowhoods, roof parapets and external stairwells. All windows are black aluminium framed. The roofs are clad in a membrane.

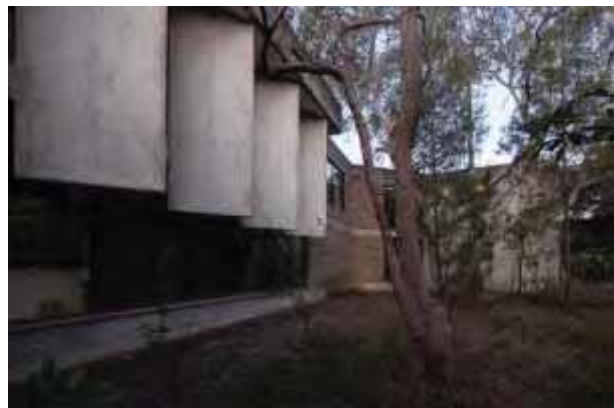
Figure 92 – Courtyard elevation, featuring pre-cast concrete sunshades

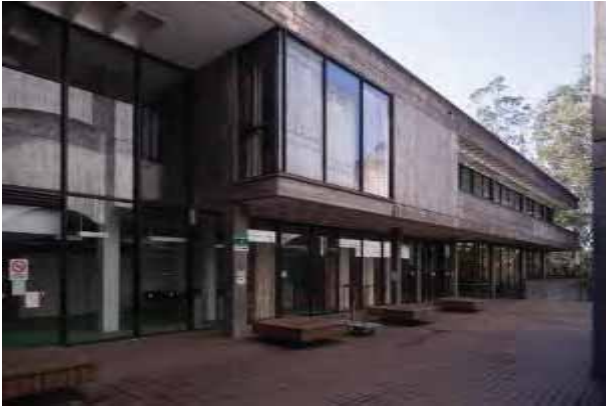
Figure 93 – Southern elevation adjacent to courtyard (bound to the south by Stage 1), featuring off-board concrete

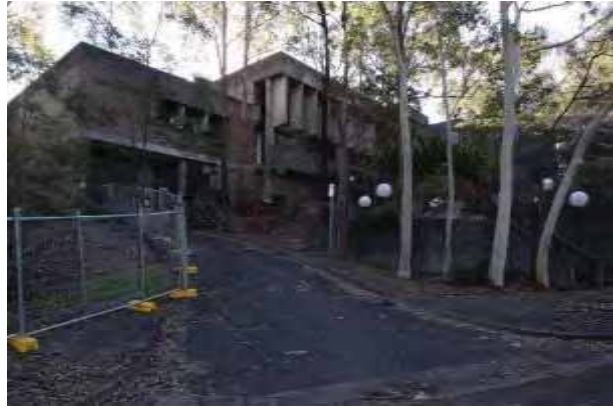
Figure 94 – Portion of Eastern elevation featuring pre-cast concrete sunshades

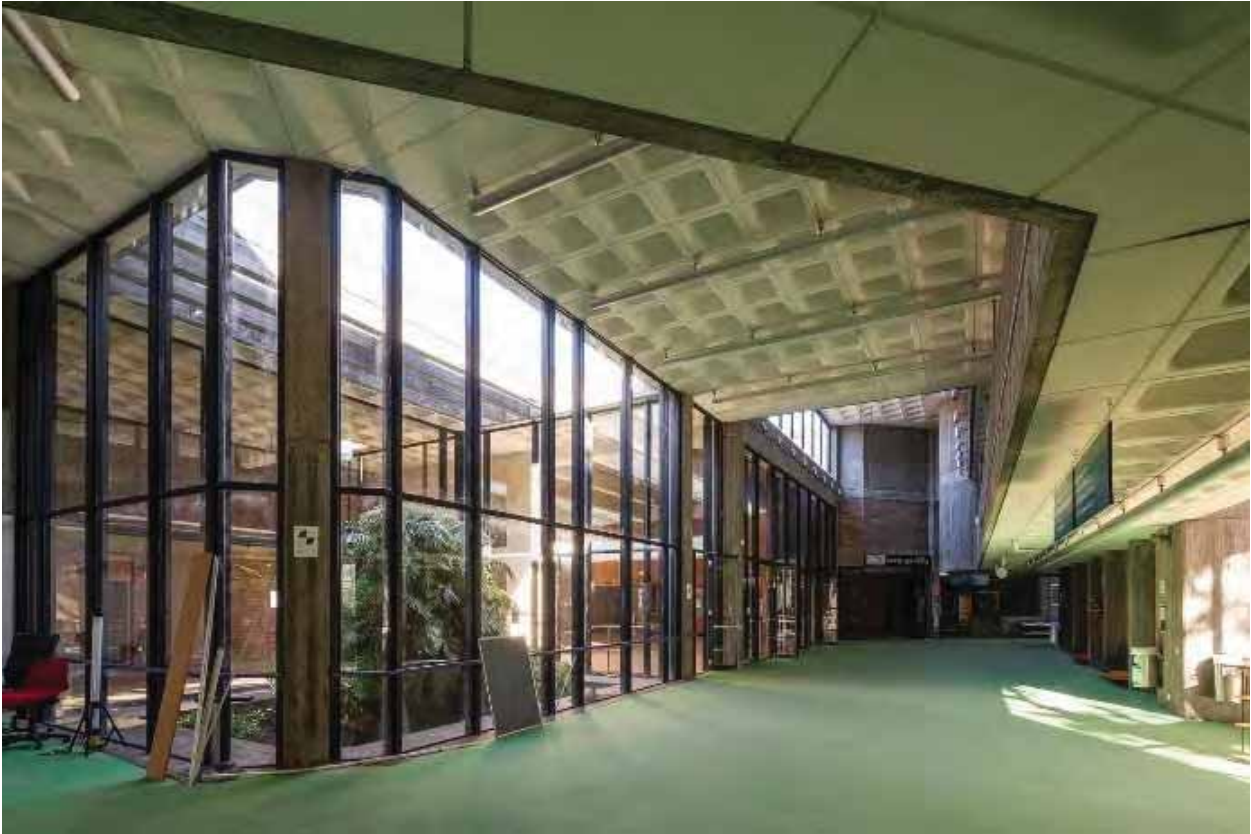
Figure 95 – View from the main entrance across the double height main circulation spine of the Stage 2 building (Level 5) showing the atrium/fishpond to the left and adjoining cafeteria

The main entrance of the Lindfield Learning Village complex is located in the north-western portion of the Stage 2 building at Level 5. The main entrance features a double-height space filled with light from the atrium/fishpond adjacent and windows scattered throughout the space. Suspended walkways snake around the space at Level 6. Large expanses of off-board concrete line the walls of the main circulation spine, with waffle slab ceilings. An early school bell is remnant at the Level 6 ceiling.

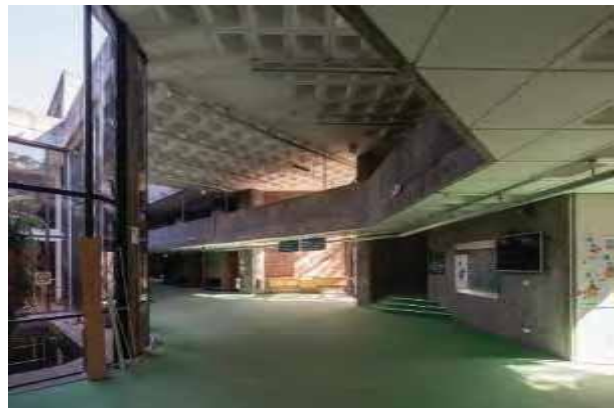
Figure 97 – View from the main entrance to Stage 2 building at Level 5 showing the double height main circulation spine and walkway to level 6 above

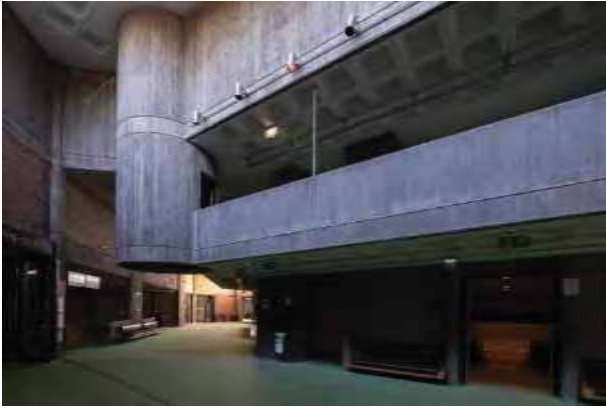
Figure 98 – Suspended walkway and stairwell at Level 6 viewed from Level 5

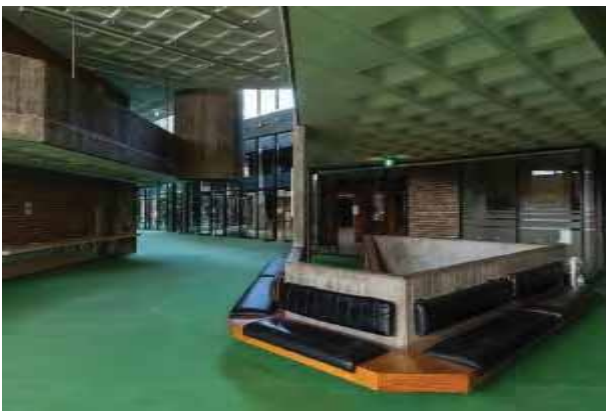
Figure 100 – Common circulation space in the south-western portion of Level 5 showing original built in furnishings and the suspended walkway to level 6

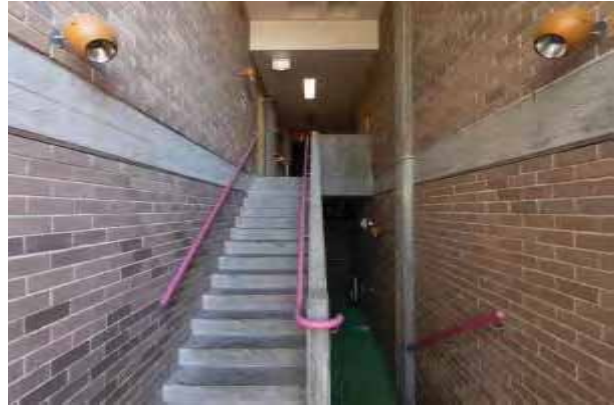
Figure 105 – Stair at the rear of the large auditorium showing the distinctive original pink handrail and orange spherical lights
Source: Alexander Mayes

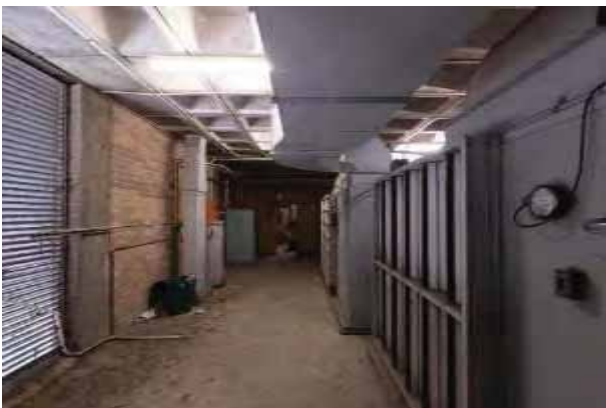
Figure 122 – Plant room on Level 5 at the rear of Auditorium

The Stage 2 buildings has a few service areas. A plant room is located to the rear of auditorium at Level 5 and a loading dock area is located on Level 4 on the eastern side of the Stage 2 building. Service cupboards are also located throughout all levels of the Stage 1 building.

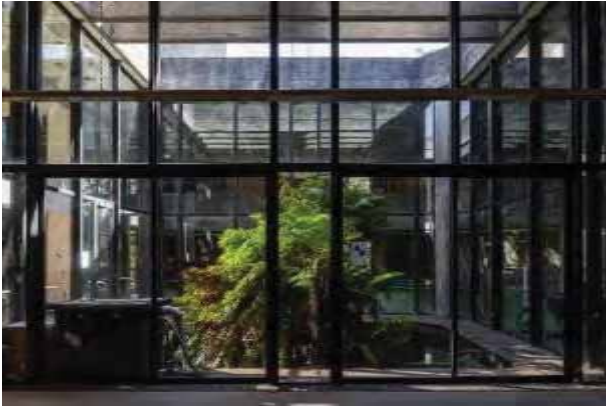
Figure 125 – Atrium at Level 5 with pond and plantings
Source: Alexander Mayes

Directly to the south-east of the bushland courtyard is a glassed atrium space which adjoins the main circulation spine and cafeteria. A water feature with pond and planting feature in the space and pre-cast concrete fins span across the opening.

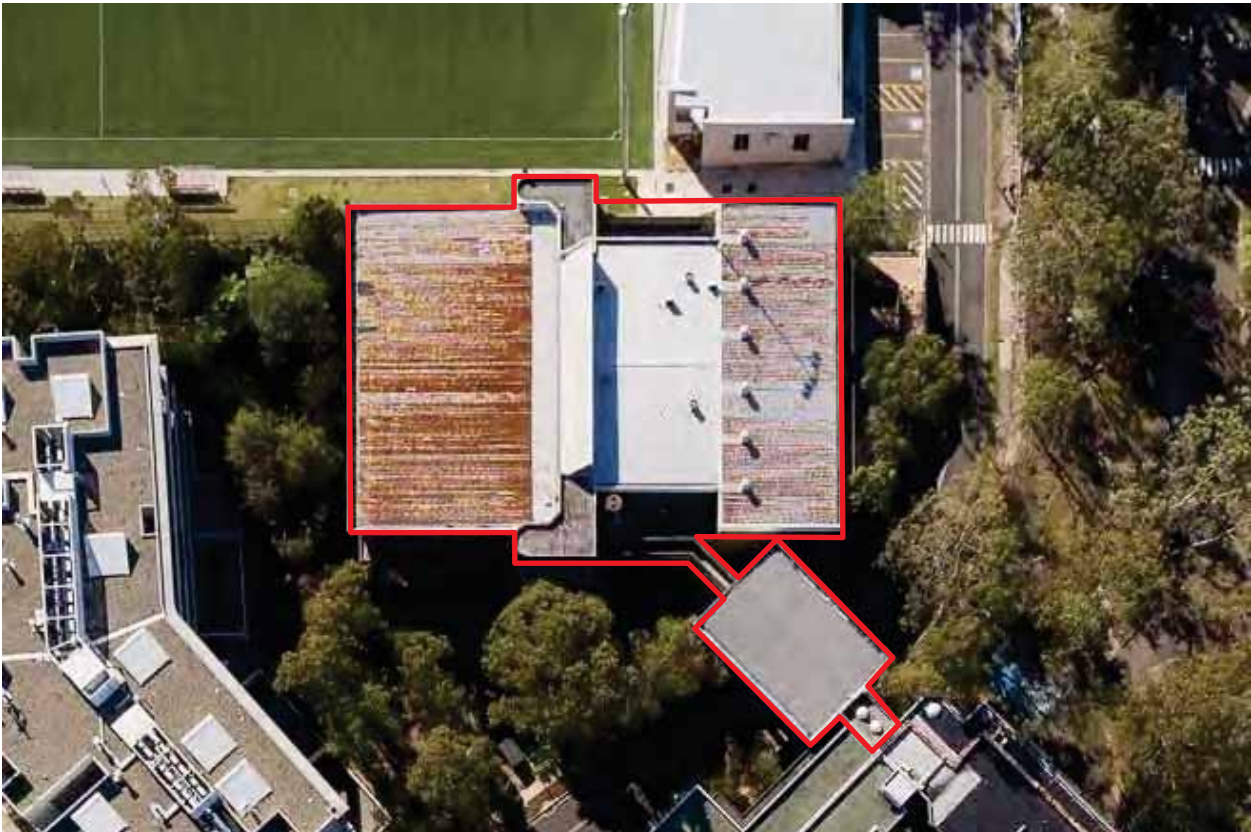
Figure 130 – Aerial view of Stage 3 buildings, circled in red
Source: Alexander Mayes

The Stage 3 building was completed in 1976 and was originally designed as a gymnasium.

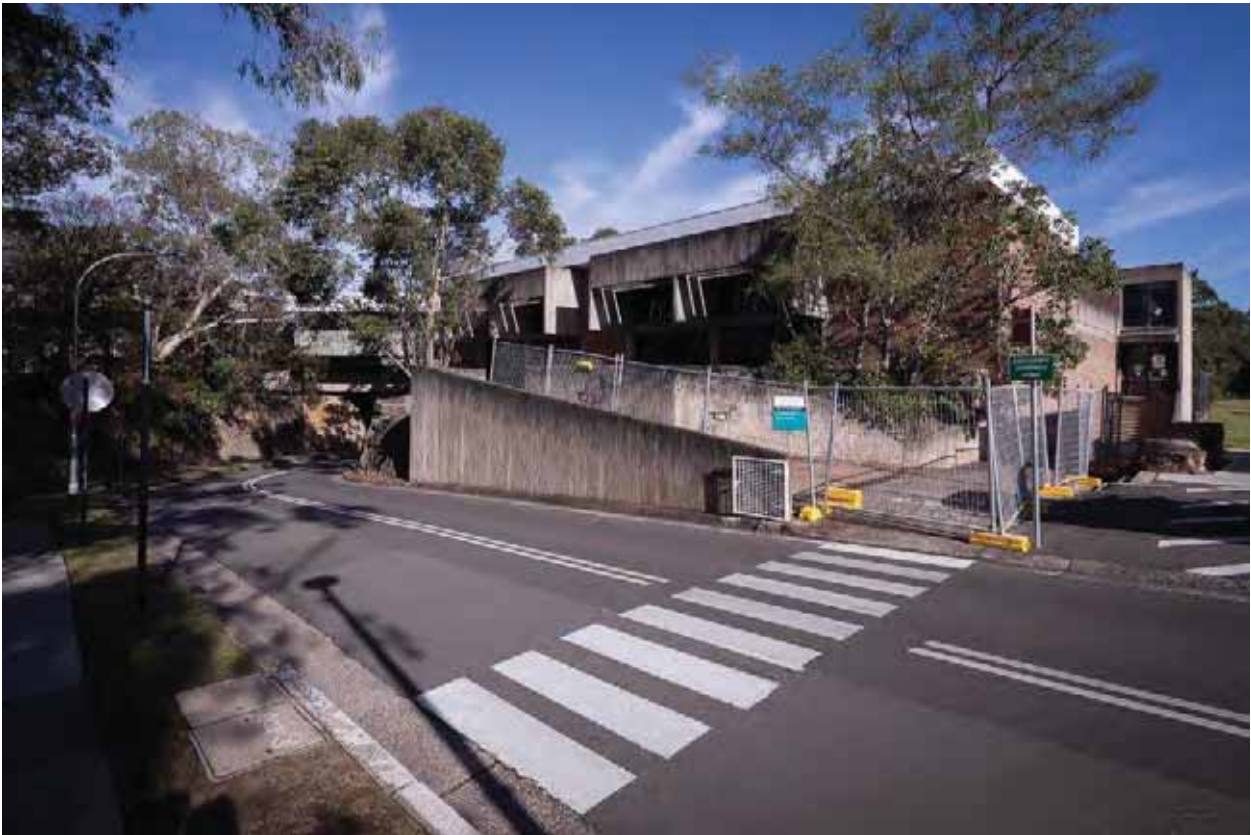
Figure 131 – Eastern elevation of Stage 3 building viewed from Dunstan Grove.

of the of the northern and southern elevations. The exterior walls of the building primarily feature facebrick infill between off-board concrete. Pre-cast concrete sunhoods feature on the eastern elevation of the building over an outdoor terrace with a pre-cast concrete ramp leading to the outdoor space. The soffit of Level 2 to the west of the gym is clad in timber. All external windows are black aluminium framed. The roof is primarily clad with corrugated metal sheeting, apart from the roofs of the stairwells, which have only the waterproof membrane.

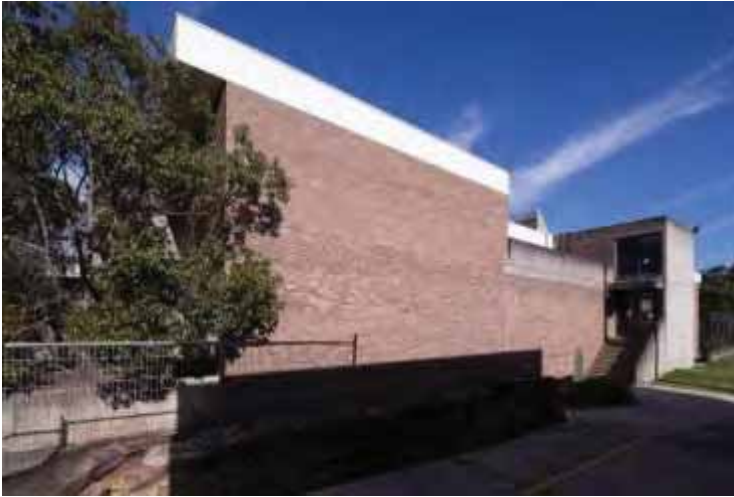
Figure 134 – Northern elevation of the Stage 3 building set on natural sandstone base, with facebrick walls

The Stage 3 building is located in the northern section of the site and is linked to the Stage 2 building via an elevated link bridge at Level 5 and 6, spanning across Dunstan Grove. The building is constructed on a sandstone outcrop and spans over five storeys from Level 2 to 6. As with all the building of the Lindfield Learning Village stage buildings Stage 3 is consistent with the Stage 1 building, however due to budget cutbacks, the Stage 3 building was constructed in a simpler manner and with less expensive materials and finishes. The building is rectangular in form with curved off-board concrete stairwells jutting out in the middle

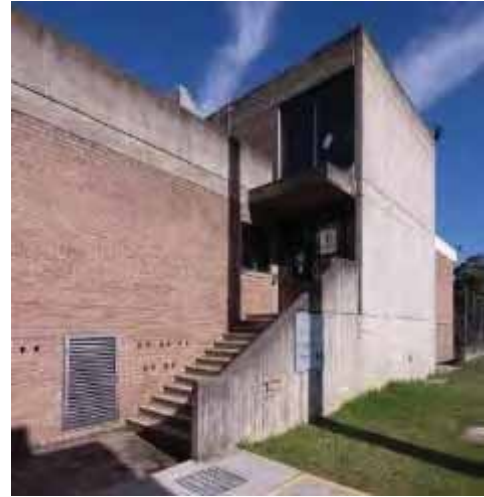
Figure 135 – Exterior stairwell on northern elevation of the Stage 3 building

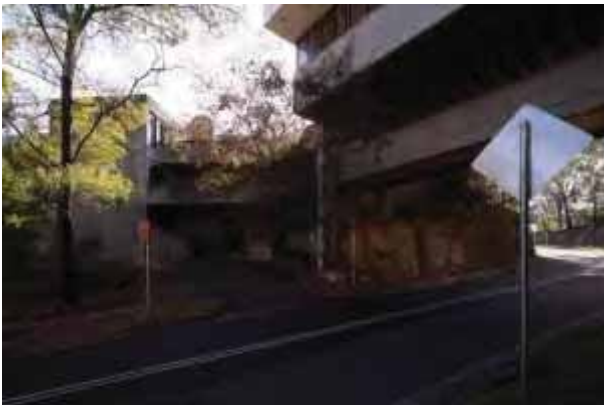
Figure 136 – Part of southern elevation of the Stage 3 building with the link bridge in the top right

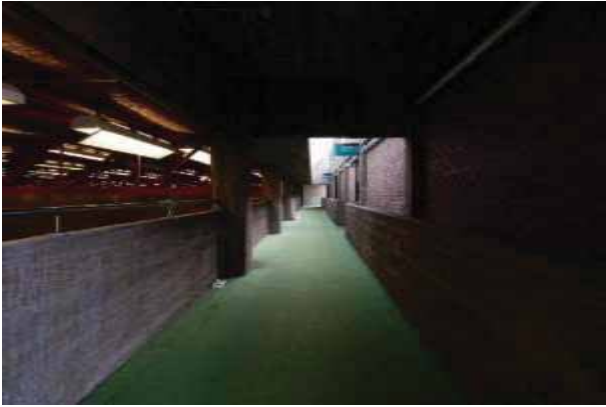
Figure 138 – Corridor on Level 6, overlooking the basketball courts (at left)

The internal circulation spaces within the Stage 3 building are primarily located in the centre of the building on Levels 5 and 6, with secondary corridors running perpendicular to the main central walkways on each level, providing access to learning and teaching spaces on Level 6 and access to bathrooms and change rooms on Level 5. The primary walkway is open to the triple height basketball space to the west.

The corridors primarily feature off-board concrete columns with brick infill and green carpeted floors, while the ceilings vary between off-board concrete, plasterboard and timber boarded ceilings. Staircases are located at the northern and southern ends of the main corridors in the centre of the building providing access to each level. The stairwells feature off form concrete walls with pink metal handrails and tiled treads.

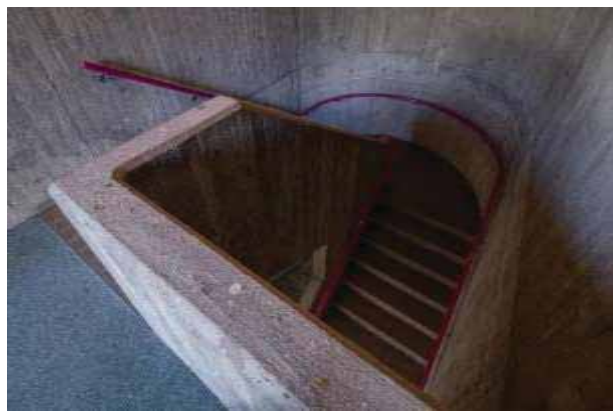
Figure 141 – Spiral staircase with characteristic pink handrail

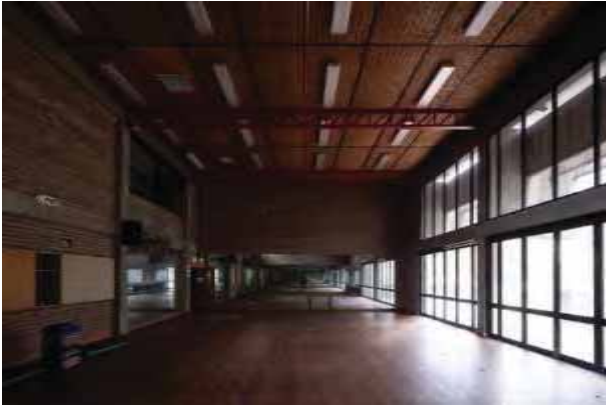
Figure 142 – Dance Studio located on Level 5
Source: Alexander Mayes

A variety of learning teaching spaces are provided within the Stage 5 building, located across Levels 4, 5 and 6. A double-height space is located at Level 5, which formerly served as a dance studio (Figure 142). The walls of the space feature off-board concrete columns and exposed floor slabs with brick infill and timber skirting. Mirrors are affixed on the northern and southern walls. The ceilings feature exposed steel beams painted red, with a matted straw ceiling. At Level 6 are a variety of smaller spaces with plasterboard clad partition walls and ceilings, each opening onto balconies on the northern and southern sides (Figure 143). Another space is located in the middle of Level 6, also featuring plasterboard clad walls and ceilings (Figure 144). At Level 4, there is a long open space located behind the basketball courts, which features brick walls and suspended ceiling (Figure 145).

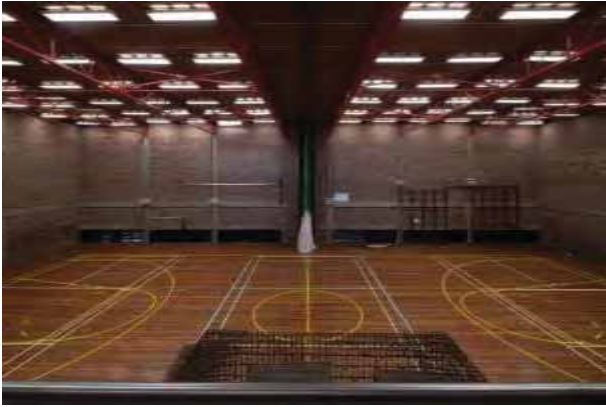
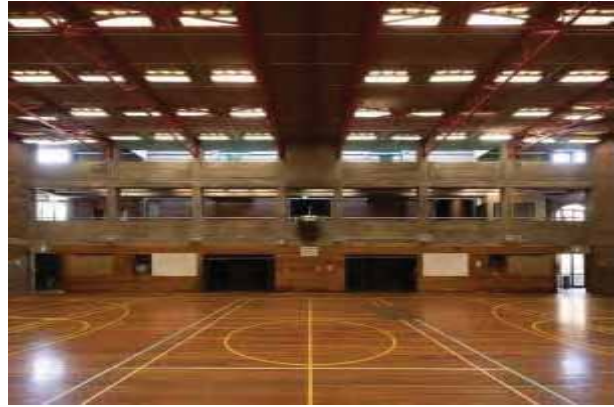
Figure 146 – Basketball Court on Level 4, western wall
Source: Alexander Mayes

Figure 147 – Basketball Court on Level 4, eastern wall
Source: Alexander Mayes

The Stage 3 buildings is the only building to contain sporting facilities. A basketball court is located on Level 4 (Figure 146 and Figure 147). The space expands over three levels and can be viewed from the elevated walkways which line the eastern wall of the basketball court space. The walls of the space feature off-board concrete columns and exposed floor slabs with brick infill. The ceilings feature exposed steel beams painted red, with a matted straw ceiling. The southern wall of the basketball court featuring timber paneling, with two tilt up doors providing access to storage areas. Two squash courts are located on Level 2, accessed via the southern stairwell (Figure 148 and Figure 149).

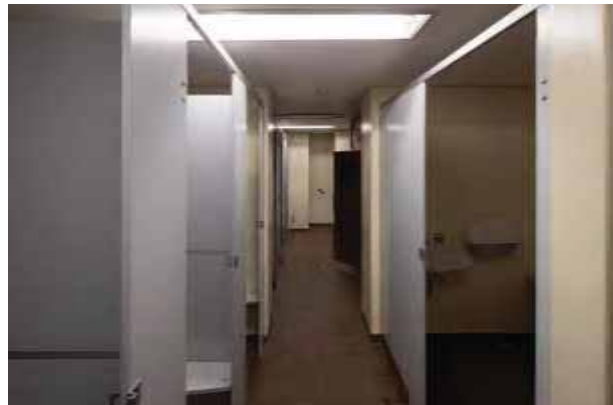
Figure 153 – Bathrooms on Level 5

Bathrooms and changerooms are located in the center of Level 5. Two individual bathrooms are located on Level 6. The spaces feature tiled floors, painted walls and dropped plasterboard ceilings. Bathroom fittings include characteristic coloured timber partitions and joinery.

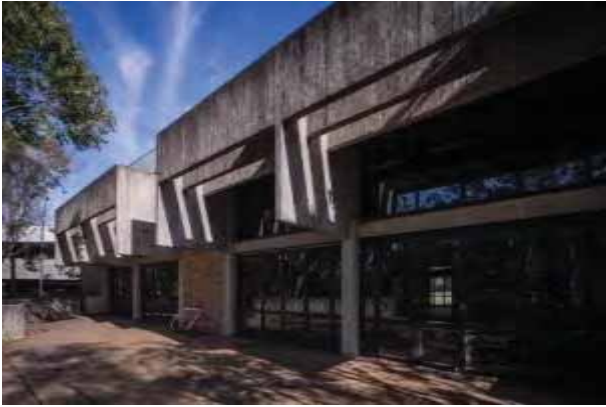
Figure 154 – Terrace outside dance studio located on Level 5

Two balconies are located on Level 6 on the northern and southern side of the Stage 3 building, accessed via the learning and teaching spaces (Figure 155). An open paved terraced is located on Level 5, with pre-cast concrete sunhoods extending over the space (Figure 154).

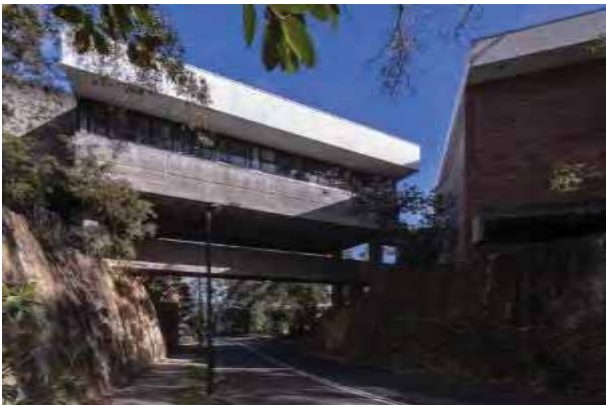
Figure 156 – Link bridge viewed from the north-east, with the Stage 3 building visible on the left.

The link bridge is built over two levels and spans across Dunstan Grove. The bridge is located at Levels 5 and 6 and connects the Stage 3 building to the main building complex via the Stage 2 building. The link bridge features off-board concrete and waffle slab ceilings on both levels. The lower level, Level 5 is an open walkway, whilst the upper level, Level 6 is enclosed with aluminium framed windows, providing additional learning and teaching spaces.

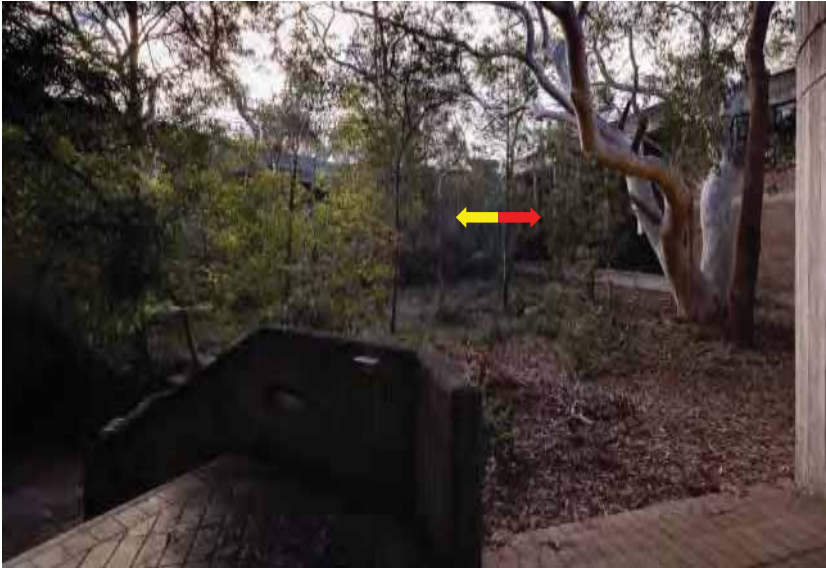
Figure 165 – View of courtyard formed by Stage 2 (red arrow) and Stage 4 (yellow arrow) buildings

The building is an irregular Y-shaped form which spans across three levels. The building adjoins the Stage 2 building including the main auditorium to the south and the very northern extent of the Stage 2 building. The Stage 4 building created an enclosed courtyard between the stage 2 and 4 buildings. The Stage 4 building matches the earlier buildings in its design and materials, incorporating the characteristic palette of facebrick walls and off-board concrete slabs and details including precast window hoods. The latter stages however tend to comprise more brick construction, with concrete accents. All external windows are black aluminium framed and the roof is clad with a waterproof membrane.

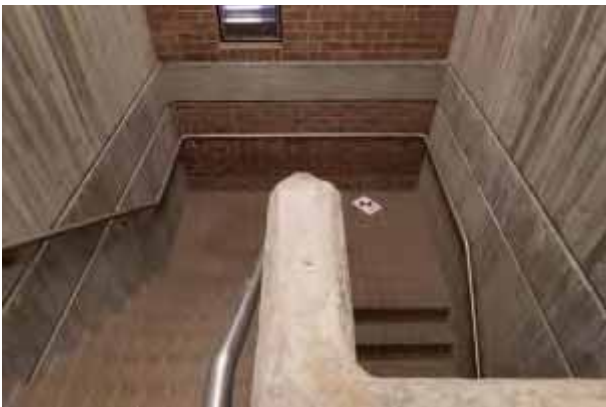
Figure 171 – Staircase at south end of Stage 4

The internal circulation spaces within the Stage 4 building are located in the centre of each of the three levels of the buildings, with access to each of the flanking learning and teaching spaces directly from central hallways. The corridors primarily feature waffle slab ceiling and exposed services. A staircase is located at the southern end of the building providing access to all three floors and a second staircase is located between Levels 4 and 5. Both staircases feature off-board concrete walls and metal handrails.

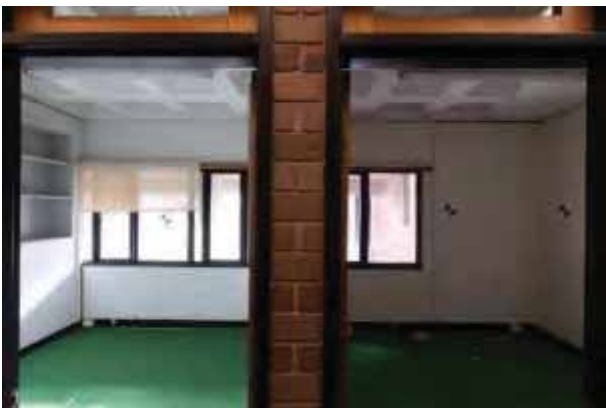
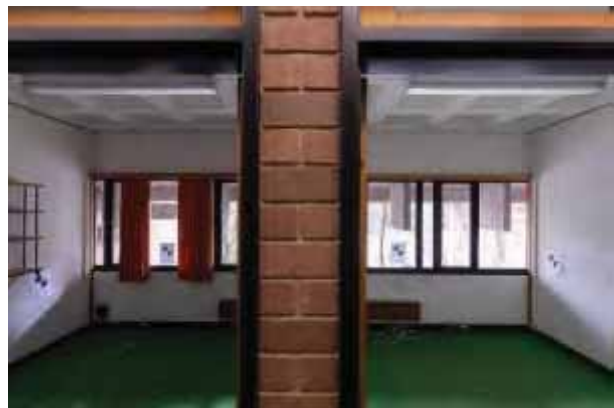
Figure 173 – Typical learning and teaching spaces

Learning and Teaching spaces are located across all three levels of the Stage 4 building and are located in the same position across each floor. All feature waffle slab ceilings, plasterboard partition walls (where they adjoin another learning and teaching space), facebrick walls (where they adjoin circulation spaces) and green carpeted floors.

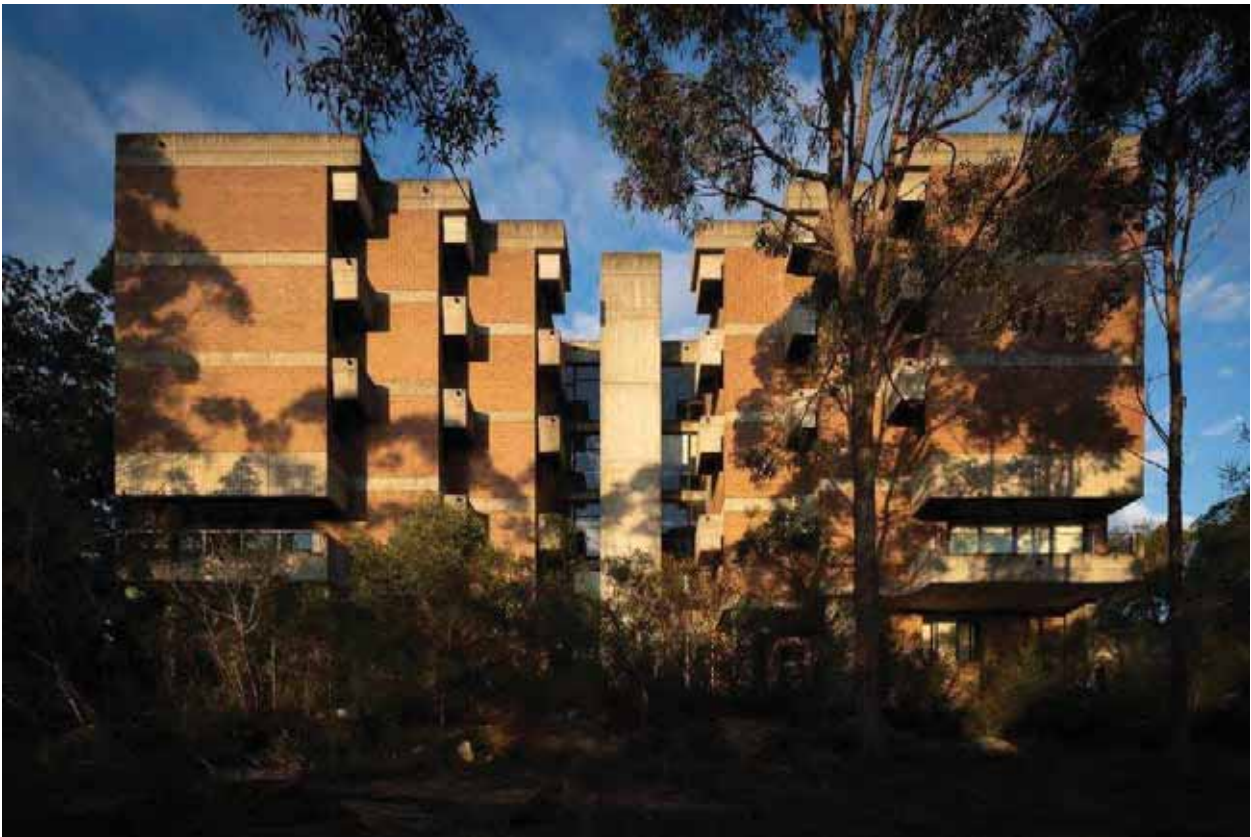
Figure 180 – Western elevation of Stage 5 building
Source: Alexander Mayes

The Stage 5 building spans over five levels and is located in the south-western portion of the Lindfield Learning Village site. It is linked to the Stage 1 building via an internally linked walkway at Levels 1 to 4. The Stage 5 building matches the earlier buildings in its design and materials, incorporating the characteristic palette of facebrick walls and off-board concrete slabs and details including precast concrete window hoods, with waffle slab ceiling inserts. The latter stages however tend to comprise more brick construction, with concrete accents.

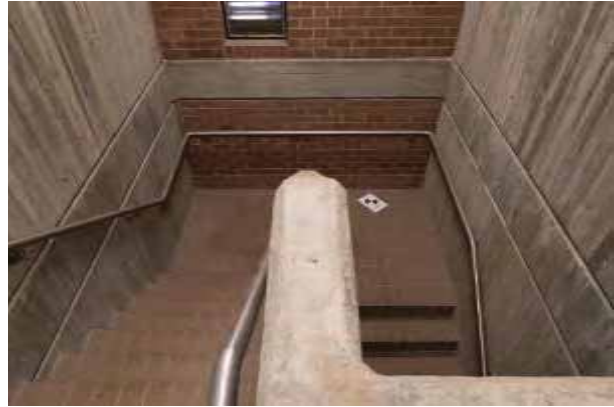
Figure 191 – Stairwell

A lift is located on the western side of the building in the central of the main corridor. The two staircases are located to the north and south of the lift well, however separated due to the step in the buildings elevation. Consistent with the earlier stages, the staircases feature off-board concrete walls with metal handrails and tiled treads.
