CONSERVATION MANAGEMENT PLAN LINDFIELD LEARNING VILLAGE

16 NOVEMBER 2018
SH801
PREPARED FOR DEPARTMENT OF EDUCATION

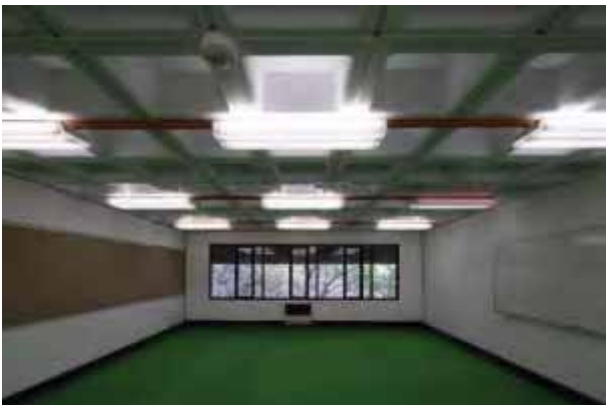
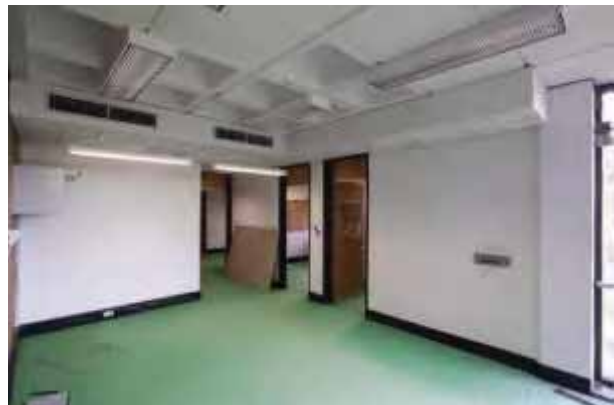
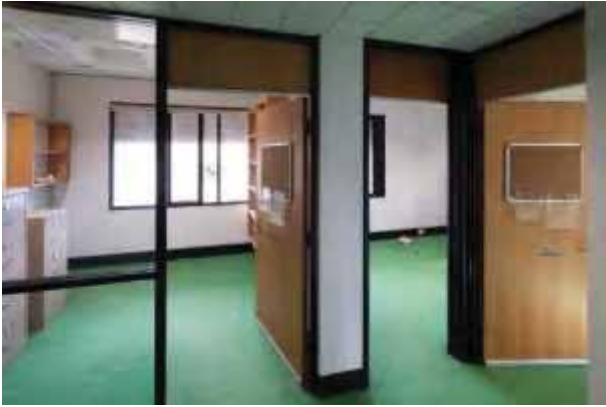
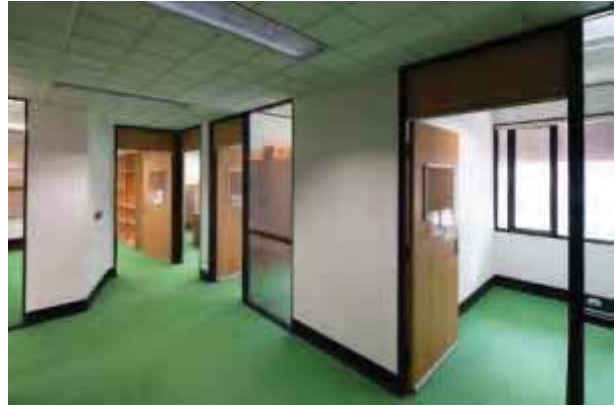
Figure 192 – Typical large learning and teaching space on Level 0, 2, 3 and 4

Learning and Teaching spaces are present across all five levels of the Stage 5 building and are located in the same position across each floor. The Learning and Teaching spaces on Levels 0, 2, 3 and 4 plasterboard partition walls (where they adjoin another learning and teaching space), facebrick walls (where they adjoin circulation spaces). Ceilings are typically waffle slab or suspended.

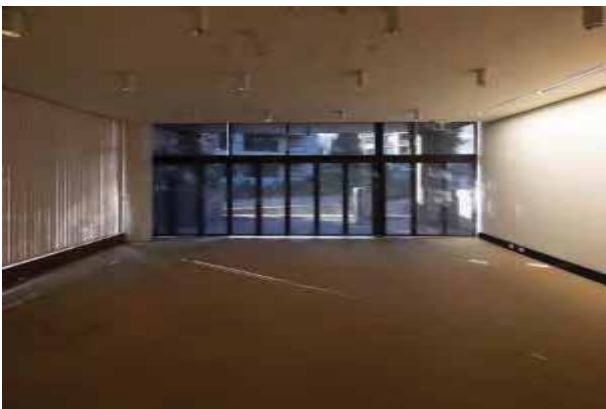
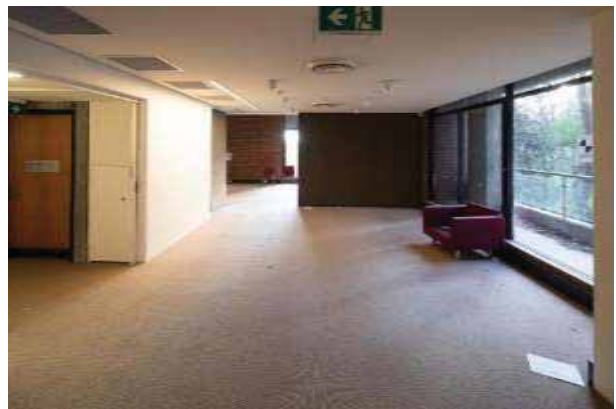
Figure 196 – Large Learning and Teaching space on Level 1

Level 1 differs from the other levels in its finishes due to its more recent alterations. Walls in the Learning and Teaching spaces feature small areas of off-board concrete and brick, however the walls are primarily partition walls clad with plaster board. Ceilings are dropped and clad with plaster board.

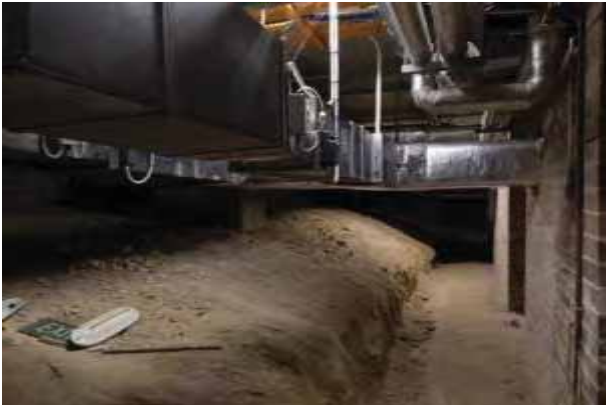
Figure 198 – Service space on the eastern half of Level 0

Small service cupboards are located on the western wall of the main corridors of each level of the Stage 5 building. Service cupboards are located in the middle of the building on each level. The eastern half of Level 0 is built into the sandstone bedrock and is used as service spaces, including a plant room.

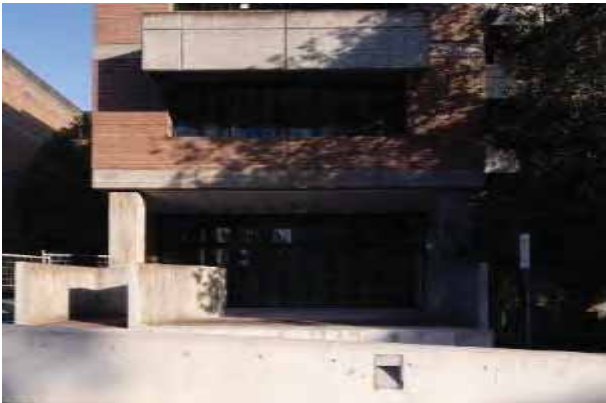
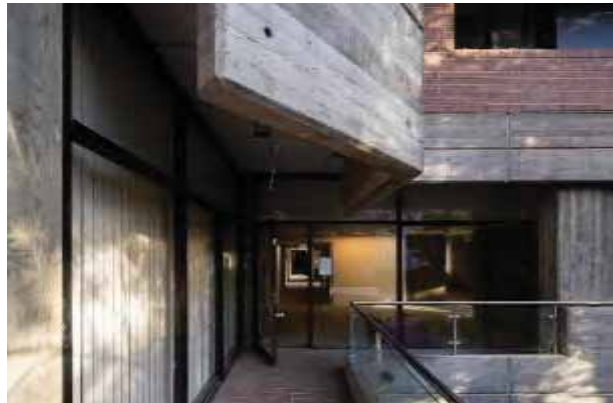
Figure 200 – Balcony on Level 1 on northern elevation

Outdoor spaces in the Stage 5 building are located only on Level 1 and are located on the northern and southern ends of the floor. Balustrades for the northern and southern outdoor spaces are of off-board concrete, while the two small corner balconies have metal and glazed balustrades.

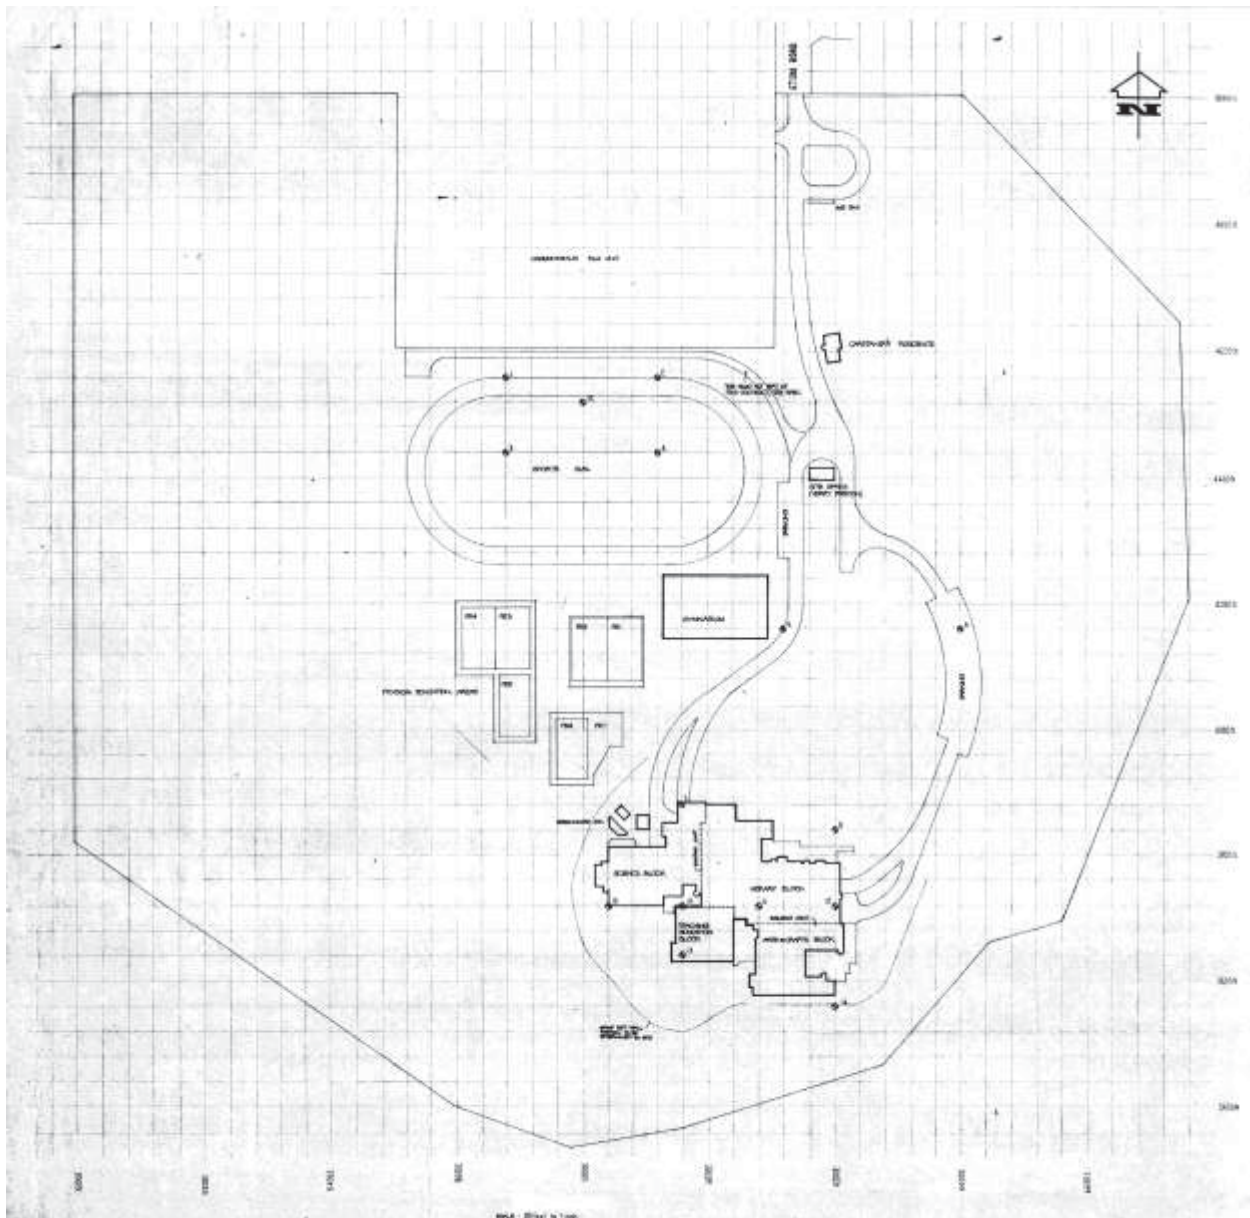
Figure 205 – William Balmain Teachers College Stage 1 – Site Plan (sheet number 4)

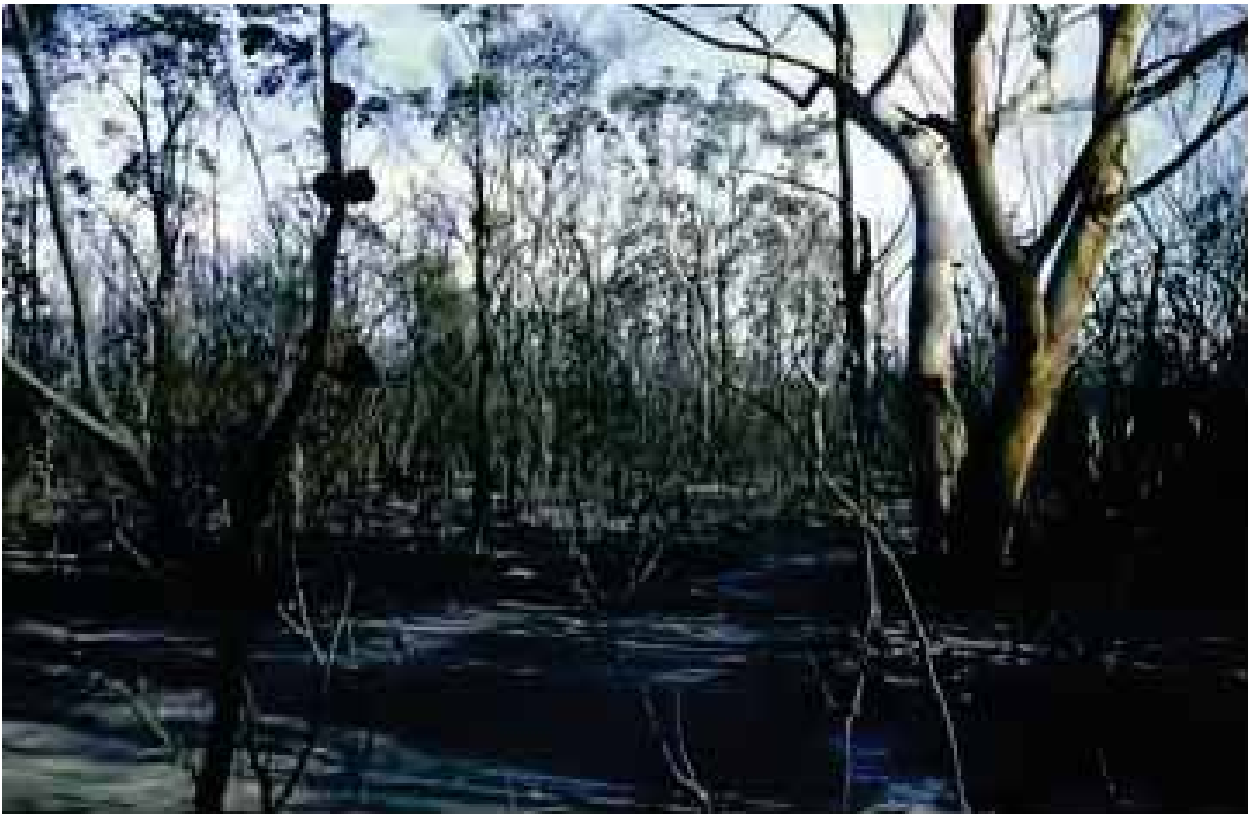
Figure 211 - Bush Fire damages vegetation within the site prior to the commencement of construction works associated with Stage 1

Before construction work commenced the construction area was clearly marked out on site and all the trees labelled as either 'to be removed' or preserved. Access routes and open areas had been carefully planned on the basis of vegetation that was worthy of being preserved. Just before construction commenced, a severe bushfire razed most of the site, and destroyed the vast majority of the vegetation.

Despite, the damage caused by the bushfire in the late 1960s which seriously affected the site immediately prior to construction, by completion of Stage 1, the landscape had completely recovered and Mackenzie was able to implement the above steps to achieve the sense of the College having been dropped into the site.

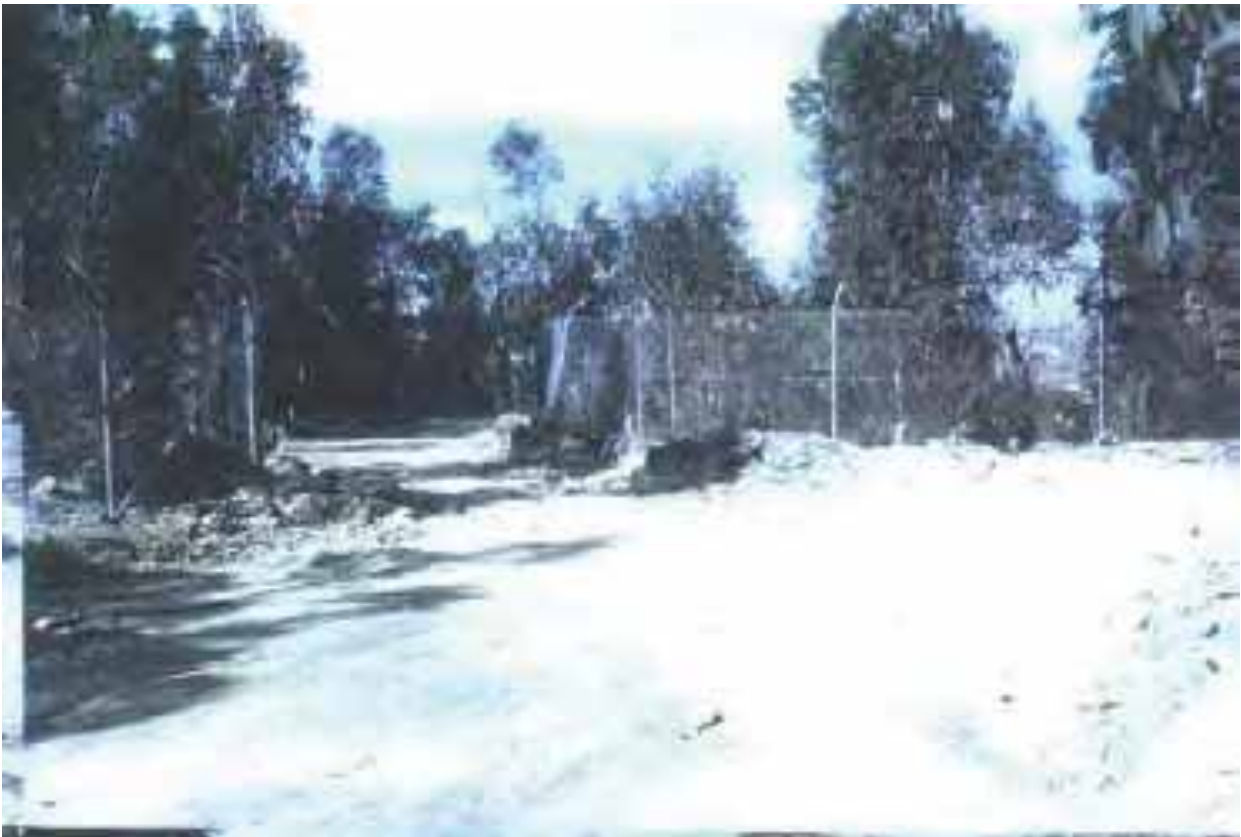
Figure 218 – Careful protection placed around natural landscape during construction works

Contract documents prescribed the conditions that applied to access and preservation requirements. Needless to say the process was extremely unorthodox but with the full cooperation of David Turner the NSW Public Works Department's project architect, the programme was formally accepted and acted upon. Another trick was to have the contractor install a 600mm thick blanket of site fill material over selected sandstone surfaces, one large enough to become a substantial storage and access area. The contract demanded, also, a removal of the fill blanket at project end, by machine, by shovel, by rake, broom and fire hose – in that order. The outcome was very satisfying using this sequential method previously trialled successfully on the rock faces of the Peacock Point park.

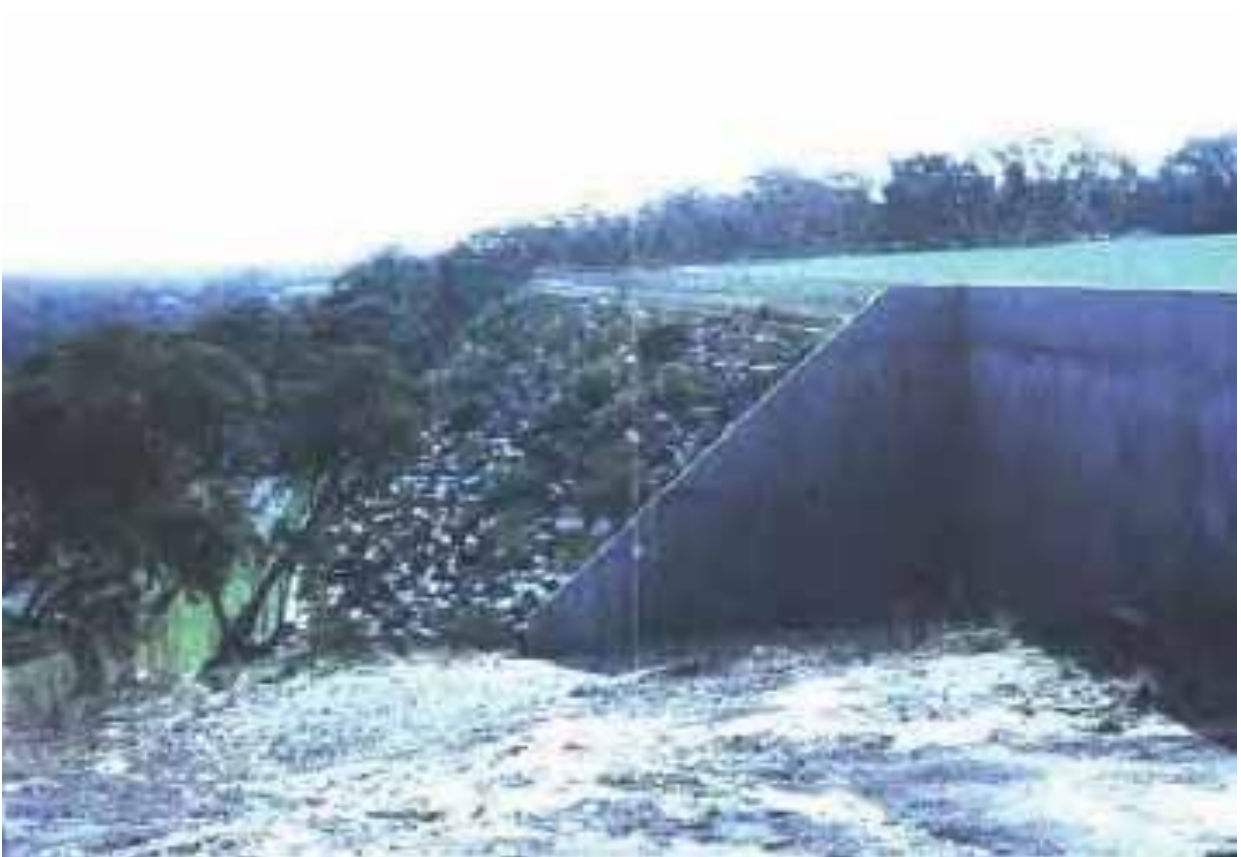
Figure 219 – Battered slope and natural rock retaining wall to Oval, with concrete wall for future Gymnasium

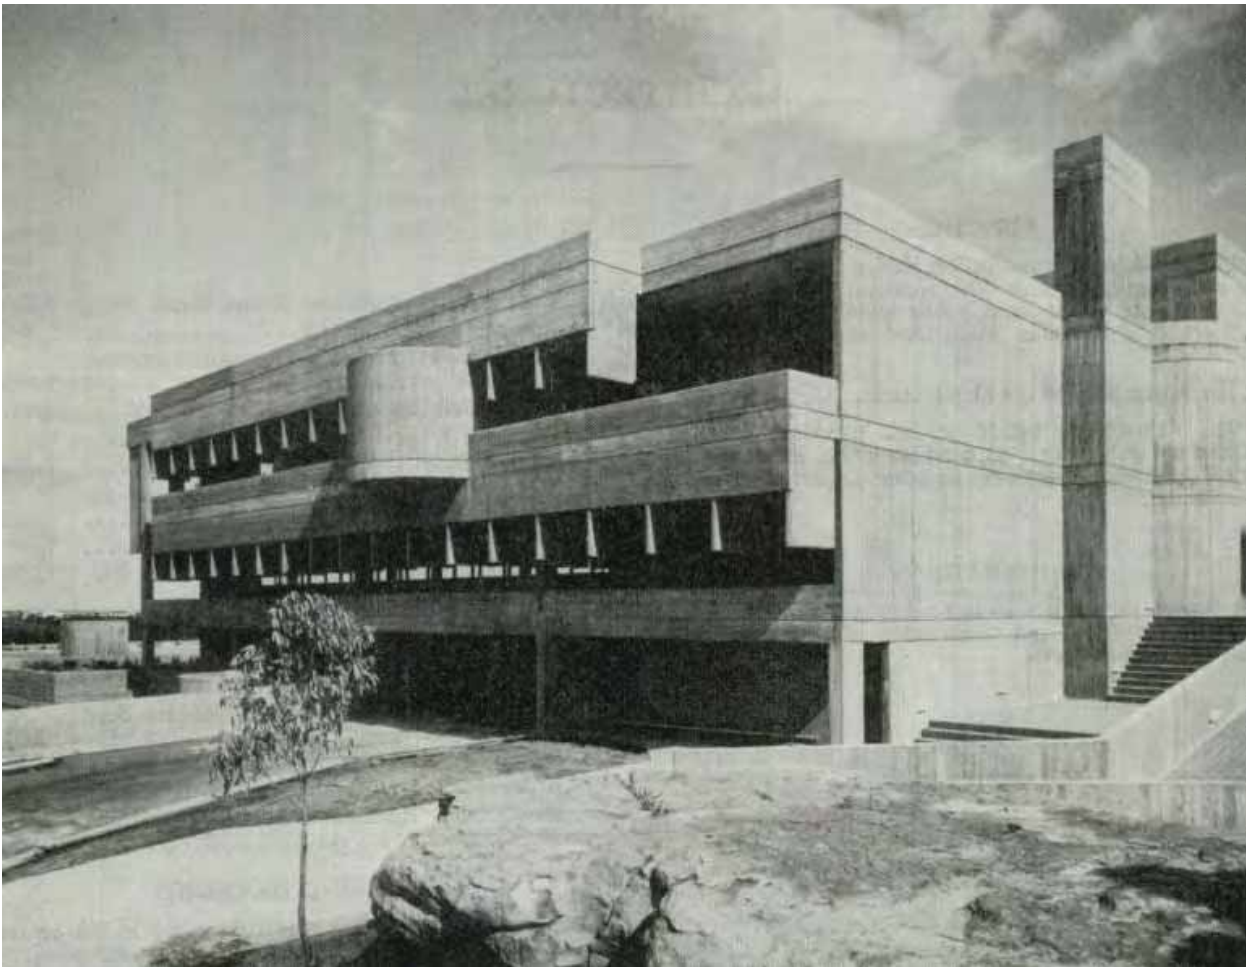
Figure 225 – William Balmain Teachers College, Lindfield – Stage One, eastern elevation of Library

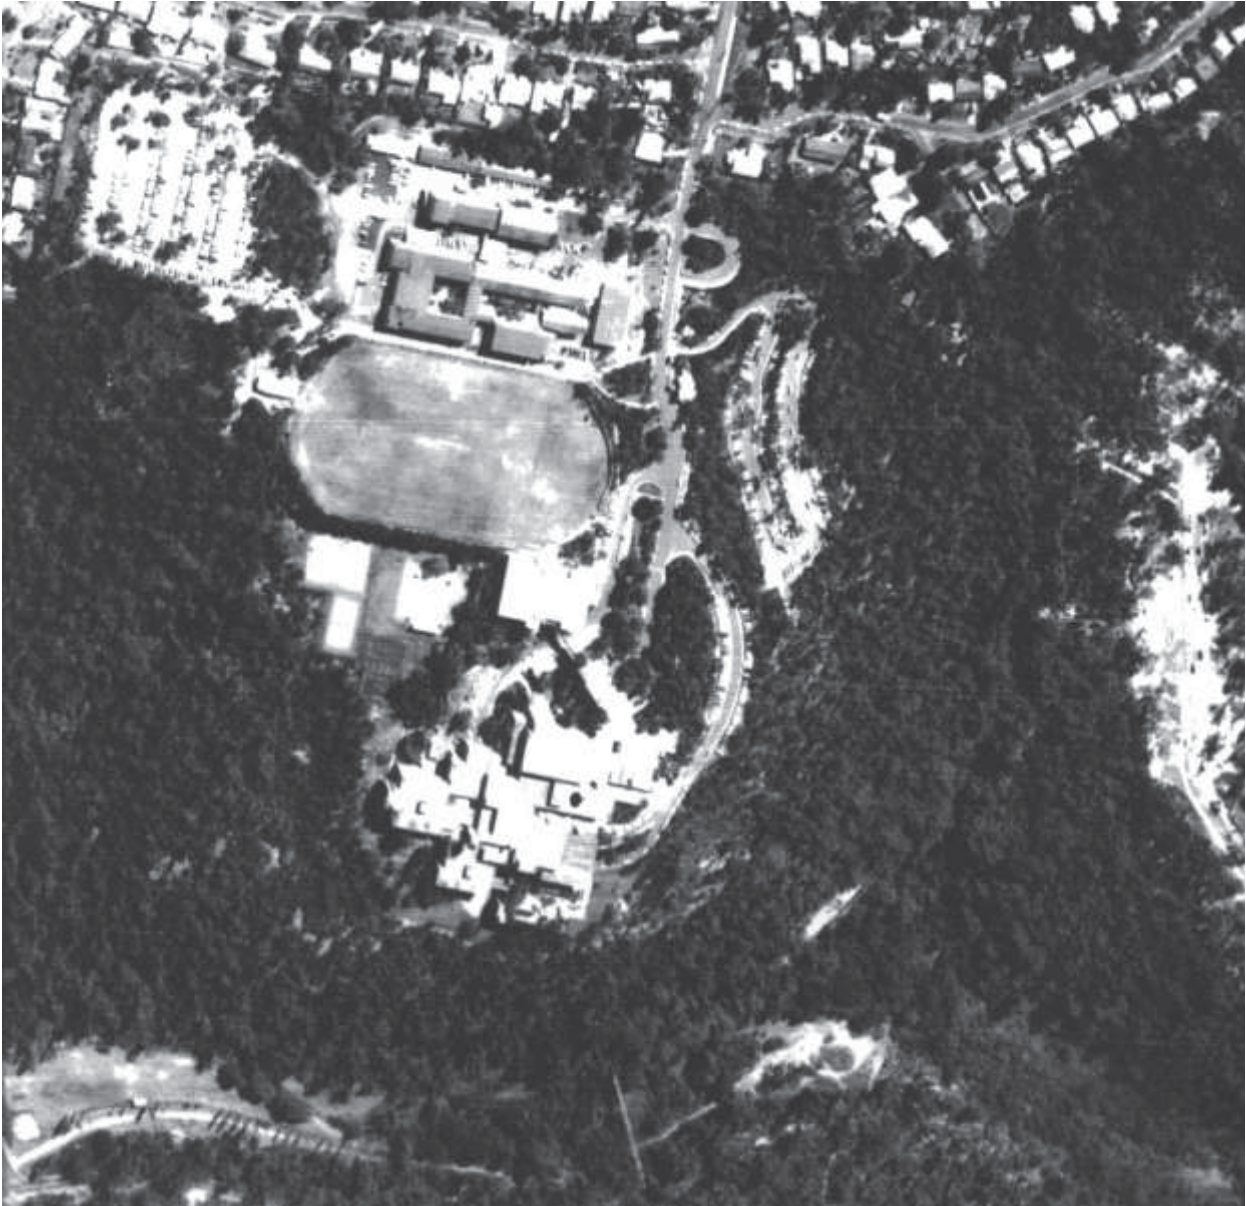
Figure 239 – Aerial view of subject site, 1978

An aerial photo taken in 1978 shows the college in a largely completed form, lacking only the infill section of Stage Four and the western extension, known as Stage Five (Figure 239). The north western and north eastern car parking areas are functioning, although the south eastern car park has yet to be constructed. The main oval and associated tennis courts are well established and the enhanced landscape character around the buildings and external works is gaining a stronghold. There are a few major trees identifiable in the north western carpark, and the nearby child care facilities are in place.

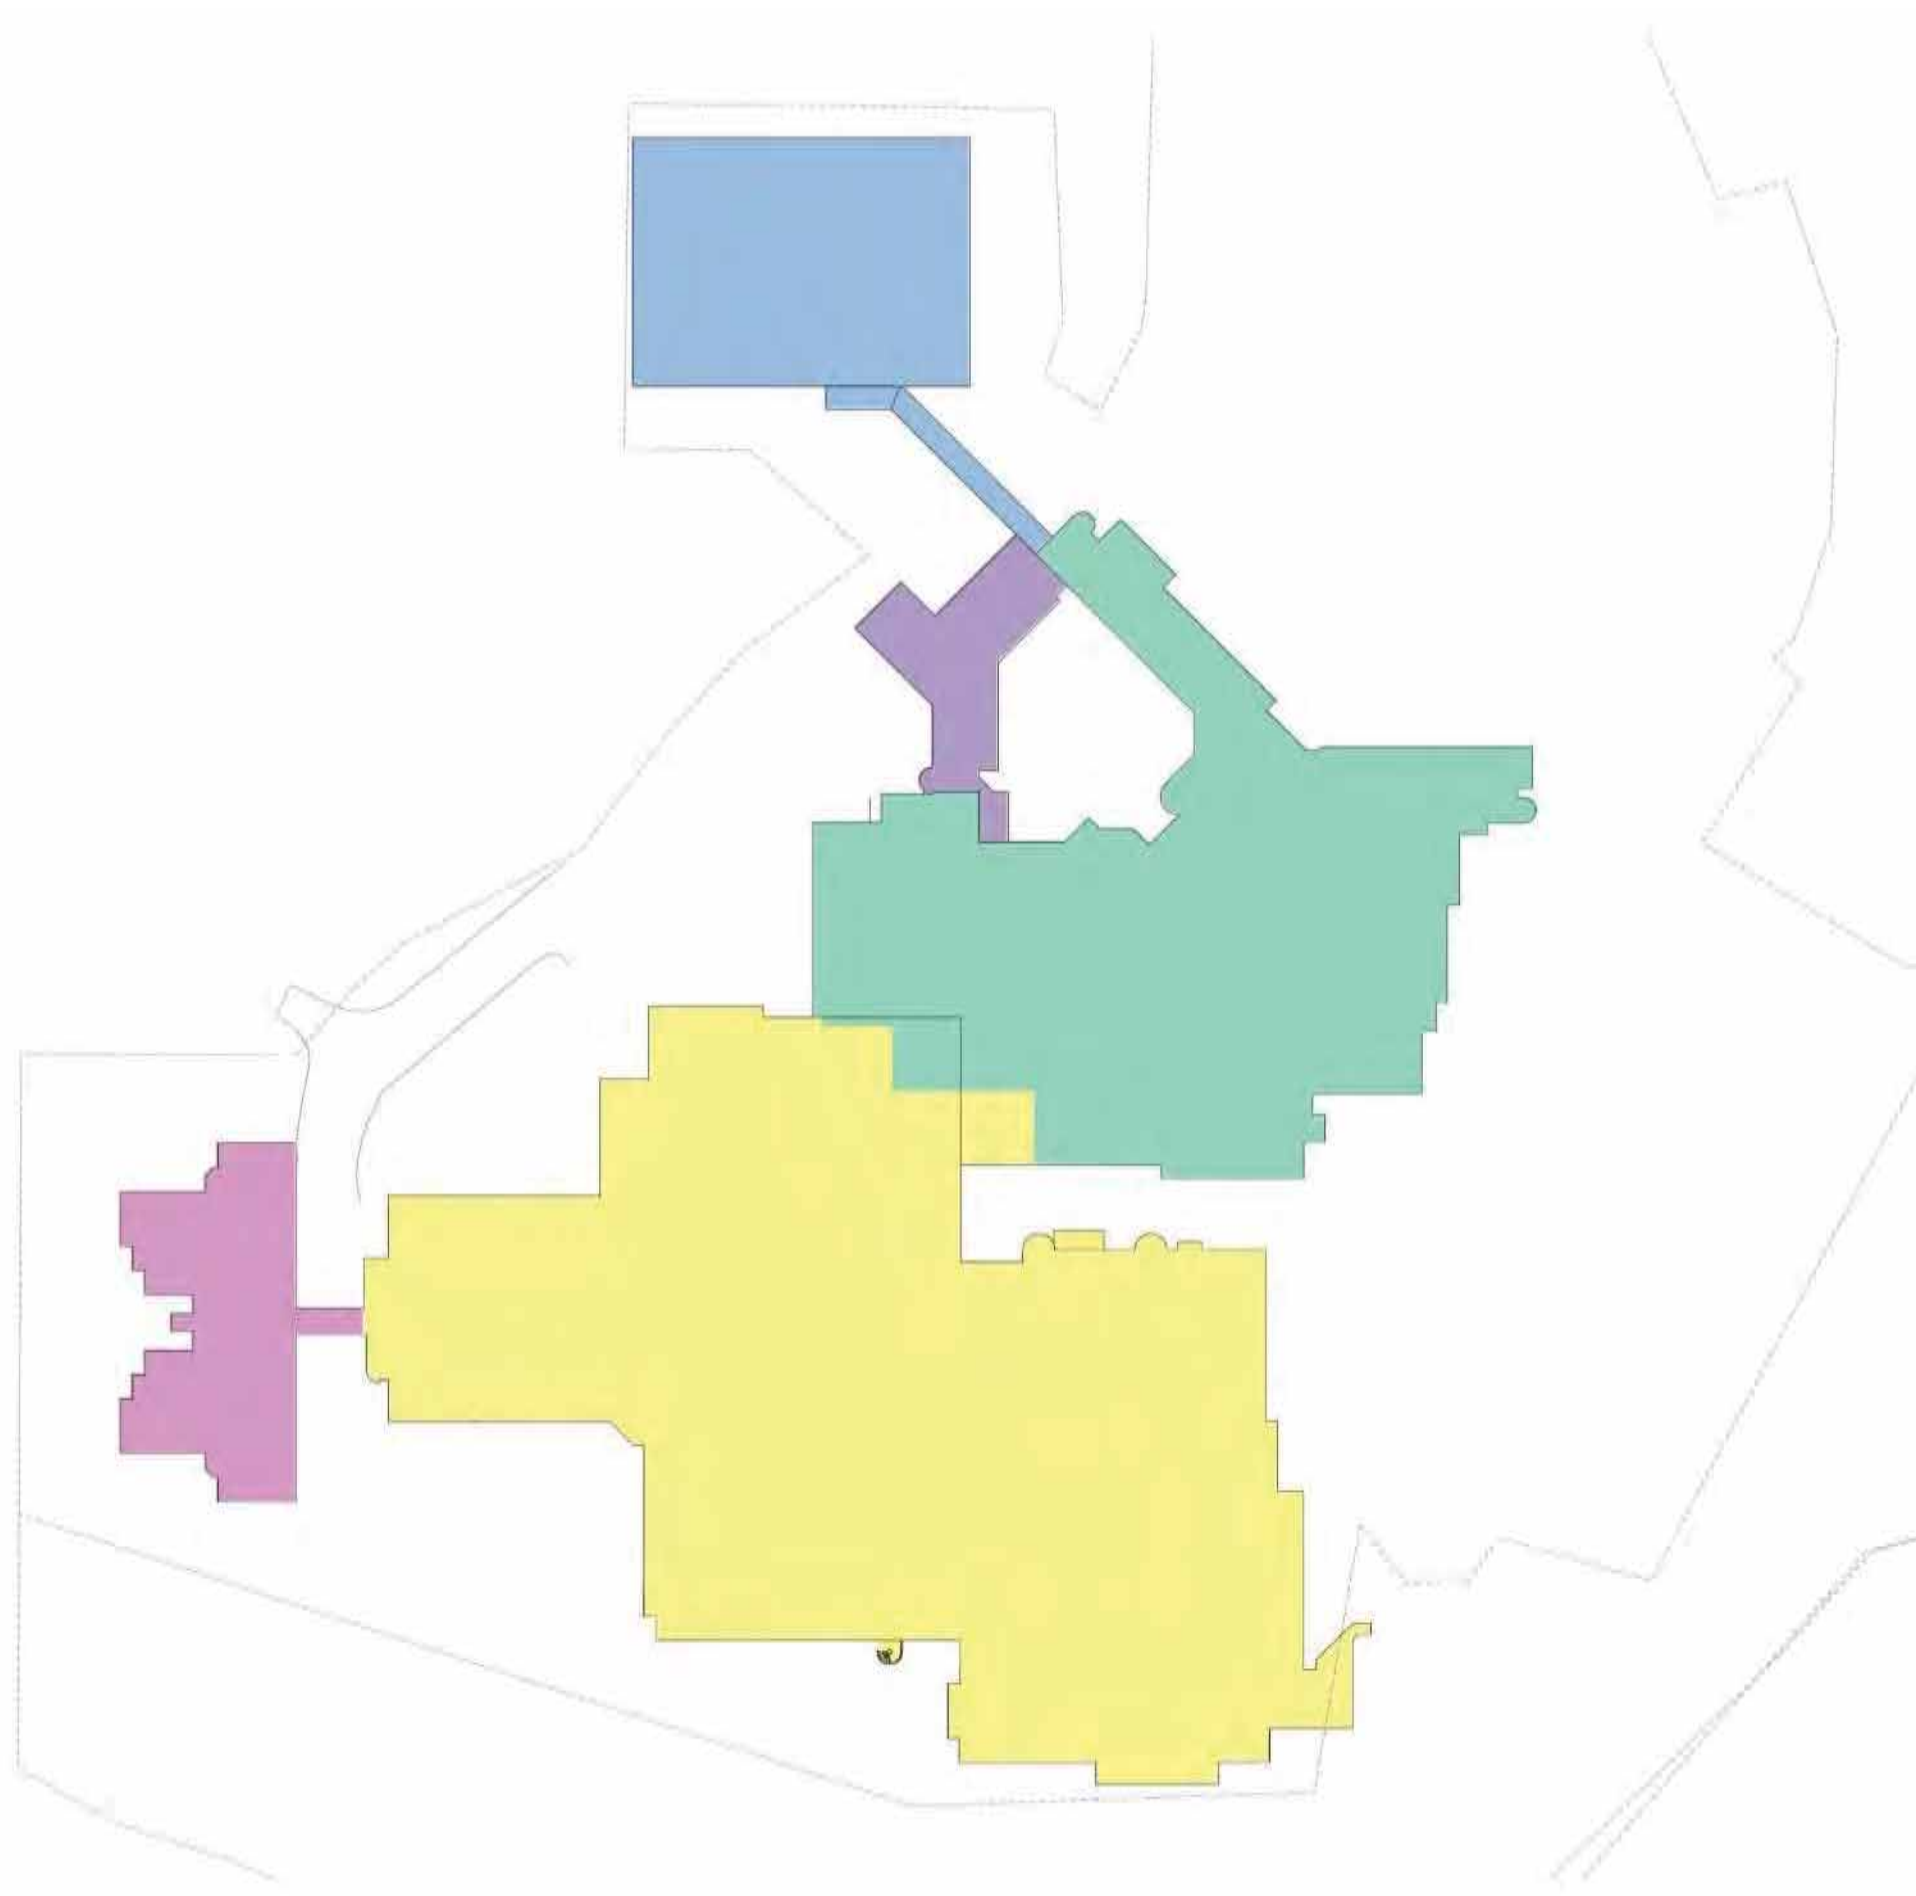
PHASES OF DEVELOPMENT

The following diagram present the development of the Lindfield Learning Village from the development of Stage 1 in 1968 to the development of Stage 5 in 1984.

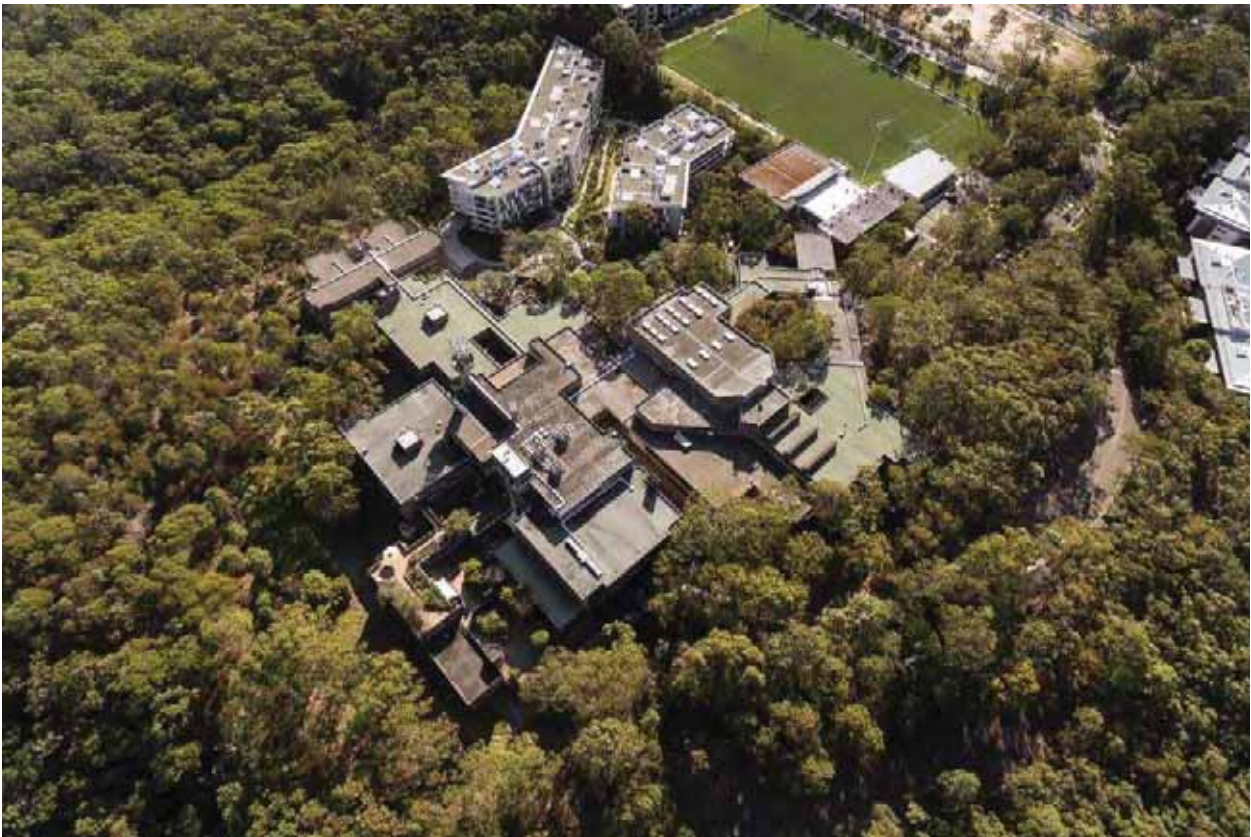
Figure 276 – Oblique aerial photo taken 2018. The vegetation surrounding the site is significantly denser in comparison with the site during the 1970s.

Figure 275 – Undated photograph, with Stage 1 and 2 buildings complete. Note the density in vegetation surrounding the site in comparison with the contemporary aerial at Figure 276 – Oblique aerial photo taken 2018. The vegetation surrounding the site is significantly denser in comparison with the site during the 1970s. Figure 276.

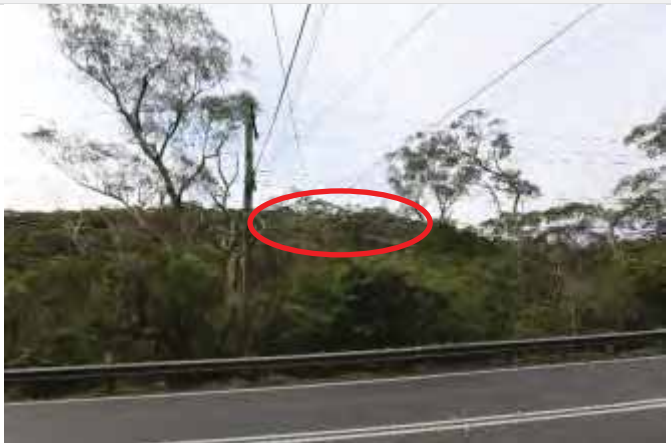
<p>Figure 280 – View from Millwood Avenue, Chatswood West</p>

View Point	Description	Image
1	<p>FULLERS ROAD, CHATSWOOD WEST</p> <p>Distance: Approx. 350m to the south, south-west of the site</p> <p>Visibility: Restricted views available of the site through Lane Cove National Park bushland and narrow view corridors between residential dwellings on Fullers Road.</p> <p>Position: Location is approximately level with the site</p> <p>Present View: The observation tower and parts of Levels 5 and 6 of the complex are visible in the distance, although substantially obscured by the surrounding bushland.</p>	  <p>Figure 278 – View from corner of Fullers Road and the Fairway, Chatswood West</p>   <p>Figure 279 – View from 197A Fullers Road</p>
2	<p>MILLWOOD AVENUE, CHATSWOOD WEST</p> <p>Distance: Approx. 220m to south of site</p> <p>Visibility: Very restricted views available of the site through trees</p> <p>Position: Located approximately mid slope of the with the site</p> <p>Present View: Some very restricted outlines of Levels 5 and 6 of the complex is visible through the dense bushland which surrounds the site</p>

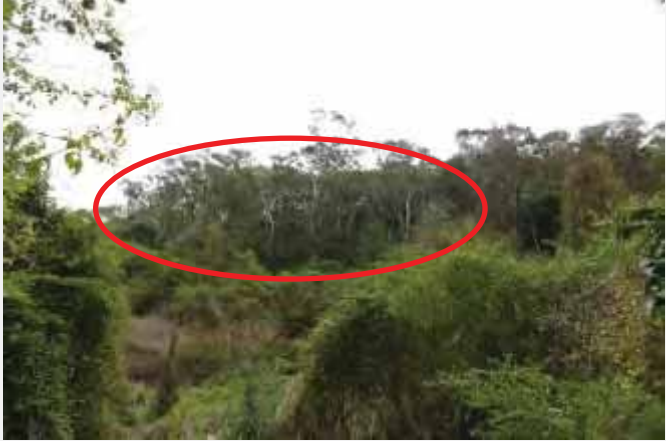
3	<p>FULLERS PARK ROAD, CHATSWOOD WEST</p> <p>Distance: Approx. 180m to south of site</p> <p>Visibility: Very restricted views available of the site through trees</p> <p>Position: Located at the bottom of the valley of the Lane Cove River</p> <p>Present View: The outline of the southern elevation of the complex can be seen through the trees, however, it is very difficult to determine that a structure is there</p>

<p>Figure 281 – View from Fullers Park Road, Chatswood West</p>
4	<p>SHOUT RIDGE, LINDFIELD</p> <p>Distance: Approx. 90m to the north of the site</p> <p>Visibility: Mostly unrestricted view to north-western border of site</p> <p>Position: Located above the slope of the site</p> <p>Present View: Views of the northern and western elevation of the Stage 5 building of the site are visible from Shout Ridge, however, views to the other buildings of the site are not visible.</p>

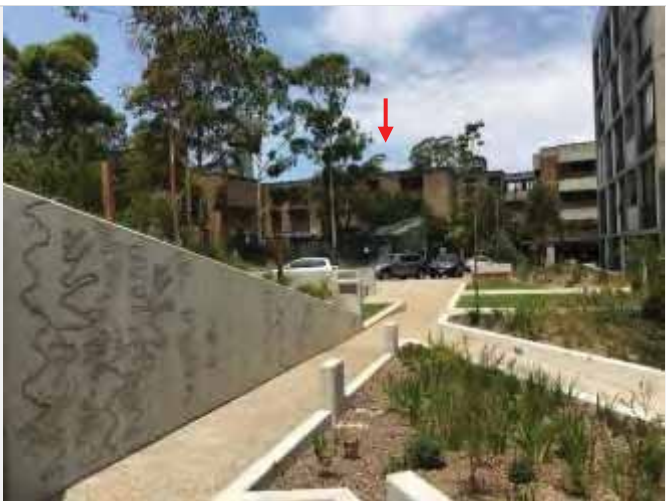
<p>Figure 283 – View from Arcadia on Dunstan Grove, Lindfield</p>

5	<p>DUNSTAN GROVE, LINDFIELD</p> <p>Distance: On north-western border of site</p> <p>Visibility: Unrestricted views of north-western elevations of complex</p> <p>Position: Located level with the site.</p> <p>Present View: Uninterrupted views of the north-western elevations of the complex</p>

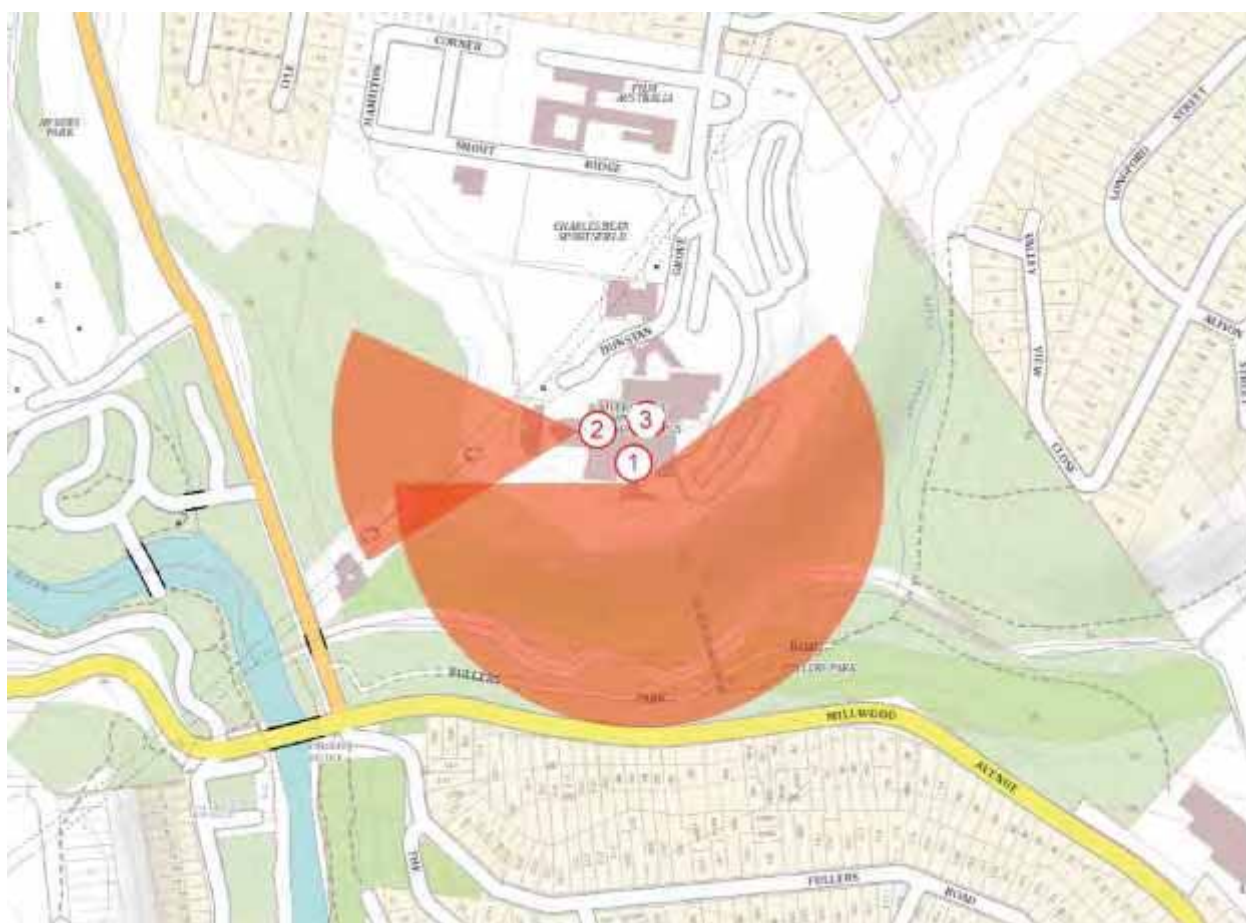
Figure 284 – Views from Lindfield Learning Village diagram

The following diagram (Figure 284) and figures in table 12 provide an overview of the existing views from the Lindfield Learning Village from to the surrounding locality.

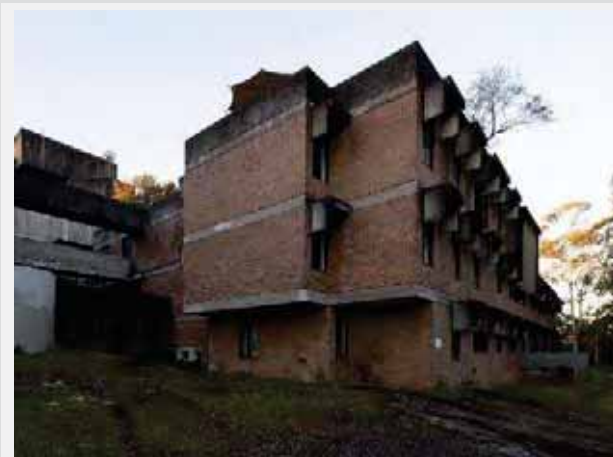
<p>Figure 289 – Stage 1 Building</p>

Element	Description	Stage	Significance Ranking	Image
Stage 1 Building	<p>Construction on the Stage 1 building was between 1968 and 1971. Stage 1 was constructed using earth toned face brickwork and off-form concrete. The otherwise brutal nature of the concrete is lessened by the strong grained textured pattern of the timber formwork. The concrete elements are also massed together so as to present contrasts between the warm brick tones and the more monolithic concrete structures, for example the library has a high concentration of concrete work, including the extensive use of pre-cast concrete sun shades. The lower levels of the building at its south end are predominantly brick with off form concrete slabs, window hoods, sunshades, roof parapets and stairwells. One of the principal features of Stage 1 are the roof top gardens and walkways above the art/craft block at the lower end of the building. The general layout of the rooftop gardens and their functions remains largely unaltered; however the original plantings appear to have been altered over time. Changes also appear to have been made as a result of repairs to the roofing of the building.</p> <p>Internally the configuration of the building is still largely intact. Classrooms appear to have been refurbished over time. The main circulation areas of the interior are largely as originally planned. Green carpet is still located throughout the principal circulation areas, and hand rails are still painted purple/pink. The interior finishes are of a high quality, with careful attention to the quality of the concrete form work. The Stage 1 building has a close relationship to the topography and environment outside the</p>	S1	Exceptional

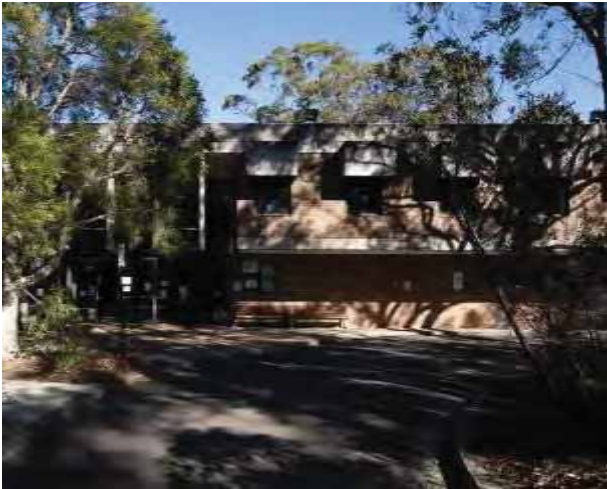
<p>Figure 290 – Stage 2 Building</p>

Element	Description	Stage	Significance Ranking	Image
	<p>building. The interior is provided with planned views to the exterior.</p> <p>The building does not present a single elevation as such, but appears as though designed from the inside out, the exterior being the outward modelling of functional areas within the building. The building was also designed in such a manner as to allow for further additions in an agglutinative fashion.</p>			
Stage 2 Building	<p>Stage 2 of the College was constructed in 1972. The college was constructed in the same manner as Stage 1 with the use of matching brickwork and detailing, and off-form concrete. The transition between the Stage 1 and Stage 2 buildings is virtually seamless. The principal features of the Stage 2 building are the main entry and circulation corridor, the Greenhalgh Auditorium and the dining areas. The central circulation space leading from the main entry past the eating areas and towards the library of the Stage 1 building is the core focus of the building. The central circulation space does not act as an enclosed corridor, but as a street within the building. The circulation space has a tall void space, and does not appear as an enclosed area. Green carpet throughout (possibly replaced), and pink/purple hand rails. The Stage 2 building is relatively low in scale, of two stories at its northern end, and when viewed from the north, sits comfortably and unobtrusively within the landscape.</p>	S2	Exceptional

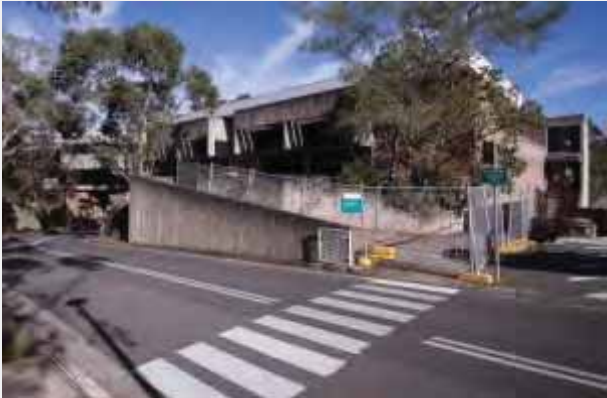
Element	Description	Stage	Significance Ranking	Image
Stage 3 Building	The Stage 3 building was completed in 1976 and entirely comprises the original gym. It is located to the northernmost portion of the site and north of the road cutting over which the link bridge (described below) extends. This building features the same techniques as the earlier stages, with masonry walls, and off-form concrete slabs and details, including precast window hoods. The eastern elevation of the building features substantial window hoods over double height windows.	S3	High

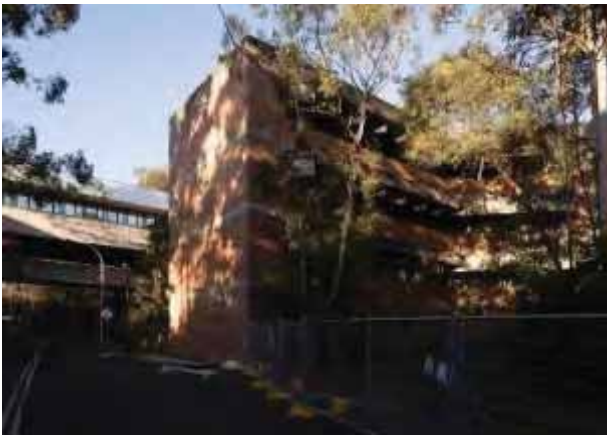
<p>Figure 292 – Stage 4 Building</p>

<p>Figure 291 – Stage 3 Building</p>
Stage 4 Building	The Stage 4 building (1977) comprised the construction of a link between the back of the Greenhalgh auditorium and the north arm of the Stage 2 building near the link bridge to the gymnasium. This link building was constructed using the same techniques as the earlier stages, with masonry walls and off-form concrete slabs and details, including precast window hoods. The building of this linking section created a courtyard enclosed on three sides which features a bedrock outcrop, and native plantings.	S4	High

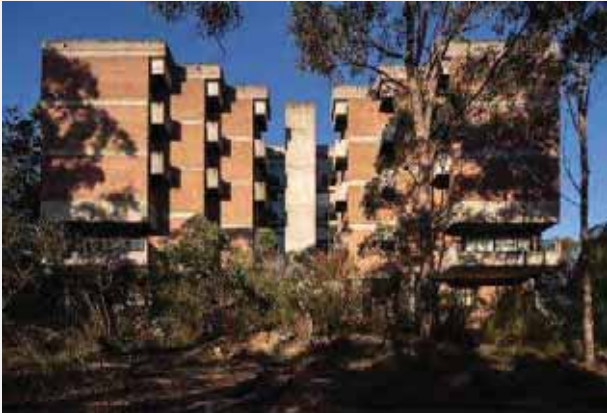
Element	Description	Stage	Significance Ranking	Image
Stage 5 Building	The Stage 5 building (1984) was constructed as an extension to the south west block of the Stage 1 building to meet the additional demand arising from the teaching of nursing at the College. The new block was built in the same manner as the Stage 1 and Stage 2 building. While closely integrated with the earlier Stage, the building does not feature quite the same level and attention to detail as the earlier Stages.	S5	High

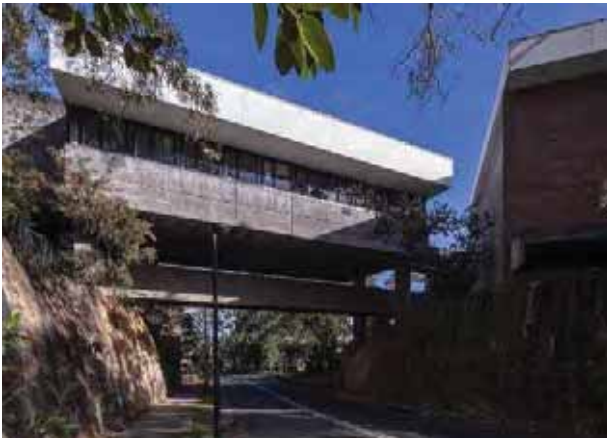
<p>Figure 294 – Link Bridge</p>

<p>Figure 293 – Stage 5 Building</p>
Link Bridge	Link bridge built to connect the north end of Stage 2 with the gymnasium. Off-form concrete construction with waffle-pan slab ceiling. The link between the earlier and later buildings is well blended, and the link is consistent in its construction method and appearance. The bridge has tiled floor and the same waffle ceiling evident in Stages 1 and 2.	S3	High

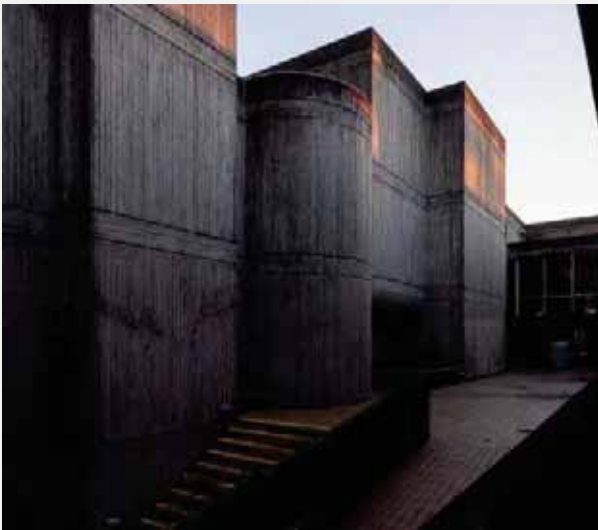
<p>Figure 295 – Off board concrete – Stage 1.</p>

Element	Description/Significance	Stage	Significance Ranking	Image
Off board concrete including balustrades	<p>The building is dominated by off board concrete. The use of the natural material for the formwork and the resultant textured pattern on the concrete offsets it's otherwise monolithic character. The composition of the geometric forms also serves this purpose as shown in the image opposite where an expression of the internal spaces (including stairwell) is reflected externally</p> <p>The off-board texture is integral to the predominant design philosophy of maintaining a connection to the natural landscape where possible.</p> <p>The concrete forms are highly intact and in fair condition. However, the weathering of the grey concrete has created a mottled effect which allows the building to blend in with the surrounding bush.</p> <p>The concrete highlights prominent areas of the building including the library which has a higher proportion of concrete than brick.</p>	S1-S5	High

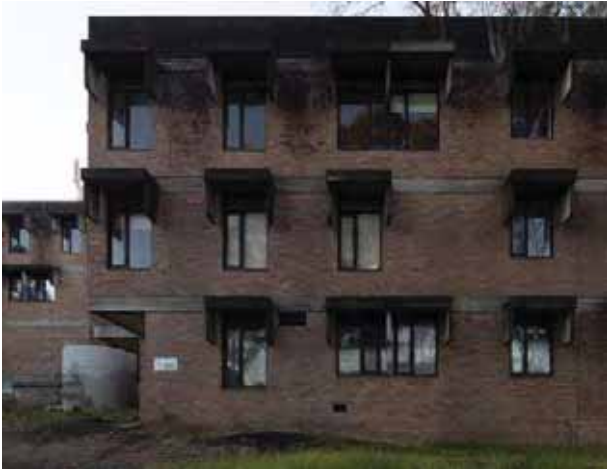
Element	Description/Significance	Stage	Significance Ranking	Image
Brick walls	<p>In addition to the off-board concrete face brick is a dominant feature of the building. Entire walls are constructed of face brick (S1) contrasting the concrete exposed slab and sun hoods. In some areas the face brick constitutes infill between a frame of off board frame.</p> <p>The brickwork breaks up the form of the concrete with a contrasting material which has earth tones but also a tonal relationship to the concrete.</p>	S1-S5	High
