CONSERVATION MANAGEMENT PLAN LINDFIELD LEARNING VILLAGE

16 NOVEMBER 2018
SH801
PREPARED FOR DEPARTMENT OF EDUCATION

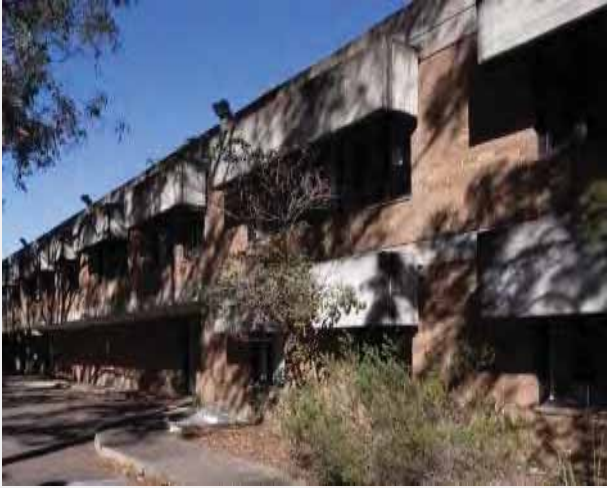
<p>Figure 297 – Figure 298 – Pre-cast concrete sun shades – Stage 2.</p>

<p>Figure 296 – Brick walls – Stage 1.</p>
Pre-cast concrete sun hoods and louvres	<p>While the majority of the building is dominated by off board concrete, the sun hoods and louvres are pre-cast concrete. These details are predominantly used in contrast to the face brickwork walls behind and articulate the otherwise prismatic building.</p> <p>The hoods are fixed into the sides of the exposed slab. The hoods are of varying depth and have different effects on the quality of the internal spaces. Similarly, the vertical blades/louvres variously extend single or double height.</p> <p>The concrete shades at Stage 5 are not as intricate as those on the earlier stages.</p>	S1-S5	High

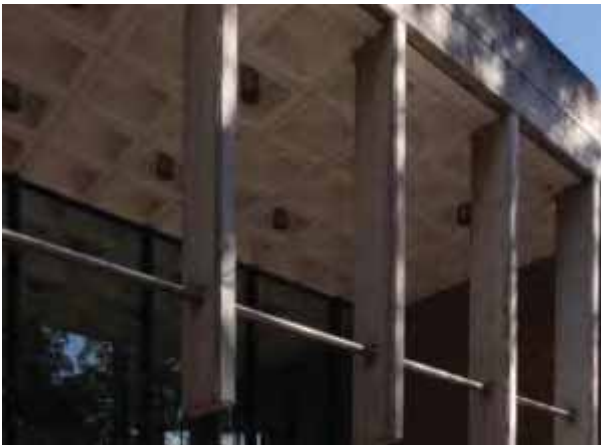
<p>Figure 299 – Waffle slab – Stage 2.</p>
Exterior aluminium entry doors/windows (including internal courtyards)	<p>The aluminium windows do not constitute remarkable fabric in themselves, the windows have standard profiles and are in fair condition. However, the frames facilitate large expanses of glazing in considered locations which offset the surrounding masonry and open wide views to the surrounding landscape. In several key areas including the main entrance, central courtyard and Stage 1 courtyard adjacent to the library the glazing is double height. These dramatic areas of glazing provide relief from the heavy masonry and enhance the impression of scale and openness in the adjacent internal spaces, particularly the main circulation spine.</p> <p>The frames, specifically the arrangement of the mullions, relate to both the geometry of the waffle slab and the pre-cast concrete blades/hoods i.e. the mullions generally run directly behind the hoods or have a rational and consistent offset from them.</p>	S1-S5	Moderate

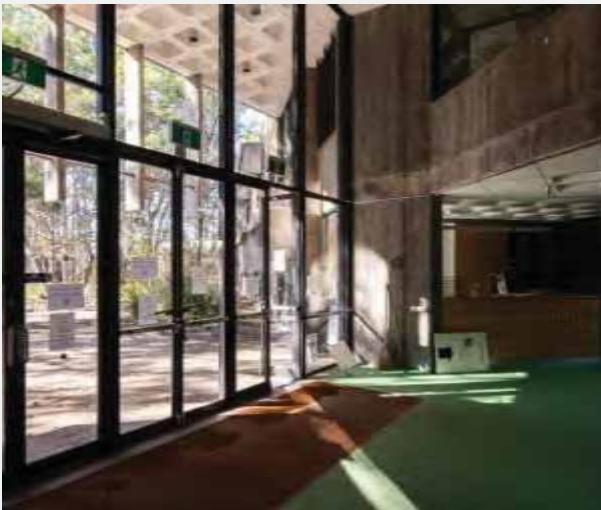
<p>Figure 300 – Aluminium doors and windows – Stage 2.</p>

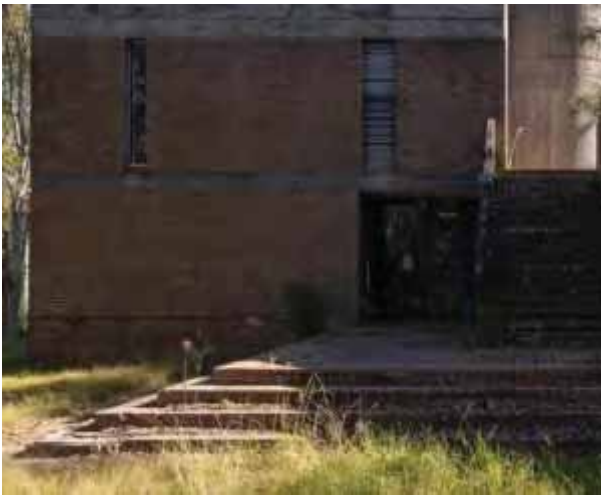
Element	Description/Significance	Stage	Significance Ranking	Image
Exterior Stairs	<p>Numerous sets of stairs throughout the building connect the building to the surrounding landscape. Three sets of stairs around Stage 1 extend to highly significant courtyard spaces. This connection is integral to the design of the building.</p> <p>The contrasting forms of the flights of stairs reflects the general approach to the overall building forms i.e. a panoply of contrasting geometric forms. As shown in the adjacent image, wide flat areas are juxtaposed against narrow flights offset from the centre.</p> <p>The stairs are covered in pavers which complement the tones in the bricks and concrete however the pavers are not significant in themselves.</p>	S1, S5	High

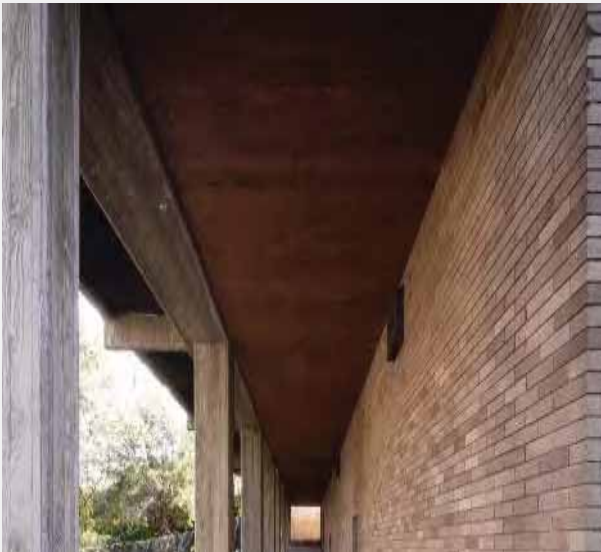
<p>Figure 302 – Timber lining – Stage 3</p>

<p>Figure 301 – Exterior stairs – Stage 1.</p>
Timber lining	<p>External timber lining is evident to the soffit of the projecting first floor to the rear (west) of the gym. The timber is in keeping with the character of the place overall and provides a counterpoint to the off-board impression in the concrete.</p>	S3	Moderate

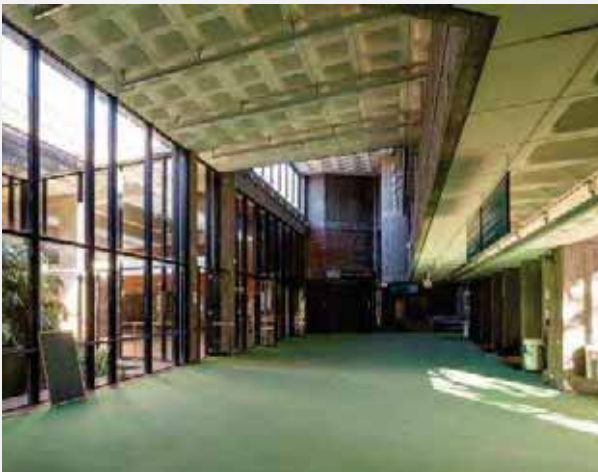
Figure 303 – Main circulation corridor – Stage 2 Level 5.

Element	Description/Significance	Stage	Significance Ranking	Image
Main circulation corridor	<p>The main circulation corridor is primarily considered to be the extension across Levels 5 and 6. The corridor extends partway across Level 4 however the quality of the space is lesser than the former which constitutes a double height space.</p> <p>The main entrance accesses the circulation spine at Level 5. The corridor has a Level 6 extension which primarily constitutes the mezzanine access to the upper floor of the main auditorium. Level 6 extends over the western side of the wider corridor at Level 5 and occupies part of the otherwise double height space.</p> <p>The corridor features all the key significant characteristics of the building including a composition of different concrete forms, brick infills, waffle slab and an expanse of glazing (in the form of the walls to the fishpond and the cafeteria).</p> <p>The original architect David Turner referenced an Italian Hill Village when speaking of the design of the building and described the central corridor as the circulation spine to the village.</p>	S2	Exceptional (L5 and 6)

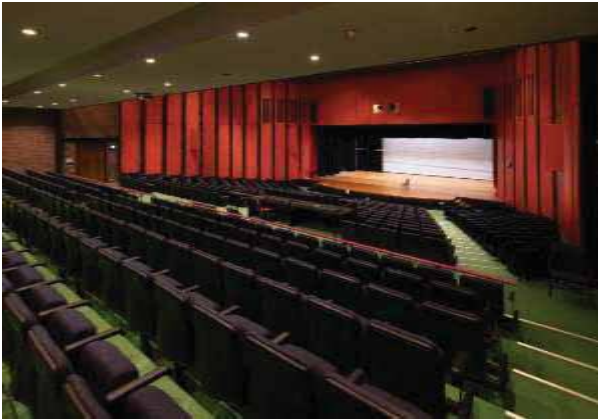
Greenhalgh Auditorium	<p>The double height auditorium is accessed directly off the main circulation spine at Level 5. When the building was awarded the Sulman Award by the NSW Chapter of the RAlA they stated that <i>the auditorium did exemplify the care in detailed design which maintains the building's consistency of character.</i></p> <p>The seating in the auditorium is not original however it appears that the wall coverings are.</p>	S2	High

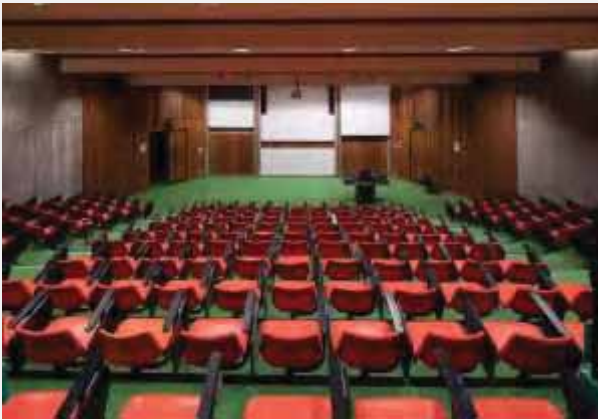
<p>Figure 305 – Auditorium – Stage 2.</p>

<p>Figure 304 – Greenhalgh Auditorium – Stage 2.</p>
Ancillary auditoriums	<p>There are two auditoriums in addition to Greenhalgh Auditorium. Both are located in the Stage 1 building. These auditoriums reference the character of the remainder of the building more strongly with exposed concrete and timber panelling to the walls.</p>	S1	High

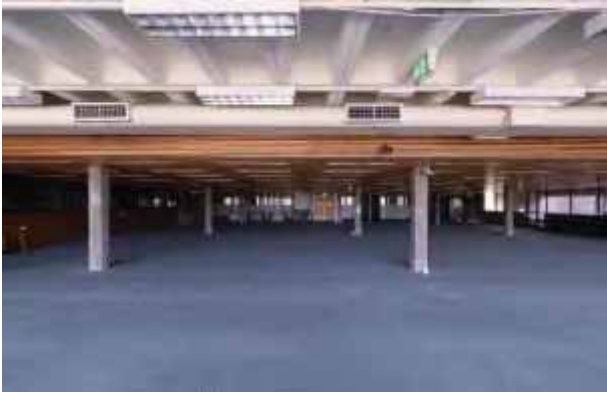
Original Library	<p>The original library space is located in Stage 1 of the building. The library originally occupied part of level 4 and 5 however it was later extended to also occupy part of Level 3.</p> <p>The library has a strong visual connection with its natural surroundings. It has wide views to the bushland to the west and south through the long windows. The library also looks onto the rooftop courtyard to the south.</p> <p>The library has a significant original timber ceiling (discussed below)</p>	<p>S1</p> <p>S1 infill (L3)</p>	<p>High</p> <p>Moderate</p>

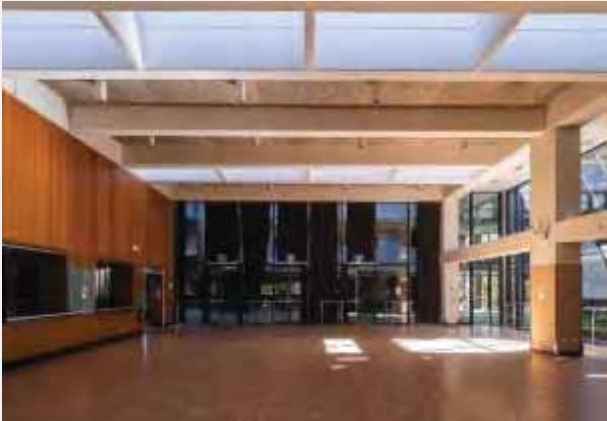
<p>Figure 307 – Cafeteria – Stage 2.</p>

<p>Figure 306 – Original library space – Stage 1.</p>
Cafeteria	<p>The cafeteria is located in Stage 2 of the building. The double height space is accessed directly from the main circulation spine.</p> <p>The quality of the space is enhanced by the clerestory windows and the adjacent atrium with water feature.</p> <p>The cafeteria features significant finishes, specifically, the timber parquetry floor and timber wall panelling.</p>	<p>S2</p>	<p>High</p>

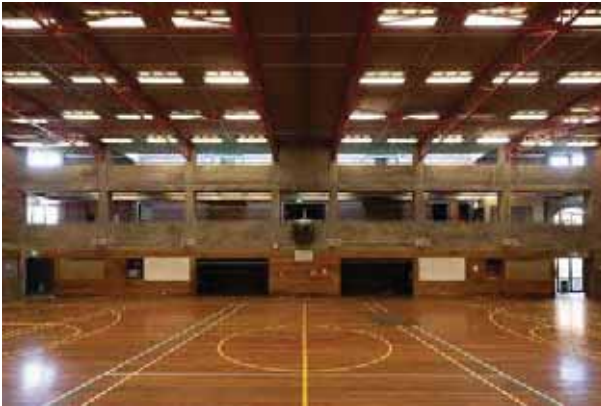
Main gym space (basketball court)	The basketball court is a triple height space in the original gym building to the north of the campus. The space features exposed concrete, timber wall joinery and original trusses. The space represents the original use of this area of the school.	S3	Moderate

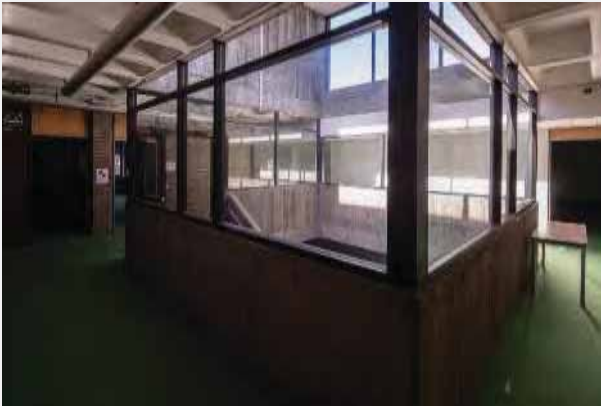
<p>Figure 309 – Light well – Stage 1.</p>

<p>Figure 308 – Gym space – Stage 3.</p>
Light wells	Light wells in Stage 1 enhance the quality of the adjacent spaces. The lights wells are located in areas which were original the centre of several classrooms and enhance the Italian Village design philosophy and general amenity. The light wells are partly constructed of concrete. They have been retrofitted with aluminium framed glazing for smoke separation requirements.	S1	High

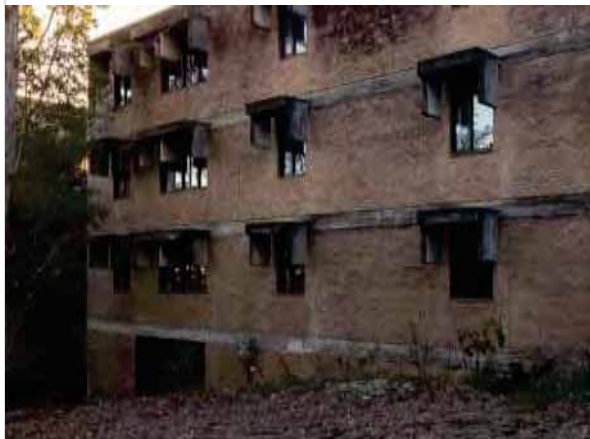
<p>Figure 310 – Exposed Slab – Stage 1.</p>
Timber floor structure	<p>Section of timber floor structure are evident in the gym under the basketball court. The flooring reflects the original and continued use of the space as a basketball court.</p>	S3	Moderate

Element	Description/Significance	Stage	Significance Ranking	Image
Structure				
External expression of concrete slab	<p>The building is constructed on a concrete slab. The slab is exposed on the external elevations throughout the building above the header of each row of windows. The slab is easily legible in contrast to the brick either side.</p> <p>Internally the slab is generally expressed as a waffle slab which is evident on the ceilings throughout.</p>	S1, S5	High

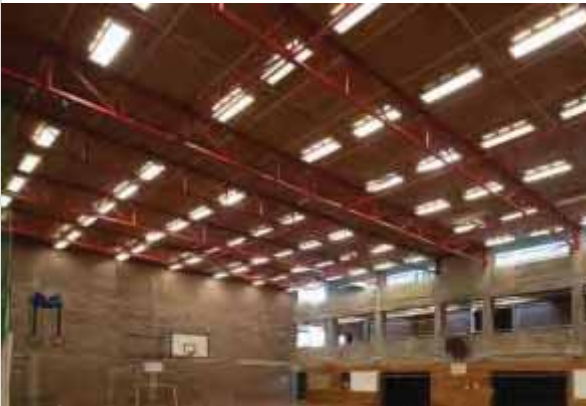
Element	Description/Significance	Stage	Significance Ranking	Image
Trusses	The trusses above the basketball court in the gym enhance the sense of scale in the double height space.	S3	Moderate

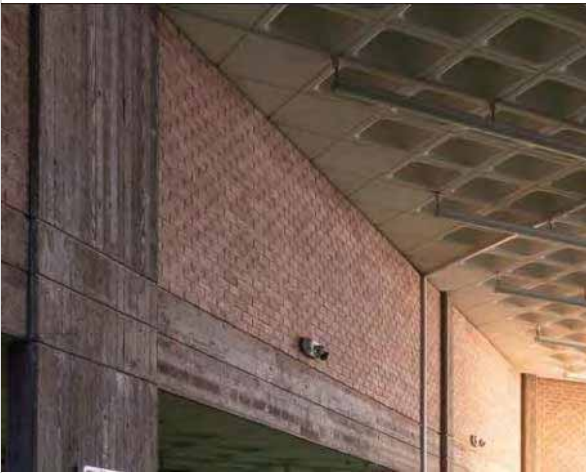
<p>Figure 313 – Brick wall – Stage 2.</p>

<p>Figure 312 – Trusses – Stage 3.</p>
Walls				
Brick walls	<p>Brick walls define some highly significant areas and in some areas the brick constitutes infill between a frame of off board concrete as shown in the image opposite.</p> <p>The brickwork breaks up the form of the concrete with a contrasting material which has earth tones but also a tonal relationship to the concrete.</p>	<p>S1 – S2</p> <p>S3 - S5</p>	<p>High (where walls bound spaces of high significance)/ Moderate</p> <p>Moderate</p>

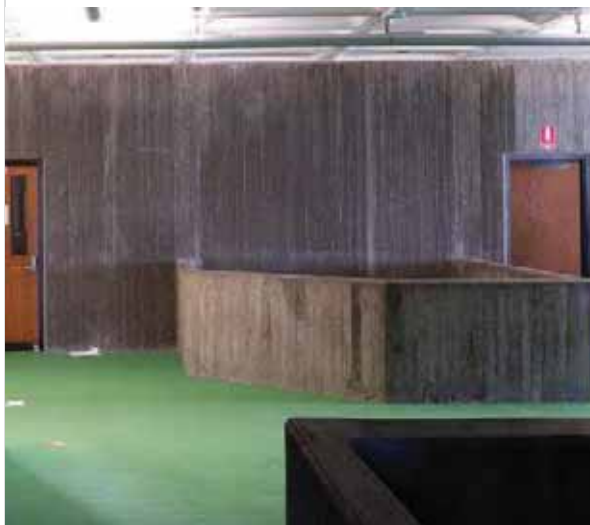
<p>Figure 314 – Concrete walls – Stage 1.</p>

Element	Description/Significance	Stage	Significance Ranking	Image
Off form concrete walls (including balustrades)	<p>The building is dominated by off board concrete. The use of the natural material for the formwork and the resultant textured pattern on the concrete offsets it's otherwise monolithic character. The composition of the geometric forms also serves this purpose as shown in the image opposite.</p> <p>The off-board texture is integral to the predominant design philosophy of maintaining a connection to the natural landscape where possible.</p> <p>The concrete forms are highly intact and in fair condition. The circular marks from the formwork fixings are visible in some areas.</p> <p>The concrete highlights prominent internal areas of the building. There is a predominance of concrete in the central circulation spine at Level 5 and concrete defines highly significant areas including the auditorium and the Level 6 mezzanine.</p>	S1 – S5	Exceptional (where walls bound spaces of exceptional significance/High

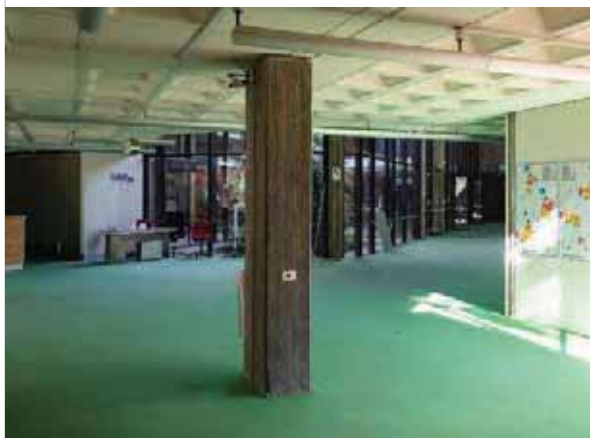
<p>Figure 315 – Concrete column – Stage 2.</p>

Concrete Columns	<p>Concrete columns are variously utilised throughout to provide a framework for bricks infill/used independently in the centre of circulation spaces as shown opposite.</p> <p>The columns similarly have an off-board impression.</p>	S1 – S5	High

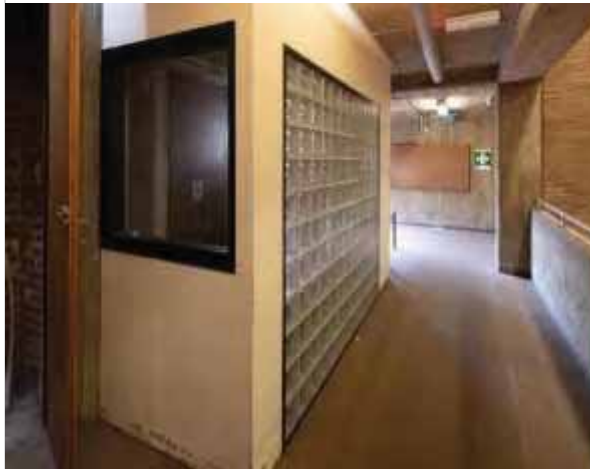
Element	Description/Significance	Stage	Significance Ranking	Image
Glass bricks	Small areas of glass bricks are used throughout the building. The glass bricks are unusual in the context of the building in that the palette of materials only otherwise includes transparent materials for the windows. The bricks interpret some of the monolithic quality of the concrete and bricks in that they are bricks rather than glazing panels. However, the glass walls interestingly do not define key spaces.	S1, S3 & S5	Little

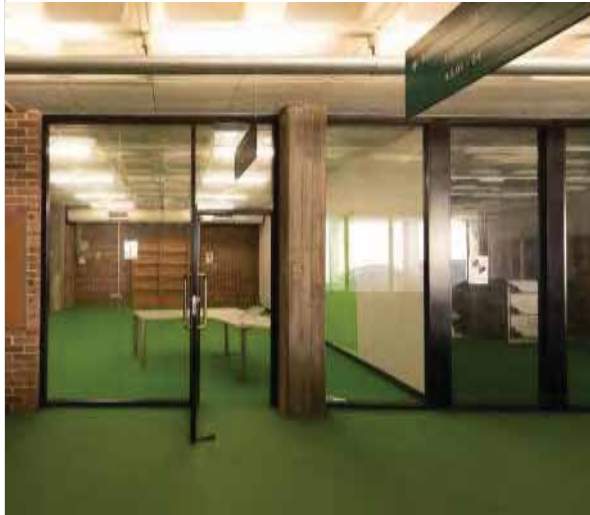
<p>Figure 317 – Glazed partition walls – Stage 1.</p>

<p>Figure 316 – Glass bricks – Stage 3.</p>
Original glazed partition walls	The original glazed partition walls do continue the same aesthetic as the external faces and in some areas define the circulation spine. They feature aluminium frames and clear glazed panels. The glazed partition walls however are not remarkable where they define internal spaces. This does not include any of the exterior windows which define the internal courtyards.	Throughout	Little

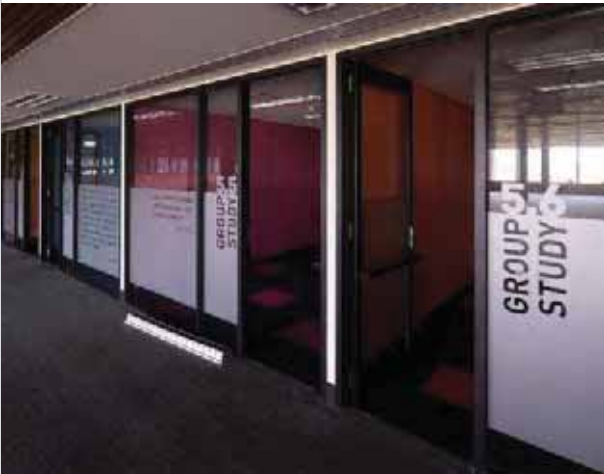
Element	Description/Significance	Stage	Significance Ranking	Image
Non-original glazed walls/partition walls	The later glazed partition walls throughout are in keeping with the character of the building however are not remarkable.	Throughout	Neutral

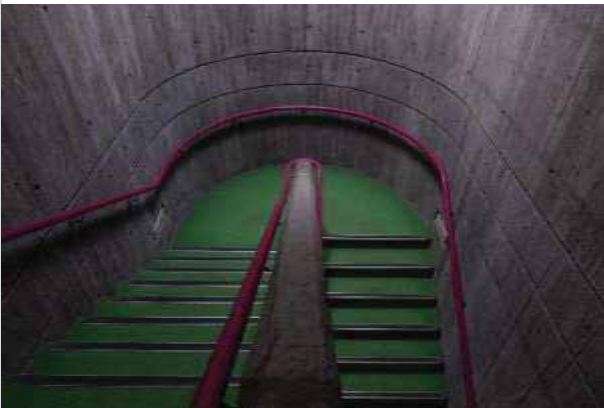
<p>Figure 319 – Concrete stairwell – Stage 2.</p>

<p>Figure 318 – Glazed partition walls – Stage 1.</p>
Circulation				
Stairs	<p>The stairs throughout including the stairwell walls are constructed of off board concrete.</p> <p>The internal stairwells contribute to the character of the adjoining spaces. Specifically, the cylindrical walls of the concrete stairwell at Level 6 are prominent above the main circulation spine at Level 5. These circular elements offset the predominant rectilinear lines within the building and contribute to the unique composition of built forms.</p> <p>The circular marks from the formwork fixings are particularly visible in the stairwells.</p> <p>Stairwells are characterised by coloured handrails throughout.</p>	S1 – S5	High

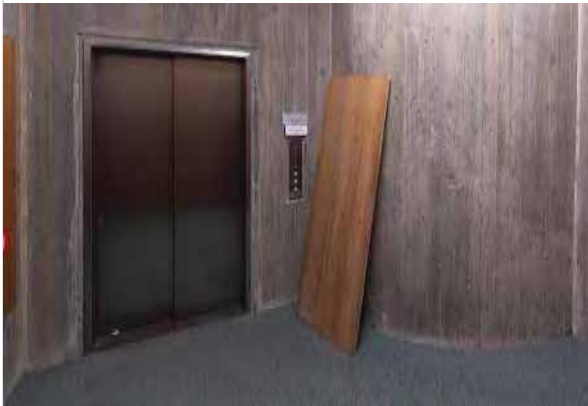
Element	Description/Significance	Stage	Significance Ranking	Image
Lifts	The lifts are utilitarian in character and don't comprise any remarkable fabric. This applies to the lift cars and associated doors and does not include the surrounding off-board concrete structure.	S1 S4 – S5	Little Little

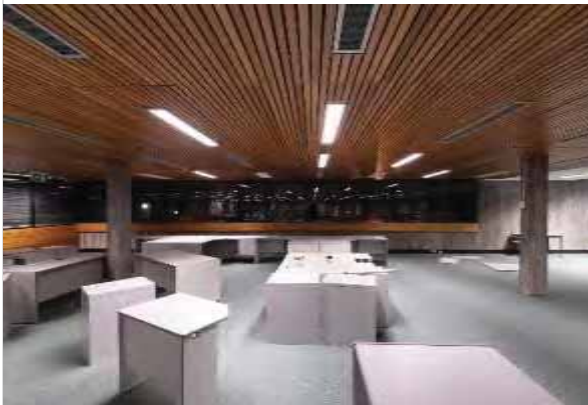
<p>Figure 321 – Timber ceiling lining – Stage 1</p>

<p>Figure 320 – Lift – Stage 1</p>
Ceiling Treatment				
Timber ceiling lining	<p>Timber ceilings contribute to the character of the place and are in keeping with the natural design philosophy. The timber ceiling lining provides a counterpart to the concrete which retains impressions of the timber formwork.</p> <p>Small sections of timber ceiling lining are evident in the gym. The cafeteria and original library space have timber ceilings with thinner battens set further apart.</p>	S1 S2 S3	High High Moderate

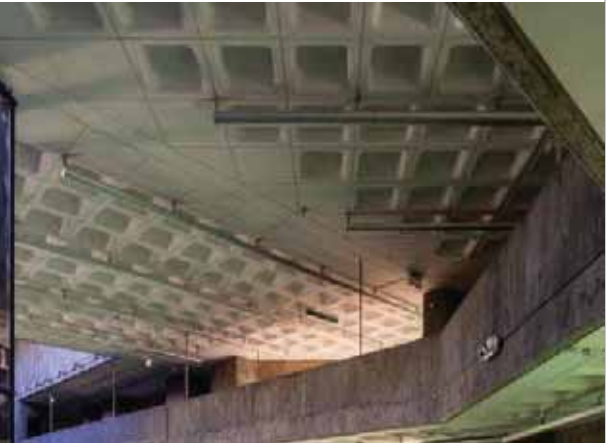
Element	Description/Significance	Stage	Significance Ranking	Image
Waffle slab ceiling	The original waffle slab throughout presents as a series of rectangular coffers with rounded edges. The ceilings have a similarly geometric character seen throughout the building. The slab is painted white and represents a departure from the connection to the landscape evoked by other elements.	Throughout	High

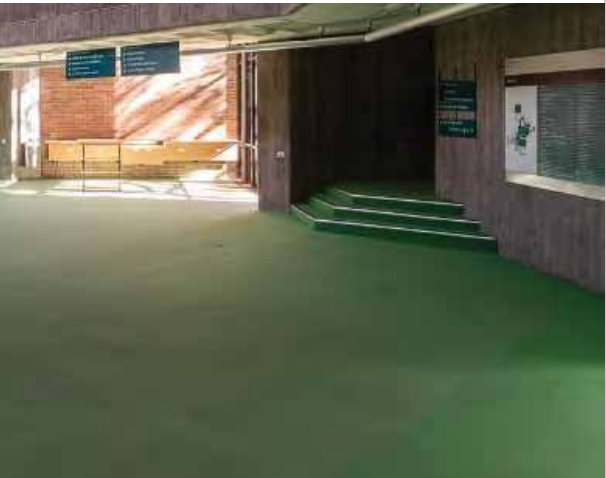
<p>Figure 323 – Green carpet – Stage 2</p>

<p>Figure 322 – Waffle slab ceiling – Stage 1</p>
Floor Treatments				
Green carpet	The significance of green carpet is vested in the contribution it makes to an understanding of the connection between the building and the surrounding landscape, i.e. the green continues from the surrounding bush throughout the building. The significance is associated with the design intent rather than the carpets fabric specifically.	S1, S2 (Lvl 4, 5 and 6) S1, S2 (Lvl 1, 2 and 3) S4 and S5	High Moderate

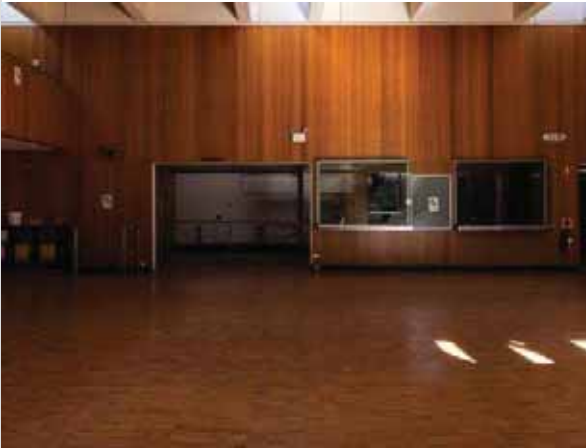
<p>Figure 324 – Timber parquetry – Stage 2.</p>
Timber flooring	Timber flooring is evident in the gym to the large exercise spaces (dance and basketball court). The floors are a functional requirement of the original use of the space.	S2 & S3	Moderate

Element	Description/Significance	Stage	Significance Ranking	Image
Timber parquetry	The timber parquetry in the cafeteria is unique in the context of the building. It does however have the same tonal relationship to the remainder of the building as the wall and window joinery. The parquetry is also indicative of the original use of this space as a eating area.	S2 (cafeteria)	Moderate

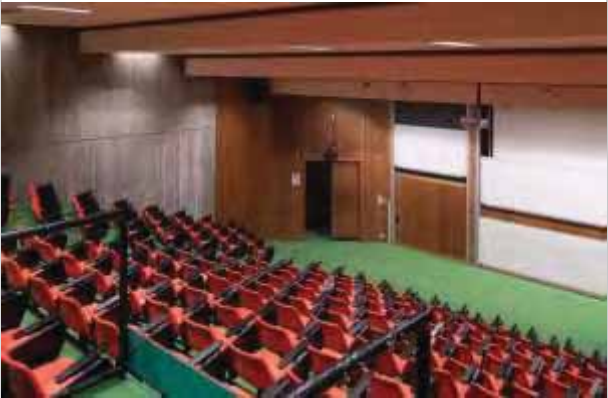
<p>Figure 326 – Wall joinery – Stage 1.</p>
Built in furniture (timber and leather benches)	<p>Built in furniture was originally constructed throughout and included benches, cupboards and notice boards. The furniture has a relationship with the material palette of the built fabric in that it features a stained timber similar to the wall joinery throughout and the original doors. The bespoke furniture is indicative of the level of quality of the building and the attention paid to small details.</p> <p>The built in benches have black vinyl cushion coverings in keeping with the grey, black and green colour palette.</p>	S1 & S2	High

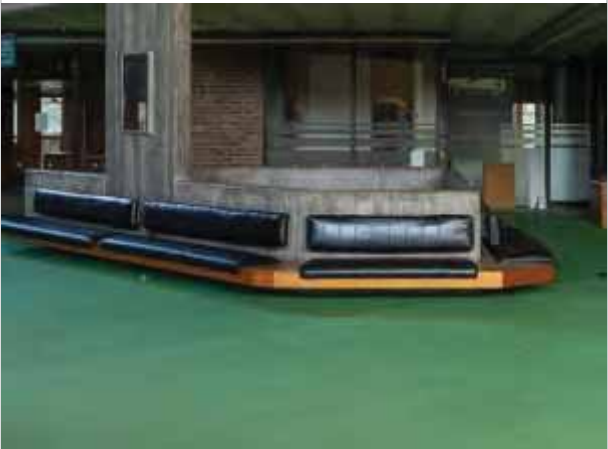
<p>Figure 327 – Built in benches – Stage 2.</p>

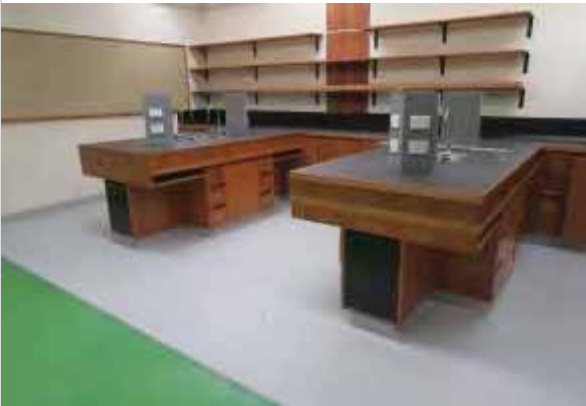
<p>Figure 328 – Science lab benches on Level 4 of Stage 1</p>

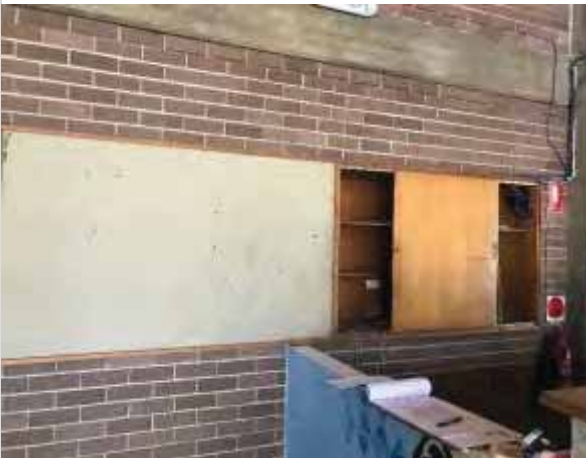
<p>Figure 329 – Built in cabinet</p>

Element	Description/Significance	Stage	Significance Ranking	Image
Built in furniture (display cases, science lab desks)	<p>Built in furniture was originally constructed throughout and included benches, cupboards and notice boards. The furniture has a relationship with the material palette of the built fabric in that it features a stained timber similar to the wall joinery throughout and the original doors. The bespoke furniture is indicative of the level of quality of the building and the attention paid to small details.</p> <p>Throughout the building are a number of built in display cabinets, cabinets and science lab desks which are original and still in a good condition.</p>	Throughout	Moderate

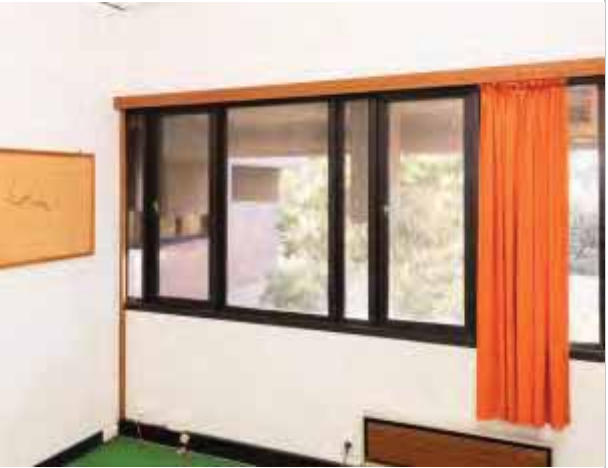
<p>Figure 330 – Timber window details – Stage 2.</p>

Element	Description/Significance	Stage	Significance Ranking	Image
<p>Timber window details</p> <p>Including sills and surrounds.</p>	<p>Timber window details frame views through the aluminium windows to the landscape outside with a natural material. The finish and materiality of the details is similar to the wall joinery throughout and the original doors and contributes to a consistent palette of concrete, brick and timber throughout.</p>	S2, S3, S4	Moderate

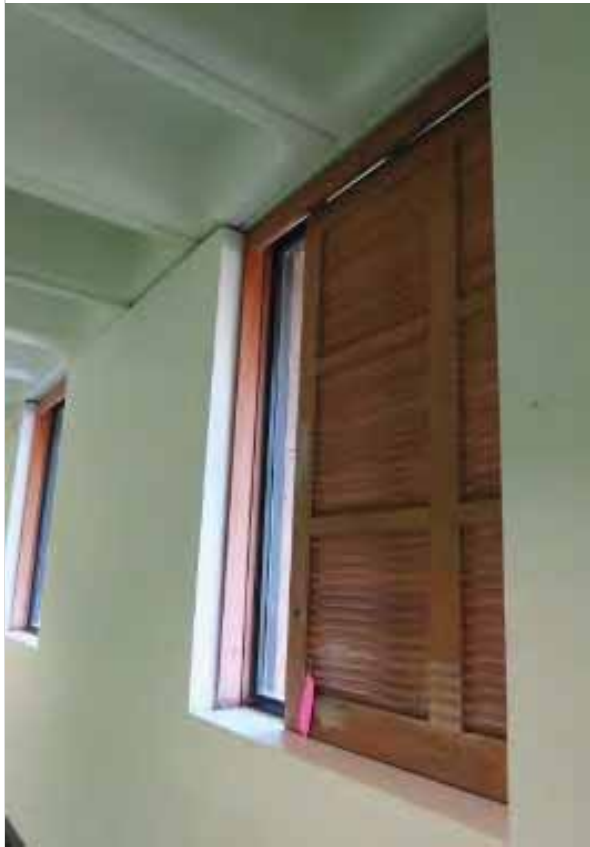
<p>Figure 331 – Timber window shutters – Stage 2.</p>

Element	Description/Significance	Stage	Significance Ranking	Image
Timber window shutters	<p>The finish and materiality of the shutters is similar to the wall joinery throughout and the original doors and contributes to a consistent palette of concrete, brick and timber throughout.</p> <p>The shutters recess entirely within the walls and sit flush with the reveals. The shutters represent a bespoke shade solution which are indicative of the quality of the building overall and the attention paid to details. The shutters are primarily located on the southern wall of the Stage 1 building.</p> <p>A number of shutters have been damaged, painted shut or removed entirely.</p>	S1	High

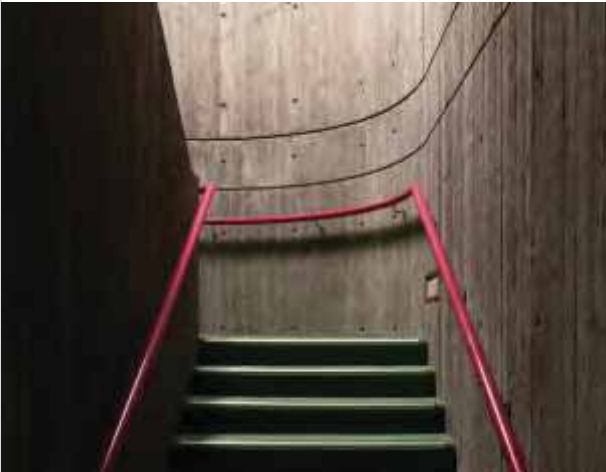
Element	Description/Significance	Stage	Significance Ranking	Image
Handrails (painted pink)	The pink handrails are a remnant of the original design of the place. The pink handrails are viewed in direct contrast with the grey off form concrete behind. Small pops of colour are evident throughout the building and offset the neutral walls and grass green carpet.	S1 & S2	High

<p>Figure 332 – Pink Handrails – Stage 2.</p>
Handrails (painted purple)	Purple handrails are located throughout the building and are primarily located on the black aluminium framed windows and doors as either push bars or safety rails. The purple subtly contrasts with the black framed windows and doors and adds a small pop of colour through the building, offsetting the neutral walls and grass green carpet.	Throughout	Moderate

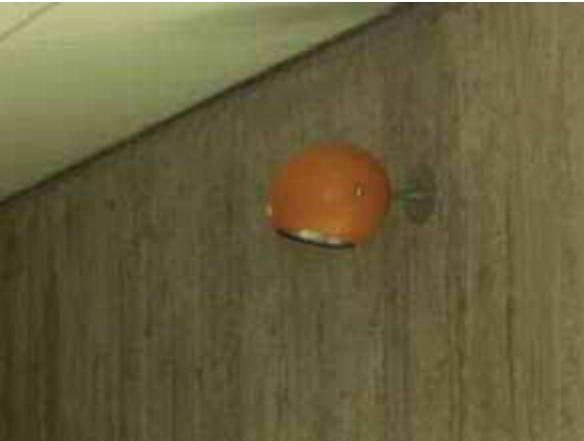
Element	Description/Significance	Stage	Significance Ranking	Image
Services				
Light fittings (orange spherical fittings)	<p>Orange spherical light fittings are visible in some stairwells and hallways.</p> <p>Small pops of colour are evident throughout the building and offset the neutral walls and grass green carpet.</p>	S1, S2 & S4	High

<p>Figure 334 – Light fittings – Stage 2.</p>
Light fittings (silver spherical fittings)	Silver spherical light fittings are located in the Greenhalgh Auditorium in the Stage 2 building.	S2	High

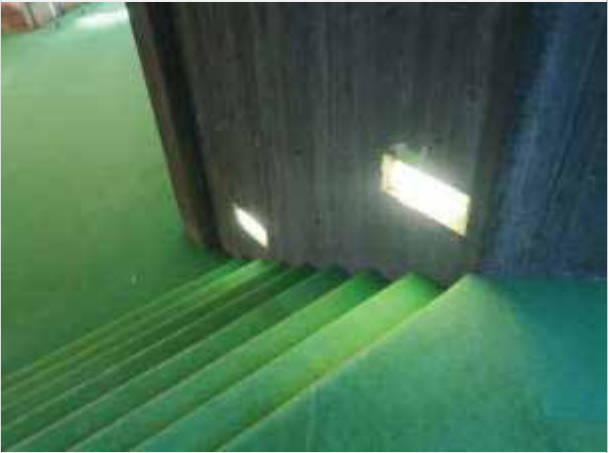
Element	Description/Significance	Stage	Significance Ranking	Image
Inset Horizontal Lights	Horizontal lights fitting set into concrete walls of staircases.	Throughout	Moderate

<p>Figure 336 – Inset horizontal lights in main circulation staircase - Stage 2</p>
Other Internal Elements				
Sulman Award Plaque	<p>Bronze Sulman Award for Architectural Merit, 1978, awarded by the NSW Chapter of RAIA.</p> <p>The plaque is located on Level 5 of the Stage 2 building, adjacent to the main entry.</p>	S2	Moderate

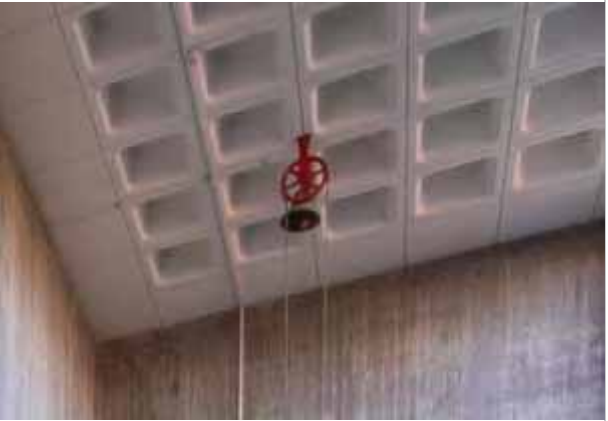
<p>Figure 338 – Bell</p>

Element	Description/Significance	Stage	Significance Ranking	Image
Bell	Original bell at ceiling to Level 6 in main circulation spine.	S2	High

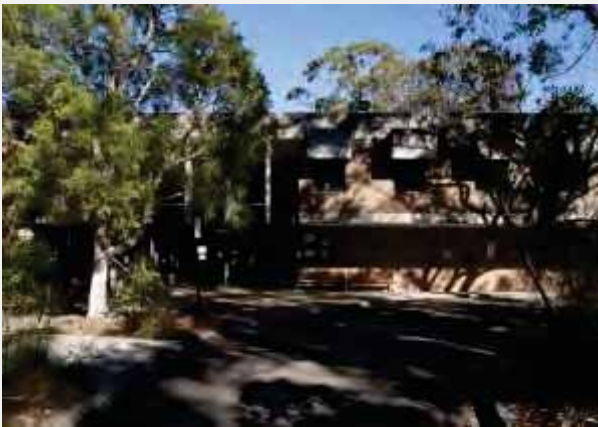
Element	Description/Significance	Stage	Significance Ranking	Image
Main entry	Pedestrian entry and vehicle drop-off point with traffic turning circle, located at southern end of southern extension of Eton Road	S1	Exceptional

<p>Figure 339 – Main entry – Stage 2.</p>
Rooftop gardens	Series of more formal spaces providing areas for study, meals, and observing panoramic views to the east, south and north. A mix of garden beds on impermeable membrane and containerised plants, with outdoor seating areas.	S1	Exceptional

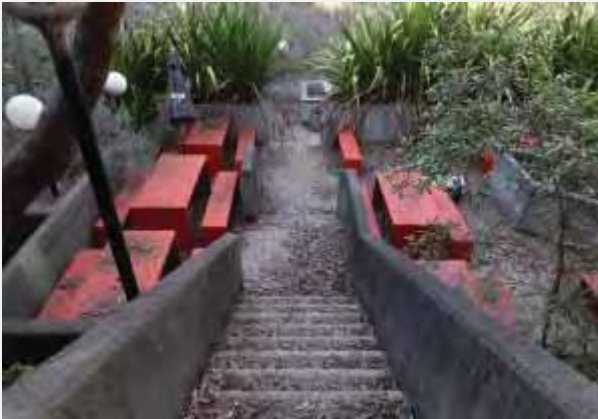
Verandas	Series of formal spaces often closely linked with emphasised concrete sun hoods which drop from above and into the views out to the surrounding landscaping (including from the cafeteria and original library).	S1 – S4 S5	Exceptional / High Moderate

<p>Figure 341 – Veranda – Stage 2</p>
Central courtyard	Informal courtyard featuring remnant native trees, shrubs and ground covers and a rock outcrop, located between the auditorium and Stage 4 building. The courtyard is visible from the main circulation spine, Stage 4 building and areas to the north of the Stage 1 building. The courtyard enhances the connection between the building and it's surroundings. It is understood that this area of bush was not altered during the construction of the building.	Defined by S2, S4	Exceptional

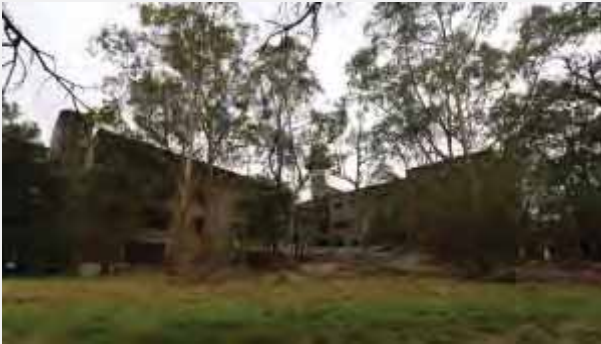
Large Rock Outcrop	Located directly to the south-west of the Stage 1 building is a large rock outcrop of Hawkesbury Sandstone which was carefully protected during the construction stage to ensure the preservation of the natural site features.	S1	High

<p>Figure 345 – Large Rock Outcrop adjacent to Stage 1 building</p>
--------------------	---	----	------	---

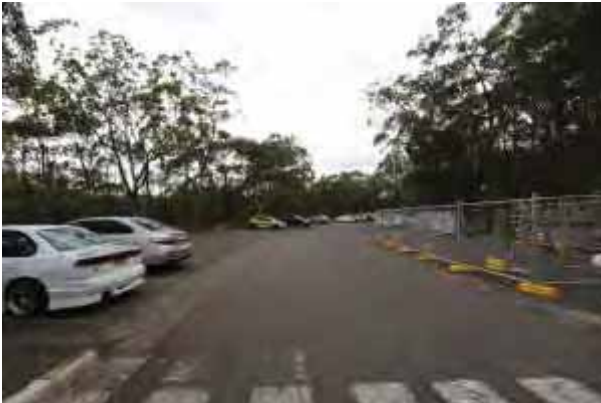
<p>Figure 346 – Stage 1 eastern carpark</p>

East carparks	Series of carparking area cut into the slope and carved out of the bushland. Parking bay located on the main road down to Stage 1 building were constructed as part of the original building.	S1	Moderate

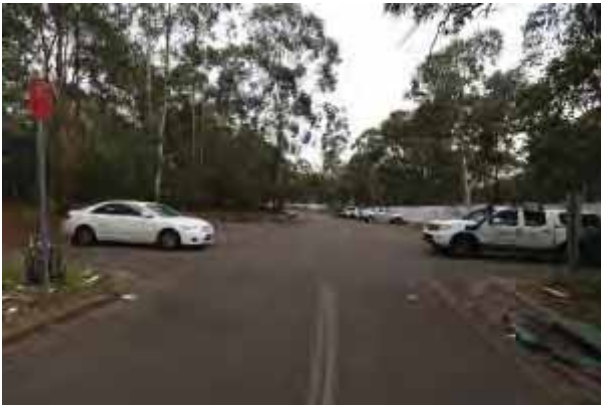
<p>Figure 347 – Stage 6 far-eastern carpark</p>
	The lower carparking area was added later to meet increasing demand for parking.	S6	Little

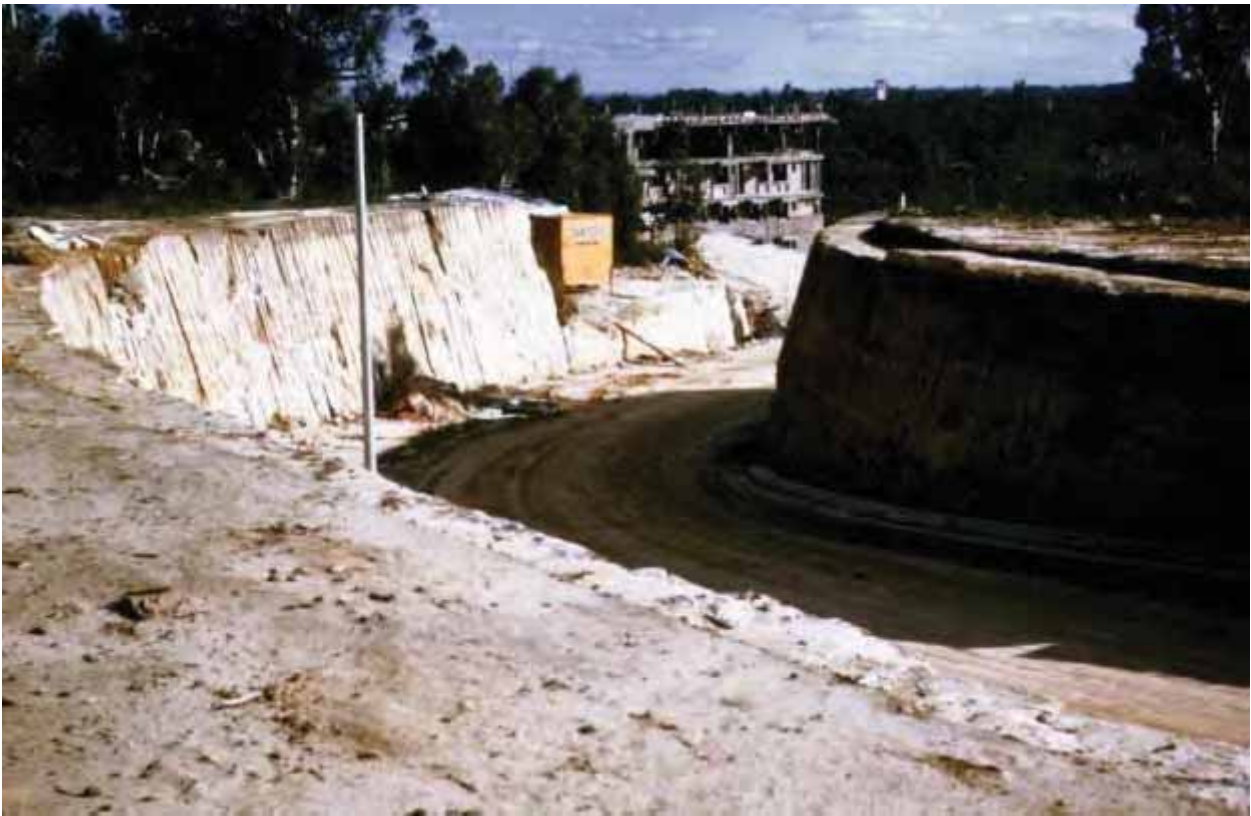
Figure 348 – Extensive disturbance associated with the construction Dunstan Road, early 1970s

To facilitate the development of the former UTS campus, the Study Area was subject to extensive vegetation clearance and re-grading. This is clearly shown in the below photographs, taken during the construction of the former campus buildings.

As is shown, the vast majority of original topsoil in the Study Area was removed and/or severely disturbed by these works. This, combined with subsequent re-landscaping works, including the introduction of fill to the Study Area to create a more level terrain, has resulted in severe disturbance across the entire Study Area. In areas where new fencing is proposed, a sandstone retaining wall that was introduced in association with the establishment of the former campus is present, further indicating the modifications to the landscape that have occurred.

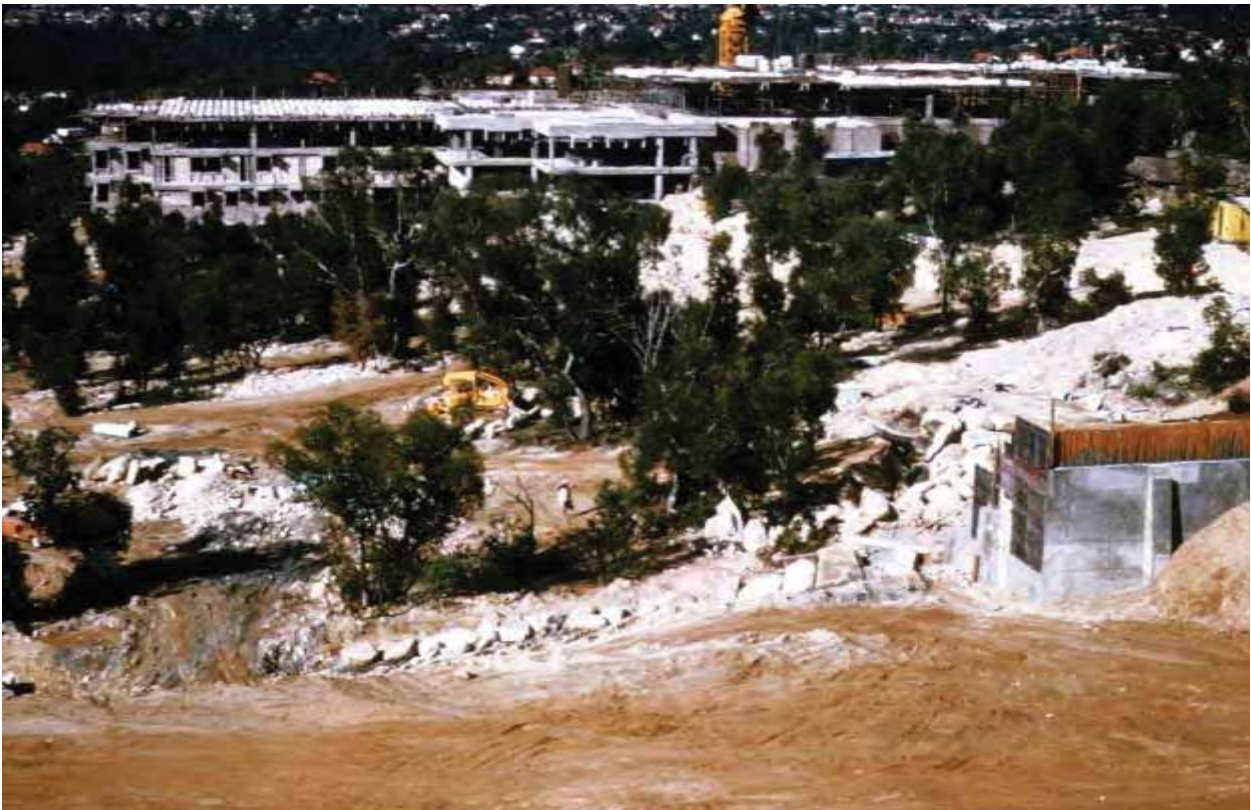
Figure 349 – Extensive disturbance associated with the construction of the former UTS buildings, facing north. Remnant vegetation stands visible, early 1970s

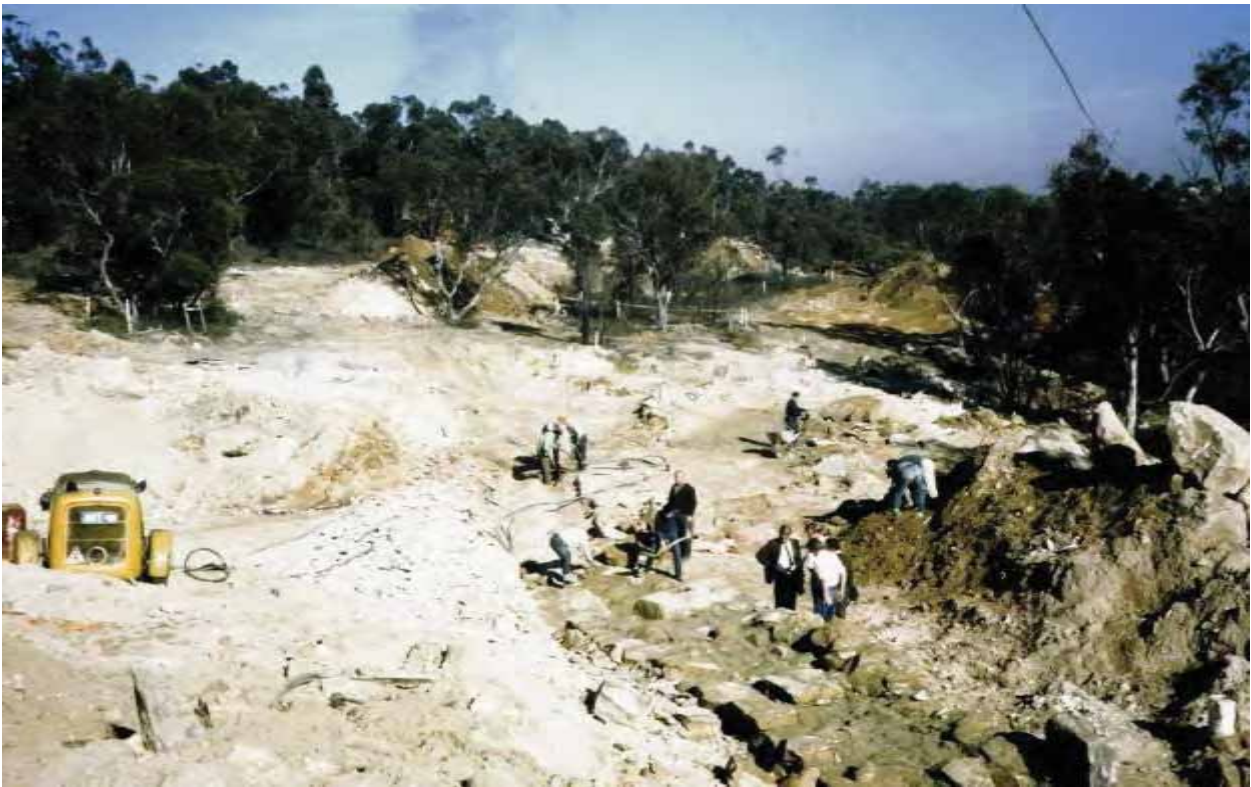
Figure 350 – Clear disturbance associated with the construction of the former UTS buildings, showing general site preparation works, early 1970s

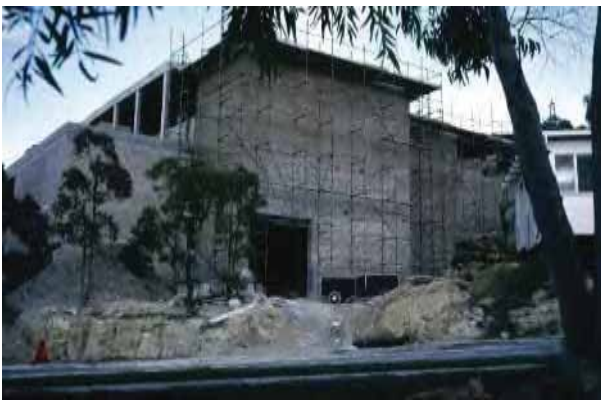
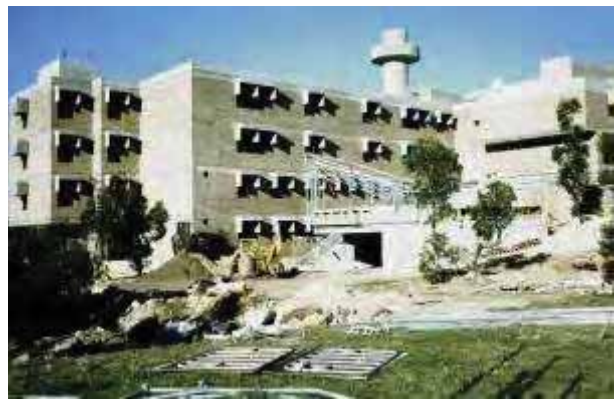
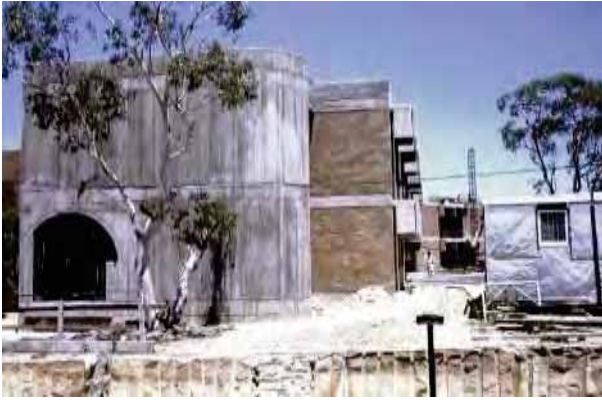
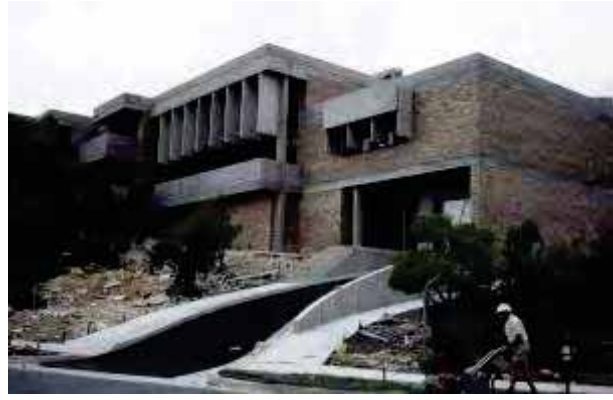
Figure 351 – Disturbance associated with the construction of the former UTS buildings

Figure 352 – Disturbance associated with the construction of the former UTS buildings

Figure 353 – Disturbance associated with the construction of the former UTS buildings

Figure 354 – Disturbance associated with the construction of the former UTS buildings
