CONSERVATION MANAGEMENT PLAN LINDFIELD LEARNING VILLAGE

16 NOVEMBER 2018
SH801
PREPARED FOR DEPARTMENT OF EDUCATION

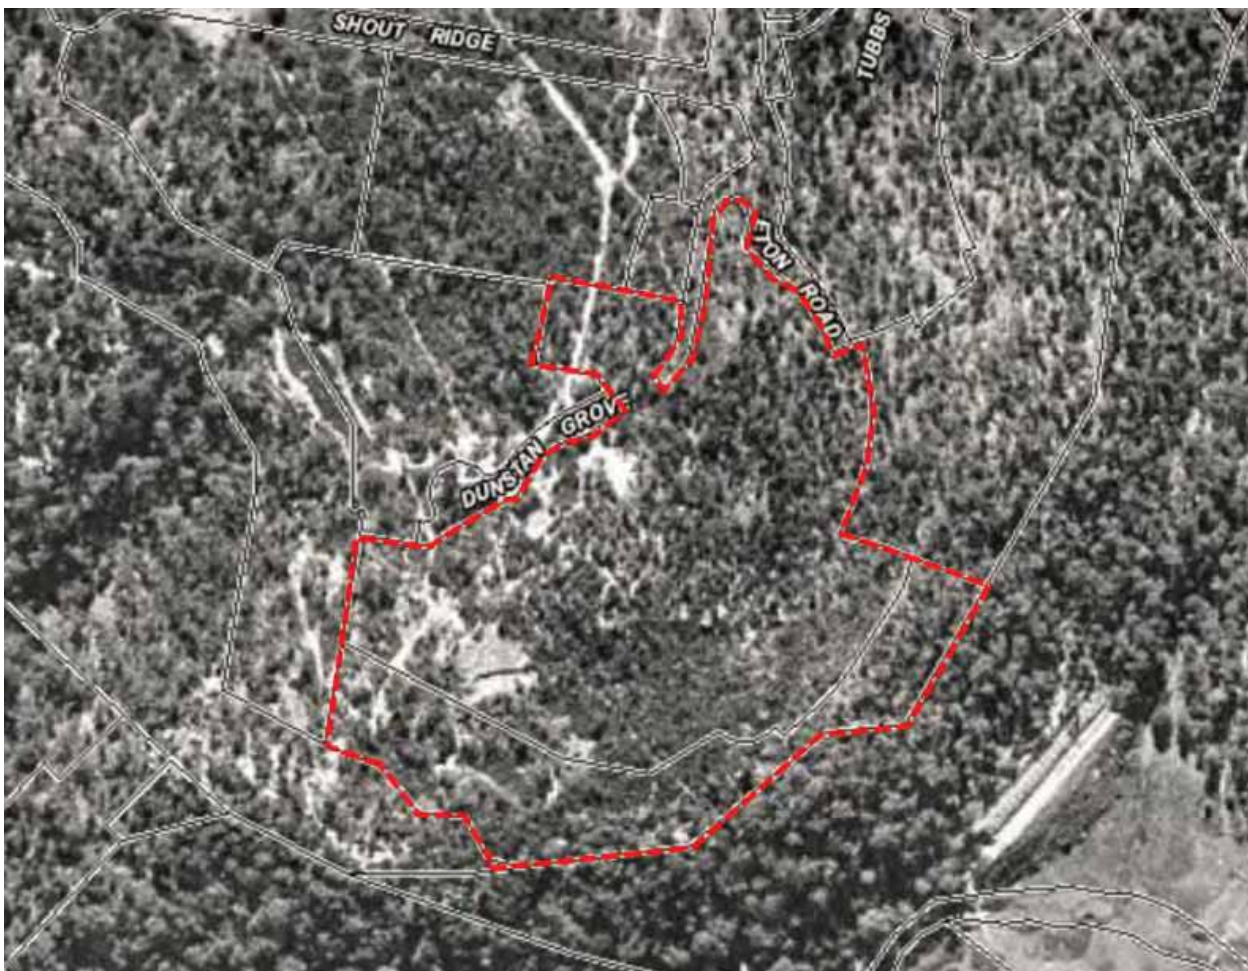
Figure 357 - Aerial imagery from 1943, showing the absence of development within the subject site

A review of aerial imagery from 1943, and prior to the development of the Teacher's College or university campus, shows that former elements that may have been associated with these 'defence' uses is likely to have been limited to defined tracks, target mounds, beam walls, concrete structures and dugouts, with no evidence of more substantial development visible. The three sheds believed to have been built by the respective rifle clubs are similarly unlikely to have been robust or substantial.
