Vibration Monitoring Report

SMEEP – Early Works

Document Number: W-EN-FM-o8 V2.0

Revision 1.0

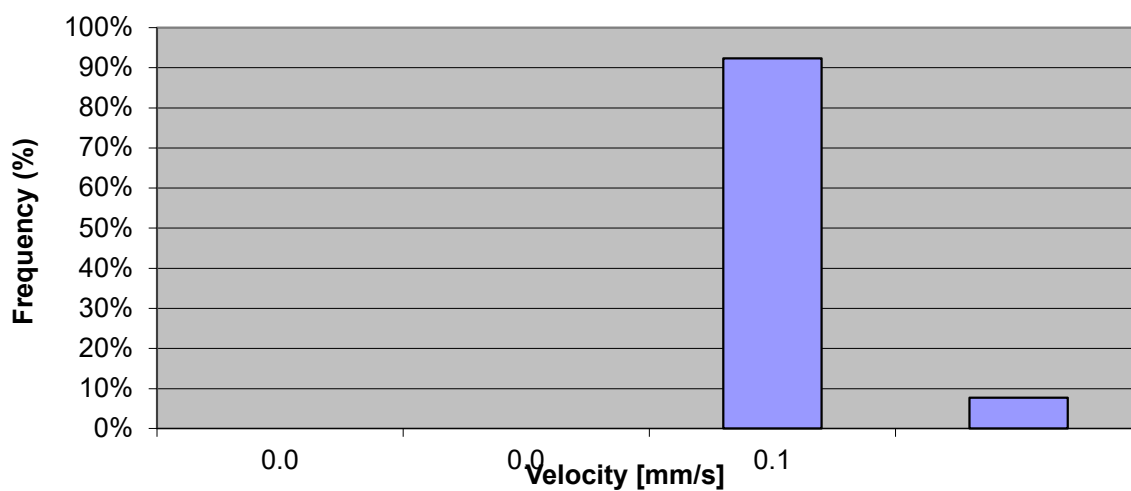
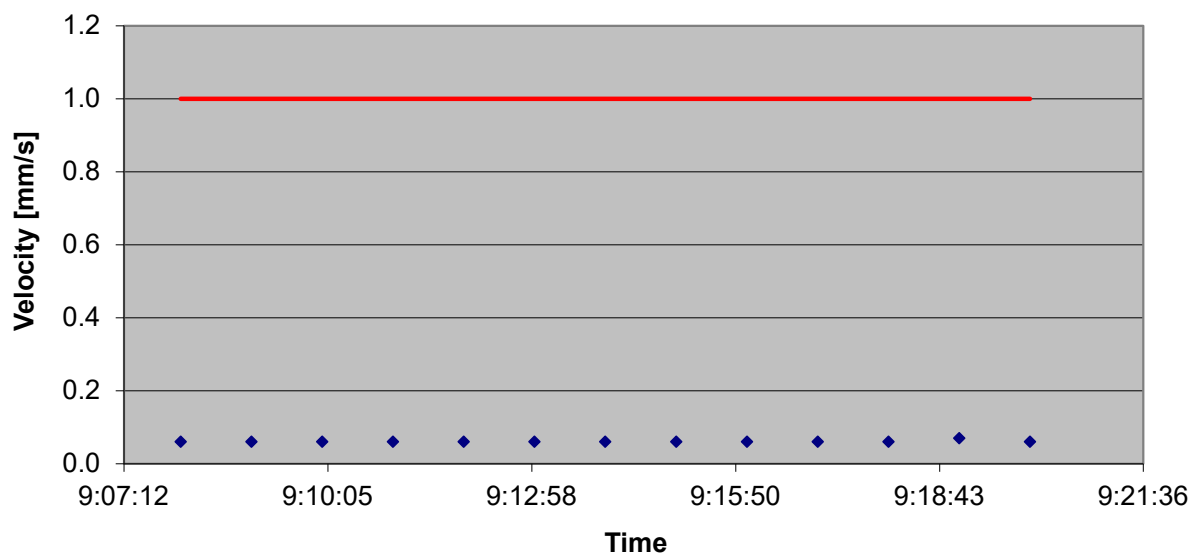
Vector Sum Frequency Histogram

Date	Start: Thu, 23 Jul 2020, 9:00 am	End: Thu, 23 Jul 2020, 9:30 am
Test Conducted By	Vanessa Zbinden	
Model Instrument	Texcel / Serial Number: 7497 / Calibrated on 06/07/2020 by ACU-VIB Certificate Number 27237	
Comments/Activities	Two excavators loading material on trucks for disposal. Monitoring Location: Next to hoarding between TAFE Building and Work site.	
Peak-Particle Vlocity (PPV) - For the assessment of Cosmetic Damage Concern	0.13 mm/s. Result comply with Condition C16 - EPA Recommended Vibration Criteria (Table 6, Section 6.2.2 Noise & Vibration Management Plan), and German Standard DIN 4150-3 (1999-02) - Ground Borne Vibrations and Damage Limits (Table 5, Section 6.2.1 Noise & Vibration Management Plan). Closest receiver located 15m away from monitoring location and work boundary.

Tran	Vert	Long	Unit
0.03	0.03	0.11	mm/s
-	-	-

Peak Permissible Value : **1 mm/s**
Number of Events > 1 mm/s : **0**

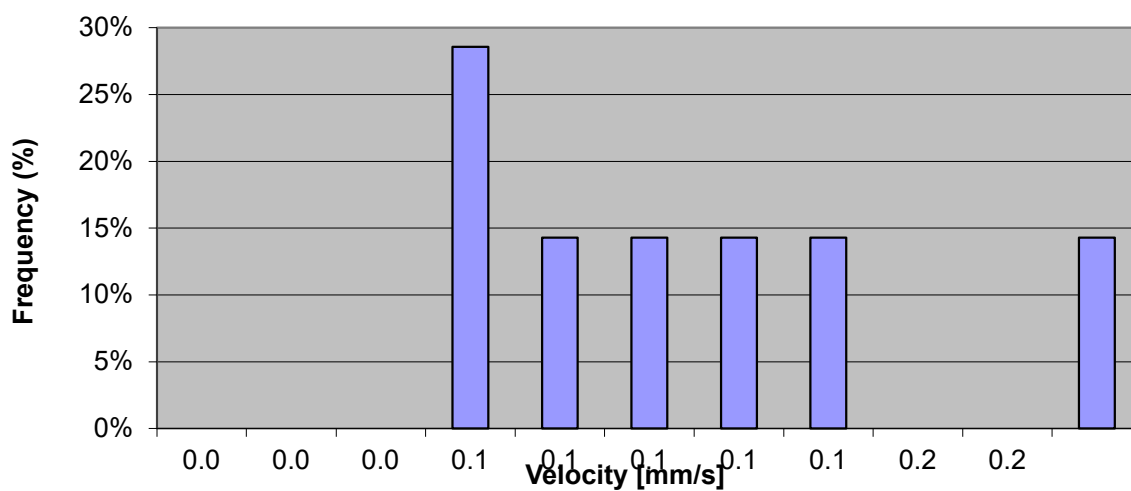
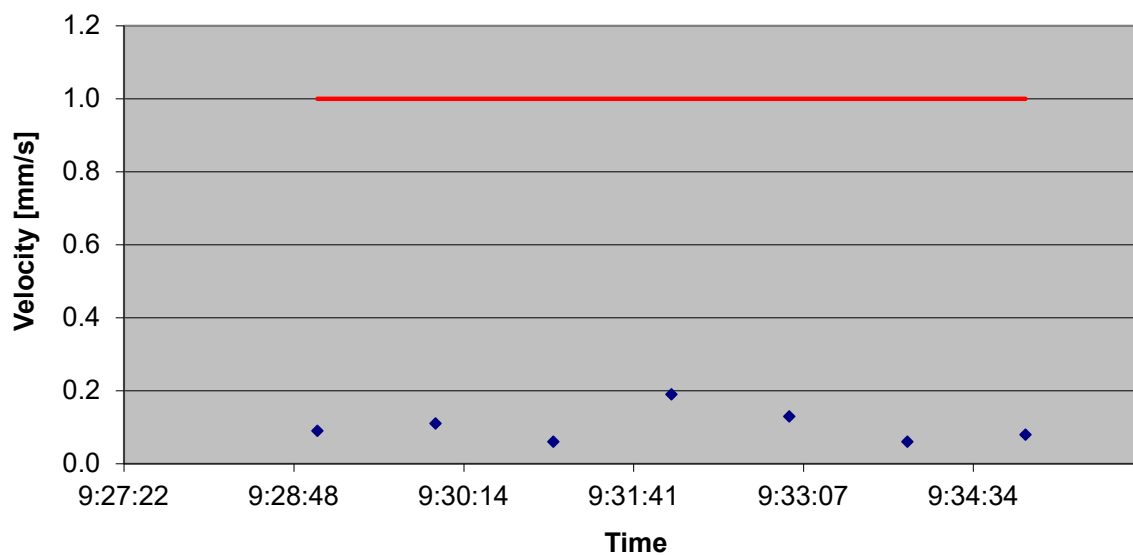
Vector Sum Frequency Histogram

Date	Start: Thu, 23 Jul 2020, 9:27 am	End: Thu, 23 Jul 2020, 9:35 am
Test Conducted By	Vanessa Zbinden	
Model Instrument	Texcel / Serial Number: 7497 / Calibrated on 06/07/2020 by ACU-VIB Certificate Number 27237	
Comments/Activities	Two excavators loading material on trucks for disposal. Intermittent source identified: Trucks passing 5m away from monitor. Monitoring Location: Next to hoarding along Rhodes Street in front 7 Rhodes Street	
Peak-Particle Vlocity (PPV) - For the assessment of Cosmetic Damage Concern	0.19 mm/s. Result comply with Condition C16 - EPA Recommended Vibration Criteria (Table 6, Section 6.2.2 Noise & Vibration Management Plan), and German Standard DIN 4150-3 (1999-02) - Ground Borne Vibrations and Damage Limits (Table 5, Section 6.2.1 Noise & Vibration Management Plan). Closest receiver located 15m away from monitoring location and work boundary.

Tran	Vert	Long	Unit
0.05	0.05	0.11	mm/s
-	-	-

Peak Permissible Value : **1 mm/s**
Number of Events > 1 mm/s : **0**

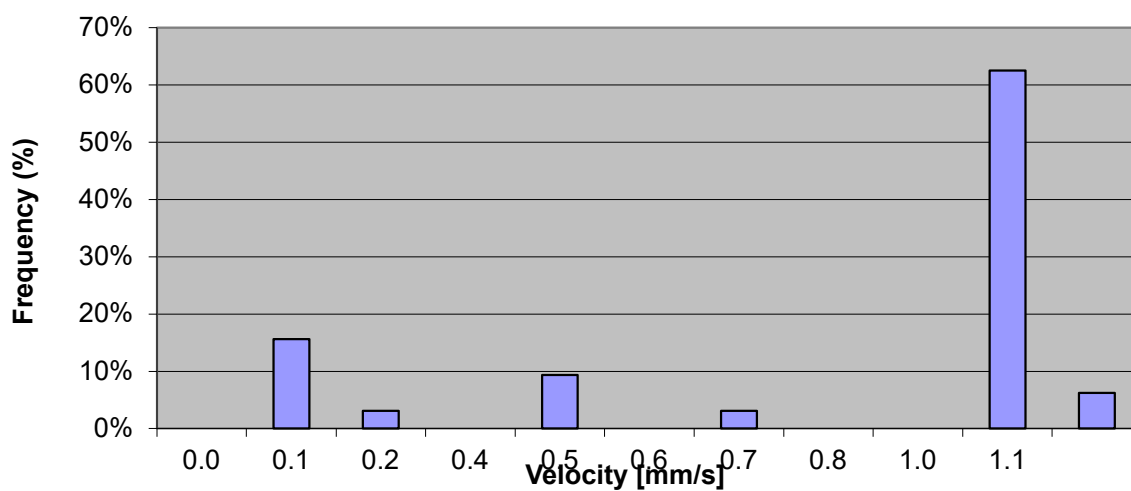
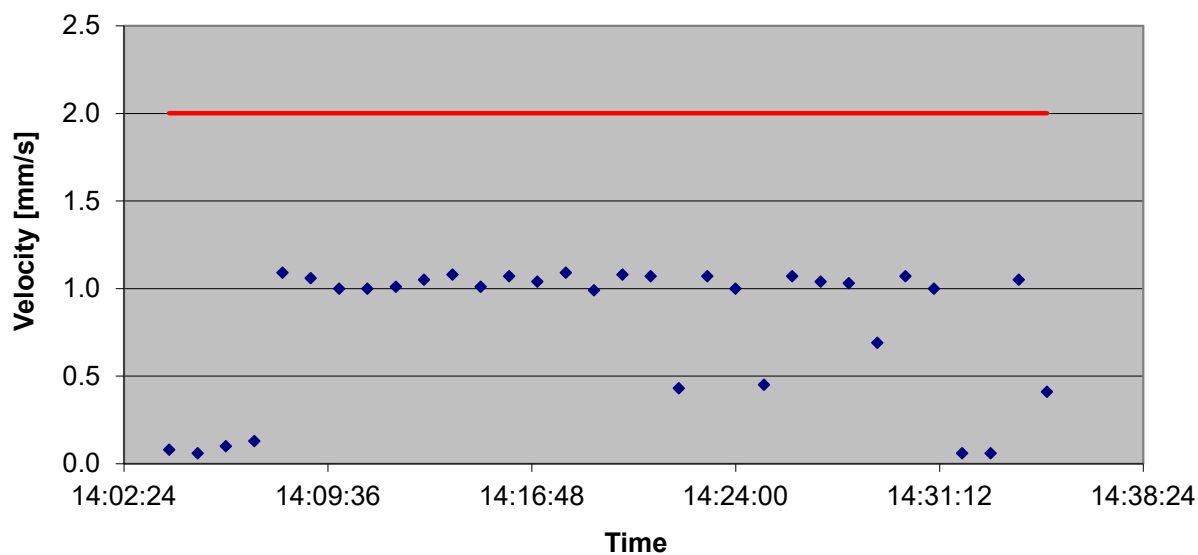
Vector Sum Frequency Histogram

Date	Start: Thu, 06 Aug 2020, 2:03 pm	End: Thu, 06 Aug 2020, 2:28 pm
Test Conducted By	Vanessa Zbinden	
Model Instrument	Texcel / Serial Number: 7497 / Calibrated on 06/07/2020 by ACU-VIB Certificate Number 27237	
Comments/Activities	Rolling material within site boundary. (14t roller). Monitoring location: next to hoarding between work site and TAFE building.	
Peak-Particle Vlocity (PPV) - For the assessment of Cosmetic Damage Concern	1.09mm/s Result comply with Condition C16 - EPA Recommended Vibration Criteria (Table 6, Section 6.2.2 Noise & Vibration Management Plan), and German Standard DIN 4150-3 (1999-02) - Ground Borne Vibrations and Damage Limits (Table 5, Section 6.2.1 Noise & Vibration Management Plan).

Tran	Vert	Long	Unit
0.05	0.05	0.11	mm/s
-	-	-

Peak Permissible Value : **2 mm/s**
Number of Events > 2 mm/s : **0**

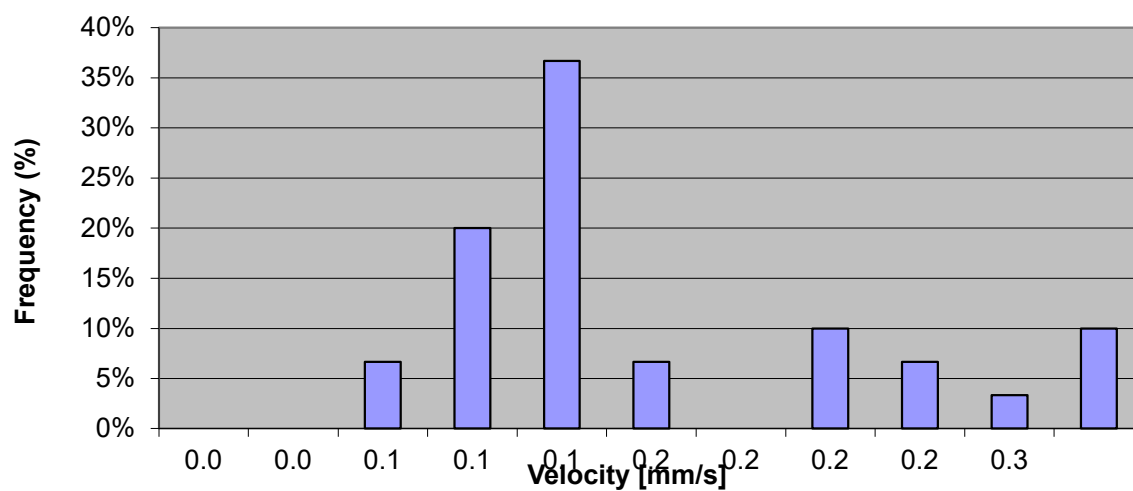
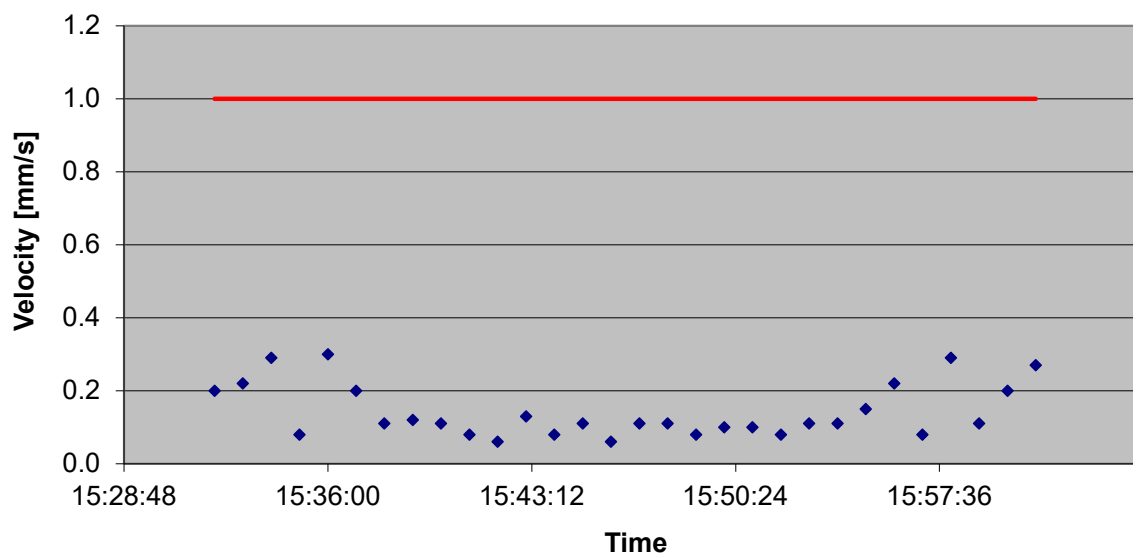
Vector Sum Frequency Histogram

Date	Start: Thu, 06 Aug 2020, 3:28 pm	End: Thu, 06 Aug 2020, 3:57 pm
Test Conducted By	Vanessa Zbinden	
Model Instrument	Texcel / Serial Number: 7497 / Calibrated on 06/07/2020 by ACU-VIB Certificate Number 27237	
Comments/Activities	Rolling material within site boundary (14t roller). Intermittent source: Trucks along Rhodes st. Monitoring location: intersection Rhodes Street / Mellor St . SE side of the work site.	
Peak-Particle Vlocity (PPV) - For the assessment of Cosmetic Damage Concern	0.3 mm/s Result comply with Condition C16 - EPA Recommended Vibration Criteria (Table 6, Section 6.2.2 Noise & Vibration Management Plan), and German Standard DIN 4150-3 (1999-02) - Ground Borne Vibrations and Damage Limits (Table 5, Section 6.2.1 Noise & Vibration Management Plan).

Tran	Vert	Long	Unit
0.16	0.18	0.27	mm/s
-	-	-

Peak Permissible Value : **1 mm/s**
Number of Events > 1 mm/s : **0**

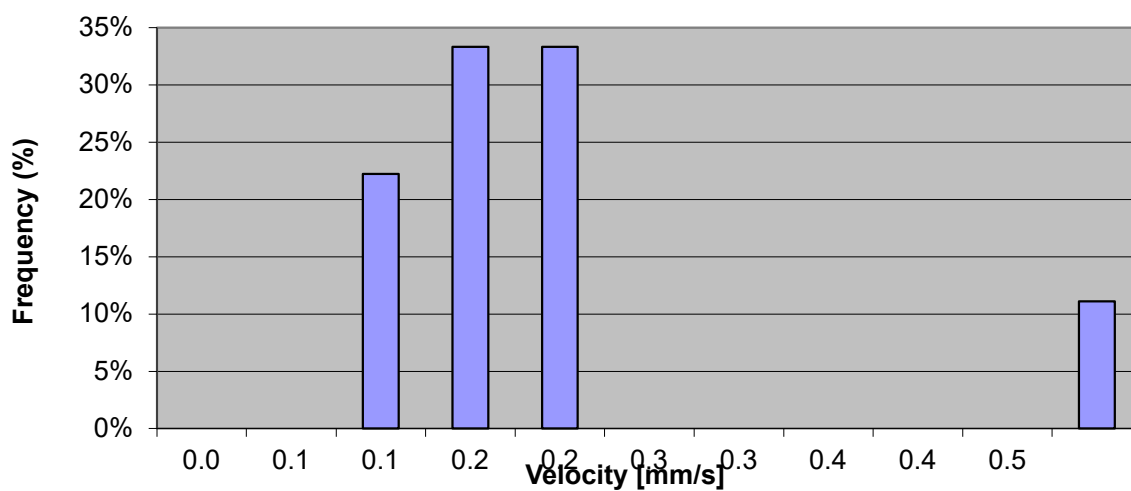
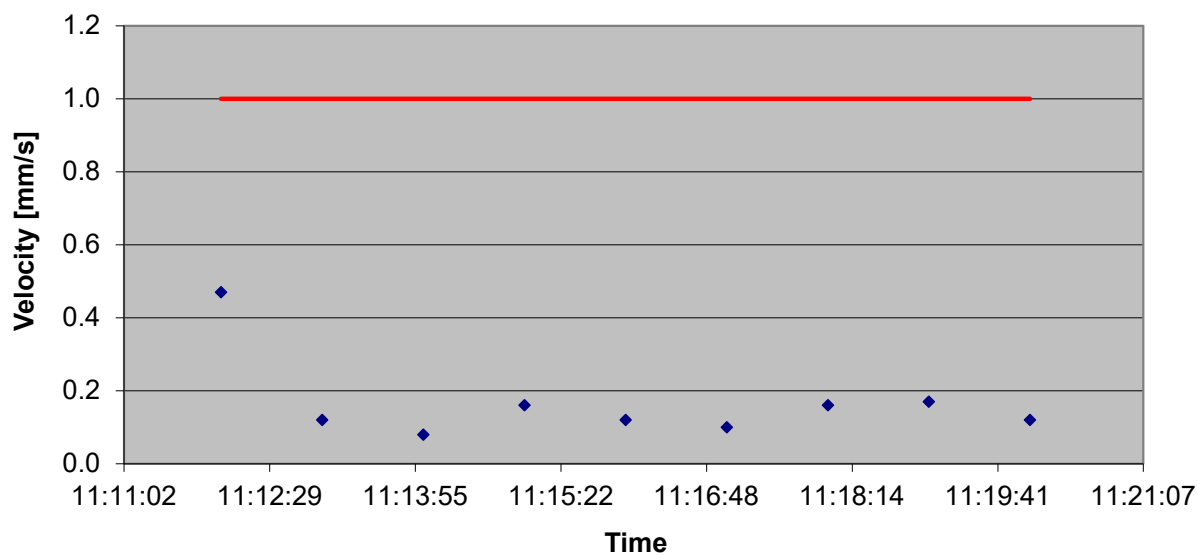
Vector Sum Frequency Histogram

Comments/Activities Excavator 22t loading material on trucks. Intermittent source: trucks along Rhodes st. Monitoring location: Outside Project boundary, in front 15 Rhodes st (near the gate due to increase of truck movements)

Peak-Particle Vlocity (PPV) - For the assessment of Cosmetic Damage Concern 0.47 mm/s Result comply with Condition C16 - EPA Recommended Vibration Criteria (Table 6, Section 6.2.2 Noise & Vibration Management Plan), and German Standard DIN 4150-3 (1999-02) - Ground Borne Vibrations and Damage Limits (Table 5, Section 6.2.1 Noise & Vibration Management Plan).

Tran	Vert	Long	Unit
0.32	0.08	0.4	mm/s
-	-	-

Peak Permissible Value : **1 mm/s**
Number of Events > 1 mm/s : **0**

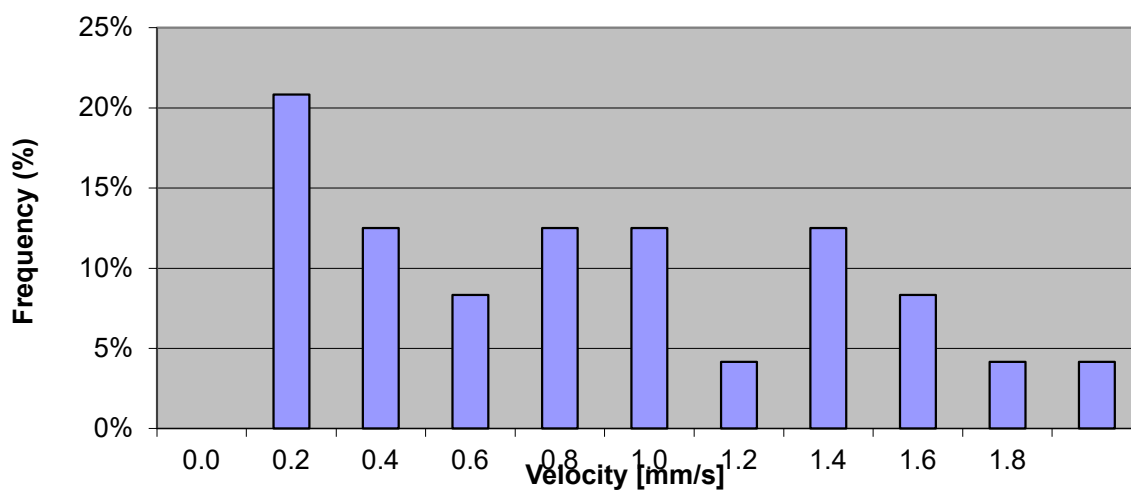
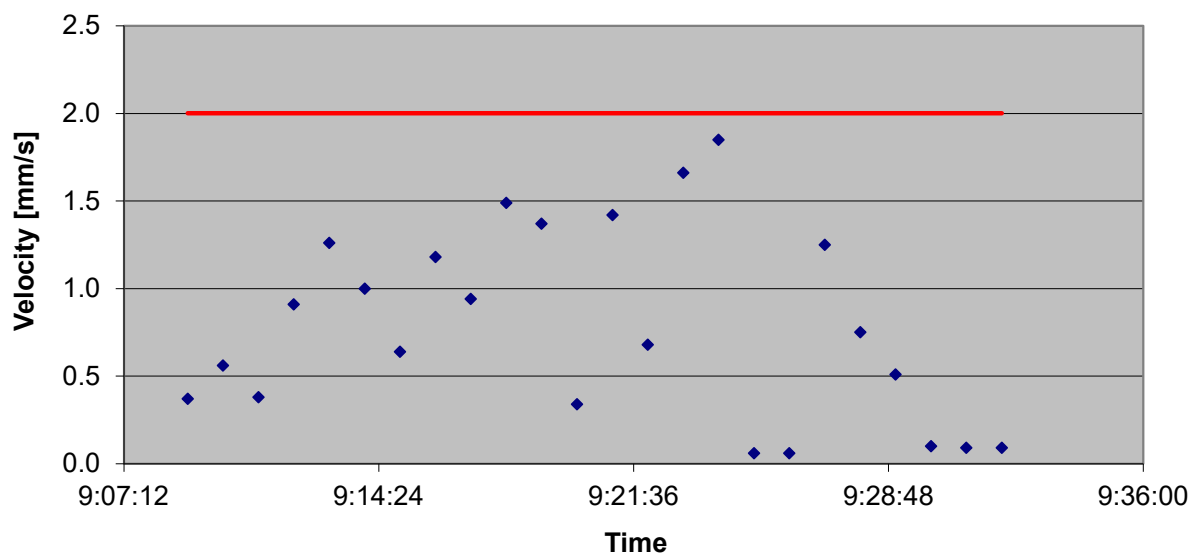
Vector Sum Frequency Histogram

Date	Start: Wed, 12 Aug 2020, 9:07 am	End: Wed, 12 Aug 2020, 9:31 am
Test Conducted By	Vanessa Zbinden	
Model Instrument	Texcel / Serial Number: 7497 / Calibrated on 06/07/2020 by ACU-VIB Certificate Number 27237	
Comments/Activities	Rolling material within site boundary (14t roller). Intermittent source: Trucks along Rhodes st. Monitoring location: Next to the hoarding between TAFE building and work boundary	
Peak-Particle Vlocity (PPV) - For the assessment of Cosmetic Damage Concern	1.85 mm/s. Result comply with Condition C16 - EPA Recommended Vibration Criteria (Table 6, Section 6.2.2 Noise & Vibration Management Plan).

Tran	Vert	Long	Unit
1.06	1.0	1.5	mm/s

Peak Permissible Value : **2 mm/s**
Number of Events > 2 mm/s : **0**

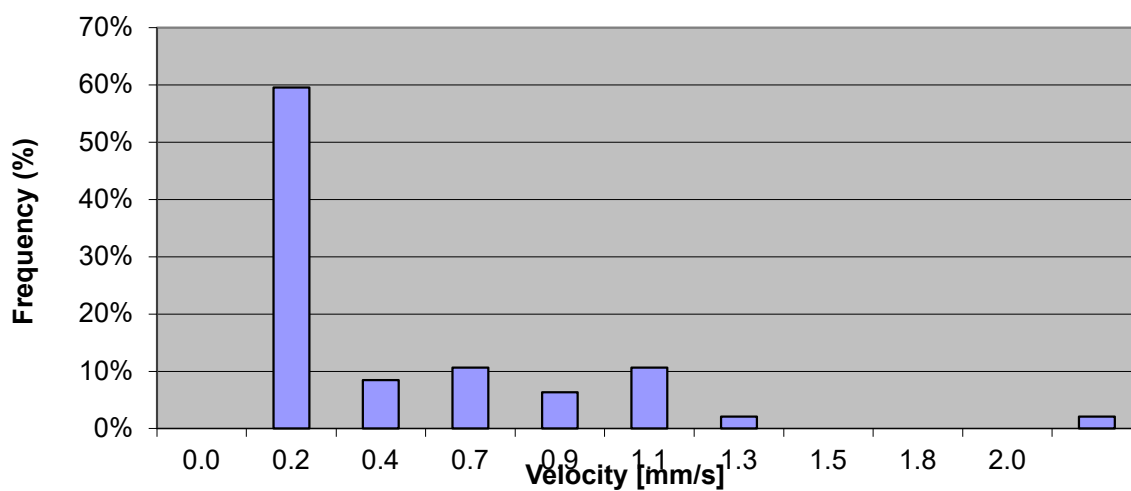
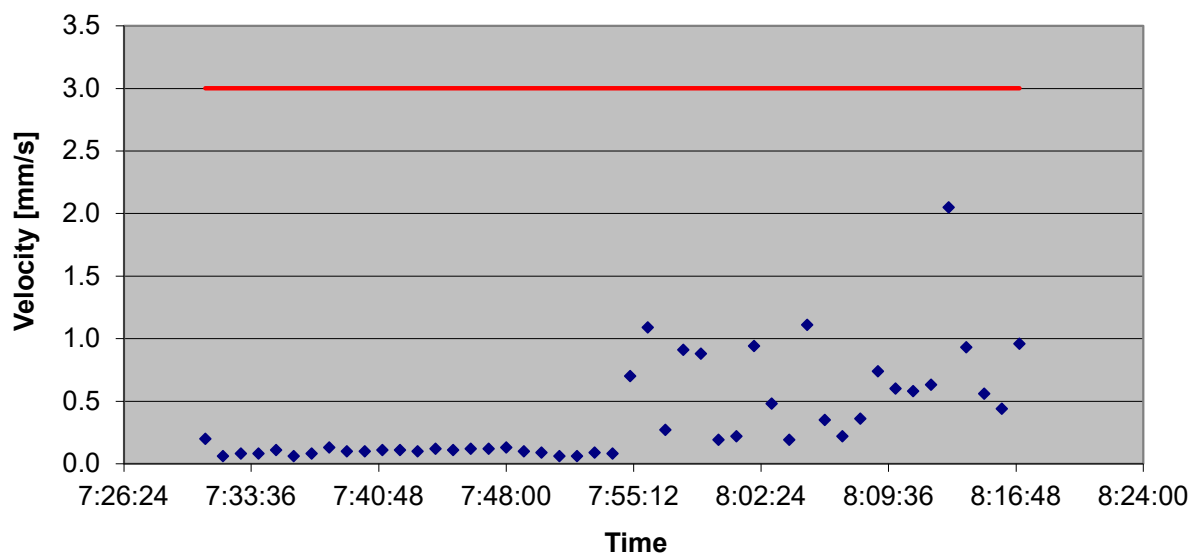
Vector Sum Frequency Histogram

Date	Start: Wed, 12 Aug 2020, 7:26 am	End: Wed, 12 Aug 2020, 8:24 am
Test Conducted By	Vanessa Zbinden	
Model Instrument	Texcel / Serial Number: 7497 / Calibrated on 06/07/2020 by ACU-VIB Certificate Number 27237	
Comments/Activities	From 7:26 to 7:54 2 excavators loading material on trucks. From 7:54 to 8:16 Rolling material within site boundary (14t roller). Intermittent source: Trucks along Rhodes st. Monitoring location: Next to the hoarding in the SE side of the site,	
Peak-Particle Vlocity (PPV) - For the assessment of Cosmetic Damage Concern	PPV was 0.13mm/s when excavators were working (continuous source) and PPV was 2.05 mm/s when roller commenced (impulsive source). Result comply with Condition C16 - EPA Recommended Vibration Criteria (Table 6, Section 6.2.2 Noise & Vibration Management Plan).

Tran	Vert	Long	Unit
1.85	0.52	1.23	mm/s
0.13	0.08	0.05	mm/s

Peak Permissible Value : **3 mm/s**
Number of Events > 3 mm/s : **0**

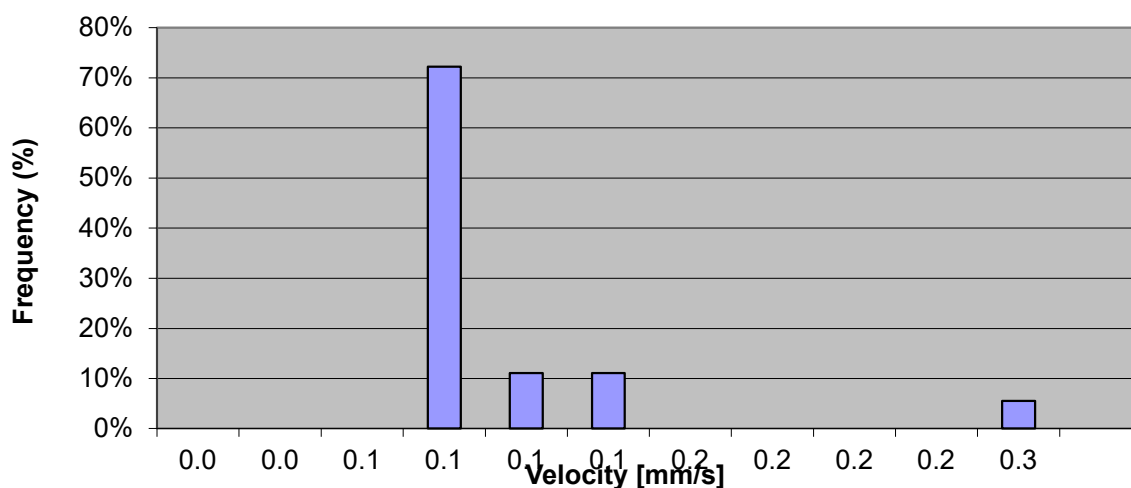
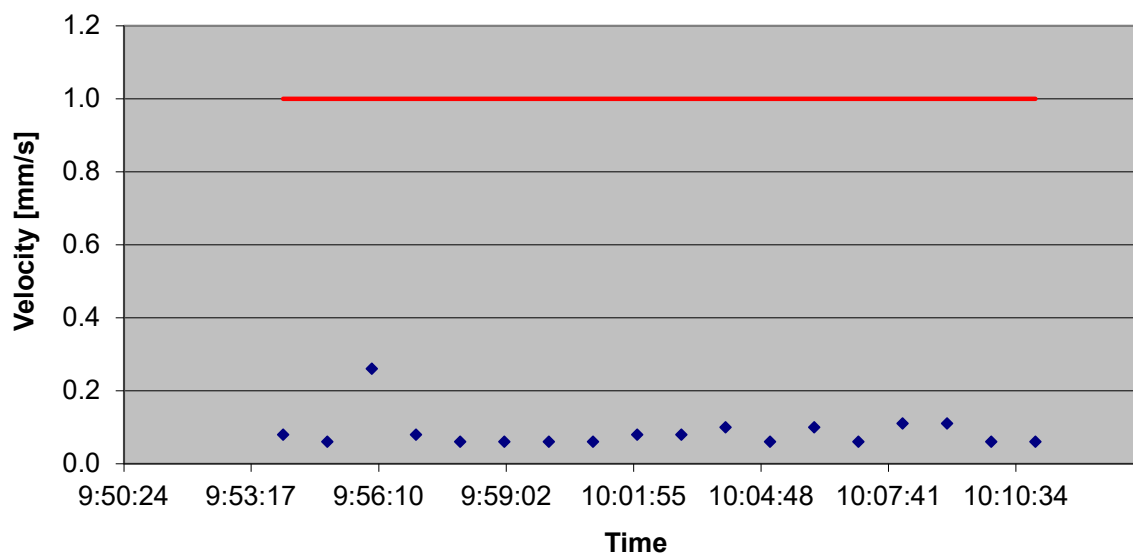
Vector Sum Frequency Histogram

Date	Start: Mon, 17 Aug 2020, 9:50 am	End: Mon, 17 Aug 2020, 10:10 am
Test Conducted By	Vanessa Zbinden	
Model Instrument	Texcel / Serial Number: 7497 / Calibrated on 06/07/2020 by ACU-VIB Certificate Number 27237	
Comments/Activities	Asbestos removal. Intermittent source: Trucks along Rhodes st. Monitoring location: Next to the hoarding between the site and TAFE	
Peak-Particle Vlocity (PPV) - For the assessment of Cosmetic Damage Concern	PPV was 0.26mm/s at 09:56. When excavators were working (continuous source). Result comply with Condition C16 - EPA Recommended Vibration Criteria (Table 6, Section 6.2.2 Noise & Vibration Management Plan)./

Tran	Vert	Long	Unit
0.26	0.13	0.11	mm/s

Peak Permissible Value : **1 mm/s**
Number of Events > 1 mm/s : **0**

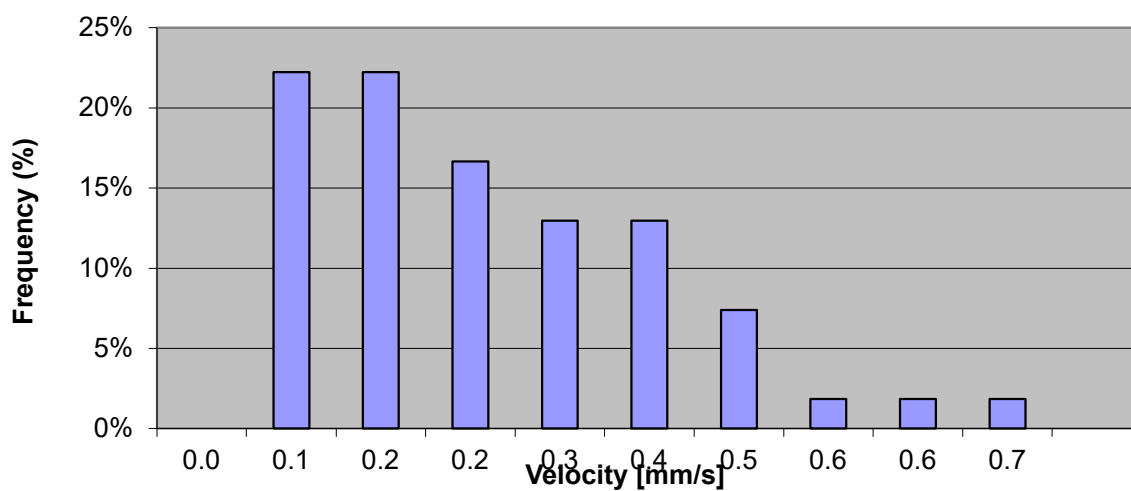
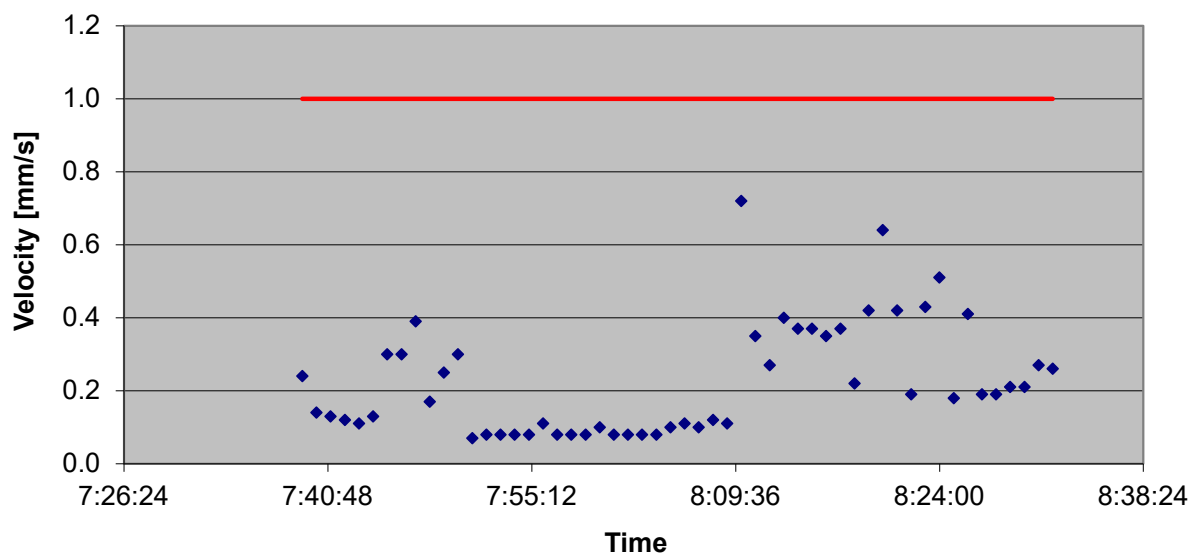
Vector Sum Frequency Histogram

Comments/Activities 2 excavators loading material on trucks. Monitoring location: Next to the hoarding in the SE side of the site.

Peak-Particle Vlocity (PPV) - For the assessment of Cosmetic Damage Concern PPV was 0.72mm/s when trucks were passing by Rhodes St (continuous source). Result comply with Condition C16 - EPA Recommended Vibration Criteria (Table 6, Section 6.2.2 Noise & Vibration Management Plan).

Tran	Vert	Long	Unit
0.13	0.71	0.37	mm/s

Peak Permissible Value : **1 mm/s**
Number of Events > 1 mm/s : **0**

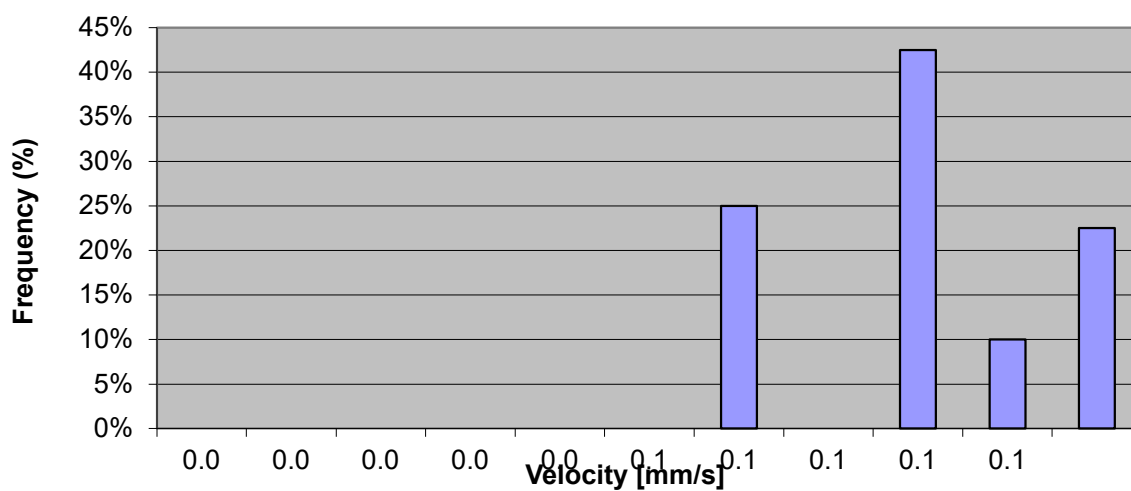
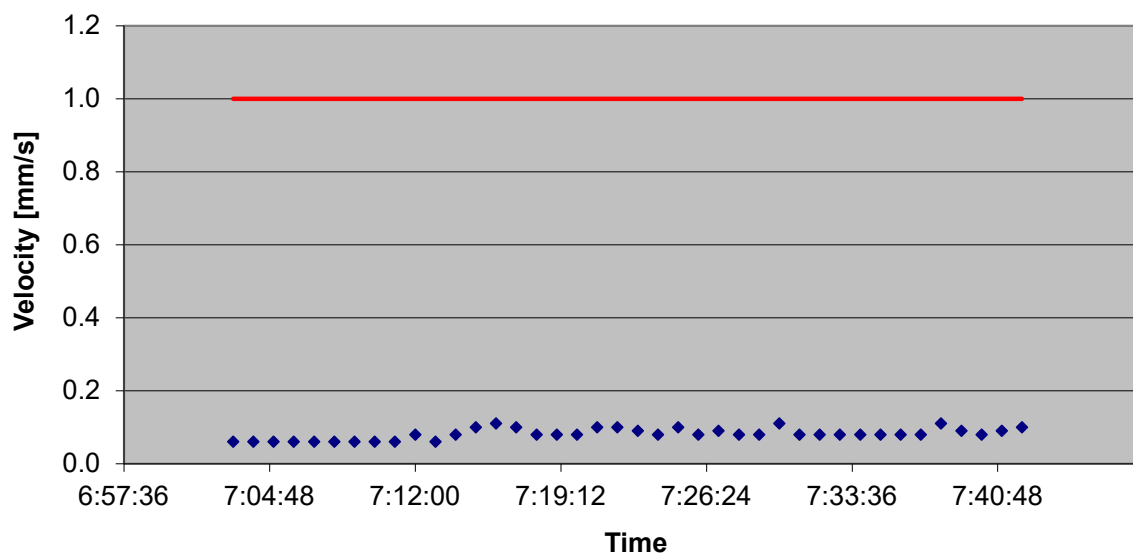
Vector Sum Frequency Histogram

Comments/Activities Back filling, vacuum truck excavating, ac removal behind brick wall. Monitoring location near Vacuum truck Rhodes St

Peak-Particle Vlocity (PPV) - For the assessment of Cosmetic Damage Concern PPV was 0.11 mm/s when vacuum truck was working onsite (continuous source). Result comply with Condition C16 - EPA Recommended Vibration Criteria (Table 6, Section 6.2.2 Noise & Vibration Management Plan).

Tran	Vert	Long	Unit
0.11	0.05	0.08	mm/s

Peak Permissible Value : **1 mm/s**
Number of Events > 1 mm/s : **0**

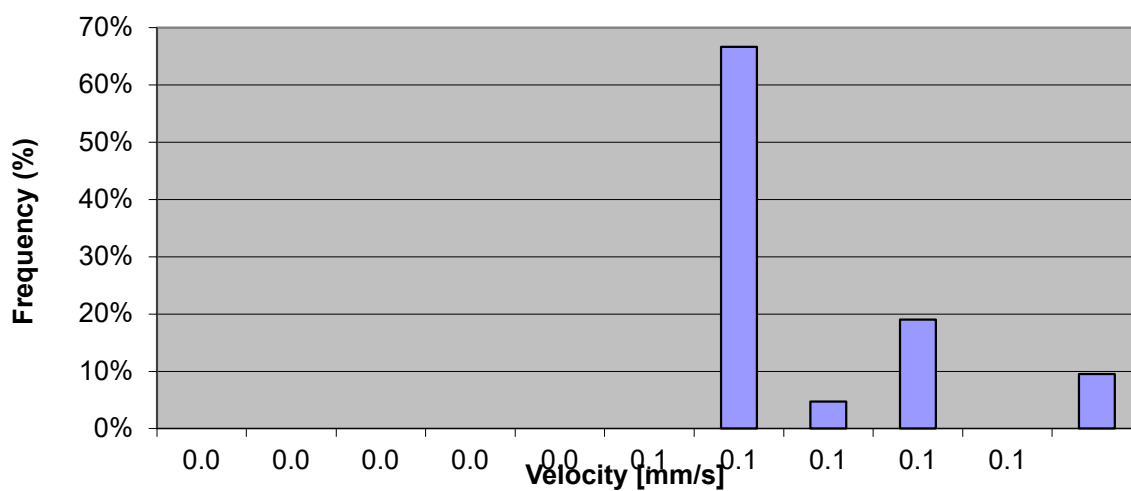
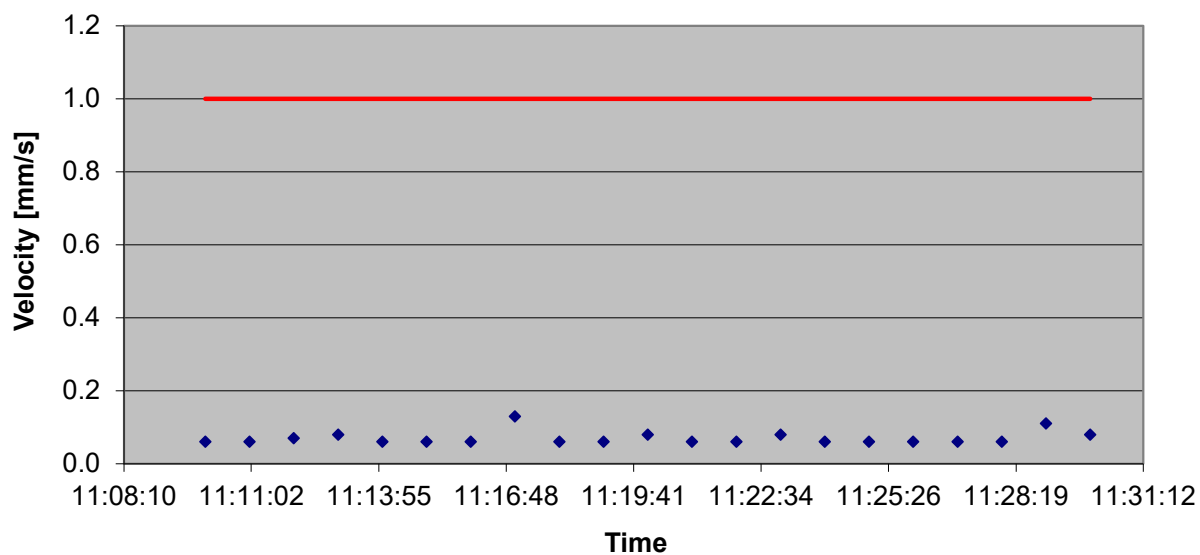
Vector Sum Frequency Histogram

Date	Start: Mon, 07 Sep 2020, 11:08 am	End: Mon, 07 Sep 2020, 11:32 am
Test Conducted By	Vanessa Zbinden	
Model Instrument	Texcel / Serial Number: 7497 / Calibrated on 06/07/2020 by ACU-VIB Certificate Number 27237	
Comments/Activities	Vacuum truck working around trees. Monitoring location: Next to the hoarding in front 7-9 Rhodes St	
Peak-Particle Vlocity (PPV) - For the assessment of Cosmetic Damage Concern	PPV was 0.13 mm/s when vacuum truck was working onsite (continuous source). Result comply with Condition C16 - EPA Recommended Vibration Criteria (Table 6, Section 6.2.2 Noise & Vibration Management Plan).

Tran	Vert	Long	Unit
0.11	0.05	0.08	mm/s

Peak Permissible Value : **1 mm/s**
Number of Events > 1 mm/s : **0**

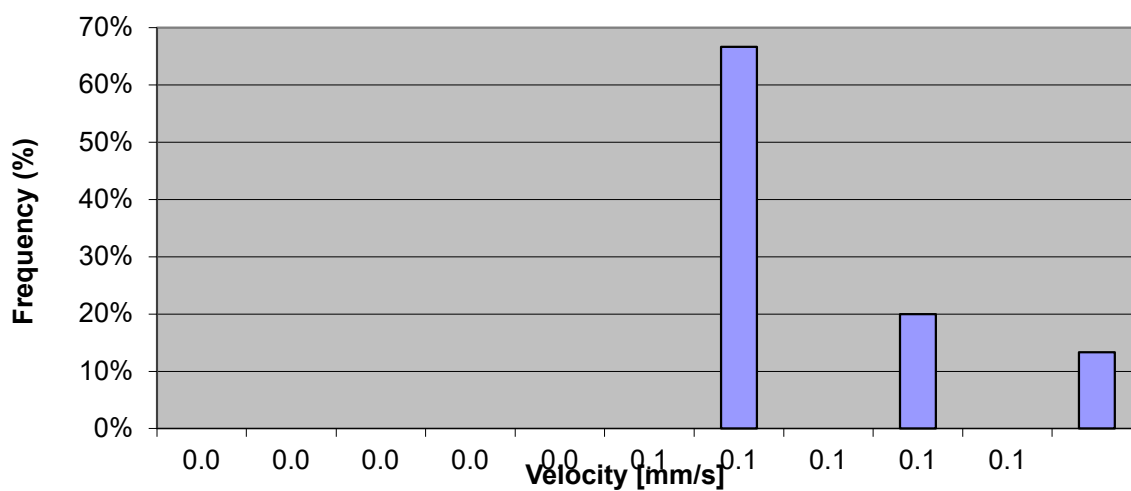
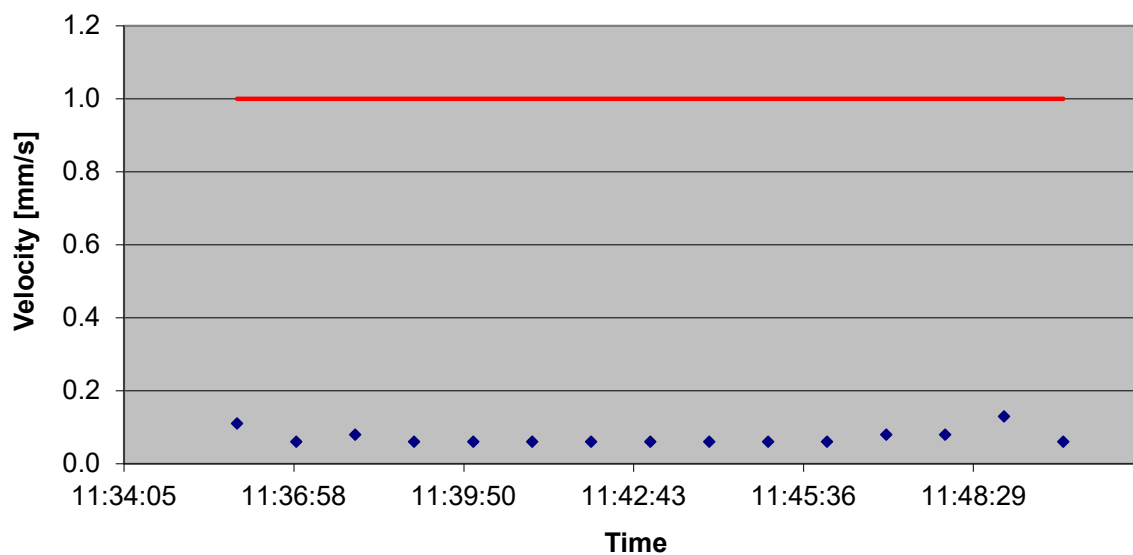
Vector Sum Frequency Histogram

Date	Start: Mon, 07 Sep 2020, 11:34 am	End: Mon, 07 Sep 2020, 11:52 am
Test Conducted By	Vanessa Zbinden	
Model Instrument	Texcel / Serial Number: 7497 / Calibrated on 06/07/2020 by ACU-VIB Certificate Number 27237	
Comments/Activities	Vacuum truck working around trees. Monitoring location: Next to the hoarding in front 7-9 Rhodes St	
Peak-Particle Vlocity (PPV) - For the assessment of Cosmetic Damage Concern	PPV was 0.13 mm/s when vacuum truck was working onsite (continuous source). Result comply with Condition C16 - EPA Recommended Vibration Criteria (Table 6, Section 6.2.2 Noise & Vibration Management Plan).

Tran	Vert	Long	Unit
0.05	0.16	0.08	mm/s

Peak Permissible Value :	1 mm/s
Number of Events > 1 mm/s :	0

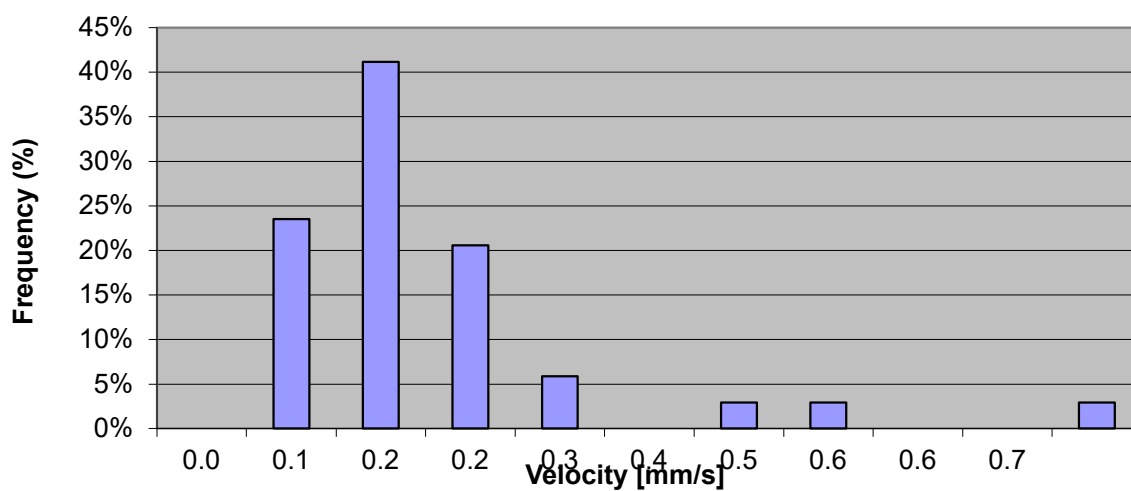
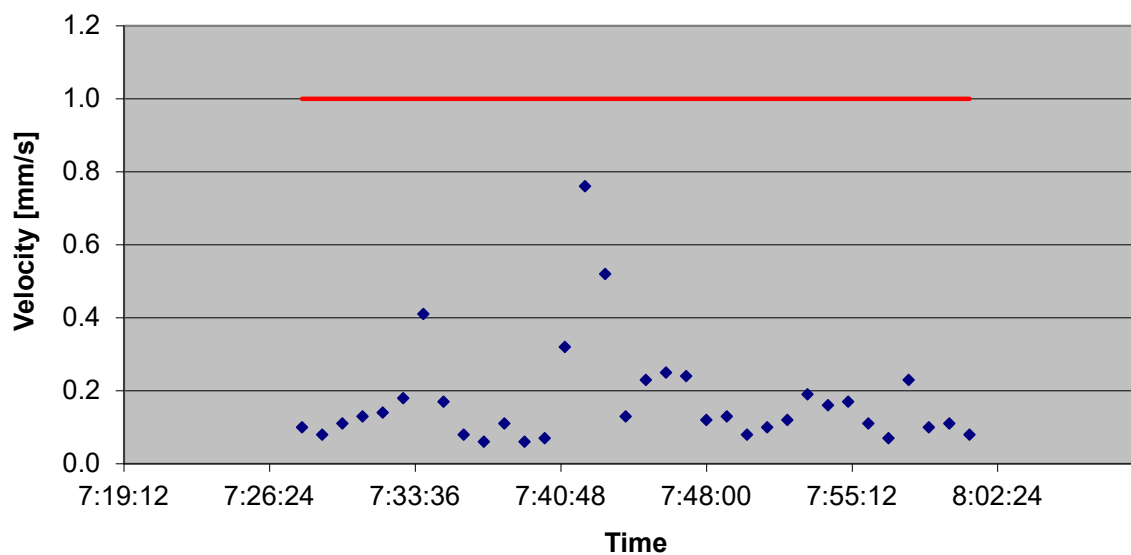
Vector Sum Frequency Histogram

Date	Start: Thu, 24 Sep 2020, 7:19 am	End: Thu, 24 Sep 2020, 8:02 am
Test Conducted By	Vanessa Zbinden	
Model Instrument	Texcel / Serial Number: 7497 / Calibrated on 06/07/2020 by ACU-VIB Certificate Number 27237	
Comments/Activities	Drilling. Monitoring location: Next to the hoarding in front 7-9 Rhodes St	
Peak-Particle Vlocity (PPV) - For the assessment of Cosmetic Damage Concern	PPV was 0.76 mm/s when drilling works were undertaken. (impulsive source). Result comply with Condition C16 - EPA Recommended Vibration Criteria (Table 6, Section 6.2.2 Noise & Vibration Management Plan).

Tran	Vert	Long	Unit
0.74	0.34	0.45	mm/s

Peak Permissible Value : **1 mm/s**
Number of Events > 1 mm/s : **0**

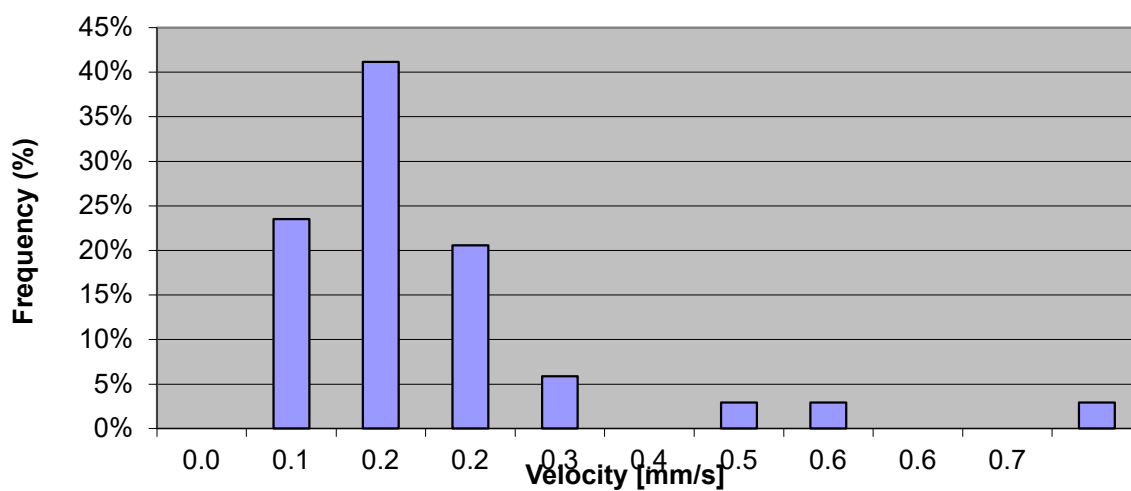
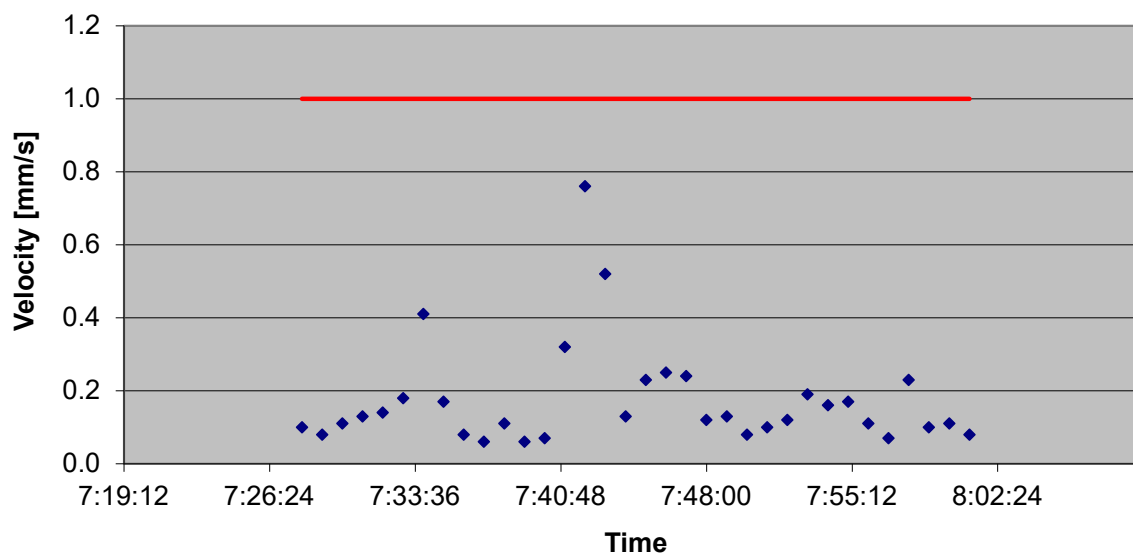
Vector Sum Frequency Histogram

Date	Start: Thu, 24 Sep 2020, 7:19 am	End: Thu, 24 Sep 2020, 8:02 am
Test Conducted By	Vanessa Zbinden	
Model Instrument	Texcel / Serial Number: 7497 / Calibrated on 06/07/2020 by ACU-VIB Certificate Number 27237	
Comments/Activities	Drilling. Monitoring location: Next to the hoarding in front 7-9 Rhodes St	
Peak-Particle Vlocity (PPV) - For the assessment of Cosmetic Damage Concern	PPV was 0.76 mm/s when drilling works were undertaken. (impulsive source). Result comply with Condition C16 - EPA Recommended Vibration Criteria (Table 6, Section 6.2.2 Noise & Vibration Management Plan).

Tran	Vert	Long	Unit
0.74	0.34	0.45	mm/s

Peak Permissible Value : **1 mm/s**
Number of Events > 1 mm/s : **0**

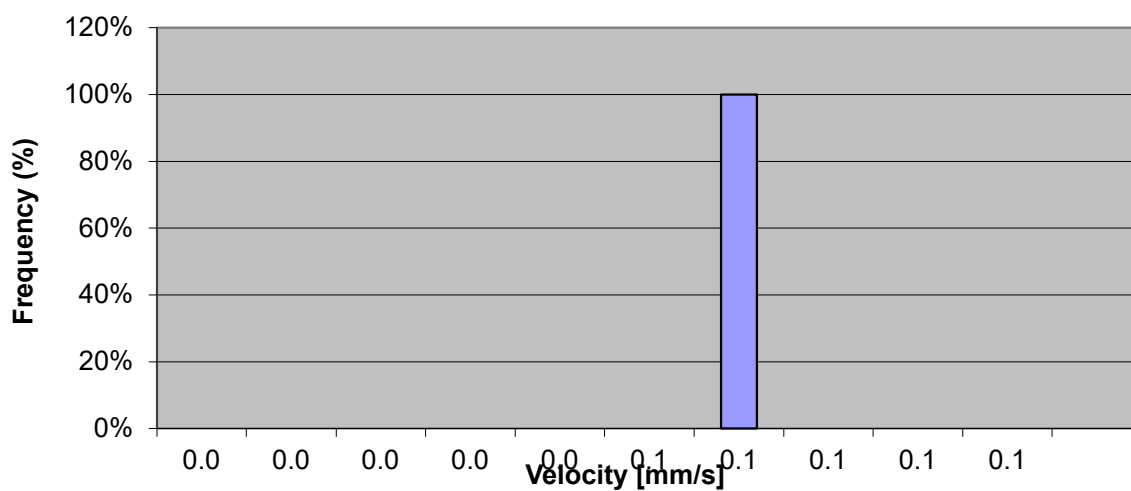
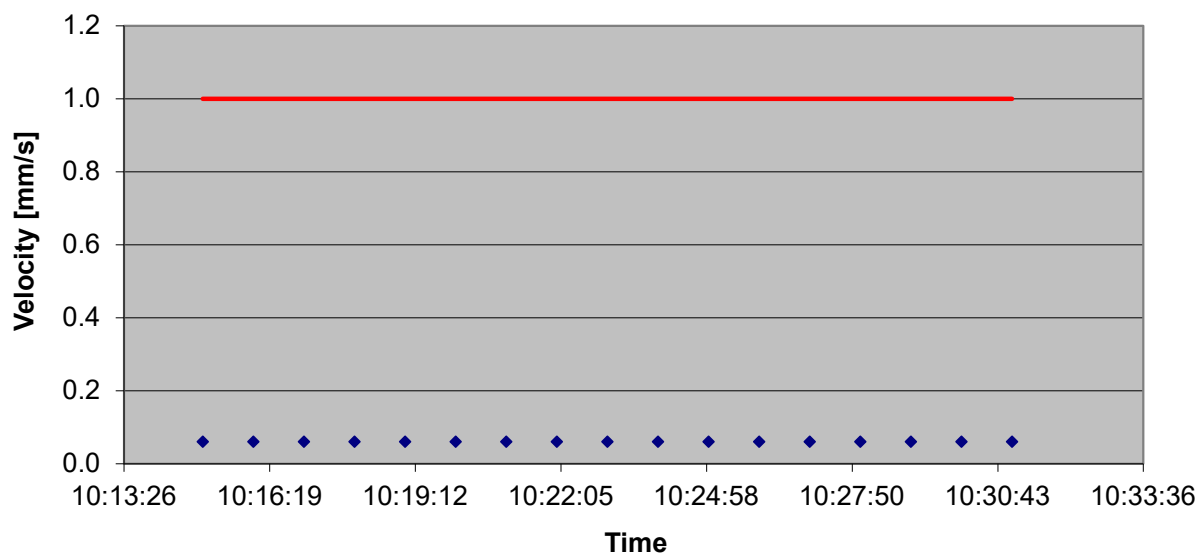
Vector Sum Frequency Histogram

Date	Start: Tue, 29 Sep 2020, 10:13 am	End: Tue, 29 Sep 2020, 10:33 am
Test Conducted By	Vanessa Zbinden	
Model Instrument	Texcel / Serial Number: 7497 / Calibrated on 06/07/2020 by ACU-VIB Certificate Number 27237	
Comments/Activities	Drilling. Monitoring location: Next to the hoarding in front 7-9 Rhodes St	
Peak-Particle Vlocity (PPV) - For the assessment of Cosmetic Damage Concern	PPV was 0.06 mm/s when drilling works were undertaken. (impulsive source). Result comply with Condition C16 - EPA Recommended Vibration Criteria (Table 6, Section 6.2.2 Noise & Vibration Management Plan).

Peak Permissible Value : **1 mm/s**
Number of Events > 1 mm/s : **0**

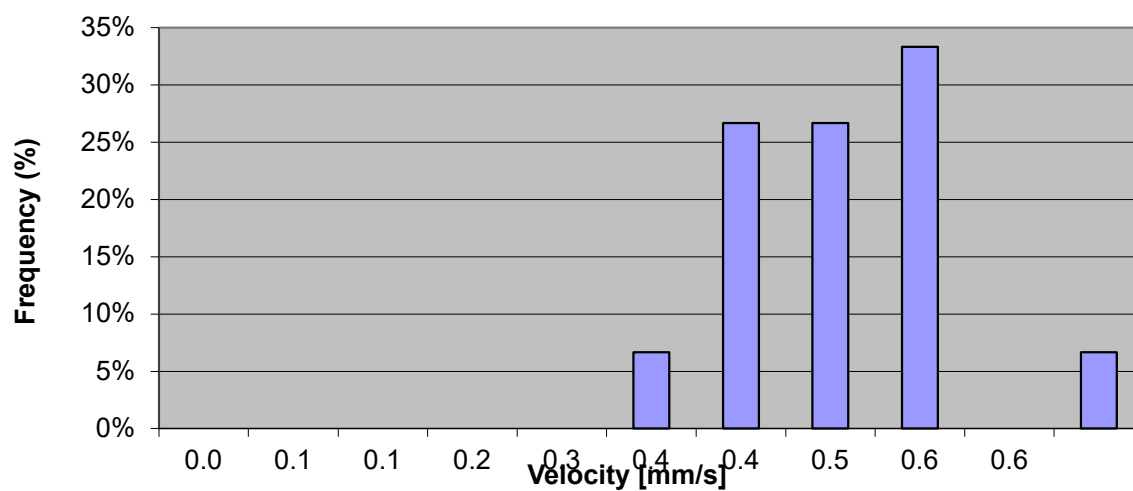
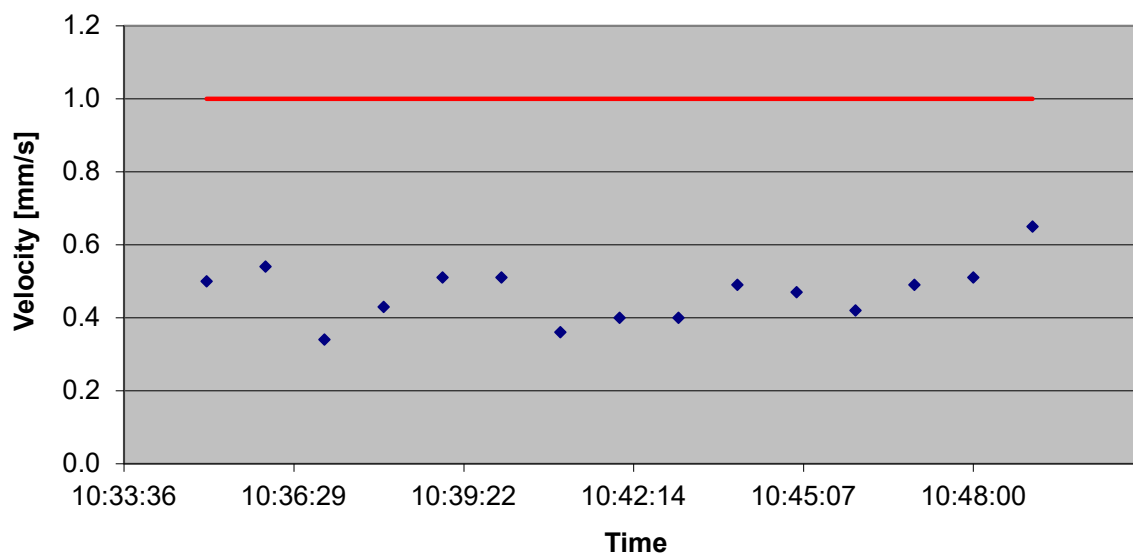
Vector Sum Frequency Histogram

Peak-Particle Vlocity (PPV) - For the assessment of Cosmetic Damage Concern PPV was 0.65 mm/s when rock breaking works were undertaken. (impulsive source). Result comply with Condition C16 - EPA Recommended Vibration Criteria (Table 6, Section 6.2.2 Noise & Vibration Management Plan).

Peak Permissible Value : **1 mm/s**
Number of Events > 1 mm/s : **0**
