Vibration Monitoring Report

SMEEP – Early Works

Document Number: W-EN-FM-o8 V2.0

Revision 1.0

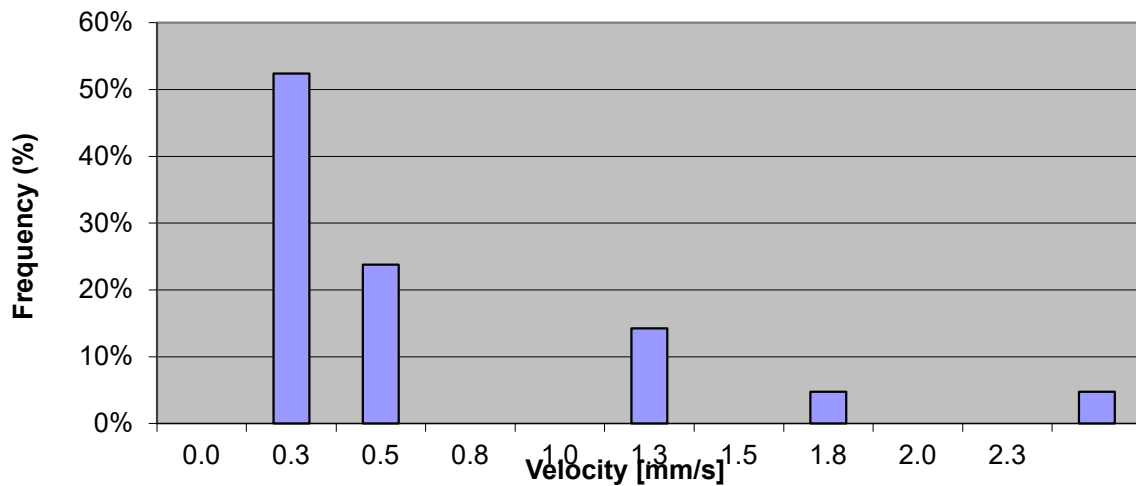
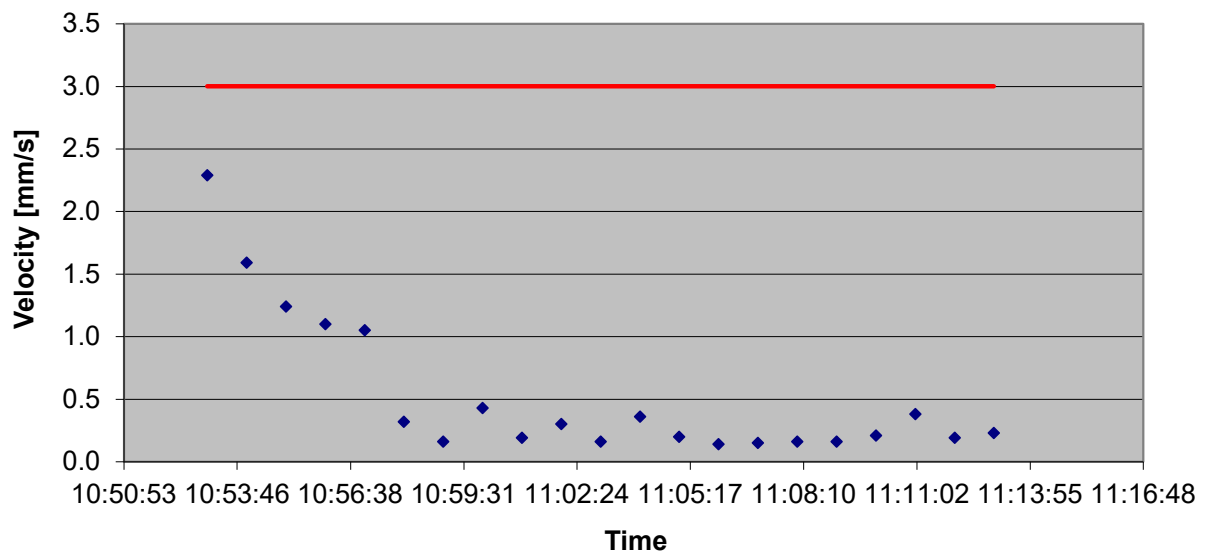
Vector Sum Frequency Histogram

Date	Start: Tue, 29 Sep 2020, 10:50 am	End: Tue, 29 Sep 2020, 11:16 am
Test Conducted By	Vanessa Zbinden	
Model Instrument	Texcel / Serial Number: 7497 / Calibrated on 06/07/2020 by ACU-VIB Certificate Number 27237	
Comments/Activities	Drilling and excavator working 2m away from monitoring location. Monitoring location: Next to the hoarding between work site and TAFE building	
Peak-Particle Vlocity (PPV) - For the assessment of Cosmetic Damage Concern	PPV was 2.29 mm/s when rock breaking works were undertaken. (impulsive source). Result comply with Condition C16 - EPA Recommended Vibration Criteria (Table 6, Section 6.2.2 Noise & Vibration Management Plan).

Peak Permissible Value : **3 mm/s**
Number of Events > 3 mm/s : **0**
