Bushfire Assessment

**New Primary School at
Murrumbateman**

Hansen Yuncken

30 April 2021

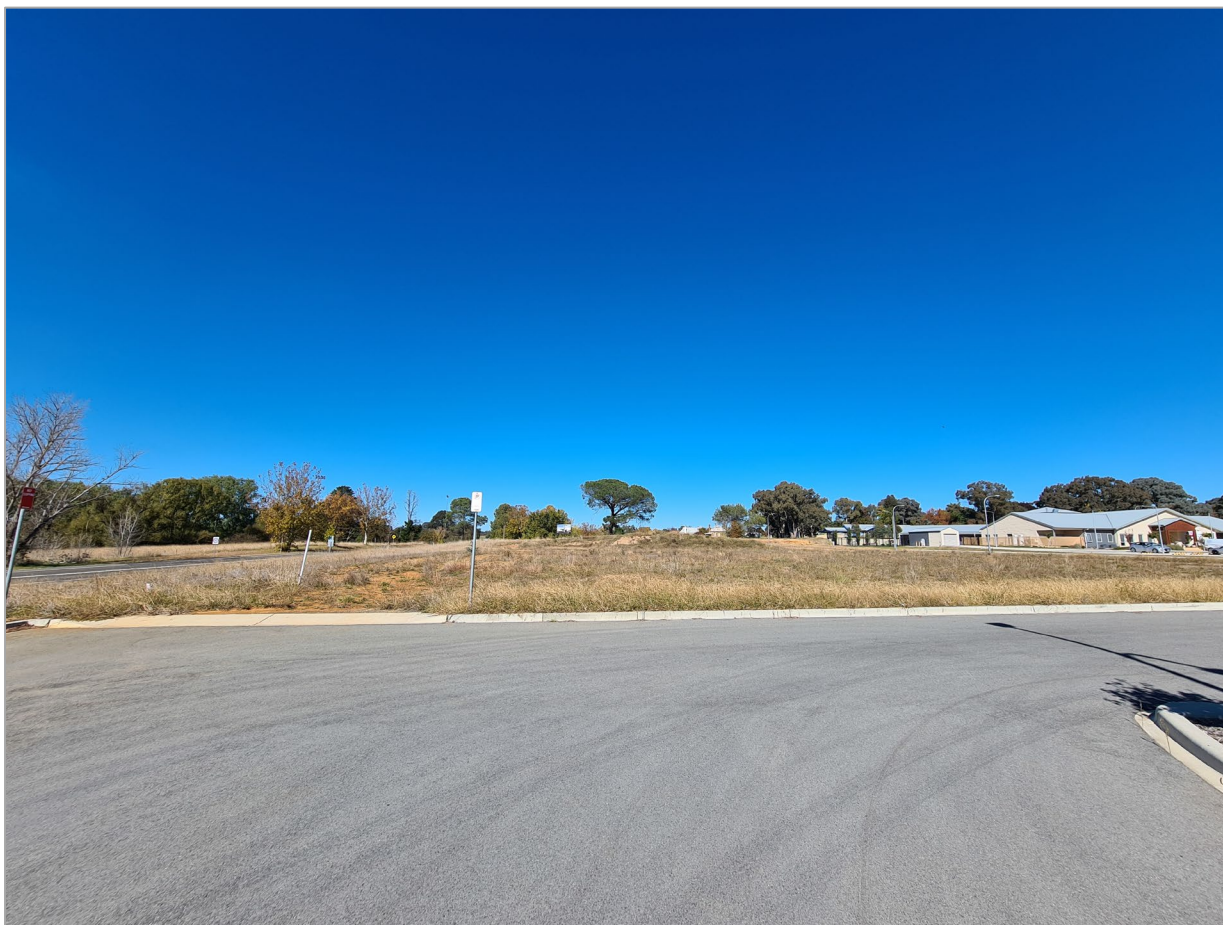
Photograph 1: View of subject land (view from north to south)

The site contains an existing parking lot in its northern end and a driveway along its western boundary. There is also a mound of soil at the southern end of the site. The site is otherwise cleared and vacant.

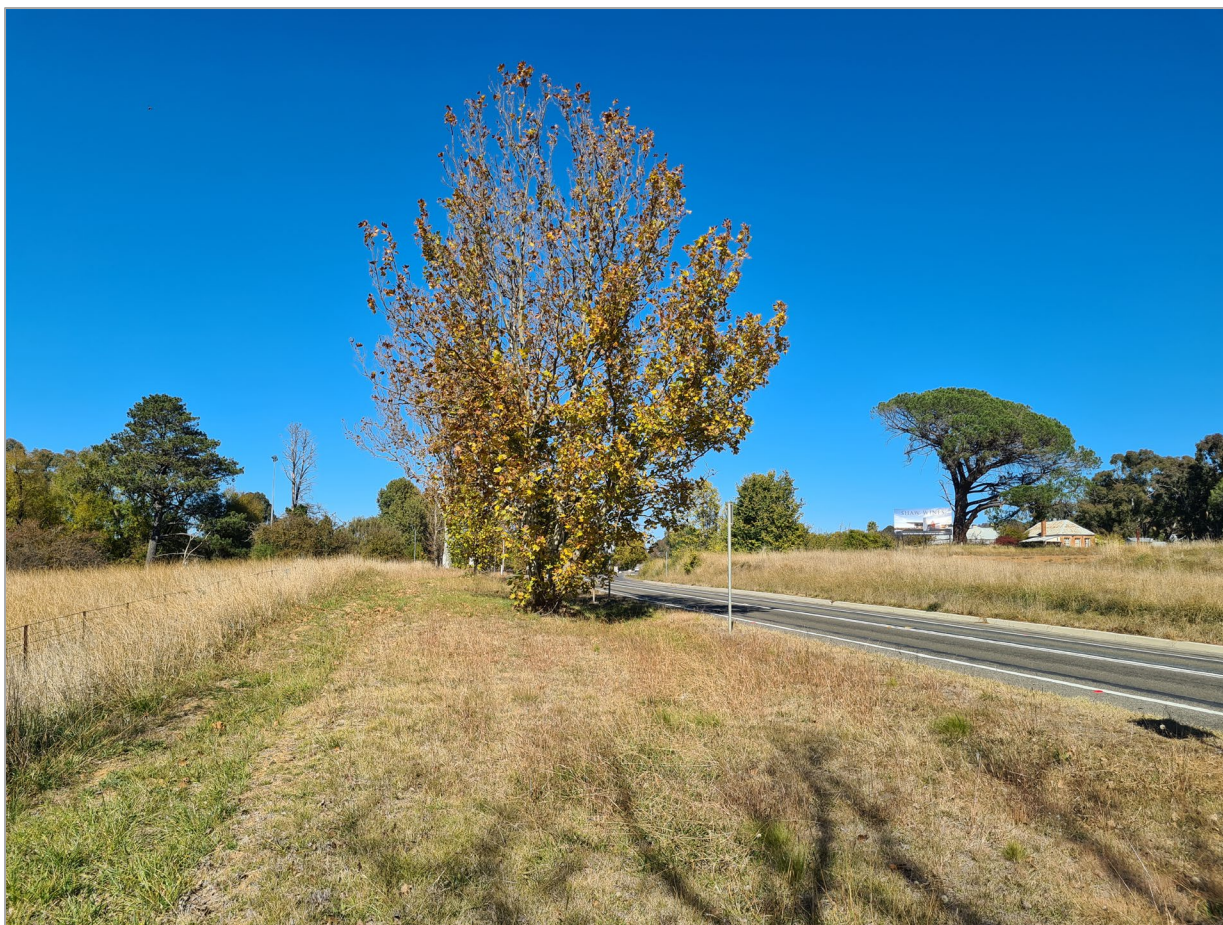
Photograph 2: Managed road reserve of Barton Highway to the east of the subject land

Table 2 shows that the available APZ achieves the minimum requirements therefore compliance is achieved. The required APZ to the grassland to the east is provided by the building setback within the subject land and the managed portion of the Barton Highway corridor up to the fence.

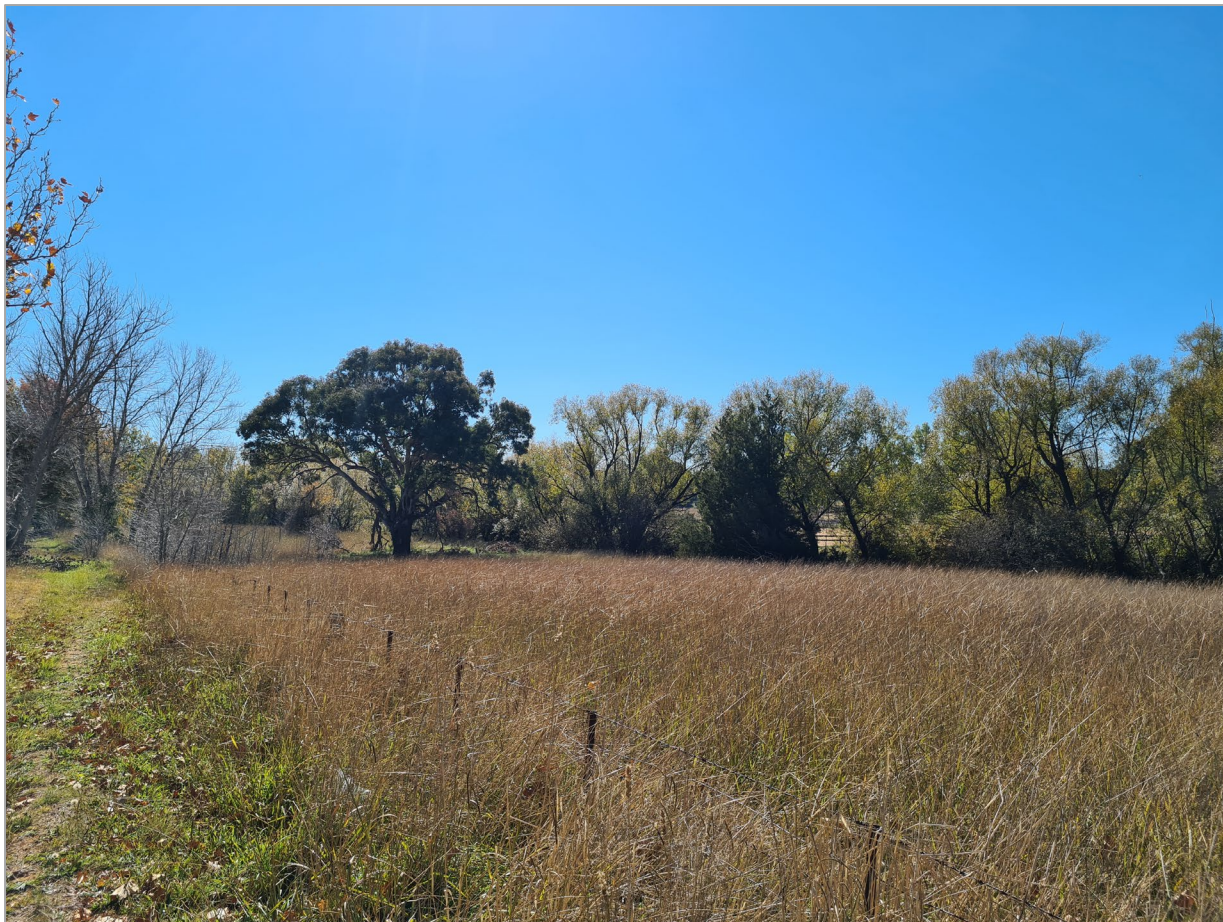
Photograph 3: Grassland hazard on downslope east of Barton Highway

The slope contributing to the rate of fire spread towards a proposed development is measured underneath the hazard where it is situated within 100 m of the subject land. The grassland hazard to the east is situated on a gradient in the PBP slope class of 'downslope 0-5 degrees'. The topography of the surrounding lands can be appreciated by the 1 m contour intervals shown on Figure 4.

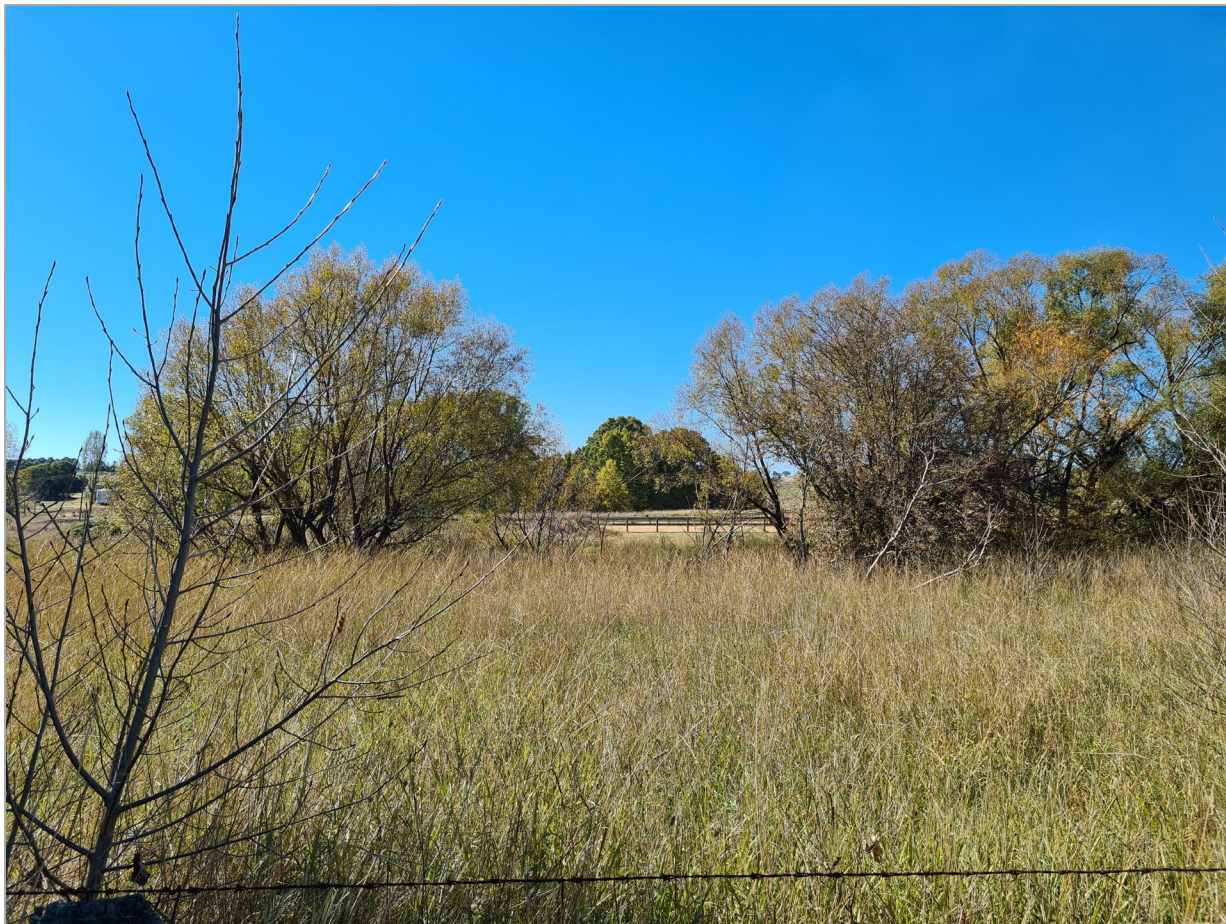
Photograph 4: Low threat vegetation located along drainage line to the east of grassland hazard

The bushfire hazard within the 140 m assessment area consists of unmanaged grassland to the east of Barton Highway as mapped on Figure 4. Beyond the grassland is a narrow corridor of exotic trees along a drainage line that is classified as 'low threat – exclusion' in accordance with PBP Section A1.10. This classification is due to the width of the corridor being less than 20 m wide and separation from the site and other areas of vegetation by at least 20 m. The vegetation is also regarded as low threat due to its composition being entirely exotic deciduous trees that do not present the flammability and fuel availability as with native trees. The corridor is therefore not considered a bushfire hazard and consideration of APZ and BAL is not required. The hazard classification was agreed to by RFS during consultation over the phone on 29th April 2021.
