Construction Soil and Water Management Plan

Newcastle High School Redevelopment

Document no: NA230761 R03

Project
**NEWCASTLE HIGH SCHOOL REDEVELOPMENT
CONSTRUCTION CERTIFICATE 1 - EARLY WORKS**
25A NATIONAL PARK STREET
NEWCASTLE WEST NSW 2302

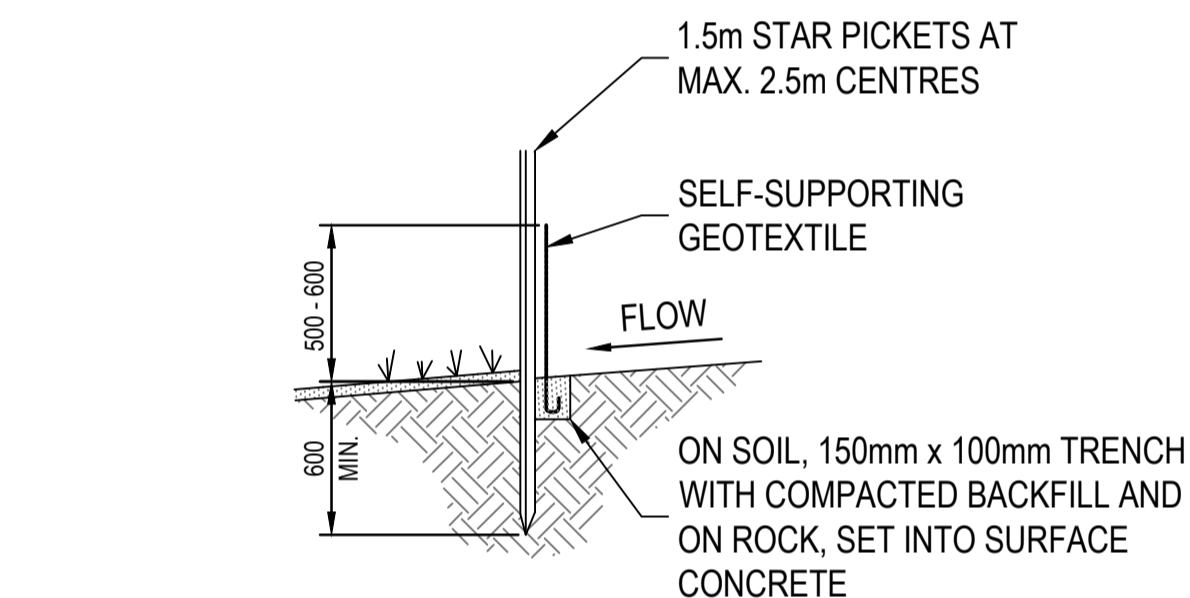
SECTION DETAIL

4. FIX SELF SUPPORTING GEOTEXTILE TO THE UPSLOPE SIDE OF THE POSTS ENSURING IT GOES TO THE BASE OF THE TRENCH. FIX THE GEOTEXTILE WITH WIRE TIES OR AS RECOMMENDED BY THE MANUFACTURER. ONLY USE GEOTEXTILE SPECIFICALLY PRODUCED FOR SEDIMENT FENCING. THE USE OF SHADE CLOTH FOR THIS PURPOSE IS NOT SATISFACTORY.

5. JOIN SECTIONS OF FABRIC AT A SUPPORT POST WITH A 150mm OVERLAP.
6. BACKFILL THE TRENCH OVER THE BASE OF THE FABRIC AND COMPACT IT THOROUGHLY OVER THE GEOTEXTILE.

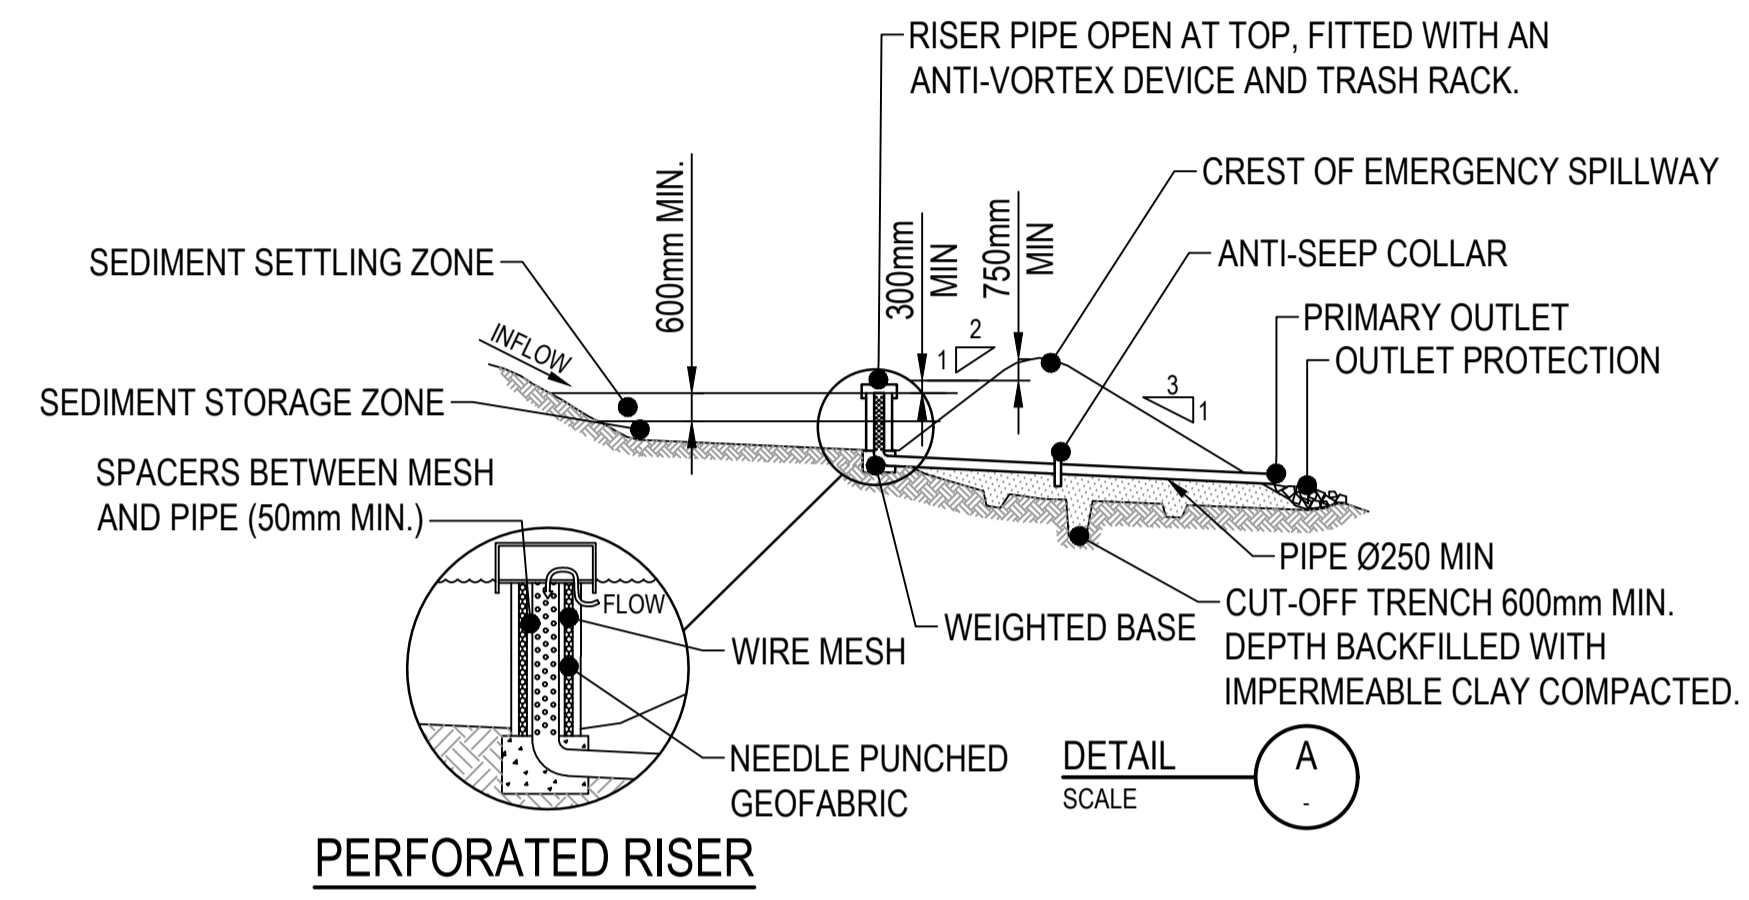
EARTH BASIN - DRY (SD 6-3)

- PREPARE THE SITE UNDER THE EMBANKMENT BY RIPPING TO AT LEAST 100mm TO HELP BOND THE COMPACTED FILL TO THE EXISTING SUBSTRATE.
- SPREAD THE FILL IN 100mm TO 150mm LAYERS AND COMPACT IT AT OPTIMUM MOISTURE CONTENT FOLLOWING THE SWMP.

- INSTALL THE PIPE OUTLET WITH SEEPAGE COLLARS AS SPECIFIED IN THE SWMP AND STANDARD DRAWING 6-3B.
- FORM BATTER GRADES AT 2(H):1(V) UPSTREAM AND 3(H):1(V) DOWNSTREAM OR AS SPECIFIED IN THE SWMP.

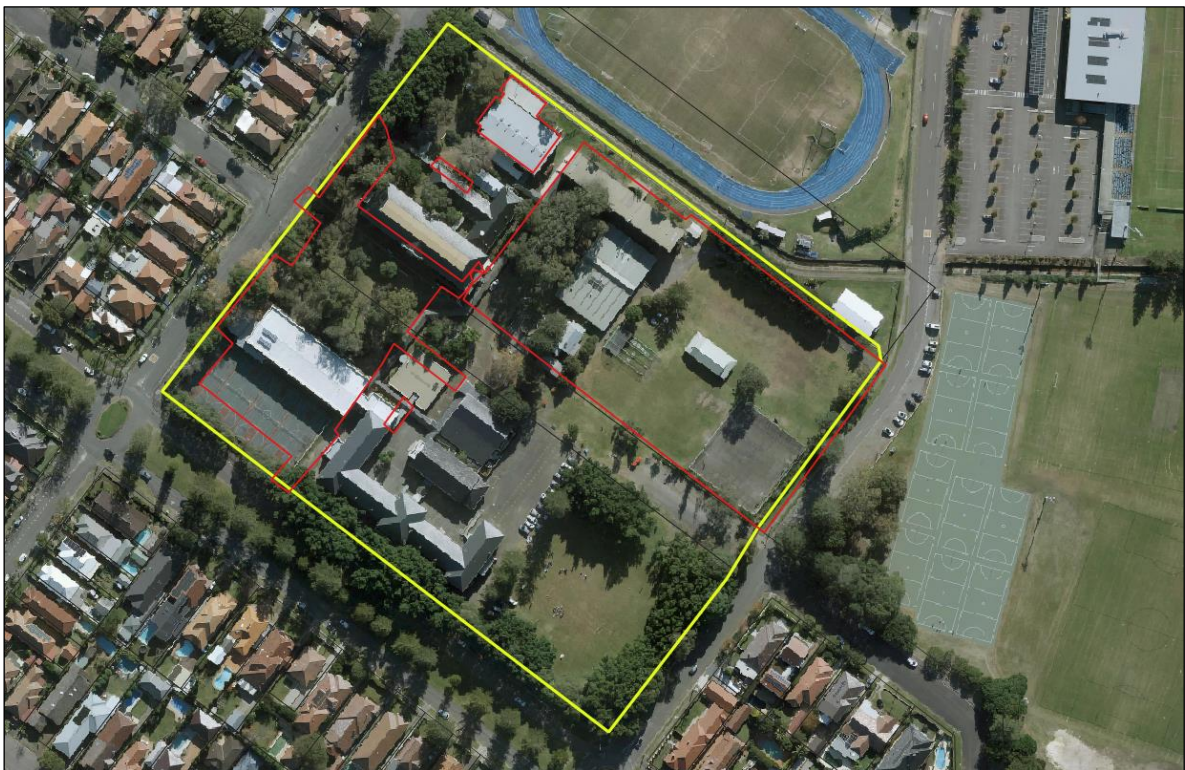
Figure 1: School Boundary (yellow) and site investigation boundary 'the site' (red)

The site is shown on Figure 1.

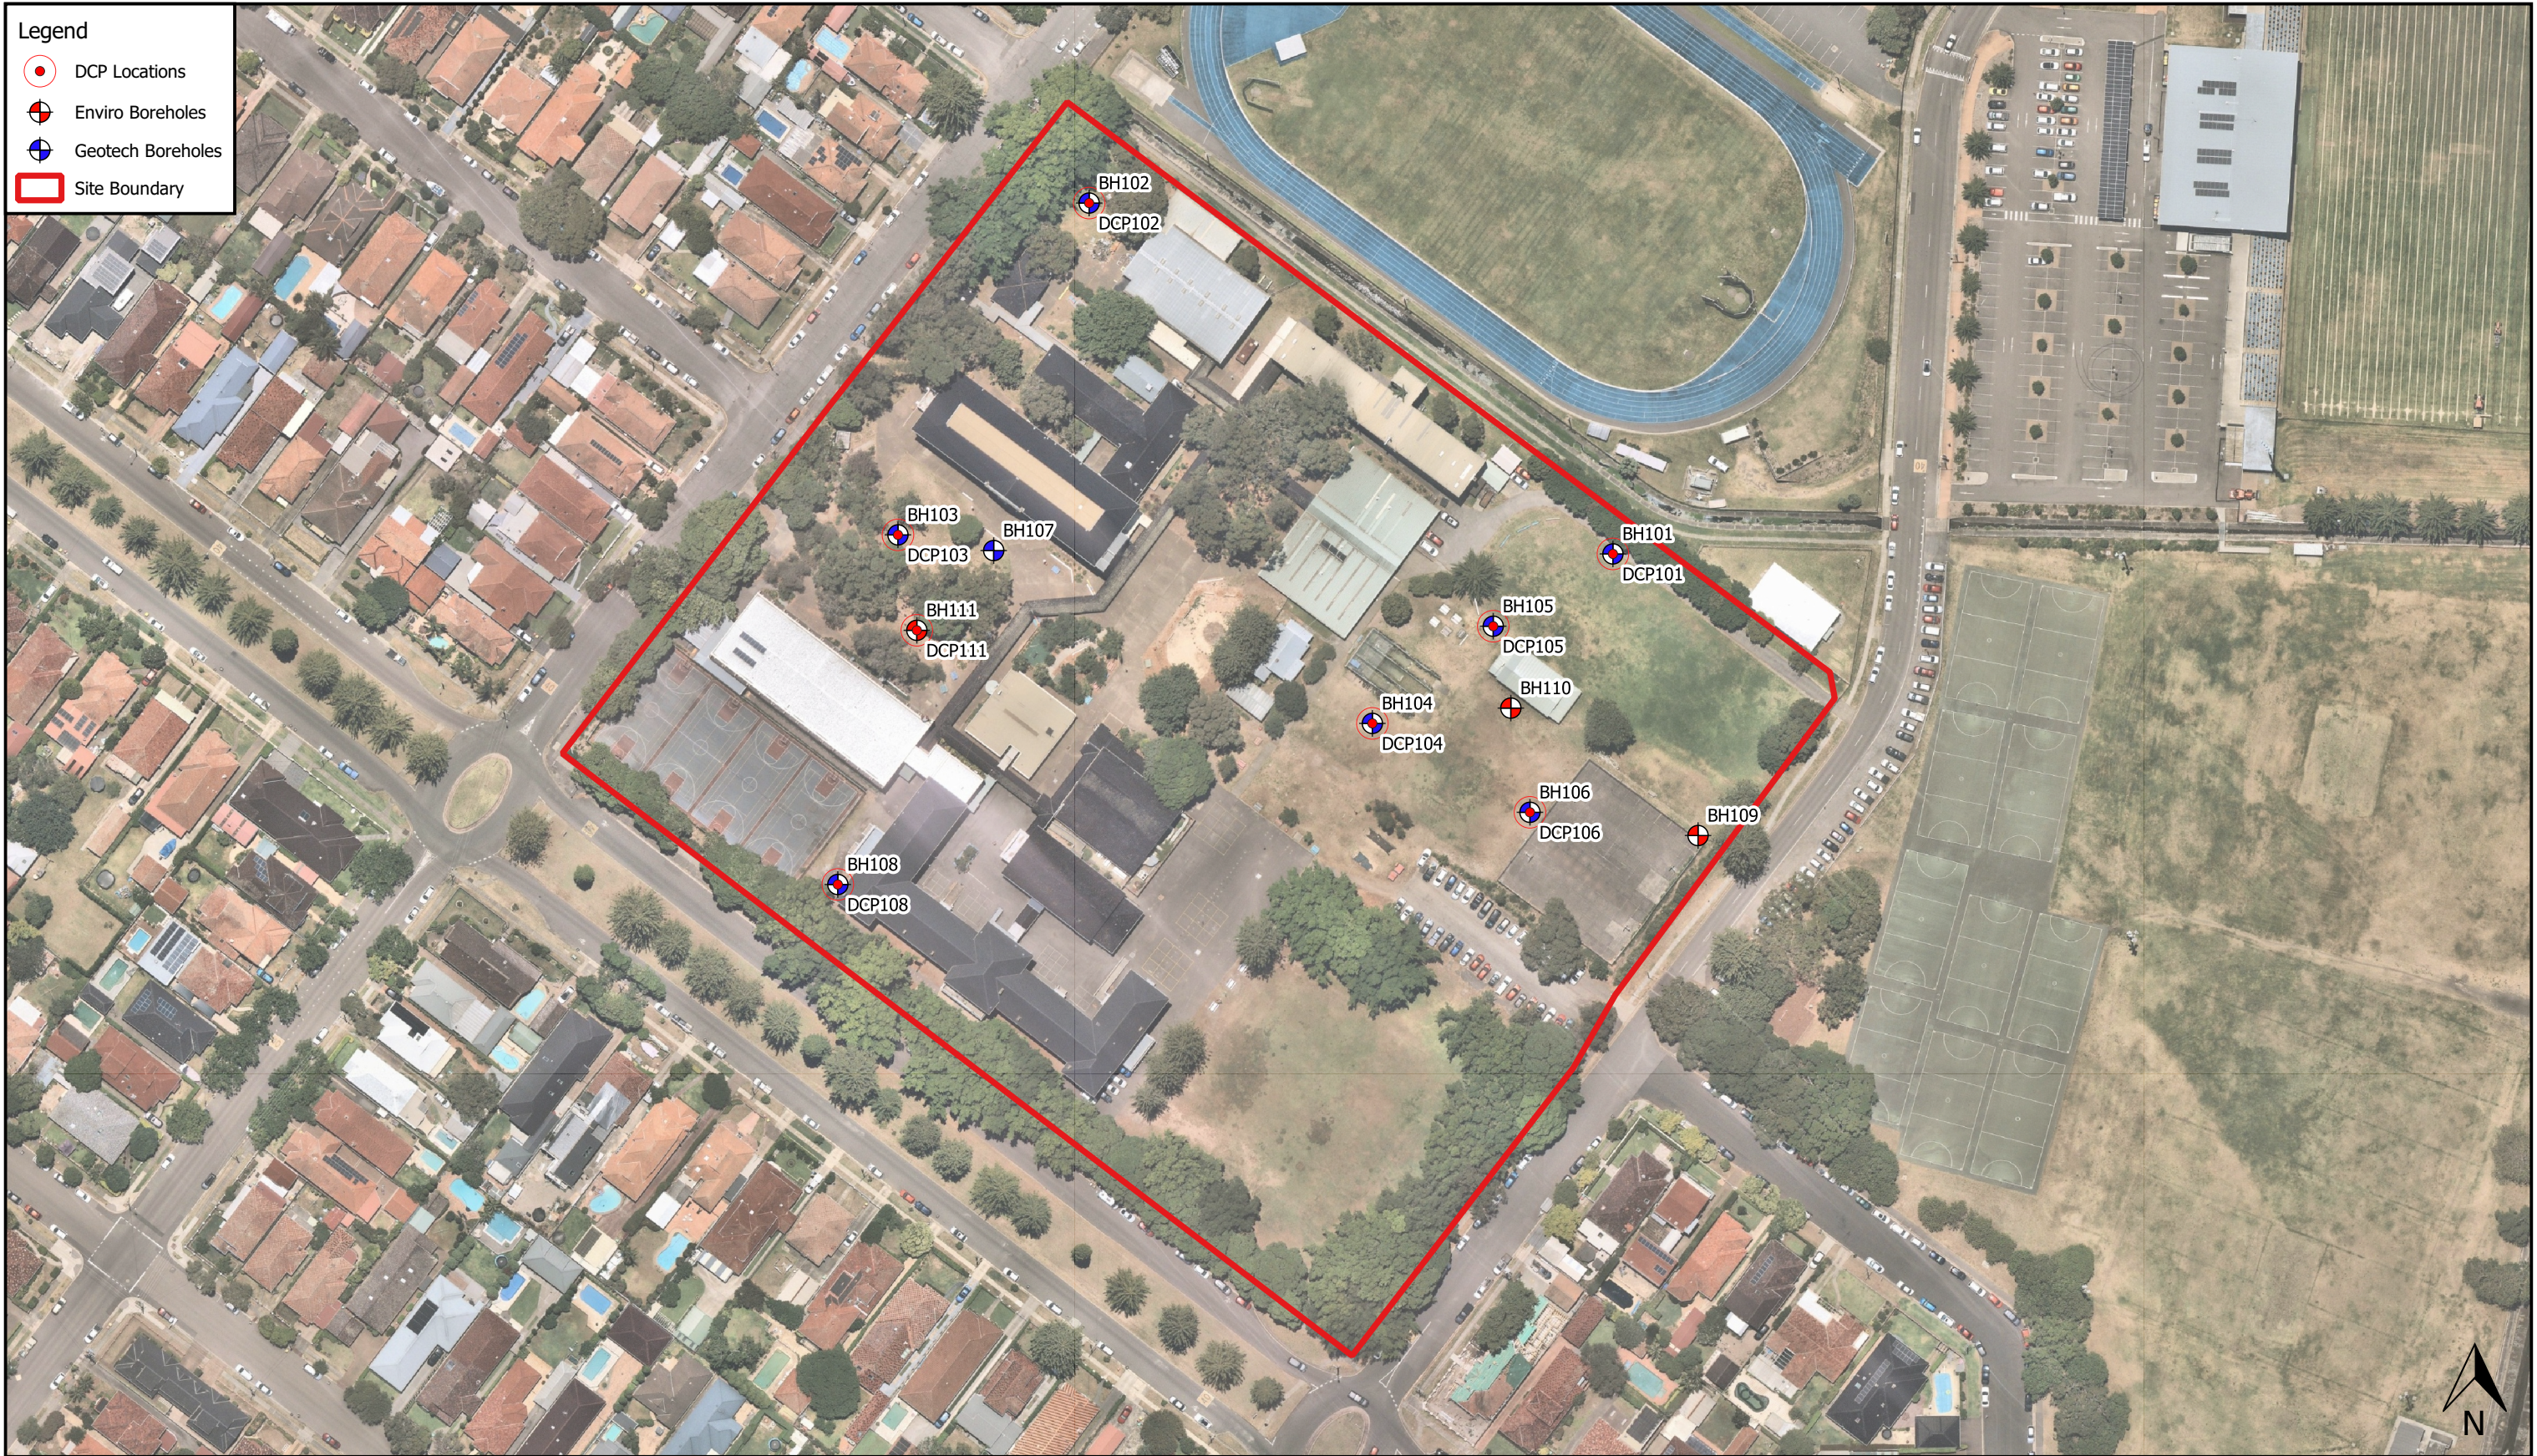
- DCP Locations
- ⊕ Enviro Boreholes
- ⊕ Geotech Boreholes
- Site Boundary
