**Revised Dewatering Management Plan
(Temporary Dewatering for Construction)**

**Newcastle High School Upgrade
25a National Park Street, Newcastle West**

Prepared for Hansen Yuncken Pty Ltd

Project 213618.04

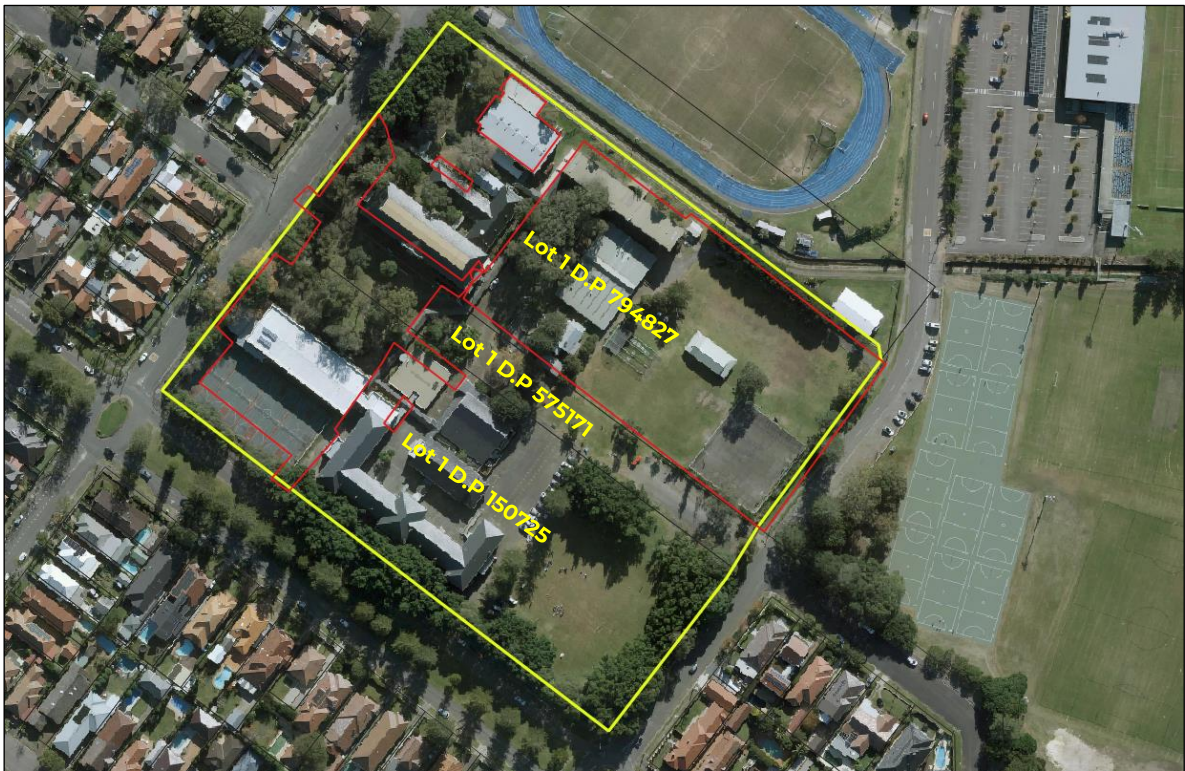
Figure 1: Newcastle High School boundary in yellow, and site investigation boundary 'the site' in red.

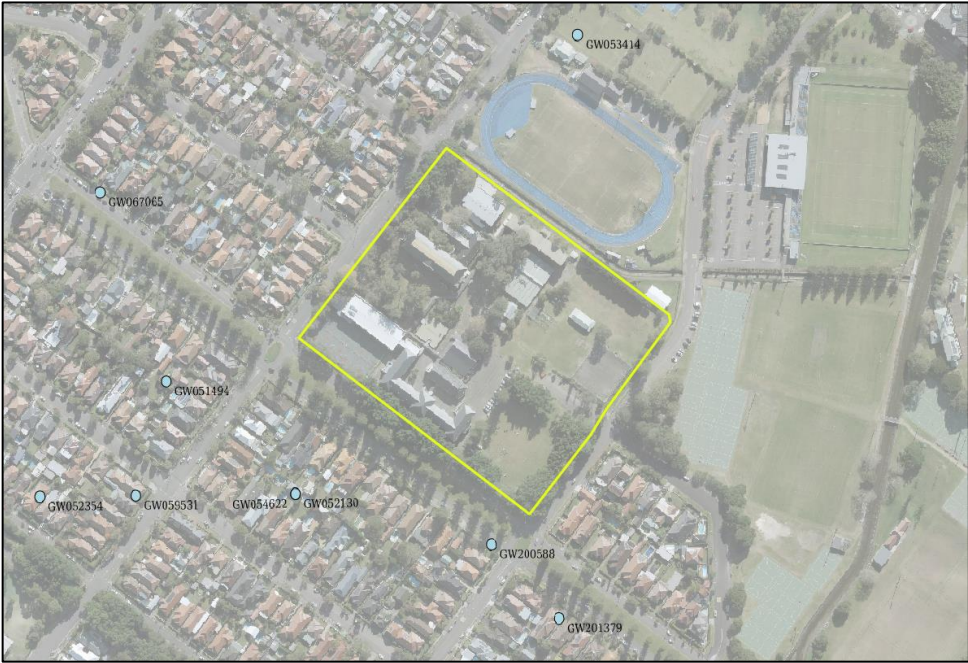
<p>Figure 4: Registered groundwater bores in blue, site in yellow.</p>
<p>Groundwater Dependant Ecosystems (GDE)</p>	<p>A review of the Bureau of Meteorology Groundwater Dependant Ecosystems Atlas indicates that there are no mapped aquatic, subterranean or terrestrial GDEs within 1 km of the site. The closest GDE to the site is approximately 1.3 km south-east which comprises a moderate potential for terrestrial GDE (South Coast Sands Dry Sclerophyll Forests). No springs were listed within 500 m of the NSW Hydrography Spatial Data site (The Central Resource for Sharing and Enabling Environmental Data in NSW, SEED).</p>
<p>Salinity</p>	<p>A review of NSW Government online eSPADE mapping indicates limited salinity data within the Newcastle area. Mapping indicates one data point approximately 400 m north of the site as “no salting evident”. A review of the Australia Dryland Salinity Assessment Spatial Data (1:2,500,000) - NLWRA 2001 indicates the site lies outside a mapped high salinity risk or high salinity hazard area with the nearest mapped area located approximately 7 km away. Groundwater field testing of monitoring wells and the adjacent surface water drain as part of the DSI (Douglas, 2023b) indicated electrical conductivity (EC) were “fresh” which is consistent with the limited salinity data (ie EC 243 to 642 $\mu\text{S}/\text{cm}$).</p>

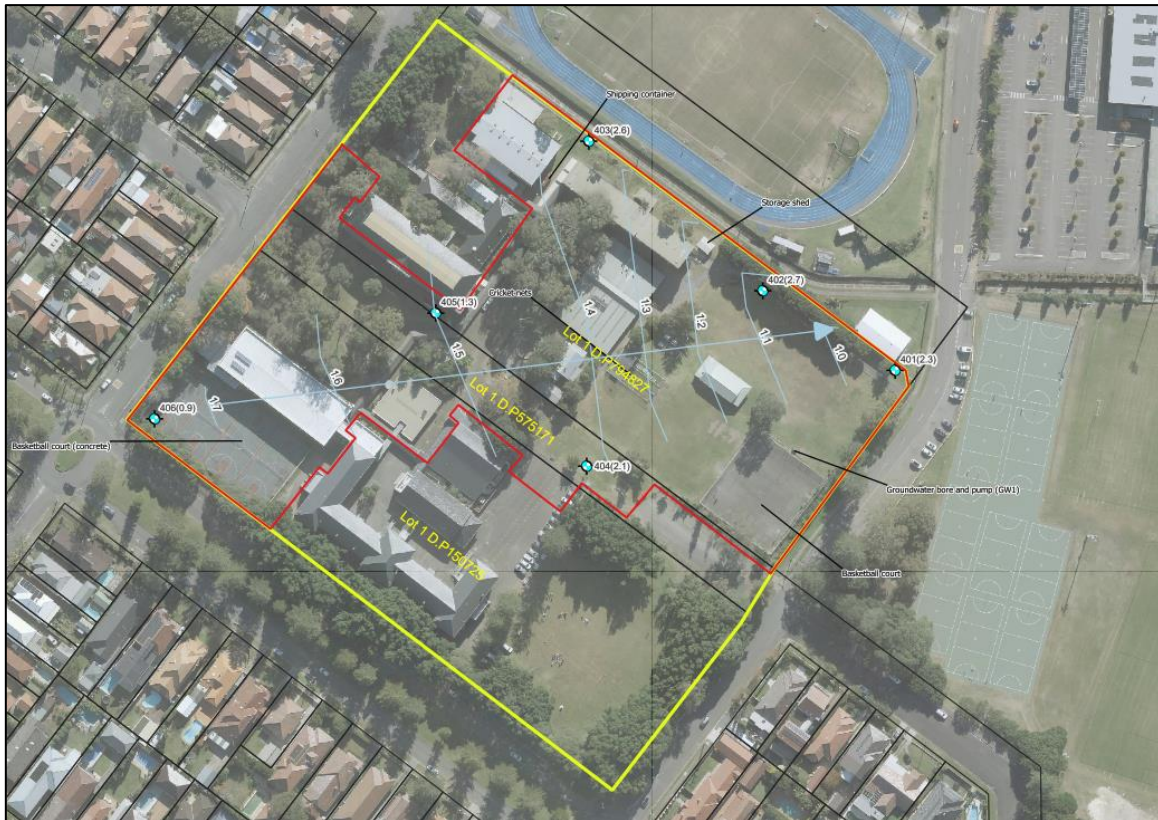
Figure 5: Inferred groundwater contours – 23 March 2023 (Douglas, 2023b)

Groundwater level monitoring using automated dataloggers was undertaken in three wells near and downgradient of the proposed borrow pits (Wells 402, 404 and 405) from 27 November 2023 to 16 January 2024. Groundwater levels versus rainfall are shown on Figure F1 in Appendix C. Contours from 23 March 2023 from Douglas (2023e) are shown in Figure 5.

It is noted groundwater levels recorded during drilling or from CPTs are not always representative of stabilised conditions and levels in monitoring wells would generally be considered more accurate. The levels reported by Martens (2021) which are 0 AHD or less are likely to be spurious, and as a minimum would be expected > RL 0.5.

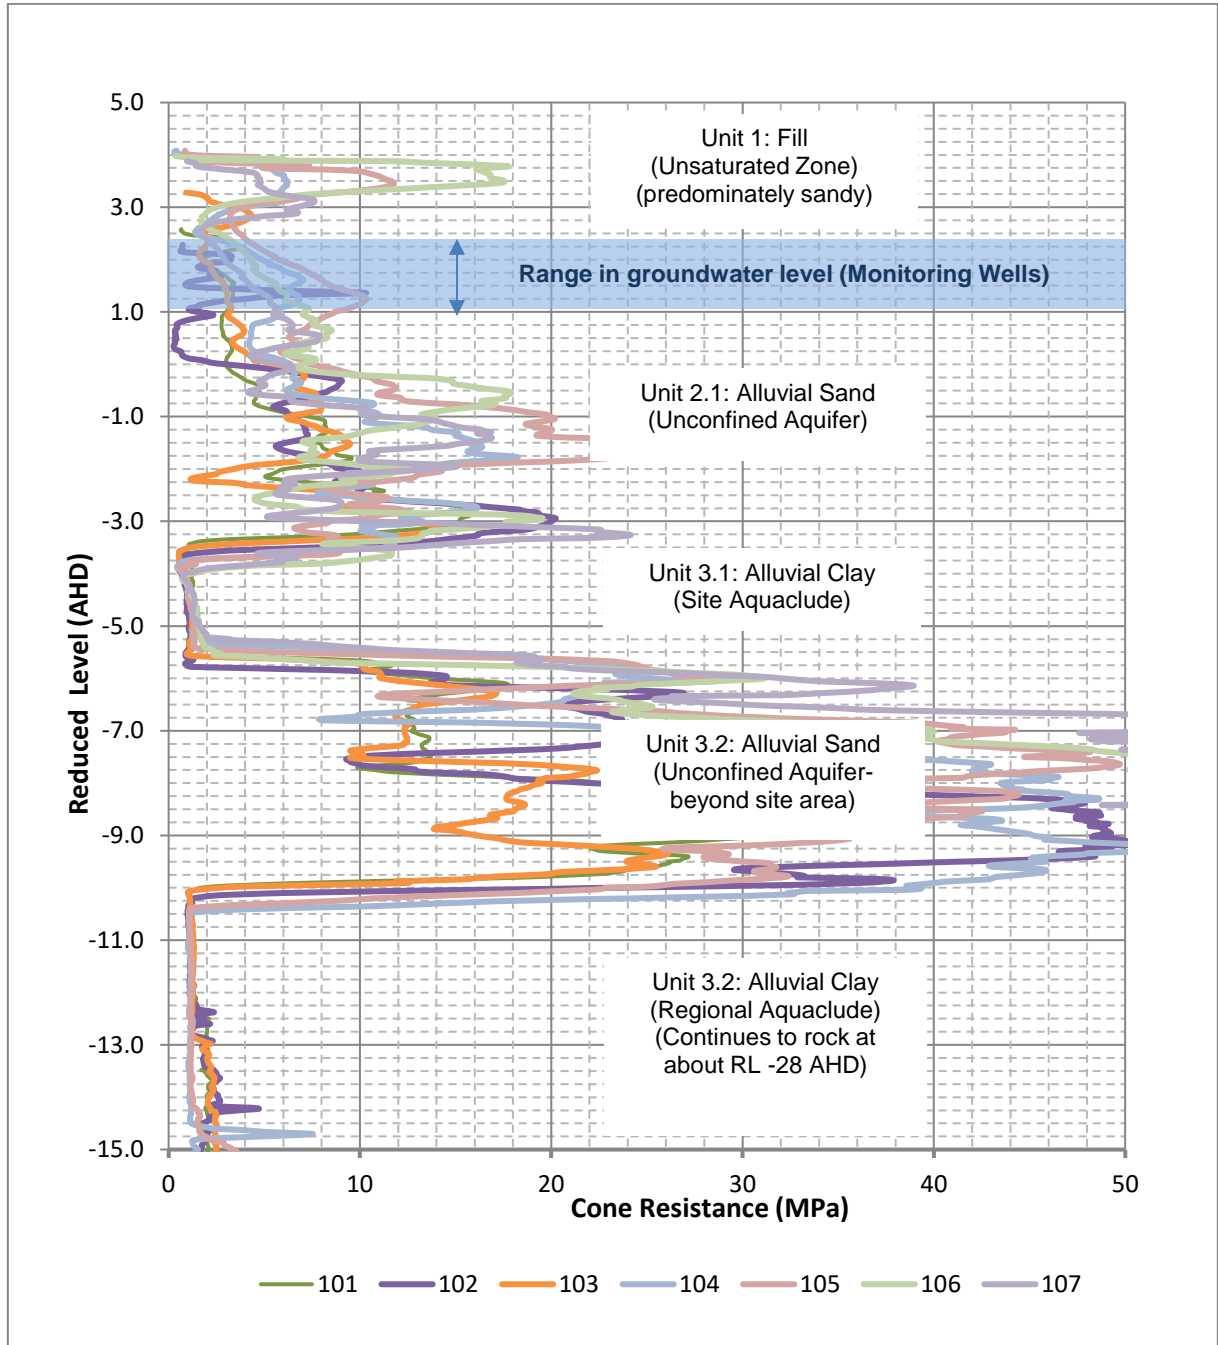
Figure 6: CPT plot showing cone resistance compared to elevation (AHD)

Based on the previous subsurface investigations, the following preliminary conceptual hydrogeological (CHM) model has been prepared for the purposes of estimating groundwater inflows, in the instance that dewatering is required. The various layers are illustrated in Figure 6. Estimated ranges of hydraulic conductivities presented in Table 5 based on measured parameters and published literature by Fetter (2001) and experience with similar soils.
