Report on
Supplementary Contamination Assessment

Pendle Hill High School Development
Cornock Avenue, Toongabbie

Prepared for
TSA Management Pty Ltd

Project 86977.01
May 2021

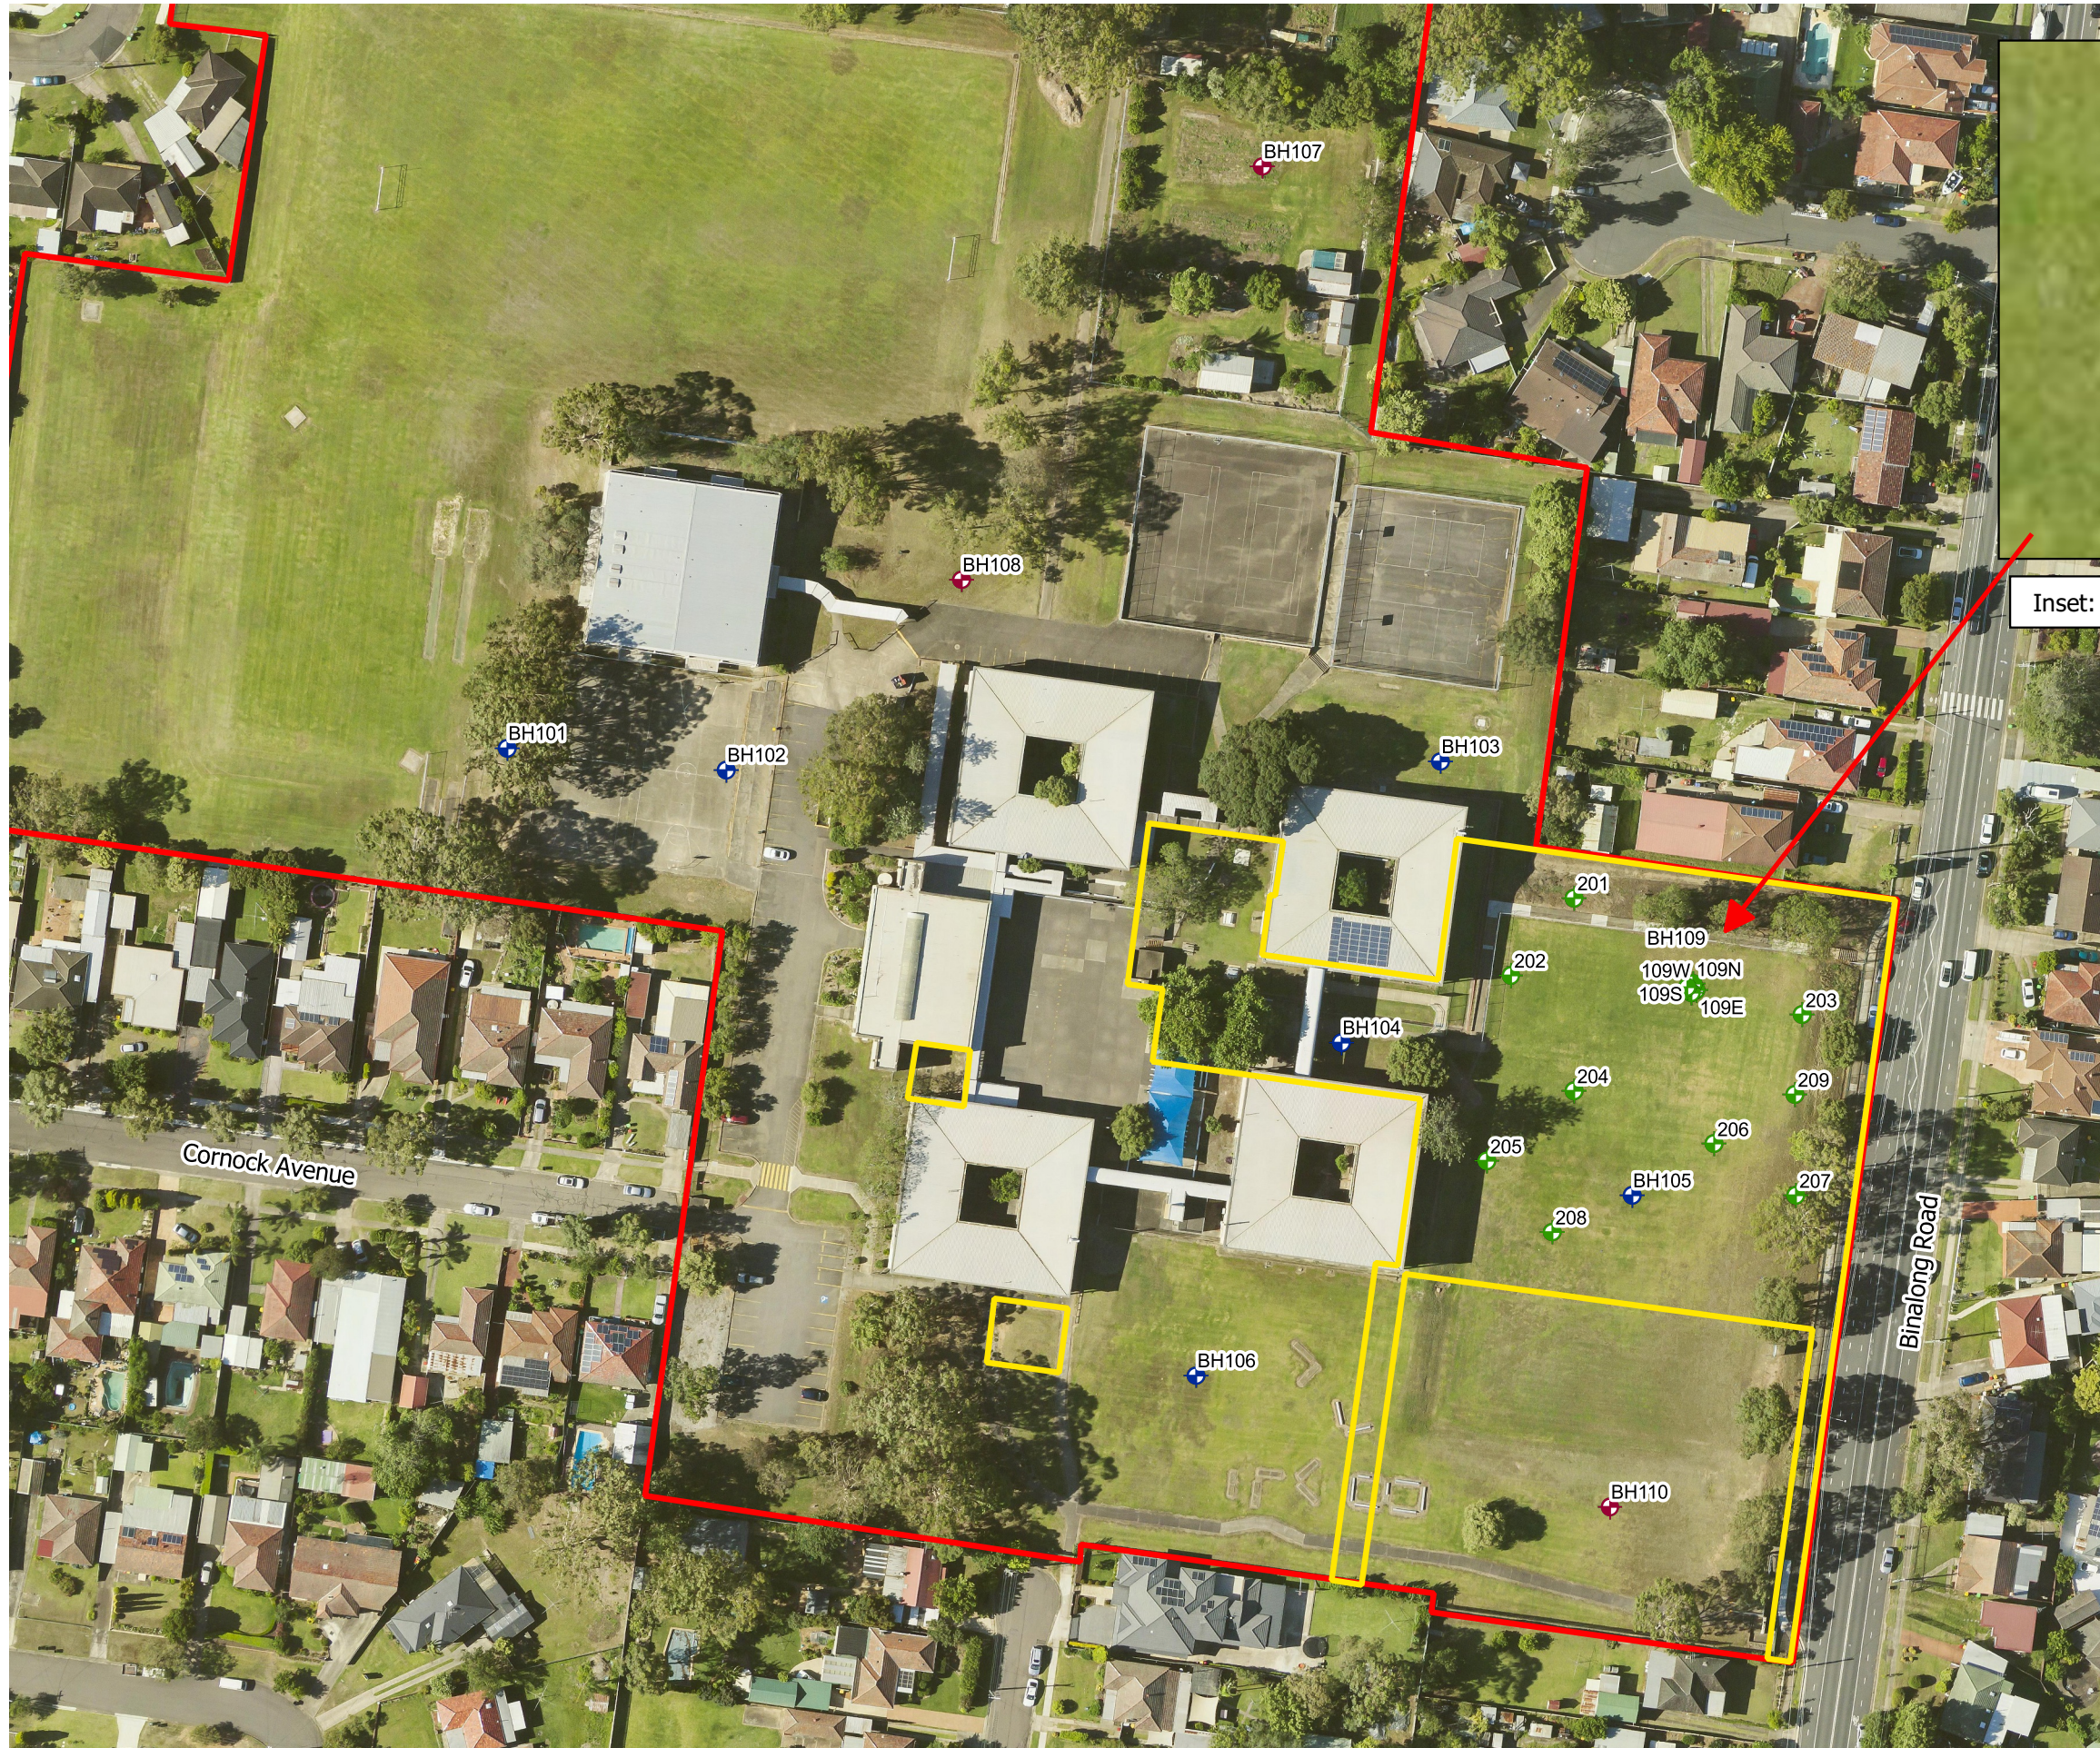
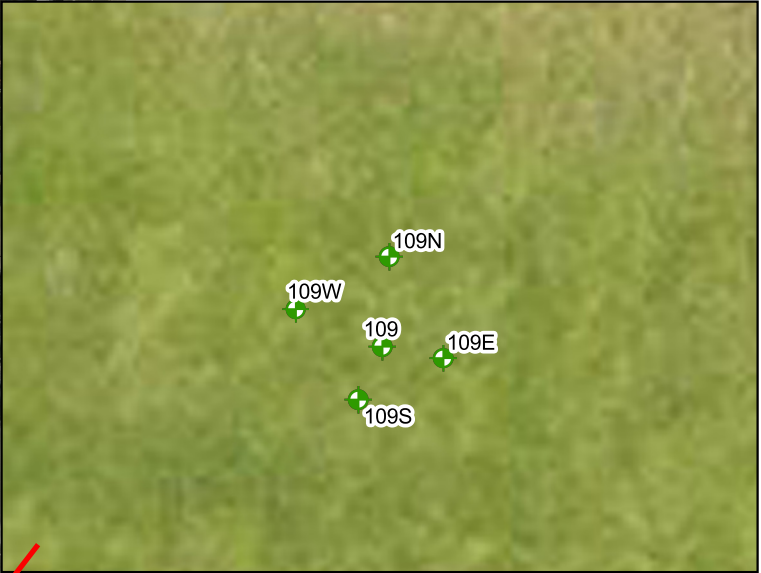
Inset: Sample Locations around 109

The supplementary assessment included the drilling of four test bores (BH109 N, E, S, W). An additional 9 boreholes (BH201-209) were also drilled within the remainder of the Site for the purposes of a concurrent salinity investigation. The details of the field work and testing are presented in this report, together with comments and recommendations on the issues listed above. The investigation and report have been carried out as with reference made to relevant EPA Guidelines and or other regulatory instruments and as required by general requirement 19 of the Planning Secretary's Environmental Assessment Requirements (SEARS), as listed below:
