Remediation Action Plan

Pendle Hill High School Development  
Cornock Avenue, Toongabbie

Prepared for  
TSA Management Pty Ltd

Project 86977.01  
May 2021

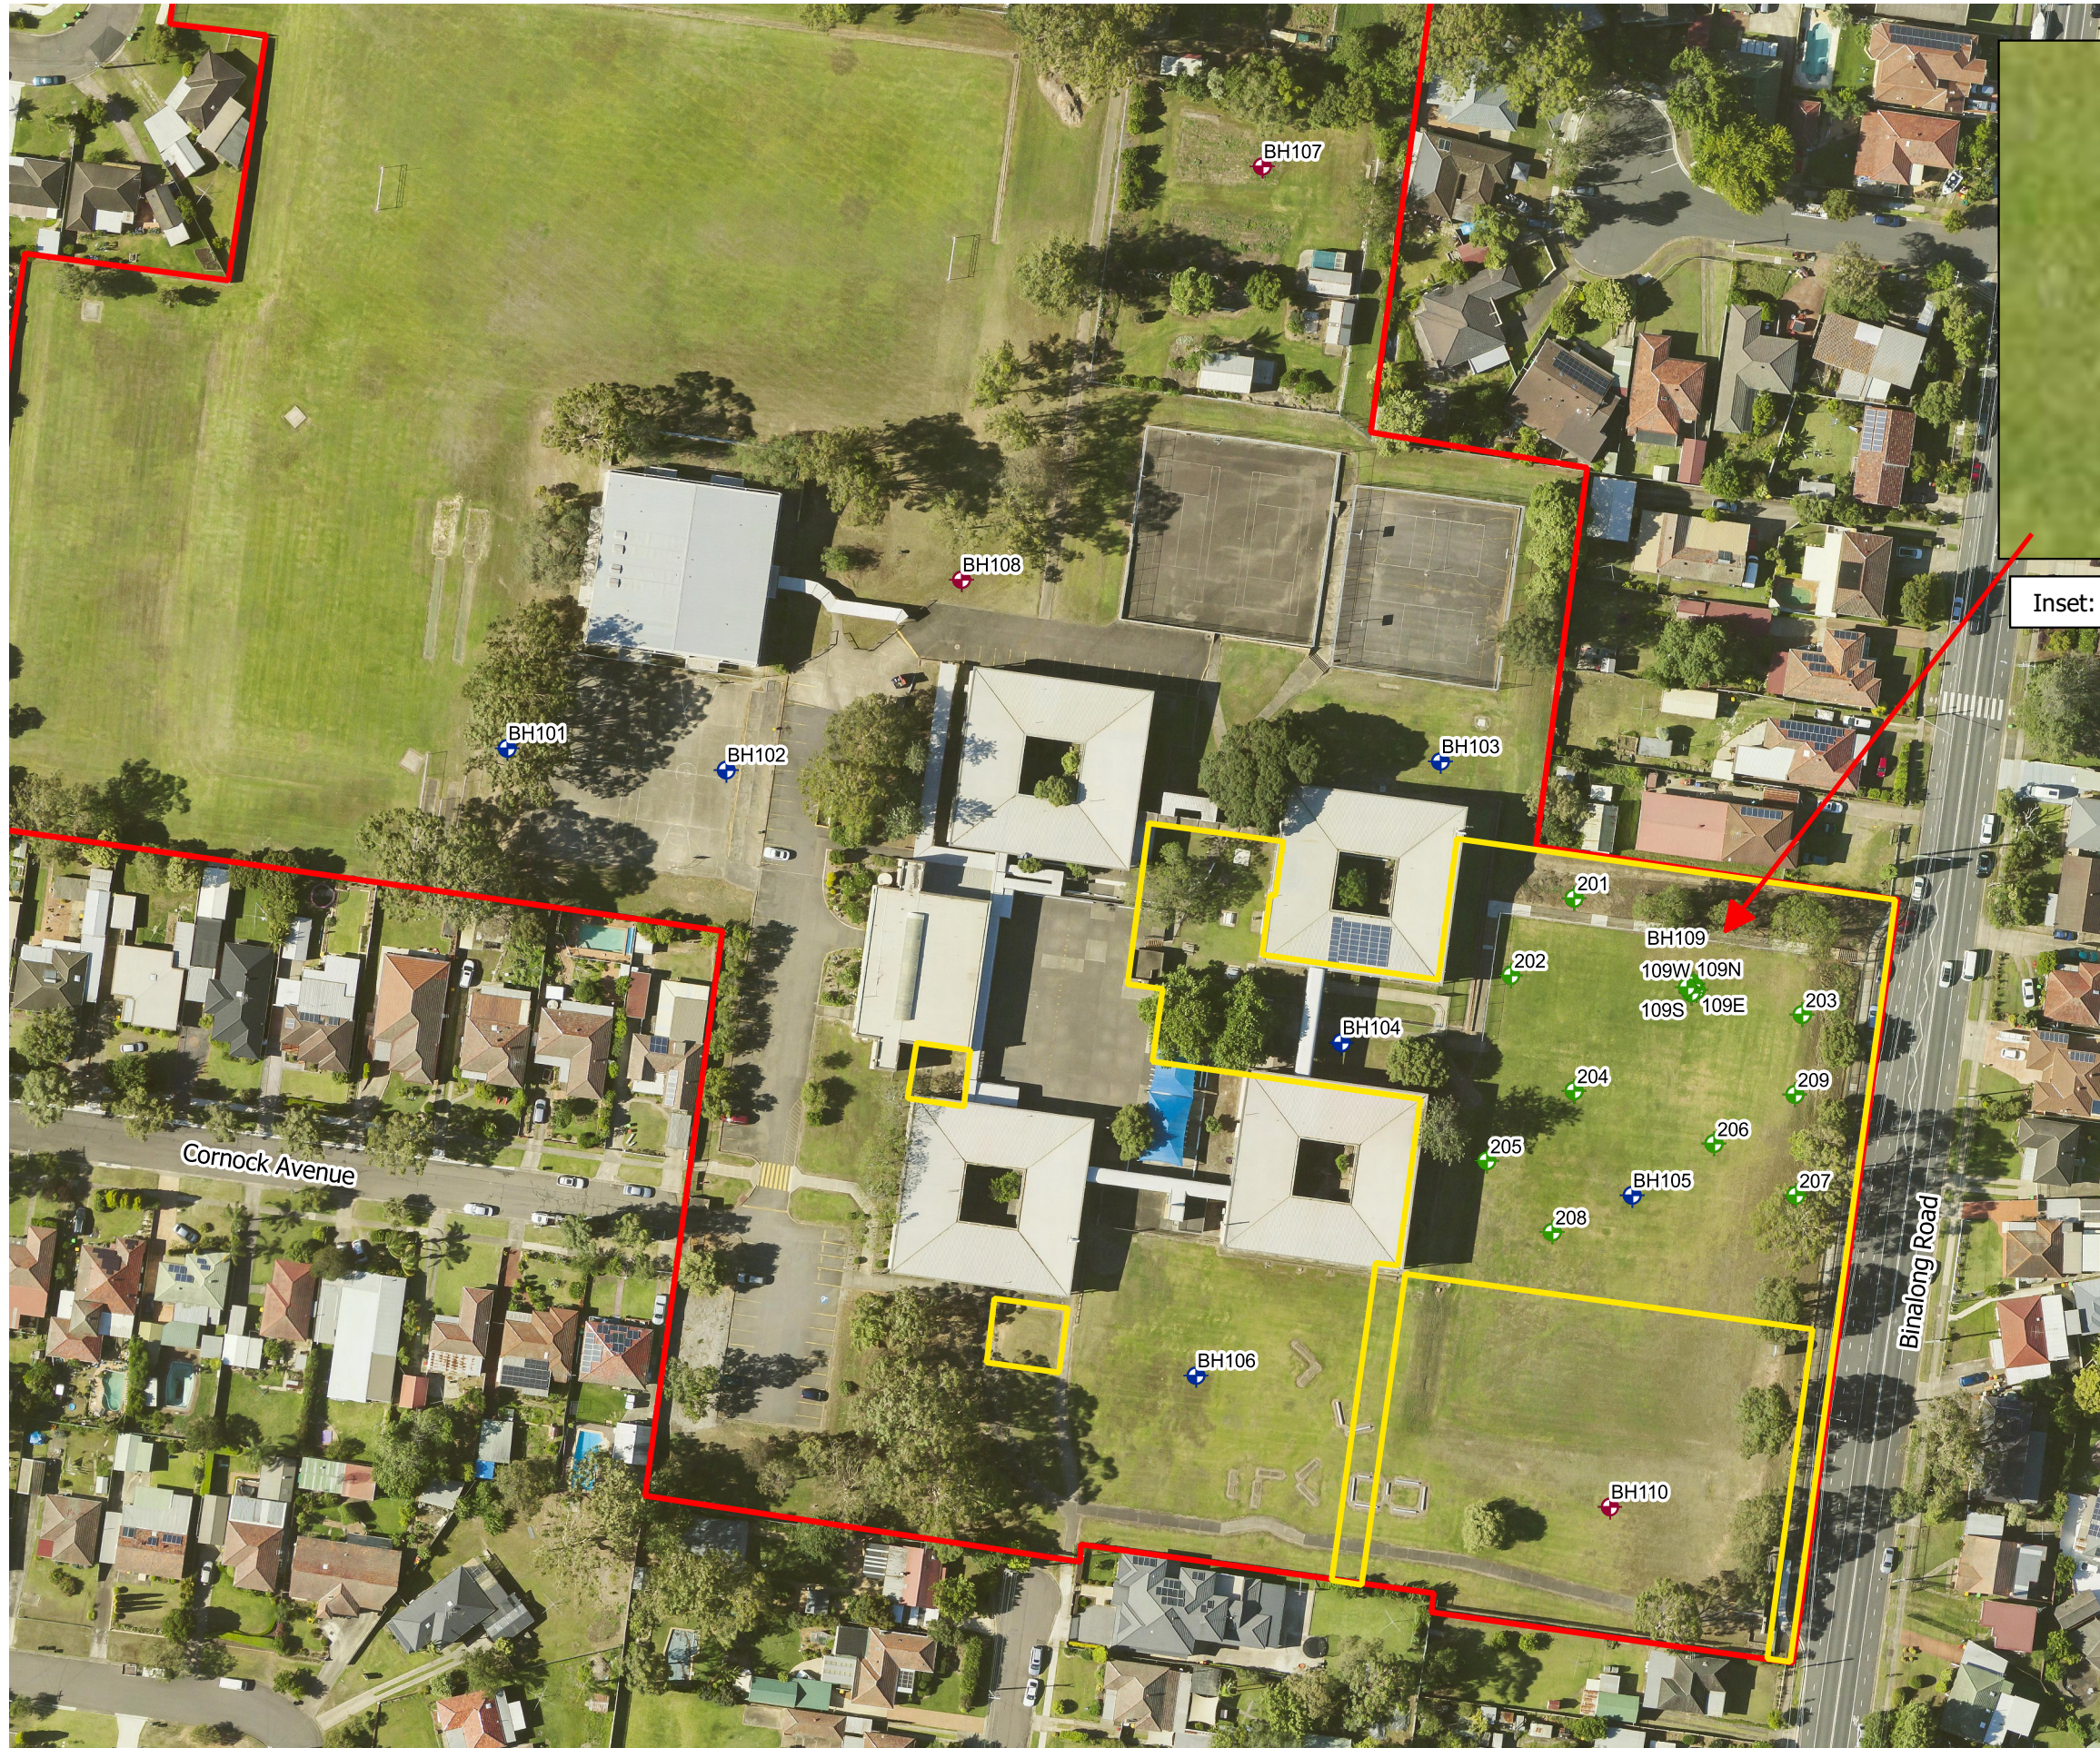
Inset: Sample Locations around 109

- Legend
- Approximate School Boundary
  - Approximate Stage 2 Site Boundary
  - DP (2021) Borehole Location
  - DP (2020) Environmental Borehole Location
  - DP (2020) Geotechnical and Environmental Borehole Location
