| project | THE FOREST HIGH SCHOOL |

| drawing title | CIVIL SITEWORKS AND STORMWATER KEY PLAN |

# **The Forest High School – Allambie Road, Allambie Heights NSW 2100**

**Unexpected Finds Management Plan**

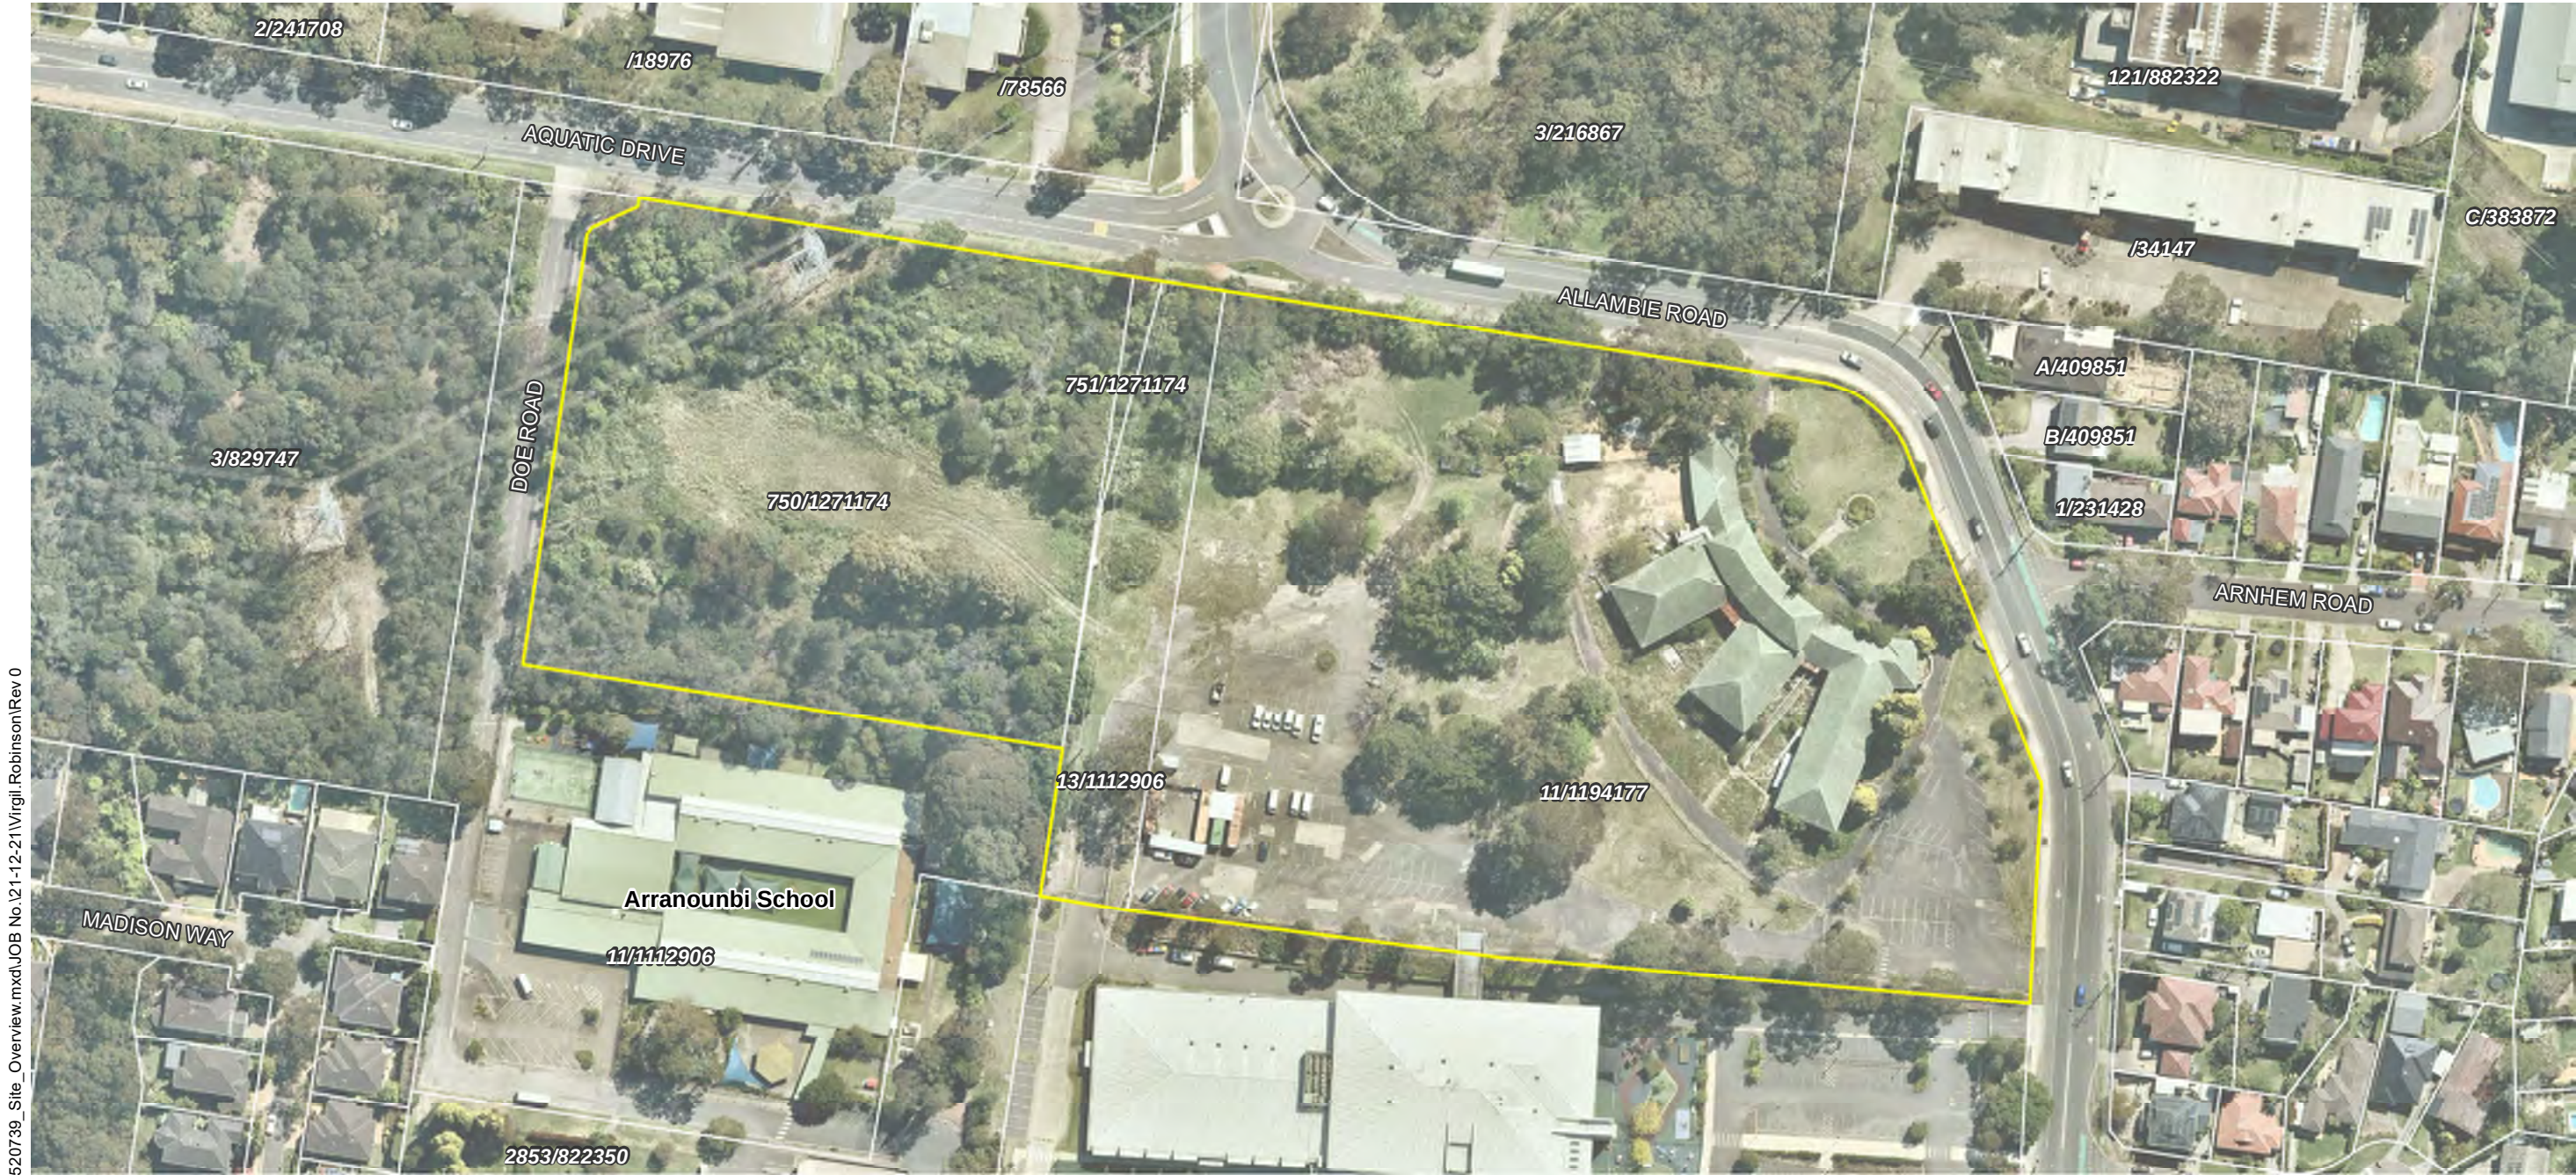
- Site boundary
- Cadastre

A site plan is provided in **Appendix A** with applicable boundaries for this UFMP.

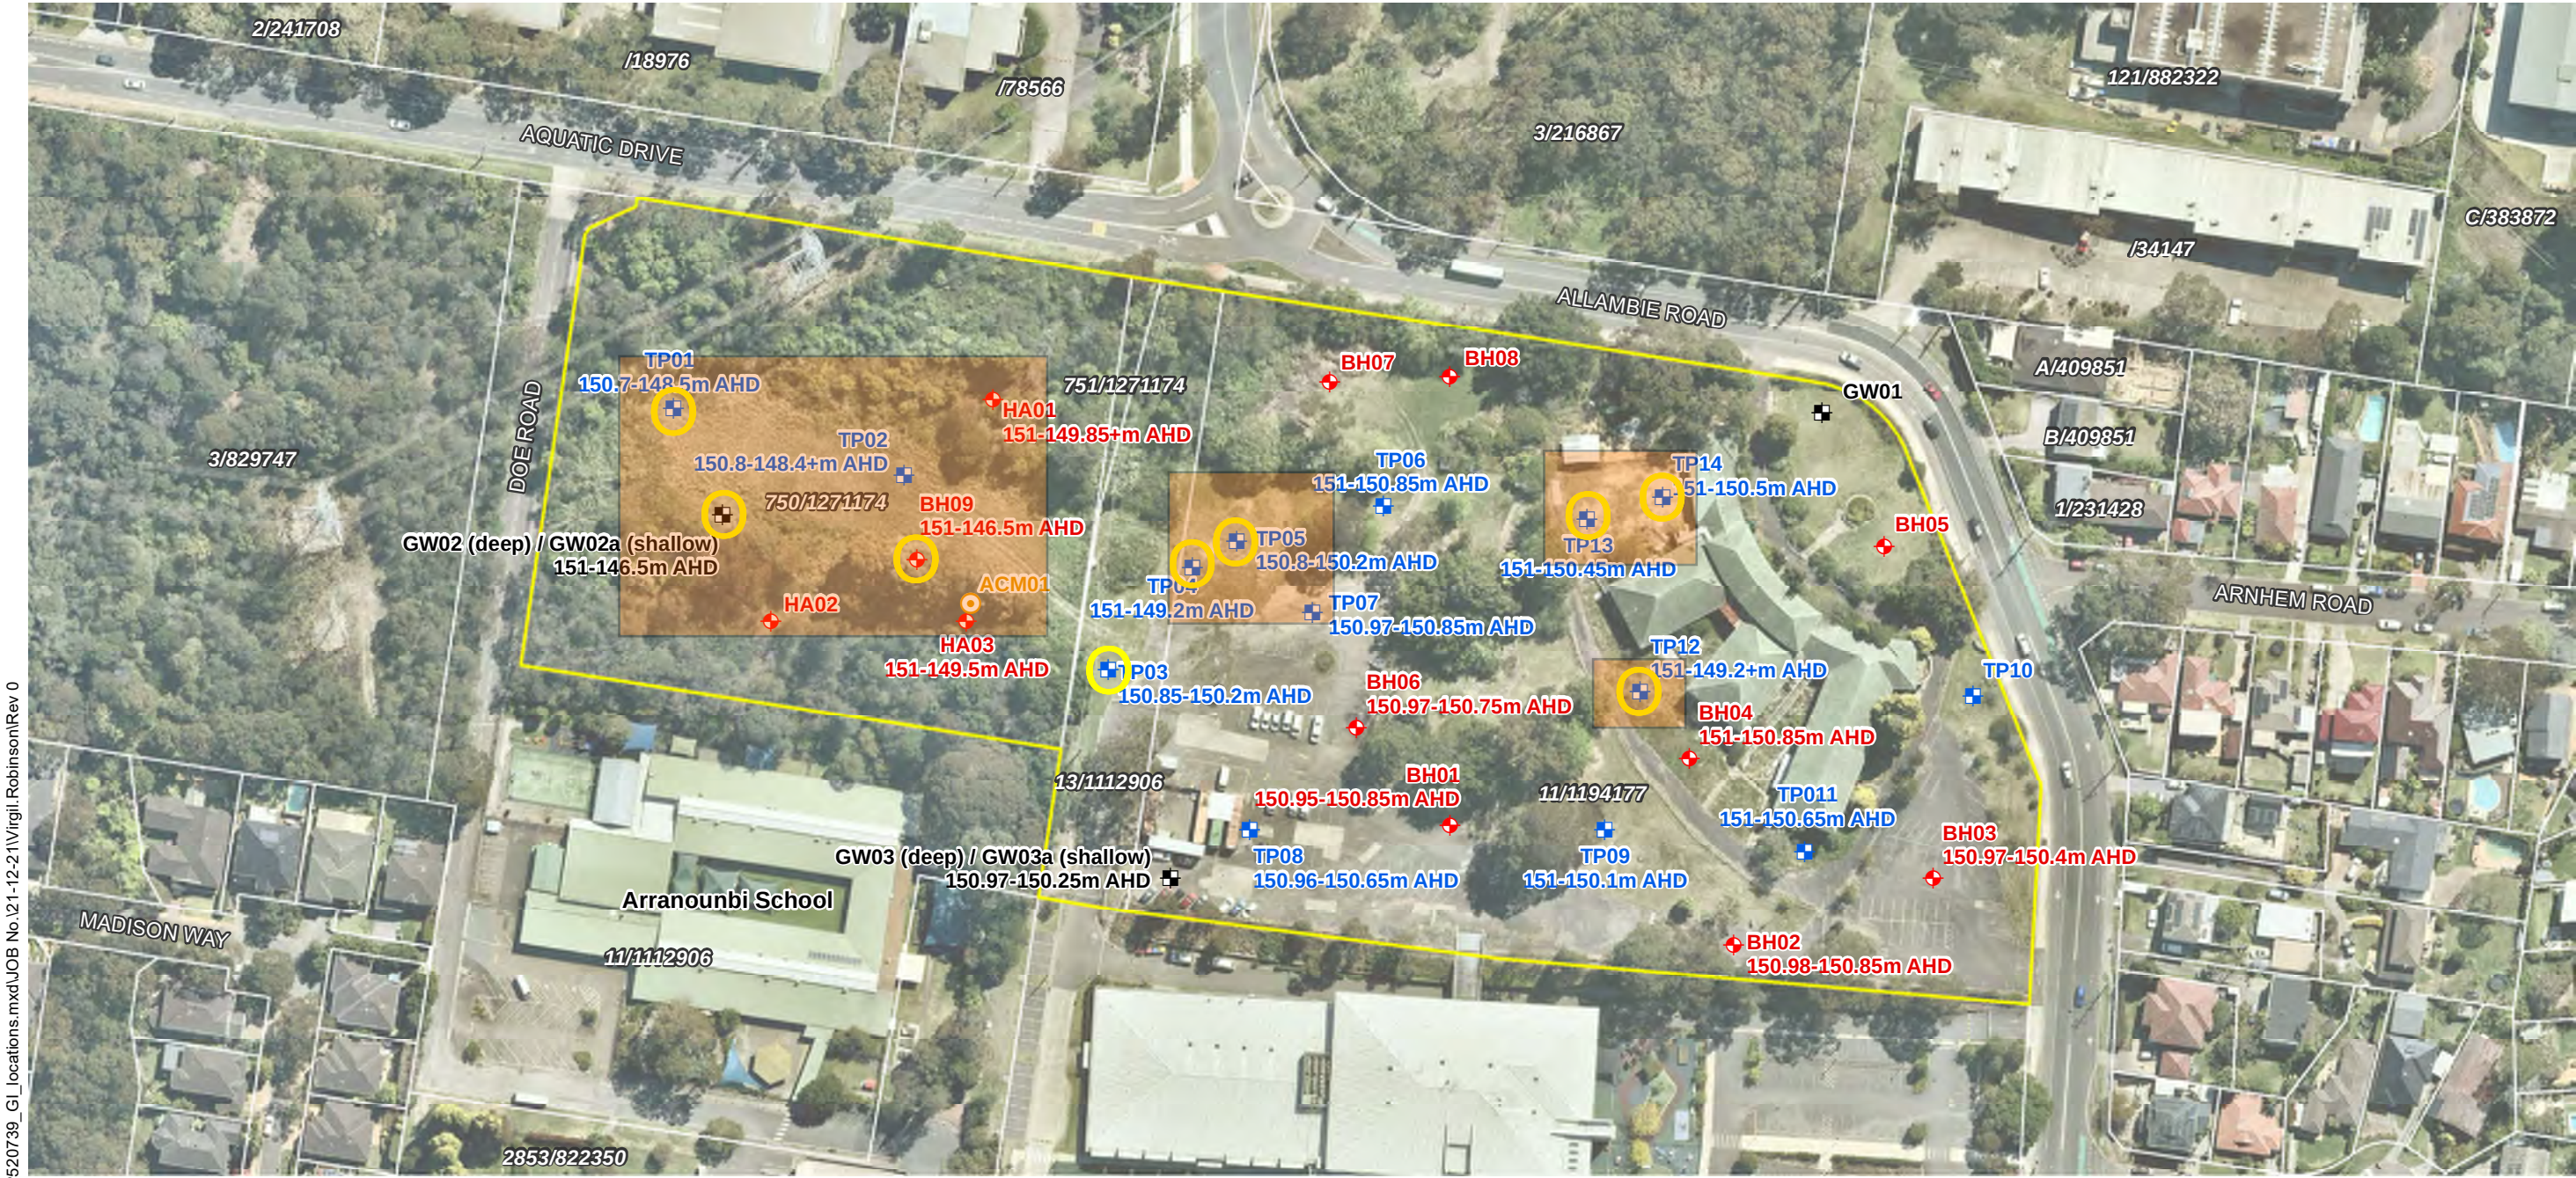
Thickest fill layers with inclusions of brick, terracotta, potential for ACM (based on Tetra Tech Coffey 2021)

Indicative subsurface filling areas of the site and mounding of fill (based on GHD 2020 and Tetra Tech Coffey 2021)

(Thickness of logged fill labelled where available)

Potentially relevant features identified in the DSI (Tetra Tech Coffey 2021) are detailed in Table 3.1 below, and shown on Figures within **Appendix A**.

| Feature | Description |
|---|---|
| Feature 1 – Filling in subsurface | Anthropogenic materials were observed in subsurface fill materials broadly across the site, generally including bricks, tile fragments, clay pipes, scrap steel and PVC. Refer to Figure within <b>Appendix A</b> for areas. |
| Feature 2 – ACM Fragments on surface and within filled ground | Confirmed ACM was identified in pipe lagging (ACM01) at the toe of the fill embankment in the western portion of the site (refer to Figure within <b>Appendix A</b> ), while the Tetra Tech Coffey (2021) HAZMAT survey also noted fragments of confirmed ACM in localised areas surrounding McLeod House. Additional unexpected finds of ACM may be present across the site in surface and subsurface soils. |
| Feature 3 – Logged boreholes and test pits with fill containing wastes | Refer to marked boreholes and test pits in Appendix A figure where deeper fill materials have been recorded that include waste materials in the log sheet. |
