Waste Management Plan

Wentworth Point New High School

Date: 30 May 2023

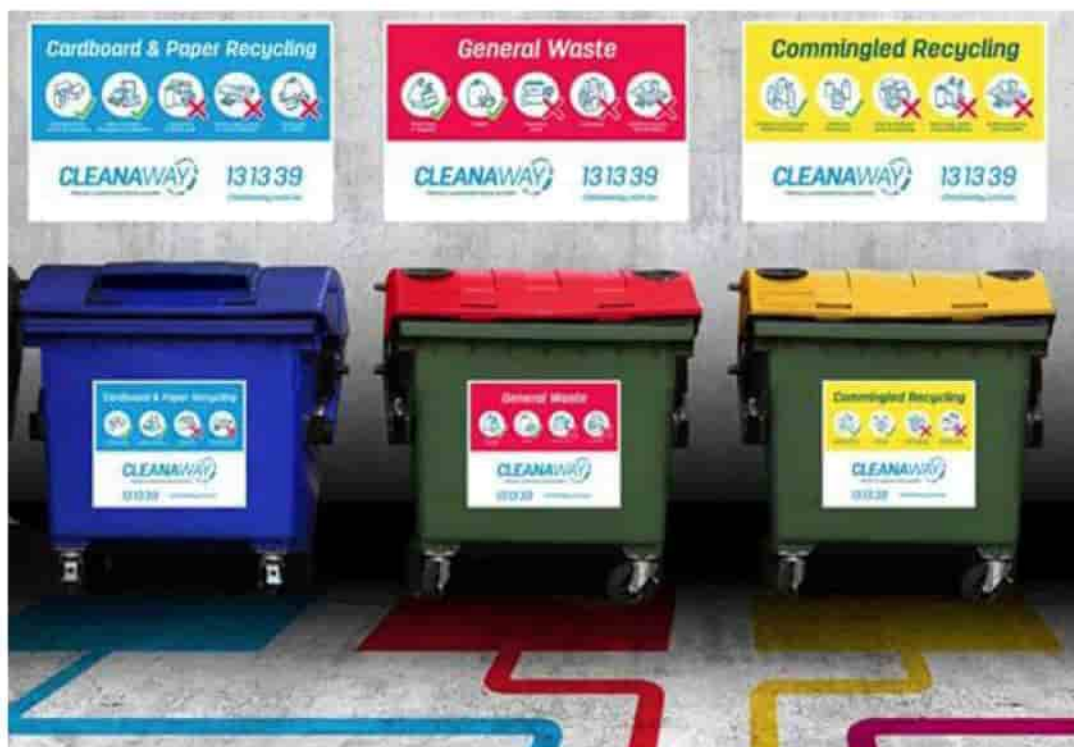
- Recycling of general waste such as paper, cardboard, aluminium cans and similar materials from offices and site facilities. Source separation will be provided for these facilities as shown below.

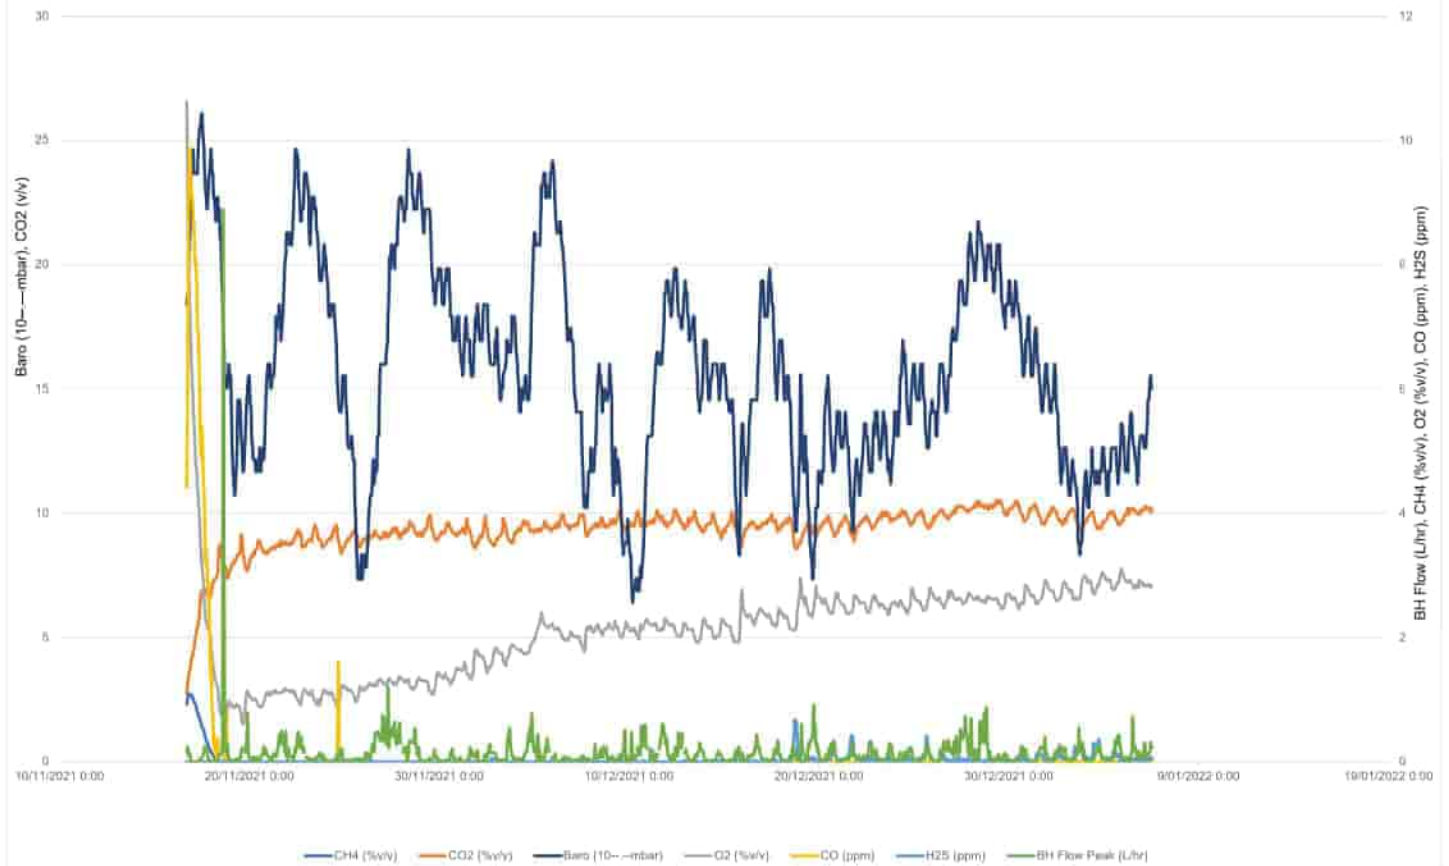
Continuous Gas Monitoring Results - GG01

A Gas Flux unit was deployed in well GG1 on 16 November 2021 at 4:50pm and retrieved on 6 January 2022 at 1:15pm, with a total deployment period of seven weeks and two days. The Gas Flux unit collected continuous (hourly) data for methane, carbon dioxide, oxygen, carbon monoxide, hydrogen sulfide, borehole flow and barometric pressure. It is noted that during the deployment of the Gas Flux unit in well GG1, 'worst-case meteorological scenario' conditions eventuated on several occasions (based on site specific 3-hourly barometric pressure data collected by the Gas Flux unit). The greatest five pressure drops are summarised below:
