Site Address: 7 Burroway Road, Wentworth

Client: Roberts Co (NSW) Pty Ltd

Job Number: AU122229

Appendix A Figures

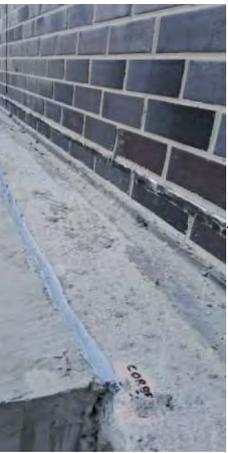
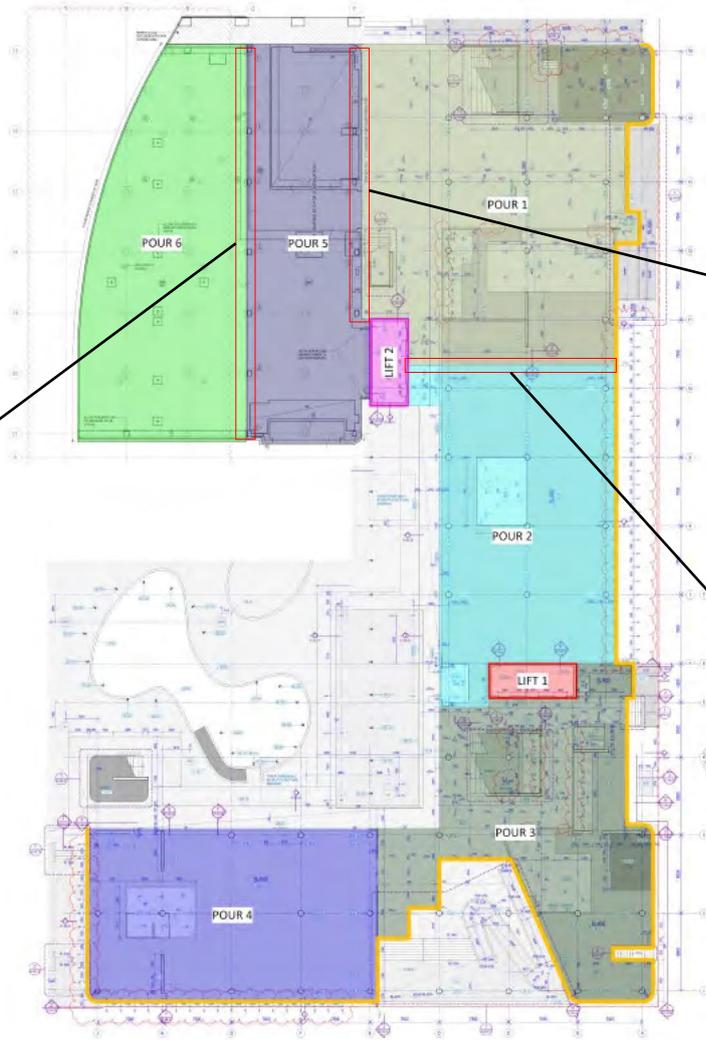
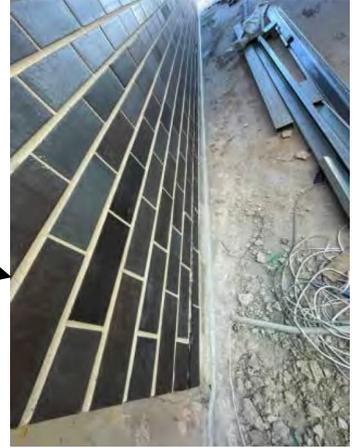
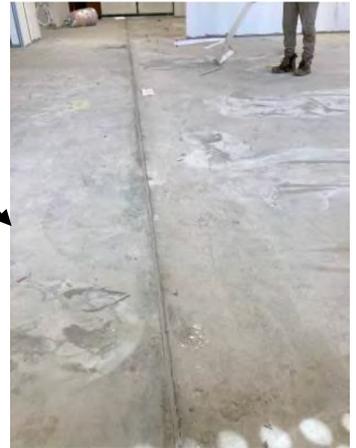
Figure B1: Construction Joints

Construction Joint Between Cold Pours

- Cold pour joints in building slabs and penetrations are accommodated waterbars.
- It was identified that below slab service cable hangers clash at several locations along the temporary movement joints (TMJ) preventing the installation of PVC water bars targeted at sealing joints in concrete floor slabs to prevent hazardous ground gas ingress. A tooled rebate was created at the TMJ atop the proposed grout using a timber formwork fillet during concrete pours to facilitate the subsequent application of a bead of caulking to seal breaches in the concrete slab. The installation of caulking was verified by BGL and inspected by Geosyntec during floor slab inspections. This was approved by the Site Auditor prior to implementation.

Geosyntec was advised by Colin Chu (Senior Design Engineer) on 19 June 2023 that, *“Construction joints are only temporary joints between two pours. Once both pours on either side is cast, it is considered structurally a continuous slab. The slab deflects as a whole, and there are no differential deflection expected locally at the joint between 2 pours, unless there is a serious construction and/or formwork defect”.*

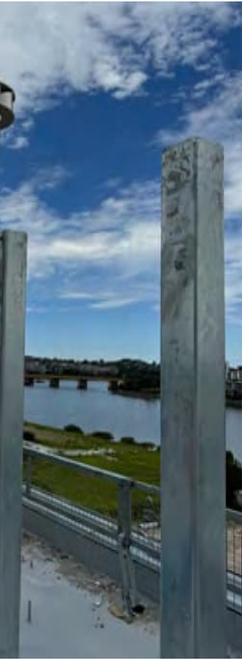
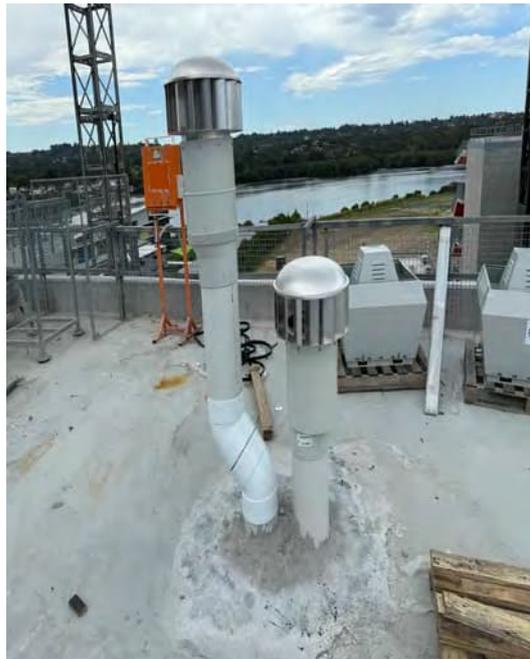
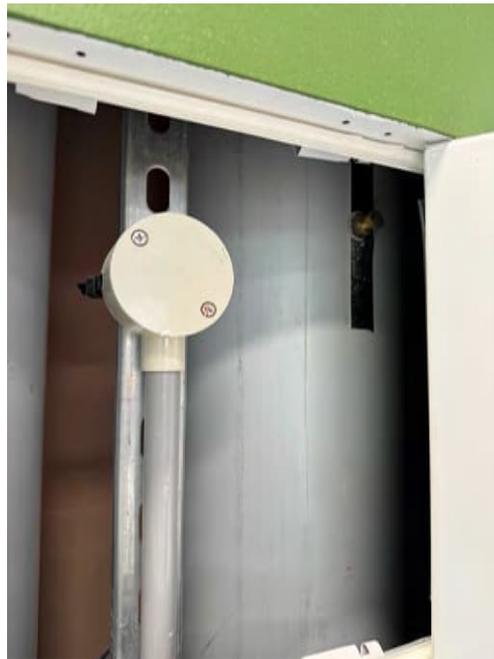
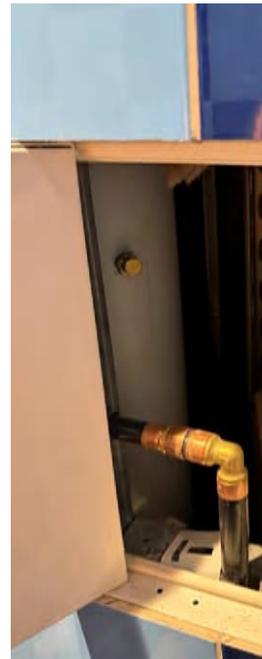
Figure B2: Outlet Termination

et Termination

Example 225mm ID Outlet Termination

Example Level 1 Riser and Subfloor Monitoring Ports

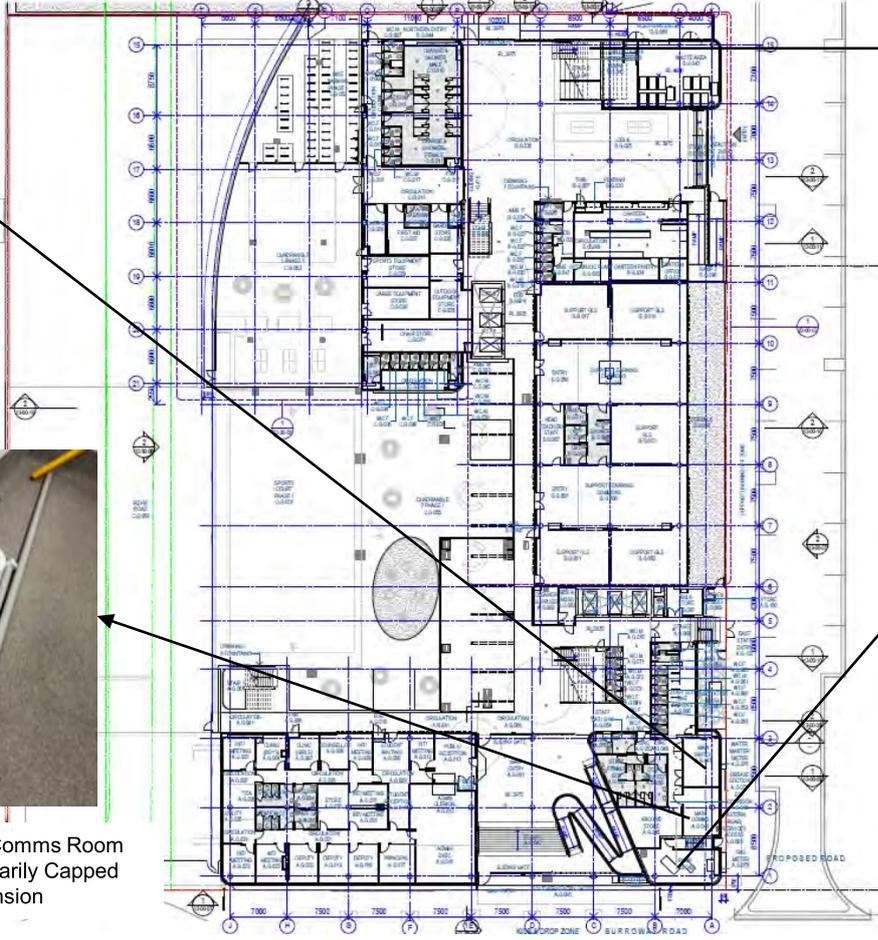
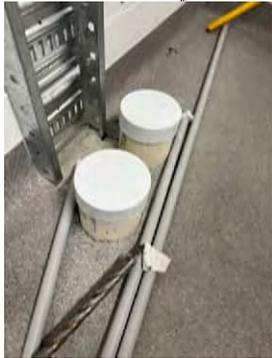
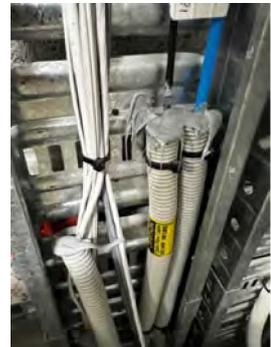
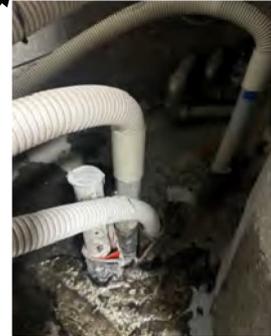
Figure B3: Sealed Conduit

Example Main Comms Room Conduit Temporarily Capped for Future Expansion

Example Room Capped

Example Pump Room Comms Cable and Conduit

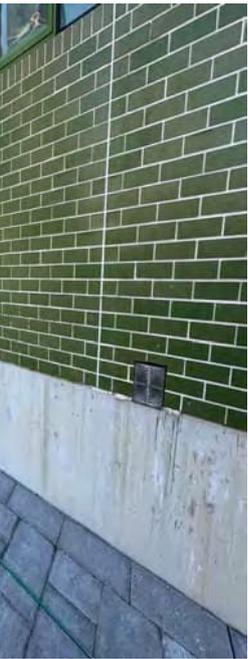
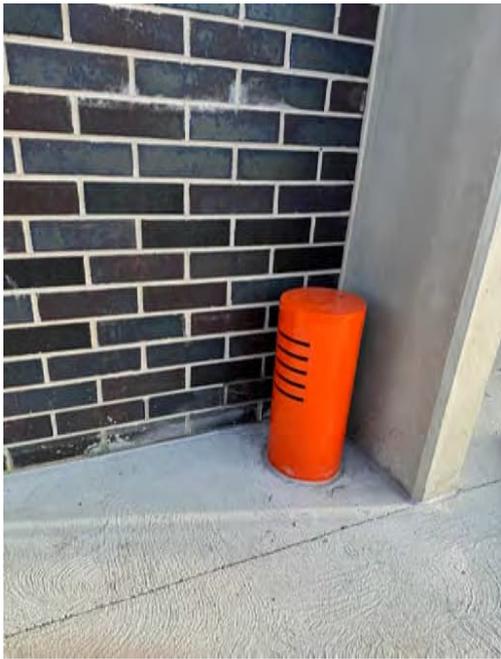
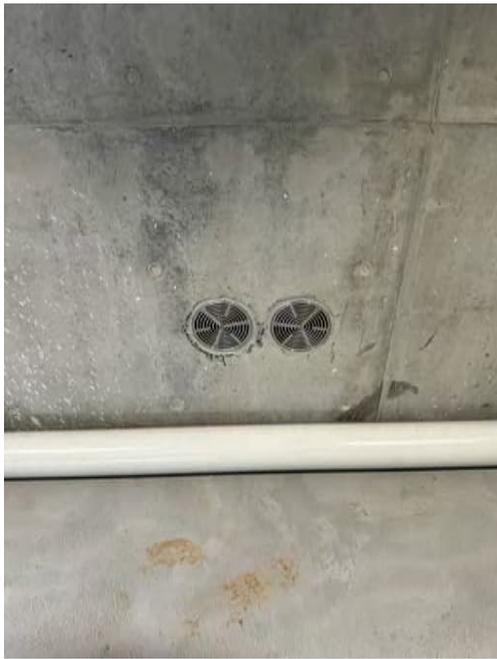
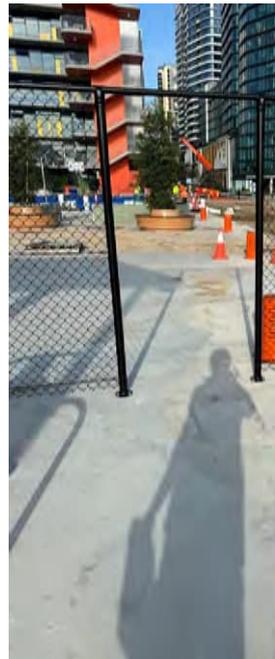
Figure B4: Inlet Termination

Inlet Termination

Example 150mm ID Inlet Termination

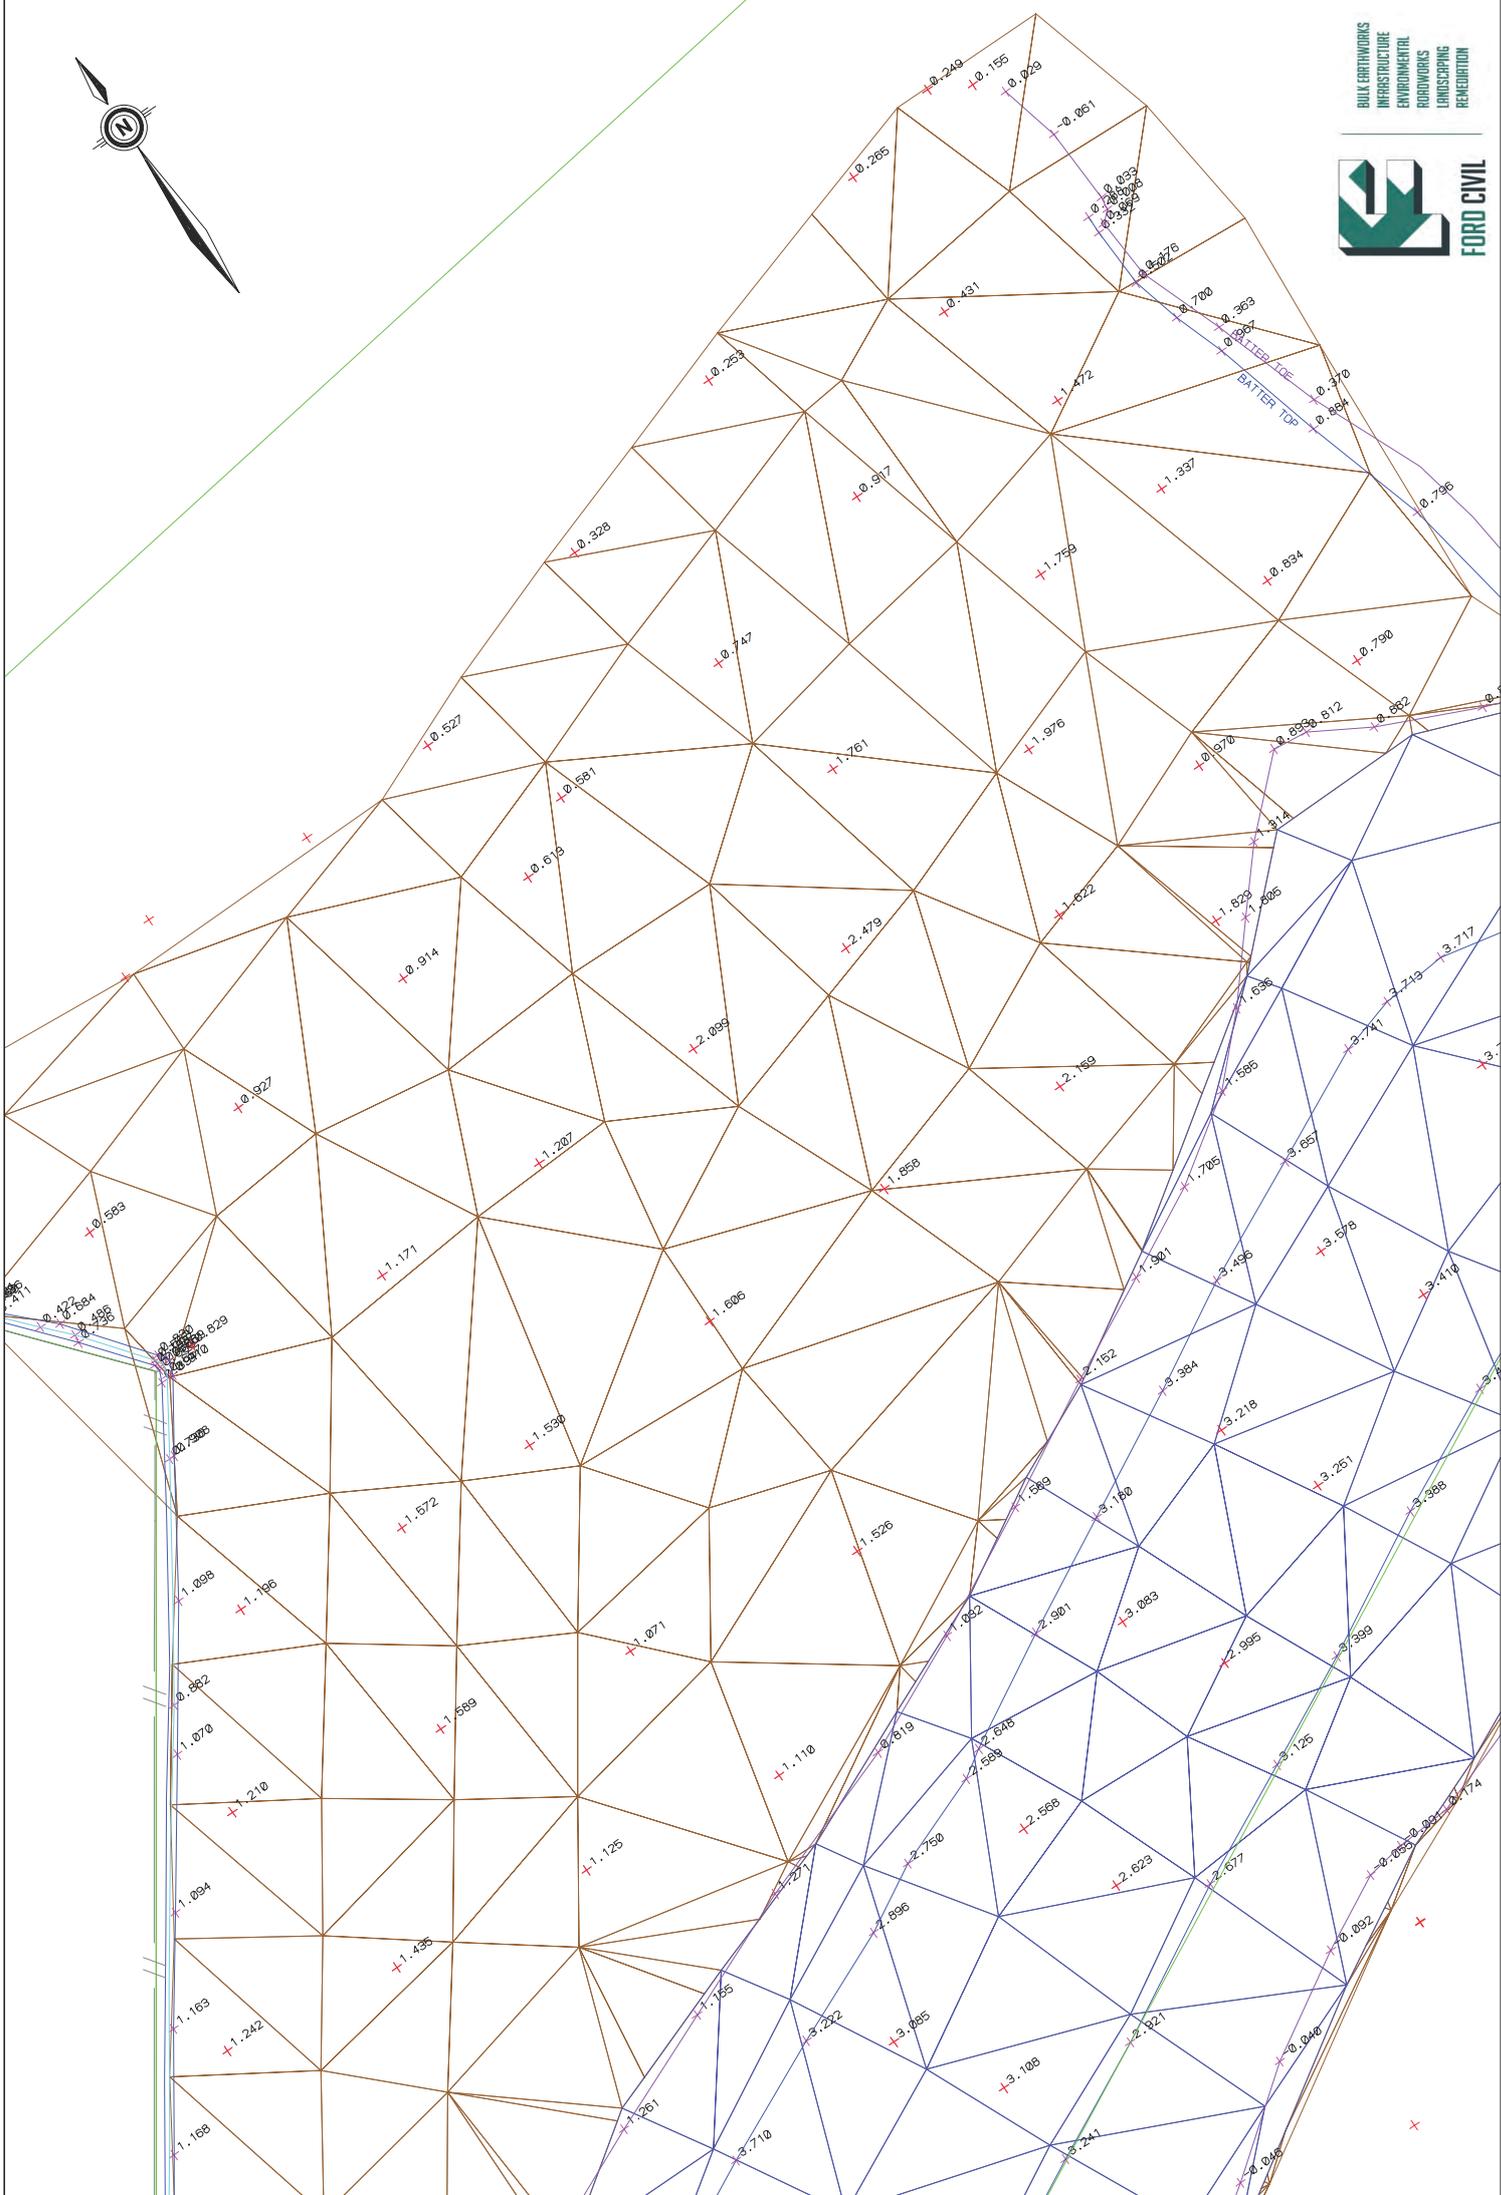
Wentworth Point
191213B Final as built layer WAE vs Marker Layer was height differences

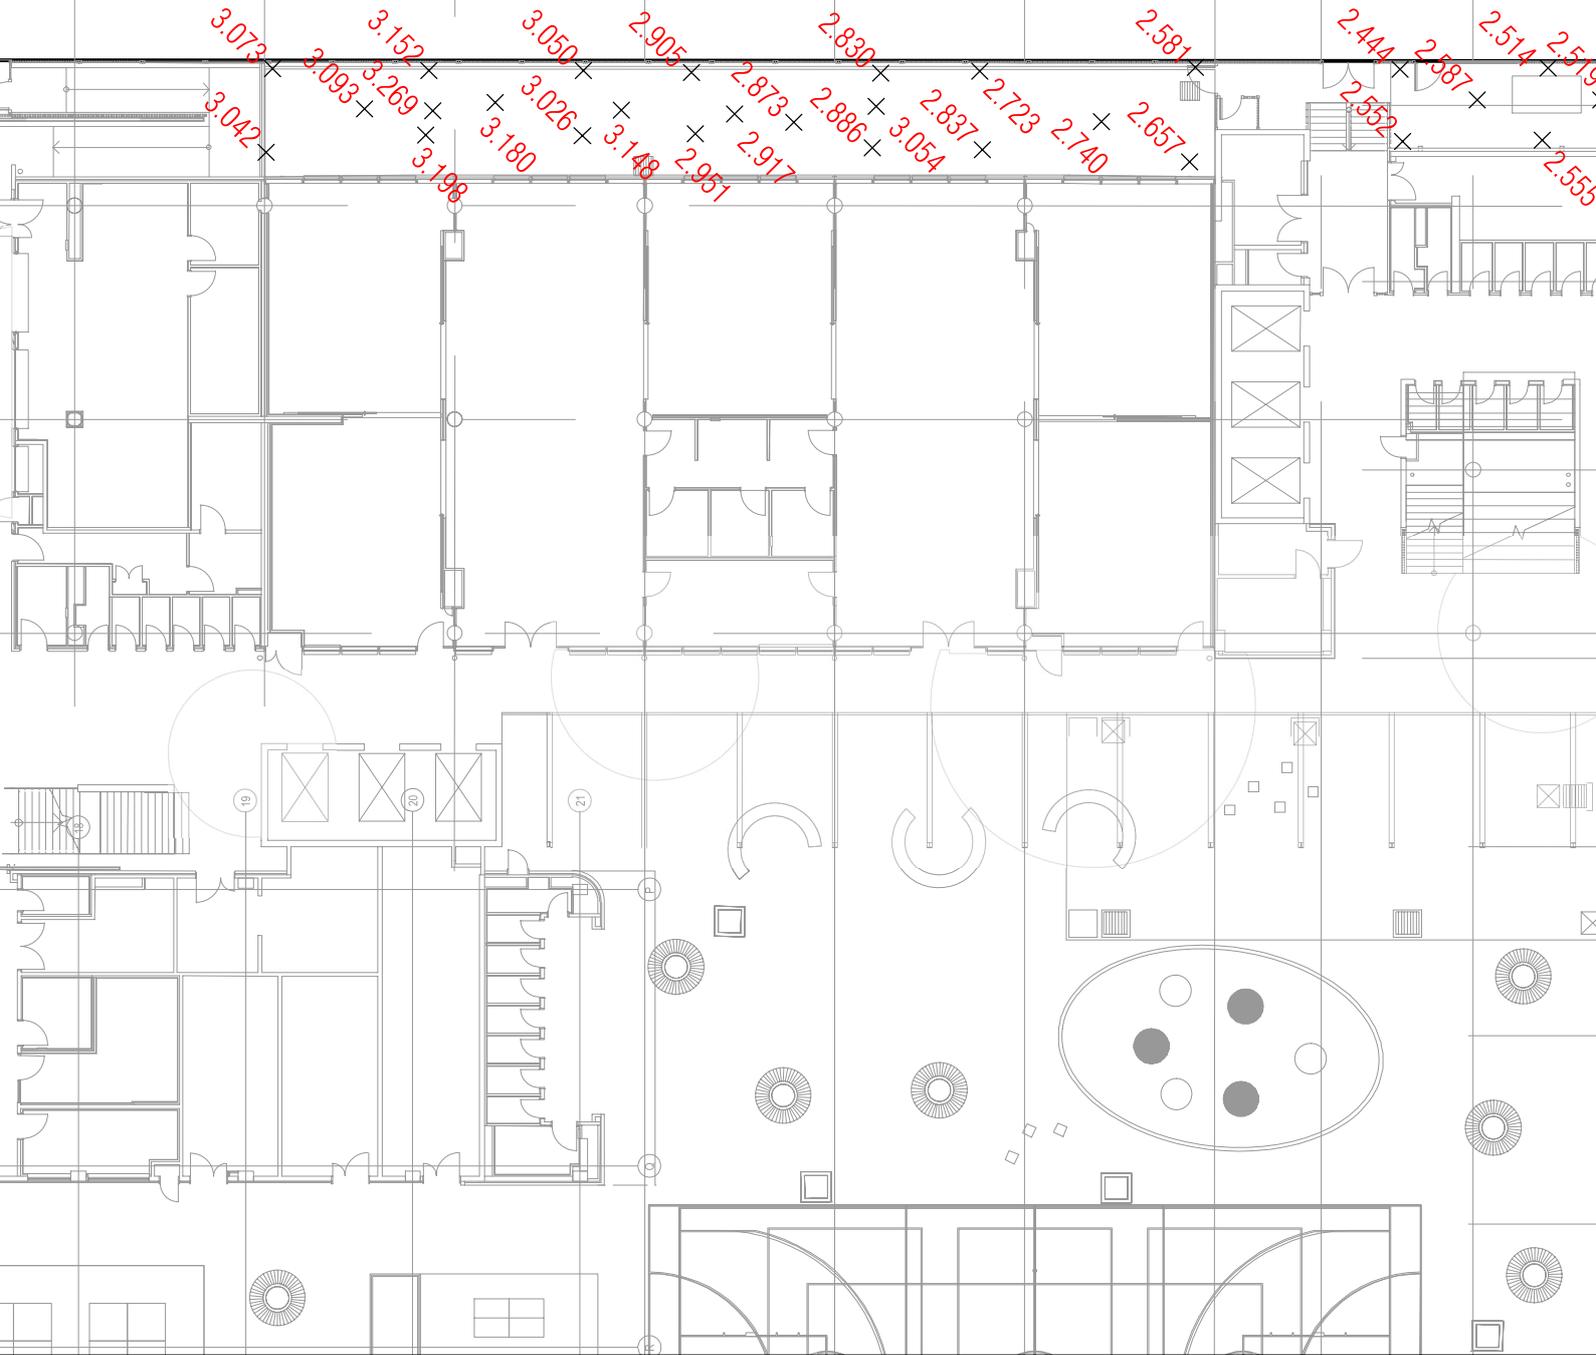
**PLAN SHOWING SURVEY AS BUILT OF THE BUILDING
EXTERNAL AREAS LEVELS ON
THE EAST SIDE OF THE BUILDING SITE AT
No.7 BURROWAY ROAD, WENTWORTH POINT**

- Black Crosses and Red RLs Indicate the As Built Points on 28/05/2024.

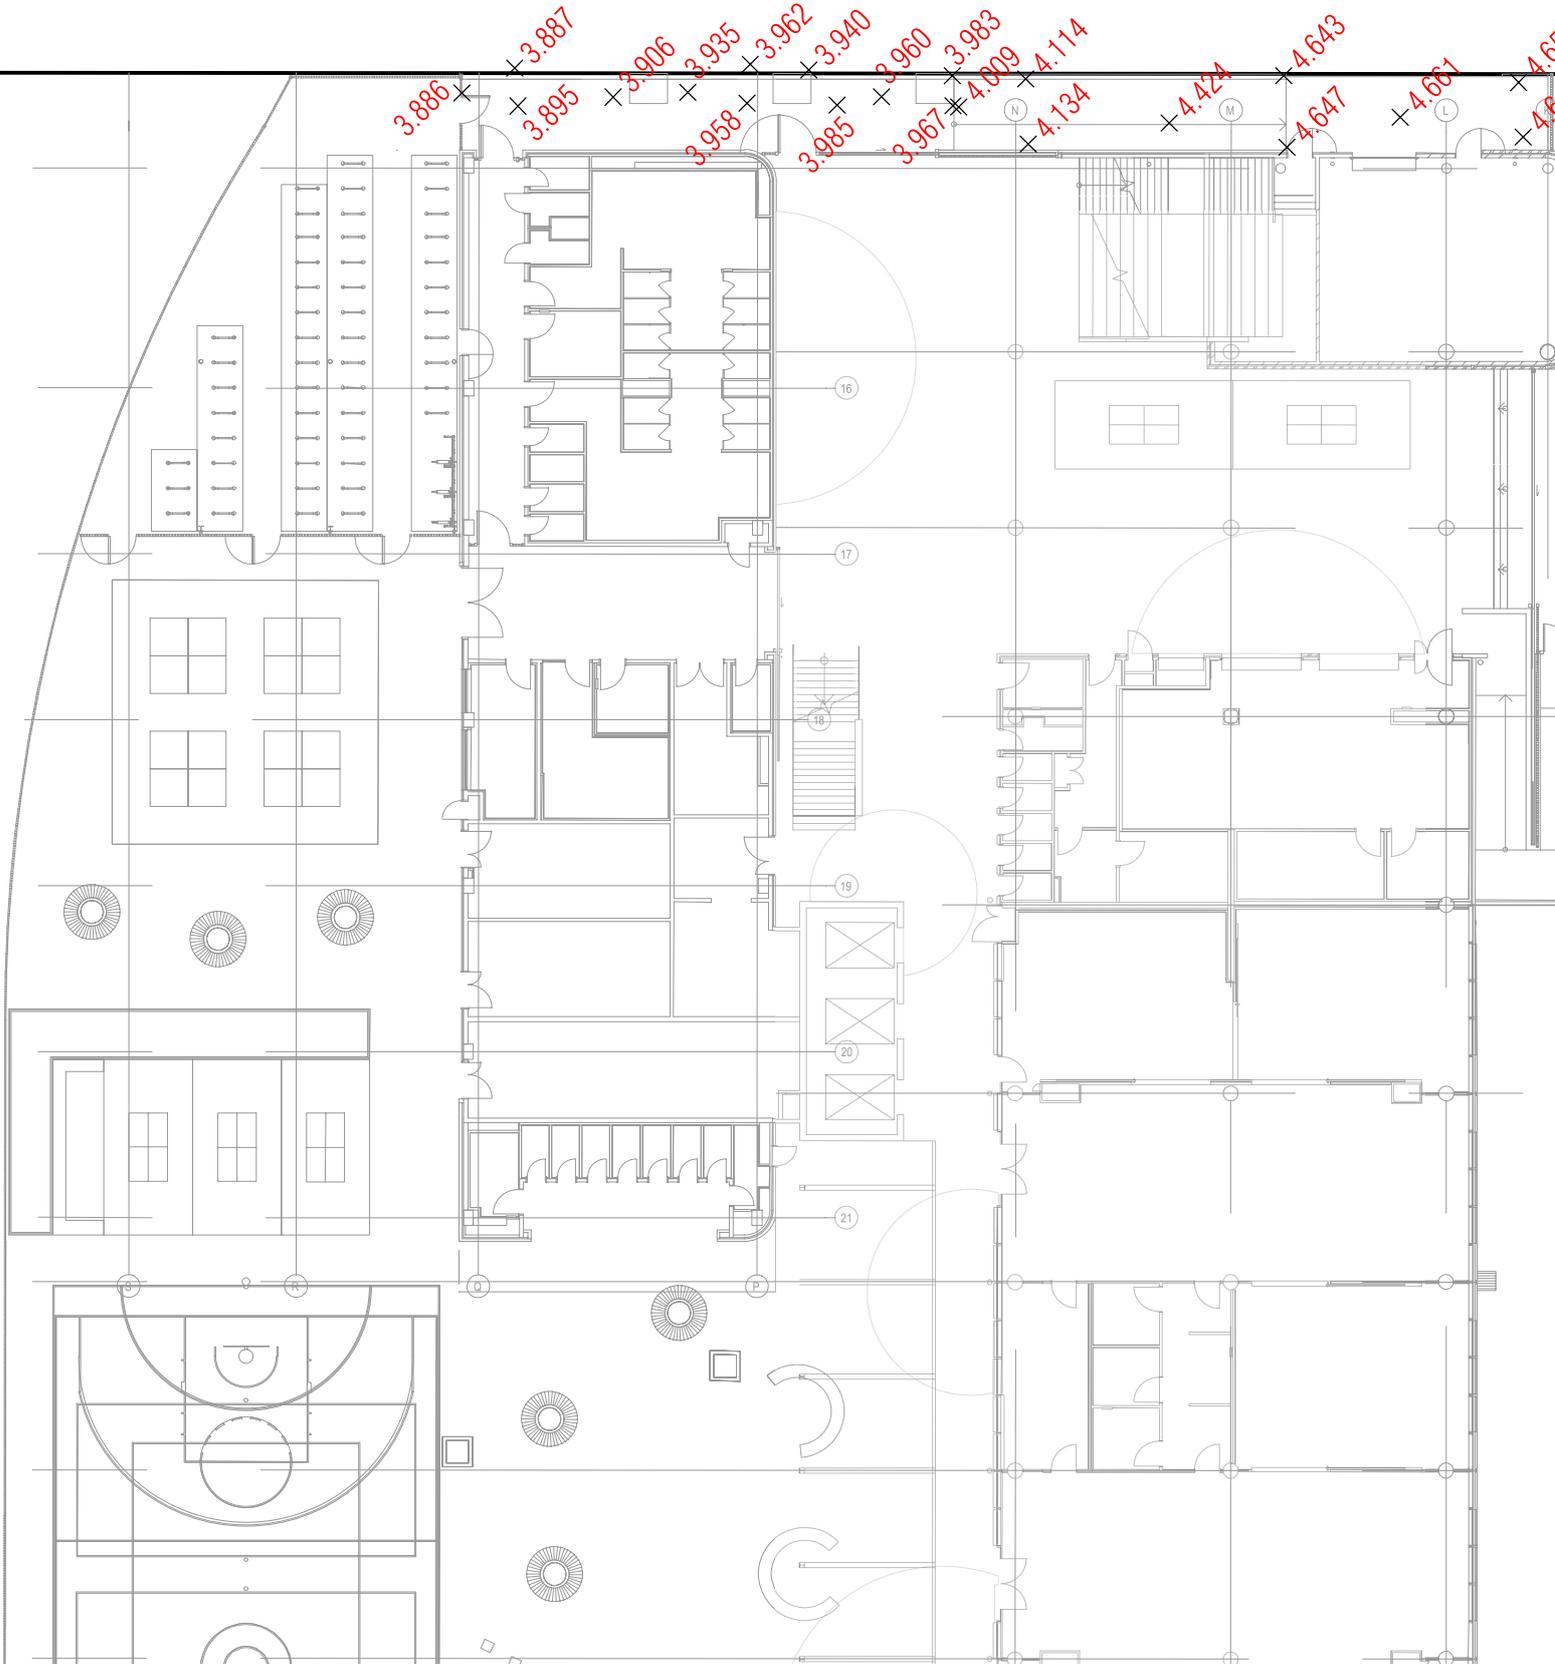
**PLAN SHOWING SURVEY AS BUILT OF THE BUILDING
EXTERNAL AREAS LEVELS ON
THE NORTH SITE OF THE BUILDING SITE AT
No.7 BURROWAY ROAD, WENTWORTH POINT**

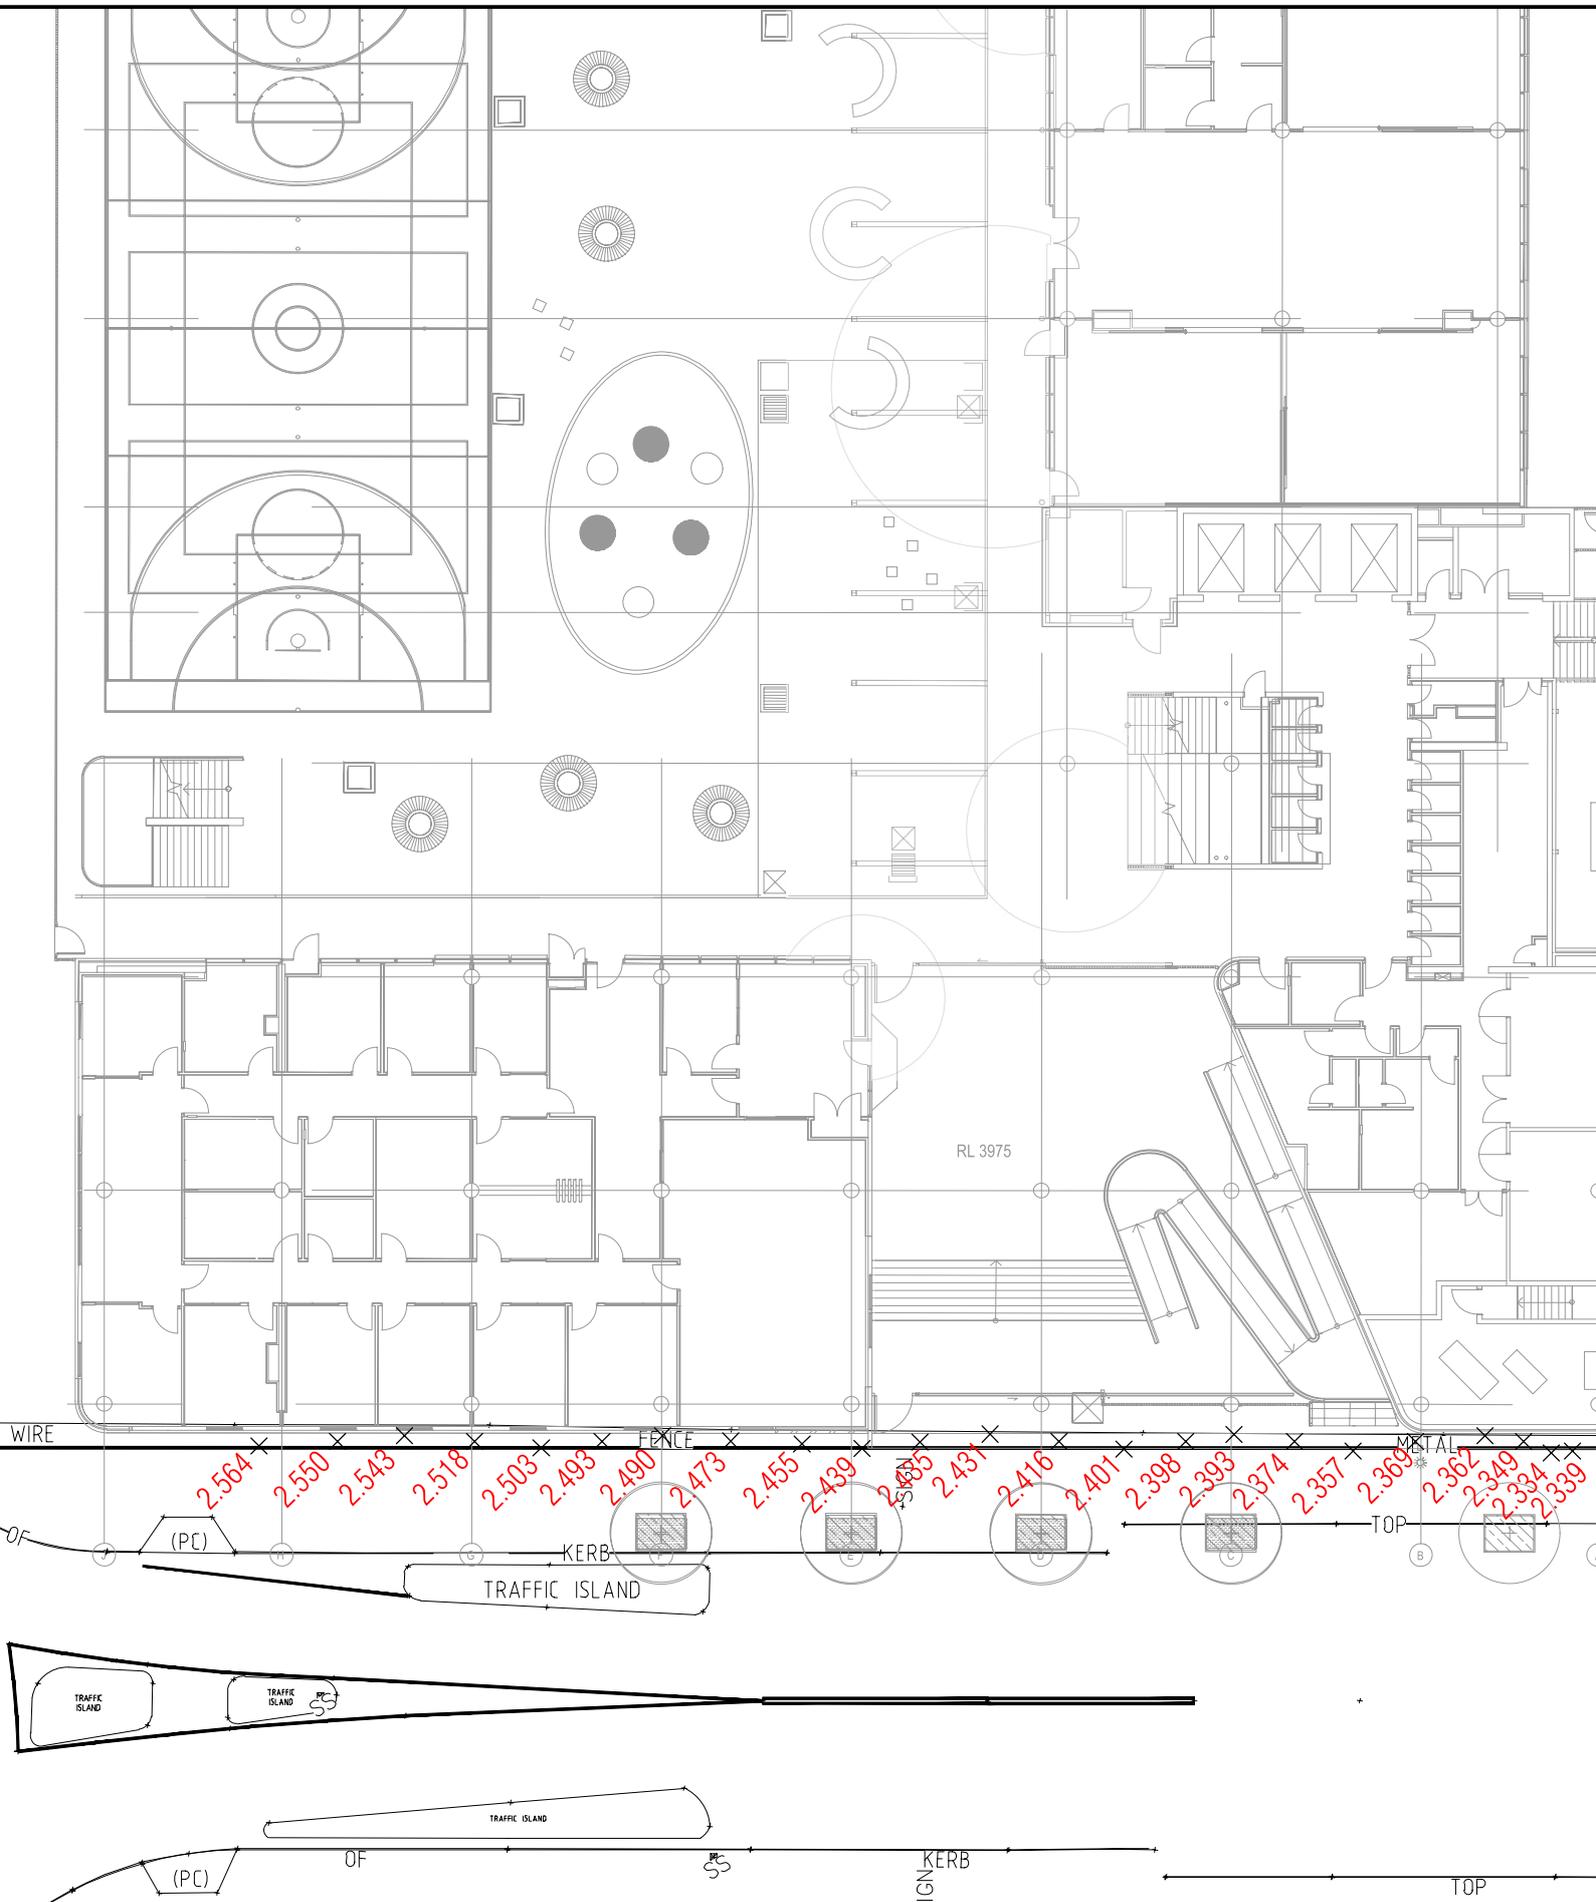
**PLAN SHOWING SURVEY AS BUILT OF THE BUILDING
 EXTERNAL AREAS LEVELS ON
 THE SOUTH SITE OF THE BUILDING SITE AT
 No.7 BURROWAY ROAD, WENTWORTH POINT**

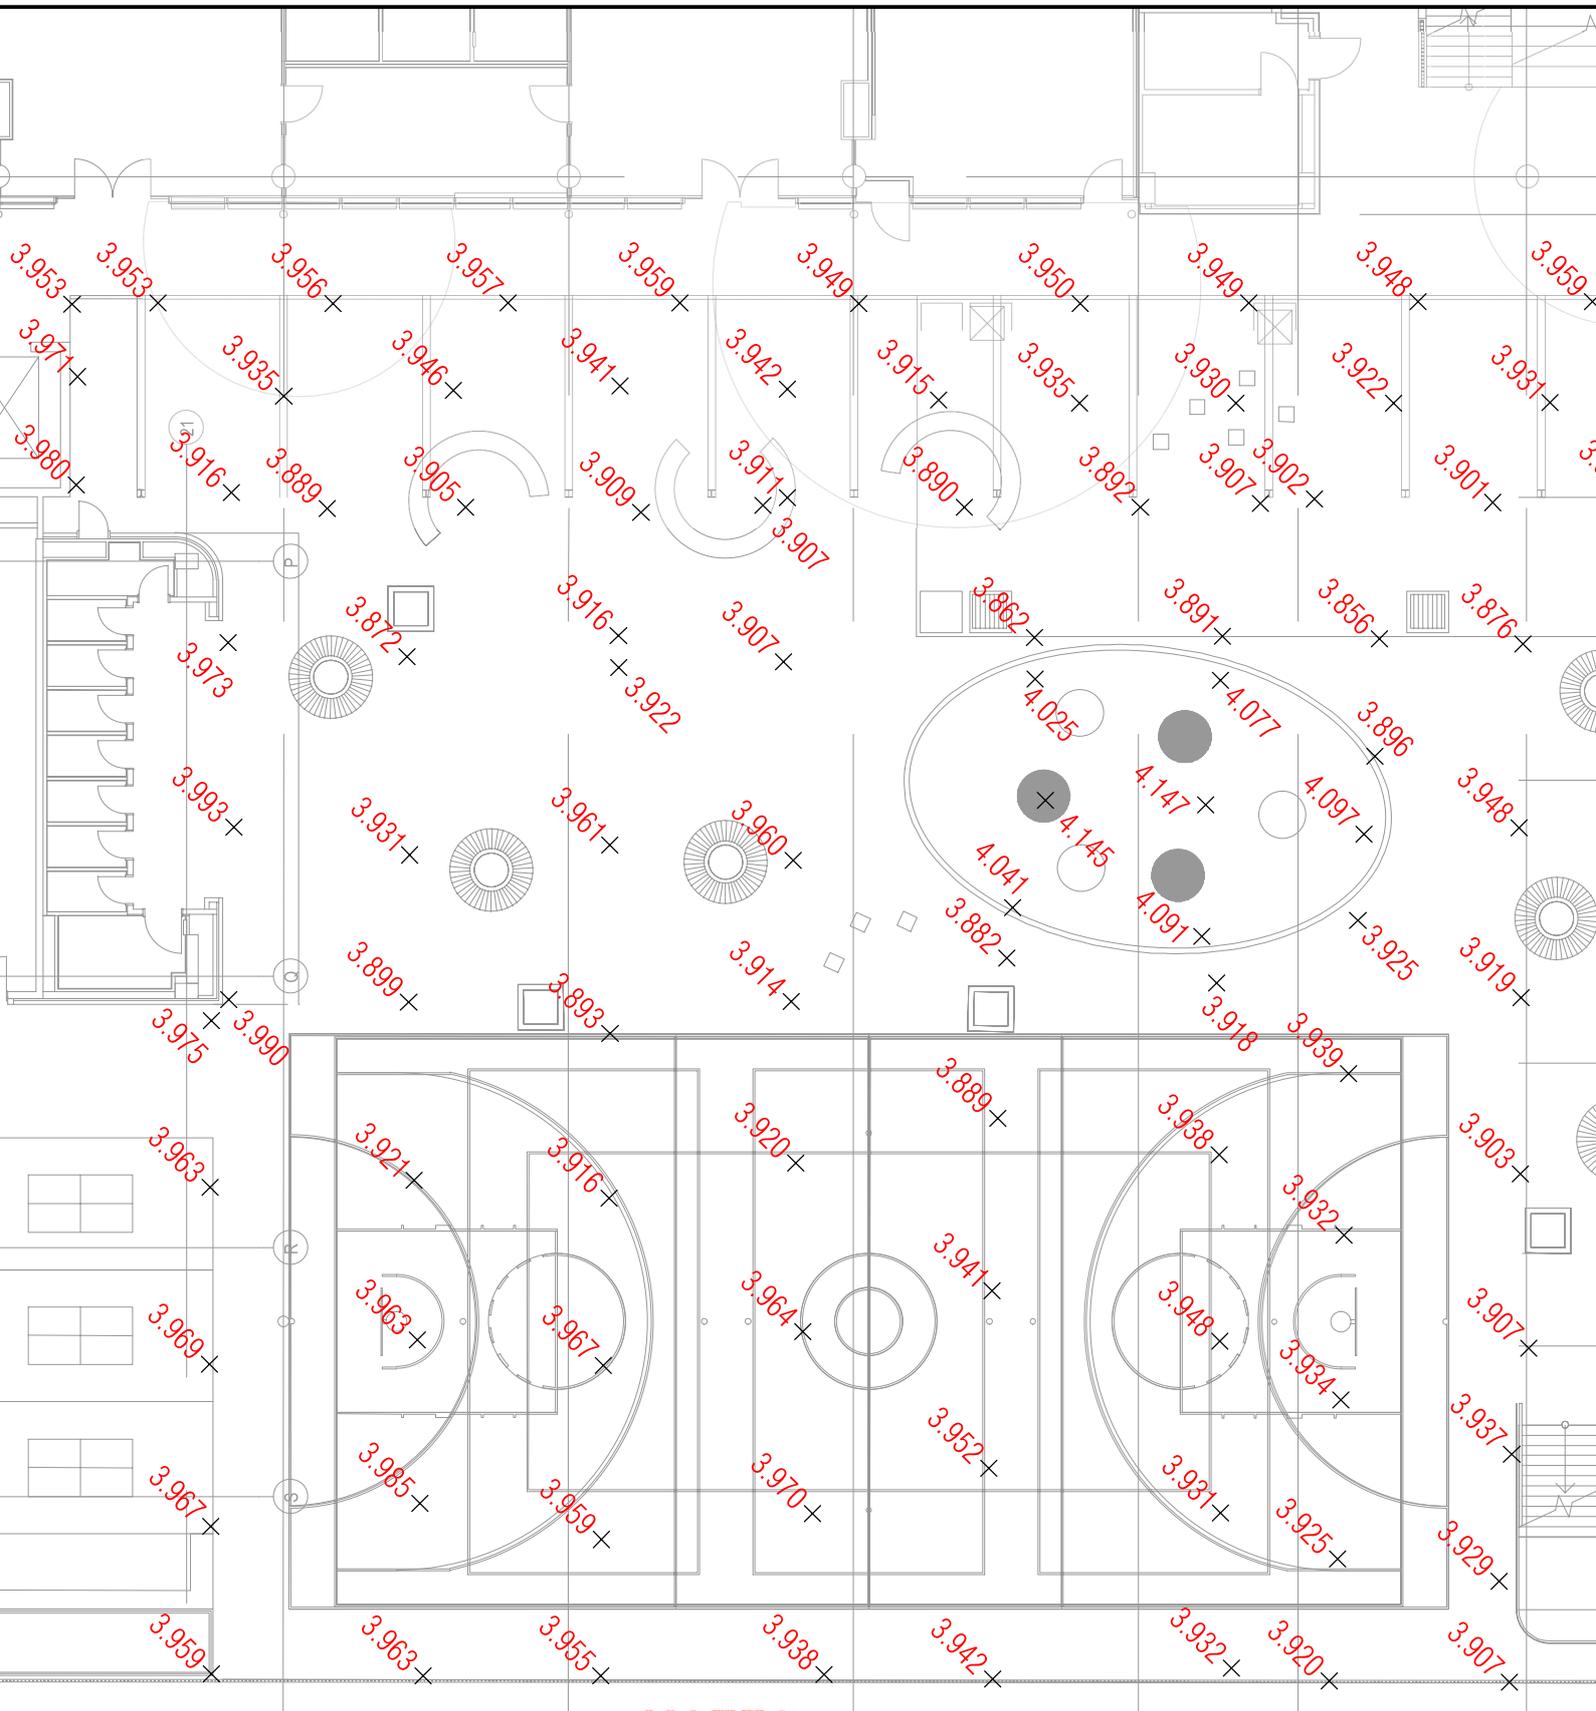
- Black Crosses and Red RLs Indicate the As Built Points on 28/05/2024.

**PLAN SHOWING SURVEY AS BUILT OF THE
 PLAYGROUND AREA LEVELS
 AT
 No.7 BURROWAY ROAD, WENTWORTH POINT**

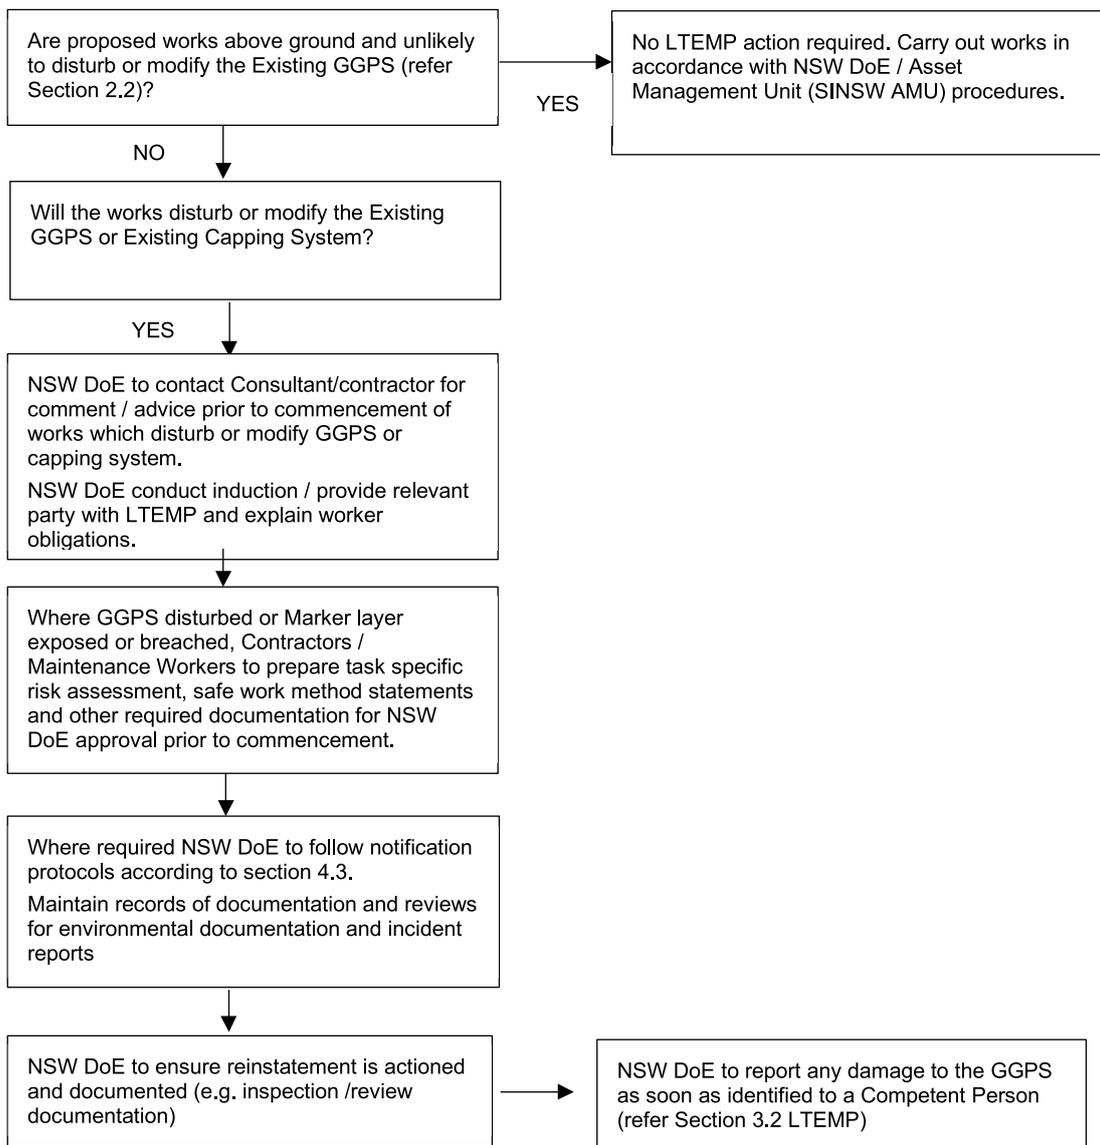
Chart E1: General LTEMP process Flow Chart and Actions

To ensure that site buildings, below ground utilities (i.e. electrical / communications / stormwater / sewer pits) and site users (e.g. staff, children, parents, visitors, maintenance staff) are protected from potential hazards associated with landfill gas (e.g. explosion or asphyxiation) and contaminated material underlying capping layers, it is imperative that the requirements of this LTEMP are understood and strictly adhered to by relevant personnel as a requirement of continued site suitability. It is the responsibility of Department of Education (NSW DoE) and Infrastructure Assets Branch (IAB) to ensure that all relevant parties are aware of the existence of this LTEMP and comply with its requirements. The nature and extent of the installed GGPS and capping layer are presented in Figure 3 Appendix A. Chart E1 provides the decision matrix for any works that may breach the capping layer (in the western portion of the site) or the ground gas protection system (GGPS) installed under the site structures.
