# Wee Waa High School – Public Health Investigation

*Prepared for: NSW Department of Education*

9 March 2022

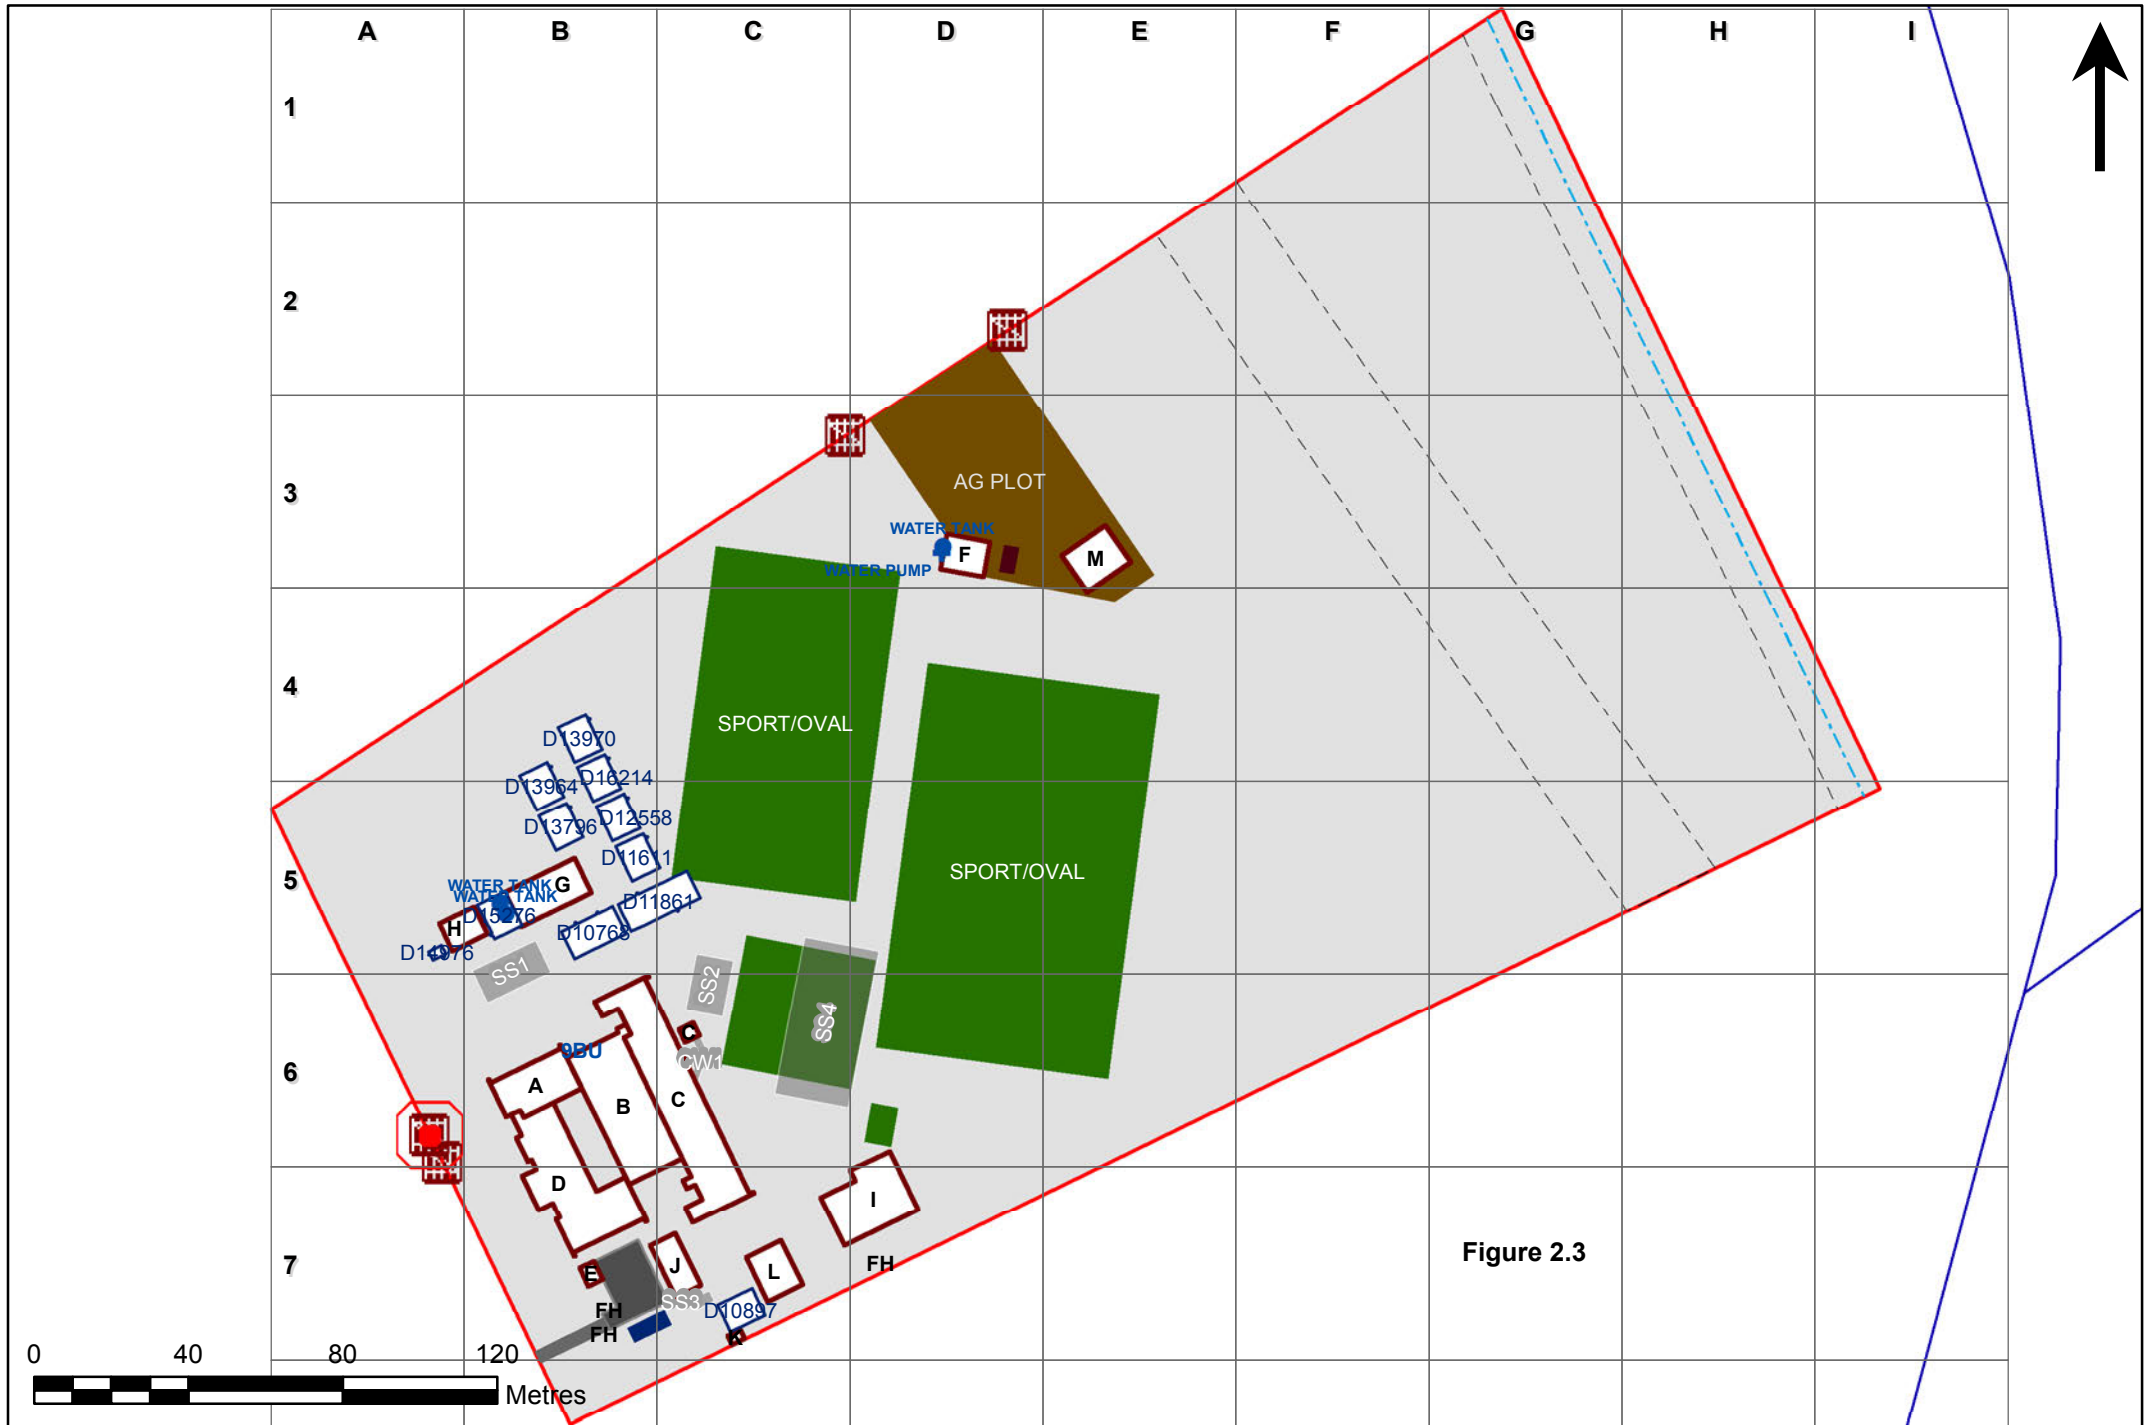
# 8270 - Wee Waa High School Site Plan (11390)

The following notifications were made, and investigations conducted during 2019 that relate to air conditioners (evaporative), water and plumbing issues, moisture and mould (refer to **Appendix A** and **Figure 2.3** to see locations of specific areas):

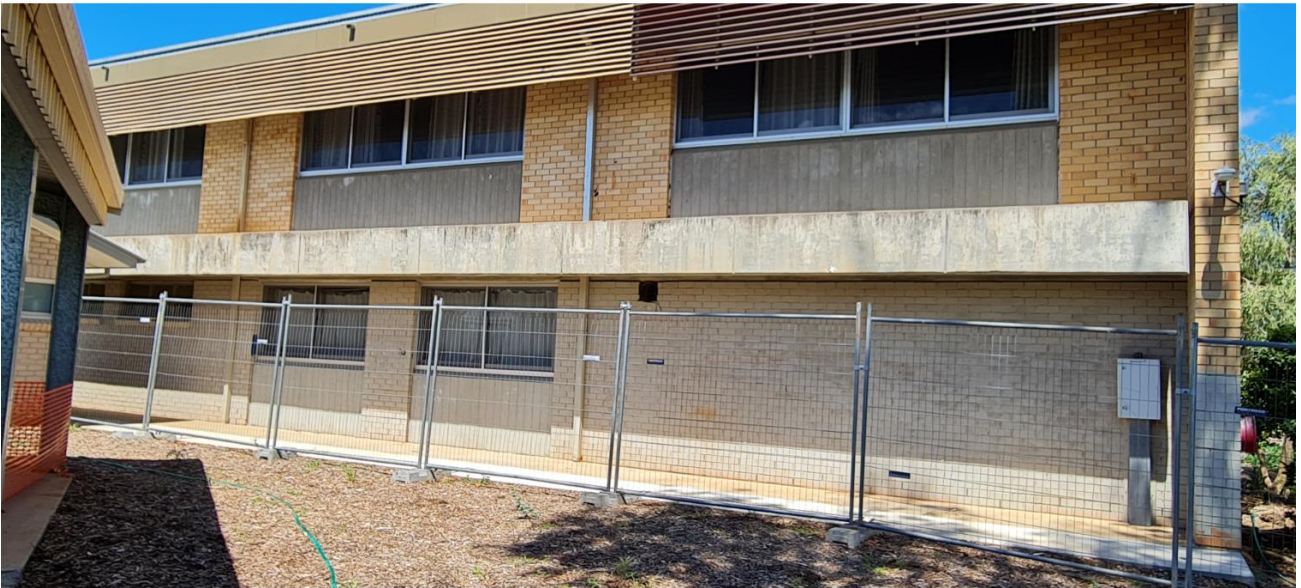
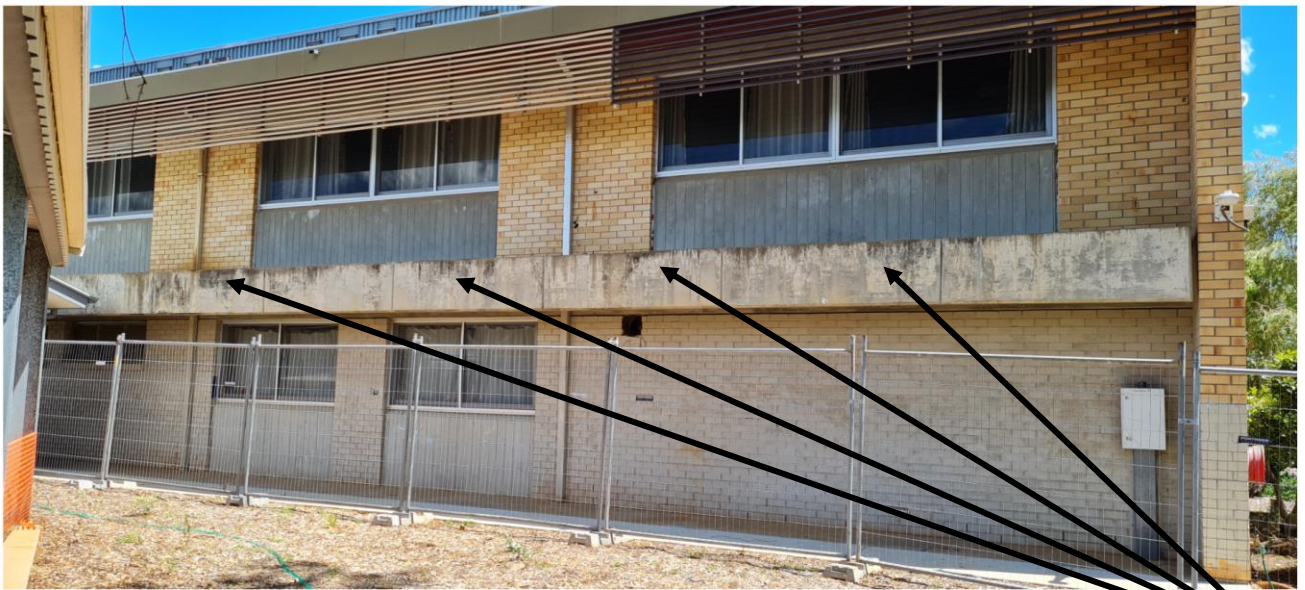
**Figure 4.1: Photographs of concrete plinth from 20 October 2020**

In October 2020, there was a day when mould appeared to grow over just a few hours on the outside of the main building at the high school site on the concrete and also the windows. **Figure 4.1** shows the concrete plinth in the morning and in the afternoon.

Photo taken at 11.30 am

Photo taken at 2 pm

Visible mould on external part of building

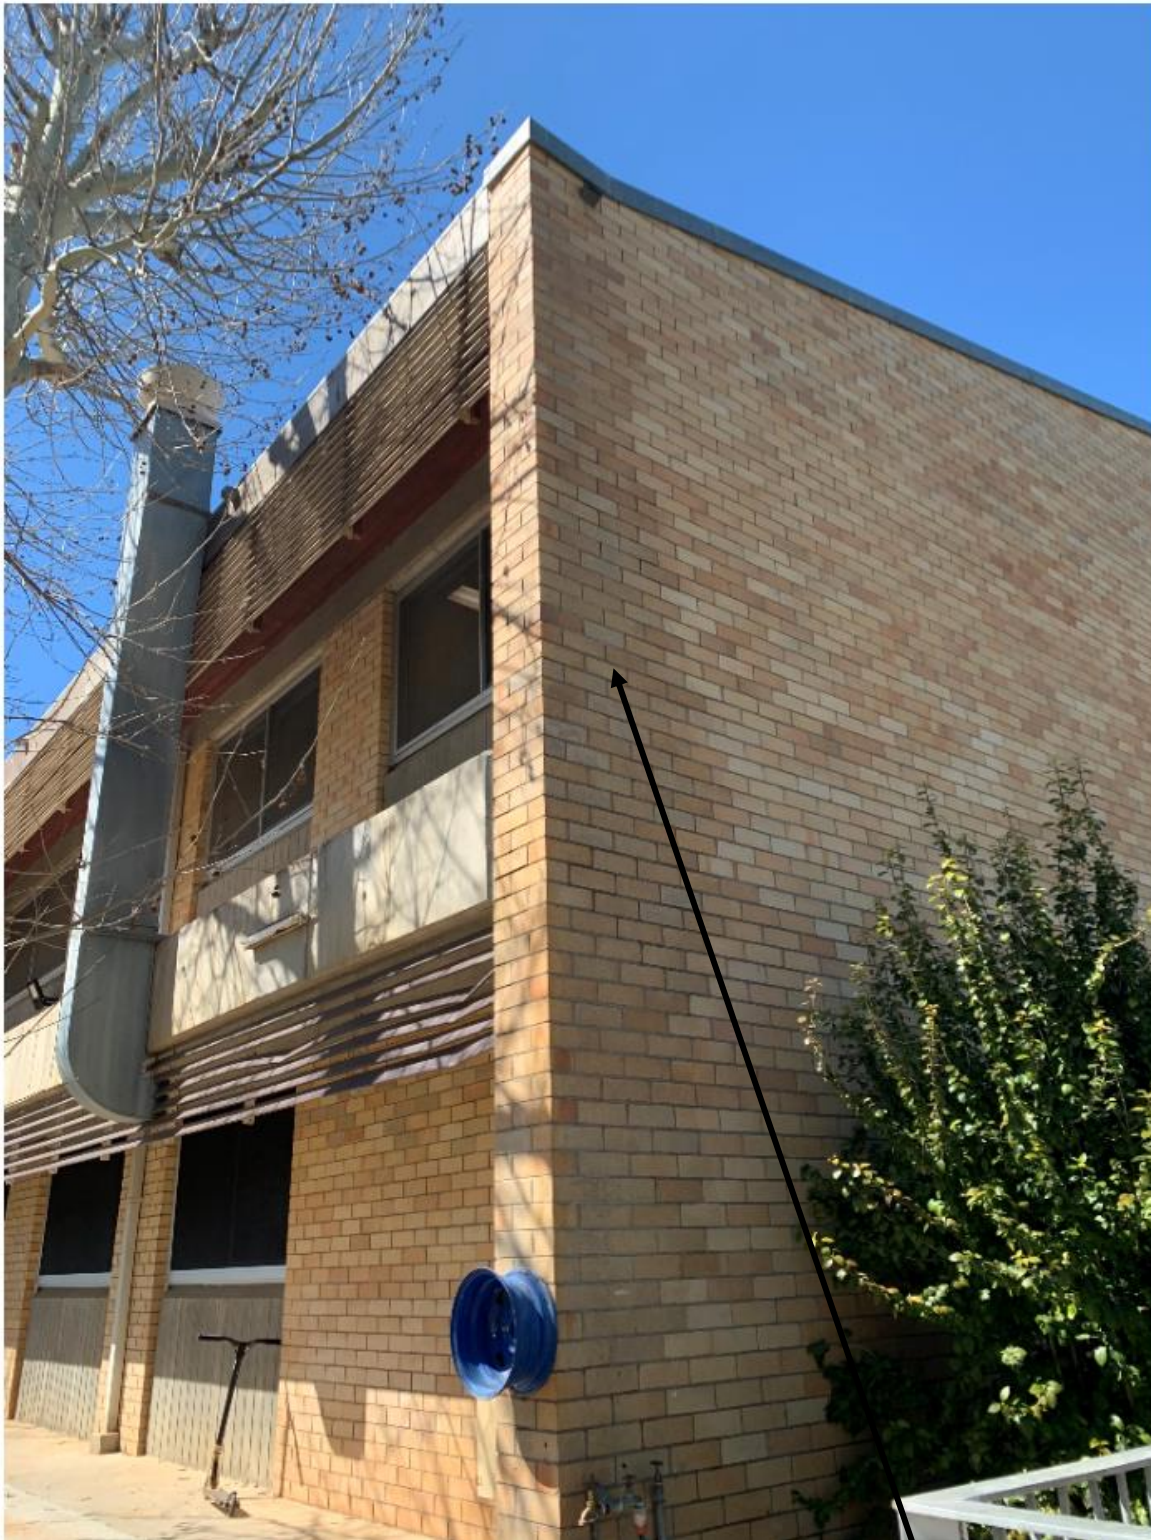
**Figure 4.2: Photograph showing rising damp in external brick (20 October 2020)**

Another useful photo taken on this day (October 2020) showed the extent of rising damp within the external bricks. This photo is included in **Figure 4.2**. The darker coloured bricks on the edge of the wall show that there is dampness rising up the entire height of the wall.

Visible damp (dark area)

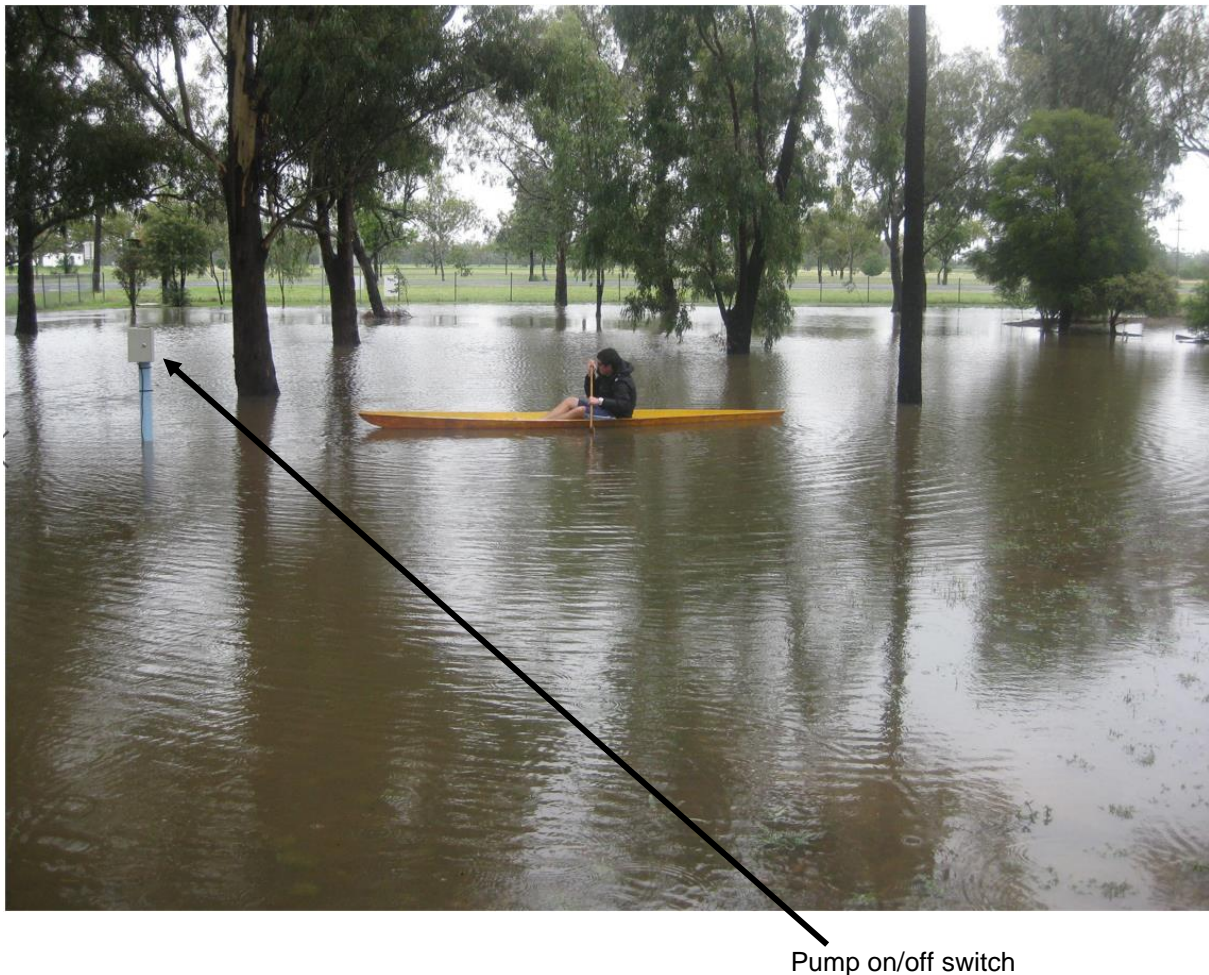
**Figure 4.3: Photograph of flooding at school in 2011, and access to pump switch**

Management of stormwater at the school site has been difficult at times. **Figure 4.3** shows a staff member canoeing across the site during a flood event to reach the location of the stormwater pump on/off switch. This situation arose in 2011 so is not related to the current time frame but it indicates how much water can be present at the site. **Figures 4.4 and 4.5** show that such large amounts of standing water were also present on site in 2020 and 2021.

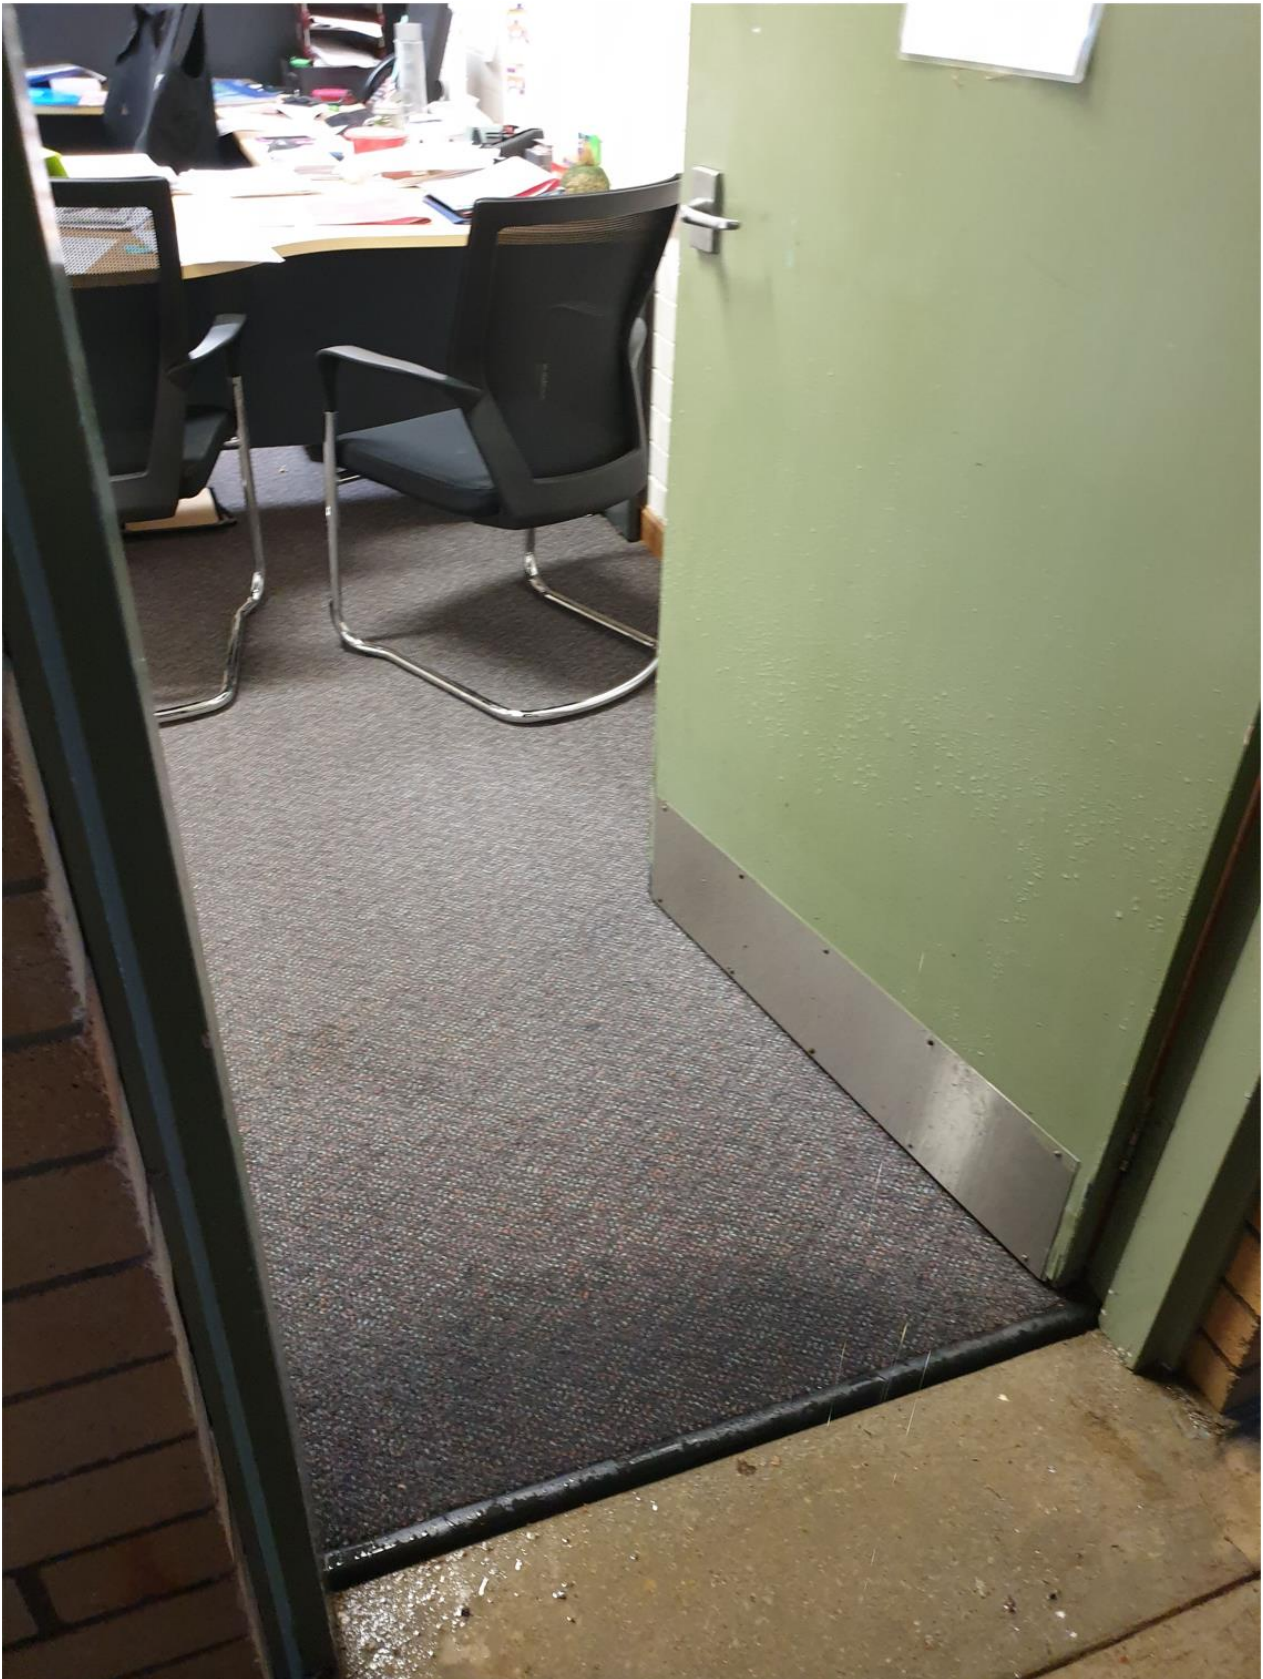
**Figure 4.6: Roof leak A block in February 2020 – water damage**

Other situations have occurred within the buildings at the school resulting in excess moisture. **Figures 4.6 and 4.7** show a roof leak in 2020 in A block as an example of what can occur when large rainfall events occur.

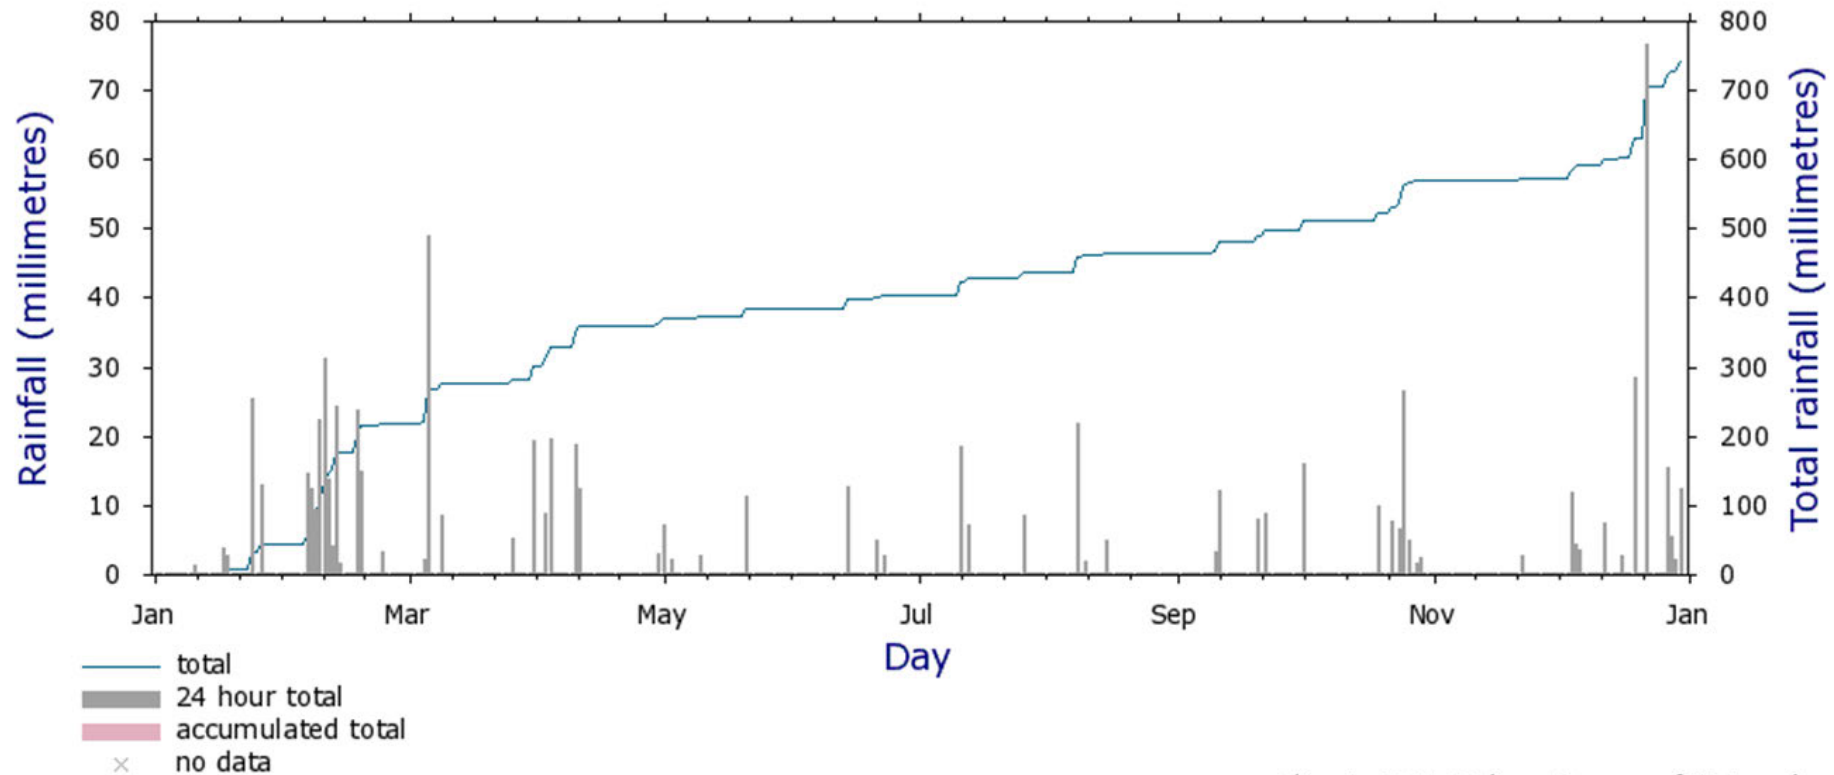
**Figure 4.11: Daily rainfall data for Wee Waa – 2020 (source: Bureau of Meteorology)**

### Wee Waa (George St) (053044) 2020 rainfall

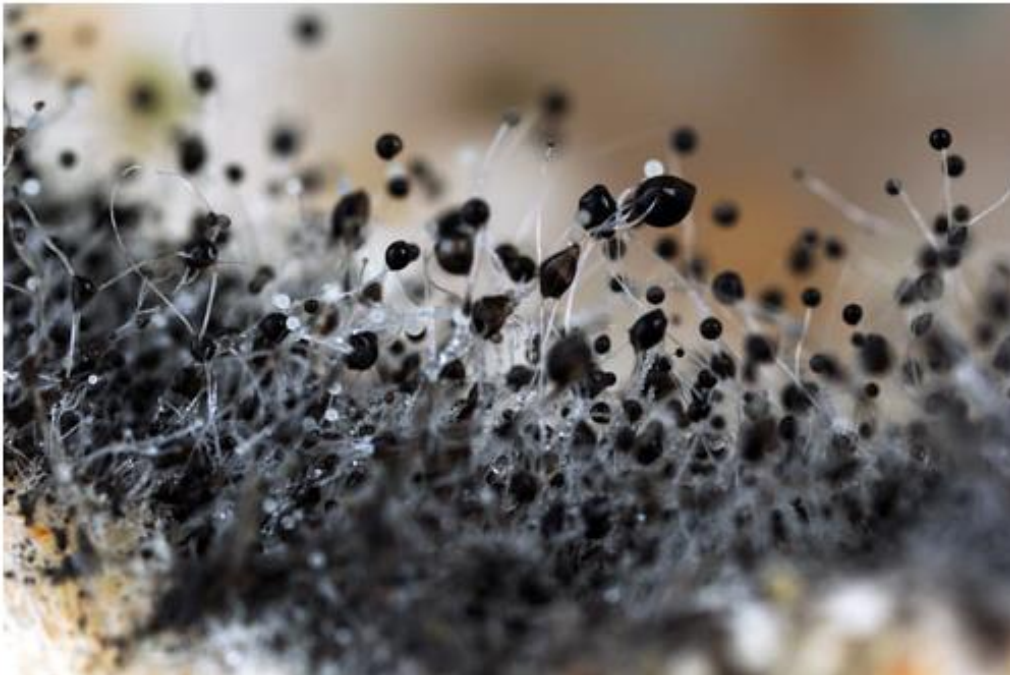
**Figure 9.1: Close up of mould structure**

Some photos showing what moulds look like are shown in **Figures 9.1, 9.2** and **9.3**. The first 2 are close up photos of the structure of a mould and the final photo shows an outbreak of mould on a damp wall.

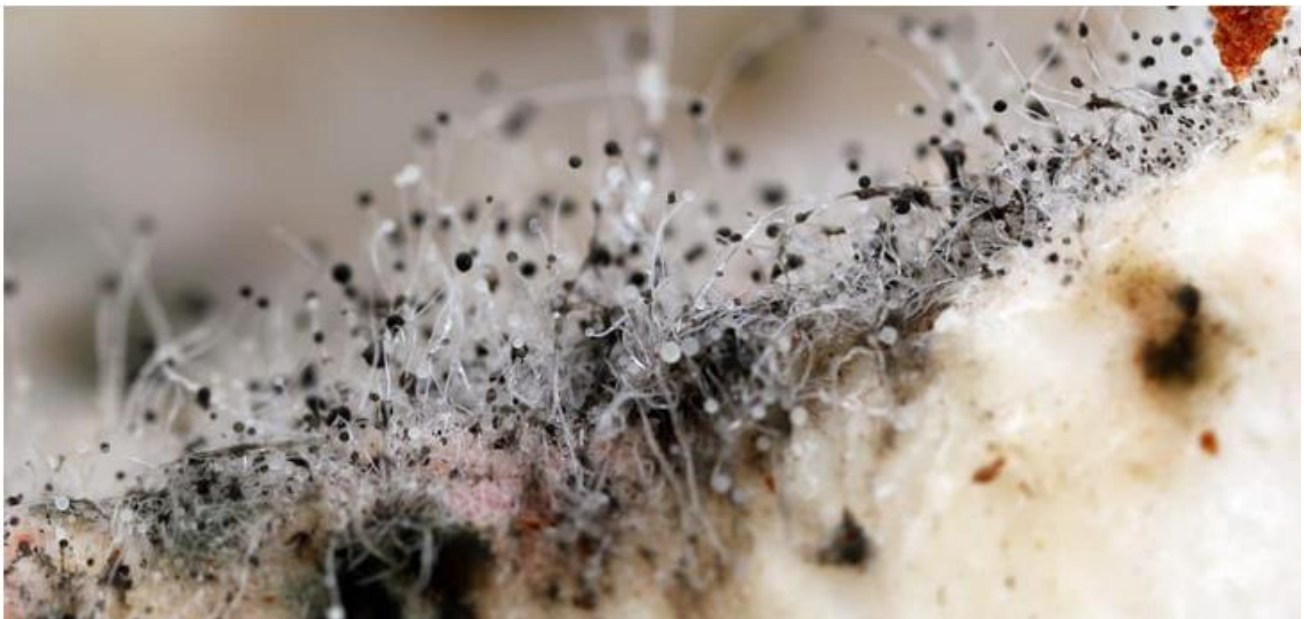
**Figure 9.2: Close up of mould structure**

When moulds are present inside a building, they grow by sending out filaments (hyphae) (the white/clear filaments in **Figure 9.2**) across the surface on which they are growing. Fruiting bodies then grow up from the surface (the black balls in **Figure 9.2**). These structures produce the spores which are then released into the air to spread the mould further.

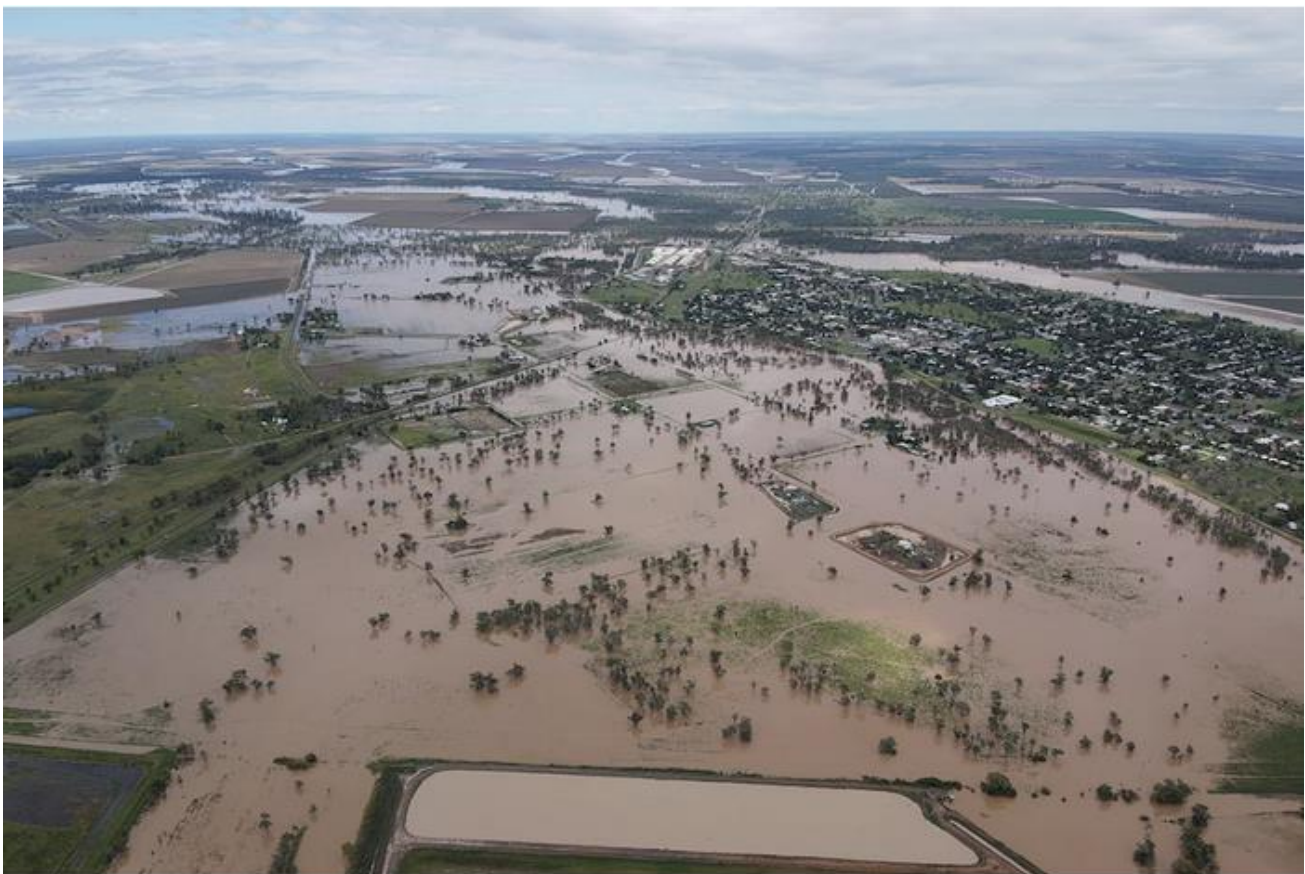
**Figure 10.1: Photograph of flooding at Wee Waa in December 2021**

Unfortunately, significant rainfall occurred in Wee Waa in October/ November 2021 which ended up cutting the town off for around 10 days up to 13 December 2021. Standing water has been significant as shown in the photo below taken from <https://www.abc.net.au/news/2021-12-13/flooded-wee-waa-residents-celebrate-freedom/100689160>. The start of the rain coincided with the school returning to on-site classes after a lockdown due to COVID-19 across NSW.

Symptoms returned for some individuals at this time. This provides some support for the proposed hypothesis as the return of significant moisture/damp (with the potential for limited ventilation in some rooms in the school) coincided with the return of symptoms.
