MONTLY SITE INSPECTION REPORT

November 2020
J153825-04

Cringila Public School
35 Sheffield St, Cringila NSW 2502

| Document Quality Management Details. | | |
|---|---|--|
| Report Name: | Cringila Public School - Monthly Site Inspection Report | |

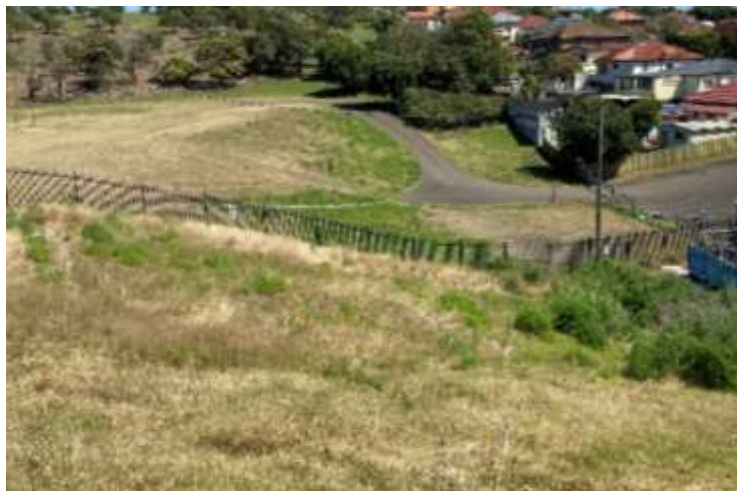
Picture 1 – Exclusion zone fencing surrounding north-western hotspot area

| Inspection Item | Yes | No | Action Required |
|---|---|---|---|
| Was the exclusion zone fencing surrounding the north-western hotspot area intact? | ✓ | | <p>Continue inspections of exclusion zone fencing on a weekly basis.</p> <p>If exclusion zone fencing is not intact, take a photo and mark the area of concern. Inform the School Principal.</p> |

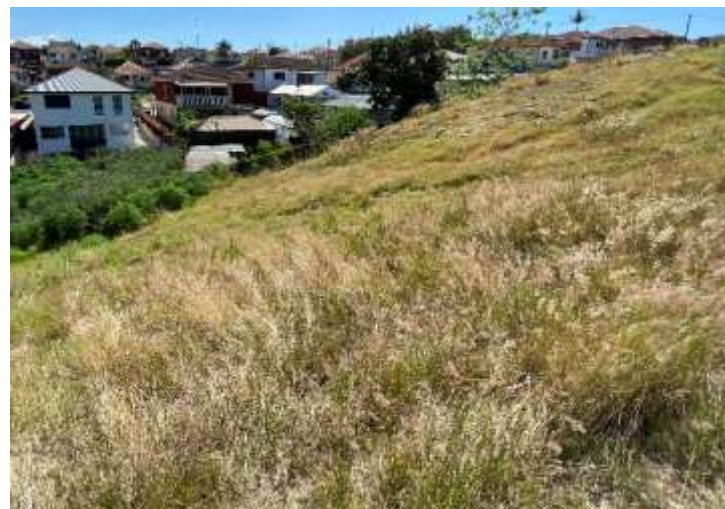
Picture 2 – Slope within north-western hotspot area

| Inspection Item | Yes | No | Action Required |
|---|---|---|---|
| Was any evidence of subsidence or slope failure observed within the north-western hotspot area? | | ✓ | <p>Continue inspections of north-western hotspot area on a weekly basis.</p> <p>If evidence of subsidence or slope failure is observed, take a photo and undertake spot monitoring for gases of concern. Inform the Greencap Project Managers (Sydney & Wollongong).</p> |

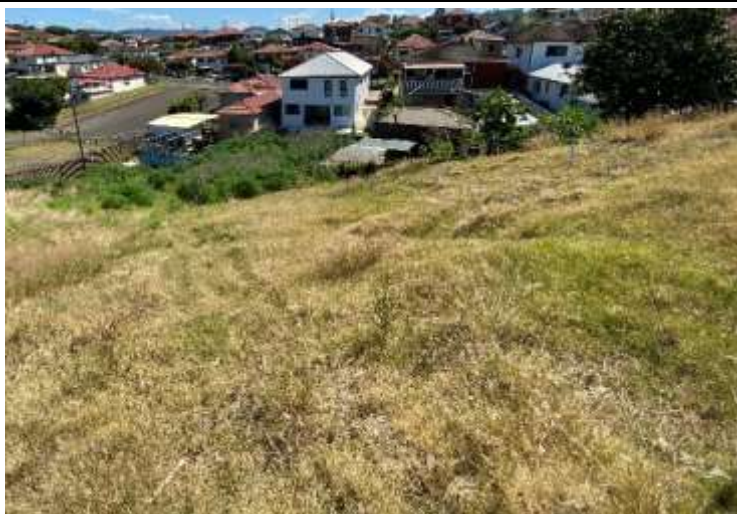
Picture 3 – Slope within north-western hotspot area

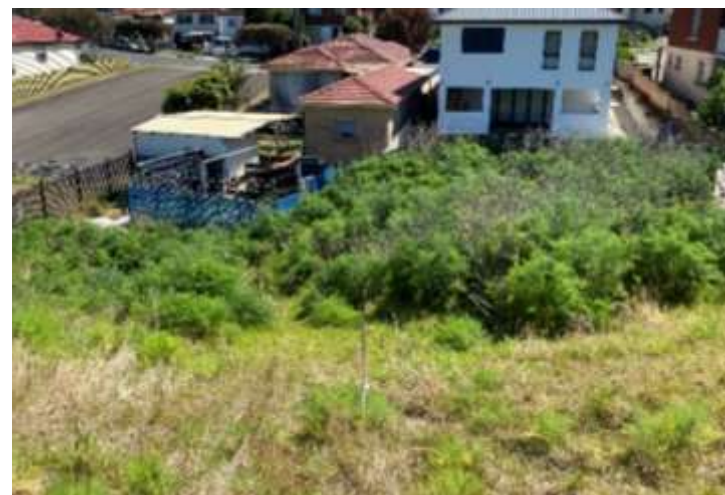
Picture 4 – Vegetation within north-western hotspot area

| Inspection Item | Yes | No | Action Required |
|---|---|---|---|
| Was any evidence of deteriorating vegetation observed within the north-western hotspot area? | | ✓ | <p>Continue inspections of north-western hotspot area on a weekly basis.</p> <p>If evidence of deteriorating vegetation is observed, take a photo and inform the Greencap Project Managers (Sydney & Wollongong).</p> |
