CRINGILA PUBLIC SCHOOL  
NEAR-SURFACE TEMPERATURE  
MONITORING INVESTIGATION

Summary Report  
19/10/2020 – 30/10/2020

Cringila Public School

Document Quality Management Details							
<b>Job Reference:</b>	J153825-04						
<b>Report Name:</b>	TI-09 Near-Surface Temperature Monitoring						
<b>Site Details:</b>	Cringila Public School – 35 Sheffield Street, Cringila NSW 2502 Northwest Hotspot						
<b>Client Name:</b>	NSW Department of Education						
<b>Client Number:</b>	C107471						
<b>Signatures:</b>

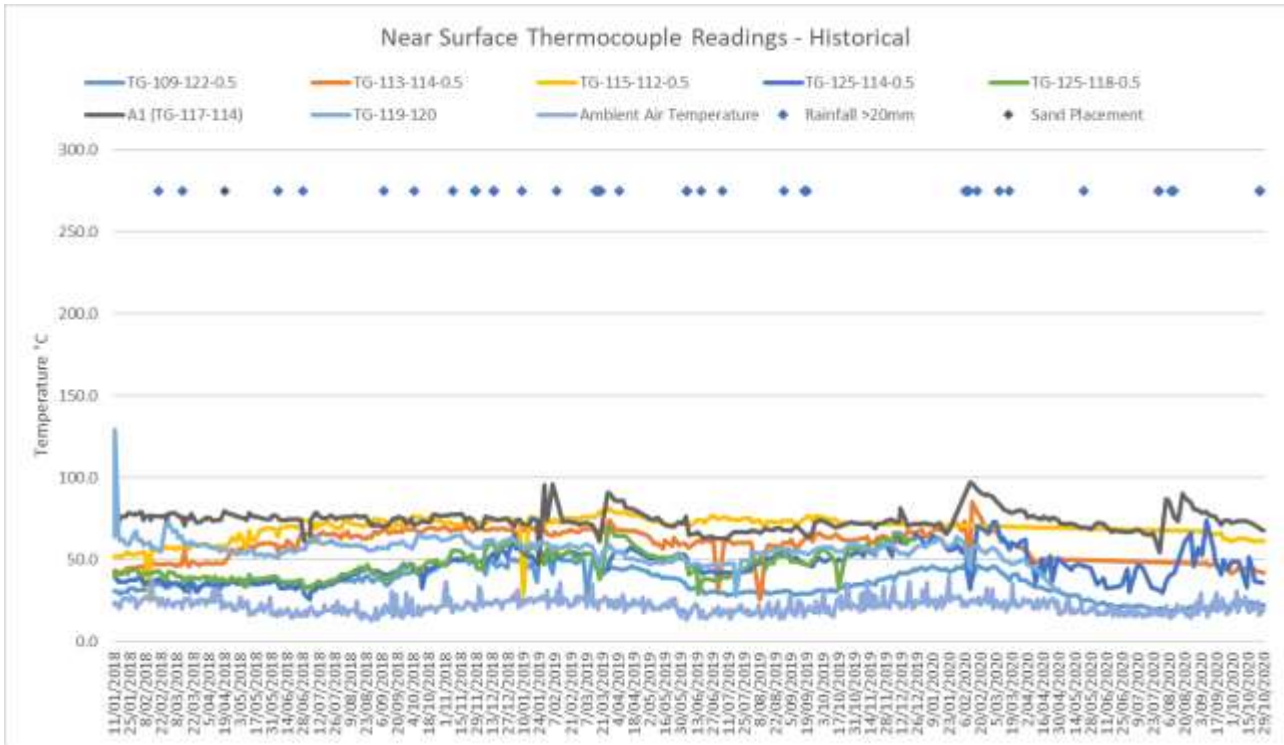
### 3.1. Near-Surface Temperature Graph – Selected Points (Historical)

Near surface temperature measurements for key thermocouple locations, progressive from Thursday 11<sup>th</sup> January 2018 to present.

The near-surface temperature appears to fluctuate seasonally across the surface of the northwest hotspot grid monitoring area.

Fluctuations in near-surface temperature are also evident following significant rain events (i.e. over 20mm rain).

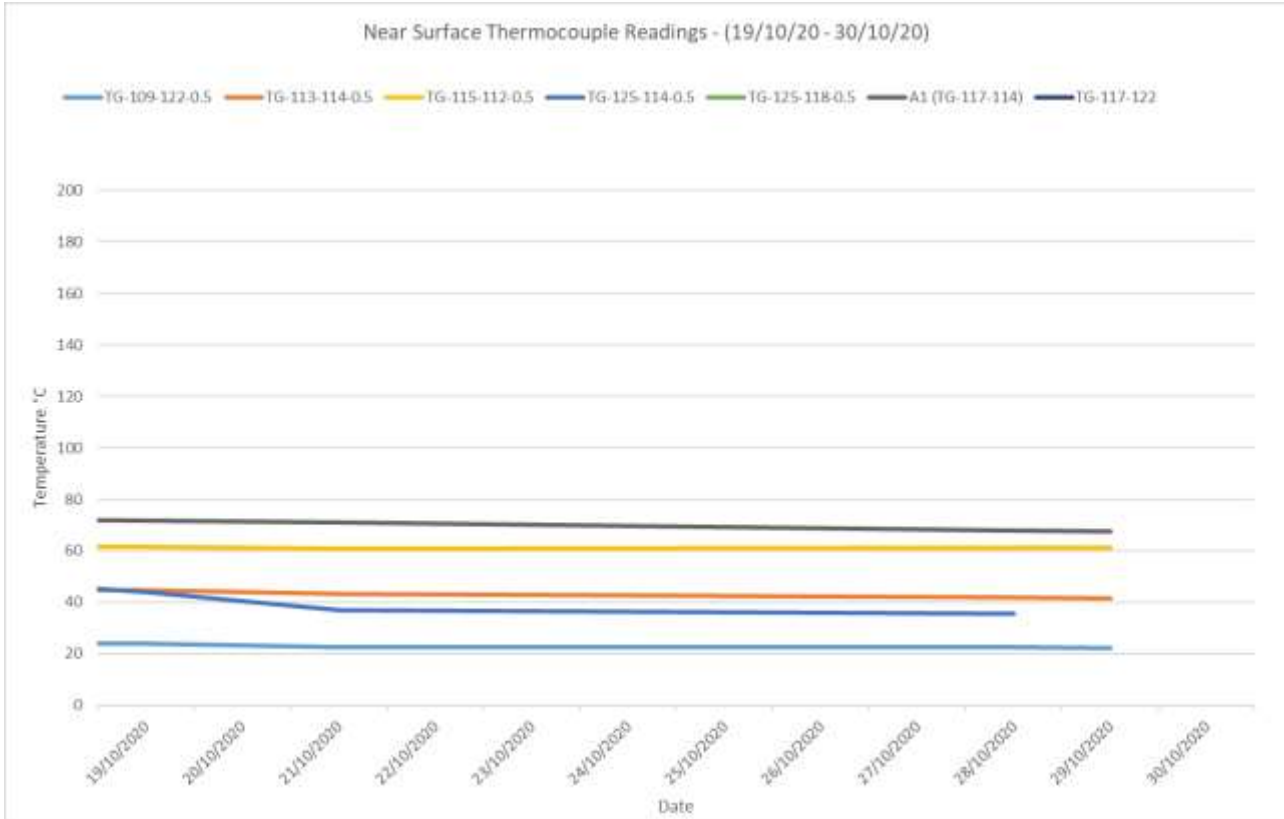
### 3.2. Near-Surface Temperature Graph – Selected Points (Fortnightly)

Near-surface temperature measurements for key thermocouple locations, over the monitoring period – between 19<sup>th</sup> October 2020 and 30<sup>th</sup> October 2020 in the northwest Hotspot, situated on the Cringila Public School grounds. Please note – data from certain points was not available within this date range due to technical constraints.

Variations in the near-surface temperature at selected points across the northwest hotspot over the period of monitoring appear to coincide with the high rainfall events during the period.

It is recommended that weekly site inspections and recording are continued to monitor the near-surface temperatures surrounding the subsurface hotspot identified at the site.

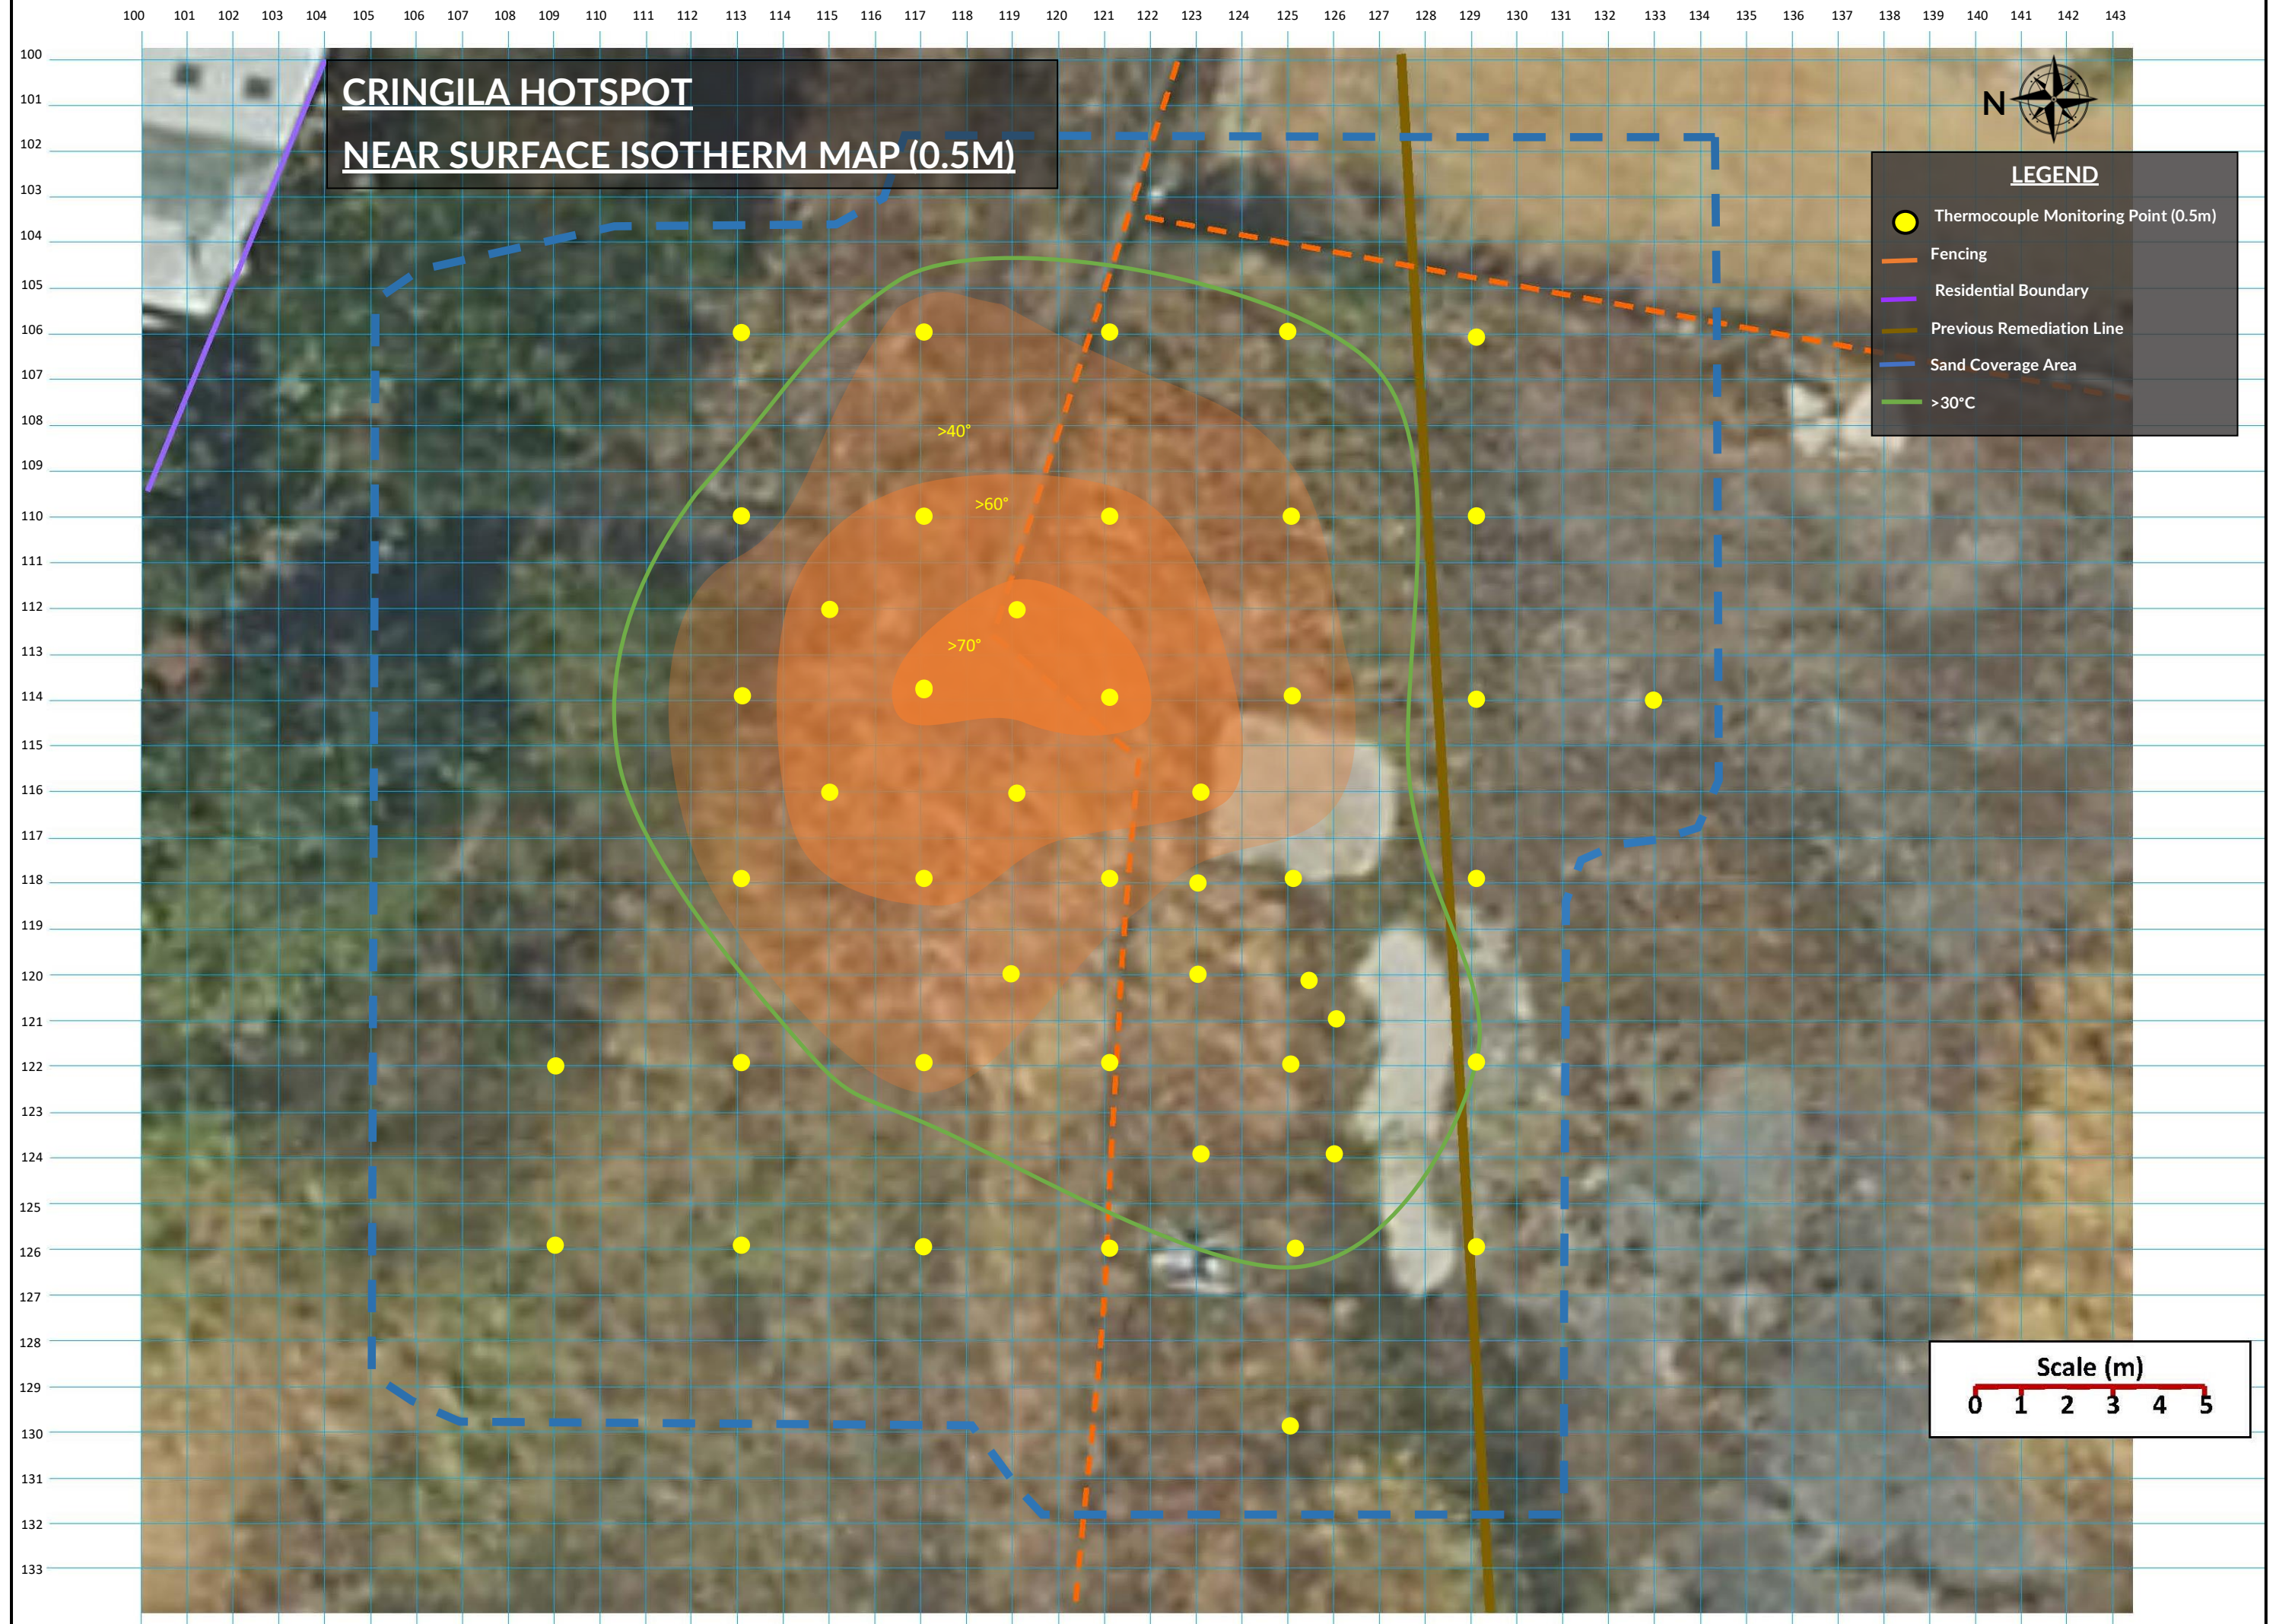
### **Appendix B: Near-Surface Temperature Isotherm Map (0.5m)**

The isotherm map shows the general zone of influence for temperatures between 30°C and 70°C at 0.5m, coloured orange. The isotherm map suggests that the hotspot may extend deeper than 0.5m and that the increased temperature in these areas is a result of heat venting to the surface.

It is noted that temperature at the near-surface may be variable across the hotspot due to inconsistencies in the consolidation and compaction of subsurface materials.
