# CRINGILA PUBLIC SCHOOL NEAR-SURFACE TEMPERATURE MONITORING INVESTIGATION

Summary Report  
16/11/2020 – 27/11/2020

Cringila Public School

# Near-Surface Temperature Monitoring

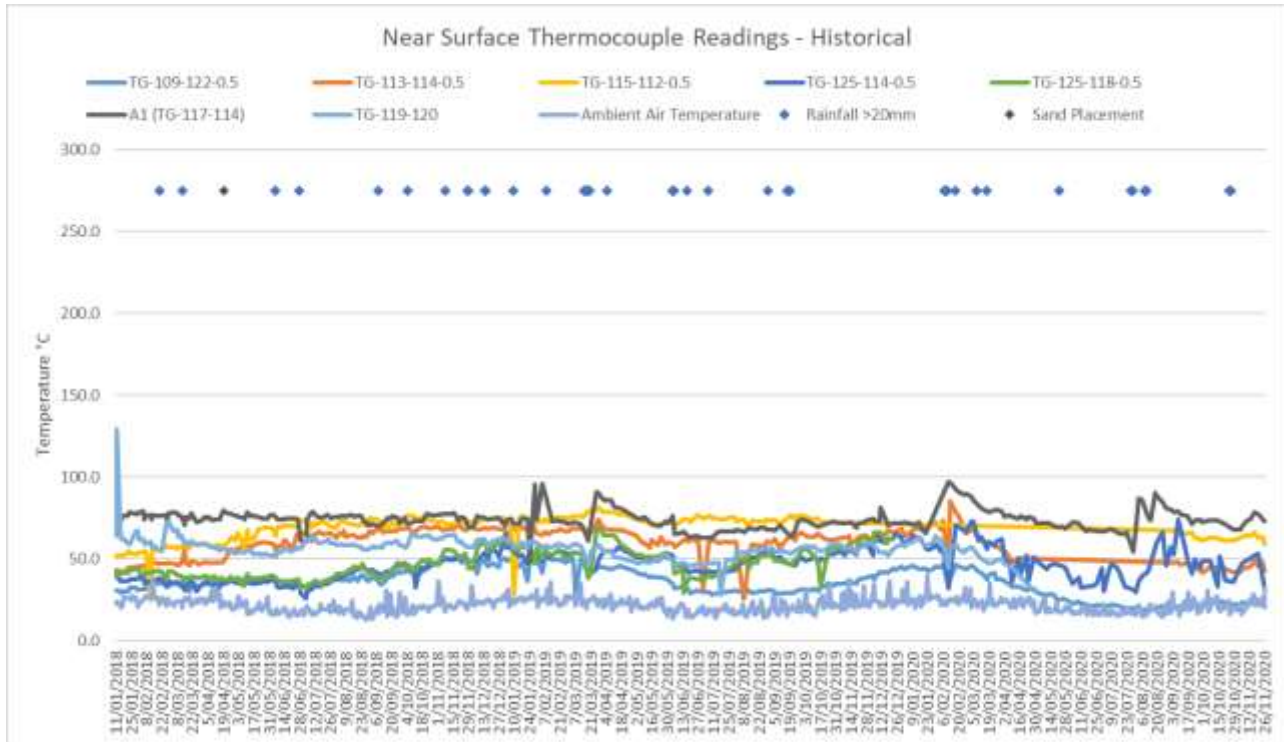
### 3.1. Near-Surface Temperature Graph – Selected Points (Historical)

Near surface temperature measurements for key thermocouple locations, progressive from Thursday 11<sup>th</sup> January 2018 to present.

The near-surface temperature appears to fluctuate seasonally across the surface of the northwest hotspot grid monitoring area.

Fluctuations in near-surface temperature are also evident following significant rain events (i.e. over 20mm rain).

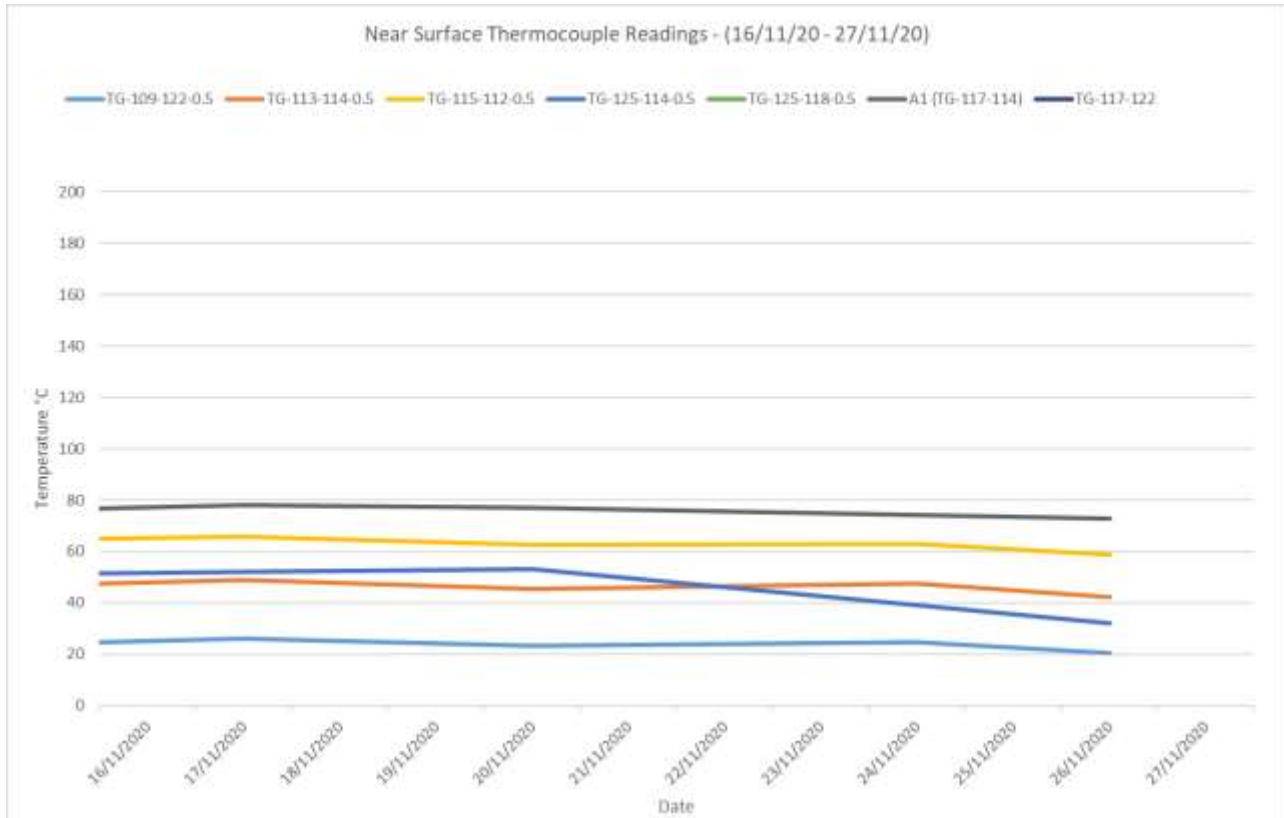
### 3.2. Near-Surface Temperature Graph – Selected Points (Fortnightly)

Near-surface temperature measurements for key thermocouple locations, over the monitoring period – between 16<sup>th</sup> November 2020 and 27<sup>th</sup> November 2020 in the northwest Hotspot, situated on the Cringila Public School grounds. Please note – data from certain points was not available within this date range due to technical constraints.

The near-surface temperature monitoring conducted between 16<sup>th</sup> November 2020 and 27<sup>th</sup> November 2020 indicates that the spatial extent of the northwest hotspot appears to remain localised.

It is recommended that weekly site inspections and recording are continued to monitor the near-surface temperatures surrounding the subsurface hotspot identified at the site.

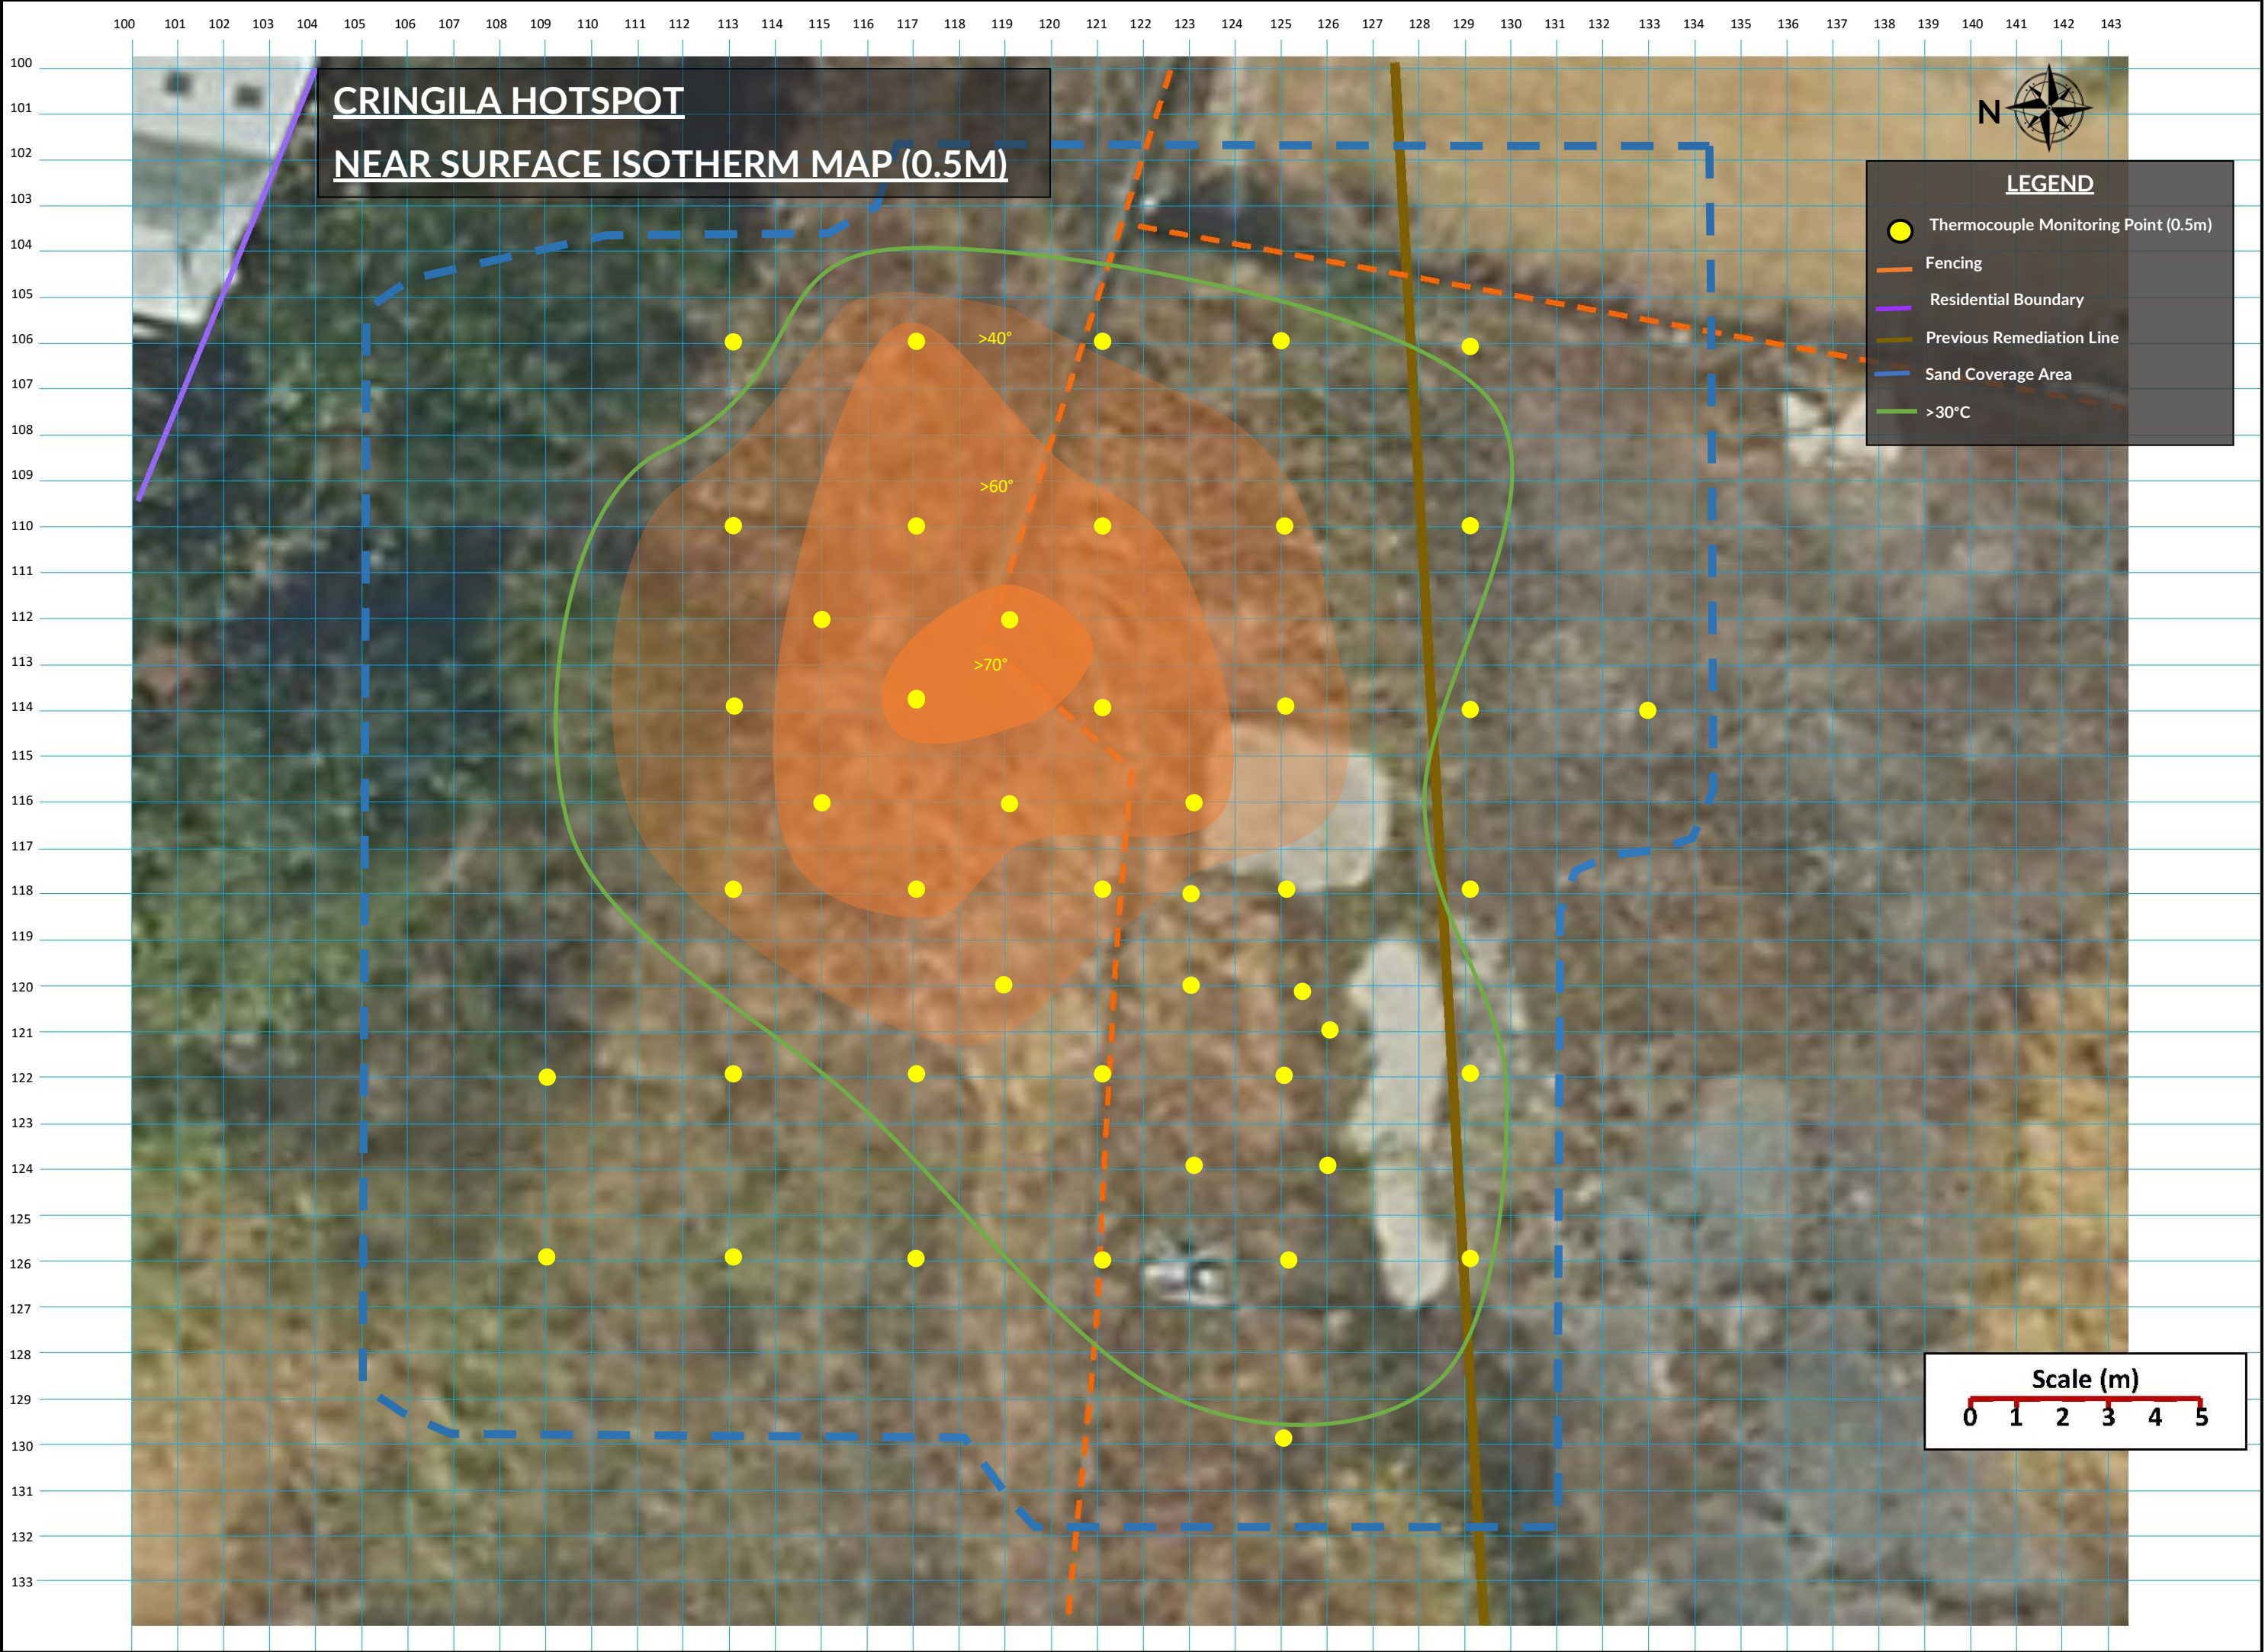
### Appendix B: Near-Surface Temperature Isotherm Map (0.5m)

The isotherm map shows the general zone of influence for temperatures between 30°C and 70°C at 0.5m, coloured orange. The isotherm map suggests that the hotspot may extend deeper than 0.5m and that the increased temperature in these areas is a result of heat venting to the surface.

It is noted that temperature at the near-surface may be variable across the hotspot due to inconsistencies in the consolidation and compaction of subsurface materials.

The near-surface temperatures for representative monitoring locations, spread across the northwest Hotspot, are presented in the tables below. Temperature isotherms have been plotted on a site map to show an illustration of the near-surface temperatures in a spatial context. Refer to **Appendix B: Near Surface Temperature Isotherm Map (0.5m)**.
