CRINGILA PUBLIC SCHOOL
NEAR-SURFACE TEMPERATURE
MONITORING INVESTIGATION

Summary Report 30/11/2020 - 11/21/2020

NSW Department of Education

Cringila Public School

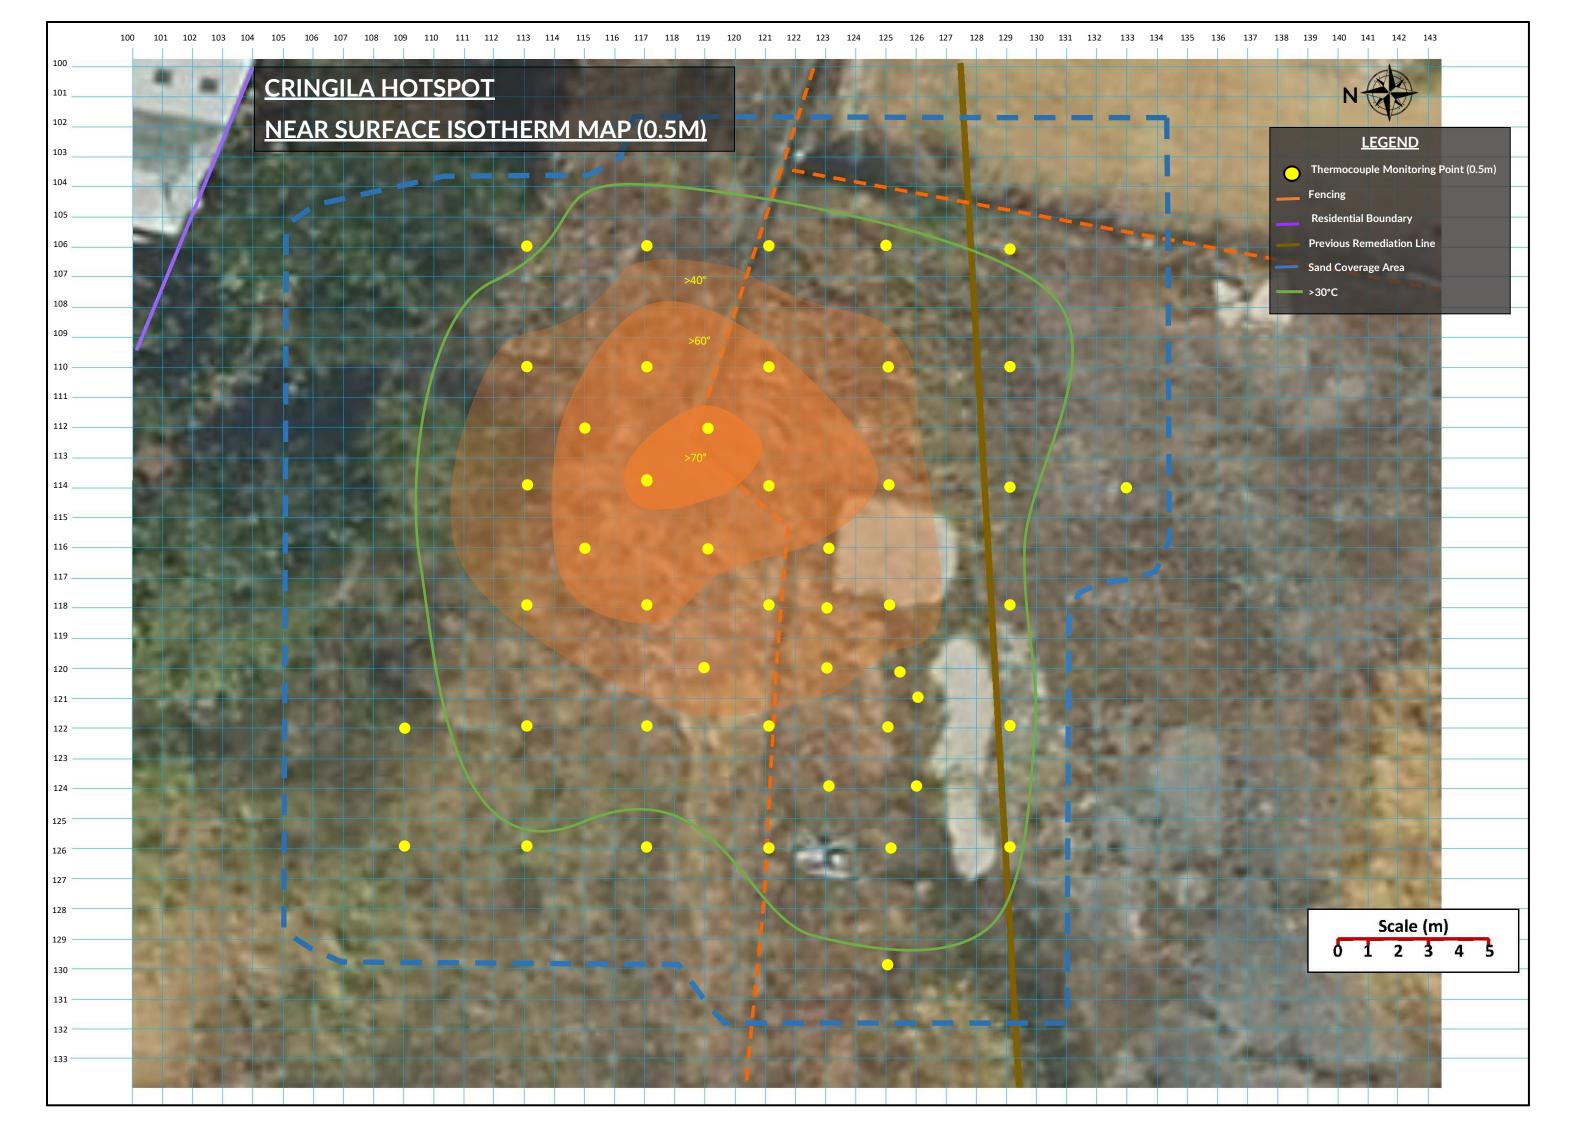
Appendix B: Near-Surface Temperature Isotherm Map (0.5m)

The isotherm map shows the general zone of influence for temperatures between 30°C and 70°C at 0.5m, coloured orange. The isotherm map suggests that the hotspot may extend deeper than 0.5m and that the increased temperature in these areas is a result of heat venting to the surface.

It is noted that temperature at the near-surface may be variable across the hotspot due to inconsistencies in the consolidation and compaction of subsurface materials.

It is recommended that weekly site inspections and recording are continued to monitor the near-surface temperatures surrounding the subsurface hotspot identified at the site.
