CRINGILA PUBLIC SCHOOL NEAR-SURFACE TEMPERATURE MONITORING INVESTIGATION

Summary Report
14/12/2020 – 25/12/2020

Cringila Public School

Document Quality Management Details		
Job Reference:	J153825-04	
Report Name:	TI-13 Near-Surface Temperature Monitoring	
Site Details:	Cringila Public School – 35 Sheffield Street, Cringila NSW 2502 Northwest Hotspot	
Client Name:	NSW Department of Education	
Client Number:	C107471	
Signatures:	Prepared By:

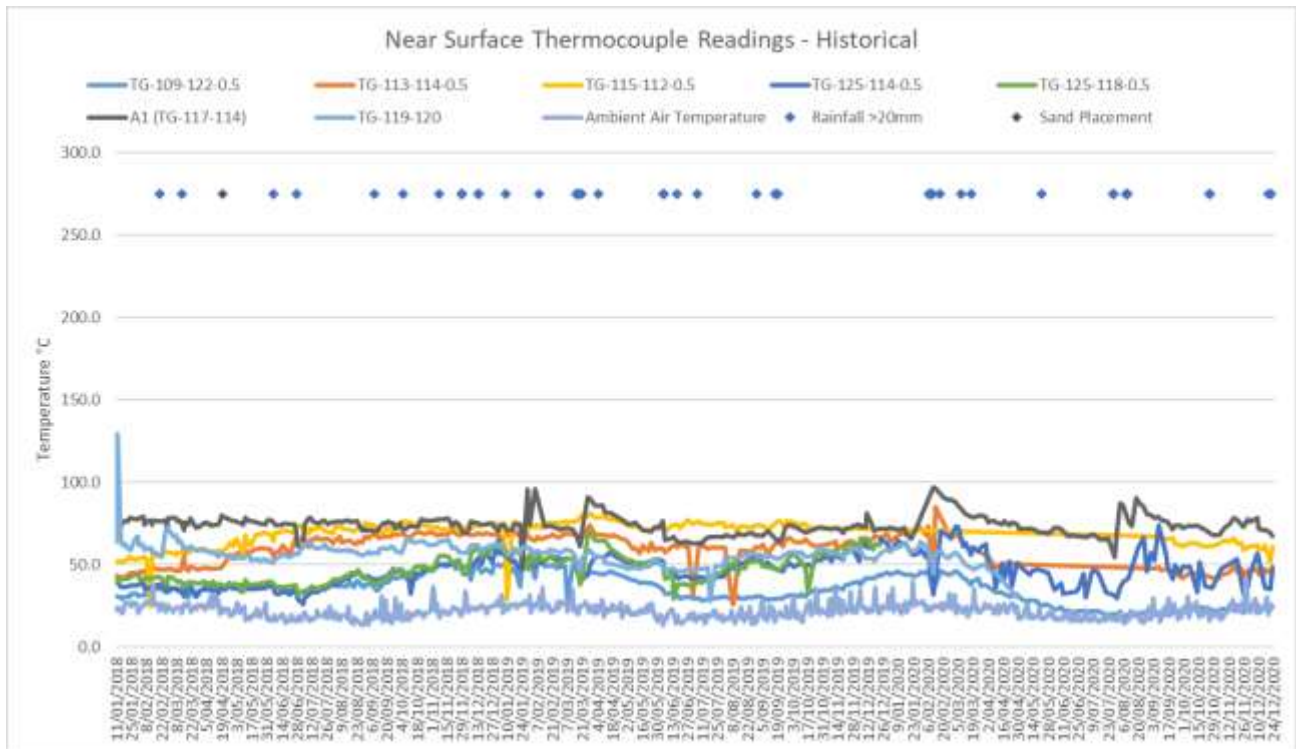
3.1. Near-Surface Temperature Graph – Selected Points (Historical)

Near surface temperature measurements for key thermocouple locations, progressive from Thursday 11th January 2018 to present.

The near-surface temperature appears to fluctuate seasonally across the surface of the northwest hotspot grid monitoring area.

Fluctuations in near-surface temperature are also evident following significant rain events (i.e. over 20mm rain).

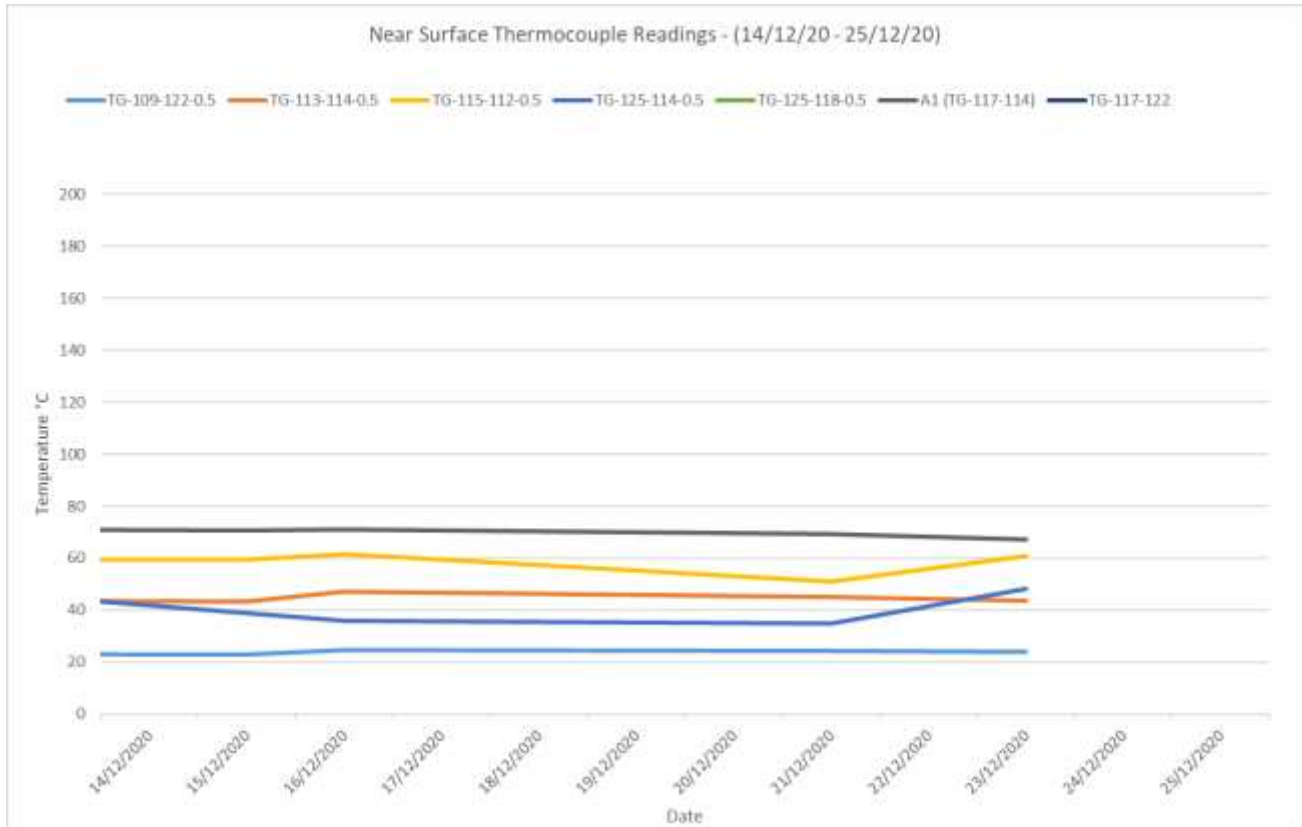
3.2. Near-Surface Temperature Graph – Selected Points (Fortnightly)

Near-surface temperature measurements for key thermocouple locations, over the monitoring period – between 14th December 2020 and 25th December 2020 in the northwest Hotspot, situated on the Cringila Public School grounds. Please note – data from certain points was not available within this date range due to technical constraints.

The near-surface temperature monitoring conducted between 14th December 2020 and 25th December 2020 indicates that the spatial extent of the northwest hotspot appears to remain localised.

No significant rainfall events were recorded during the monitoring period.

It is recommended that weekly site inspections and recording are continued to monitor the near-surface temperatures surrounding the subsurface hotspot identified at the site.

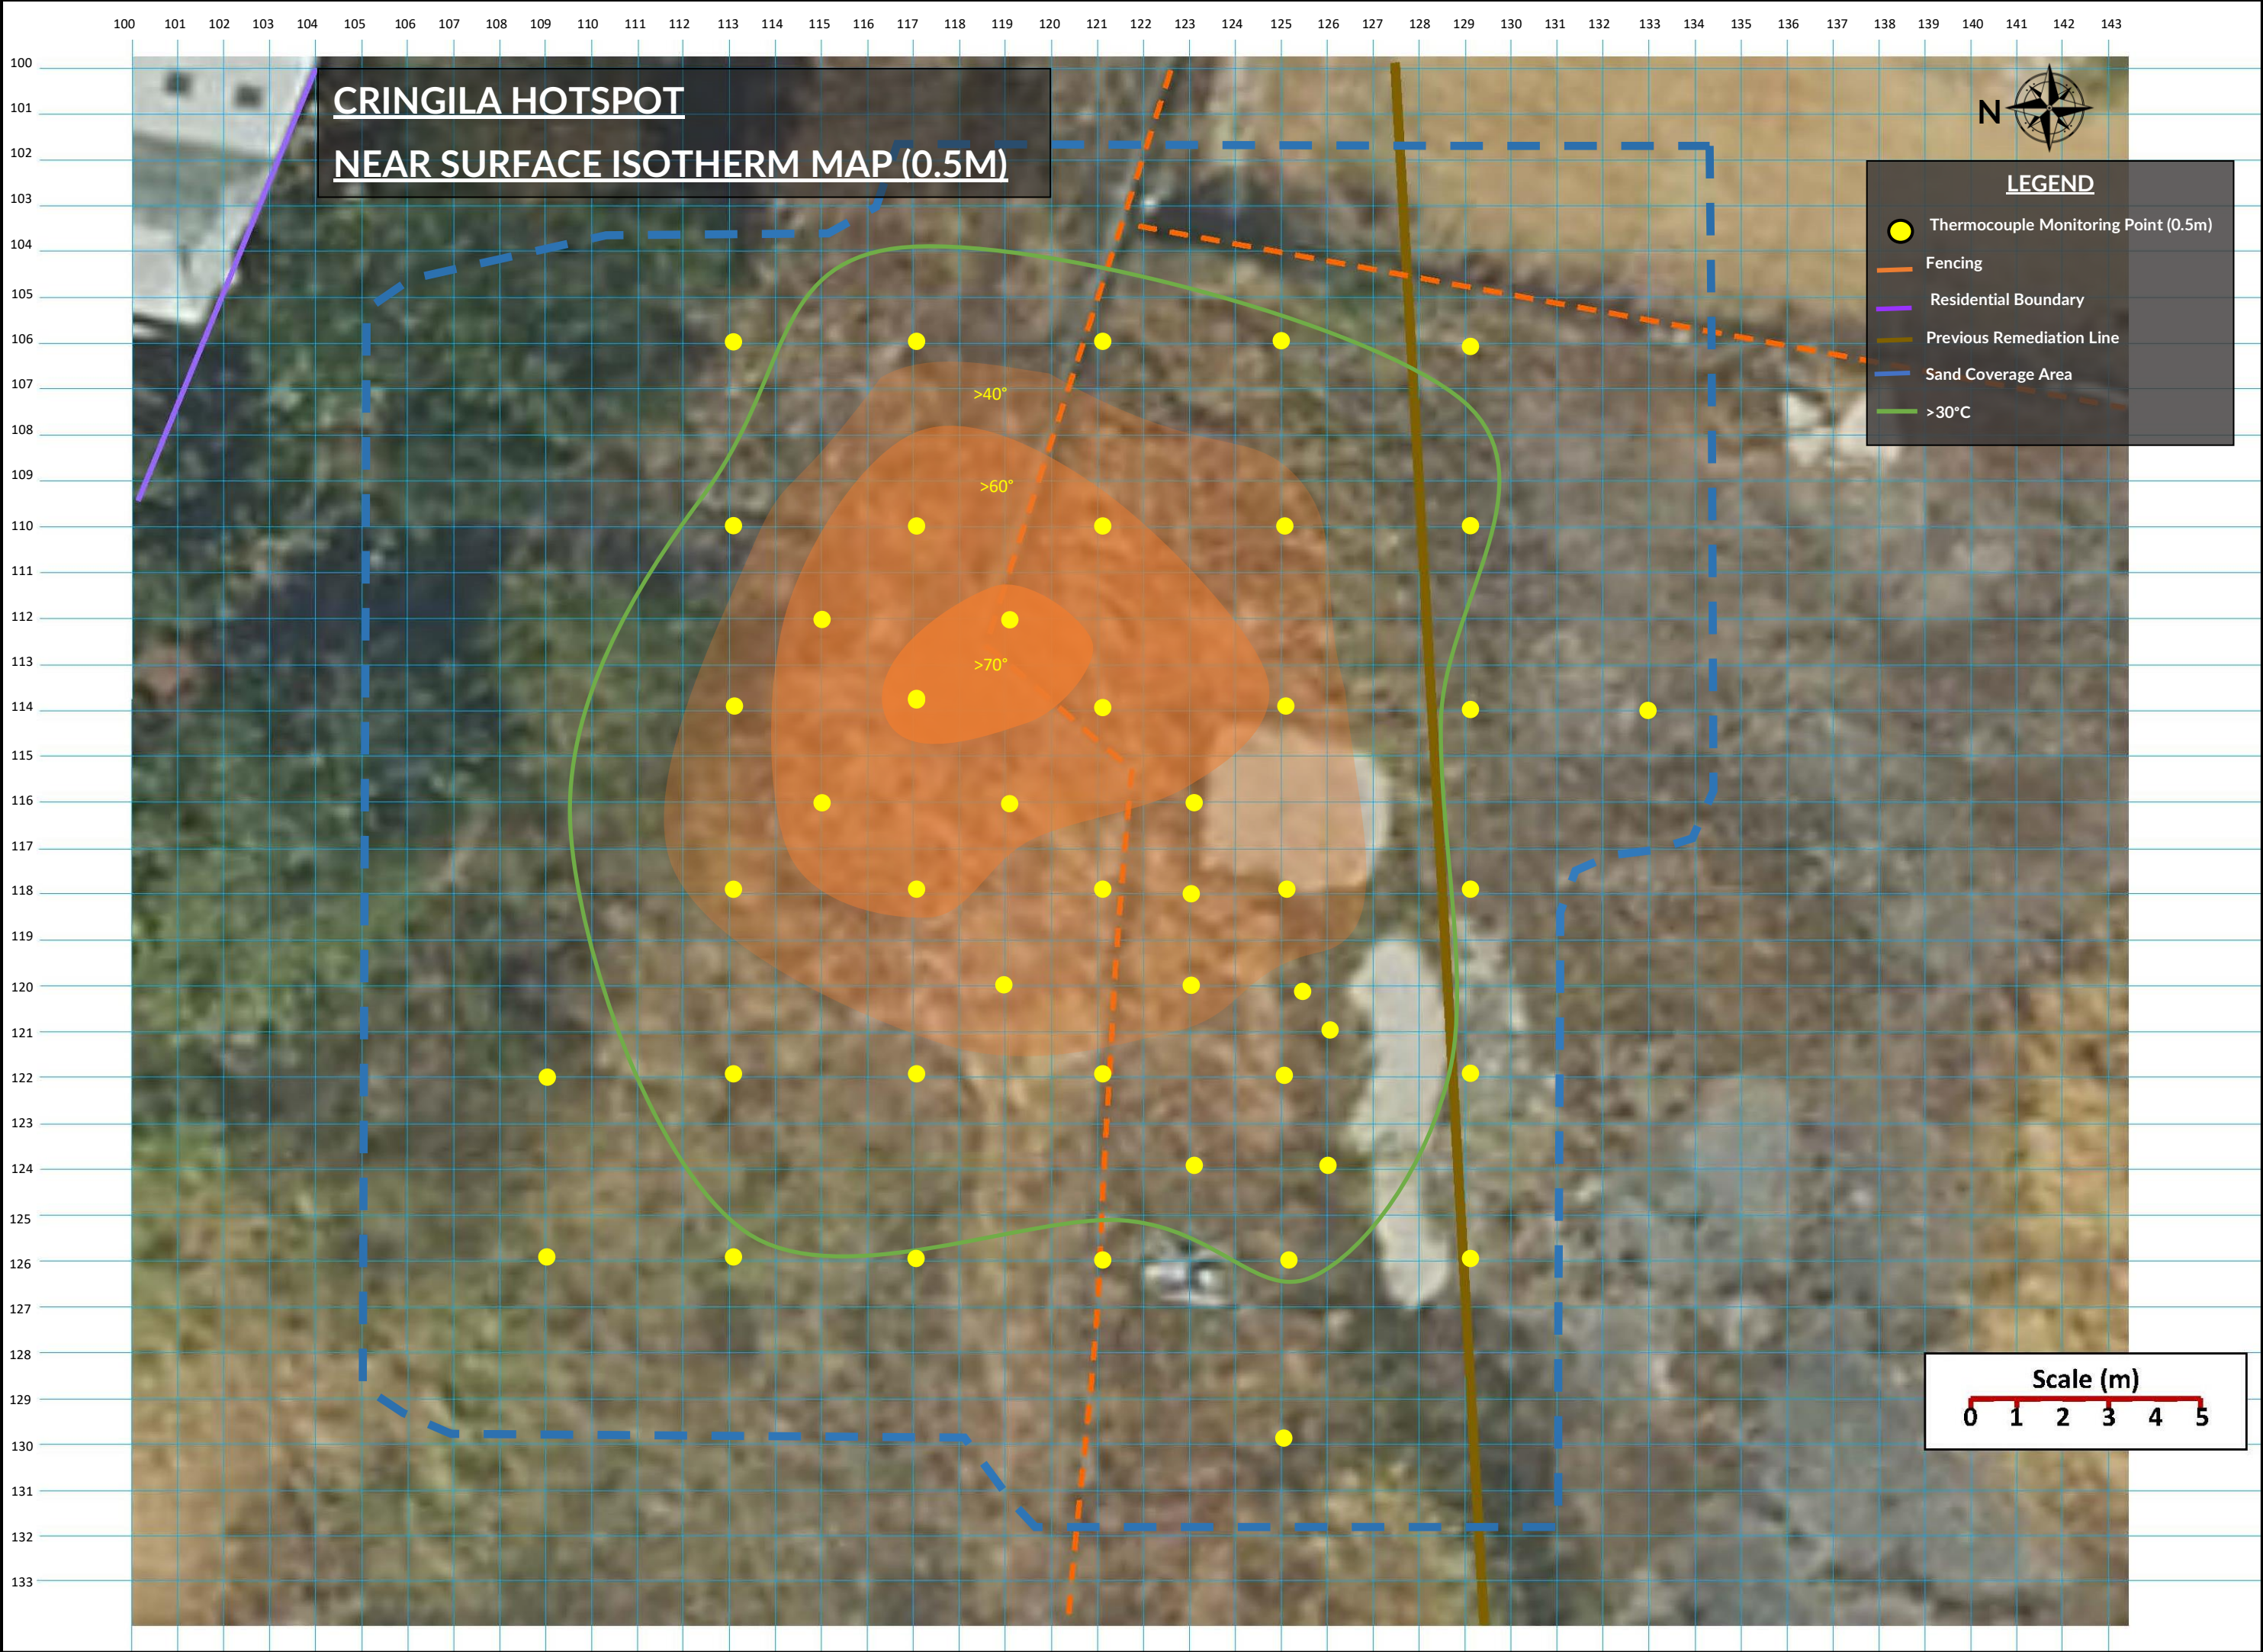
Appendix B: Near-Surface Temperature Isotherm Map (0.5m)

The isotherm map shows the general zone of influence for temperatures between 30°C and 70°C at 0.5m, coloured orange. The isotherm map suggests that the hotspot may extend deeper than 0.5m and that the increased temperature in these areas is a result of heat venting to the surface.

It is noted that temperature at the near-surface may be variable across the hotspot due to inconsistencies in the consolidation and compaction of subsurface materials.
