CRINGILA PUBLIC SCHOOL NEAR-SURFACE TEMPERATURE MONITORING INVESTIGATION

Summary Report
28/12/2020 – 08/01/2021

Cringila Public School

Document Quality Management Details		
Job Reference:	J153825-04	
Report Name:	TI-14 Near-Surface Temperature Monitoring	
Site Details:	Cringila Public School – 35 Sheffield Street, Cringila NSW 2502 Northwest Hotspot	
Client Name:	NSW Department of Education	
Client Number:	C107471	
Signatures:	Prepared By:

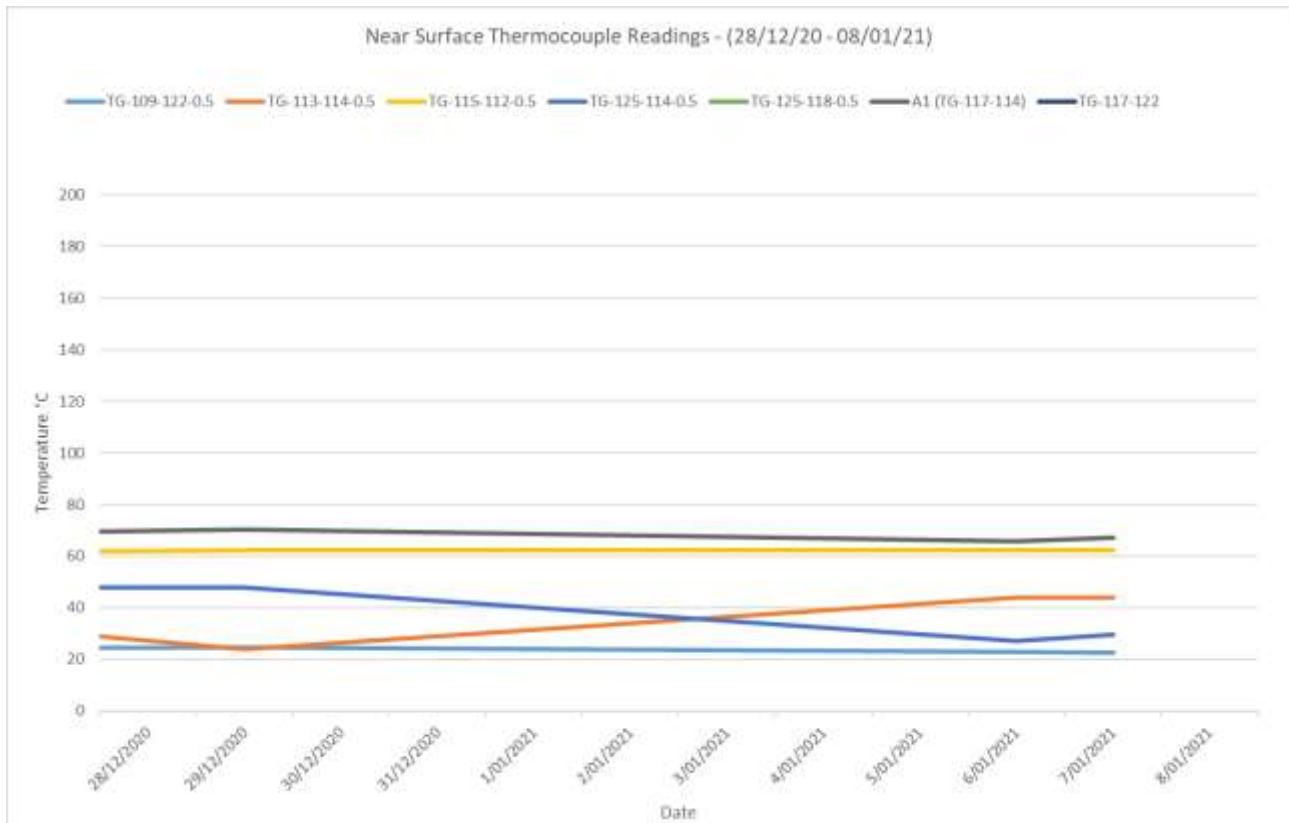
3.1. Near-Surface Temperature Graph – Selected Points (Historical)

Near surface temperature measurements for key thermocouple locations, progressive from Thursday 11th January 2018 to present.

The near-surface temperature appears to fluctuate seasonally across the surface of the northwest hotspot grid monitoring area.

Fluctuations in near-surface temperature are also evident following significant rain events (i.e. over 20mm rain).

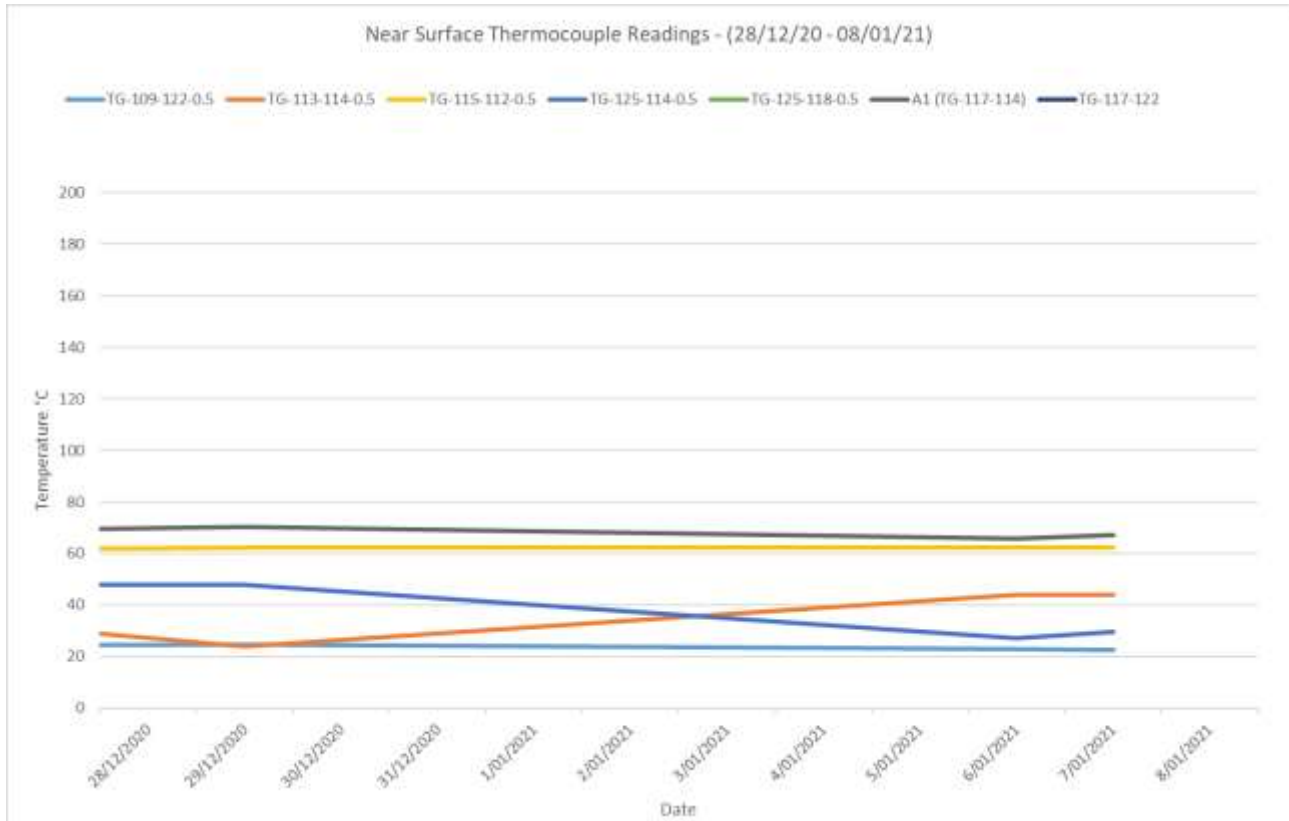
3.2. Near-Surface Temperature Graph – Selected Points (Fortnightly)

Near-surface temperature measurements for key thermocouple locations, over the monitoring period – between 28th December 2020 and 8th January 2021 in the northwest Hotspot, situated on the Cringila Public School grounds.

Please note – data from certain points was not available within this date range due to technical constraints.

The near-surface temperature monitoring conducted between 28th December 2020 and 8th January 2021 indicates that the spatial extent of the northwest hotspot appears to remain localised.

No significant rainfall events were recorded during the monitoring period.

It is recommended that weekly site inspections and recording are continued to monitor the near-surface temperatures surrounding the subsurface hotspot identified at the site.

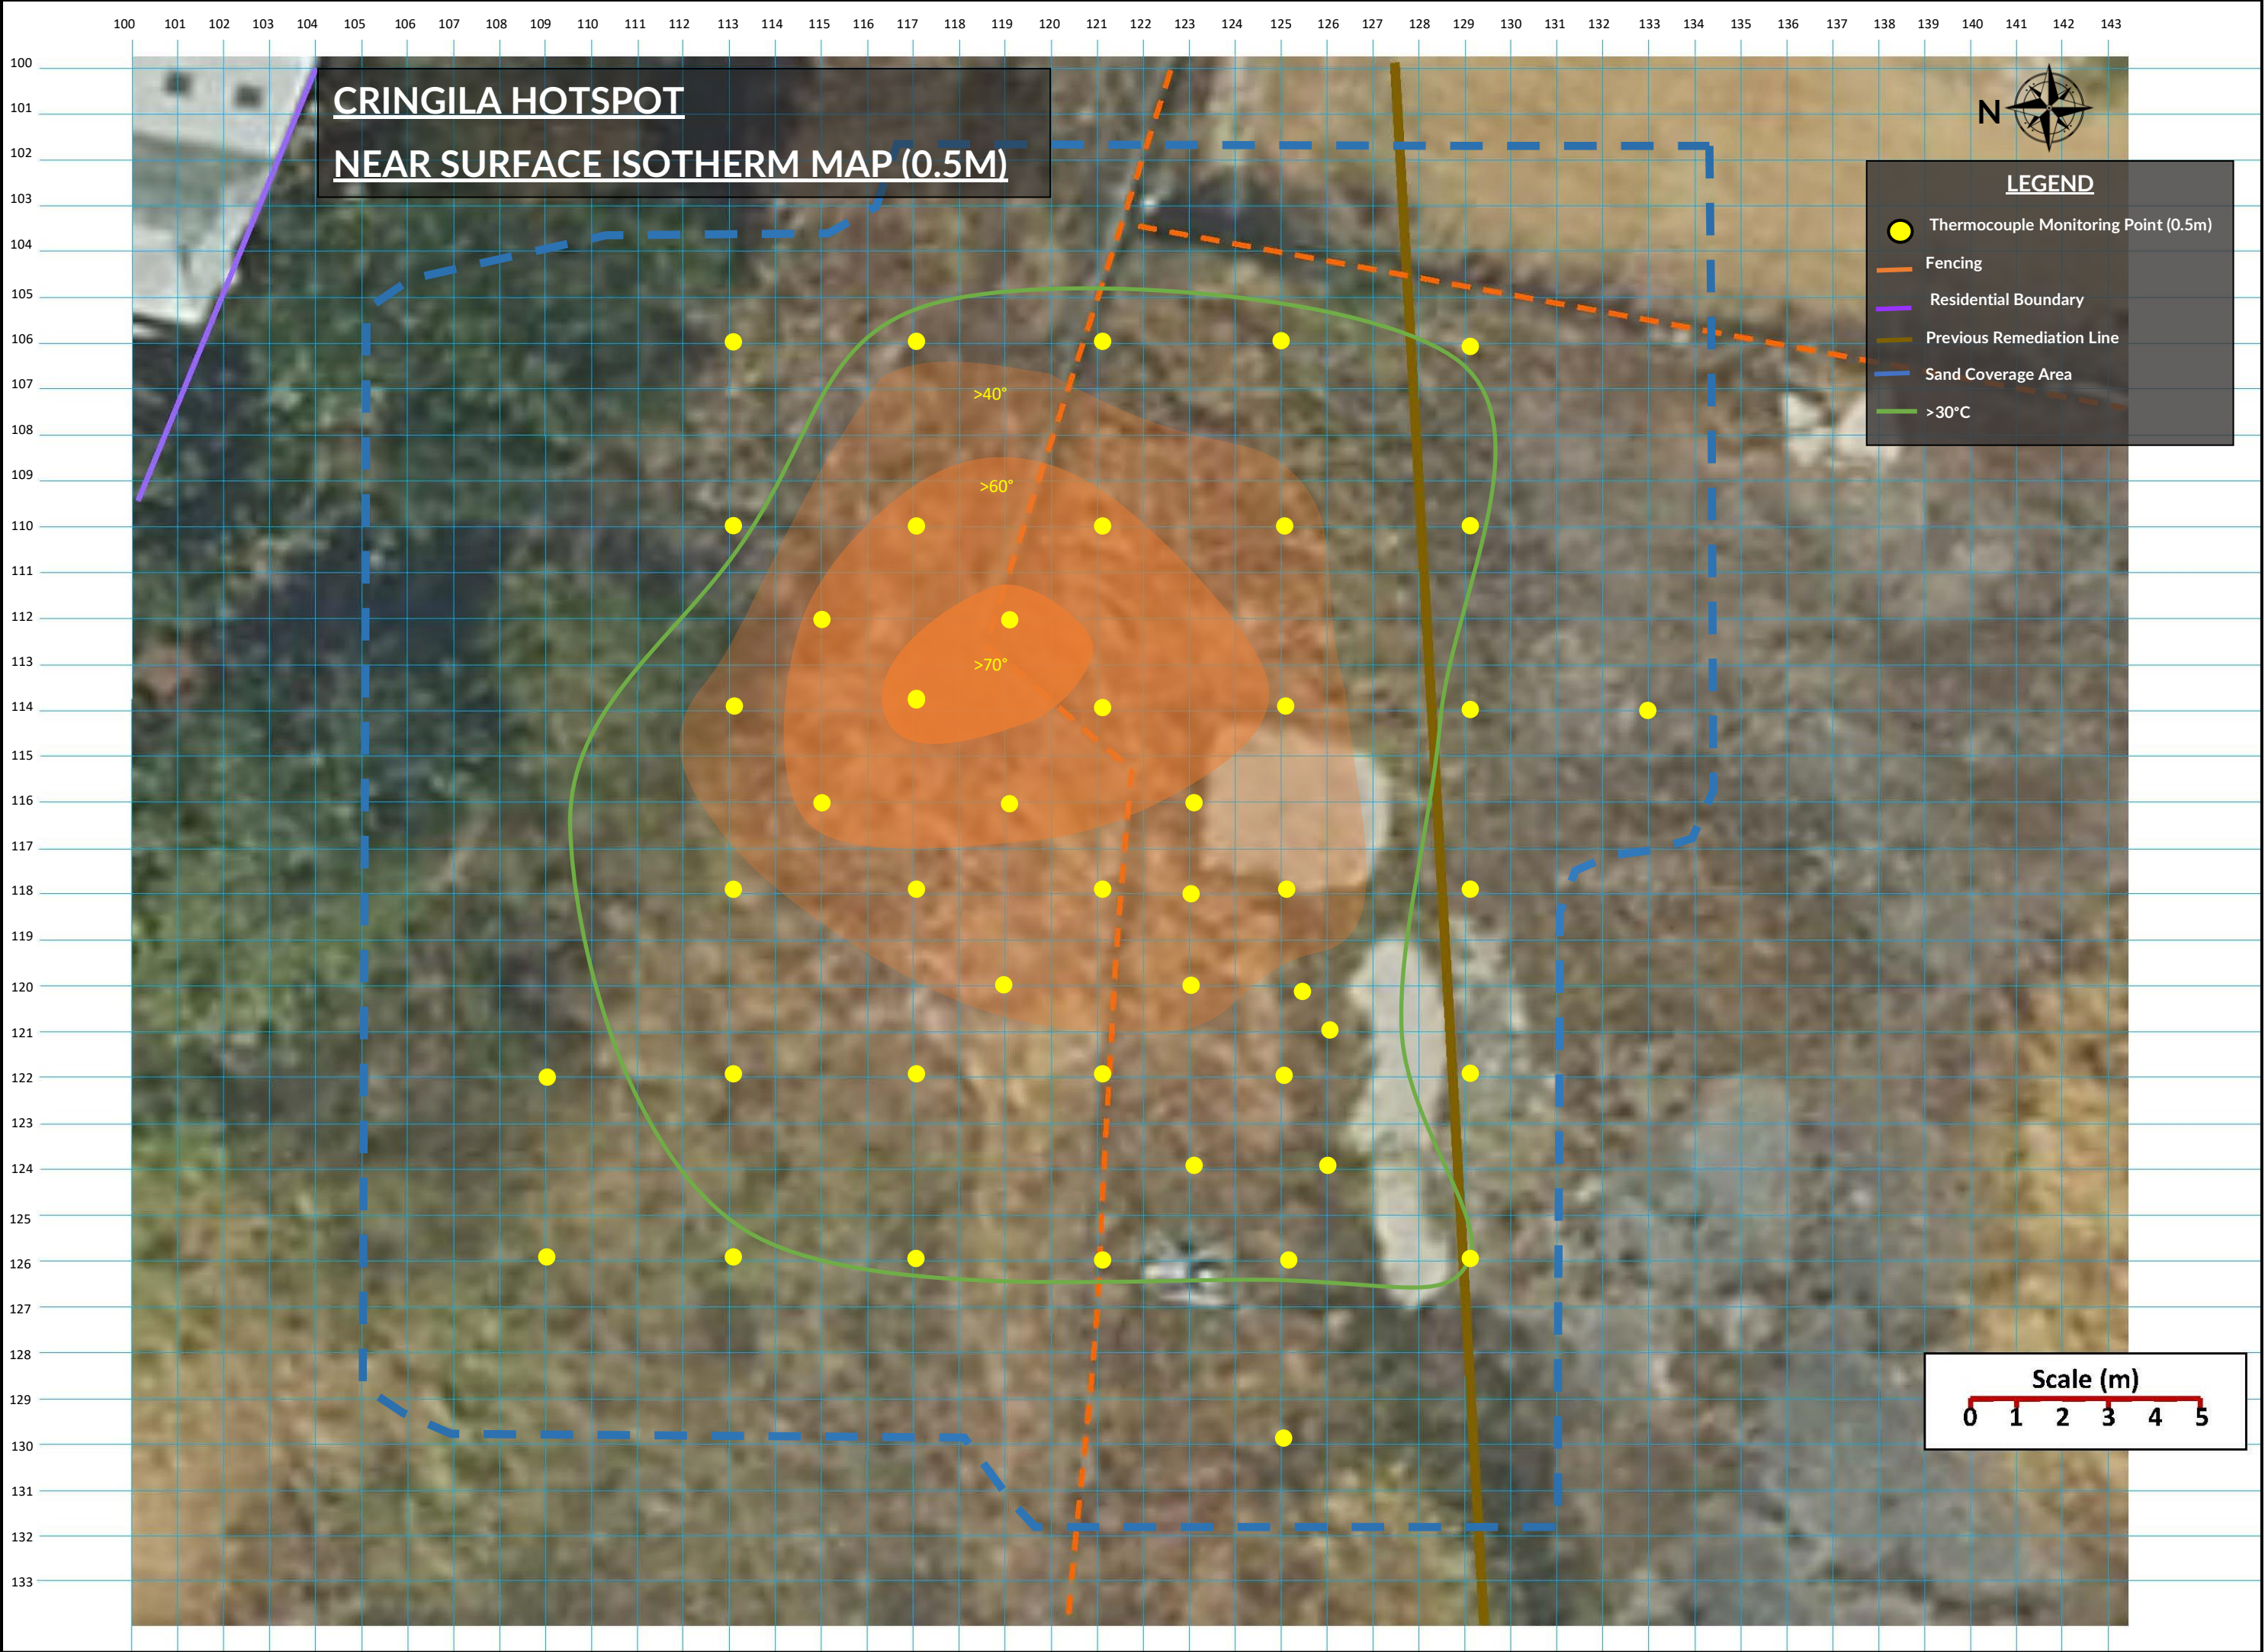
Appendix B: Near-Surface Temperature Isotherm Map (0.5m)

The isotherm map shows the general zone of influence for temperatures between 30°C and 70°C at 0.5m, coloured orange. The isotherm map suggests that the hotspot may extend deeper than 0.5m and that the increased temperature in these areas is a result of heat venting to the surface.

It is noted that temperature at the near-surface may be variable across the hotspot due to inconsistencies in the consolidation and compaction of subsurface materials.

The near-surface temperatures for representative monitoring locations, spread across the northwest Hotspot, are presented in the tables below. Temperature isotherms have been plotted on a site map to show an illustration of the near-surface temperatures in a spatial context. Refer to **Appendix B: Near Surface Temperature Isotherm Map (0.5m)**.
