# CRINGILA PUBLIC SCHOOL NEAR-SURFACE TEMPERATURE MONITORING INVESTIGATION

Summary Report  
11/01/2021 – 22/01/2021

Cringila Public School

January 2021  
C107471: J153825-04: TO/RC

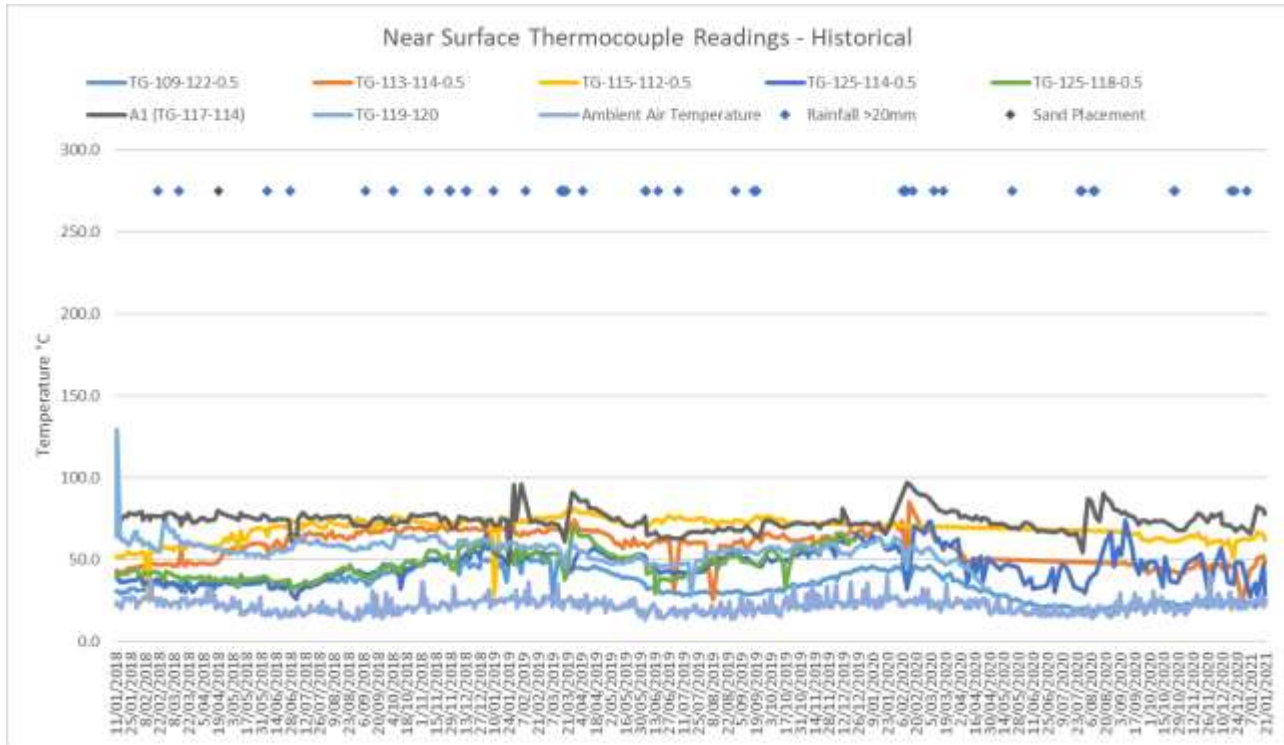
### 3.1. Near-Surface Temperature Graph – Selected Points (Historical)

Near surface temperature measurements for key thermocouple locations, progressive from Thursday 11<sup>th</sup> January 2018 to present.

The near-surface temperature appears to fluctuate seasonally across the surface of the northwest hotspot grid monitoring area.

Fluctuations in near-surface temperature are also evident following significant rain events (i.e. over 20mm rain).

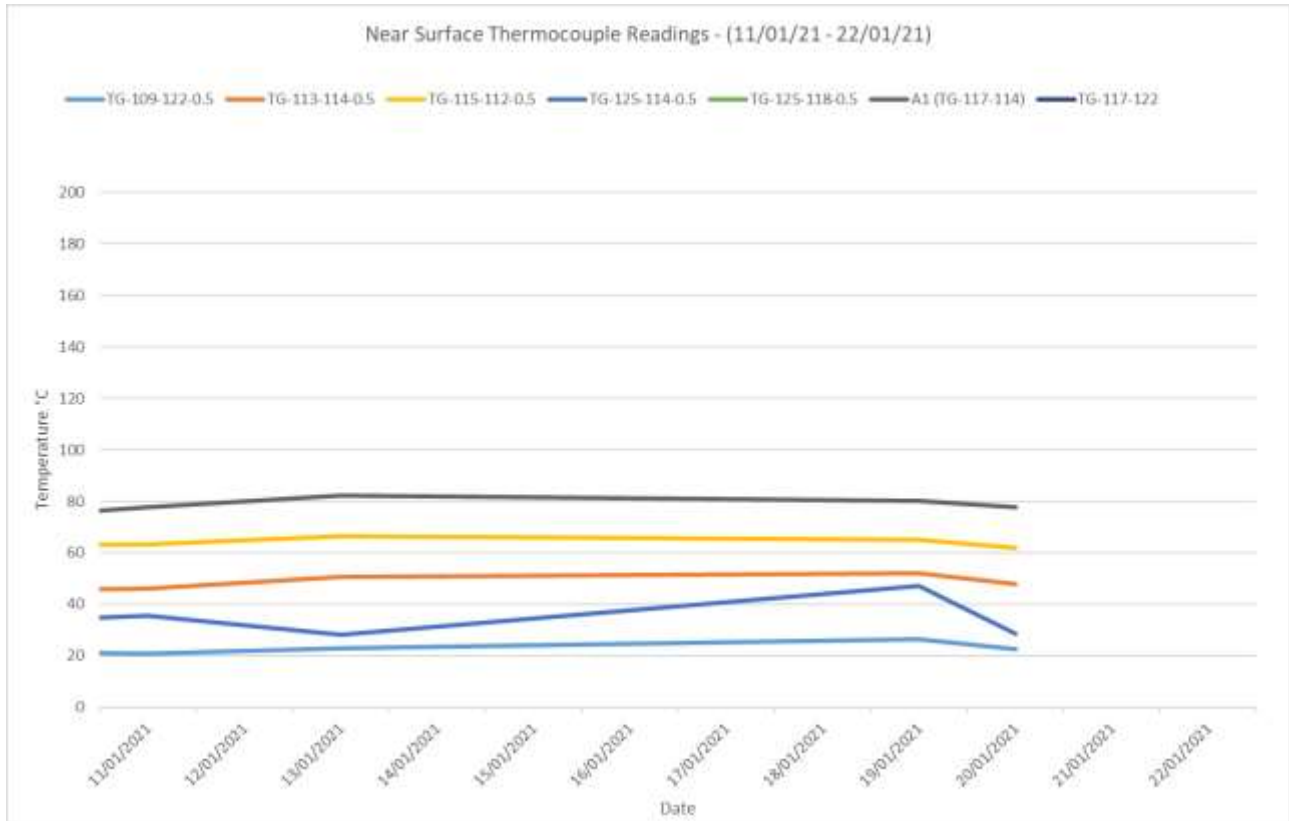
### 3.2. Near-Surface Temperature Graph – Selected Points (Fortnightly)

Near-surface temperature measurements for key thermocouple locations, over the monitoring period – between 11<sup>th</sup> January 2021 and 22<sup>nd</sup> January 2021 in the northwest Hotspot, situated on the Cringila Public School grounds.

Please note – data from certain points was not available within this date range due to technical constraints.

The near-surface temperature monitoring conducted between 11<sup>th</sup> January 2021 and 22<sup>nd</sup> January 2021 indicates that the spatial extent of the northwest hotspot appears to remain localised.

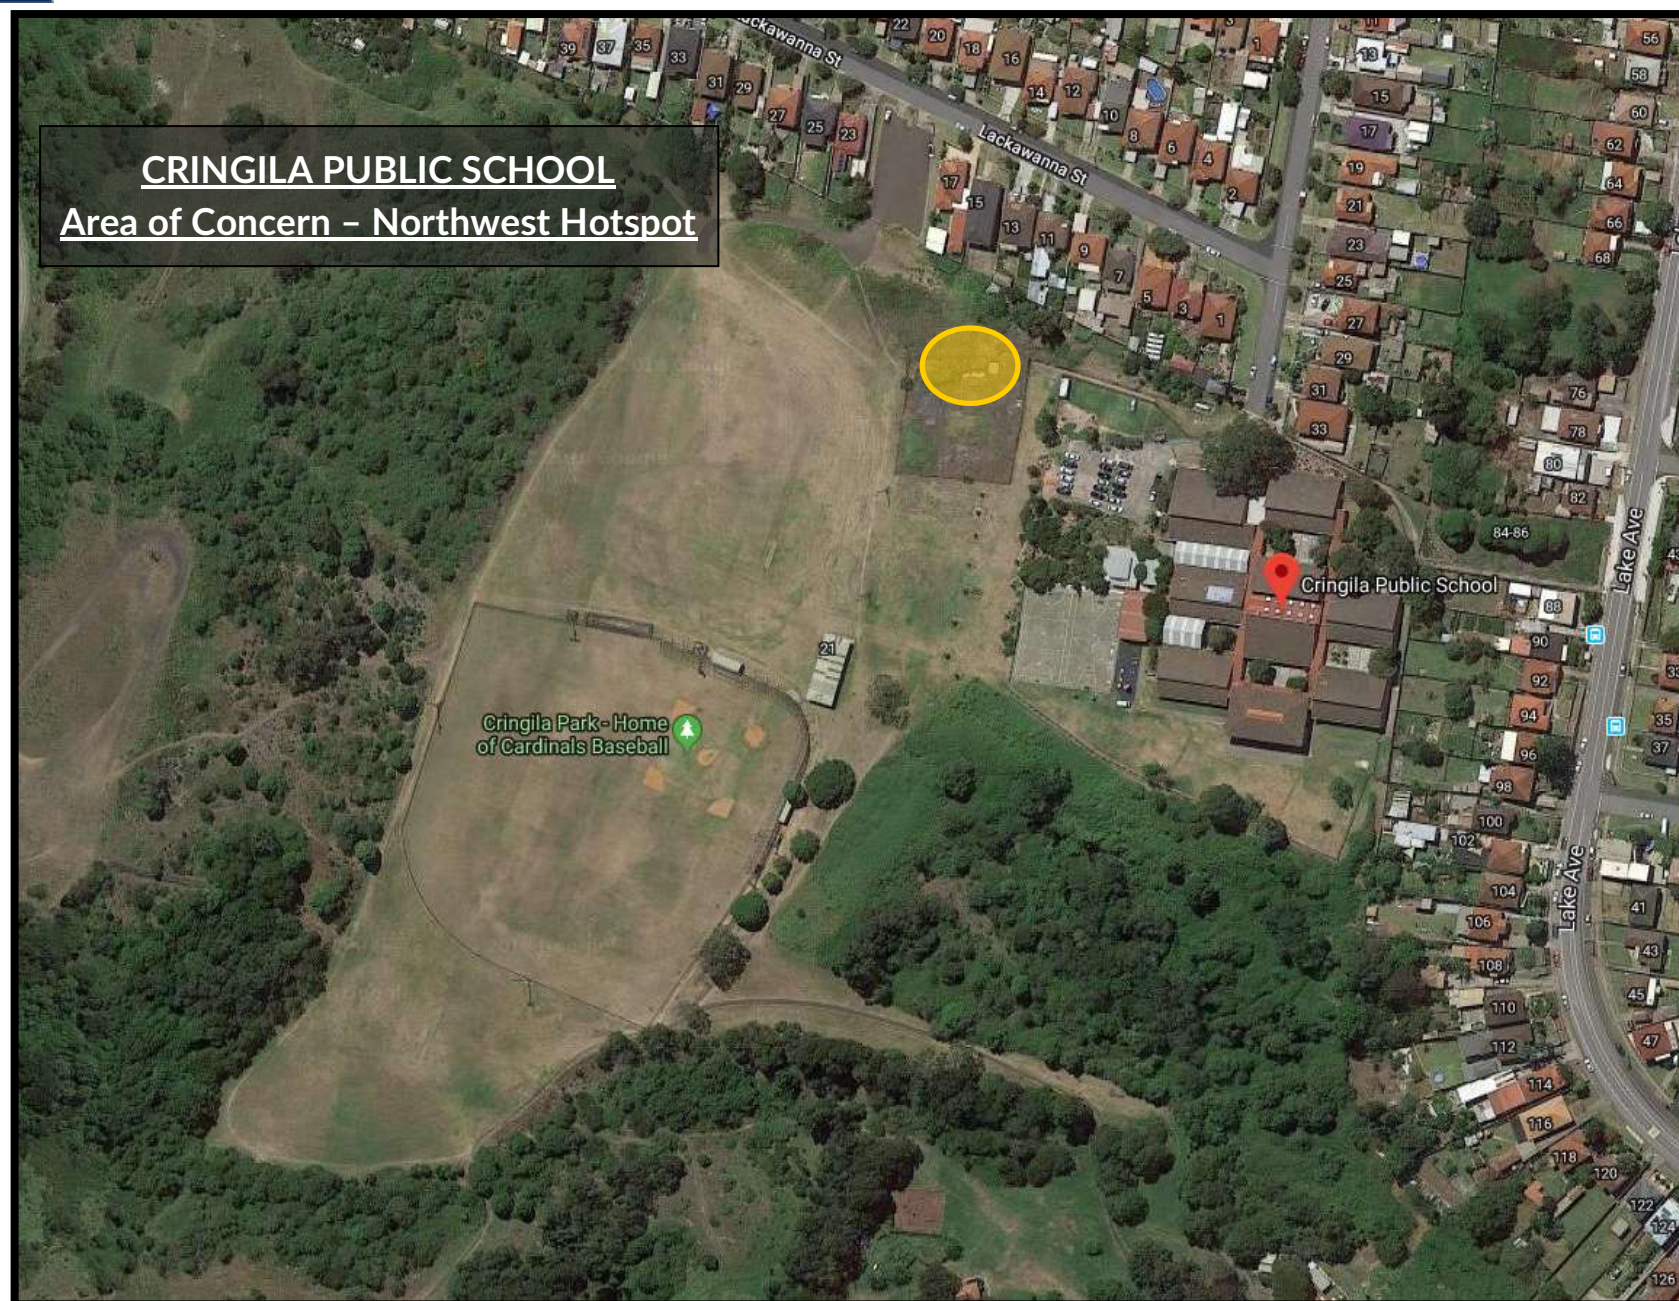
#### **Appendix A: Area of Concern – Northwest Hotspot Map**

**CRINGILA PUBLIC SCHOOL**  
**Area of Concern - Northwest Hotspot**

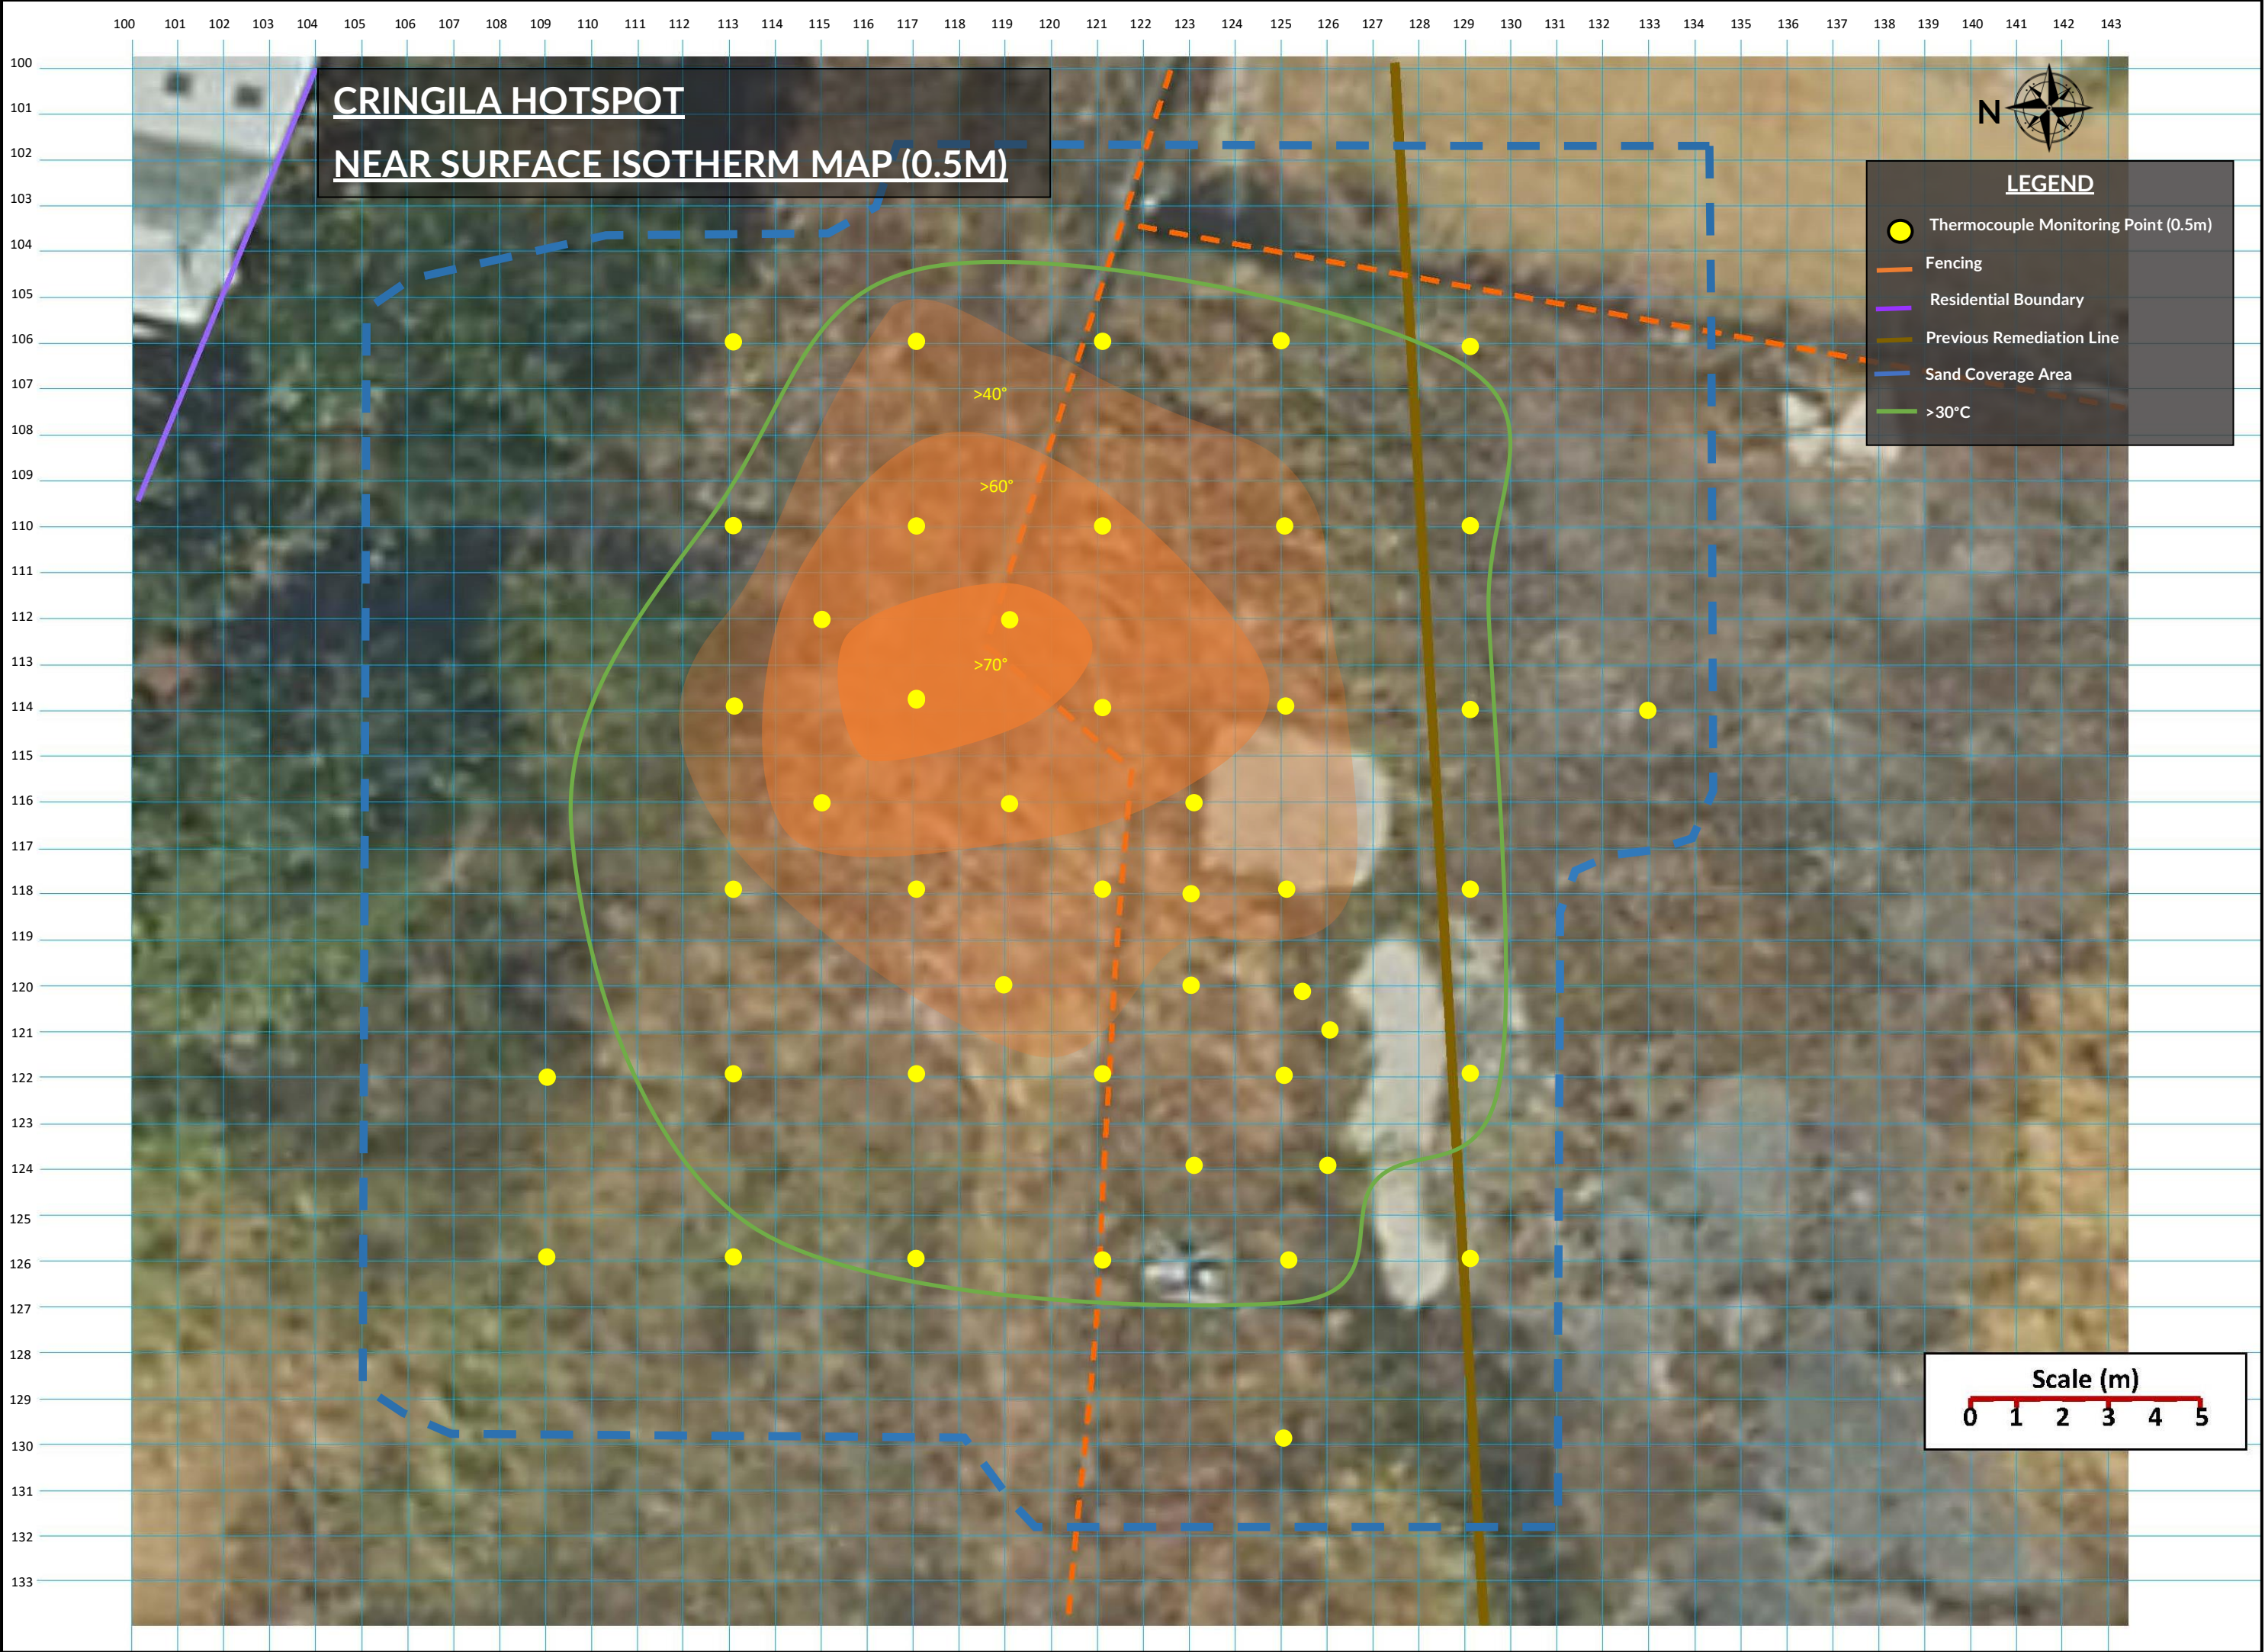
### **Appendix B: Near-Surface Temperature Isotherm Map (0.5m)**

The isotherm map shows the general zone of influence for temperatures between 30°C and 70°C at 0.5m, coloured orange. The isotherm map suggests that the hotspot may extend deeper than 0.5m and that the increased temperature in these areas is a result of heat venting to the surface.

It is noted that temperature at the near-surface may be variable across the hotspot due to inconsistencies in the consolidation and compaction of subsurface materials.

The near-surface temperatures for representative monitoring locations, spread across the northwest Hotspot, are presented in the tables below. Temperature isotherms have been plotted on a site map to show an illustration of the near-surface temperatures in a spatial context. Refer to **Appendix B: Near Surface Temperature Isotherm Map (0.5m)**.

It is recommended that weekly site inspections and recording are continued to monitor the near-surface temperatures surrounding the subsurface hotspot identified at the site.
