CRINGILA PUBLIC SCHOOL NEAR-SURFACE TEMPERATURE MONITORING INVESTIGATION

Summary Report
25/01/2021 – 05/02/2021

Cringila Public School

Near-Surface Temperature Monitoring

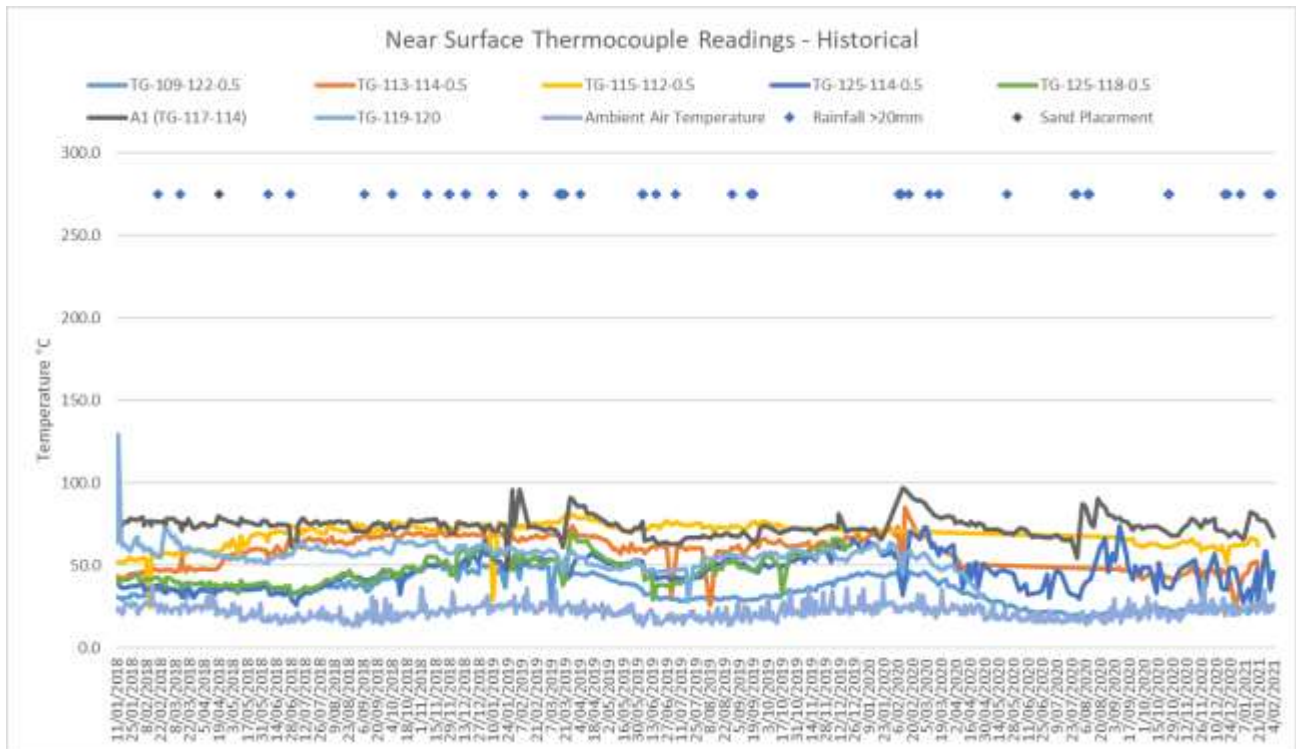
3.1. Near-Surface Temperature Graph – Selected Points (Historical)

Near surface temperature measurements for key thermocouple locations, progressive from Thursday 11th January 2018 to present.

The near-surface temperature appears to fluctuate seasonally across the surface of the northwest hotspot grid monitoring area.

Fluctuations in near-surface temperature are also evident following significant rain events (i.e. over 20mm rain).

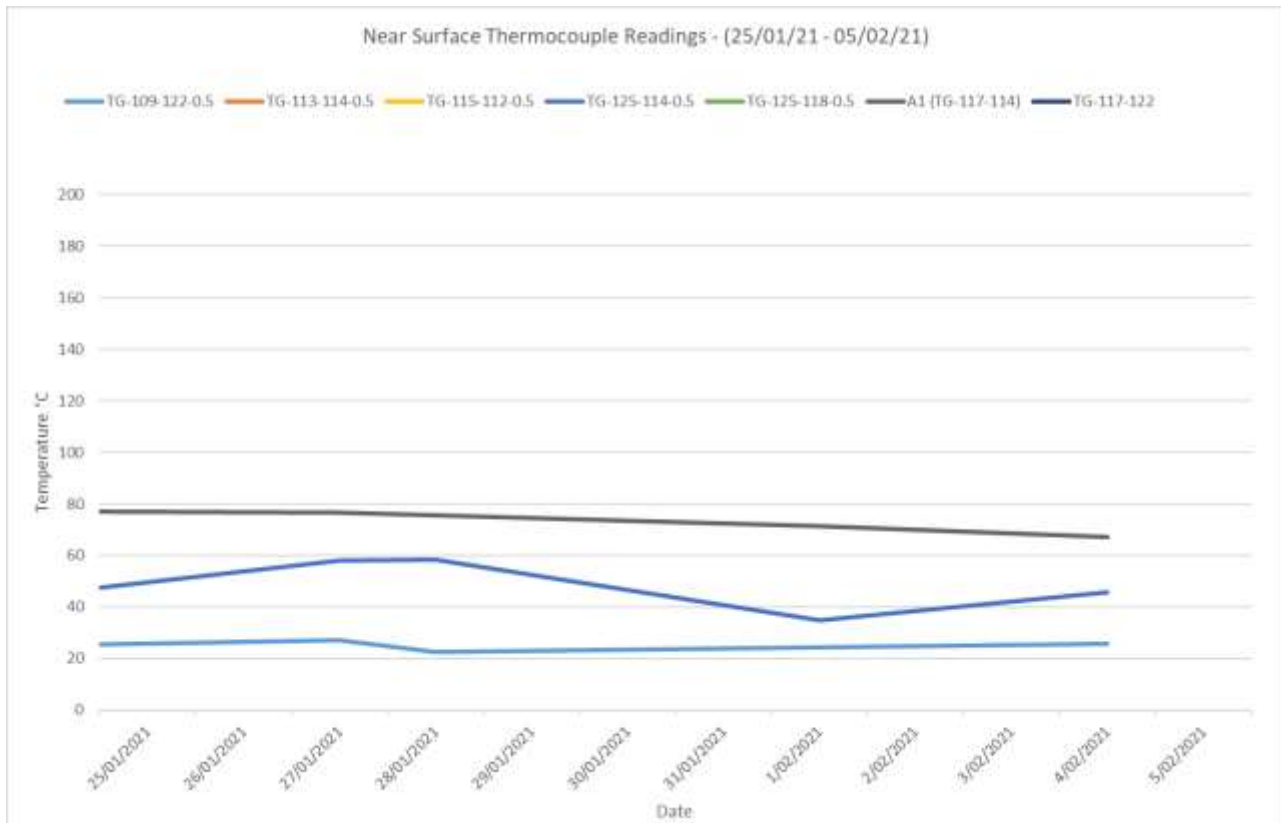
3.2. Near-Surface Temperature Graph – Selected Points (Fortnightly)

Near-surface temperature measurements for key thermocouple locations, over the monitoring period – between 25th January 2021 and 5th February 2021 in the northwest Hotspot, situated on the Cringila Public School grounds. Please note – data from certain points was not available within this date range due to technical constraints.

The near-surface temperature monitoring conducted between 25th January 2021 and 5th February 2021 indicates that the spatial extent of the northwest hotspot appears to remain localised.

No significant rainfall events were recorded during the monitoring period.

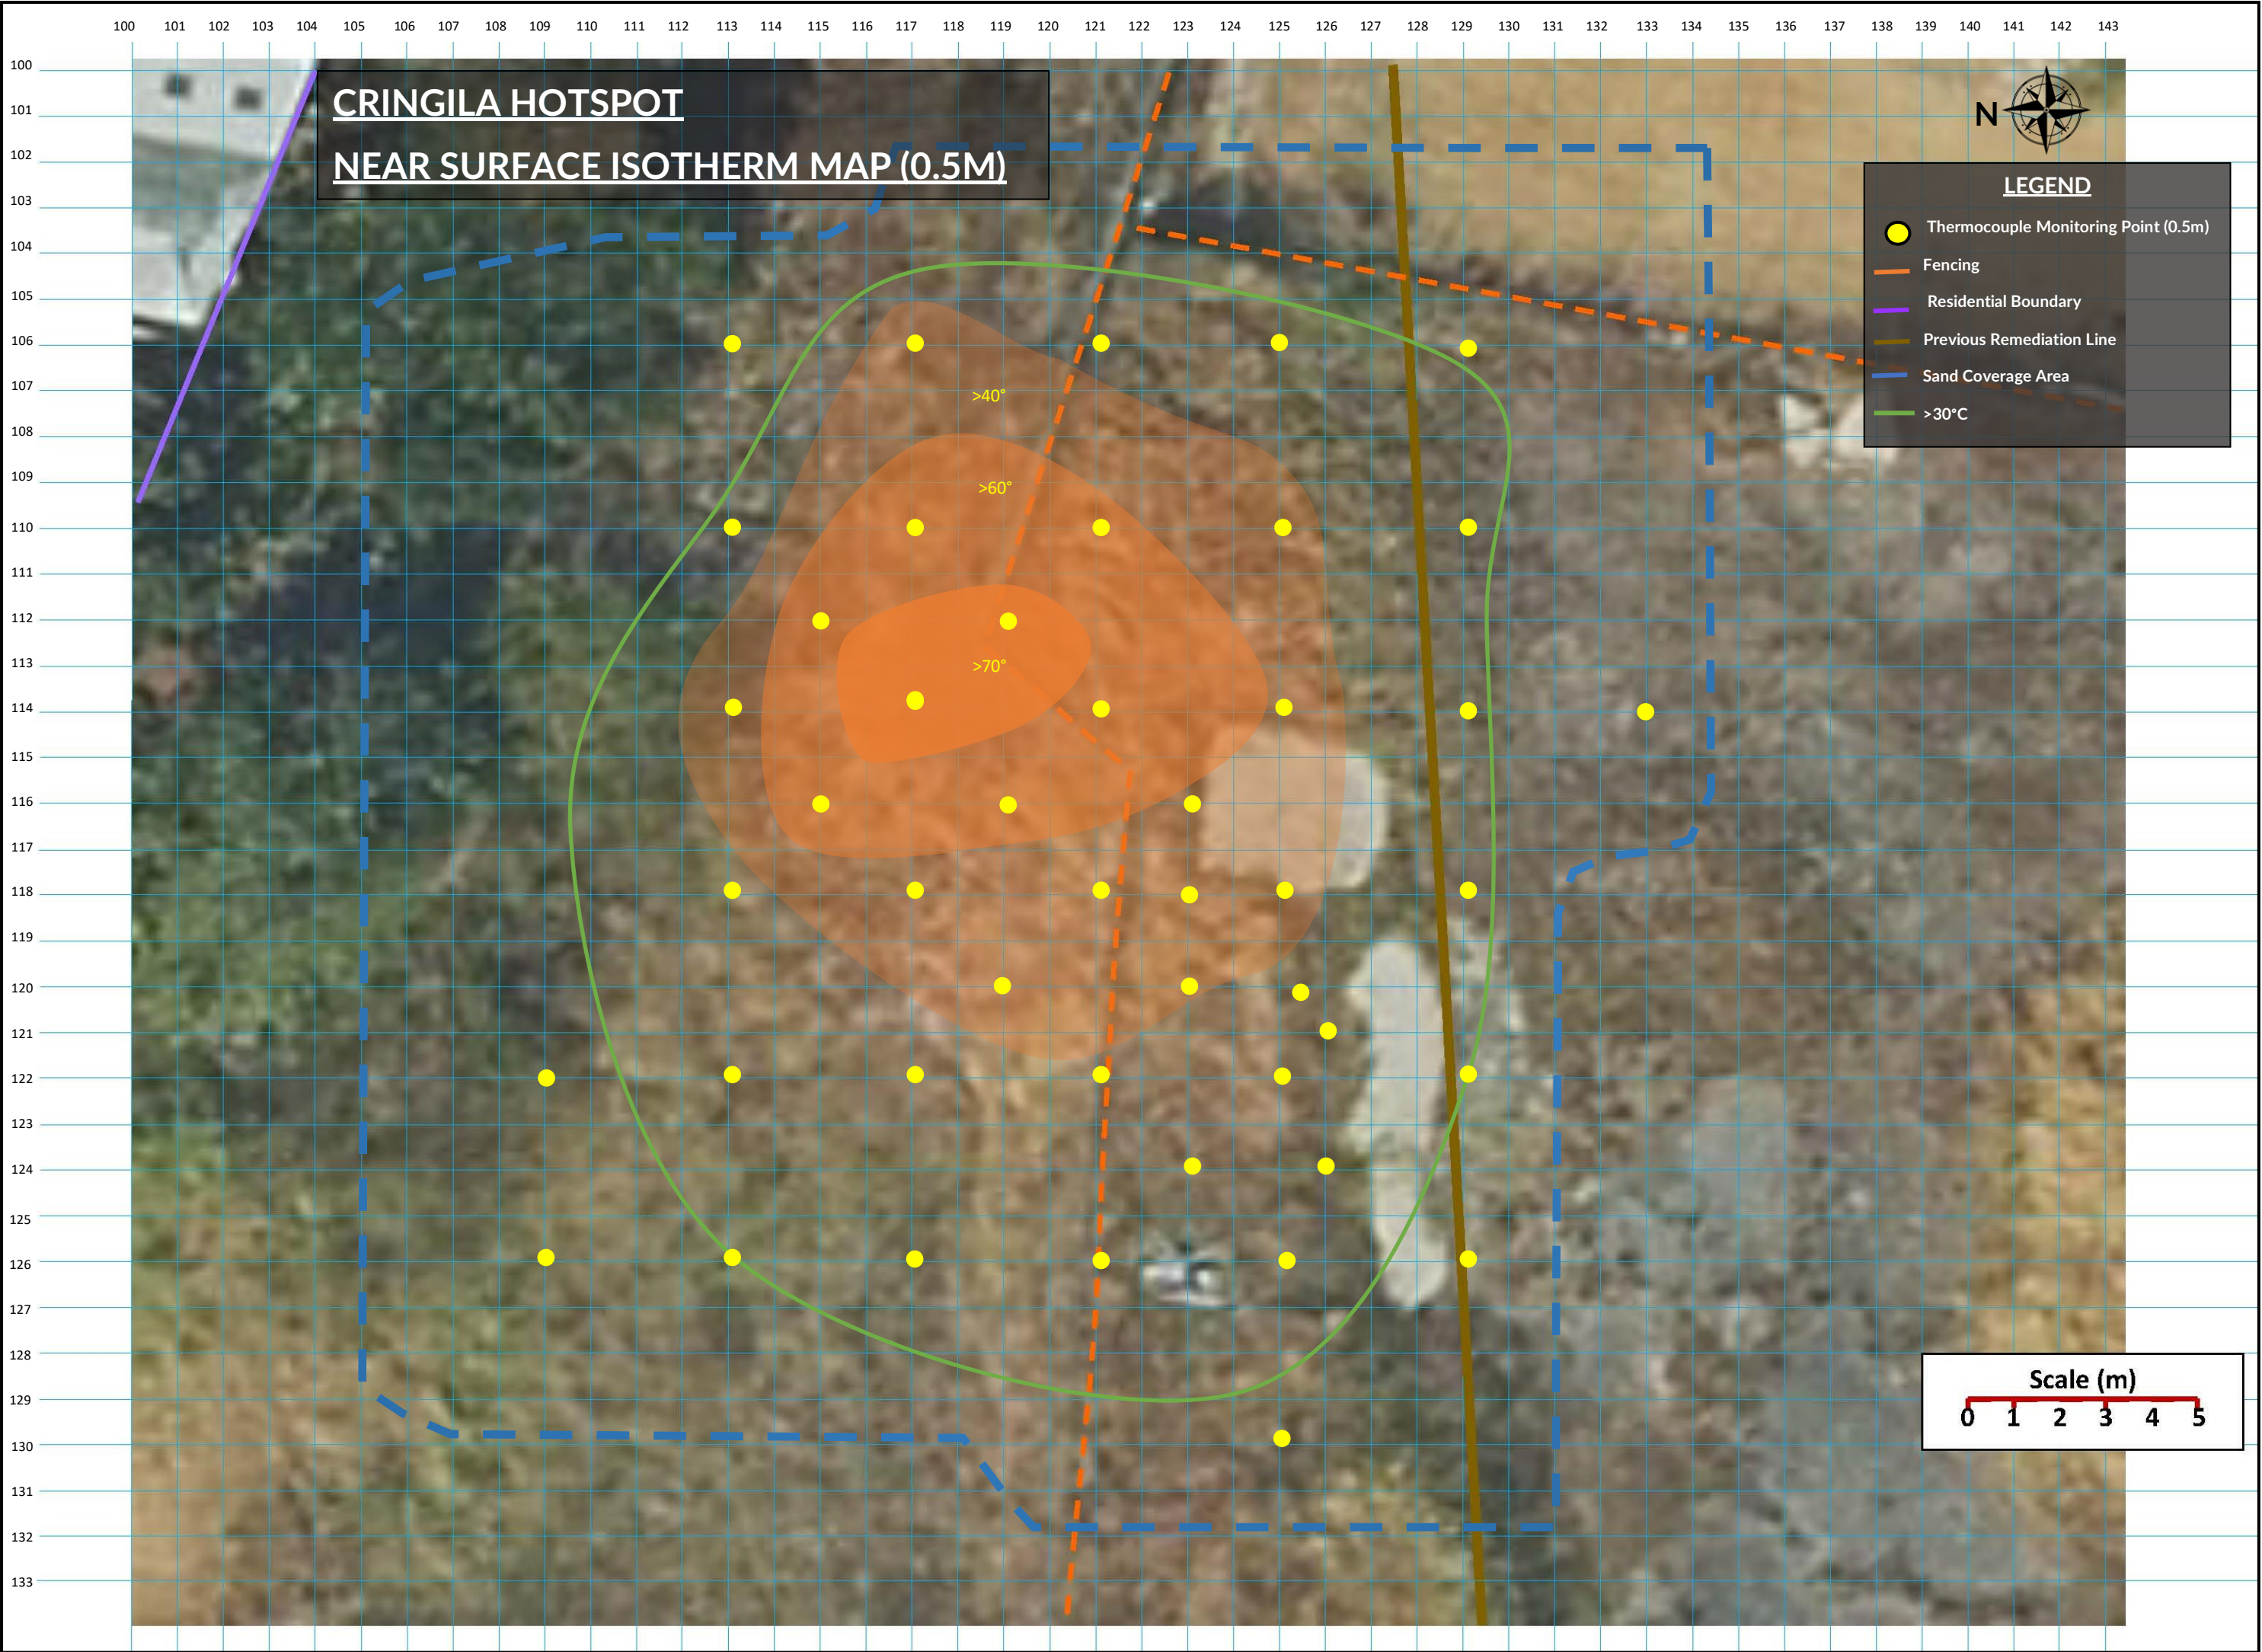
Appendix B: Near-Surface Temperature Isotherm Map (0.5m)

The isotherm map shows the general zone of influence for temperatures between 30°C and 70°C at 0.5m, coloured orange. The isotherm map suggests that the hotspot may extend deeper than 0.5m and that the increased temperature in these areas is a result of heat venting to the surface.

It is noted that temperature at the near-surface may be variable across the hotspot due to inconsistencies in the consolidation and compaction of subsurface materials.

It is recommended that weekly site inspections and recording are continued to monitor the near-surface temperatures surrounding the subsurface hotspot identified at the site.
